**RECONNAISSANCE REPORT ON DAMAGE TO
ENGINEERED STRUCTURES DURING
THE MAY 1999 OKLAHOMA CITY TORNADO**

Michael A. Riley

Building and Fire Research Laboratory
Gaithersburg, MD 20899-8611

August 2002

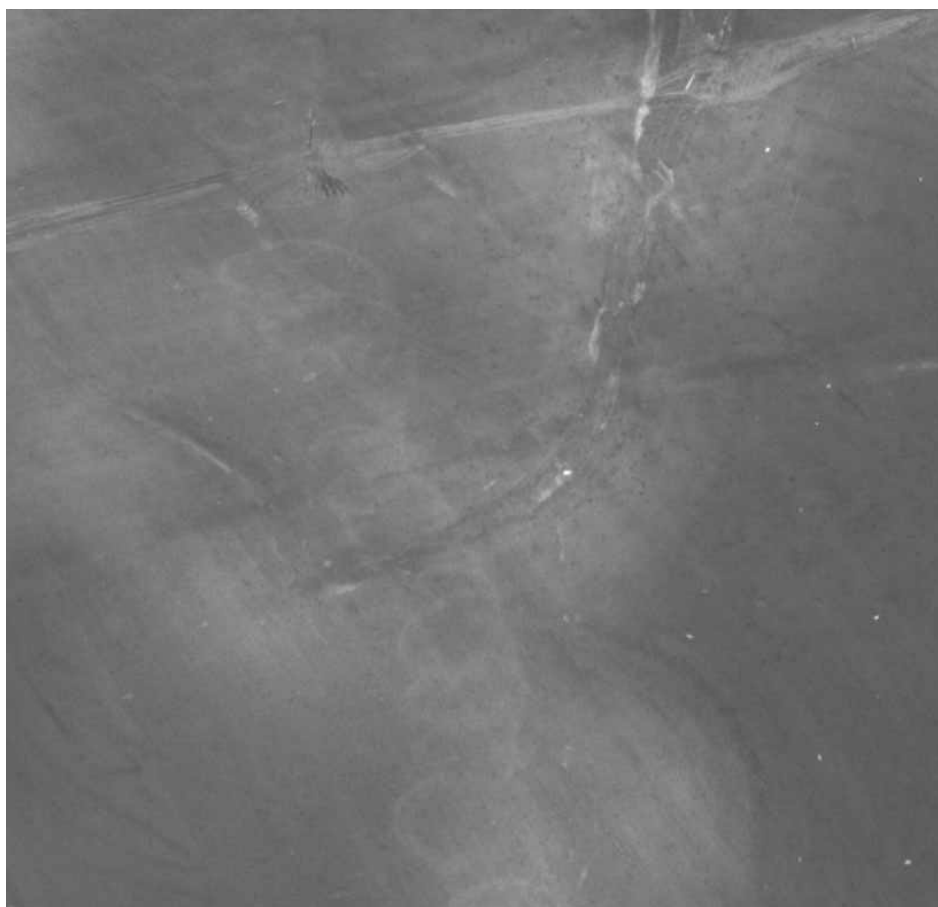
Figure 1-2: Tornado Vortex Scars in a Field near Crescent, Oklahoma.

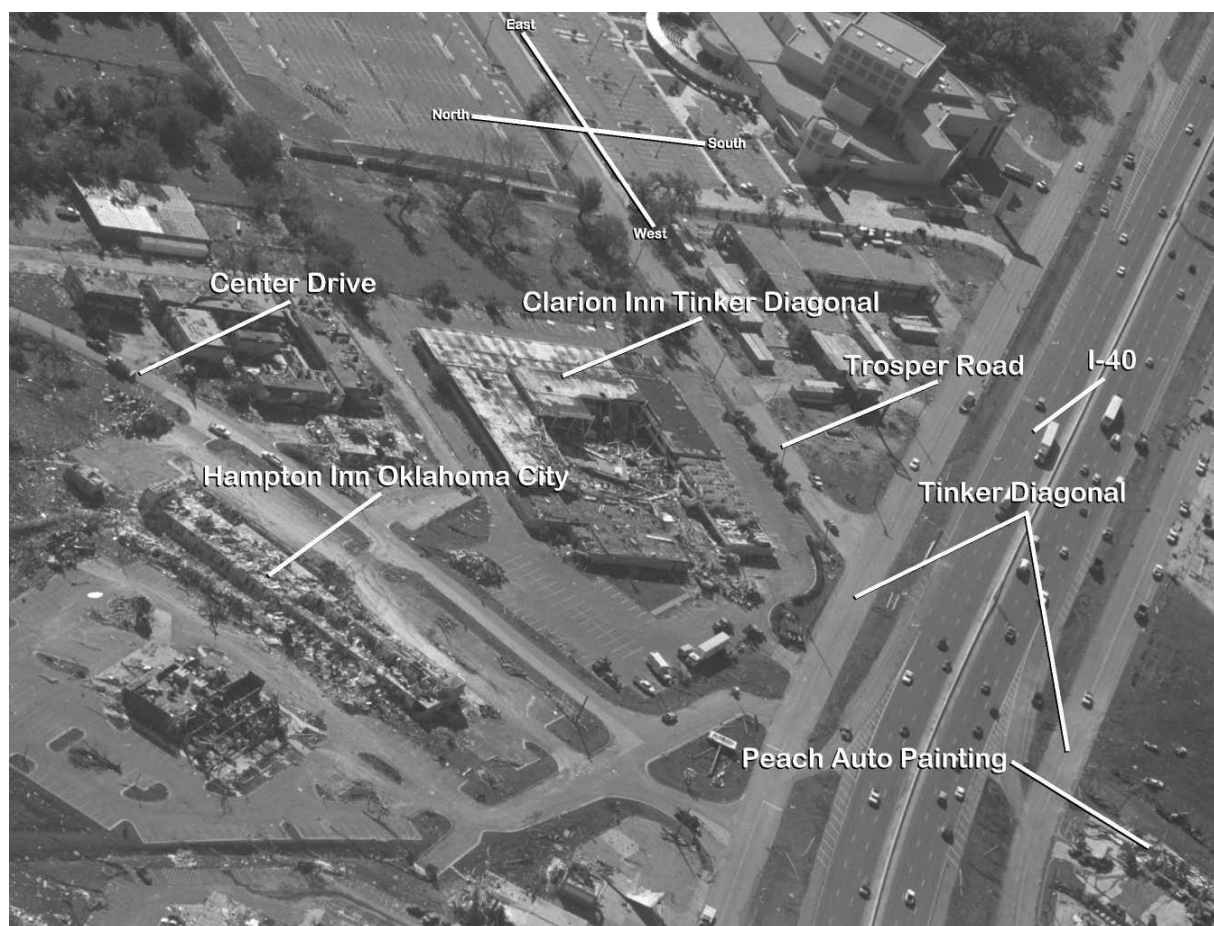
Figure 1-3. Damage to Structures along the Tinker Diagonal, Midwest City.

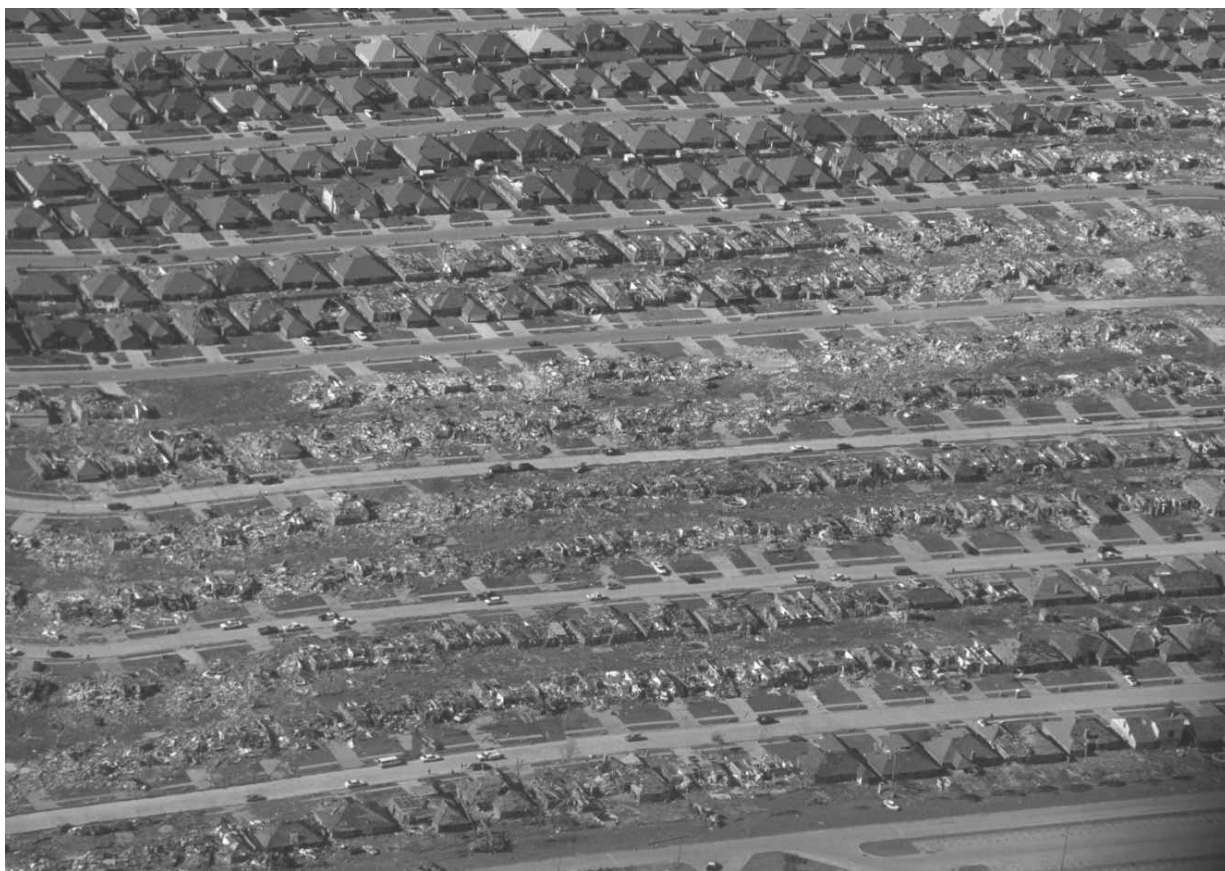
Figure 1-4. Damaged Housing Complex South of Westmoore High School, Oklahoma City.

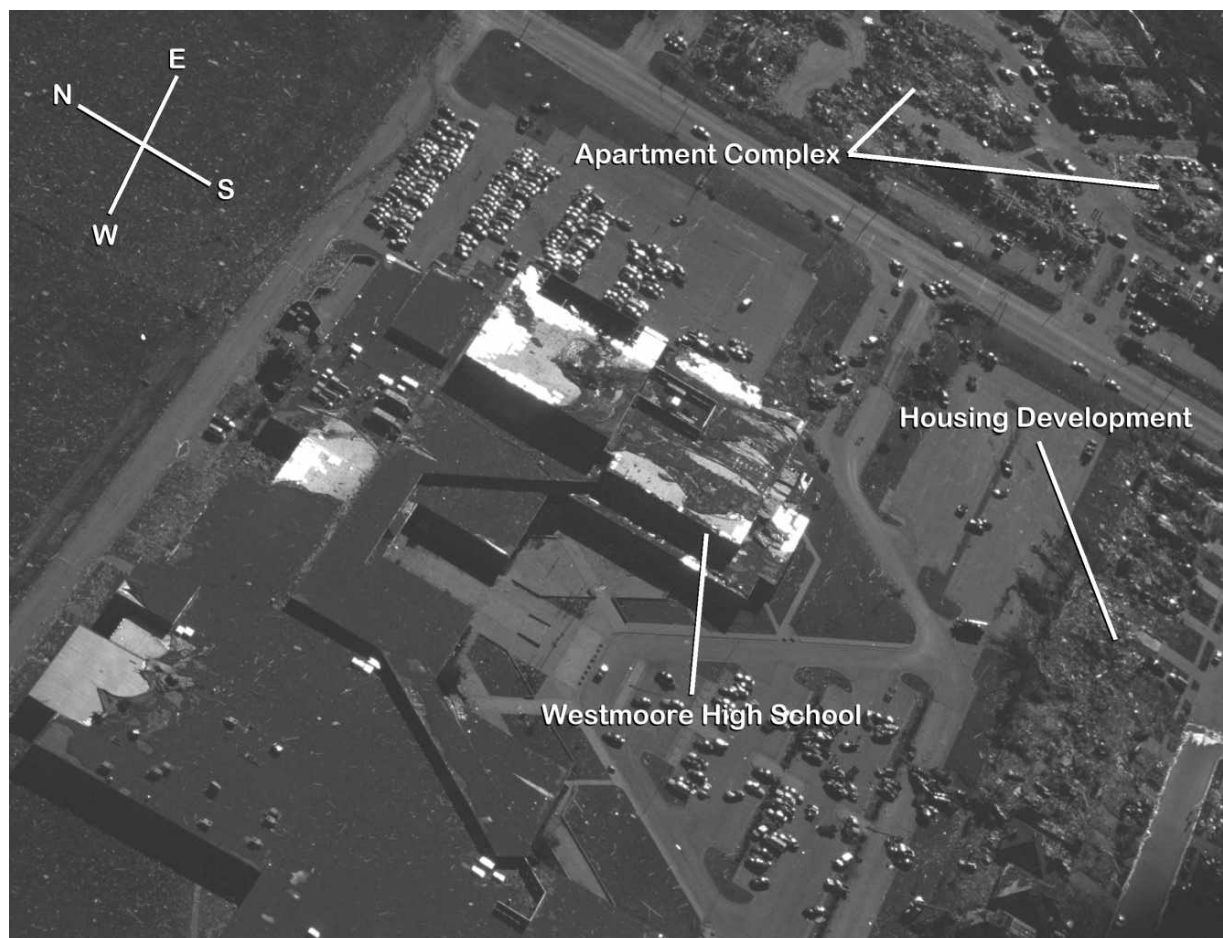
Figure 1-5. Damage to Westmoore High School and Surrounding Areas, Oklahoma City.

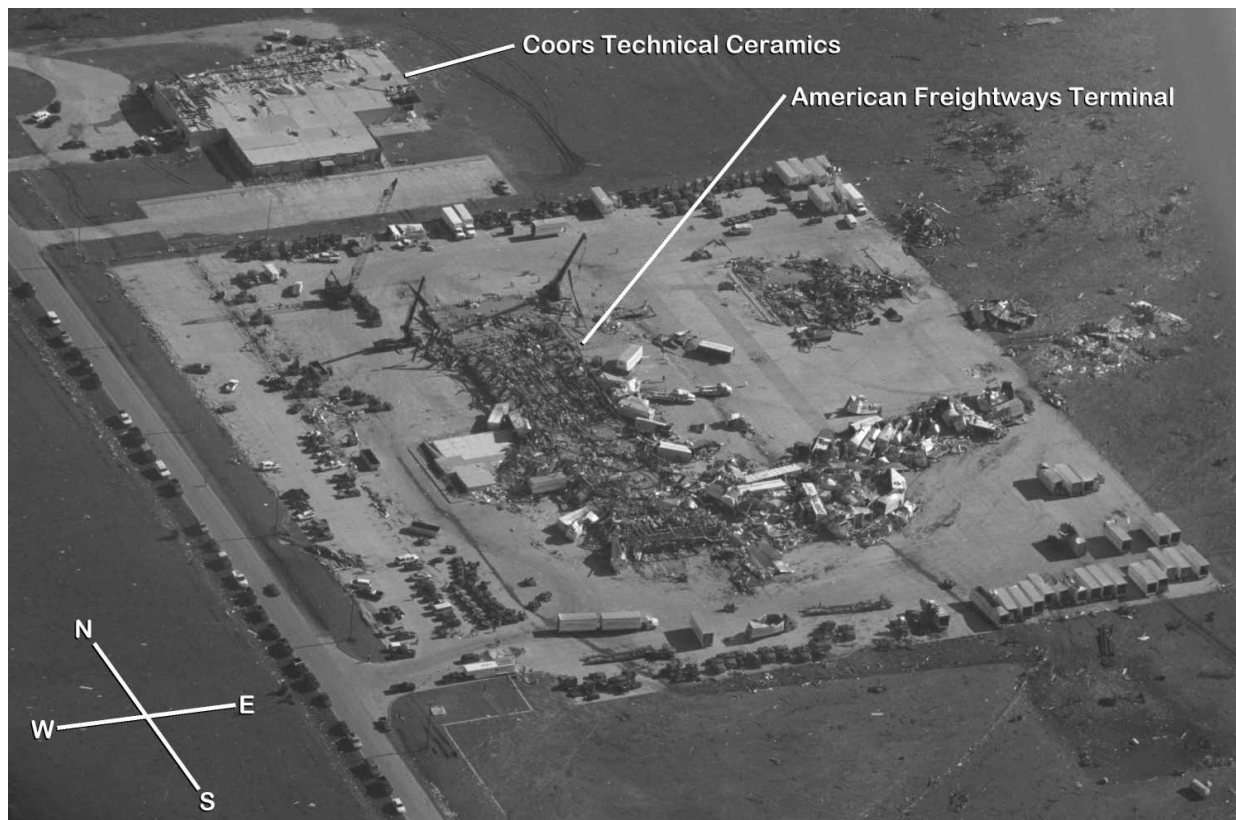
Figure 1-6: Damage to the American Freightways Terminal and Coors Ceramics Factory, Oklahoma City.

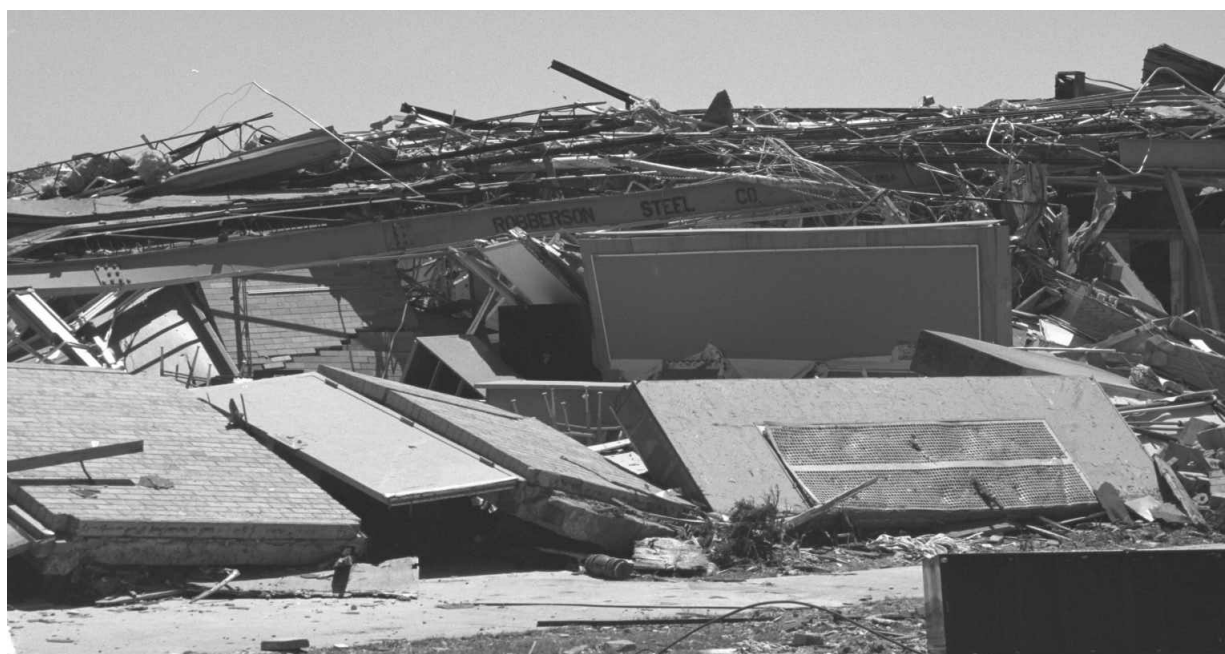
The front section of the building suffered varying damage. The main entrance was near the center of this section, and most of the structure north of the entrance was severely damaged or destroyed. As shown in Figure 2-2, most of the walls and the roof in this part of the building collapsed. The damage was less severe near and south of the entrance. Here some walls and some parts of the roof survived. Figure 2-3 shows the damage to the southern end of the front section. The front wall of the cafeteria had collapsed inward and a portion of the roof has collapsed, but much of the roof sur-

Figure 2-2: Remains of Northern End of the Front Section of Kelly Elementary School.

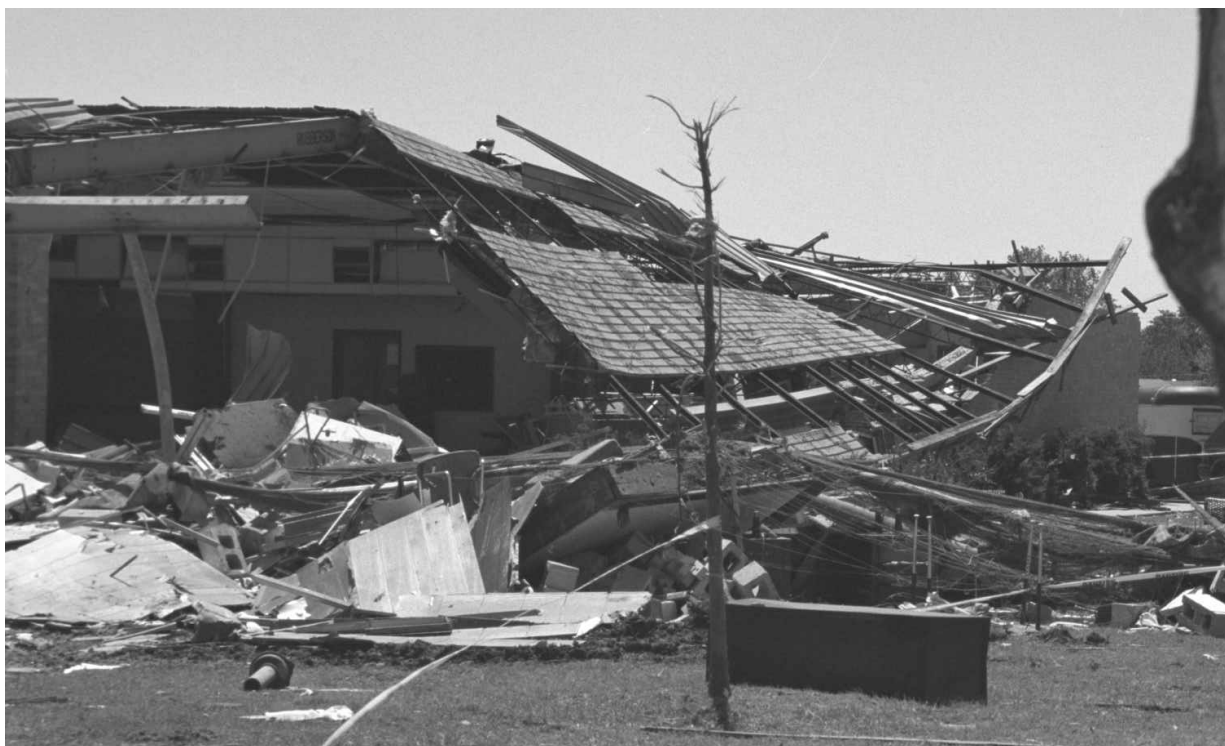
Figure 2-3: Damage to Southern End of Front Section of Kelly Elementary School.

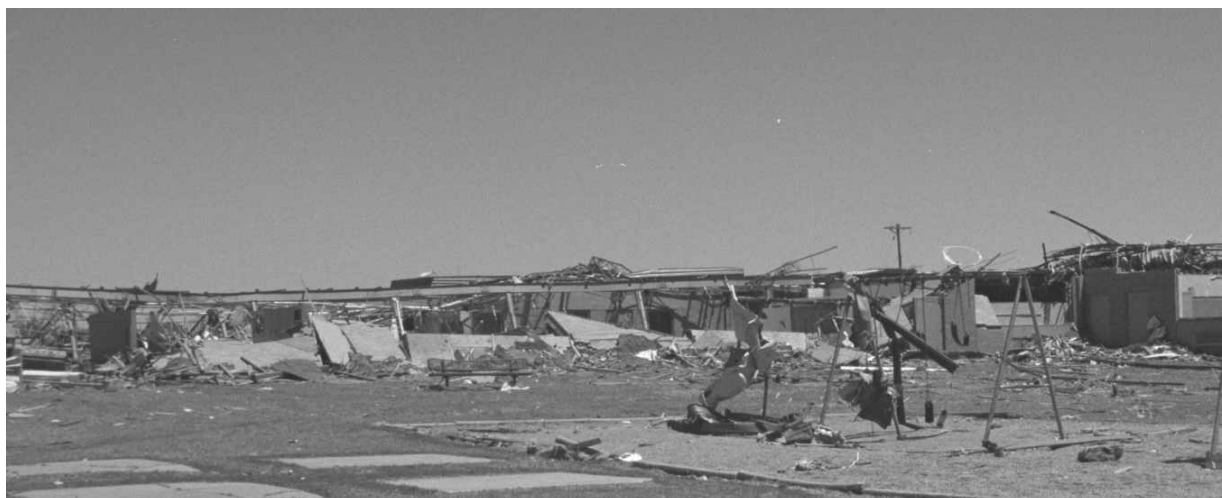
Figure 2-4: South Side of the Center Section of Kelly Elementary School.

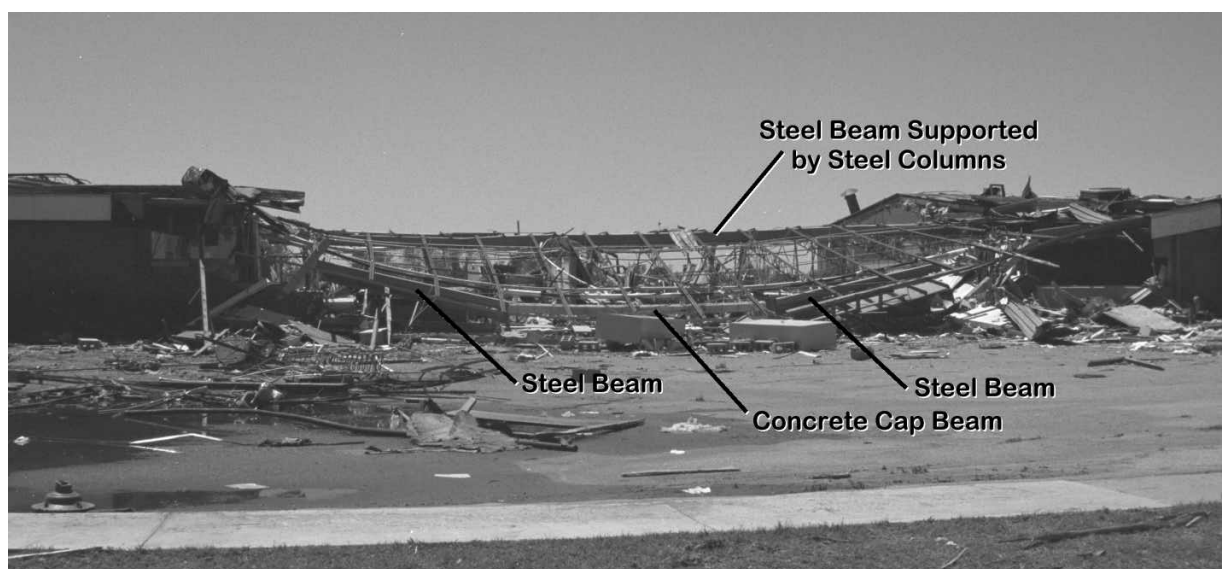
The center section of the building was the most severely damaged. Here the roof trusses ran north-south, with the southern ends supported by a steel beam on steel columns. The northern ends of the center-most trusses were supported by a reinforced concrete cap beam on a concrete block wall with brick facing, while the eastern and western trusses were supported on steel beams supported by the cap beam and the end walls. Both the southern and northern walls were destroyed and nearly all roof covering was removed. The steel columns along the south wall, visible in Figure 2-4, bent, but did not fail. The loss of the north wall, however, removed all support for the north side of the roof leading to its collapse, as shown in Figure 2-5.

Figure 2-5: North Side of the Center Section of Kelly Elementary School.

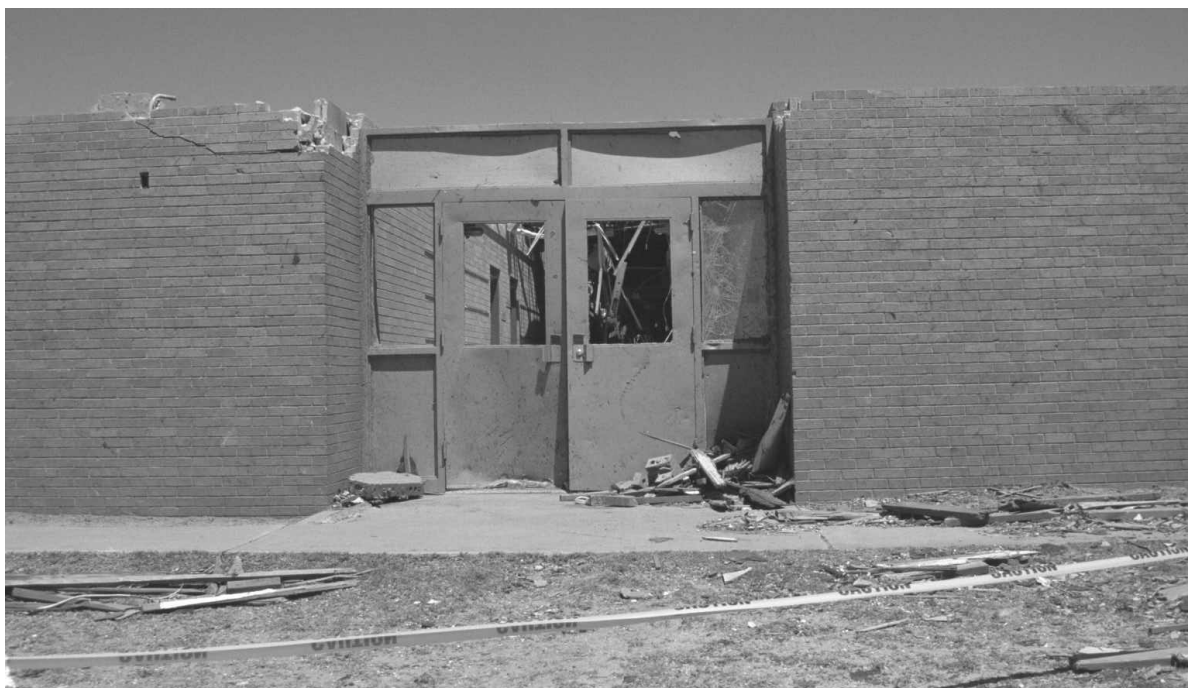
Figure 2-6: South Side of the East Section of Kelly Elementary School.

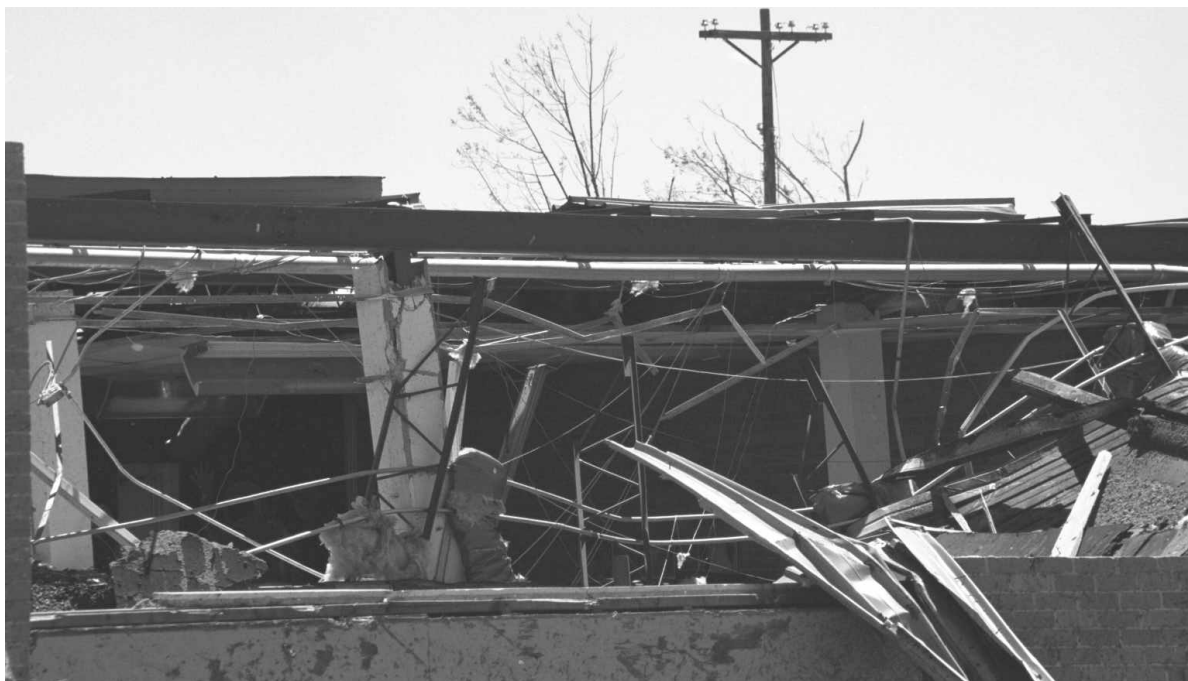
Figure 2-7: Collapsed Wall on West Side of the East Section of Kelly Elementary School.

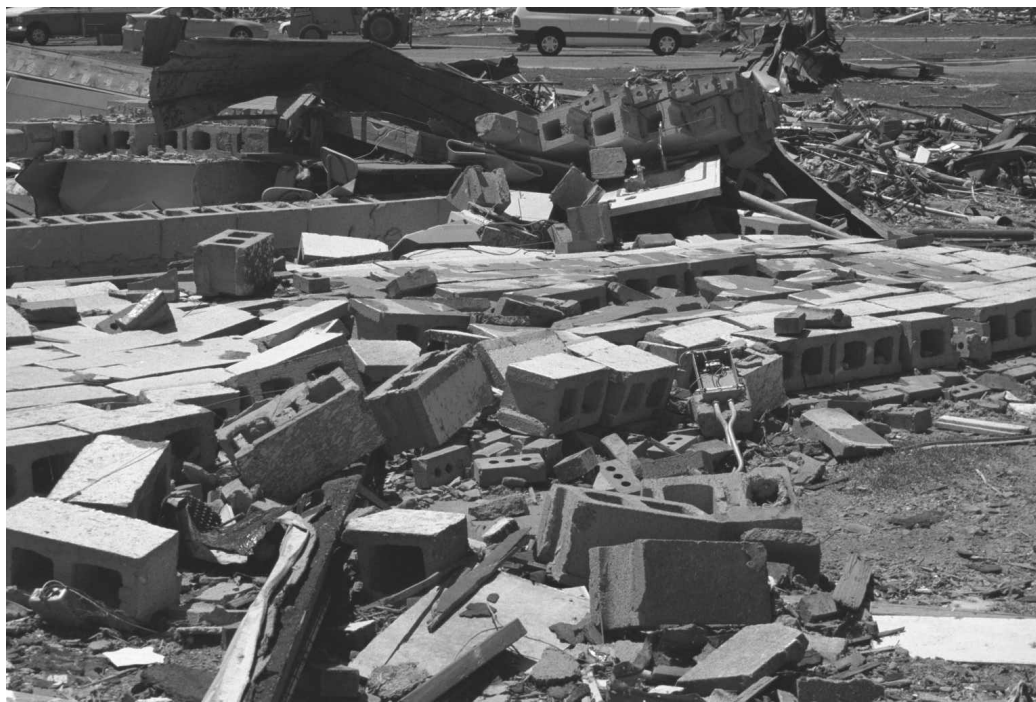
nearly its entire roof and a section of the western wall collapsed. Many of the roof trusses were lifted off and every window was broken. Although most of the walls survived, this section of the building could not have provided a safe space for the occupants. Figure 2-6 shows the south entrance to the central hallway in this section. Figure 2-7 shows the western side of the northern end of this section, where the wall and part of the roof collapsed.

Figure 2-8: Collapsed Wall at North End of West Section of Kelly Elementary School.

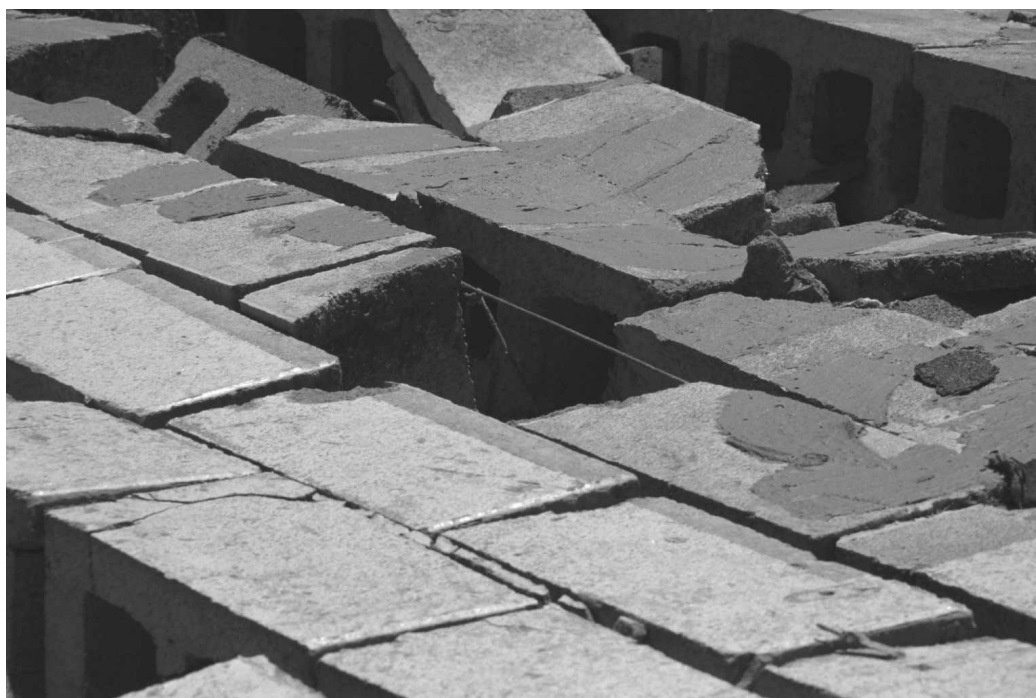
This school had numerous structural weaknesses, which contributed to the destruction. The most significant weakness that was observed was the inadequate reinforcement in the masonry walls. The walls had only minimal horizontal reinforcement and no vertical reinforcement. Inspection of one collapsed wall, shown in Figure 2-8, revealed that only every third course of the concrete block was reinforced. Moreover, the mortar was poorly bonded to both the reinforcing bars and the blocks (Figure 2-9).

Figure 2-9: Detail of Mortar and Reinforcement in the Collapsed Wall at North End of West Section of Kelly Elementary School.

Additional horizontal reinforcement, vertical reinforcement, and a better bond with the mortar would all have significantly increased the strength of the walls.

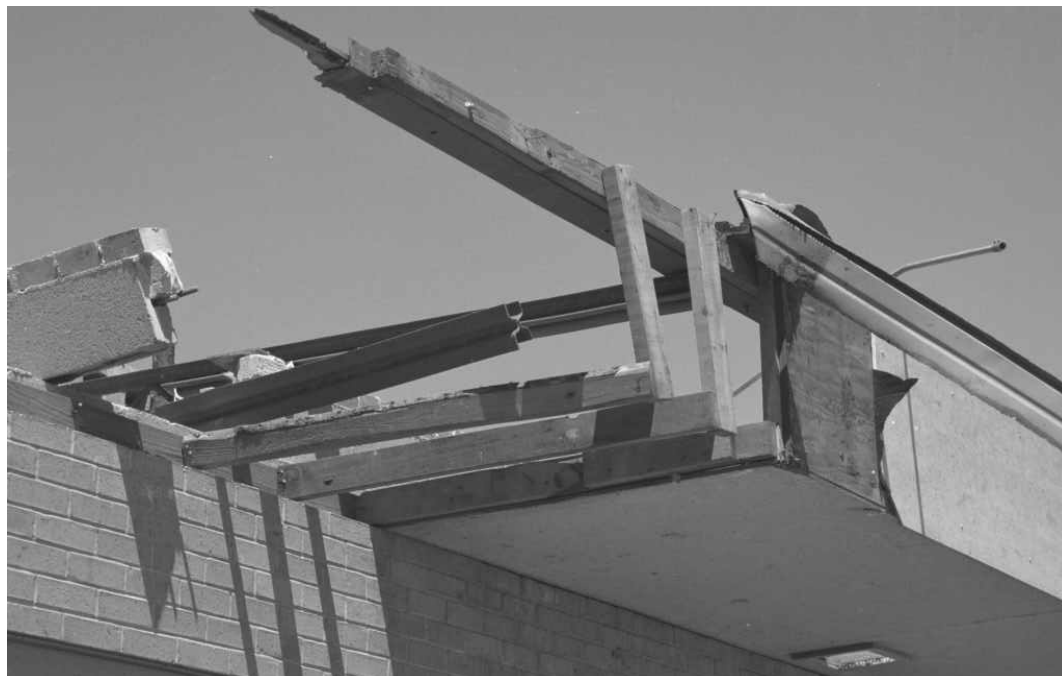
Another significant weakness was the wooden soffit beneath the cornice, shown in Figure 2-10. The failure of the soffit allowed the wind to penetrate under the roofing, thereby increasing the total wind load on the roof. The wood studs used to support the soffit were simply toe-nailed to the sup-

porting member. These connections could not withstand extreme loads, and failure of sections of the soffit contributed to the roof failures.

Figure 2-10: Detail of the Cornice and Soffit on East Side of Kelly Elementary School.

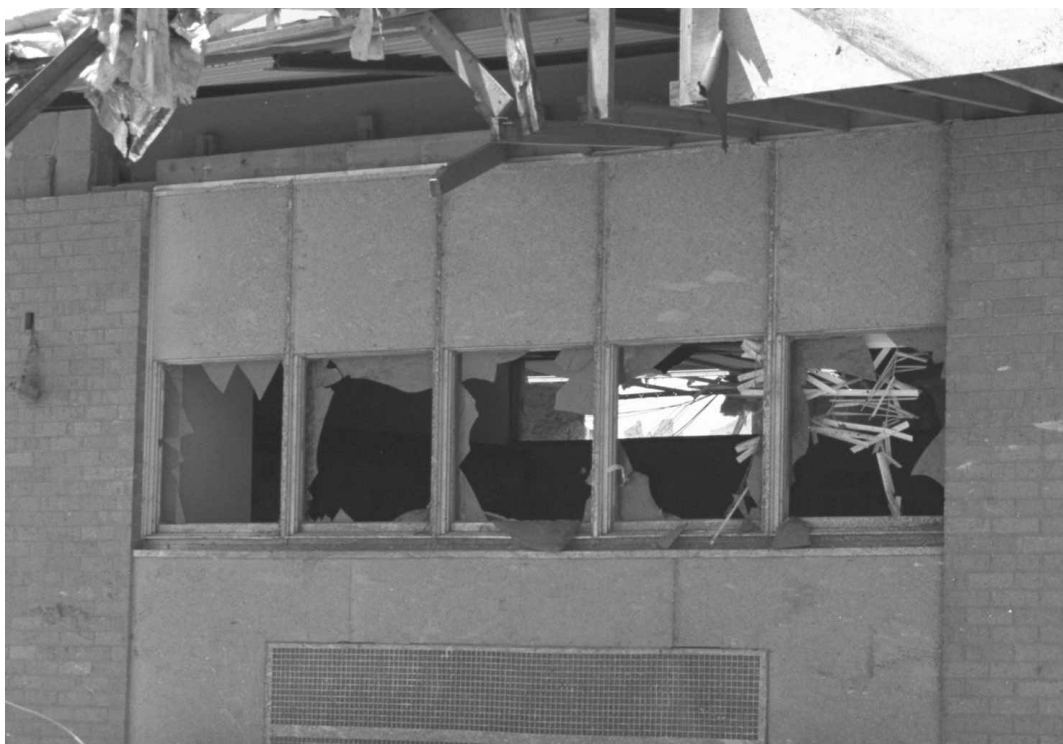
A third major weakness was the glazing. The glazing appeared to be standard weight, monolithic annealed glass, which was shattered by the wind and flying debris as shown in Figure 2-11. The glazing fragments would have posed a severe hazard to the building occupants.

Figure 2-11: Broken Windows on East Side of Kelly Elementary School.

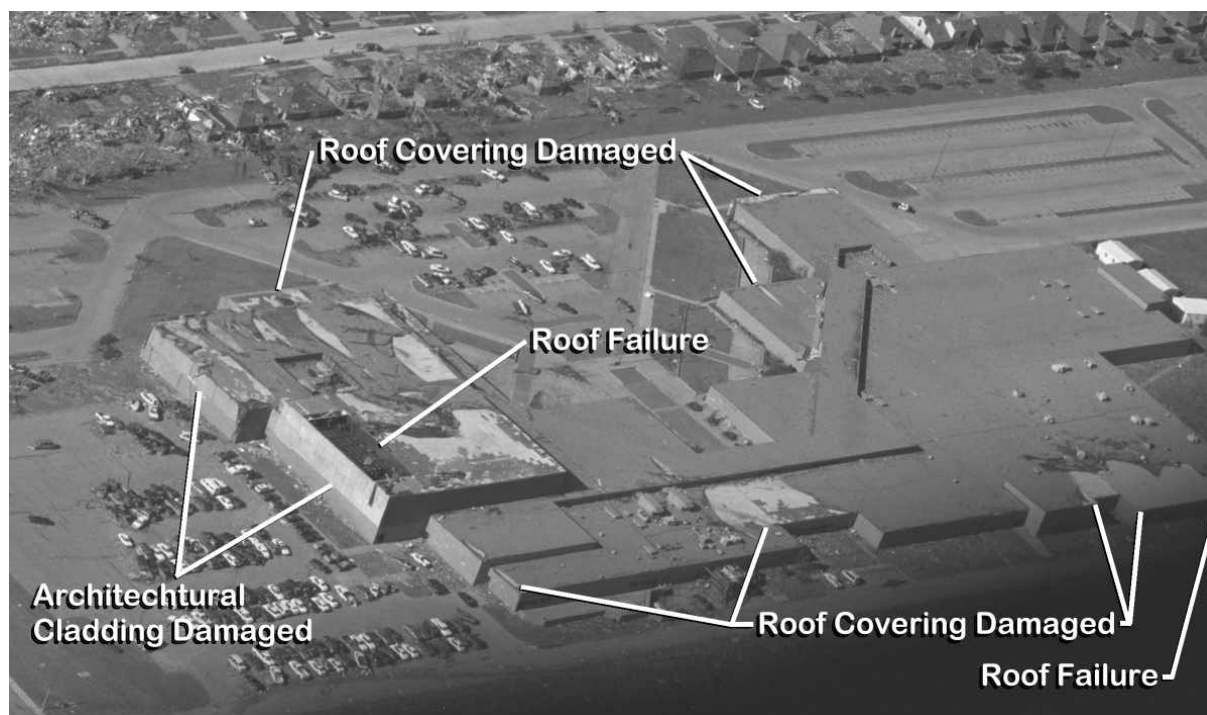
The school's roof had a wide variety of types of damage, as shown in Figure 2-12. As mentioned above and shown in Figure 2-13, a large section of the auditorium roof was destroyed. A smaller section of the northwest corner of the roof was also lost. The roof covering was heavily damaged in many locations, with the worst damage occurring in the southeast corner above the gymnasium and the auditorium. Many other sections of the roofing were damaged, including large sections near the center of

Figure 2-12: Aerial View of Westmoore High School.

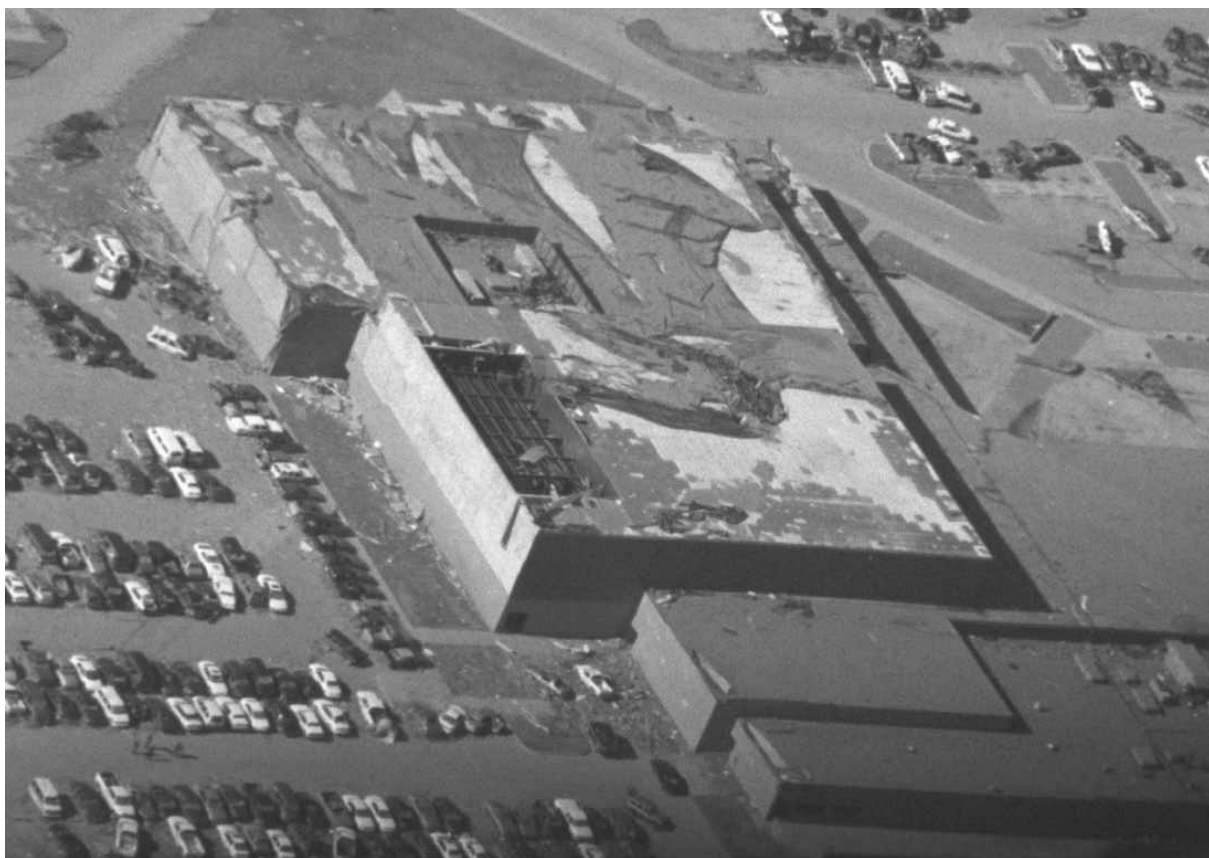
Figure 2-13: Detail of Roof Damage to Westmoore High School.

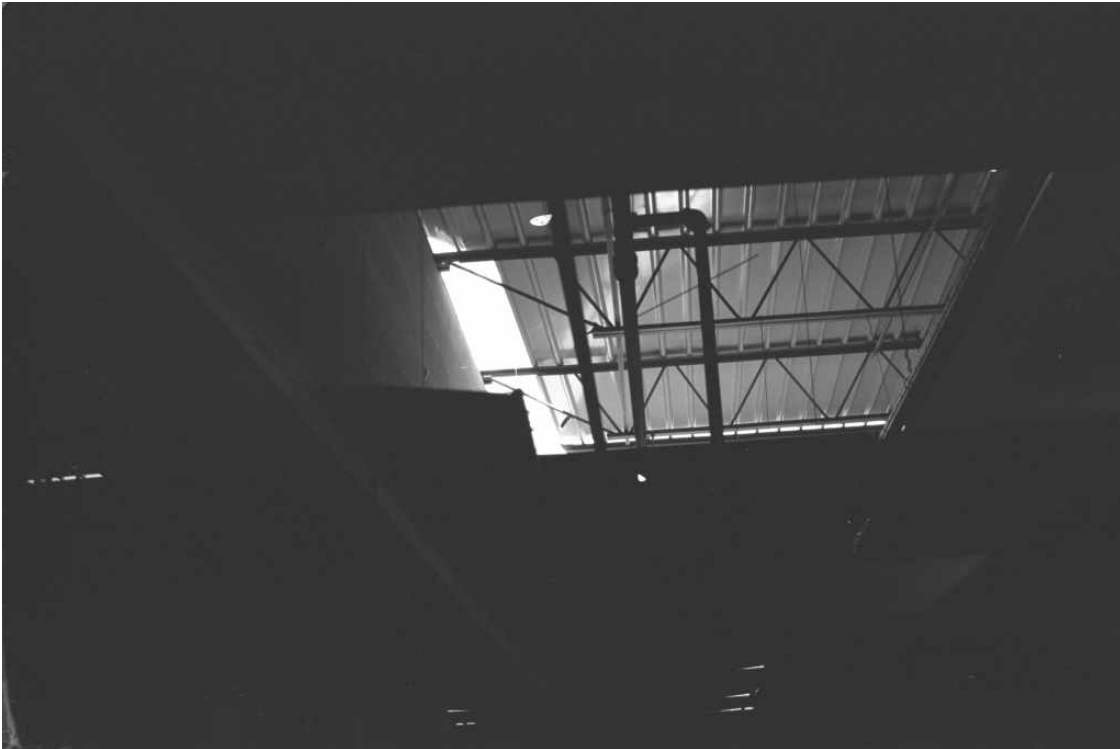
Figure 2-14 shows the section of roof that was lost from one classroom. This classroom was located near the northwest corner of the building, and had much of its contents damaged by the water and wind that entered through the damaged roof.

Figure 2-14: Damage to Westmoore High School Classroom Roof (Inside View).

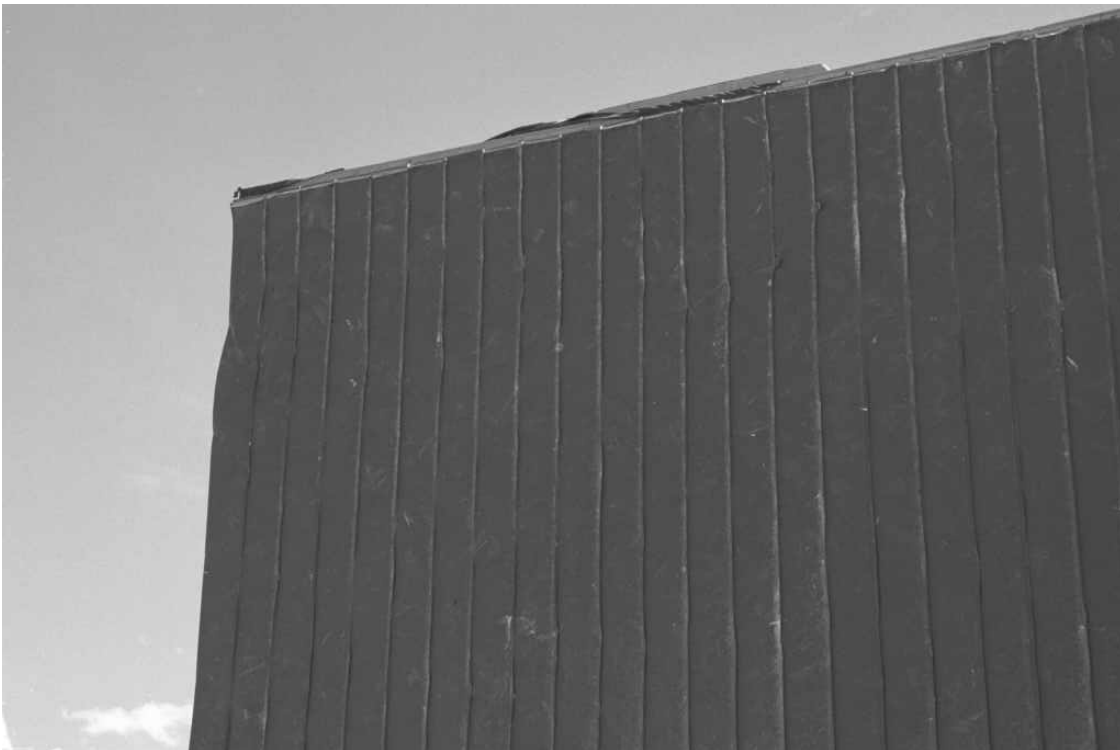
Steel architectural cladding, which appeared to be lightly attached, was also damaged. Figure 2-15 shows some of the damaged cladding on a North face of the building. This cladding appeared to be lightly connected only by nails and small diameter screws to the buildings' masonry. The tornado winds removed most of the cladding from the south and east faces of the building's southeast corner. This damage can be seen in Figure 2-16 and Figure 2-17.

Figure 2-15: Damaged, But Intact, Cladding on Westmoore High School.

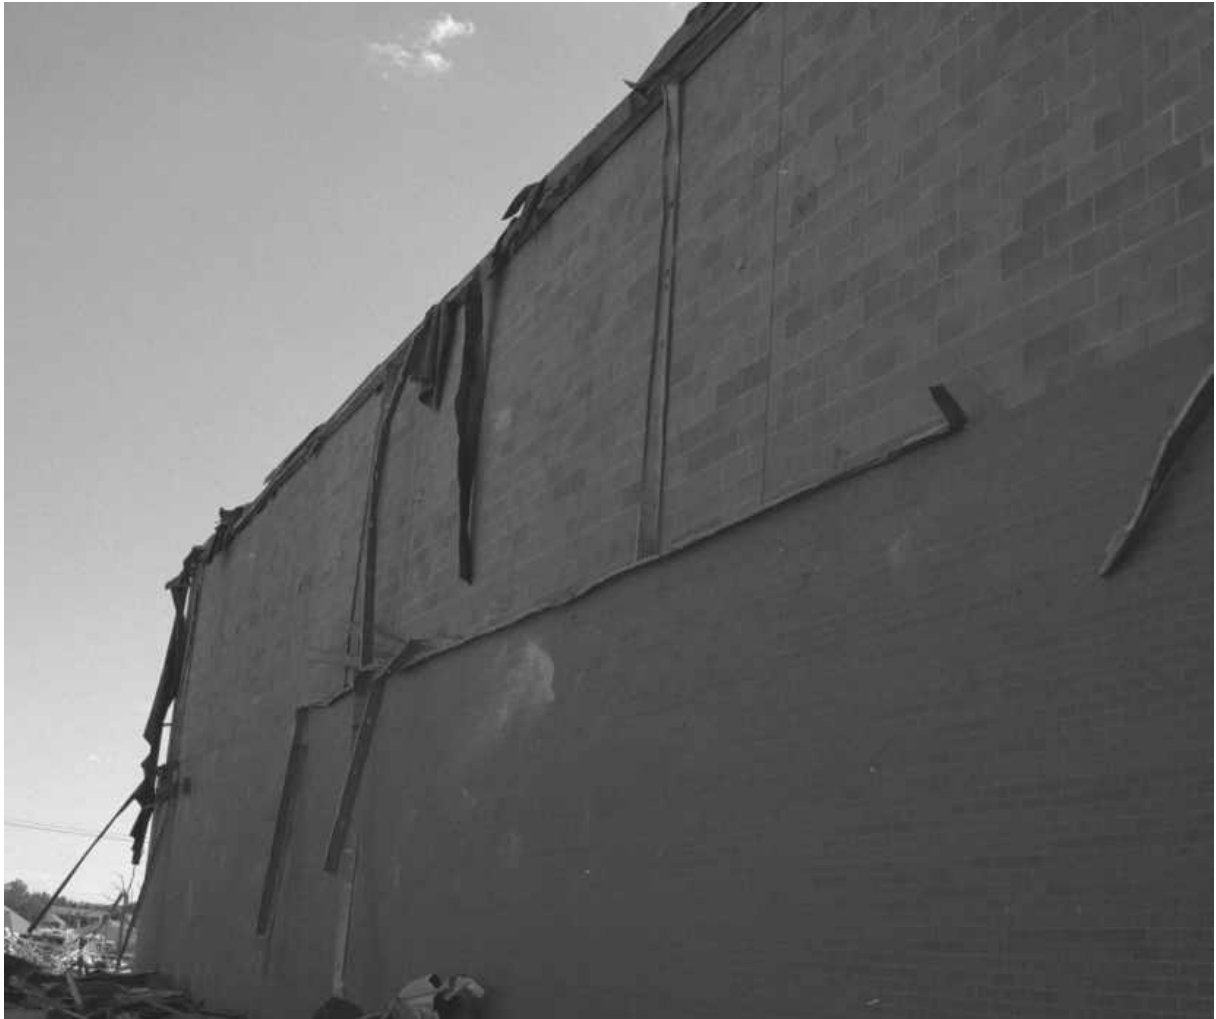
Figure 2-16: Damage to Cladding on East Side of Westmoore High School.

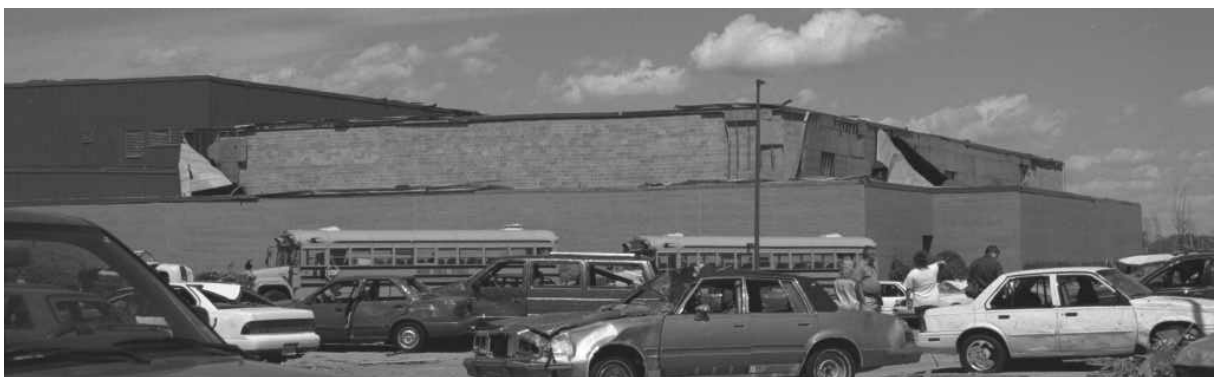
Figure 2-17: Damage to Westmoore High School and Vehicles, View From South.

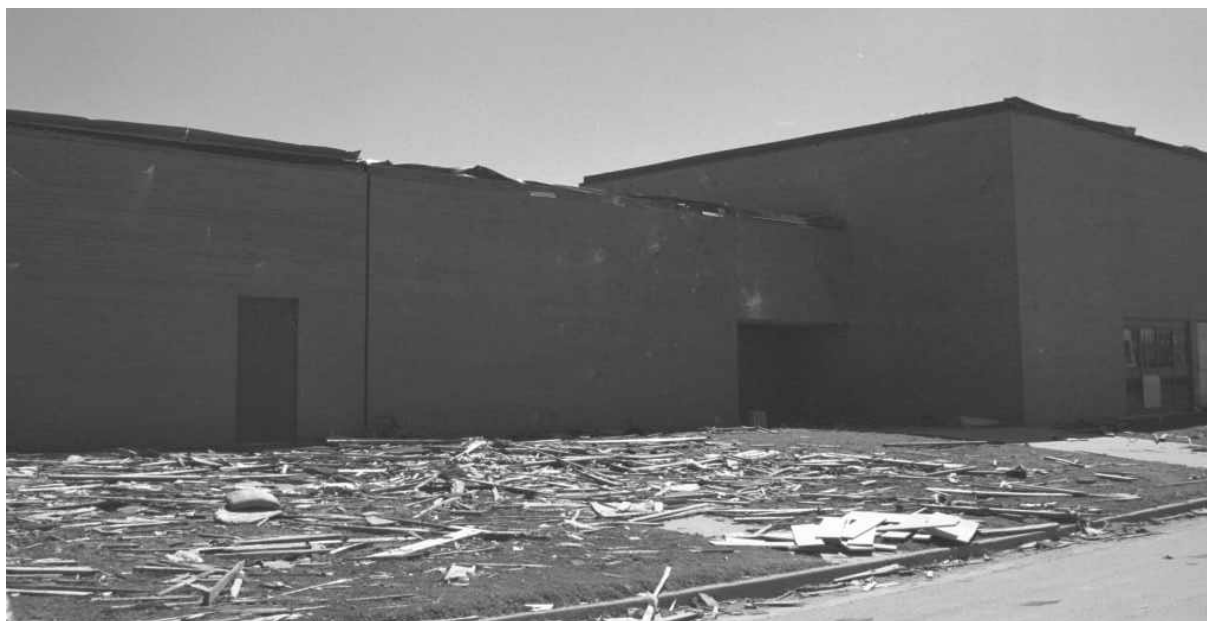
Of particular interest was the large quantity of debris in the vicinity of the school. Figure 2-18 shows some of the debris that had collected on the north side of the building. Much of this debris was likely from the large number of homes south of the high-school that were destroyed by the tornado, as shown in Figure 1-4.

Figure 2-18: Debris on North Side of Westmoore High School.

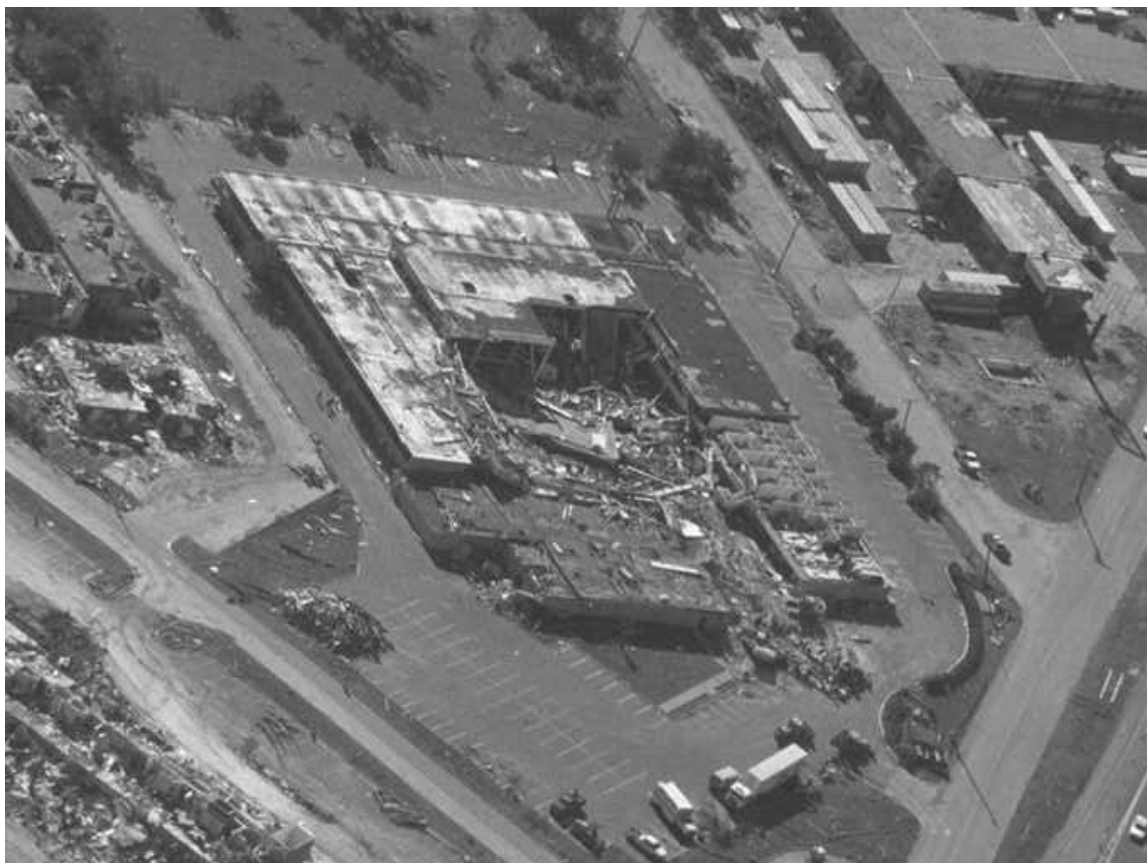
Figure 3-1: Aerial View of Damage to the Clarion Inn.

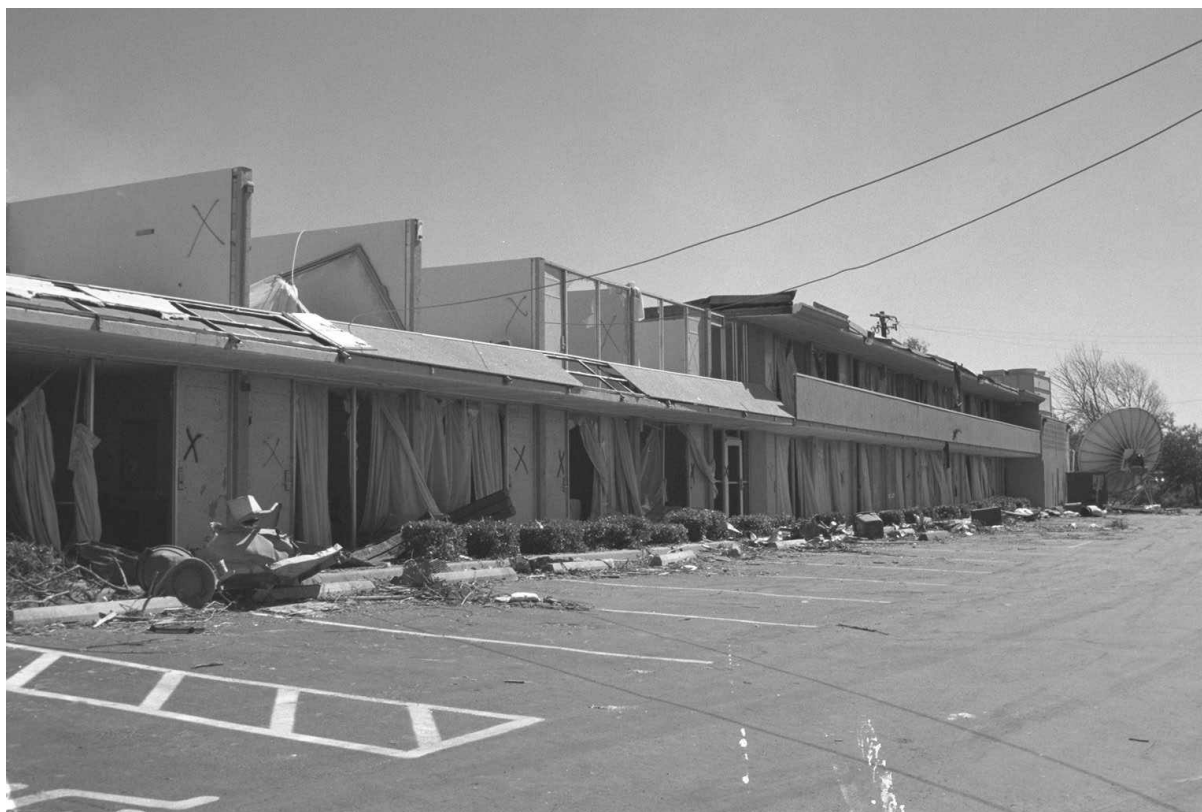
Figure 3-2: Damage to South Side of the Clarion Inn.
