**RECONNAISSANCE REPORT ON DAMAGE TO
ENGINEERED STRUCTURES DURING
THE MAY 1999 OKLAHOMA CITY TORNADO**

Michael A. Riley

Building and Fire Research Laboratory
Gaithersburg, MD 20899-8611

August 2002

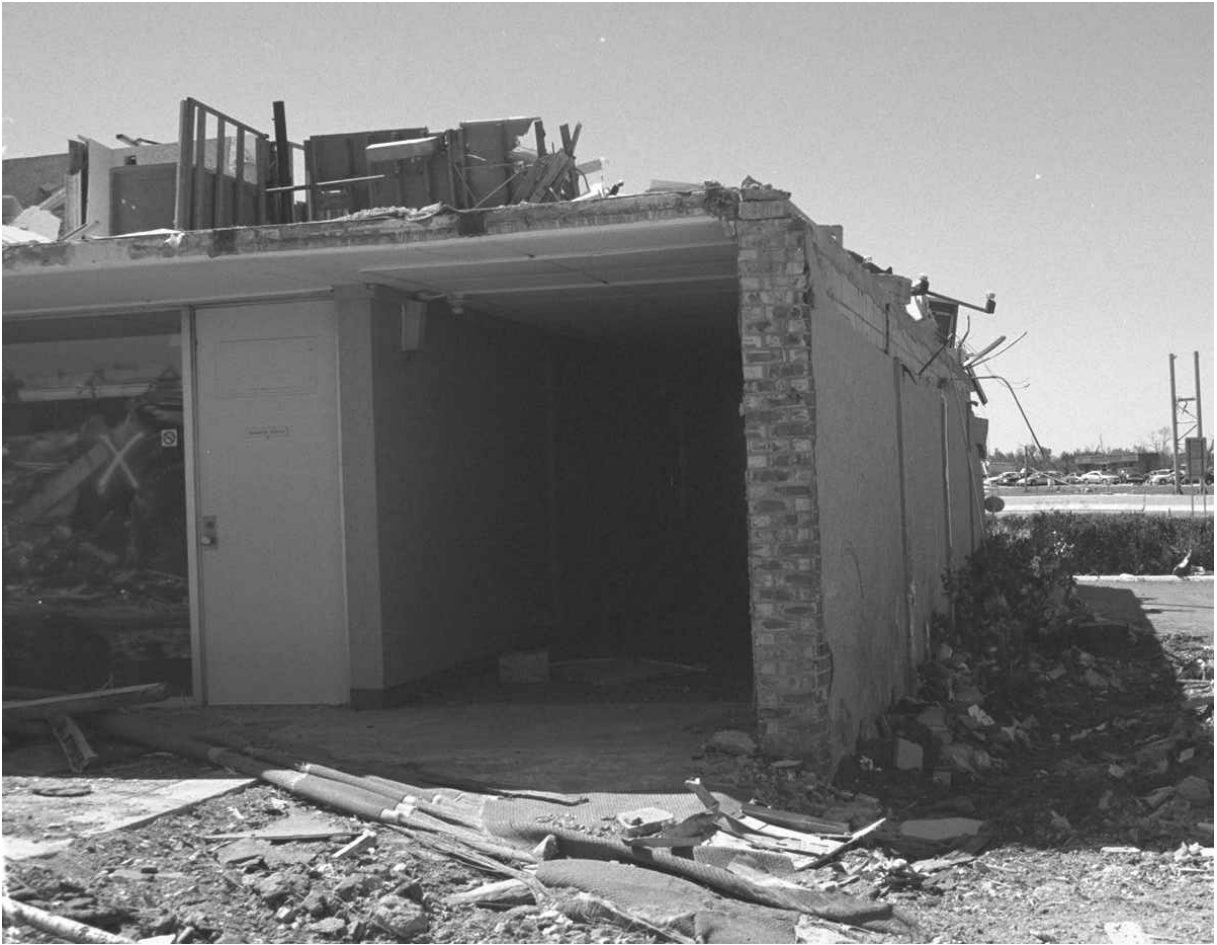
Figure 3-3: Damage to North Side of the Southwest Corner of the Clarion Inn.

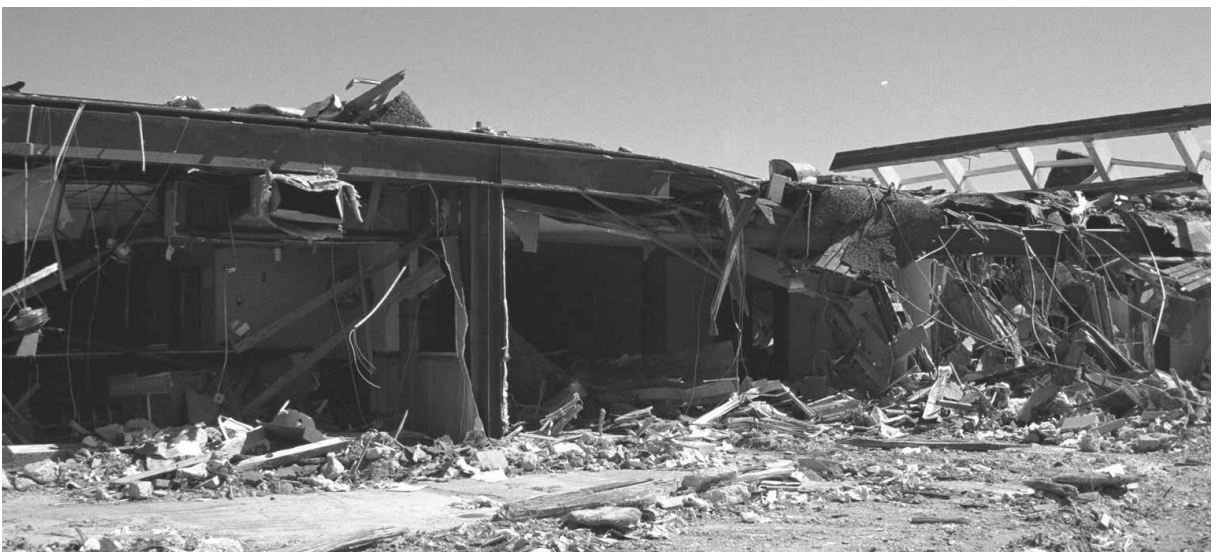
Figure 3-4: Damage to Western Section of the Clarion Inn.

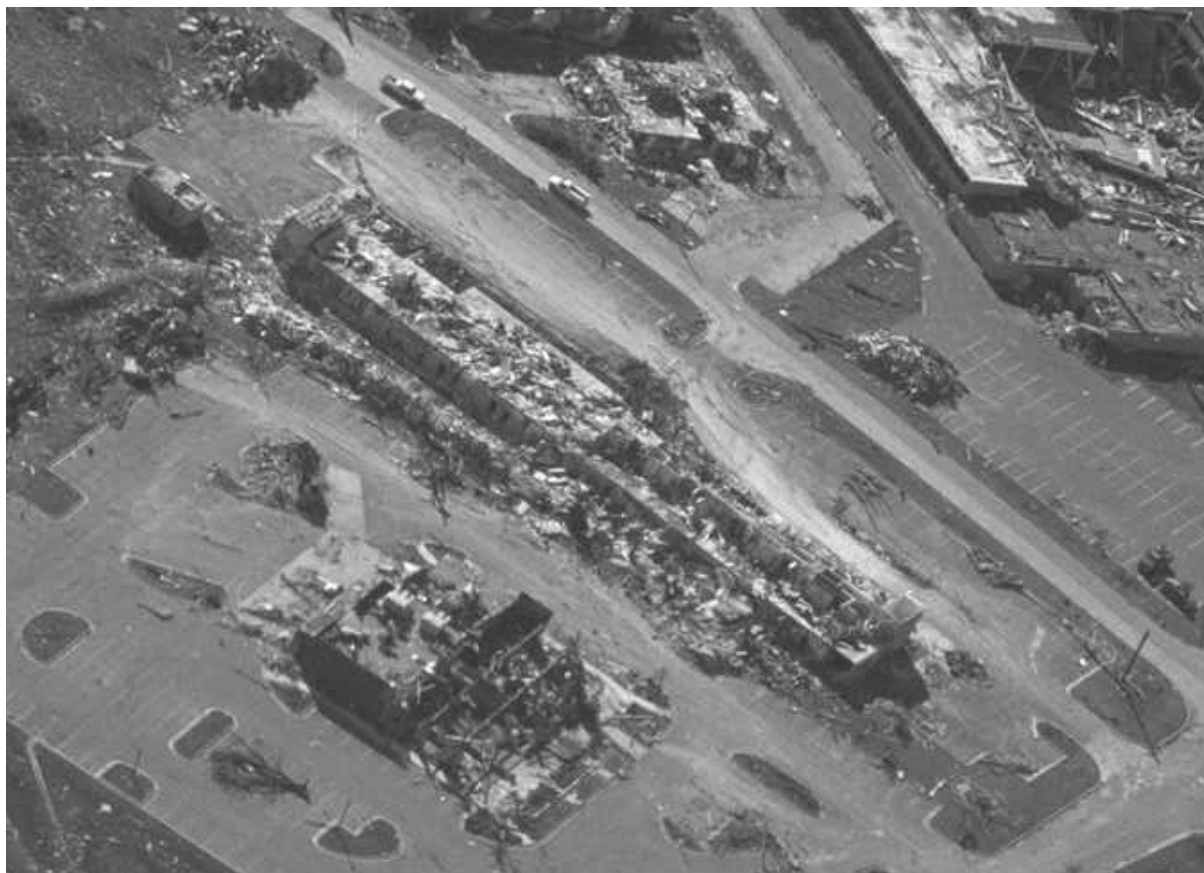
This hotel was completely destroyed as shown in Figure 1-3 and Figure 3-5. The precast concrete roof was lifted off and carried some distance. Much of the remainder of the second story collapsed and was swept off the floor slab. The outside walls of the south side of the lower floor were demolished, leaving only the masonry walls and the precast concrete floor slab of the second floor standing.

Figure 3-5: Aerial View of Damage to the Hampton Inn (long rectangular building).

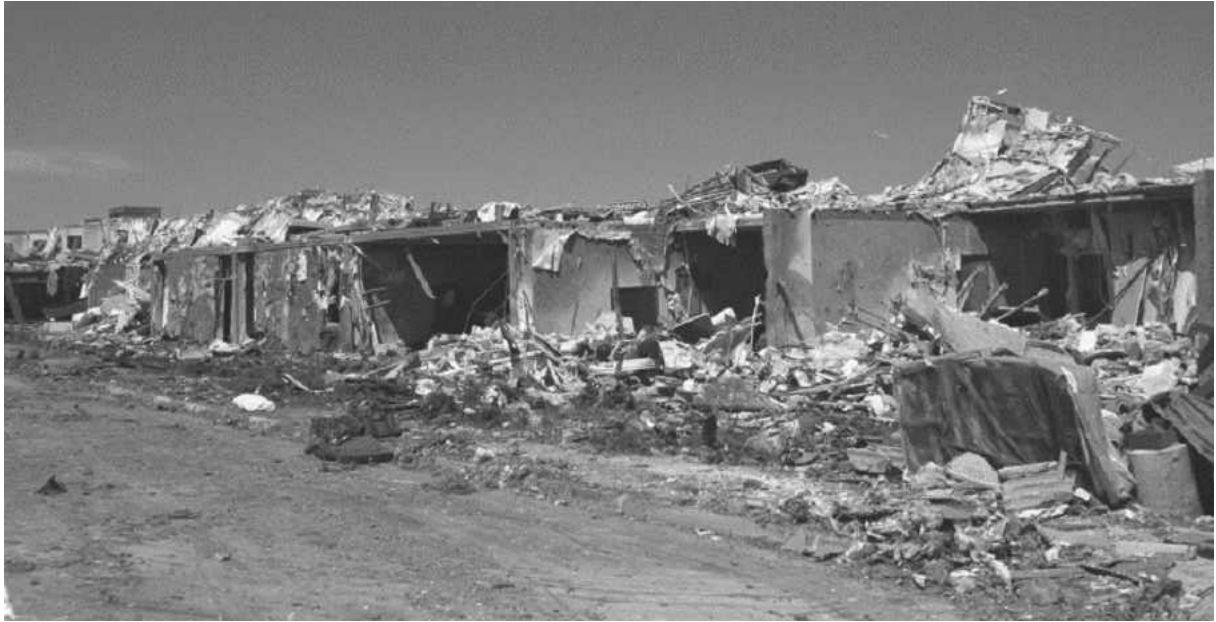
Figure 3-6: Damage to South Side of the Hampton Inn.

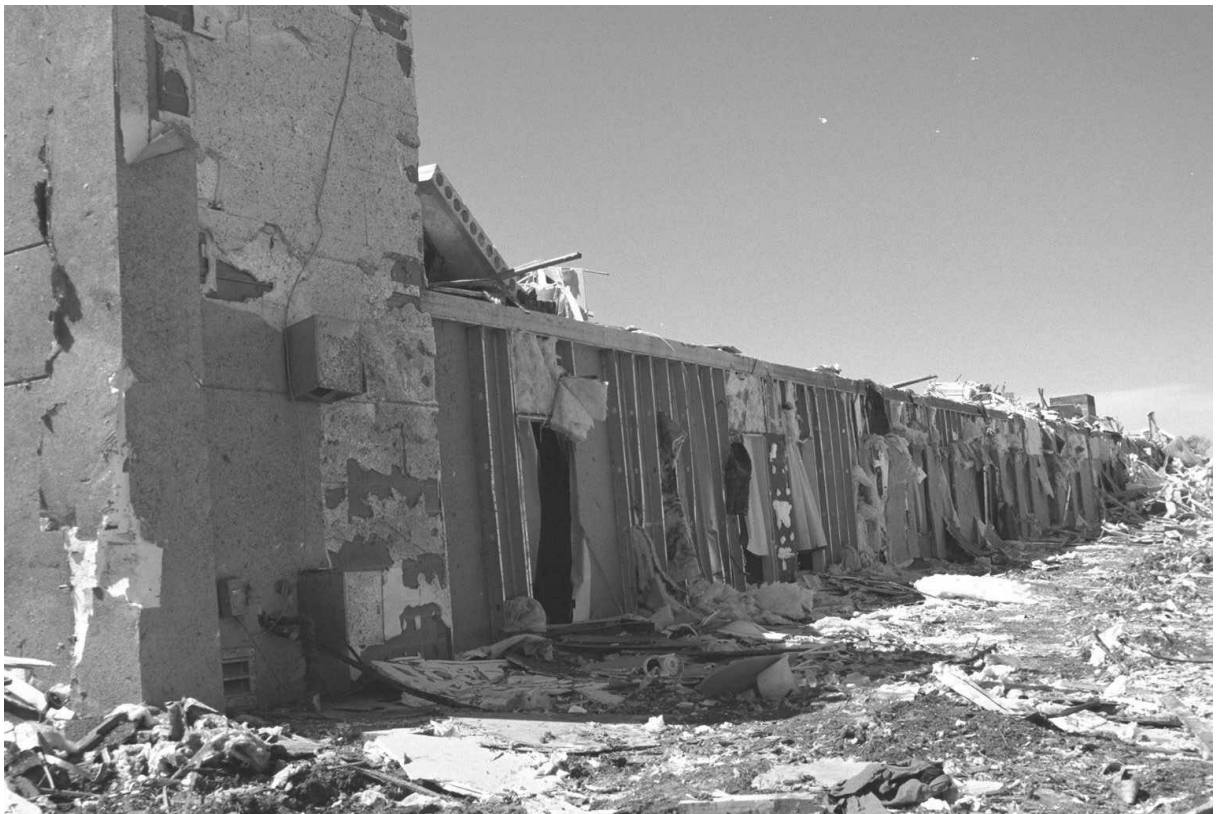
Figure 3-7: Damage to North Side of the Hampton Inn.

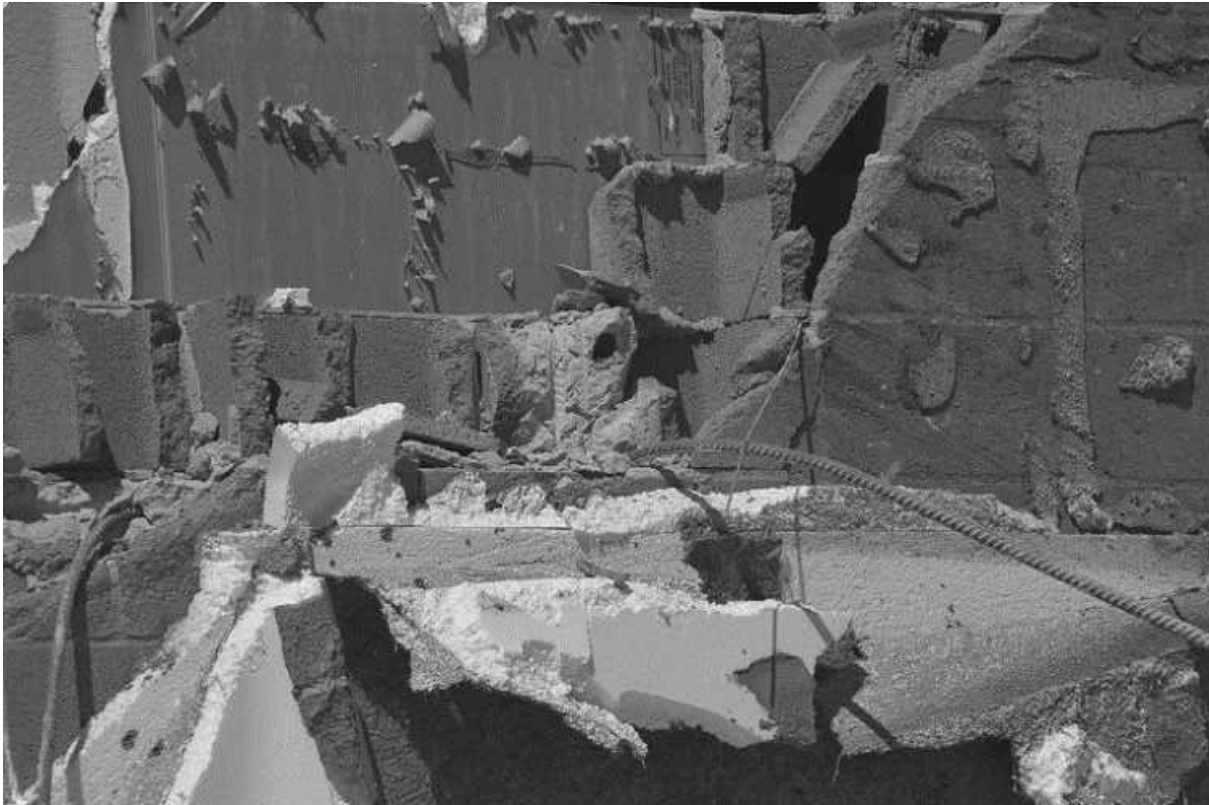
Figure 3-8 shows a detail of the damage to the masonry wall, including reinforcing bars that were exposed when the concrete block was demolished.

Figure 3-8: Detail of Damage to Masonry at the Hampton Inn.

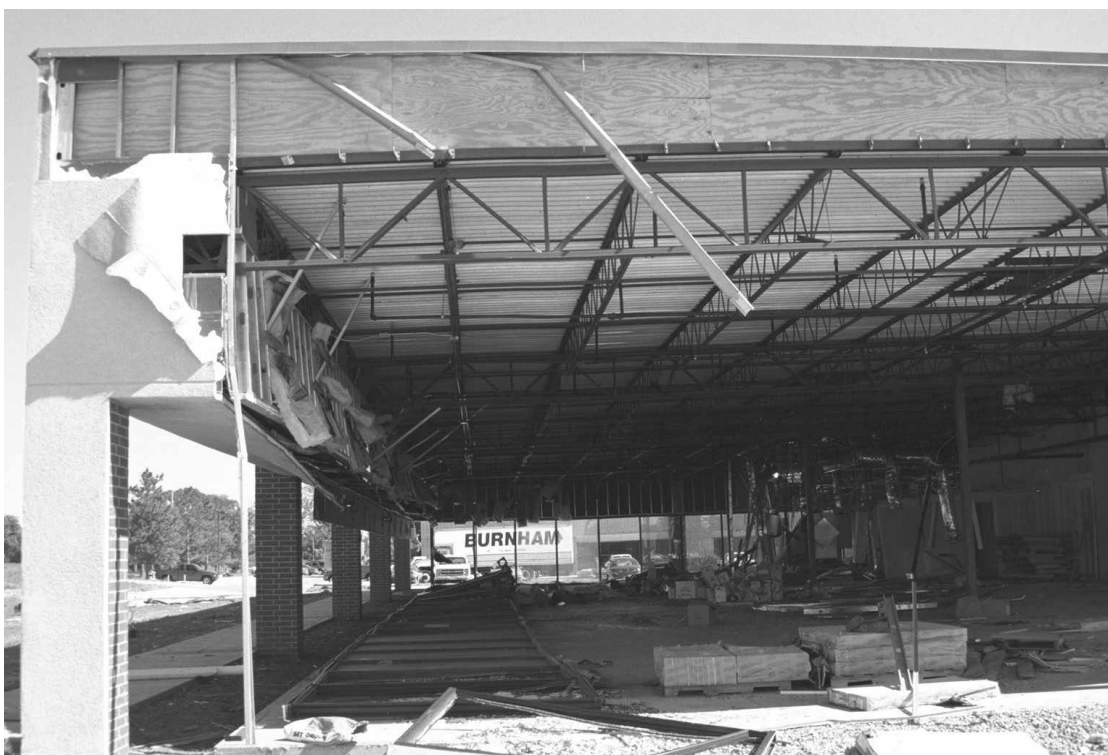
Figure 4-2: Damage to Western Section of the South Building at Tinker Industrial Park.

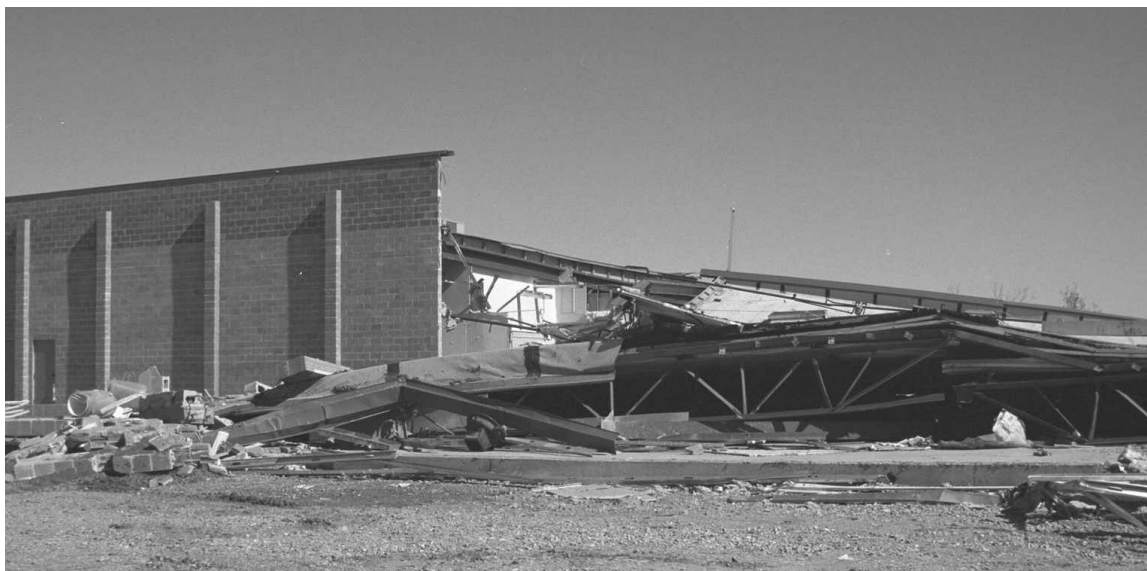
Figure 4-3: Collapsed Eastern Section of the South Building at Tinker Industrial Park (View from Southeast).

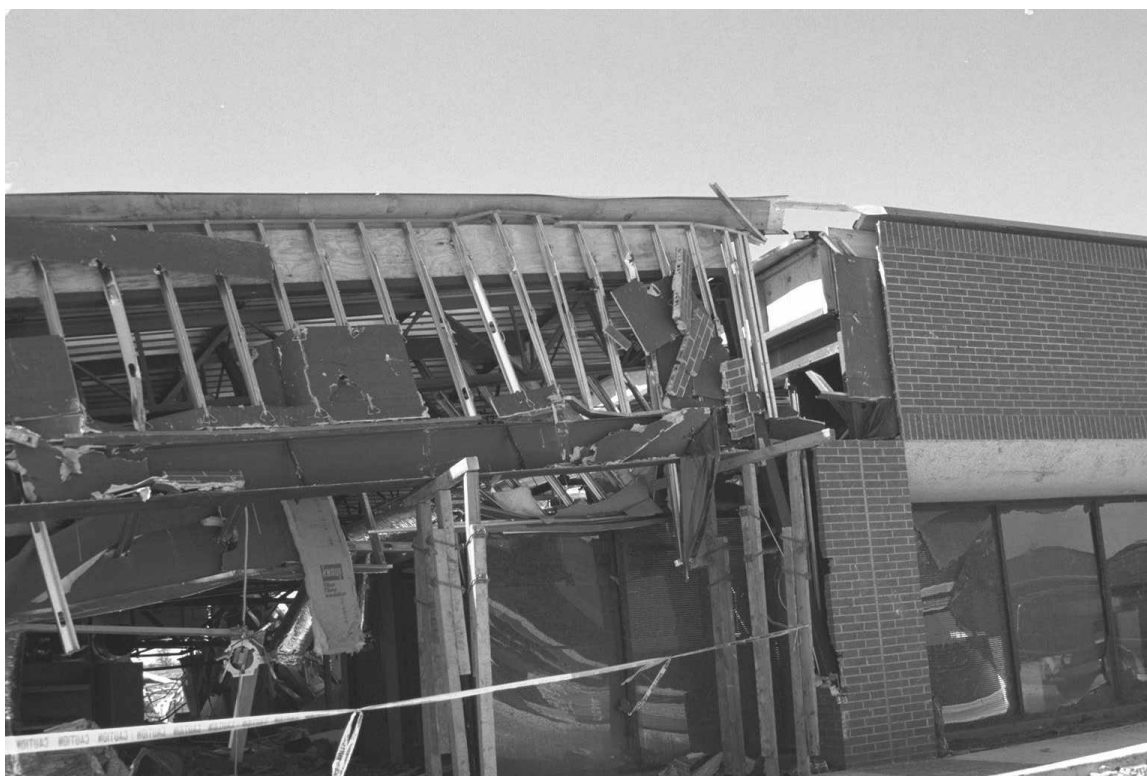
The tornado appears to have pushed this portion of the building towards the northeast, rotating it counterclockwise. The largest deformations occurred along the southern edge, while the northeast corner moved only a bit, as can be seen in Figure 4-4.

Figure 4-4: North Side of the South Building at Joint between Sections.

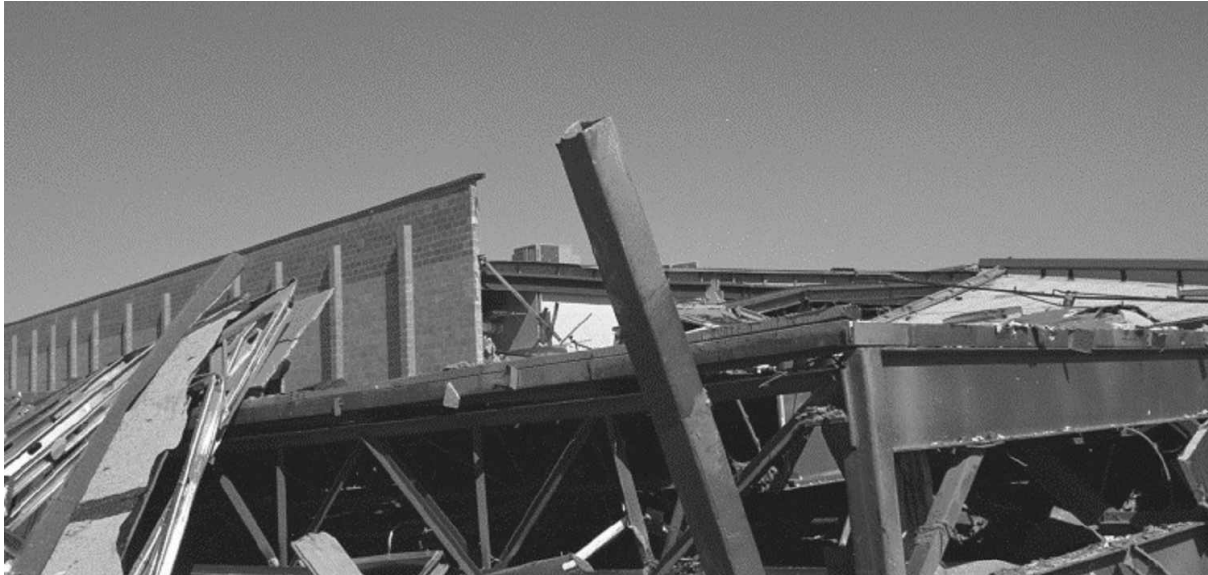
The columns on the eastern and southern sides of this portion failed, as shown in Figure 4-5, and the entire section collapsed with the roof largely intact. The relatively well-reinforced masonry wall on the west-

Figure 4-5: Detail of Failed Column and Collapsed Roof at the Southeast Corner of the South Building.

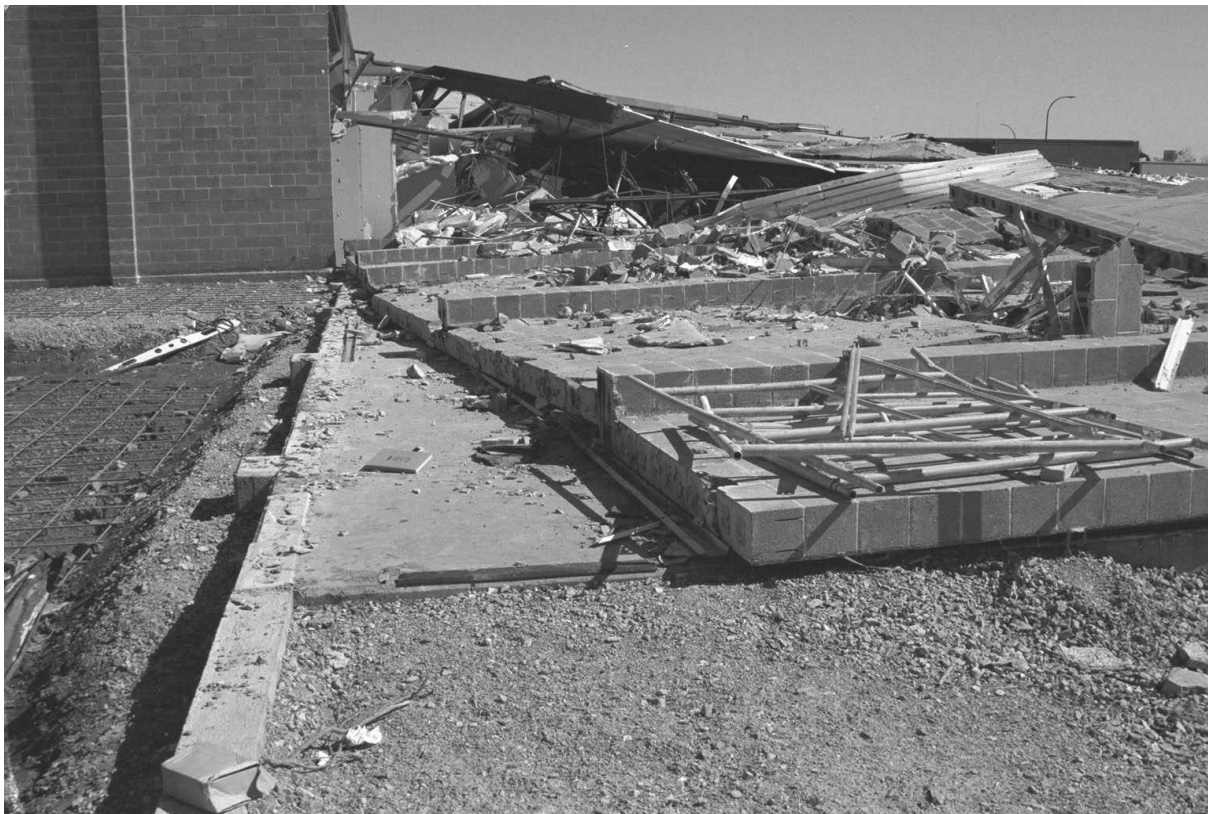
ern side of this section of the building, shown in Figure 4-6, collapsed to the east, and reinforcing bars that were anchored into the foundation pulled out or failed.

Figure 4-6: Reinforced Masonry Wall that Failed at South Building.

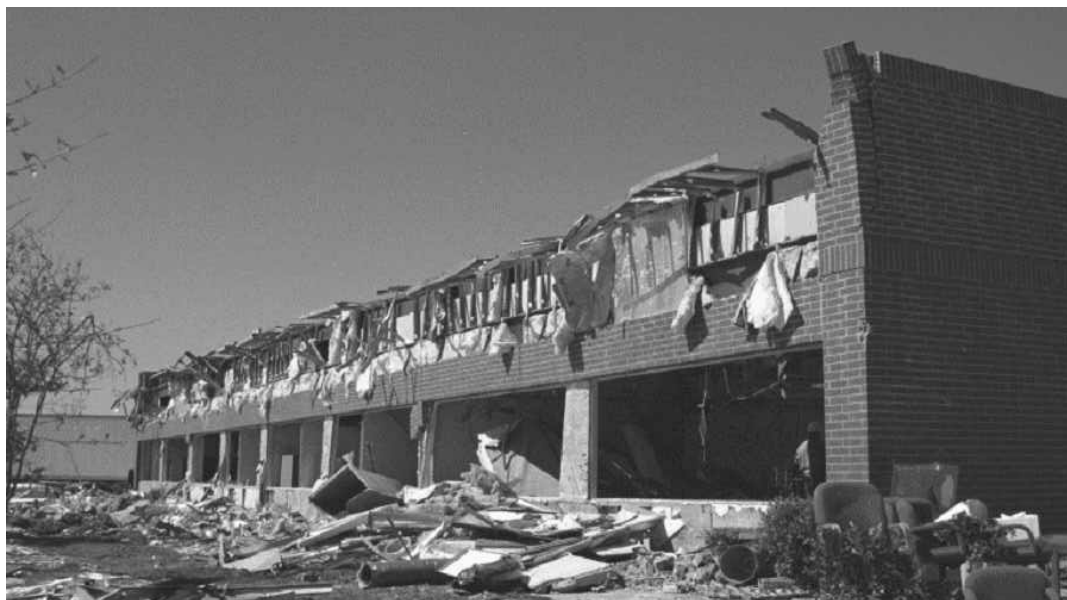
Figure 4-7: Damage to the East Side of the Middle Building at Tinker Industrial Park.

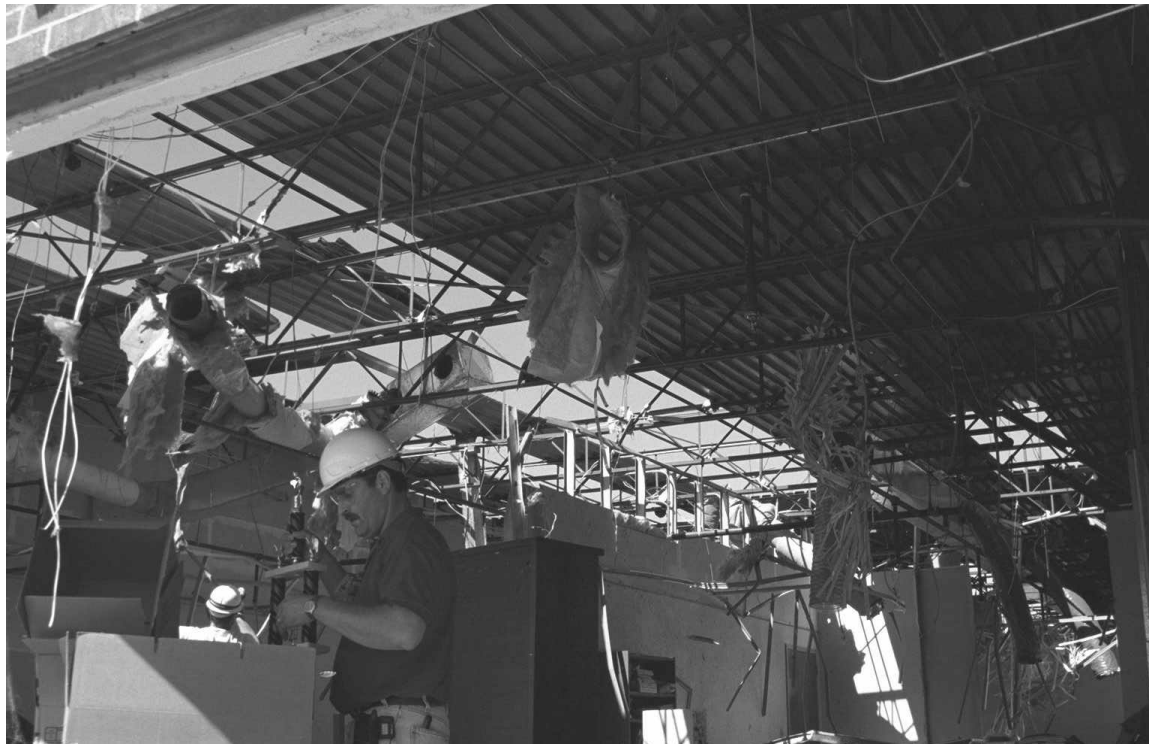
Figure 4-8: Detail of Damage to the Roof of the Middle Building.

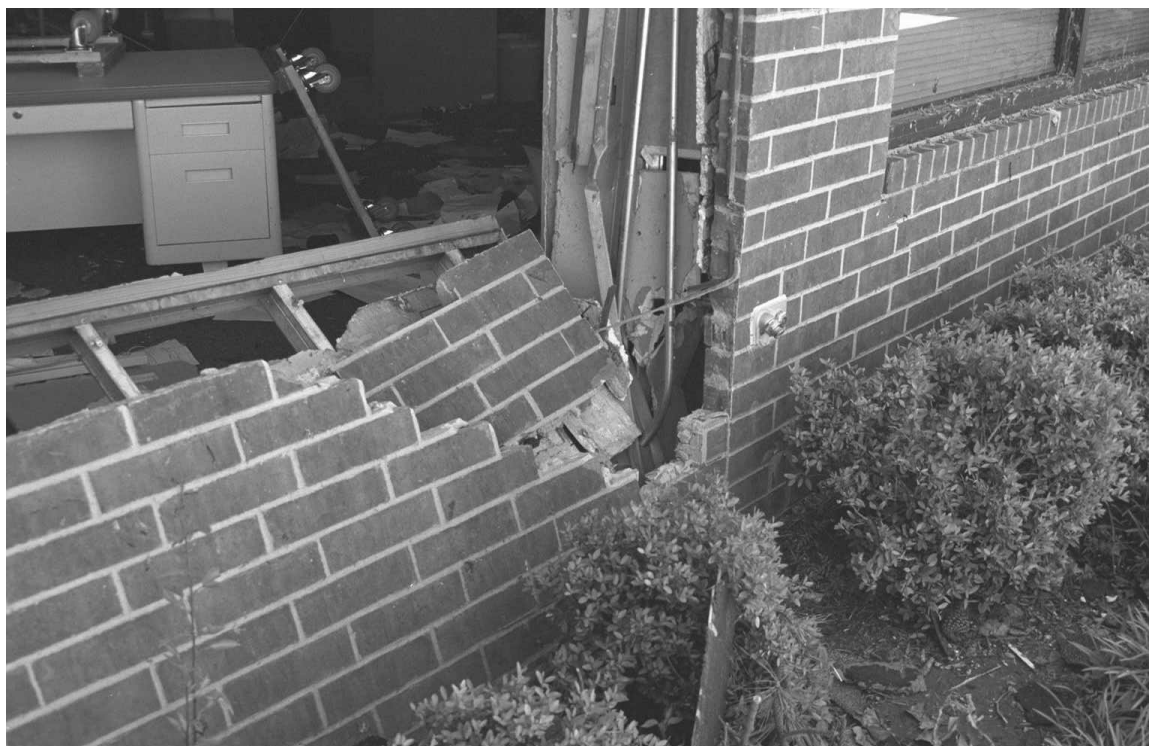
Figure 4-9: Detail of Damage to Western Wall of the Middle Building.

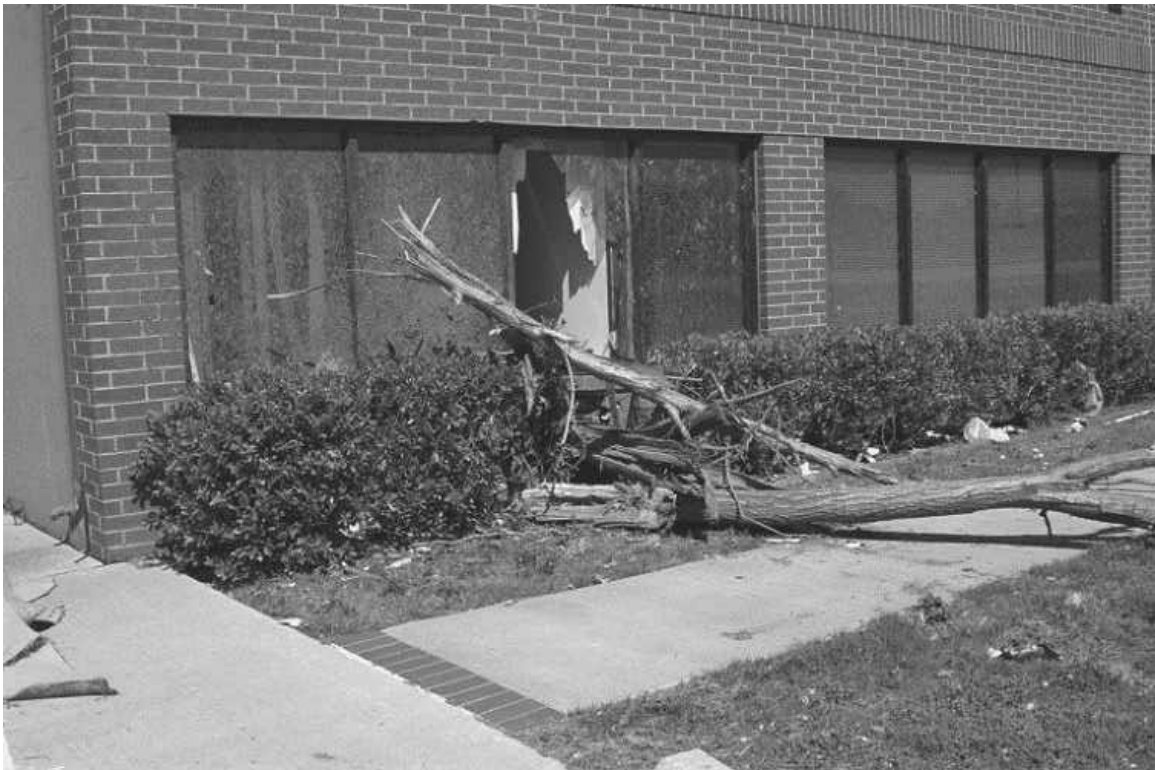
Figure 4-10: Damage to the East Side of the North Building at Tinker Industrial Park.

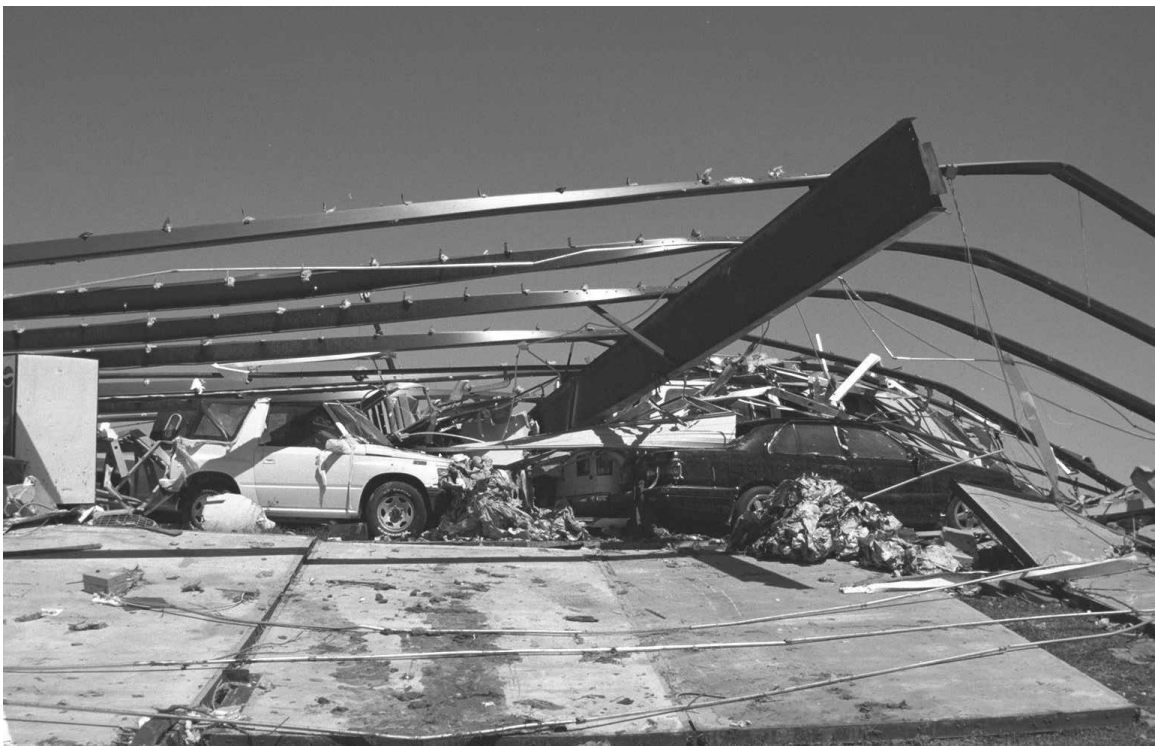
This garage-type structure was constructed of pre-cast concrete with steel columns, heavy steel roof beams, cold rolled steel roof purlins, and sheet metal roof covering. This facility appeared to be reasonably well constructed, but it had been pushed over to the east and destroyed by a nearly direct hit from the tornado. The garage doors, located on the west side of the building appeared to have failed inward before the structure collapsed, which may have contributed to the failure. Figure 4-11 shows what remained of the facility as viewed from the south. Here the walls had collapsed outward, and the roof, which had lost its covering, collapsed towards the east. Figure 4-12 shows how part of the western wall failed. The section shown in this photo was located between two garage doors.

Figure 4-11: Roof Framing and Collapsed Walls (foreground) at Peach Auto Painting.

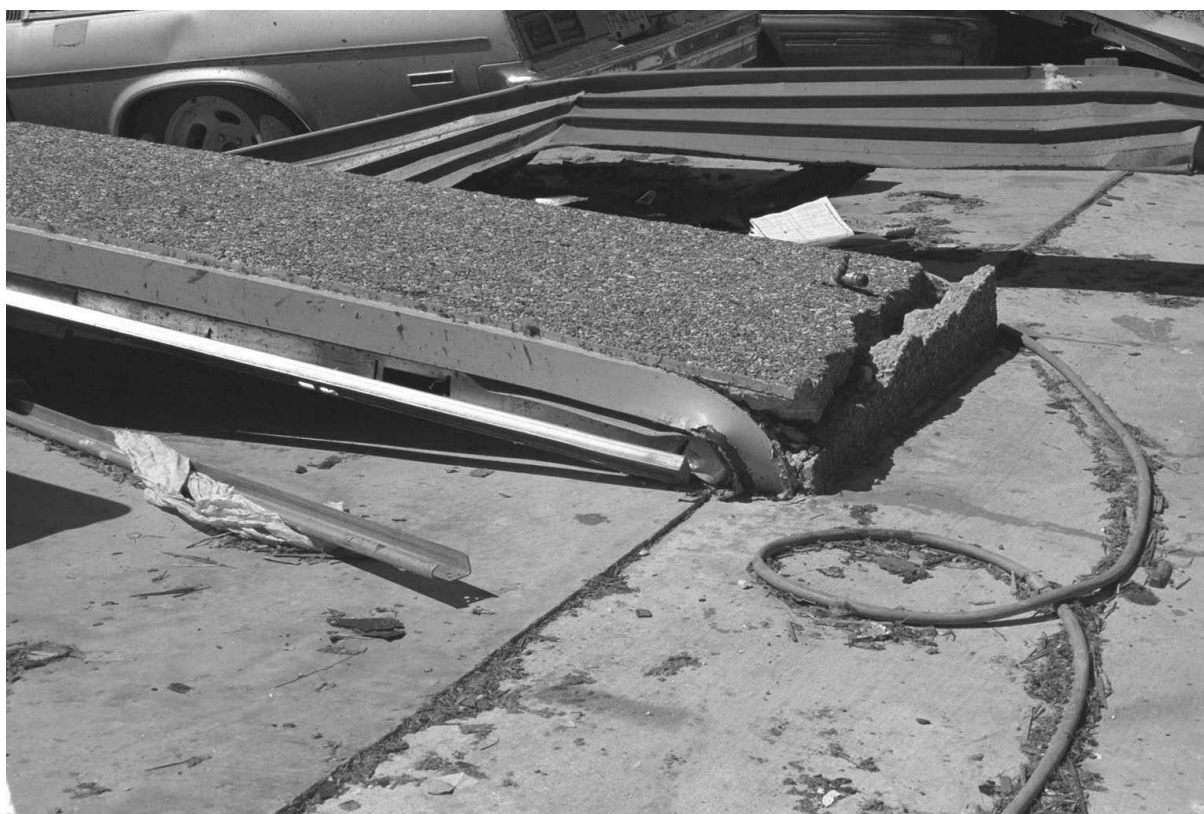
Figure 4-12: Detail of Base of Failed Wall at Peach Auto Painting.

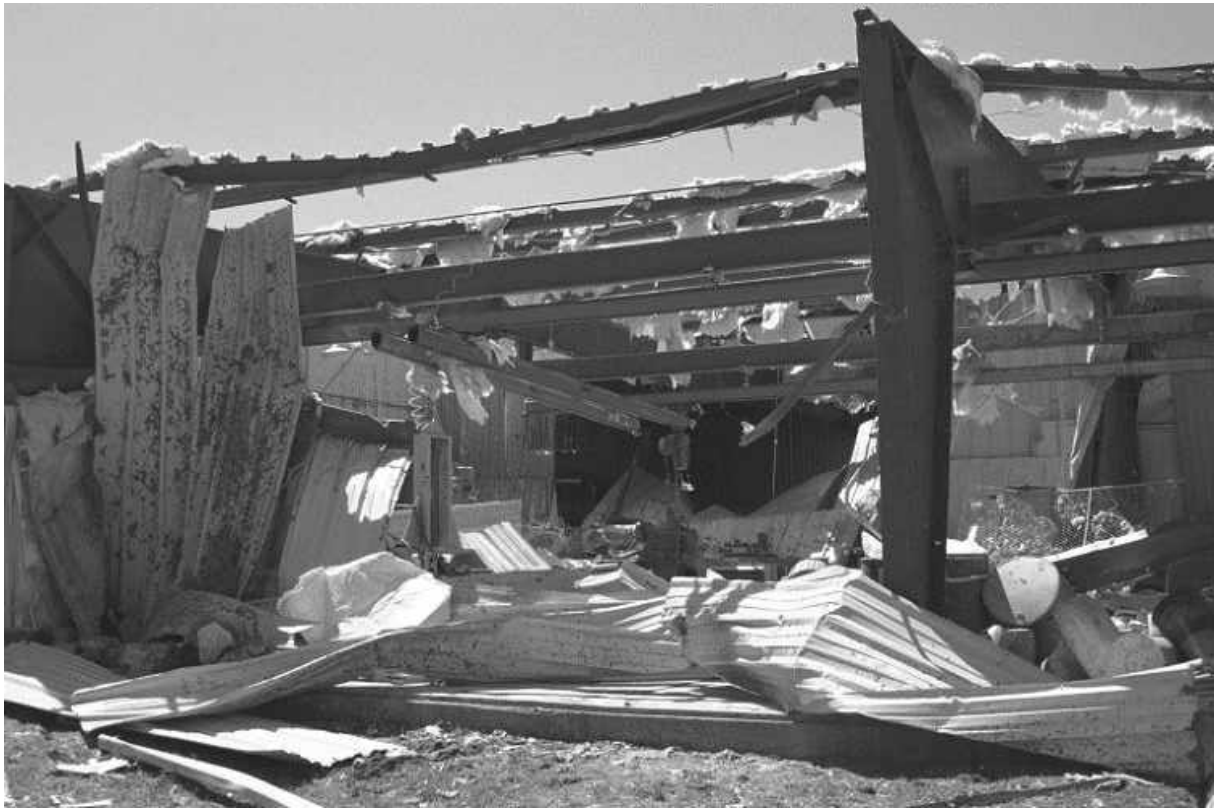
Figure 4-13: Damage to Coors Technical Ceramics Factory.

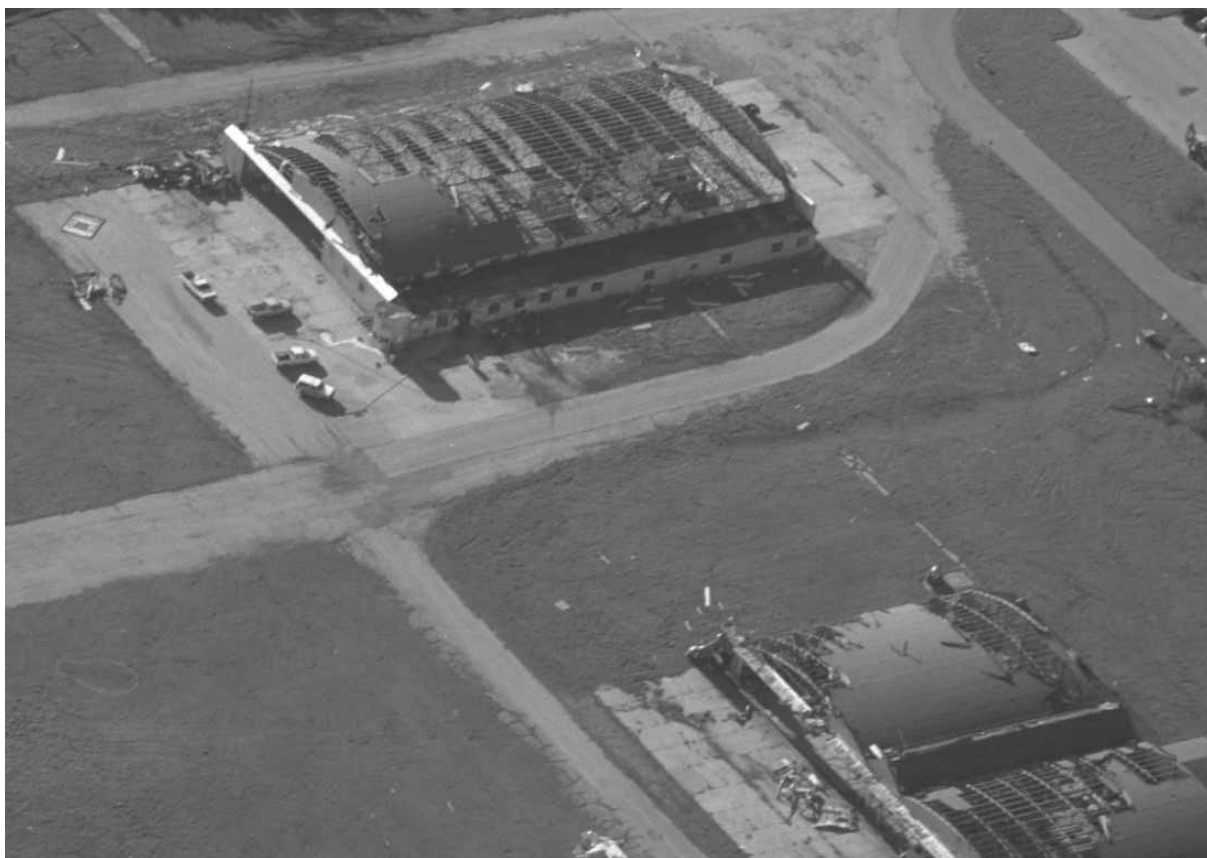
Figure 5-1: Aerial View of Damage to Hangars at Chickasha Airport

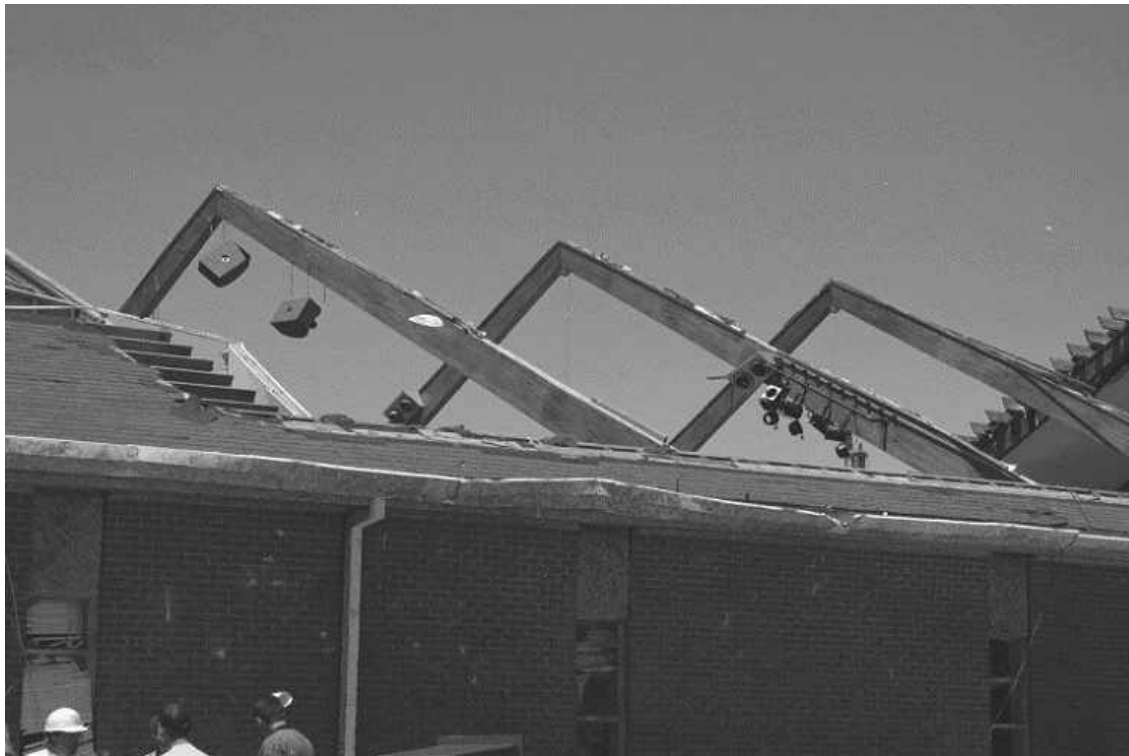
damage from flying debris. The church was constructed of masonry walls, with glulam timbers supporting a wooden roof. The tornado, which passed some distance south-east of the church, lifted off the roof, but left the timber supports intact, as shown in Figure 5-2. The masonry walls appeared to suffer only minor damage near where the roof was connected. An attached building, located to the east of the church itself, suffered much more severe damage due to heavy debris loading. The large tire, shown in Figure 5-3, was one of the largest single pieces of debris observed.

Figure 5-2: Damage to the Roof of the Regency Park Baptist Church.

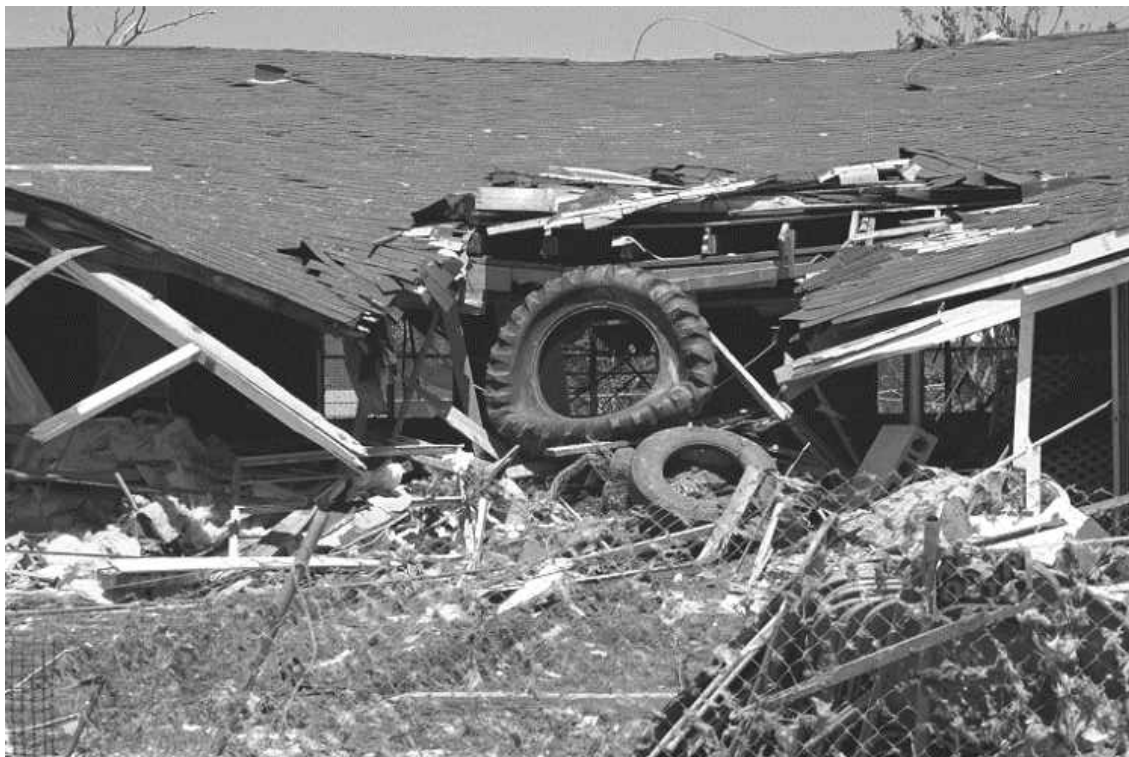
Figure 5-3: Debris Damage to Building Adjacent to Regency Park Baptist Church.

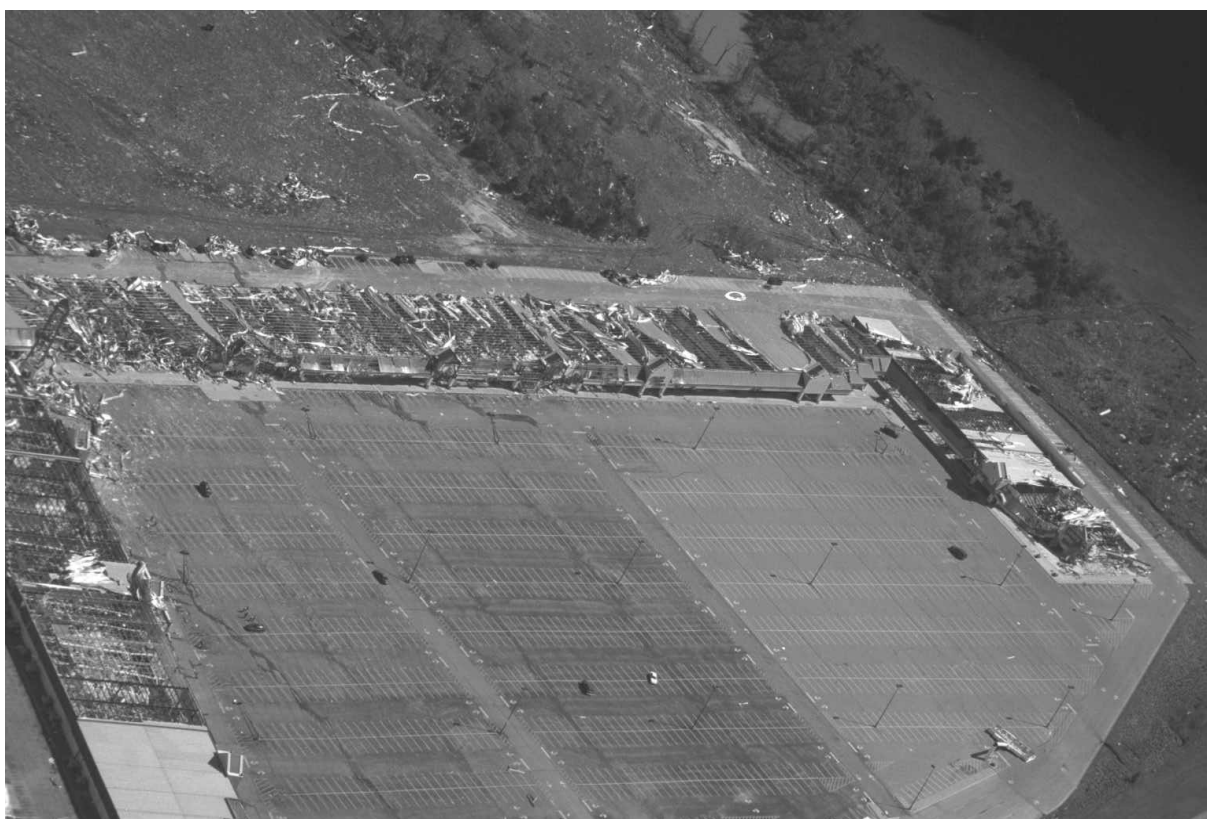
At the other extreme, the Tanger Outlet Center mall in Stroud was destroyed by tornado similar in size to the tornado that damaged the hangars at Chickasha airport. This tornado appeared to have passed directly over the mall. As shown in Figure 5-4, nearly the entire mall was destroyed. At least 53 stores demolished, and most of the roof was lost.

Figure 5-4: Aerial View of Damage to the Tanger Outlet Center Mall.

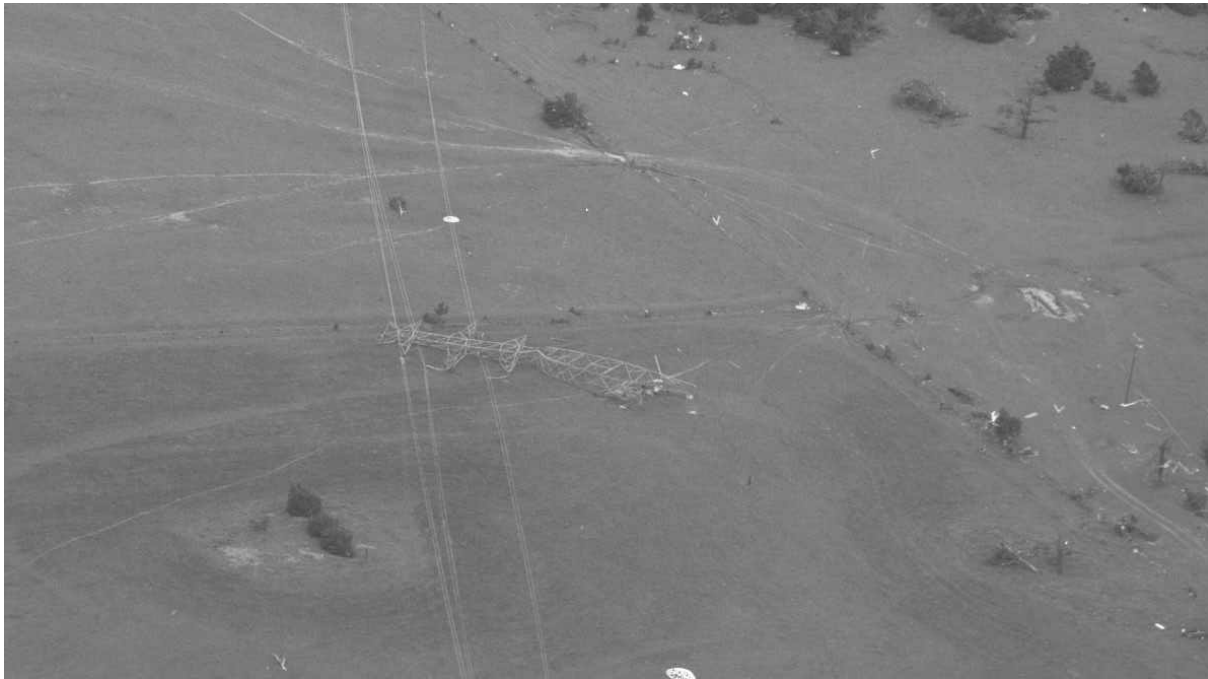
Figure 5-5: Destroyed Transmission Tower near Crescent, Oklahoma.

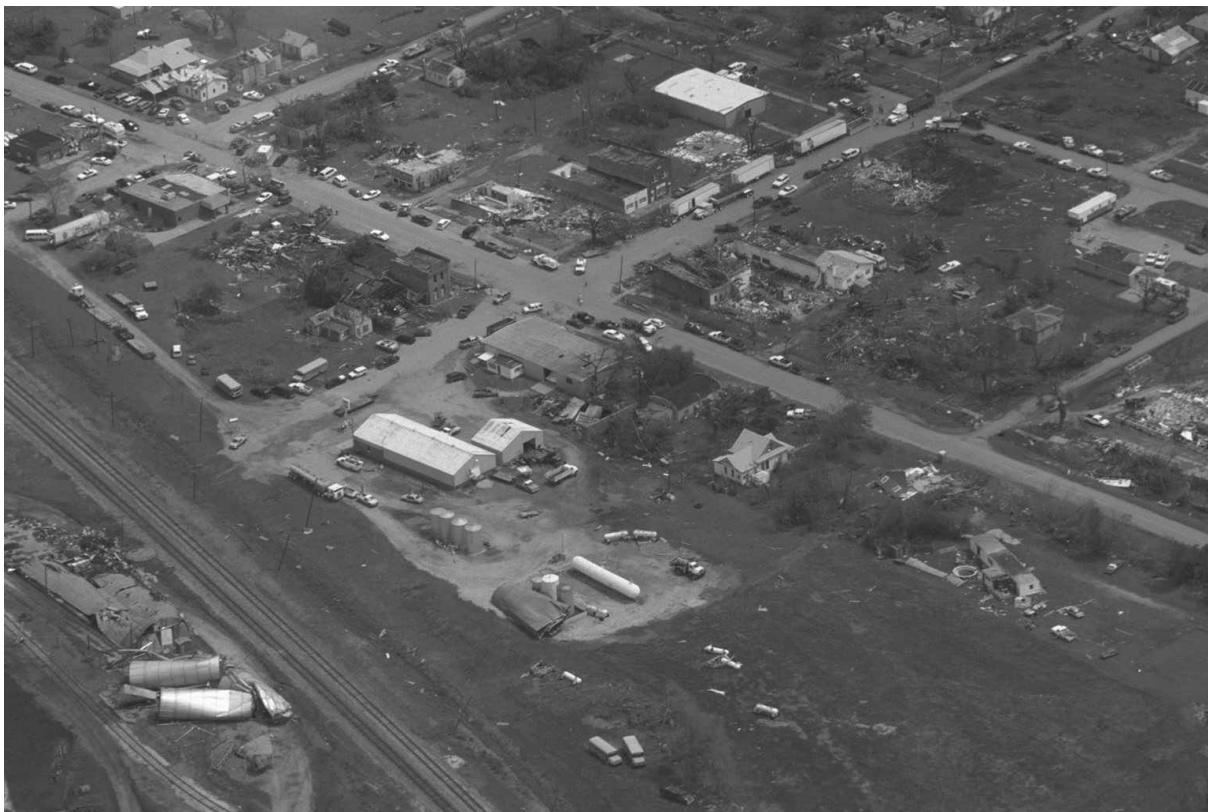
Figure 5-6: Damage to Mulhall, Oklahoma, and United Cooperative Silos.
