**RECONNAISSANCE REPORT ON DAMAGE TO
ENGINEERED STRUCTURES DURING
THE MAY 1999 OKLAHOMA CITY TORNADO**

Michael A. Riley

Building and Fire Research Laboratory
Gaithersburg, MD 20899-8611

August 2002

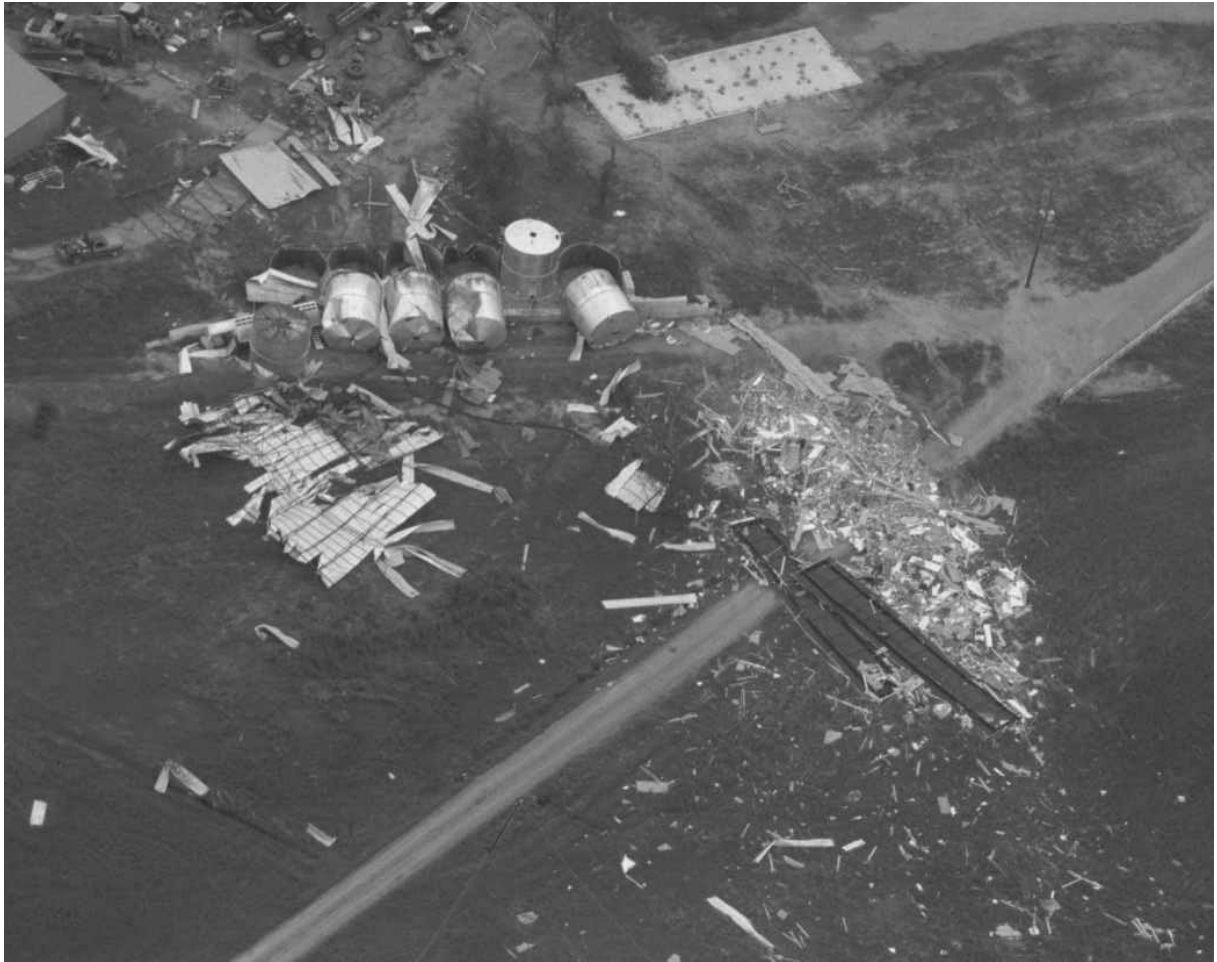
Finally, a wide variety of other infrastructure was damaged by the tornadoes. Extensive damage was observed to farm buildings and other agricultural related structures. Figure 5-6 shows some of the damage that occurred to the United Cooperative in Mulhall. A storage building and numerous grain silos (located in the lower left of the photo) were destroyed. The town of Mulhall (located in the center of the photo) was extensively damaged. Figure 5-7 shows the damage that occurred at one farm near Crescent. Here storage silos were overturned and destroyed, one farm building was leveled, and other buildings were damaged.

Figure 5-7: Damage to Farm buildings and Silos near Crescent, Oklahoma.
