NBS BUILDING SCIENCE SERIES 165

**Engineering Aspects
of the September 19, 1985
Mexico Earthquake**

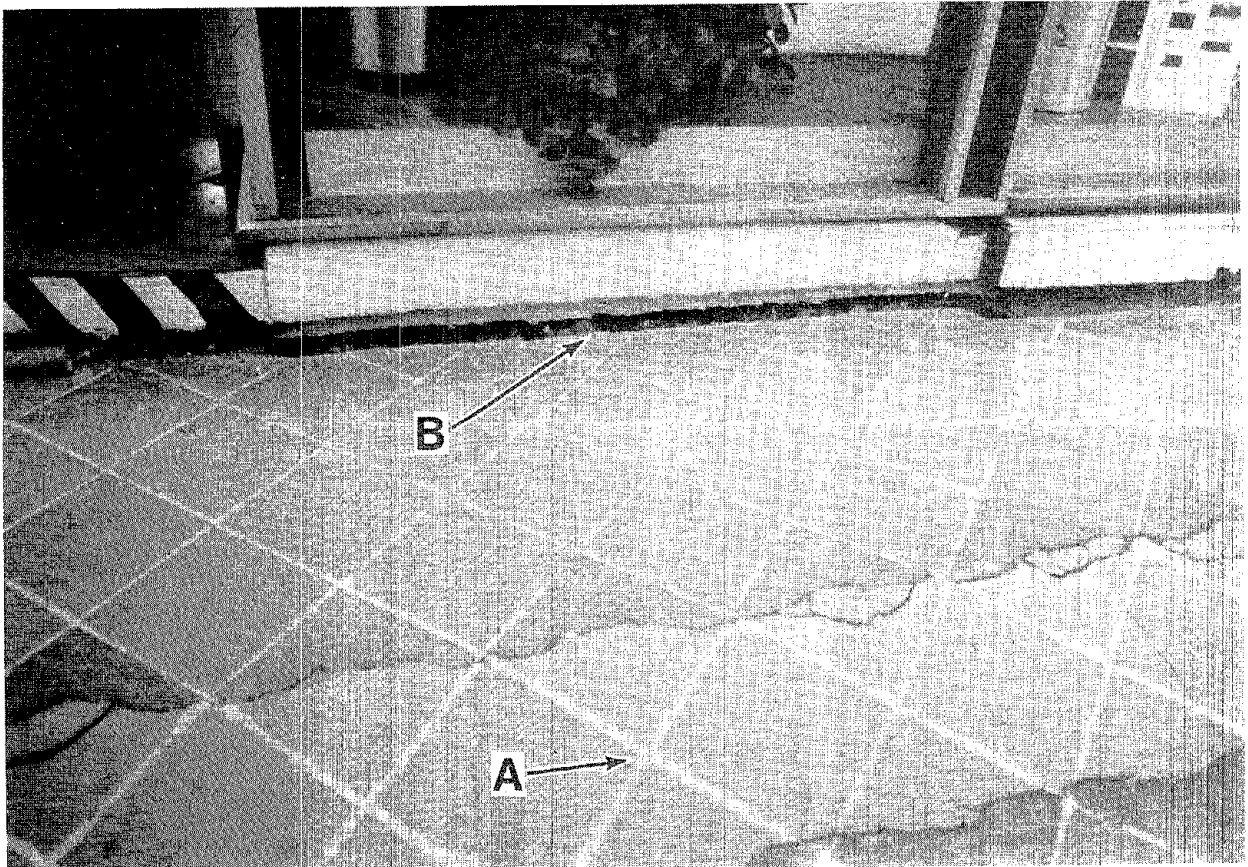
Figure 4.1. Differential displacements at the sidewalk near the Bank of America Building.

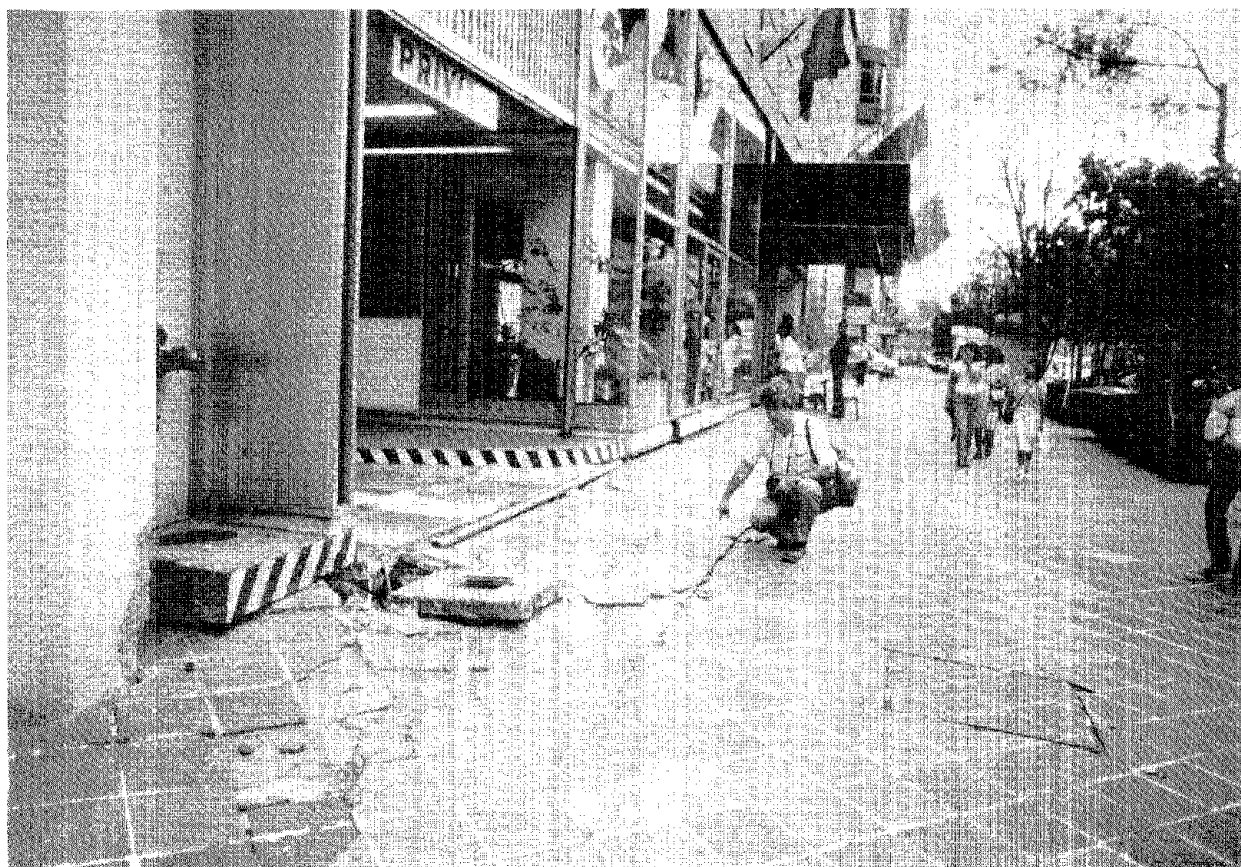
Figure 4.2. Disturbances caused by differential displacement between the sidewalk and the Bank of America Building.

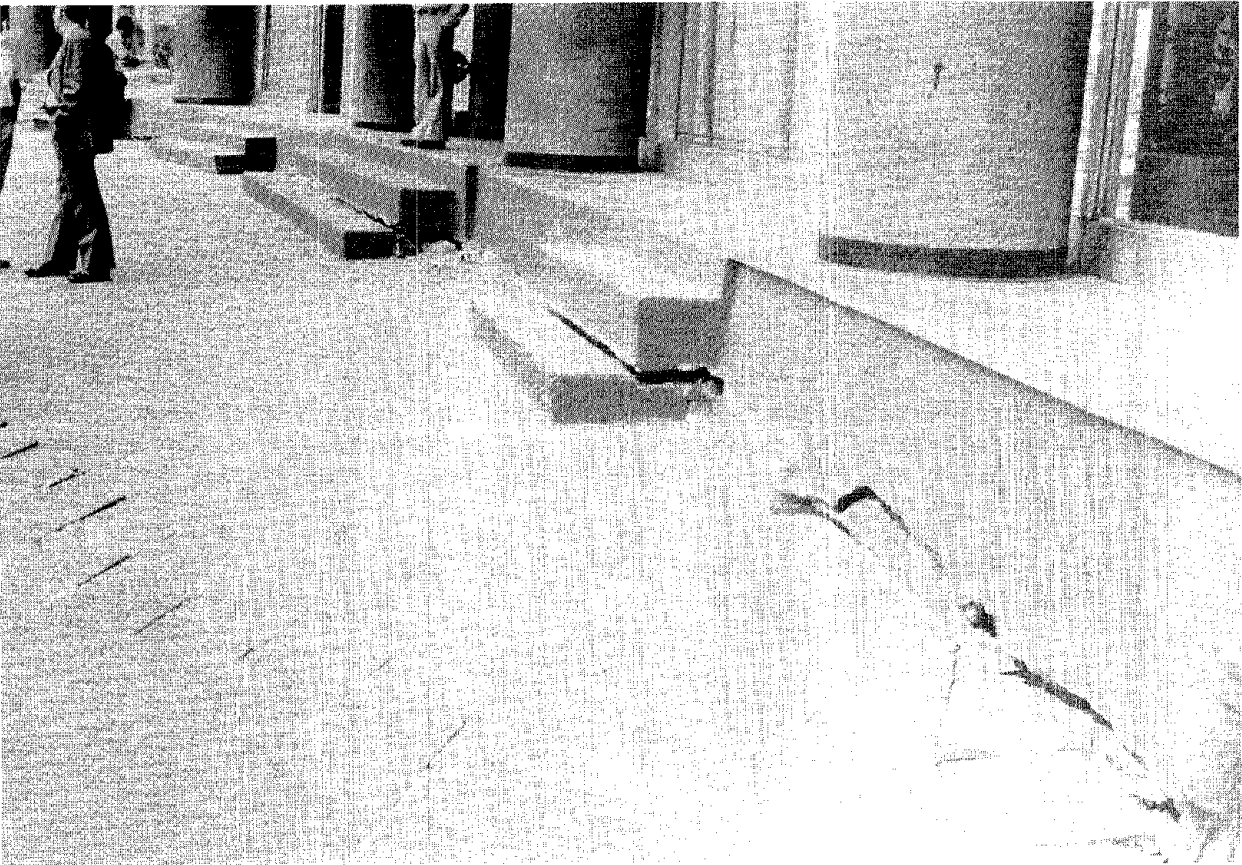
Figure 4.3 Differential displacement between sidewalk and building at the east corner of Versailles and Reforma.

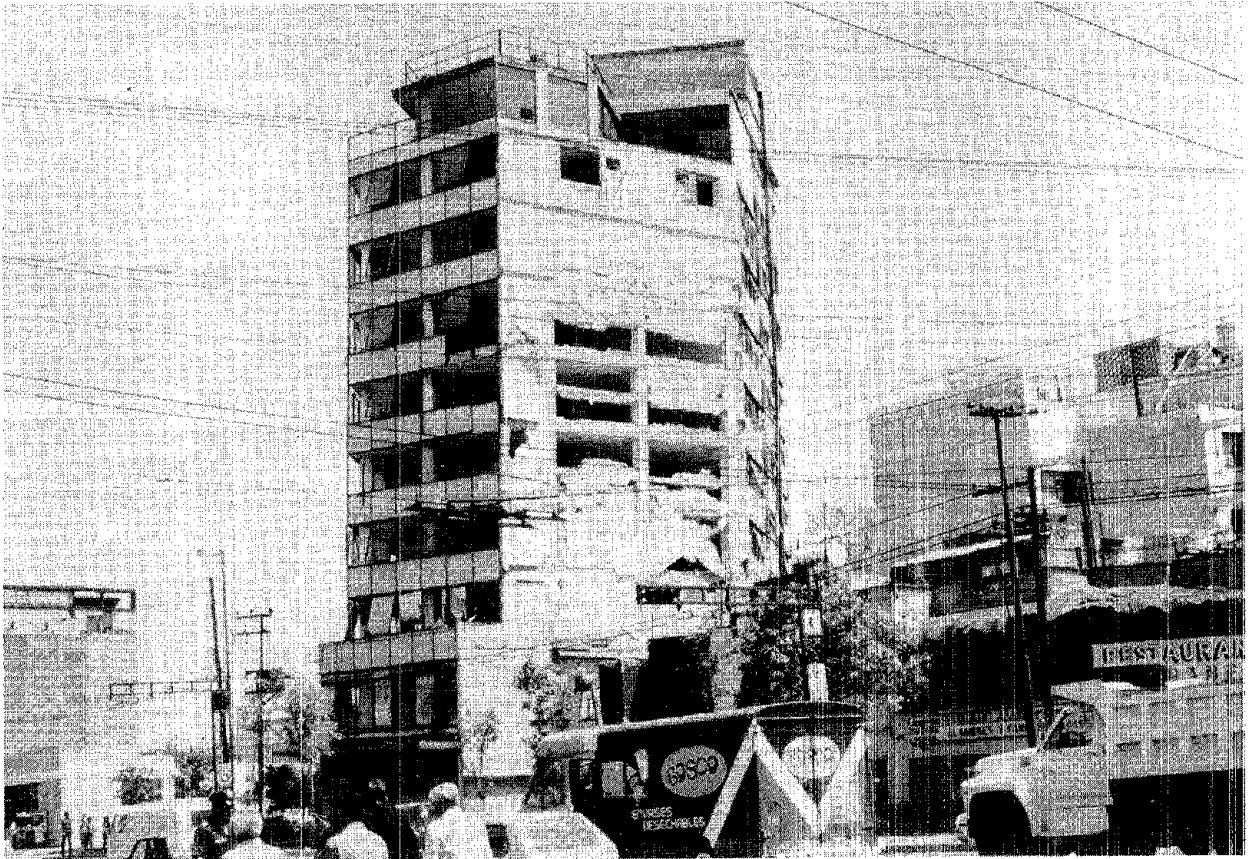
Figure 4.5. Tilted ten story building at Lazaro Cardenas and Fernando.

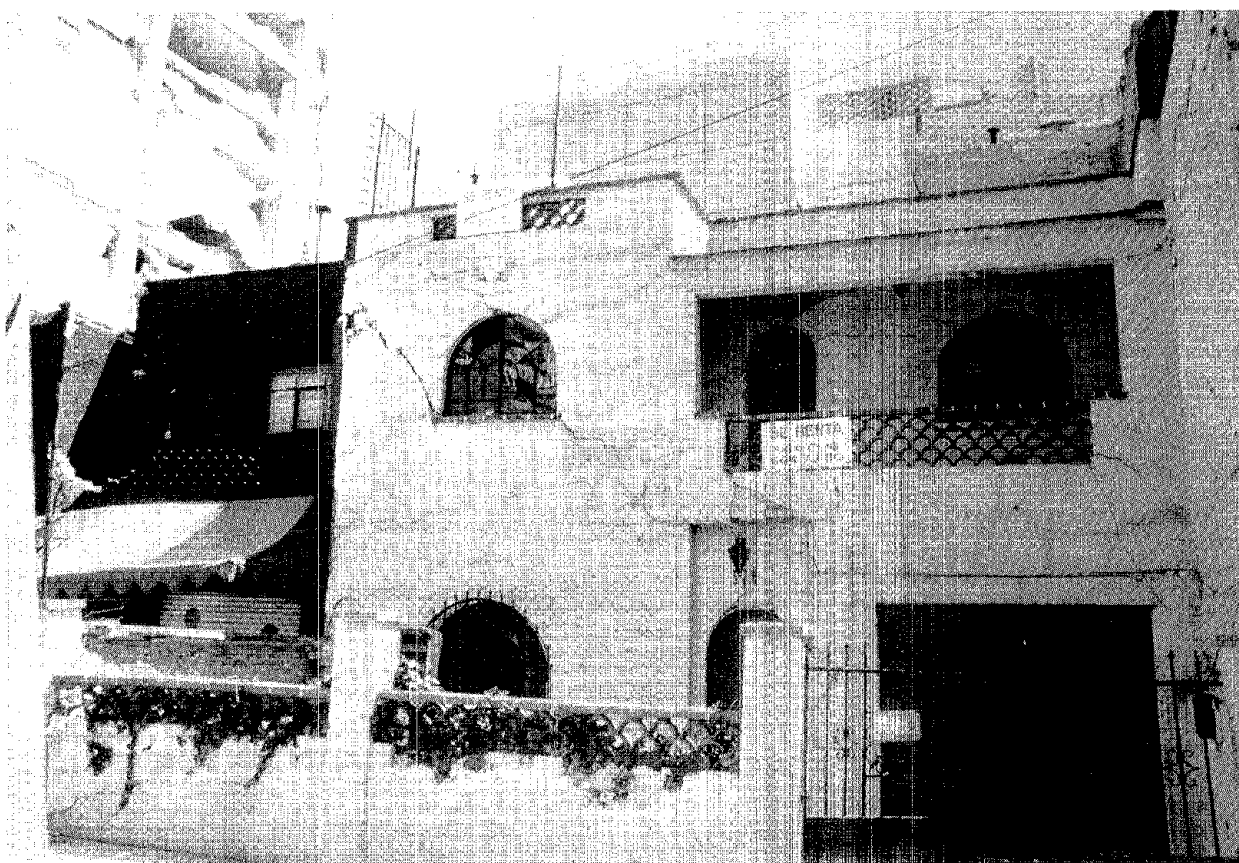
Figure 4.7. Damage to adjacent structures caused by the tilting of a ten story building at Lazaro Cardenas and Fernando.

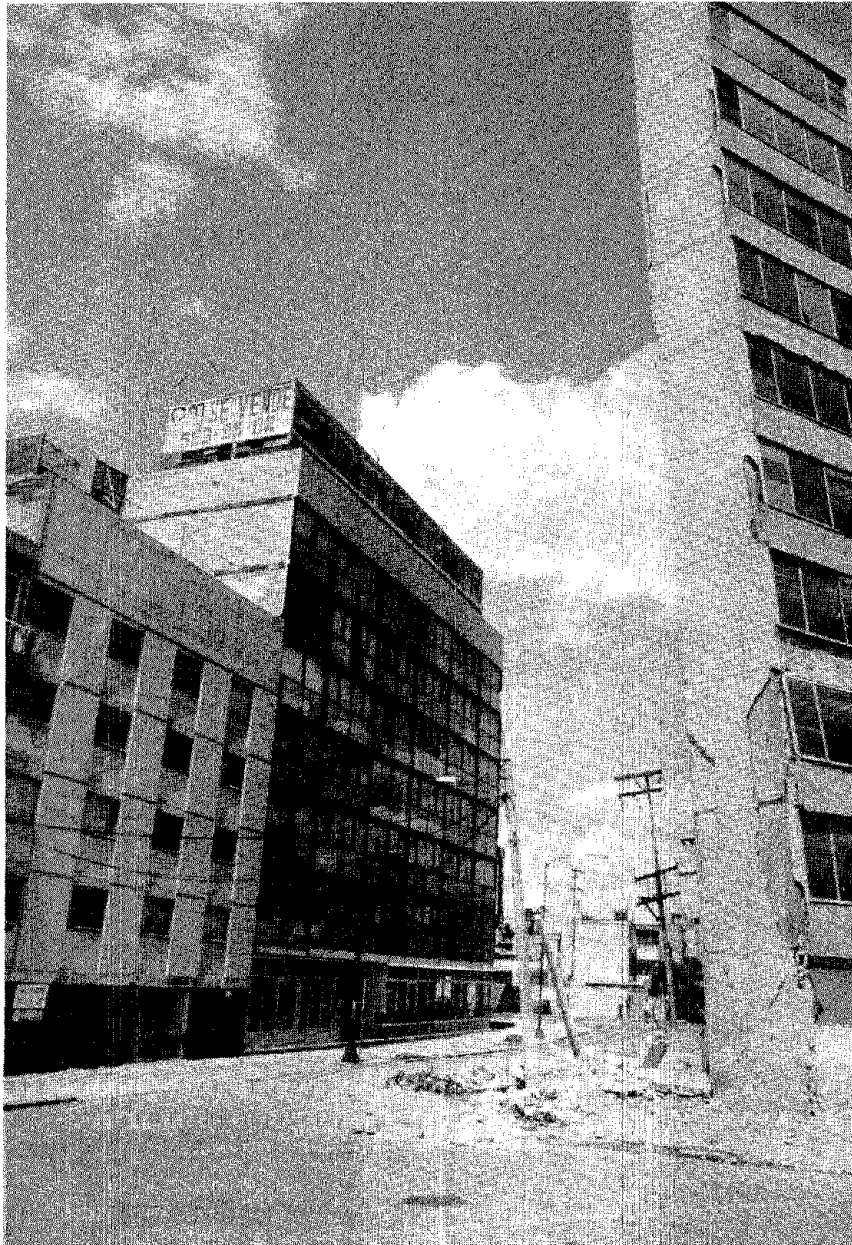
Figure 4.8. Tilted ten story building at University and Xola.

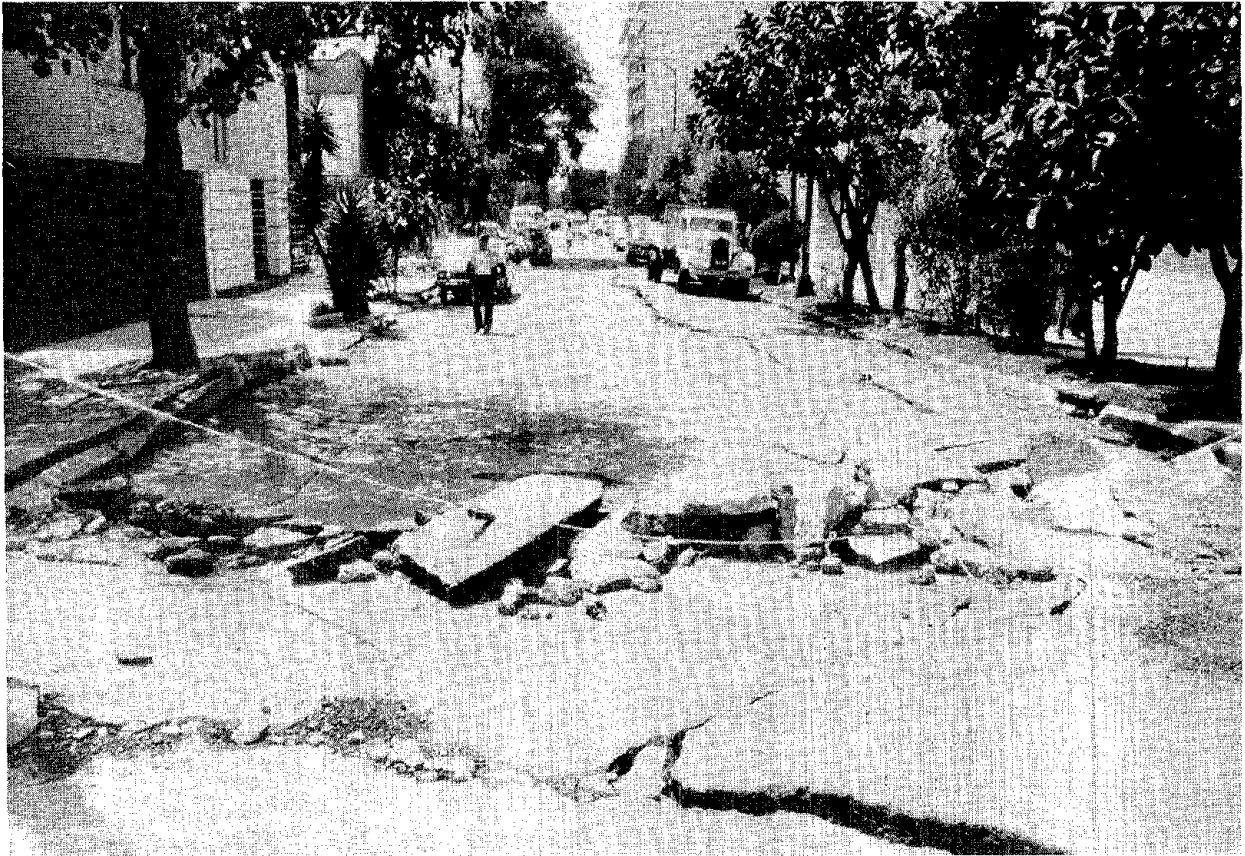
Figure 4.10. Ground disturbance on Galacia viewed from intersection of Toledo in a westerly direction.

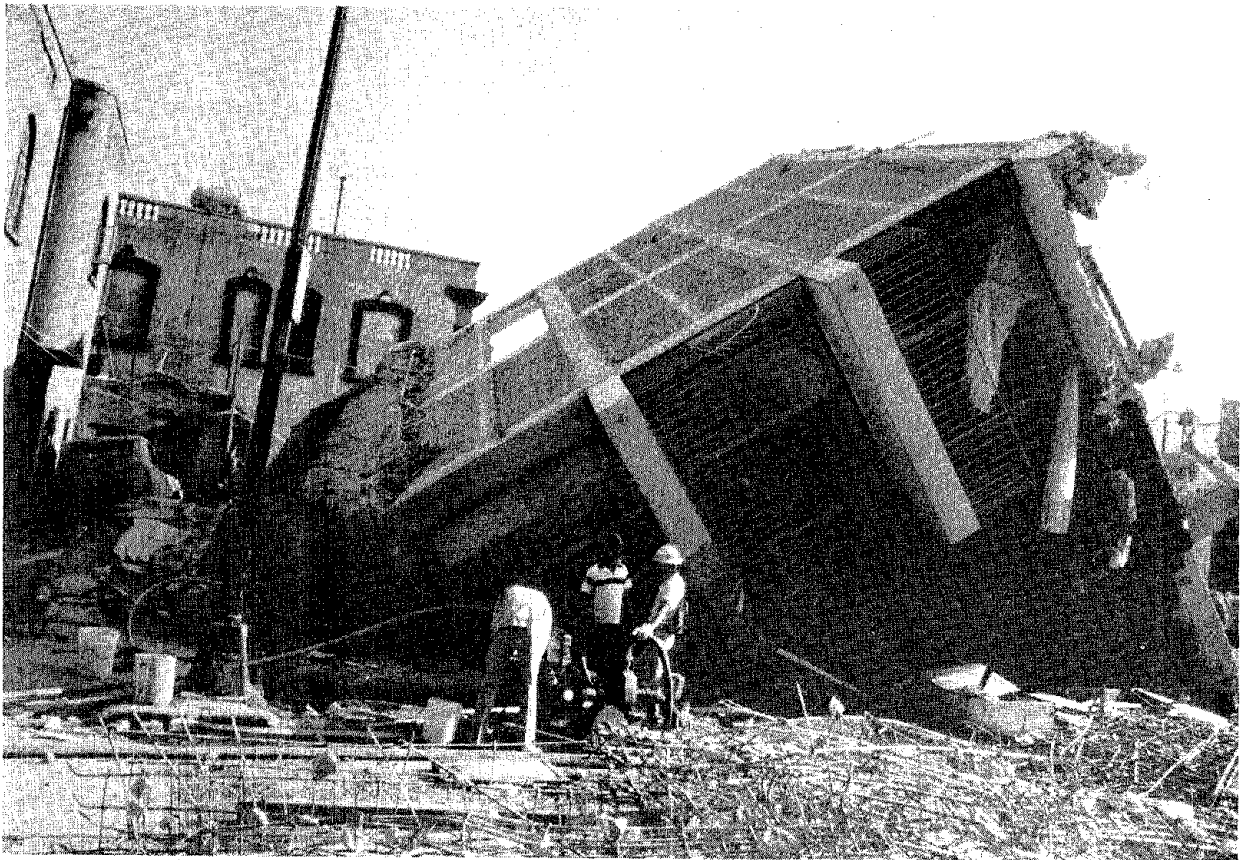
Figure 4.11. Oveturned building at southeast corner of Zacatecas and Orizaba.

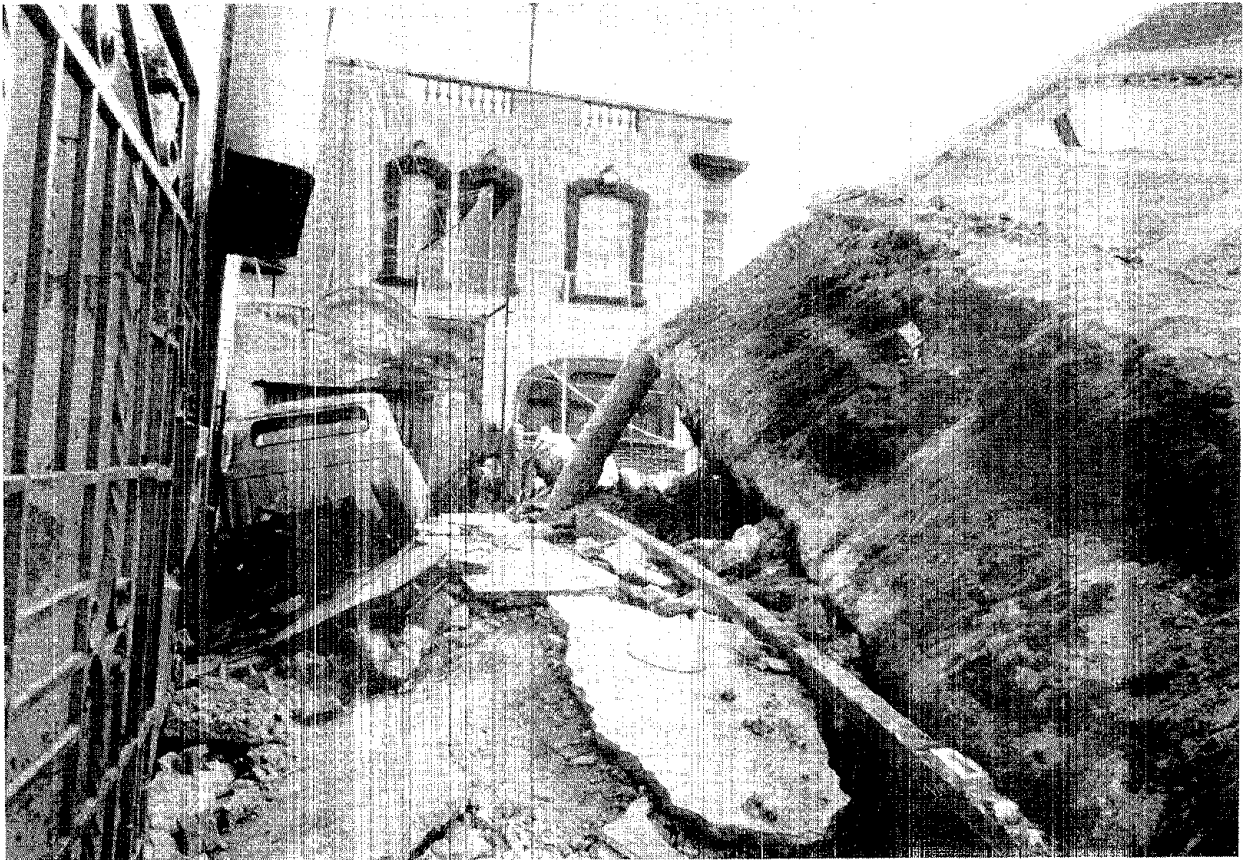
Figure 4.12. Exposed foundation of overturned building at Zacatecas and Orizaba.

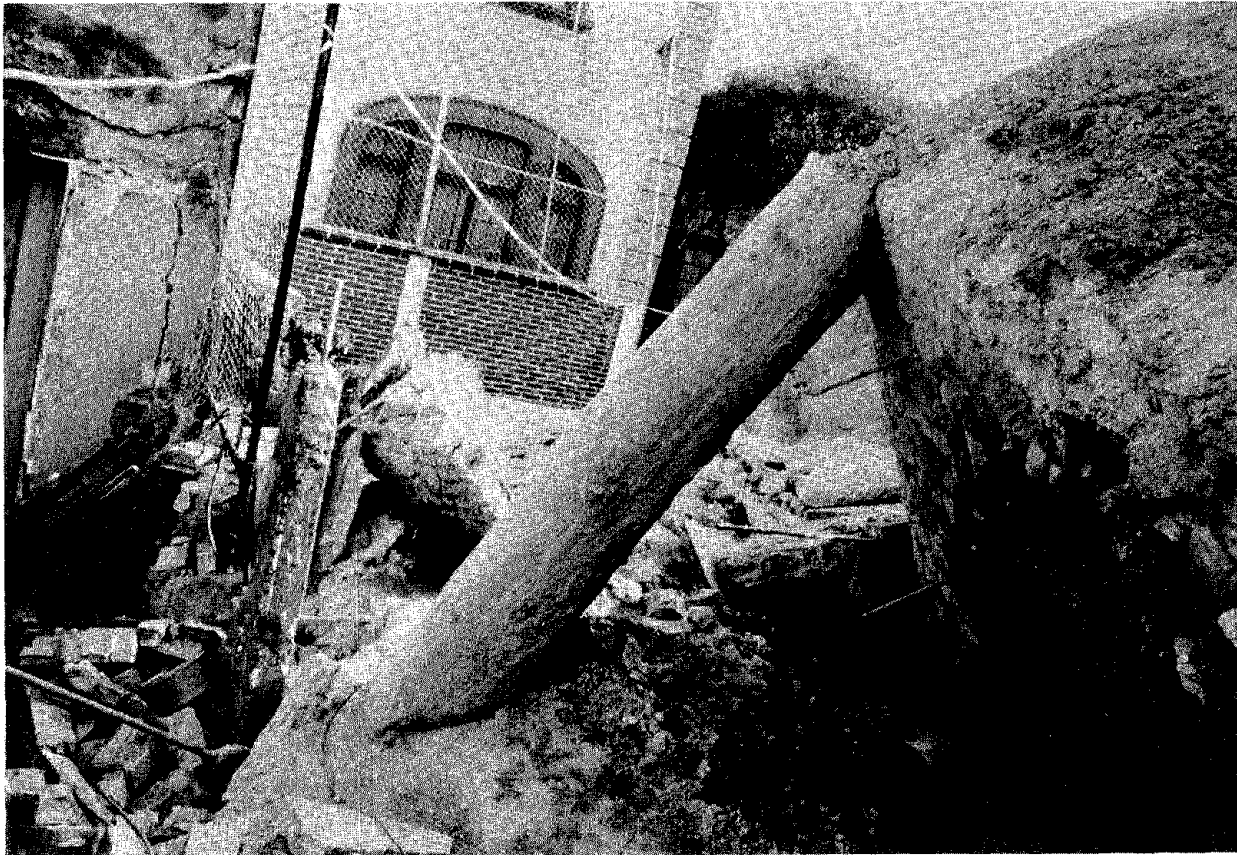
Figure 4.13. Exposed pile and dowels of the foundation of overturned building at Zacatecas and Orizaba.

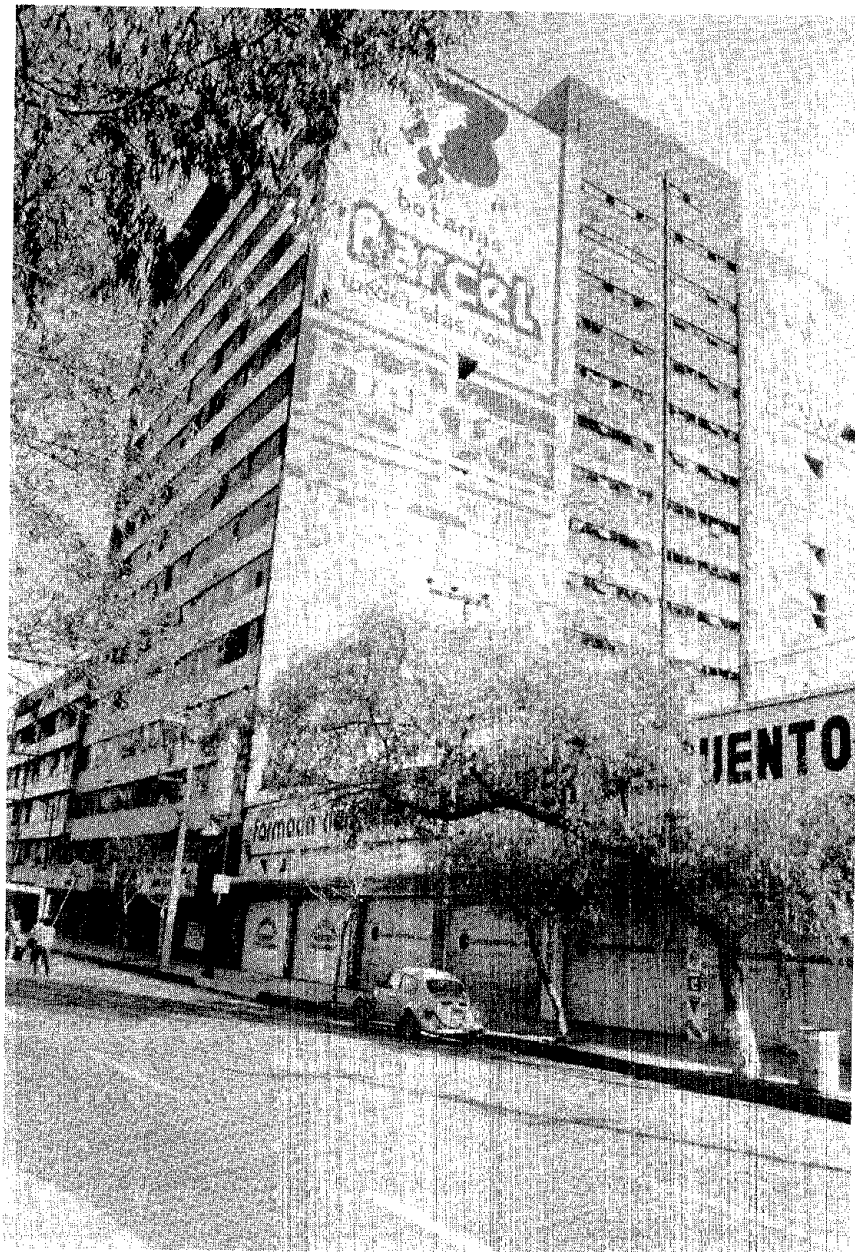
Figure 4.14. Building on the south side of Teresa de Mier which settled in one corner.

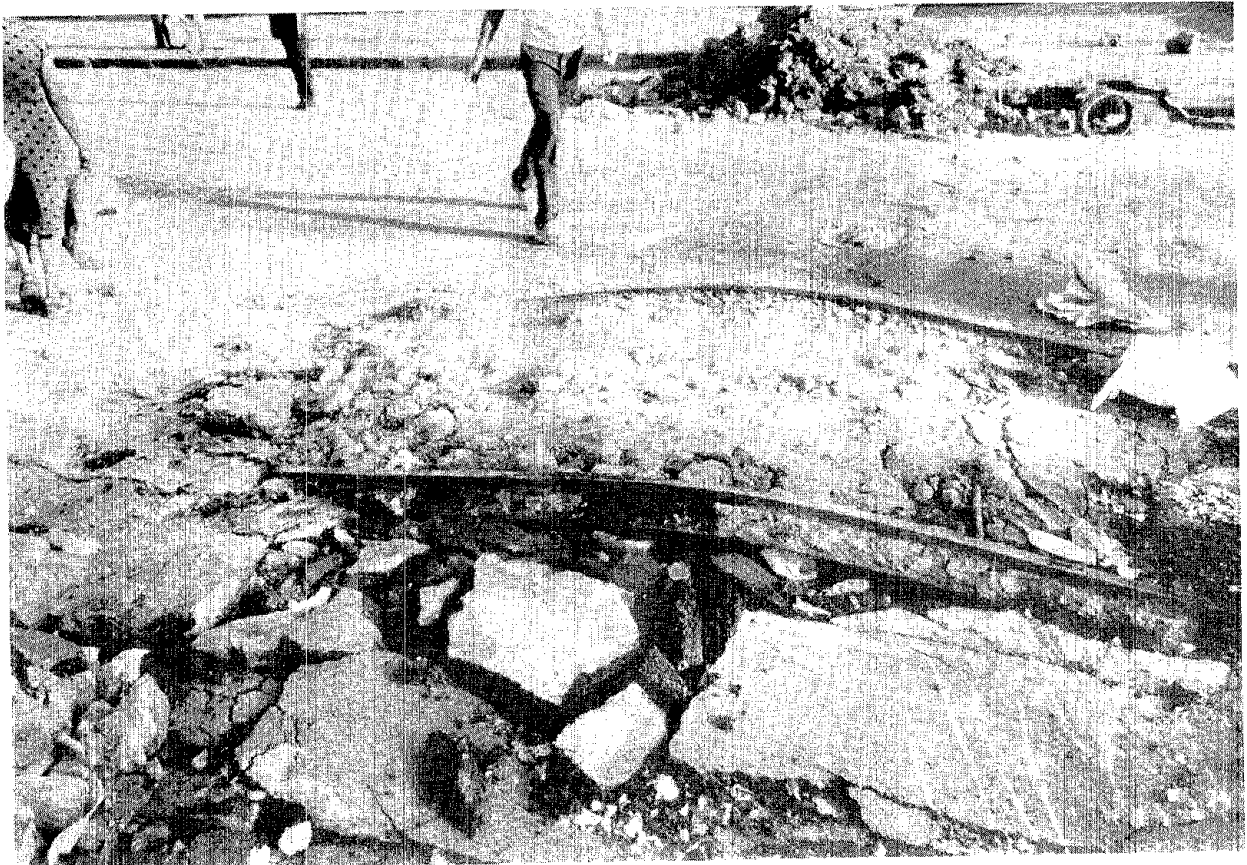
Figure 4.17. Buckled old trolley line on Obregon.

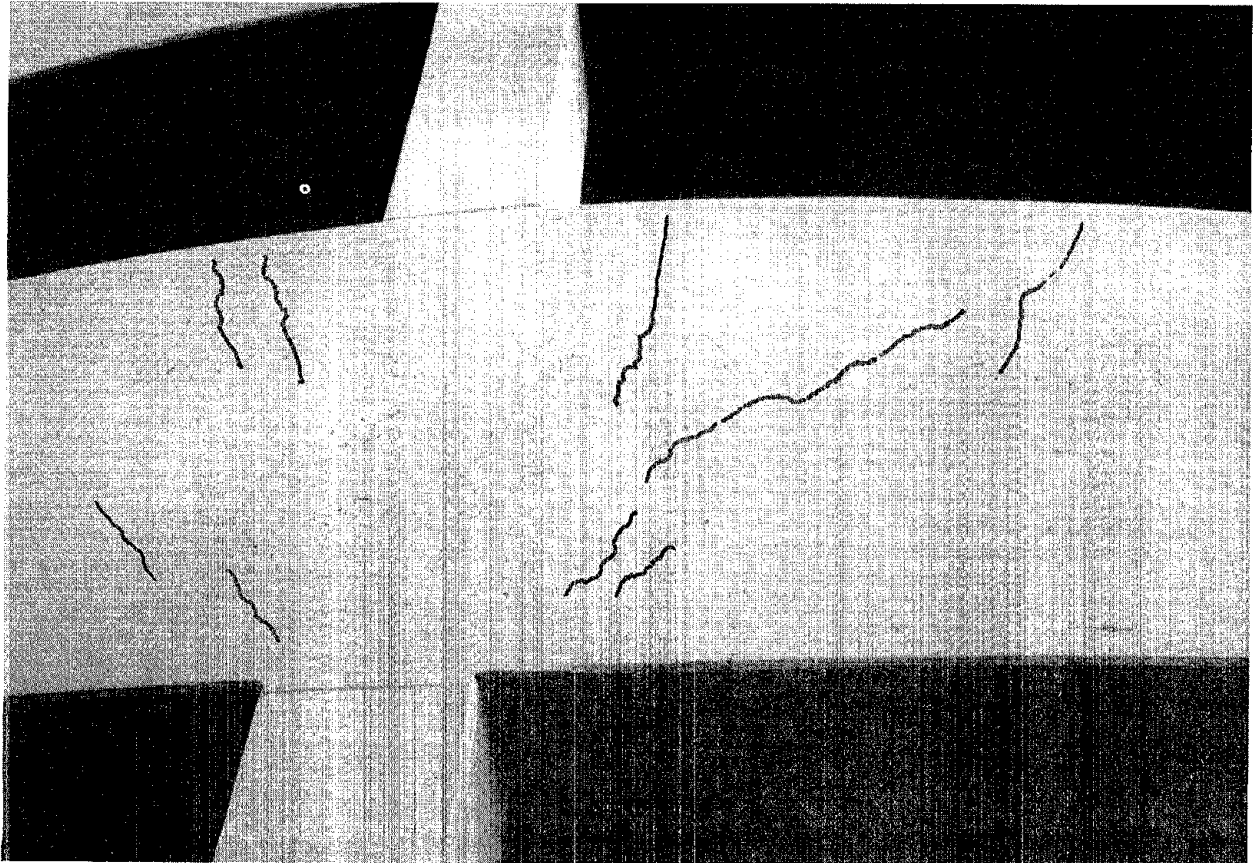
Figure 5.8. Pattern of hairline cracks near the beam column connection of the parking garage (cracks were highlighted for better visibility).

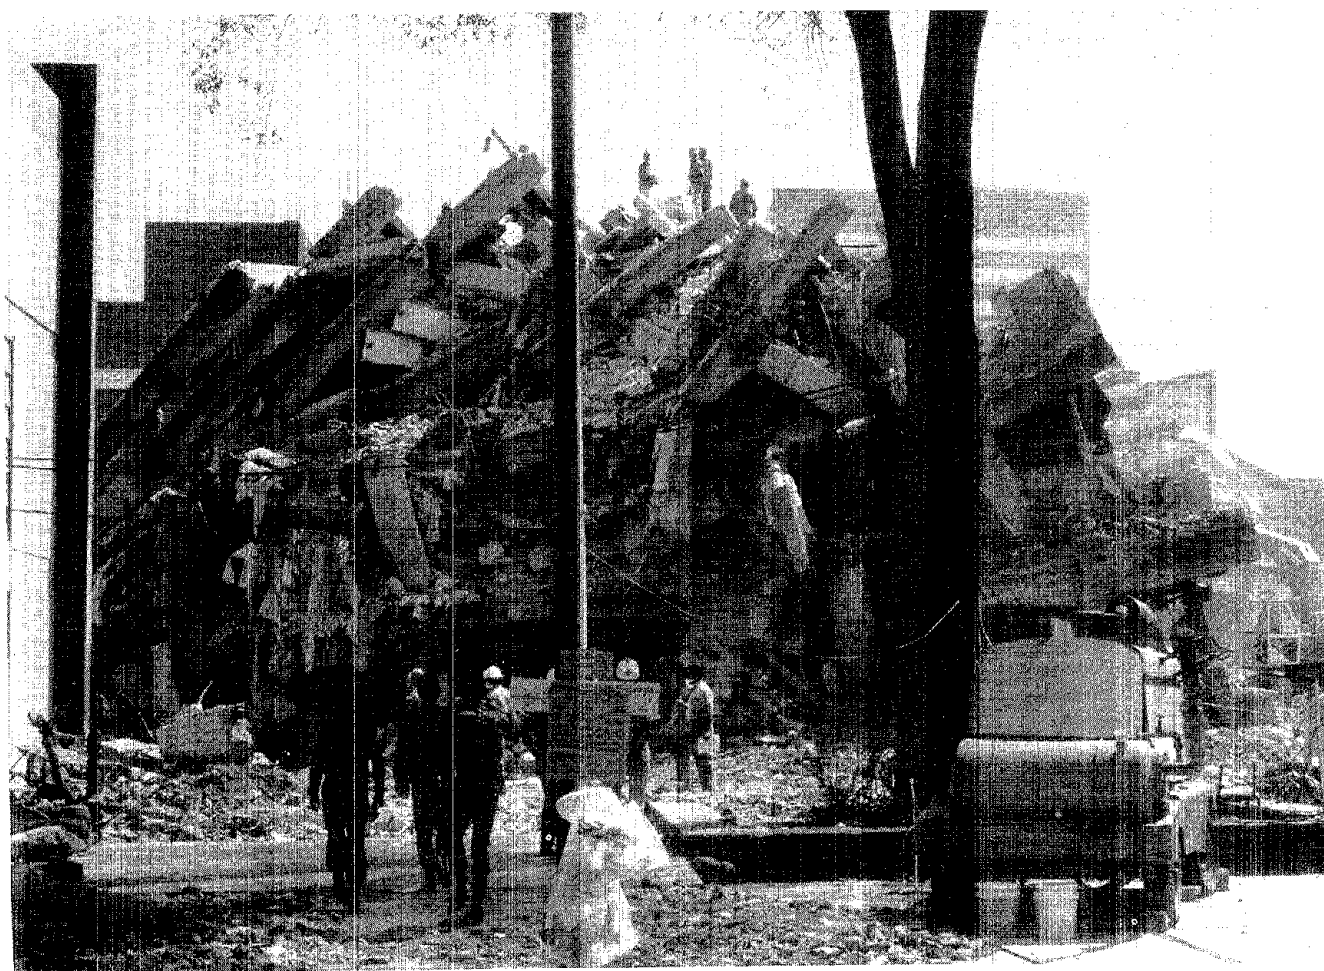
Figure 5.9. View of collapsed maternity wing of the Juarez Hospital looking south.

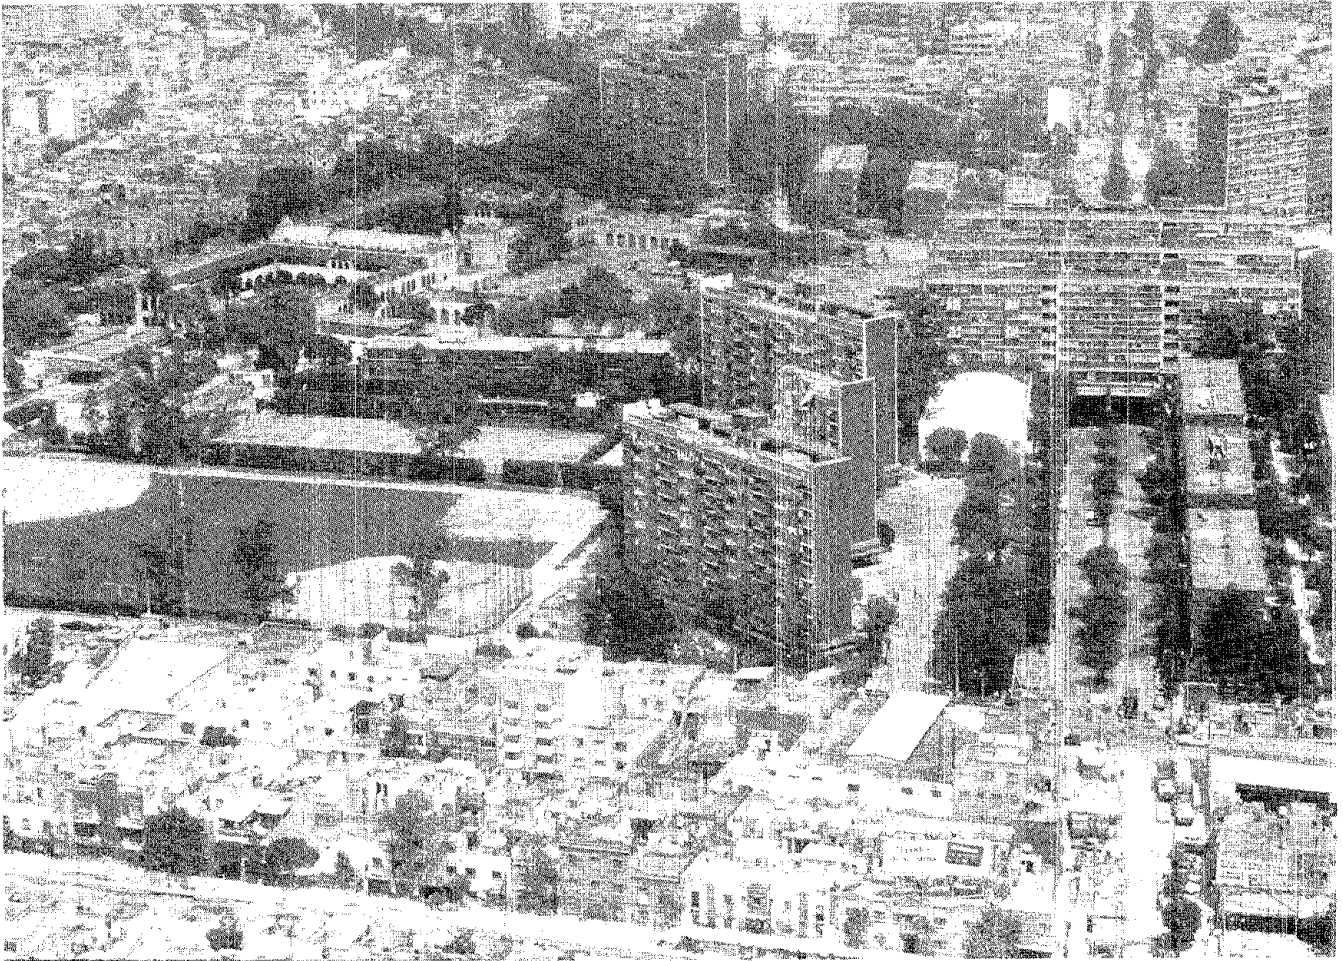
Figure 5.14. Damaged Urbana Juarez Apartment Complex west of General Hospital.

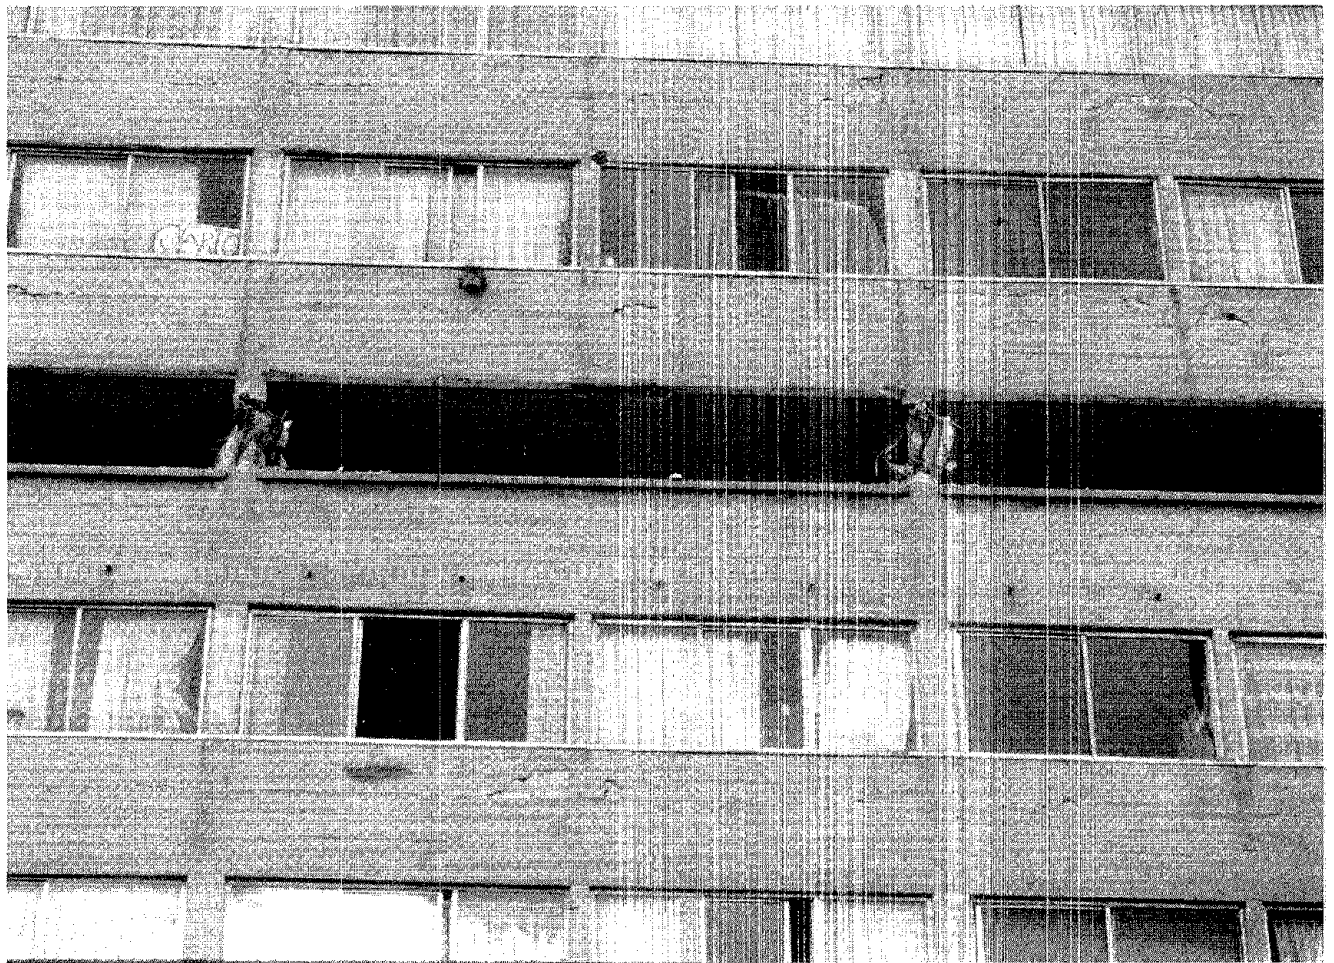
Figure 5.33. Failures in columns of the southern Nuevo Leon apartment tower (the only unit of the group of three to remain standing).

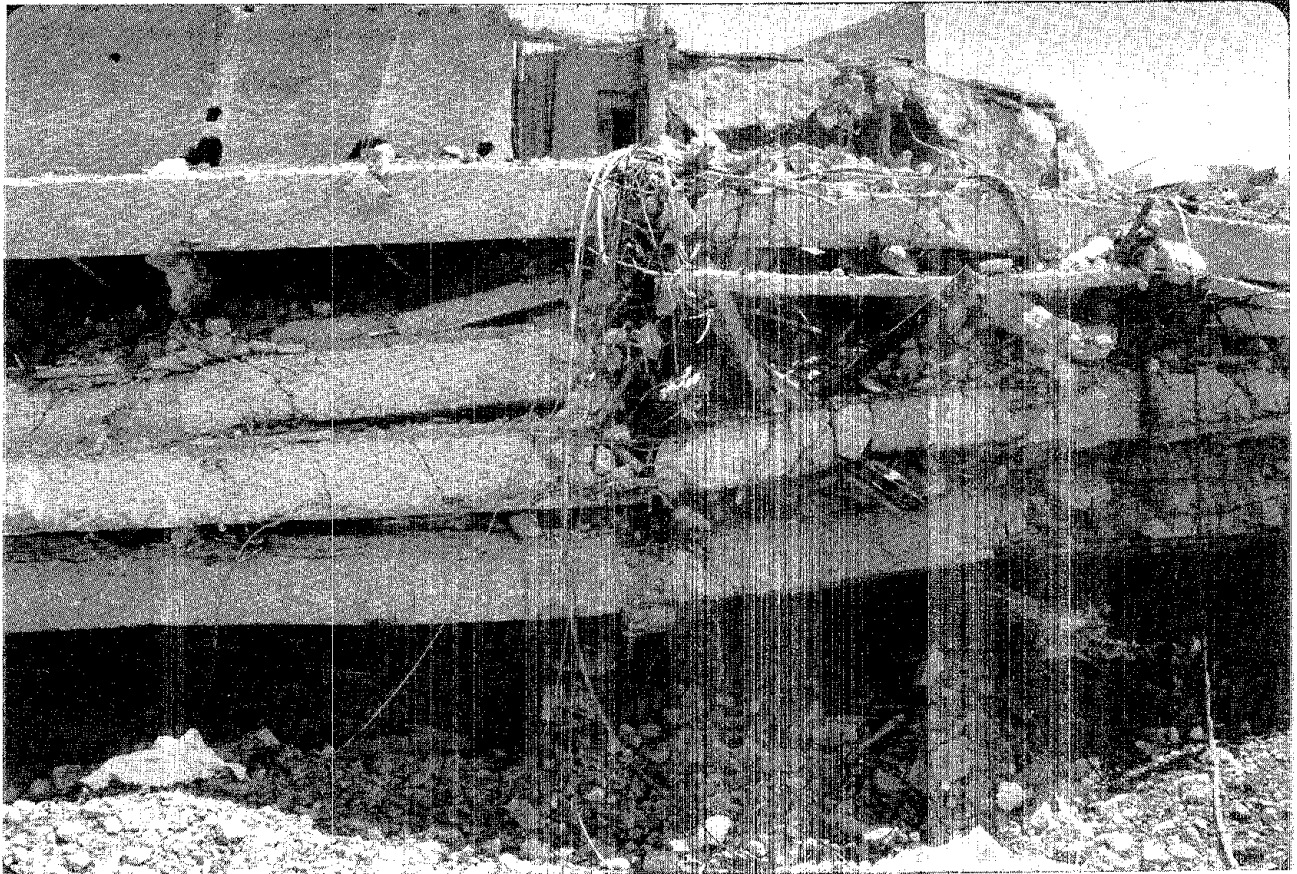
Figure 5.34. Collapsed office building near the corner of Neva and Barragan Streets.

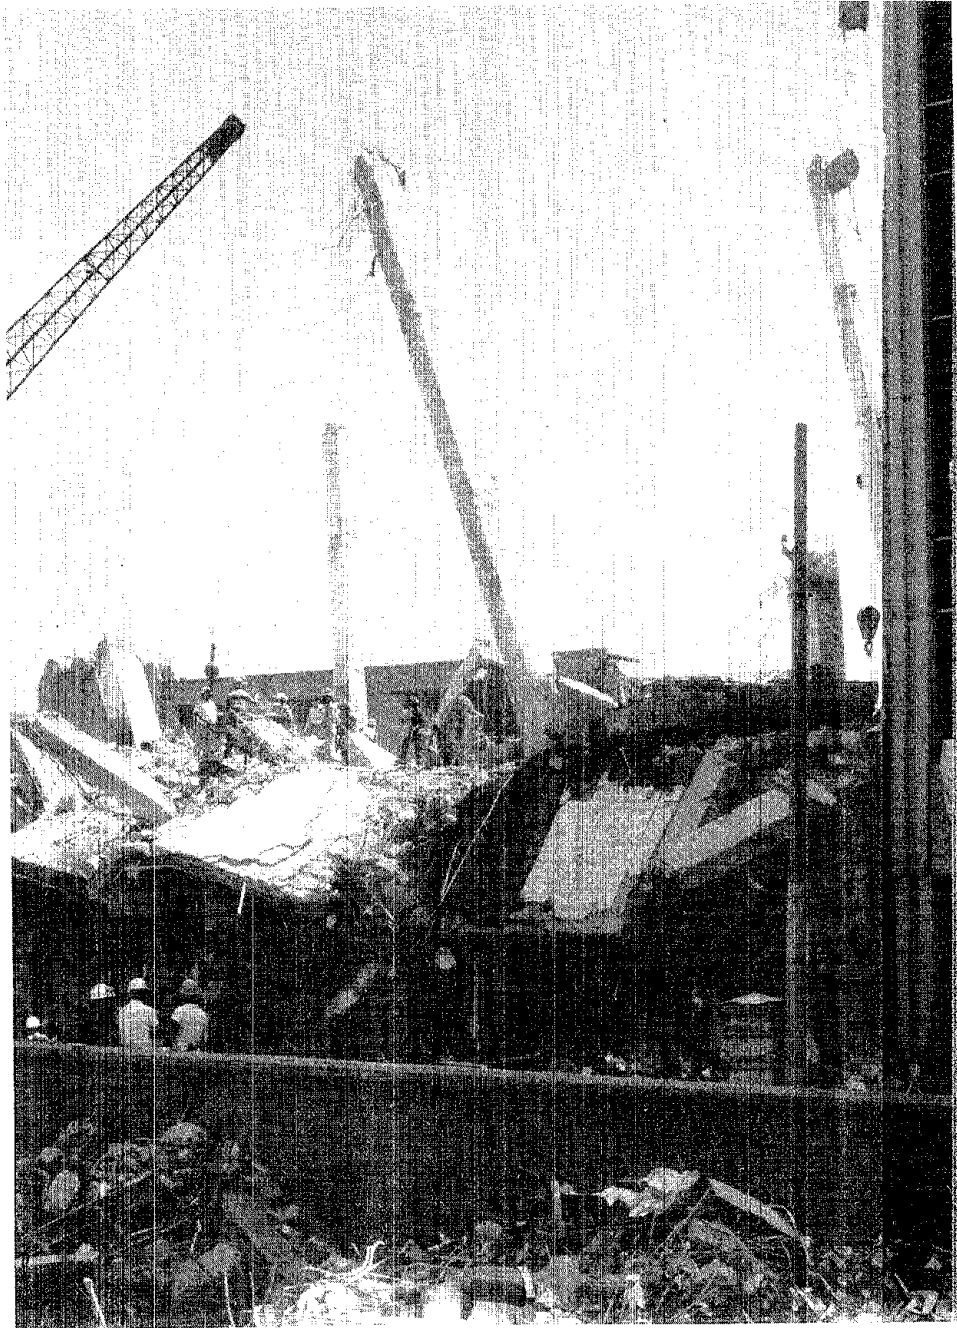
Figure 5.36. Punching shear failure of the 10 story Bancomer Building.

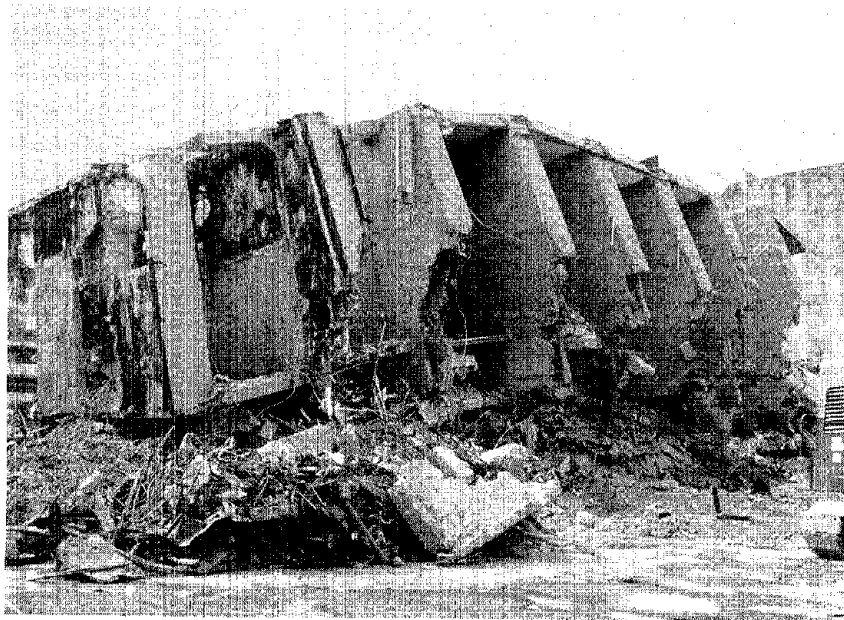
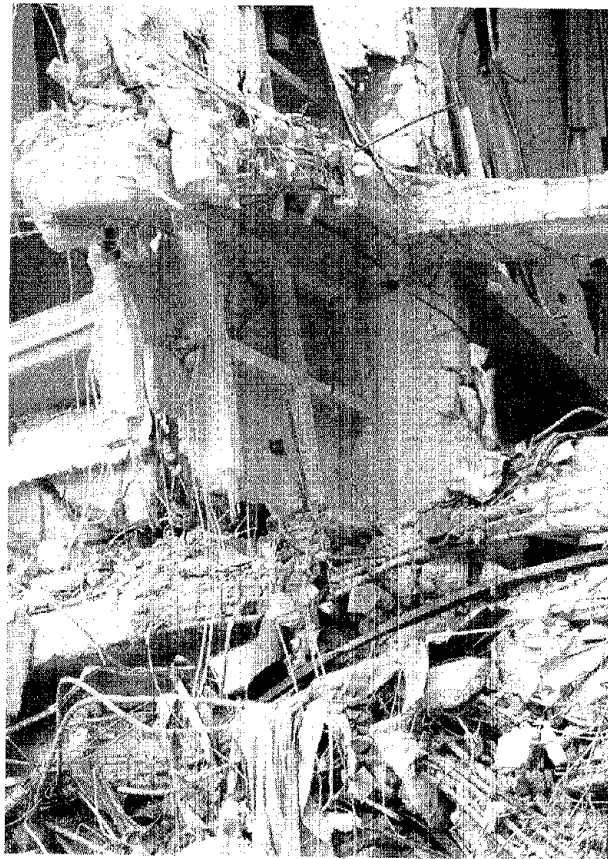
Figure 5.39. Collapsed 10 story apartment building in the corner of Dinamarca and Chapultepec. This waffle slab structure failure is attributed to base column failure and possible pounding with the neighboring structure.

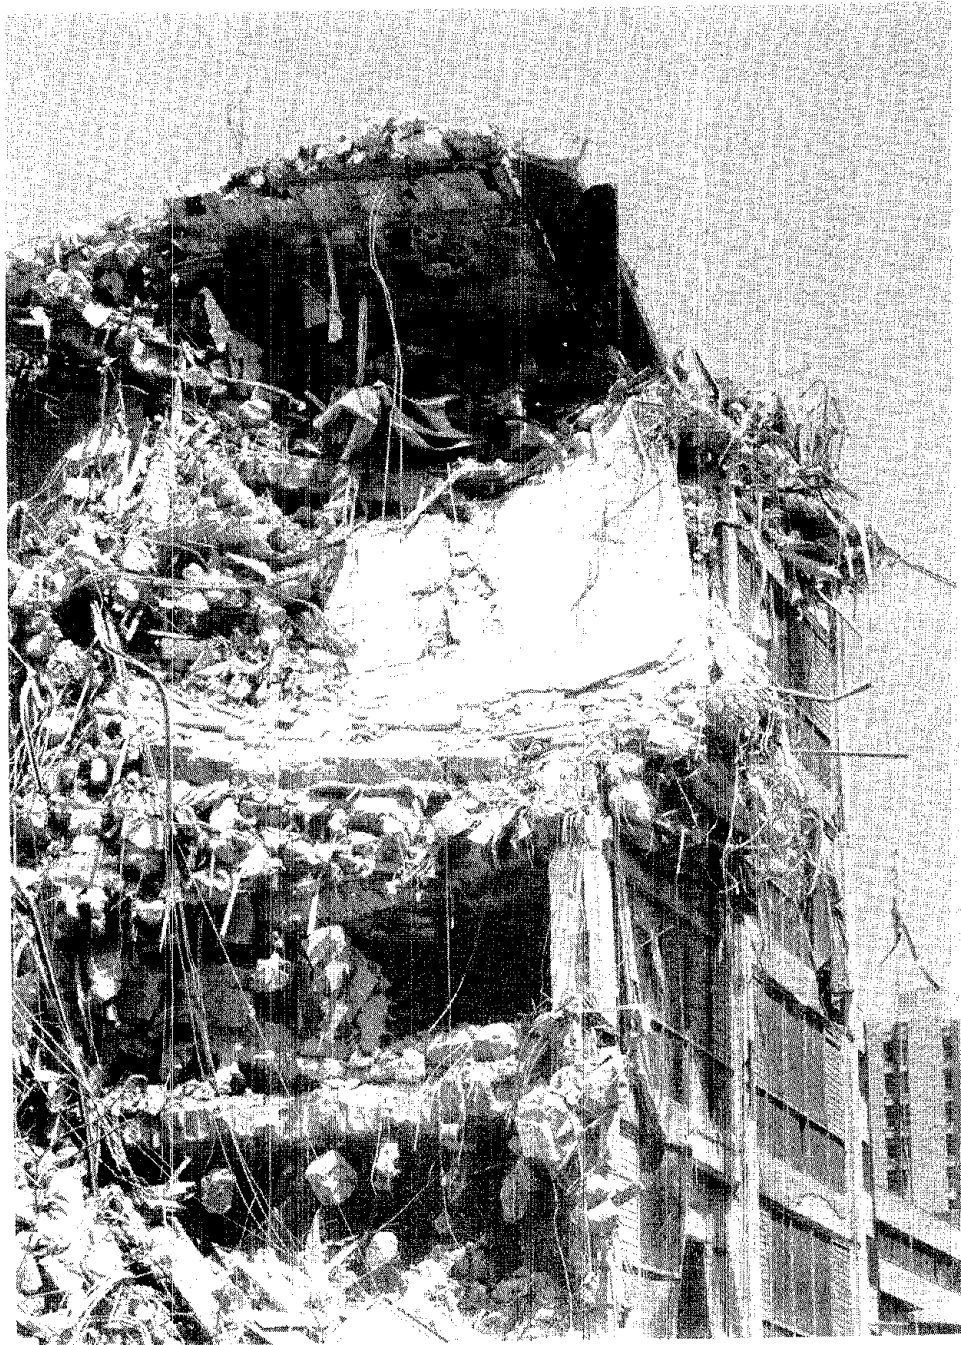
Figure 5.42. The "floor dropout" phenomenon observed in waffle slab structures with concrete block for pan forming.
