NBS BUILDING SCIENCE SERIES 165

**Engineering Aspects
of the September 19, 1985
Mexico Earthquake**

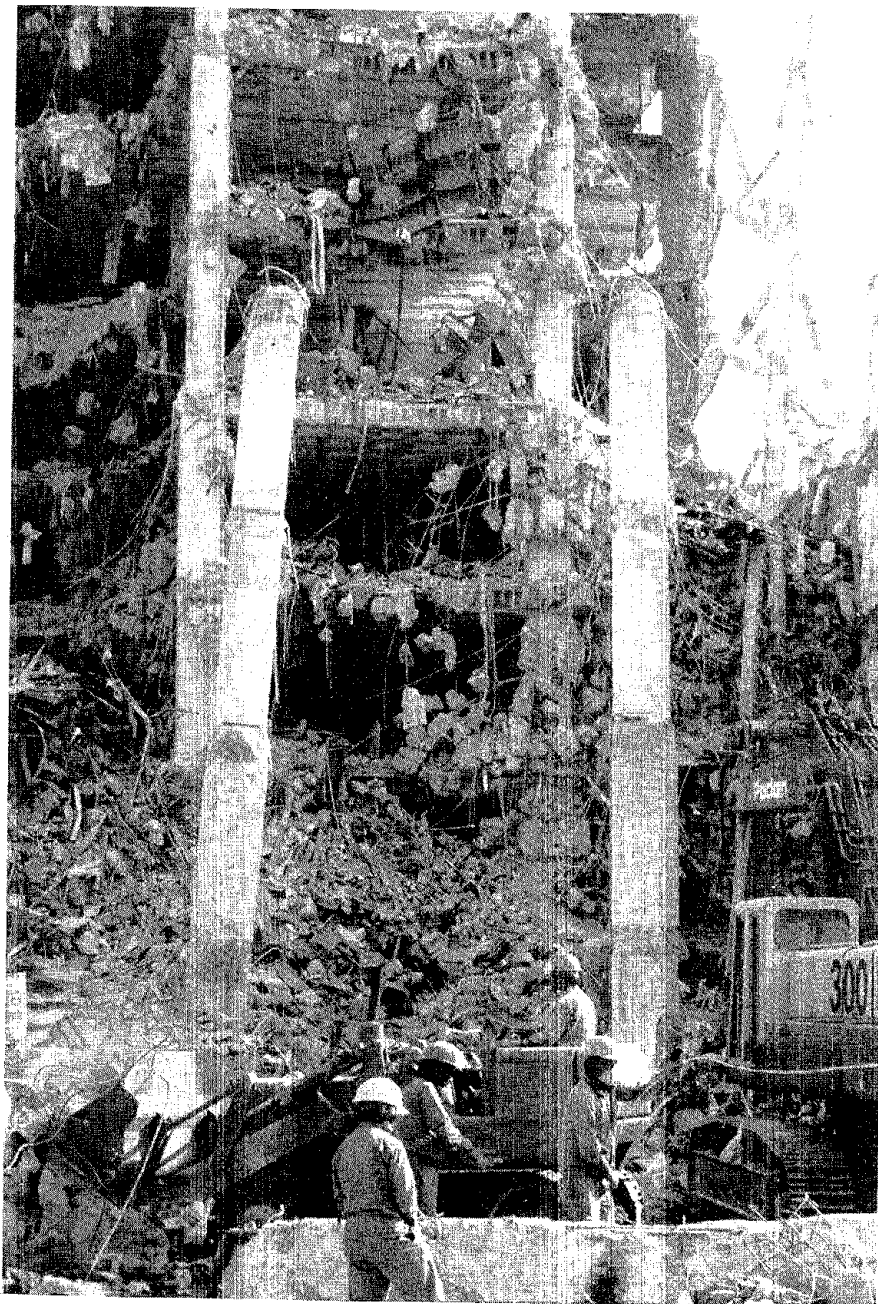
Figure 5.43. Punching shear failure in concrete-cinder block floor.

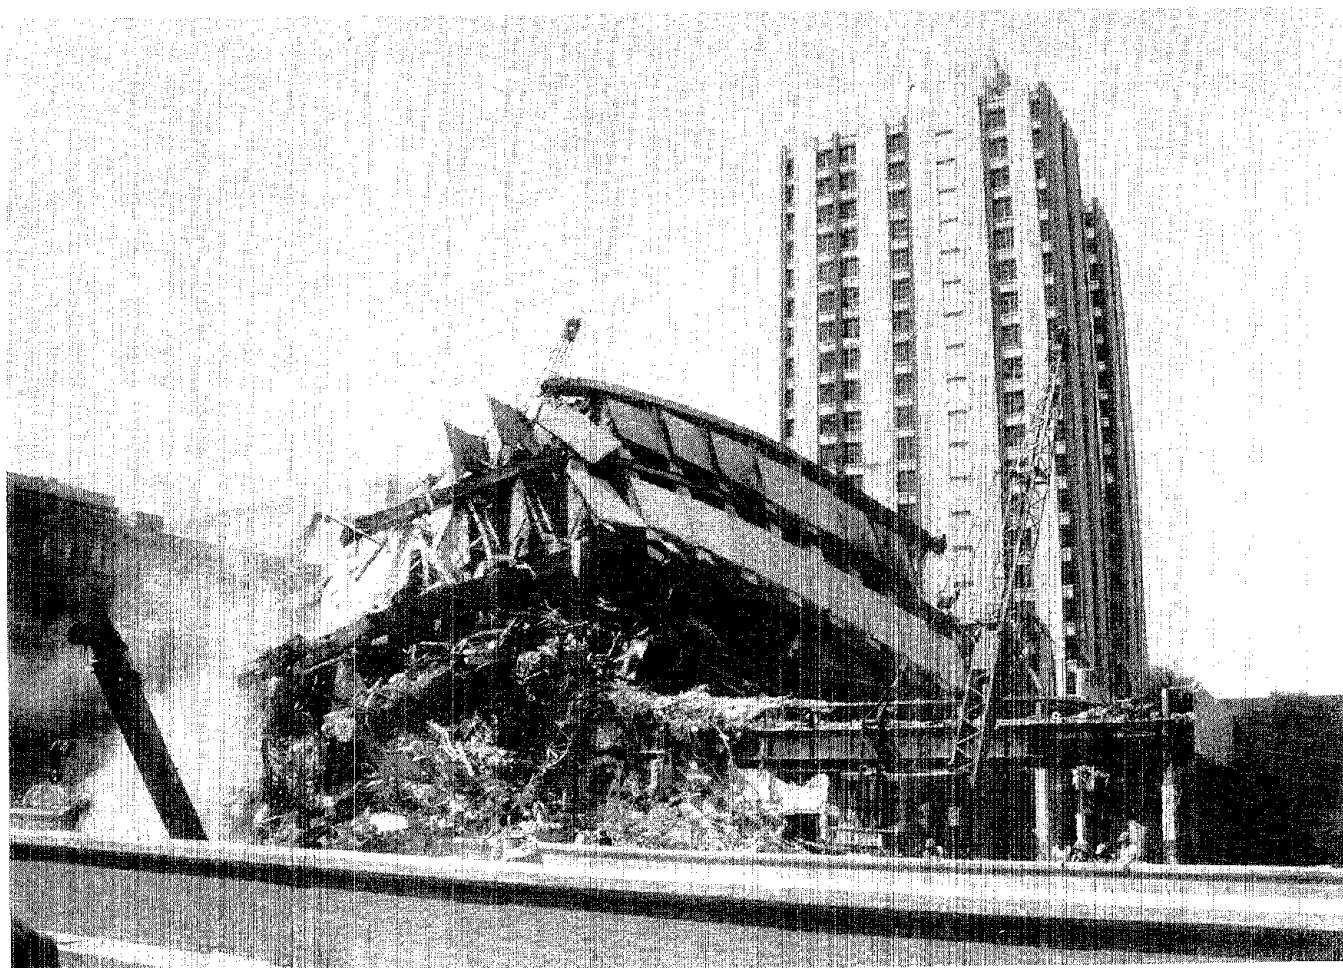
Figure 5.44. Southern towers of the Consumo Pino Suarez Complex shortly after collapse.

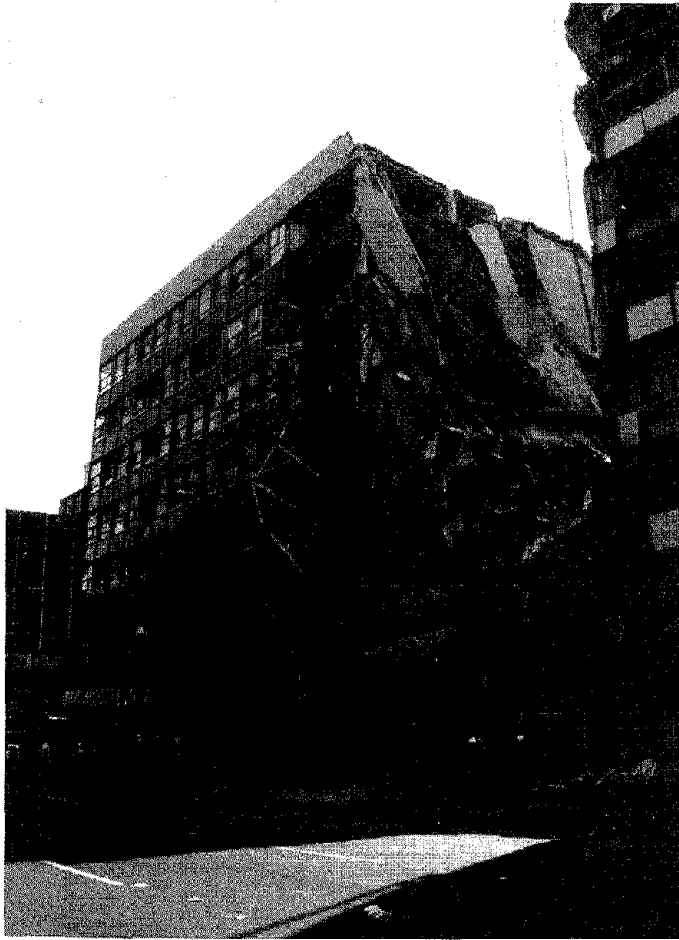
(a) Seven story office building on Ave. 20th de Novembre which collapsed due to pounding.

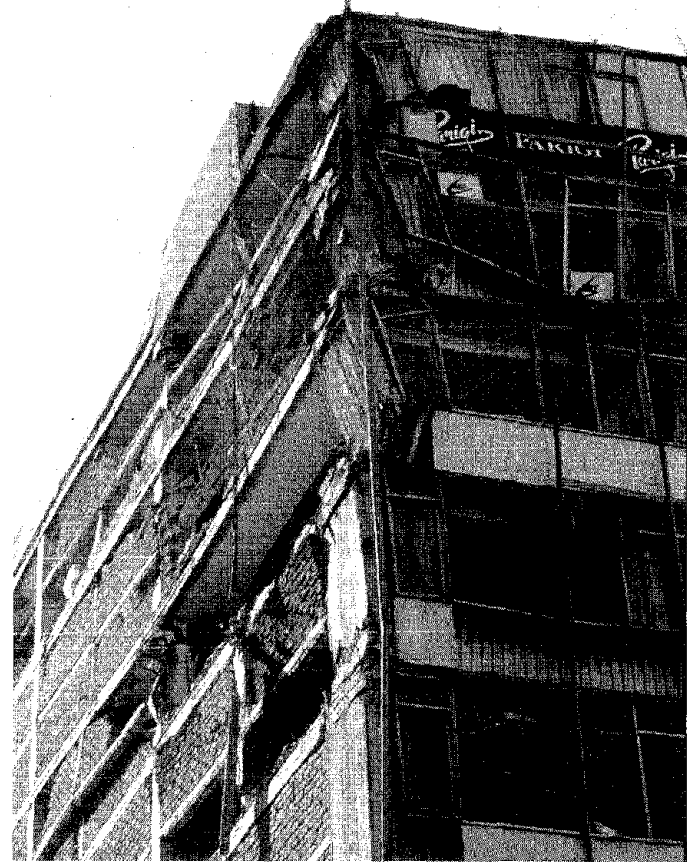
(b) Neighboring nine story building showing impact damage to columns.

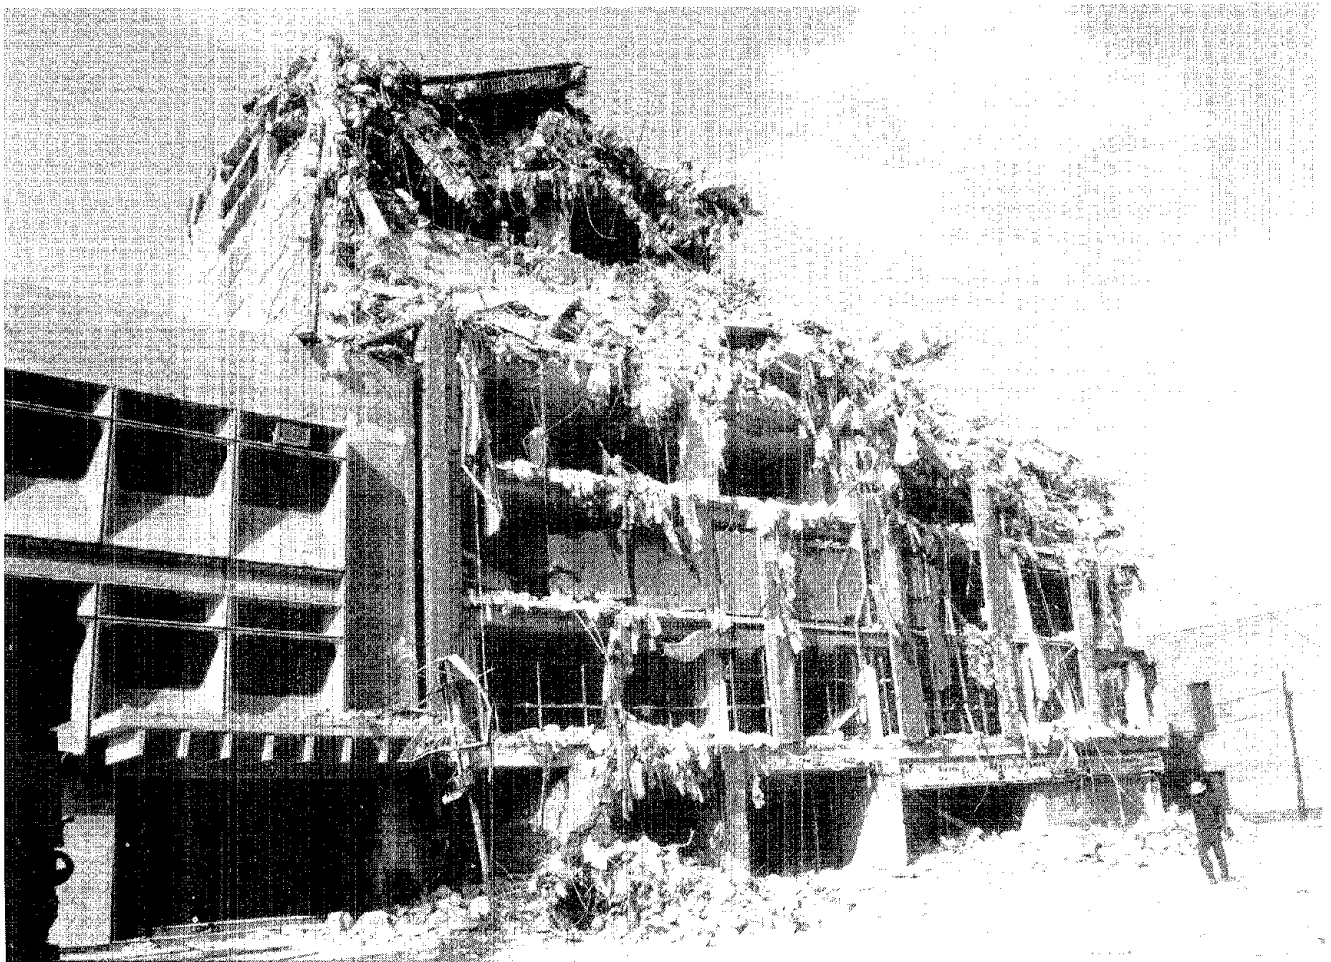
Figure 5.59. Pounding damage between buildings of dissimilar heights and stiffnesses. The upper floor of this 9-floor clothing store collapsed following pounding with its much stiffer neighboring 3-story structure. The separation between the structures was approximately 10 cm.

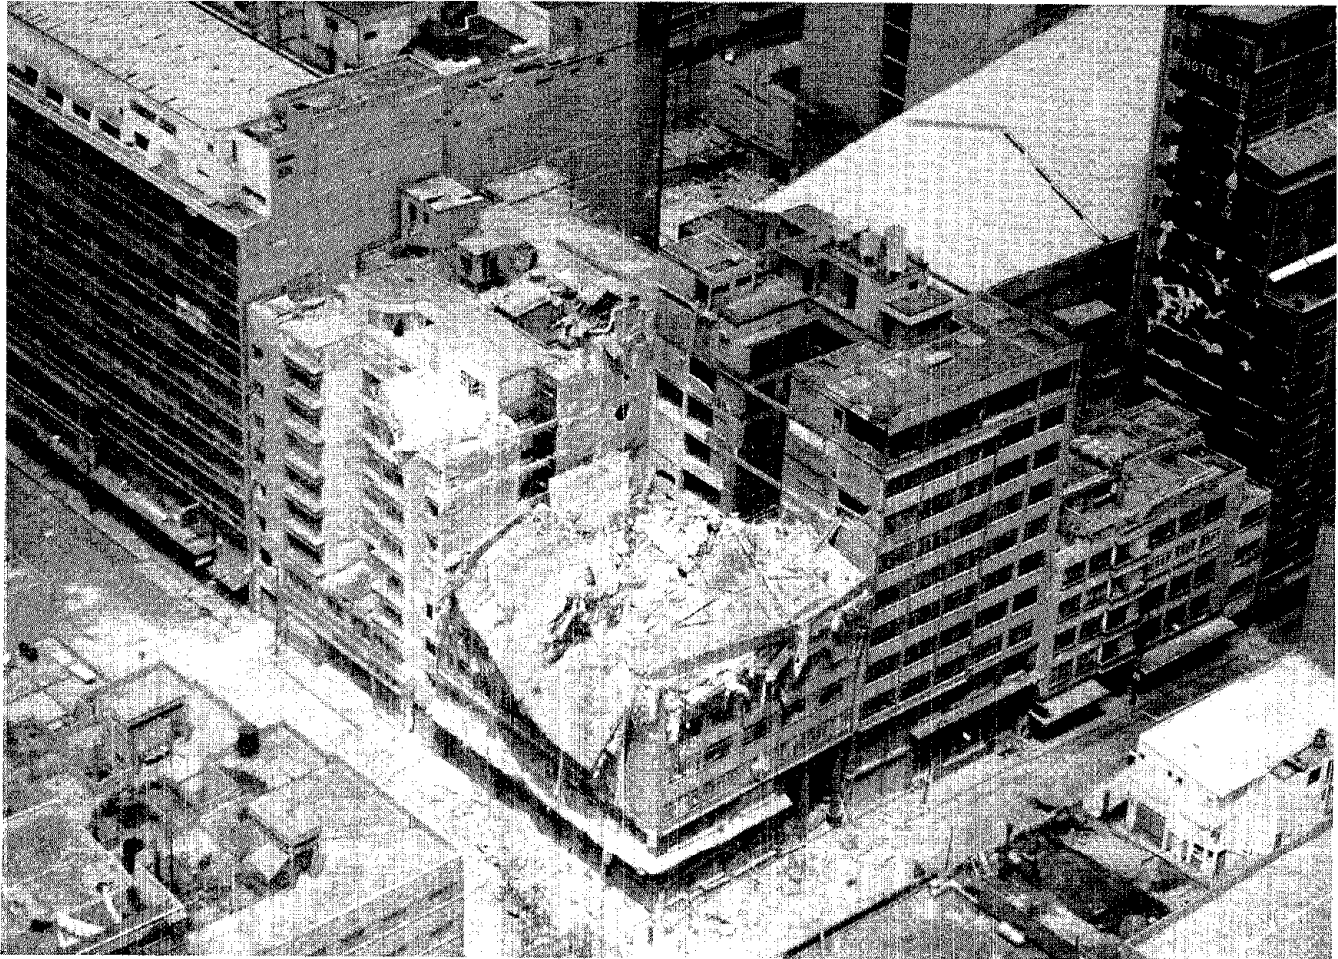
Figure 5.66. Torsionally induced pounding in corner building south of Alameda Park, near Torre Latino Americana.

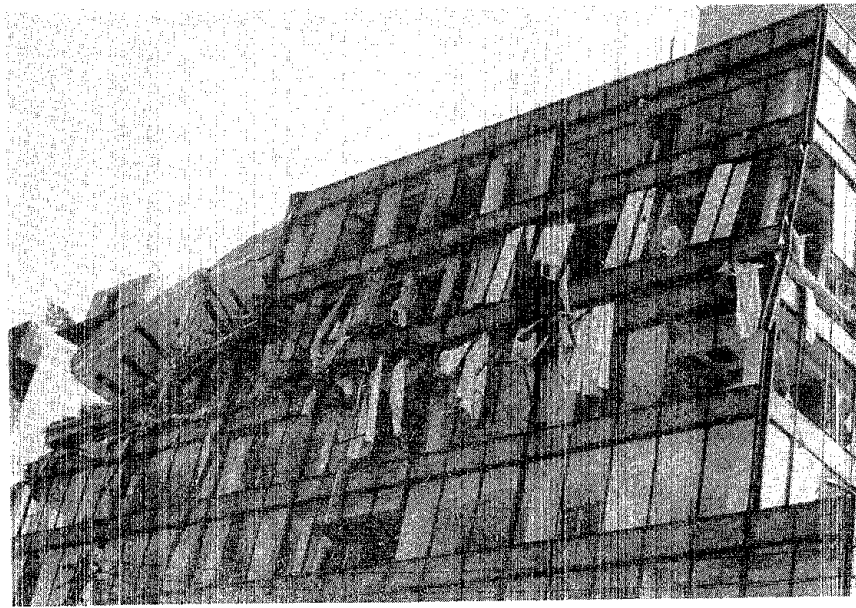
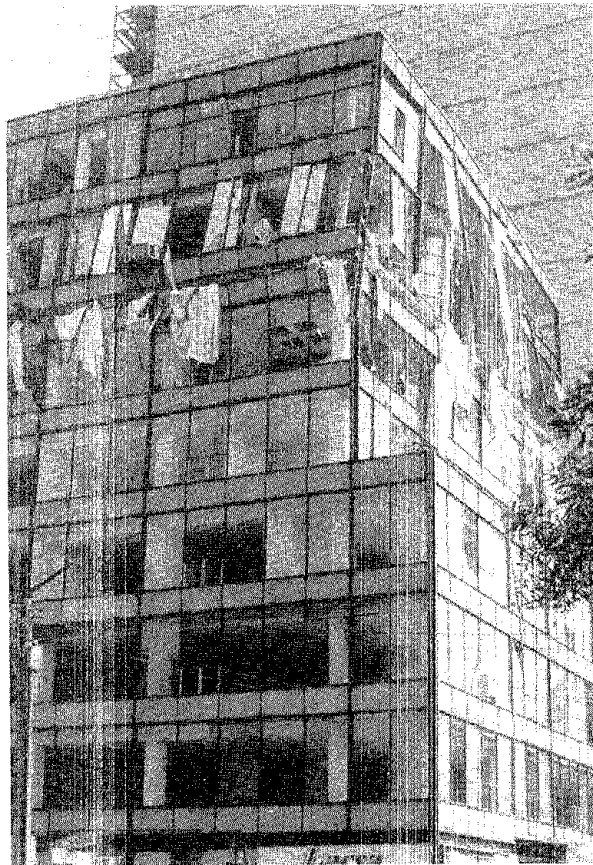
Figure 5.68. LASCA Building on Paseo de la Reforma and Marne, showing large change in column stiffness in upper two floor penthouse.

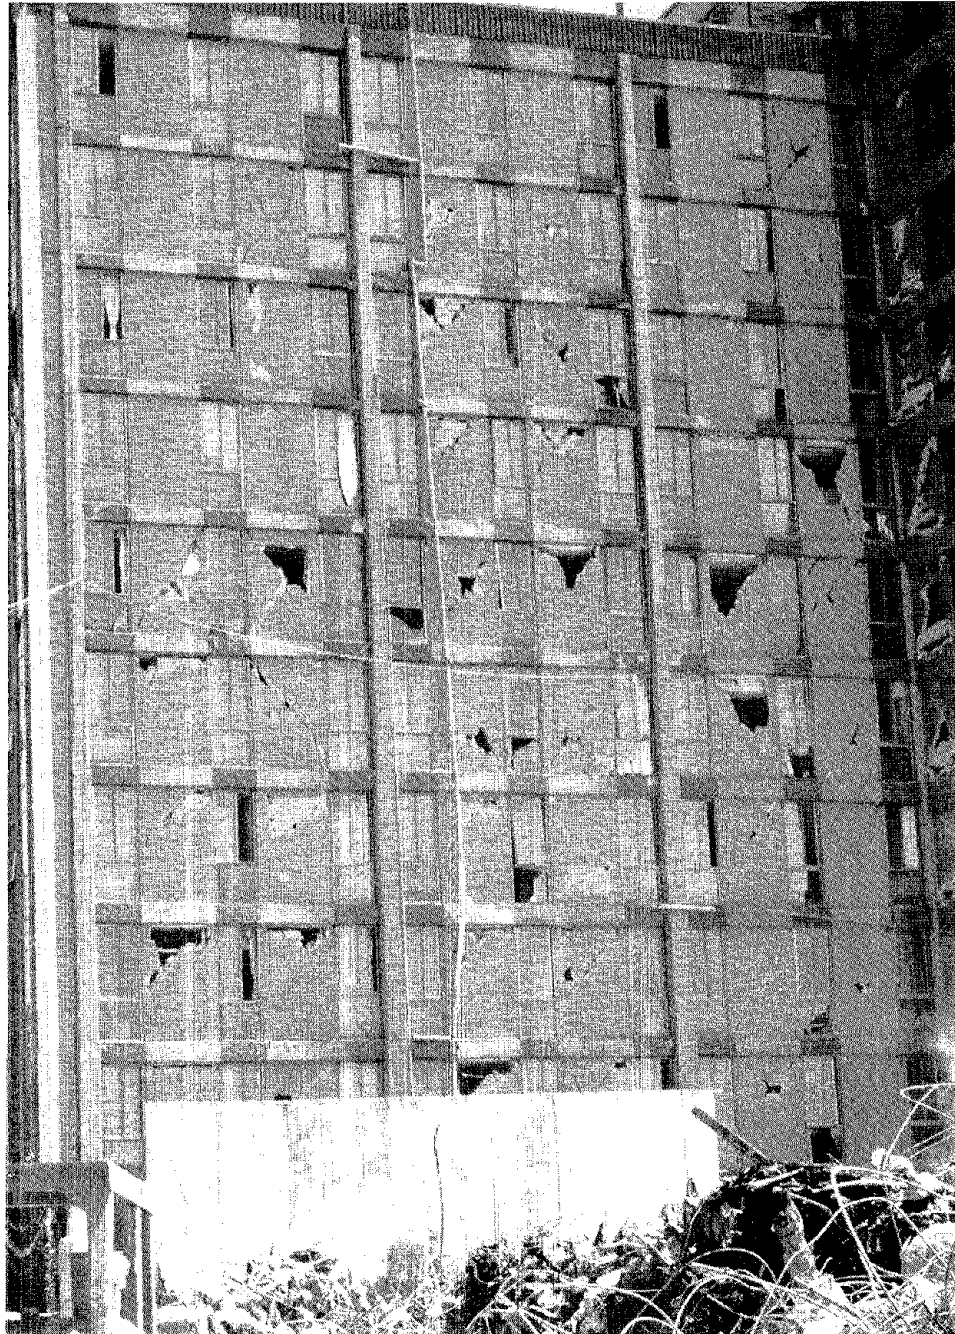
Figure 5.72. Significant diagonal shear cracking in a masonry infill structure on Ave. T. de Mier. Enough energy was dissipated in the walls to prevent collapse of the building.
