NIST Special Publication 778

*Performance of Structures During the
Loma Prieta Earthquake of October 17, 1989*

H. S. Lew, Editor

January 1990

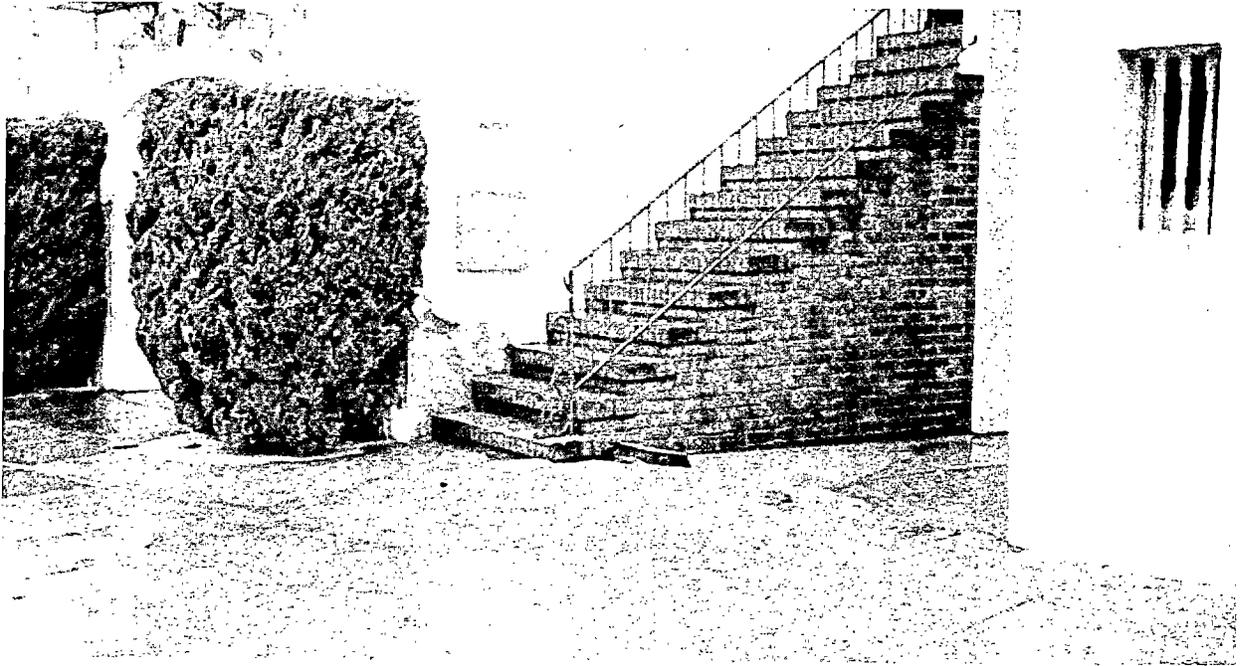
Figure 3.3.3 Sand boil in the Marina District of San Francisco.

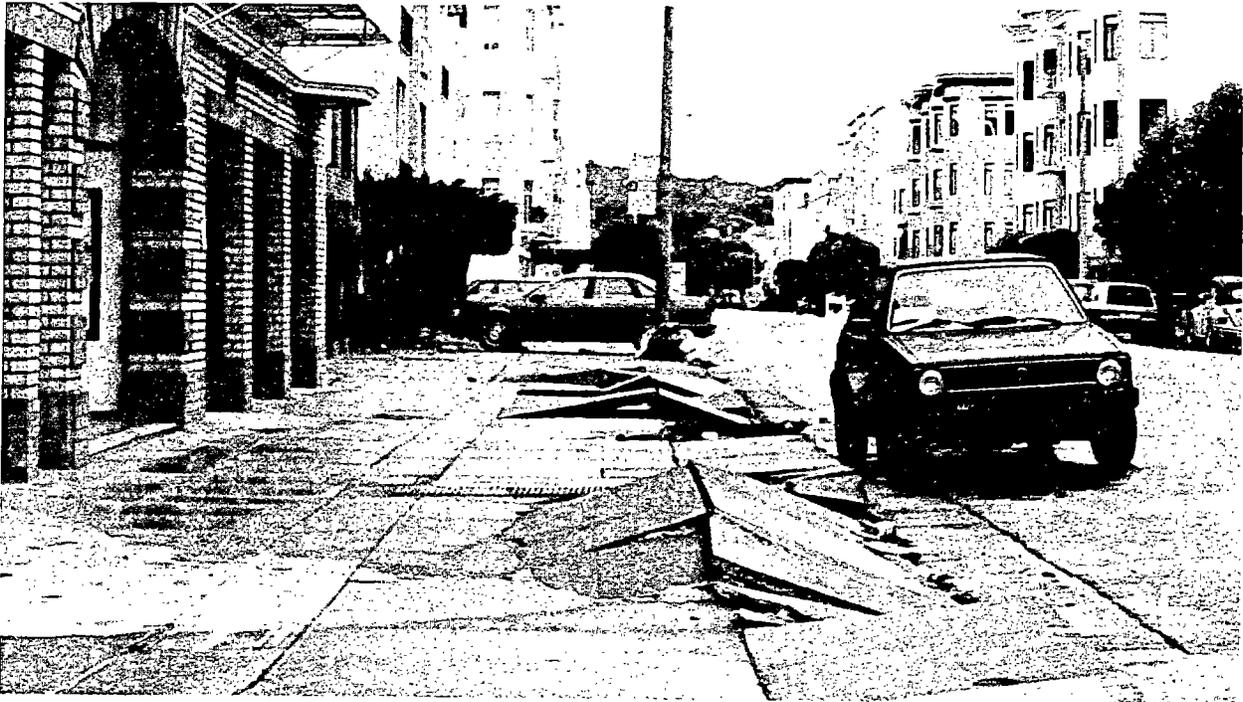
Figure 3.3.4 Typical liquefaction damage in the Marina District of San Francisco.

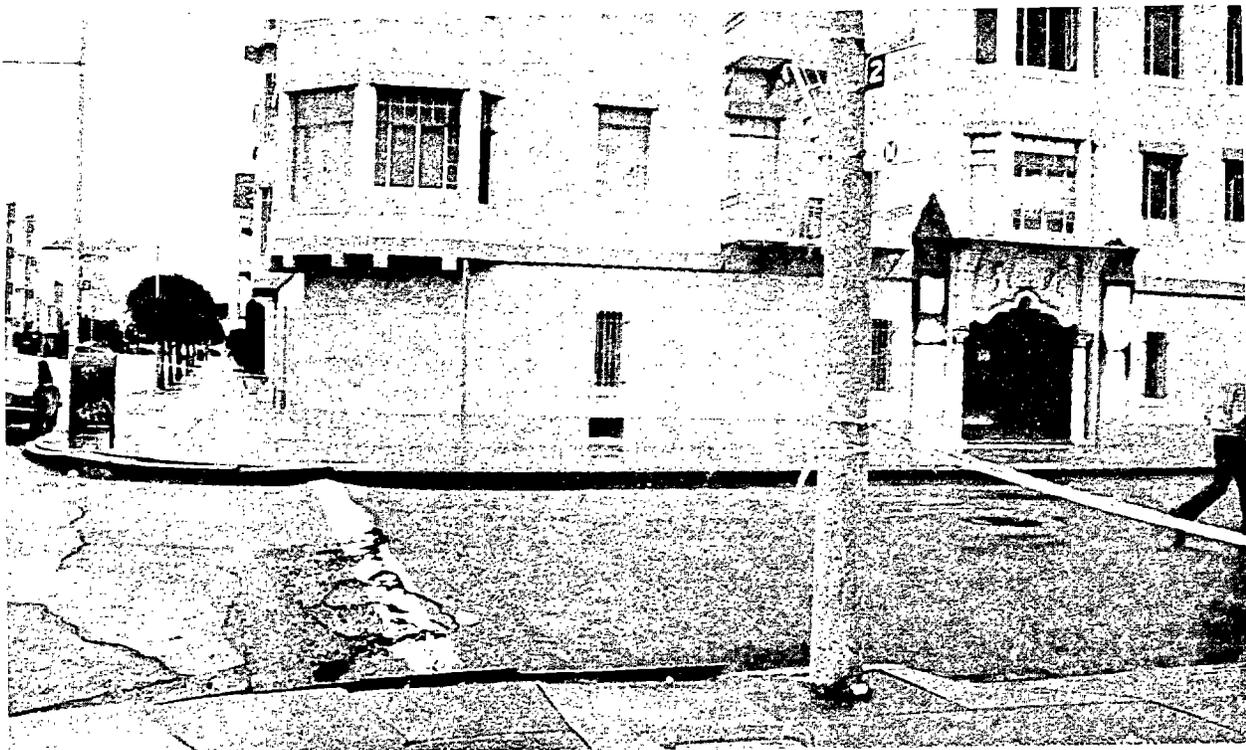
Figure 3.3.6 Pavement heave over utility pipe.

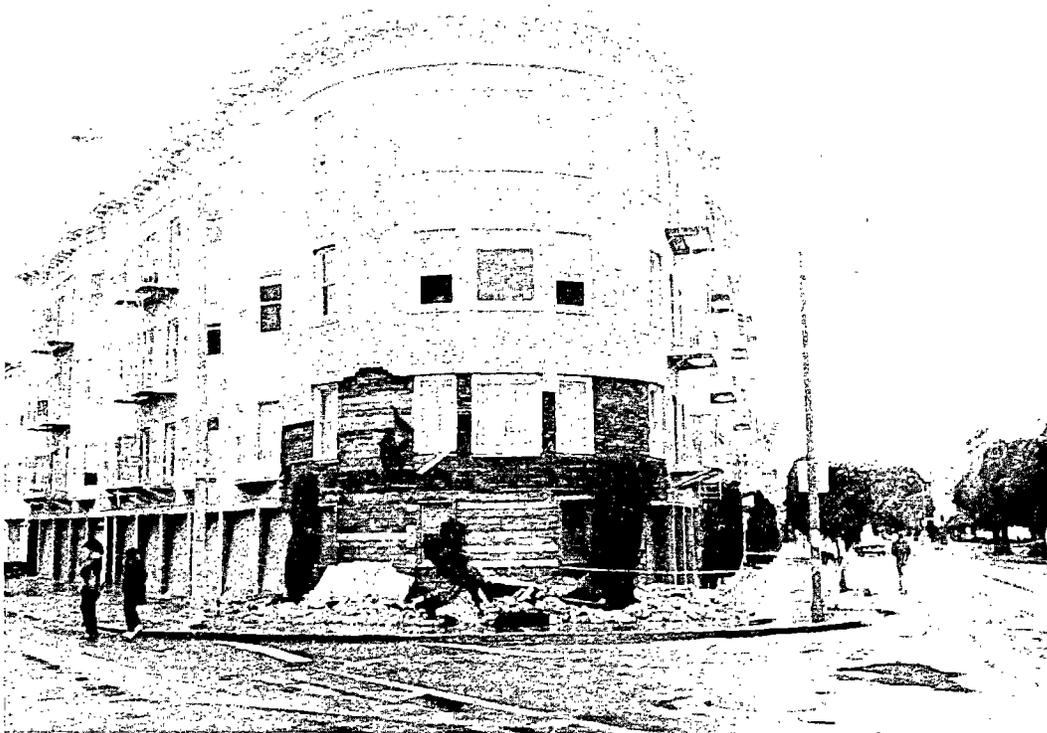
Figure 4.2.17 Example of building with failure of brick masonry facade (location #2).

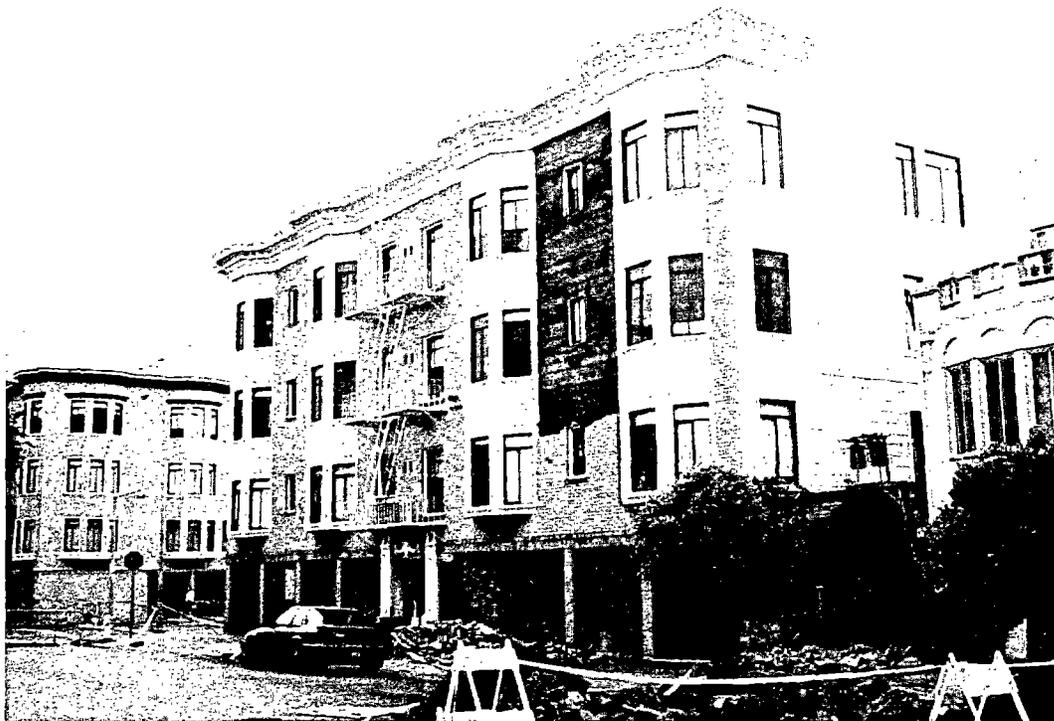
Figure 4.2.18 Example of building with failure of brick masonry facade (location #10).

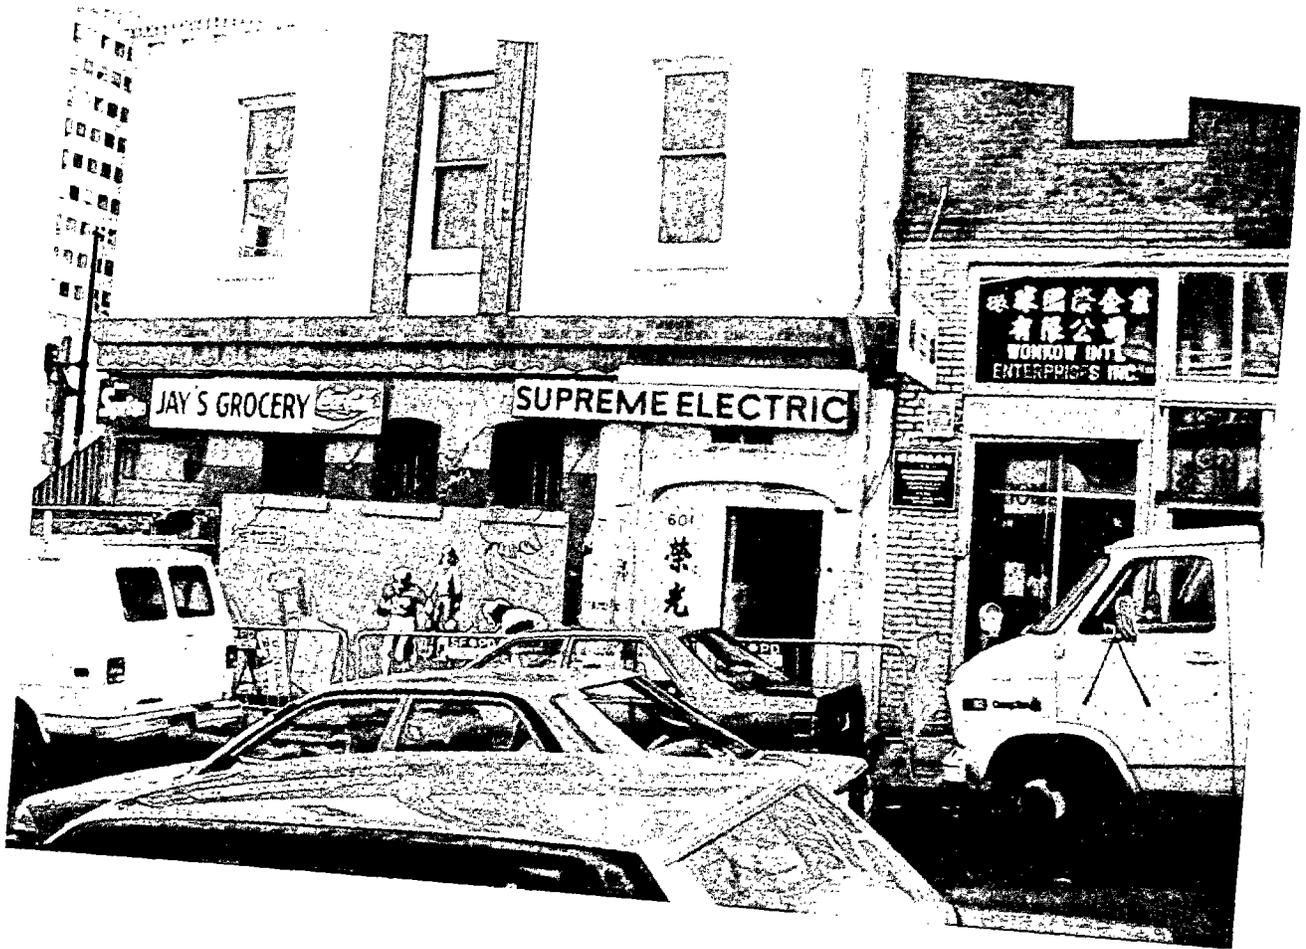
Figure 4.2.25 Example of damage to unreinforced masonry building in the Chinatown area (location #1).

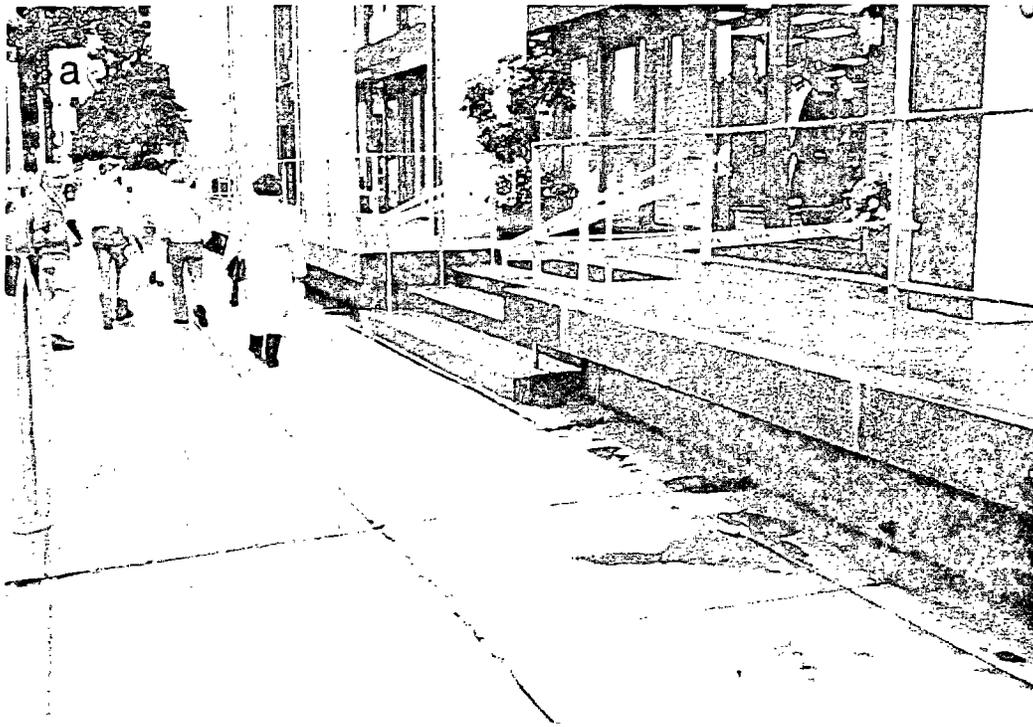
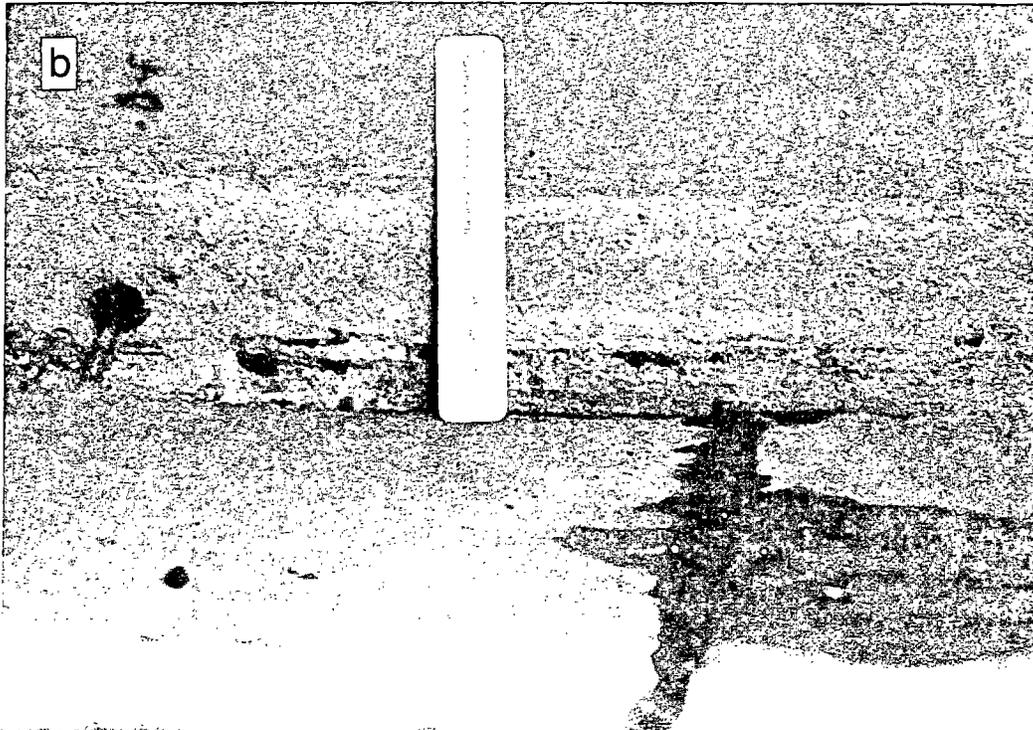
Figure 4.2.26 (a) Sidewalk showing distortions due to differential settlements, and (b) close-up view of intersection of sidewalk with retaining wall showing magnitude of differential movement.

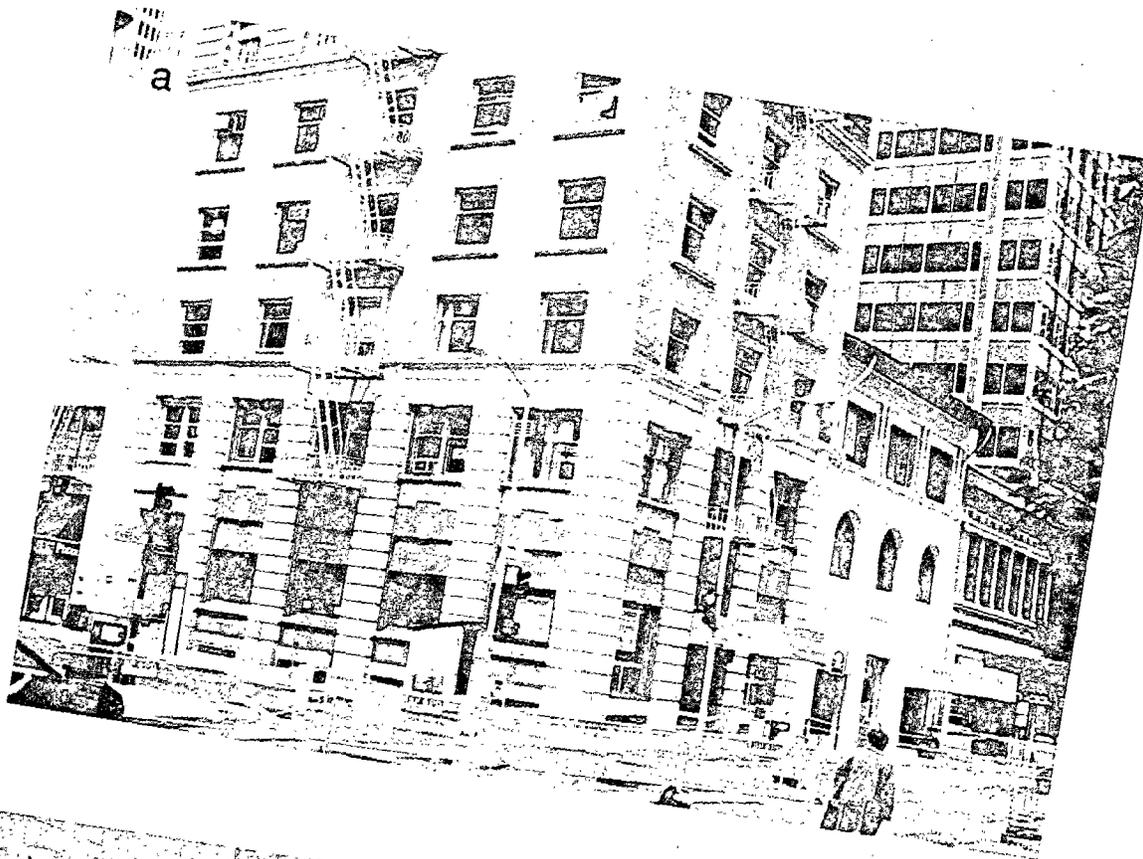
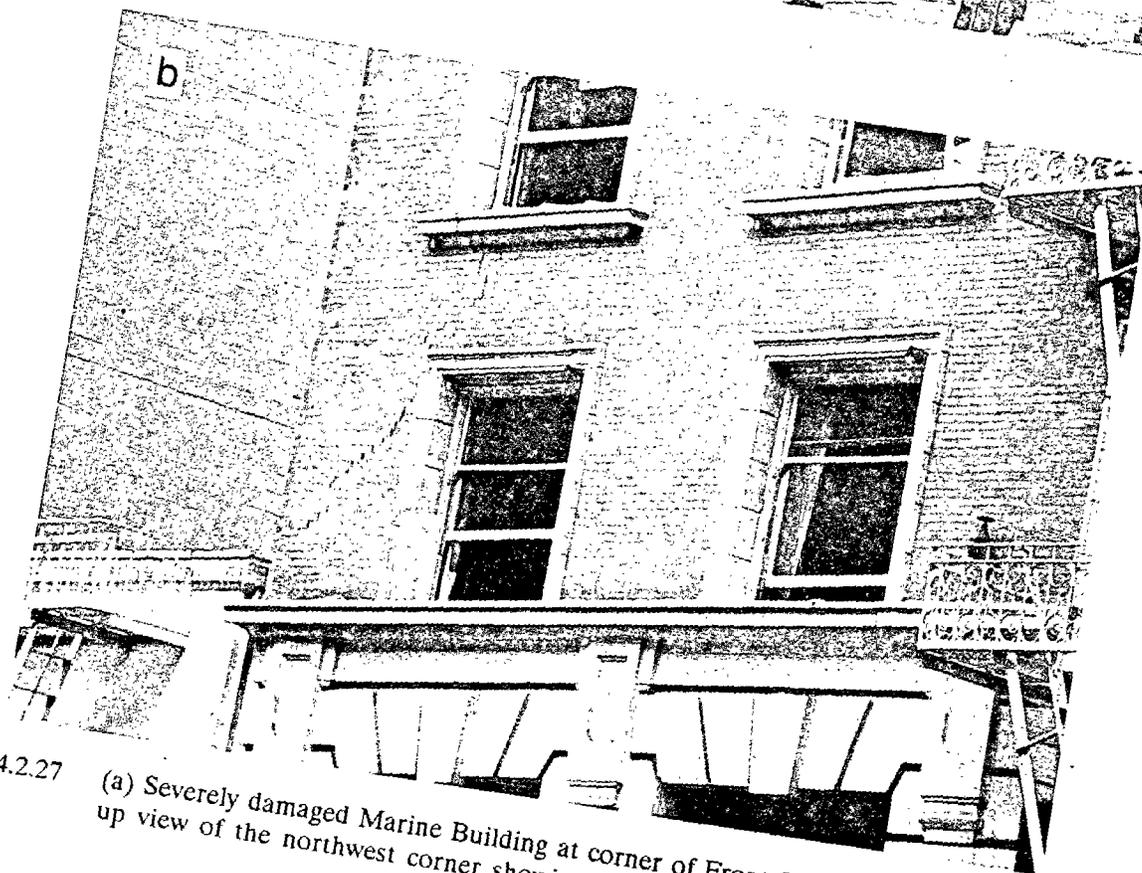
Figure 4.2.27 (a) Severely damaged Marine Building at corner of Front St. and California St.; (b) Close-up view of the northwest corner showing severity of cracking.

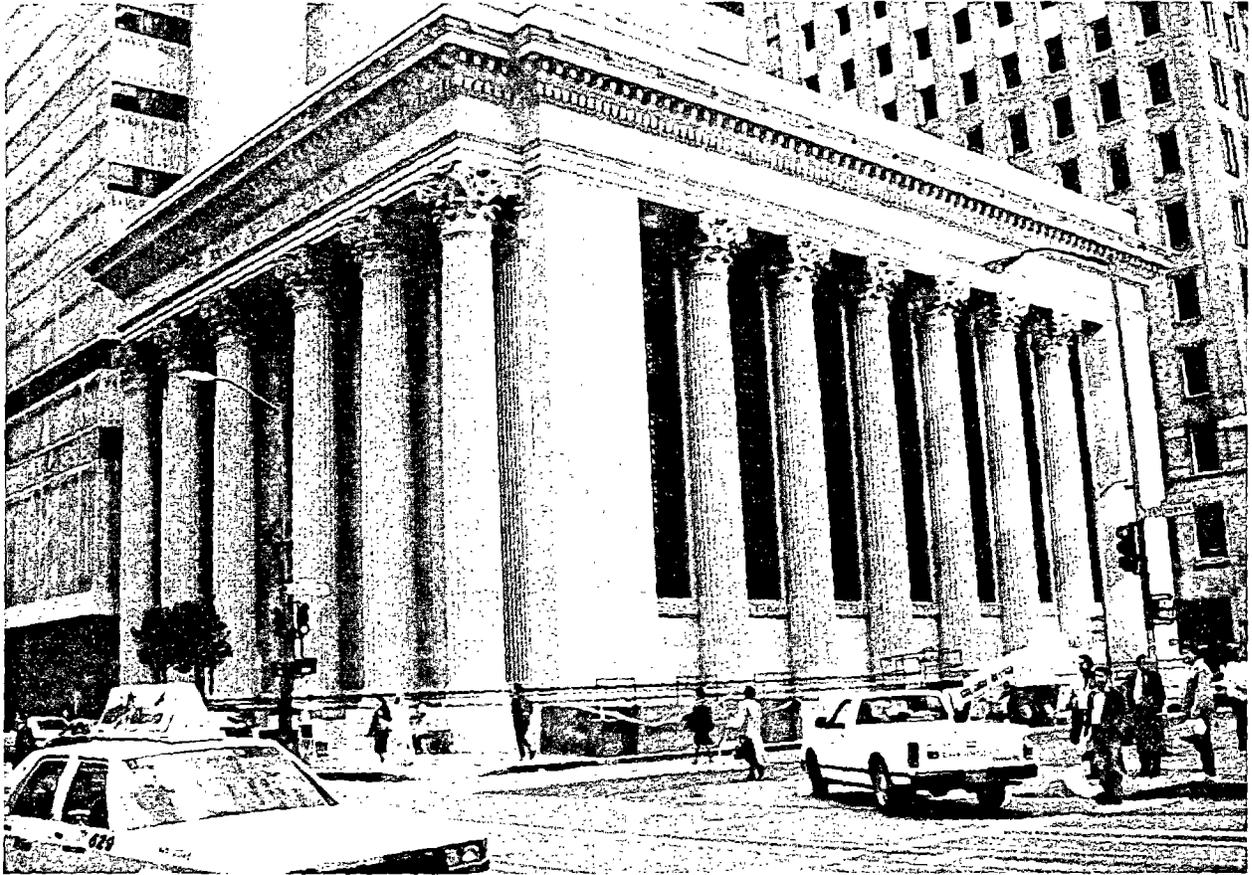
Figure 4.2.30 Damage to the stone facing of the Bank of California building.

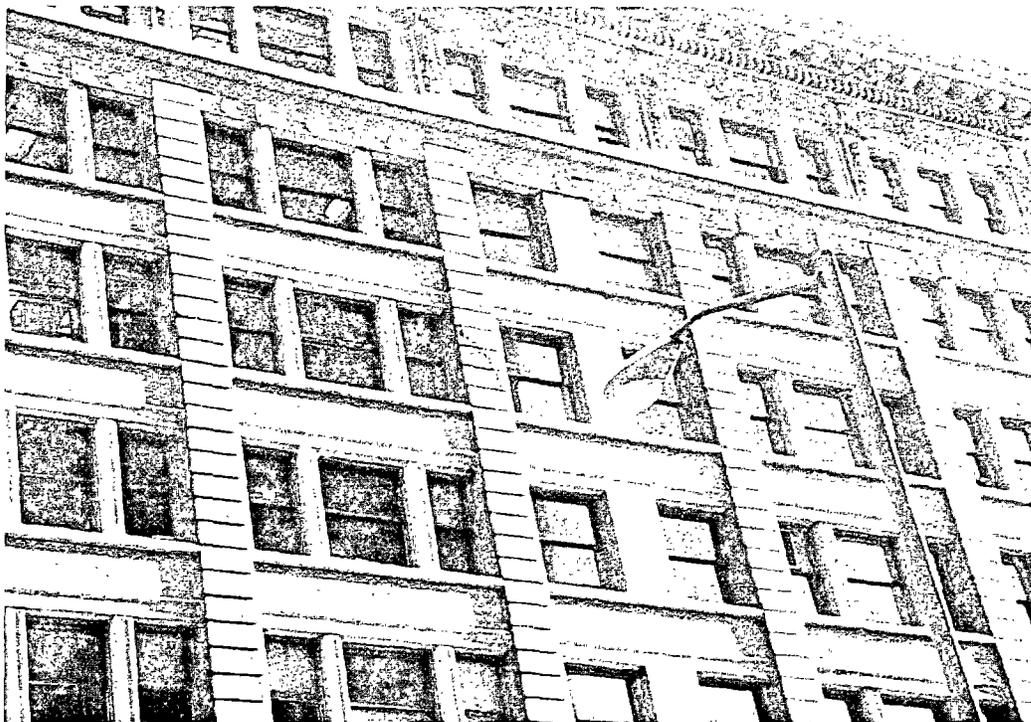
Figure 4.2.32 Example of damage to masonry cladding of Wells Fargo Bank building (location #7).

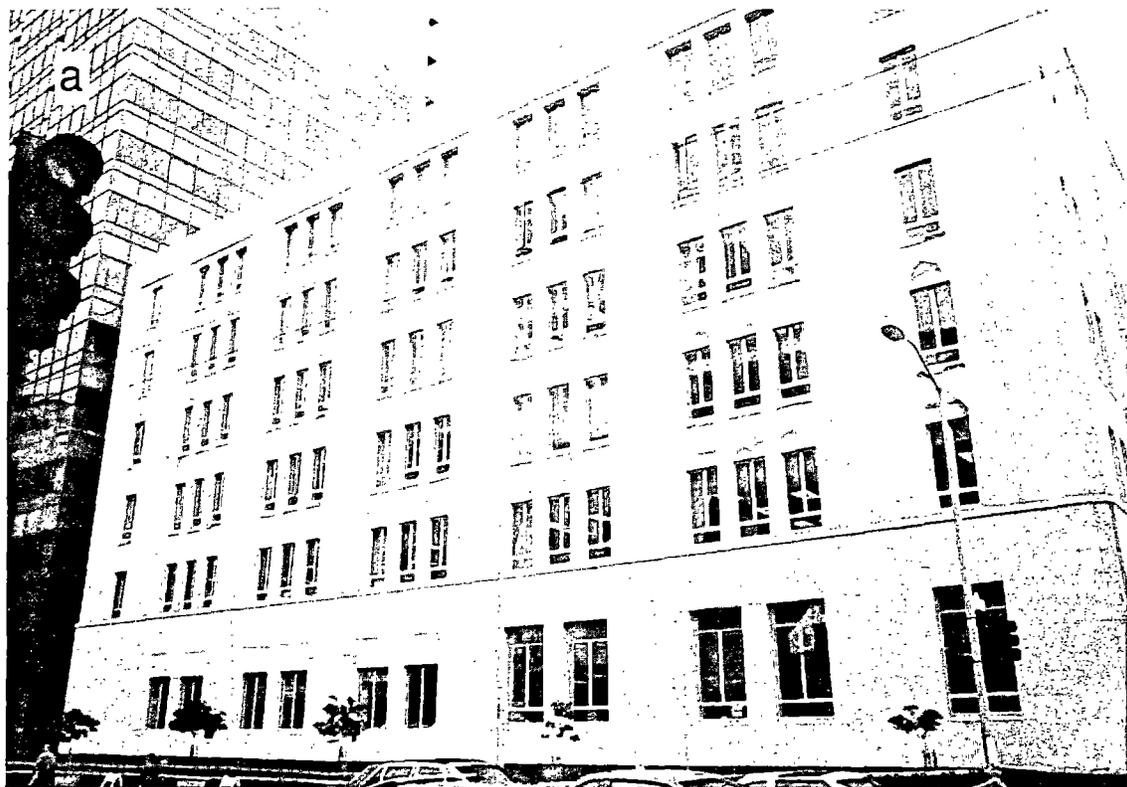
Figure 4.2.33 (a) Reinforced concrete, flat-slab building which sustained severe damage to the exterior walls (location #6); (b) close-up view of damage to spandrels.

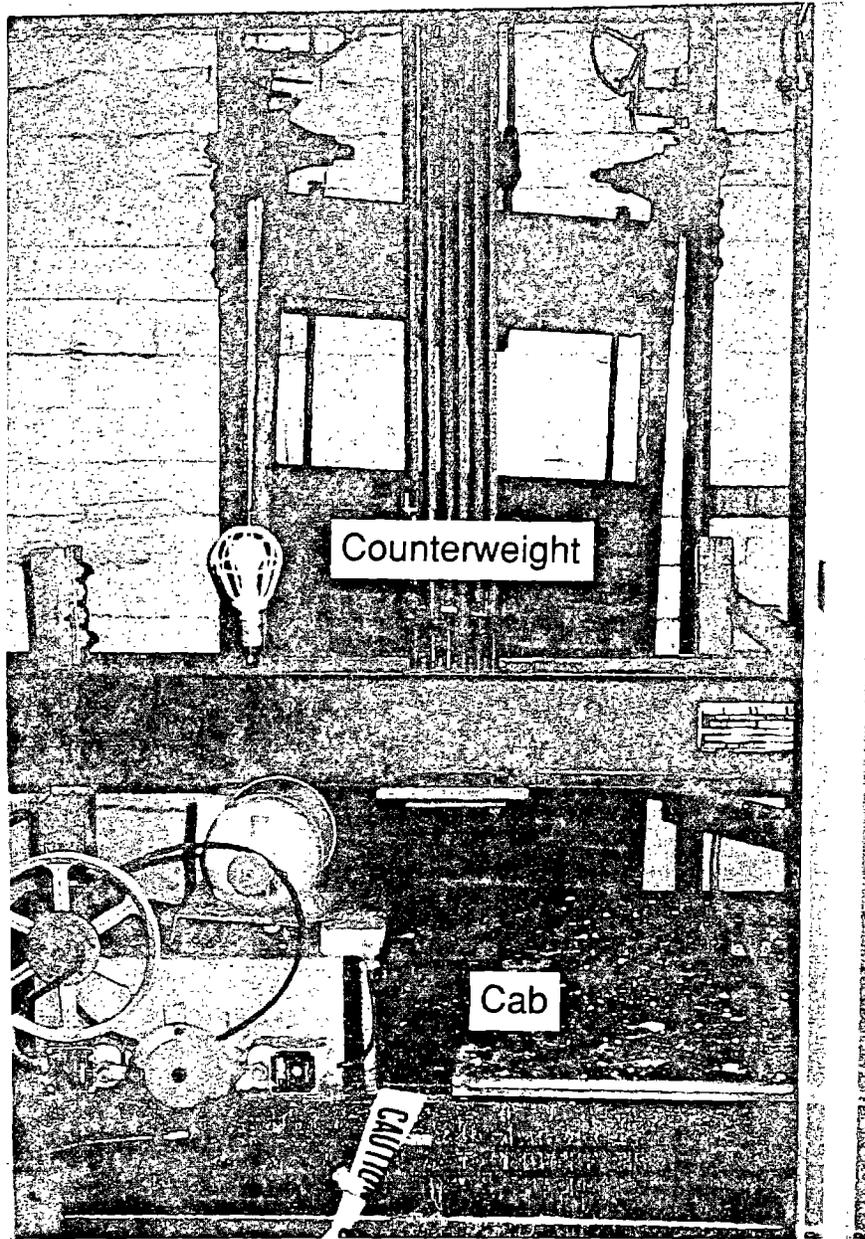
Figure 4.2.35 Elevator counterweight jumped out of its track and collided with the cab in the Old Federal Building (location #9).

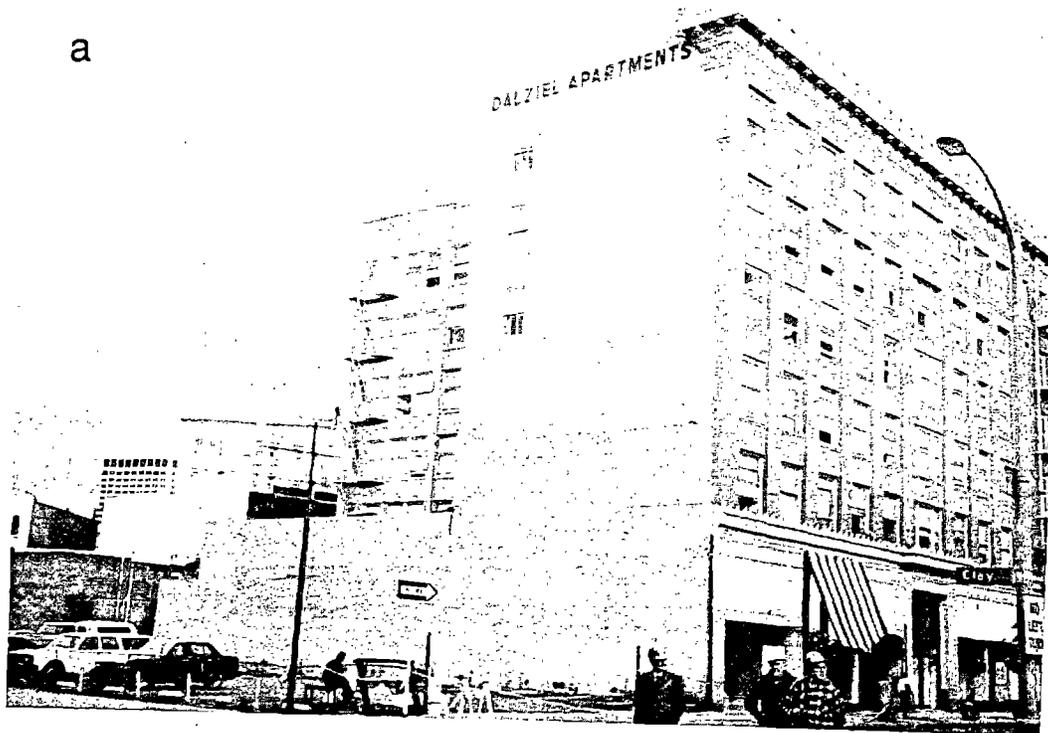
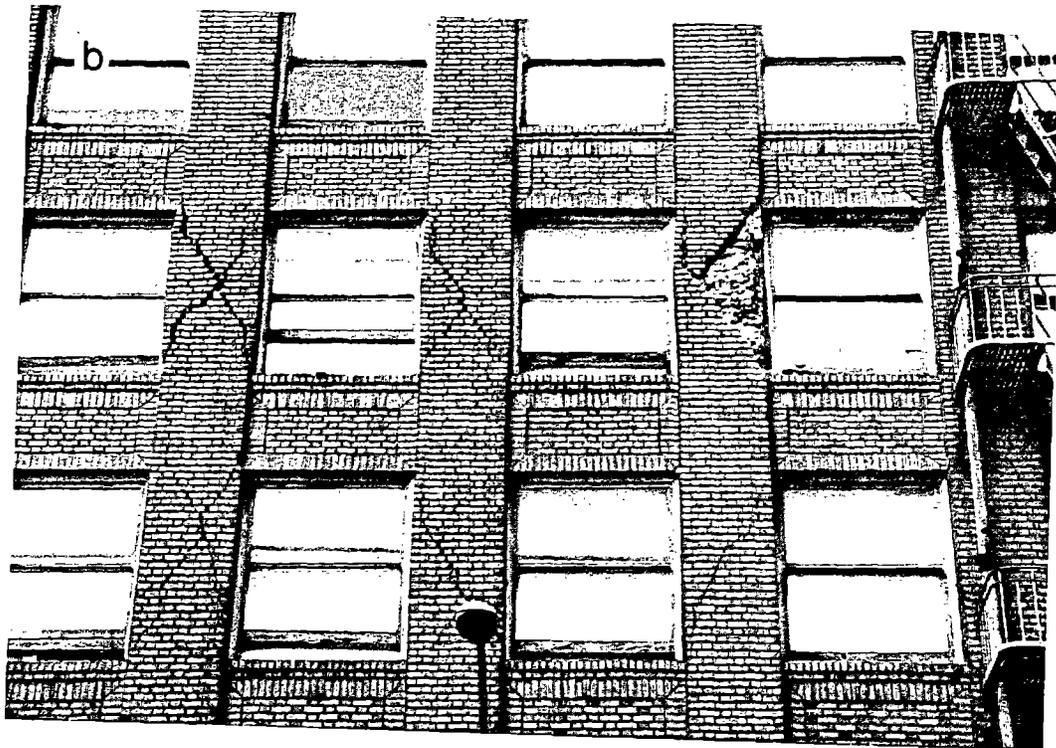
Figure 4.3.2 Dalziel apartment building: (a) overall appearance and (b) close-up view of cracking in masonry piers (location #1).

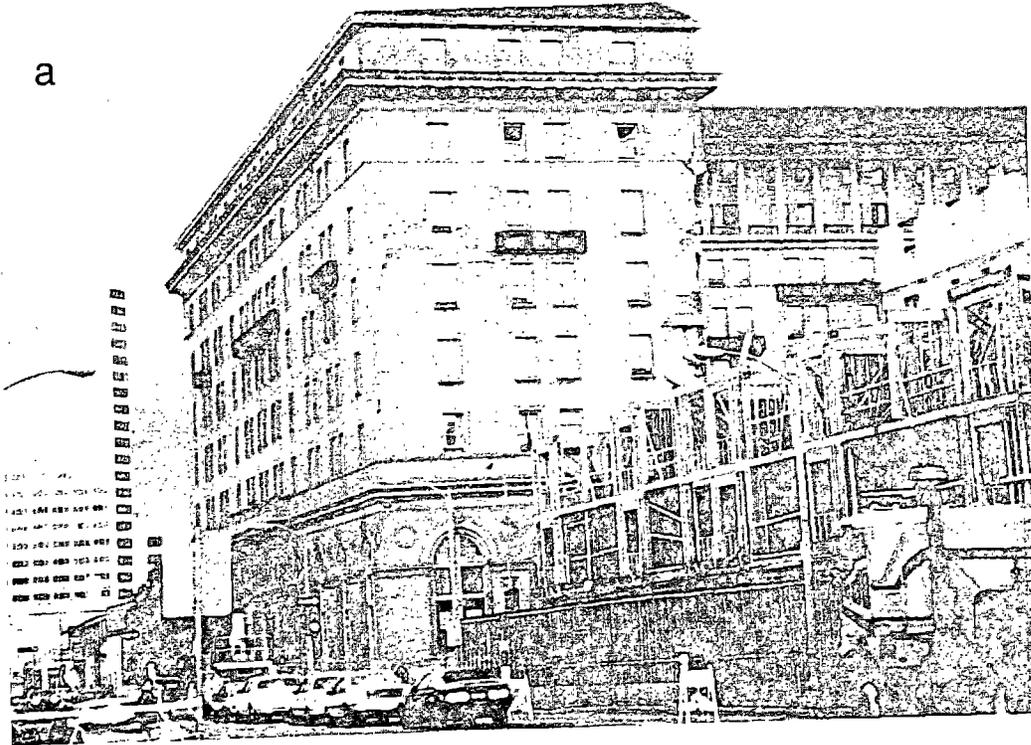
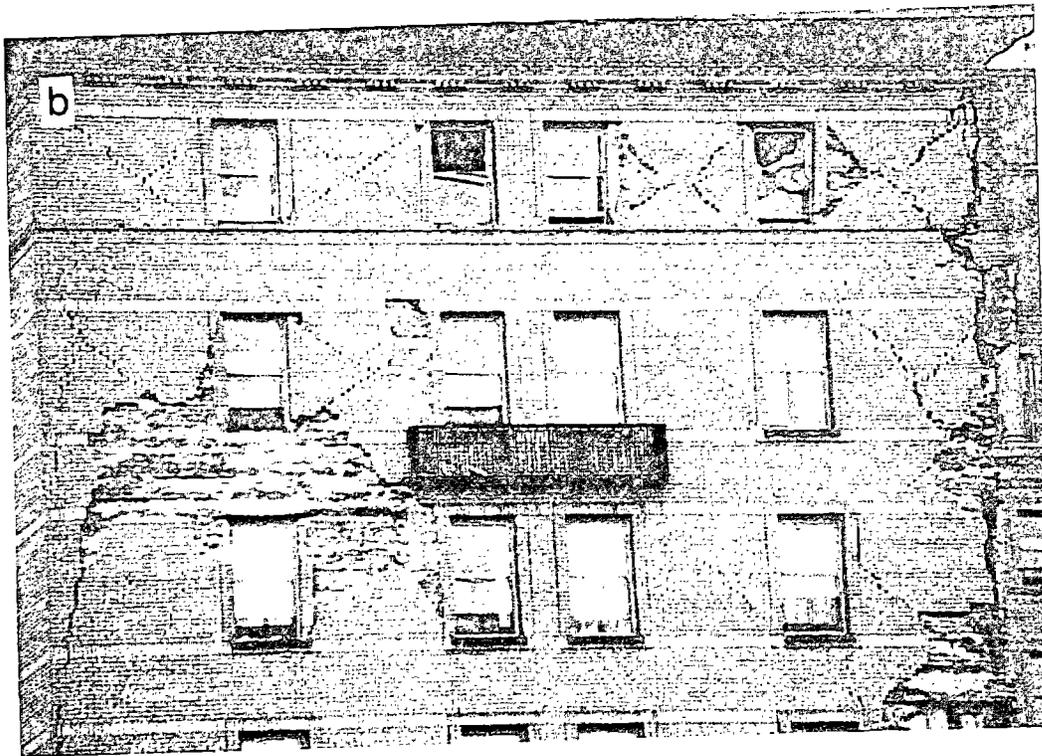
Figure 4.3.3 Oakland Hotel: (a) View of west wing and (b) close-up view of damaged masonry infill (location #6).

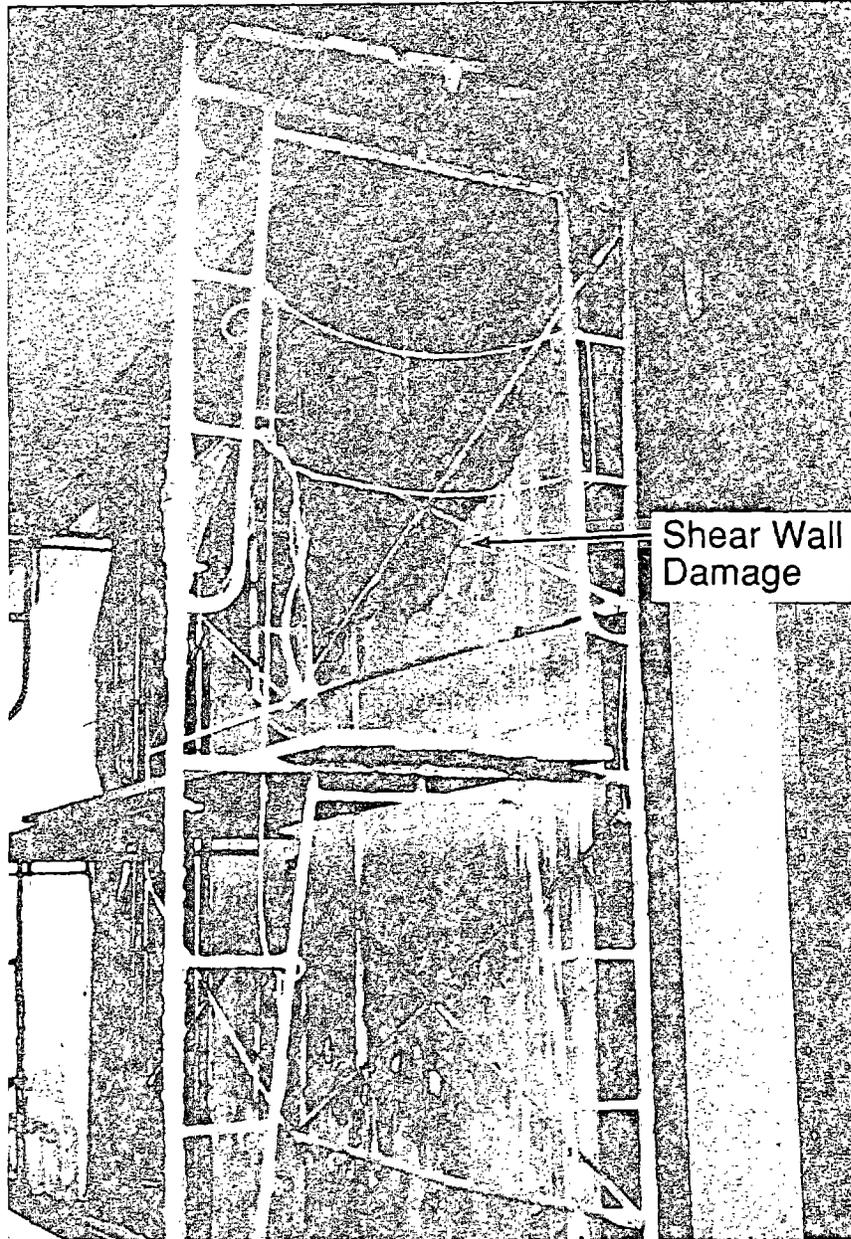
Figure 4.3.8 Damage occurred to the shear walls of a 16-story telecommunications building (location #7).

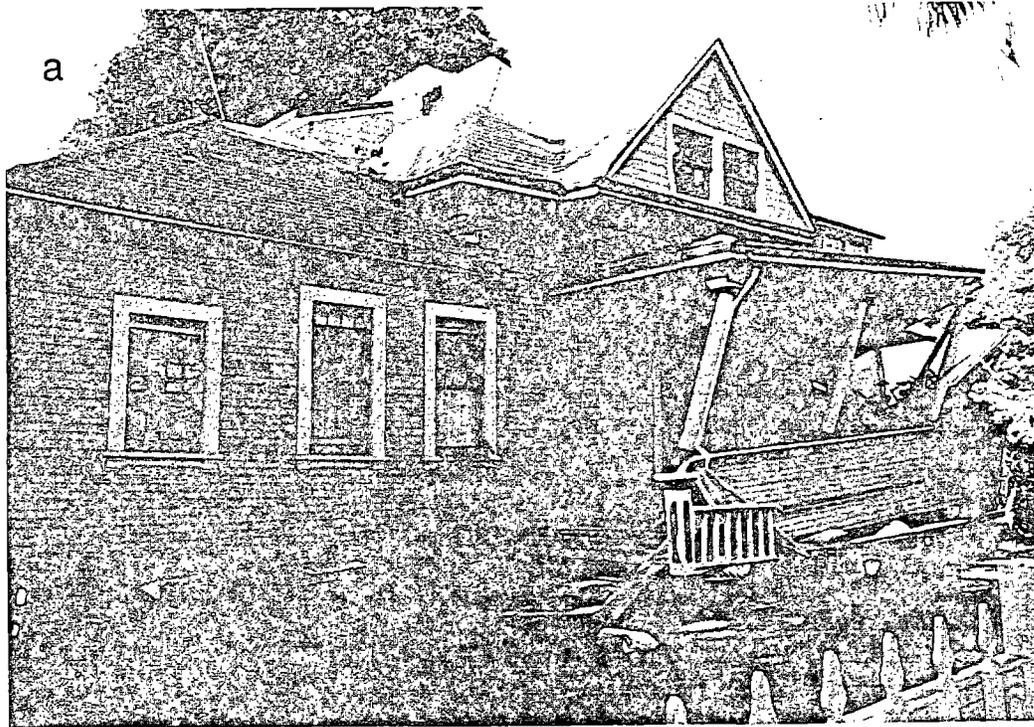
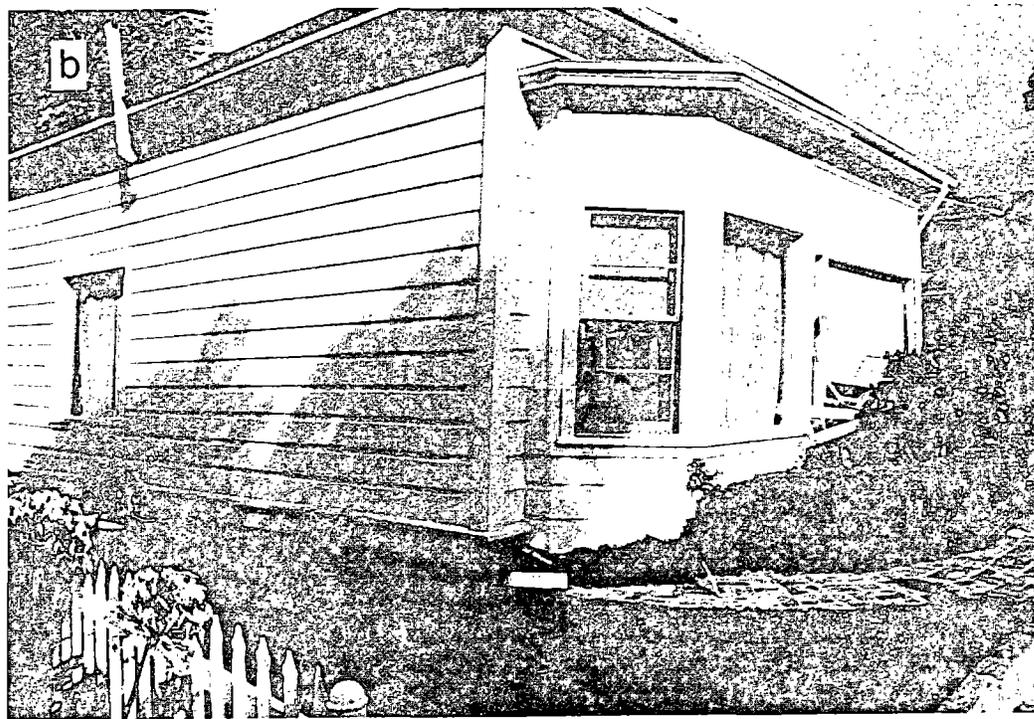
Figure 4.4.2 Examples of failures of houses in Los Gatos: (a) large house suffered large distortion and (b) a small house was rocked off of its foundation.

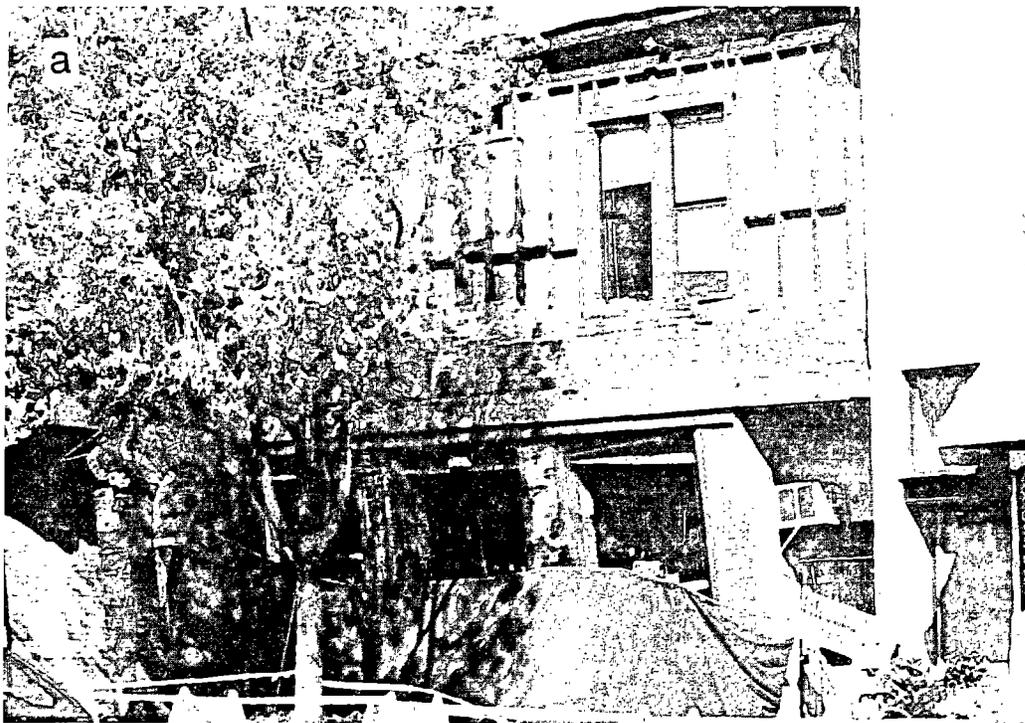
Figure 4.4.4 (a) Failure of wood-framed building with masonry walls and multiple opening in first story (Los Gatos); (b) typical damage to parapets and storefront windows (Watsonville).

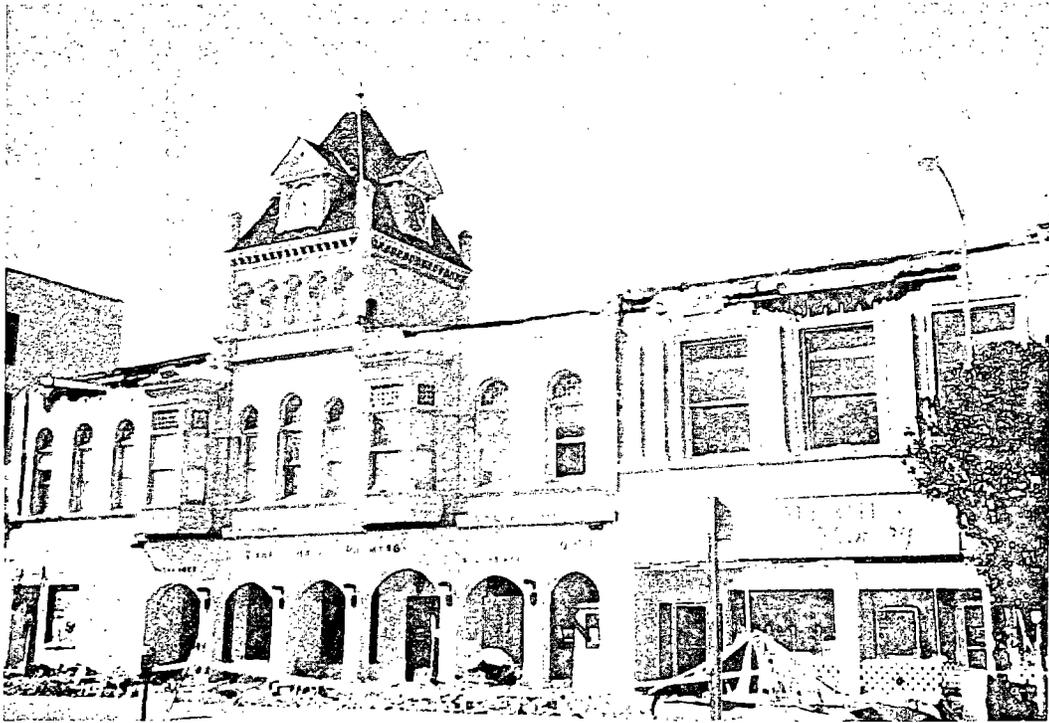
Figure 4.4.5 Falling brick from this old masonry building in Watsonville caused one death.

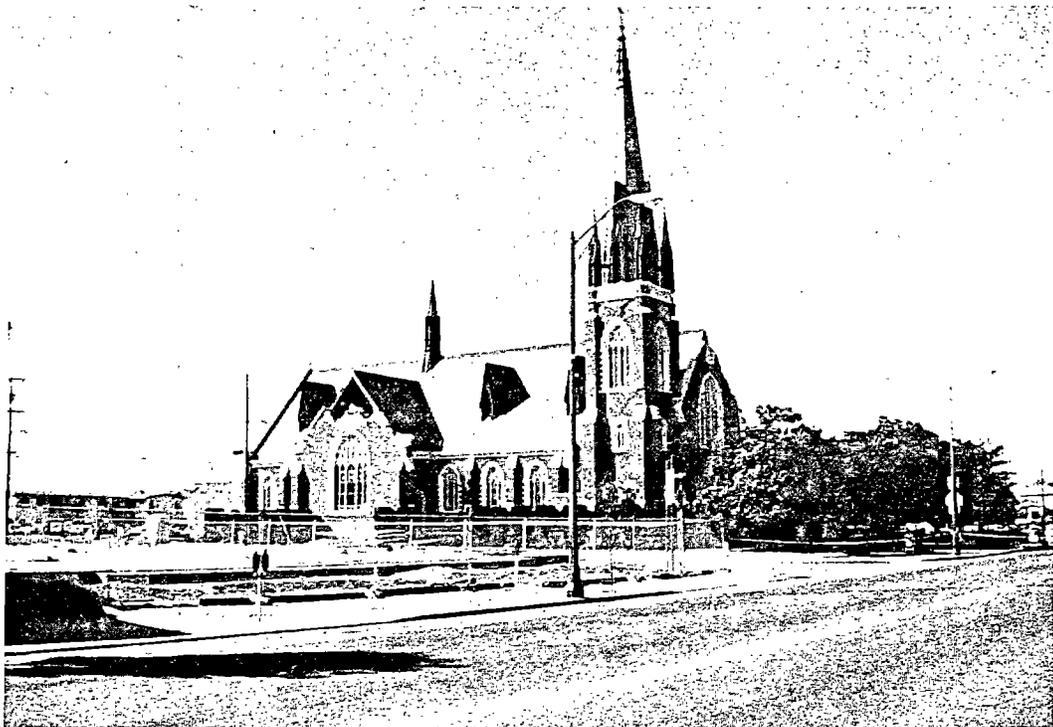
Figure 4.4.6 St. Patrick's Church in Watsonville was severely damaged.

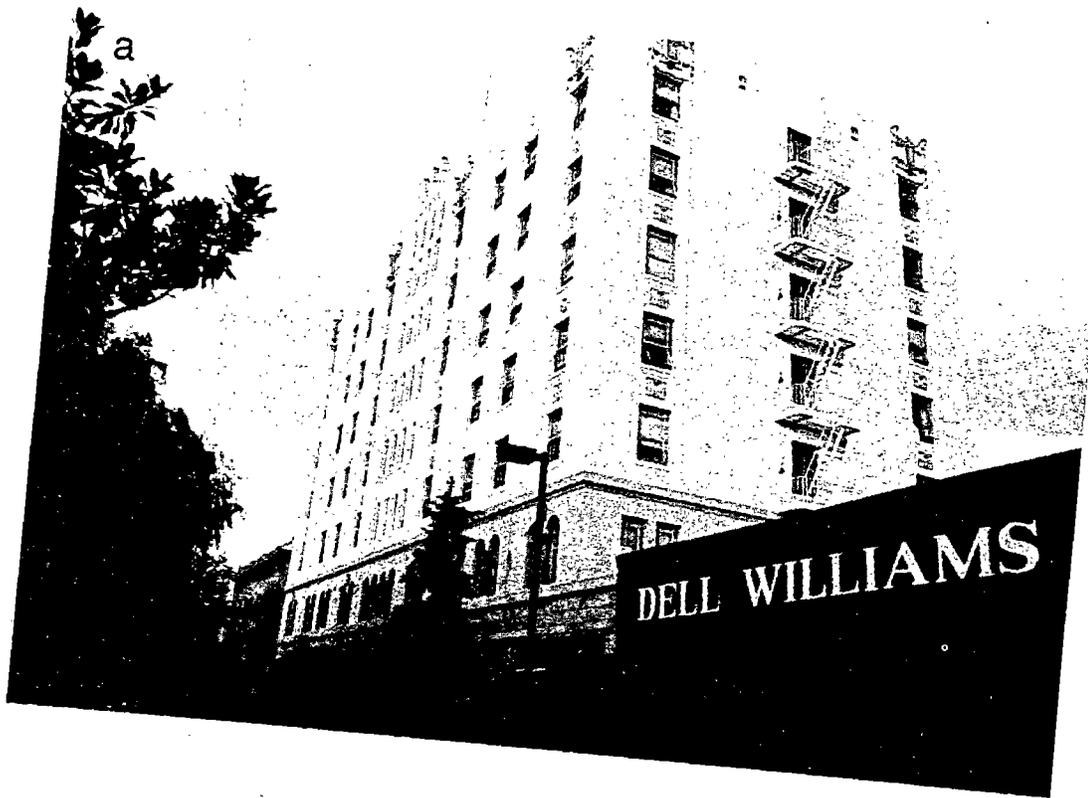
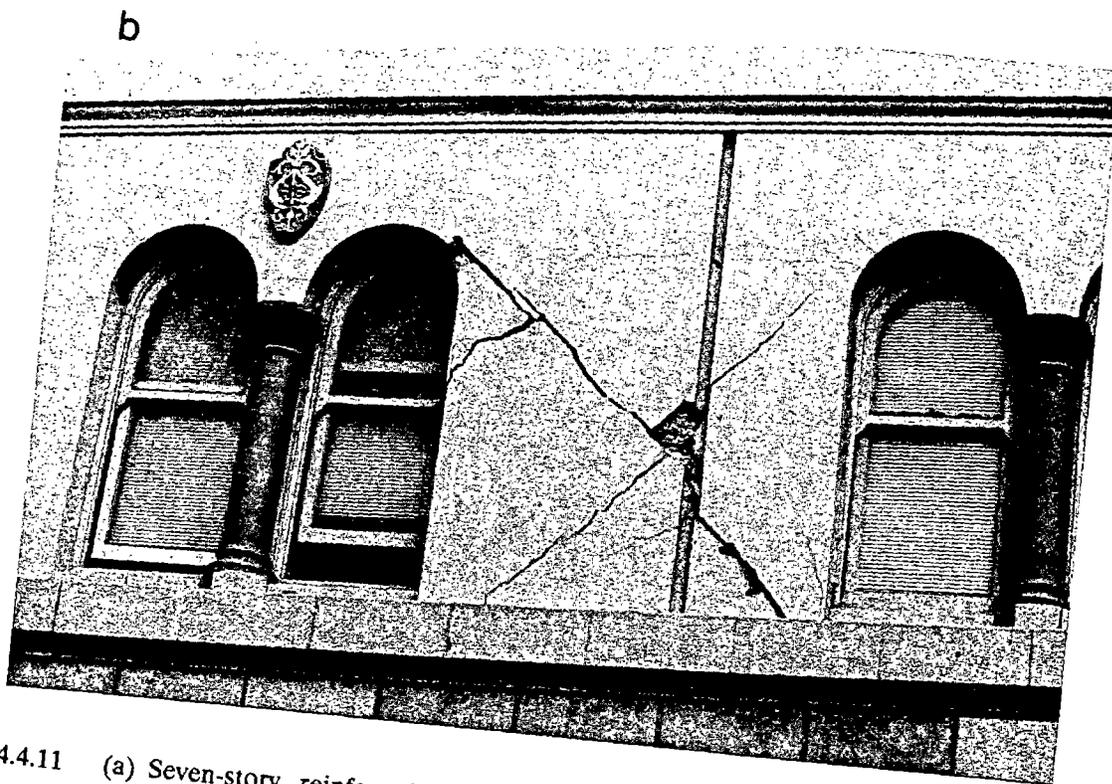
Figure 4.4.11 (a) Seven-story, reinforced concrete building suffered severe cracking; (b) Close-up view of damage to second-story walls.
