NIST Special Publication 778

*Performance of Structures During the
Loma Prieta Earthquake of October 17, 1989*

H. S. Lew, Editor

January 1990

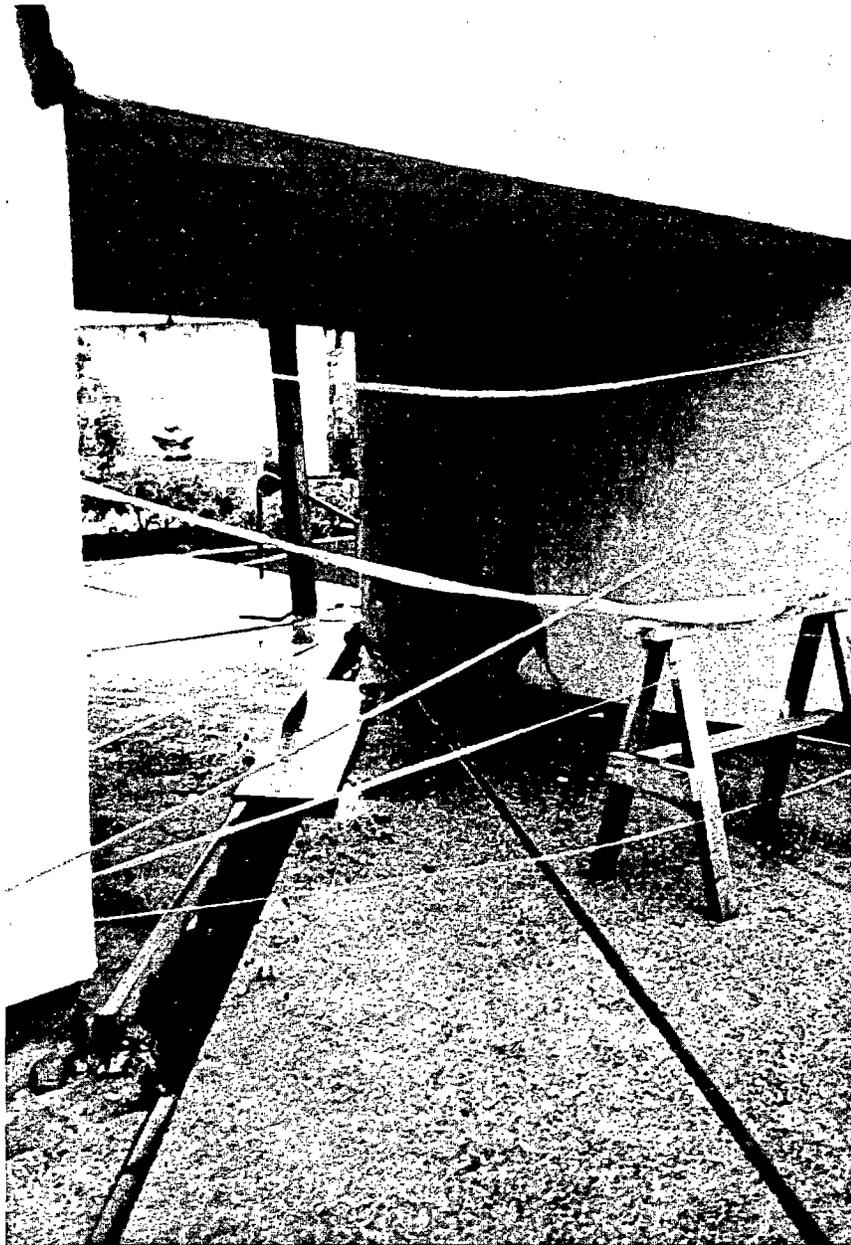
Figure 4.4.12 Damage to Marine Laboratory in Moss Landing as a result of soil liquefaction.

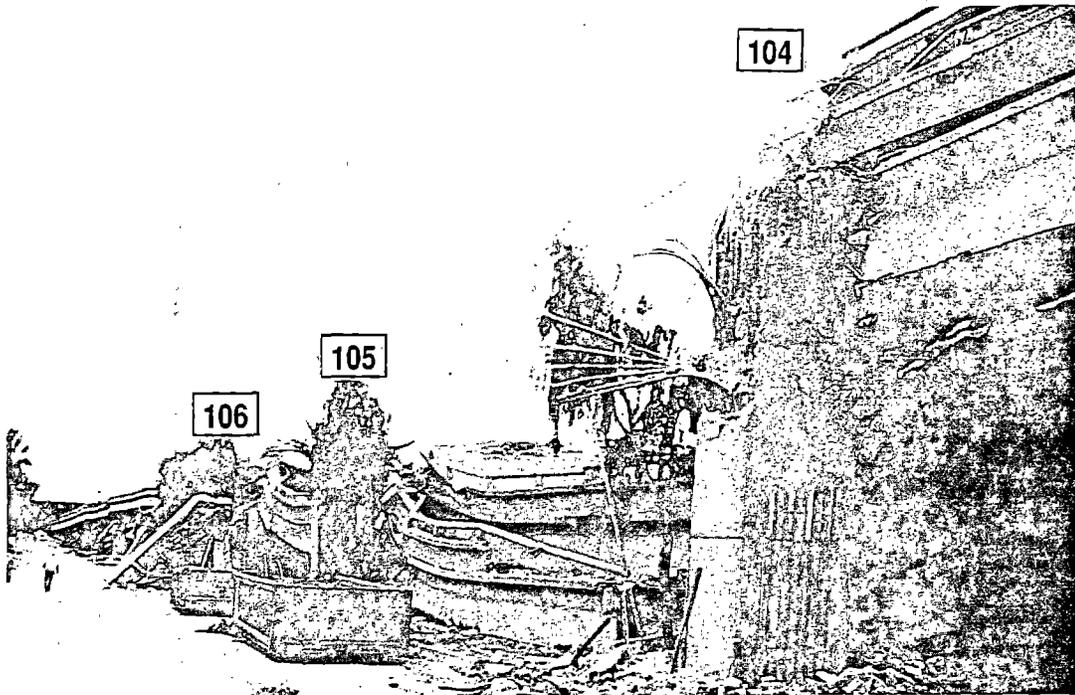
Figure 5.6.38 . The section of Cypress Structure between Bents 104 and 106 was the only location in which both upper and lower bent frames failed.

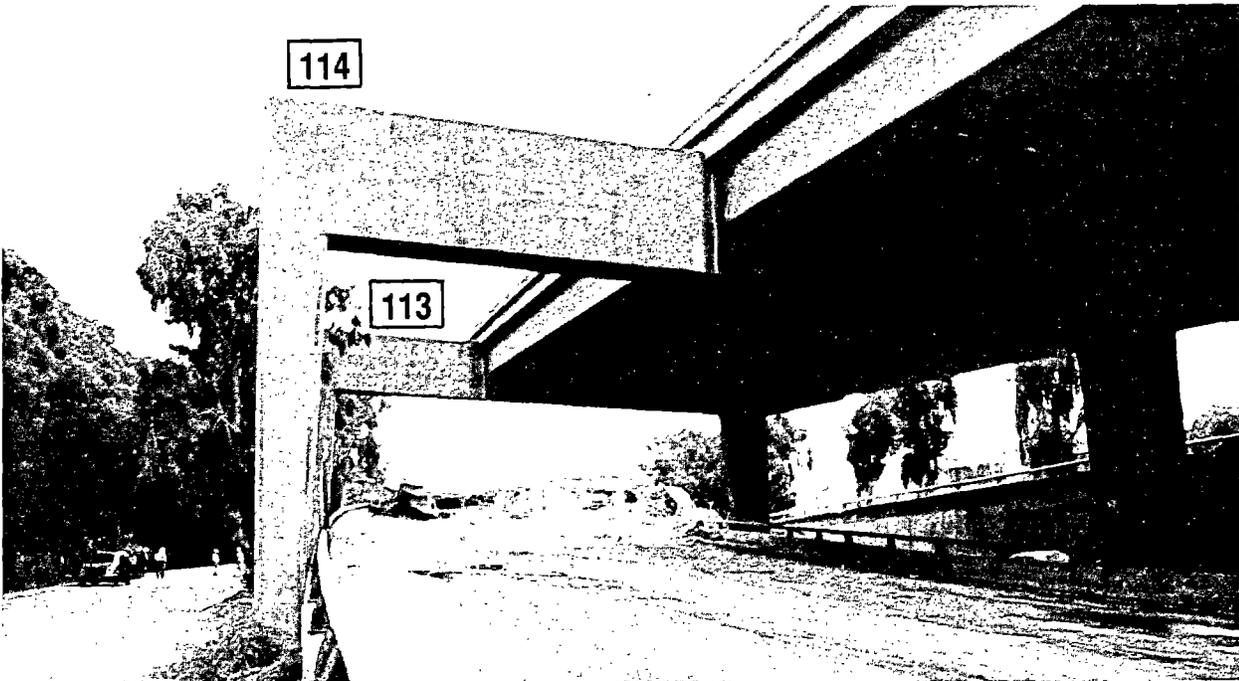
Figure 5.6.41 View looking south along the east side of Cypress Structure from Bent 115. The northern limit of the collapse extended to within six feet of Bent 113.

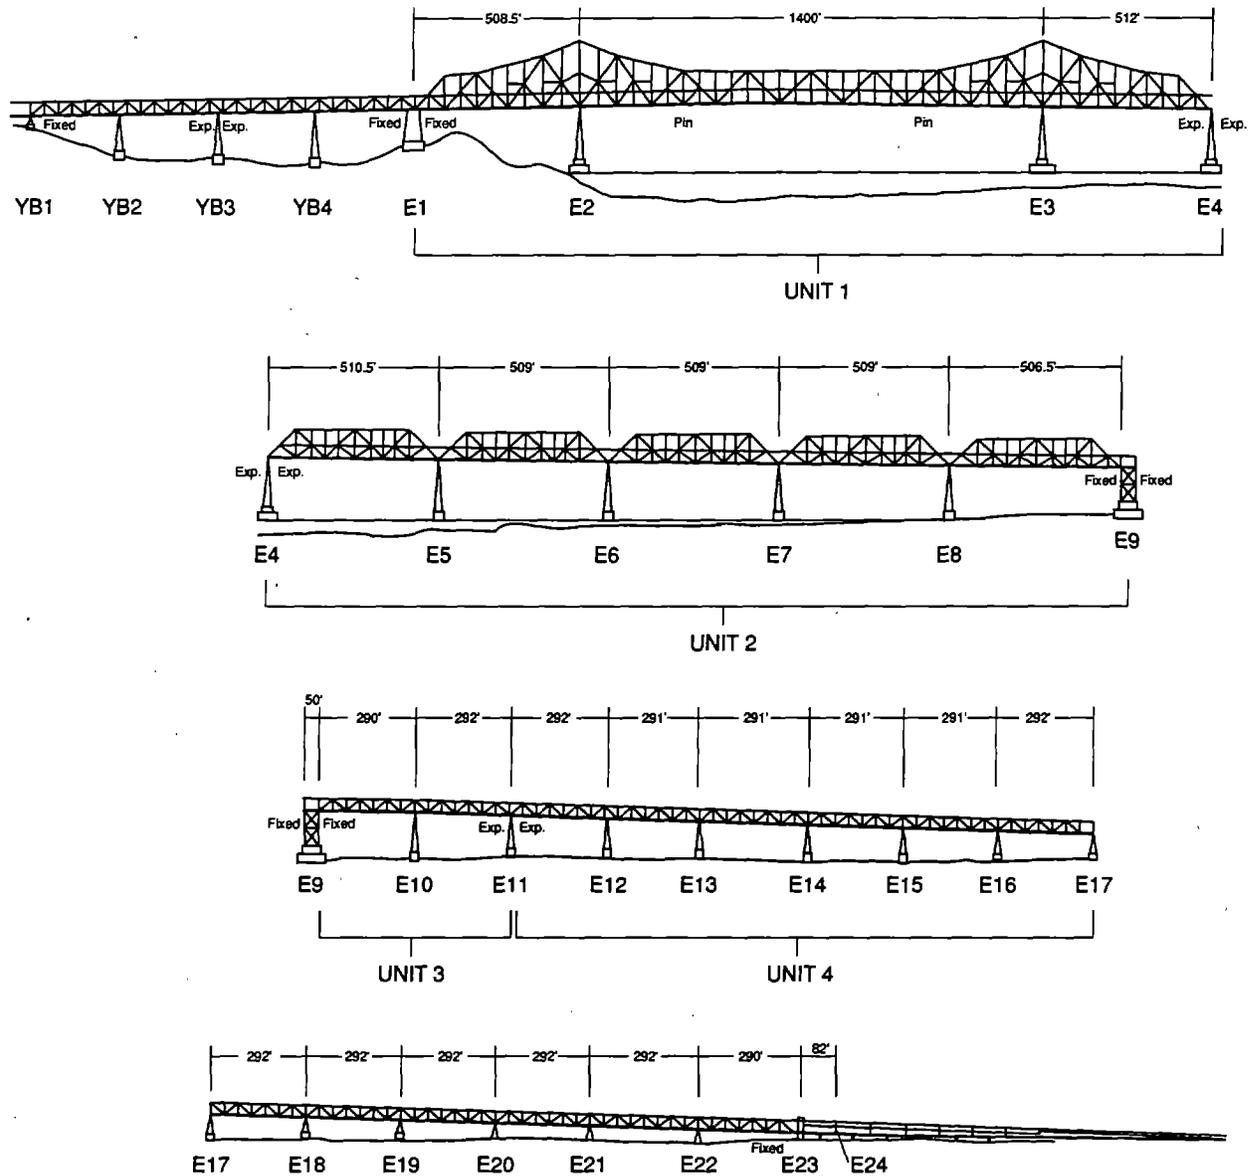
Figure 5.7.3 Detail of the east bay truss spans. Unit 3 was determined to have moved eastward as much as 10 inches, causing the collapse of the two deck segments at Pier E-9. Additional damage, generally involving the failure of retainer bolts, occurred between Piers E-17 and E-24.

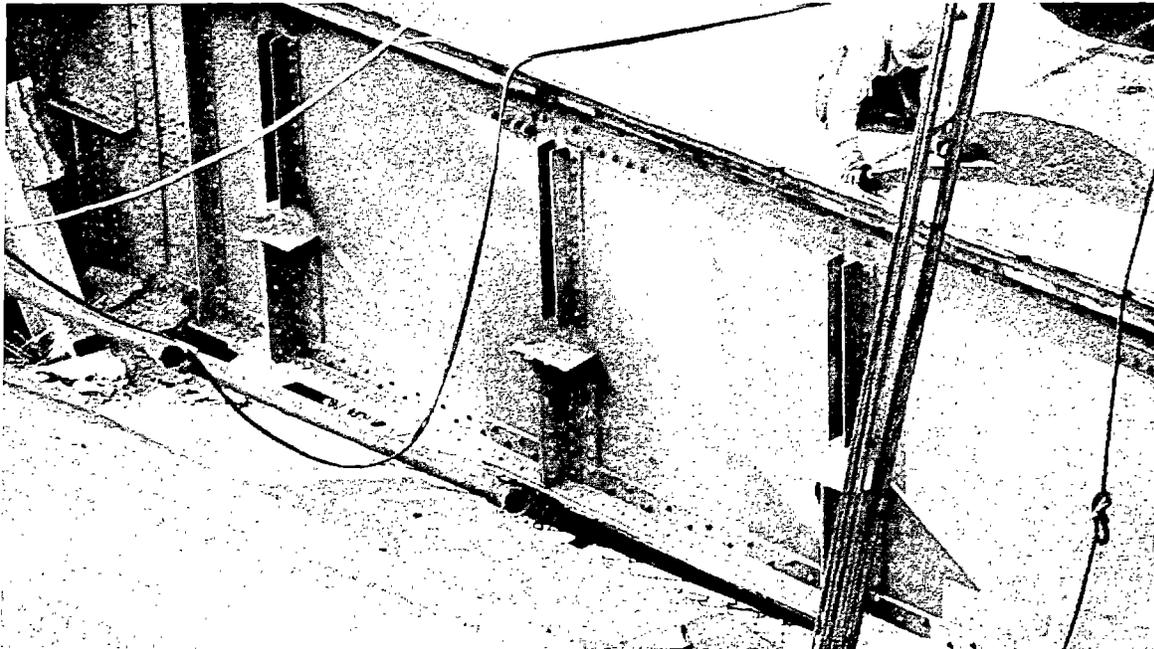
Figure 5.7.7 Close-up of the western girder seats for the lower road deck at Pier E-9. Lack of significant damage to these seats, and to those supporting the upper road deck, indicates that both upper and lower segments moved eastward by an amount sufficient to permit both to slide off the western seats and drop simultaneously.

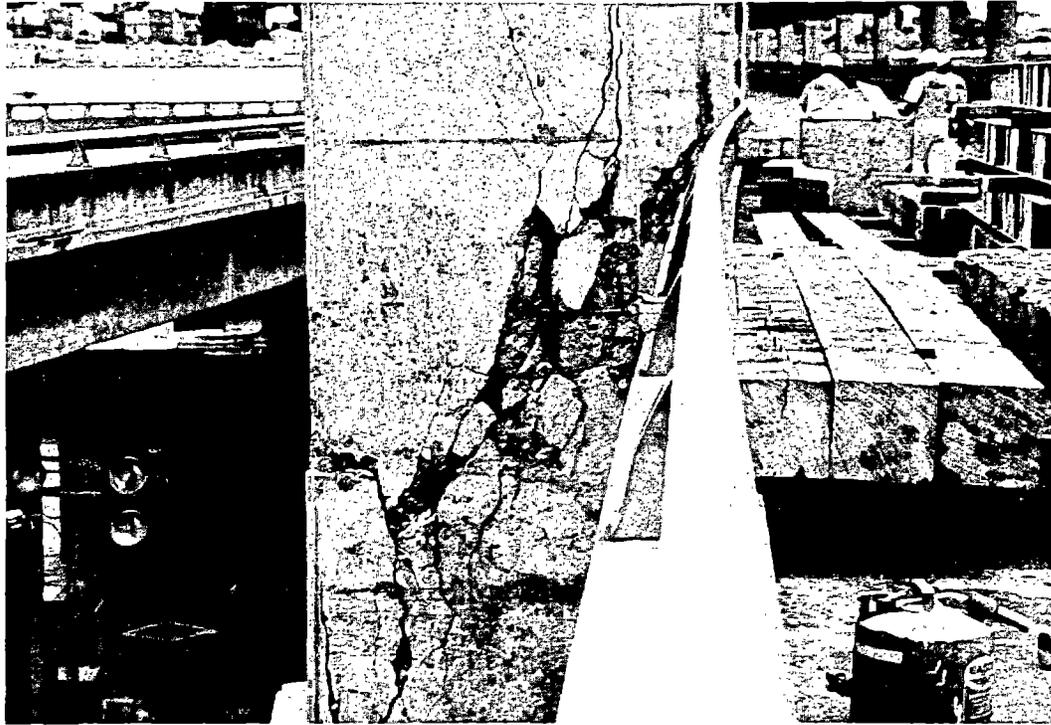
Figure 5.9.7 Diagonal cracking of the east-side column of Bent 52 (north face).

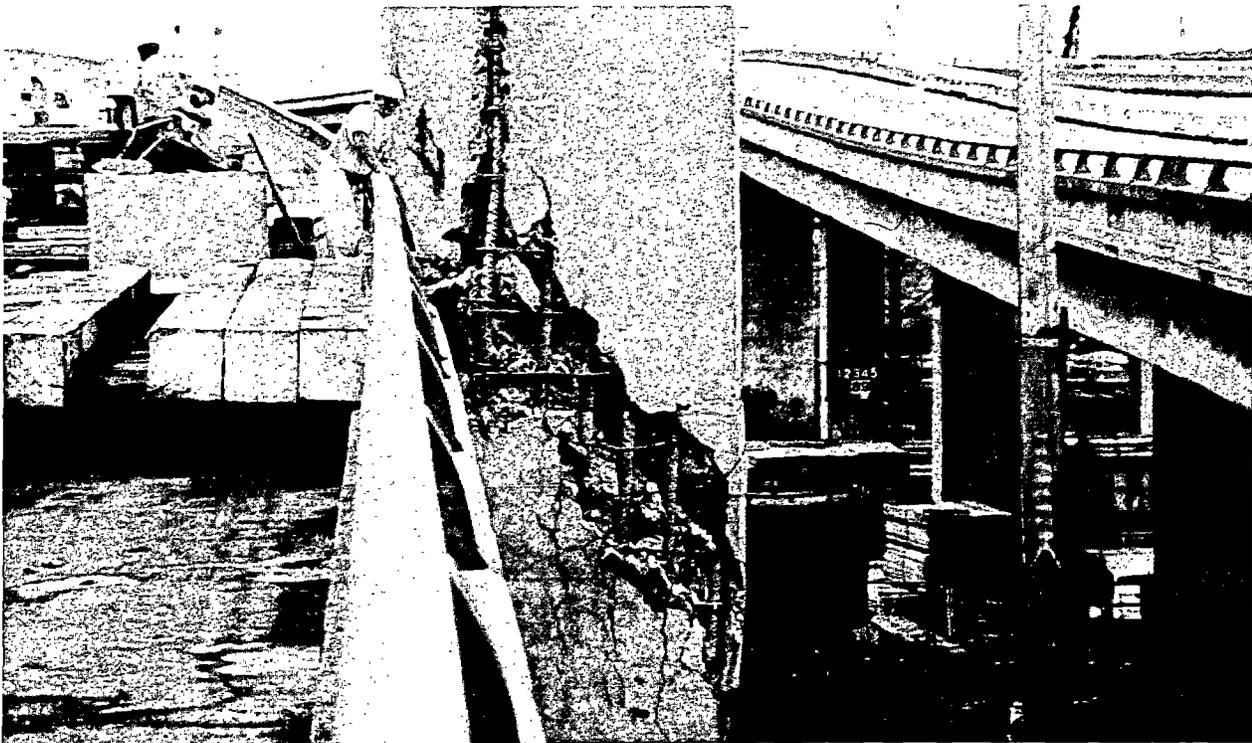
Figure 5.9.8 Diagonal cracking of the east-side column of Bent 51 (south face).

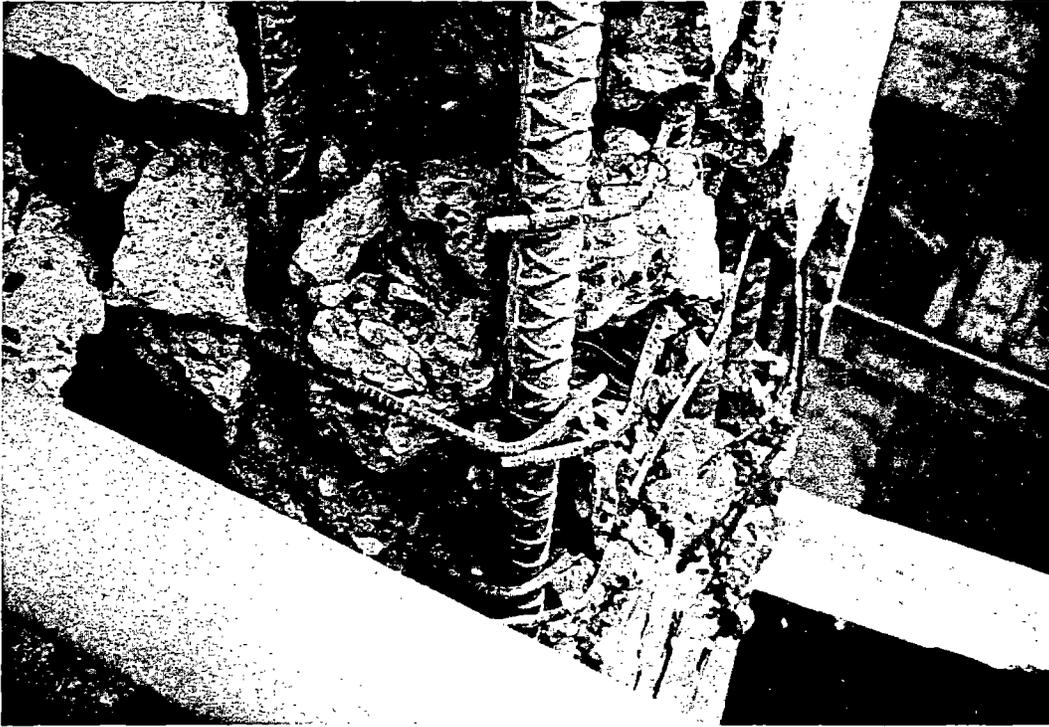
Figure 5.9.9 Close-up view of the failure zone of Bent 51, showing anchorage failure of ties.

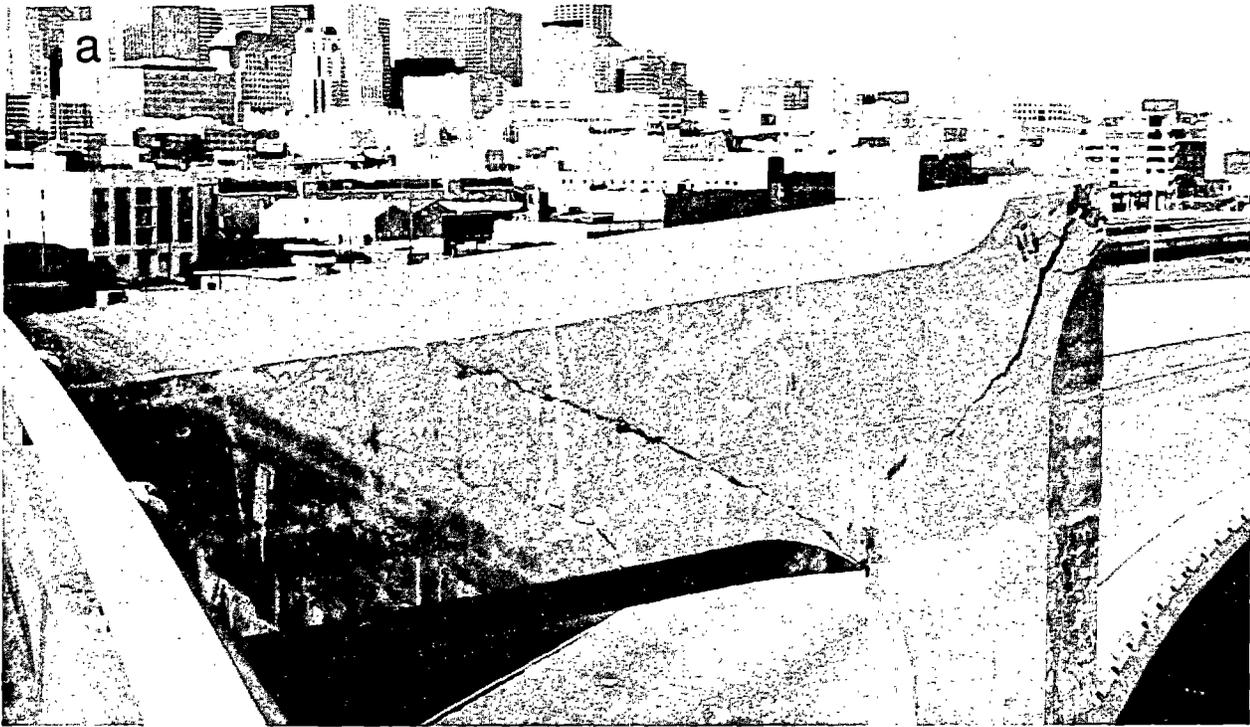
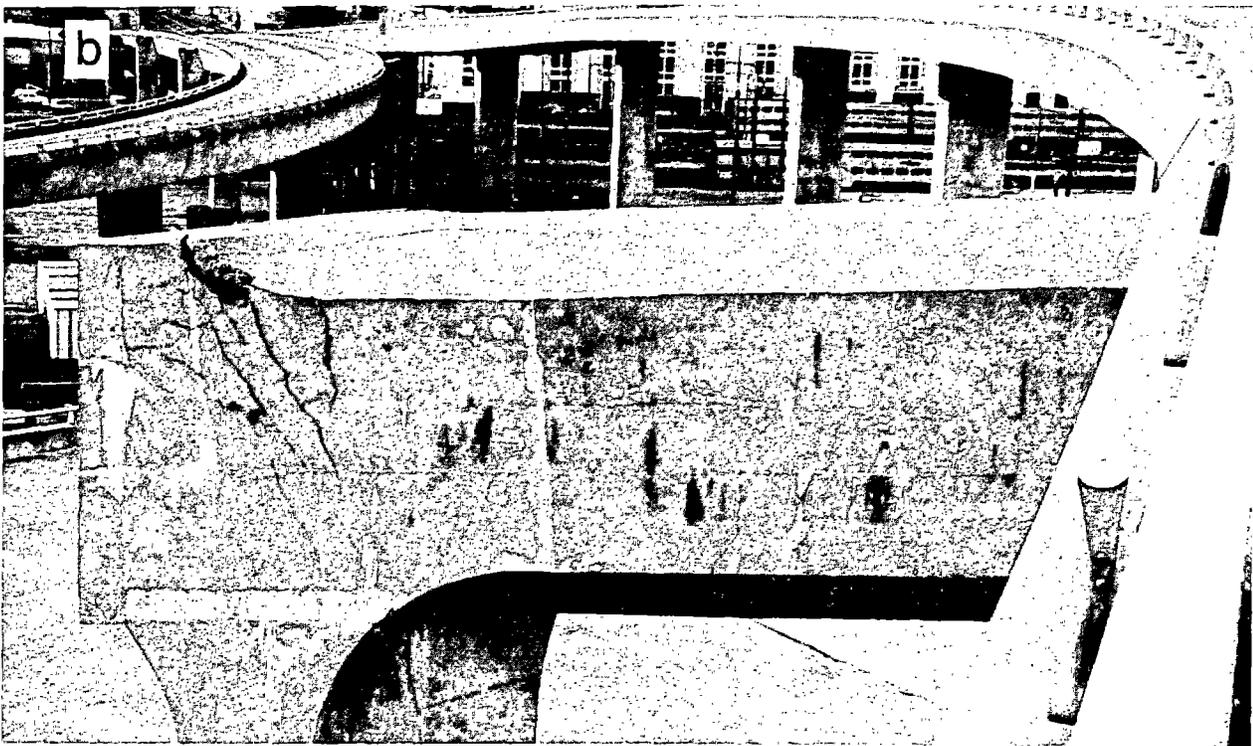
Figure 5.9.14 Damage to girder supporting exit ramp: (a) eastern portion and (b) western portion.

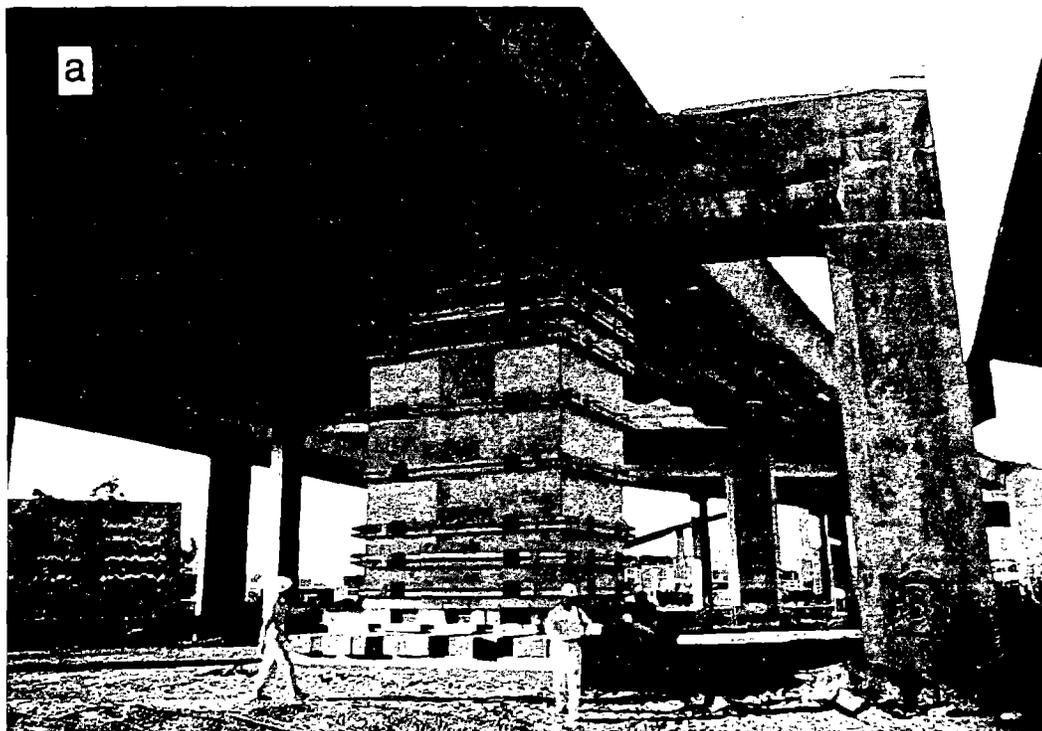
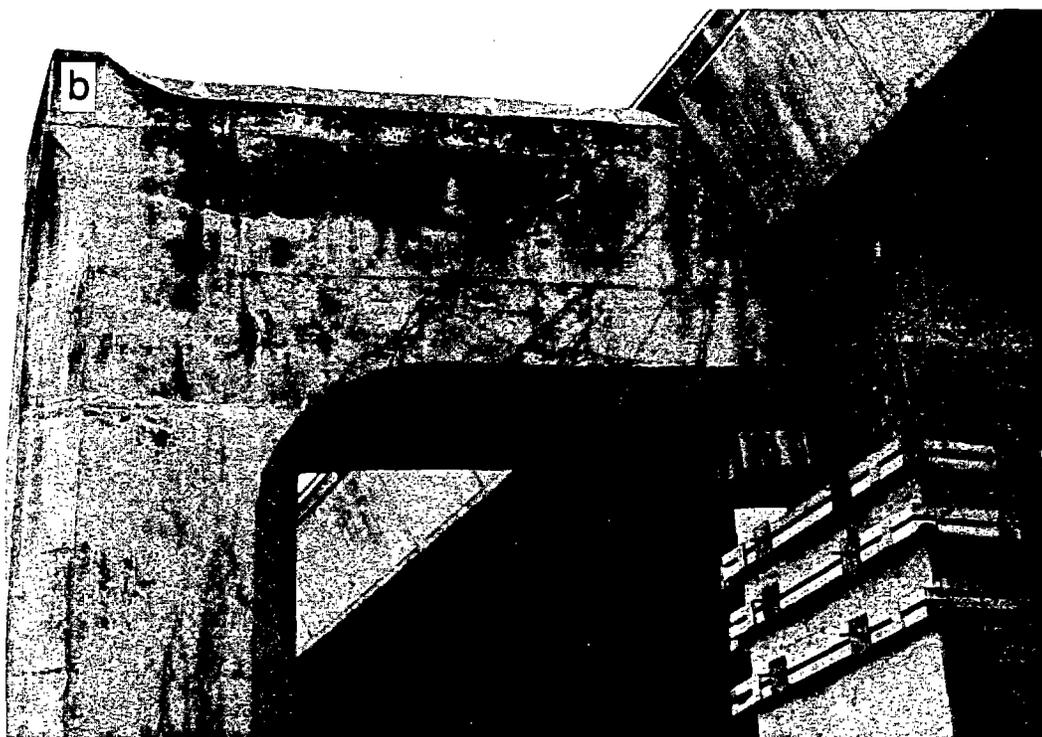
Figure 5.9.15 (a) Bent 32 supporting I-280 at Sixth St. exit ramp and (b) close-up of girder showing diagonal cracking.

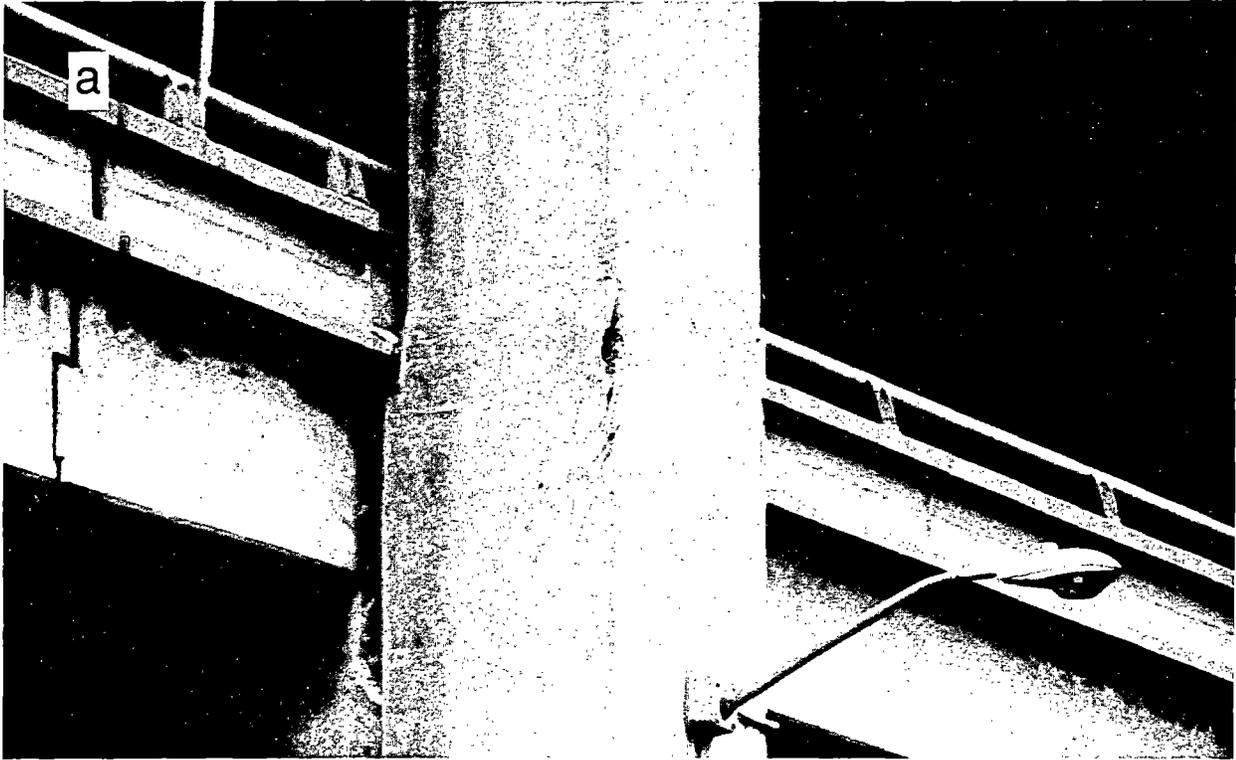
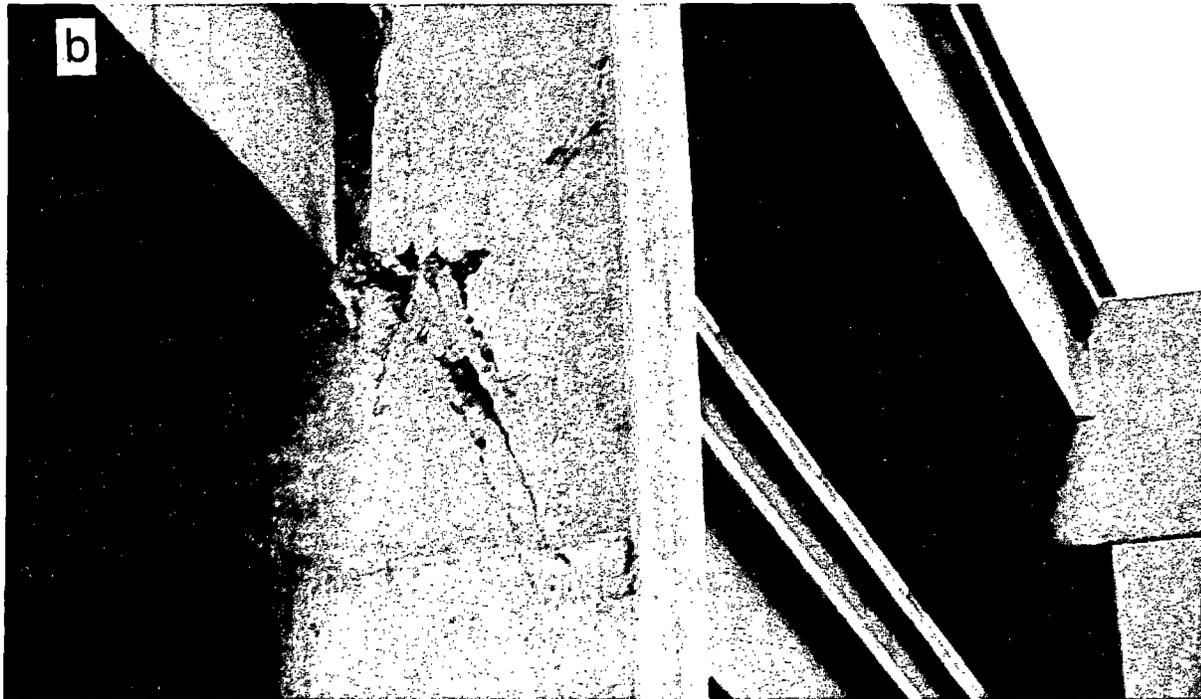
Figure 5.10.5 (a) Close-up view of west side of Bent 78 showing diagonal cracking in joint and vertical cracking at girder-column boundary; (b) close-up view of east side of Bent 79 showing diagonal cracking in joint.

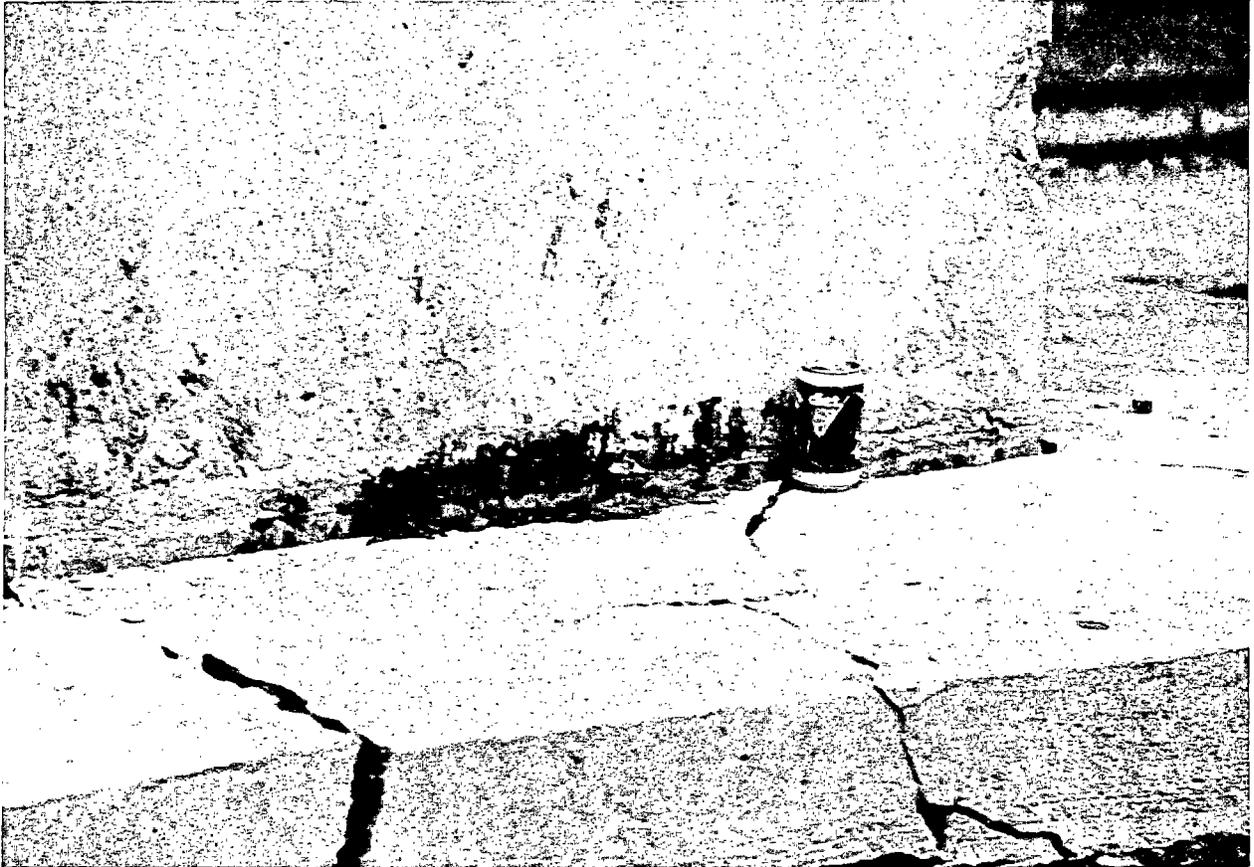
Figure 5.10.6 Evidence of large ground movement at east side base of Bent 77.

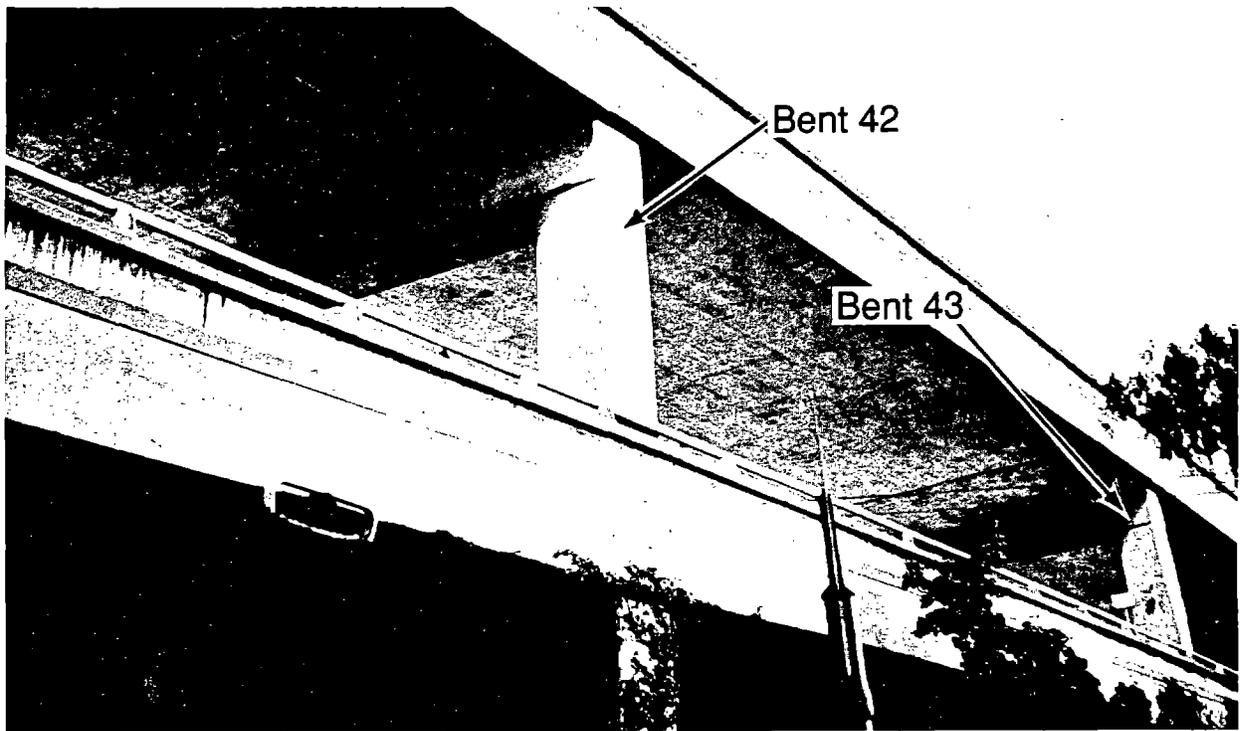
Figure 5.11.1 View of east side U.S. 101 north of Hayes St. showing damaged Bents 42 and 43.

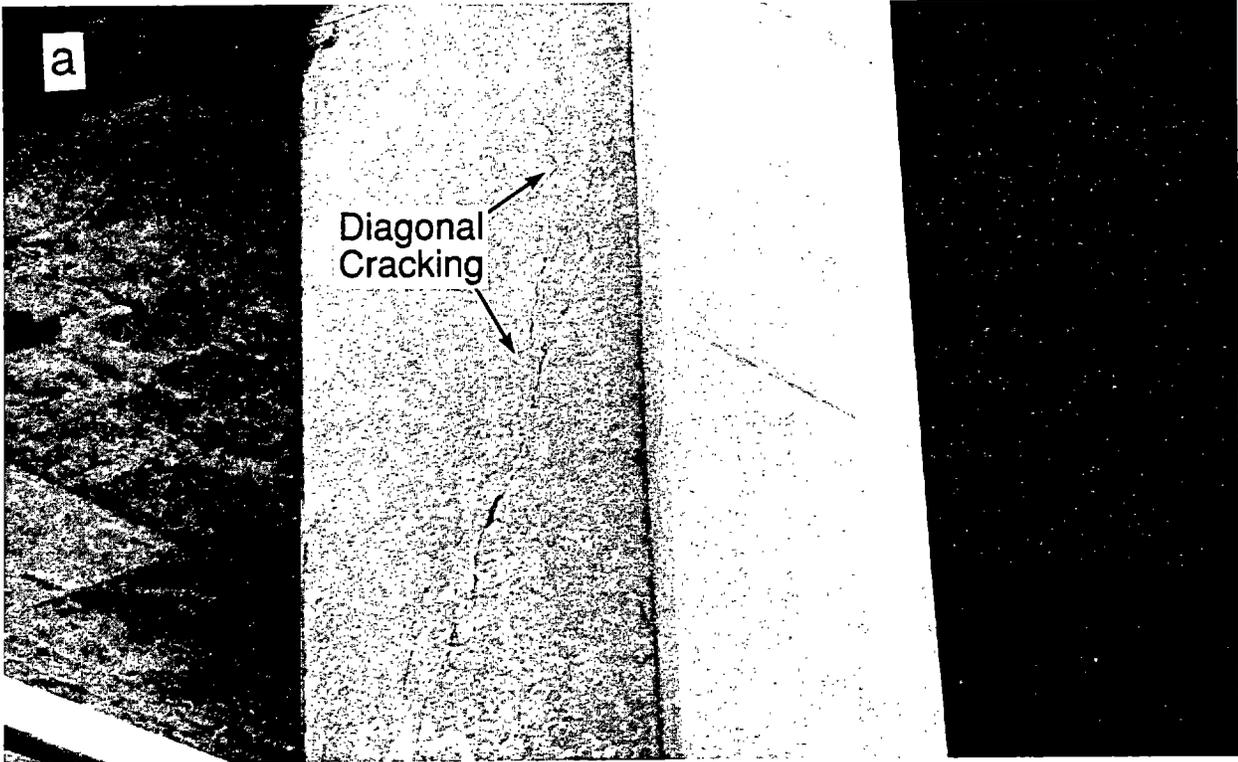
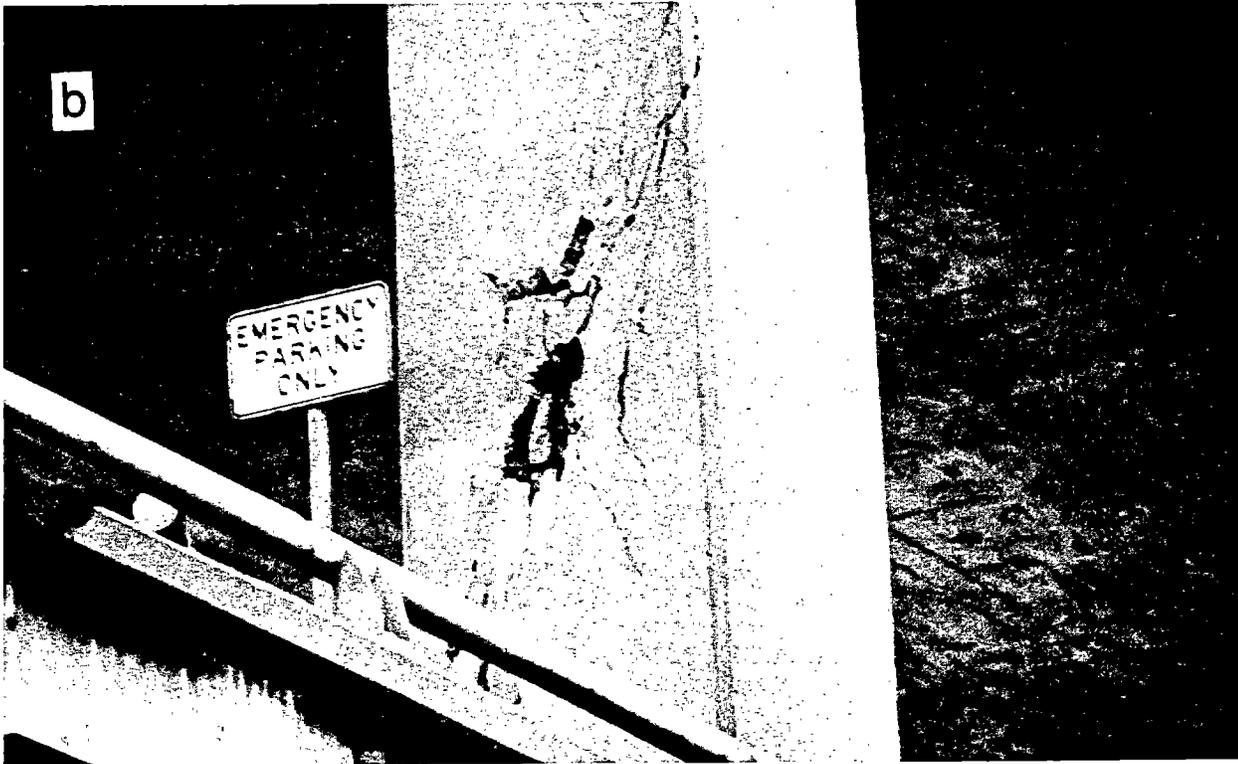
Figure 5.11.3 Close-up views of east side columns of (a) Bent 42 and (b) Bent 43.
