NBSIR 82-2593

Investigation of Construction Failure of the Riley Road Interchange Ramp, East Chicago, Indiana

October 1982

**INVESTIGATION OF CONSTRUCTION
FAILURE OF THE RILEY ROAD
INTERCHANGE RAMP, EAST CHICAGO,
INDIANA**

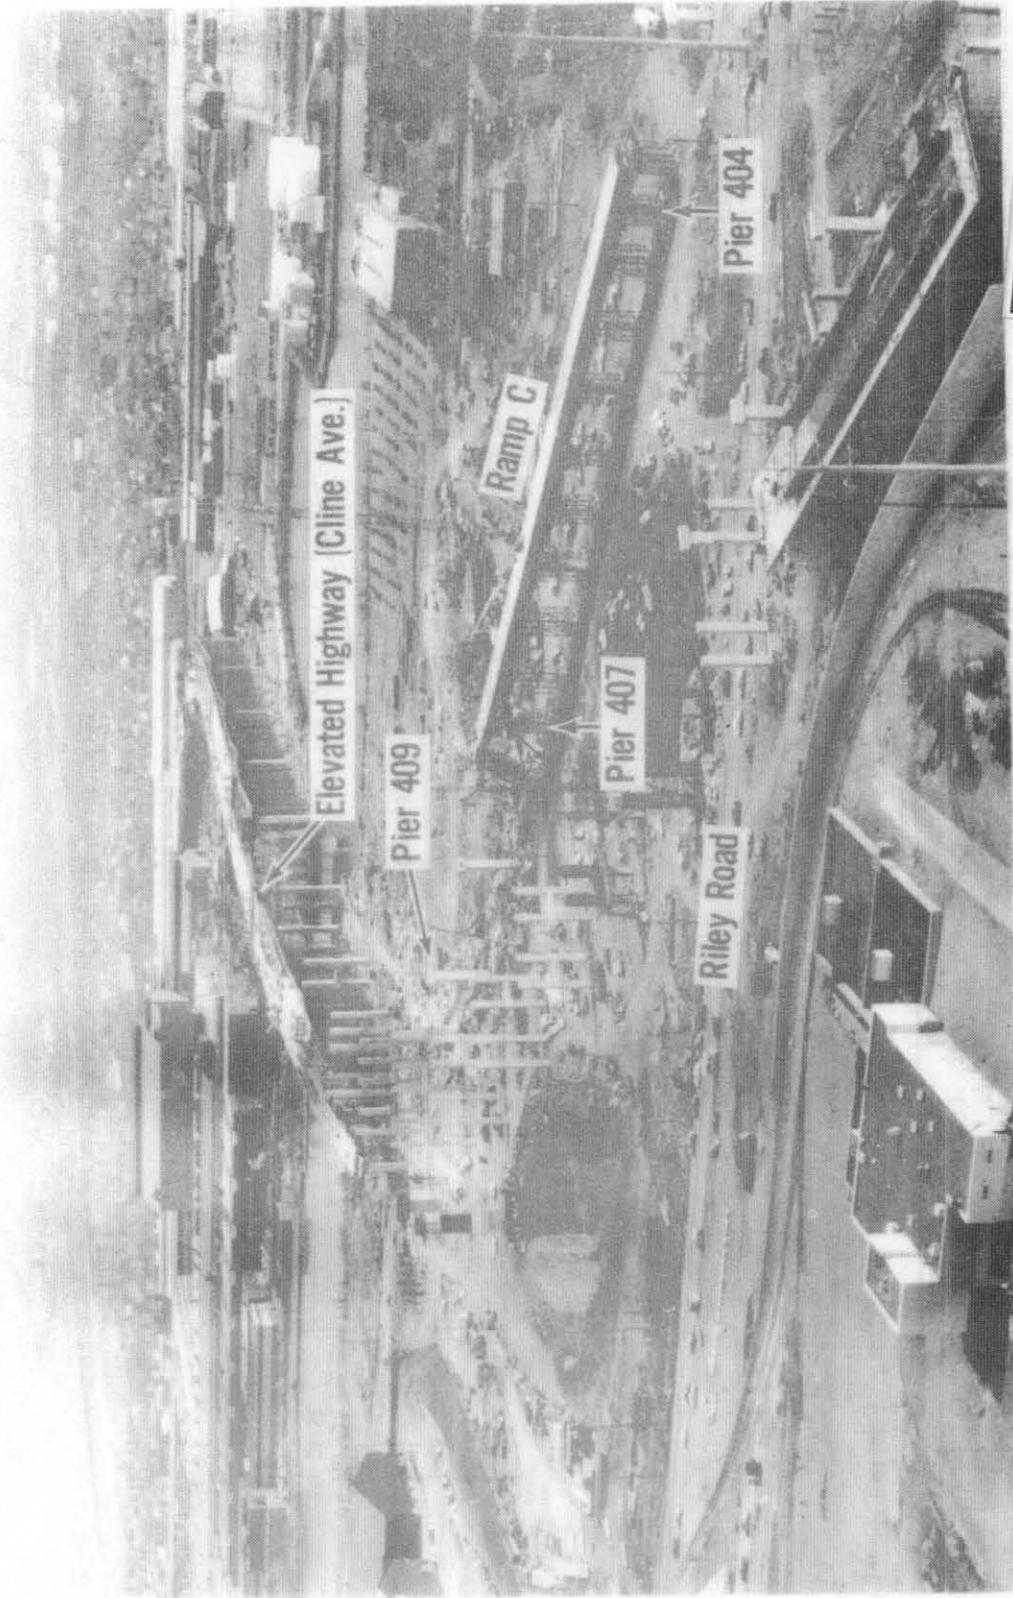
Figure 2.1 Overall view of the collapse site, looking from west to east.
(Courtesy of Post-Tribune, Gary Indiana)

The structure, known as Ramp C, is located at the interchange of Riley Road and Cline Avenue in East Chicago, Indiana. It is intended to move traffic from Riley Road onto the eastbound lane of Cline Avenue. Figure 2.1 is a view looking east taken shortly after the failure, and shows the portion of the ramp which remained standing. The ramp was to be built in two phases. In the first phase, the portion from pier 404 to an expansion joint beyond pier 409 was being built. In the second phase, the portion west of pier 404 and passing over Riley Road would be built. At the time of the collapse work was in progress east of pier 407 in the first portion.

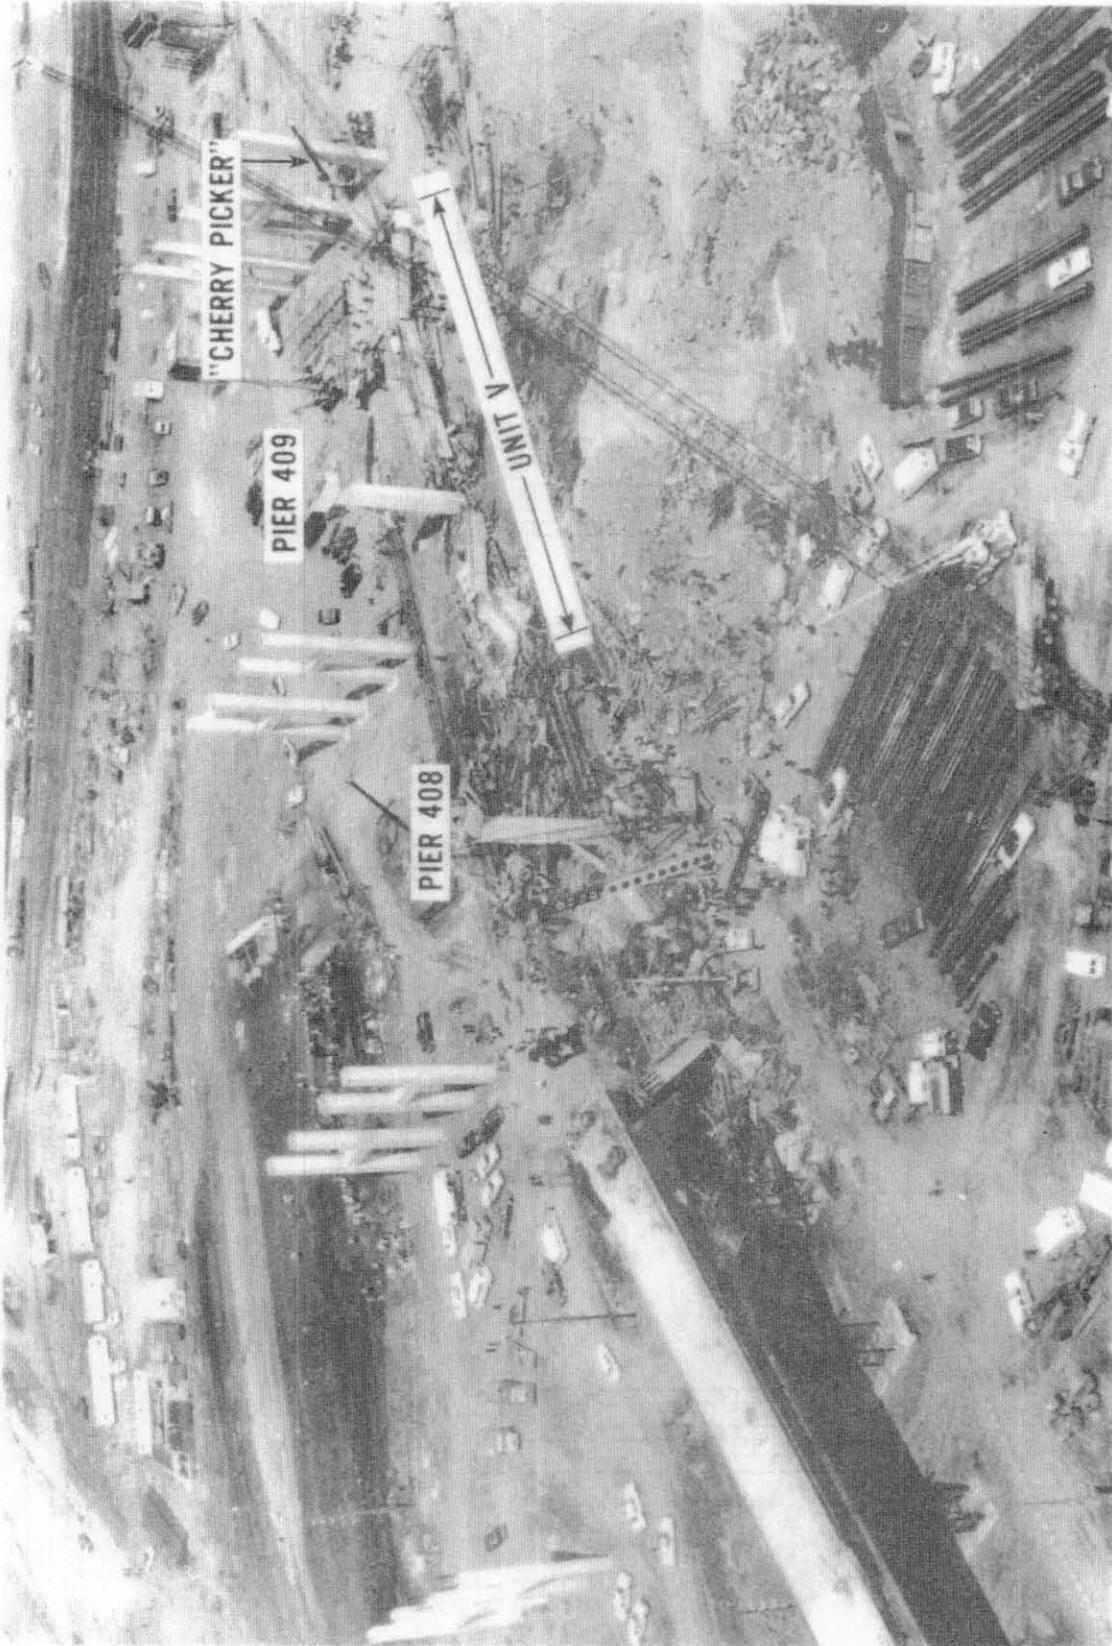
Figure 2.14 View of collapse as seen from the southwest (courtesy of Post-Tribune, Gary, Indiana)

Figures 2.14, 2.15, and 2.16 are aerial photographs taken on the day of the failure. They show the location of the debris before a significant amount of it had been moved for rescue operations.

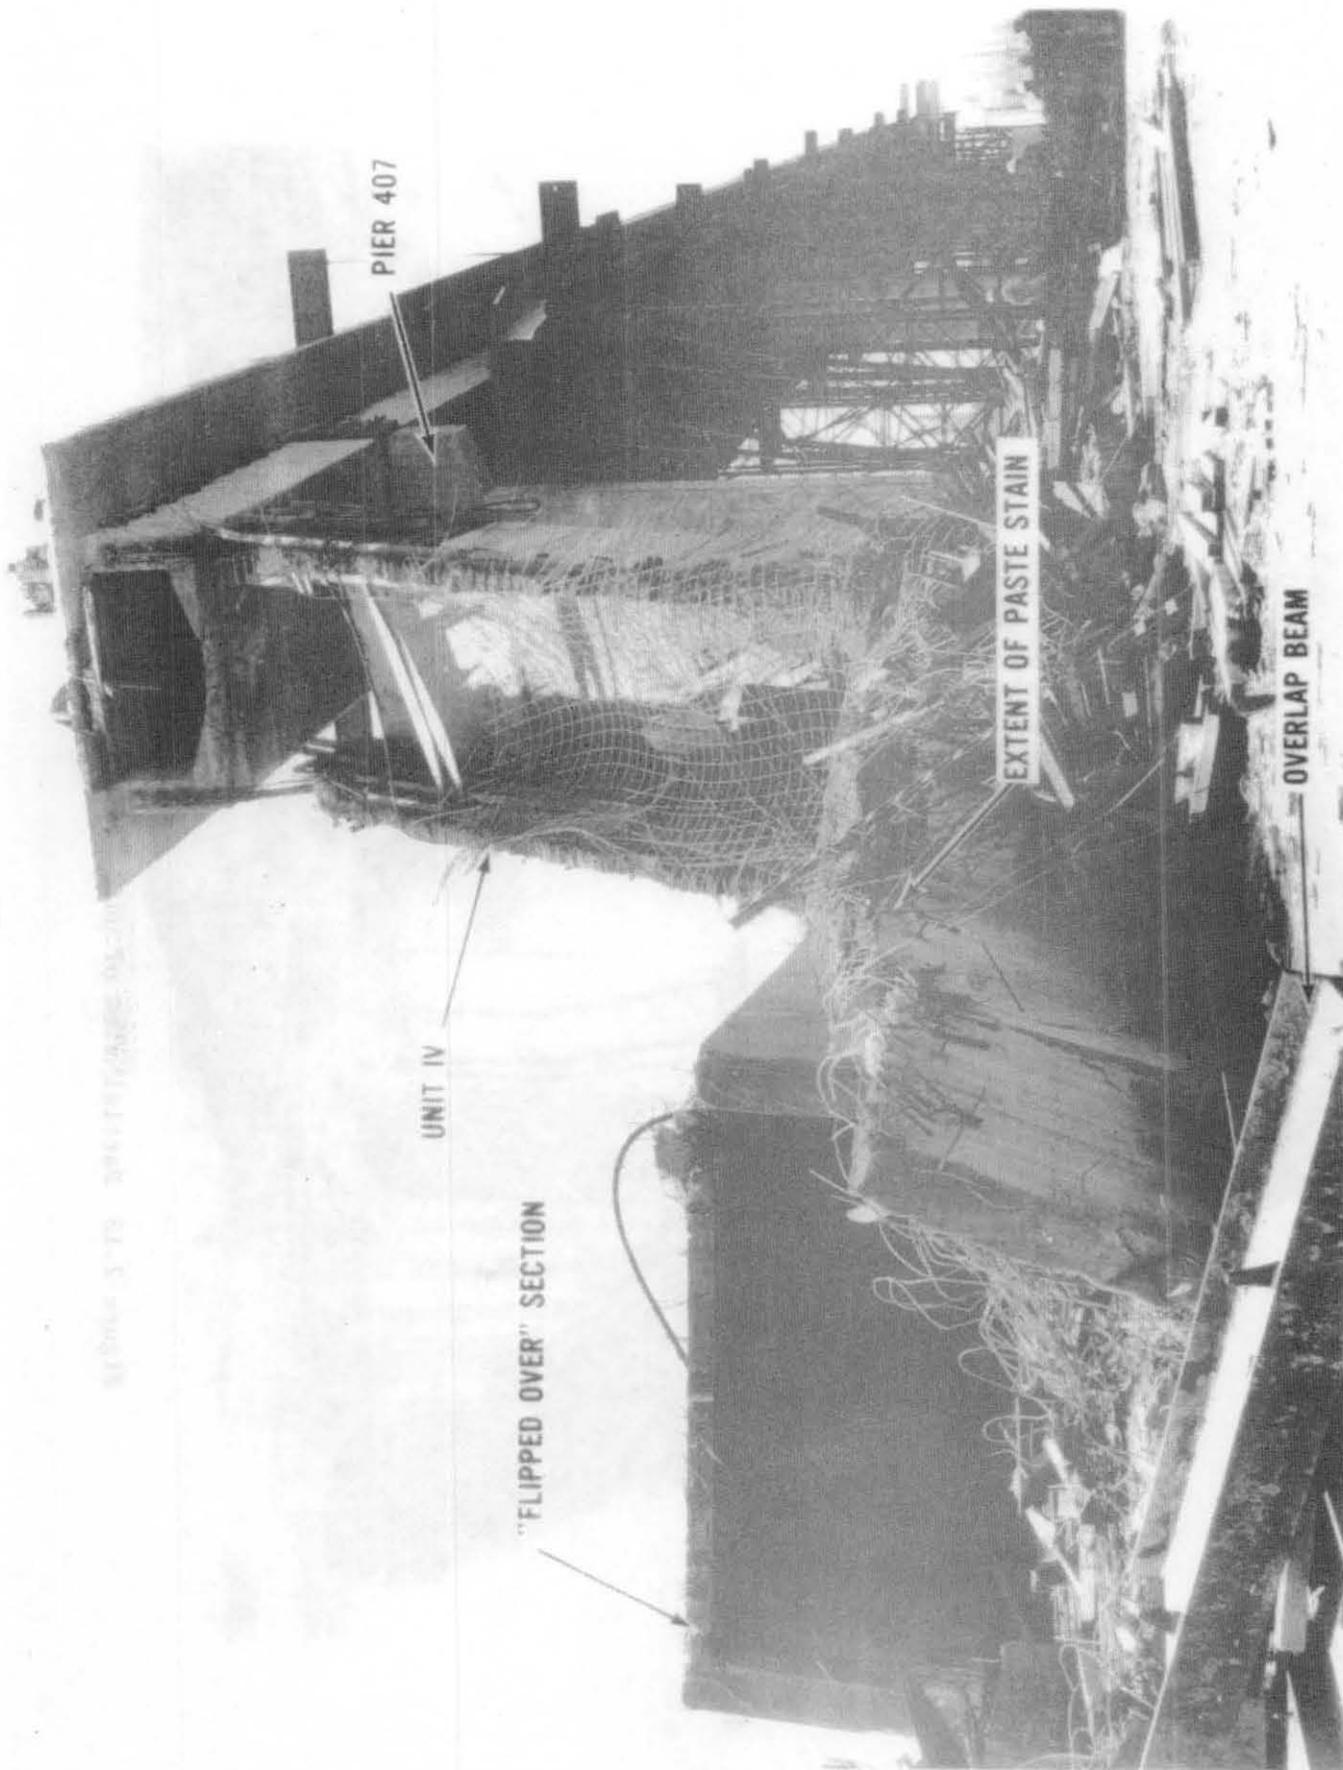
Figure 2.17 Unit IV as viewed from the northeast

concrete plant, 140 yd³ (107 m³) of concrete had been delivered for the top slab. From field measurements it was found that the diaphragm had been filled to an elevation of about 5 ft (1.5 m), thus it was calculated that the top slab had been placed to a point about 20 ft (6.1 m) west of pier 408, when the collapse initiated. This estimate was corroborated by worker statements and by measurements of the extent of the cement paste stain on the northern side wall of unit IV (see figure 2.17).

Figure 2.17, 2.18, and 2.19 are ground level views of unit IV. Figure 2.17 is a view from the northeast and shows the portions of unit IV that were adjacent to pier 408. Stains due to fresh cement paste can be seen on the northern side wall. The stained region ends at about 20 ft (6 m) from the end of the unit, and this is assumed to indicate how much of the top-slab concrete had been placed. In the foreground of figure 2.17 is seen a short, steel beam that was originally located next to the cap of pier 408. The purpose of this beam is discussed in subsection 3.2.4.

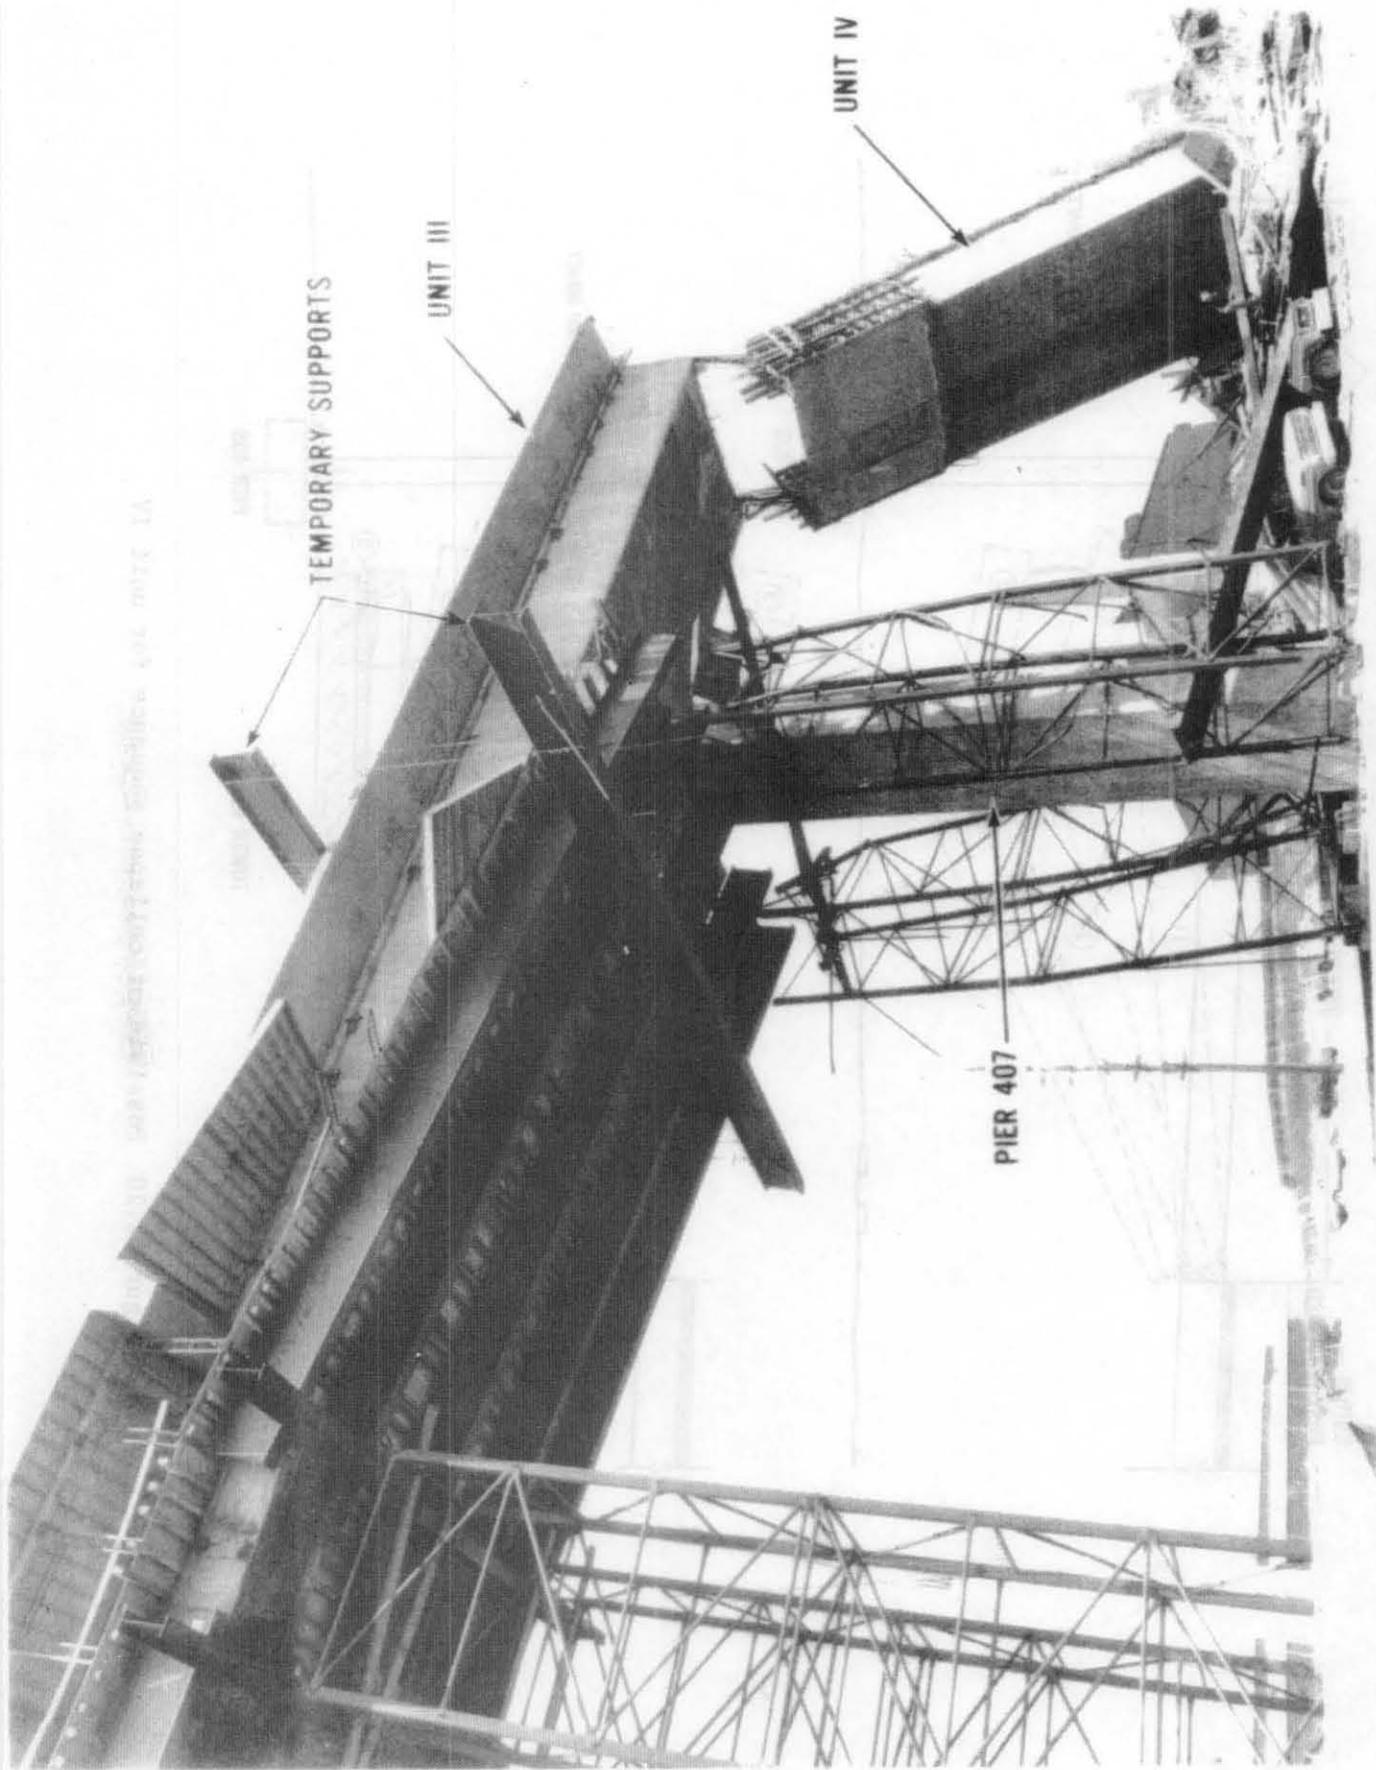
Figure 2.19 View of the hanging portion of unit IV from the southwest

Figure 2.19 is a view of the hanging portion of unit IV as seen from the southwest. The portion of the floor slab that is a lighter shade is the portion cast two days before the failure. Also seen are the damaged shoring towers at pier 407. The two transverse beams on unit III were added after the collapse to help support the stringers which were originally supported by the towers at pier 407. Figure 2.19 also shows some of the falsework details to be discussed in section 3.2.

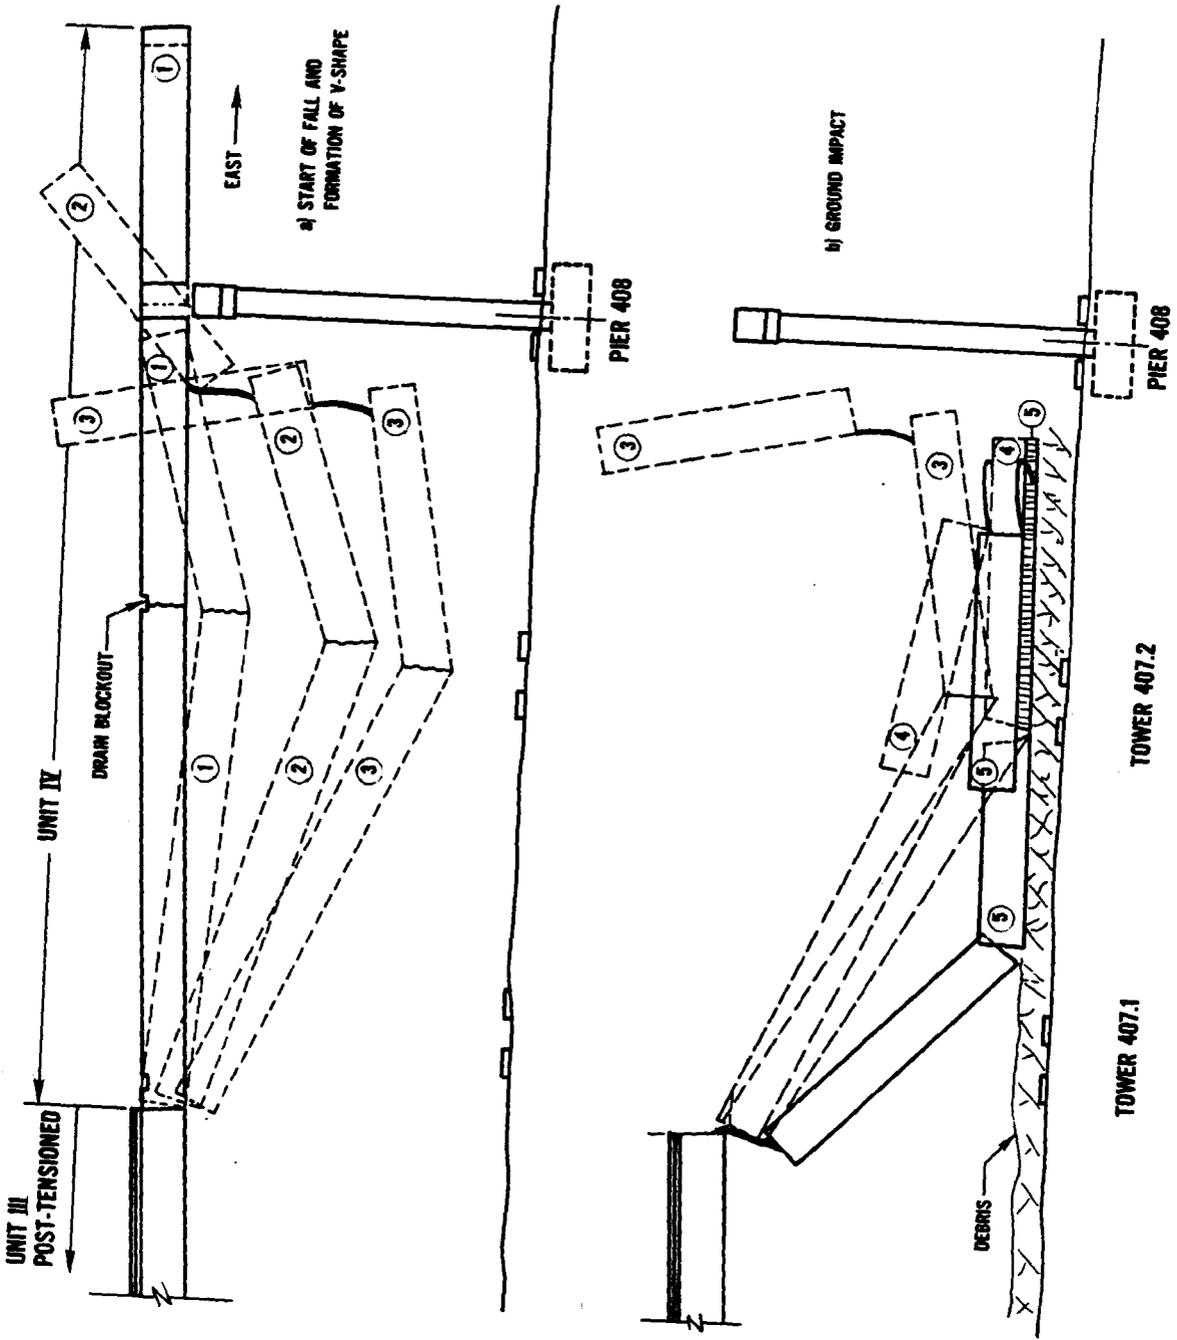
Figure 2.20 Possible of collapse sequence for unit IV

Figure 2.20 is a reconstruction of a possible mechanism of the collapse of unit IV. Field observations after the failure revealed a large gap in the northern wall of unit IV at approximately the same cross section containing the drain blockout on the south wall (see figure 2.9). Thus, it is suggested that unit IV developed initial cracking at the location of the cross-section with the blockout. As the unit fell it dragged with it the portion east of pier 408 (#1)*, because the tendons were wedged in place at the jacking end of unit IV.

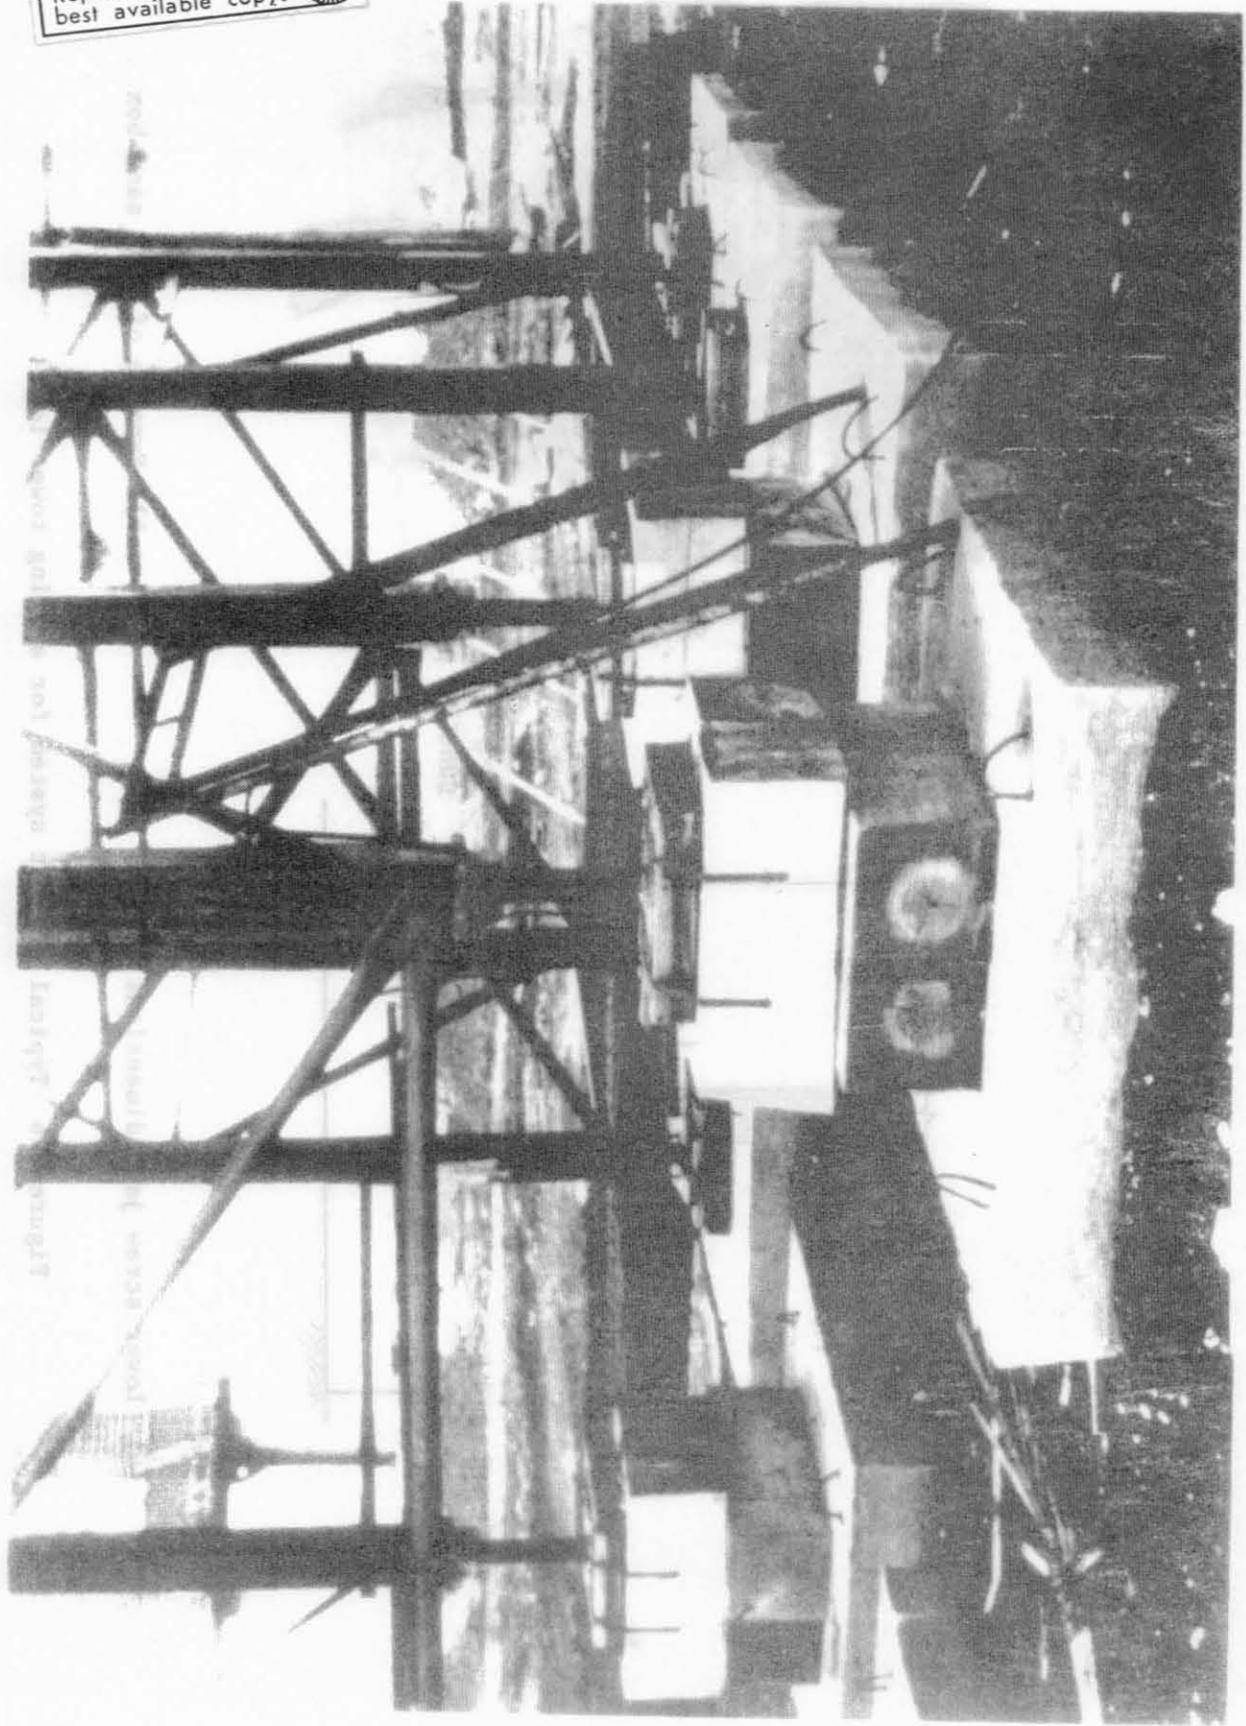
Figure 3.5 View of bottom of shoring towers at 407.1,
looking from south to north

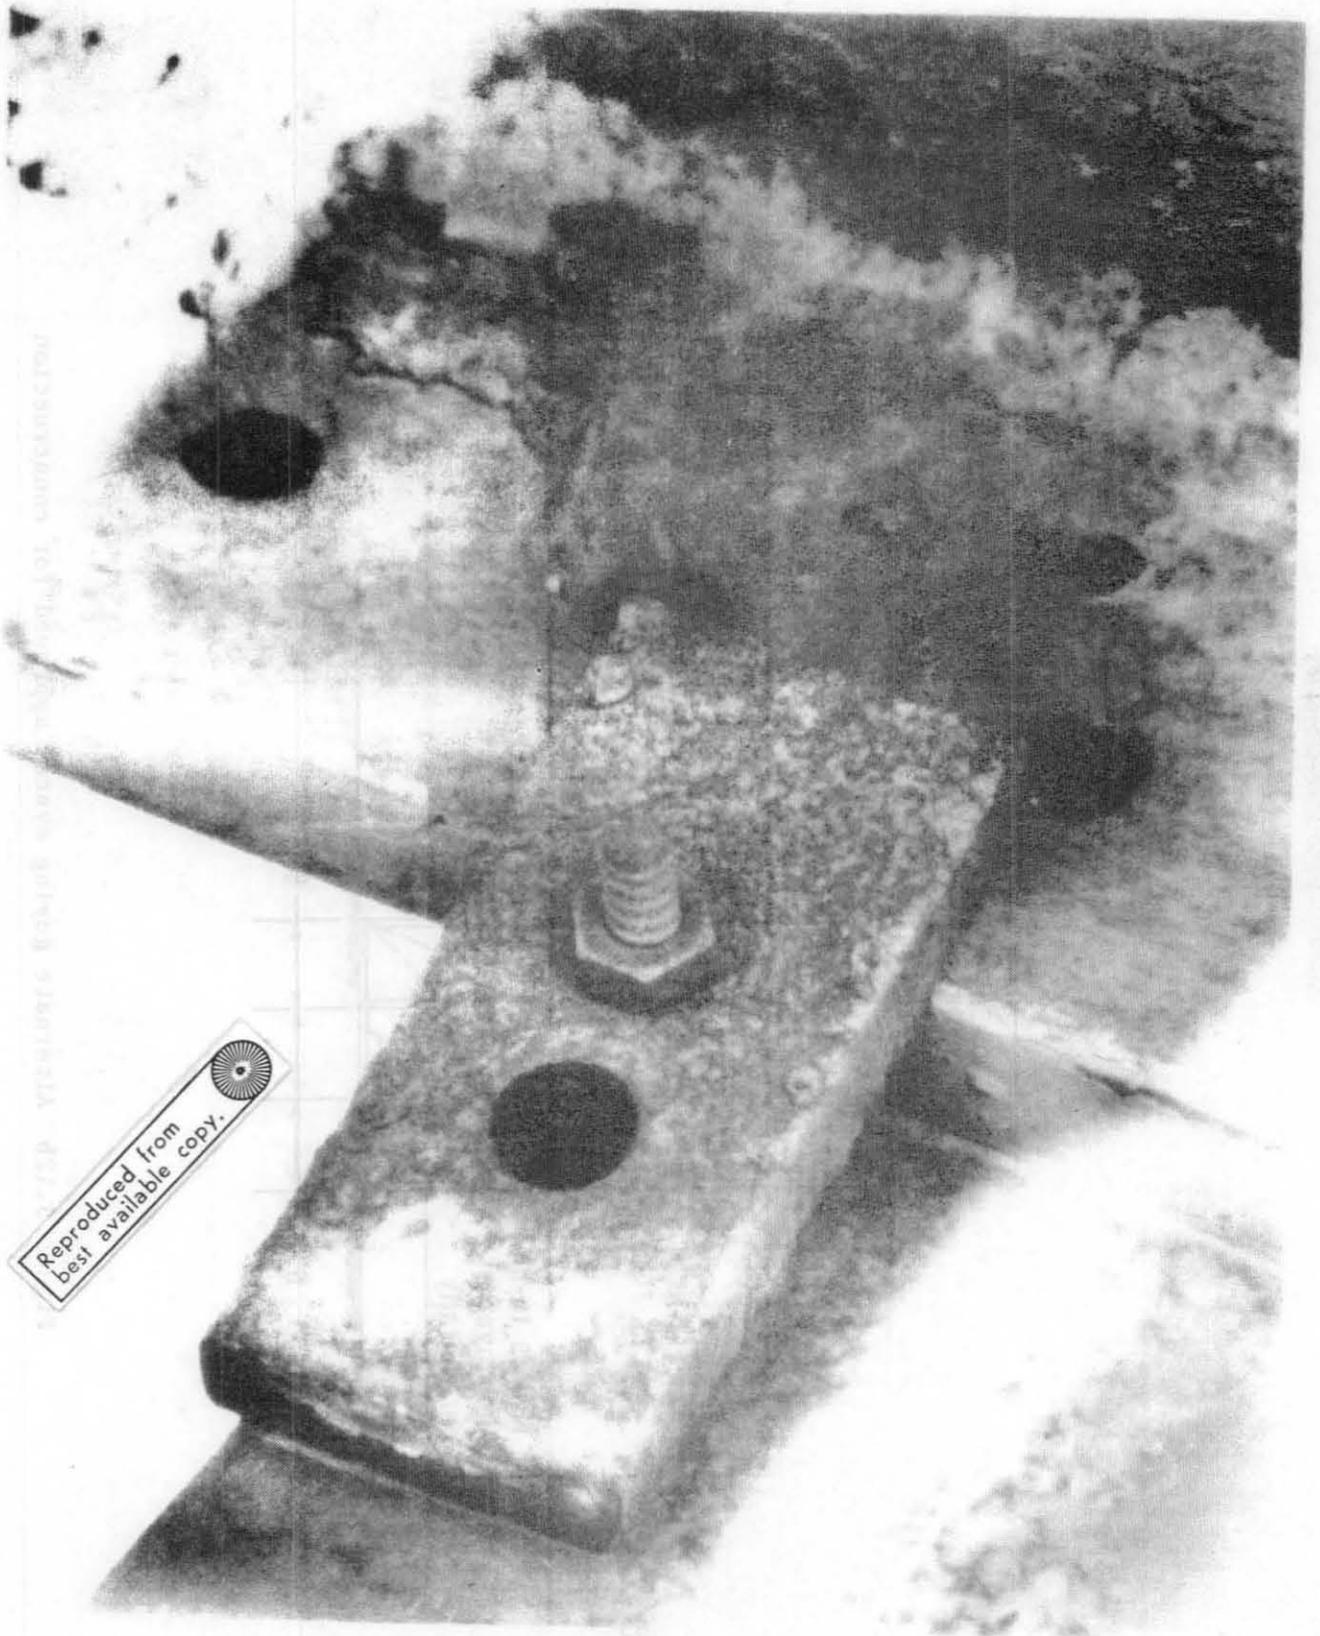
field investigation. A frictional clip was used in place of the bolts, but no documentation was found authorizing this substitution. The drawings also specified wedges between crossbeams and stringers to compensate for the slope of the roadway. There was no evidence that wedges were used, and no documentation was found approving their omission. In addition, no calculations were found for the engineering design of the concrete pads, and the construction sequence deviated from that specified in the drawings.

Figure 3.13 Connection detail employed in place of specified bolted connection

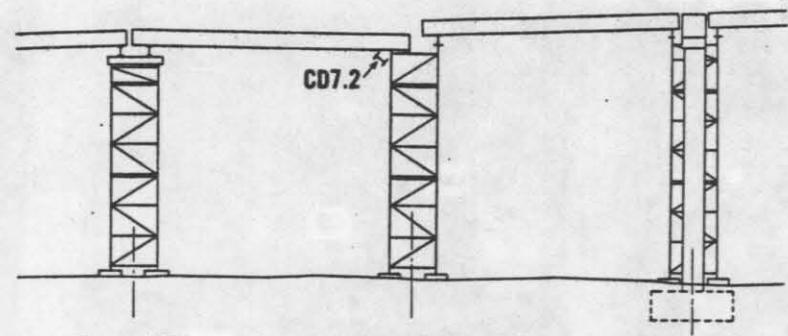
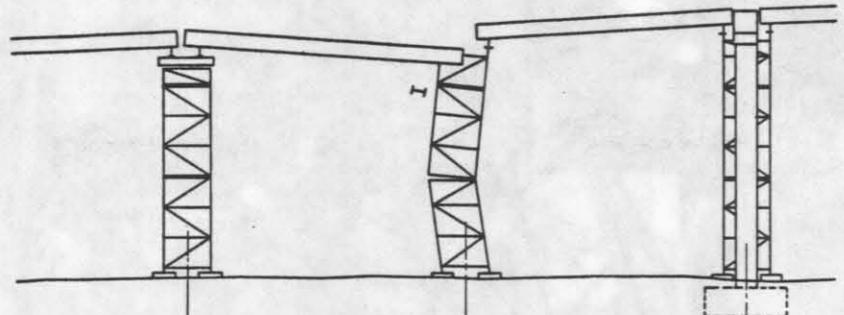
Figure 3.23 Possible collapse sequence of falsework at 407.2

a. Cross-beam CD7.2 falls down, U-heads are broken off.

b. Tower starts to fold.

c. Top portion of north tower begins to separate .

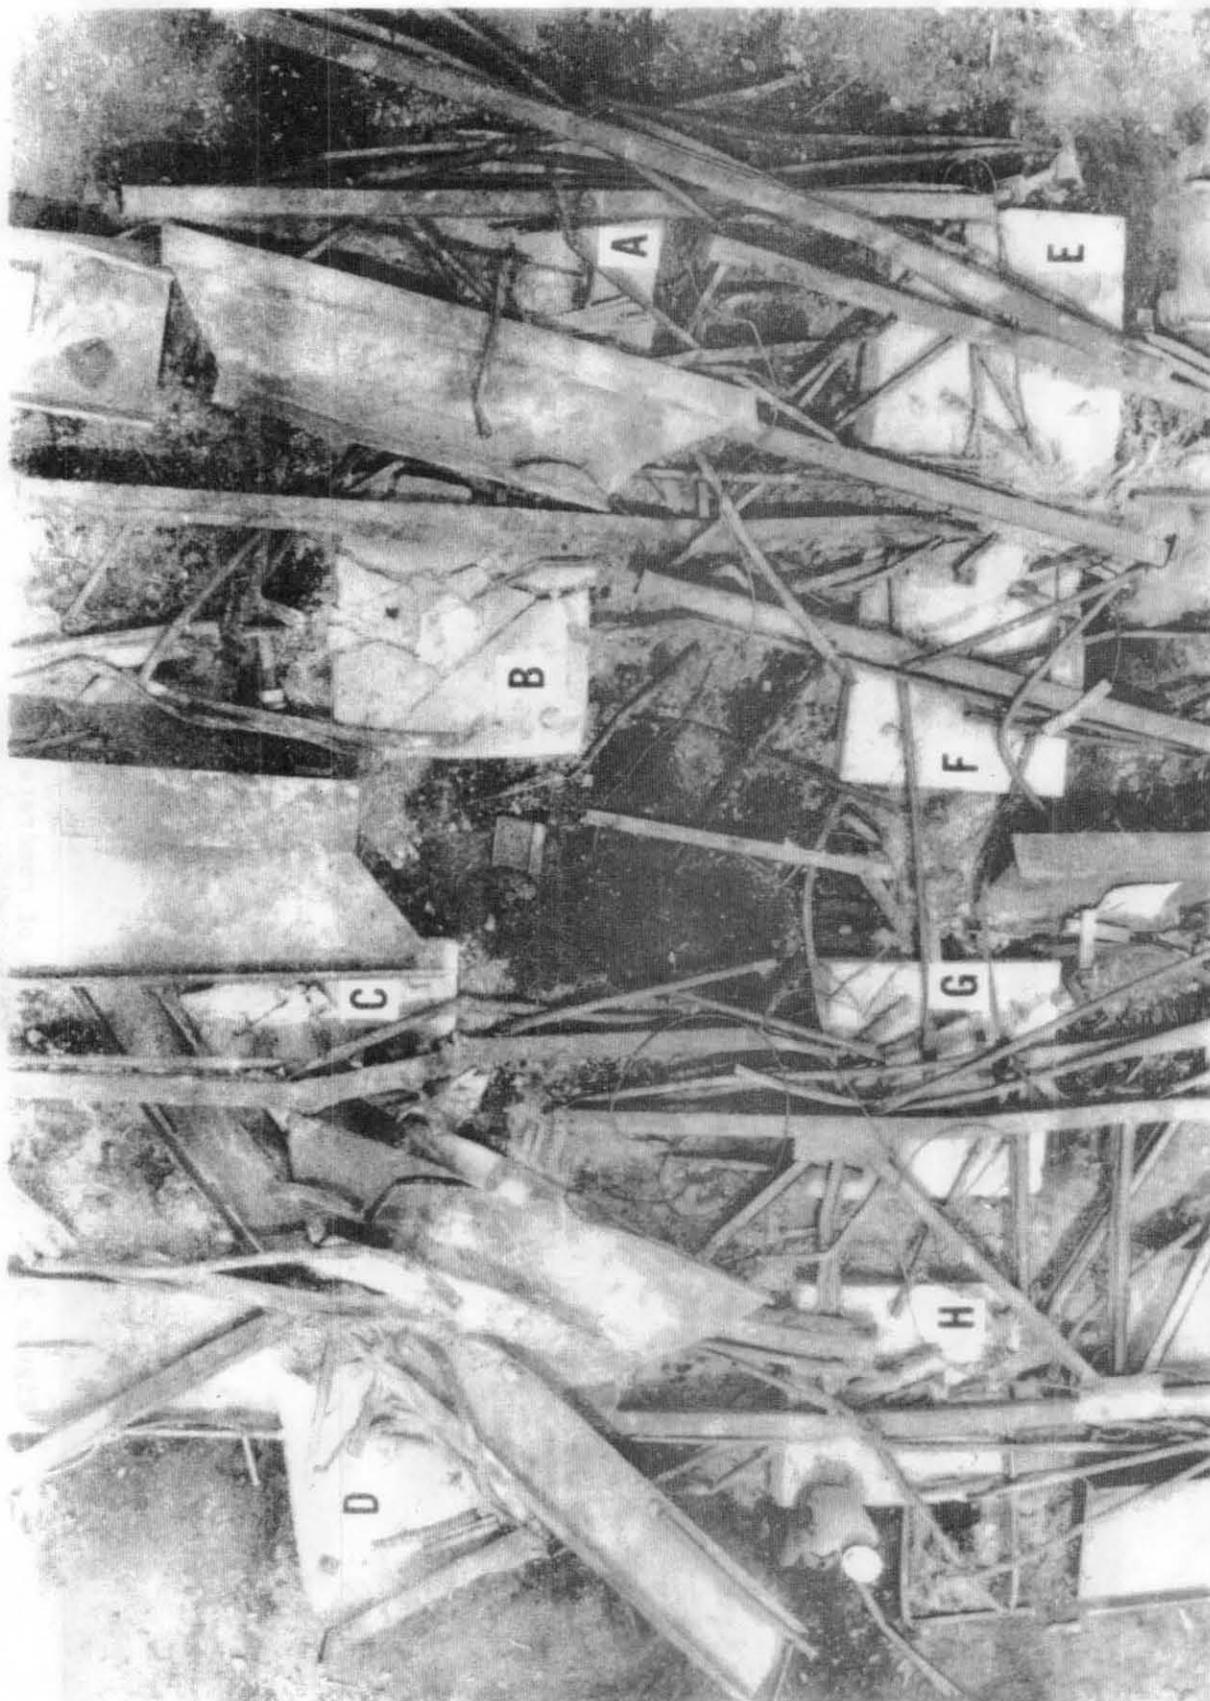
Figure 3.24 Close-up view of cracked concrete pads at tower location
407.2 (north is to the right)

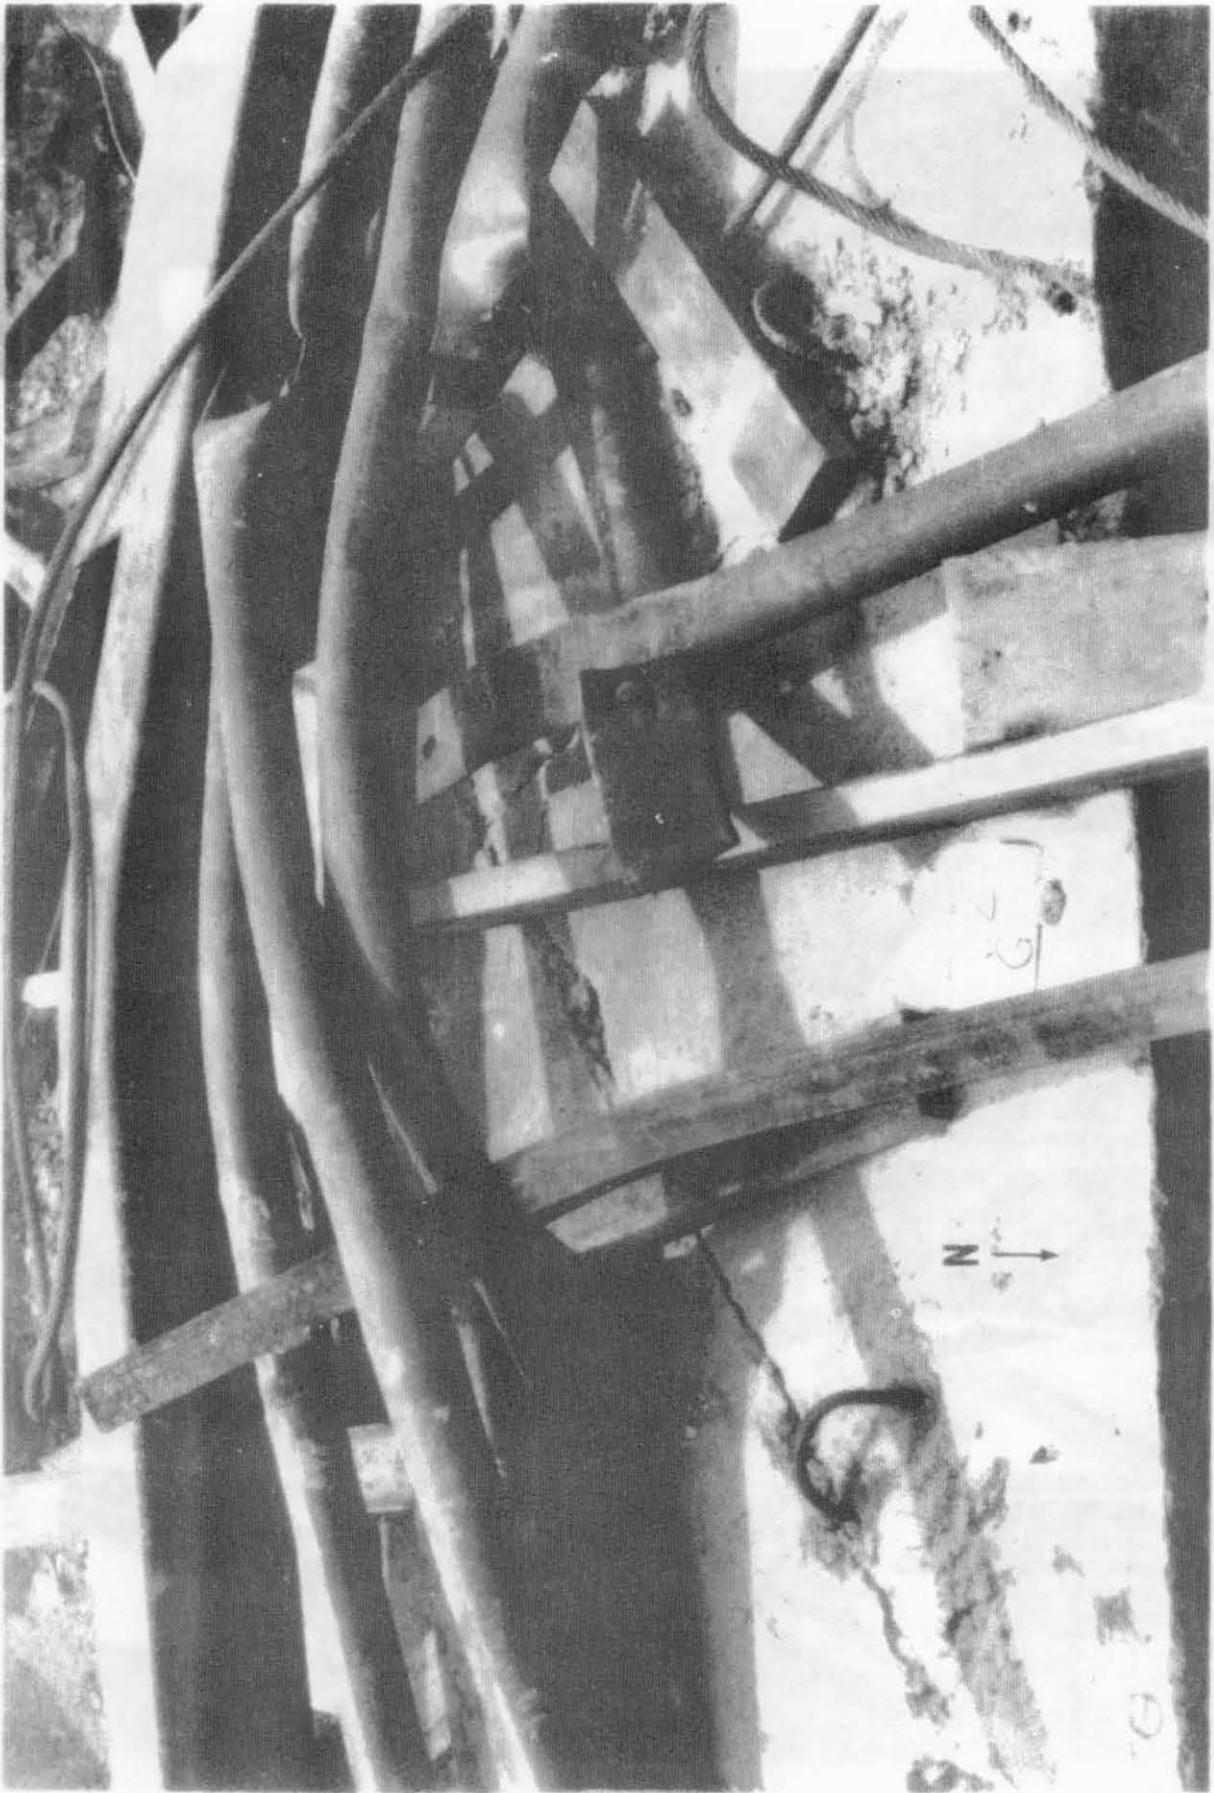
Figure 3.25 Cracking pattern of concrete pad 407.2-G

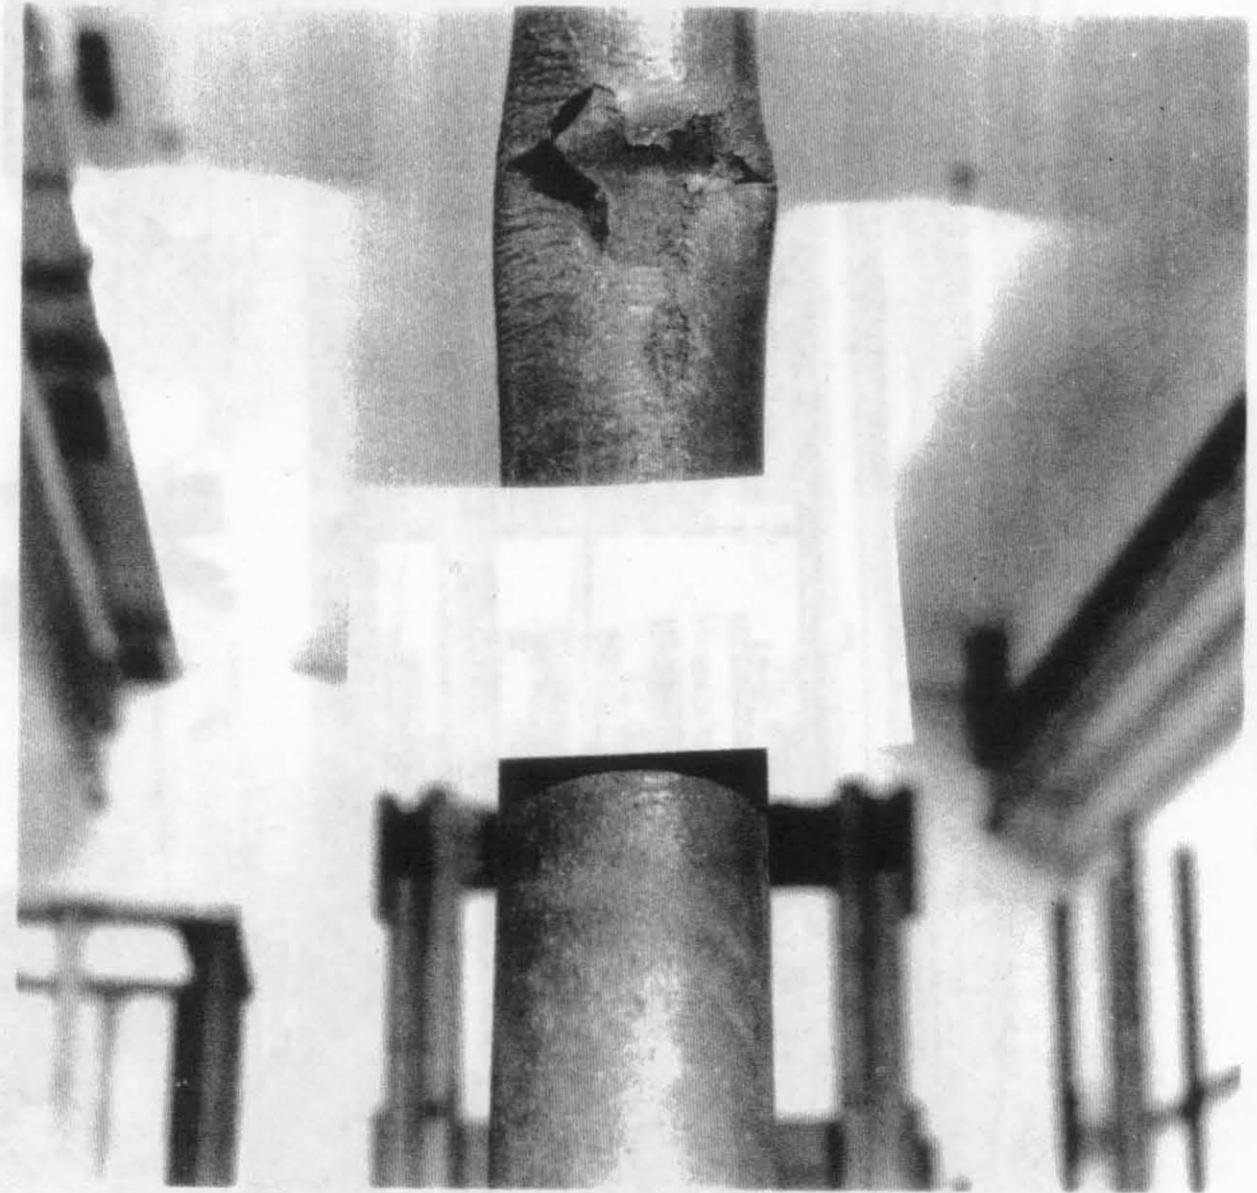
Figure 4.33 Close up view of corroded region near coupler of brace #3
