NBSIR 82-2593

Investigation of Construction Failure of the Riley Road Interchange Ramp, East Chicago, Indiana

October 1982

**INVESTIGATION OF CONSTRUCTION
FAILURE OF THE RILEY ROAD
INTERCHANGE RAMP, EAST CHICAGO,
INDIANA**

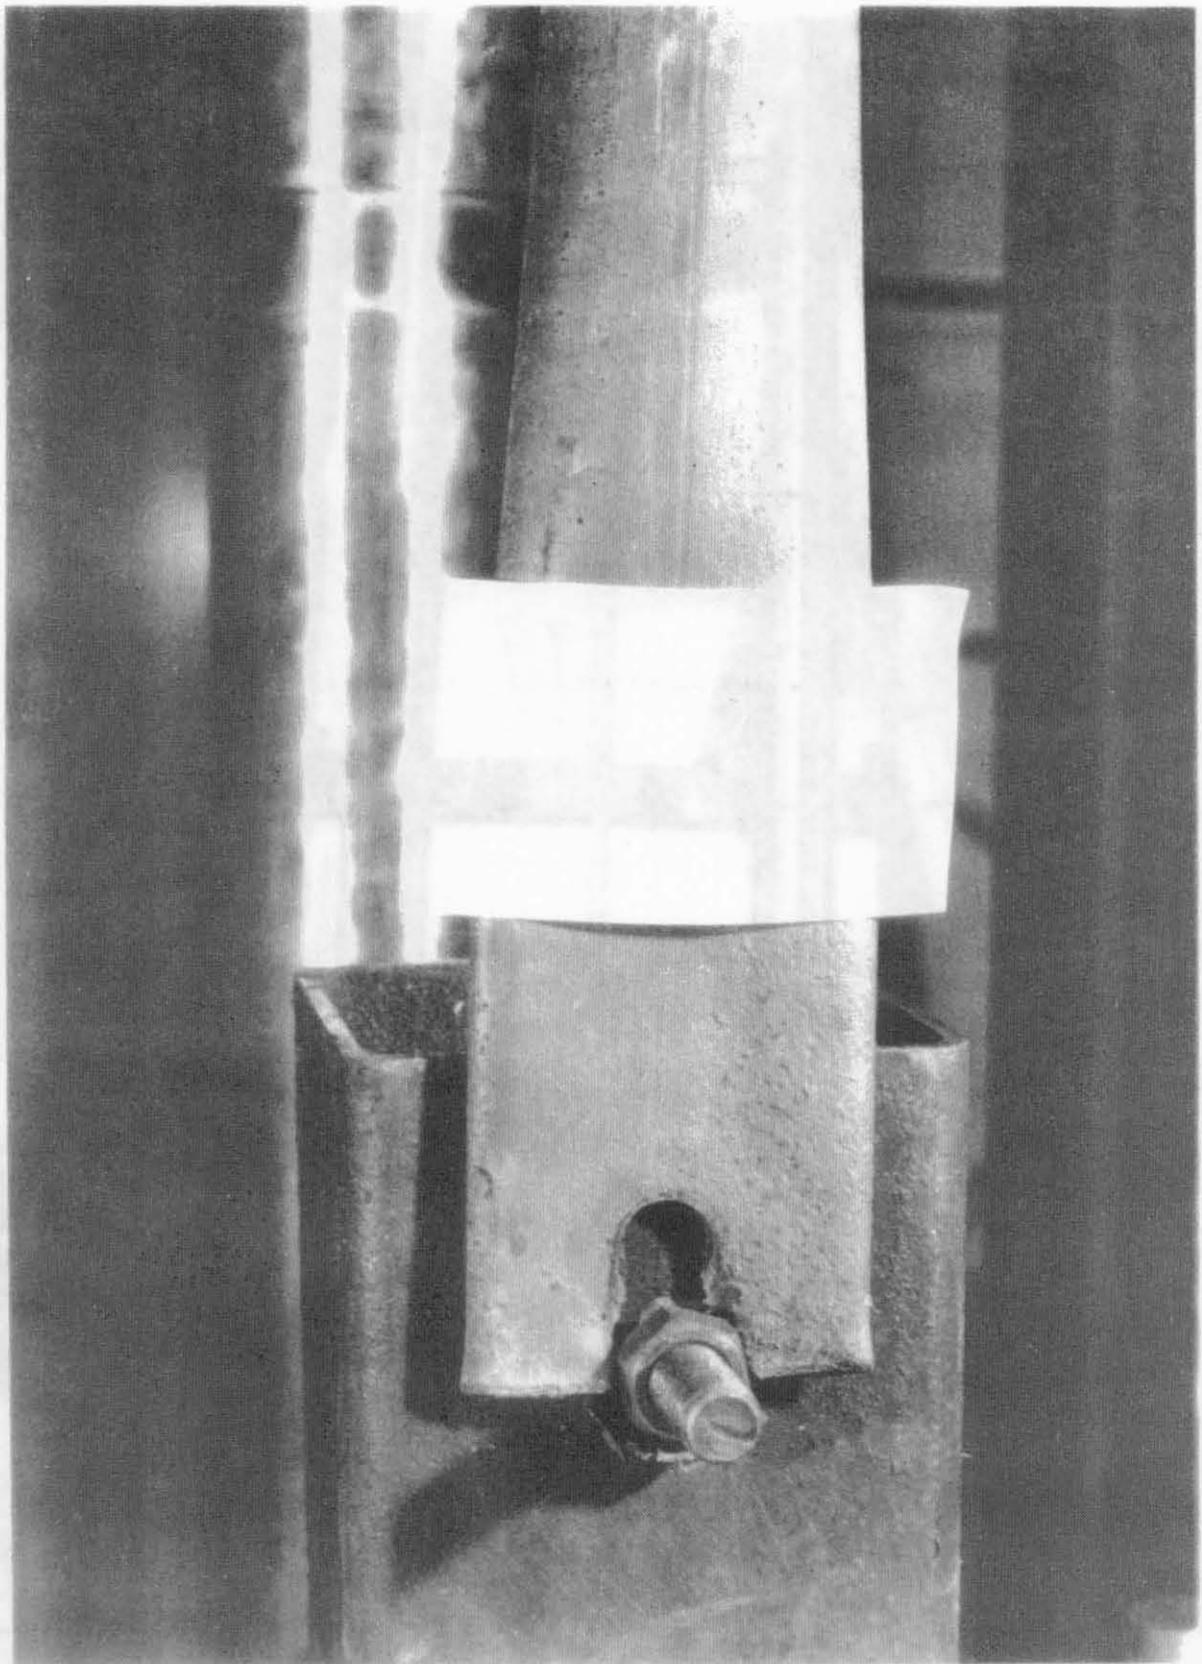
Figure 4.35 Tearing failure at bolt connection of brace #5

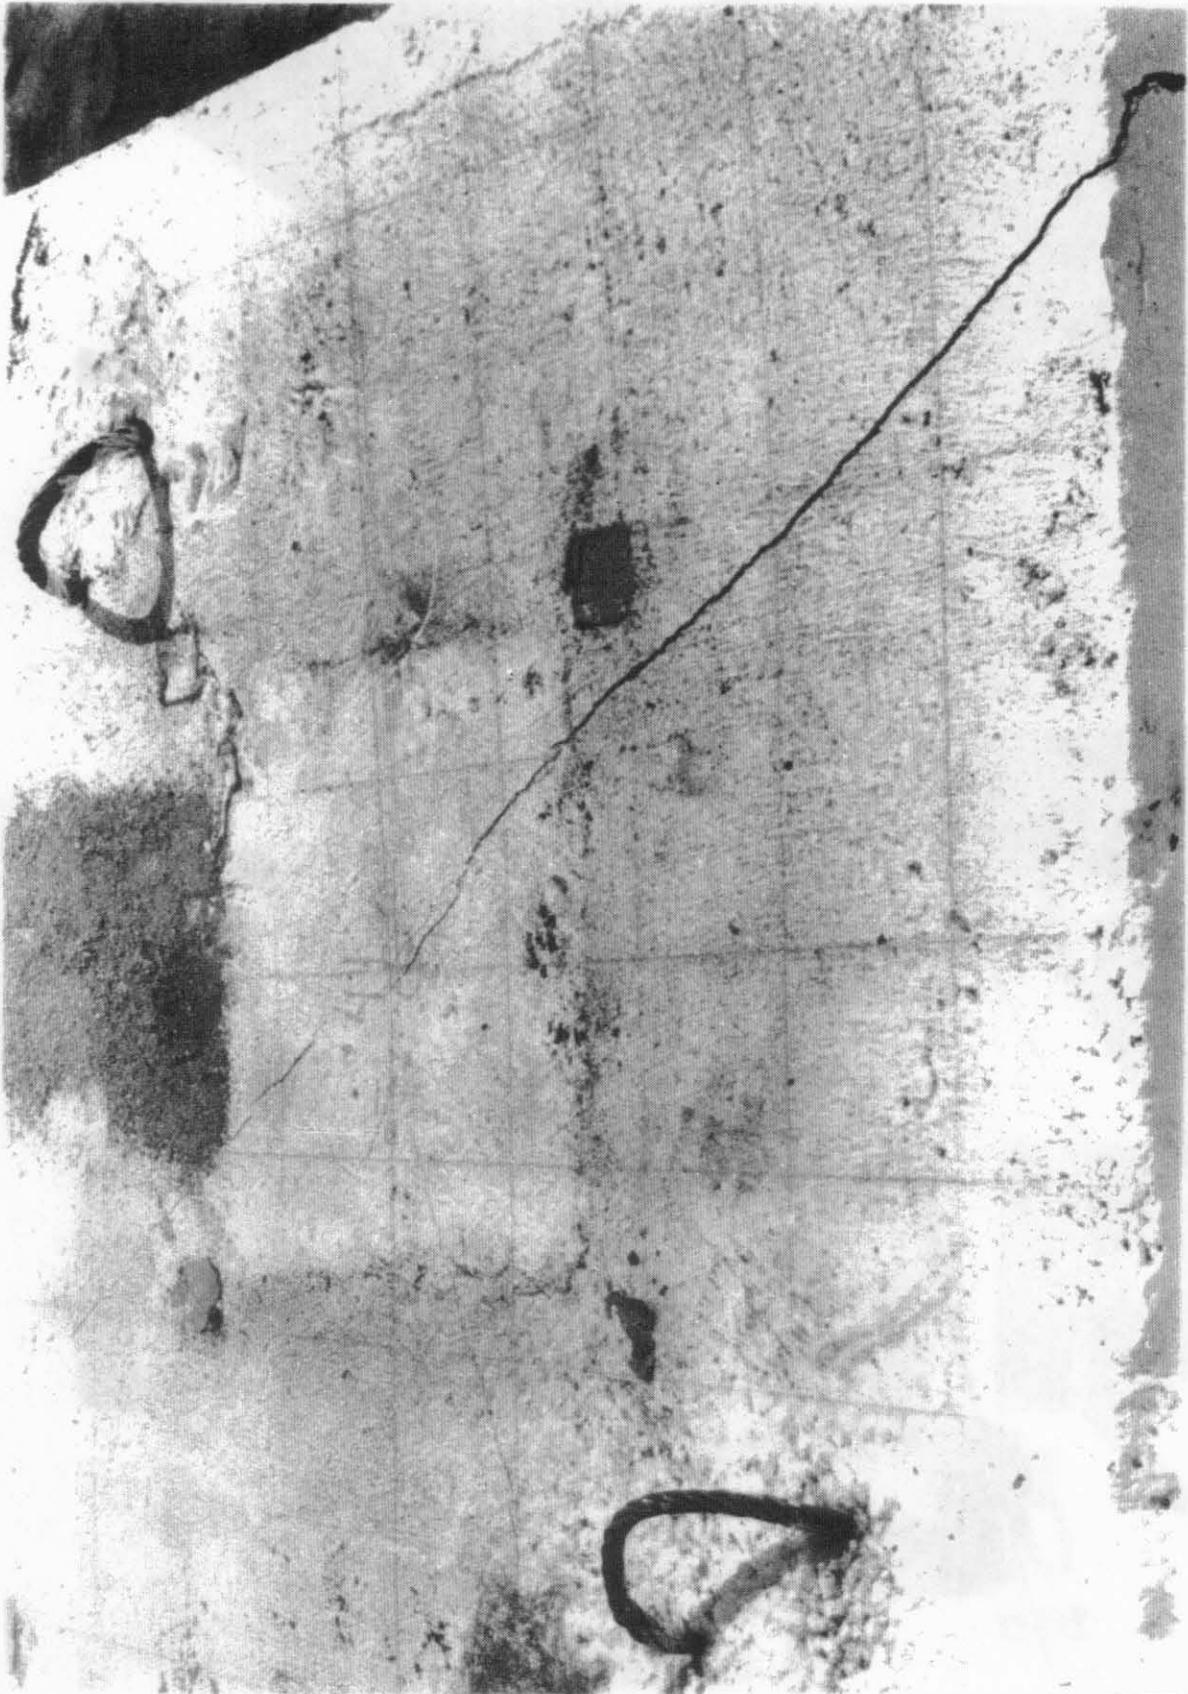
Figure 4.41 Pad crack pattern: diagonal

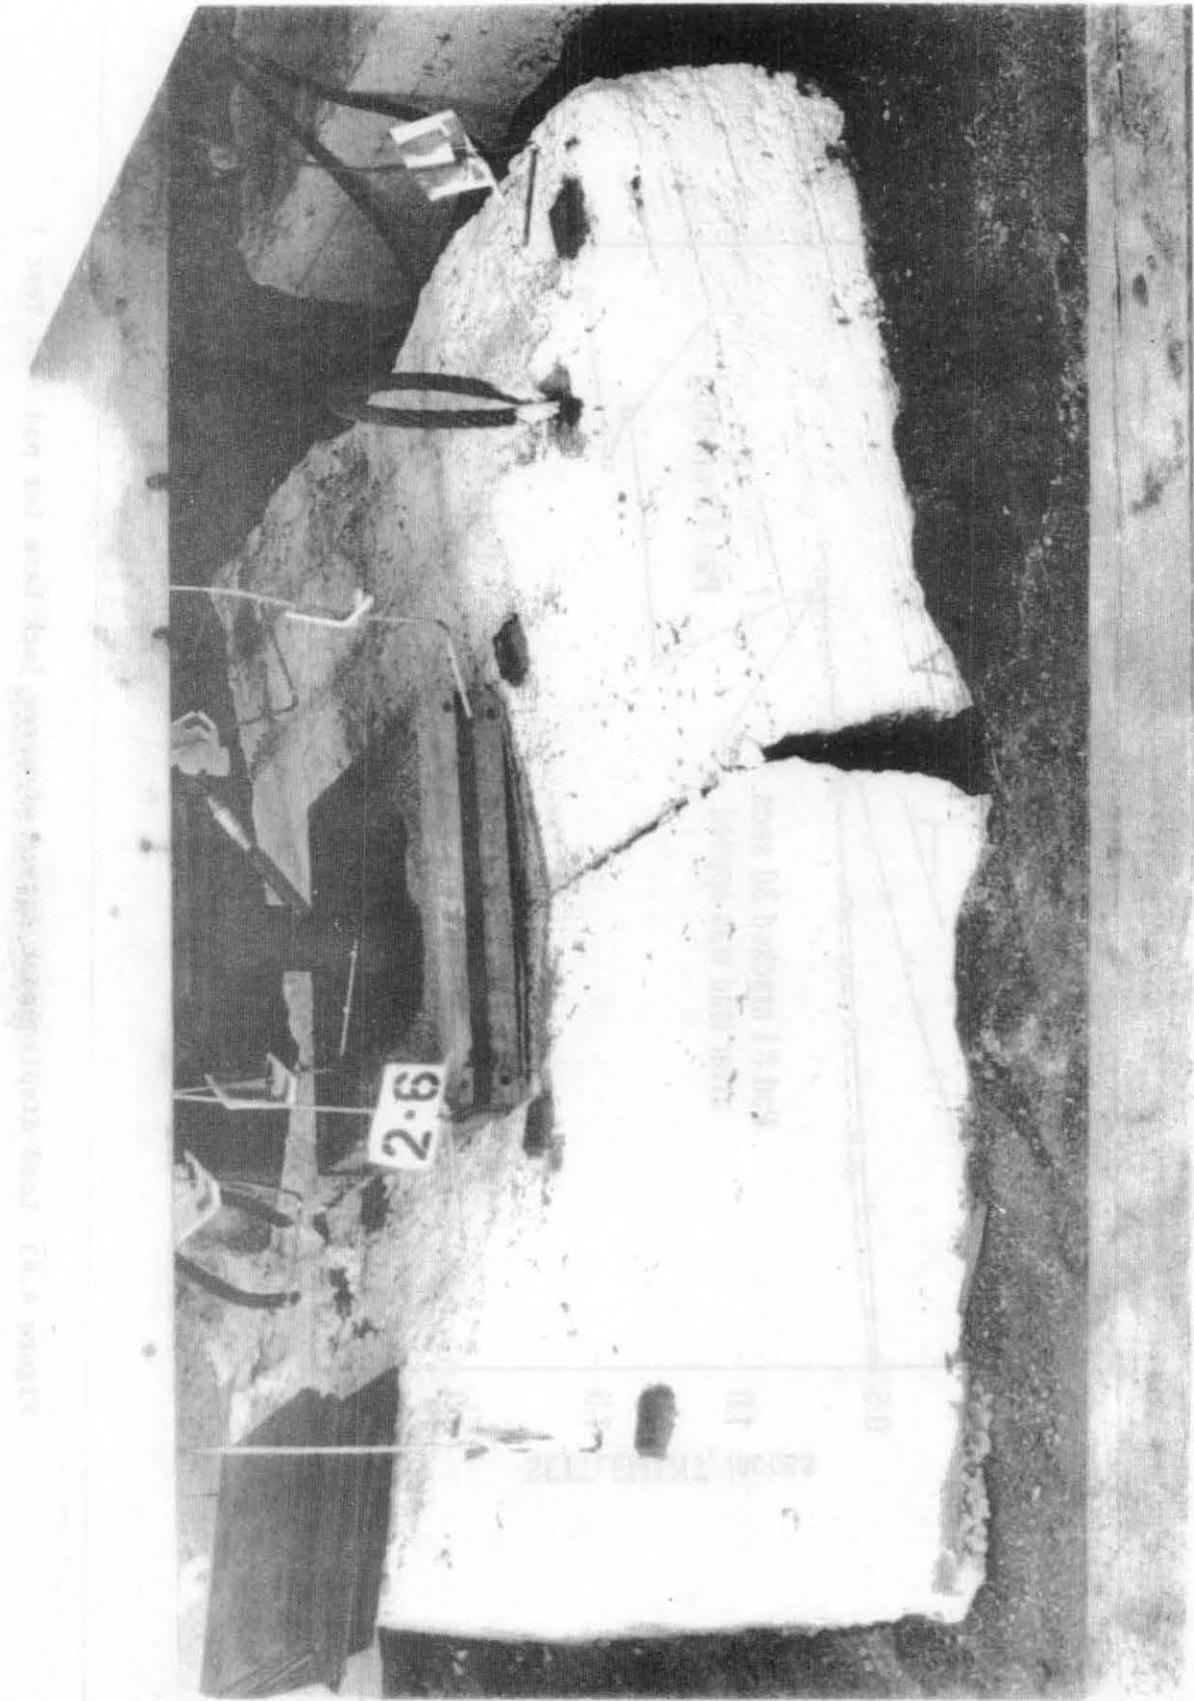
Figure 4.42 Pad crack pattern: transverse

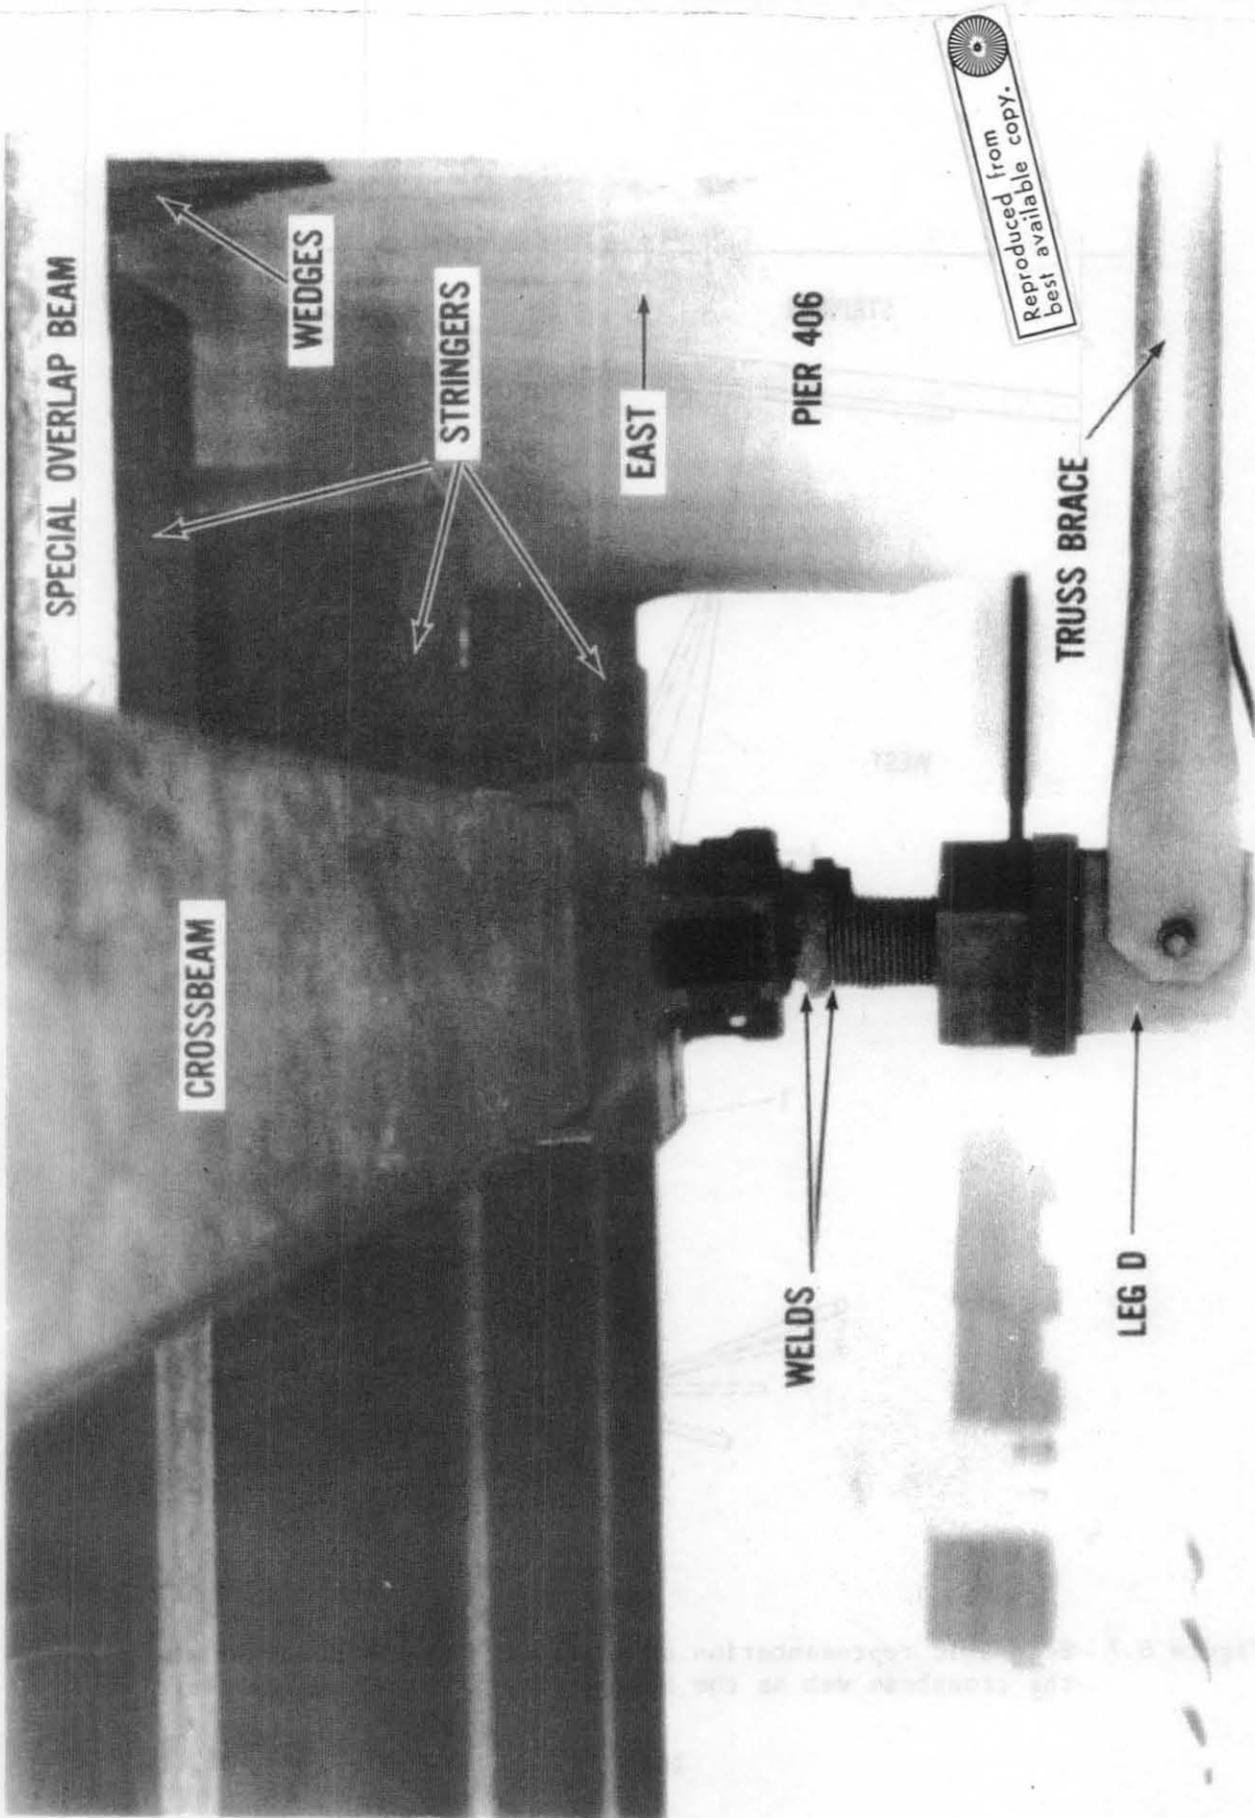
Figure 6.8 Bending of U-head on west side of pier 406
