Investigation of the Skyline Plaza Collapse in Fairfax County, Virginia

Edgar V. Leyendecker and S. George Fattal

Center for Building Technology
Institute for Applied Technology
National Bureau of Standards
Washington, D.C. 20234

National Bureau of Standards Building Science Series 94

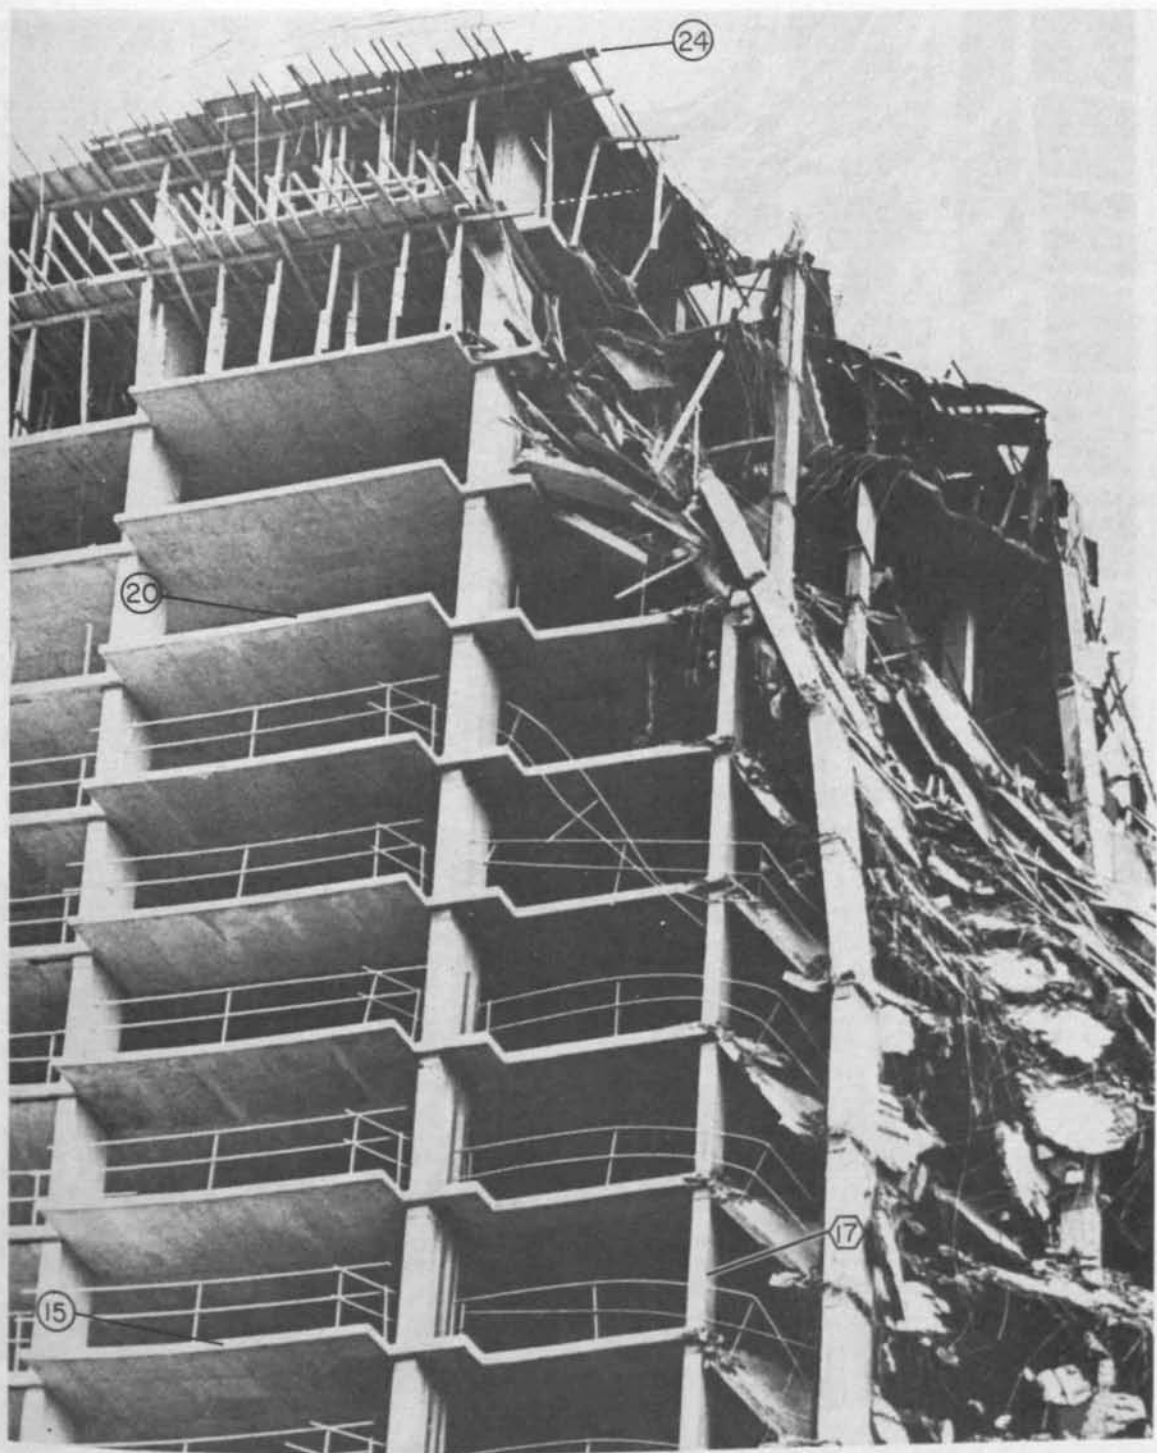
Figure 2.6 Closeup view of the top of the east end of the failure zone, looking south.

Figures 2.6 through 2.8 are closeup views of the east end of the failure zone. These figures require little comment at this time; however, it should be noted that the formwork is clearly visible in figure 2.6.

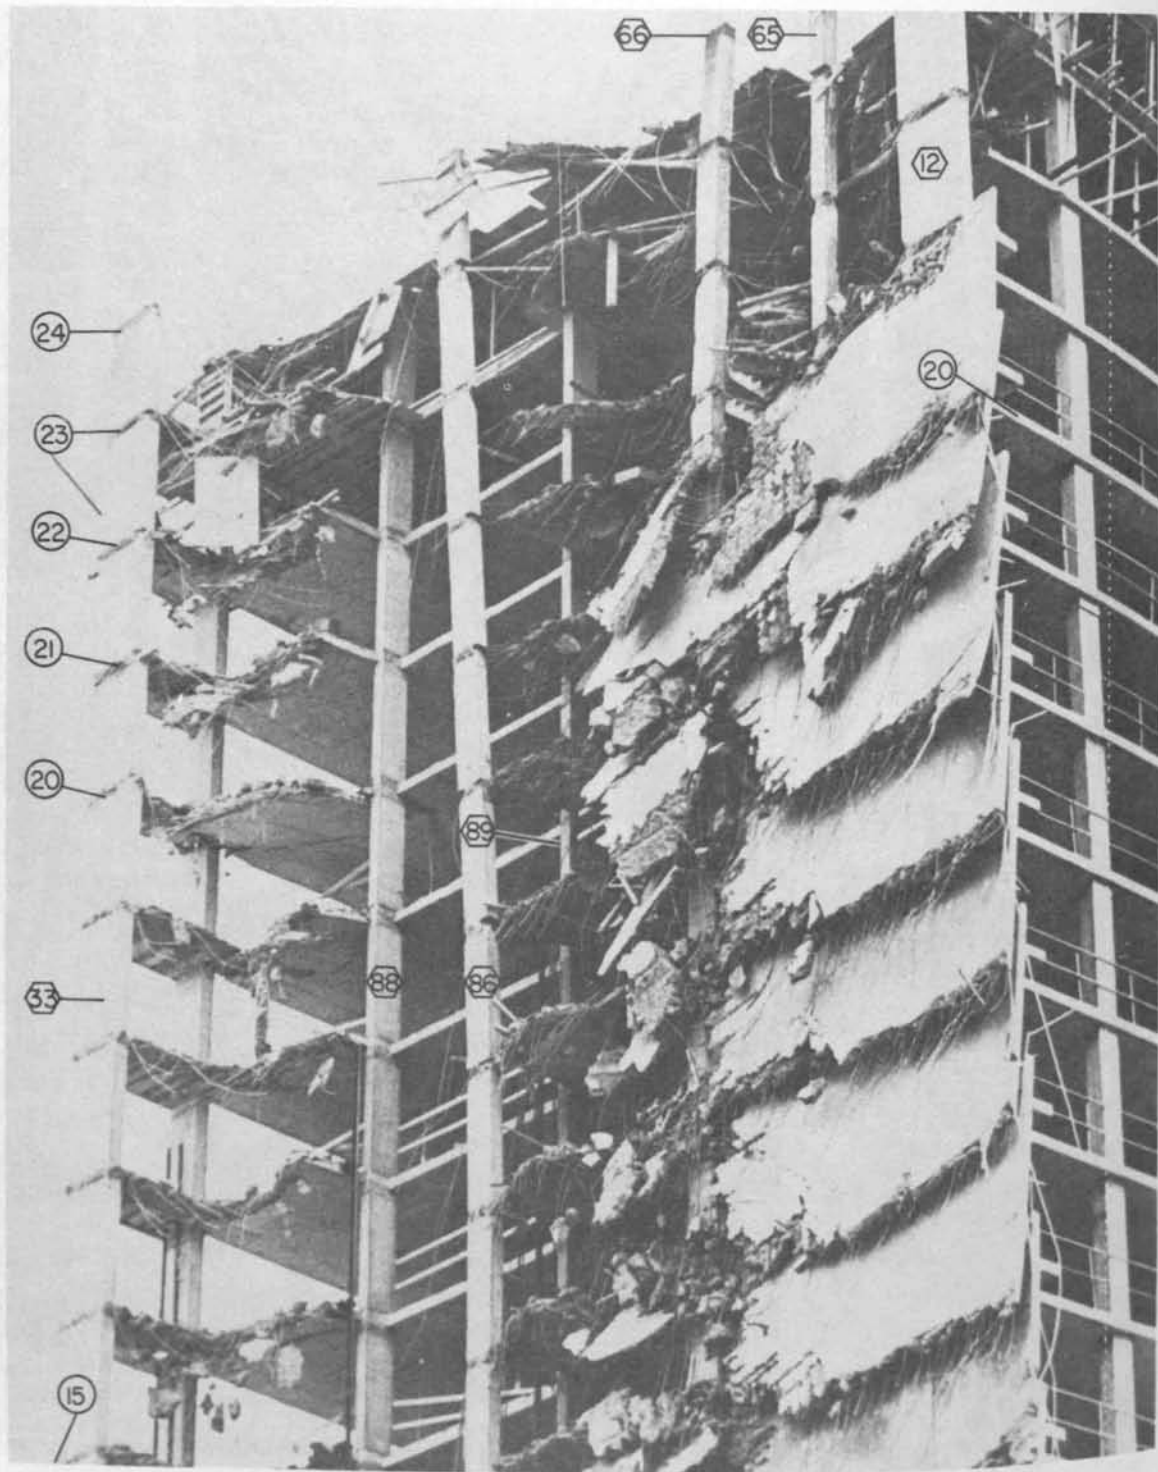
Figure 2.10 Closeup view of the top of the west end of the failure zone, looking southwest.

A general view of the west end of the failure zone is shown in figure 2.9 along with closeup views in figures 2.10 through 2.12. These figures also require little comment at this time; however, it should be noted that the formwork is clearly visible in figure 2.10.

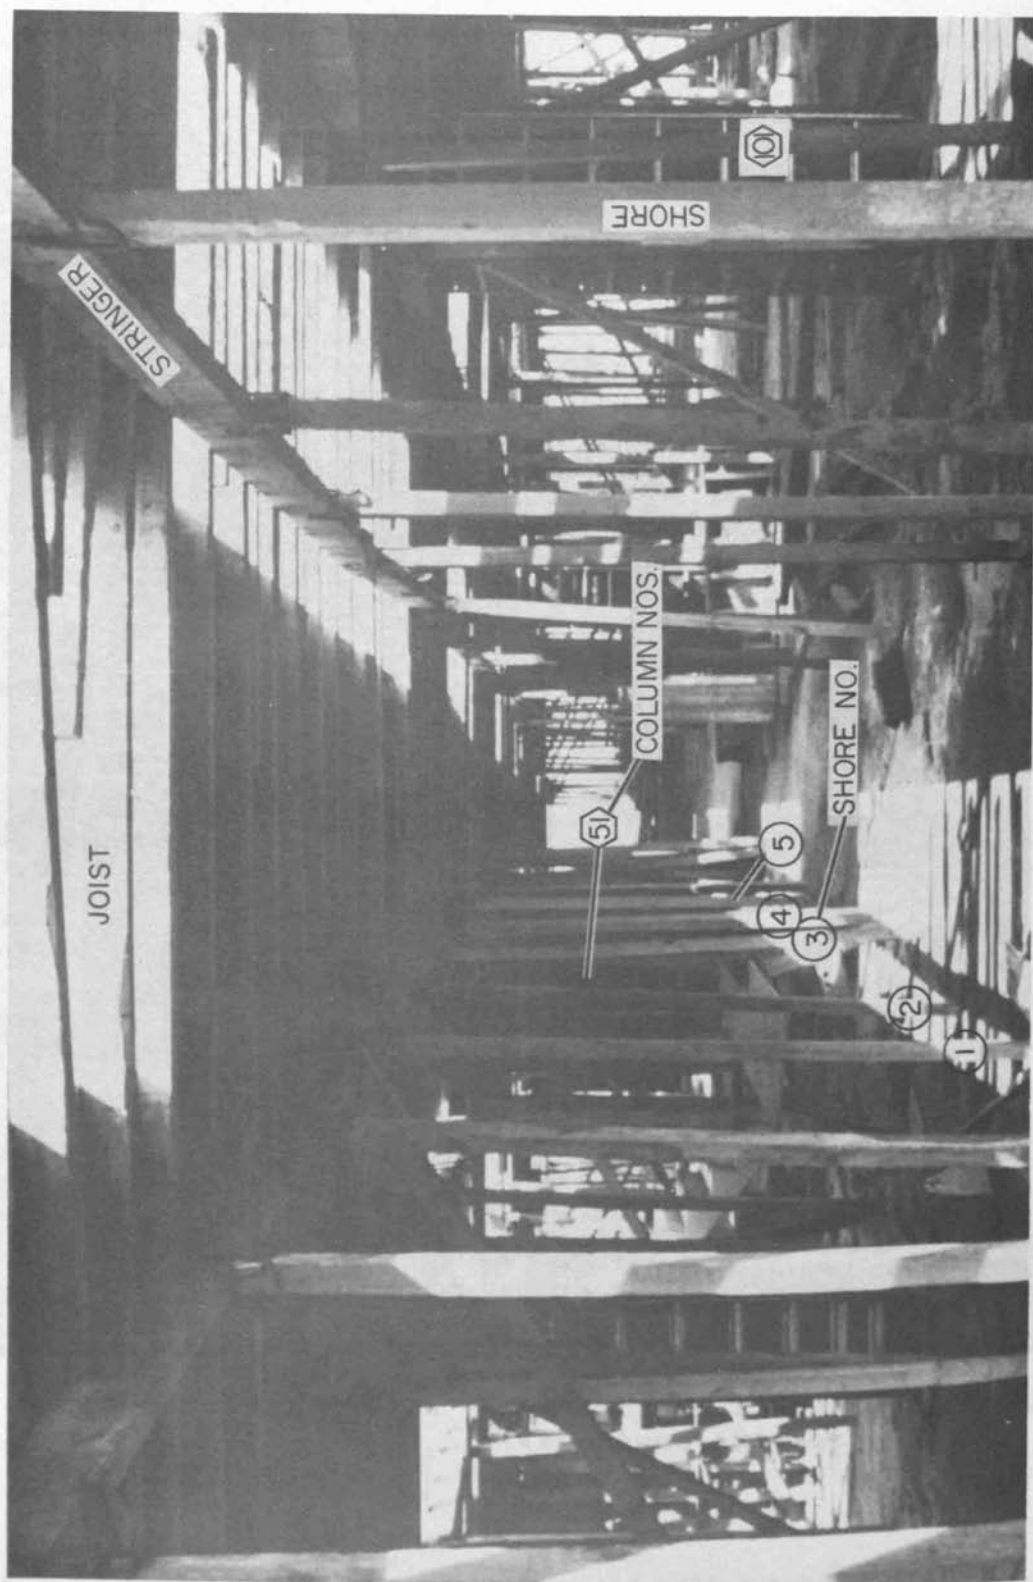
Figure 2.16 Formwork in sections 1 and 2 of 24th story, looking east.

As may be seen in figure 2.16, the stringers were placed east-west and the joists were placed north-south. Employee statements indicate that stringers and joists were usually 16 ft in length although some were as short as 6 to 8 ft.

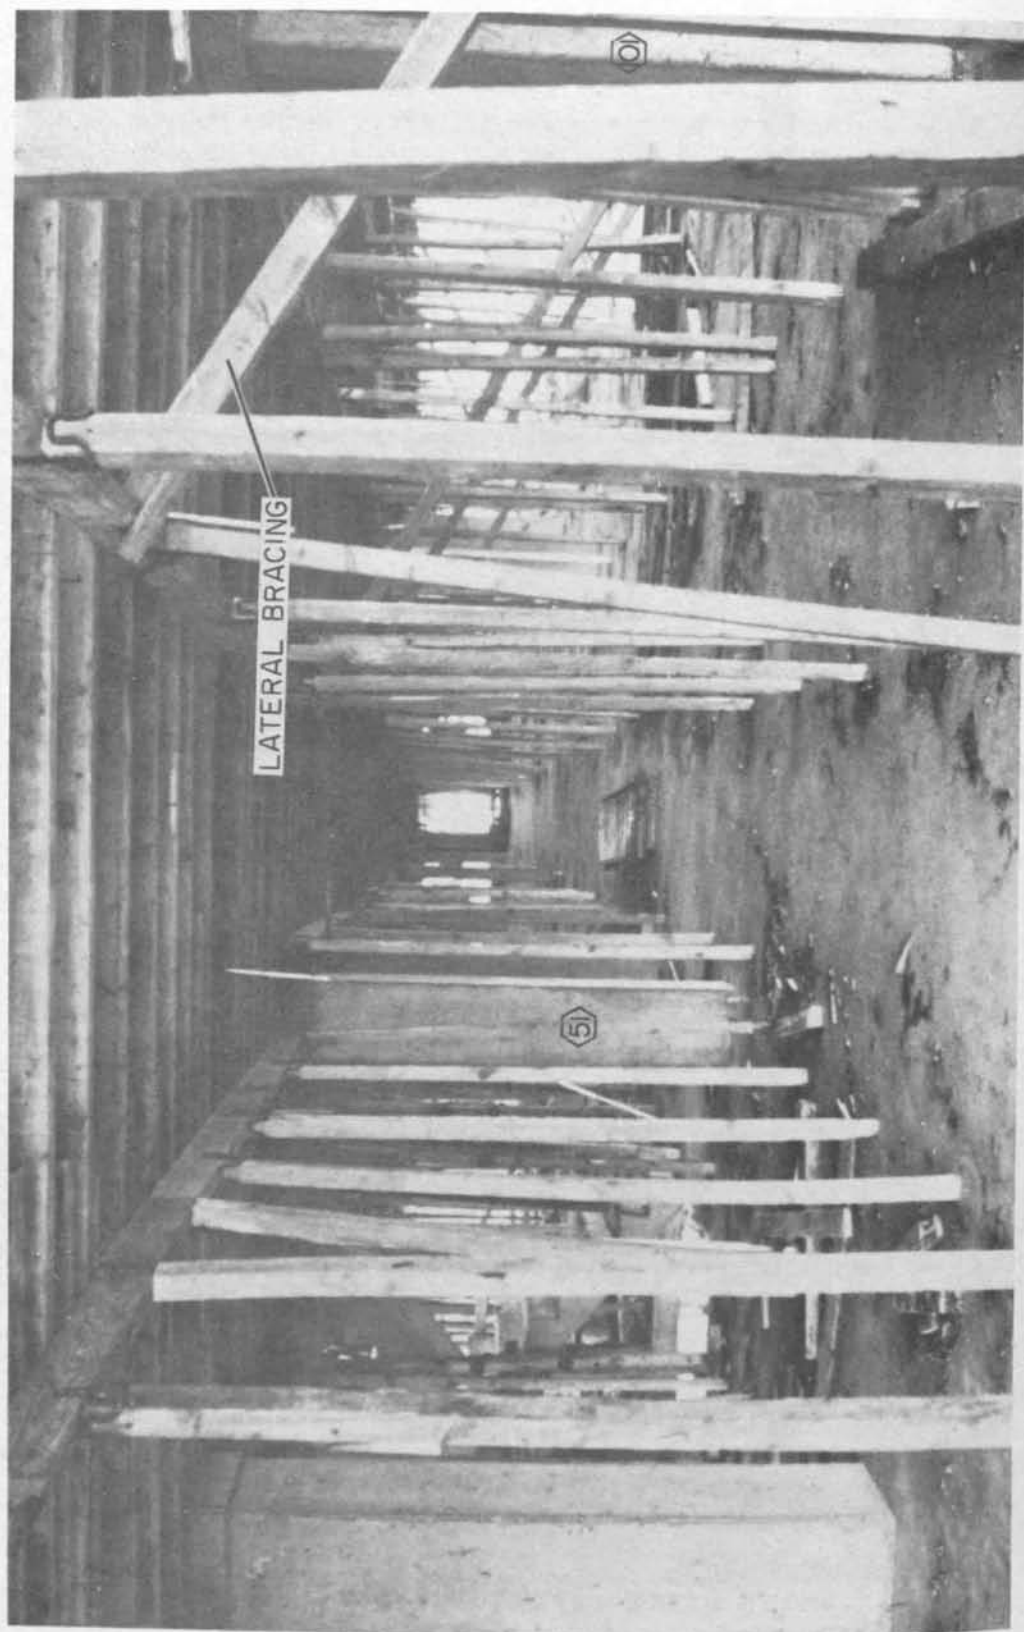
Figure 2.20 Formwork in sections 1 and 2 of 23rd story, looking east.

The formwork on the 23rd story is shown in figure 2.20. These forms supported the 24th floor which had been cast on February 28 (section 1) and March 1 (section 2). Note the number of shores out of plumb and the location of lateral bracing. The method of attaching the brace to the stringer may be seen in figure 2.20. The method of attaching the brace to the floor is shown in figure 2.21. A portion of a nominal 3 x 4 was nailed to a piece of plywood which was in turn nailed to the floor. A plywood plate was occasionally used to nail the brace to the nominal 3 x 4. Note the absence of such a plate in figure 2.21. Occasionally, the brace was installed with the plate, in other instances, there was no positive attachment of the brace to the floor. In one case, the plywood stop was not nailed to the floor, providing no lateral resistance.

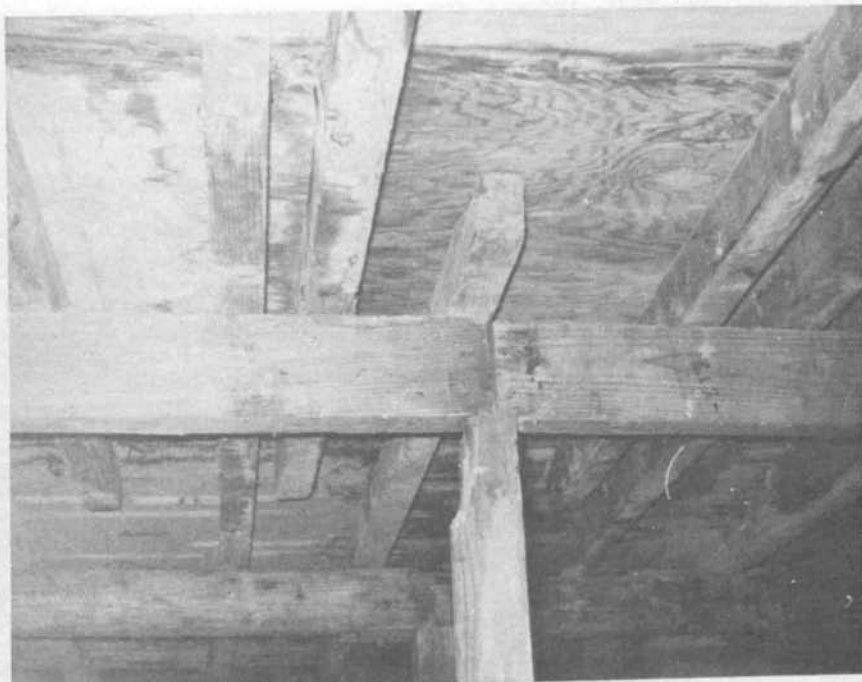
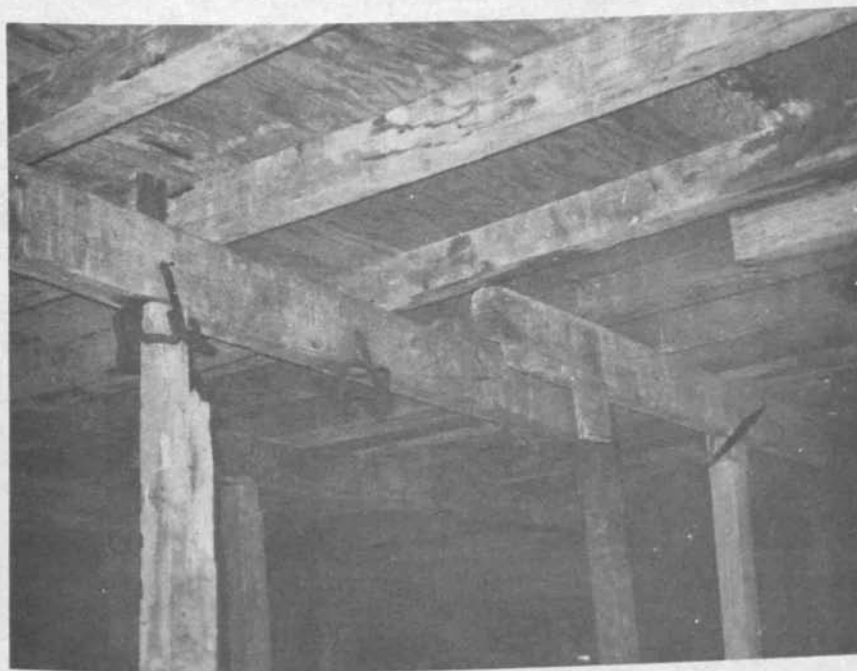
Figure 2.22 Selected details of 23rd story forms.

As in the case of the 24th story, the 23rd story lumber which was apparently damaged was reused. Examples of battered shores are shown in figure 2.22. Note the large reduction in bearing area. As in the case of the 24th story, OSHA regulations (ANSI-A10.9, sections 8.1.24 and 8.1.25) [2] required correction of these conditions prior to placing concrete.

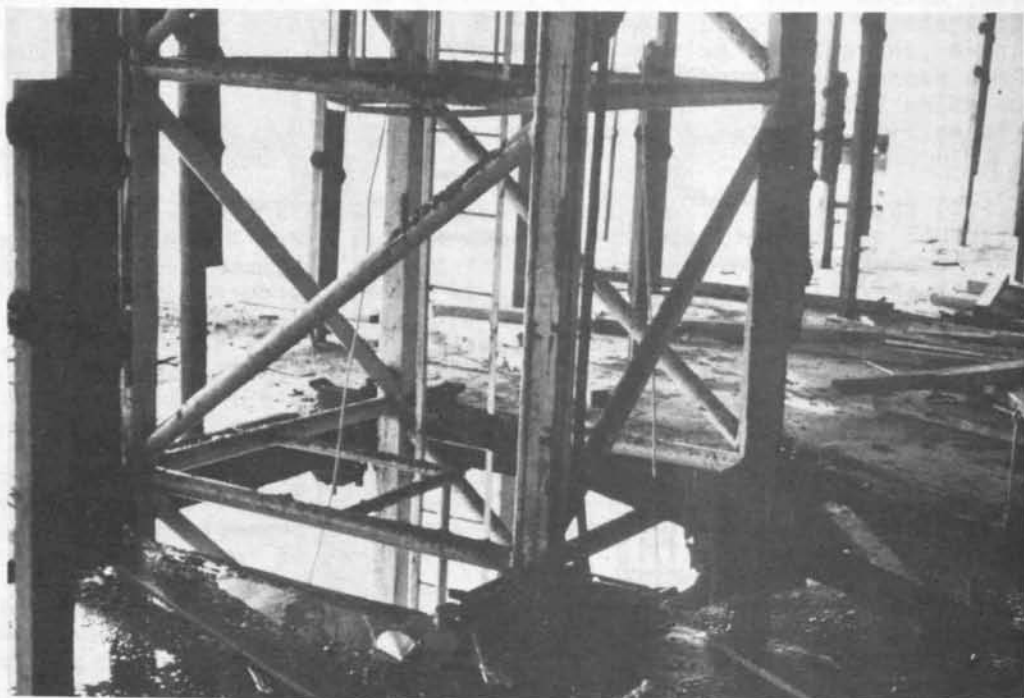
Figure 2.34 Upper support for crane no. 1.

Crane no. 1 was supported by the climbing frame, the lower support, on the 20th floor as shown in figure 2.33. The upper support was provided on the 22nd floor as shown in figure 2.34. This total distance is 18 ft, slightly less than the manufacturer's specified 18 ft 4 in. A typical corner clamp detail on the 22nd floor is shown in figure 2.35. Note the cracked slab where the clamp is attached.

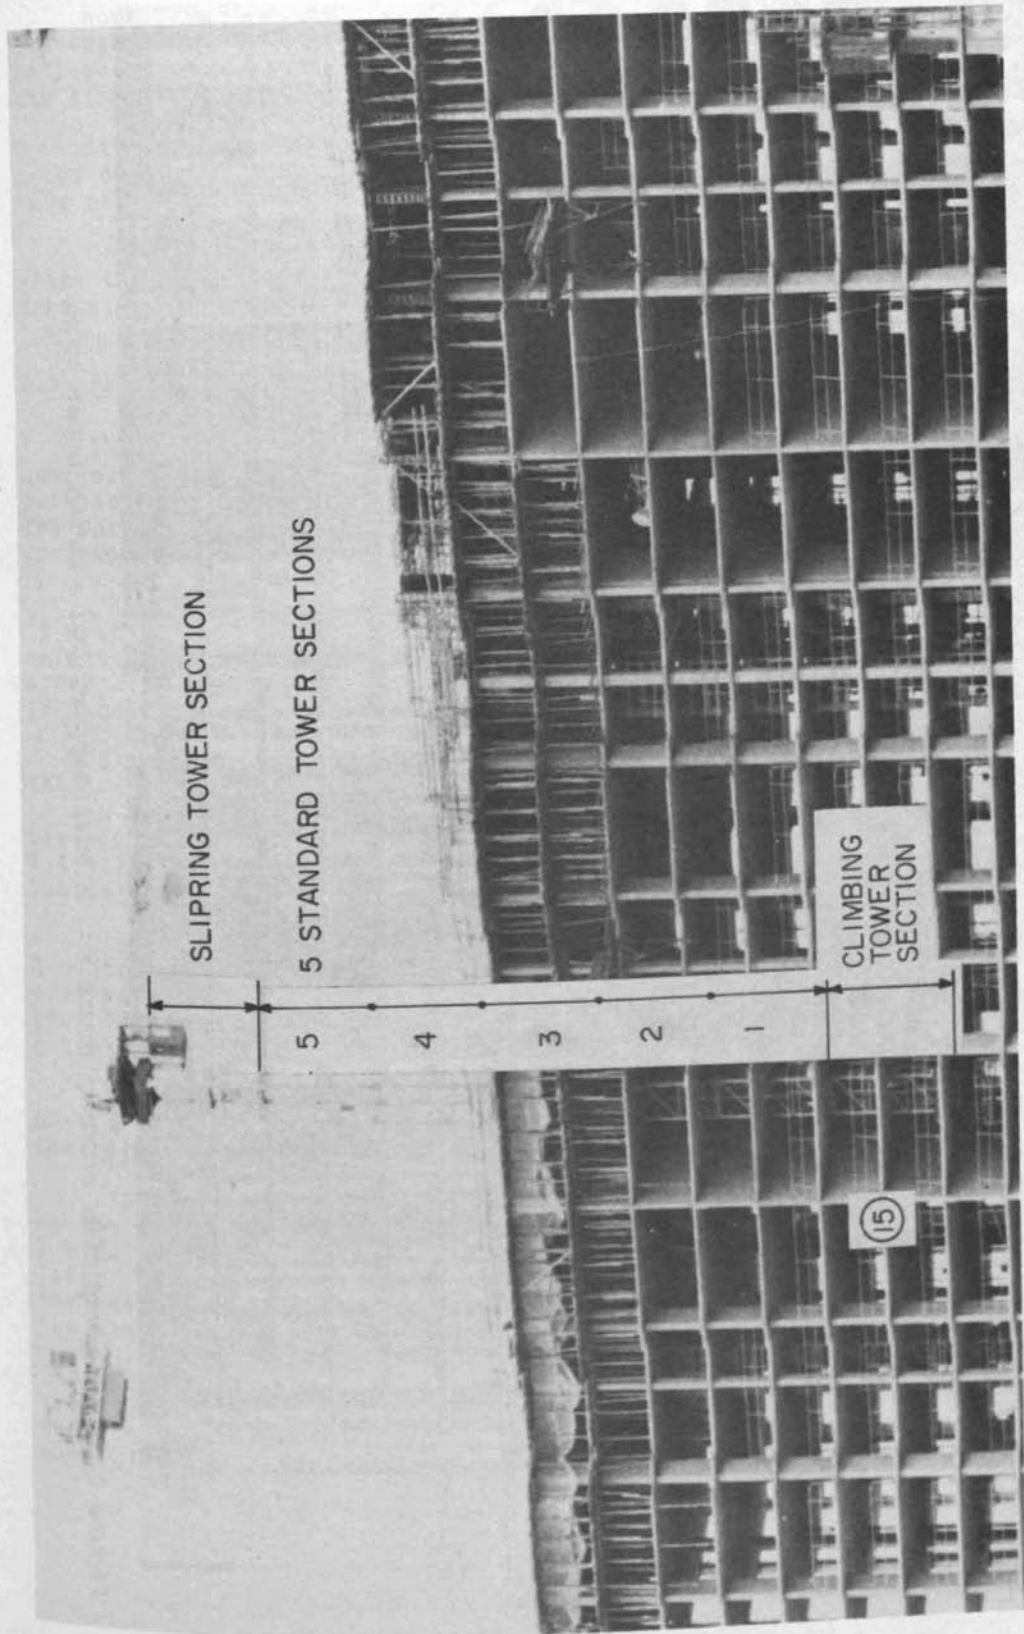
Figure 2.41 Closeup showing crane no. 2 base support.

The various tower sections of the crane are identified in figure 2.41. Note that five standard tower sections were used instead of the usual four (figure 2.31 and reference 22). Assuming the upper and lower supports were two stories apart as has been stated, the crane had a free standing height of about 99 ft which exceeds the maximum free height of 81 ft shown in figure 2.31. It is not known if any special precautions were taken to allow the difference between the actual and the recommended installation.

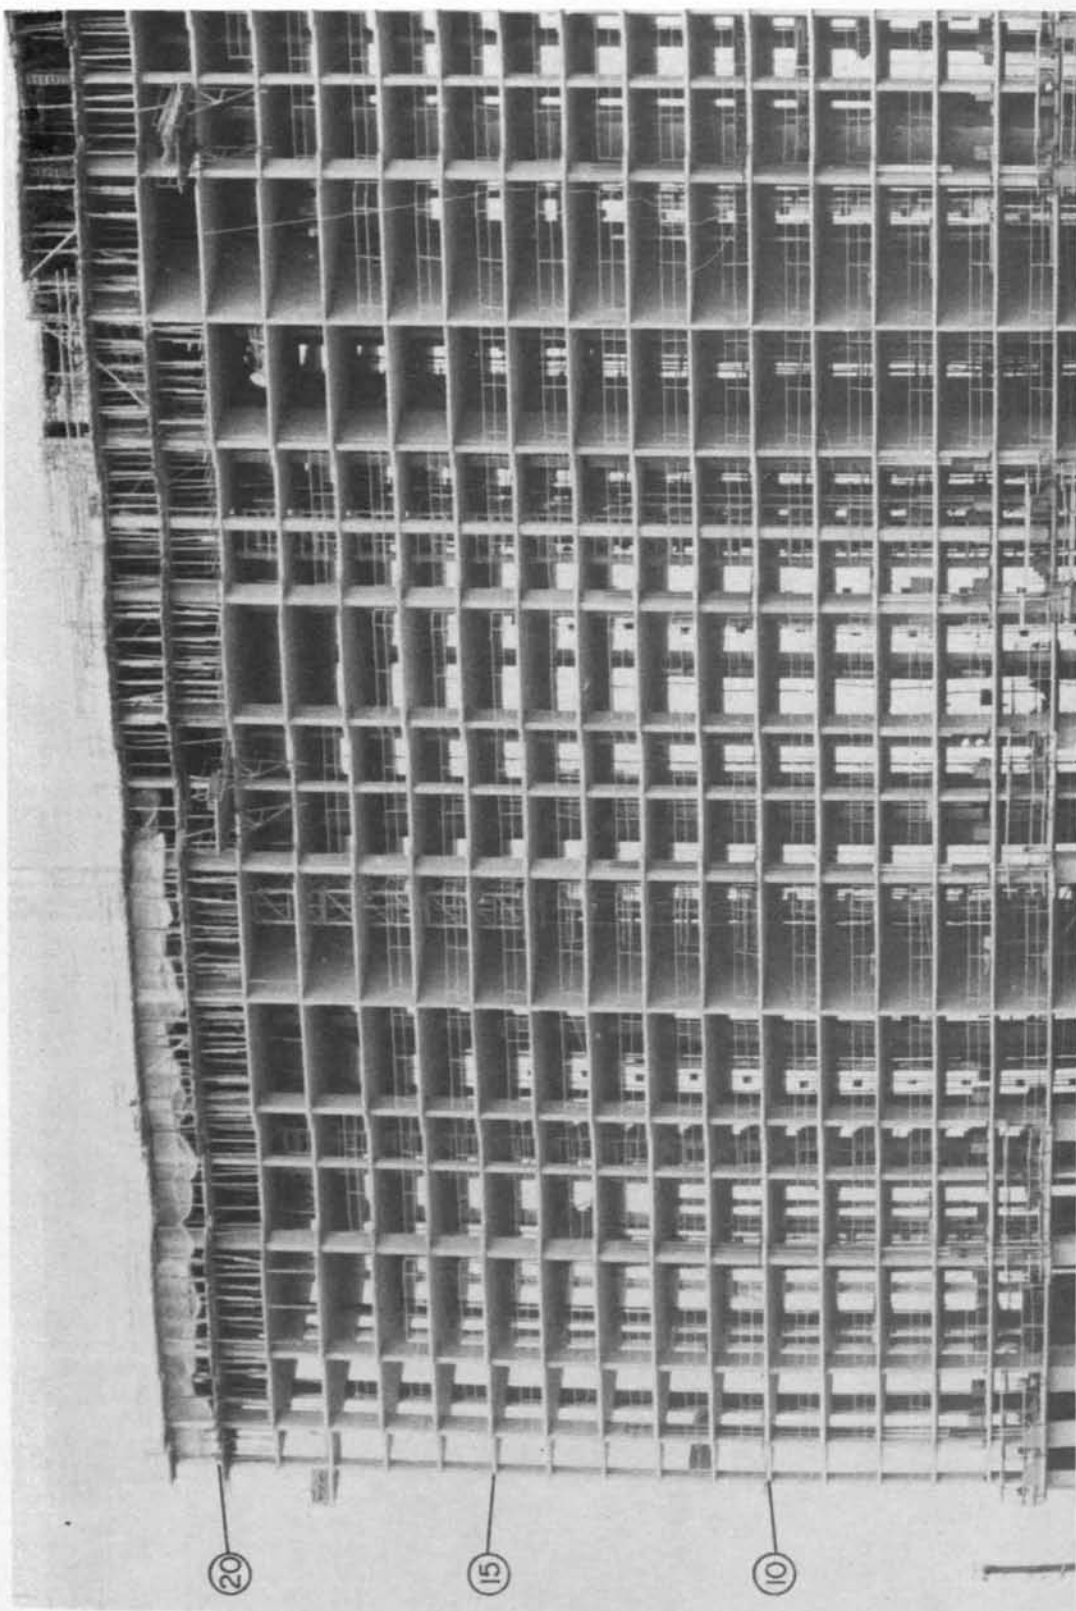
Figure 2.42 Closeup view showing crane no. 2 base support and shoring under crane.

Examination of figures 2.40 and 2.42 indicates that either the crane shoring or the formwork for the concrete closure slab of the crane opening was in place in the third through thirteenth stories on the day of the photograph. Conditions below the third story are not visible in the photograph.

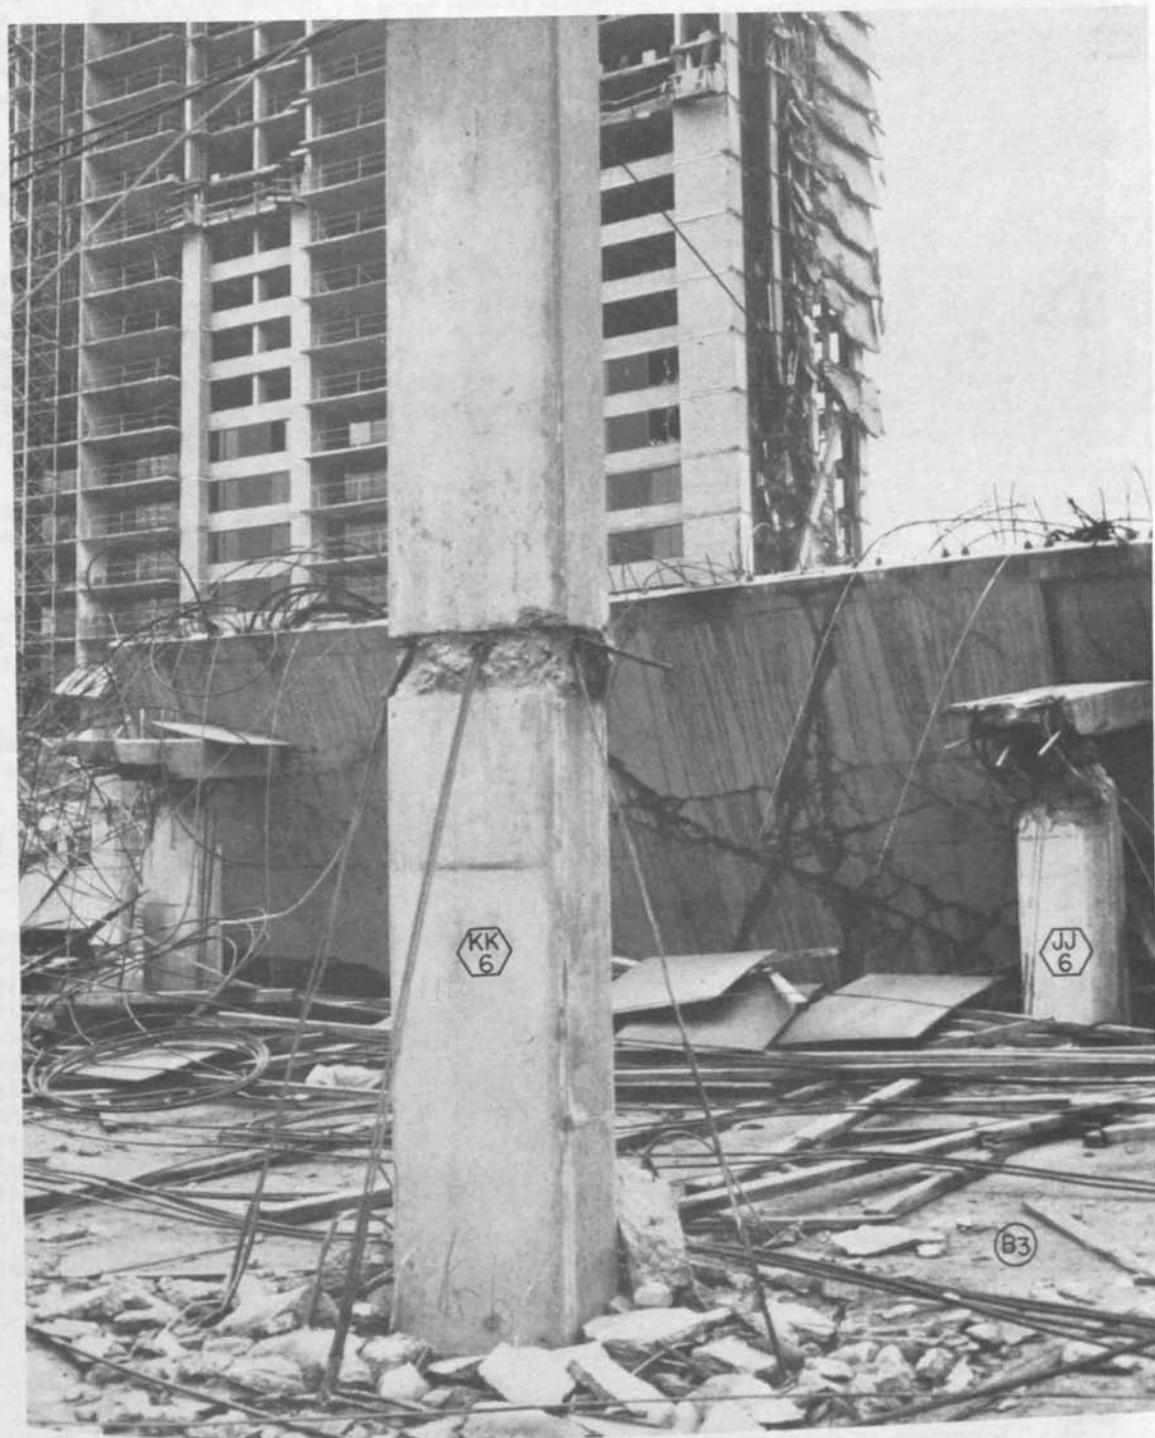
Figure 2.47 Typical column in the parking garage.

Column KK-6 may be seen in figure 2.47. Once again the shear cone usually associated with a slab punching failure is not visible in the photograph. Note the ruptured reinforcing bars at the base of the column. These are shown more clearly in figure 2.48 (but not for column KK-6).

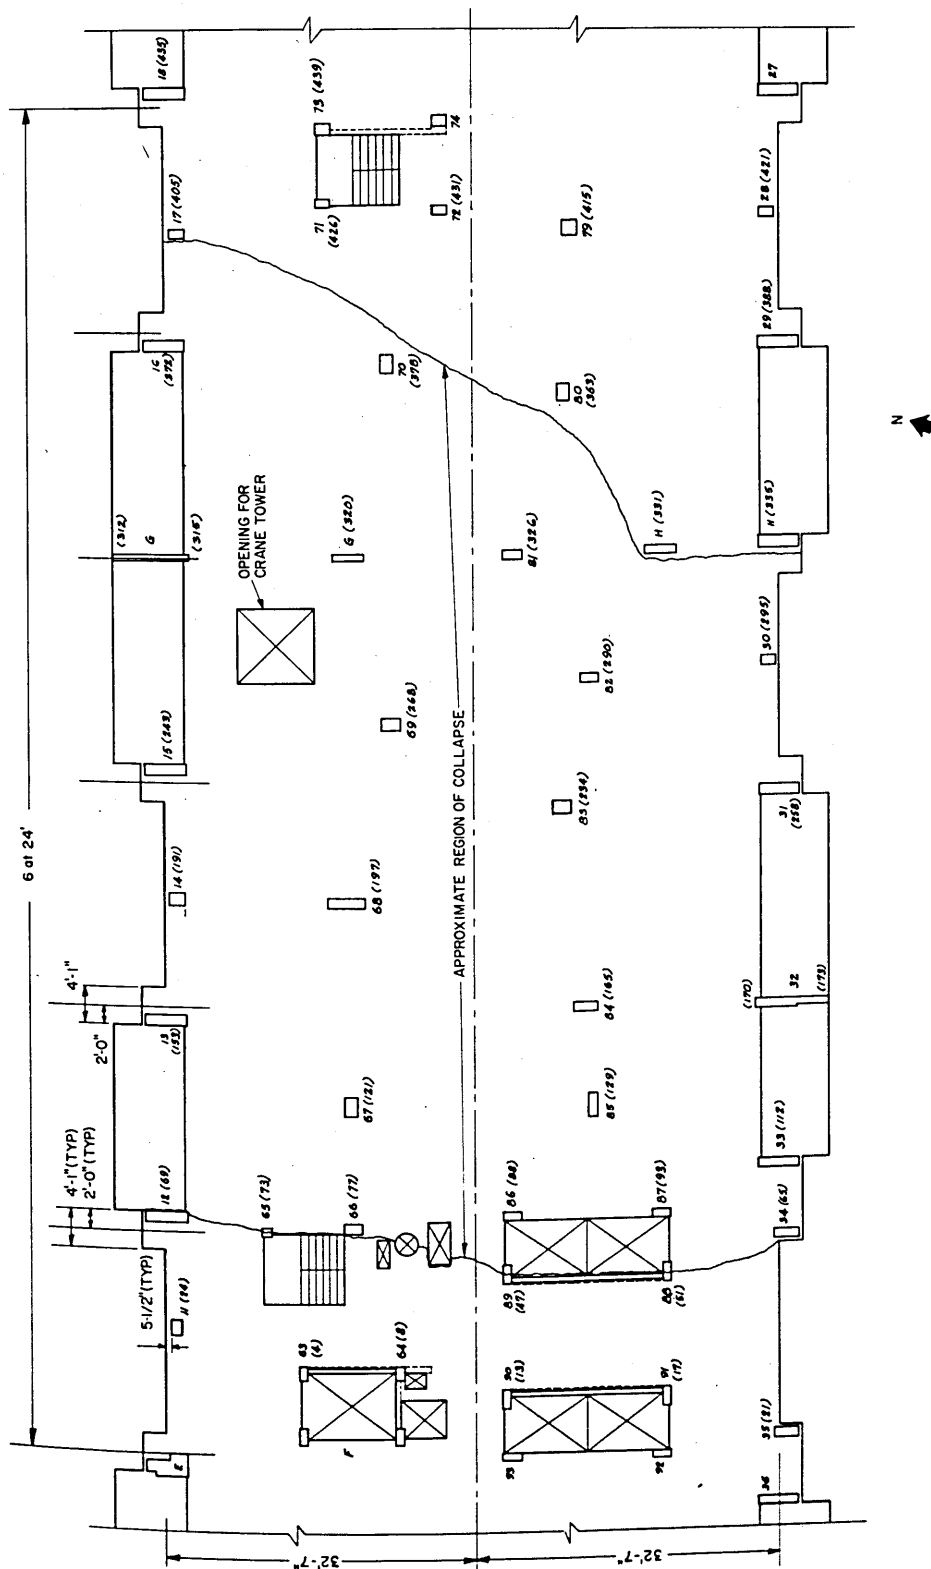
Figure 4.1 Plan of floor slab at 22nd and 23rd floors showing approximate area of collapse.

It is noted that for certain areas of the floor the spacing of columns is such that in order to comply with section 2101(e)2 of ACI 318-63, the slab thickness would have to be greater than 8 in. Section 3 of the floor slab, as identified in figure 2.1 contains such areas.
