NBSIR 87-3640

Investigation of L'Ambiance Plaza Building Collapse in Bridgeport, Connecticut

Center for Building Technology
National Engineering Laboratory
National Bureau of Standards
Gaithersburg, MD 20899

Issued September 1987

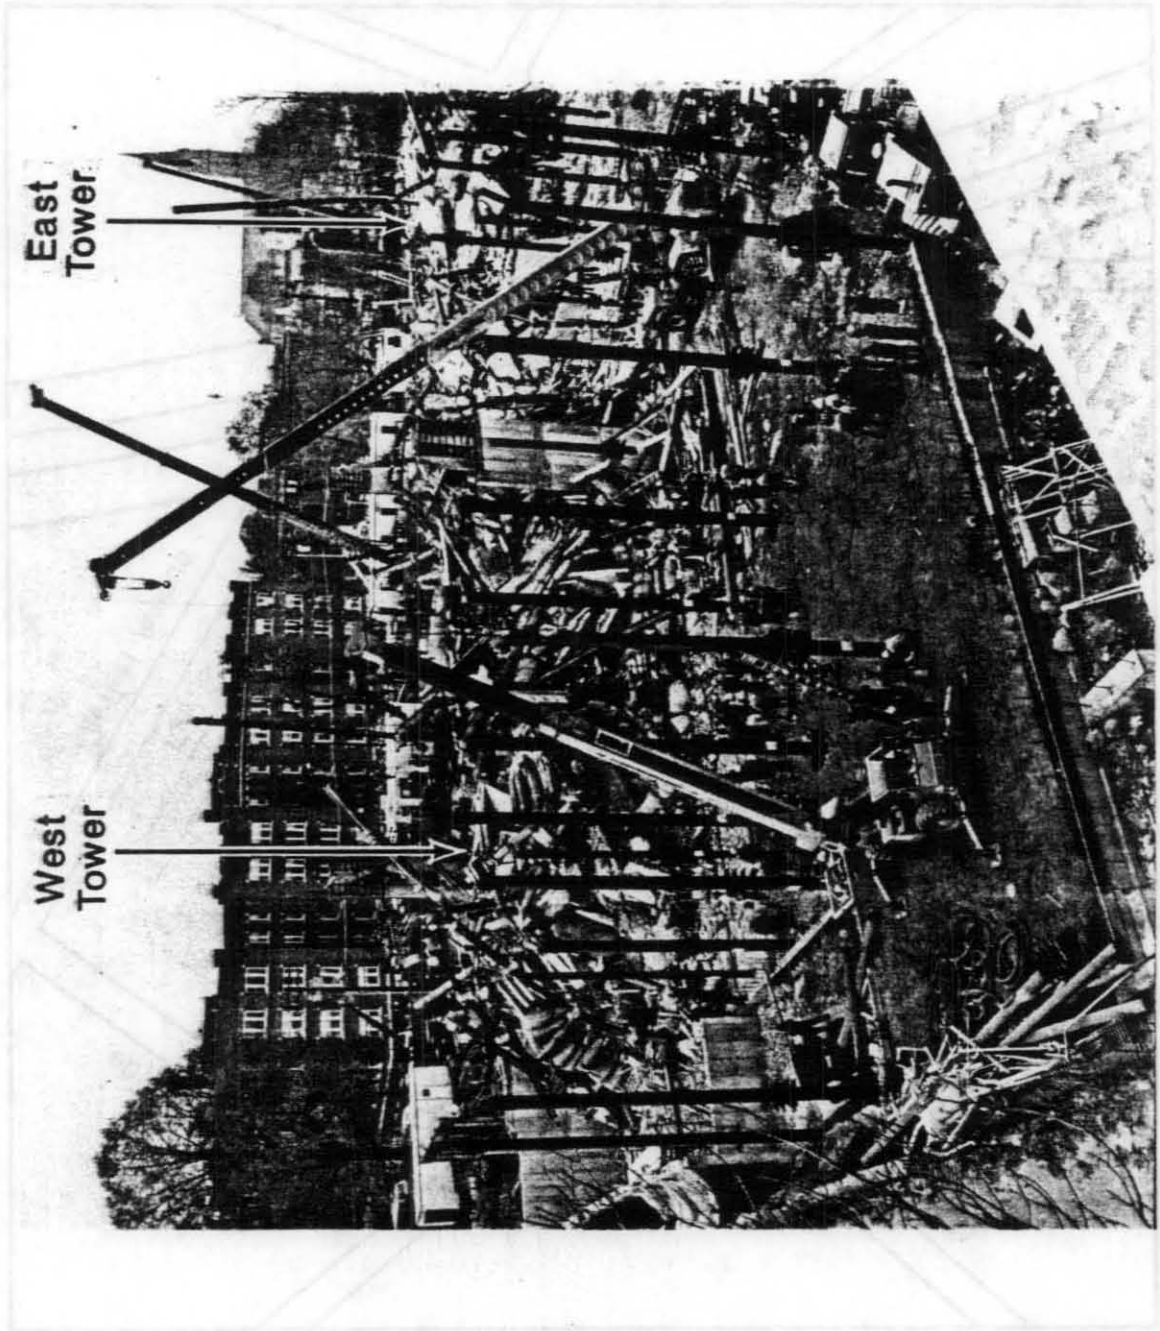
Figure 4.4.1 Overview of collapsed structure – View to the Northeast

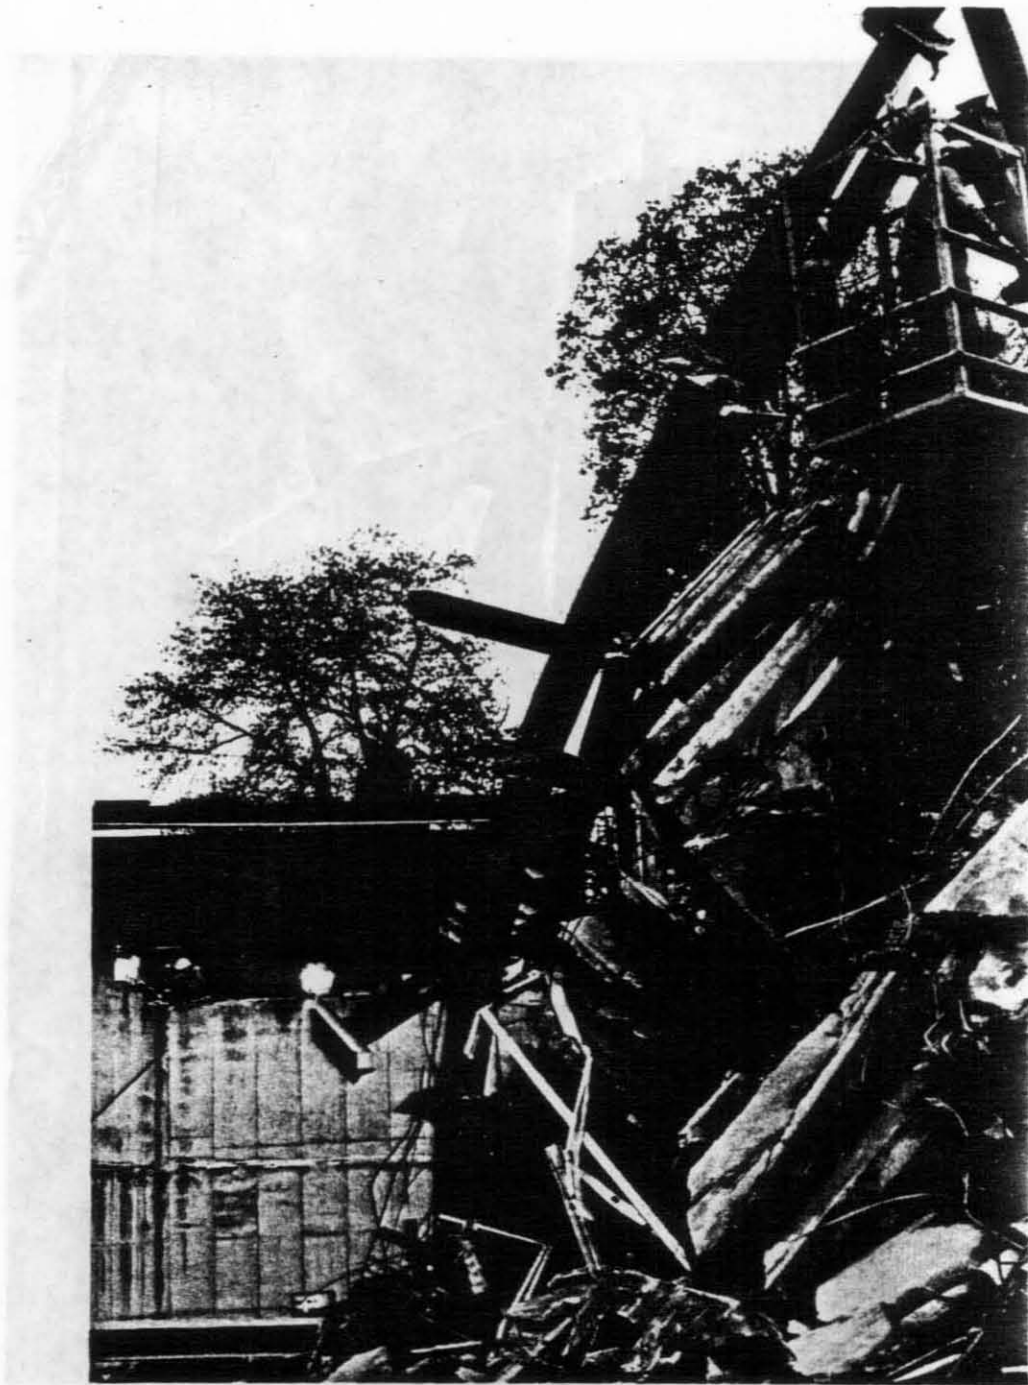
Figure 4.4.3 Deflected shape of column E1 -
View to the North

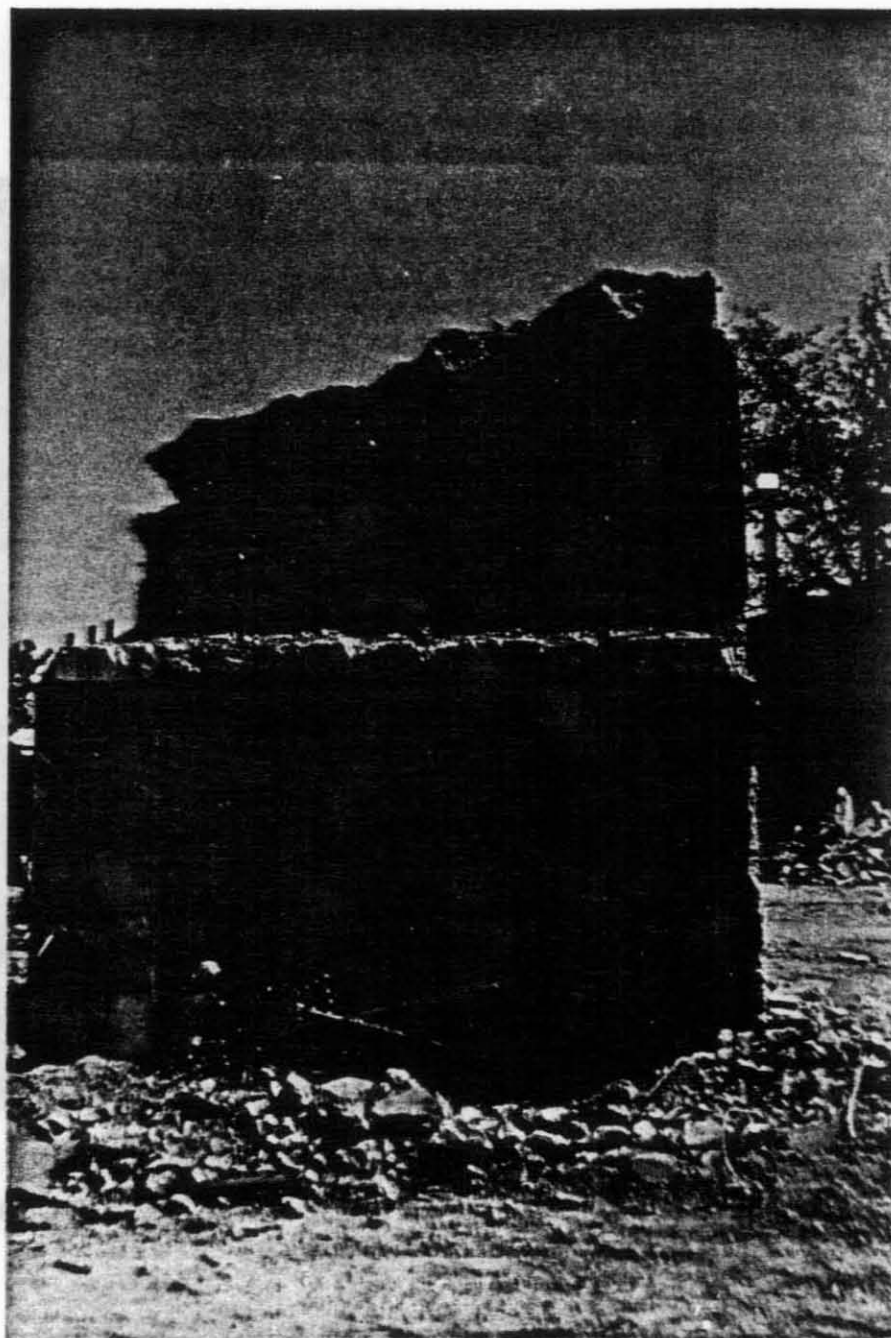
Figure 4.4.5 Diagonal tension crack in East tower shearwall -
View to the South

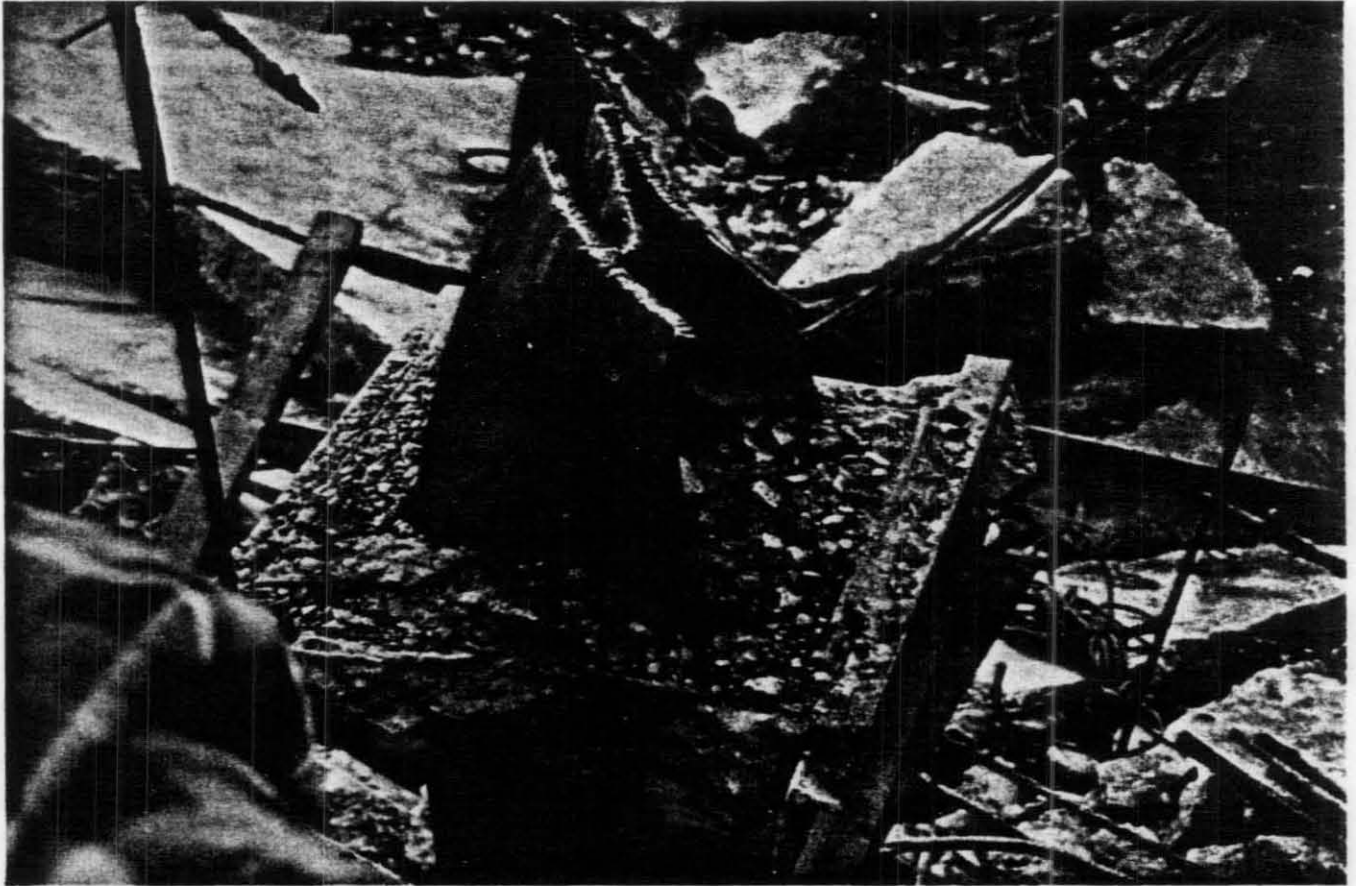
Figure 4.4.6 Twisting deformation of column in West tower :

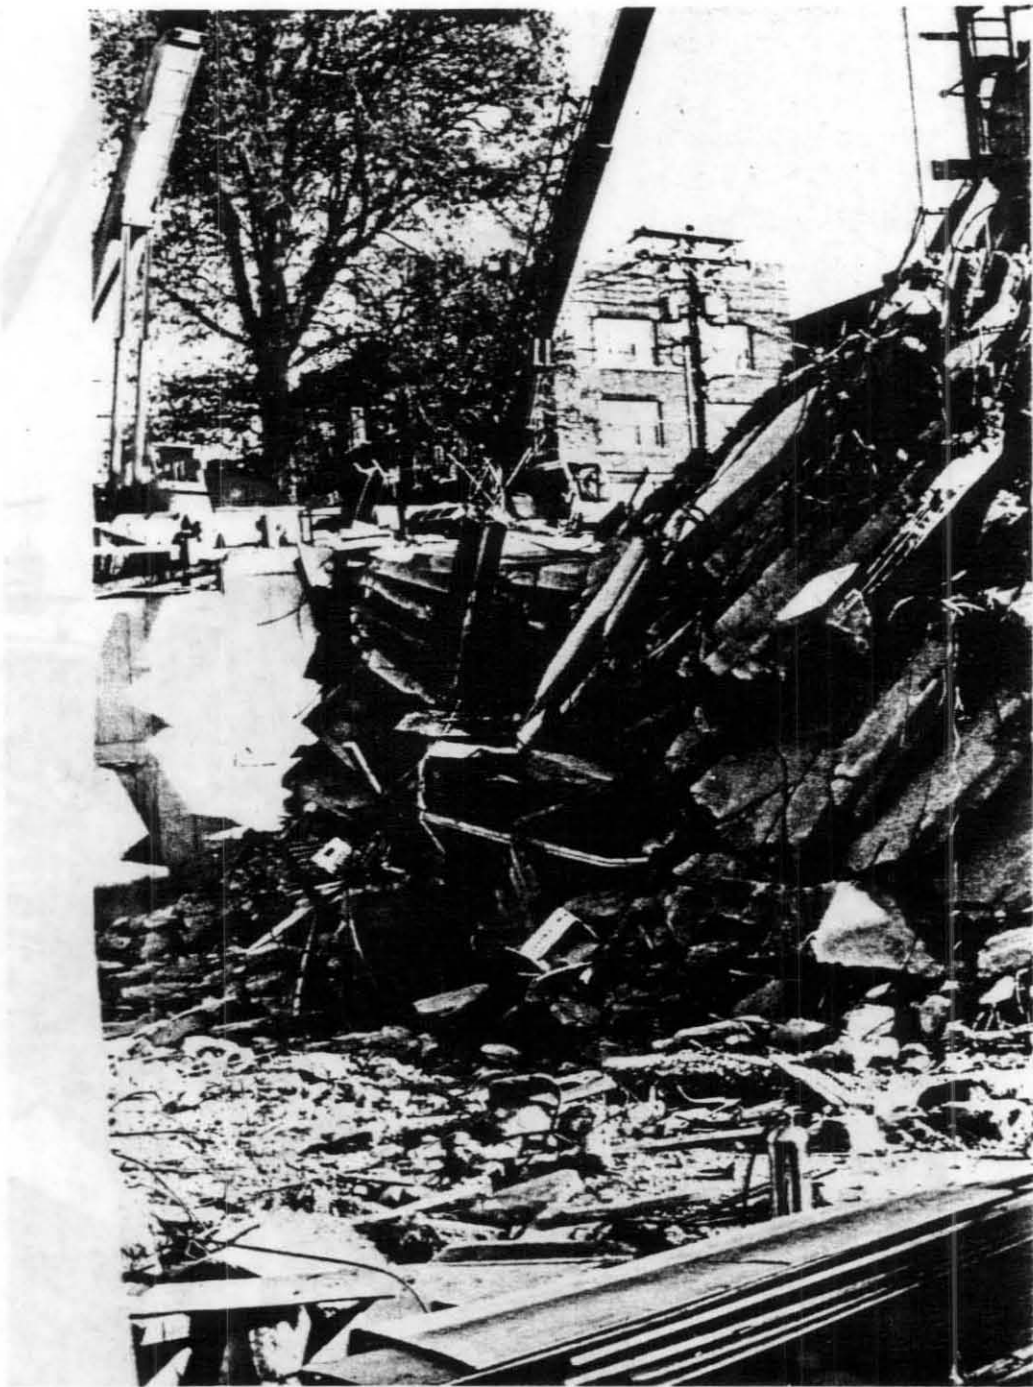
Figure 4.4.8 Lower level floor slabs at Northwest corner of West tower – View to the North; column E1

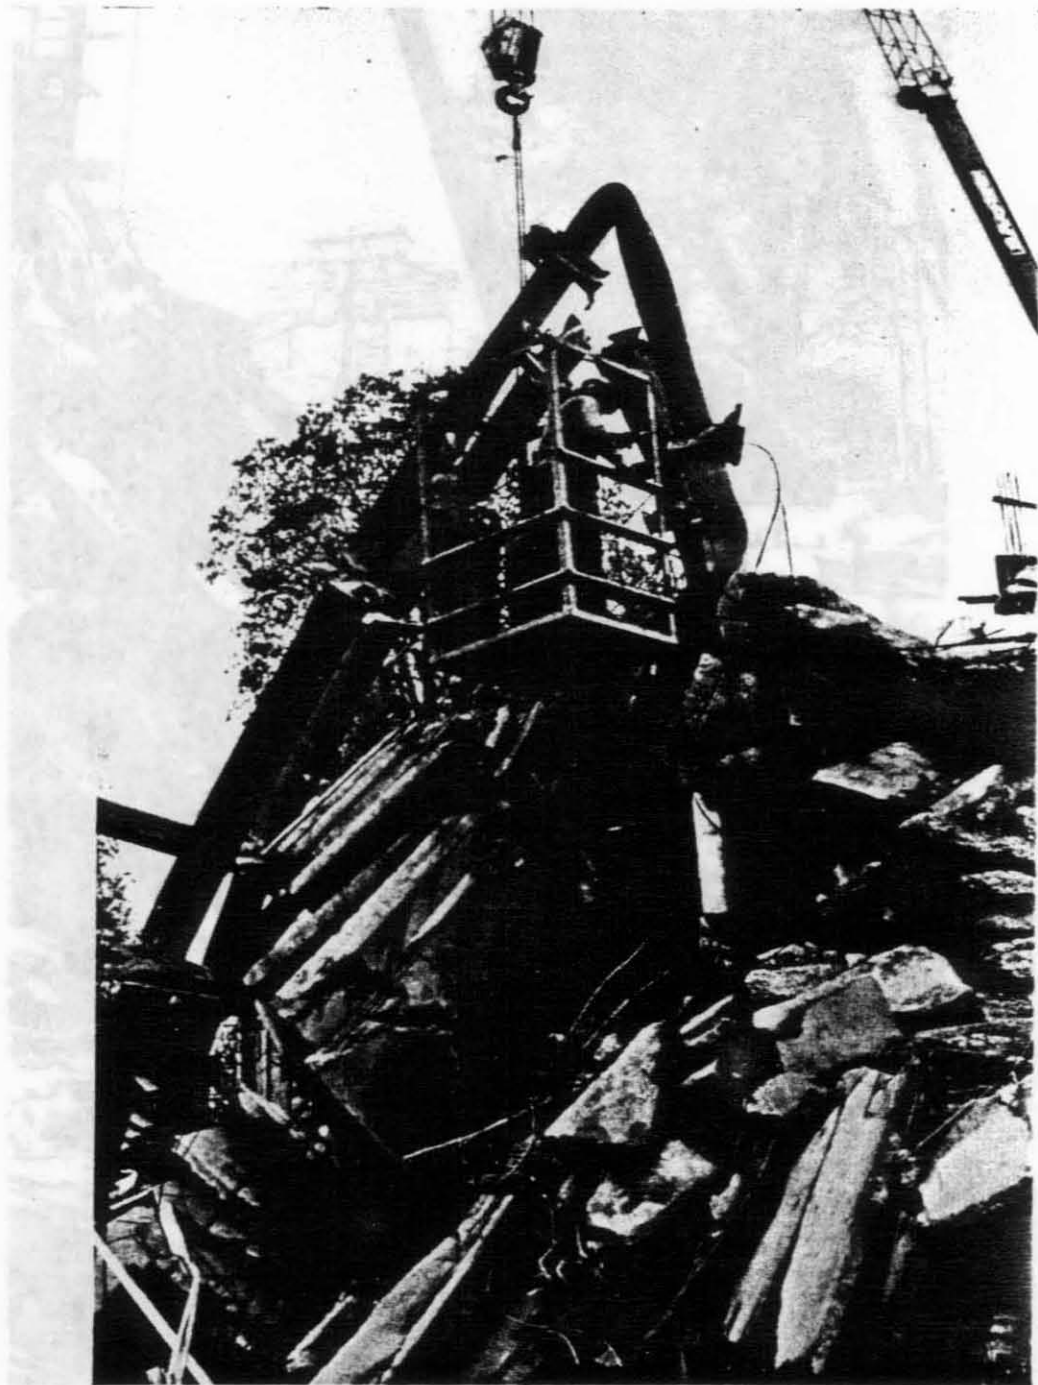
Figure 4.4.9 Upper floor slabs on Northwest corner of West tower – View to the North; column E1

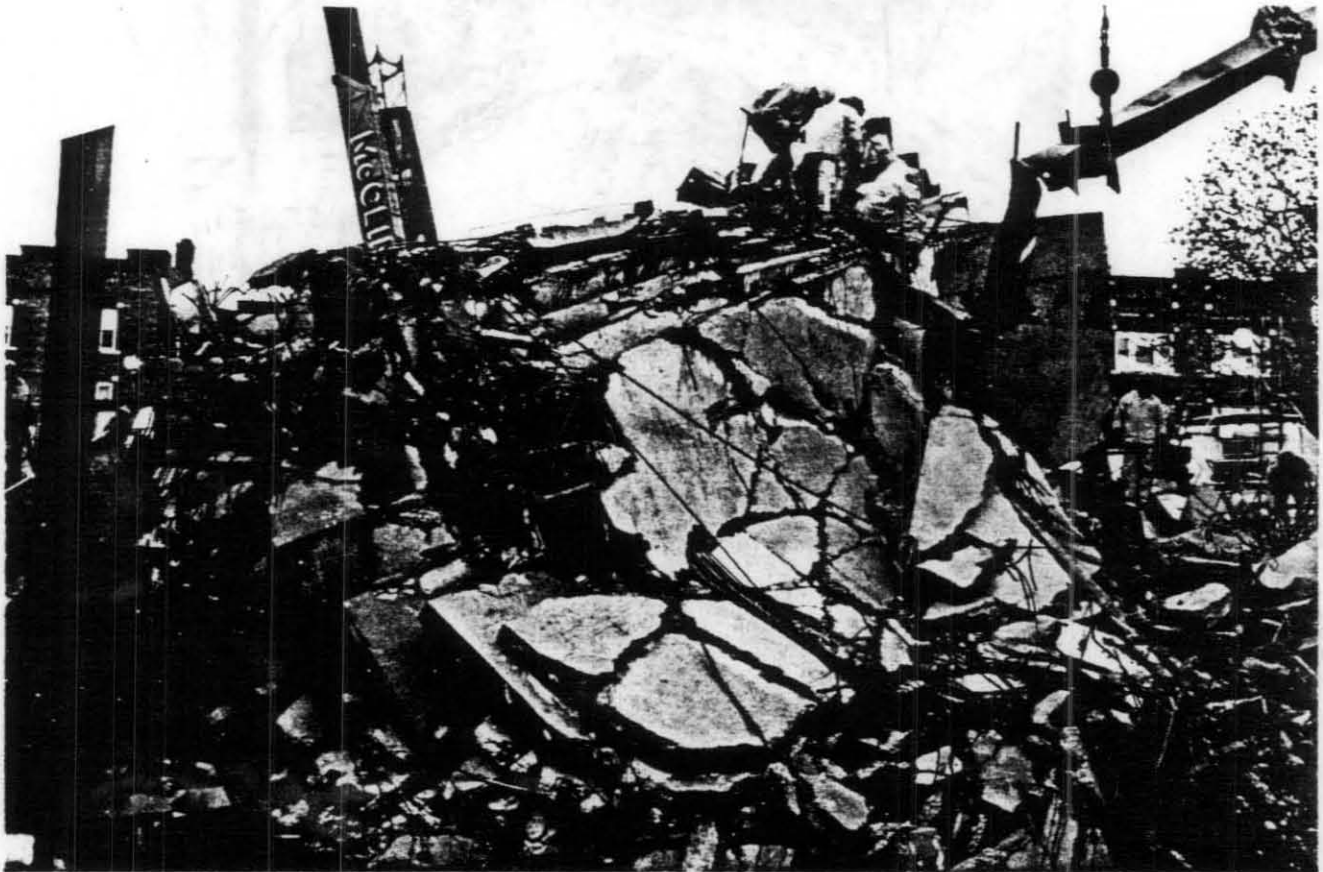
Figure 4.4.16 Floor slab crack pattern

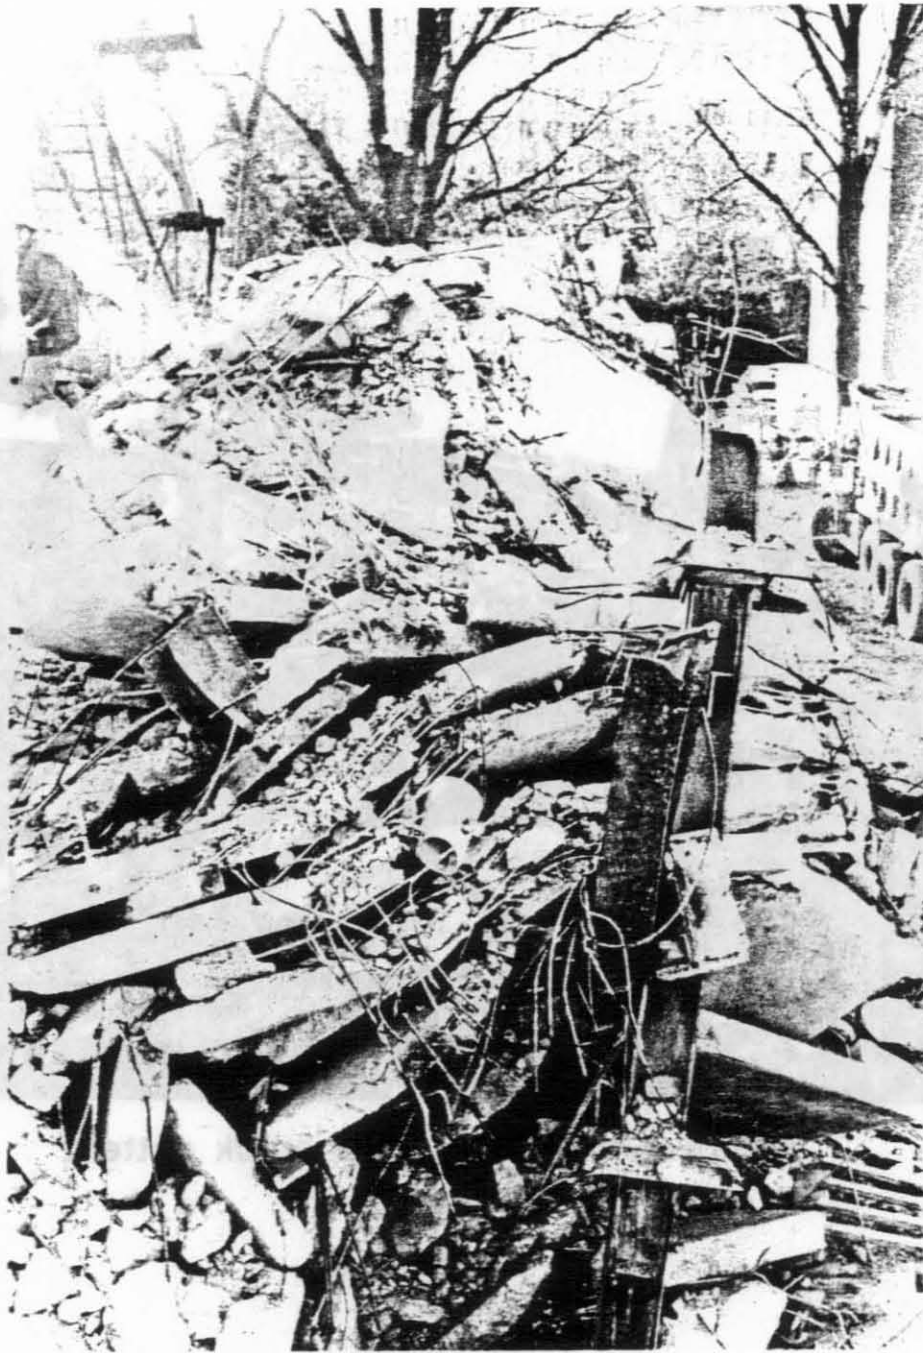
Figure 4.4.17 Broken floor slabs – View to the Southeast; column line H

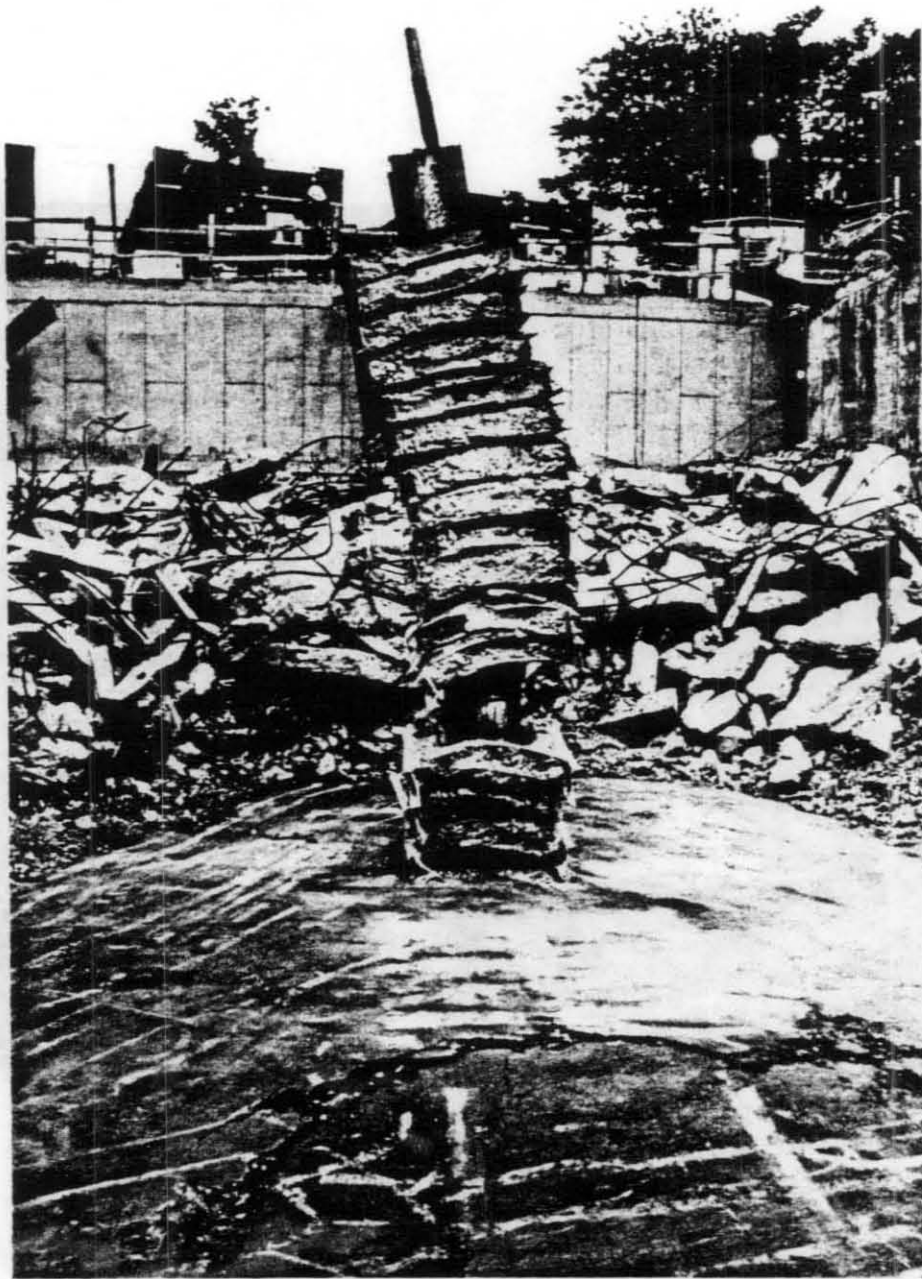
Figure 4.4.18 Deformation pattern of shearheads
– column D10

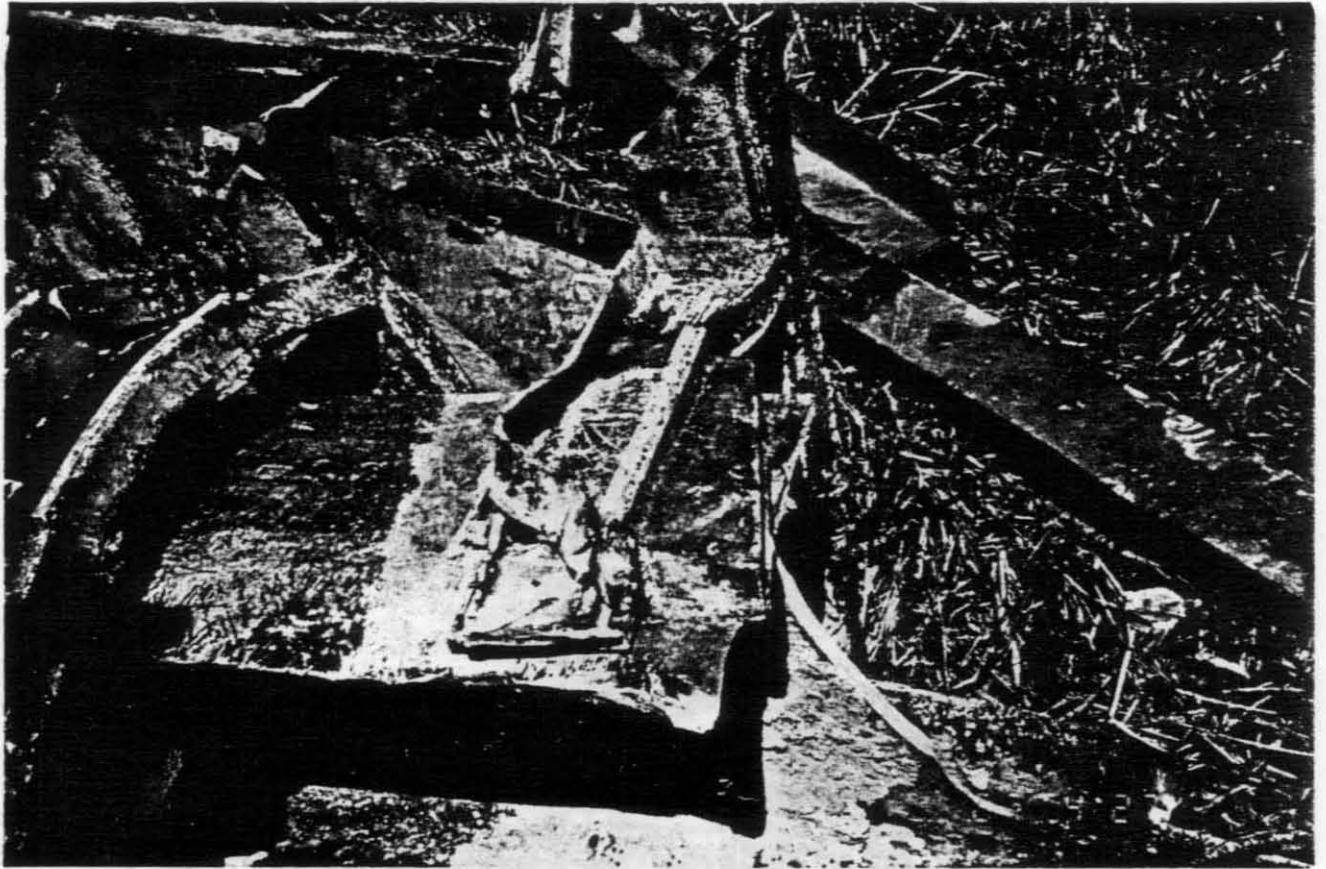
Figure 4.4.19 Failed shearheads

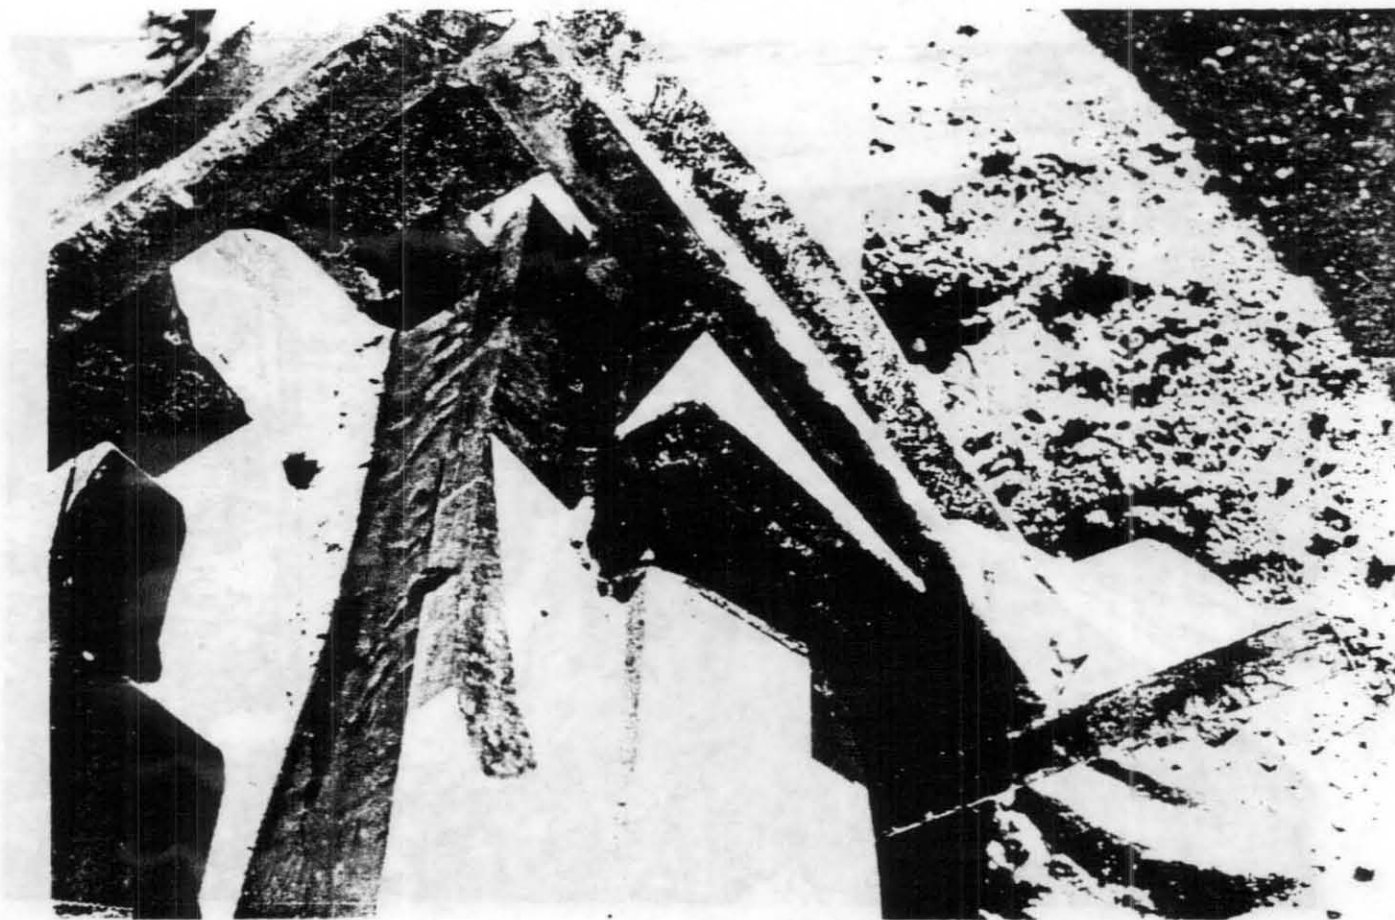
Figure 4.4.24 Weld failure at weld block

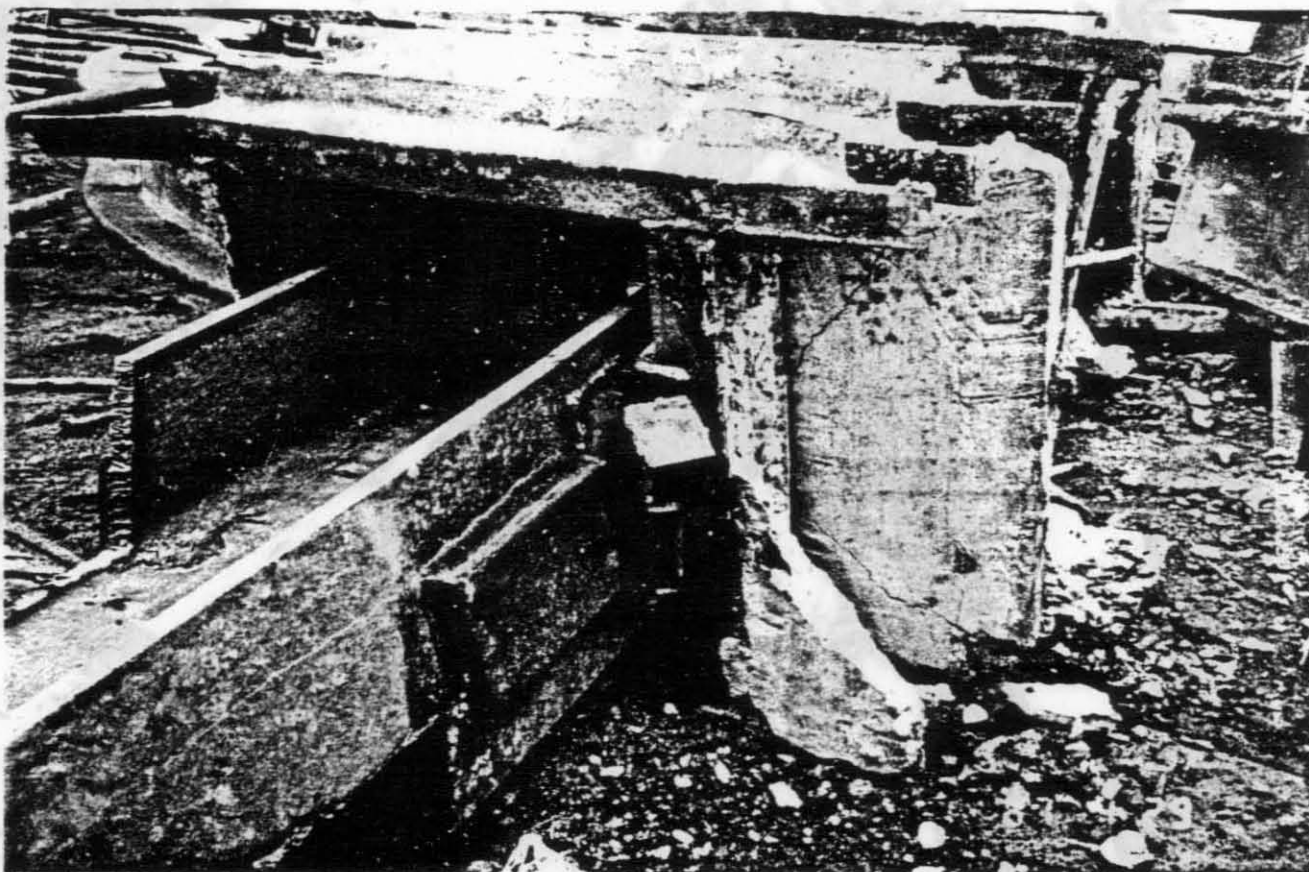
Figure 4.4.25 Weld failure at weld block with shim

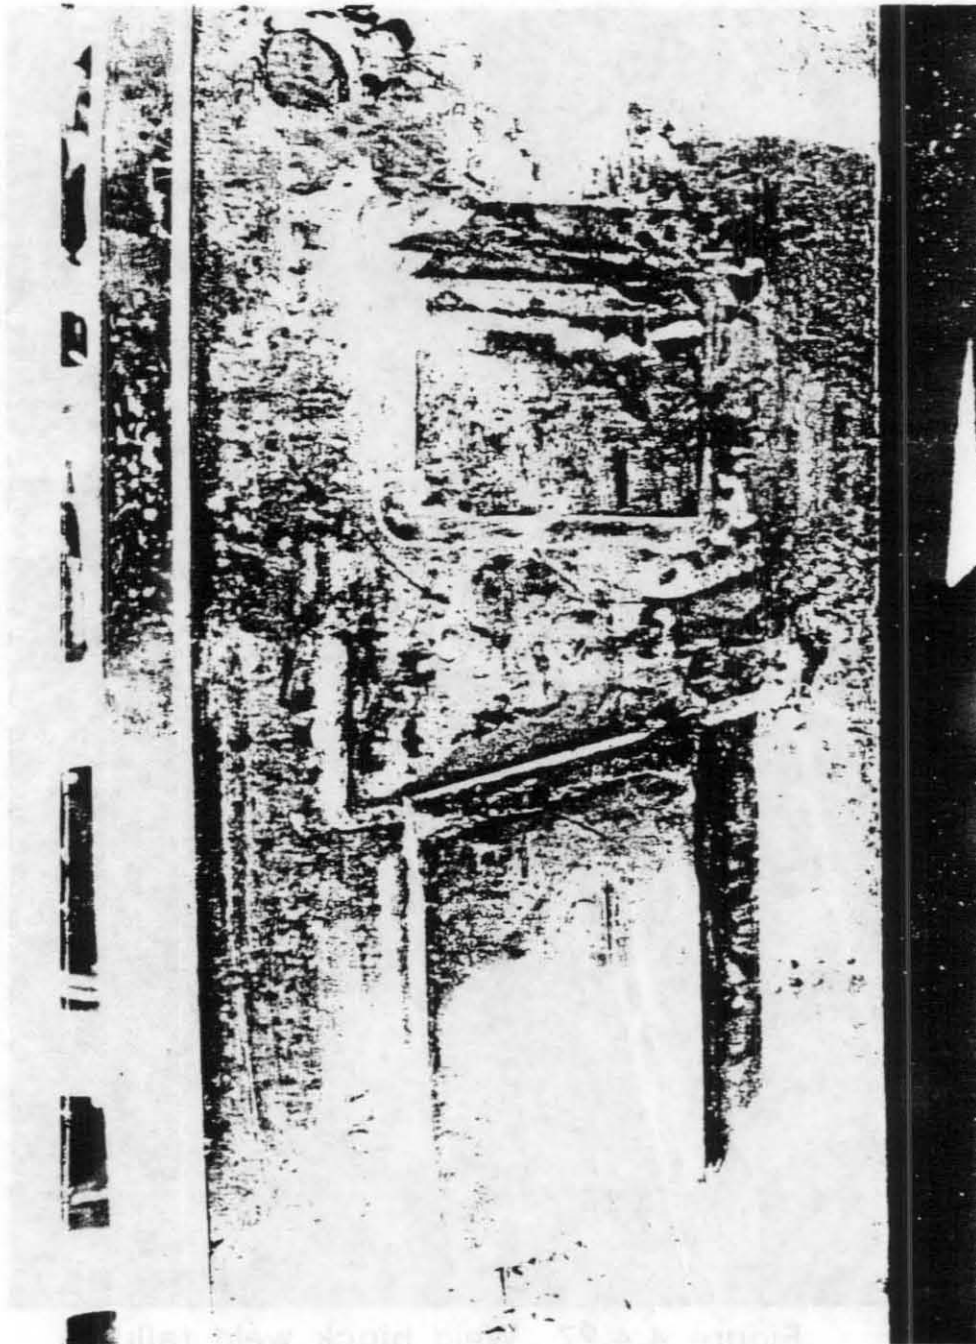
Figure 4.4.26 Weld failure at weld block

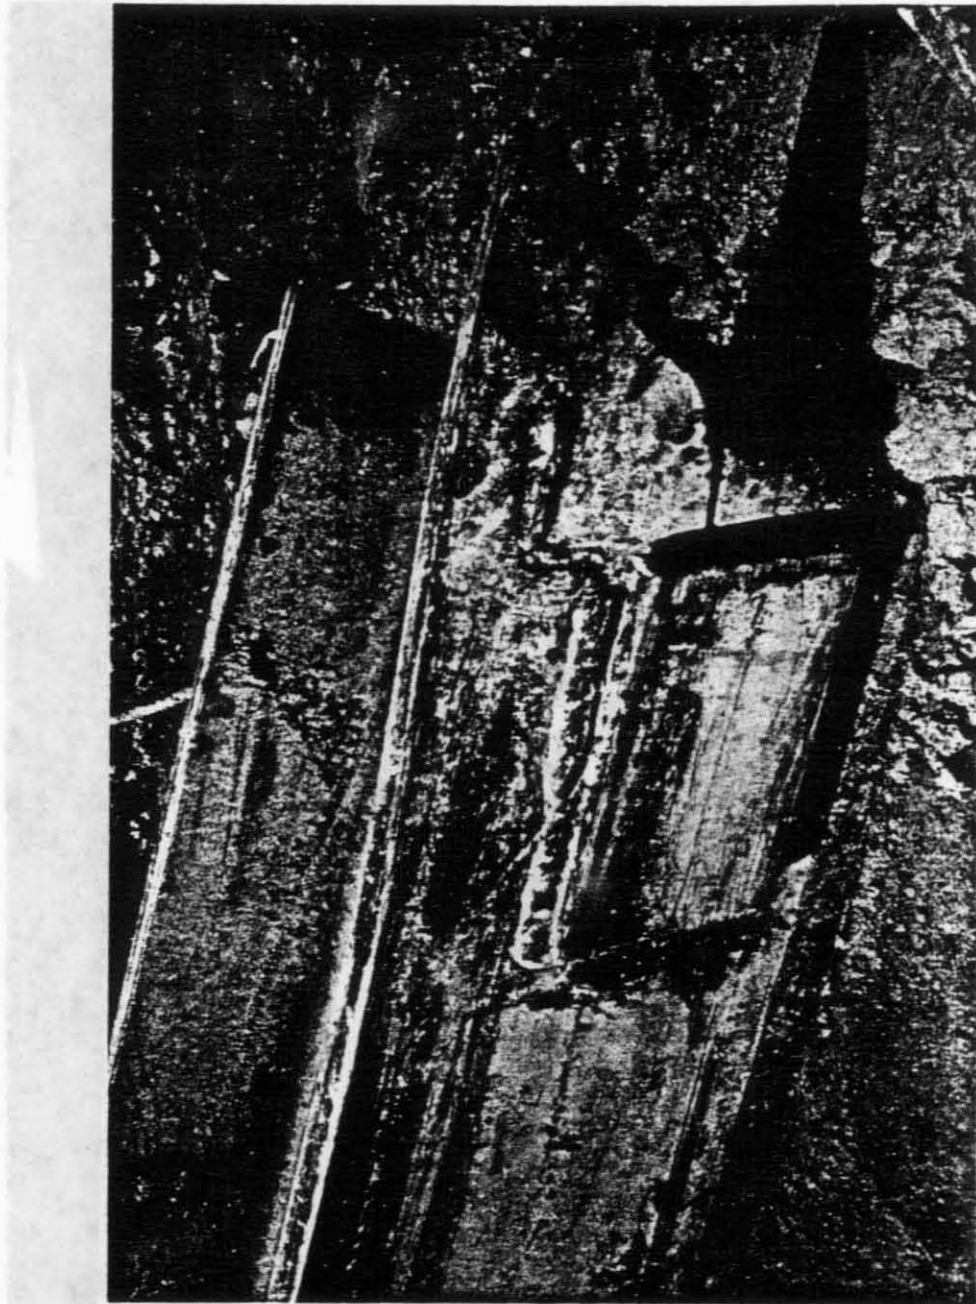
Figure 4.4.27 Weld block weld failure

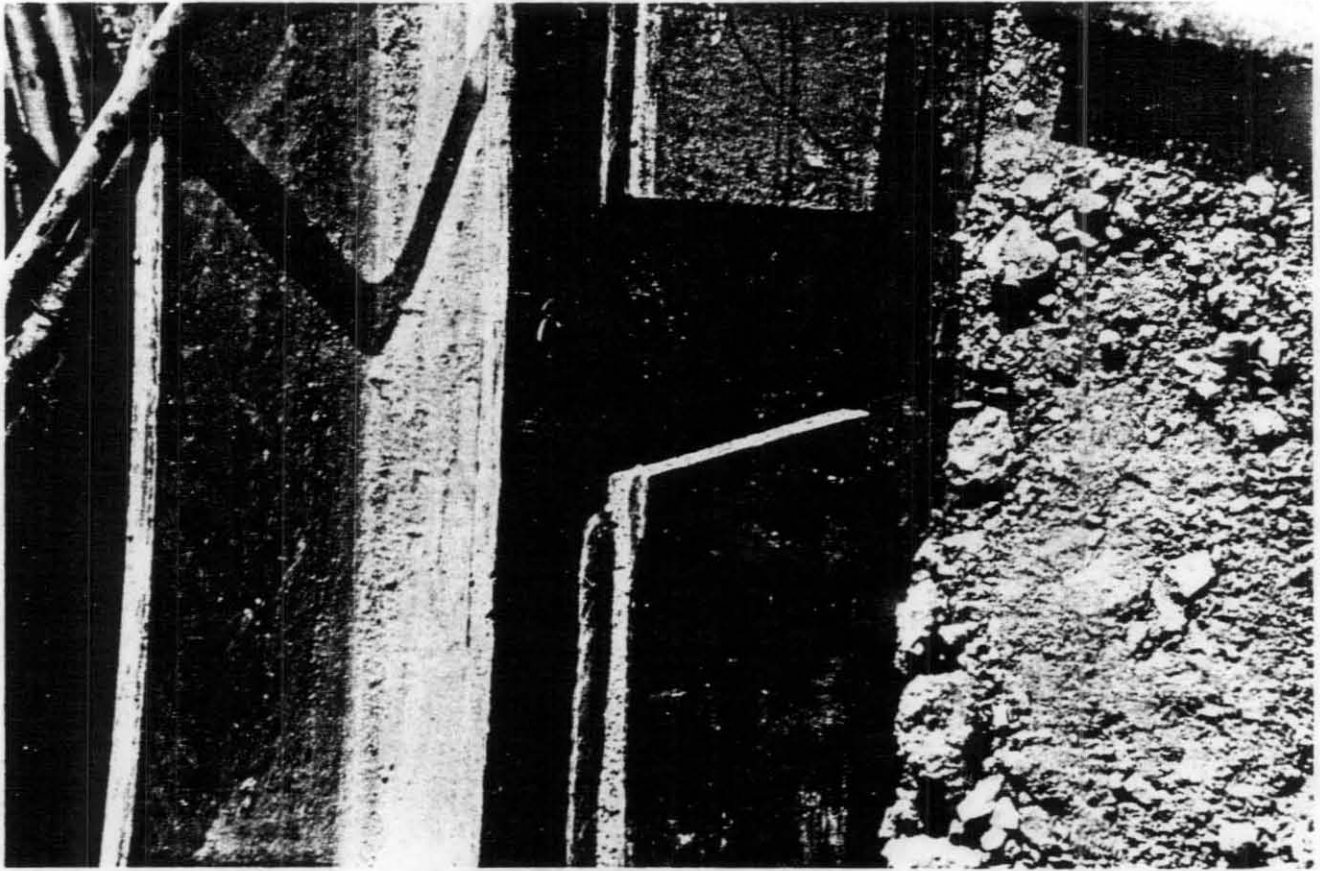
Figure 4.4.28 Failure of temporary weld at shearhead support

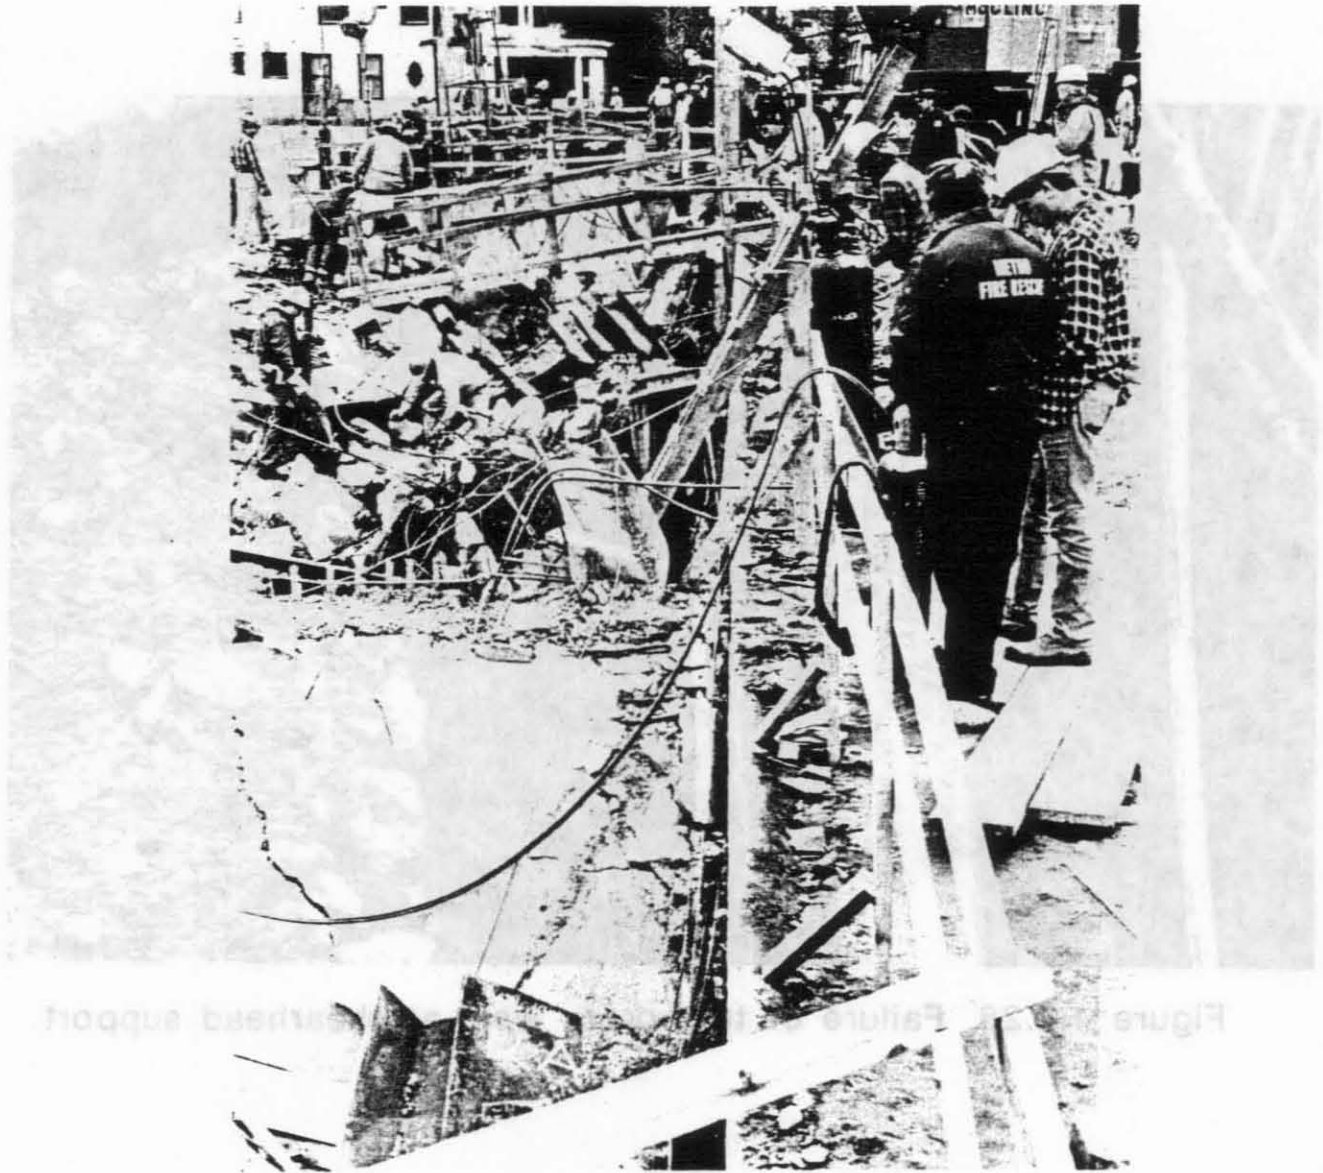
Figure 4.4.29 Basement wall on North side of East Tower –
viewed from the East, May 1, 1987

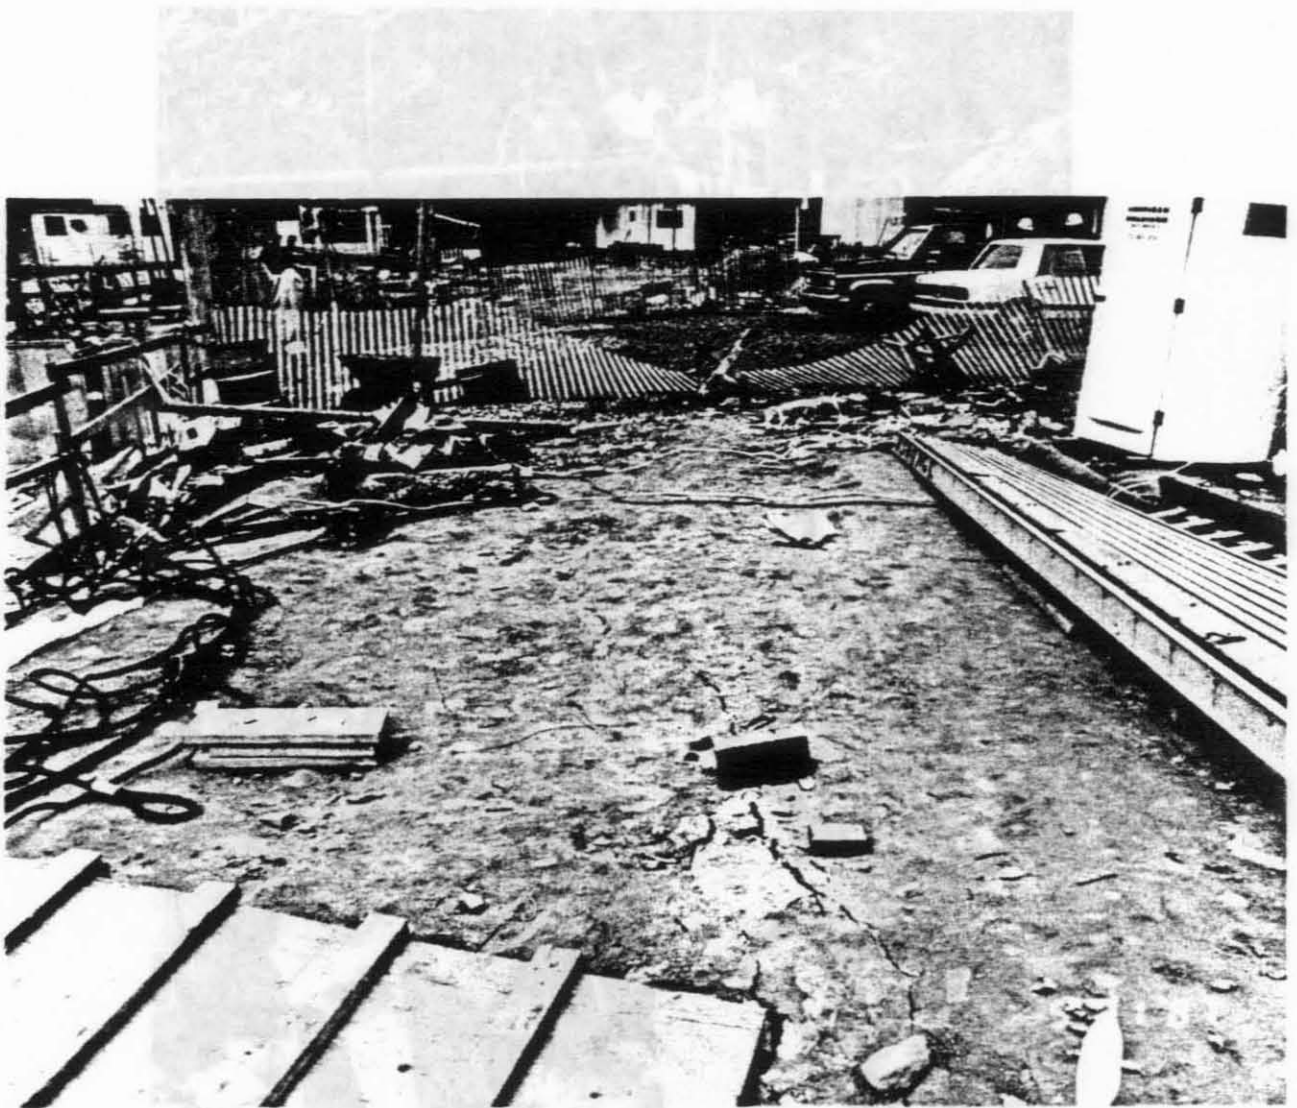
Figure 4.4.31 Tension cracks in backfill behind basement wall – North side of building

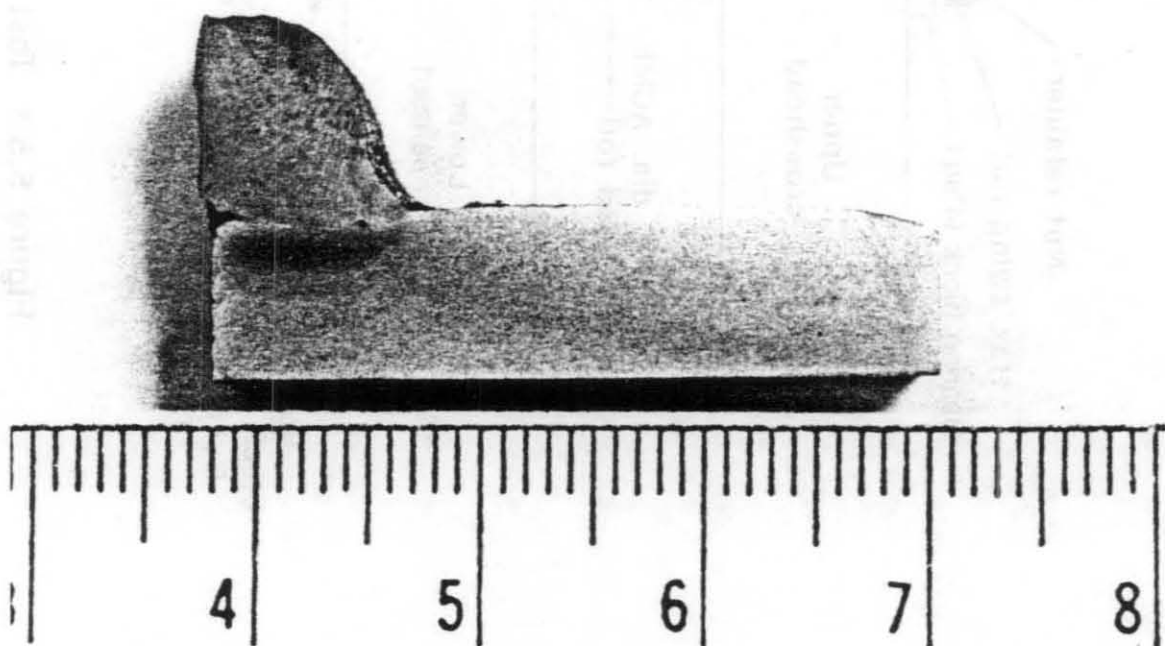
Figure 5.4.16 Metallographic cross section of failed weld
along weld/column interface - specimen
NBS 33A
