NBSIR 87-3640

Investigation of L'Ambiance Plaza Building Collapse in Bridgeport, Connecticut

Center for Building Technology
National Engineering Laboratory
National Bureau of Standards
Gaithersburg, MD 20899

Issued September 1987

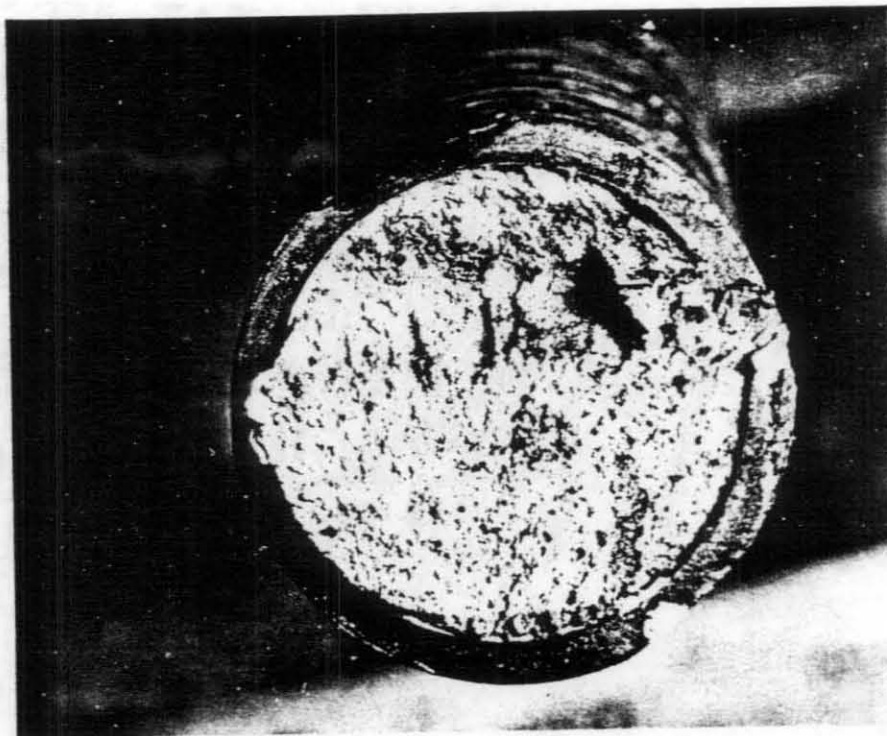
Figure 5.5.5 Fracture surface of jack rod, sample NBS 11-2 (x 1)

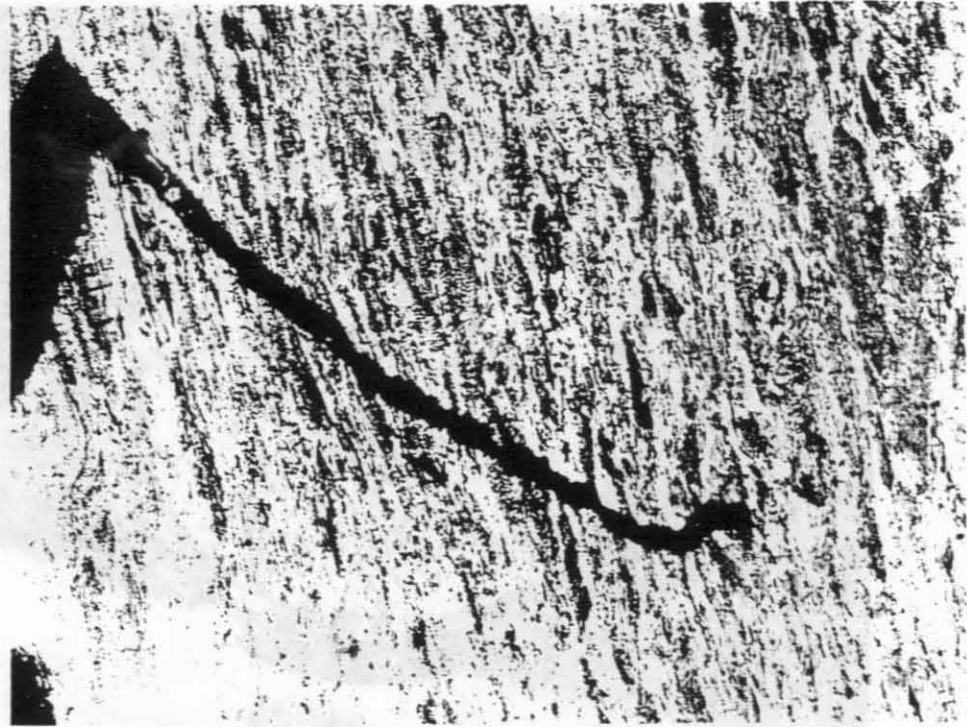
Figure 5.5.7 Lap seam at root of first thread removed from fracture of jack rod (Sample NBS 11-2) (x 500)

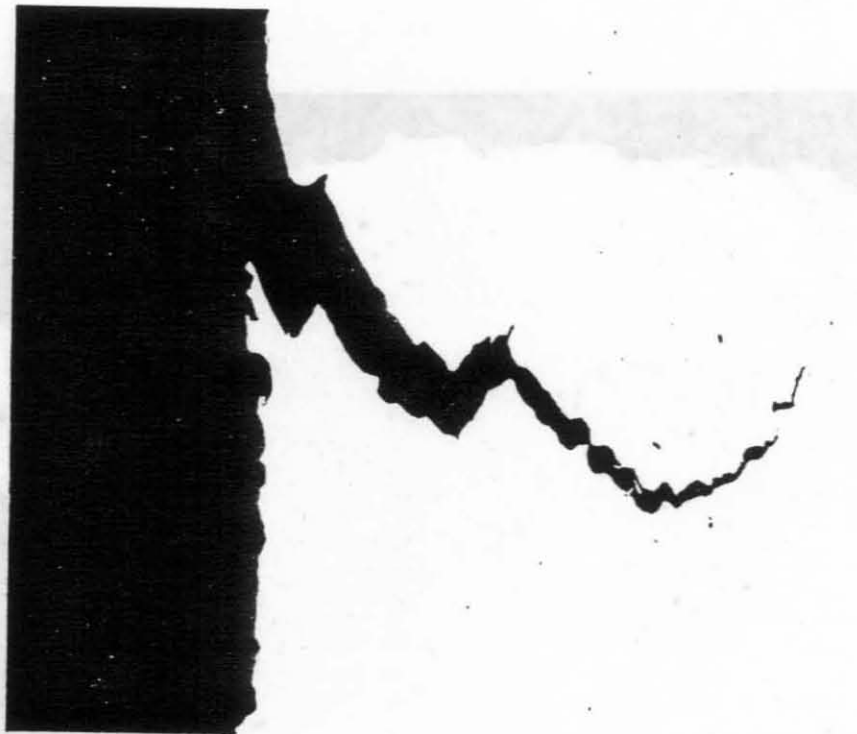
Figure 5.5.8 Lap seam at root of second thread away from fracture of jack rod. As polished (x 40)

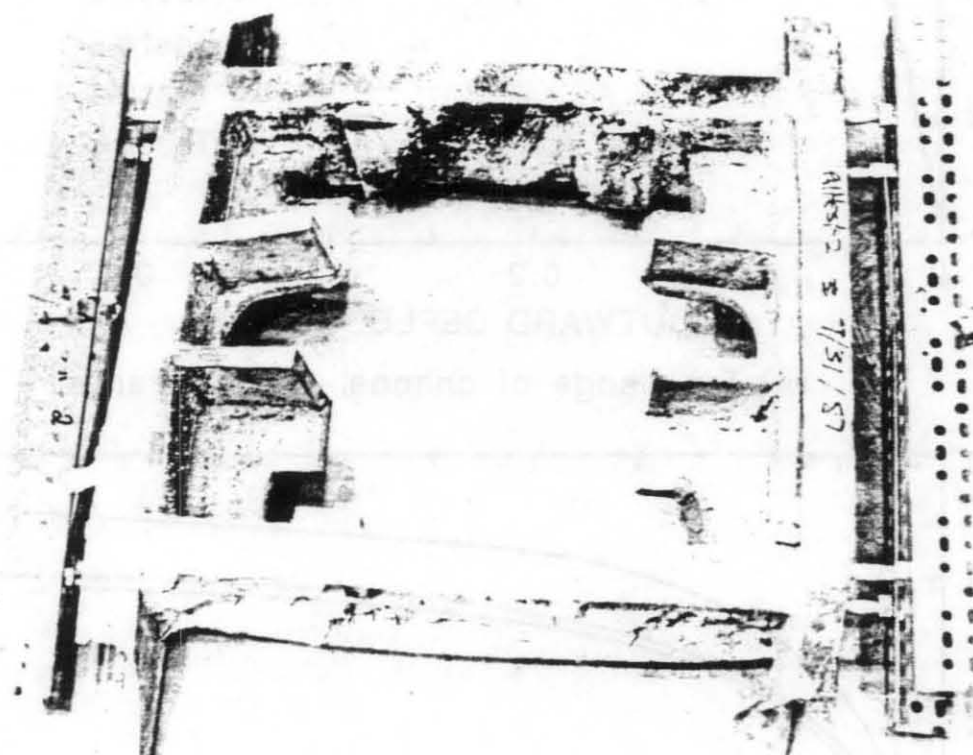
Figure 5.5.17 Shearhead No. 2 after failure showing rotation of lifting angles

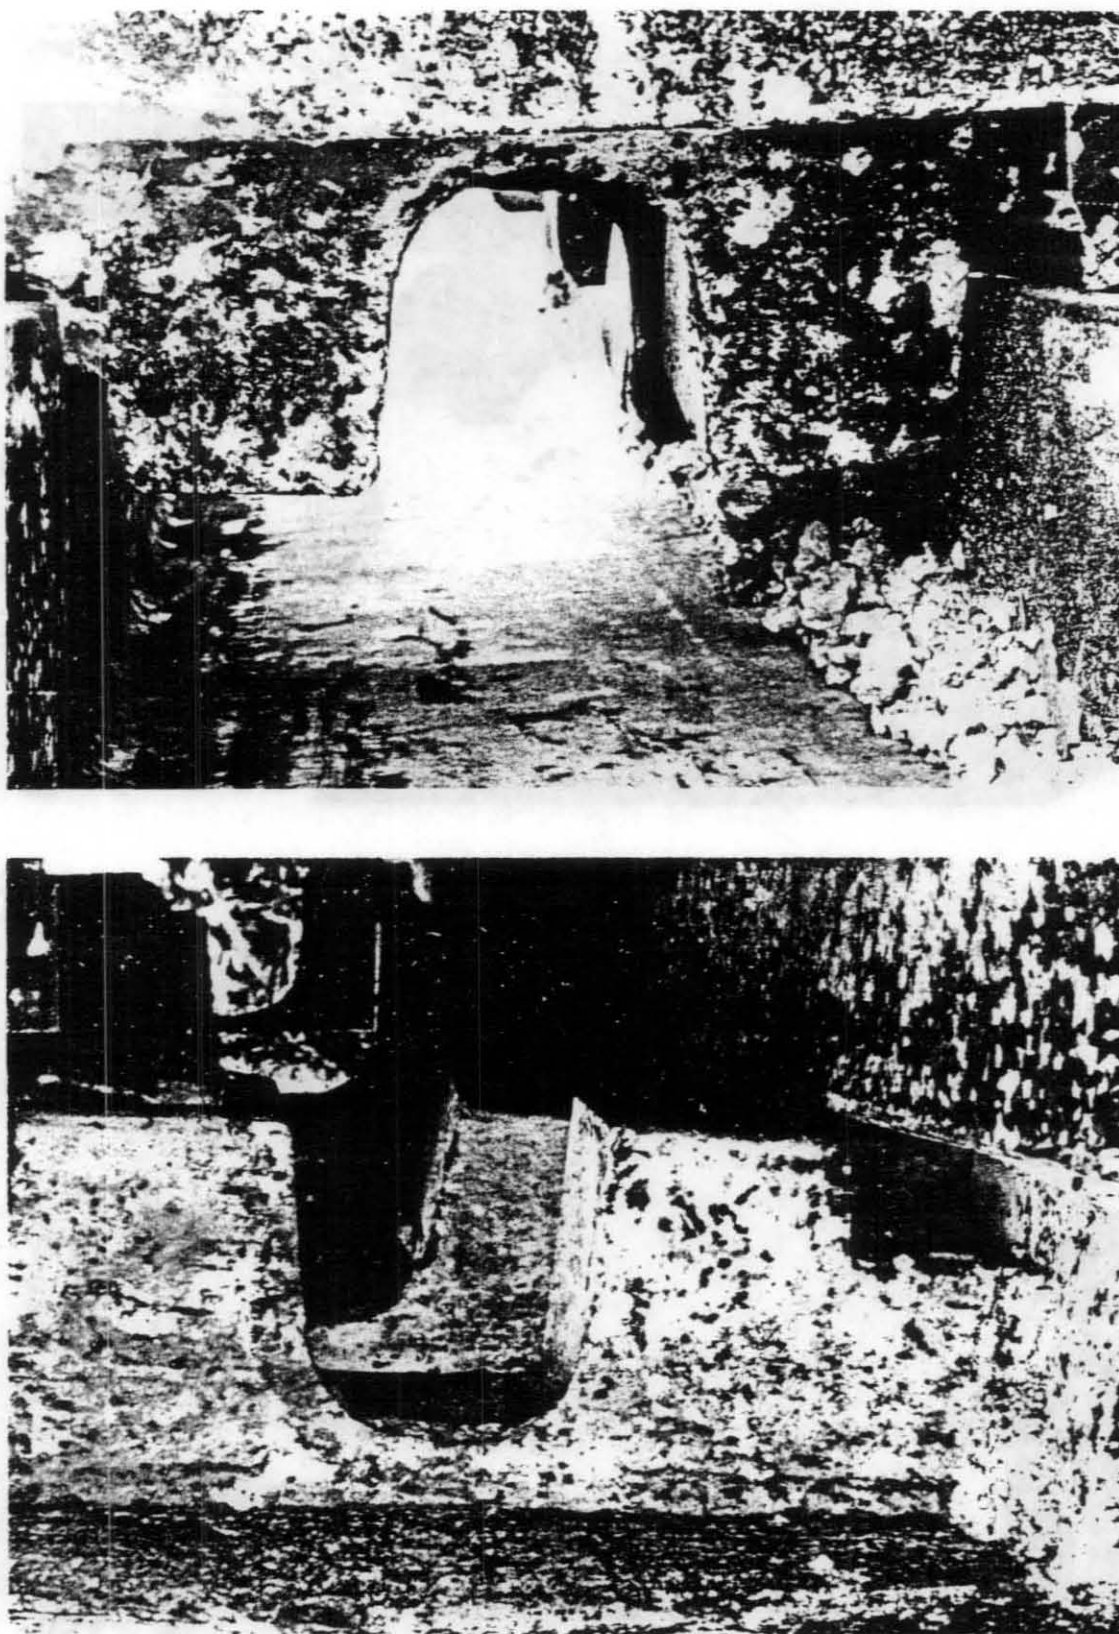
Figure 9.3.2 Indentations in underside of lifting angles, column E4.8, level 9

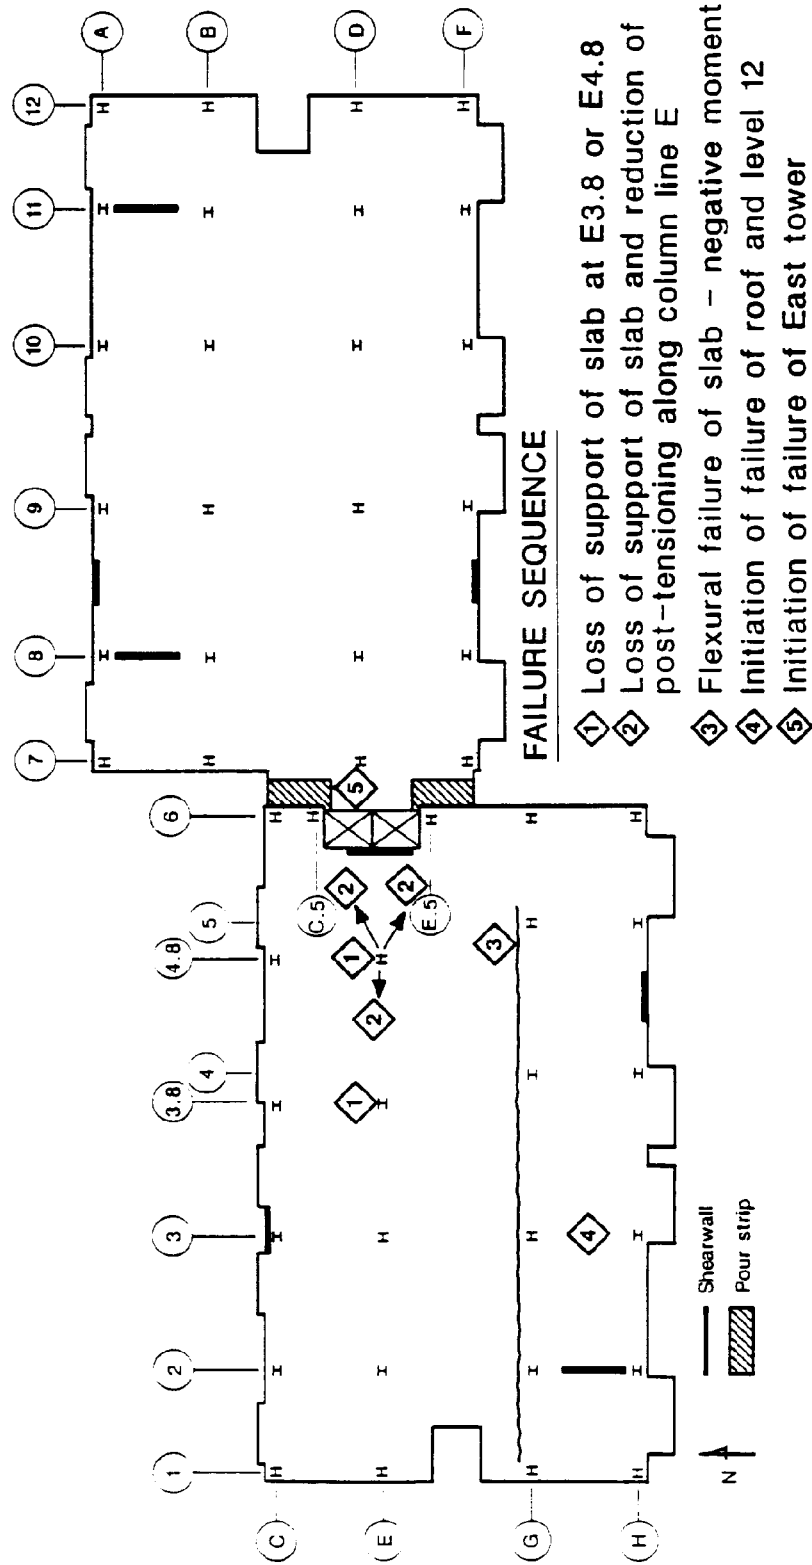
Figure 9.4.1 Probable failure sequence
