NBS SPECIAL PUBLICATION **592**

An Investigation of the Miyagi-ken-oki, Japan, Earthquake of June 12, 1978

This document is the result of the investigation by the U.S. team on the earthquake. It describes geologic features of the earthquake-stricken area, and damage to human-made structures. It is hoped the information presented in this document will add to the knowledge of seismology and earthquake engineering.

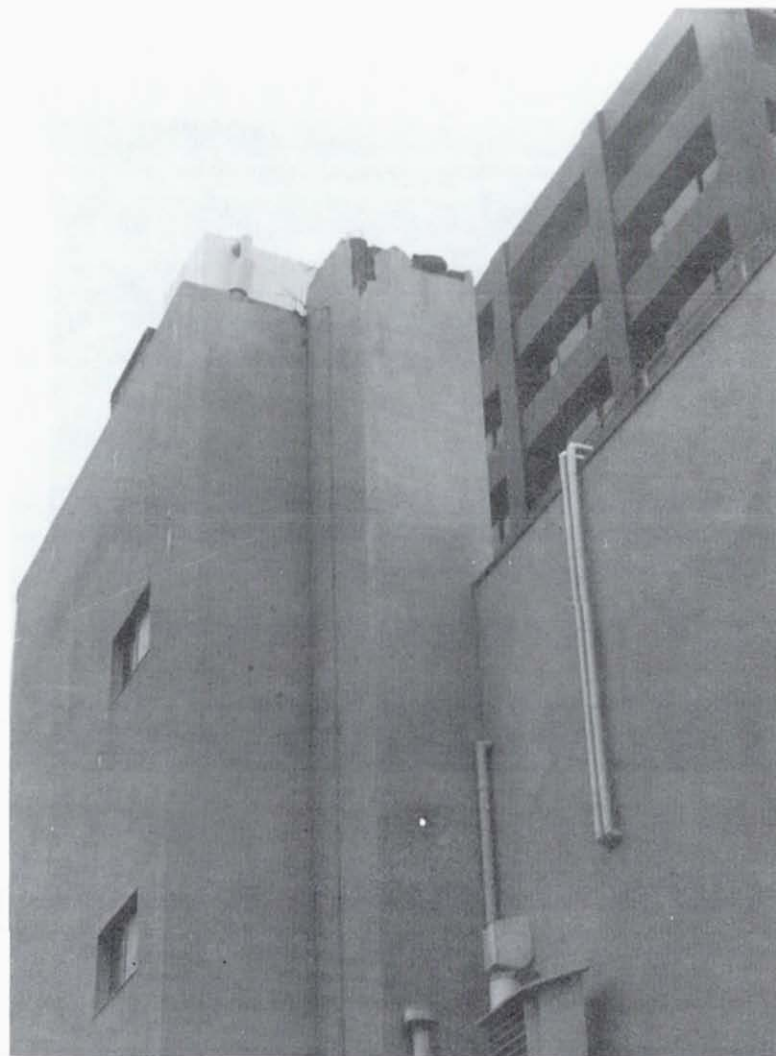
Figure 5.9 Downtown Sendai. Reinforced concrete chimney failure.

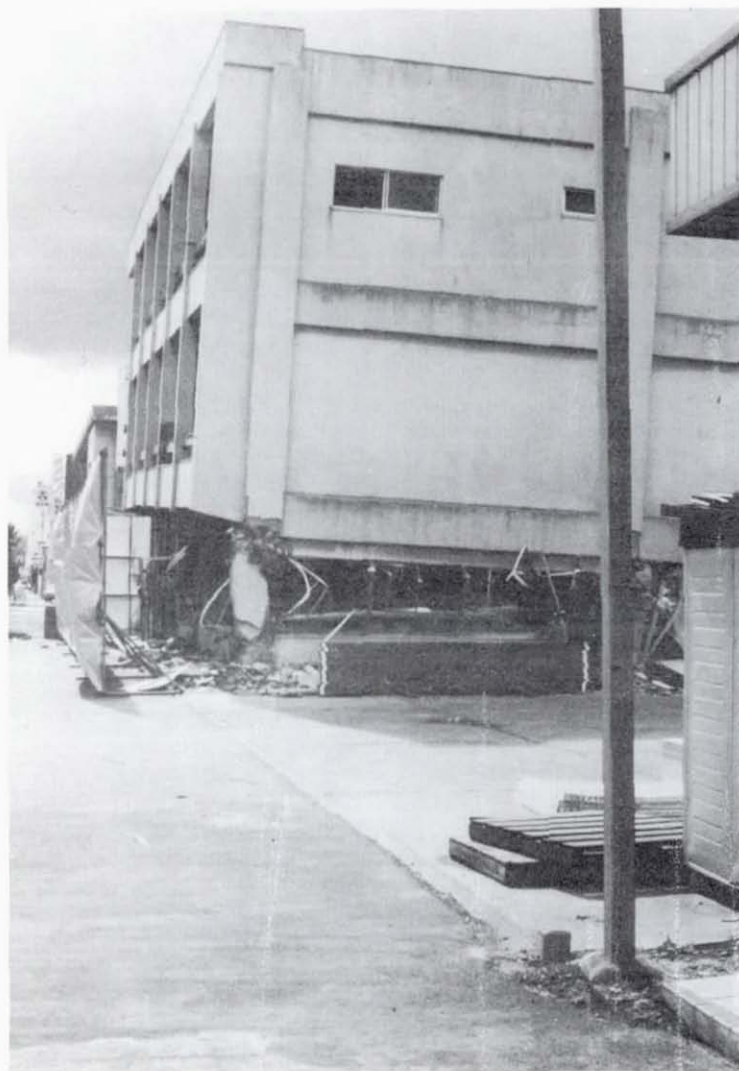
Figure 5.24 Maruyoshi Building, view from the east. Failure of first story columns occurred in shear.

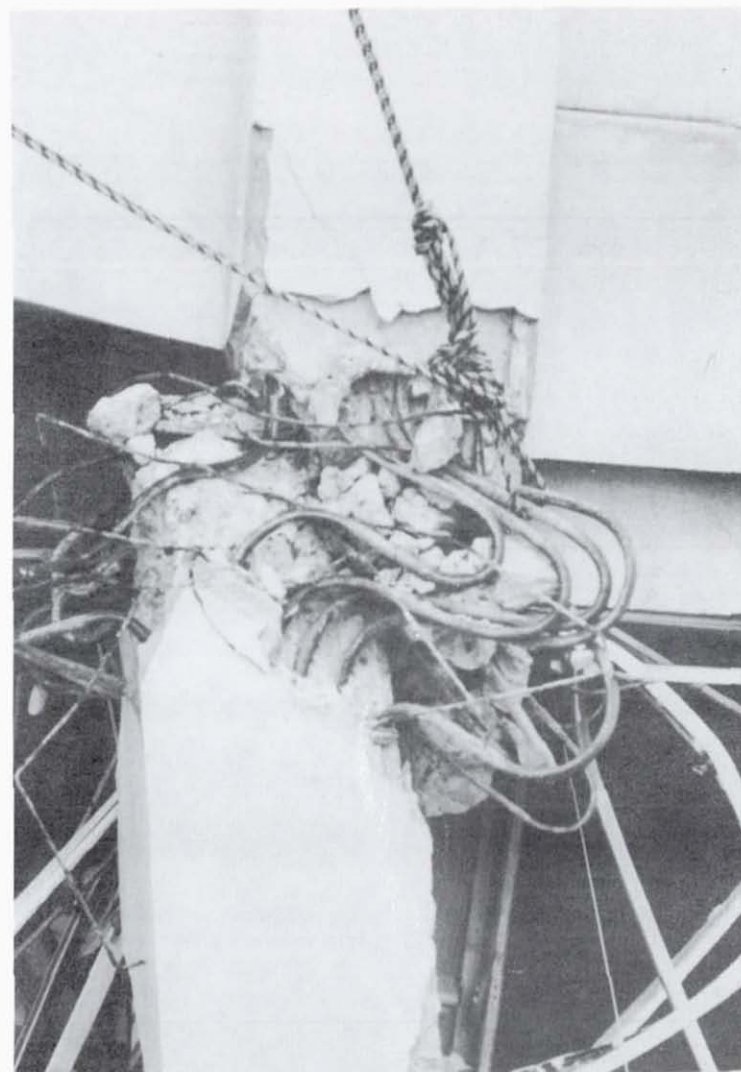
Figure 5.25 Maruyoshi Building. Detail of a joint at the top of a first story column.

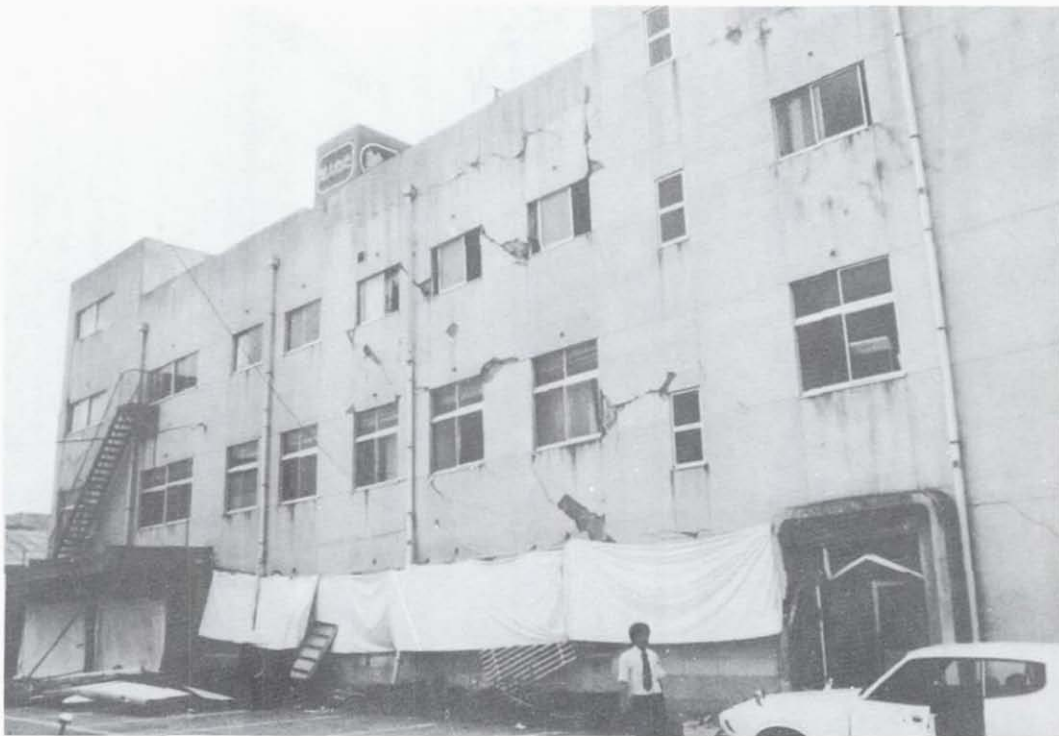
Figure 5.32 Kinoshita Building, Oroshicho area, of Sendai. Extensive diagonal cracking was observed on the east face (rear) of the building.

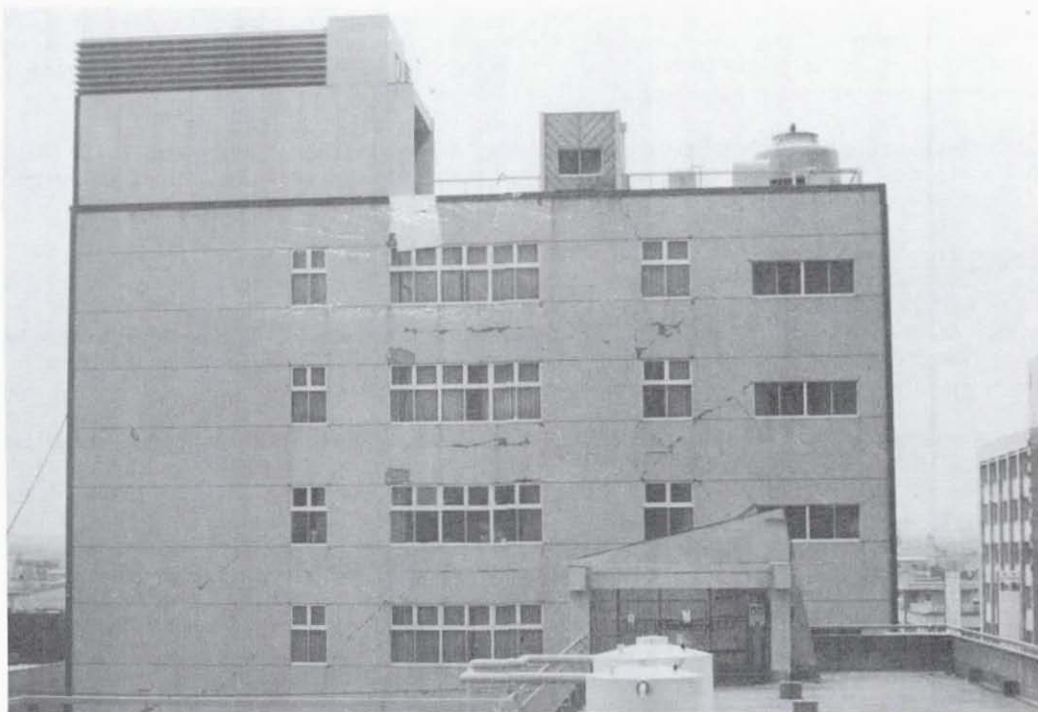
extensive diagonal cracking in the panels between window openings on both east (Figure 5.34) and west faces (Figure 5.35); this damage is especially severe on the west face, as shown in the detail in Figure 5.36. The decorative ceramic brick facing on the north side of the building did not appear to be damaged.

Figure 5.34 Maruhon Building, Oroshicho area, showing shear cracking in the panels on the east face between window openings.

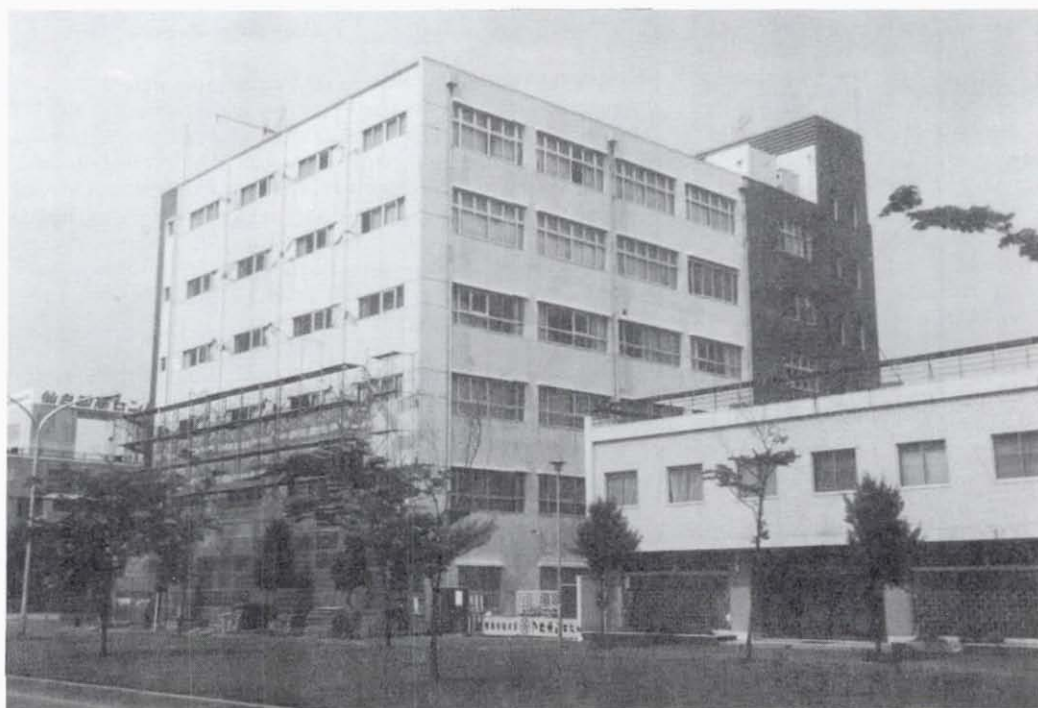
Figure 5.35 Maruhon Building, west face, showing cracking of curtain wall panels.

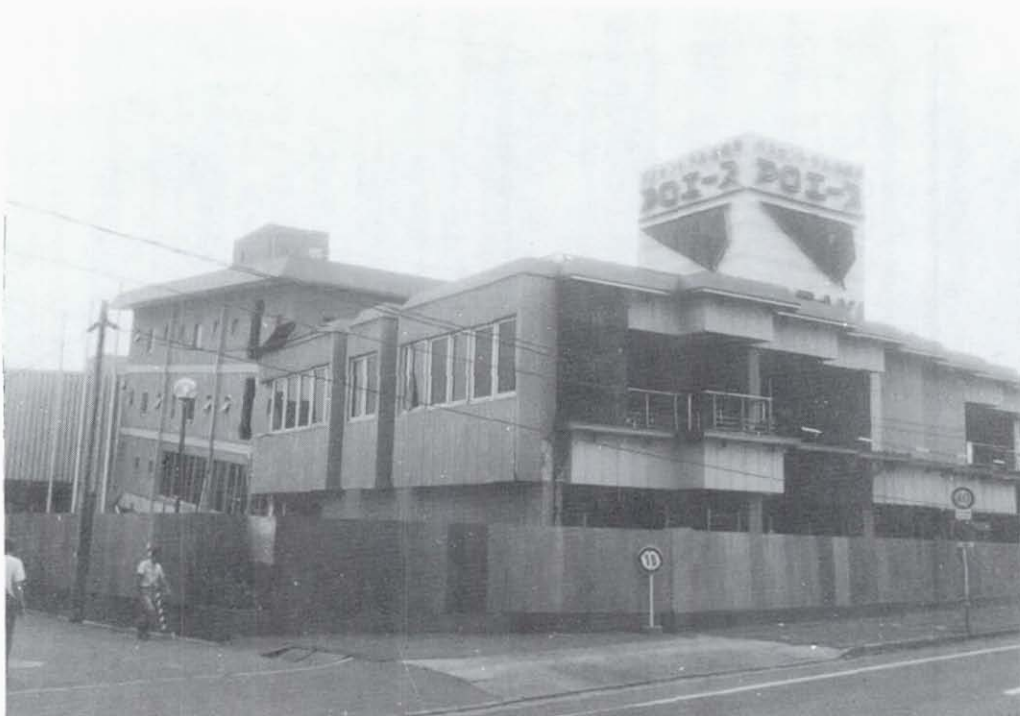
Figure 5.38 Yazaki Industries Buildings, viewed from the northeast, Oroshicho area. Portions of three Yazaki buildings are shown. Failure of the reinforced concrete middle building caused it to rack forward against the front steel structure.

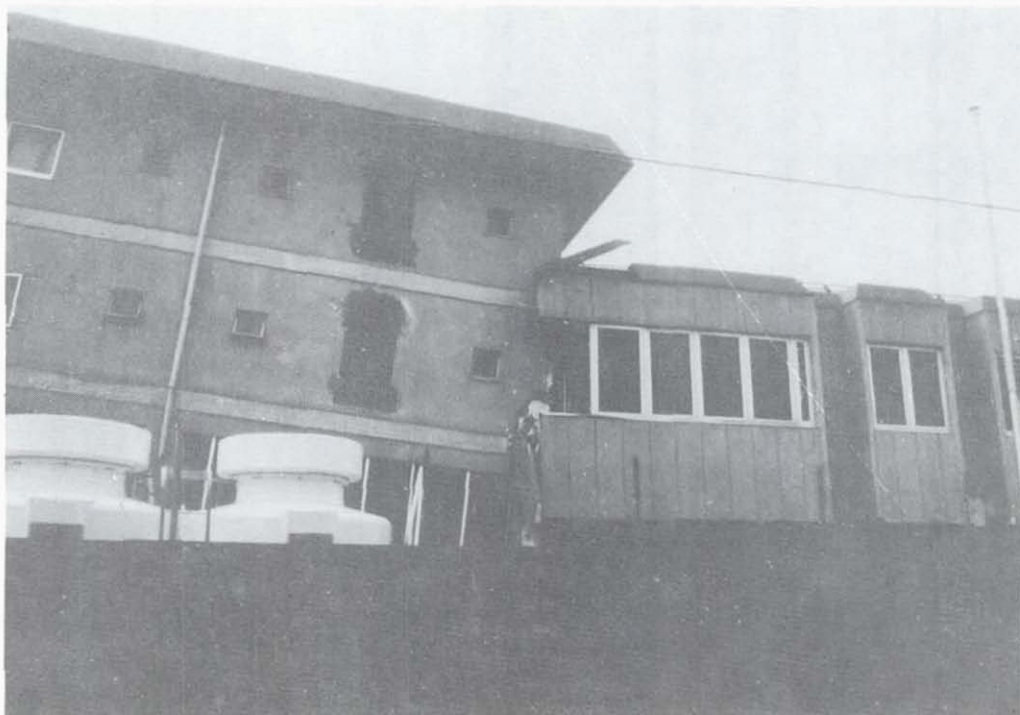
Figure 5.40 Yazaki Industries, showing area of impact between steel and reinforced concrete frames.

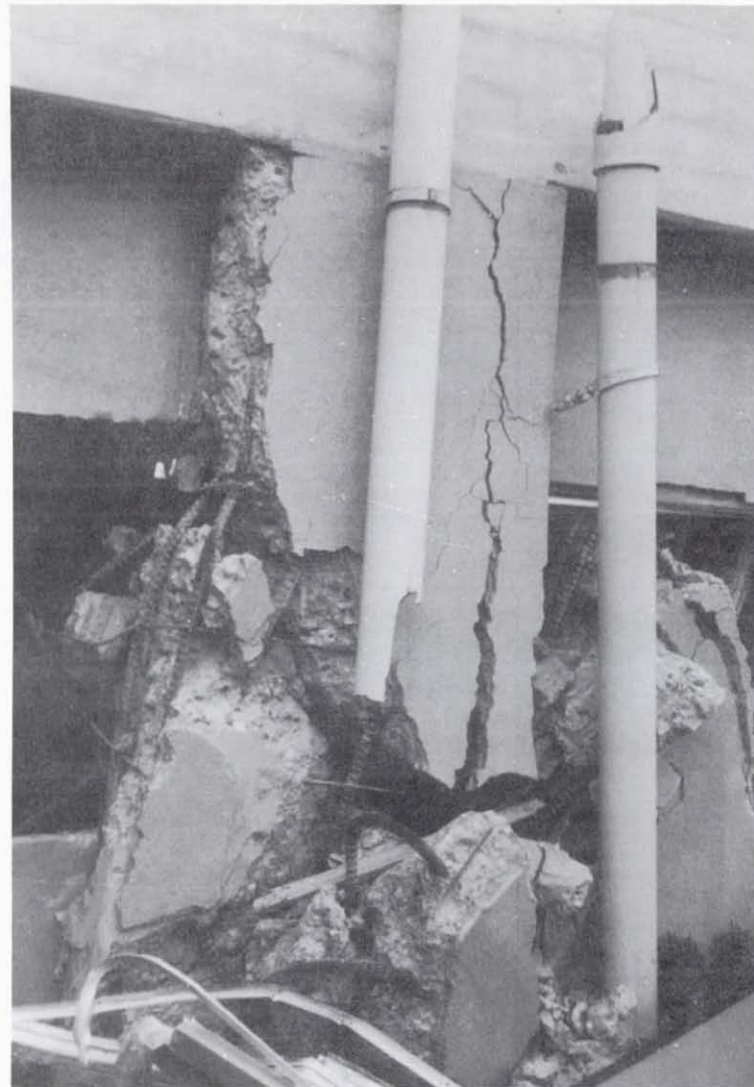
Figure 5.41 Yazaki Industries, showing damage to lower story reinforced concrete column.

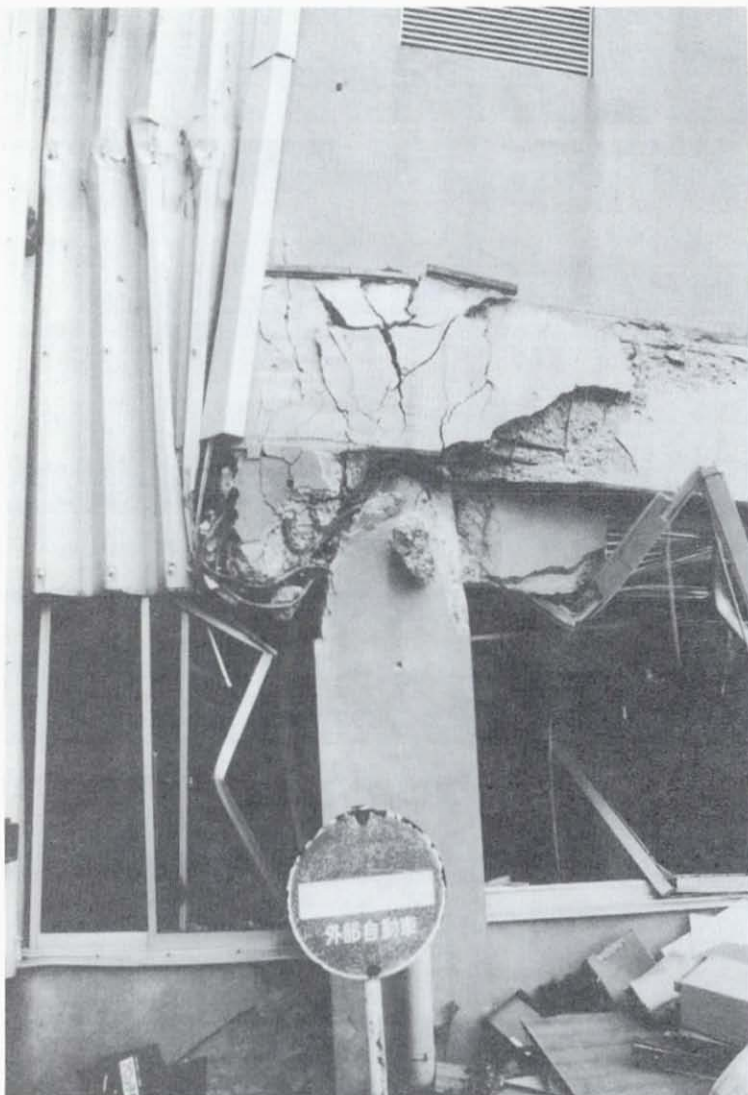
Figure 5.42 Yazaki Industries Building, showing beam-column joint at top of first story column, east side.

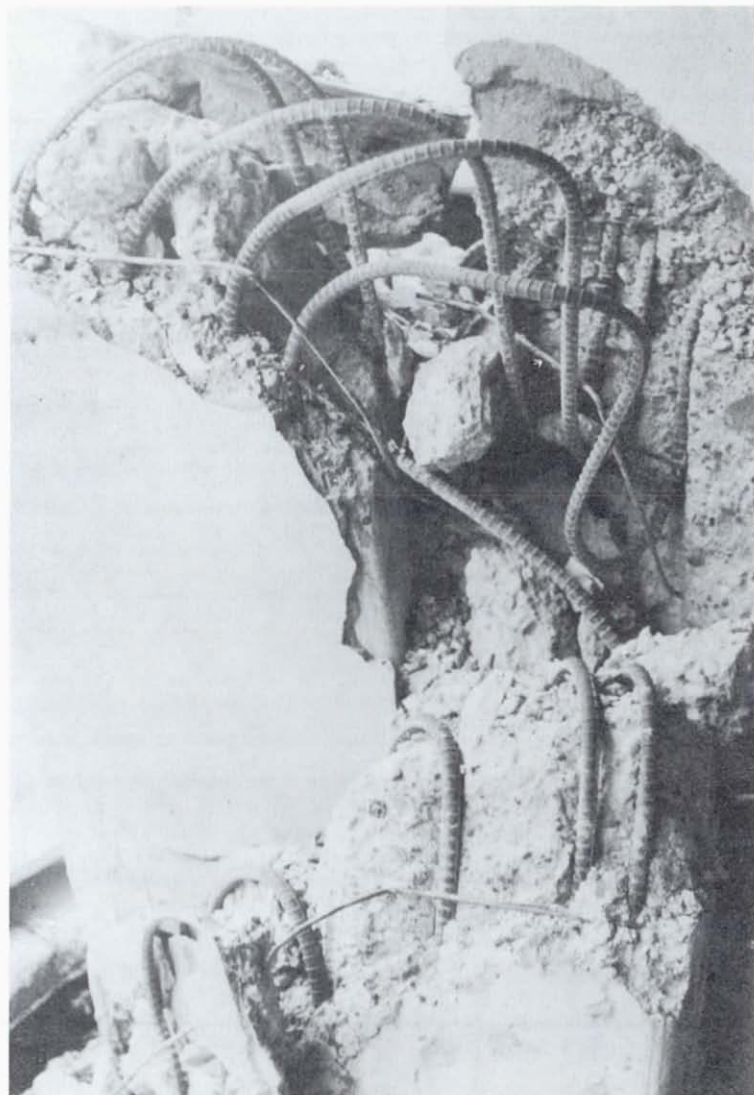
Figure 5.43 Yazaki Industries Buildings. Detail of column shear failure, east side. Note use of deformed bars.

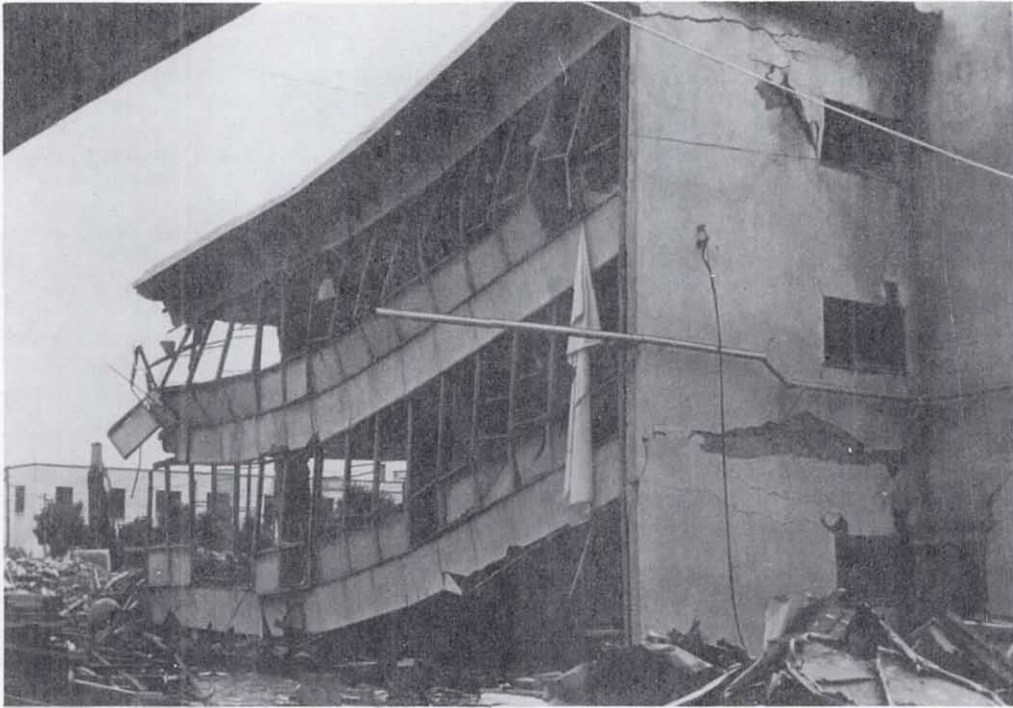
Taiyo Fisheries Plant (No. 11, Figure 5.3). This was a three-story building with a reinforced concrete frame, one span by five, the main axis of which was in the N-S direction. There were shear walls on the north and south ends of the structure. As shown in Figures 5.51 and 5.52, the first-story columns in the middle of the building failed, causing the central portion of the building to collapse but leaving the ends standing. The shear walls at the north end of the structure (running in the E-W direction) were badly cracked. At the time the site was visited, the building was being demolished.

Figure 5.52 Taiyo Fisheries Plant, viewed from the northeast. The reinforced concrete shear wall on the north end was badly damaged.

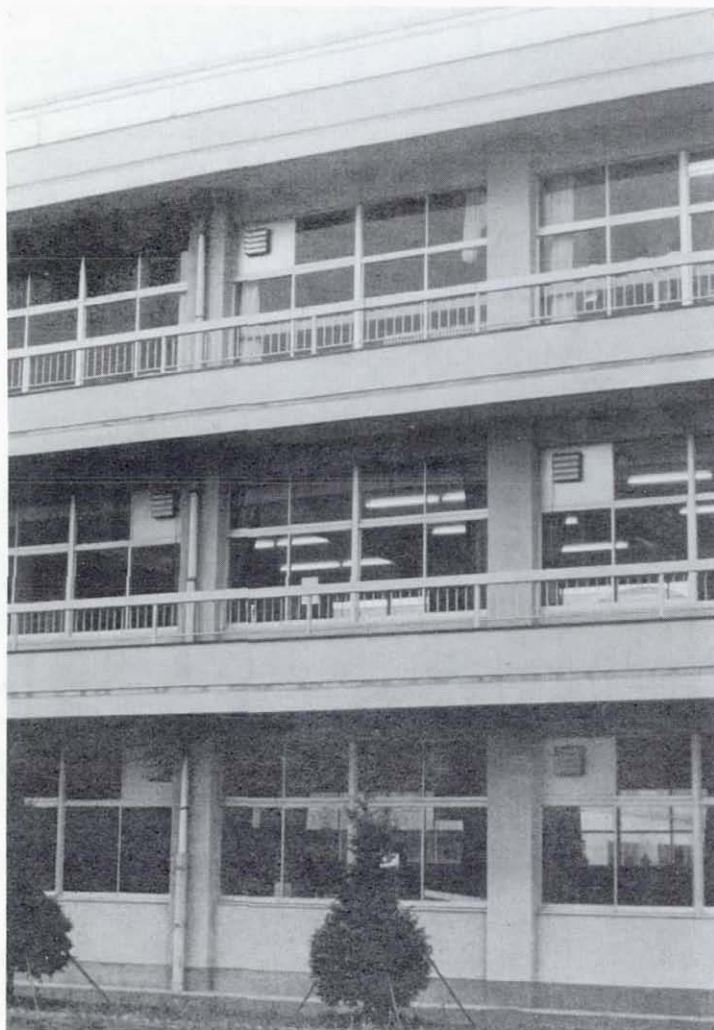
Figure 5.62 Izumi High School, typical classroom building, south face. This side of the building, which is relatively open, suffered little damage.

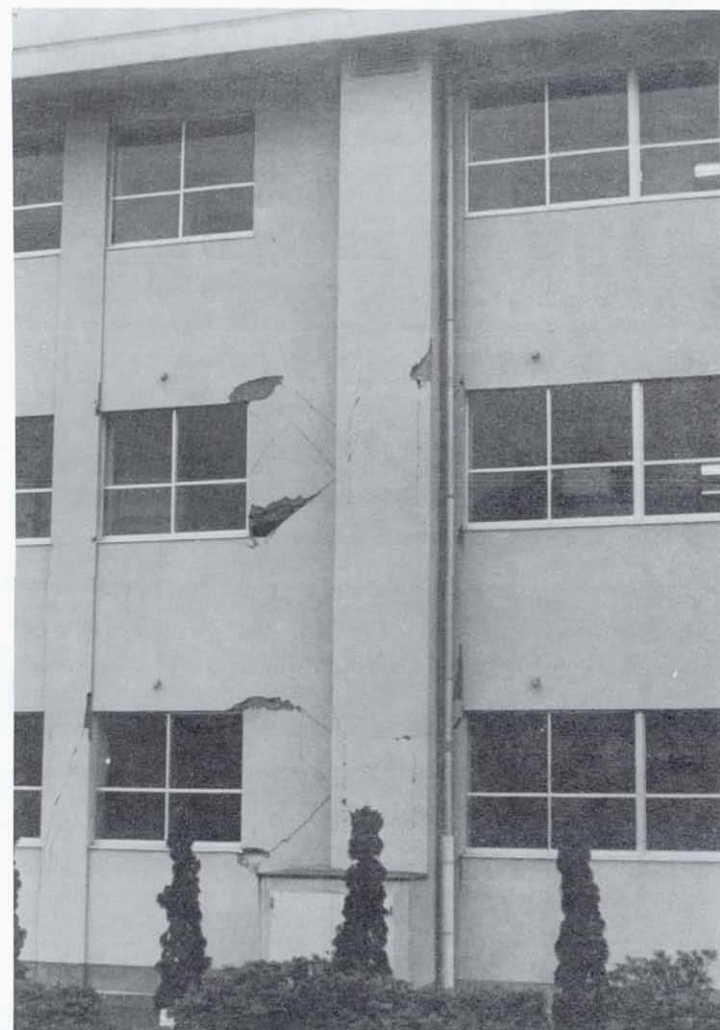
Figure 5.63 Izumi High School, typical classroom building, north face. All faces with the larger infill panels were similarly damaged.

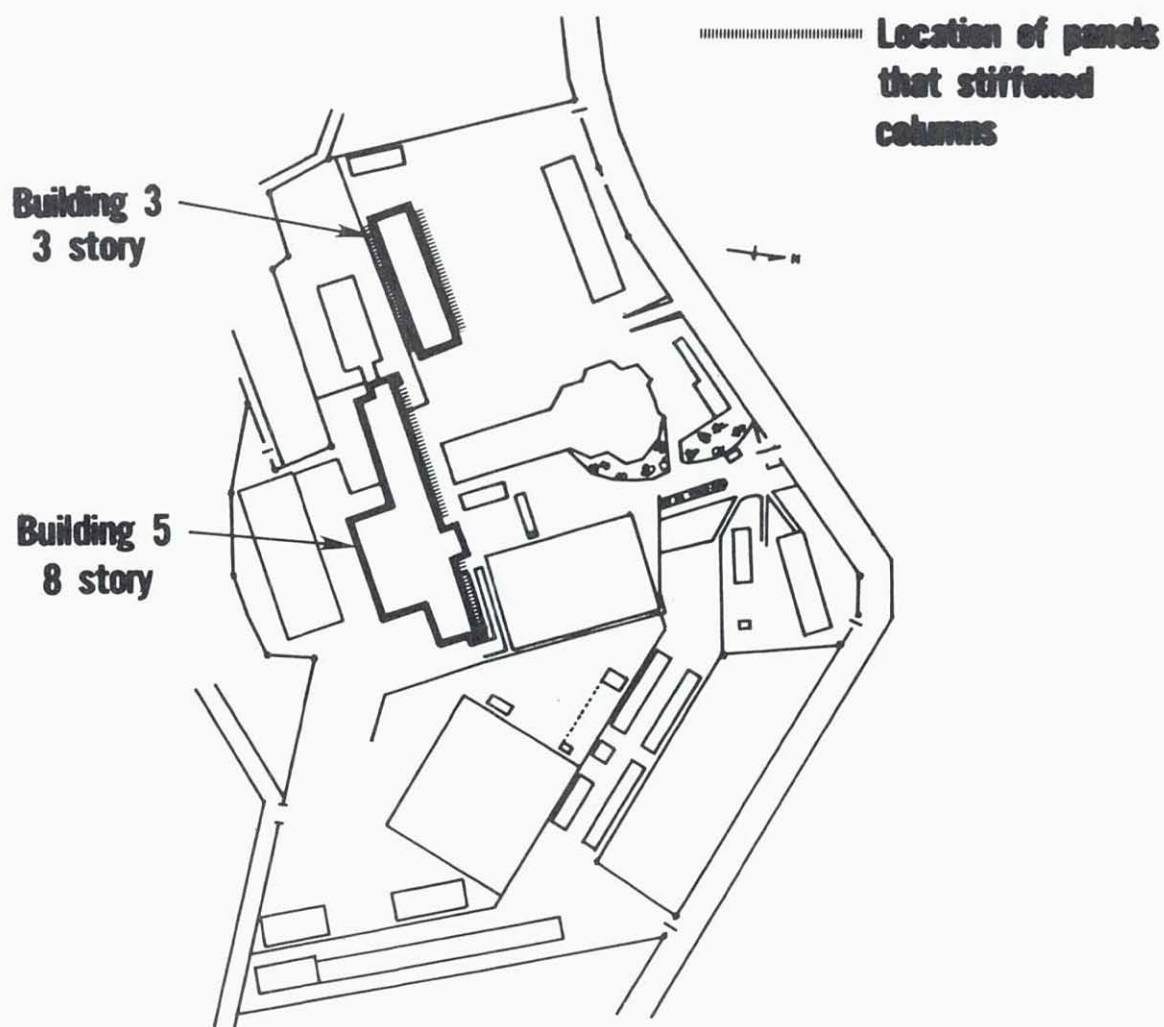
Figure 5.64 Tohoku Institute of Technology, Sendai, plan of campus. Hatching along walls of buildings 3 and 5 shows location of severely damaged columns.

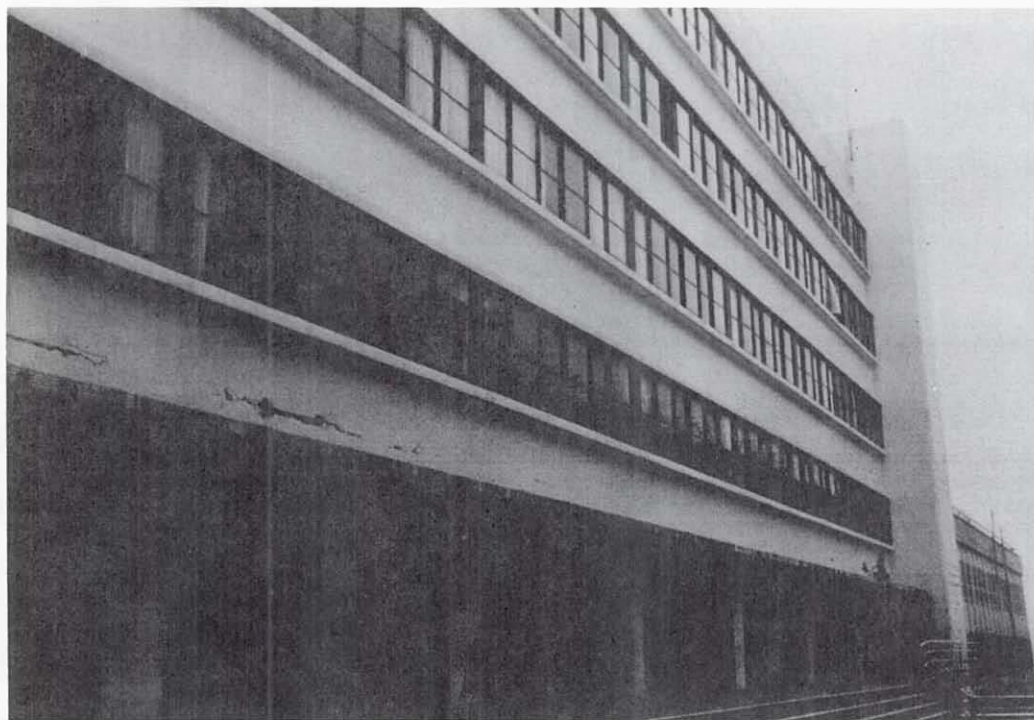
Figure 5.65 Tohoku Institute of Technology. Partial view of the entrance and north facade of building 5. Most serious damage to columns occurred on this side of the building.

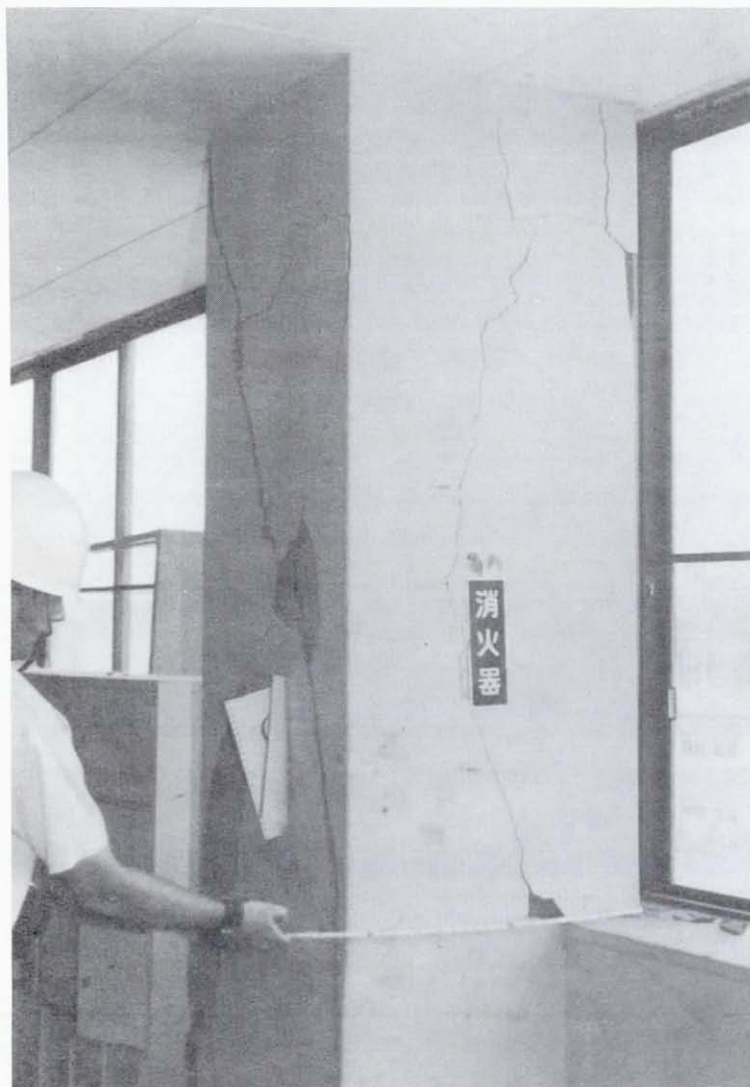
Figure 5.67 Tohoku Institute of Technology. Typical damage to seventh story column of the north facade of building 5.

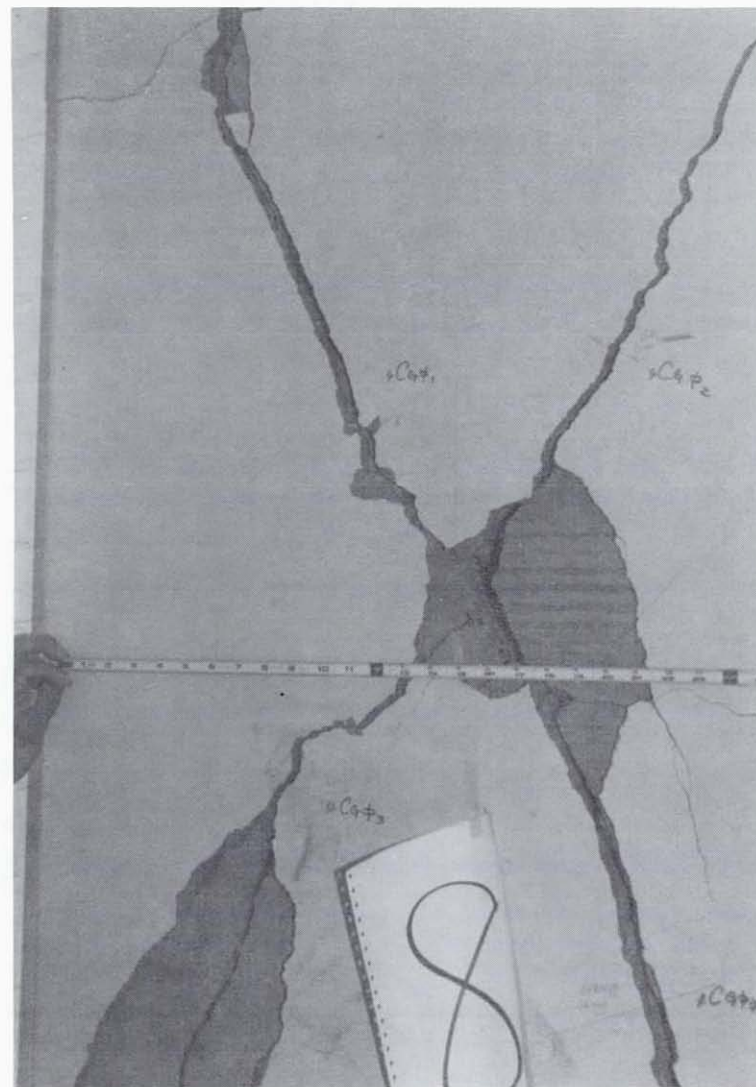
Figure 5.68 Tohoku Institute of Technology, Building 5. Detail of column damage.

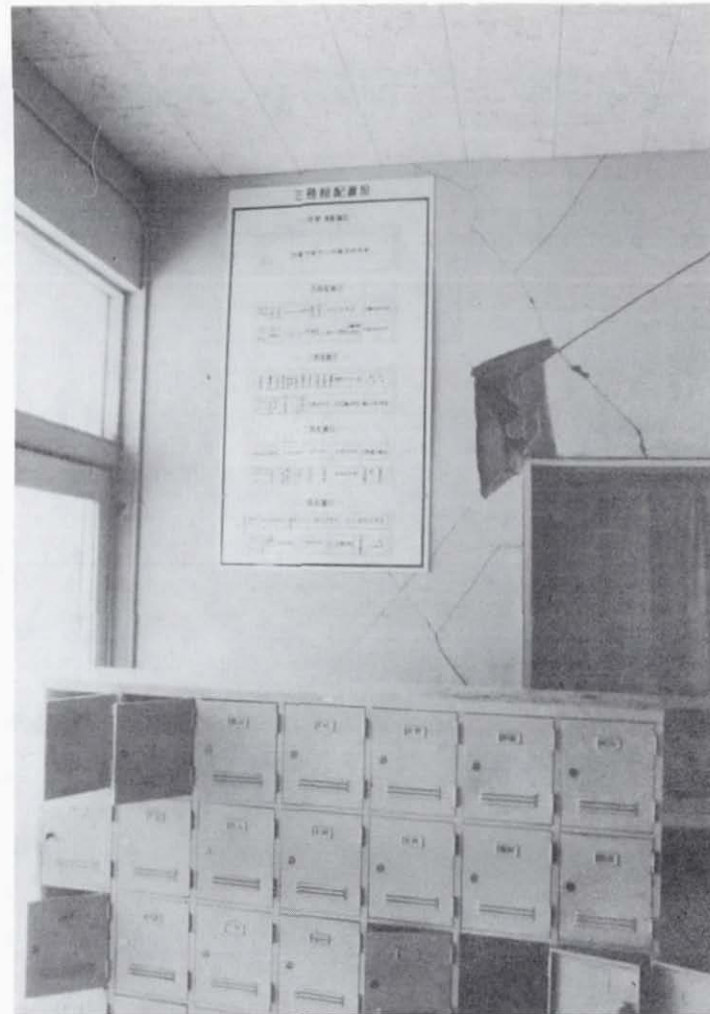
Figure 5.78 Tohoku Institute of Technology, Building 3. Interior surface of shear wall at east end of building.

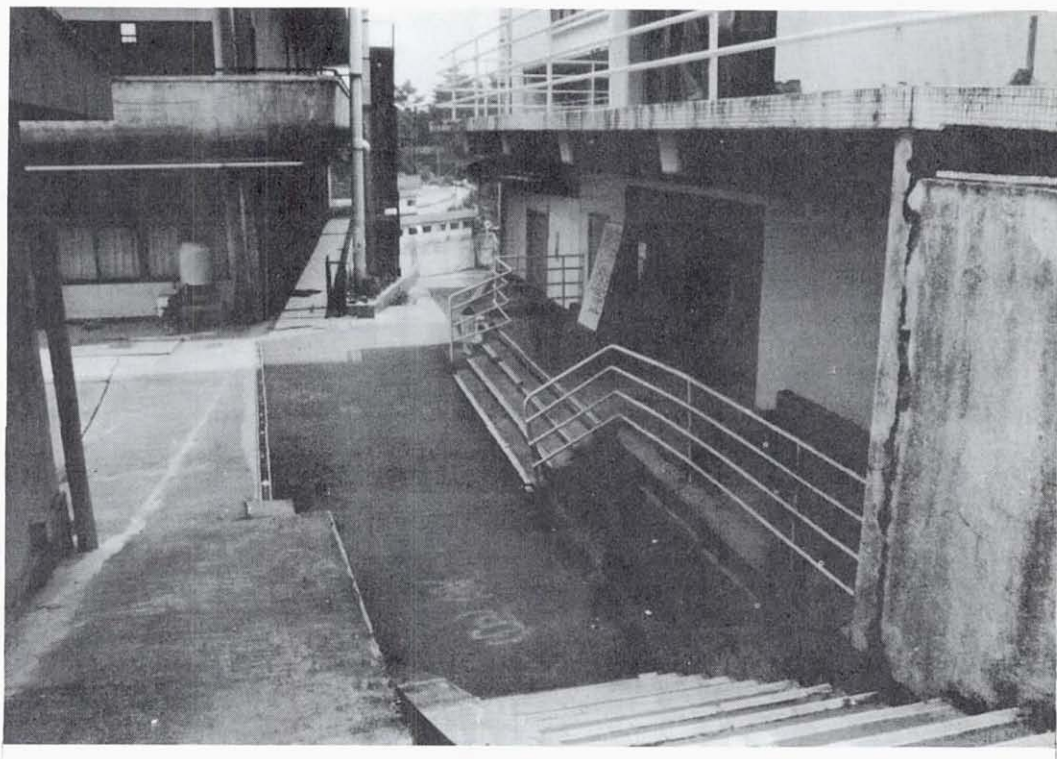
Figure 5.79 Tohoku Institute of Technology, walkway and north entrance of building 5 shows settlement of backfill along length of building.

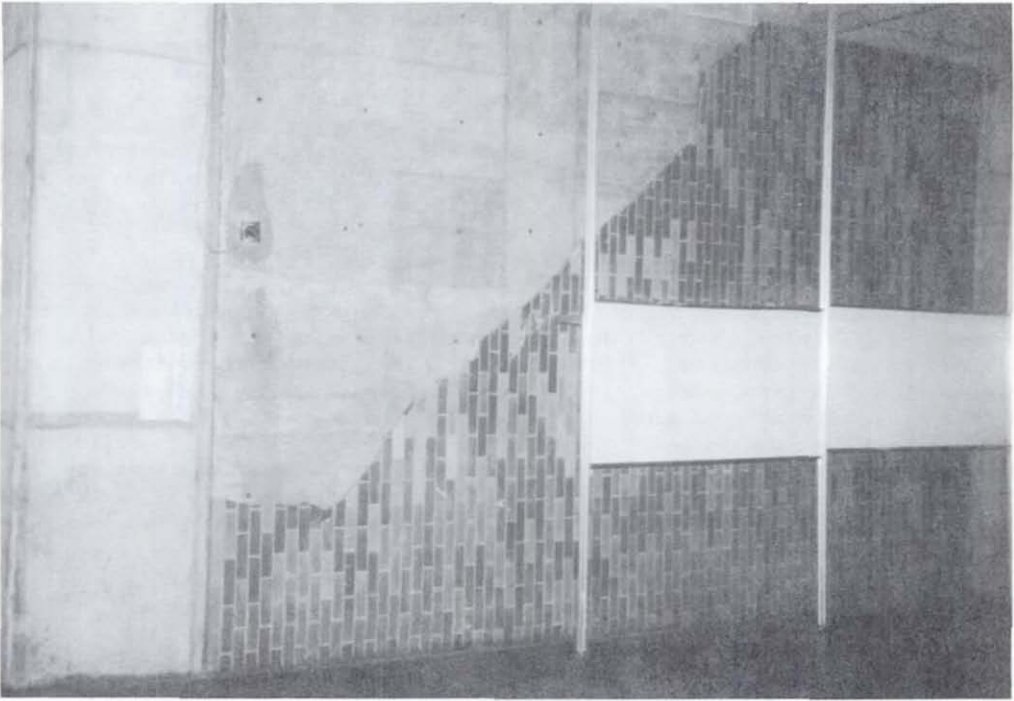
Figure 5.80 Tohoku University Engineering Building. Damage to glazed tile veneer of shear wall at ground level.

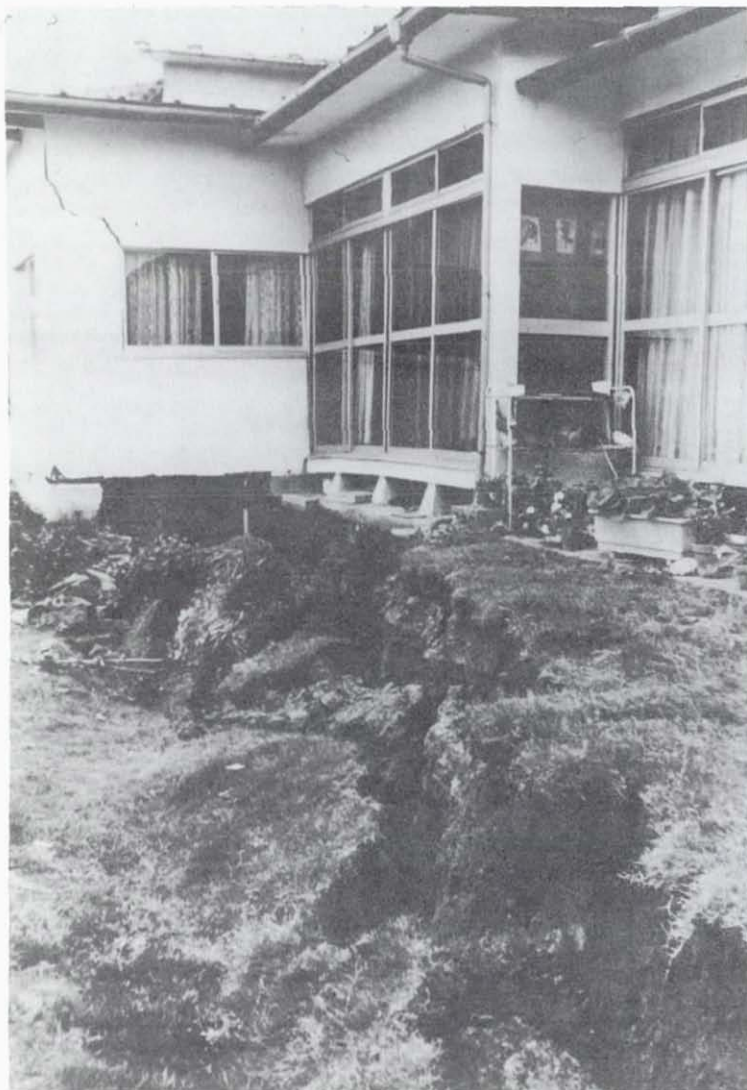
Figure 5.84 shows an example of the ground cracking resulting from subsidence in one of the hilly areas in Sendai. The loss of foundation support has caused extensive cracking in the building walls. In Figure 5.85, the front steps and breezeway have separated some 30 cm

Figure 5.84 Sendai. Damage to single family residence due to loss of foundation support. (Japan National Land Agency photograph)

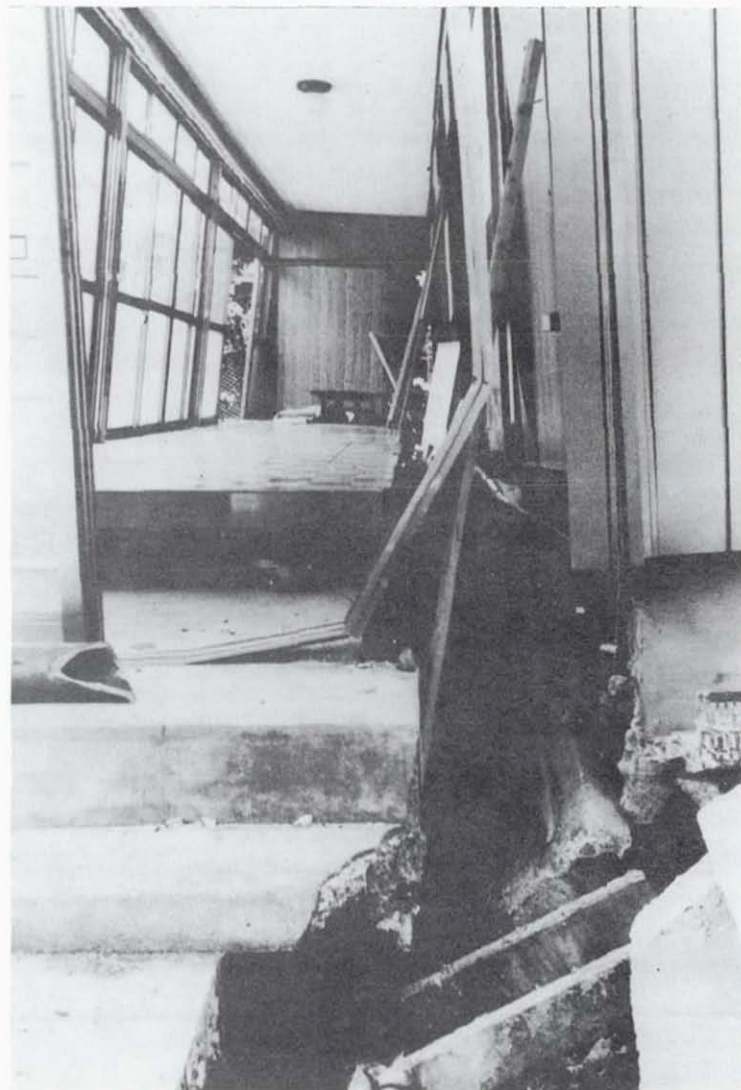
Figure 5.85 Sendai. Damage to single family residence due to ground settlement. (Japan National Land Agency photograph)

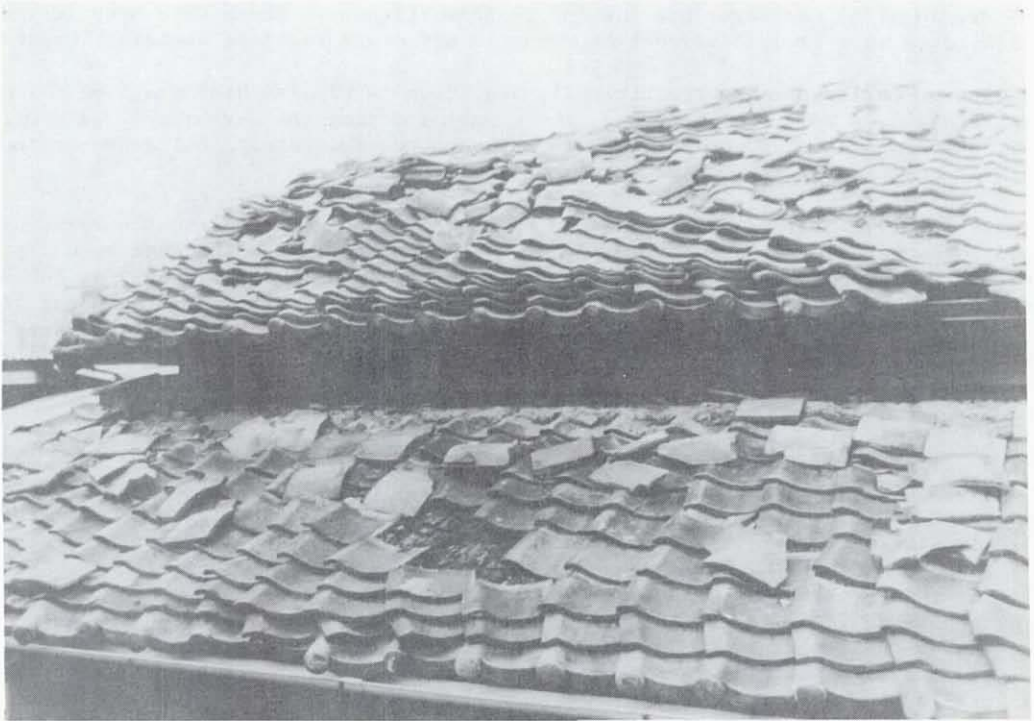
Figure 5.86 Typical damage to tile roofs in Sendai (Japan National Land Agency photograph)

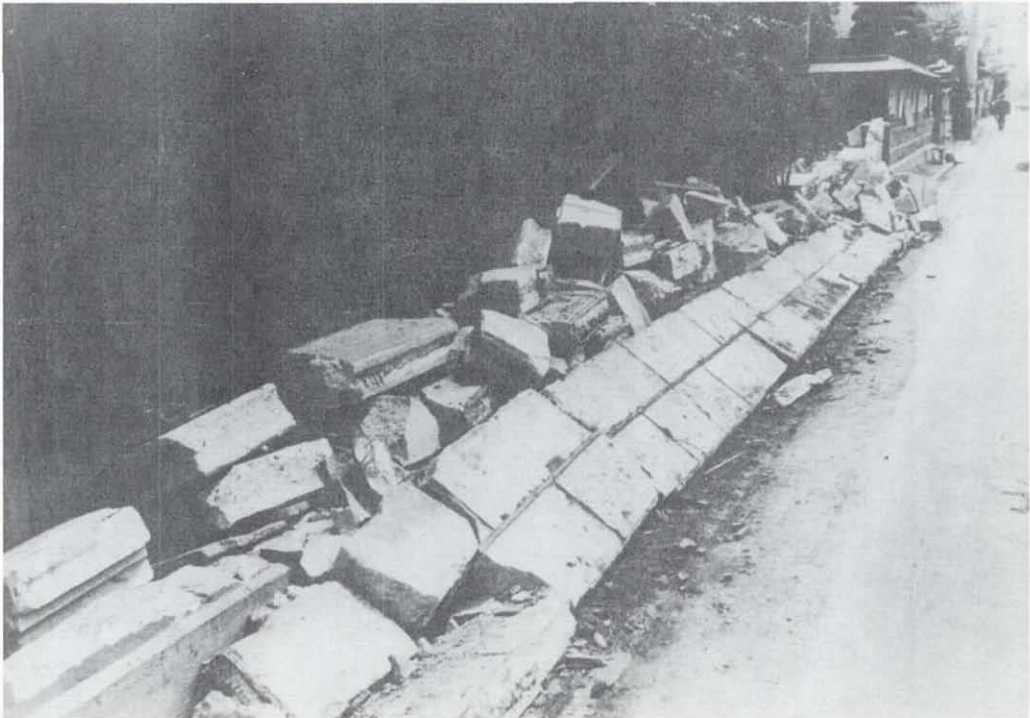
Figure 5.87 Failure of unreinforced concrete masonry wall in Sendai (Japan National Land Agency photograph)

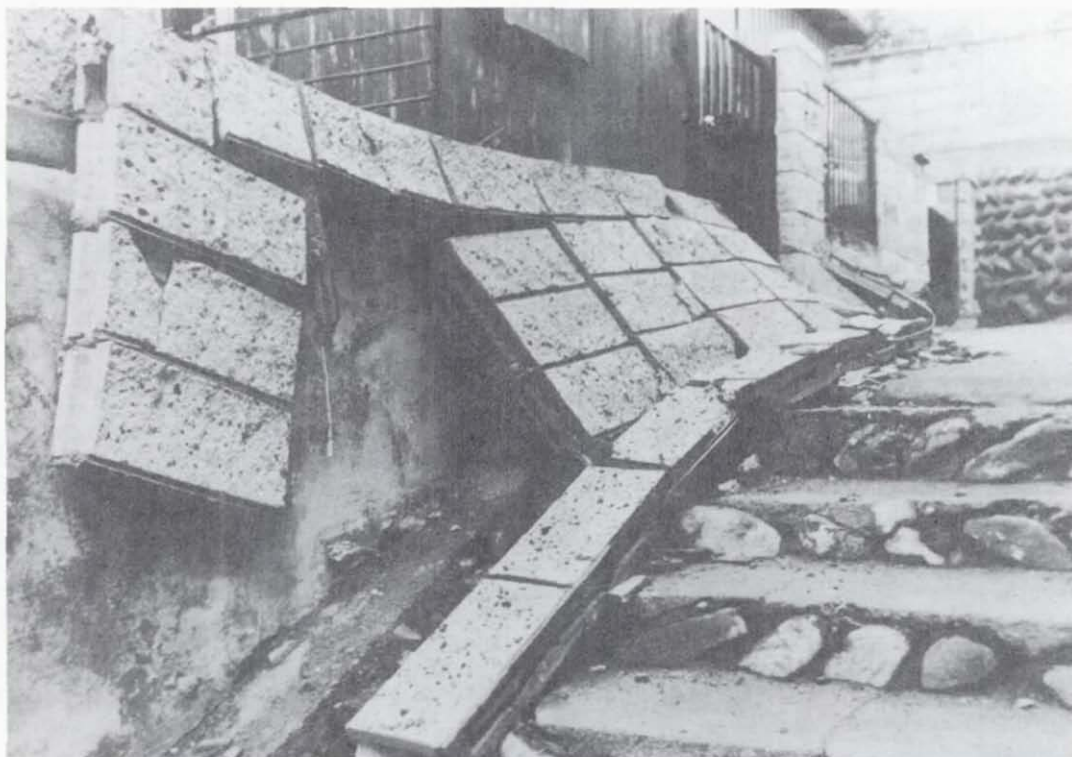
Figure 5.88 Failure of a reinforced concrete masonry privacy wall in Sendai.  
(Japan National Land Agency photograph)

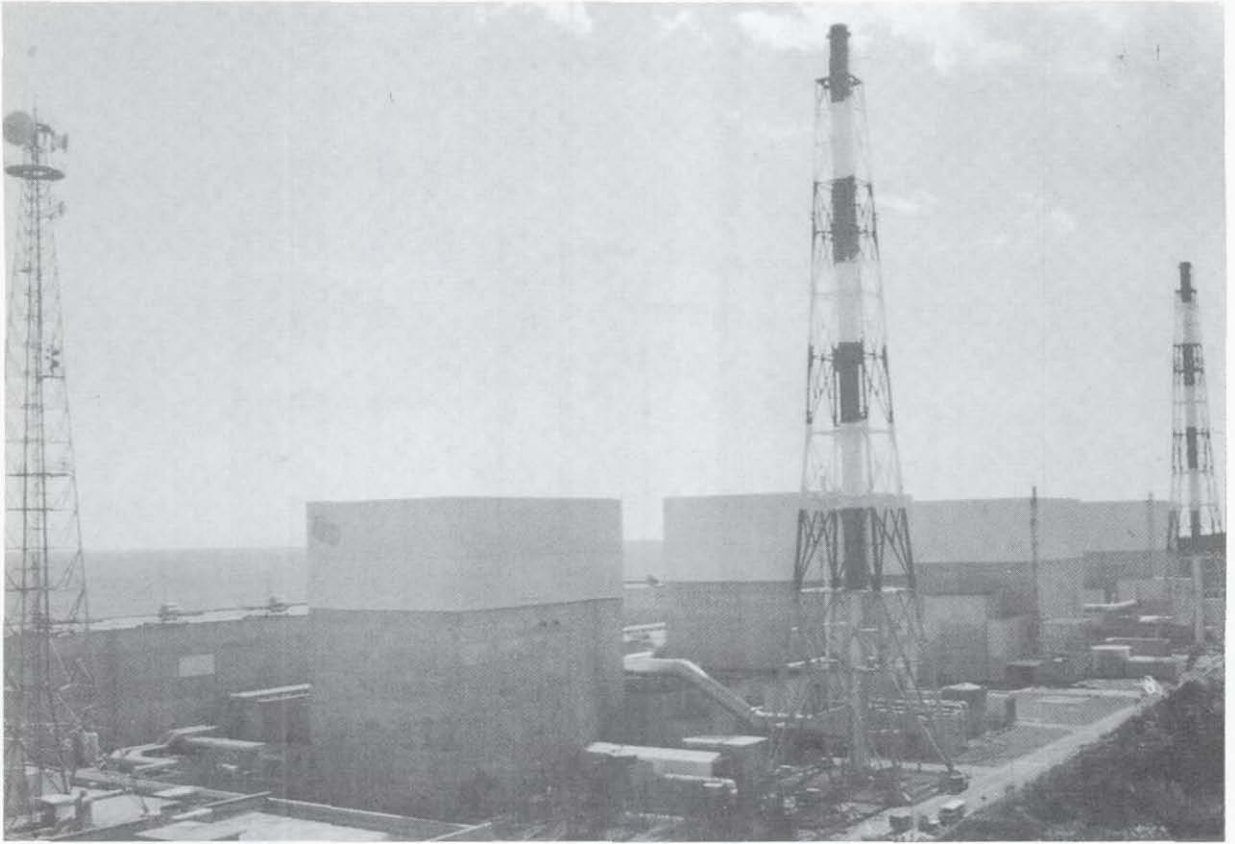
Figure 6.3 Fukushima Nuclear Power Plant: the containment structures of Units 1 through 4. None of these structures showed damage. (Tokyo Electric Co. photograph)
