NBS SPECIAL PUBLICATION **592**

An Investigation of the Miyagi-ken-oki, Japan, Earthquake of June 12, 1978

This document is the result of the investigation by the U.S. team on the earthquake. It describes geologic features of the earthquake-stricken area, and damage to human-made structures. It is hoped the information presented in this document will add to the knowledge of seismology and earthquake engineering.

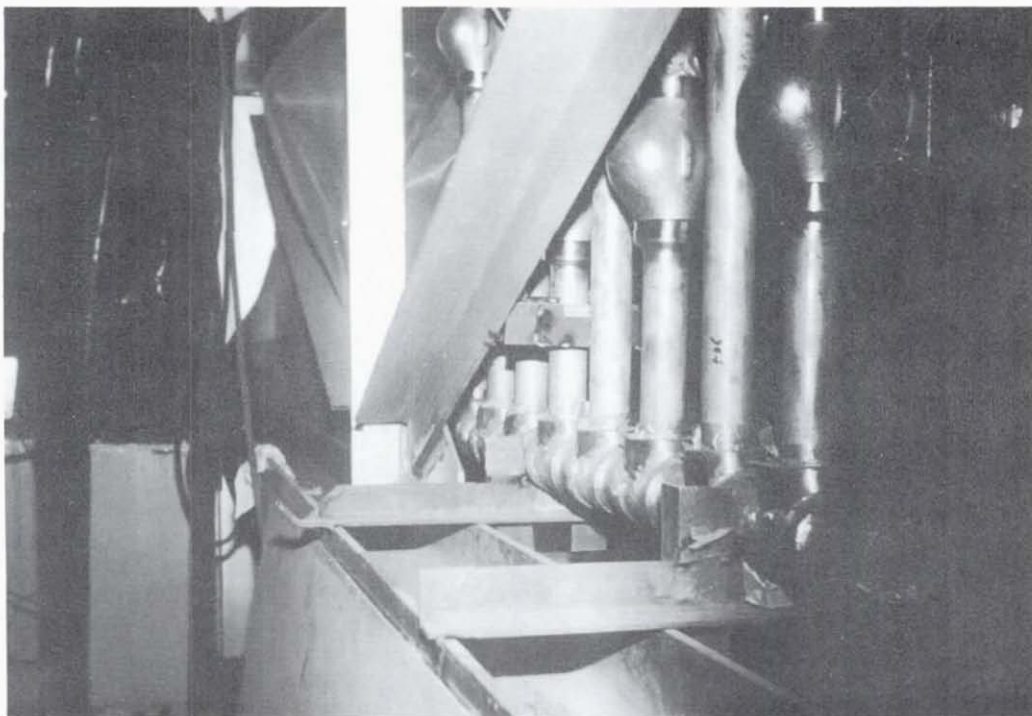
Figure 6.7 Fukushima Nuclear Power Plant: a partial view of the Unit 6 control rod drive and its supports. The unit is still under construction and was more than 95% completed at the time of the reconnaissance. There was no apparent damage or any evidence of working connections at this system or at the other systems of Unit 6 that were examined.

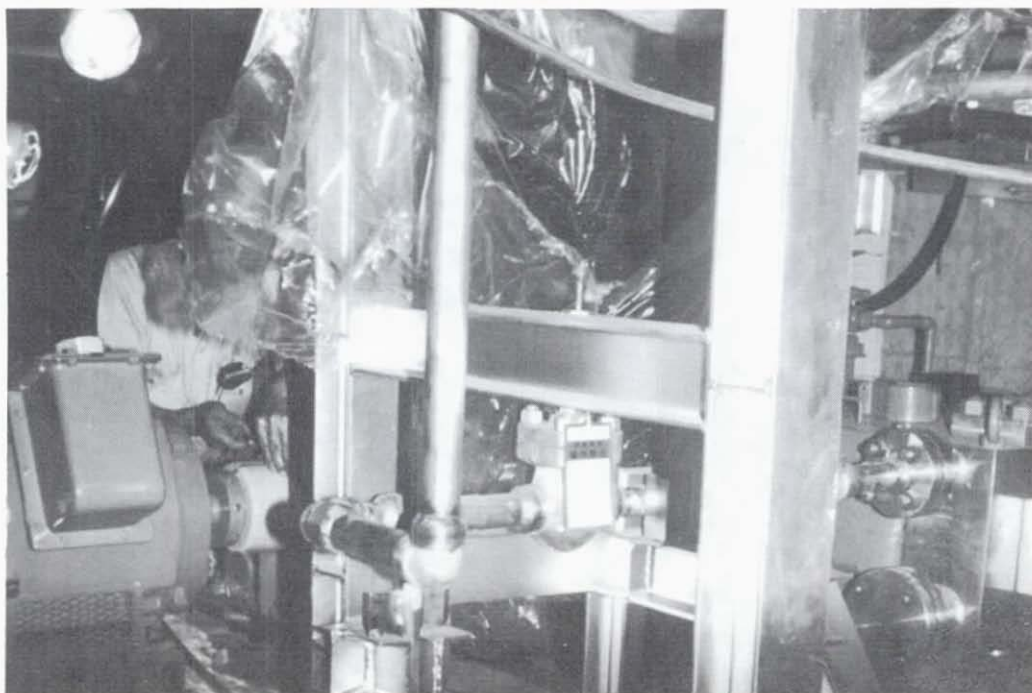
Figure 6.8 Fukushima Nuclear Power Plant: a typical view of massive seismic and/or pipe whip braking of critical piping inside the reactor building of Unit 6. The equipment showed no evidence of damage. This unit is still under construction.

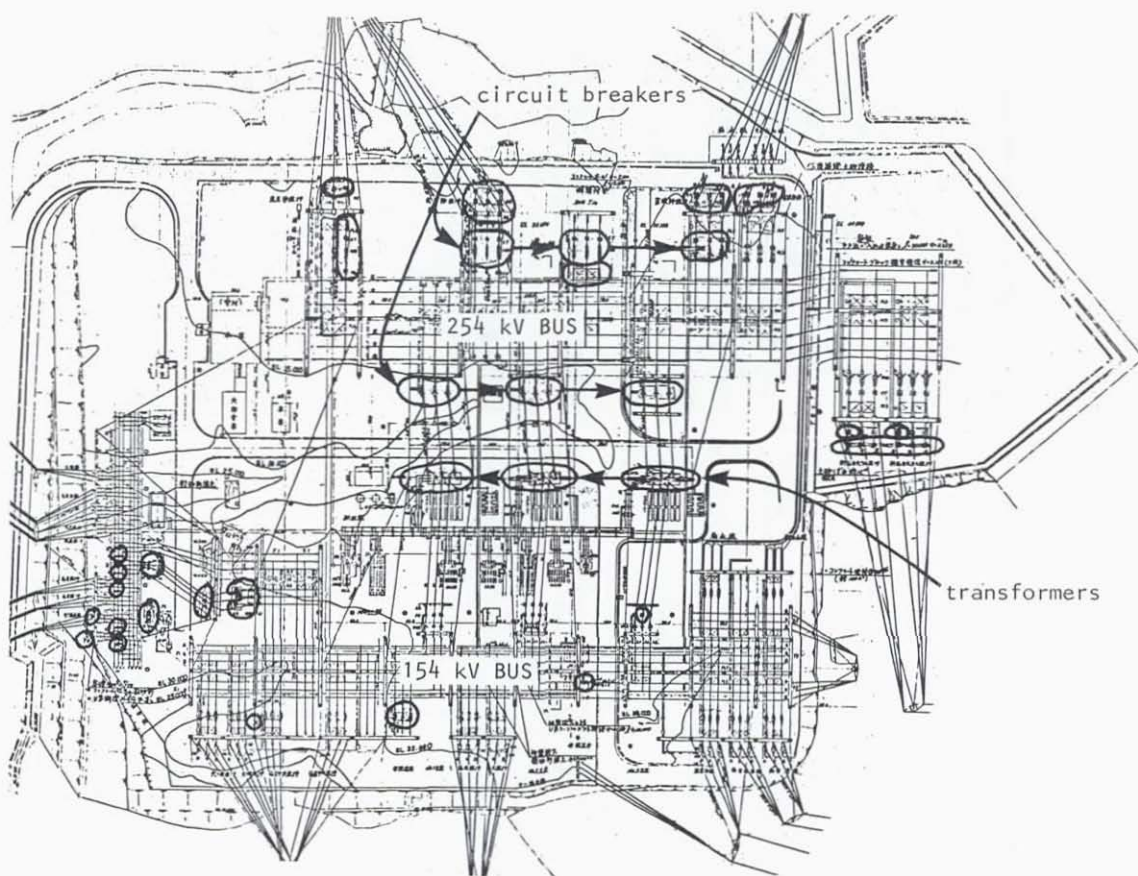
Figure 6.20 Sendai Substation, Izumi: plan of the facility showing the location of damaged equipment (circled). The solid contour lines indicate areas that were filled.

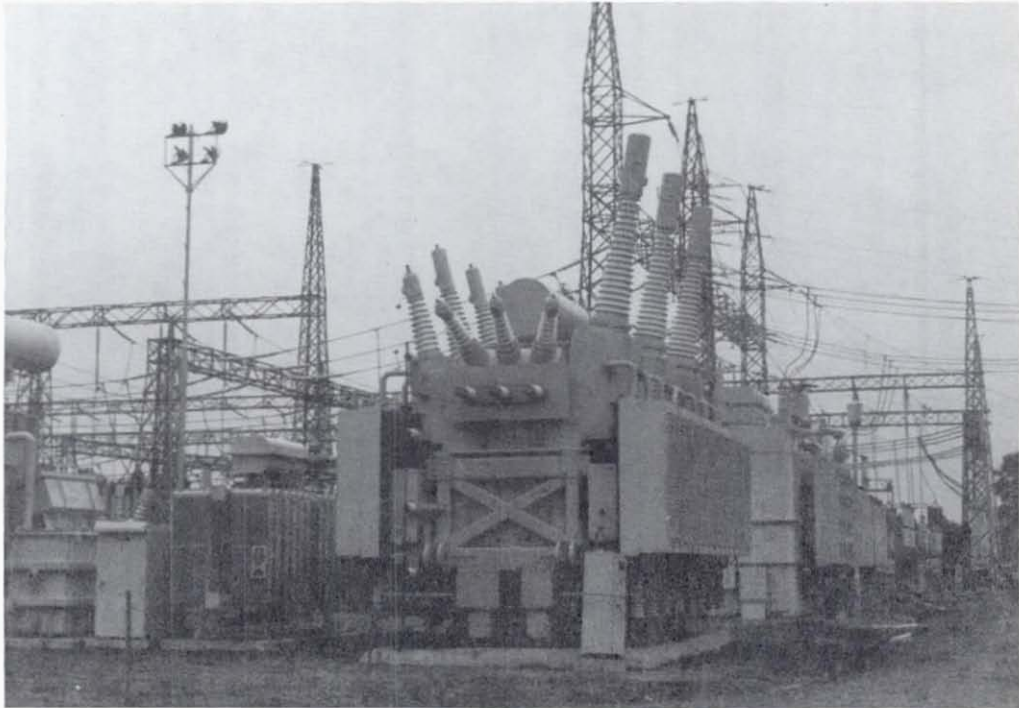
Figure 6.29 Sendai Substation, Izumi; a repaired but still disconnected transformer. All of the transformers at the substation lost some bushings or lightening arrestors. Some damaged parts were being replaced at the time of the investigation.

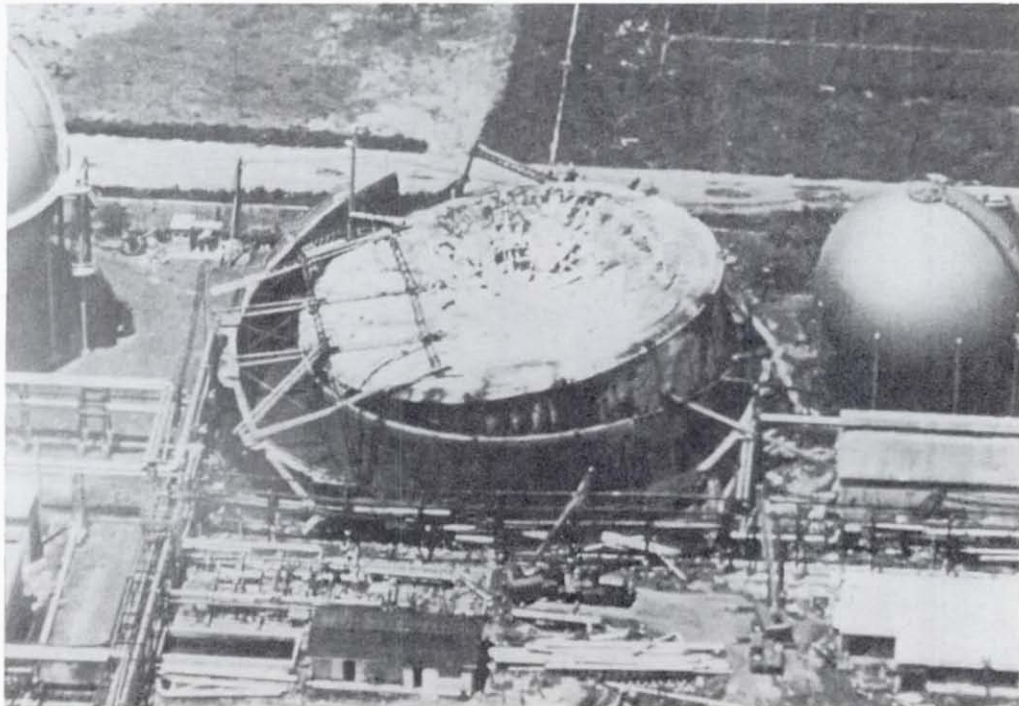
Figure 6.30 Haranomachi Plant, Sendai City Gas Bureau: an overall view of a collapsed propane gas holder and some of the surrounding propane storage tanks and affected pipeway and equipment. (Kahoku Newspaper Co. photograph)

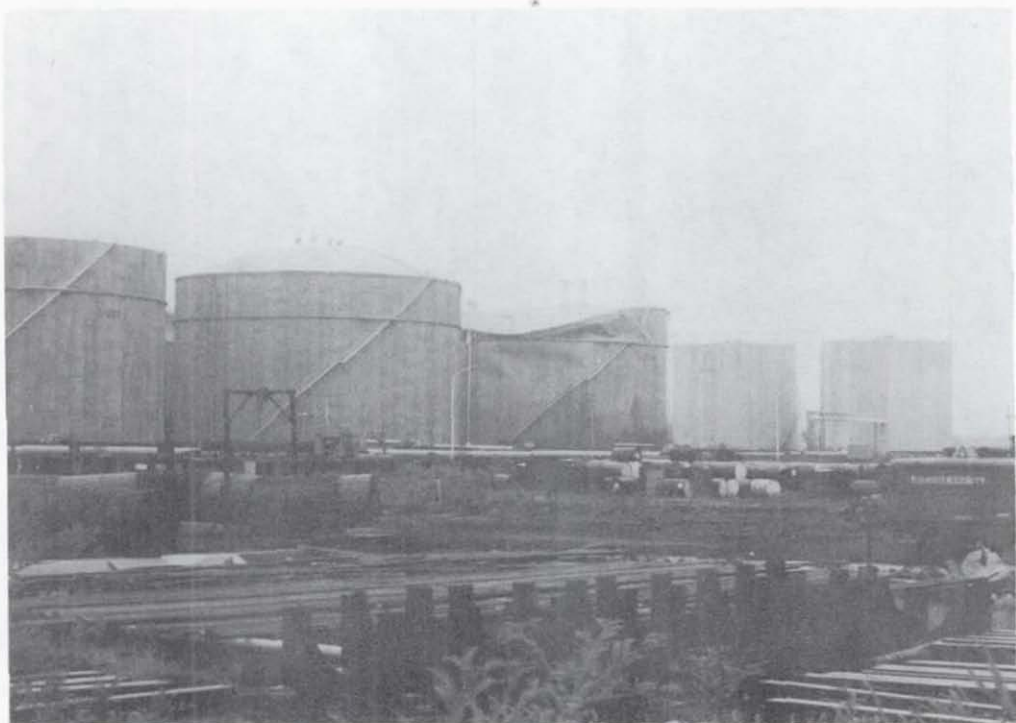
Figure 6.43 Sendai Refinery, Tohoku Oil Company, Ltd. Two other failed TC oil storage tanks.

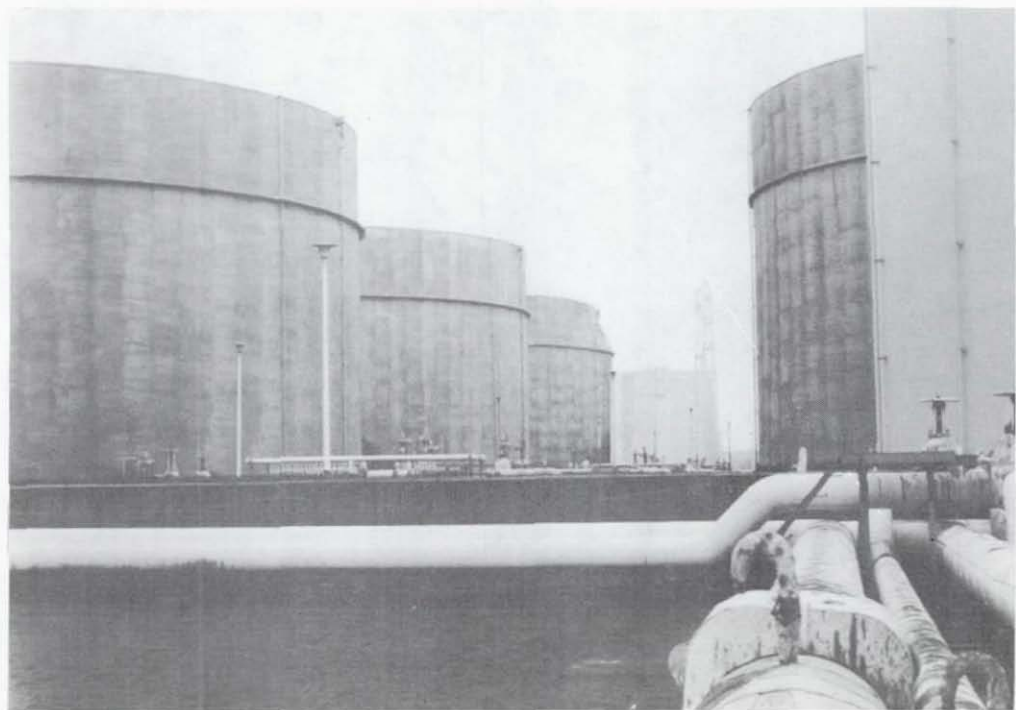
Figure 6.44 Sendai Refinery, Tohoku Oil Company, Ltd. TC oil storage tanks.

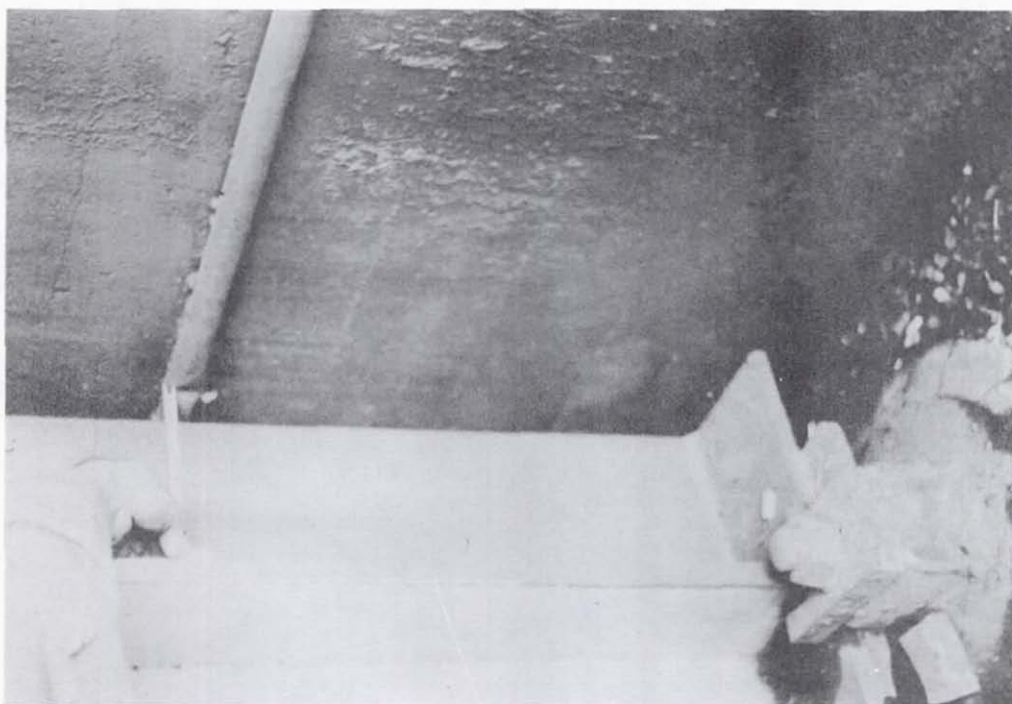
Figure 7.27 Sendai Ohashi Bridge. Abutment damage. Bearing plate broken and evidence of girder impact at abutment.

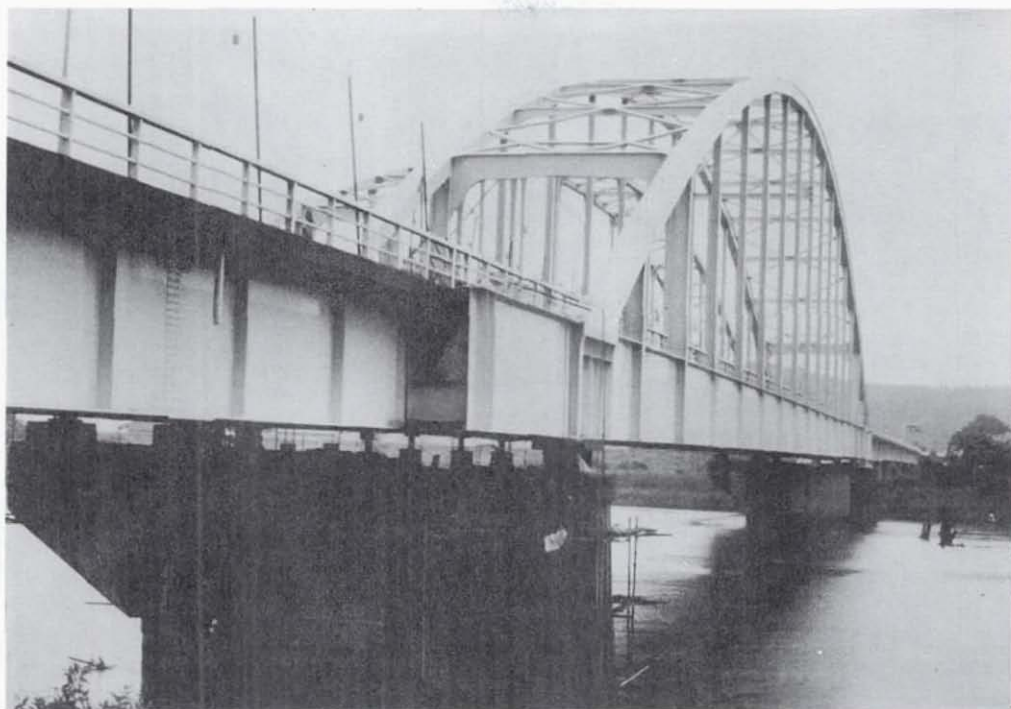
Figure 7.33 The main tied arch span of the Tenno Bridge with the cracked wall pier in the foreground. Note the smaller, pedestrian bridge in the background.

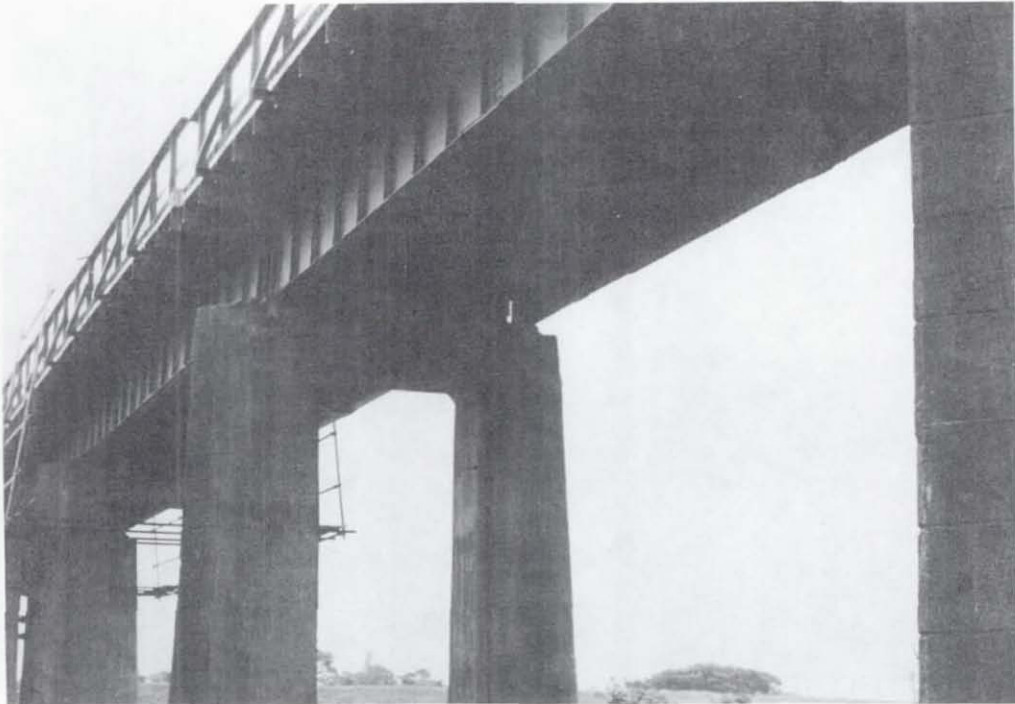
Figure 7.37 Spalled concrete at bent cap of Kimazuka Bridge.

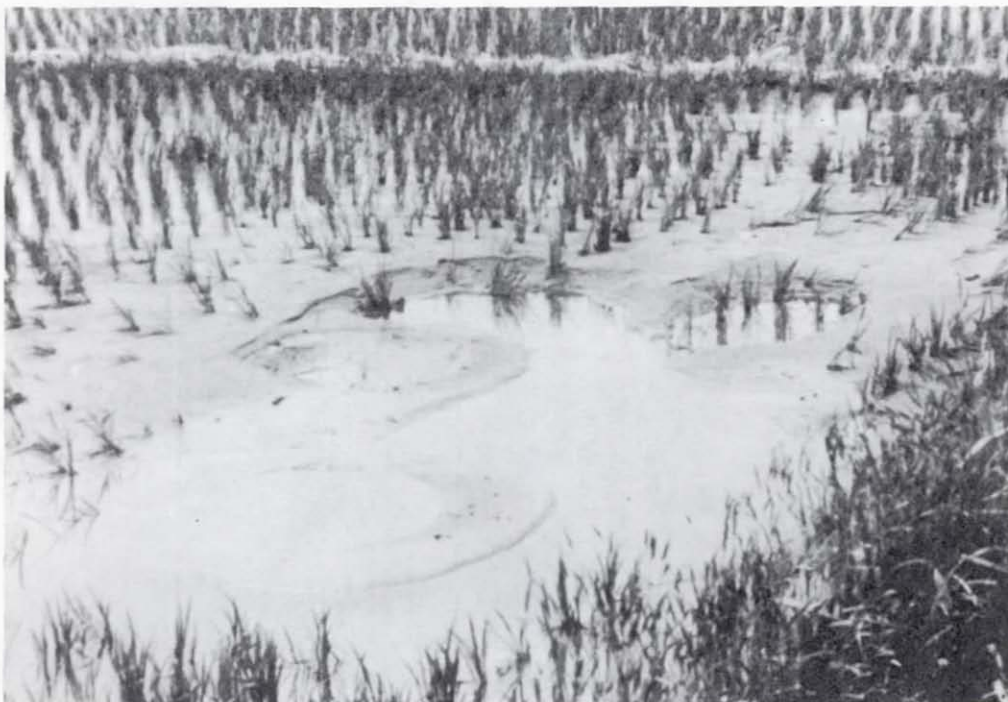
Figure 8.16 Site 5, Old Kitakami River ~ Sand boils in rice field. Plants are several centimeters tall. Damage to the dike at this site was minor. (Photo courtesy K. Kawashima, PWRI)

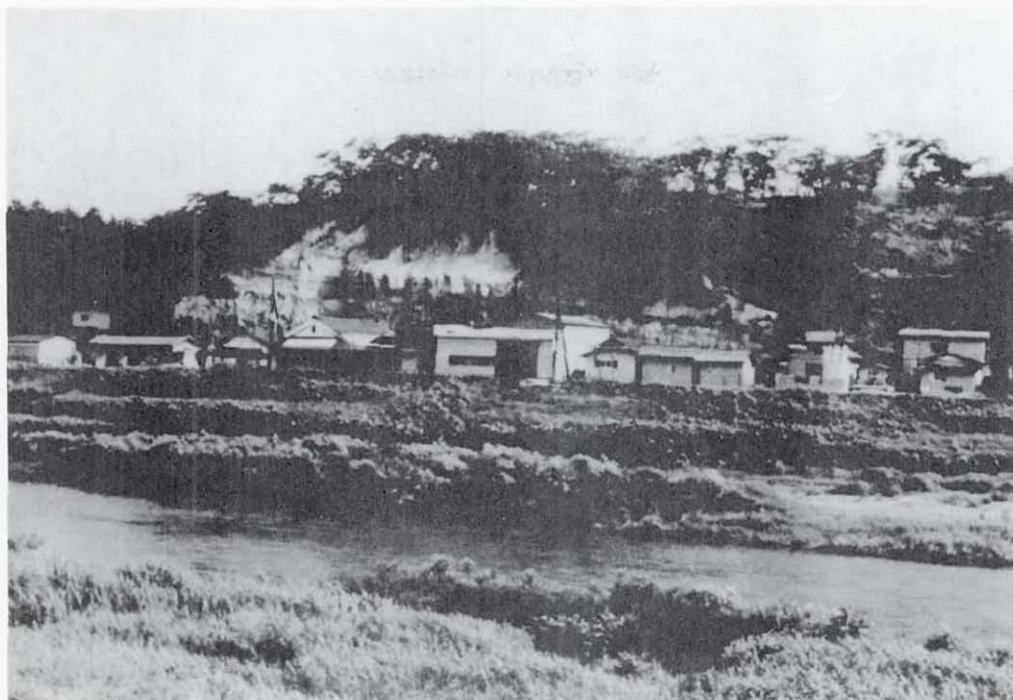
Figure 9.12 Steep slope near Hebinumayama in heavily fractured tuff which underwent failure as rock falls damaging portions of houses in front of the slope.

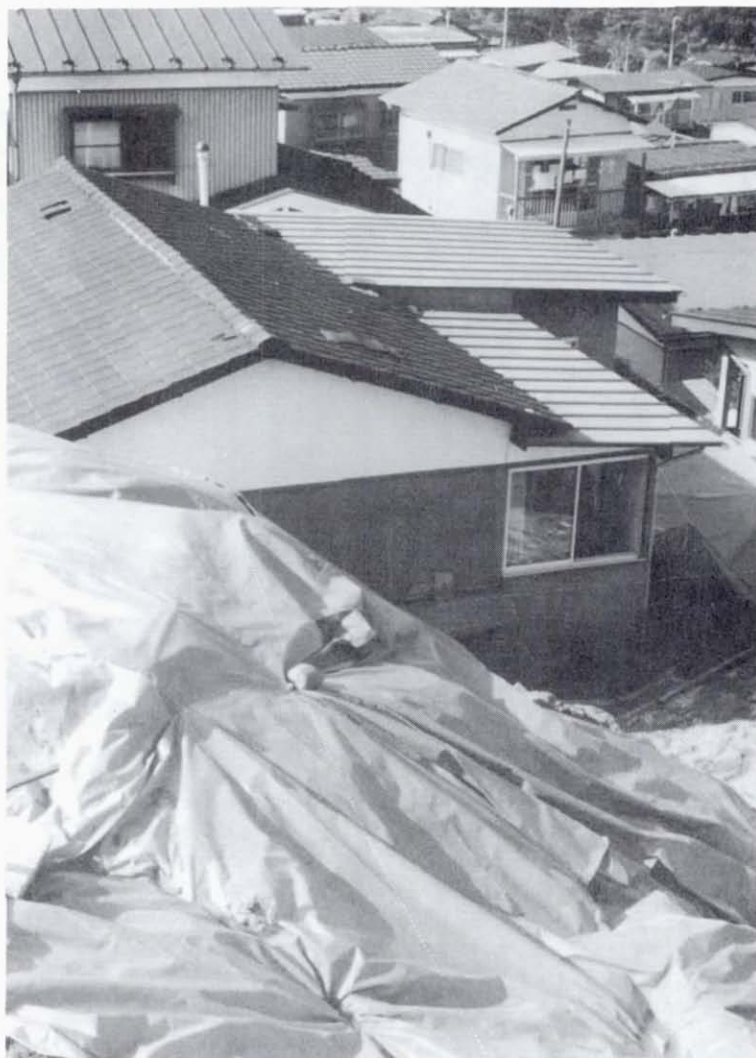
Figure 9.19 Toe of slump and house below in danger of being overridden by slide mass. House has been evacuated.
