NIST NCSTAR 1-1C (Draft)

**Federal Building and Fire Safety Investigation of the
World Trade Center Disaster**

Maintenance and Modifications to Structural Systems (Draft)

September 2005

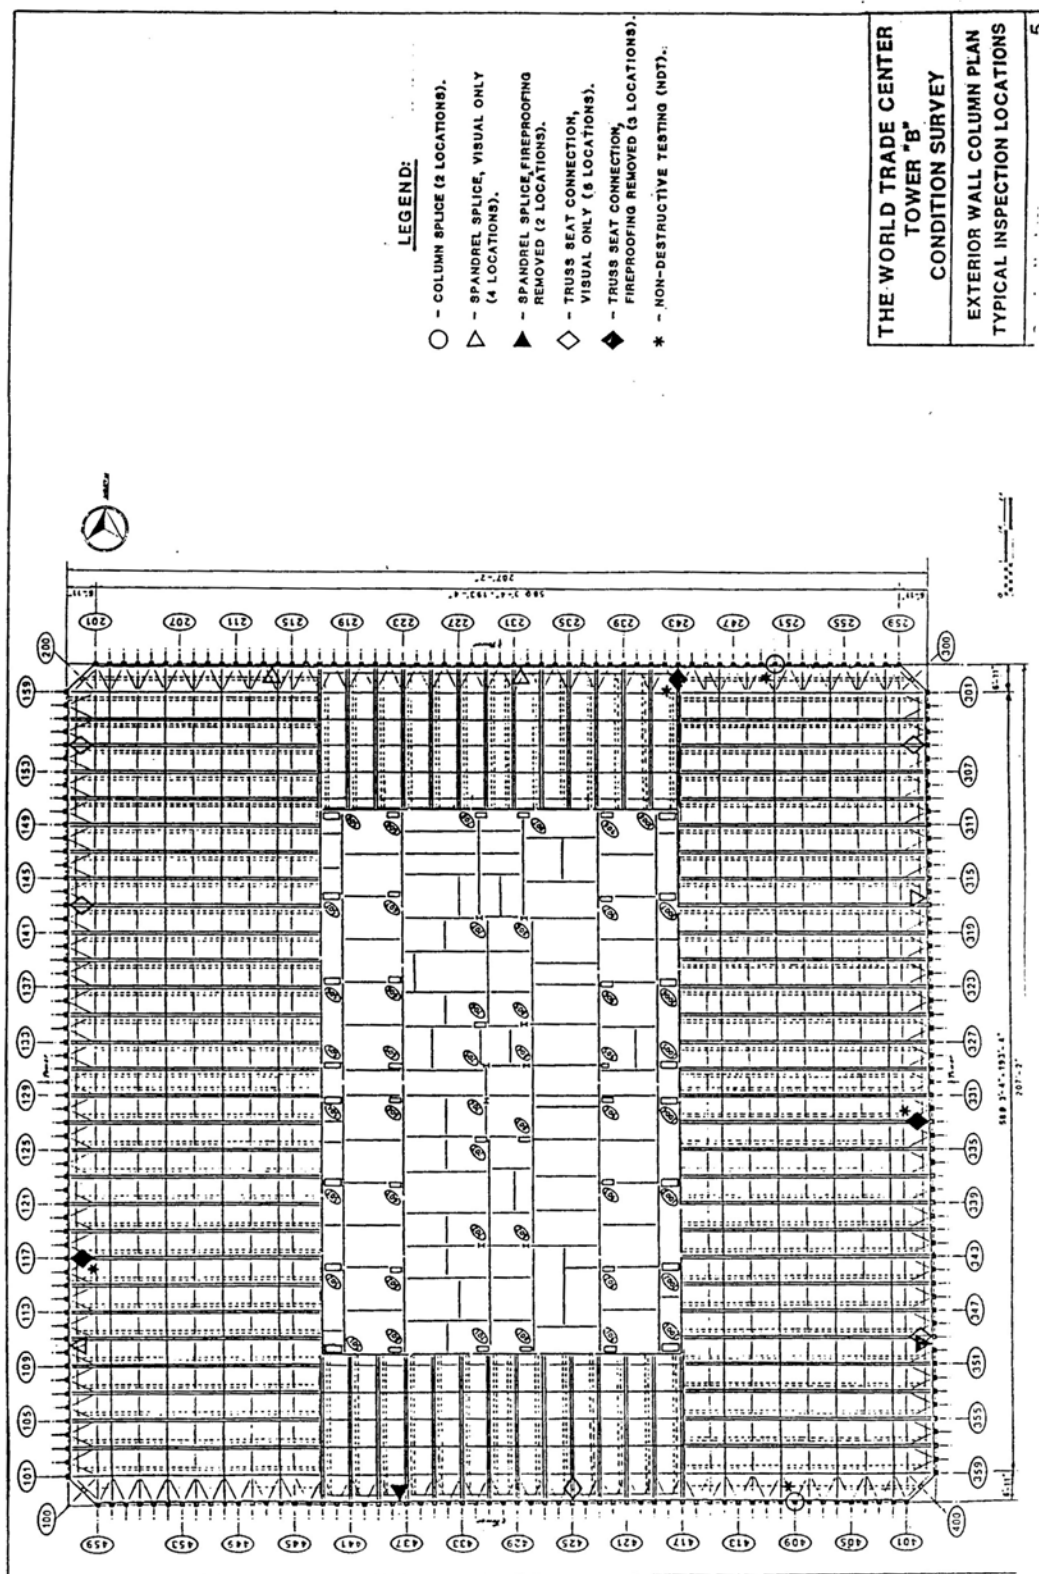
Figure 3-1. Typical inspection locations of exterior wall per 1990 Condition Survey Report of WTC 2.

Inspection of the exterior walls was made from inside the building. Inspection locations are indicated in Fig. 3–1, which is Drawing 5 from the report (PANYNJ 1990).

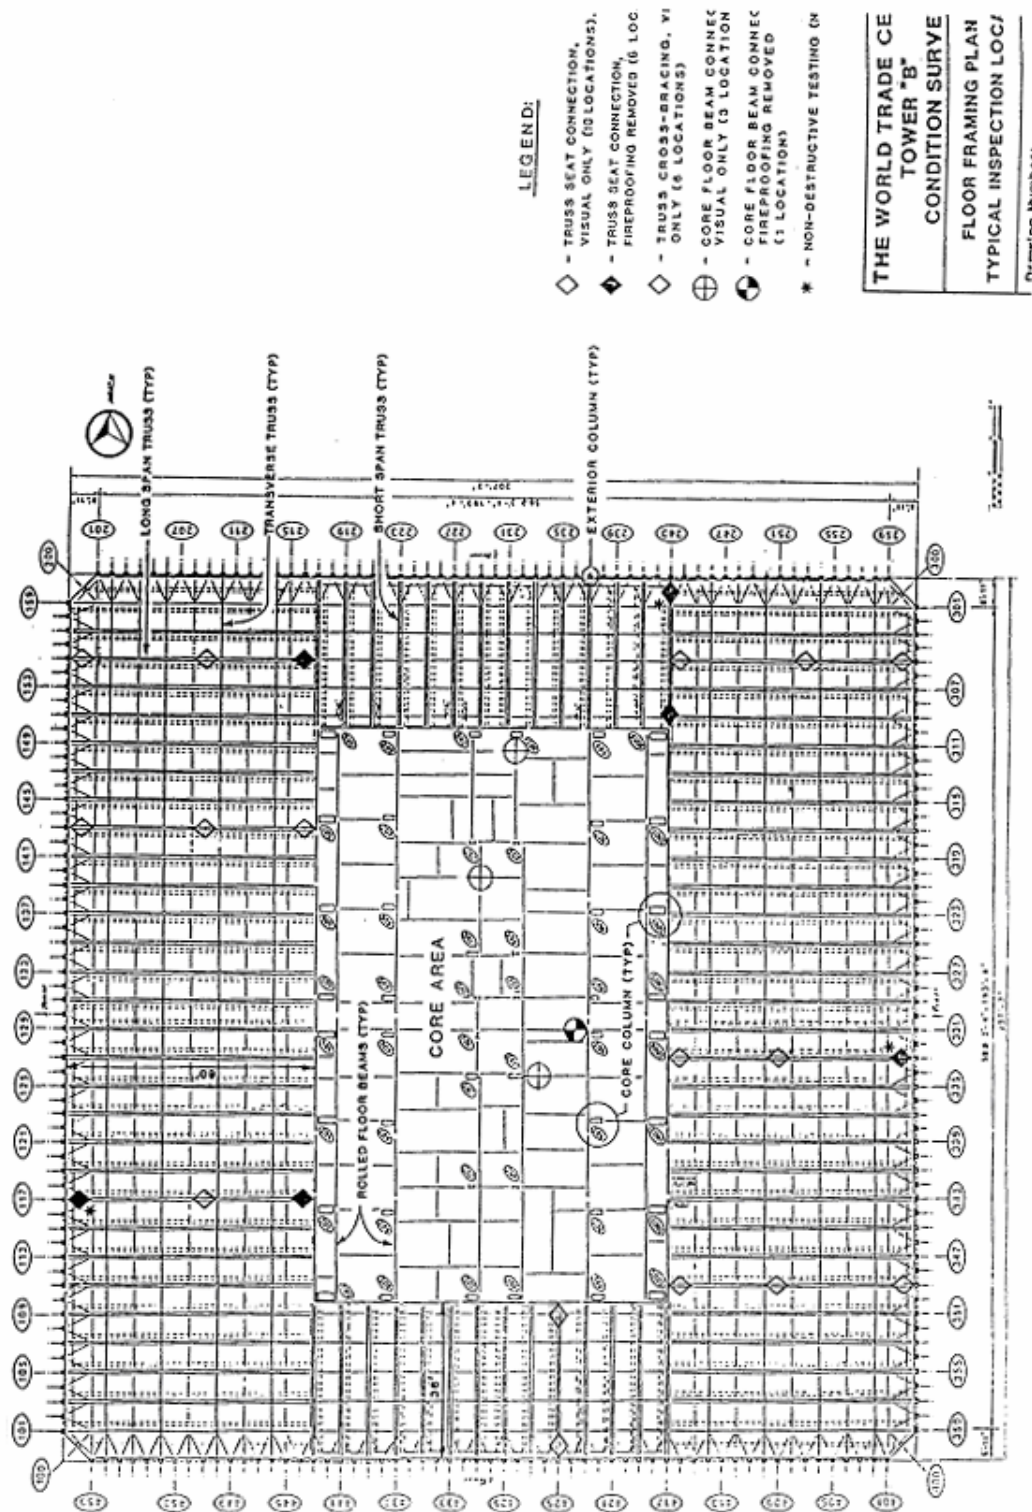
Figure 3-3. Typical inspection locations of floor framing per the 1990 Condition Survey Report of WTC 2.

Floors 9 through 41—Floor framing inspected in this zone was found to be in good condition. Light corrosion was observed on all core beams and beam connections, and on main truss connections on floors 28 and 37.

According to the report, the most significant deficiencies in this zone were found at the damping units (see Table C-1 in the survey report). Damping units on floors 18 and 37 were observed to be missing one fastener at each unit. Two fasteners were found to be missing in one damping unit on floor 29, as well as on floor 38. Also, at floor 38, a damping unit was observed to be missing four fasteners. According to the structural drawings (WSHJ 1967a), four fasteners were required to connect the damping unit to the member attached to the bottom chord of the floor truss, and two fasteners were required to connect the damping unit to the exterior column.

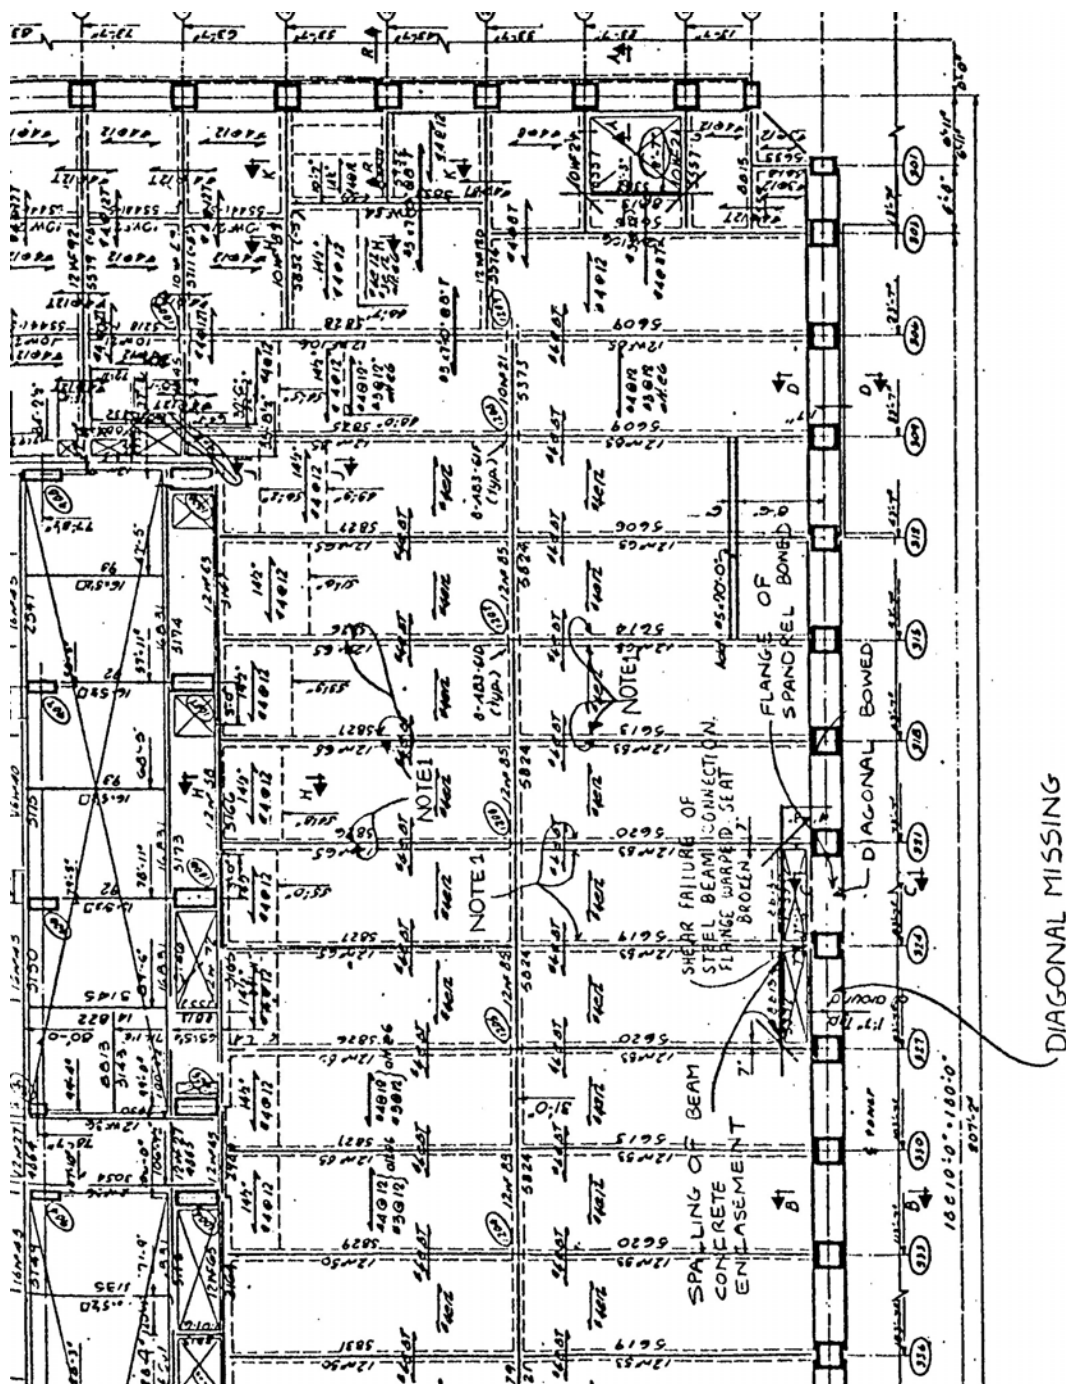
Figure 4-1. Damage assessment for WTC 1 at Level B1.

NOTE1 → SEPARATION OF SLAB FROM BEAM
CONCRETE ENCASEMENT

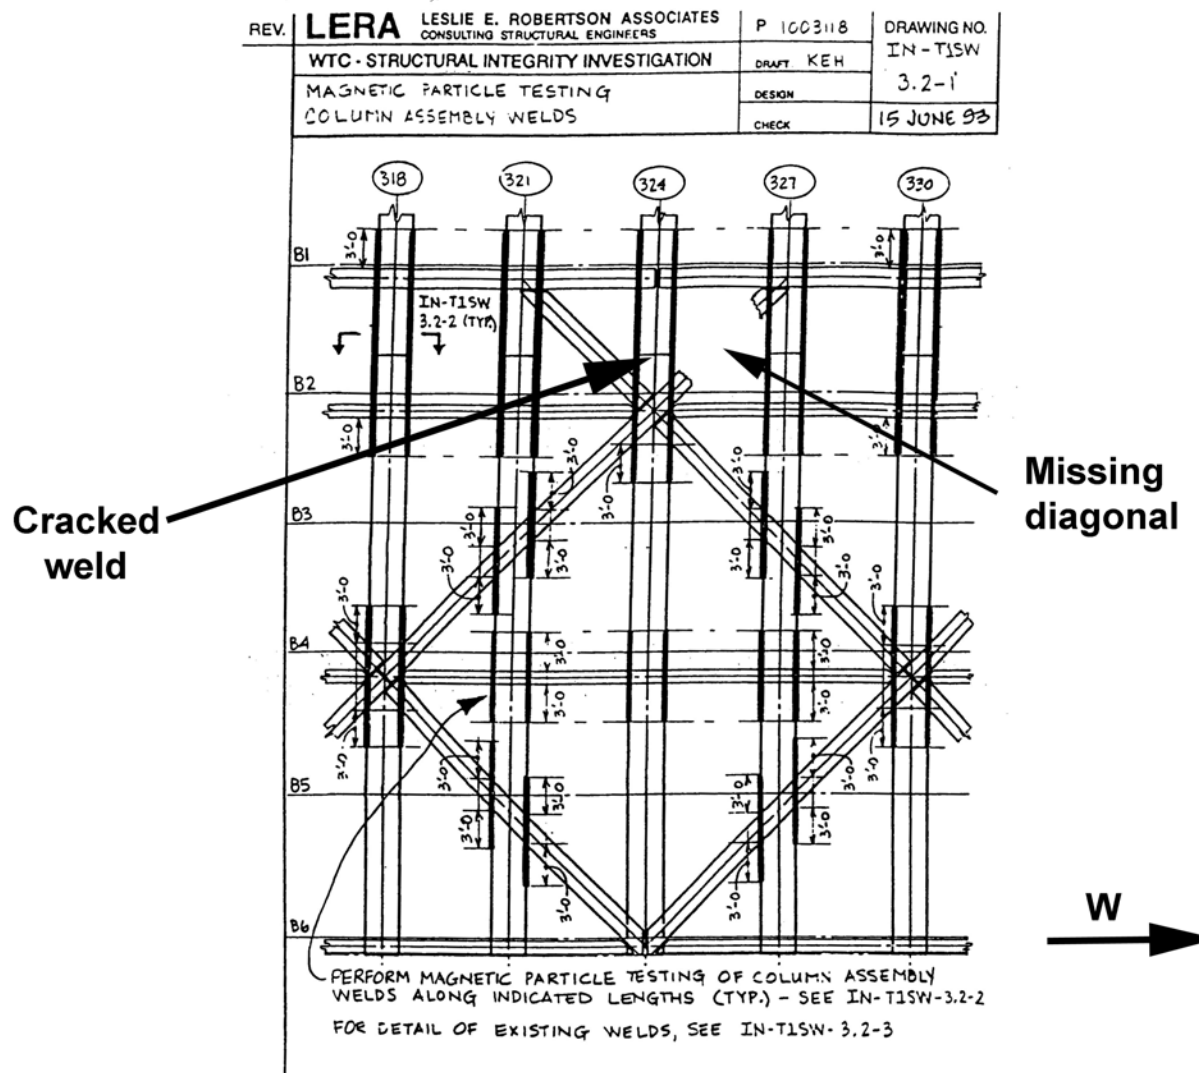
Figure 4-3. Bracing on south face of WTC 1 damaged by blast.
