Appendix A

EXAMPLES OF PERIMETER PANEL FLOOR TRUSS CONNECTORS

The floor trusses were attached to the perimeter panels at the interior intersection of the columns and spandrels by different types of connectors. The following appendix displays photographic examples, taken by National Institute of Standards and Technology (NIST), of these types of connectors as observed on the recovered panels.

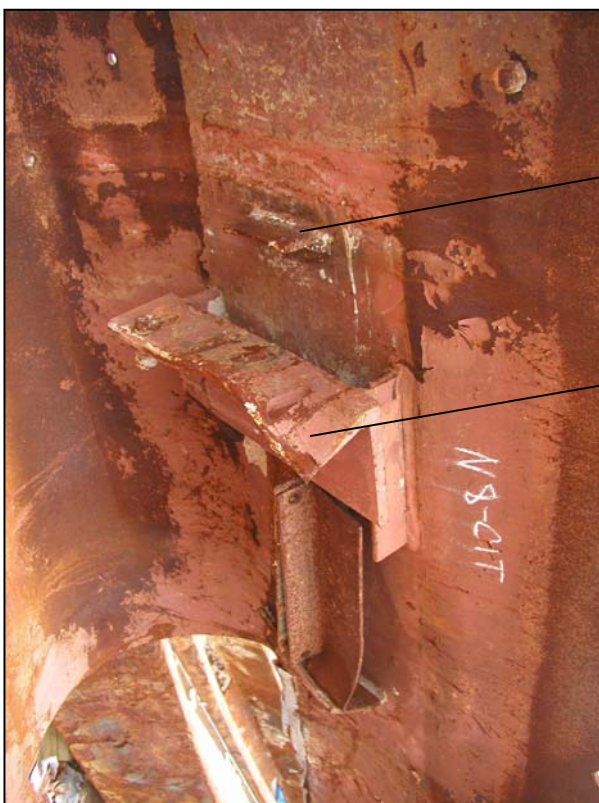
Figure A1a: Type A floor truss connector

Connection N8-CIT

Portion of welded gusset plate with backing bar

Seat with 2 intact bolt holes for truss attachment

Seat

Standoff plates used to attach seat to column interior

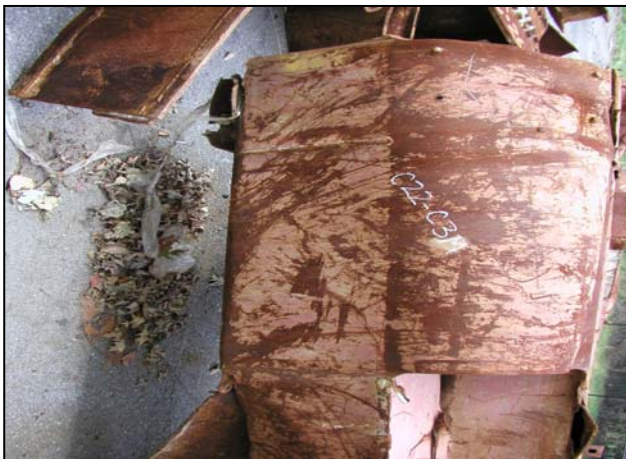
Seat 1: Both holes intact, one has bolt remaining, seat was bent

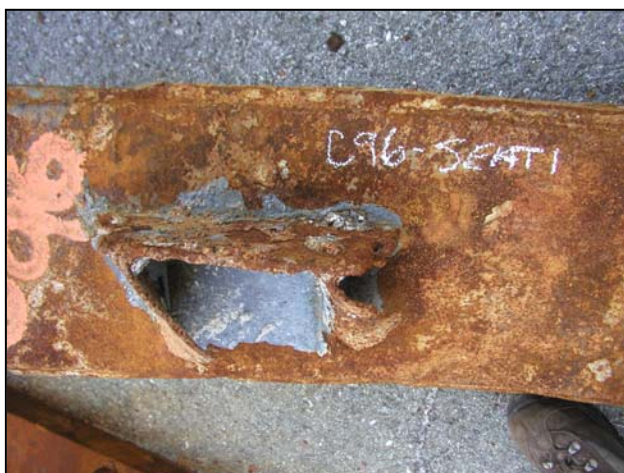
Seat 1: Both holes ripped out, seat appears corroded

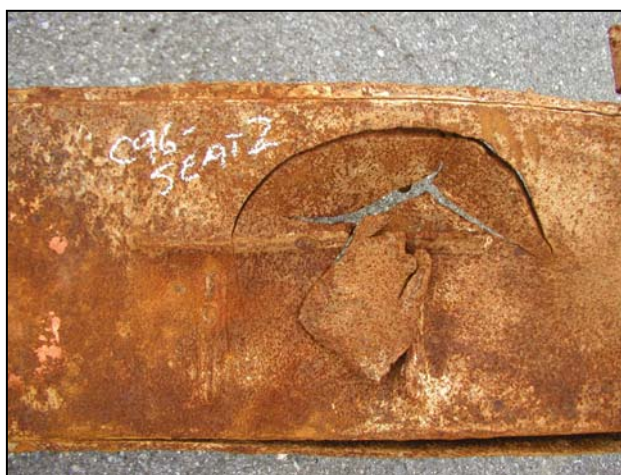
Figure C-3. Sample C-96, channel with two seats.

Seat 2: Seat ripped off at welds

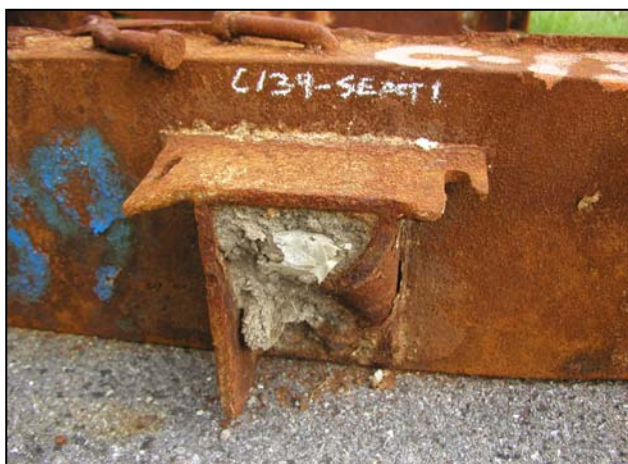
Figure C-13. Sample C-139, channel with one seat.

One seat with one hole intact, other ripped out, seat was damaged

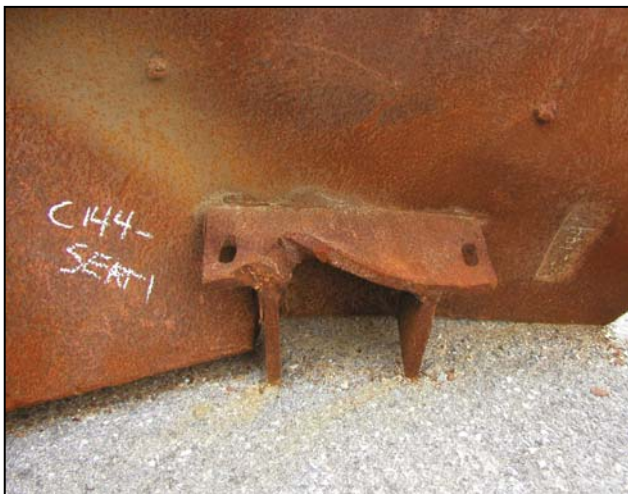
Figure C-16. Sample C-144, channel with one seat.

One seat with both holes intact,
seat was damaged

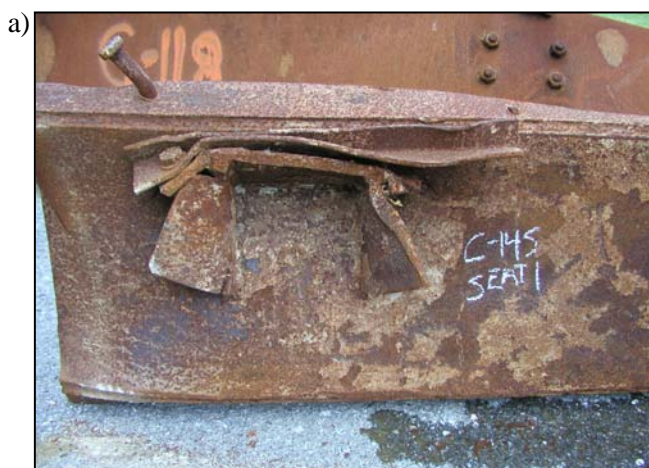
Seat 1: One hole intact with bolt
and angle attached, other ripped,
seat was damaged

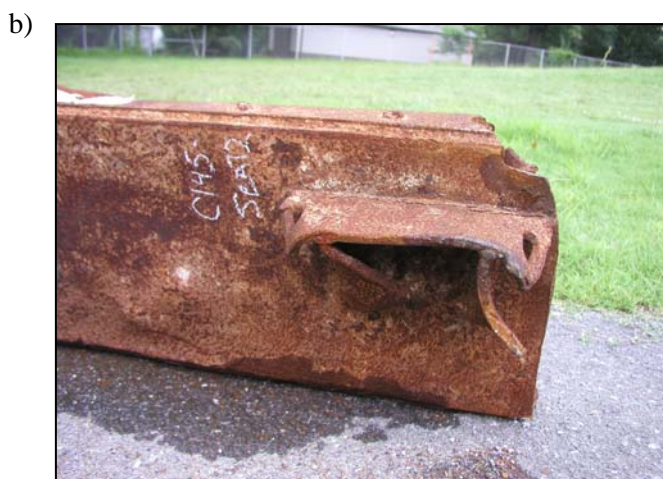
Figure C-17. Sample C-145, channel with two seats.

Seat 2: Both holes intact, seat was
bent

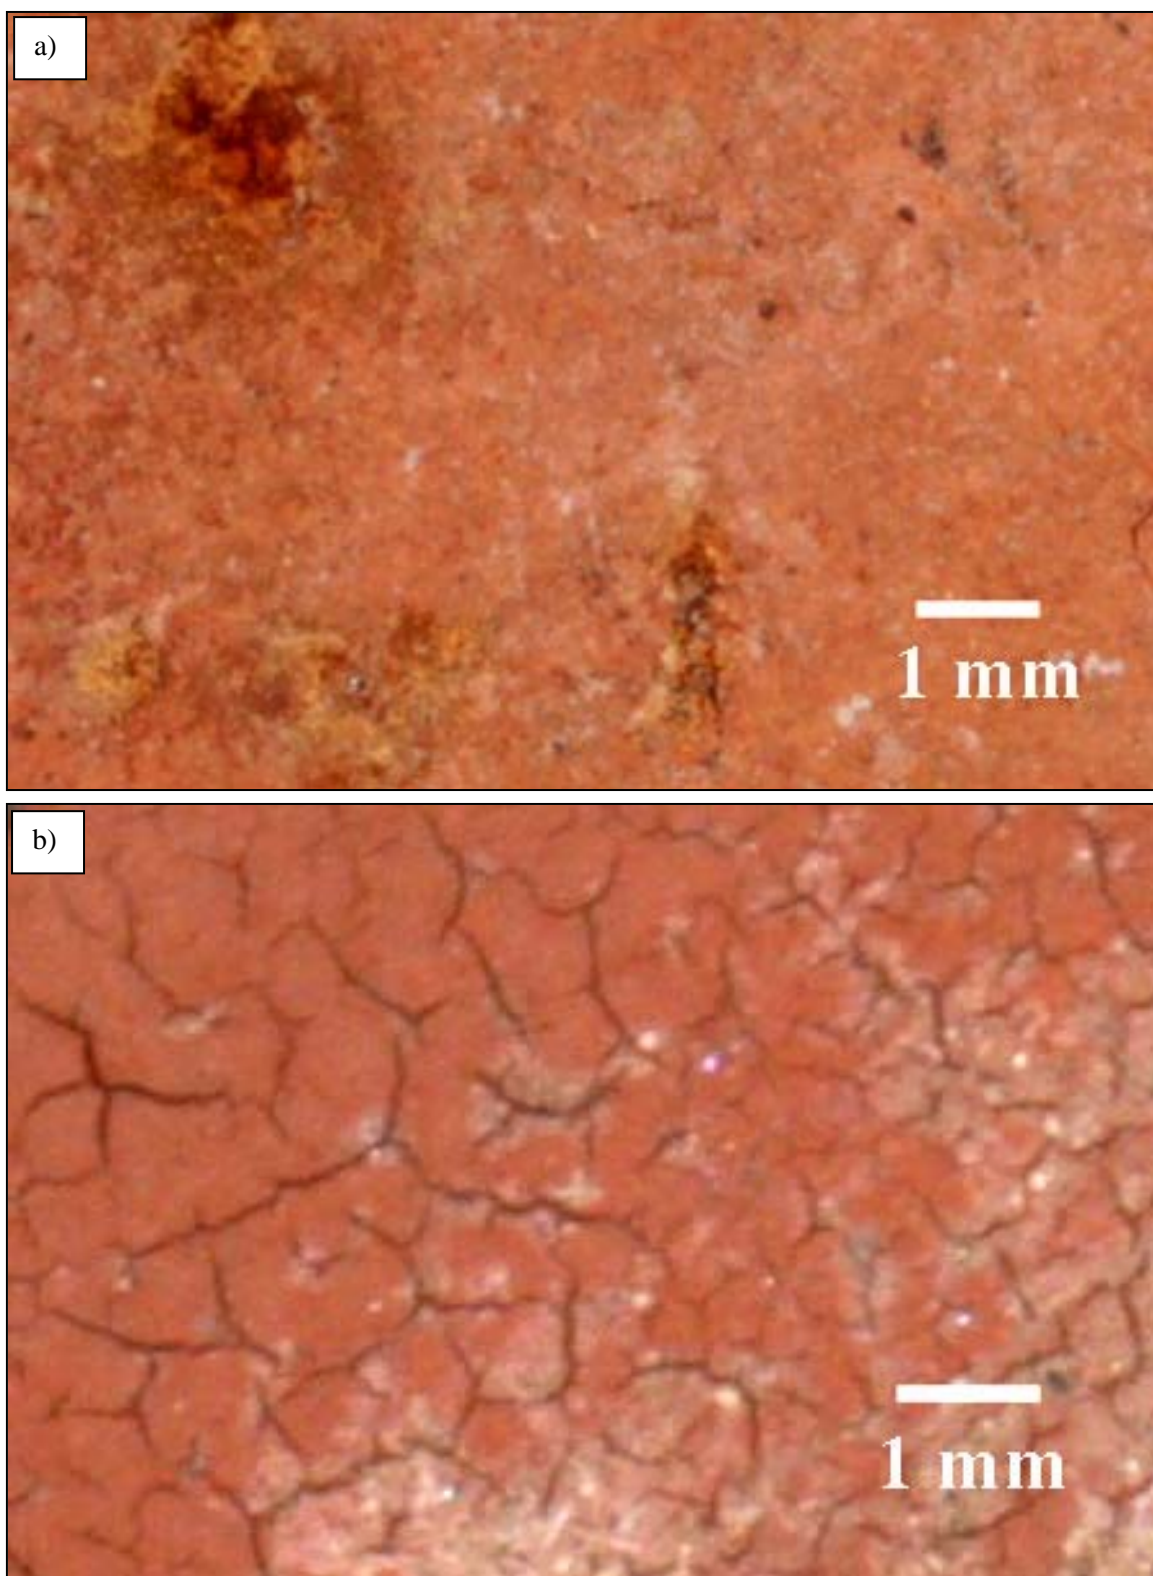
Figure D-1. Photographic images of the primer paint. a) paint in its original condition and b) mud cracking of paint after exposure at 250 °C for 1 h.

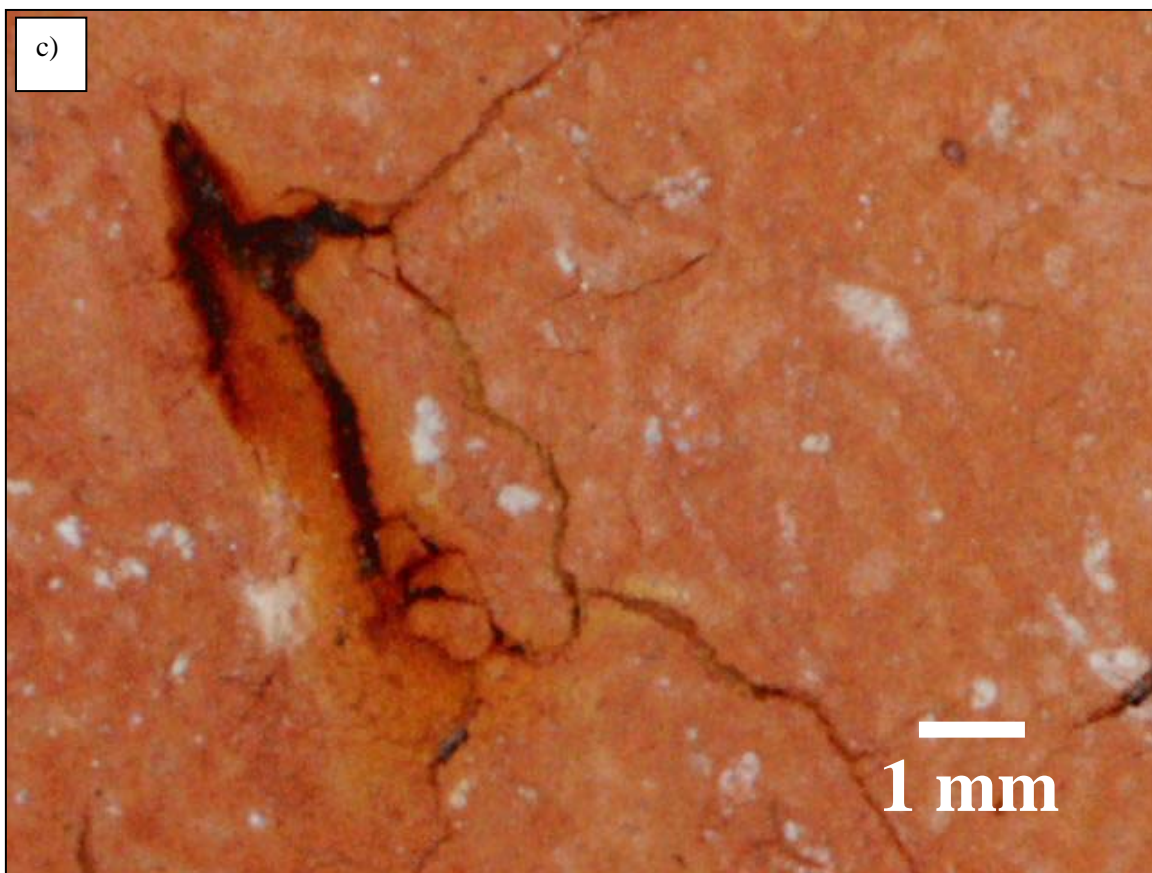
Figure D–2. Photographic images of the primer paint. c) mud cracking of paint after exposure at 650 °C for 1 h.

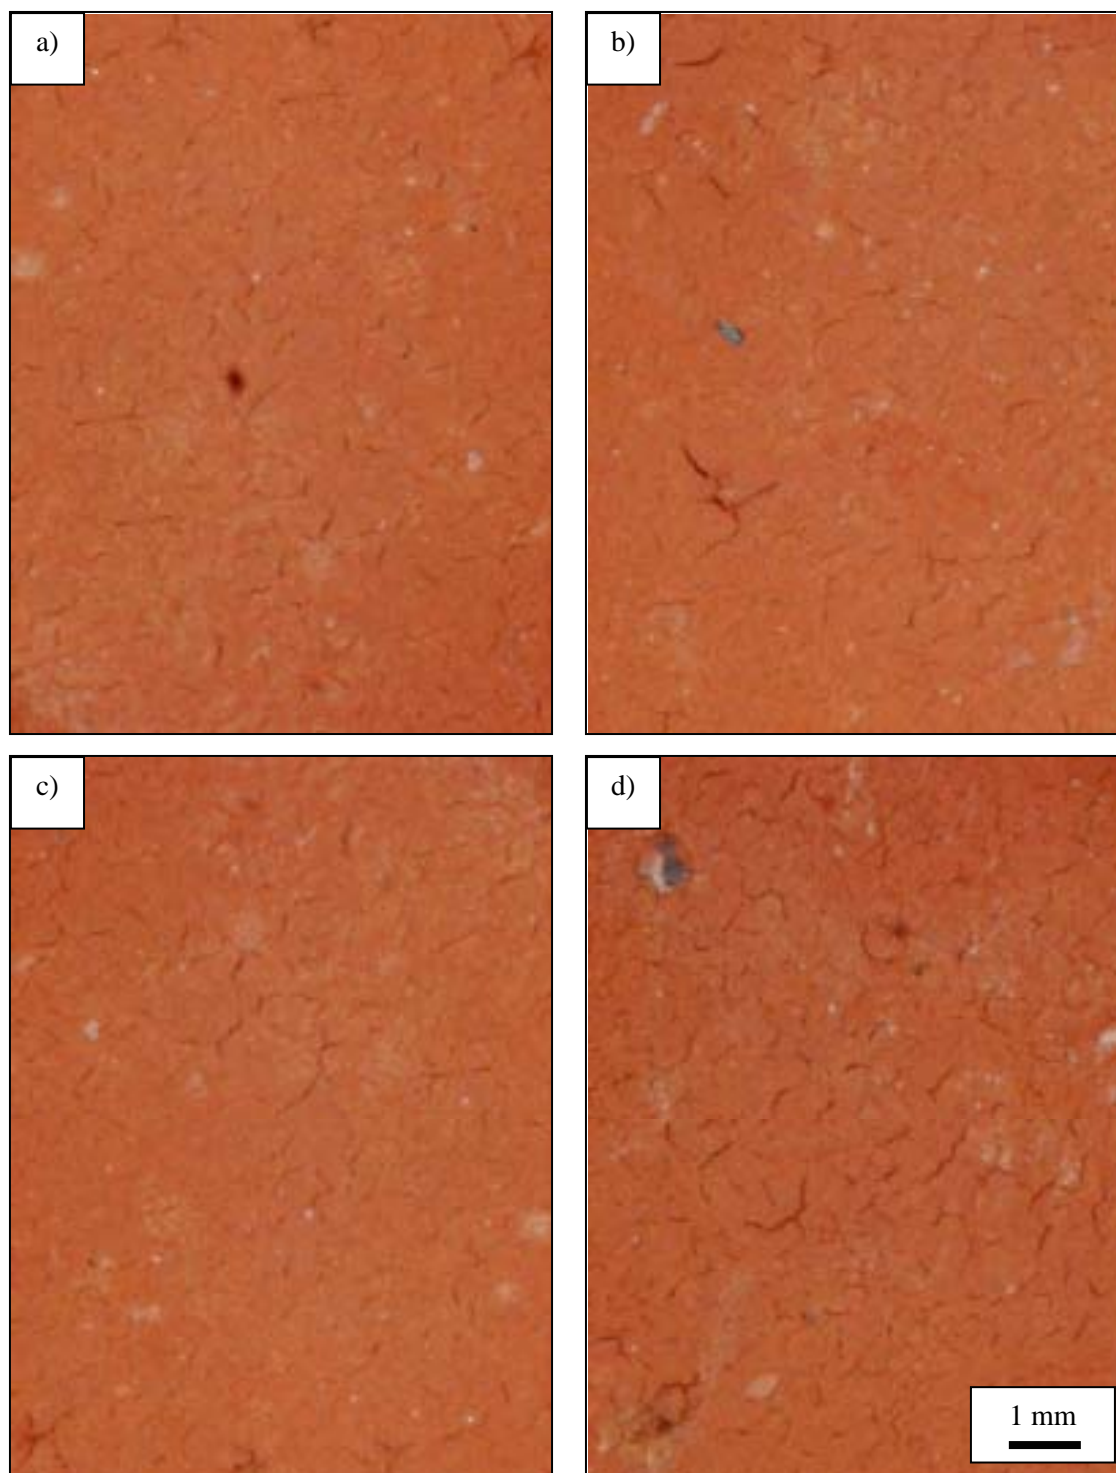
Figure D–3. Mud cracking appearance as a function of time. Exposure temperature was 250 °C. a) 0.25 h, b) 0.5 h, c) 1 h, and d) 2 h. Note that these images are taken under different magnification and illumination conditions than Figure D–1(b).

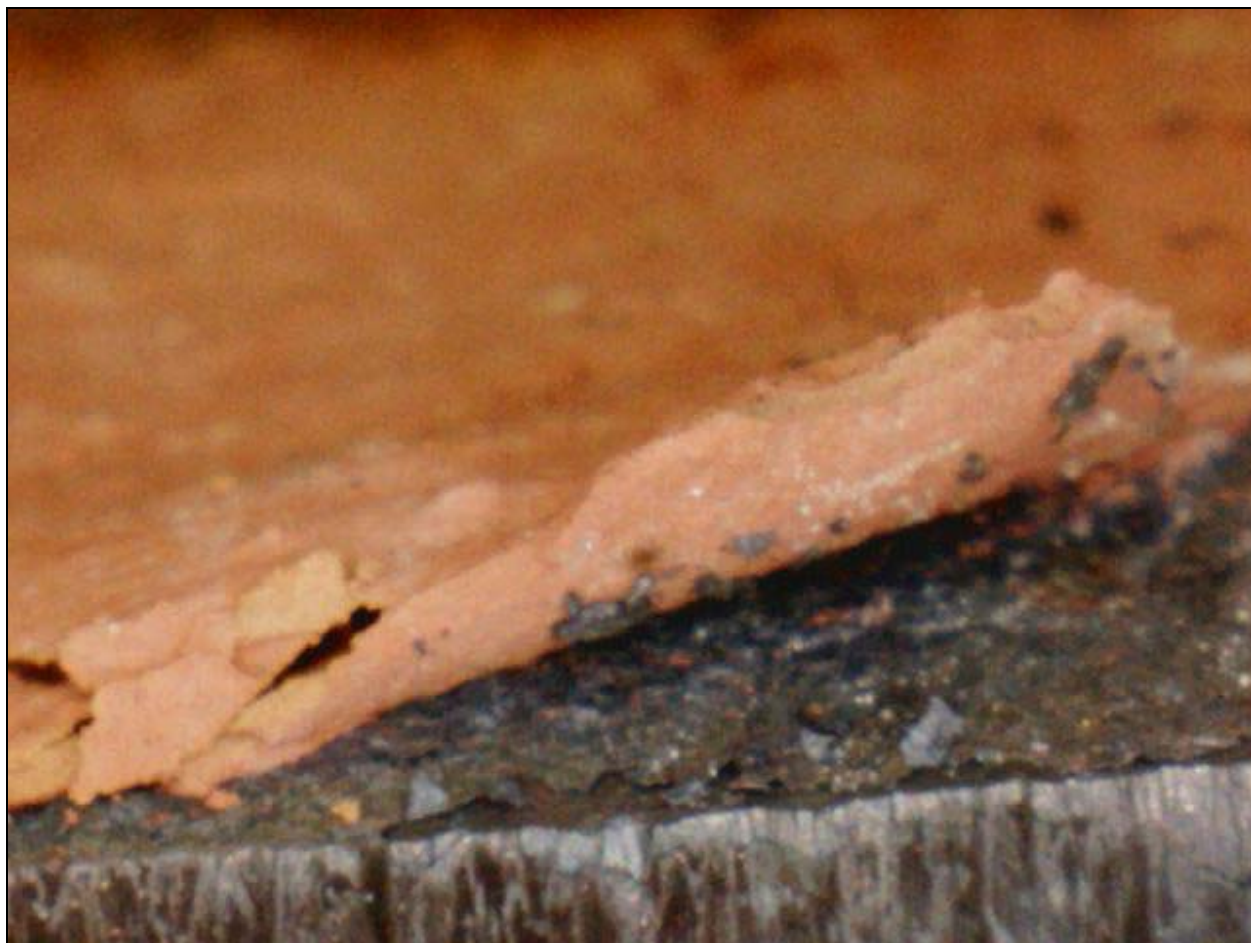
Figure D–4. Formation of a black scale between paint and steel after exposure greater than 650 °C. Paint readily spalled.

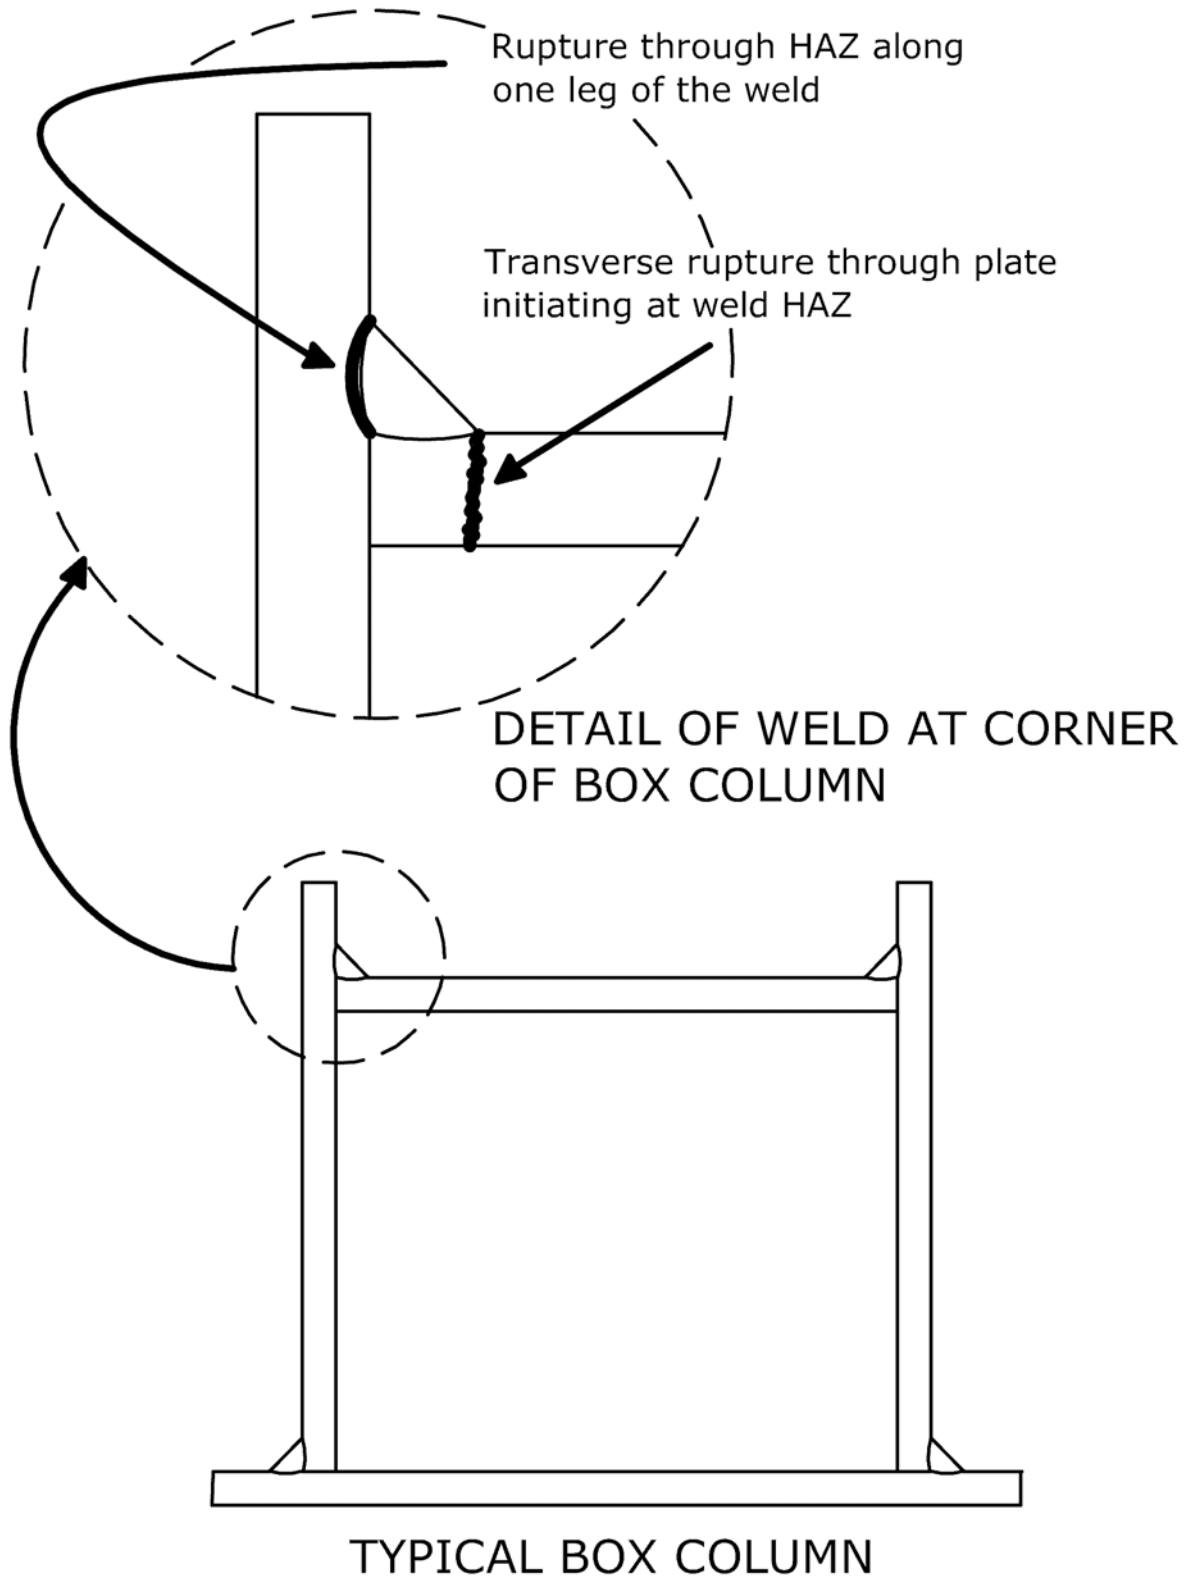
Figure 5. Schematic diagram illustrating fracture paths initiating at heat affected zone (HAZ) of weld.

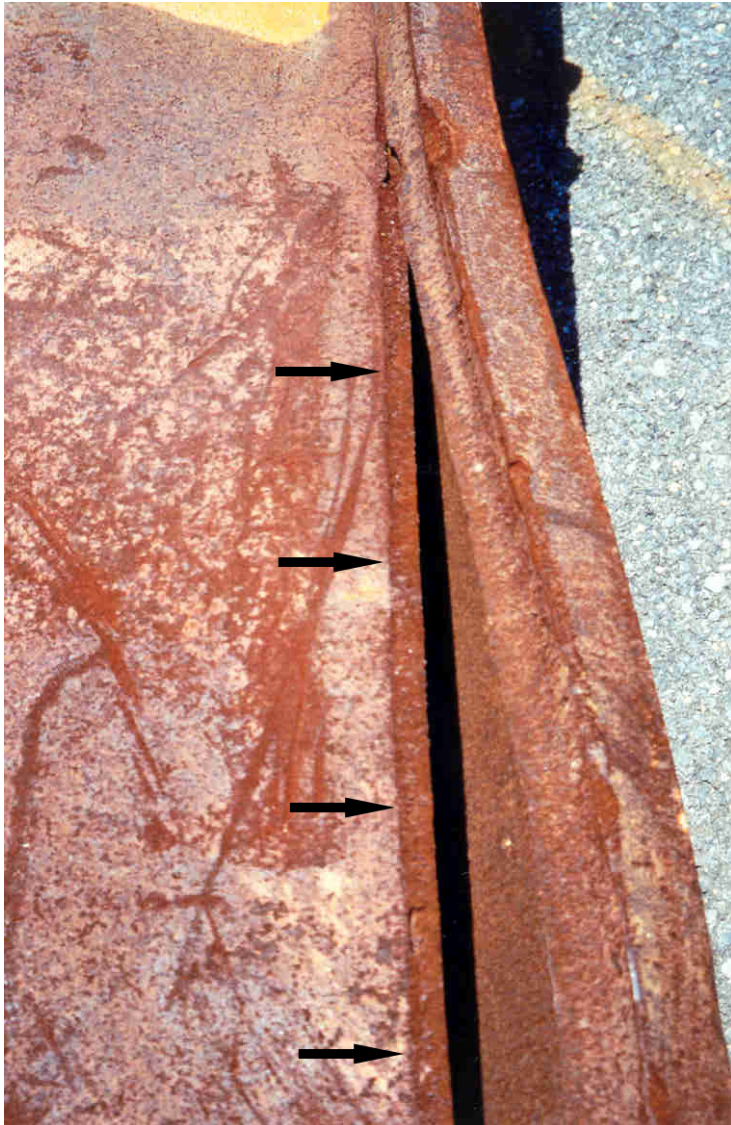
Figure 6. Close view of rupture of fillet weld through HAZ on parent material along a leg of the fillet. Arrows point to fracture surface in HAZ on parent material; the mating fillet weld is at the right.

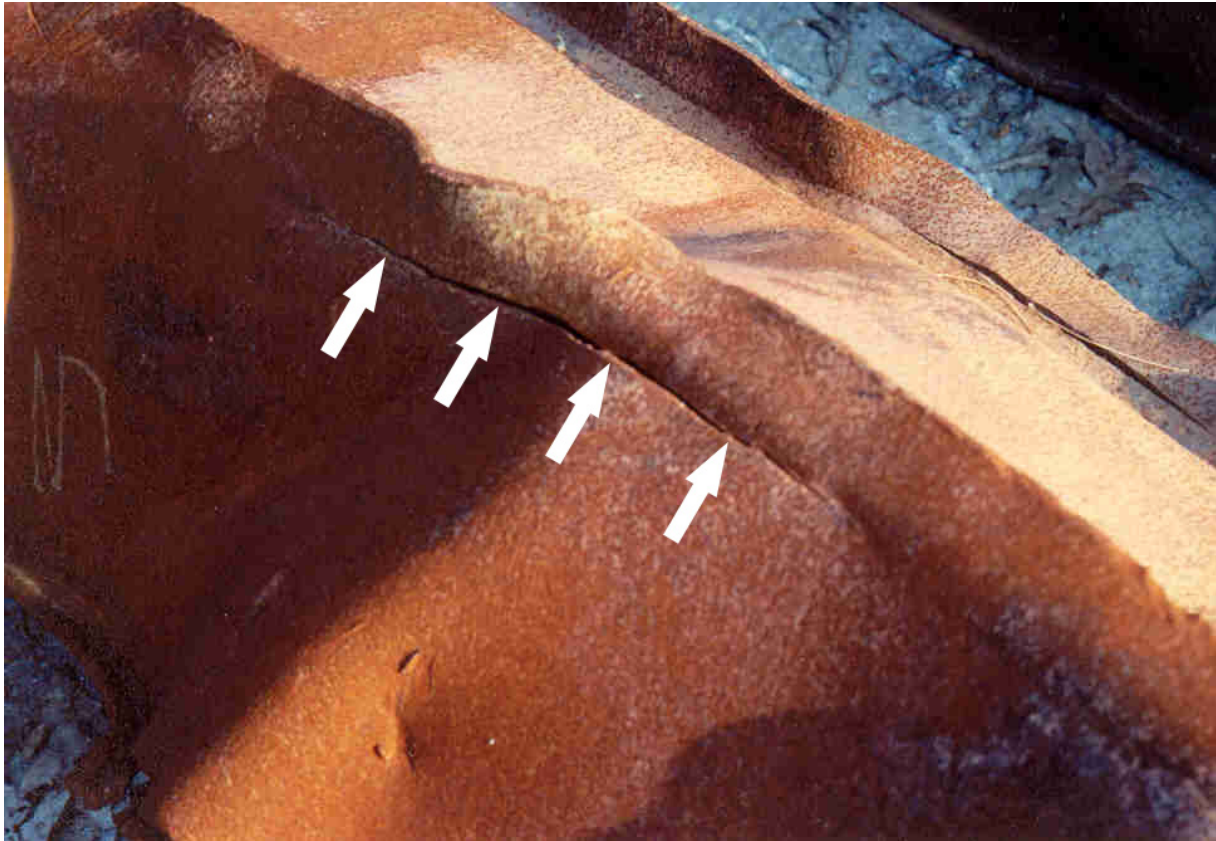
Figure 7. Transverse rupture through the thickness of the parent material, initiating in HAZ at toe of fillet welds

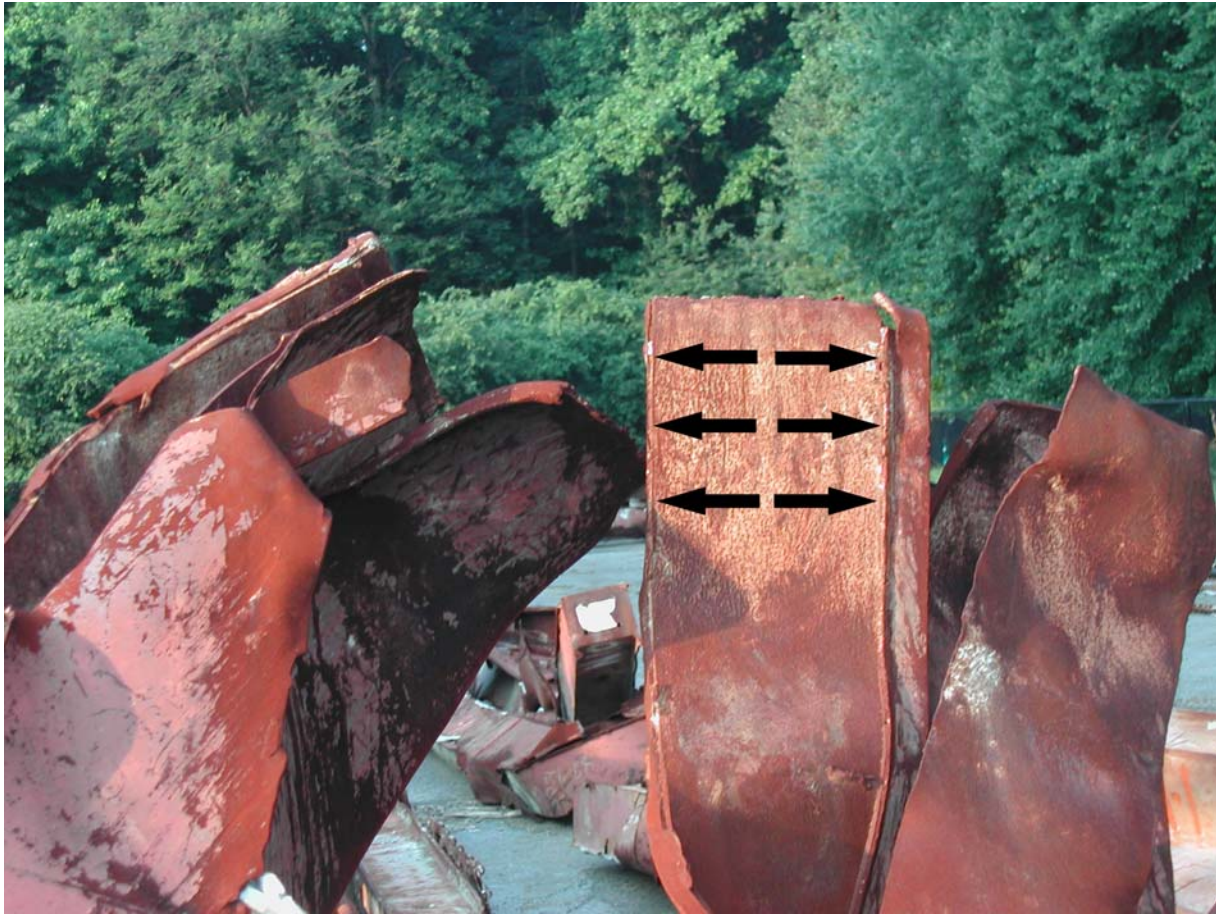
Figure 8. Ruptures of fillet welds through parent material HAZ on impact-affected region of Piece M-2

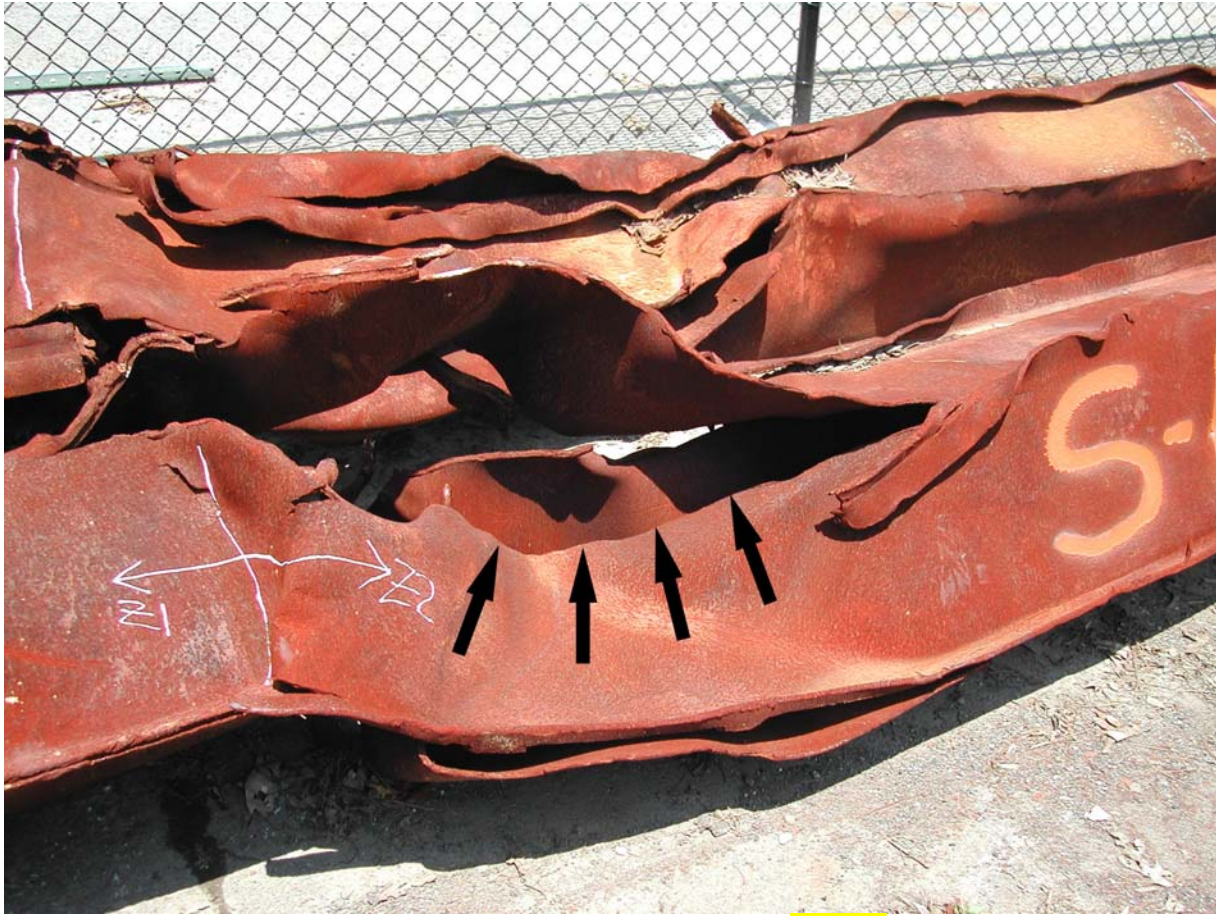
Figure 9. Ruptures of fillet welds through parent material HAZ on *possible* fire-effected region of Piece S-10

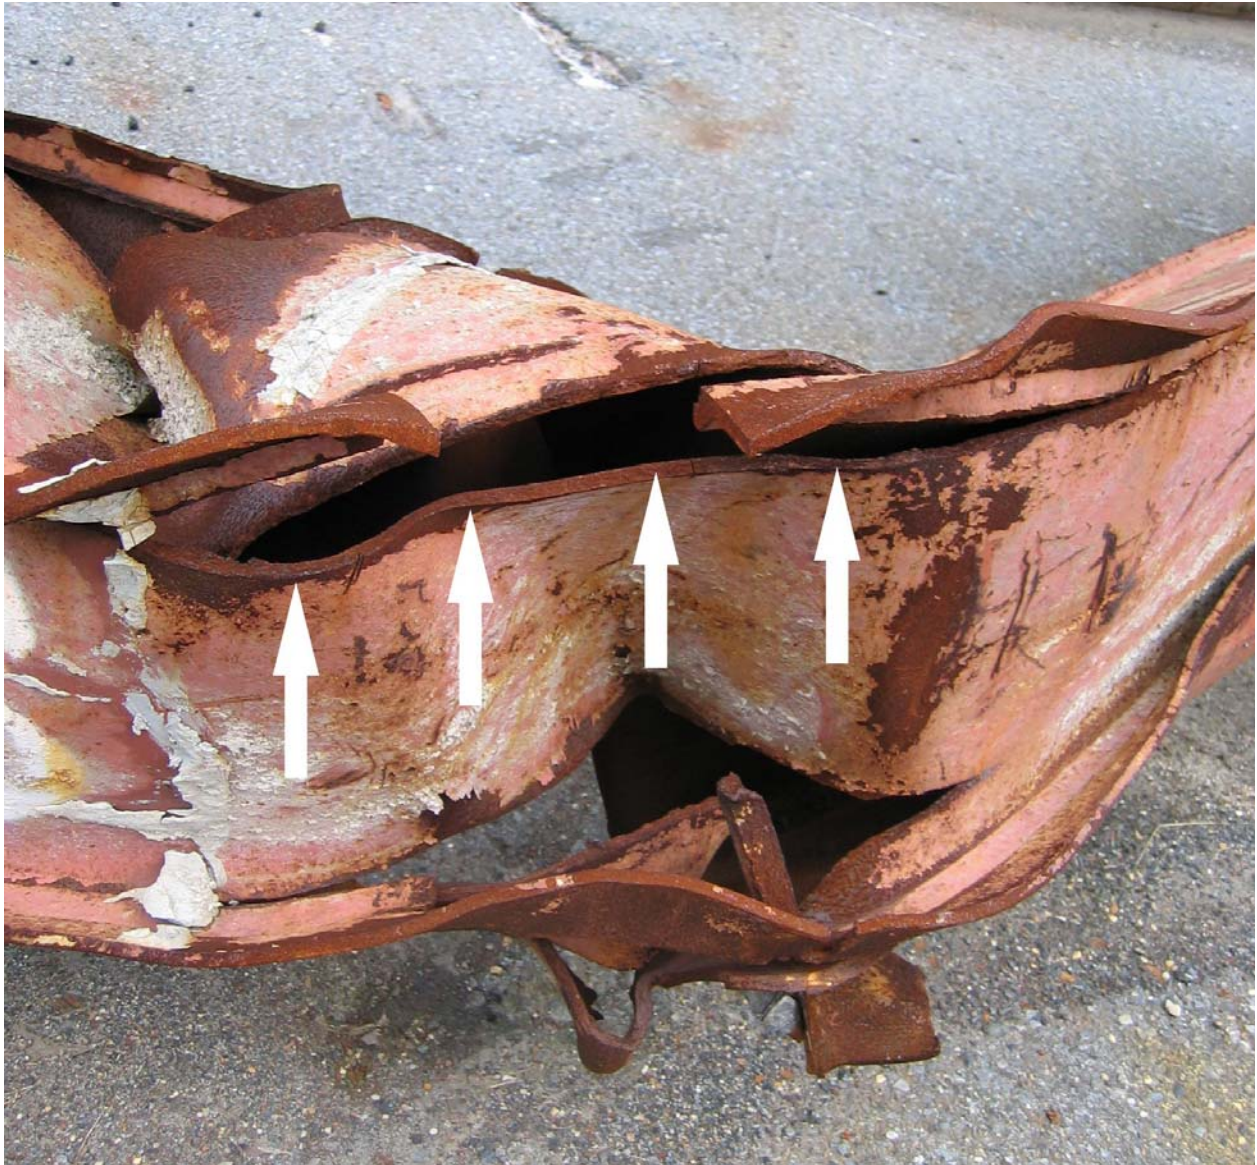
Figure 10. Ruptures of fillet welds through parent material HAZ (at arrows) on probable mechanically pinched zone on Piece C-40 (ruptures through parent material away from welds are also observable in the photo)

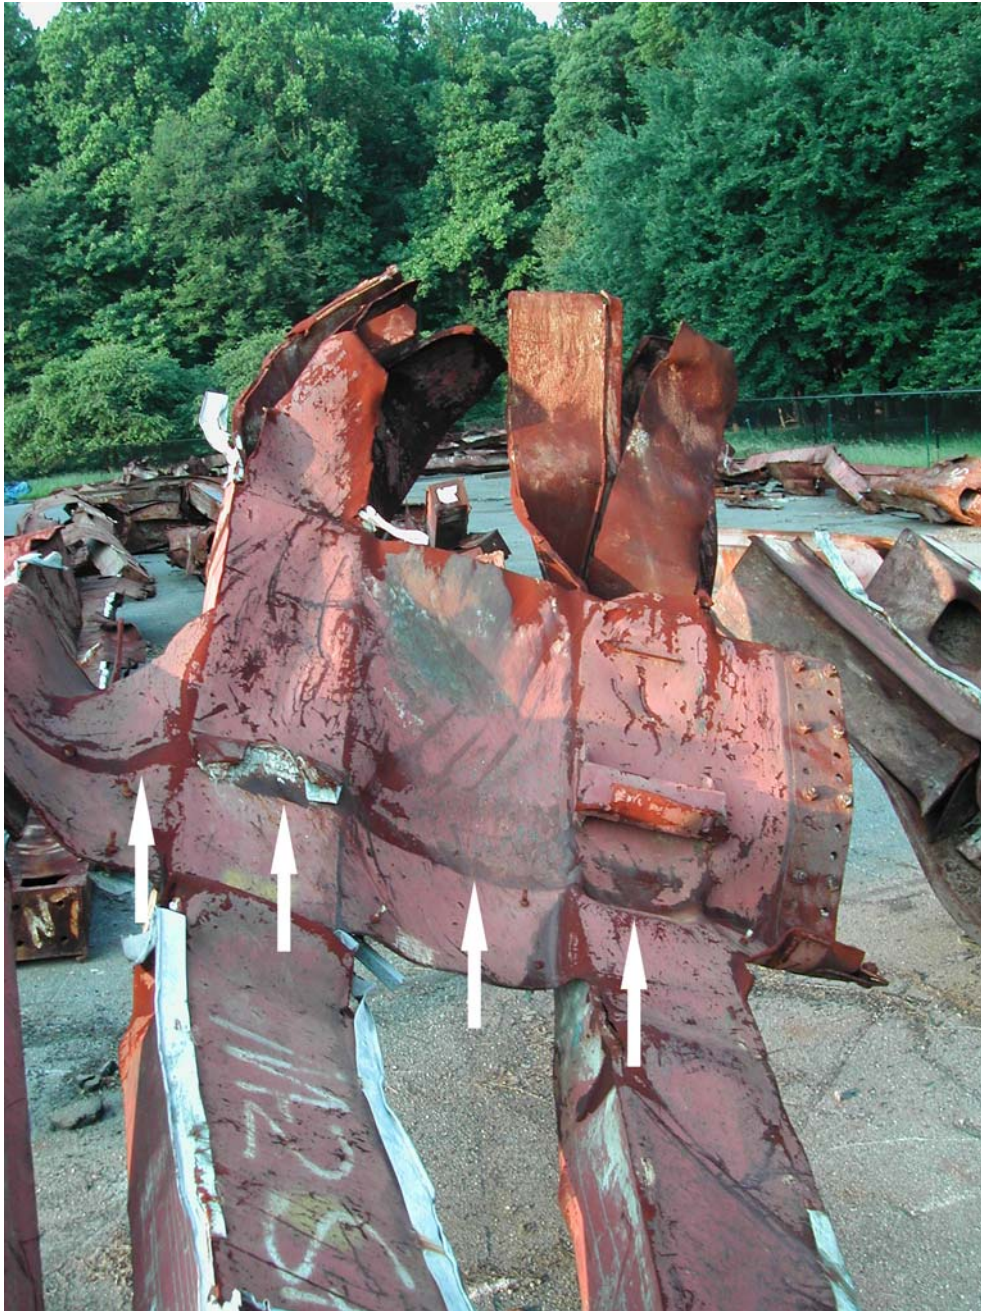
Figure 11. View of Piece M-2, showing inward bend of bottom of piece (at top of photo) about edge of the 97th floor slab(darkened line running left-to-right across spandrel plate, indicated by arrows)

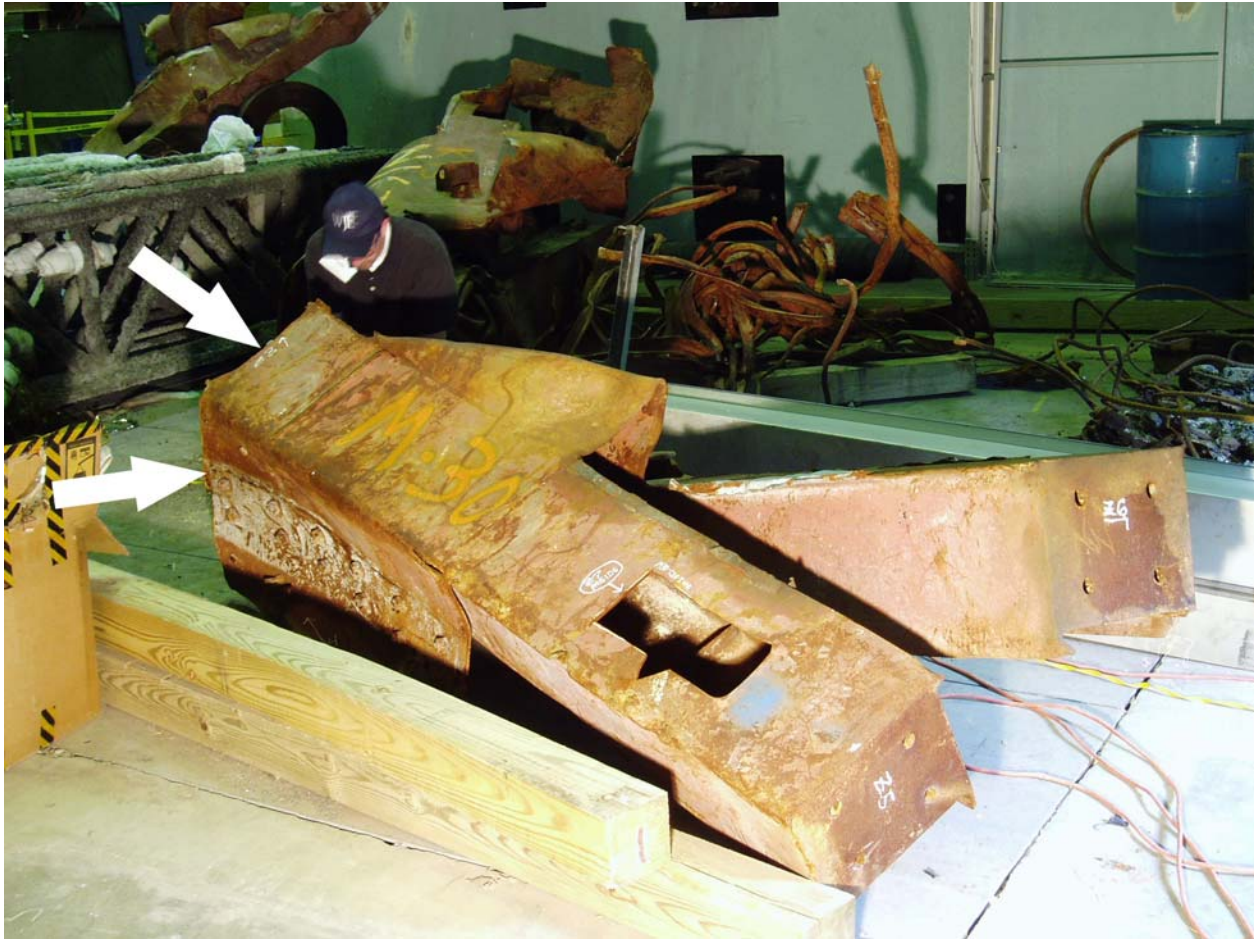
Figure 13. Severed column (at arrows) as observed on Piece M-30.

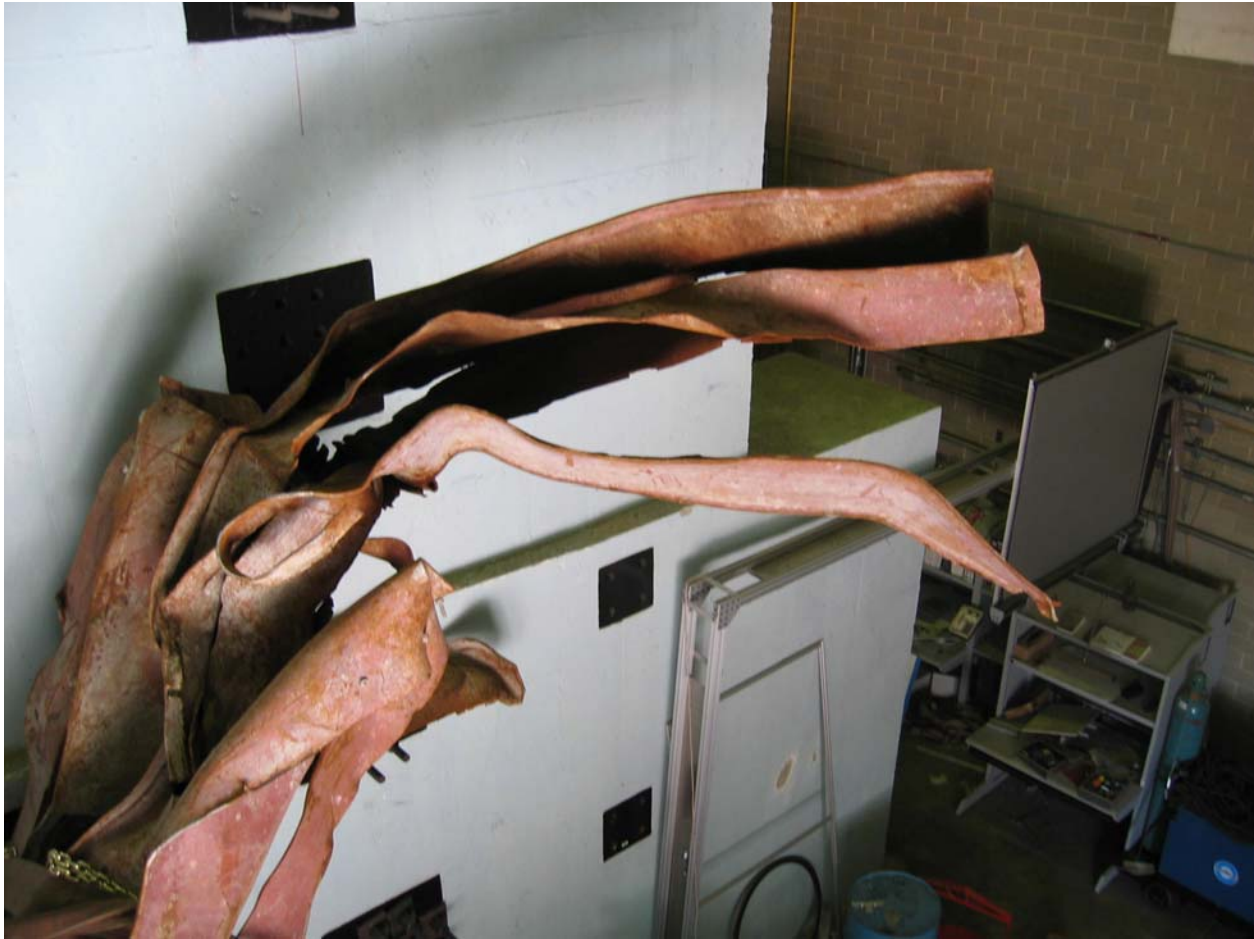
Figure 14. Column elements on Piece M-27 that have decomposed from closed box sections into ribbon-like slender plate elements as a result of the aircraft impact

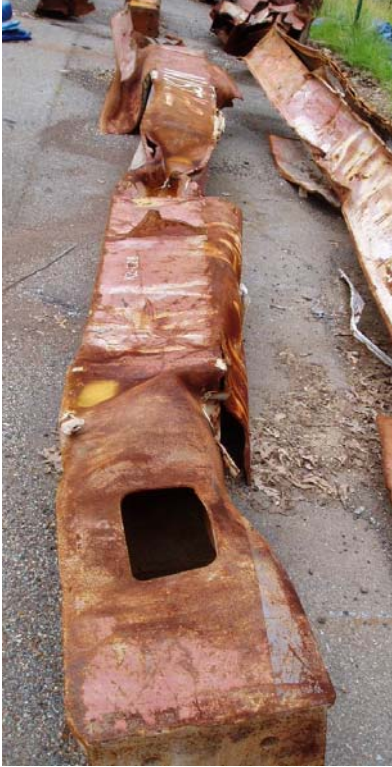
<p>Figure F-A-3a: General view of Piece K 2. Base of column is at bottom of photo.</p>		<p>Partial single column element from an exterior column panel on WTC 1. Piece recovered extends from column splice at 92nd floor to approximately base of windows opening at 94th floor. While this column is from floors where the aircraft impacted the structure, this column was not on the face of the building that was directly impacted by the aircraft.</p> <p>Distinct pattern of possible fire effects observed at windows at floors 92, 93 and 94 (loss of paint; significant section distortion), along with apparent protection of steel from fire effects at spandrels at floors 93 and 94. Pinching of column at 93rd floor window opening (Figure A-8) is most likely a result of post-collapse handling and recovery.</p>

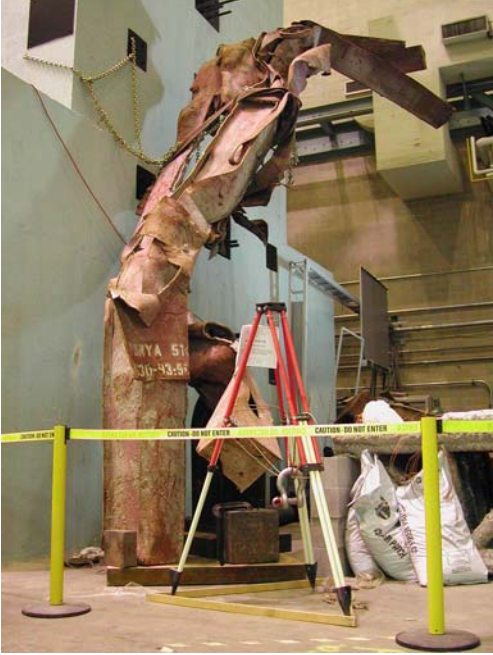
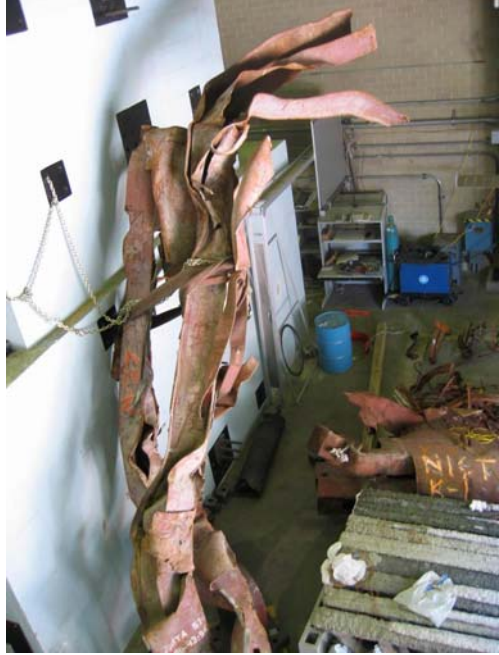
Figure F-A-5a: Piece M-27.		Figure F-A-5b: Piece M-27.	
 		<p>This exterior column panel from WTC 1 was directly impacted by the aircraft at its upper end. In the impact-affected area, the column elements have typically decomposed from their original four-sided, closed rectangular box shape into four ribbon-like, thin rectangular plate elements. It is likely that the welds at the corners of the box shape, originally joining the four face plates together, ruptured as a result of the aircraft impact. The rupture of these welds likely took place at a high rate.</p> <p>The middle column in the panel has been sheared off at the line between the top of the 95th floor window and the bottom of the 96th floor spandrel element. The fractures at the severed ends of the plates that make up this column element would likely have happened at a high rate of loading as a result of aircraft impact.</p>

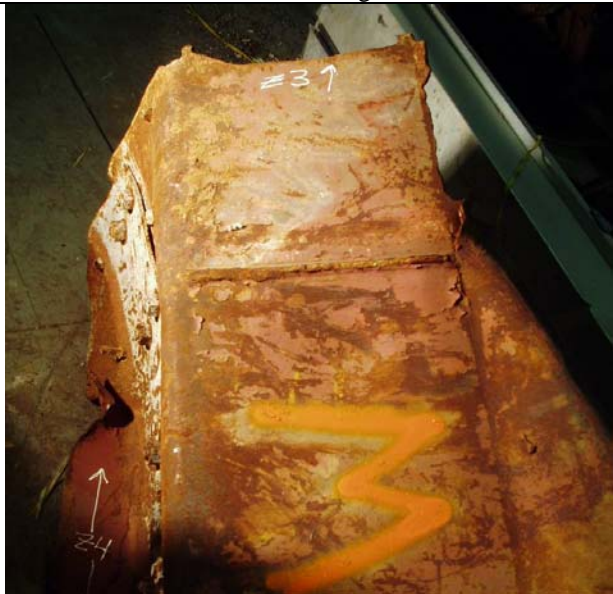
<p>Column 132 was also severed at approximately the 95th floor line, shown Figures A-23 and A-24. The severed edge is marked Z3 in Figure A-23. As with Column 133, the fracture of this column occurred generally at the location of an internal column diaphragm stiffener. It is almost certain that these fractures were caused by the impact of the aircraft and therefore occurred at a high rate of loading.</p>

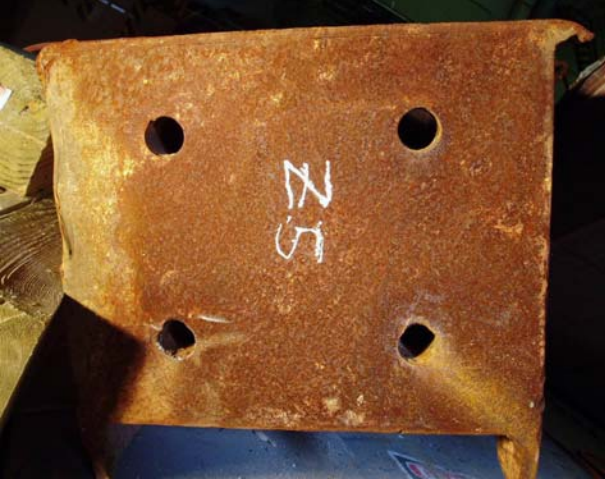
<p>Figure F-A-6h: View of column end plates on Piece M-30. Base of Column 132 is marked Z5 and base of Column 133 is marked Z6.</p>	<p>The bolt holes on the base plates for Columns 132 and 133, marked Z5 and Z6, respectively, show in Figures A-26, A-27 and A-28, were examined for hole elongation that might be related to the failure of the column splice bolts.</p> <p>On the base plate of Column 132, the two bolt holes nearest the outside face of the column exhibited elongation in a direction perpendicular to the outside face. The two bolt holes closest to the interior face exhibited insignificant elongation.</p> <p>On the base plate of Column 133, the direction of elongation of the bolt holes is consistent with the column twisting as the bolts were failing.</p>

<p>Figure F-A-6i: Base of Column 132. Outside face is down.</p>

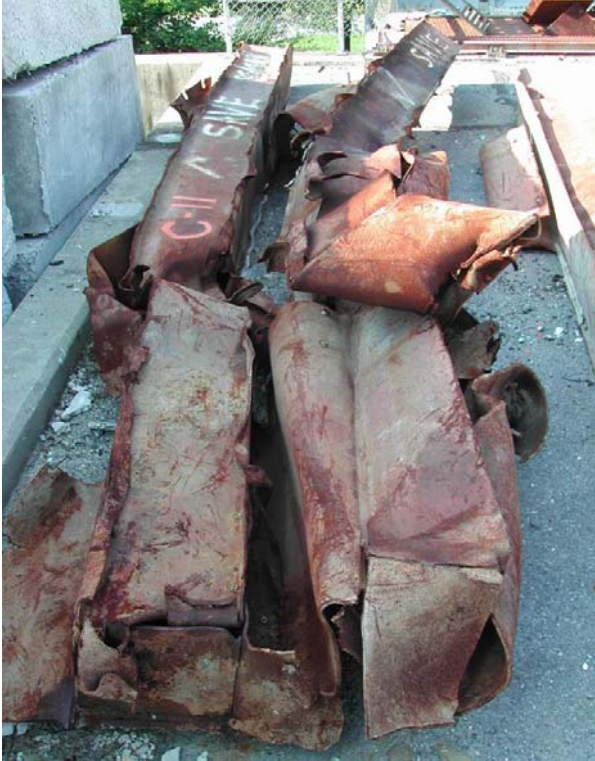
<p>Upper two-thirds of two columns from an exterior column panel. The thickness of the plates is consistent with having been located in the upper portions of one of the buildings. Indications of fire effects are present at the inside faces of the columns at the upper full window locations (between middle and top spandrel elements). Upper spandrel and column elements at the window location above the upper spandrel do not exhibit significant effects of fire.</p>	
Figure F-B-5: Piece C-11.
