Appendix A

EXAMPLES OF PERIMETER PANEL FLOOR TRUSS CONNECTORS

The floor trusses were attached to the perimeter panels at the interior intersection of the columns and spandrels by different types of connectors. The following appendix displays photographic examples, taken by National Institute of Standards and Technology (NIST), of these types of connectors as observed on the recovered panels.

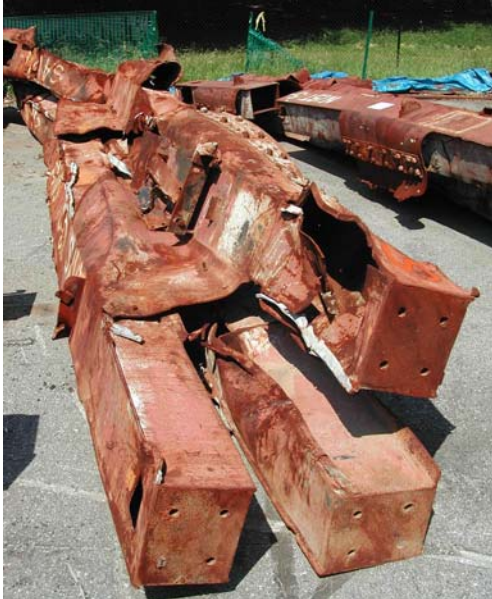
<p>Full exterior column panel from high floors in WTC 2, well above the aircraft impact zone for WTC 2. Possible fire effects observable at some locations on the piece. Given location of this piece in WTC 2, it is most probable that the observed fire effects are related to post-collapse fire rather than fire immediately after aircraft impact.</p>	
Figure F-B-11: Piece S-14 or C-20.
