**NIST NCSTAR 1-3 (Draft)**

**Federal Building and Fire Safety Investigation of the  
World Trade Center Disaster**

# **Mechanical and Metallurgical Analysis of Structural Steel (Draft)**

September 2005

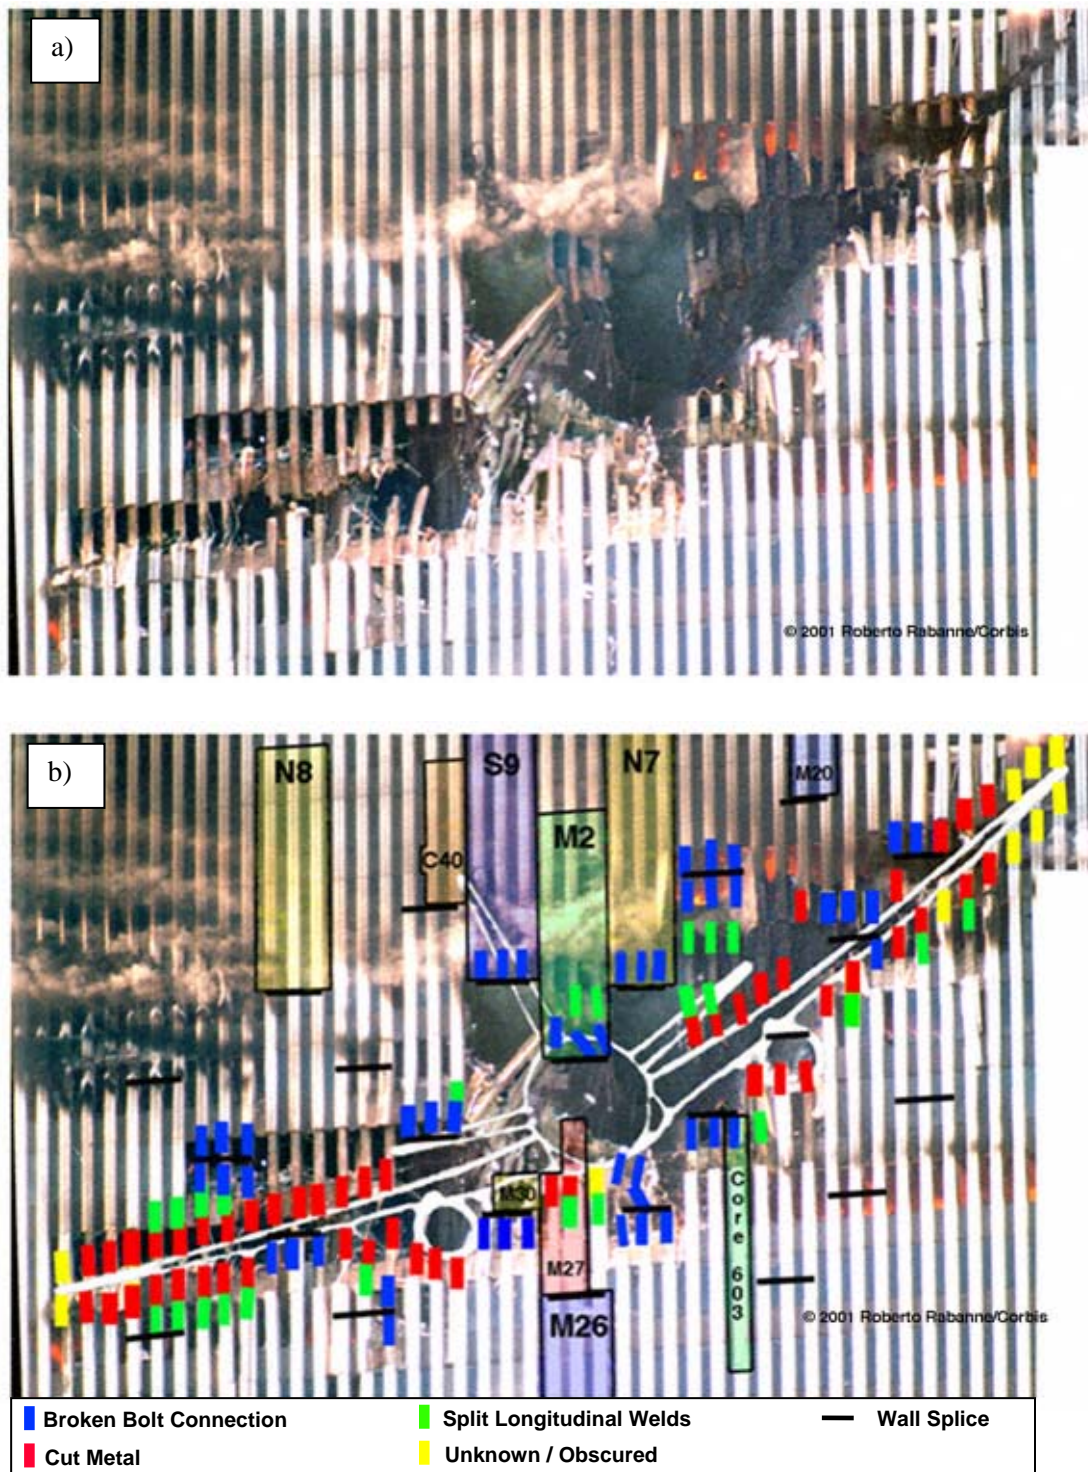
Figure 6-1. (top) Enhanced image showing the impact hole in the north face of WTC 1, and (bottom) overlay of an outline of a Boeing 767 that has been distorted to get a best approximate fit with damage to WTC 1. The location and type of localized damage has been indicated.

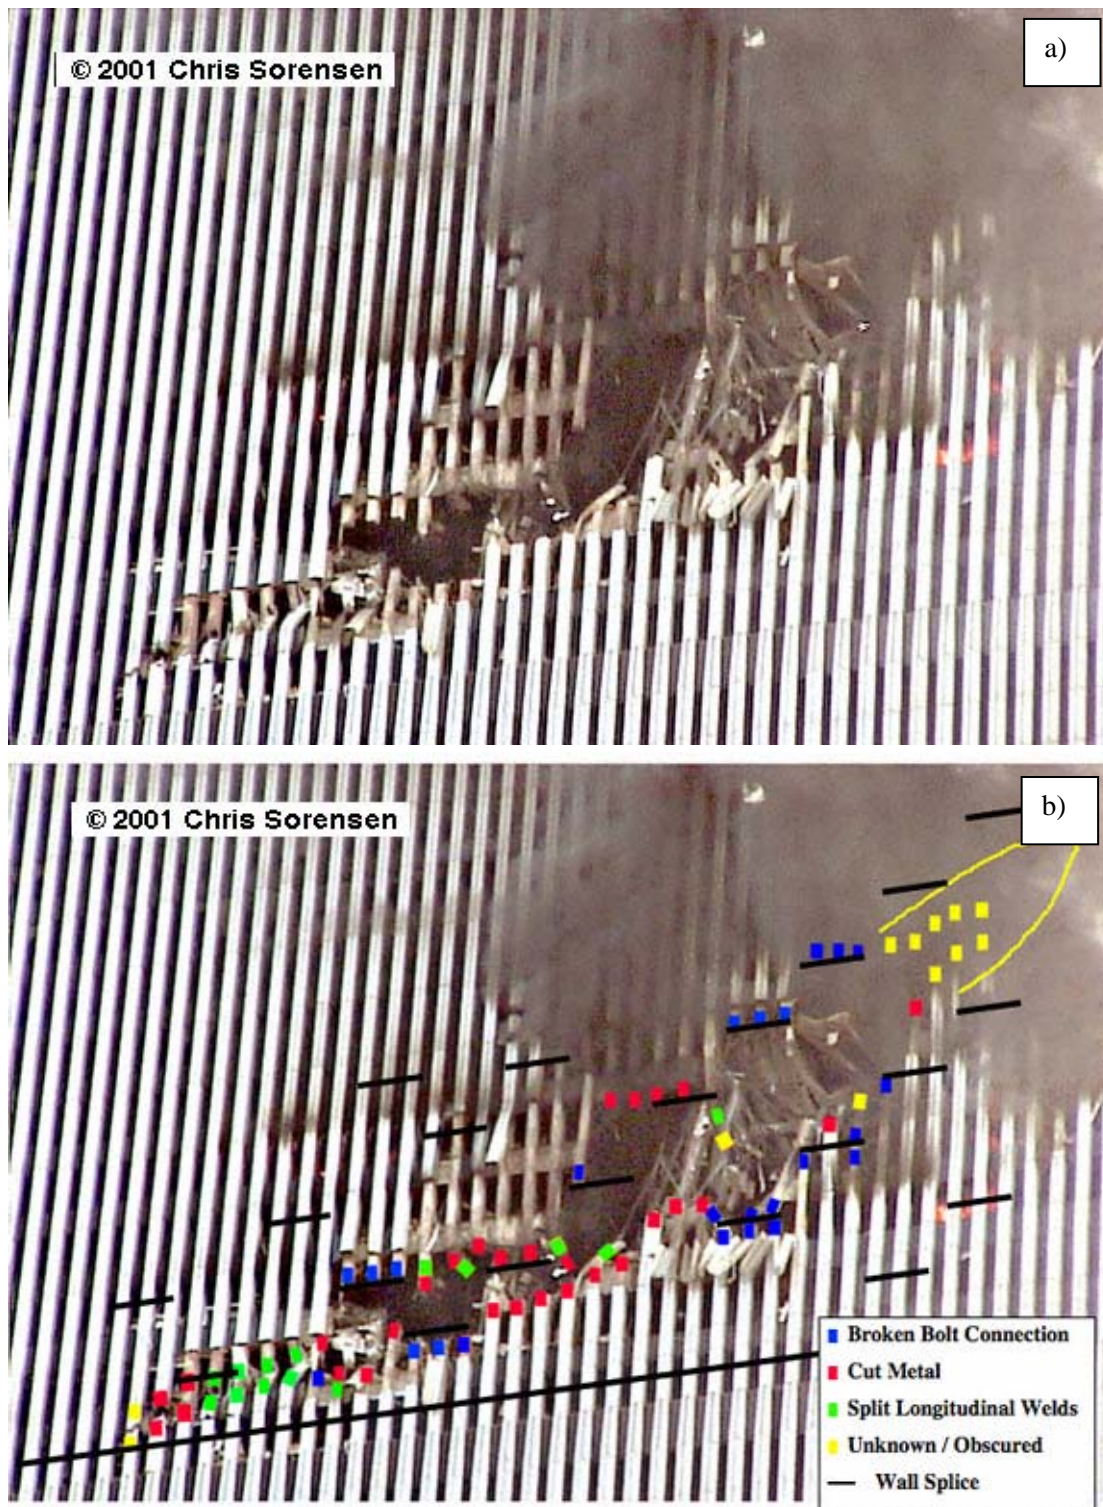
Figure 6-2. (top) Enhanced image showing the impact hole in the south face of WTC 2 and (bottom) overlay of the location and type of localized damage.

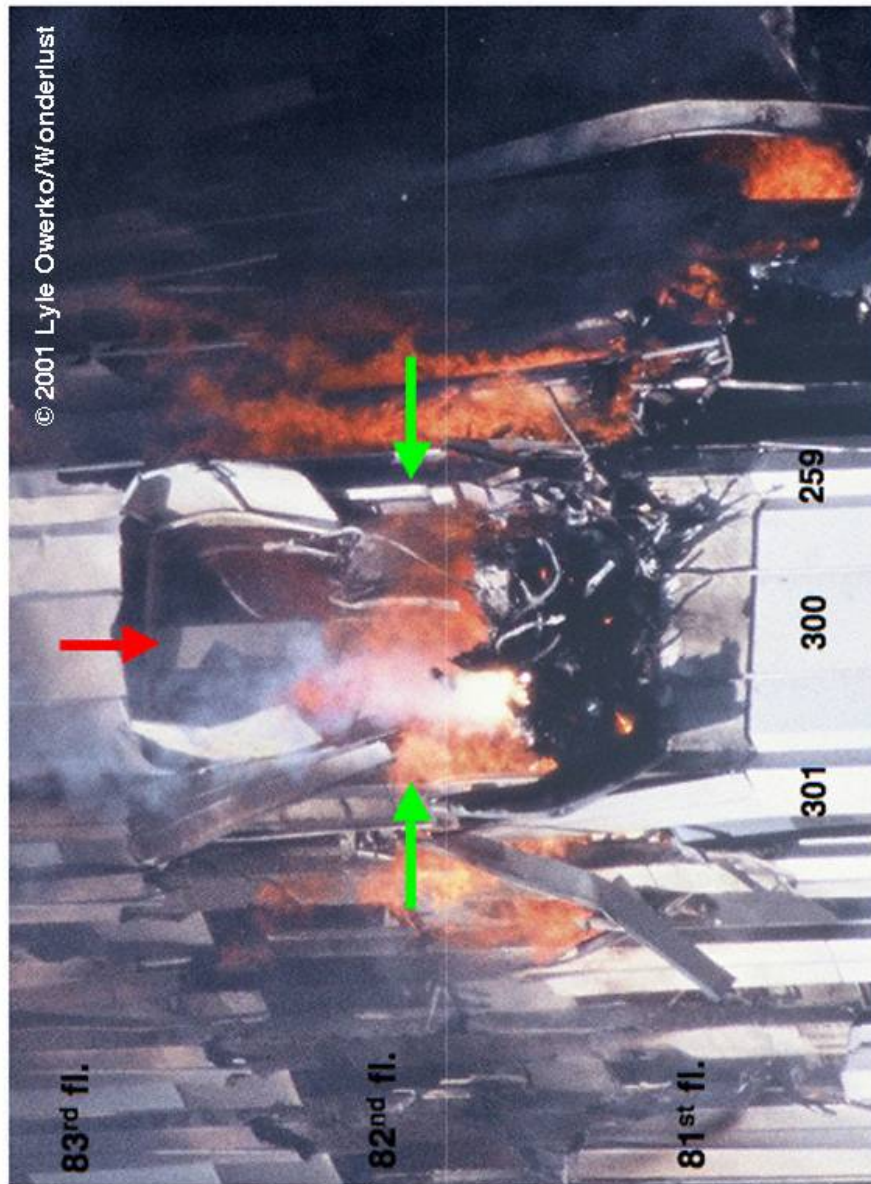
Figure 6-3. Damage to northeast corner of WTC 2 at 81st floor. The red arrow indicates an intact column 300 at the 82nd floor. Other photographs confirm that the spandrel connecting column 300 to columns 259 and 301 is also intact (location indicated by green arrows).

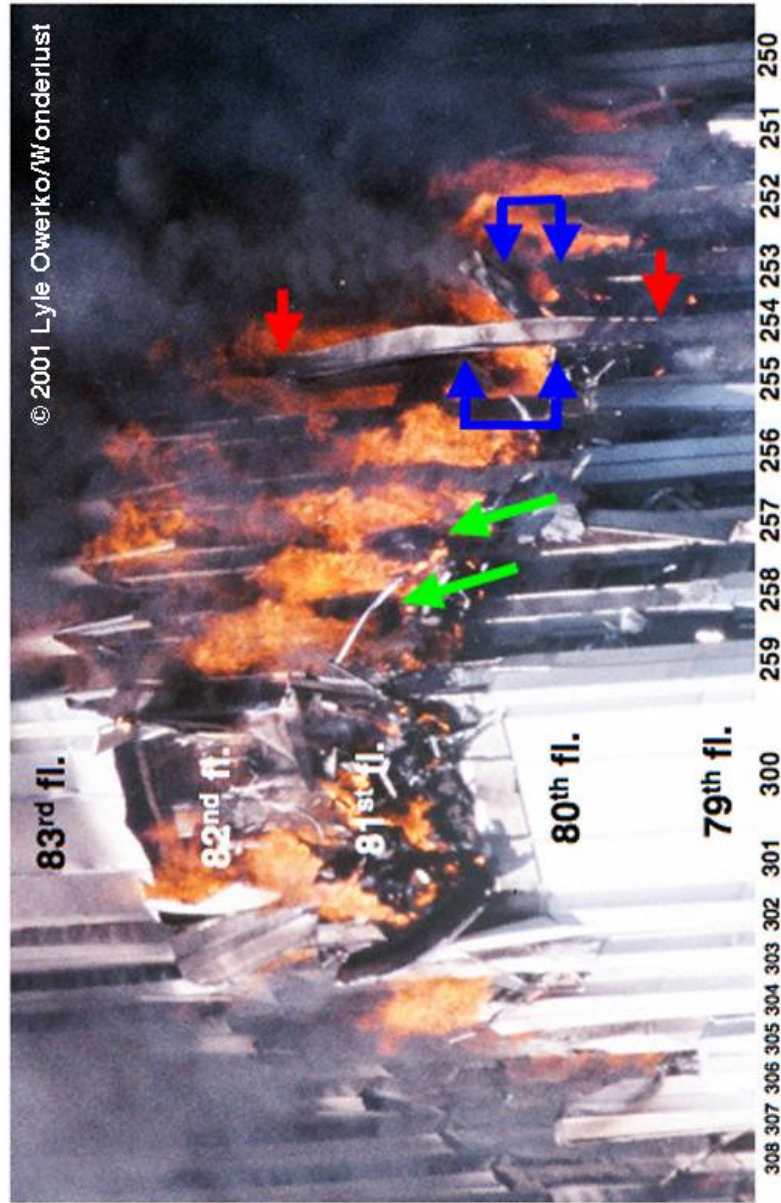
Figure 6–4. Damage to columns on north face of WTC 2 near northeast corner due to internal impact by debris. Broken vertical column bolted connections (green arrows) are visible, along with an intact outer web on column 254 (red arrows) and missing column sections (blue arrows).

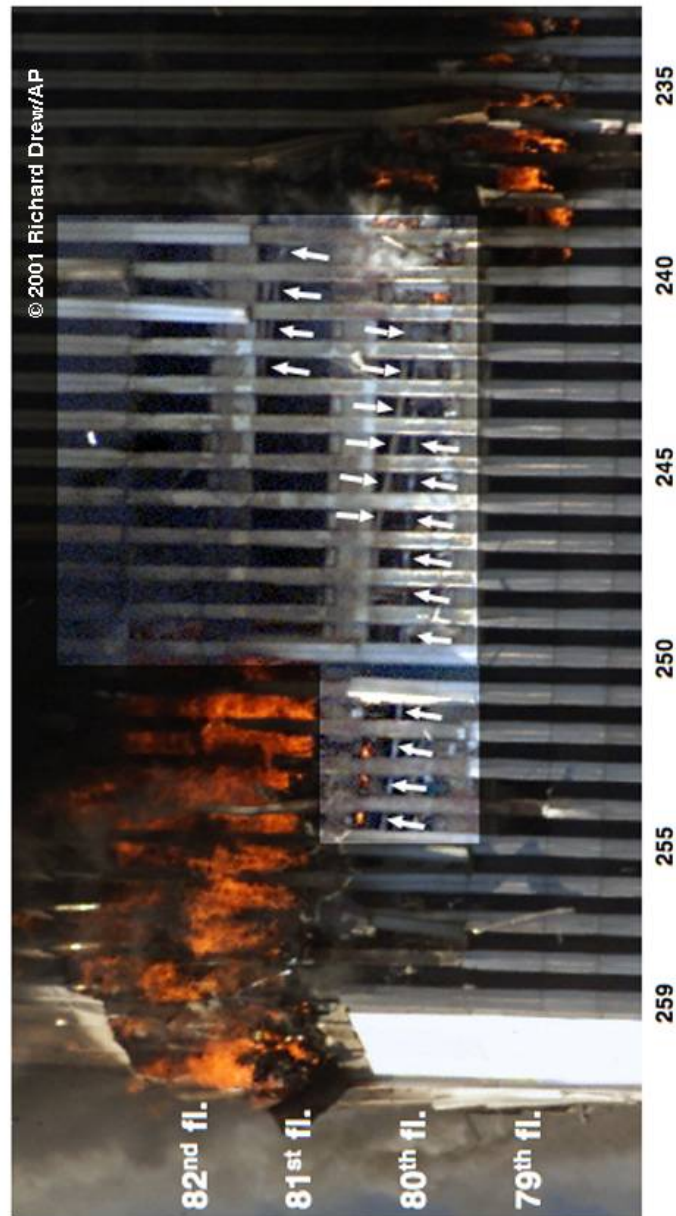
Figure 6-5. Dropped floors on north face of WTC 2.

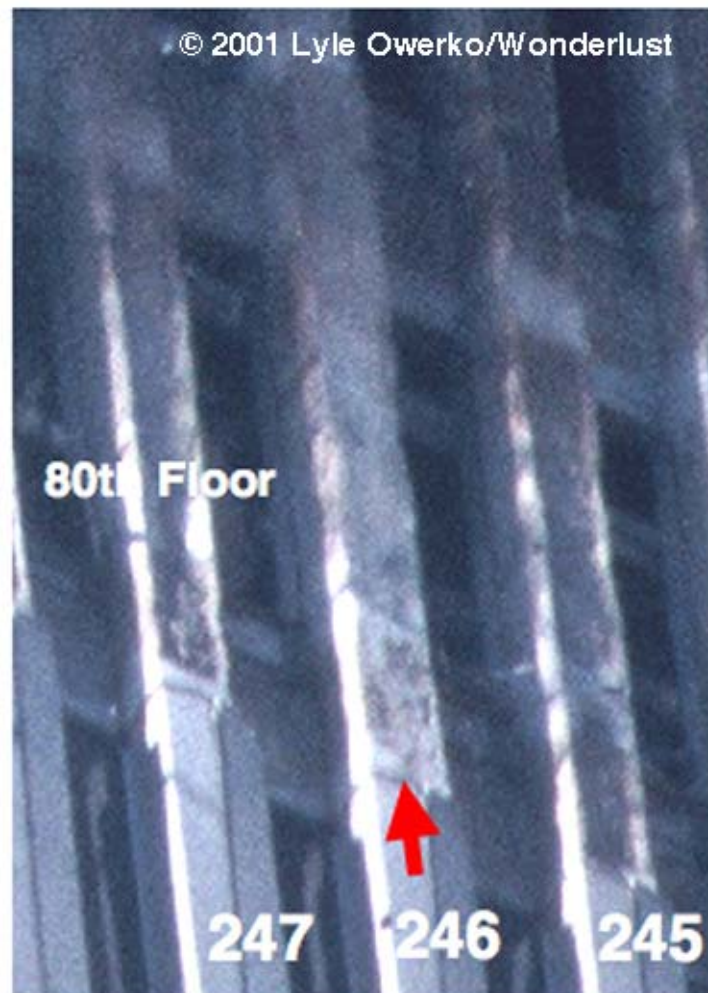
**Figure 6–7. Fireproofing that had been applied to the exterior columns. The depression formed by the outer web and the flange tips are completely filled in with fireproofing at the arrow. North face of WTC 2.**

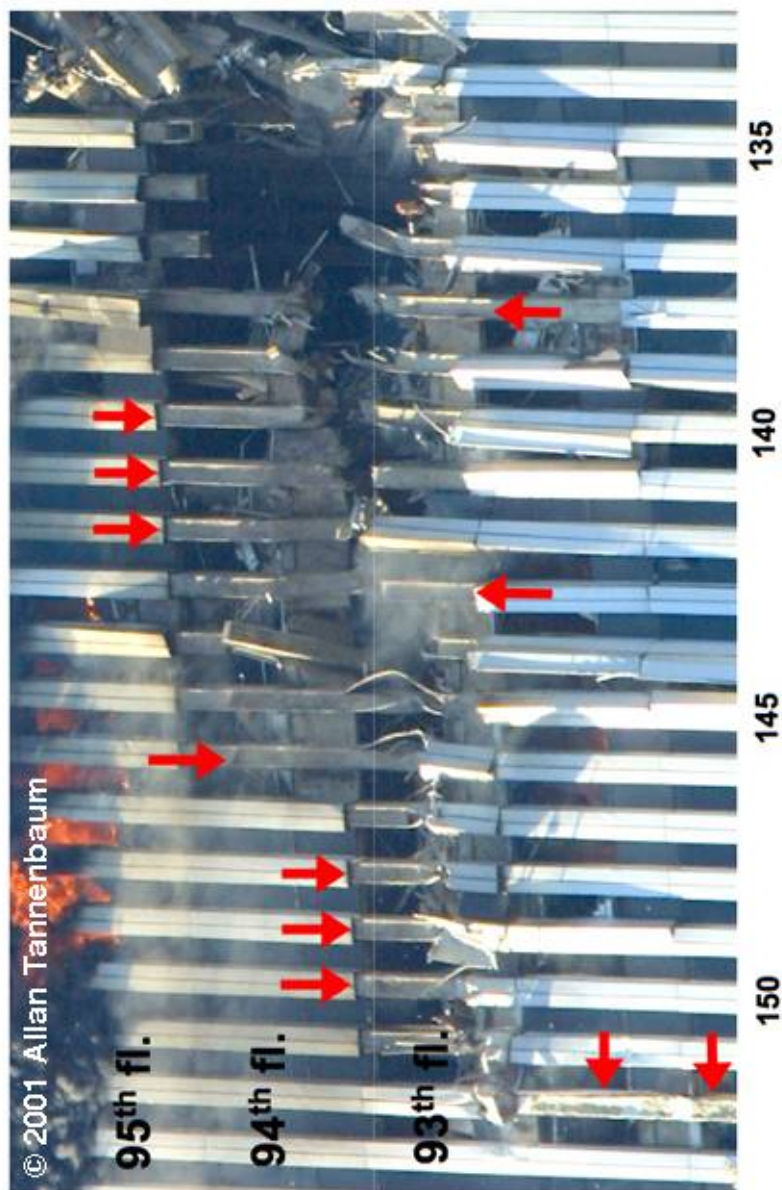
Figure 6–8. Port side of impact hole in north face of WTC 1 showing missing fireproofing. The red arrows indicate a few of the many instances of missing fireproofing around the impact hole. The region roughly approximated as the area where the aluminum panels were dislodge has been digitally enhanced for clarity.

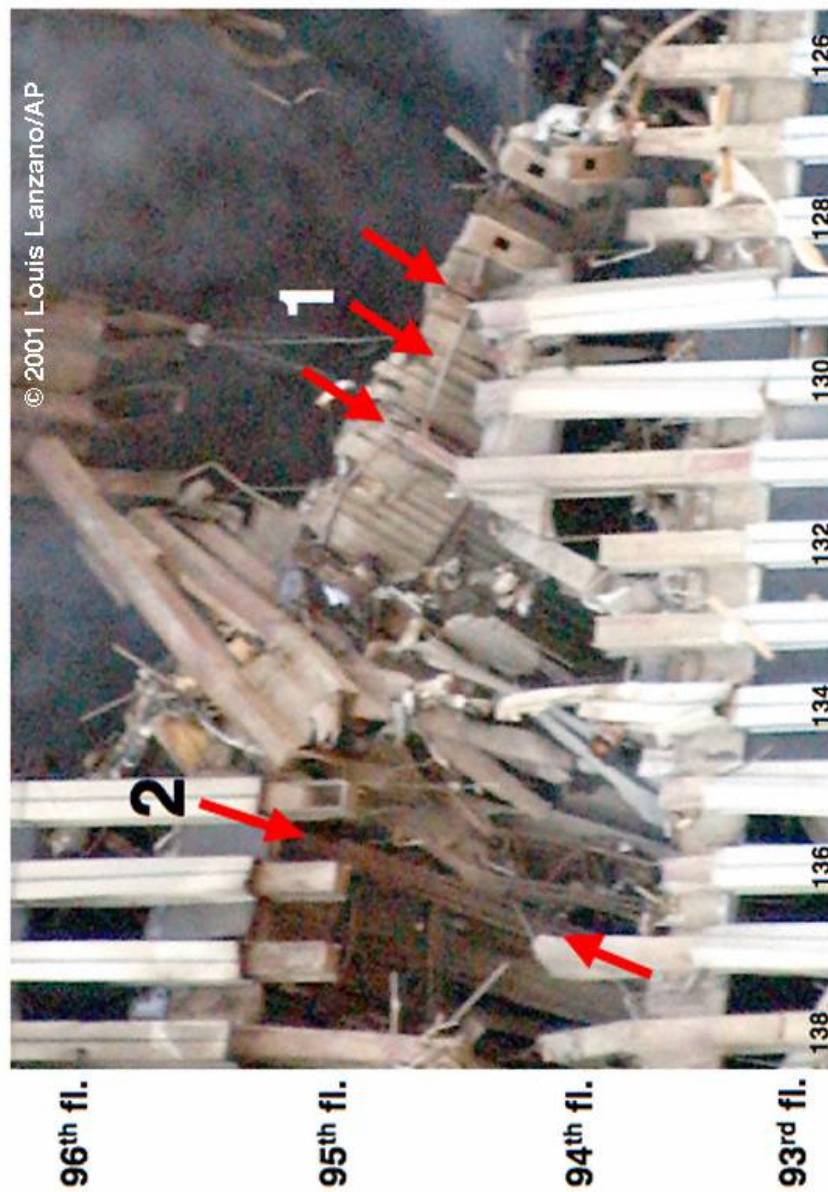
Figure 6-9. Missing fireproofing on floor trusses that fell into impact hole on north face of WTC 1. The arrows labeled “1” are three trusses where the lower or upper chords can be seen, and can distinguish the line that separates the two angle iron components. The arrows labeled “2” lie at either end of a lower chord of a truss that fell farther inside the building, and is made up of four angle irons (a double truss). The red paint color being visible and the fact that the line between the angle iron can be seen indicated that the fireproofing was displaced.

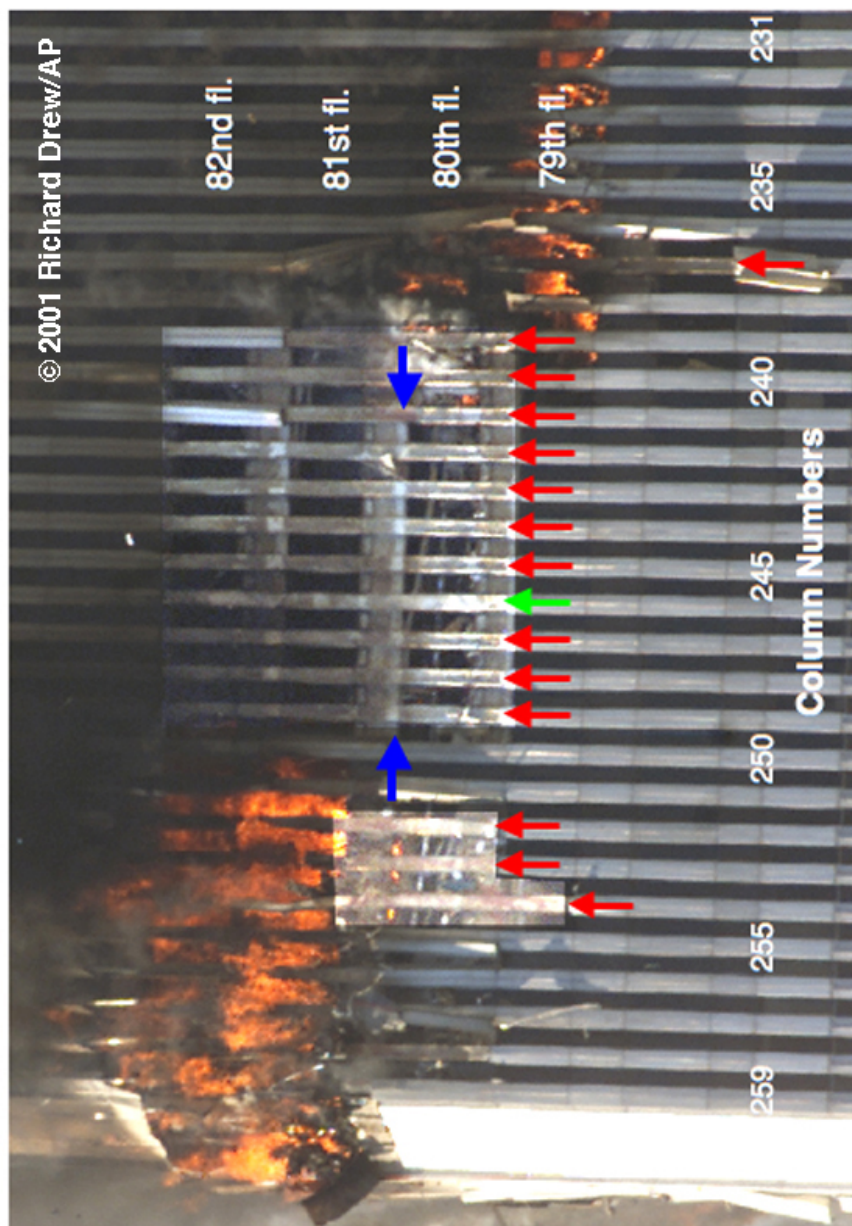
Figure 6–10. Missing façade and fireproofing on north face of WTC 2. Two regions have had contrast and gamma adjusted to enhance visibility of the features. Red arrows indicate columns with missing or damaged fireproofing. Missing or damaged fireproofing determinations were made from this and several other photos taken at different times and angles. Blue arrows indicate white features where some sort of coating has preserved the fireproofing in place.

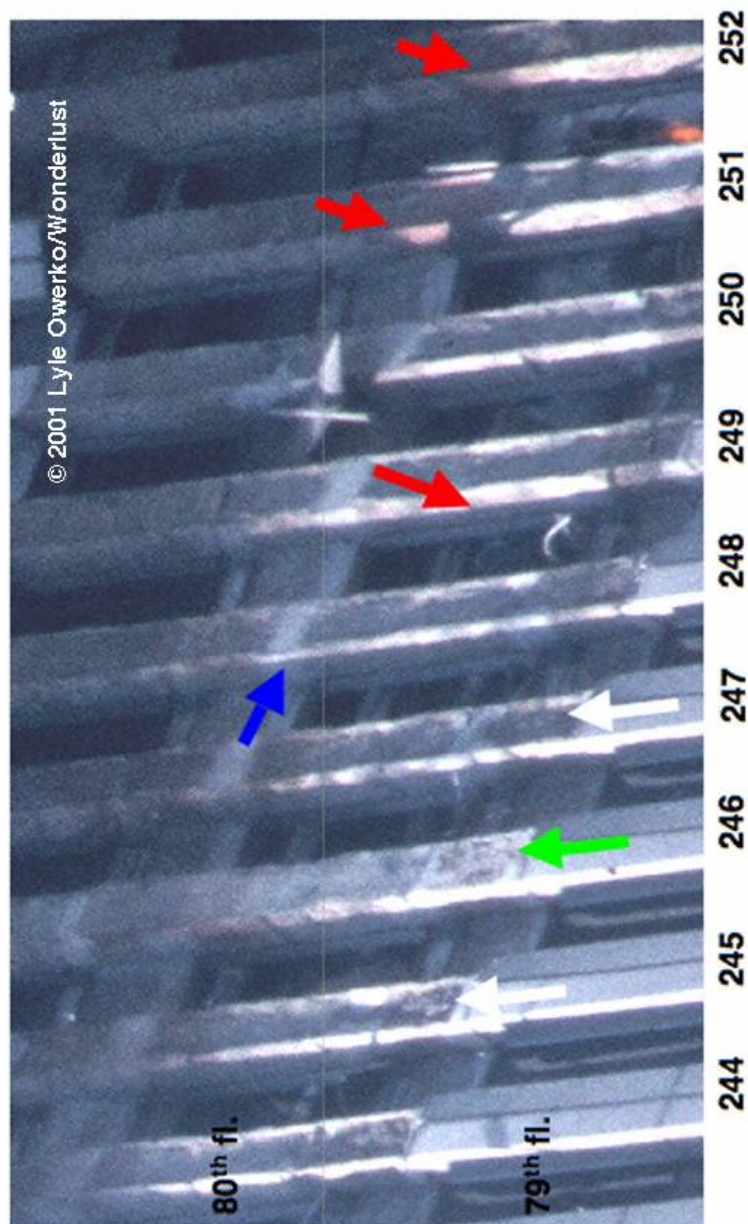
Figure 6-11. Missing fireproofing on flanges of exterior columns of north face of WTC 2. Fireproofing has come off, revealing red Tnemec paint of the column (red arrows). This image also shows how the outer web regions have been partially or completely denuded of fireproofing. Damage is evidenced by shading by sunlight - compare green (undamaged fireproofing) and white (damaged fireproofing) arrows. Blue arrow indicates same type of white coated area of fireproofing as previous figure that adhered when material above and below was dislodged.

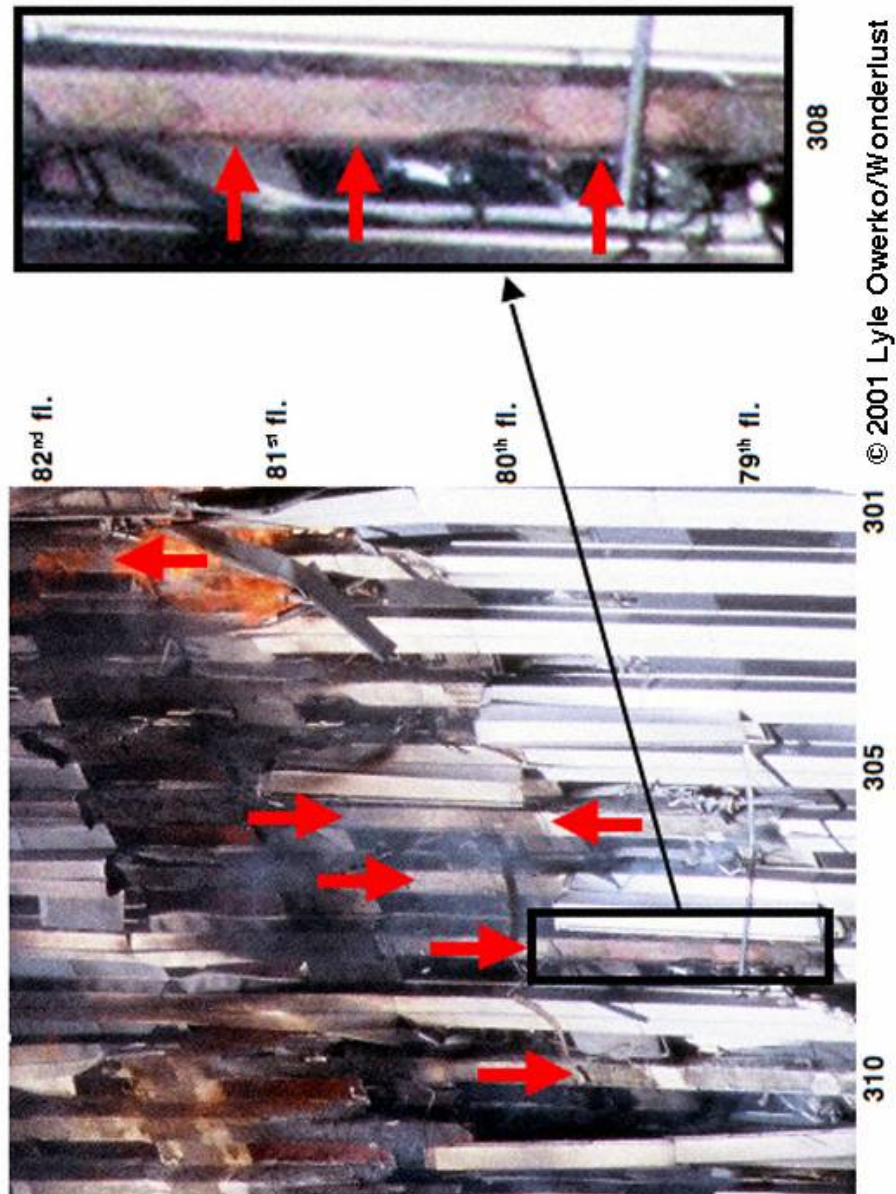
Figure 6-12. Damage to fireproofing on east face of WTC 2 due to internal impact. Red arrows highlight areas where fireproofing has been damaged. The blowup to the right shows a column where the red Tnemec paint of the column is visible.

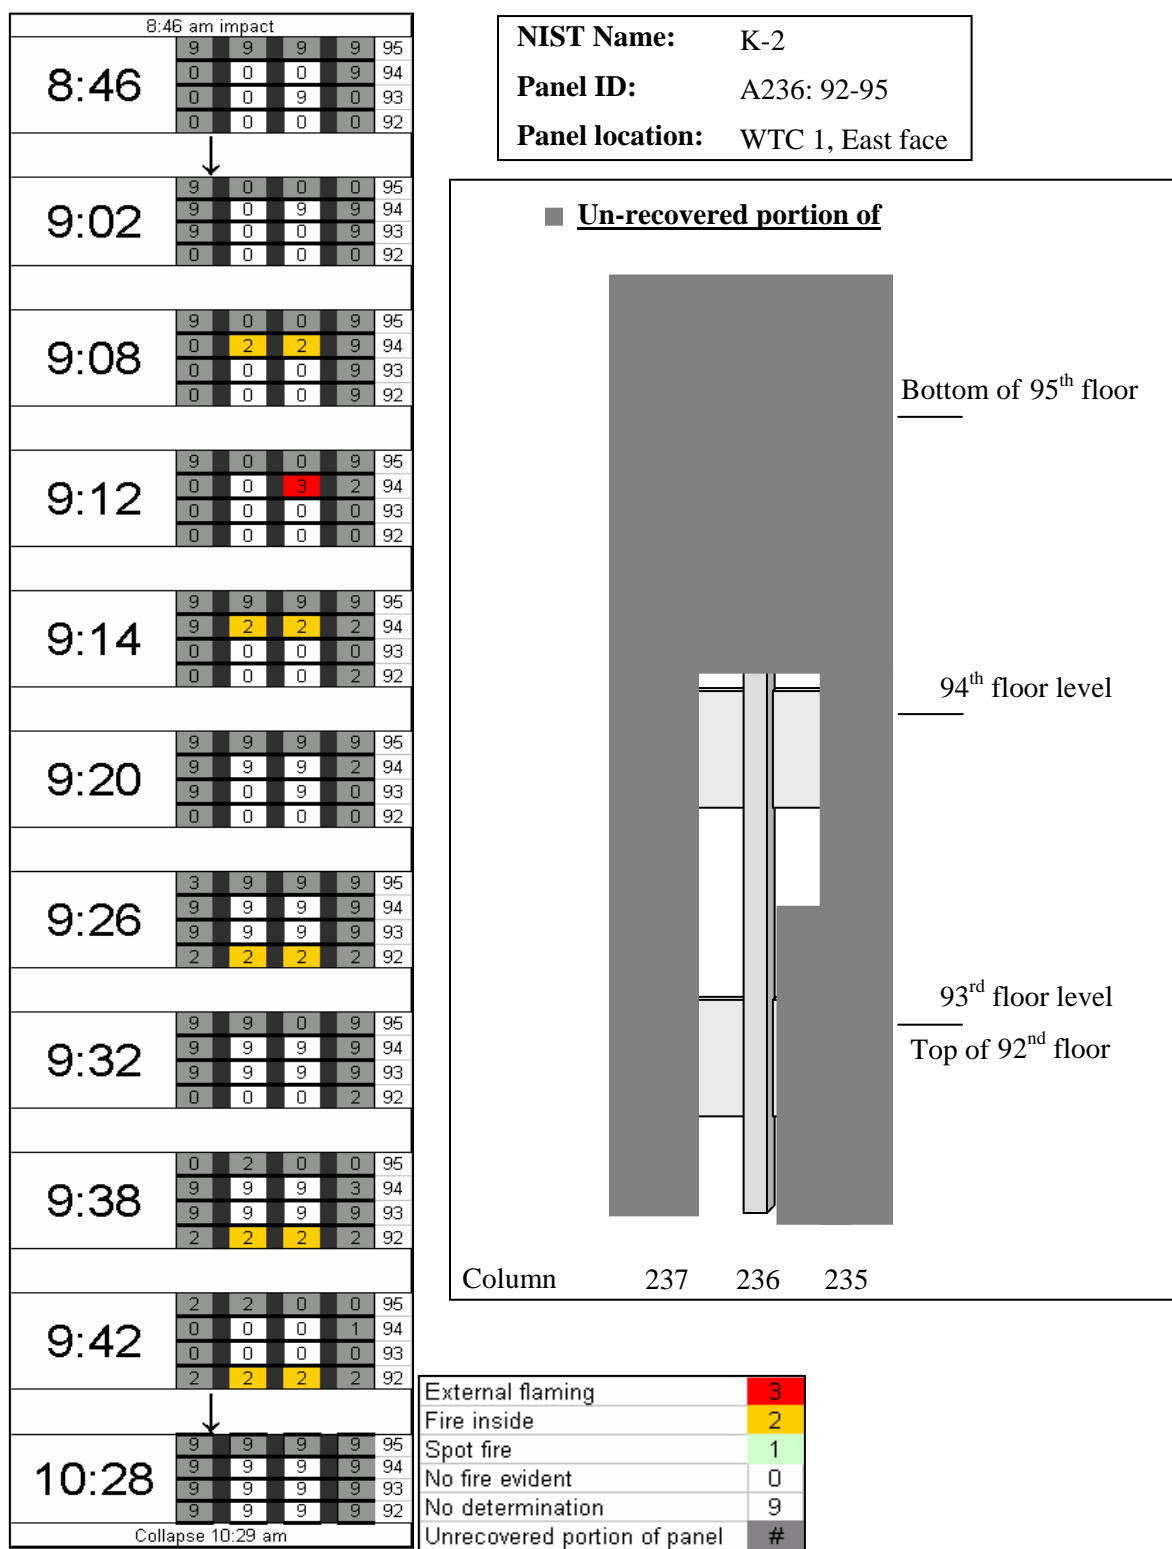
Figure 6–13 displays a time-fire exposure map for panel K-2 (WTC 1, center column line 236, floors 92 to 95). On the right-hand side is a schematic showing the recovered portion of the panel, drawn as if viewed from outside of the building, with the floors and column lines labeled. The “grayed-out” sections of the panel were not recovered, resulting in portions of only six different windows available for inspection. On the left-hand side of the figure, the time line analysis for exposure to fire can be observed for that given panel, along with the color-coded, numerical key. The location of each window for a given

**Figure 6–13. Time-fire exposure map for panel K-2 (A236: 92-95). Fire can be observed on the 92nd and 94th floors of the panel.**

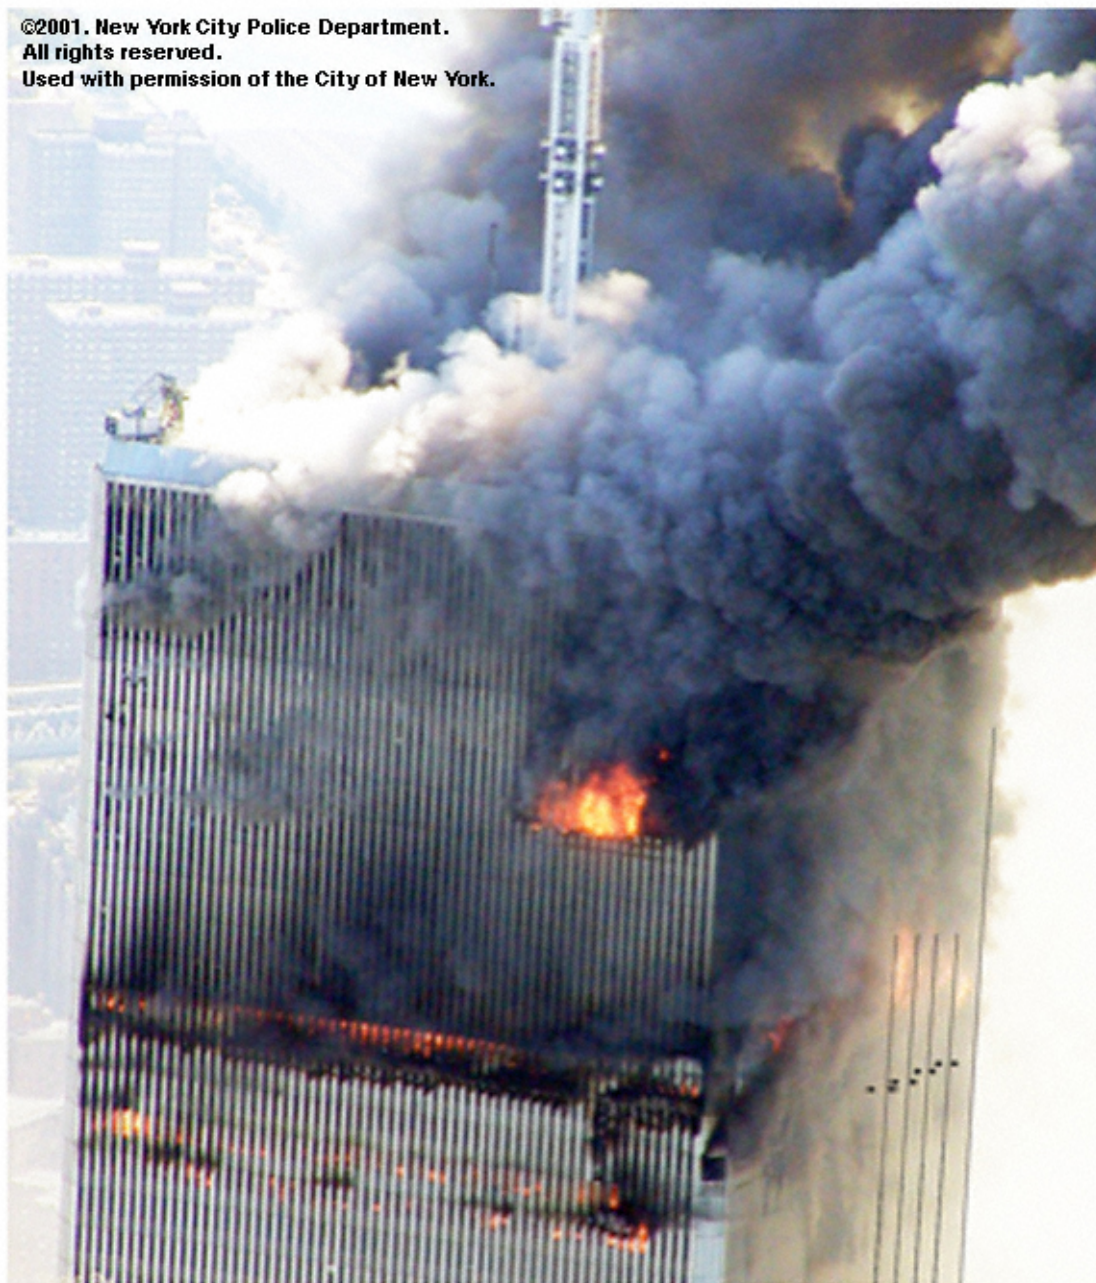
**Figure 6–14. Inward bowing of south face (at right, with dark lines overdrawn) of WTC 1.  
Taken at 10:23 a.m. from an NYPD helicopter.**

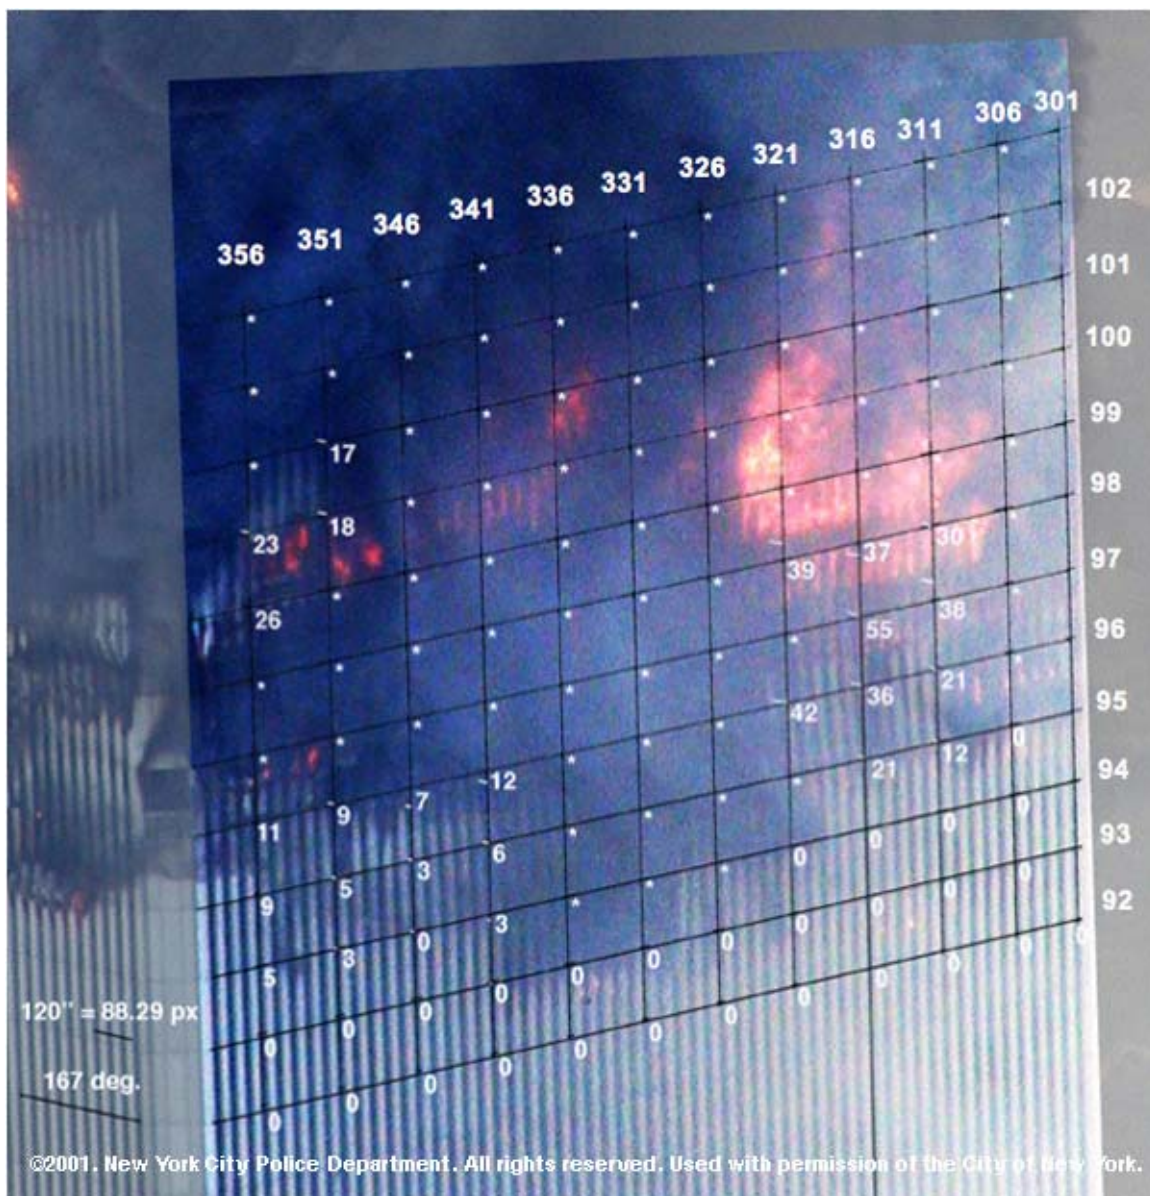
**Figure 6–15. Pull in of south face of WTC 1 at 10:23 a.m. showing considerable displacements of outer columns into the building. Faint white vertical features are the aluminum façade of the exterior. Maximum visible inward displacement of the columns is 55 in. +/- 6 in. Poor resolution leads to large uncertainties in measurements; a large fraction of the south face of the building is obscured by smoke.**

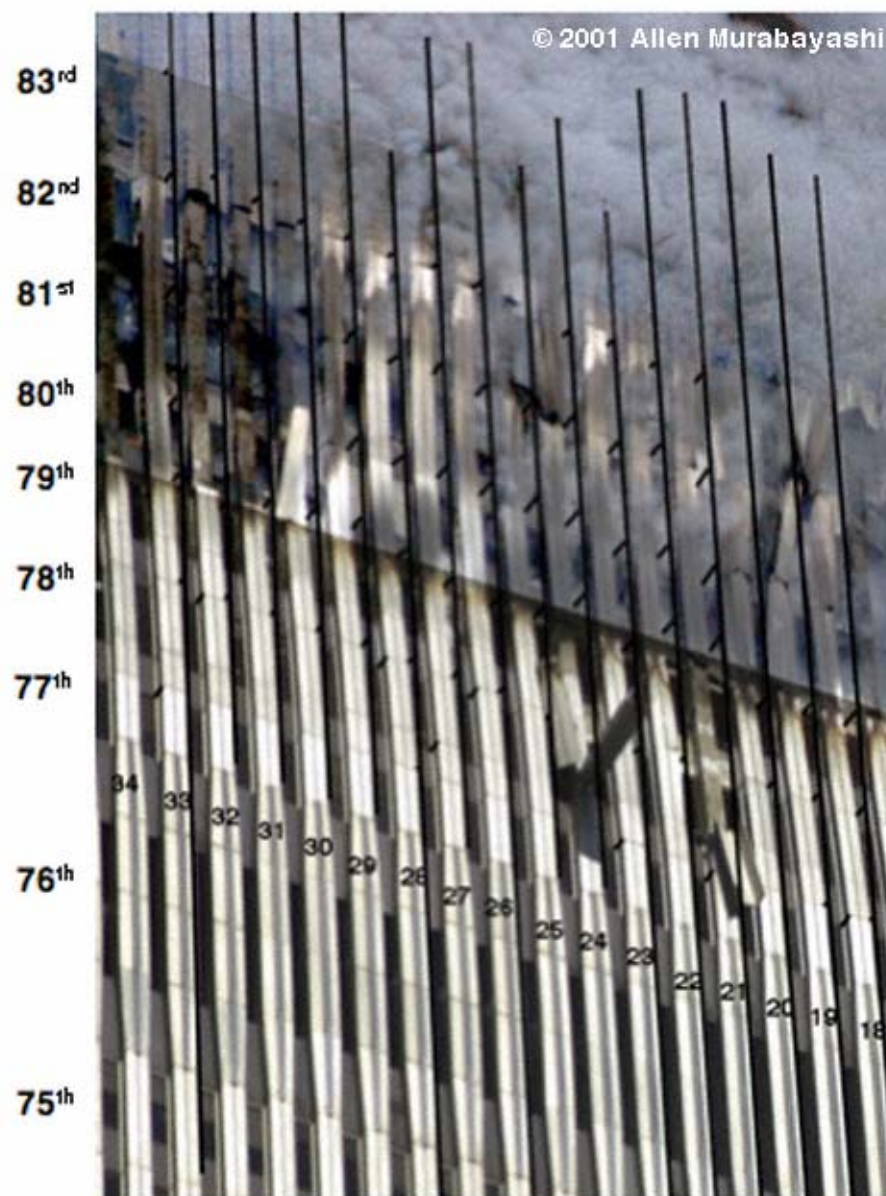
**Figure 6–16.** East face of WTC 2 at 9:53:04 a.m. showing a larger amount of pull in. The vertical black lines were drawn to establish the original line of the exterior wall columns, and the shorter line segments are drawn at the same angle as the nearest observable joint in the exterior aluminum panels to establish the inward bowing distance. For actual column numbers, add a “3” to the front of the two-digit designations in the image.

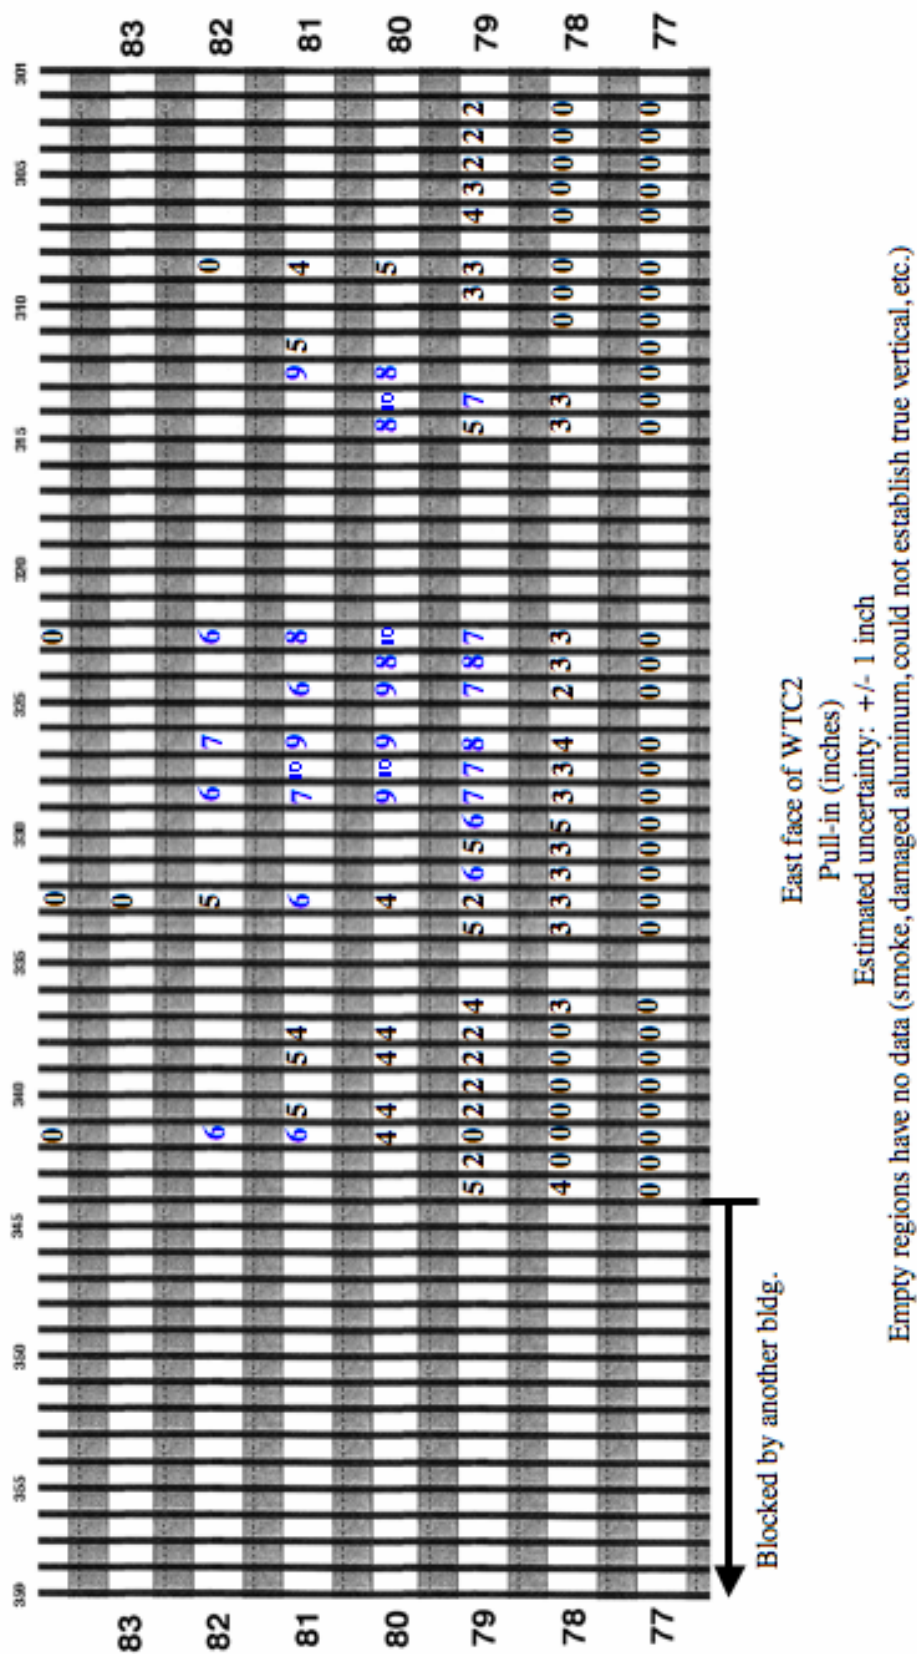
Figure 6-17. Map of inward displacements of the east outer face of WTC 2 inward at 9:21:29 a.m. Each measurement refers to the upper left corner of the window within which the number resides. Measurements were in inches. The colors refer to groups of 5 in. displacements (0-5: black, 6-10: blue) for easier visualization.

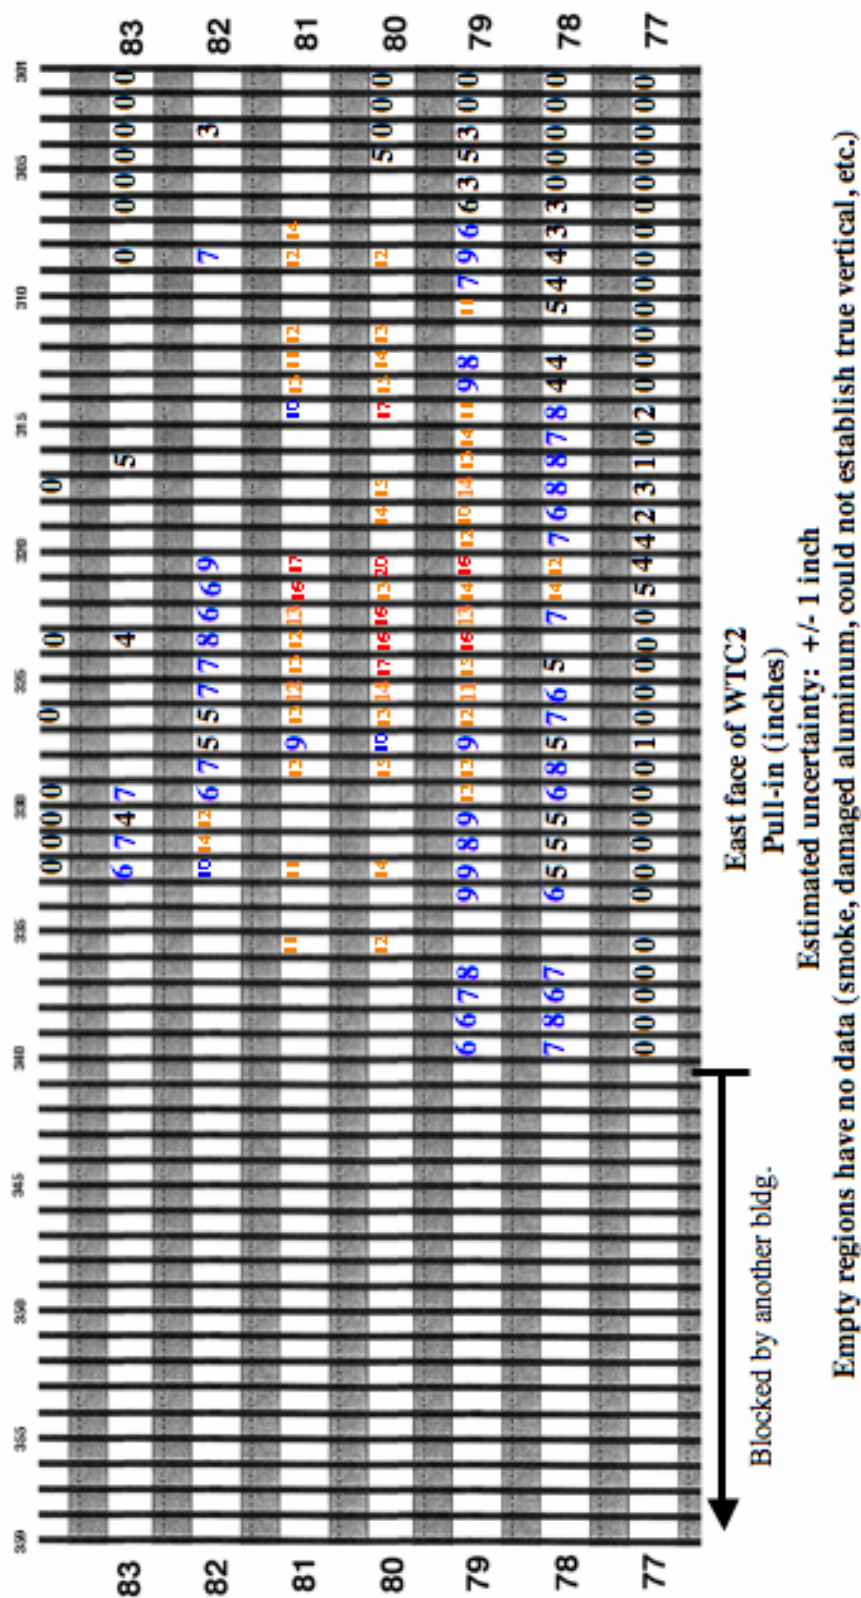
Figure 6–18. Map of pull in displacements of the east outer face of WTC 2 inward shortly before collapse. Each measurement refers to the upper left corner of the window within which the number resides. Measurements were in inches. The colors refer to groups of 5 in. displacements (0–5: black, 6–10: blue, 11–15: orange, 16–20: red) for easier visualization. This data was combined from two images taken by the same photographer at nearly the same location 10 s apart, and it is assumed that the inward deflection did not change appreciably during this time.

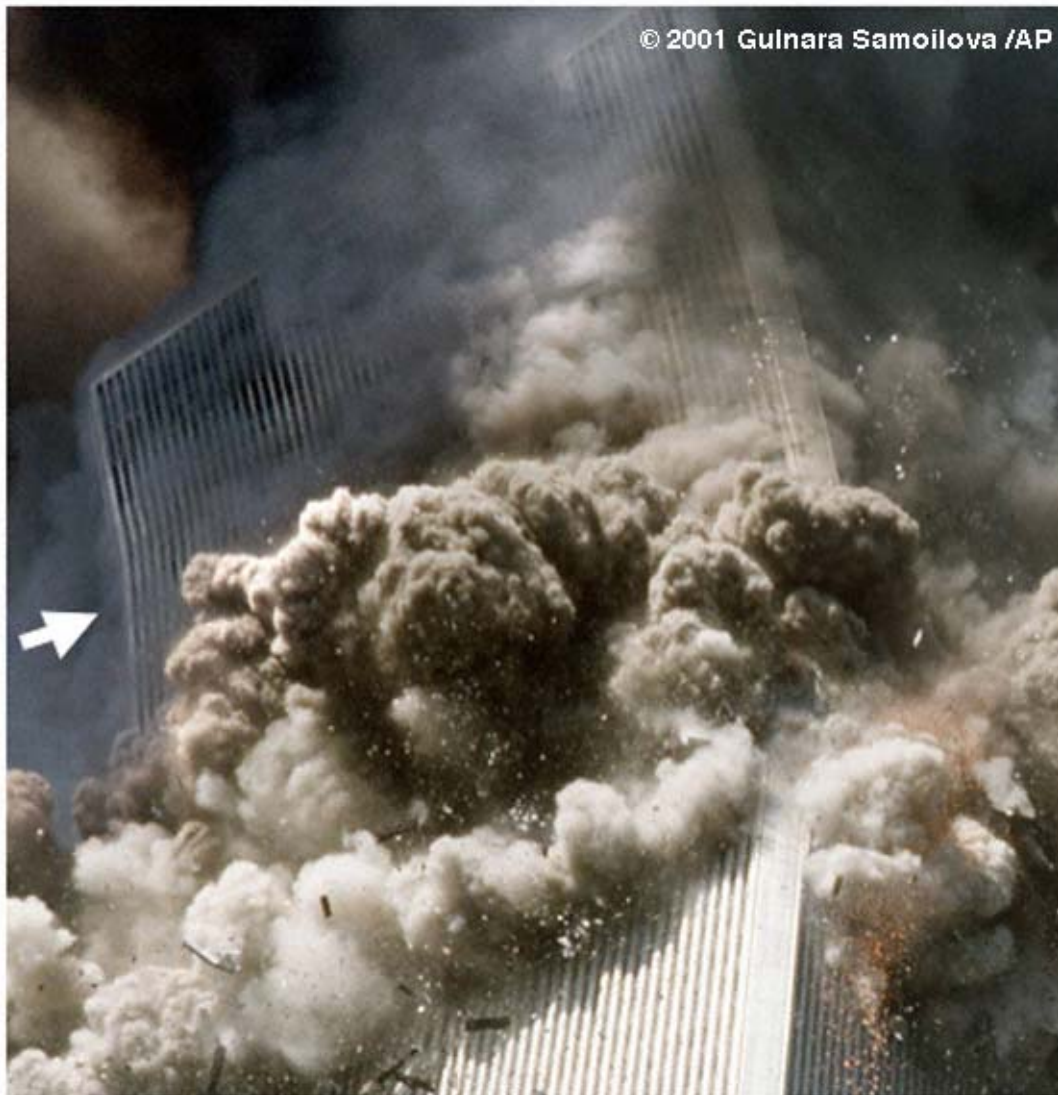
**Figure 6–19. Initial seconds of collapse of WTC 2 viewed from the east-northeast, and kink in the southeast edge of the building near the 106th floor (arrow).**
