**NIST NCSTAR 1-3 (Draft)**

**Federal Building and Fire Safety Investigation of the  
World Trade Center Disaster**

# **Mechanical and Metallurgical Analysis of Structural Steel (Draft)**

September 2005

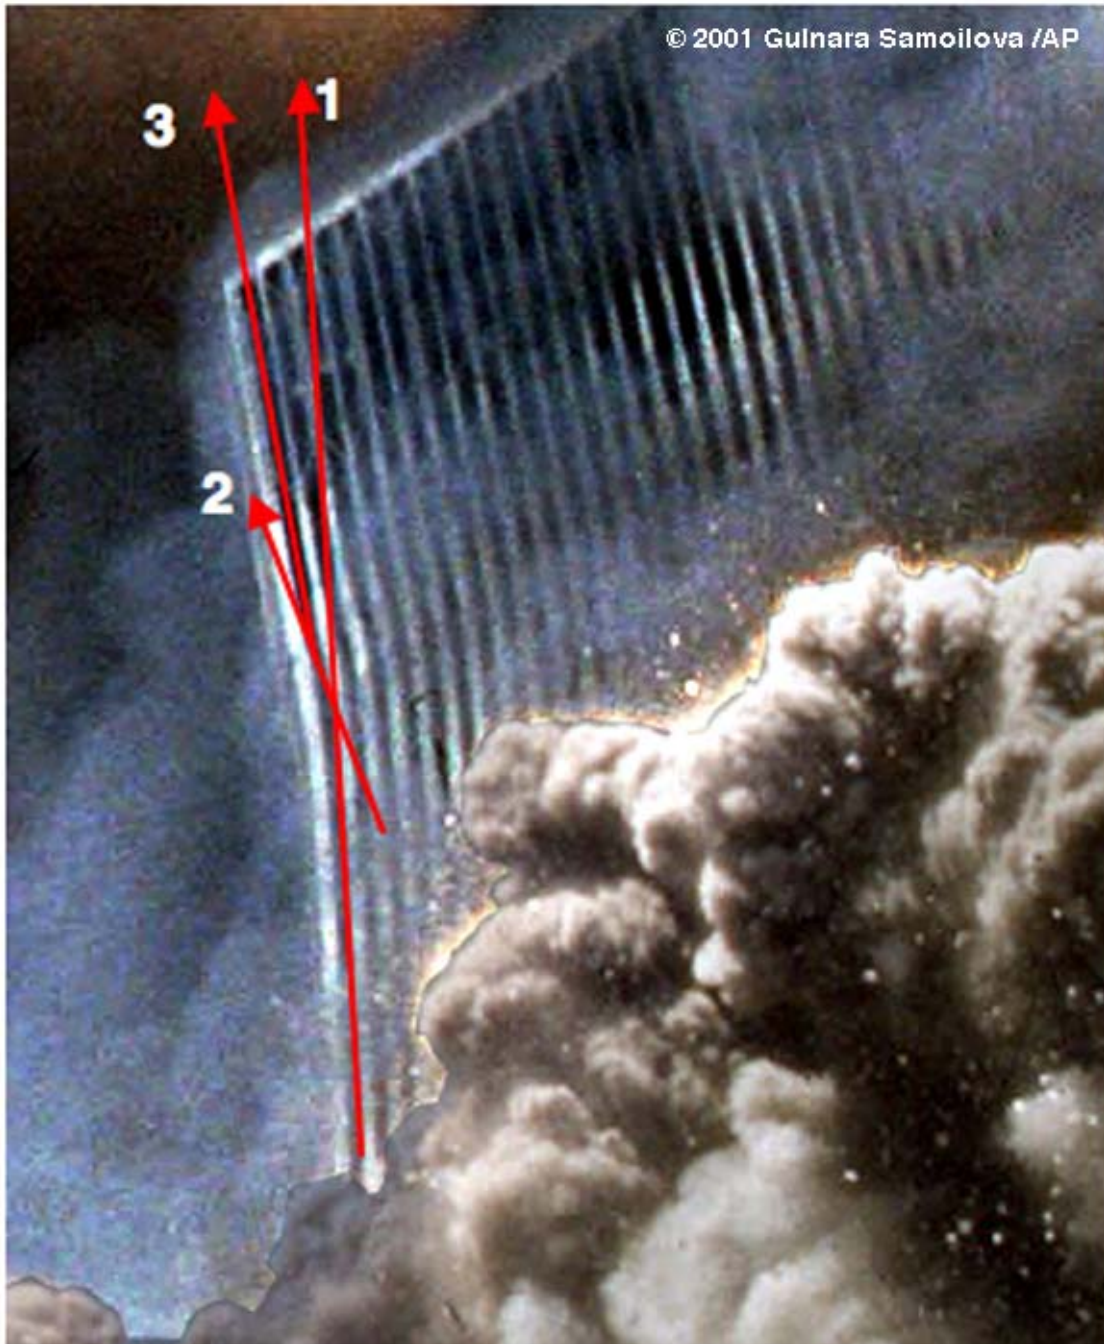
**Figure 6–20.** A close-up of the kink area in the previous figure (southeast corner, WTC 2), with overlaid lines to highlight the details of the kink geometry. The edge of the building (1) bends an angle to another direction (2), then bends back somewhat toward the original direction (3).

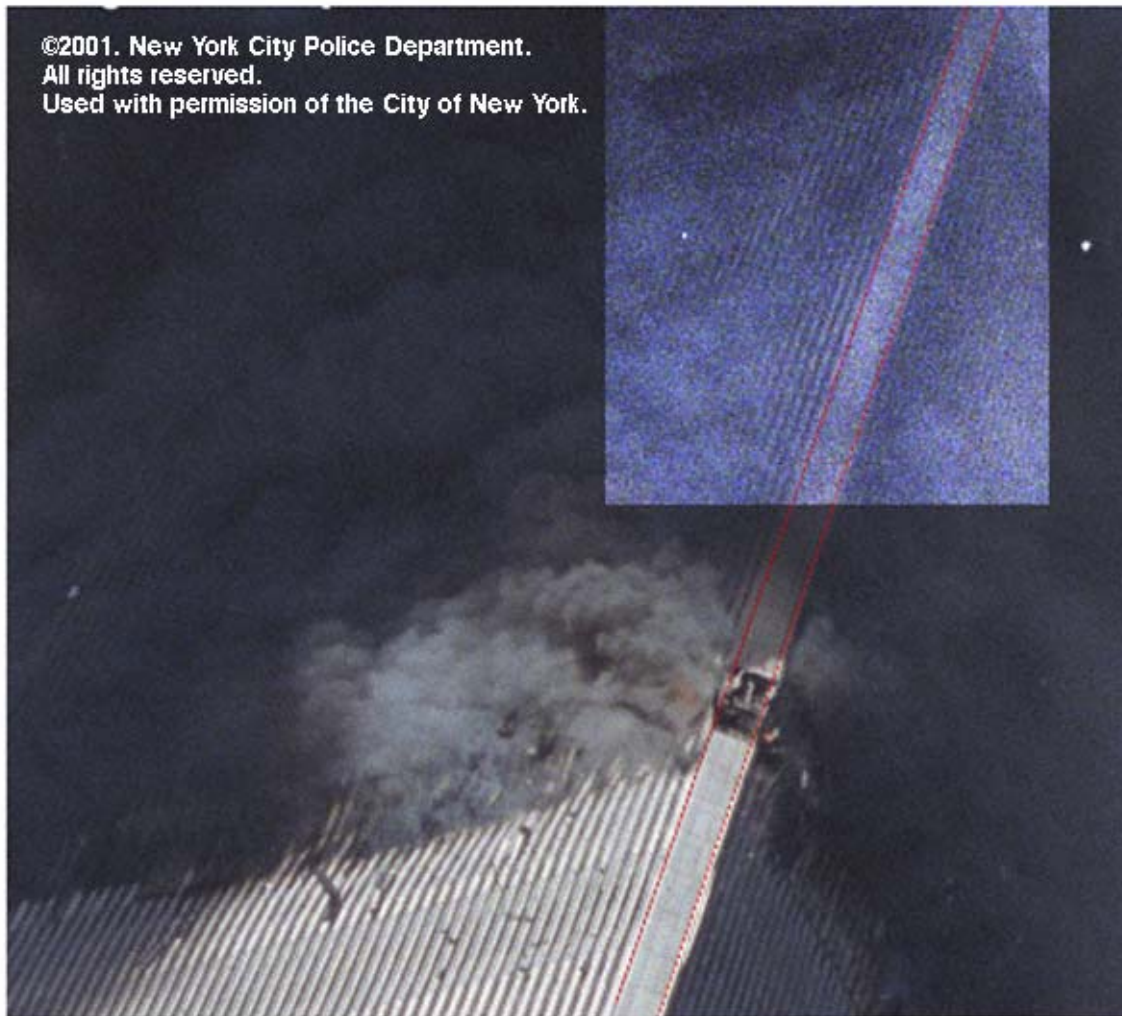
**Figure 6–21. Northeast corner of WTC 2, several seconds before collapse. The corner shows no distortion of the type in the previous figure, implying that the distortion accompanied the collapse and did not precede it. The region in the upper right is enhanced for visibility.**

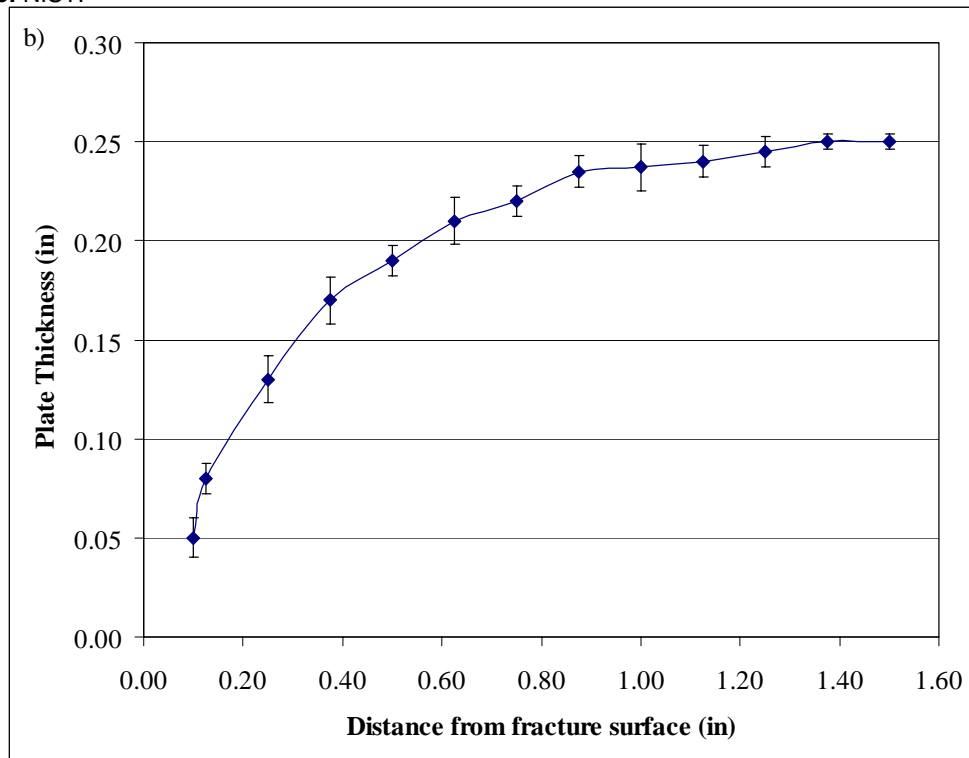
**Figure 6–23. Thinning of outer web from column 130 of panel M-2 (A130: 96-99).**  
**a) Photograph showing thinning, b) graph indicating plate thinning near fracture surface.**

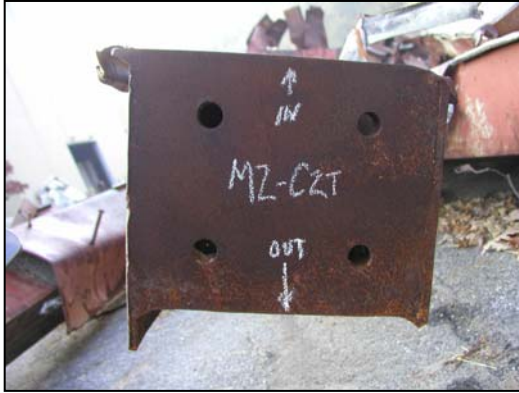
No change in bolt  
hole shape

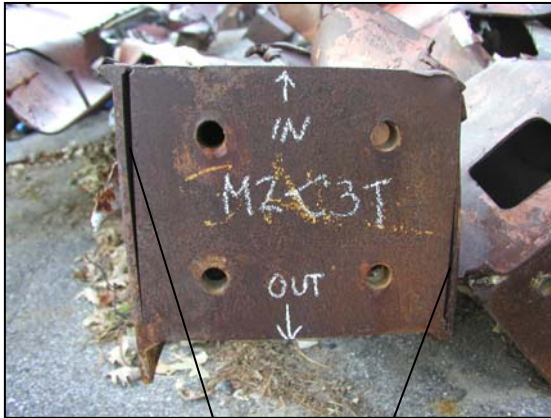
Separation between flange  
plates and butt plate

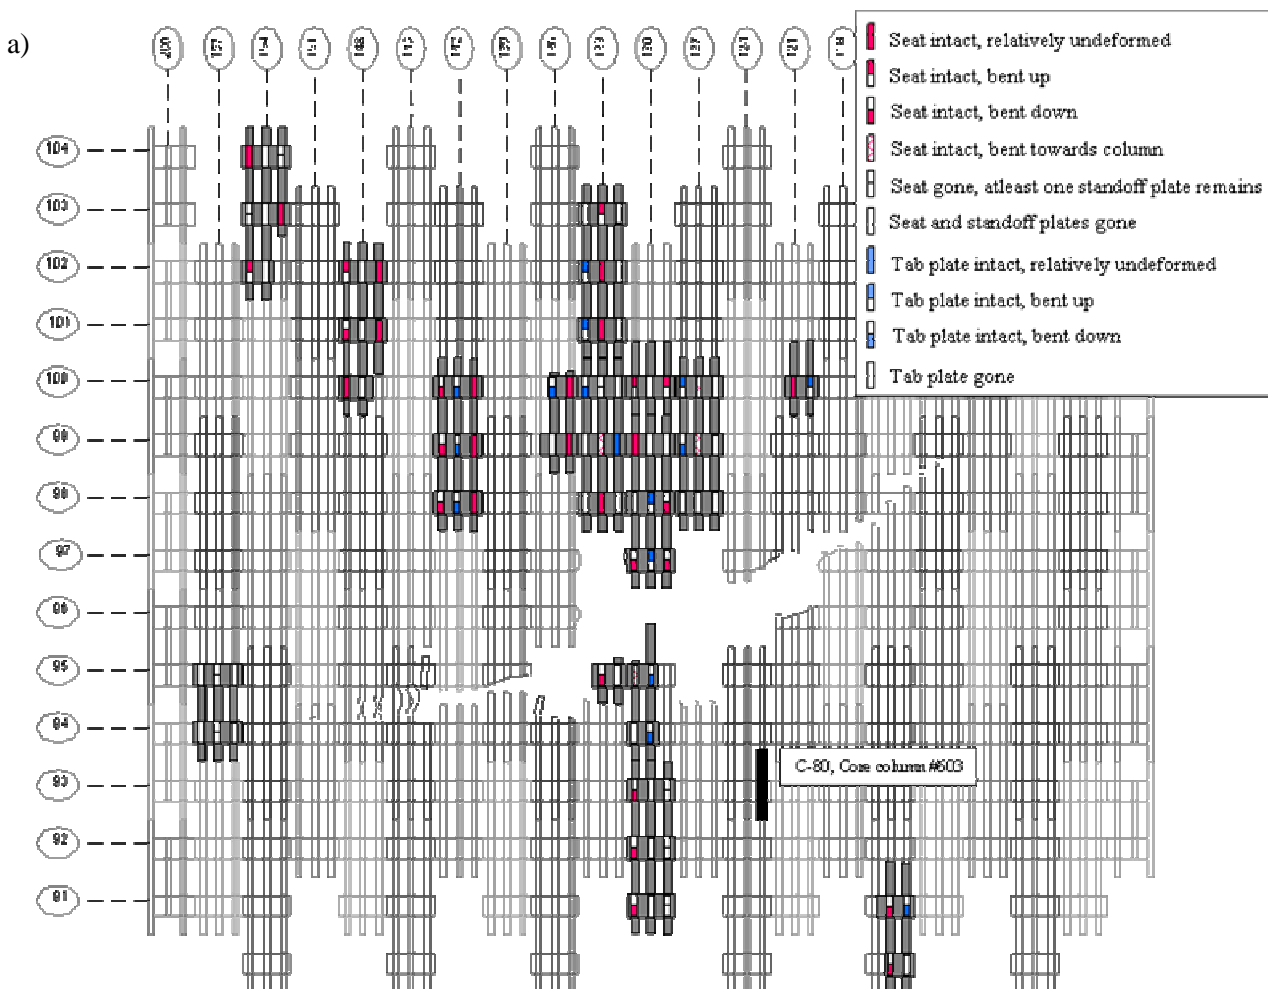
Figure 6-28a. Damage diagram overlaid with recovered samples and damage of connectors.

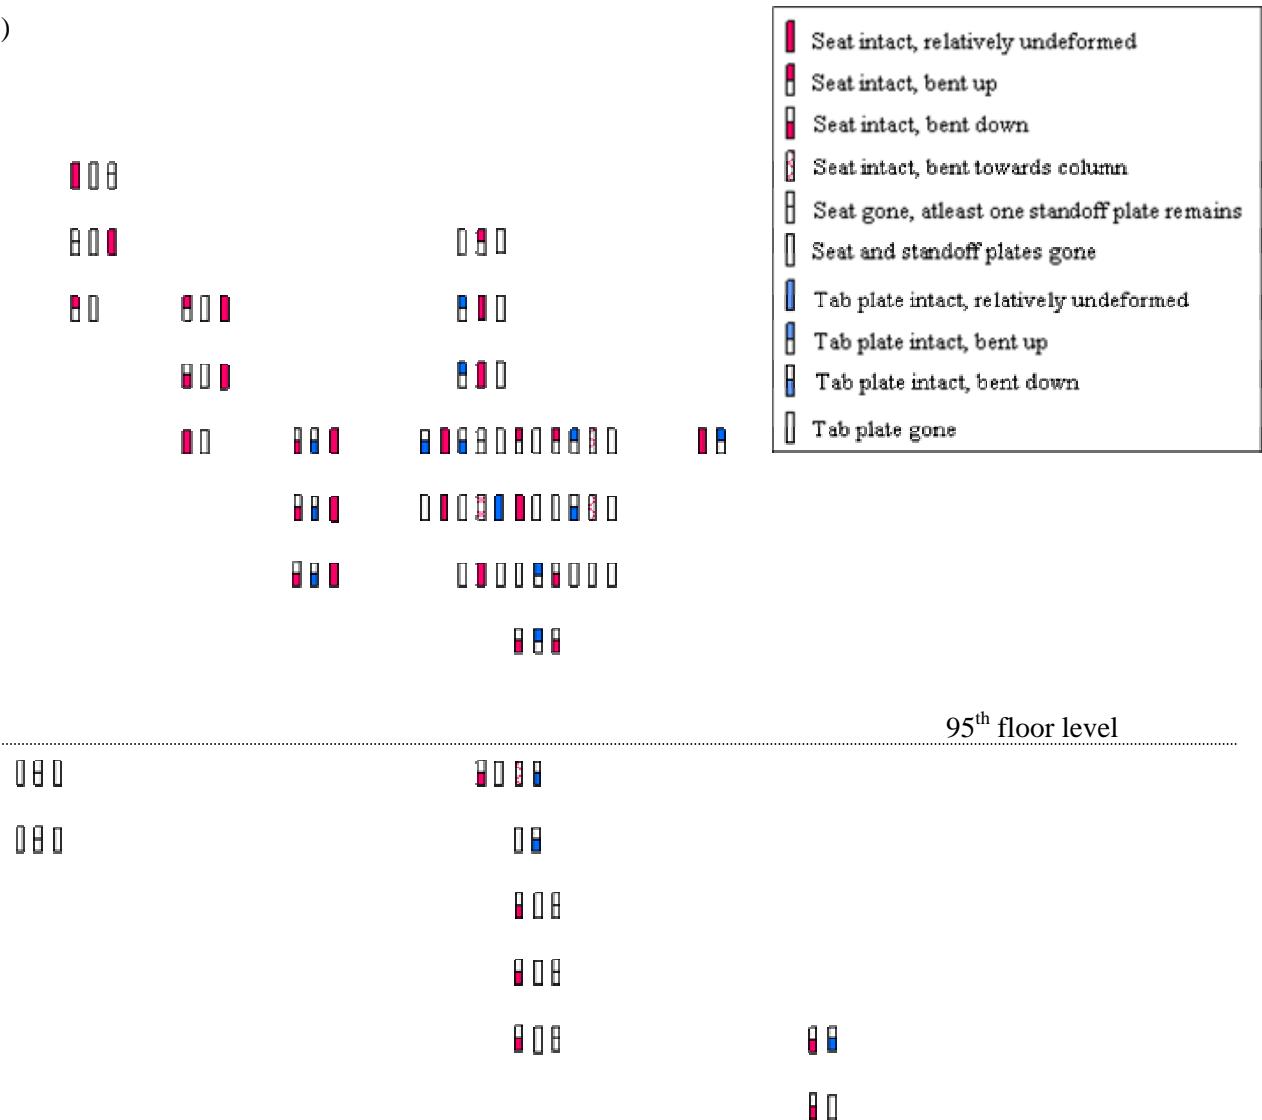
**Figure 6–28b. Damage of connectors. At or below the 95th floor, all connectors are either bent down or missing.**

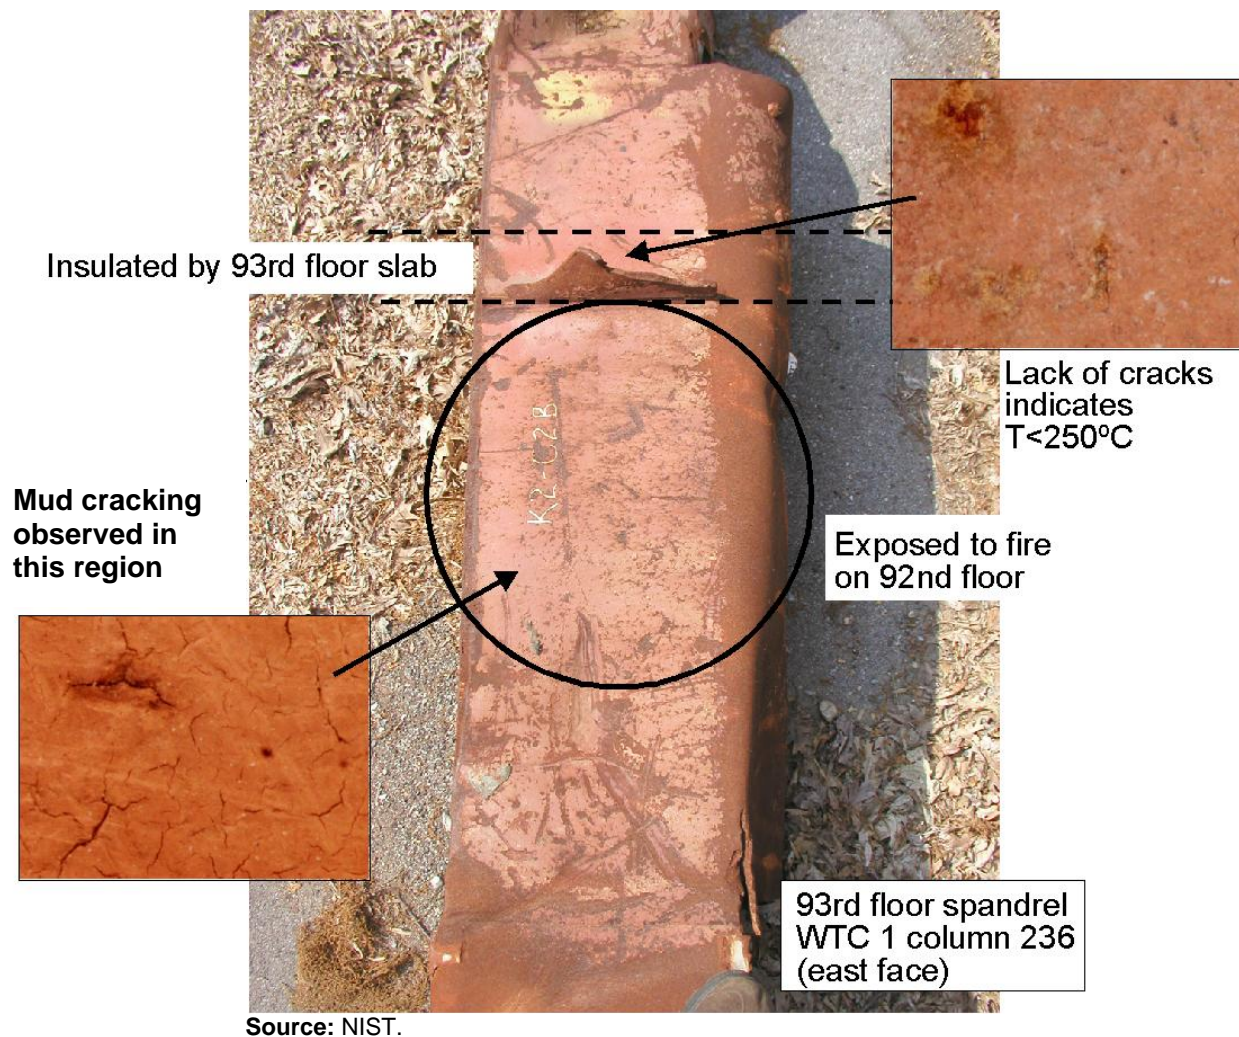
**Figure 6–37. Spandrel at the 93rd floor of column 236 from sample K-2 (A236: 92-95). Paint mud cracking was found below the 93rd floor line, no evidence of paint mud cracking was found above floor line.**
