Smoke Control and Occupant Evacuation at the World Trade Center

ABSTRACT

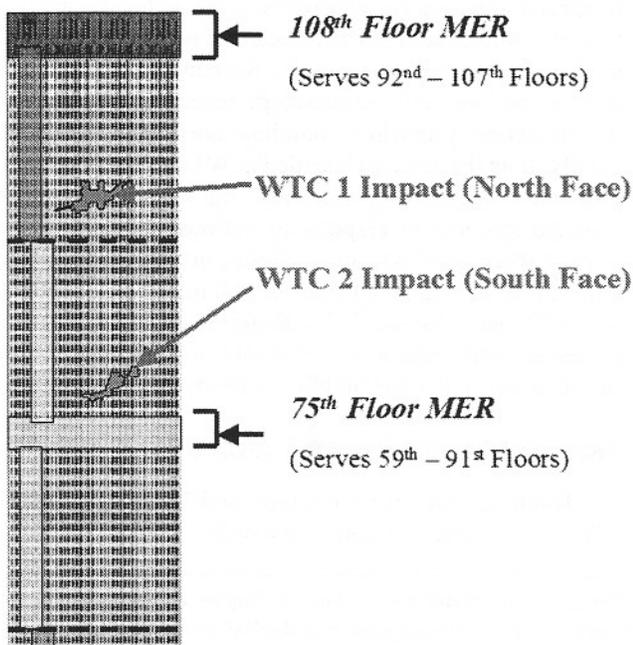
Building ventilation (heating and cooling) was provided in WTC 1 and WTC 2 by HVAC systems located in four mechanical equipment rooms (MERs) located on the 7th, 41st, 75th, and 108th floors of each building. Each MER was approximately two stories tall and had an upper and lower level. With the exception of the 108th floor MER, which was located at the top of the building, above the floors that it served, the MERs served the floors immediately above and below the floors on which they were located. The aircraft impact into WTC 1 occurred in the uppermost portion of the building (92nd–98th floors), served from above by the 108th floor MER. The aircraft impact into WTC 2 occurred lower in the building (77th–84th floors), served from below by the 75th floor MER.

Figure 1 Location of MERs for WTC 1 and WTC impact zones.
