NIST Technical Note 1796

# **A Case Study of a Community Affected by the Witch and Guejito Fires: Report #2 – Evaluating the Effects of Hazard Mitigation Actions on Structure Ignitions**

May 2013

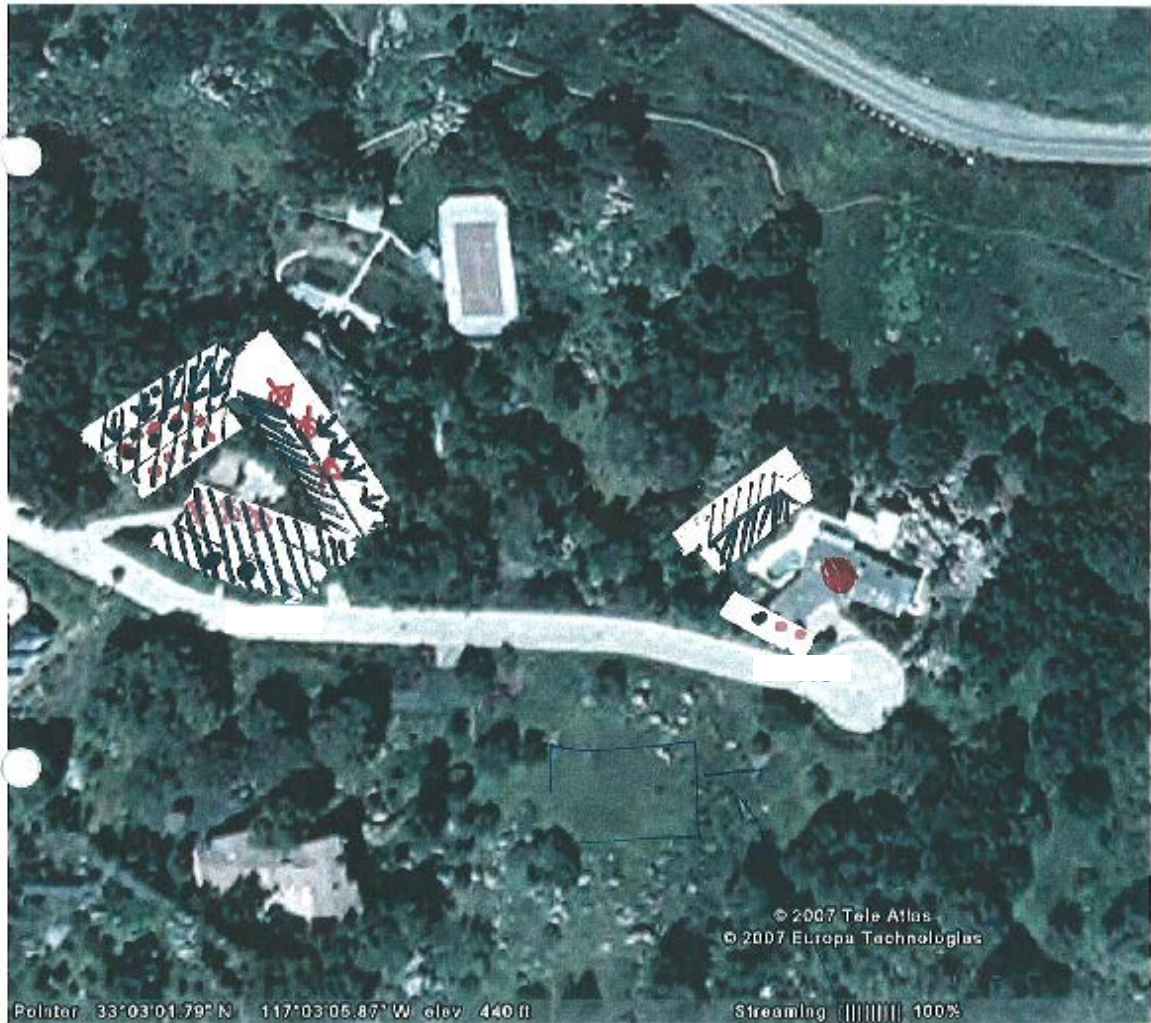
M4-7

FIRE SPREAD N/E  
Appears patio on EAST end  
was contributing factor
