**NIST Special Publication 1164**

# **Preliminary Reconnaissance of the May 20, 2013, Newcastle-Moore Tornado in Oklahoma**

Erica D. Kuligowski  
Long T. Phan  
Marc L. Levitan  
*Engineering Laboratory  
National Institute of Standards and Technology*

December 2013

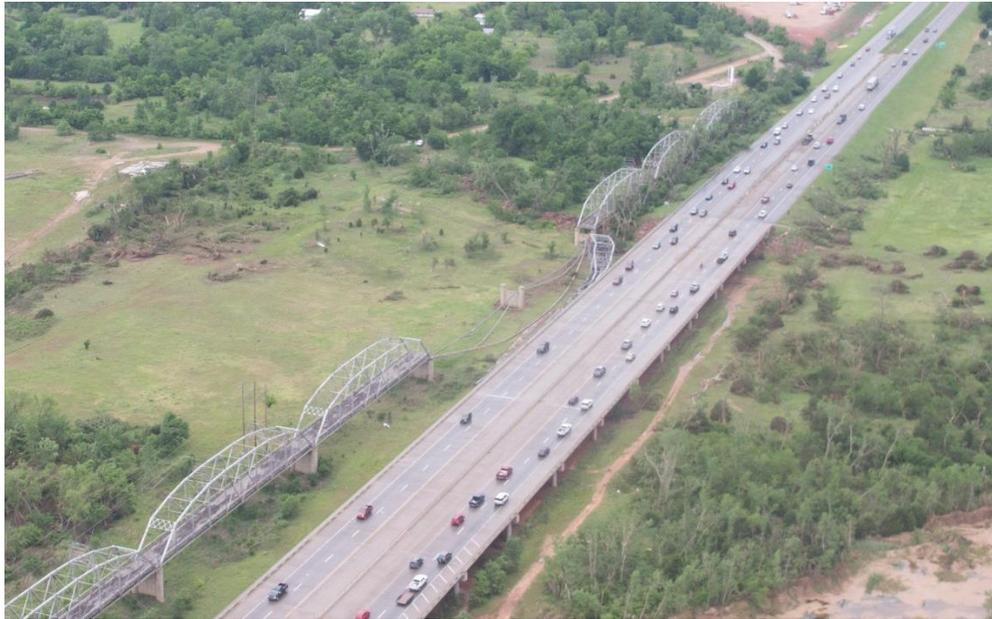
Figure 2-5. Two spans of the historic trestle bridge on US 62 running parallel to I-44 were destroyed. The bridge had been closed to traffic since 1963 but carried water pipes across the Canadian River.

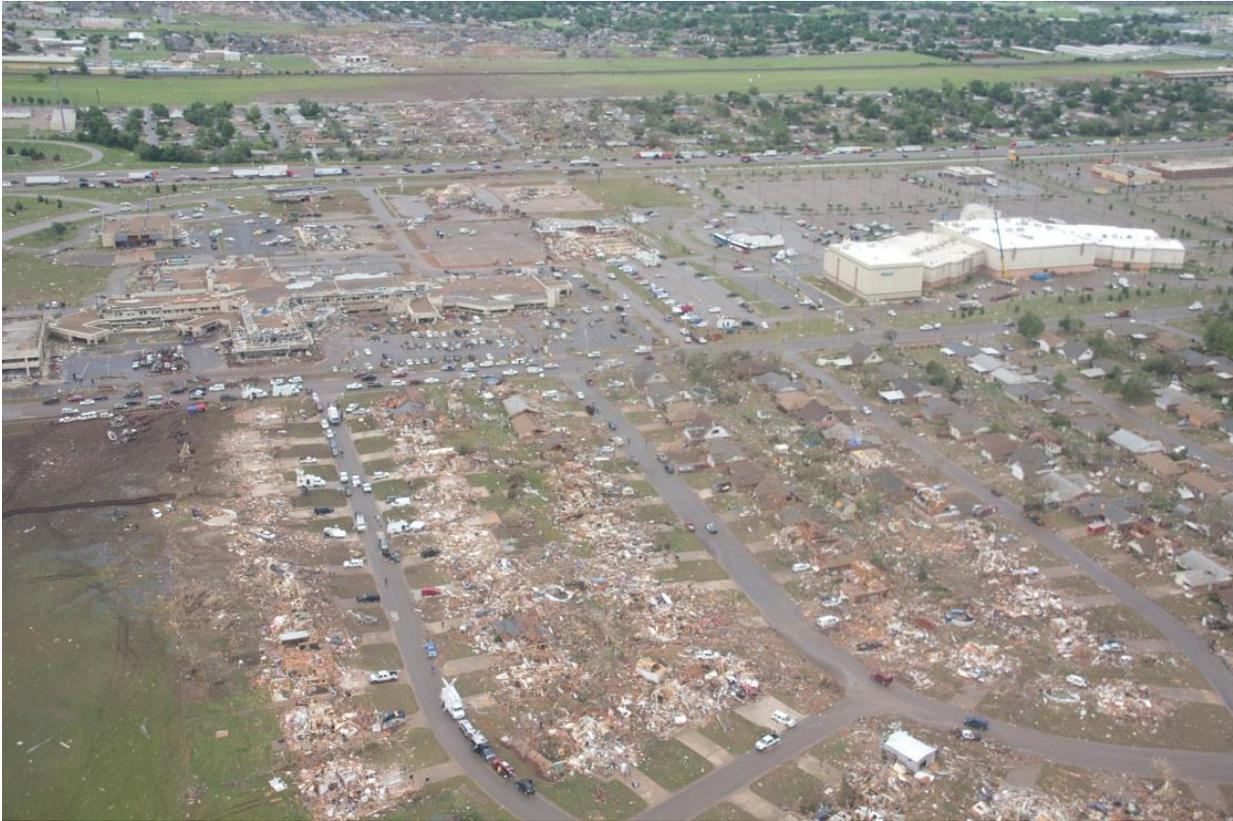
Figure 2-6. Aerial view (facing east) of damage to the Moore Medical Center (upper left), with heavily damaged residential neighborhood immediately west of the Medical Center in the foreground.

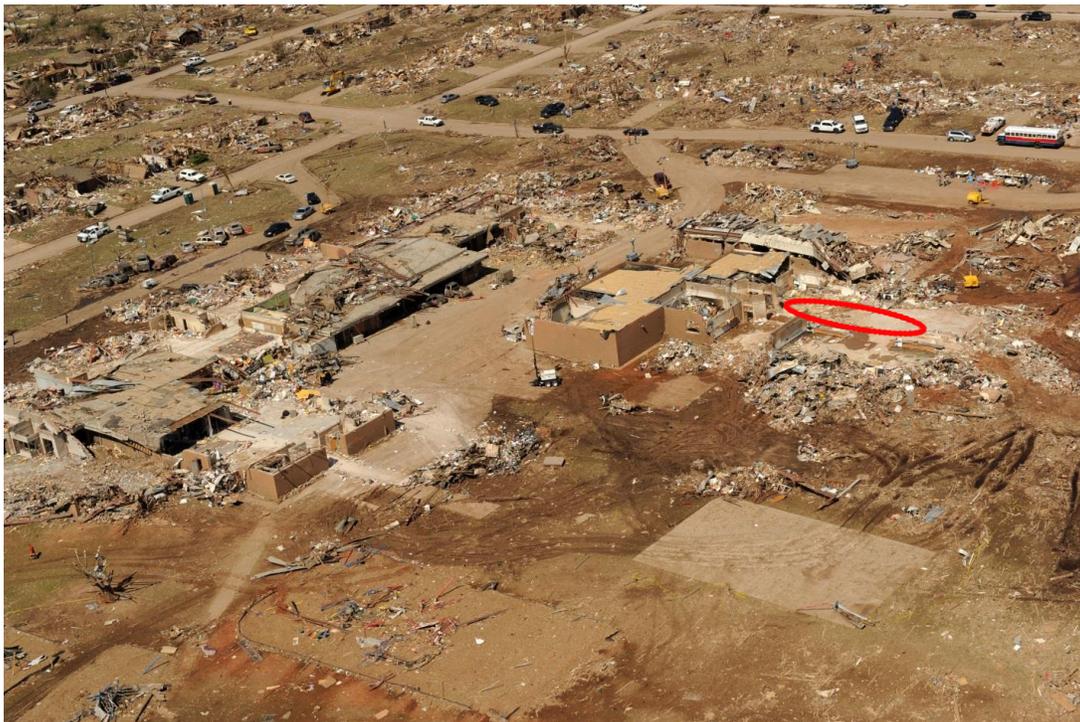
Figure 4-5. Post-tornado aerial view (looking northeast) of the Plaza Towers Elementary School taken May 21, 2013. Much of the debris had already been moved by the time of this photograph as part of the search and rescue operations. The area circled in red shows the approximate location in the hallway of the new main classroom building where the 7 fatalities occurred.

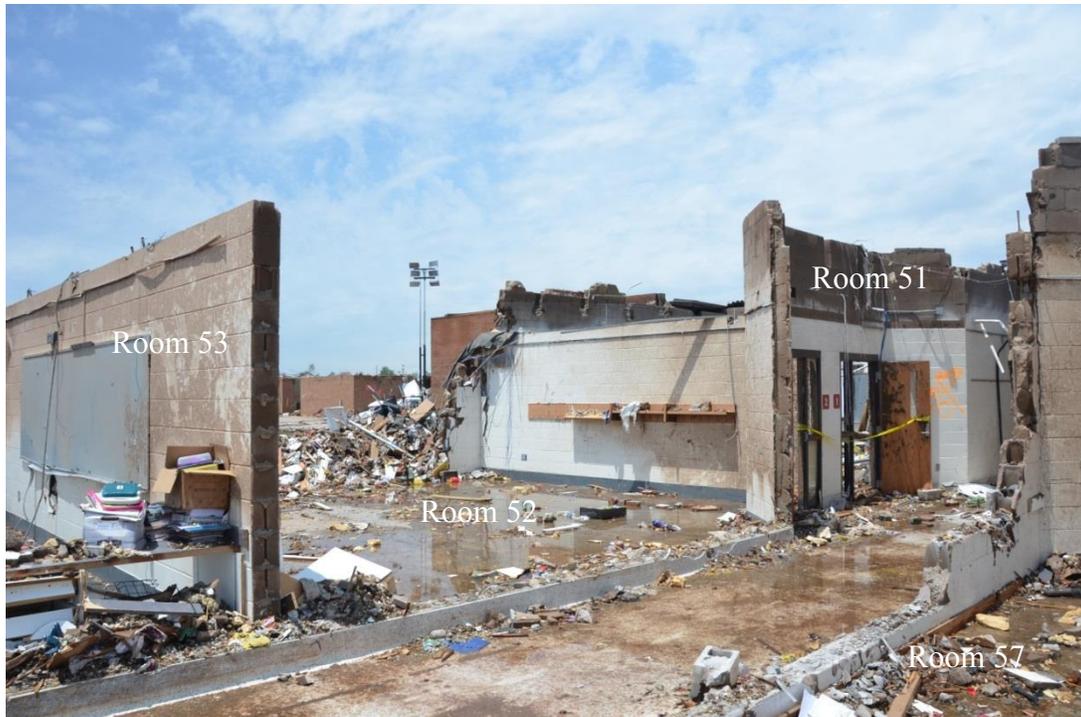
Figure 4-6. Damage to the hallway and classrooms of the new main classroom building (complete loss of roof and many walls) where the 7 fatalities occurred (most of the debris has already been removed). This hallway area was a “designated area of safety.”

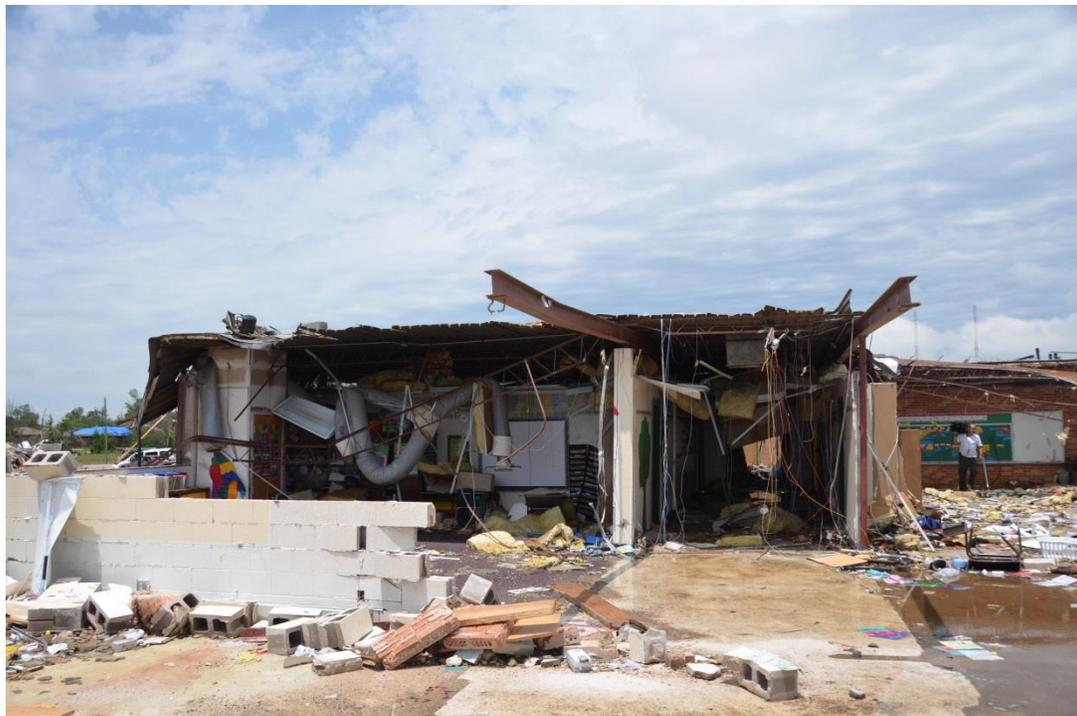
Figure 4-7. Collapsed southwest wing of original main classroom building.

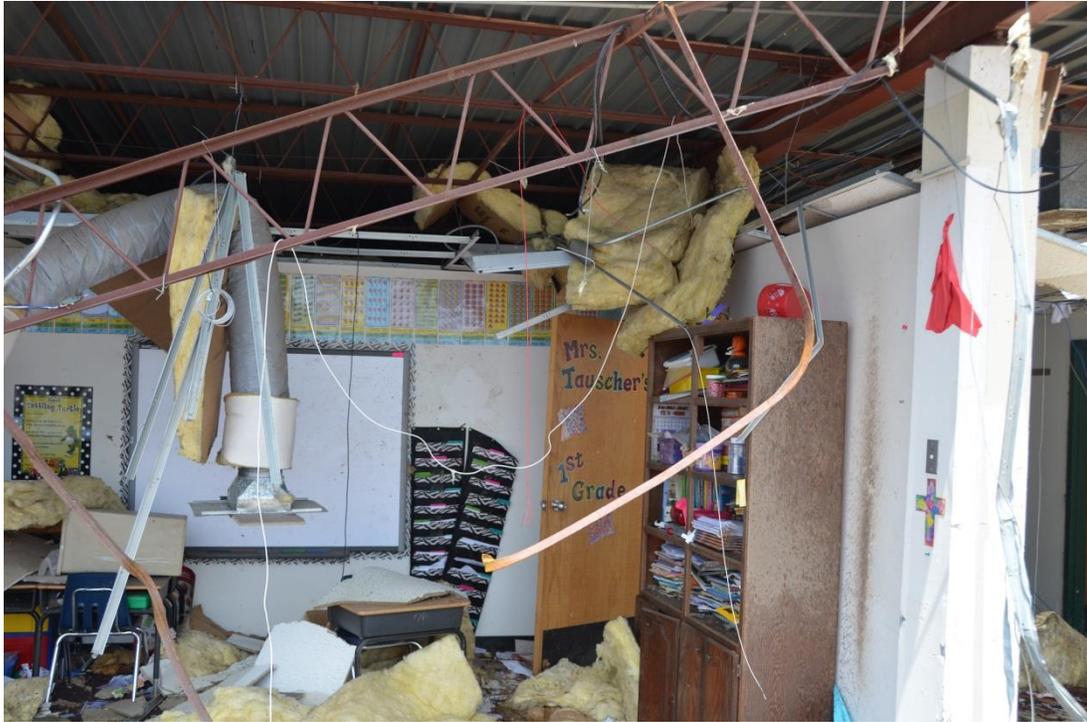
Figure 4-8. Damaged interior of a classroom in the original main classroom building.

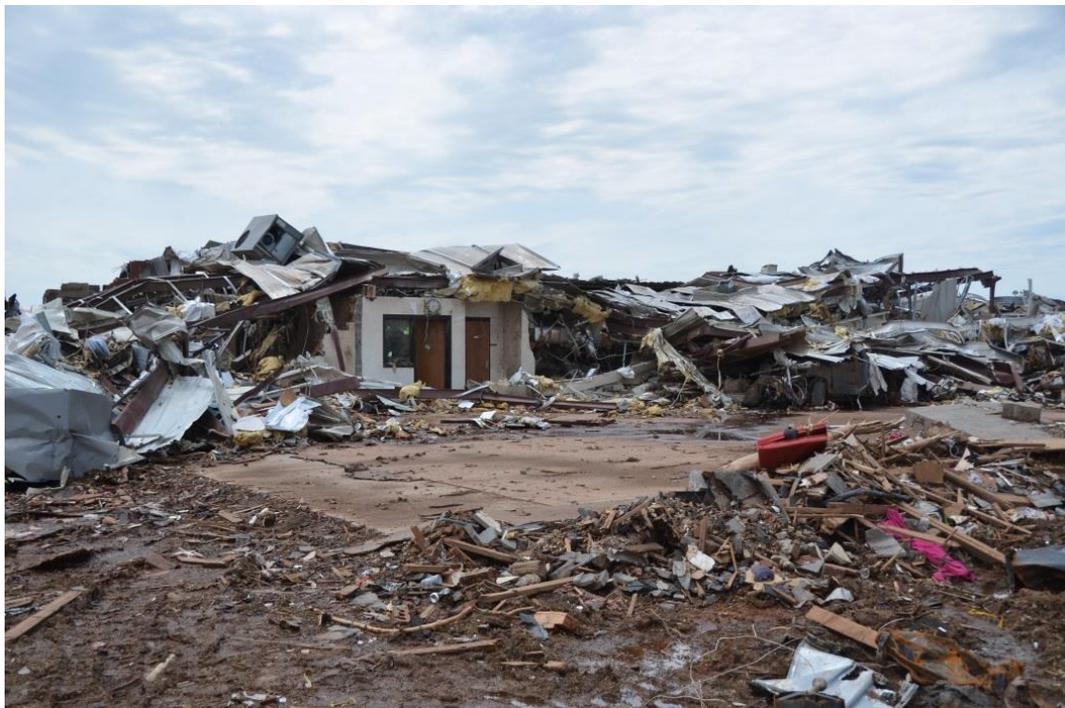
Figure 4-9. Collapsed Gymnasium building (Note the interior Gymnasium Office surrounded by a reinforced CMU wall remained standing).

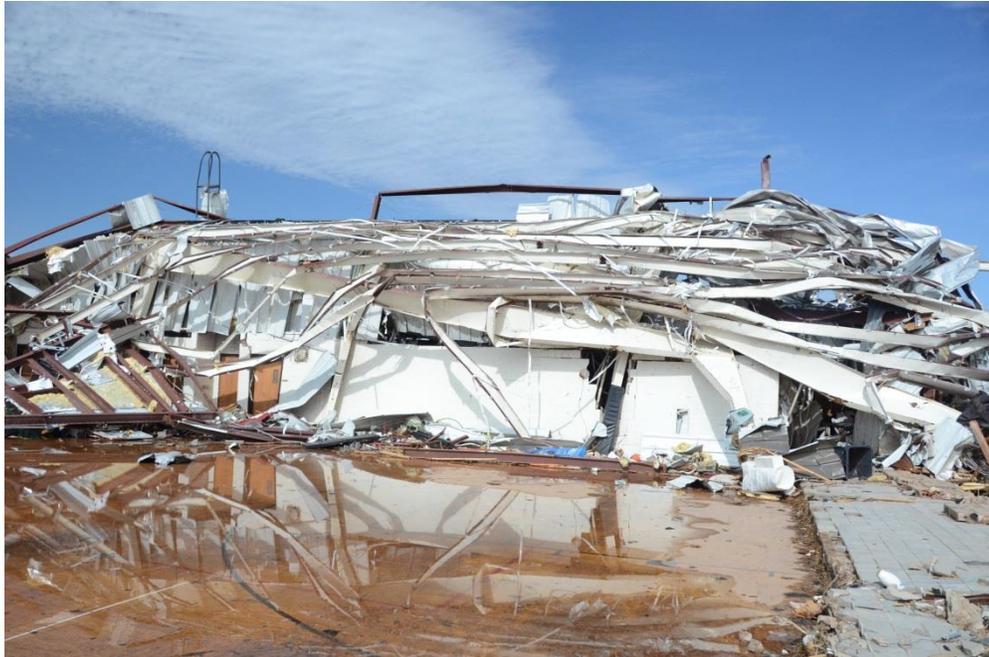
Figure 4-14. Collapsed Multipurpose Building of Briarwood Elementary School.

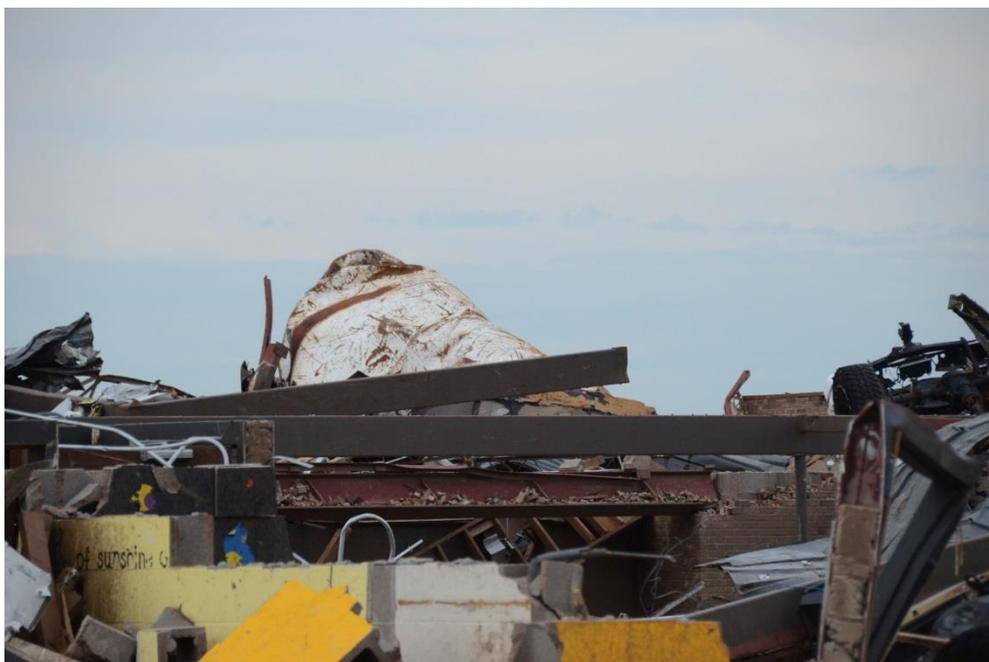
Figure 4-15. Building 300, with propane storage tank (white) that landed on top.

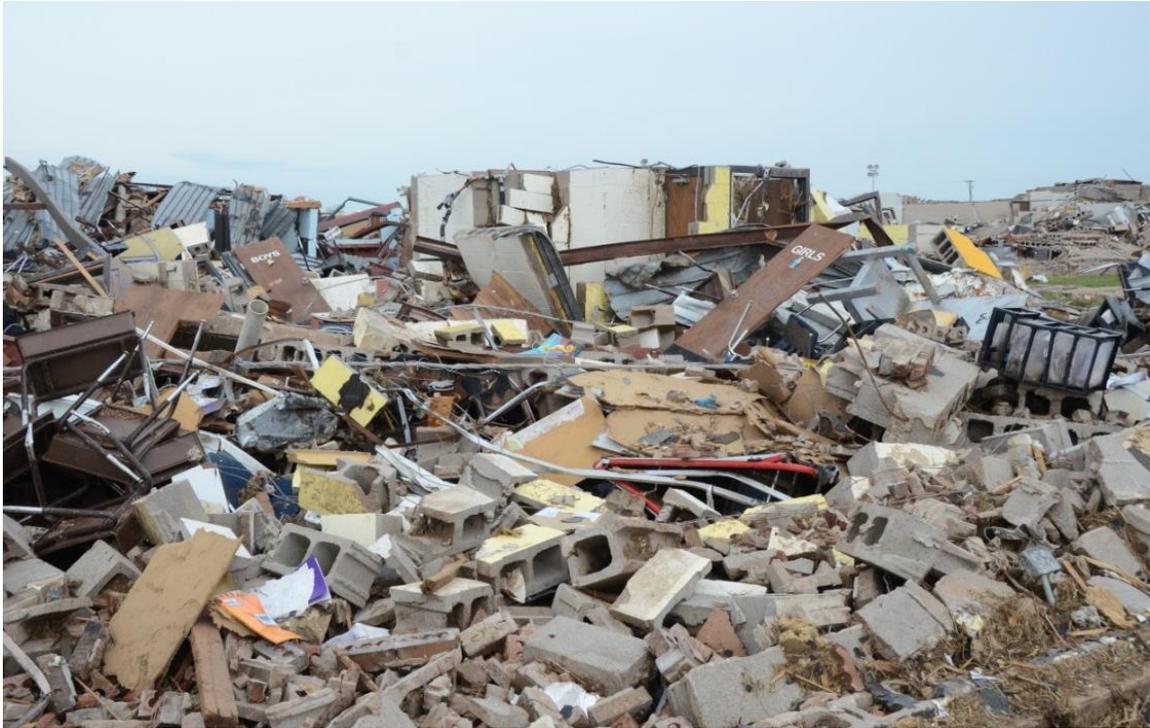
Figure 4-16. Building 200 (completely demolished, with only the boy's and girl's bathrooms remaining standing).

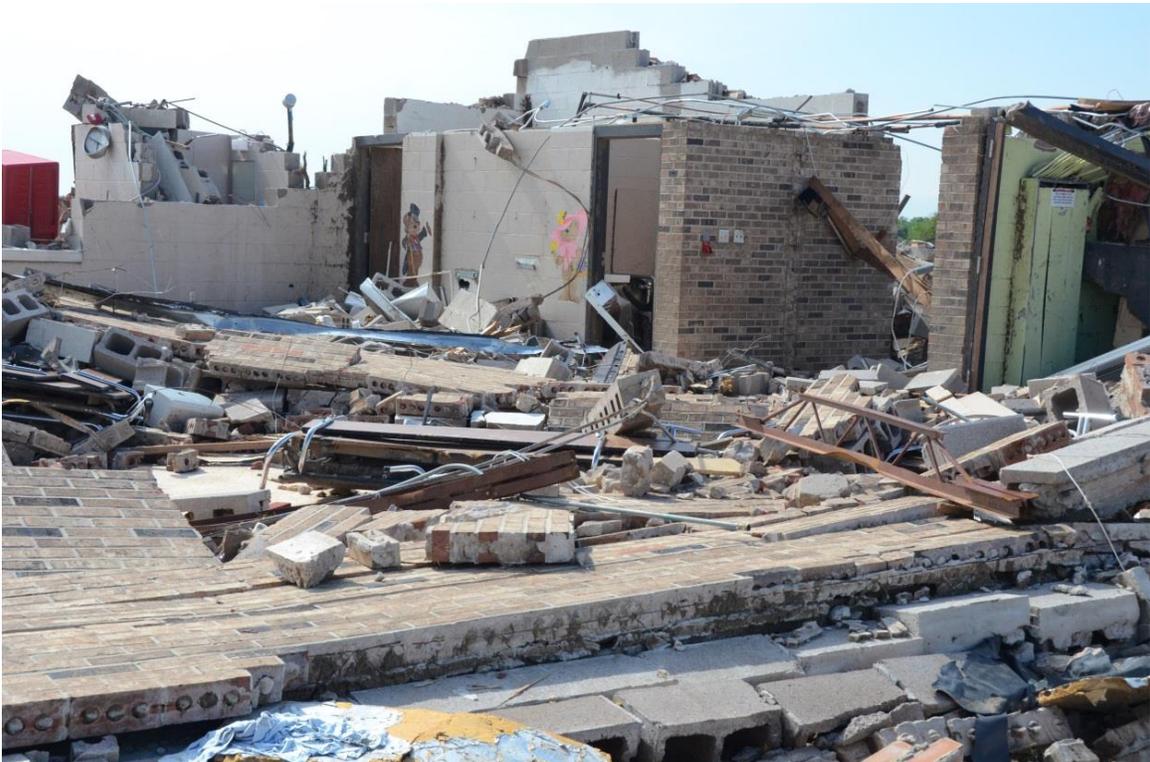
Figure 4-17. Cafeteria. Complete structural failure with only the interior bathroom remaining standing.

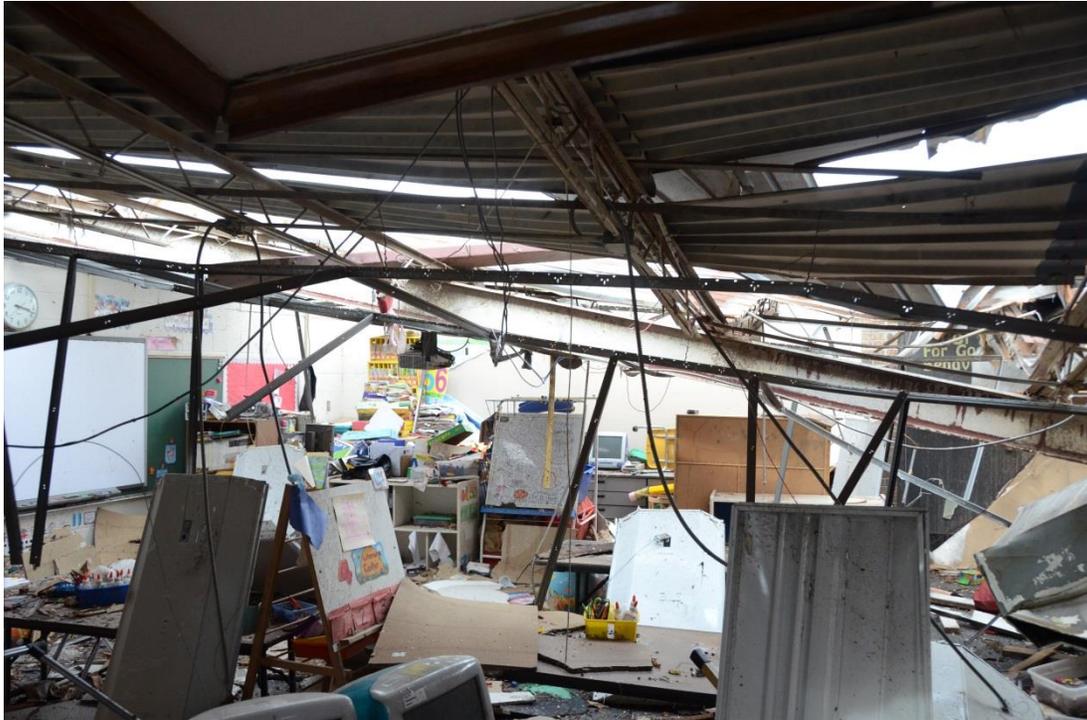
Figure 4-18. An interior view of a classroom in the 400 Building where portion of the building's metal roof system was lost.

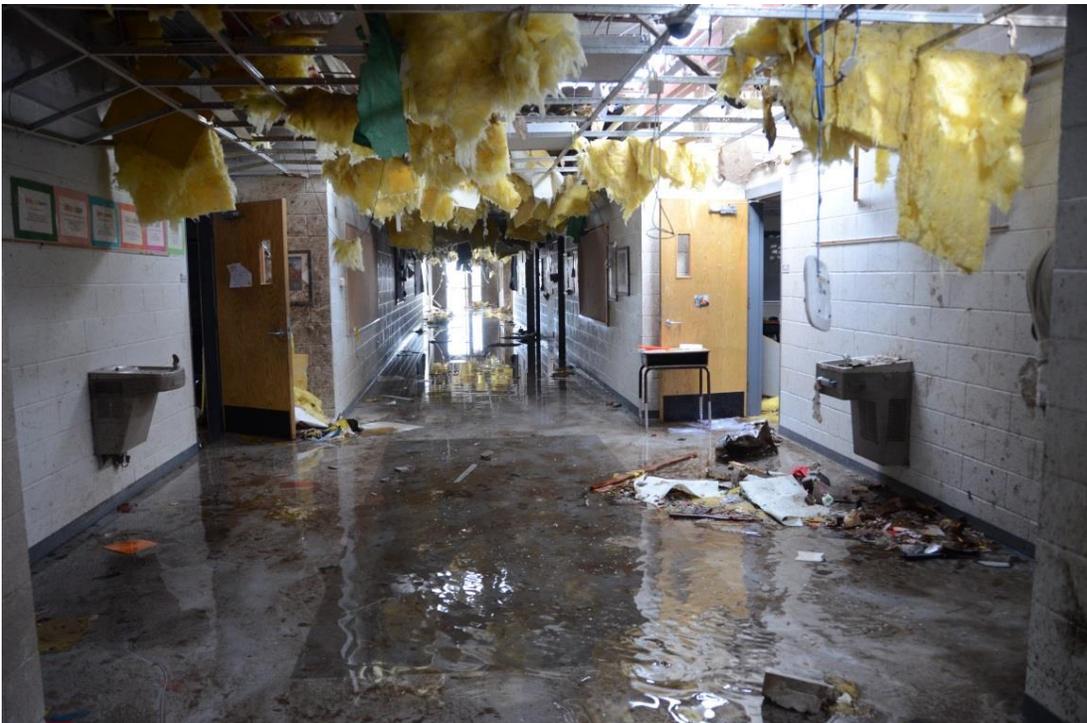
Figure 4-19. Hallway of Building 400 after the tornado (designated tornado safety area and initial location of Building 400 occupants before moving to the bathrooms just before the tornado struck)

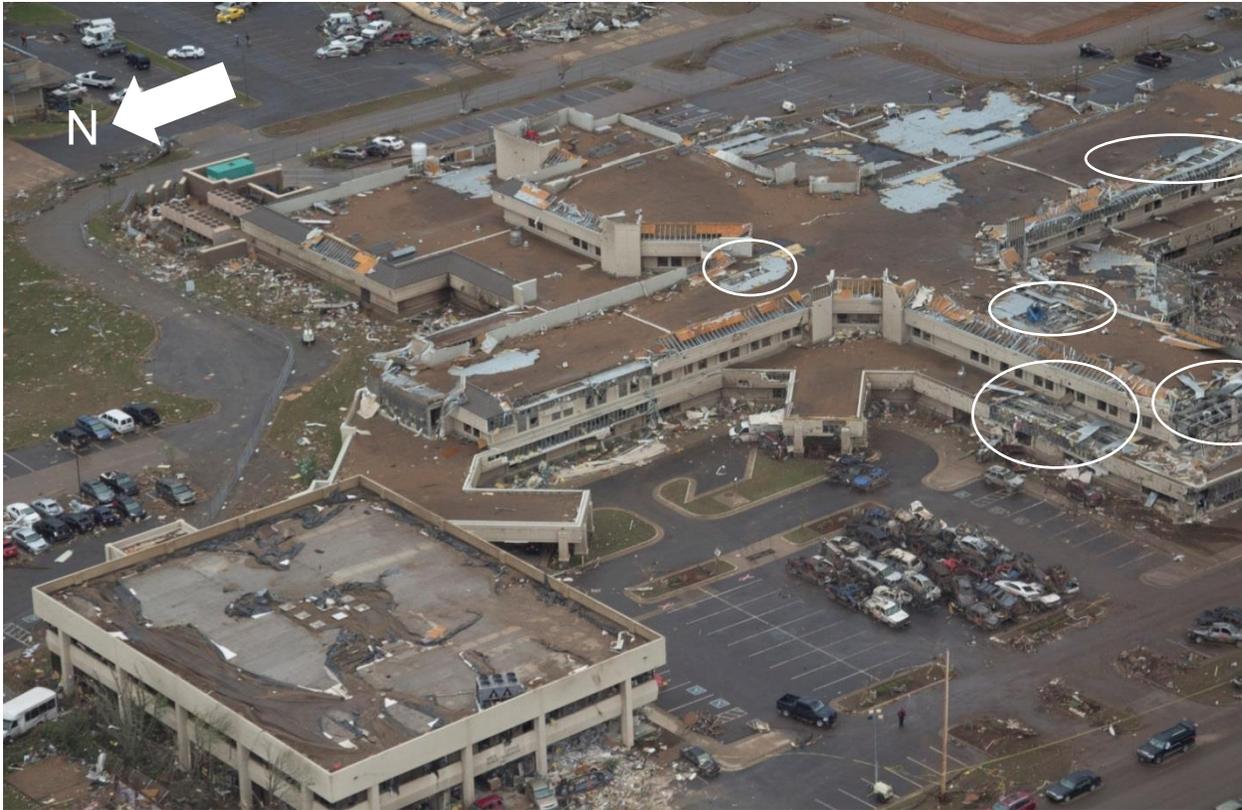
Figure 4-24. Aerial view of the heavily damaged Moore Medical Center (looking south-east). Circled locations indicate areas of roof deck damage.

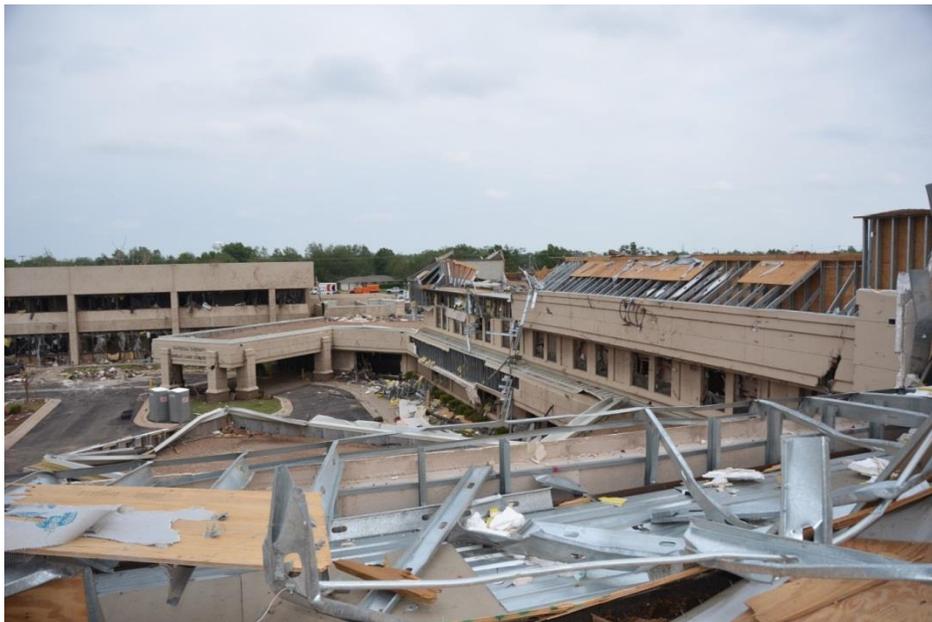
Figure 4-25. Damage to the building envelope and rooftop architectural elements of Moore Medical Center.

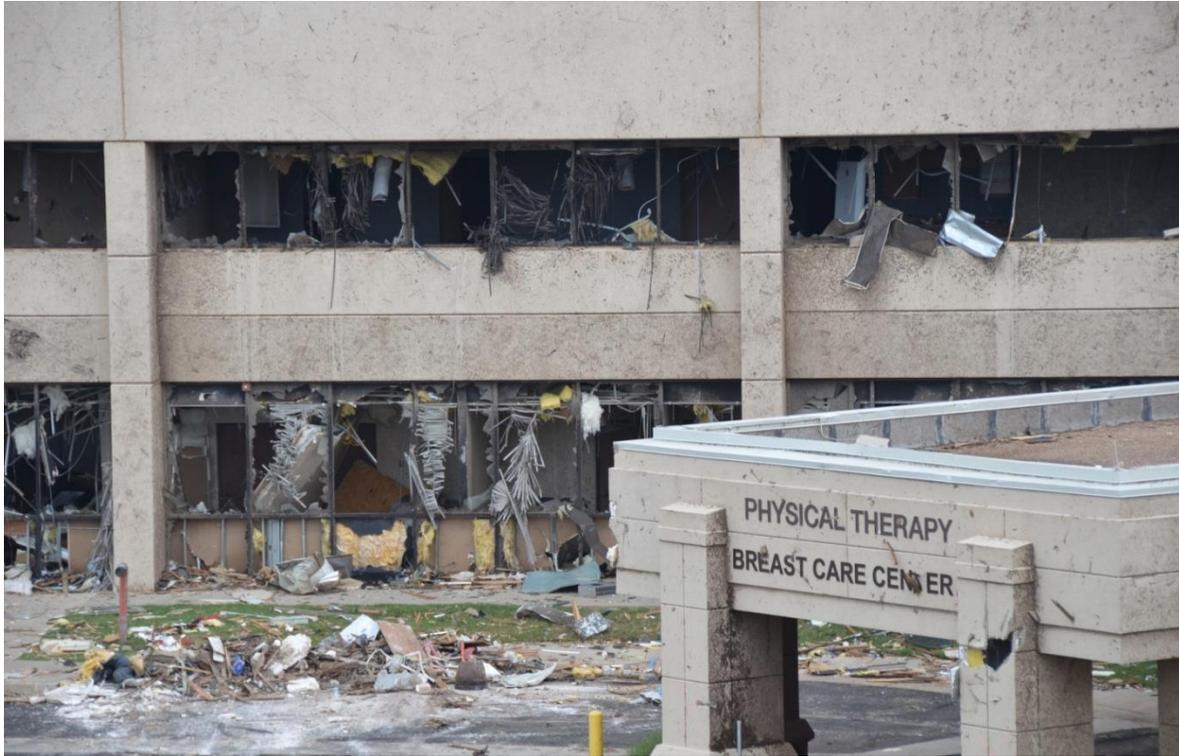
Figure 4-26. Damage to the envelope of Moore Medical Center (glazing).

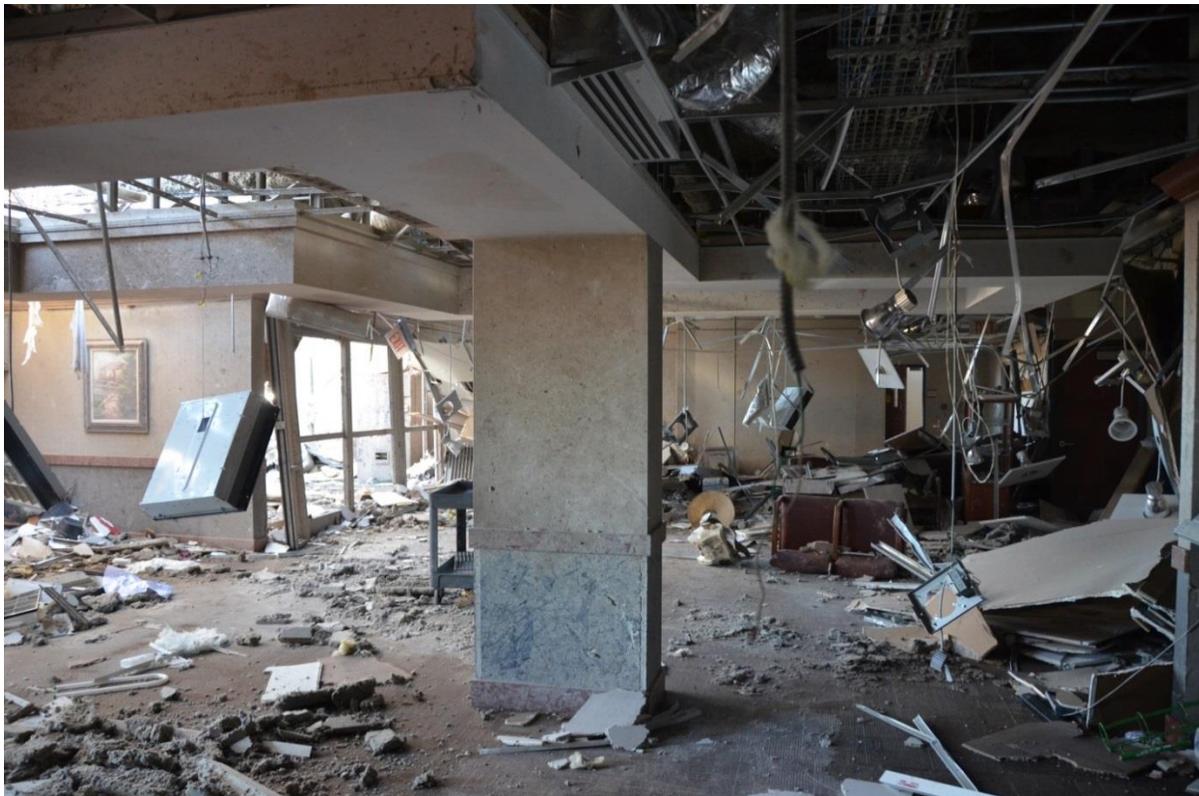
Figure 4-27. Damage to the interior of the Moore Medical Center due to wind and debris infiltration.

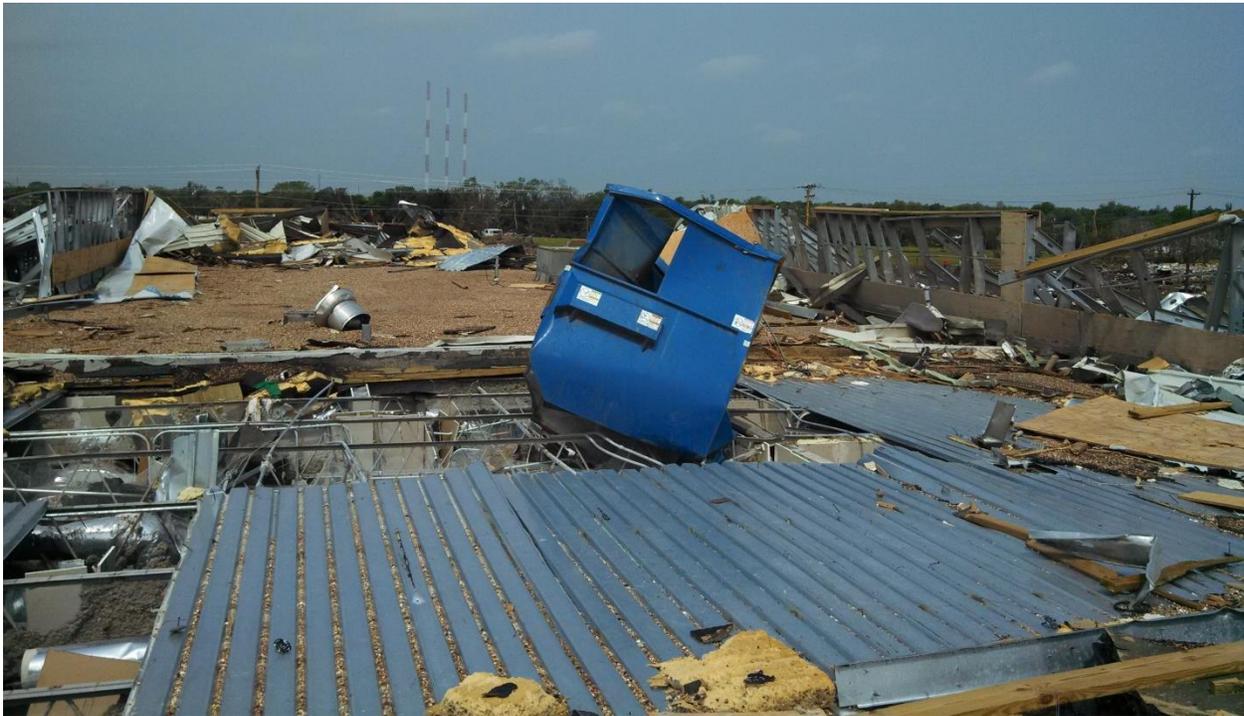
Figure 4-28. Impact damage to hospital roof bar joists from steel trash dumpster, and loss of steel roof decking.

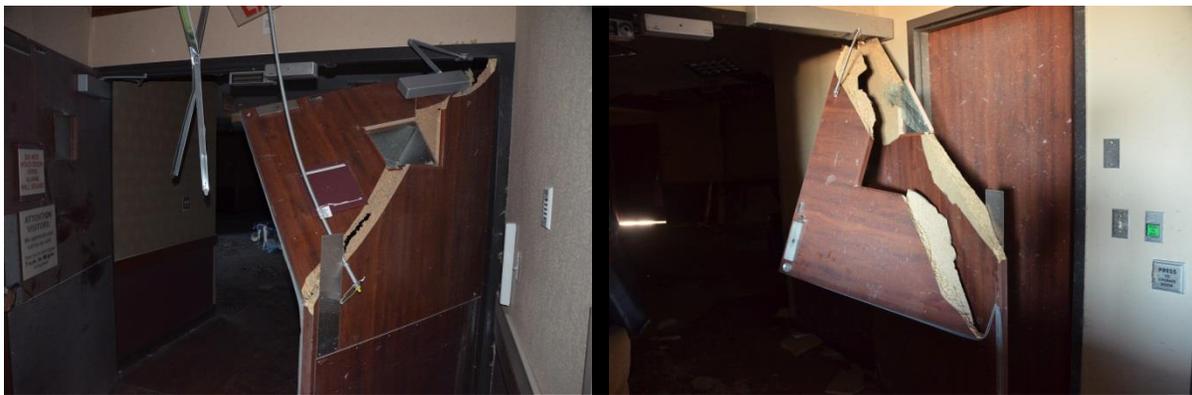
Figure 4-29. Examples of broken interior doors at the Moore Medical Center.
