NIST NCSTAR 1-6B

**Federal Building and Fire Safety Investigation of the
World Trade Center Disaster**

Fire Resistance Tests of Floor Truss Systems

September 2005

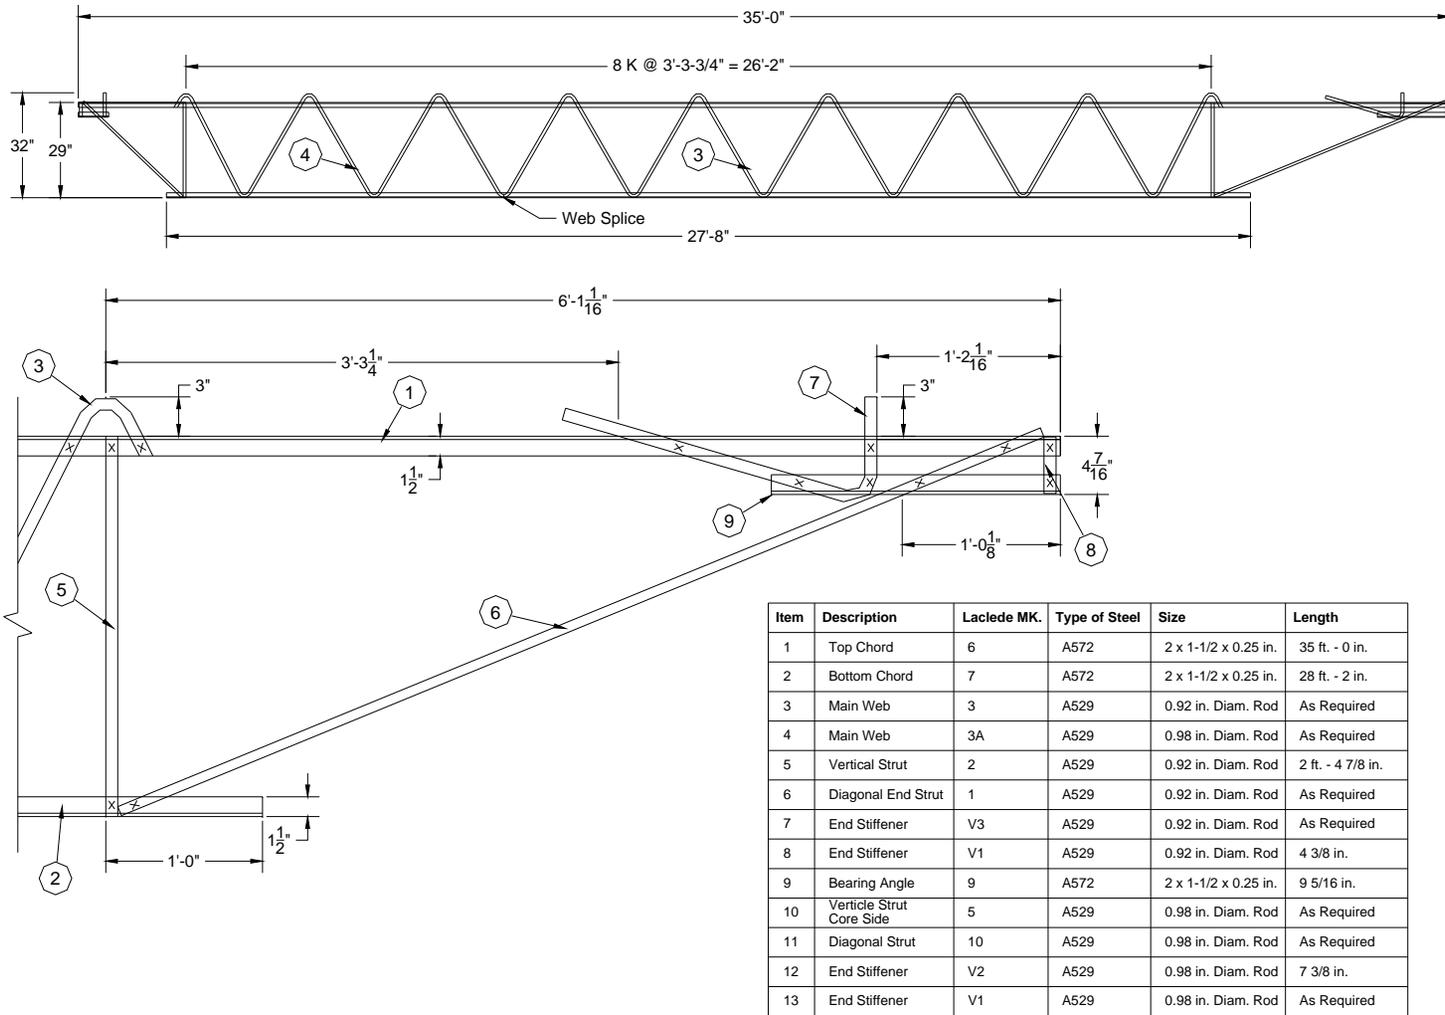
Figure 4-1. 35 ft main truss, column end.

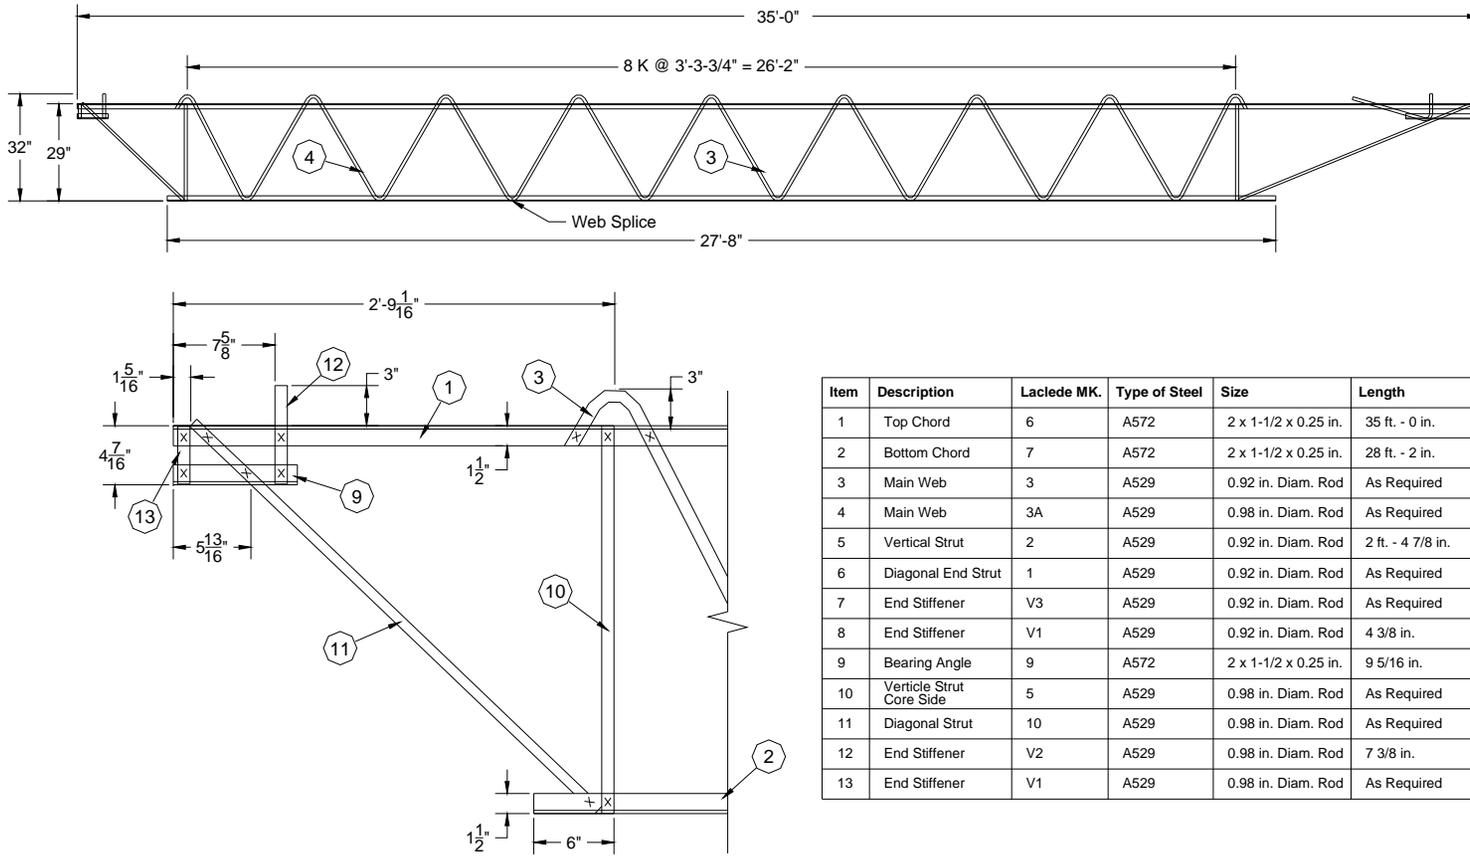
Item	Description	Laclede MK.	Type of Steel	Size	Length
1	Top Chord	6	A572	2 x 1-1/2 x 0.25 in.	35 ft. - 0 in.
2	Bottom Chord	7	A572	2 x 1-1/2 x 0.25 in.	28 ft. - 2 in.
3	Main Web	3	A529	0.92 in. Diam. Rod	As Required
4	Main Web	3A	A529	0.98 in. Diam. Rod	As Required
5	Vertical Strut	2	A529	0.92 in. Diam. Rod	2 ft. - 4 7/8 in.
6	Diagonal End Strut	1	A529	0.92 in. Diam. Rod	As Required
7	End Stiffener	V3	A529	0.92 in. Diam. Rod	As Required
8	End Stiffener	V1	A529	0.92 in. Diam. Rod	4 3/8 in.
9	Bearing Angle	9	A572	2 x 1-1/2 x 0.25 in.	9 5/16 in.
10	Verticle Strut Core Side	5	A529	0.98 in. Diam. Rod	As Required
11	Diagonal Strut	10	A529	0.98 in. Diam. Rod	As Required
12	End Stiffener	V2	A529	0.98 in. Diam. Rod	7 3/8 in.
13	End Stiffener	V1	A529	0.98 in. Diam. Rod	As Required

Figure 4-2. 35 ft main truss, core end.

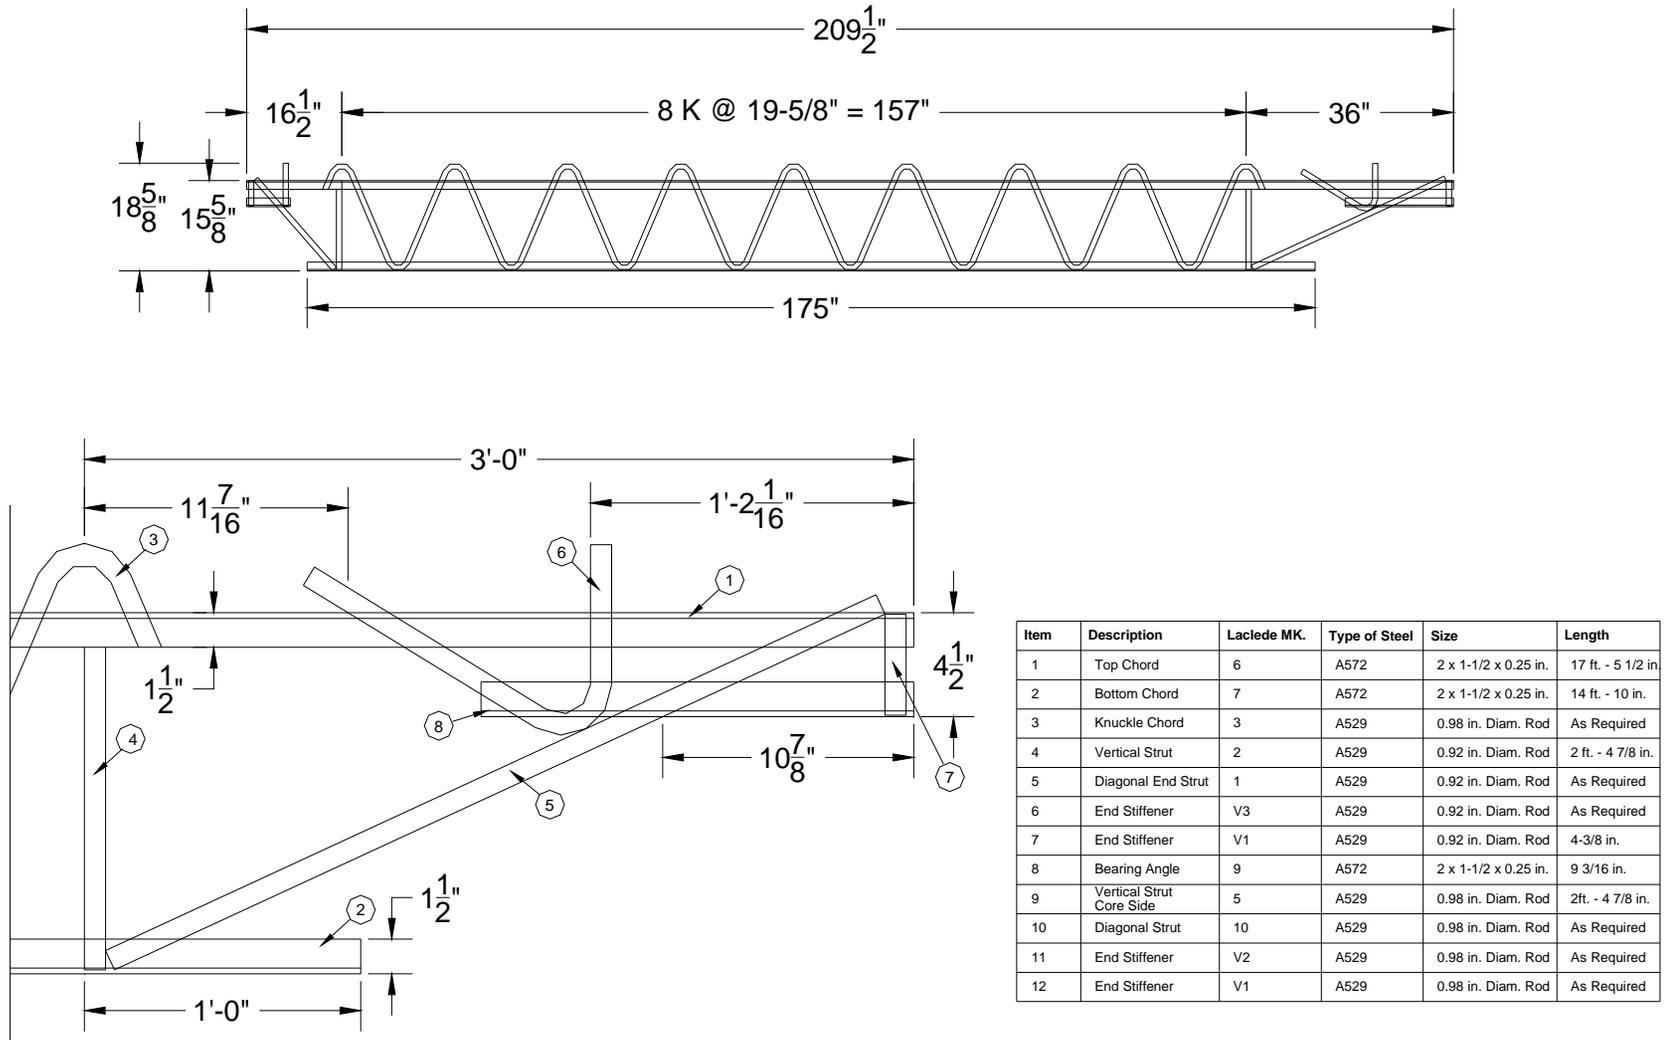
Figure 4-3. 17 ft main truss, column end.

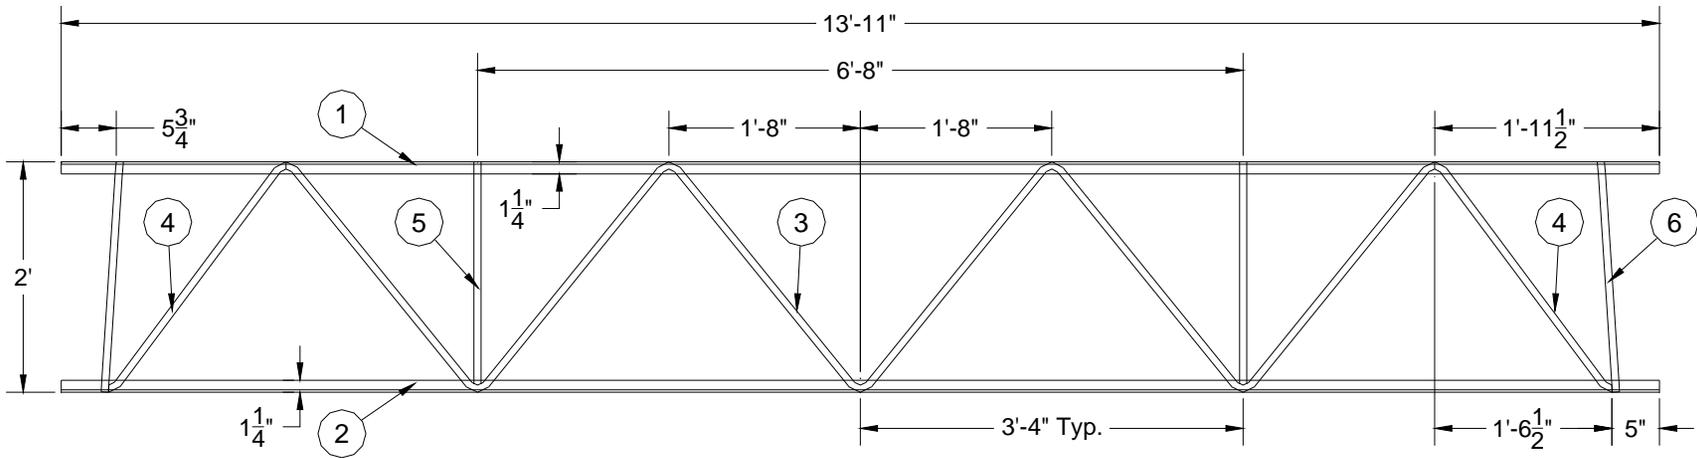
Item	Description	Laclede MK.	Type of Steel	Size	Length
1	Top Chord	6	A572	1-1/2 x 1-1/4 x 0.230 in.	13 ft. - 8 in.
2	Bottom Chord	7	A572	1-1/2 x 1-1/4 x 0.230 in.	13 ft. - 8 in.
3	Main Web	3	A572	0.75 in. Diam. Rod	As Required
4	Web Chord	4	A572	0.75 in. Diam. Rod	As Required
5	Vertical Strut	12	A572	0.75 in. Diam. Rod	1 ft. - 10-7/8 in.
6	Inclined End Strut	2	A572	0.75 in. Diam. Rod	1 ft. - 11-3/4 in.

Figure 4-5. Bridging truss for Assemblies Nos. 1 and 2.

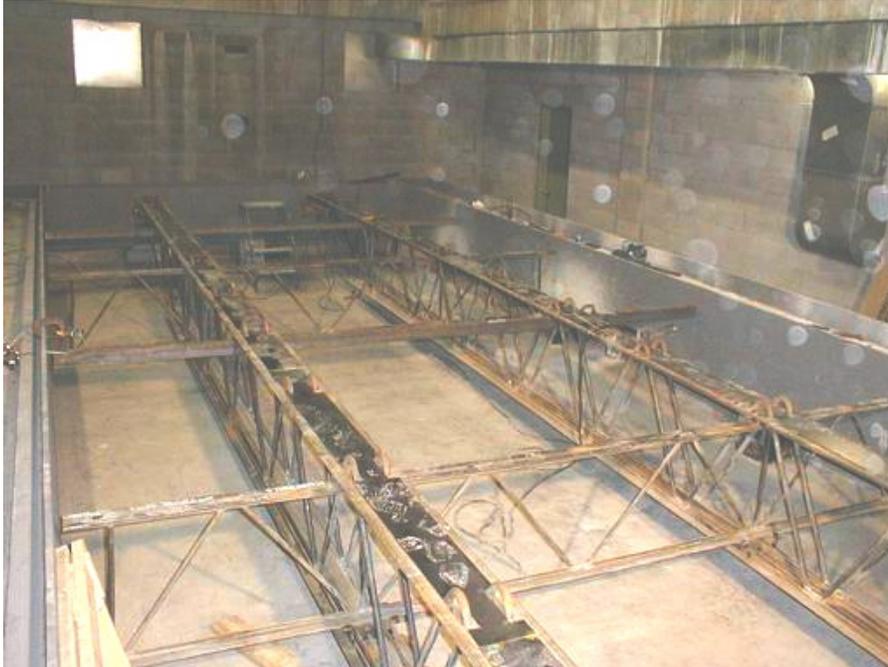
Figure 4–7. Structural steel frame of Assembly No. 1.

The ends of the main trusses in Test Assembly No. 1 were supported by L6×4×1 structural angles 12 in. long welded to the test frame. The bearing length for each main truss was $3\frac{1}{2}$ in. The ends of the main trusses were welded with a $\frac{1}{2}$ in. fillet along the entire bearing length on each side of the trusses (see Fig. 4-8). Steel plates were placed between the ends of the main trusses and the test frame, filling the gap and, thus, preventing thermal expansion.

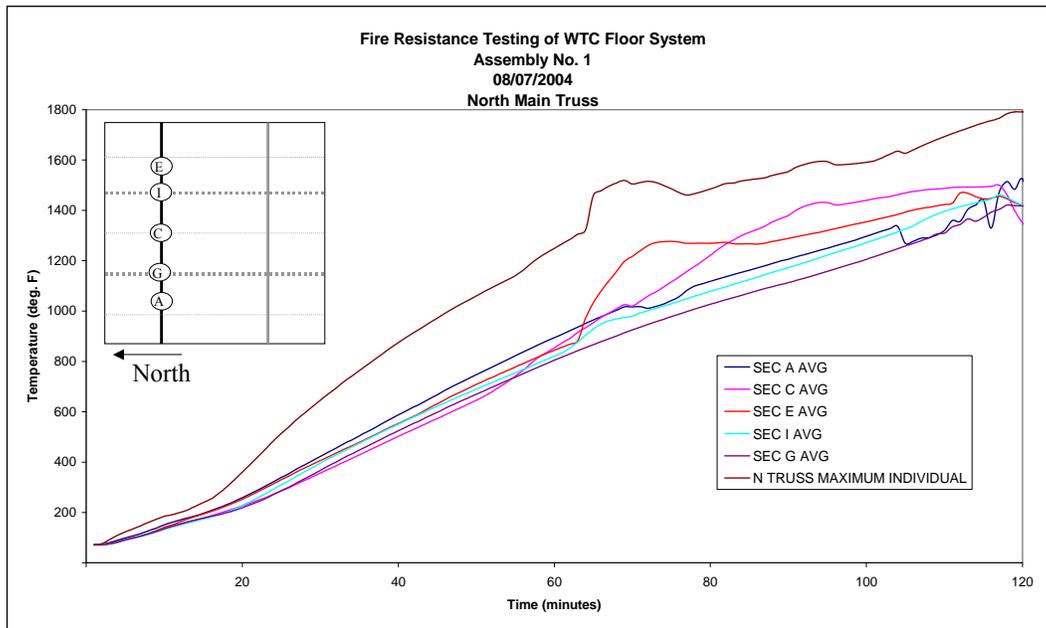
Figure 5–1. Assembly No. 1 – average and maximum individual temperatures on north main truss.

All data shown in the following figures (Figures 5–1 through 5–12) are unedited for the entire duration of the test. However, not all data shown is reliable due to the limitations of the instrumentation, i.e. thermocouples, radiometers, and calorimeters. Data may become unreliable past the rating period when structural events occur that can dislodge the instrumentation. Also, protective insulation of the thermocouple wire may burn away, and the individual wires can make contact with themselves and/or neighboring wires rendering the data unreliable. Appendix H gives a listing of the times that various instrumentation failed to give reliable data, as determined by UL.

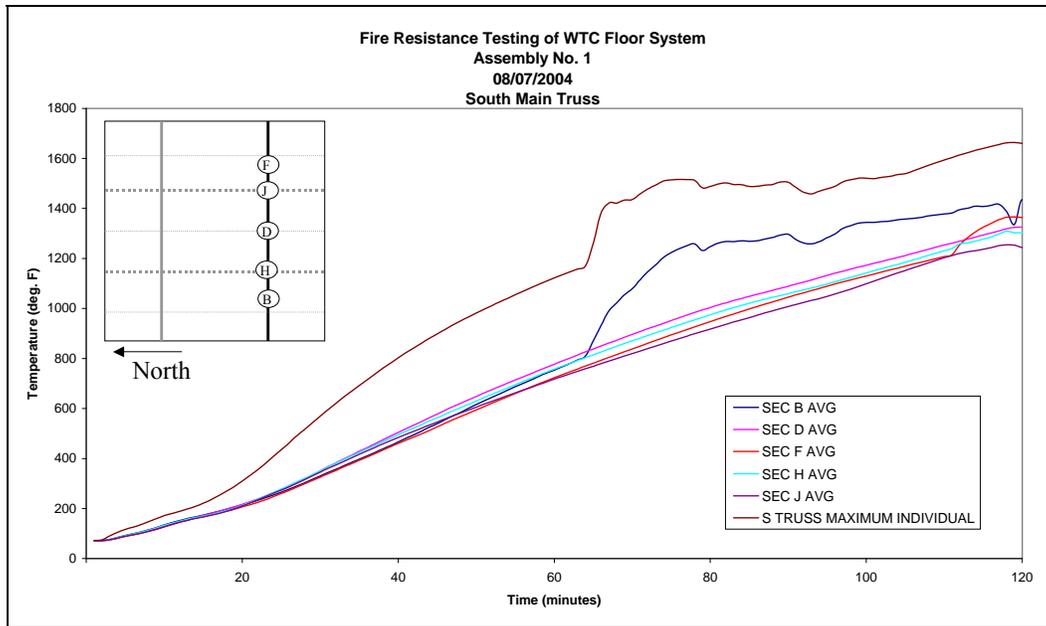
Figure 5–2. Assembly No. 1 – average and maximum individual temperatures on south main truss.

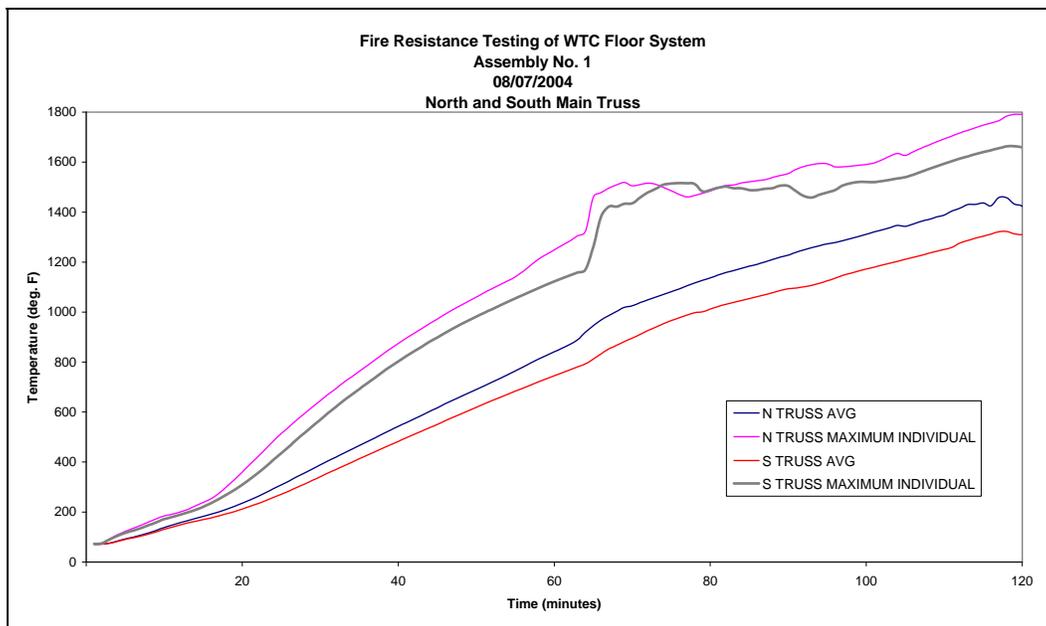
Figure 5–3. Assembly No. 1 – overall average and maximum individual temperatures on north and south main trusses.

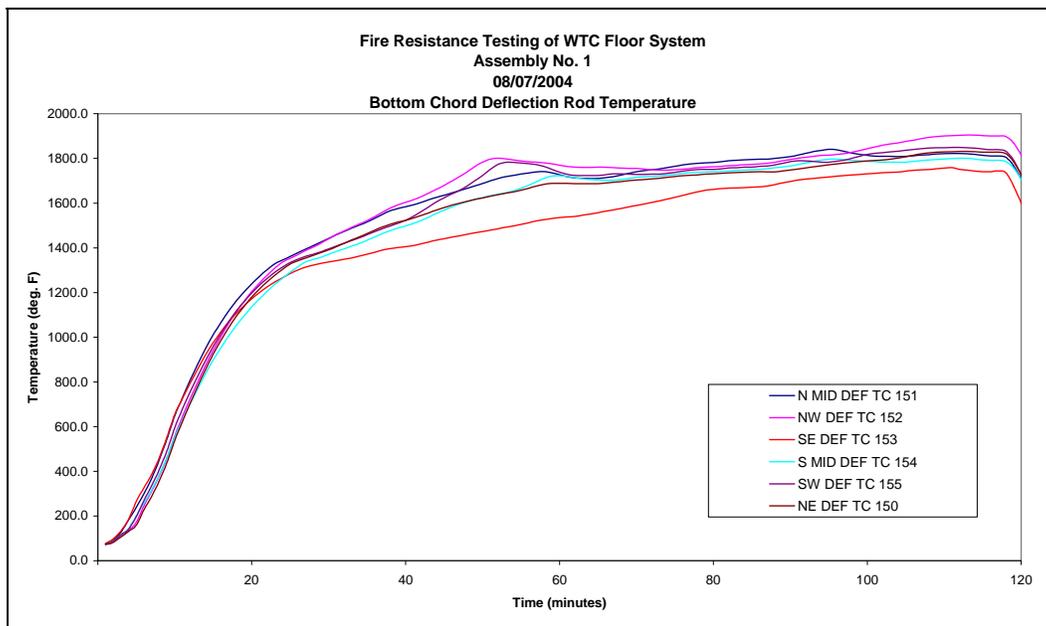
Figure 5–9. Assembly No. 1 – temperatures of bottom chord deflection rods.

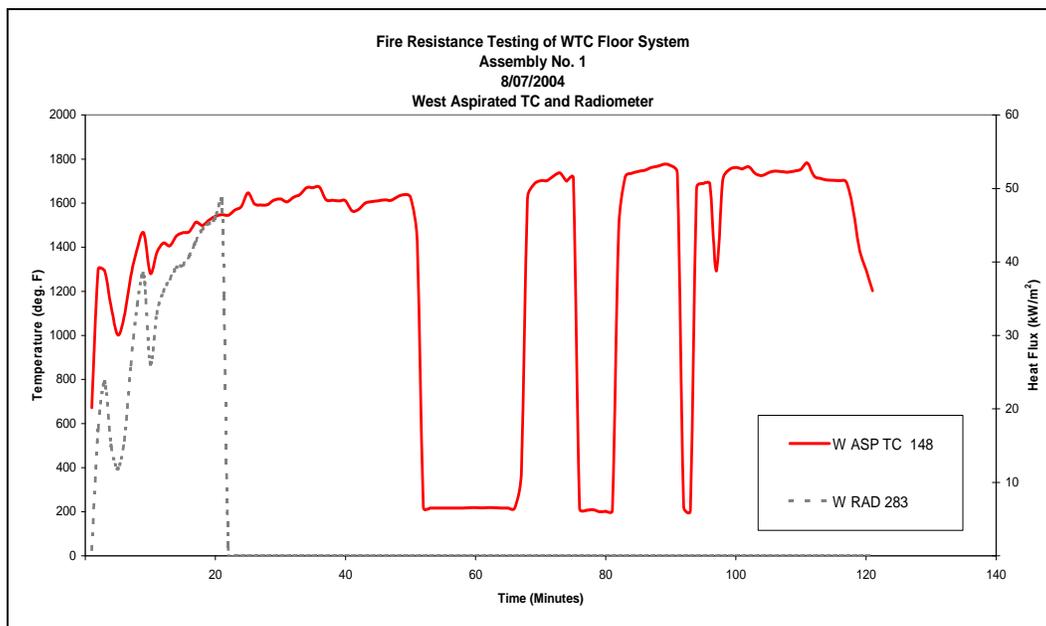
Figure 5–11. Assembly No. 1 – additional instrumentation through west opening.

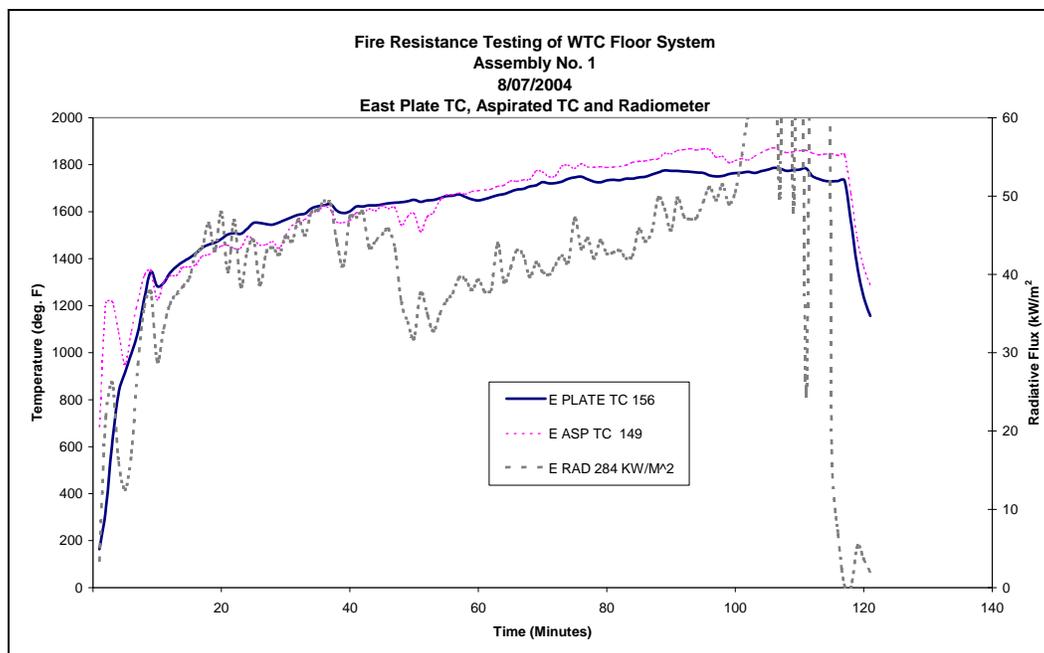
Figure 5–12. Assembly No. 1 – additional instrumentation through east opening.

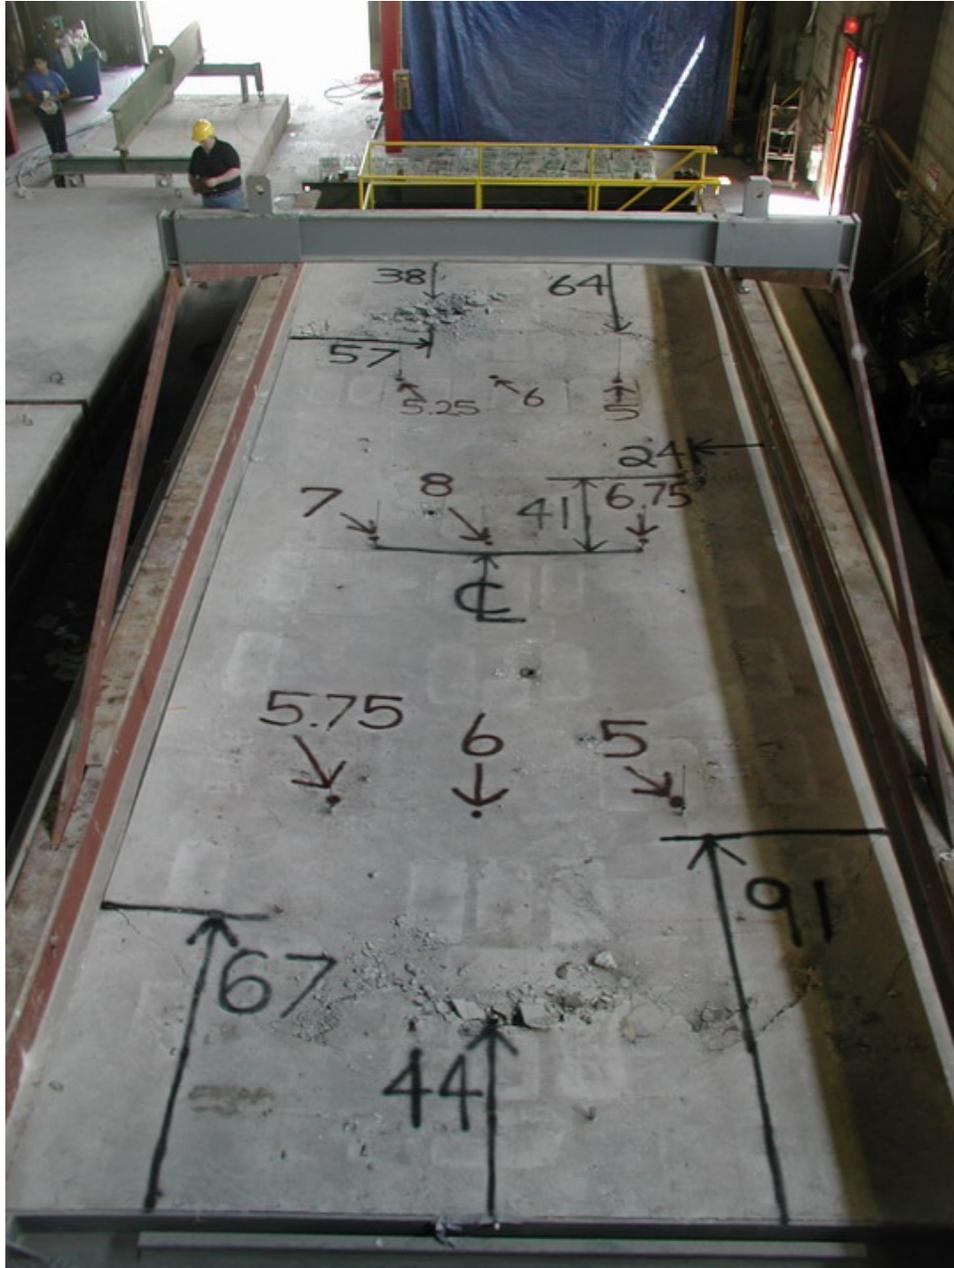
Figure 5–13. Unexposed surface of Assembly No. 1 after loading equipment was removed.

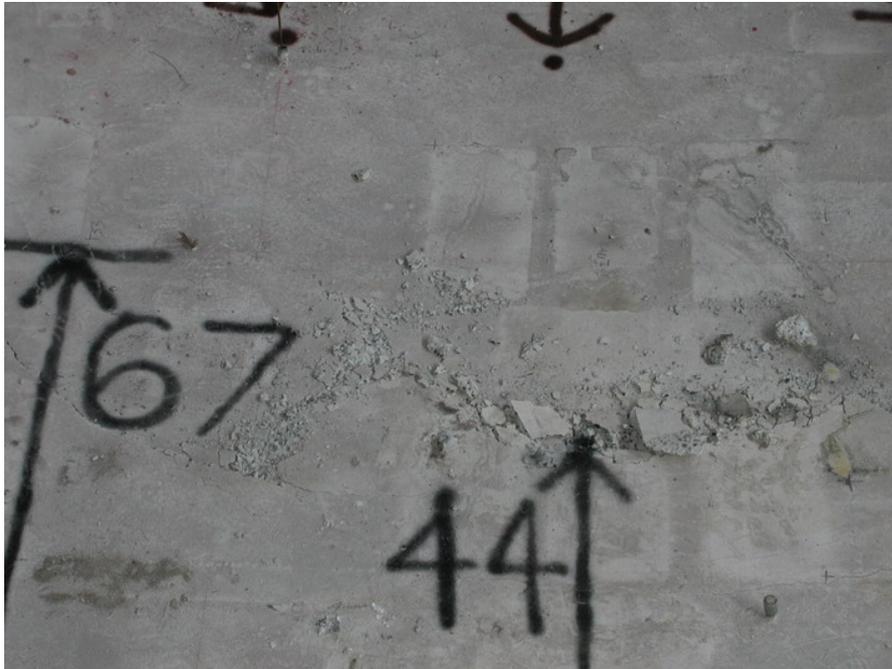
Figure 5–14. Detail of spalling concrete at west end of Assembly No. 1.

Figures 5–14 through 5–19 are additional views of the top of the specimen, showing the cracked and spalled concrete, and of the underside, showing bulging of the metal deck and deformations of the steel trusses after the test specimen had cooled and had been removed from the furnace. To confirm the spalling of the bottom side of the concrete slab and to quantify the depth of spalling, sections of the slab were cut using a diamond concrete wet saw (see Fig. 5–20). The depth of the delamination spalling varied but was on the order of 2 in. as seen in Fig. 5–21.

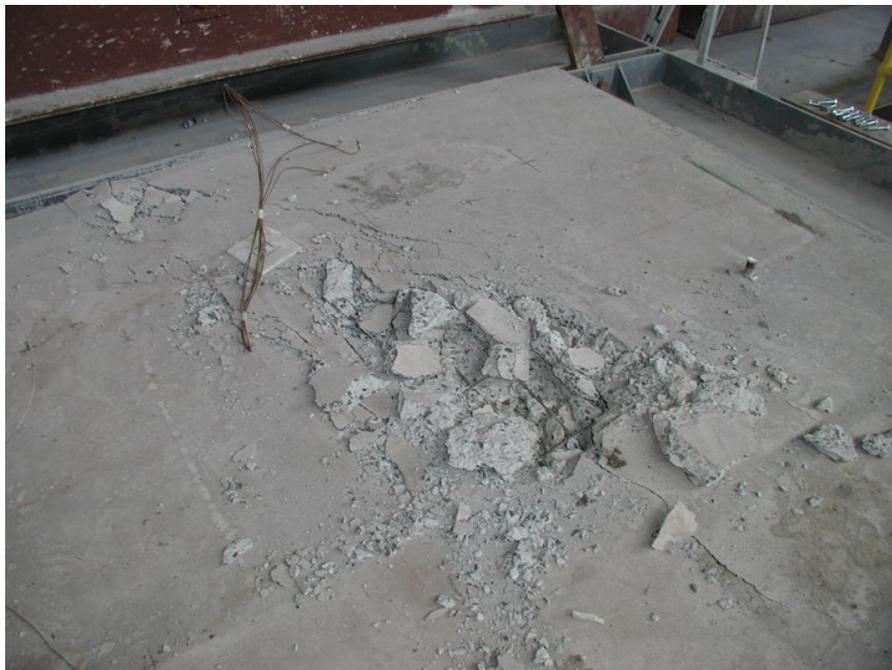
Figure 5–15. Detail of spalling concrete at east end of Assembly No. 1.

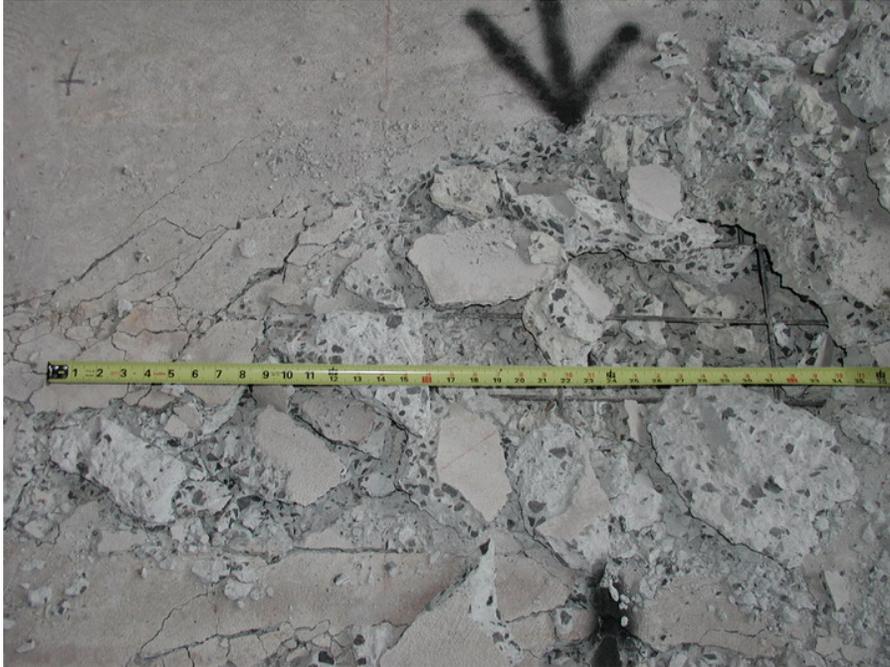
Figure 5–16. Close-up of spalling concrete at east end of Assembly No. 1.

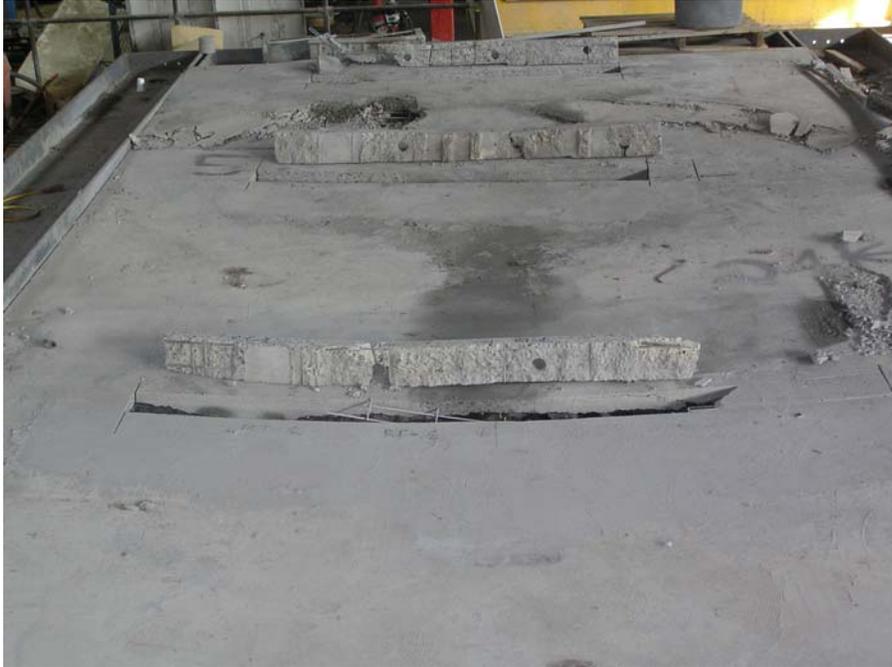
Figure 5–20. Sections cut through concrete slab to confirm delamination spalling.

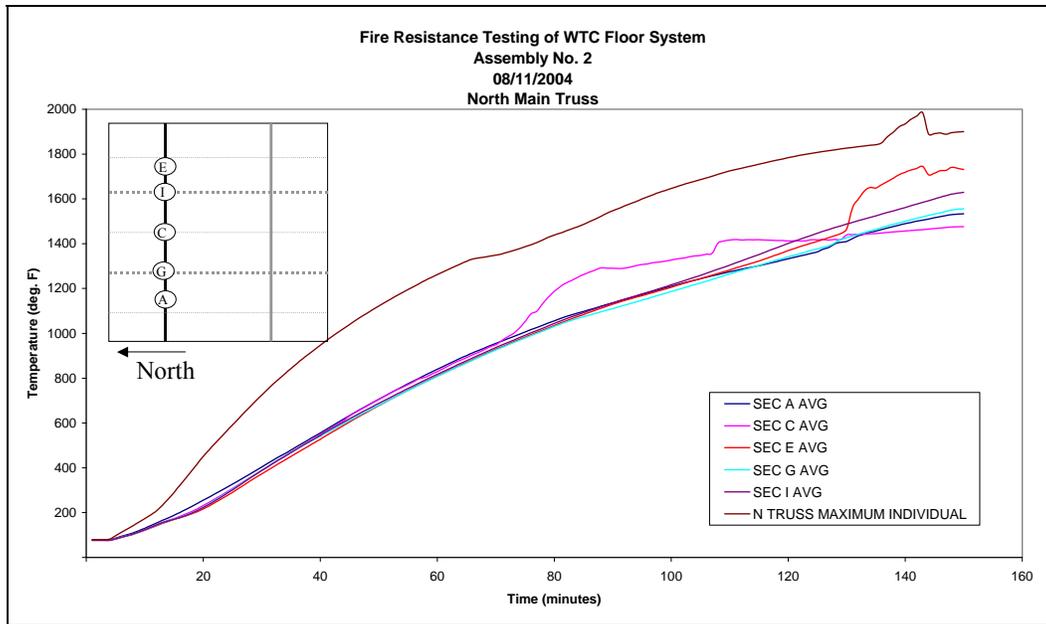
Figure 5–22. Assembly No. 2 – average and maximum individual temperatures on north main truss.

All data shown in the following figures (Figures 5–22 through 5–33) are unedited for the entire duration of the test. However, not all of the data shown is reliable due to the limitations of the instrumentation, i.e. thermocouples, radiometers, and calorimeters. Data may become unreliable past the rating period when structural events occur that can dislodge the instrumentation. Also, protective insulation of the thermocouple wire may burn away, and the individual wires make contact with themselves and/or neighboring wires rendering the data unreliable. Appendix H gives a listing of the times that instrumentation failed to give reliable data, as determined by UL.

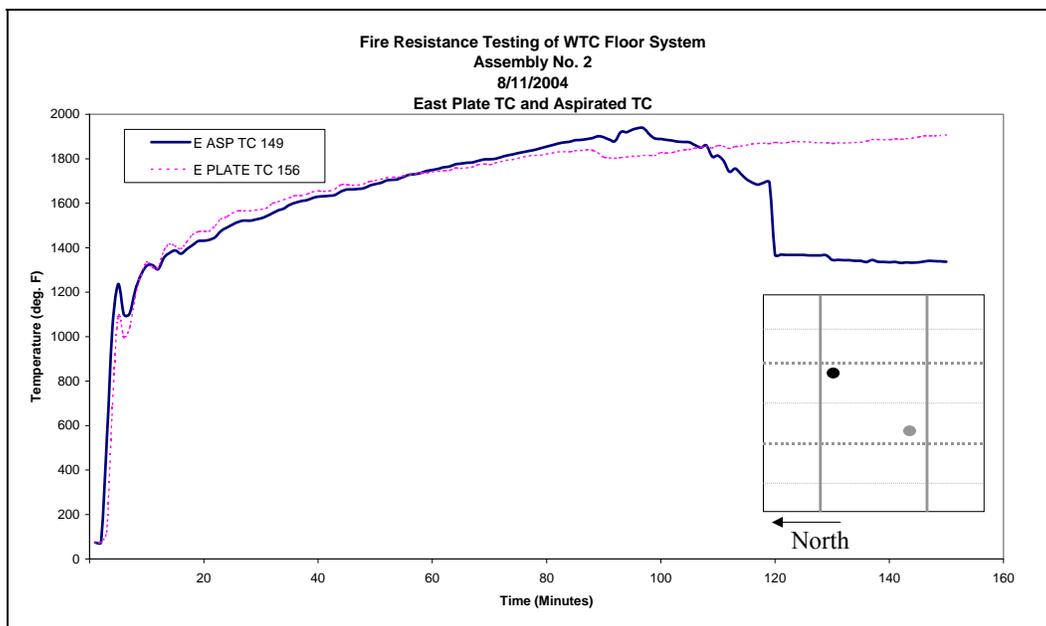
Figure 5–33. Assembly No. 2 – additional instrumentation through east opening.

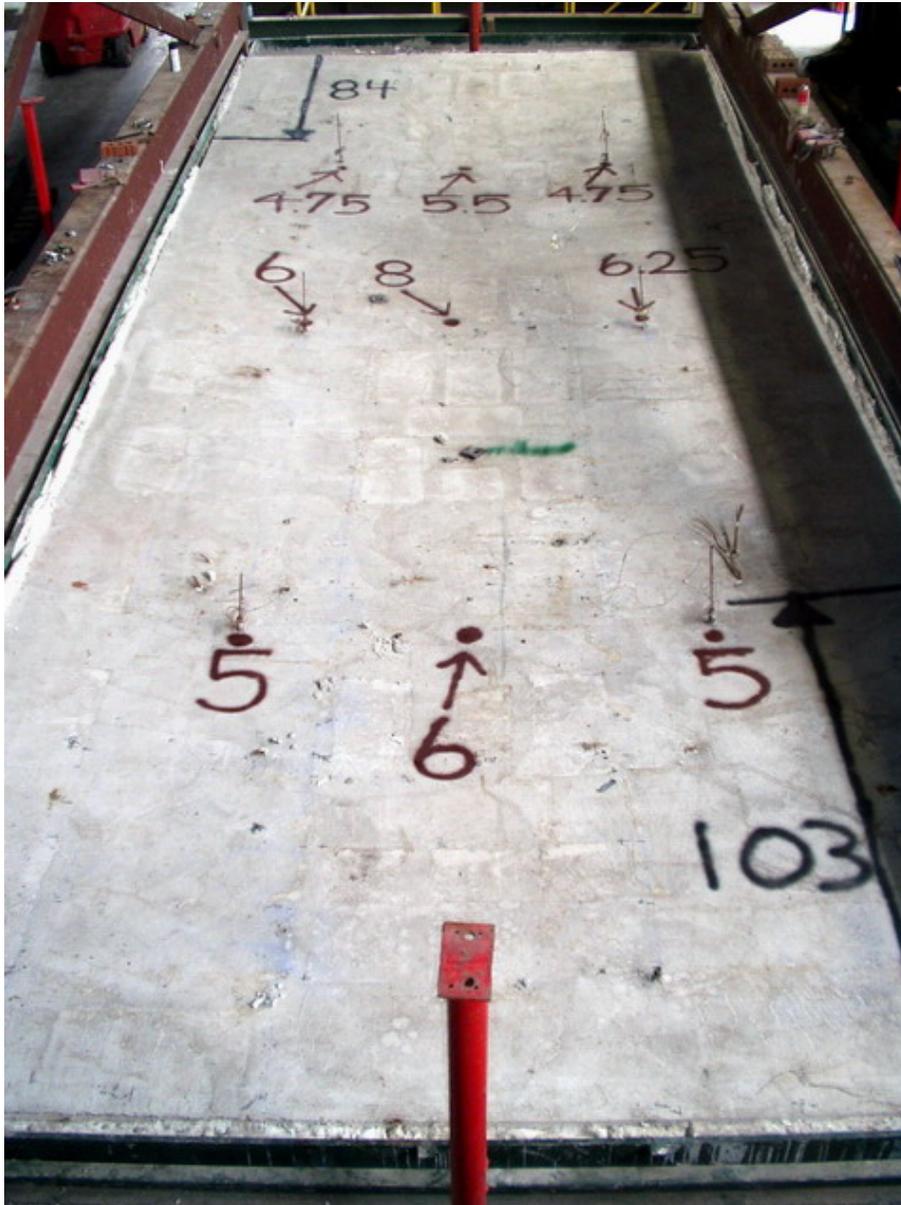
Figure 5–34 shows the unexposed side of the floor assembly after all loading equipment had been removed (view looking east). Numbers shown at the centerline and quarter points are vertical deflections after cooling. All other numbers are reference dimensions as measured from the edge of the slab. Figures 5–35 through 5–37 are views of the underside of the test specimen, showing bulging of the metal deck, and deformations of the steel trusses after the test specimen had cooled and had been removed from the furnace.

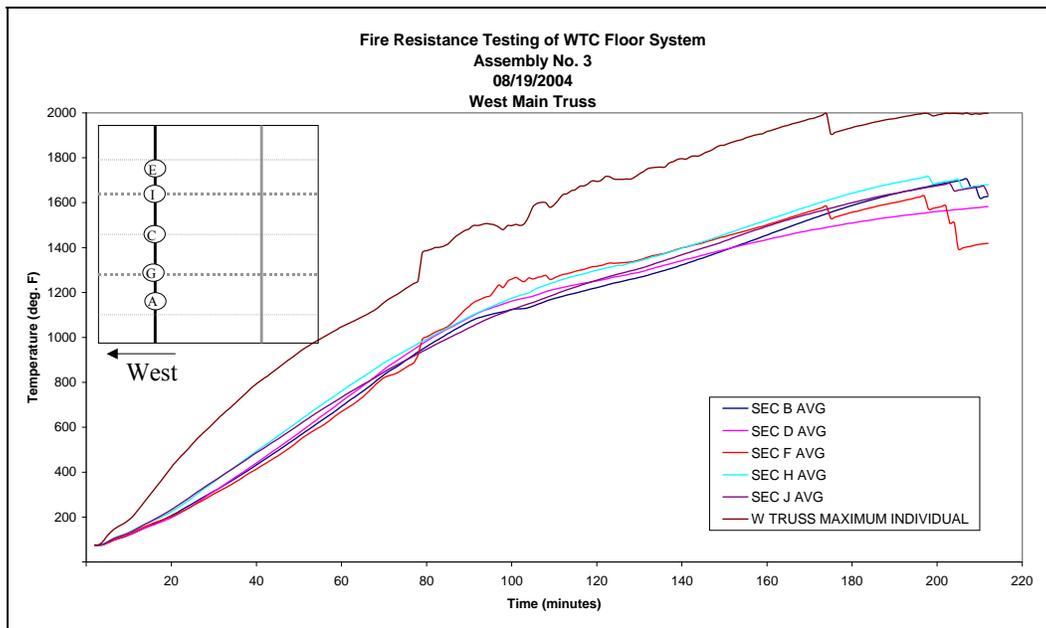
Figure 5–38. Assembly No. 3 – average and maximum individual temperatures on west main truss.

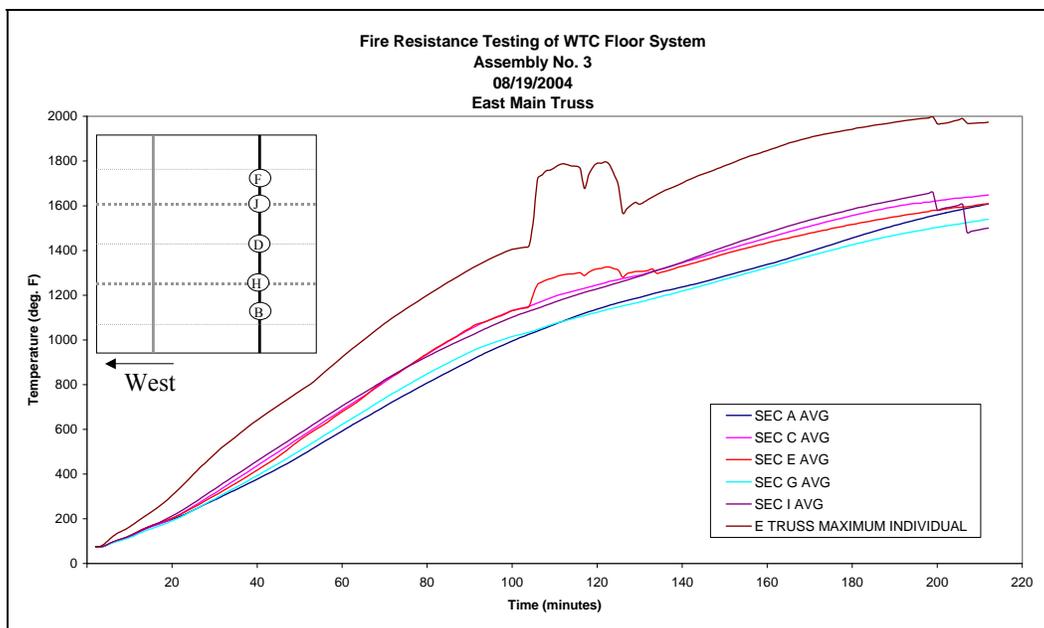
Figure 5–39. Assembly No. 3 – average and maximum individual temperatures on east main truss.

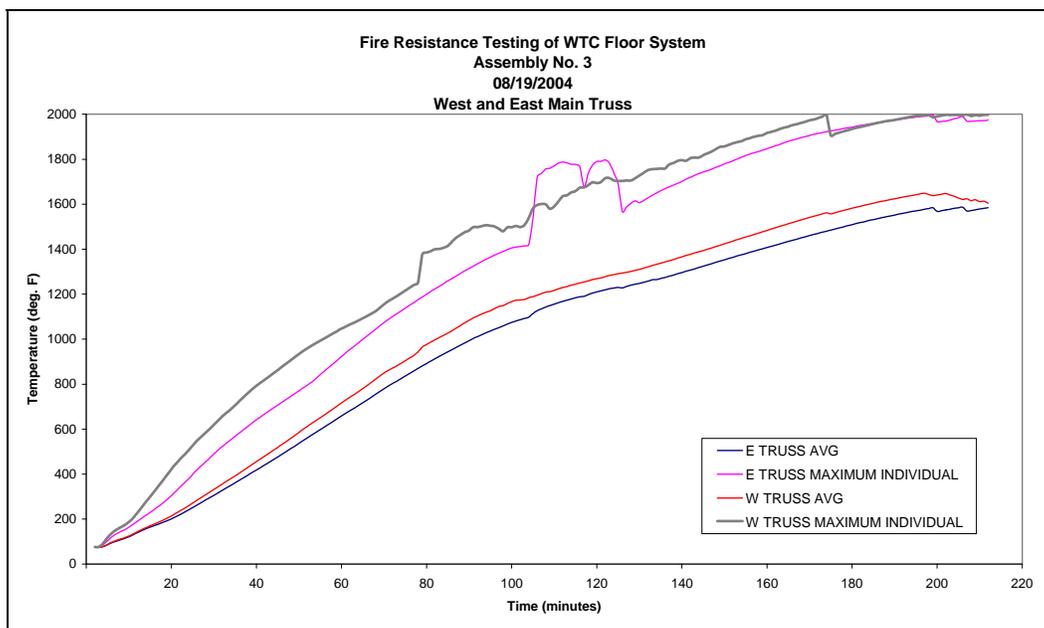
Figure 5–40. Assembly No. 3 – overall average and maximum individual temperatures on west and east main trusses.

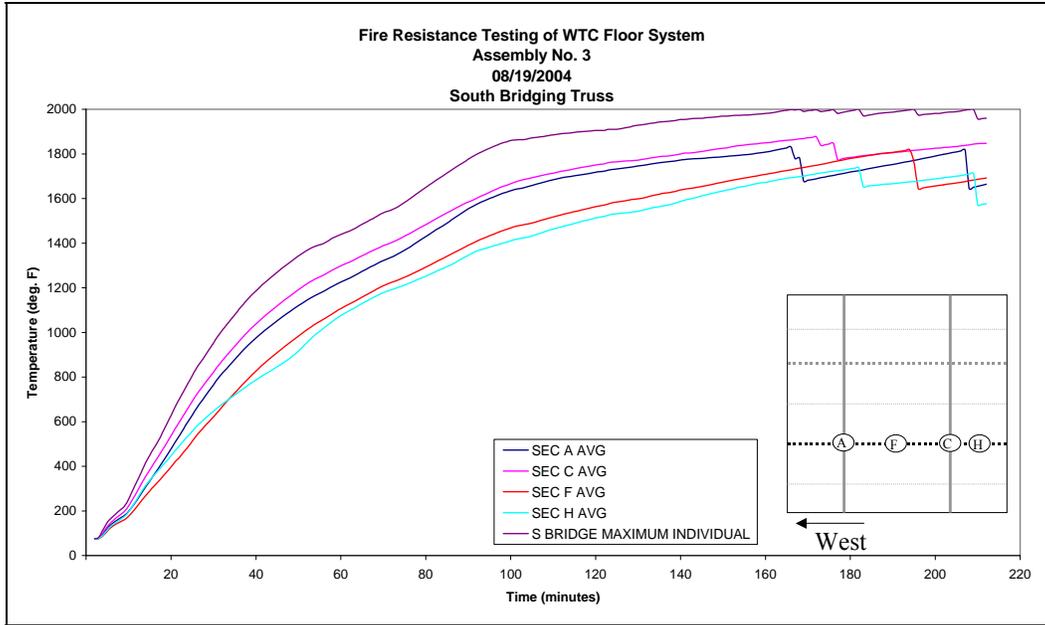
Figure 5-41. Assembly No. 3 – average and maximum individual temperatures on south bridging truss.

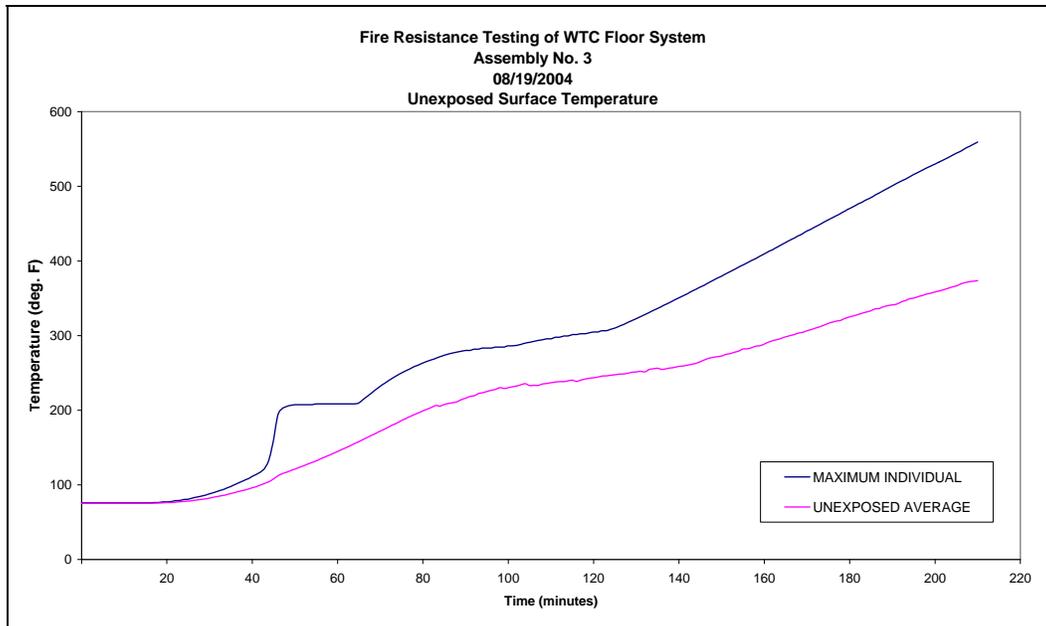
Figure 5-43. Assembly No. 3 – average and maximum individual temperatures on unexposed surface.

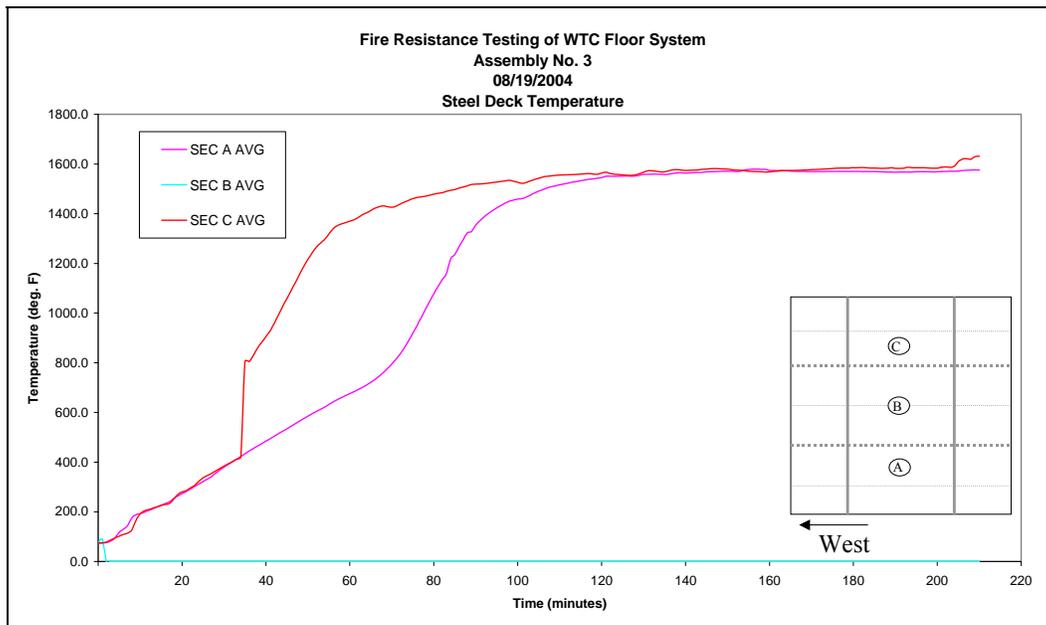
Figure 5-44. Assembly No. 3 – average temperatures on steel deck.

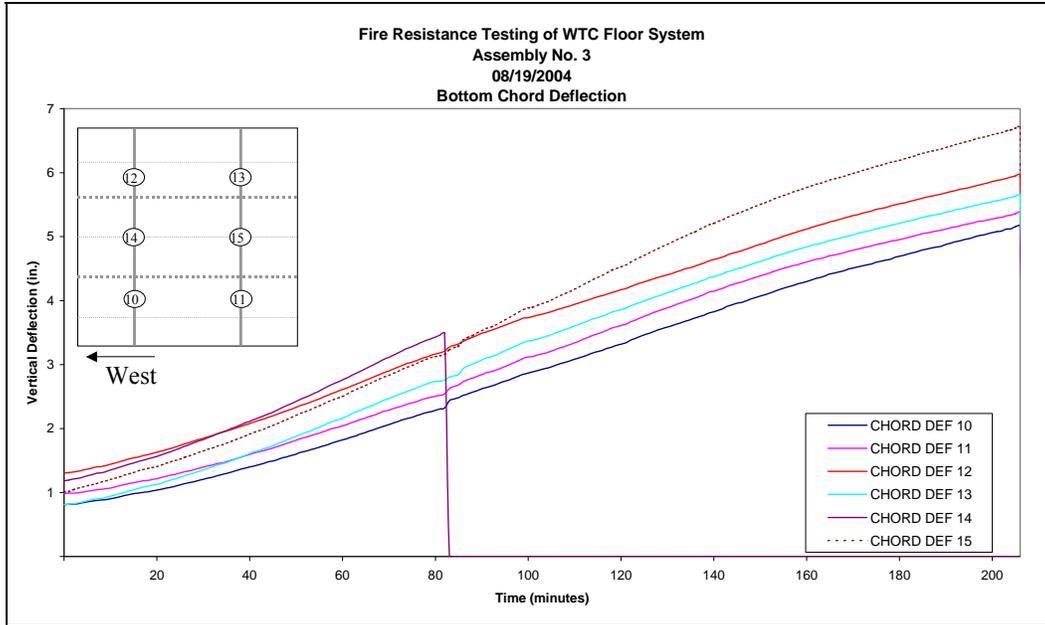
Figure 5–45. Assembly No. 3 – bottom chord deflection measurements.

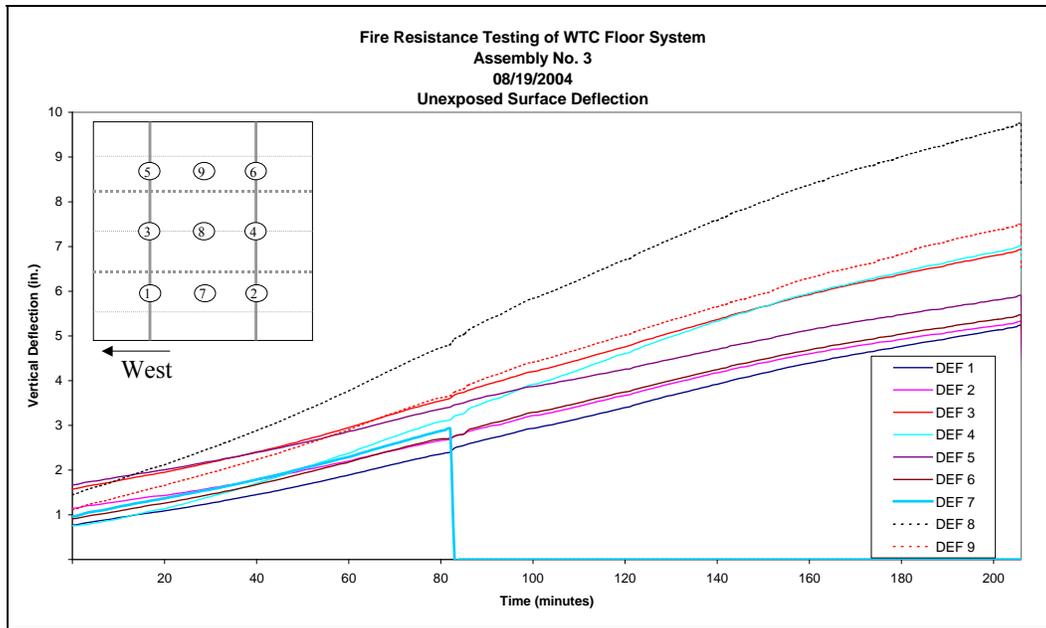
Figure 5-47. Assembly No. 3 – unexposed surface deflection measurements.
