NIST NCSTAR 1-6B

**Federal Building and Fire Safety Investigation of the
World Trade Center Disaster**

Fire Resistance Tests of Floor Truss Systems

September 2005

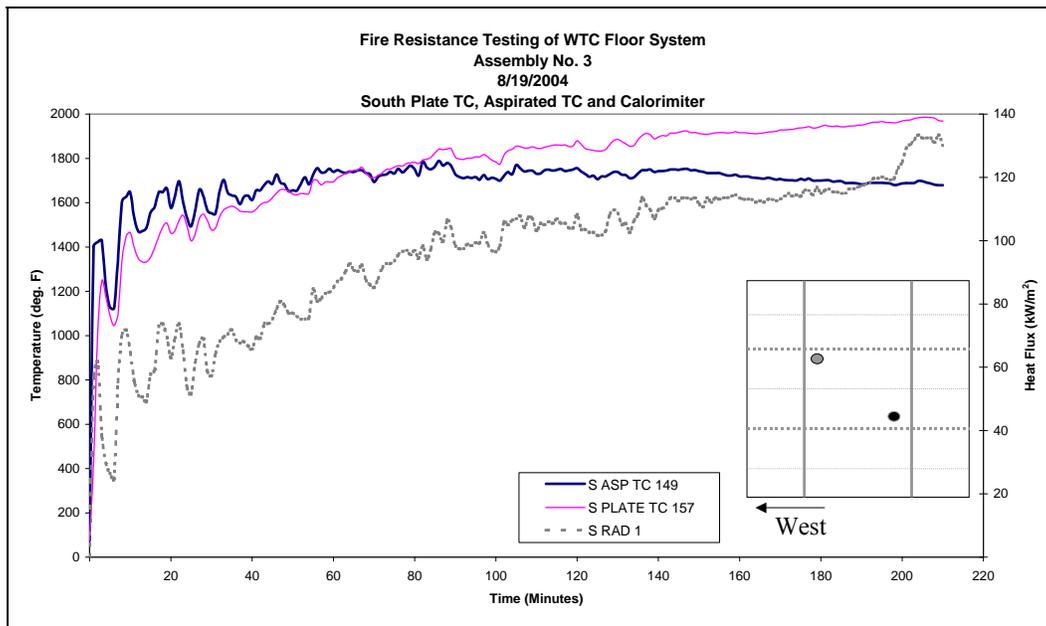
Figure 5-48. Assembly No. 3 – additional instrumentation through south opening.

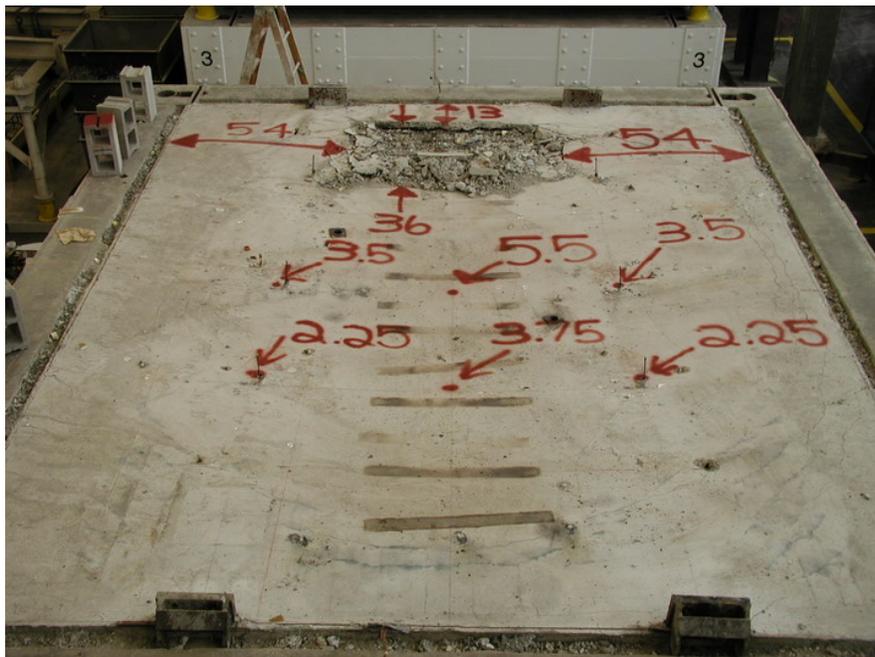
Figure 5–50 shows the unexposed side of floor assembly No. 3 after all loading equipment had been removed (view looking north). Numbers shown at the centerline and quarter points are vertical deflections after cooling. All other numbers are reference dimensions as measured from the edge of the slab. Figures 5–51 through 5–53 are additional views of the post-test condition of the test specimen.

Figure 5–50. Unexposed surface of Assembly No. 3 after loading equipment was removed.

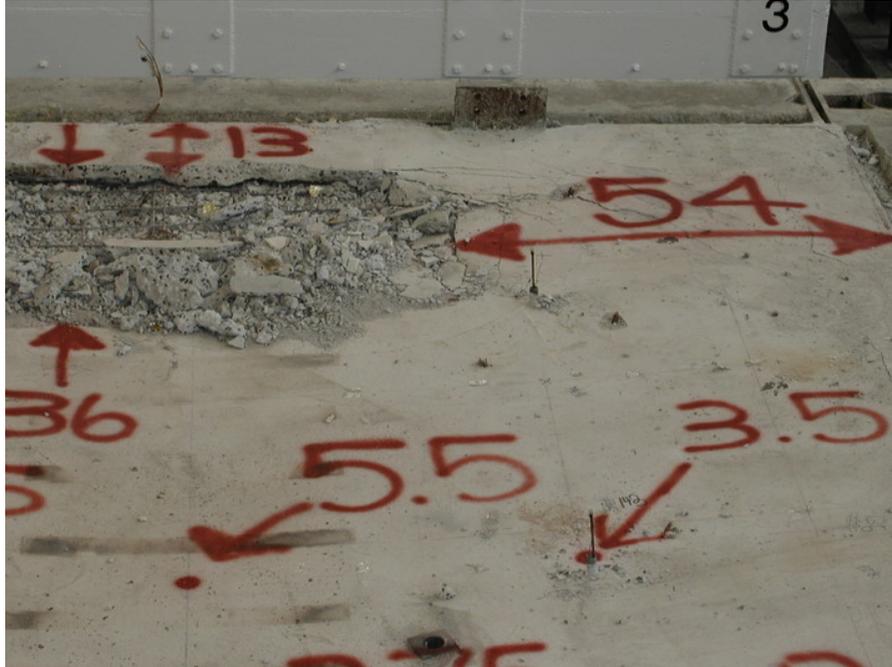
Figure 5–51. Detail of spalling concrete at north end of Assembly No. 3.

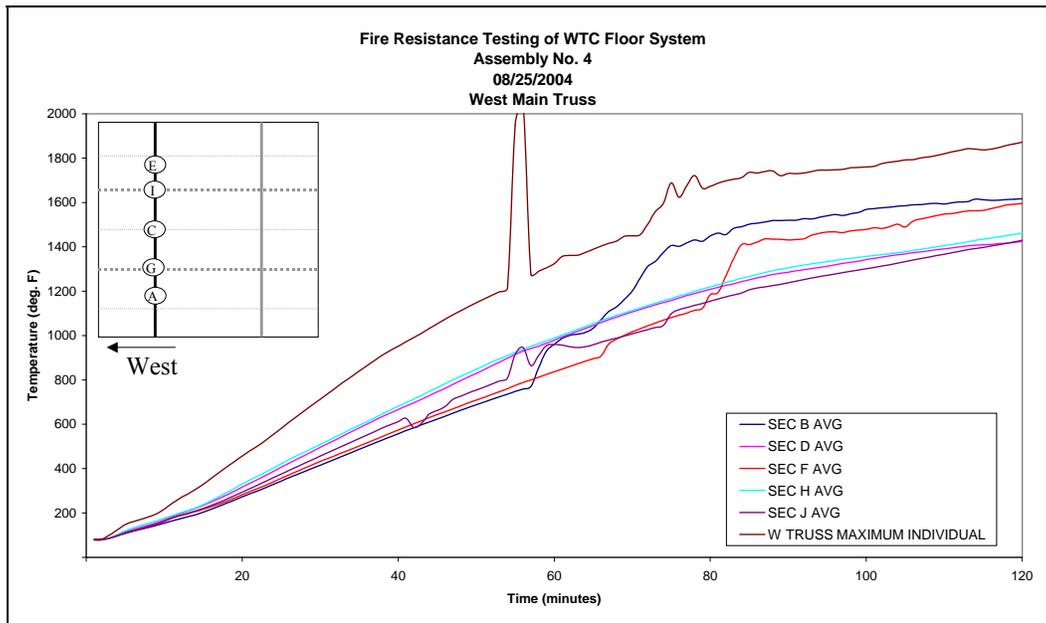
Figure 5–54. Assembly No. 4 – average and maximum individual temperatures on west main truss.

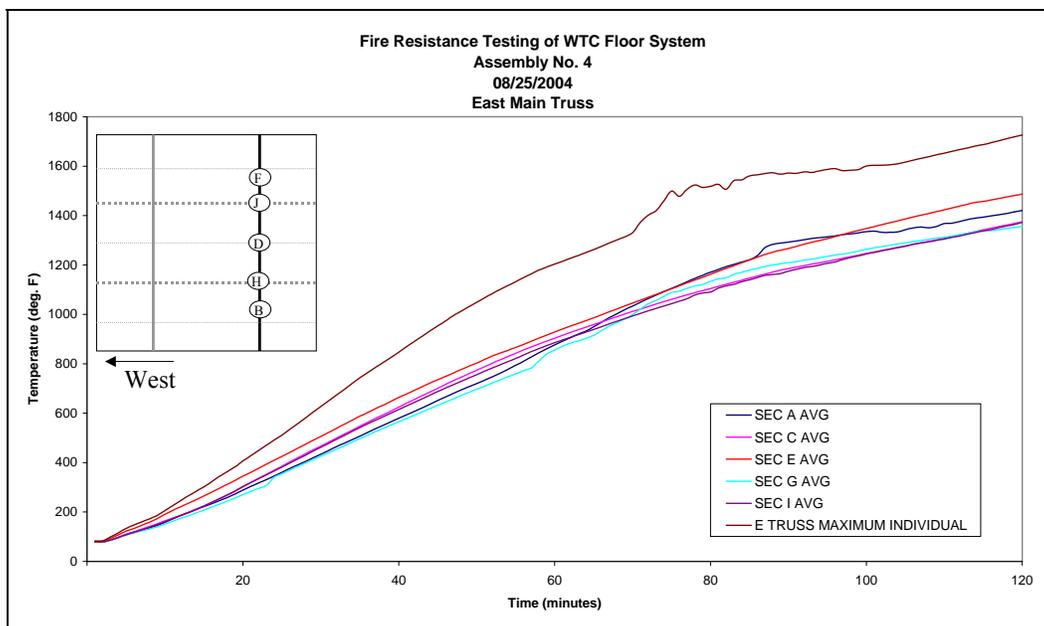
Figure 5-55. Assembly No. 4 – average and maximum individual temperatures on east main truss.

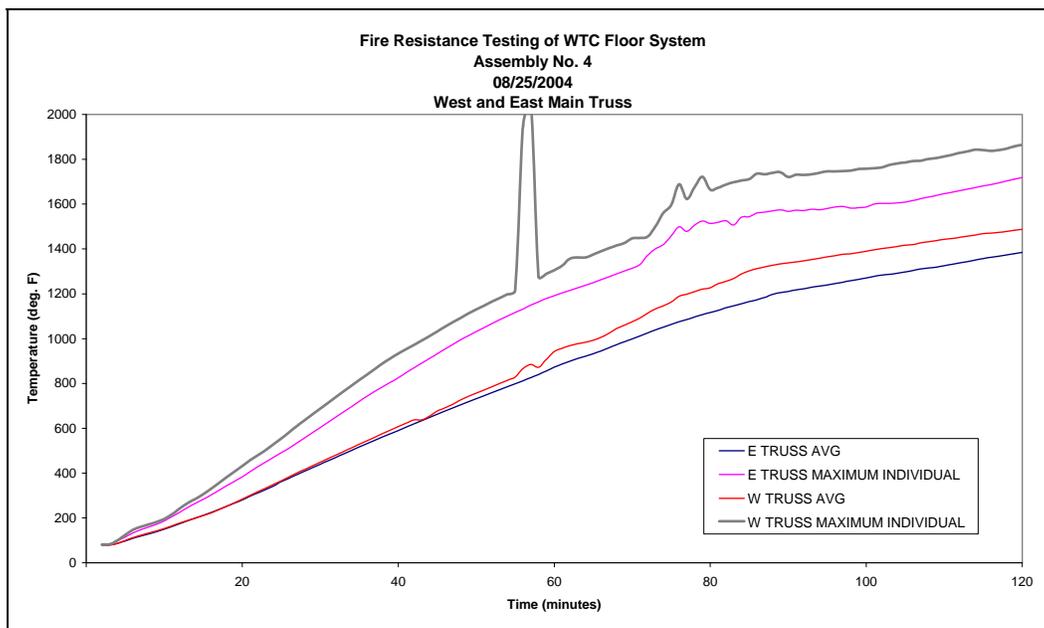
Figure 5-56. Assembly No. 4 – overall average and maximum individual temperatures on west and east main trusses.

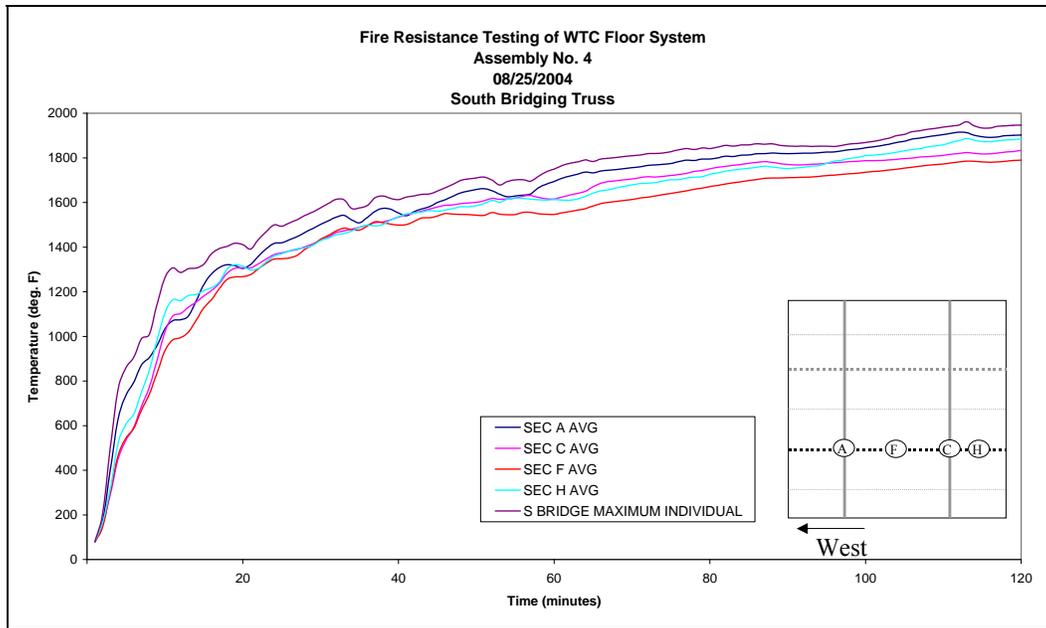
Figure 5–57. Assembly No. 4 – average and maximum individual temperatures on south bridging truss.

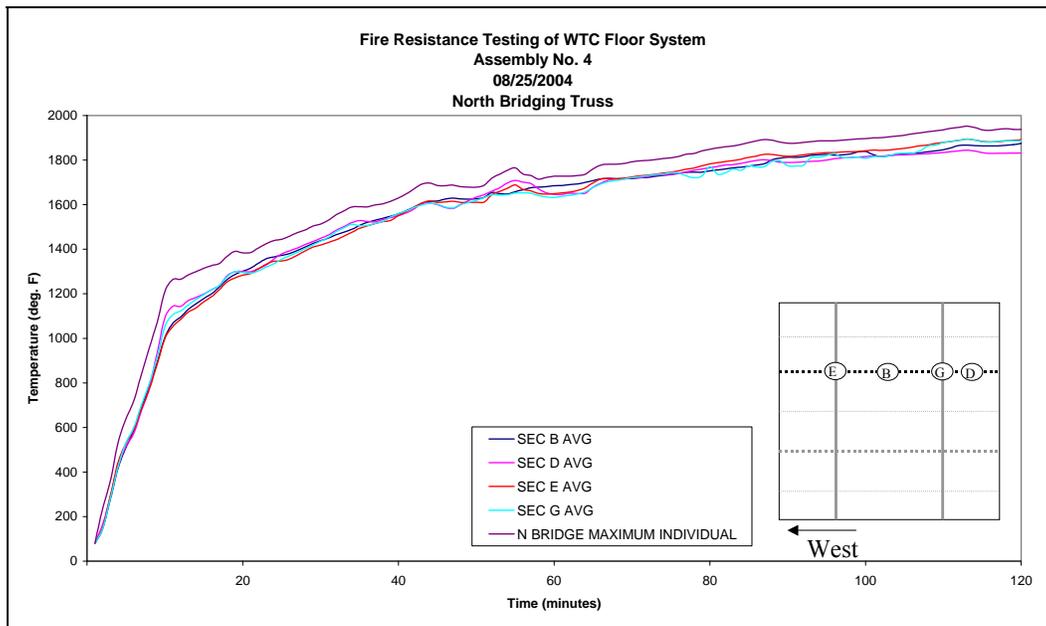
Figure 5–58. Assembly No. 4 – average and maximum individual temperatures on north bridging truss.

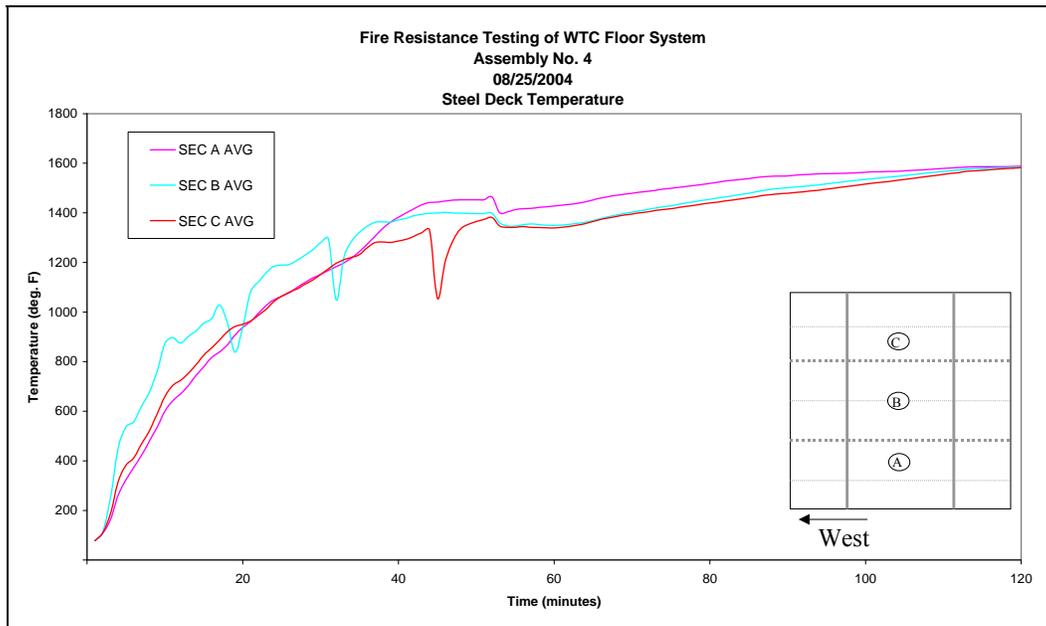
Figure 5–60. Assembly No. 4 – average temperatures on steel deck.

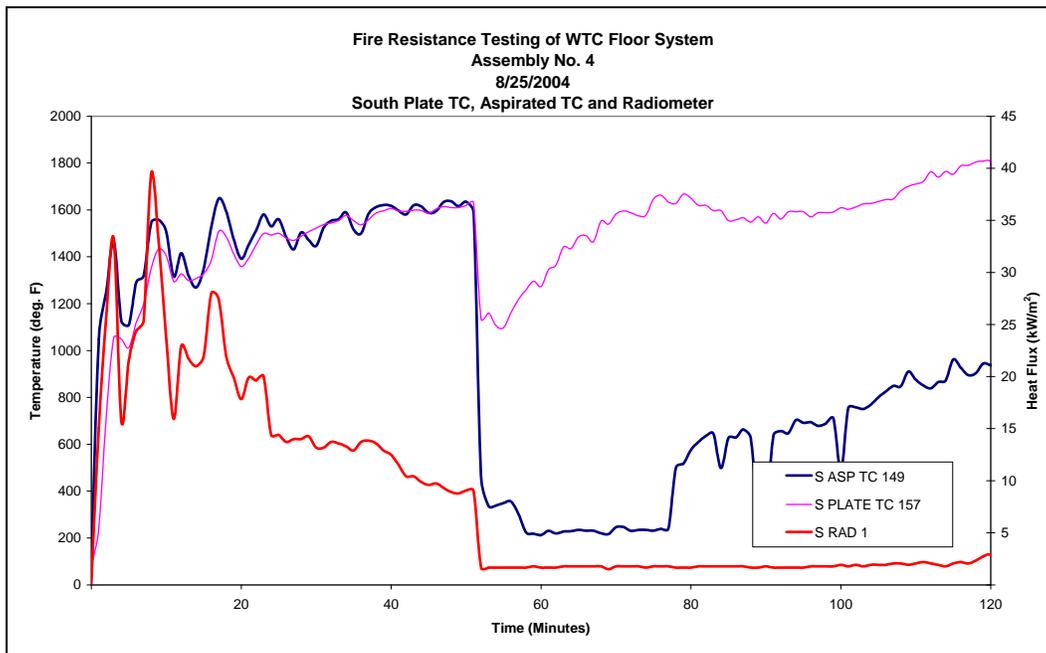
Figure 5–64. Assembly No. 4 – additional instrumentation through south opening.

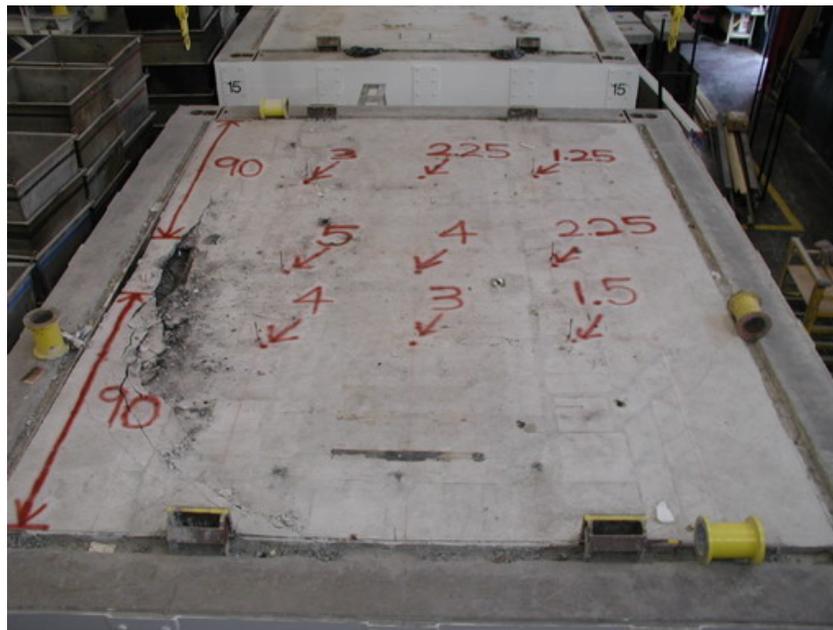
Figure 5–66 shows the unexposed side of the assembly after all loading equipment was removed (view looking north). Numbers shown at the centerline and quarter points are vertical deflections after cooling. All other numbers are reference dimensions as measured from the edge of the slab. Figures 5–67 through 5–70 are additional views of the post-test condition of the test specimen.

Figure 5–66. Unexposed surface of Assembly No. 4 after loading equipment was removed.

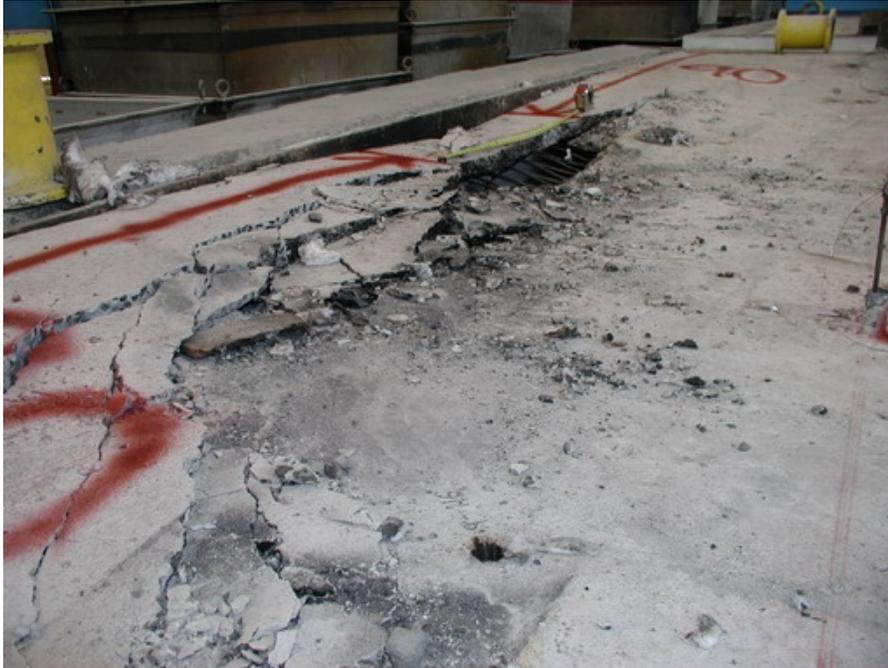
Figure 5–67. Unexposed surface of Assembly No. 4, view of concrete spalling on west side of assembly.

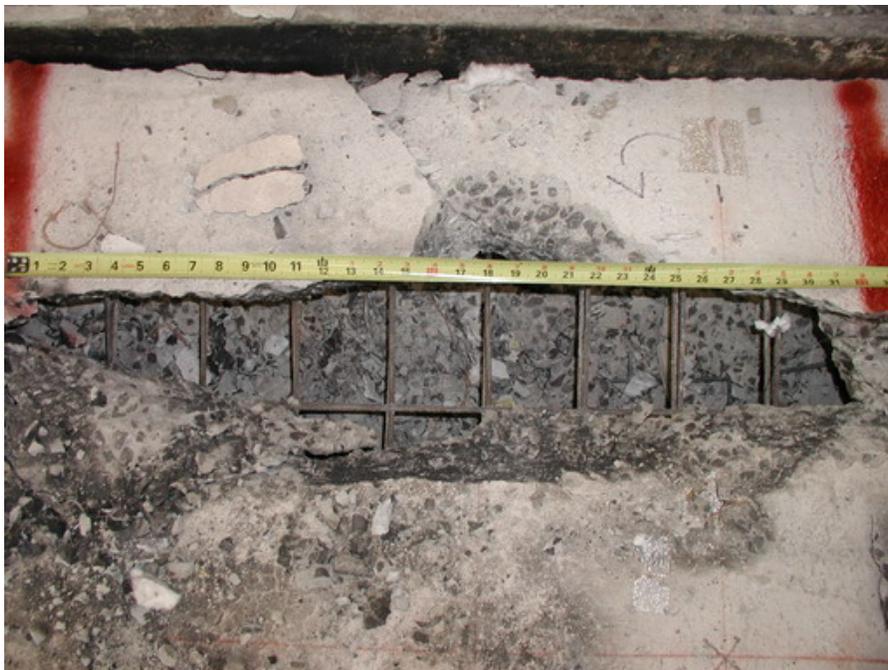
Figure 5–68. Unexposed surface of Assembly No. 4, close-up of concrete spalling on west side of assembly.

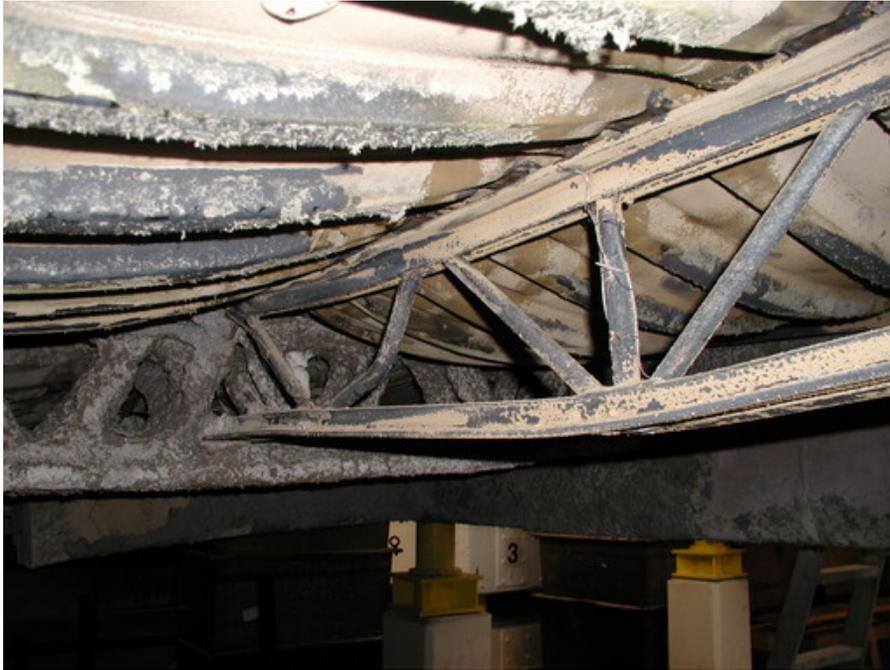
Figure 5–69. Intersection of north bridging and west main truss on Assembly 4.

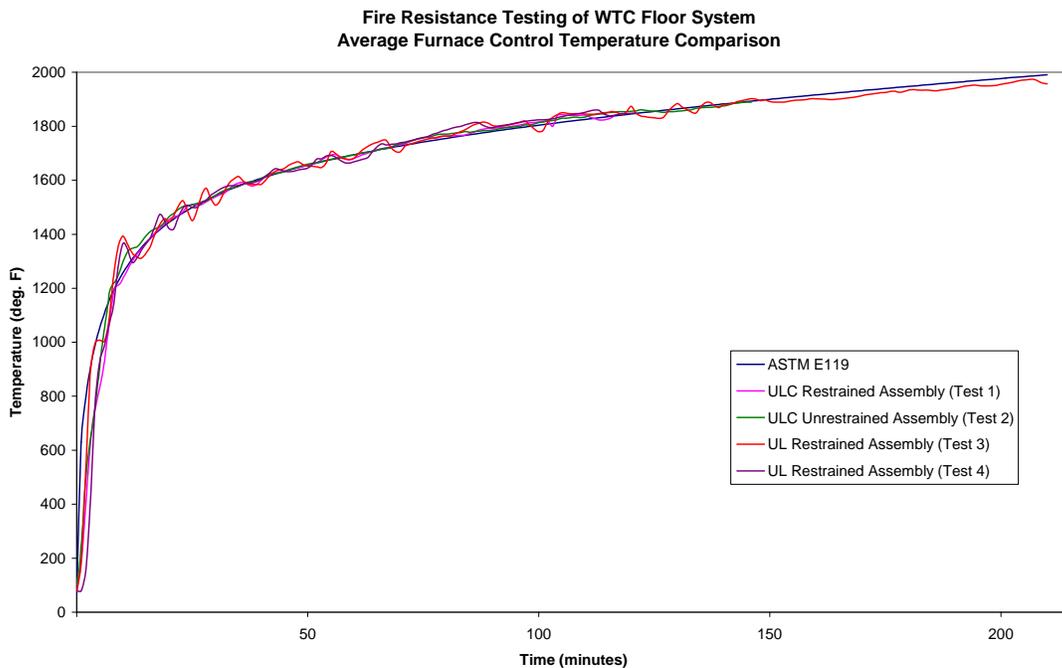
The average furnace temperatures during all four tests and the target time-temperature relationship prescribed by ASTM E 119 are shown in Fig. 6–1. It is seen that the average furnace control temperatures were very similar and indeed met the requirements of ASTM E 119.

Figure 6–1. Comparison of average furnace control temperatures.

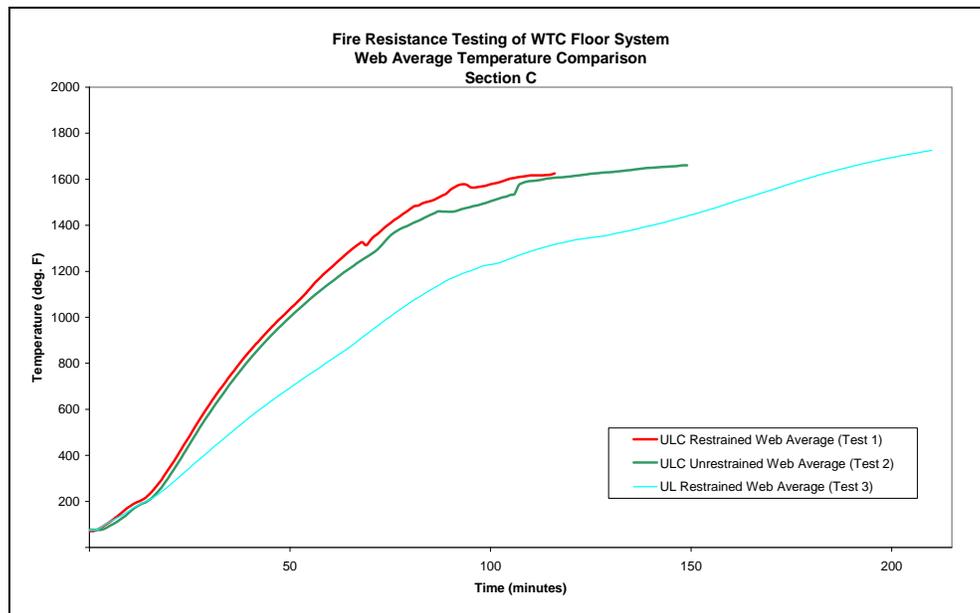
Figure 6–5 presents a comparison of temperatures of the truss web diagonals for the three tests in which the thickness of the SFRM was $\frac{3}{4}$ in. The web temperatures for the two full-scale tests (35 ft span assemblies) were greater than those for the reduced-scale test (17 ft span assembly) after about 15 min. The reason for this difference is not clear but is possibly due to the relationship between the SFRM thickness and scale of the steel trusses. Comparison of Figs. 5–35 and 5–53 illustrates the difference in the buildup of SFRM at the intersections of the webs and chord members between the full- and reduced-scale test specimens, which may affect the rate of heating of the truss web diagonals. These results illustrate that thermal scaling is an issue that needs to be addressed.

Figure 6–5. Average temperature of web diagonals for Test Nos. 1, 2, and 3 (3/4 in. thick SFRM).

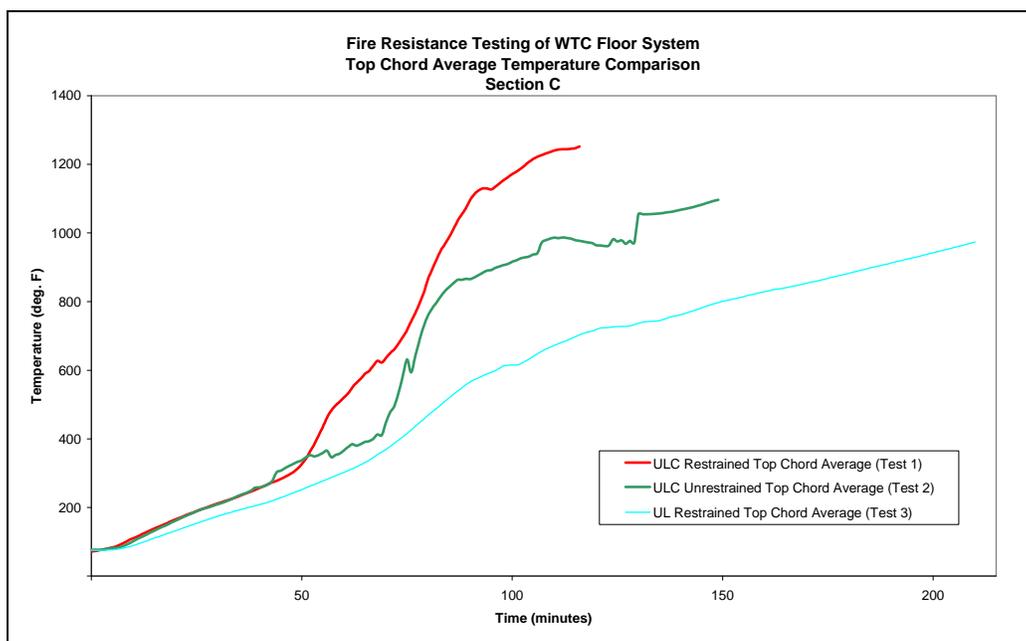
The average temperature of the top chord is plotted in Figure 6–6 for the three test assemblies with $\frac{3}{4}$ in. of SFRM. The average top chord temperature for the two full-scale tests (35 ft span test assemblies) was greater than the average temperature recorded for the reduced-scale test (17 ft span assembly) after about 50 min. Because of the comparatively abrupt changes in average temperature beginning around 50 min, the difference may be explained by sudden changes such as the onset of spalling of concrete and attendant loss of fire protection. However, since the steel temperatures in the reduced-scale test generally tend to be lower than in the full-scale test, this trend may be explained by a scale-related factor such as the difference in the buildup of SFRM affecting the rate of heating of the steel as noted above. Further, it is possible that the overspray on the metal deck was greater for test Specimen No. 3 than for the other two tests since the lower chord is closer to the metal deck. This, too, would be a geometrical scaling effect.

Figure 6–6. Average temperature of the top chord for Test Nos. 1, 2, and 3 (3/4 in. thick SFRM).

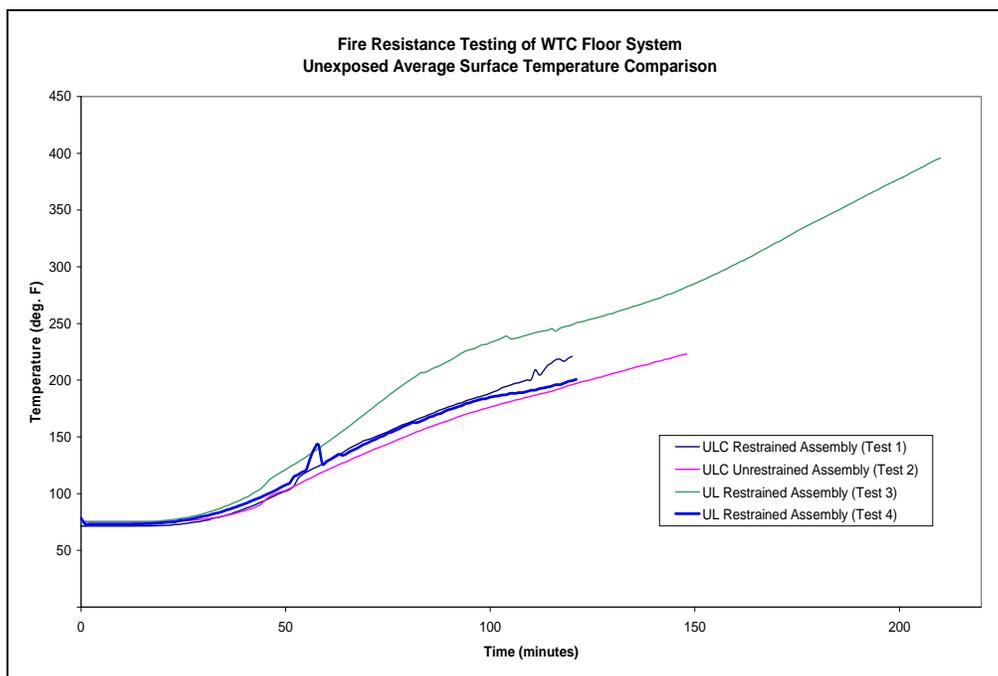
The temperature of the unexposed surface of the floor assemblies is plotted in Fig 6–8. It is observed that the unexposed surface temperatures of all four test assemblies were similar prior to the onset of significant concrete spalling at around 50 min. In Test 4, the surface-mounted TC on the west edge near the center of the span was affected by the explosive failure of the slab and recorded hot gas temperatures.

Figure 6–8. Average temperature of the unexposed surface for all four tests.

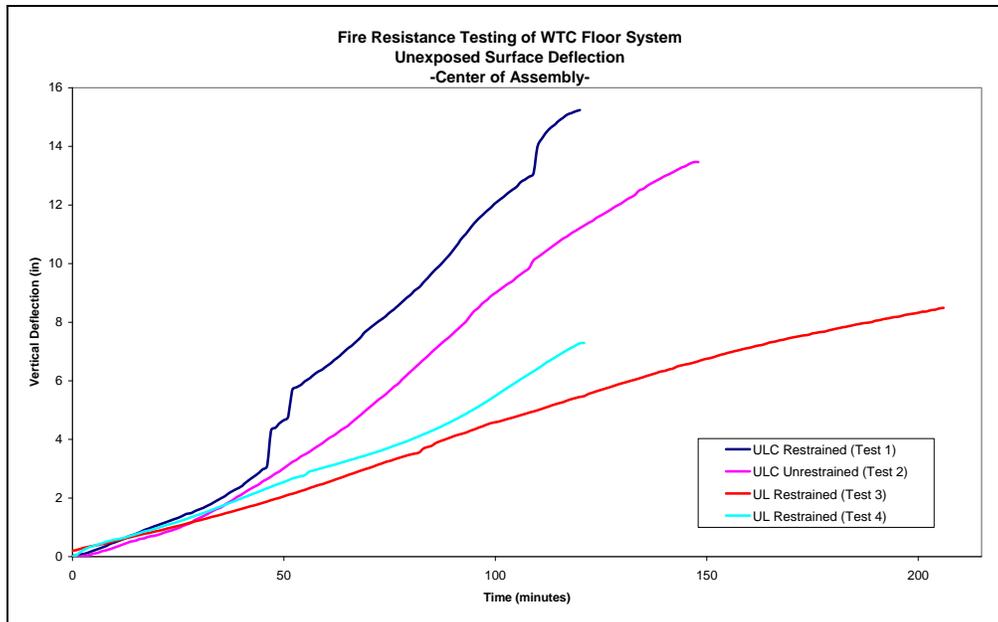
The following plots show the vertical deflection measured at the center of each assembly. Figure 6–9 shows the deflection, while Fig. 6–10 shows a plot of the deflection normalized by the span. It is seen that test Assembly No. 1 experienced a significant increase in vertical deflection at 49 min, which corresponds directly to a loud report and visible deflection noted in the test observations. Figure 5–13 shows the damage to the top side of the concrete slab that occurred with the sudden increases in deflection. The normalized curves show good agreement throughout the duration of the tests.

Figure 6–9. Deflection measured at the center of each assembly.

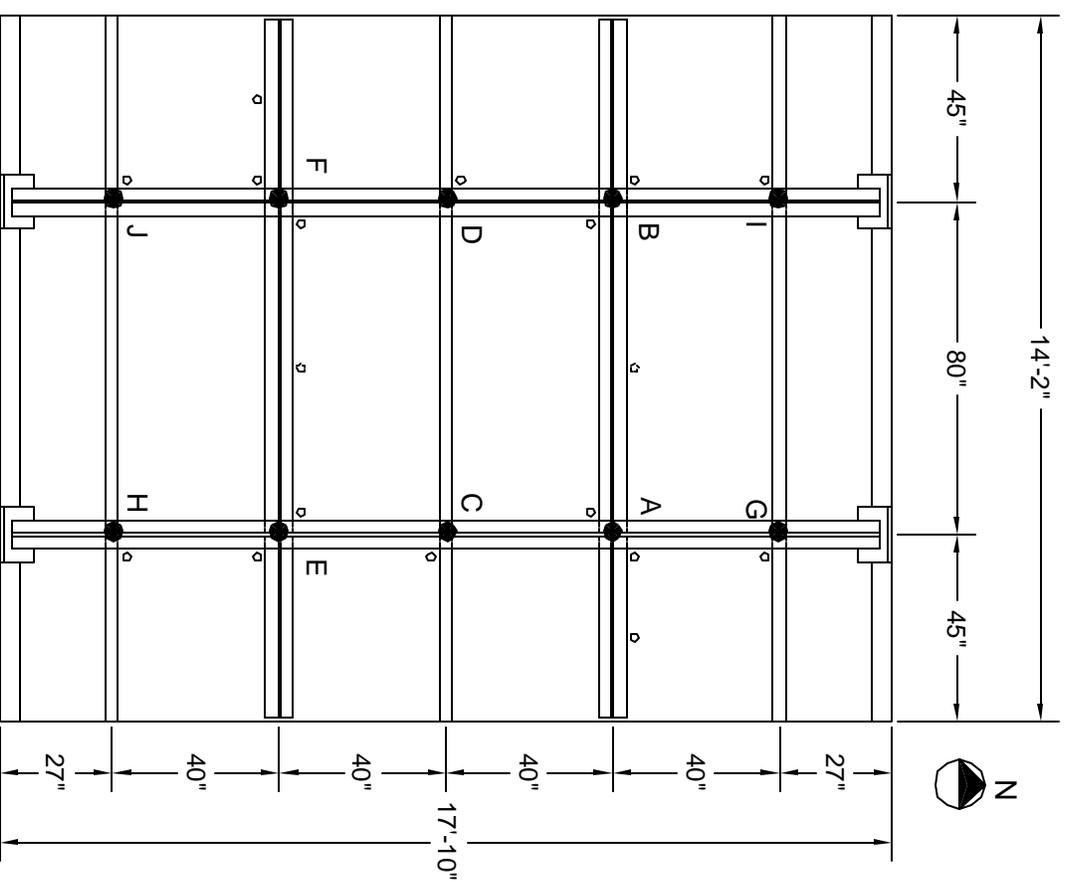
Main Truss Thermocouple Locations

ø - 1" diameter opening for thermocouple wires on main and bridging trusses.
