# **SLAB EFFECTS IN SMRF RETROFIT CONNECTION TESTS**

Reprinted from the Journal of Structural Engineering, Vol. 127, No. 3, 230-237, March 2001.

# SLAB EFFECTS IN SMRF RETROFIT CONNECTION TESTS

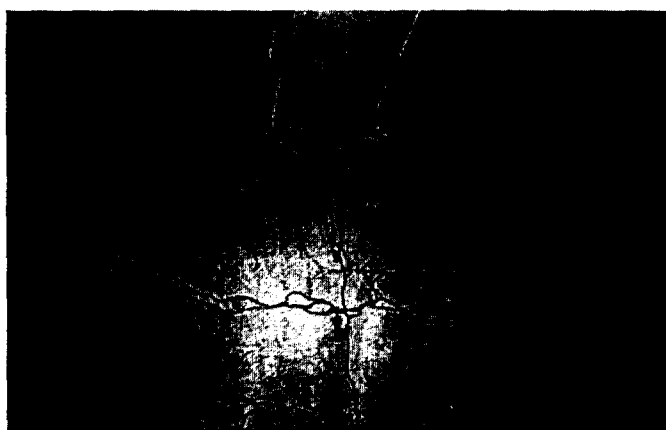
FIG. 6. Cracking Pattern at Column Face (HCH4)

of the slab after testing is shown in Fig. 5, and a view of the column flange face is shown in Fig. 6. A compression zone is indicated by the predominantly longitudinal cracking, which extends from the corners of the column and gradually bounds a wider swath of the slab. This type of crack pattern was somewhat restrained by the transverse steel that was provided for shrinkage and temperature control.

Some diagonal cracks propagating from both the column flange face as well as from the inside edges of the far column flange were seen (Fig. 6). Therefore, it may be speculated that maximum concrete compressive forces may not only be increased beyond  $f_c$ , but that the effective width of the compression zone at the column face is wider than the column flange face. This increase in the effective width of the compression zone would be related to the stress distribution of the compression zone that initiates at the inside of the opposite flange face. Maximum compressive forces would be a factor of column flange width and depth. The compression zone distributed at approximately  $15^\circ$  to  $30^\circ$ , as estimated from crack patterns in the specimens.

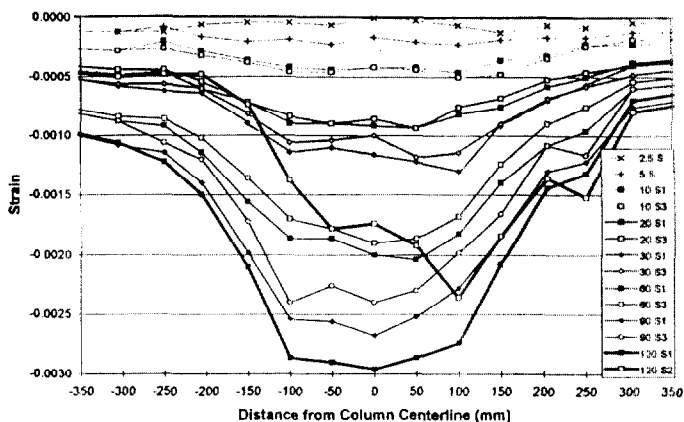
The increased number of Dmcc points at the column face of specimen HCH4 (NB1 and SB1) provided some insight into the maximum compressive forces in the slab (Fig. 7). Peak strains that would typically correlate to approximately 85% of full compression stress (about 0.0010 mm/mm) were attained

FIG. 7. Strains at Column Face (HCH4 Gauge Line SB1)

for the 20 mm (0.8 in.) load cycles, while at the 60 mm (2.4 in.) load cycles, this value was exceeded across the entire 610 mm (24 in.) of gauge readings, indicating stresses on the order of  $f_c$ . The 610 mm (24 in.) width exceeds the column flange width of 330 mm (13 in.), indicating the initiation of the compression zone at the far column flange. At the 60 mm (2.4 in.) load cycles, the achieved moments were approximately 90–95% of the total achieved in the test. It was impossible to determine the actual compressive force of the slabs or estimate a strain distribution through the slab thickness due to scatter in strain gauge data at the column face.
