Fire Safety Journal

Experimental study on the performance of a load-bearing steel stud gypsum board wall assembly exposed to a real fire

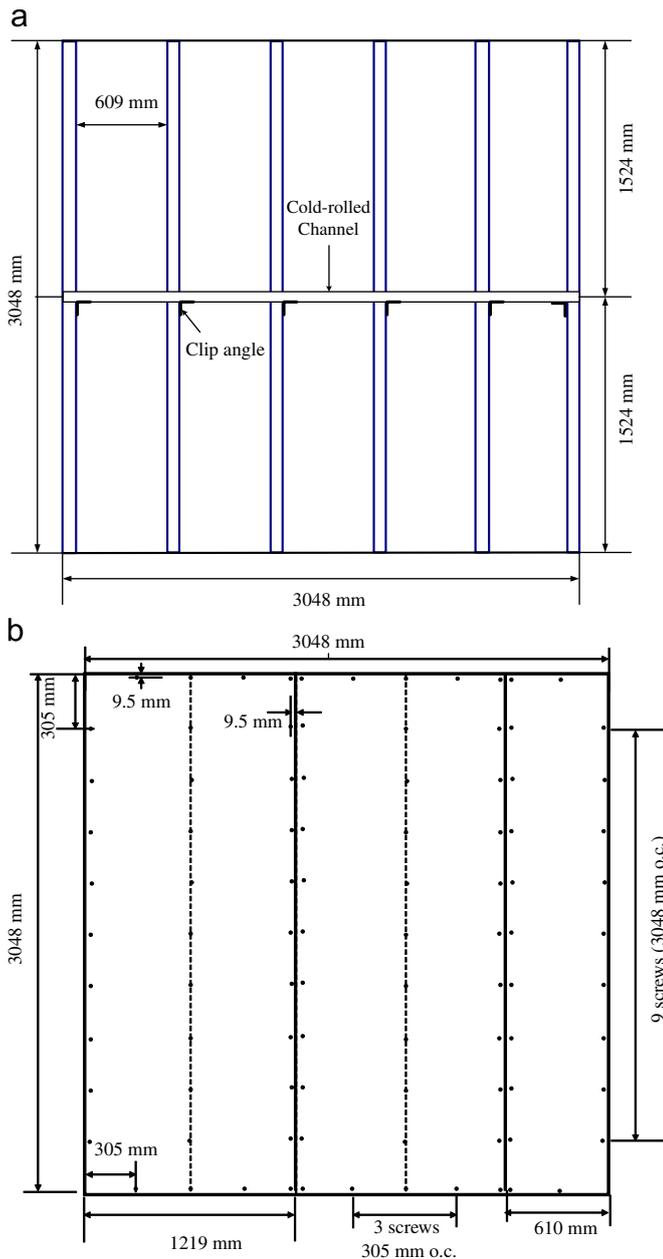
Fig. 1. Schematic of load-bearing steel stud/gypsum wall assembly: (a) steel frame assembly; and (b) gypsum wall assembly attached to studs.

shown in Fig. 1a. Steel studs with yield strength of 228 MPa were equally spaced at 609 mm, and a bridging channel (3.0 m long) was installed at mid-height of the frame. The installation of the gypsum board to the studs was performed in accordance with ASTM guidelines [4–7]. Fig. 1b displays the steel stud gypsum wall assembly that includes two layers of gypsum board on each face. Each layer consisted of three single gypsum board panels; two with dimension of 1219 mm × 3048 mm and one gypsum board panel with dimensions of 610 mm × 3048 mm. Each was attached to the studs using type S drywall screws. The seams of each layer were then staggered as done in practice.

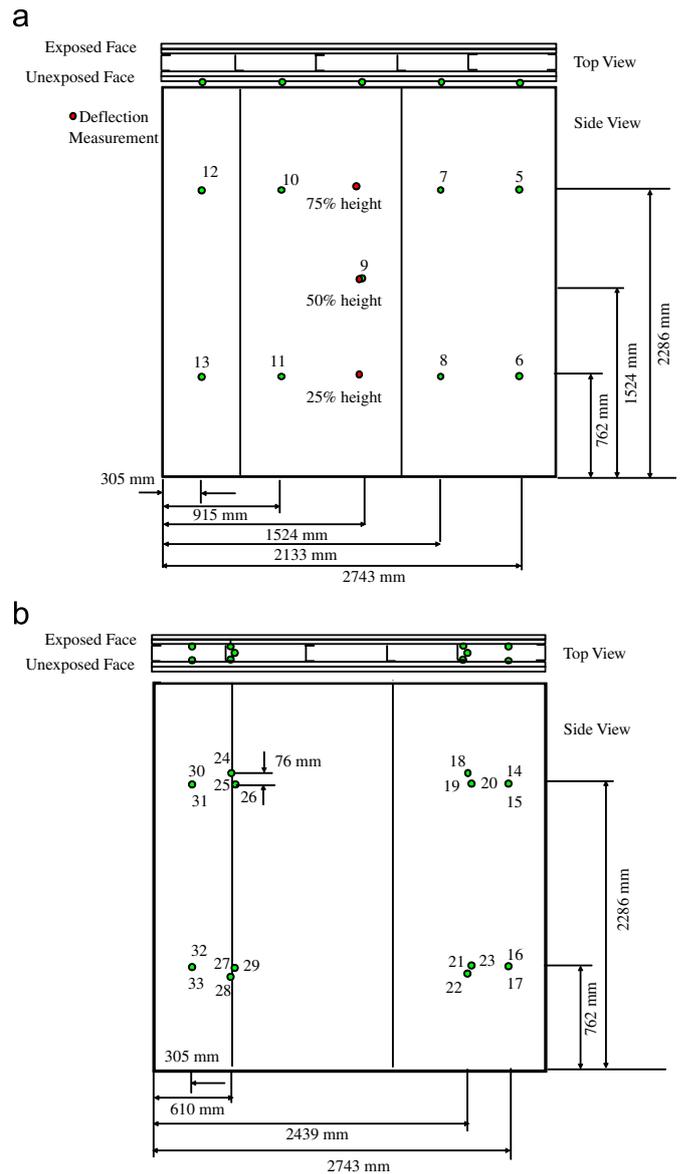
Fig. 2. Drawing of the test wall assembly showing the location of thermocouples and deflection gages installed: (a) location of thermocouples and deflection gages on the unexposed face; and (b) location of thermocouples inside the cavity.

information on the locations of the thermocouples is displayed in Fig. 2a and b.

During the test, horizontal deflection at three points (25% wall height, 50% wall height, and 75% wall height; (see Fig. 2b) was also measured on the test wall assembly in order to examine the out-of-plane deflection of the assembly. In addition, the vertical displacement of the sliding platen that rested on the hydraulic jacks was measured.

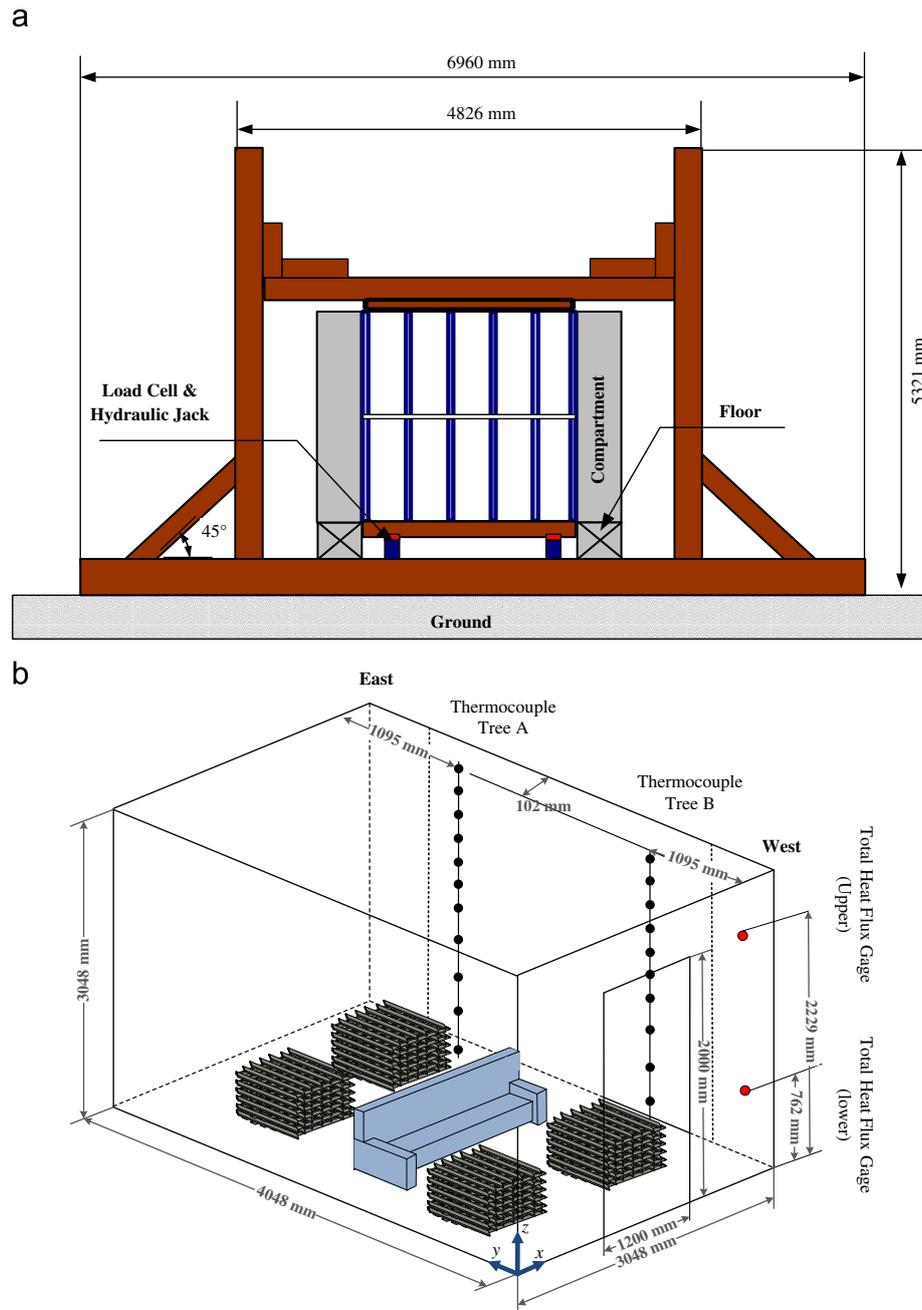
Fig. 3. Schematic of test facilities and the compartment: (a) front view of the compartment equipped with a gypsum stud wall assembly and test facilities; and (b) perspective view of the compartment.

A compartment of dimensions 3048 mm (width) × 3048 mm (height) × 4048 mm (length) was finally placed against the loading frame (see Fig. 3a–b). Gaps between the compartment and the test wall assembly were sealed with fire-resistant ceramic fiber material. The compartment was designed not to interact mechanically with the test wall assembly. This design is very similar to how the thermal exposure is provided during furnace testing [1,8]. A 1200 mm × 2000 mm opening was constructed at the western side of the compartment. As shown in Fig. 3a, the

steel stud gypsum wall assembly was loaded via two hydraulic jacks mounted on the bottom of the test frame. A load cell was mounted above each of the hydraulic jacks. Each of the load cells was calibrated using instrumentation in the NIST manufacturing metrology division prior to the test. In these calibration tests, various loads were applied to the load cells and a plot of voltage as a function of applied load was generated. The applied loads during the calibration procedure encompassed the full range of load detectable with these particular load cells. In this study, the applied load to the test wall assembly was a nominal value of 65 kN, which corresponded to 90.5% of the maximum design load. The maximum design load was determined by following the specification of the design of a cold-formed steel structural member proposed by the American Iron and Steel Institute (AISI) [9].

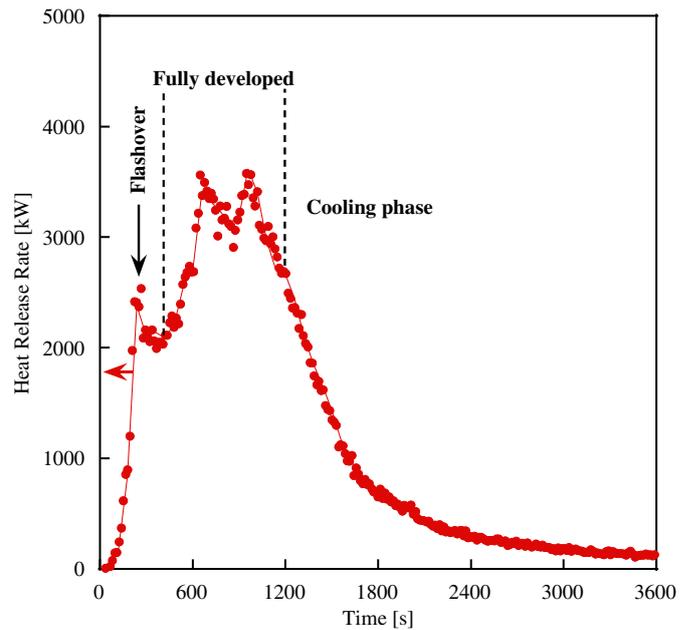
Fig. 5. Measured heat release rate and total heat fluxes as a function of time.

Fig. 5 displays the measured heat release rate (HRR) as a function of time. In the figure, the measured HRR rapidly increased over a period of approximately 260 s, producing the first peak of HRR, which occurred at the onset of flashover. During this period, radiant heat from the fire resulted in ignition of two cribs located at the western side of the compartment, accelerating the transition to a fully developed fire. As the fire grew into the fully developed phase, two identical peaks of HRR of 3710 kW were observed. This can be attributed to the fact that the fuel (i.e., pyrolysates from cribs and a sofa) in the western side of the compartment was consumed faster than that in the eastern side. This interesting phenomenon can be confirmed by gas-phase temperatures measured from each thermocouple tree installed at different locations of the compartment (which are displayed and discussed in Fig. 6).

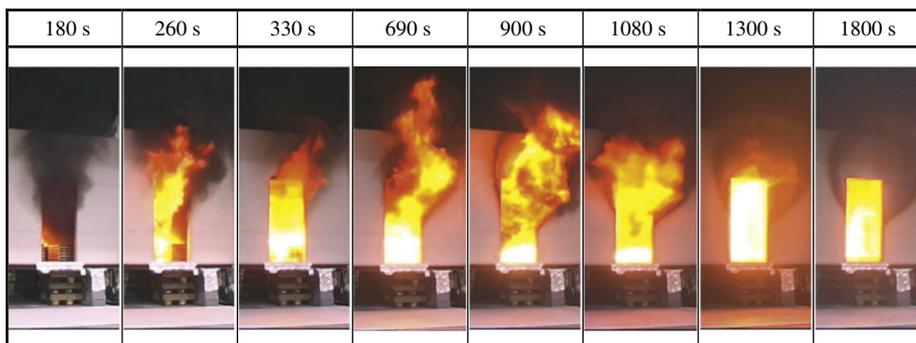
Fig. 4. Sequential images of compartment fire after ignition.

Fig. 4 displays temporal images of the compartment fire development after ignition. Piloted ignition initiated on the sofa resulted in a rapidly developing fire. As shown in the figure, the onset of flashover was observed approximately 260 s after ignition and then a ventilation-controlled fire developed. As the fuel was consumed, the fire began to diminish 1080 s after ignition. The maximum radiant intensities (judged by the luminosity from fire) in the compartment were observed around 1300 s after ignition (See Fig. 4).

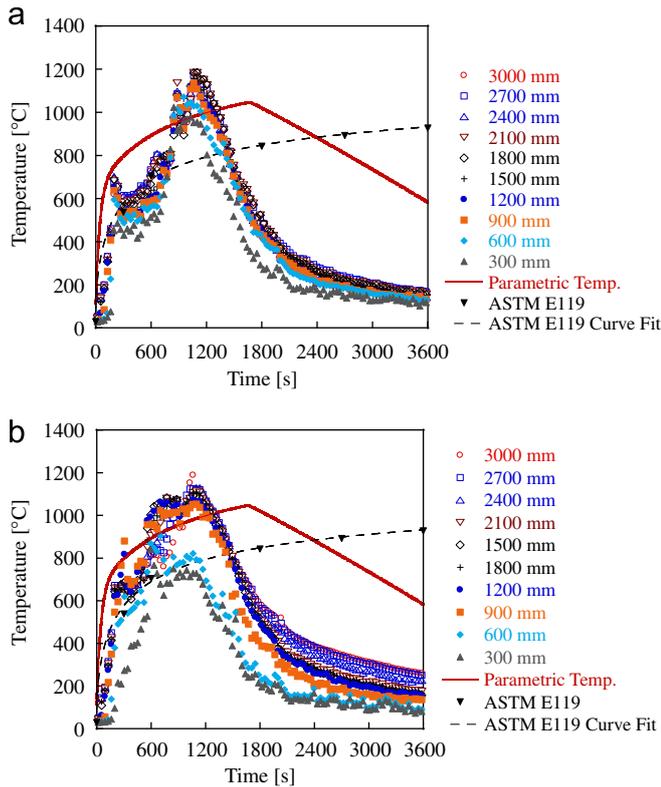
Fig. 6. Measured temperatures as a function of time: (a) eastern side of compartment; and (b) western side of compartment.

Fig. 6a–b displays the measured temperatures inside the compartment as a function of time after ignition. In Fig. 6b, two distinct peaks (except for bottom regime) were observed in

temperature measured from the thermocouple tree B (installed close to the door way), similar to the HRR measurement. After flashover, more radiant energy was delivered to the cribs installed near the door way (compared to those inside the compartment) due to the projected flames, resulting in fast fuel pyrolysis reactions and thus the first peak of the HRR. As a result, the rate of temperature rise measured from thermocouple tree B was much faster than that measured from thermocouple tree A over the same period (between 600 s and 900 s). This result suggests that the fuel load distribution will affect the temperature profiles inside the compartment. Therefore, the thermal loads that are delivered to the structure exposed to real fires will not be uniform along the compartment in contrast to the furnace exposure tests. As temperatures inside the compartment rapidly increased, fuel produced from the cribs installed at the rear of the compartment began to burn actively, producing the second peak of the HRR.

In Fig. 6a–b, the time–temperature histories specified in ASTM E119 testing protocol [13] and parametric fire equations (given in Annex A of Eurocode 1 [14]) were also plotted for a direct comparison to that of real fire exposure in this experiment. These prescribed time–temperature curves have been commonly used for a standard fire resistance testing of load bearing steel stud gypsum board wall assemblies [1,8,15]. The time–temperature relationship prescribed by ASTM E 119 in Fig. 6 was fitted using

Except for the bottom regime of the western side of the compartment, the measured temperatures from real fire exposures increased in a rate similar to other time-temperature curves until flashover. After this period, the rate of temperature rise measured from each thermocouple tree was much faster and greater than that observed in other time-temperature curves. The measured temperatures in the compartment continued to increase until 1200 s, reaching a maximum temperature of 1200 °C, and then decayed. In contrast to the ASTM E 119 time-temperature curve (that continuously increased and does not decay), the parametric fire temperature curve produced a fair approximation in terms of estimating the maximum compartment temperature and its corresponding time (although the maximum compartment temperature is slightly lower and its corresponding time is overestimated compared to real fire measurements). However, there was a large difference in the temperature decay rate between the two cases for the cooling phase. In addition, the parametric fire temperature curve does not

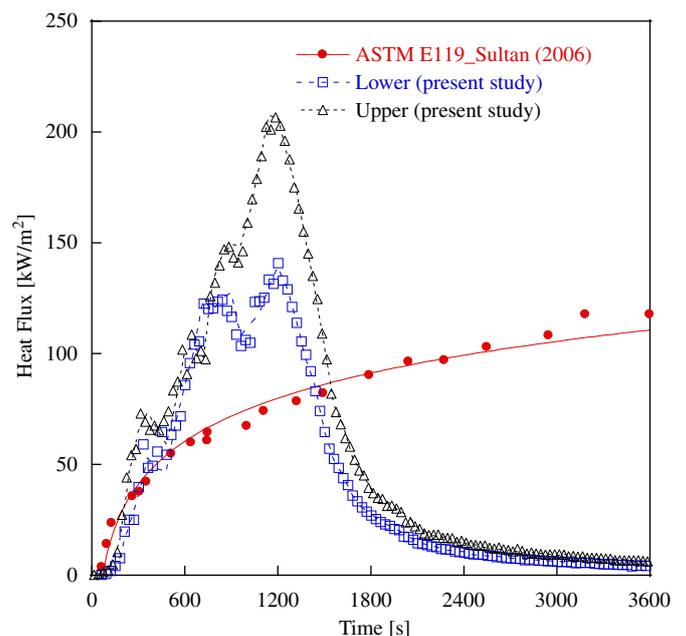
Fig. 7. Total heat flux comparison between real fire exposure and furnace tests.

The total heat flux impinging on the surface of the compartment wall was measured using two heat flux gauges (vertically mounted 762 mm and 2229 mm away from the compartment floor) and is displayed in Fig. 7. It is important to note that the total heat flux gauges were not installed on the test wall assembly to protect them from possible damage caused by structural failure and, more importantly, not perturb the test wall itself. For comparison, the total heat flux measured in a furnace test operated following the ASTM E119 testing protocol [17] was also plotted in the figure. Initially, heat fluxes measured from both the real fire and furnace exposures were similar, suggesting that the ASTM E119 method produces a similar magnitude of thermal load as the real fire test performed in this particular study. After the onset of flashover (approximately at 260 s), the total heat flux measured for the real fire exposures, however, increased much faster compared to that for the furnace exposures, reaching the maximum value for both locations approximately at 1300 s. The measured heat flux distributions in the present study were very similar to those measured from other real fire tests [18,19]. Another significant difference in the measured total heat flux, compared to the furnace exposures, was that the magnitude of the total heat flux varied as a function of height in the compartment. For furnace exposures, the measured total heat was of the same magnitude, irrespective of height of the furnace. For the load-bearing wall assembly subjected to non-uniform heat flux distributions along the height, a thermally induced curvature (due to thermal load) can affect the integrity of structural elements and thus some elements can attain the load limit, causing the structural failure [20].

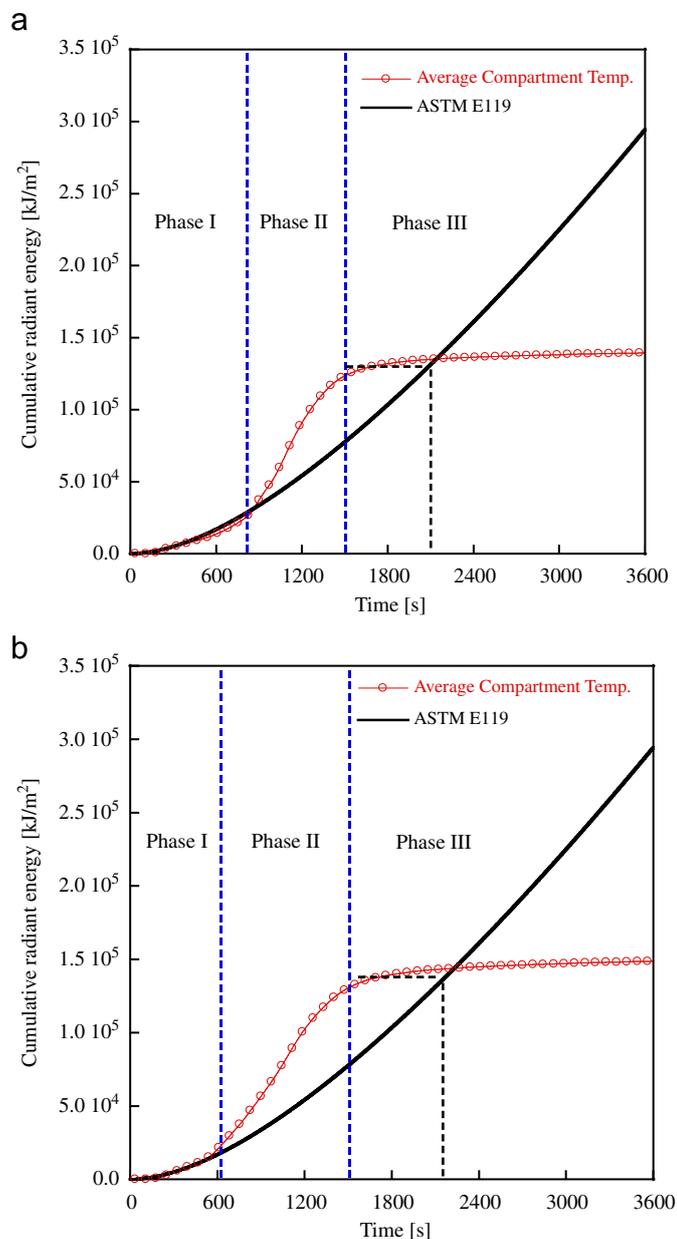
Fig. 8. Calculated cumulative radiant as a function of time: (a) eastern side of compartment; and (b) western side of compartment.

The cumulative radiant energy, E , was calculated using the averaged compartment fire temperature along the height (determined from temperature profiles in Fig. 6a–b) and plotted against time in Fig. 8a–b. For comparison, the calculated E from the ASTM E119 time–temperature curve (i.e., furnace exposures) was also plotted in the figure. The calculated E for the furnace exposures continuously increased; for the real fire exposure in the present study it was clearly divided into three phases. In phase I, the calculated E for both in real fire and furnace exposures slowly increased, keeping a similar value in magnitude, suggesting that the ASTM E119 method produced a similar magnitude of thermal load with the real fire test performed in this particular study during this phase. In phase II, there were distinct deviations in E

for each of the exposures. The rate of E rise for the real fire exposures was much faster compared to that for the furnace exposures expected for the bottom regime of the compartment. In Fig. 8a, for example, the time at which the test wall assembly is exposed to 1.3×10^5 kJ/m² was approximately 1500 s (near the end of phase I) for the real fire exposures while the equivalent magnitude of E for the furnace exposures was observed approximately at 2250 s. Similar behaviors were observed in Fig. 8b. It is also interesting to note that a maximum value in the calculated E is higher in the western side of the compartment than in the eastern side but the transition of E from phase II to phase III at both locations occurs at the same time ($t=1500$ s). For the real fire exposure test performed in this study, the steel studs installed near the door way, therefore, would be subjected to most severe thermal load.

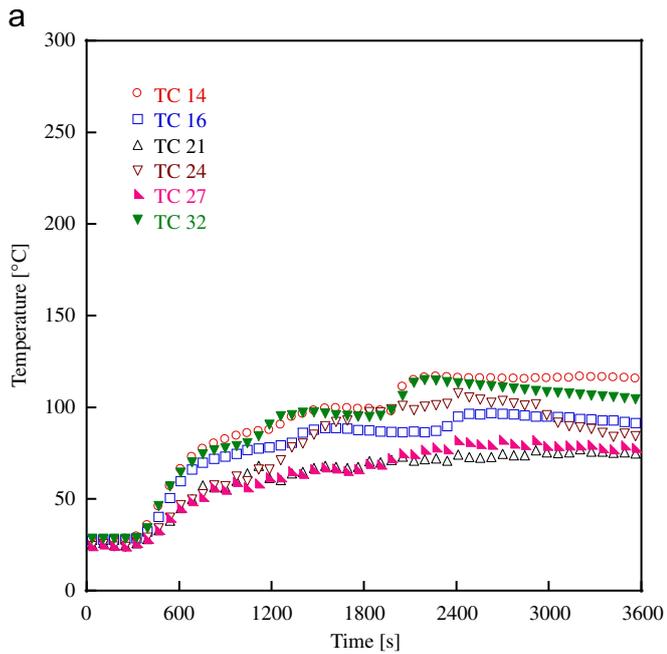
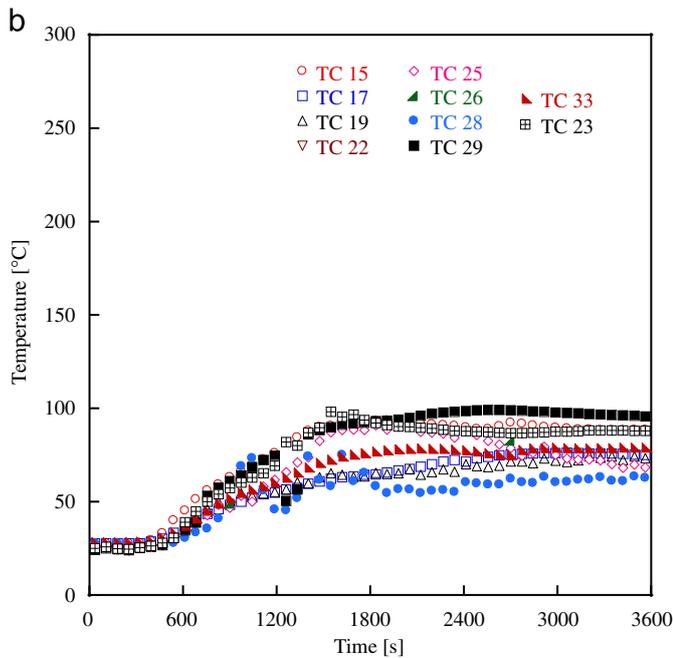
Fig. 9. Temperature profiles inside the interior cavity: (a) measured temperatures on the inside of the exposed face; and (b) measured temperatures on the inside of the unexposed face.

Measured interior temperatures are displayed in Fig. 9a: those temperatures measured on the inside of the exposed face of the assembly. Fig. 9b displays temperatures measured on the inside of the unexposed face. The maximum temperature measured on the steel studs and gypsum board inside the cavity did not exceed 130 °C. In addition, the unexposed face temperatures measured on designated locations were found to be less than 60 °C (see Fig. 10). This was mainly due to the good thermal protection of two layer gypsum boards (2 h fire resistance rating) combined with the relatively short fire exposures, which allowed both gypsum board layers on the exposed face to remain intact and prevented them from falling out during the experiment. The reactions in which crystalline gypsum dehydrates and water is liberated occur between 125 °C and 225 °C and help establish the fire resistance properties of gypsum wall assembly [21,22]. In the previous load bearing tests performed in the furnace [1], severe cracks and fall off of gypsum board on the fire-exposed face occurred several minutes prior to structural failure, resulting in the overall out-of-plane buckling of the test wall assembly. Therefore, it was concluded that the number of the gypsum board layer as well as the fire-retarding properties of gypsum boards are a major factor contributing to the fire resistance characteristics of the load bearing gypsum steel stud wall assembly. Even though an opening at the joint between the two vertically mounted gypsum boards and traverse cracks were observed in this study, similar to previous non-load bearing tests in real fire exposure [2], they were limited to the face layer of the exposed side (see Fig. 11). This minimized the conduction through gypsum layers (on exposed side) to interior cavity of the test assembly. In addition, the temperature of the unexposed face was not observed to be greater than 60 °C; clearly failure based on the temperature rise criterion was not observed. Due to good thermal protection, any passage of flame or fire through the test wall assembly was

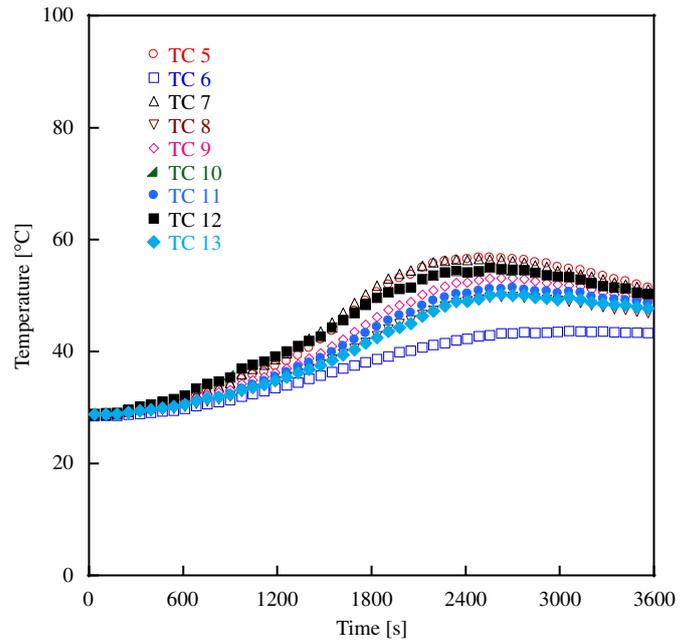
Fig. 10. Measured temperatures on the unexposed face.

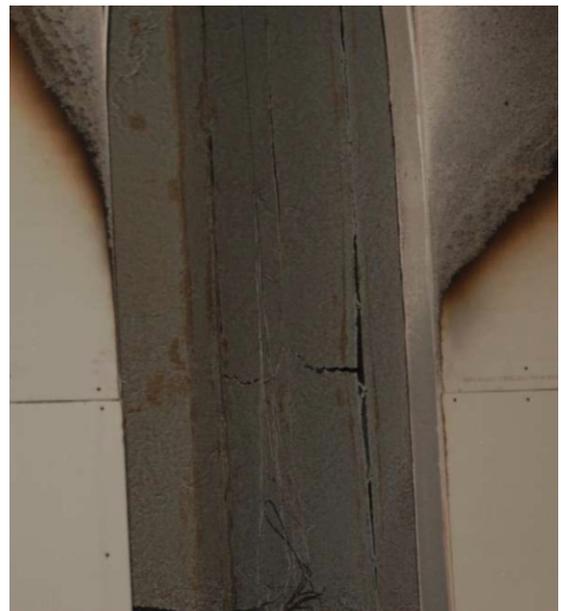
Fig. 11. Picture of the exposed face immediately after the extinguishment of the fire.

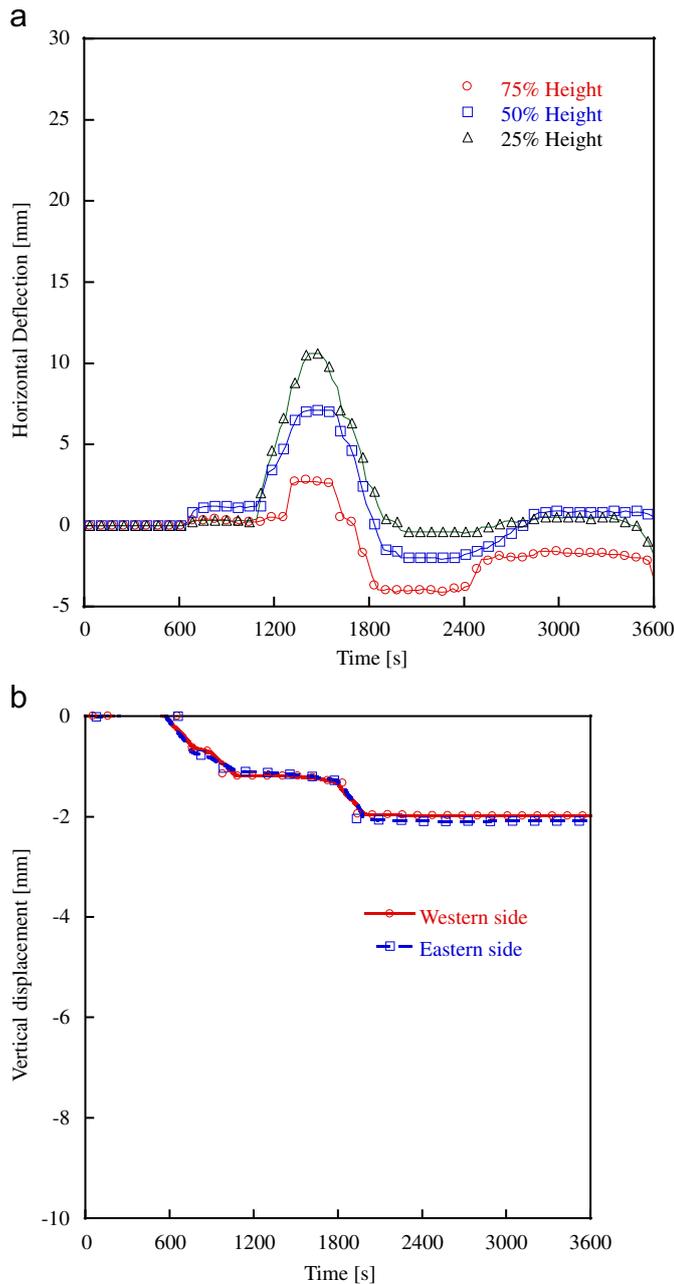
Fig. 12. Horizontal deflection and vertical displacement profiles plotted as a function of time: (a) horizontal deflection; and (b) vertical displacement.

As the fire became more intense, the test wall assembly subjected to the vertical load will degrade further and structural deformation may occur, which can result in the structural failure eventually described in criterion 3. To quantify the ability of the assembly to sustain the applied load, the horizontal deflection, δ was measured using three deflection meters (potentiometers) along the height of the central part of the test wall assembly. Fig. 12a–b displays the measured δ along the height of the central part of the test wall assembly (25% wall height, 50% wall height, and 75% wall height) and vertical displacement of the sliding platen measured at the western and eastern side of the compartment as a function of time. As shown in Fig. 12b, the vertical

displacement of the sliding platen was due to thermal expansion of the studs, similar to other studies [1,8].

The horizontal deflections represent the sum of stress-free thermal bowing due to a temperature gradient across the steel stud and secondary deflection due to the load applied to the steel studs [9]. In this study, the positive values of deflection measured are due to the movement of the test wall assembly inward in the direction of the compartment. The deflection caused by the applied load prior to ignition was offset in the present study. As the fire progressed, thermal bowing became dominant, producing a distinguished change in δ approximately 1500 s after ignition for all heights investigated (see Fig. 12a). Interestingly, this time coincides well with the time when E reached the maximum value at the end of phase II. The maximum δ , 10.7 mm was observed at

25% wall height, followed by 7.1 mm at 50% wall height, and 2.7 mm at 75% wall height. Since the duration of the fire was limited by reduced fuel loads (manifested by HRR and heat flux measurements), the measured δ immediately decreased as the fire diminished. It was also found that the observed variations in δ did not cause the loss of ability of the test assembly to sustain the applied load.
