NIST NCSTAR 1-6B (Draft)

**Federal Building and Fire Safety Investigation of the
World Trade Center Disaster**

Fire Resistance Tests of Floor Truss Systems (Draft)

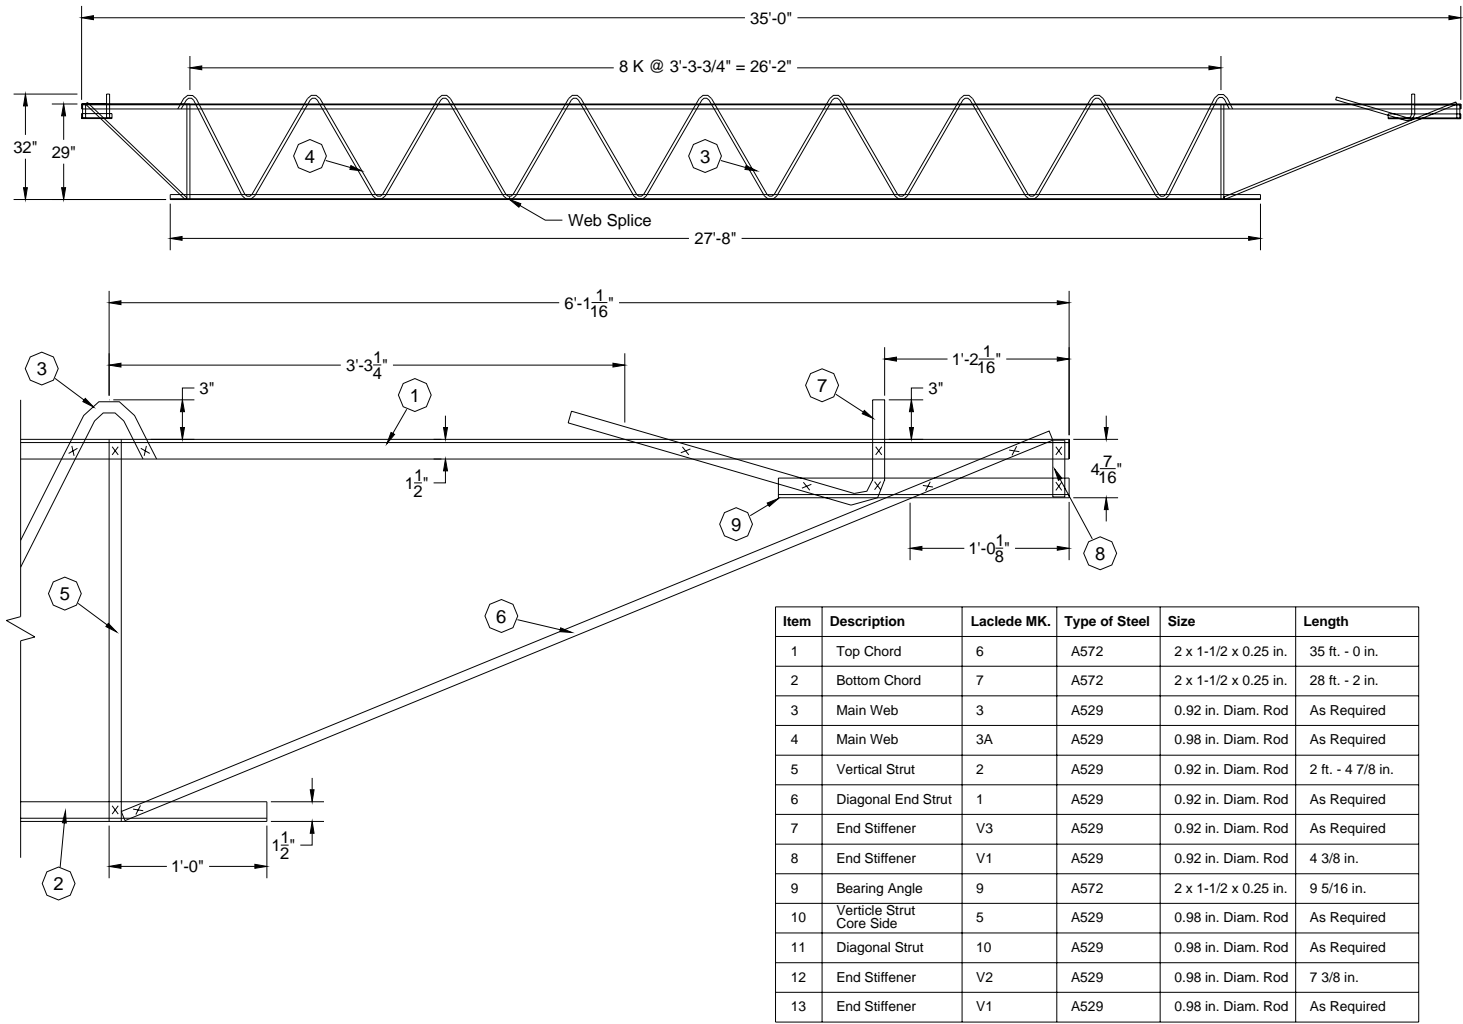
Figure 4-1. 35 ft main truss, column end.

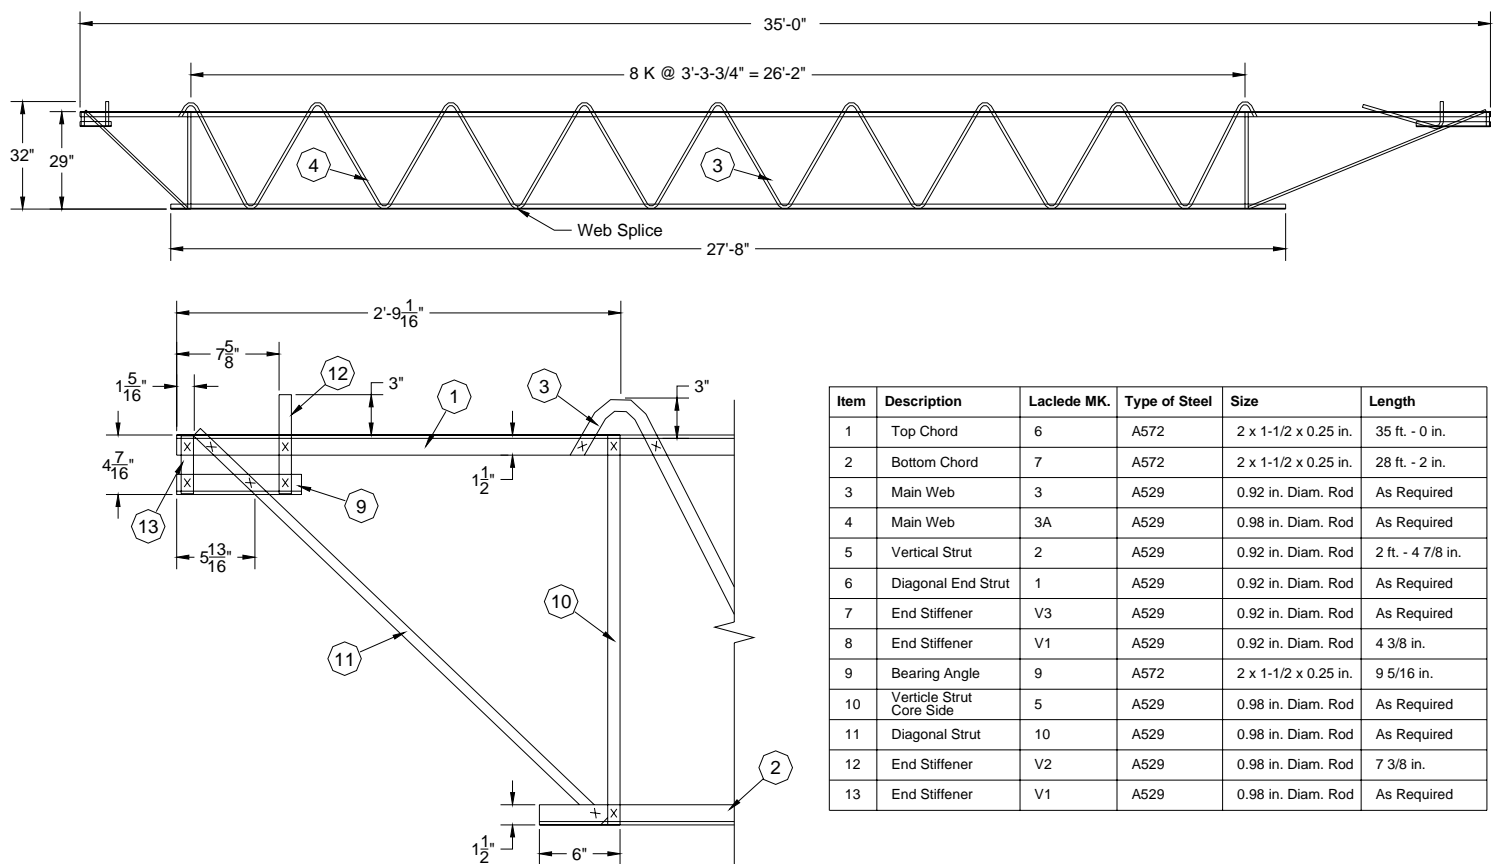
Figure 4–2. 35 ft main truss, core end.

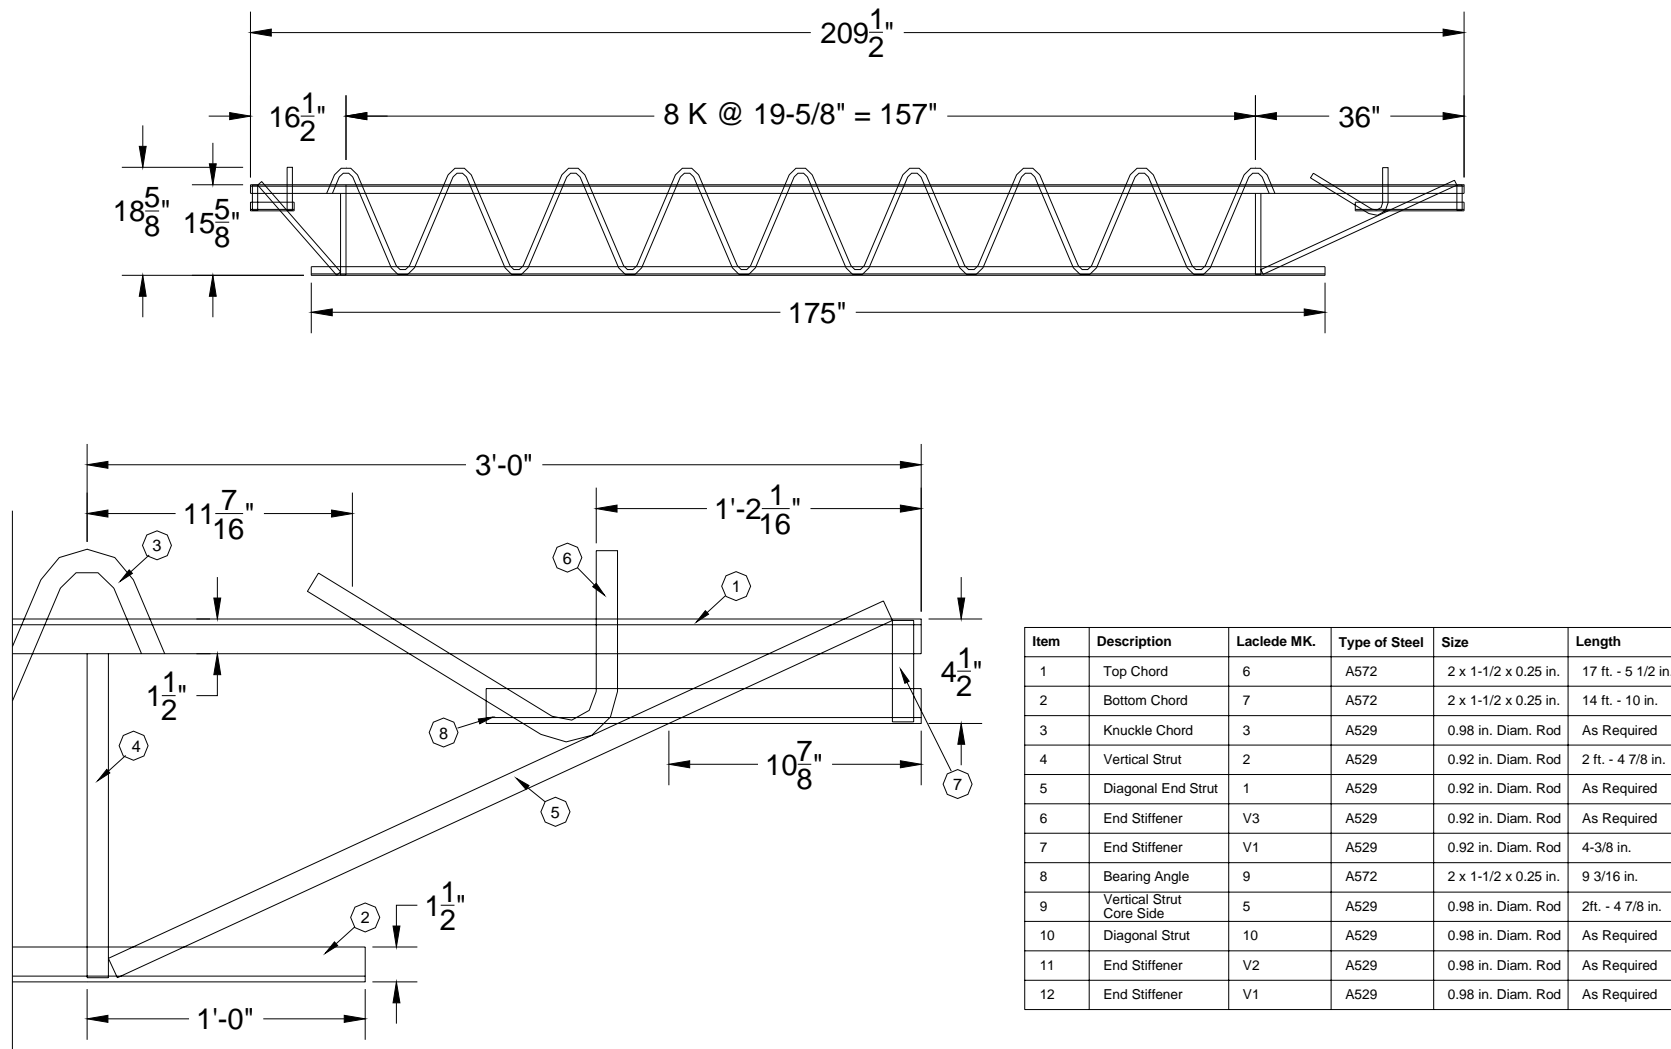
Figure 4-3. 17 ft main truss, column end.

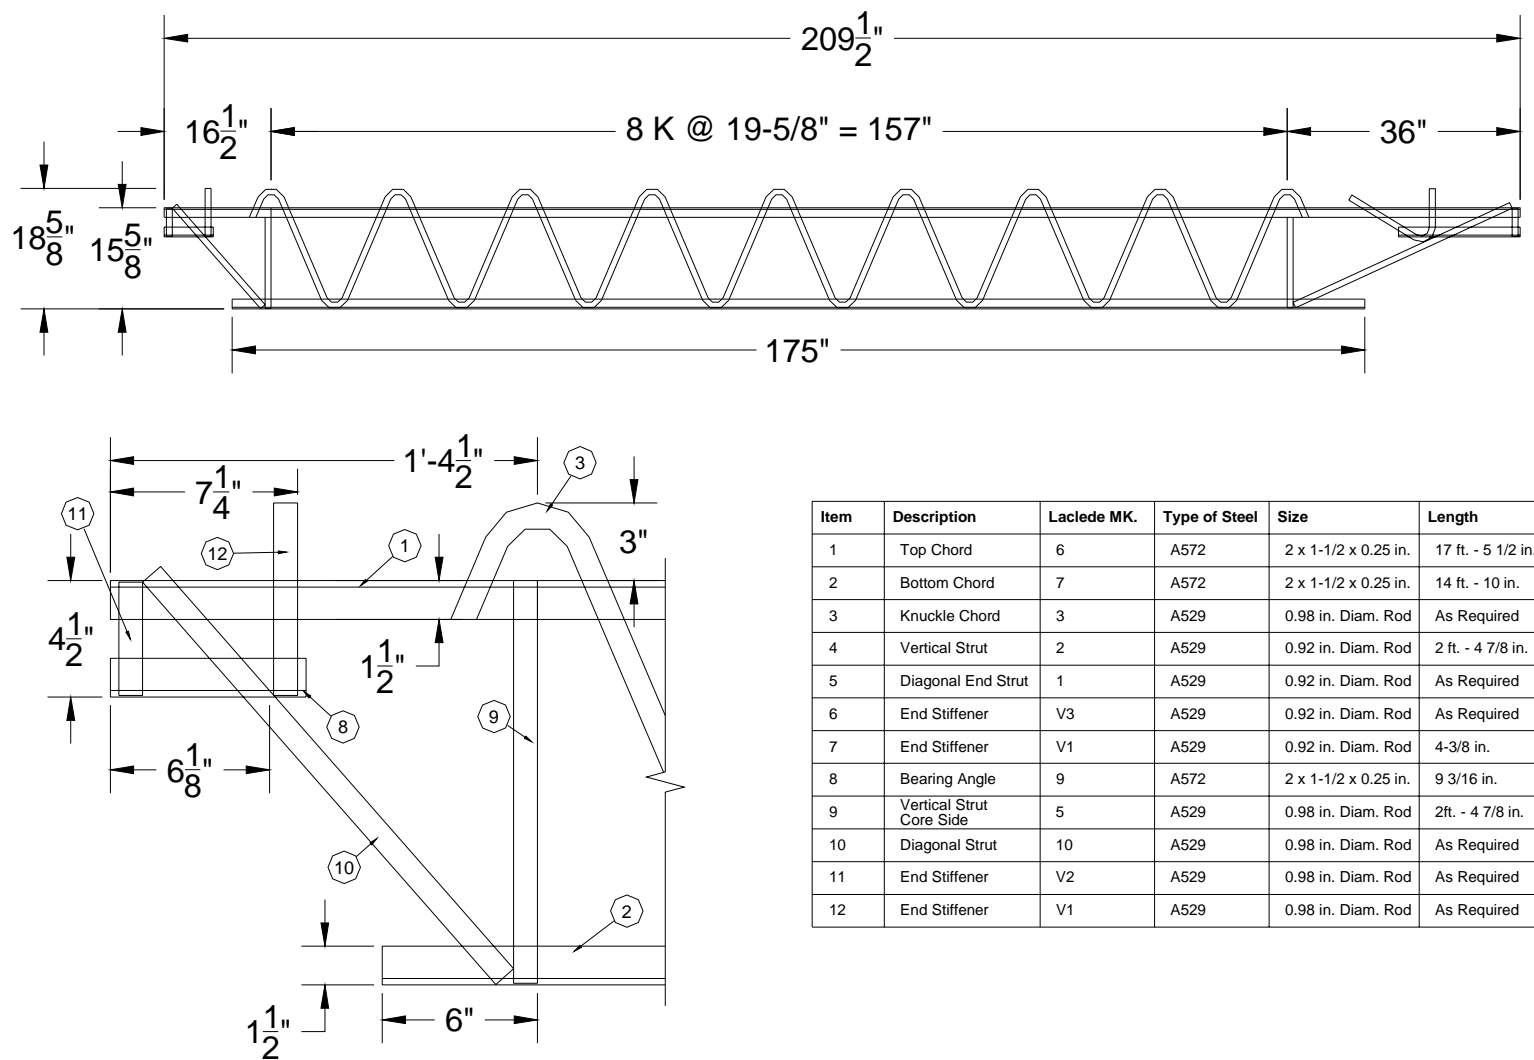
Item	Description	Laclede MK.	Type of Steel	Size	Length
1	Top Chord	6	A572	2 x 1-1/2 x 0.25 in.	17 ft. - 5 1/2 in.
2	Bottom Chord	7	A572	2 x 1-1/2 x 0.25 in.	14 ft. - 10 in.
3	Knuckle Chord	3	A529	0.98 in. Diam. Rod	As Required
4	Vertical Strut	2	A529	0.92 in. Diam. Rod	2 ft. - 4 7/8 in.
5	Diagonal End Strut	1	A529	0.92 in. Diam. Rod	As Required
6	End Stiffener	V3	A529	0.92 in. Diam. Rod	As Required
7	End Stiffener	V1	A529	0.92 in. Diam. Rod	4-3/8 in.
8	Bearing Angle	9	A572	2 x 1-1/2 x 0.25 in.	9 3/16 in.
9	Vertical Strut Core Side	5	A529	0.98 in. Diam. Rod	2ft. - 4 7/8 in.
10	Diagonal Strut	10	A529	0.98 in. Diam. Rod	As Required
11	End Stiffener	V2	A529	0.98 in. Diam. Rod	As Required
12	End Stiffener	V1	A529	0.98 in. Diam. Rod	As Required

Figure 4-4. 17 ft main truss, core end.

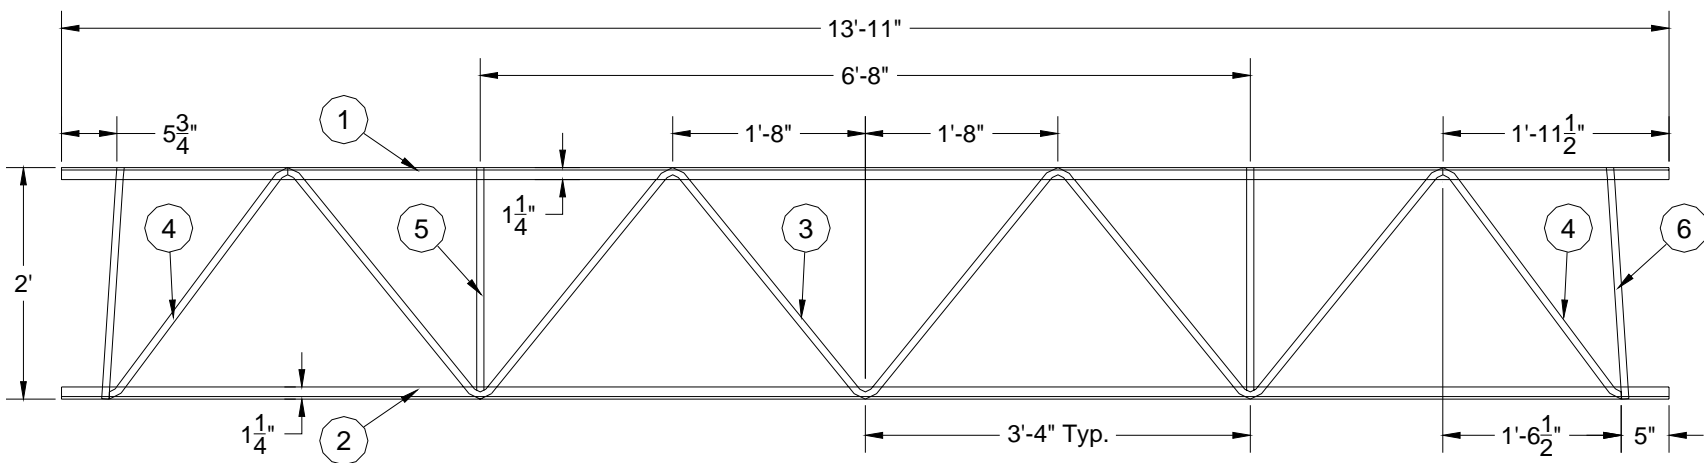
Item	Description	Laclede MK.	Type of Steel	Size	Length
1	Top Chord	6	A572	1-1/2 x 1-1/4 x 0.230 in.	13 ft. - 8 in.
2	Bottom Chord	7	A572	1-1/2 x 1-1/4 x 0.230 in.	13 ft. - 8 in.
3	Main Web	3	A572	0.75 in. Diam. Rod	As Required
4	Web Chord	4	A572	0.75 in. Diam. Rod	As Required
5	Vertical Strut	12	A572	0.75 in. Diam. Rod	1 ft. - 10-7/8 in.
6	Inclined End Strut	2	A572	0.75 in. Diam. Rod	1 ft. - 11-3/4 in.

Figure 4–5. Bridging truss for Assemblies No. 1 and 2.

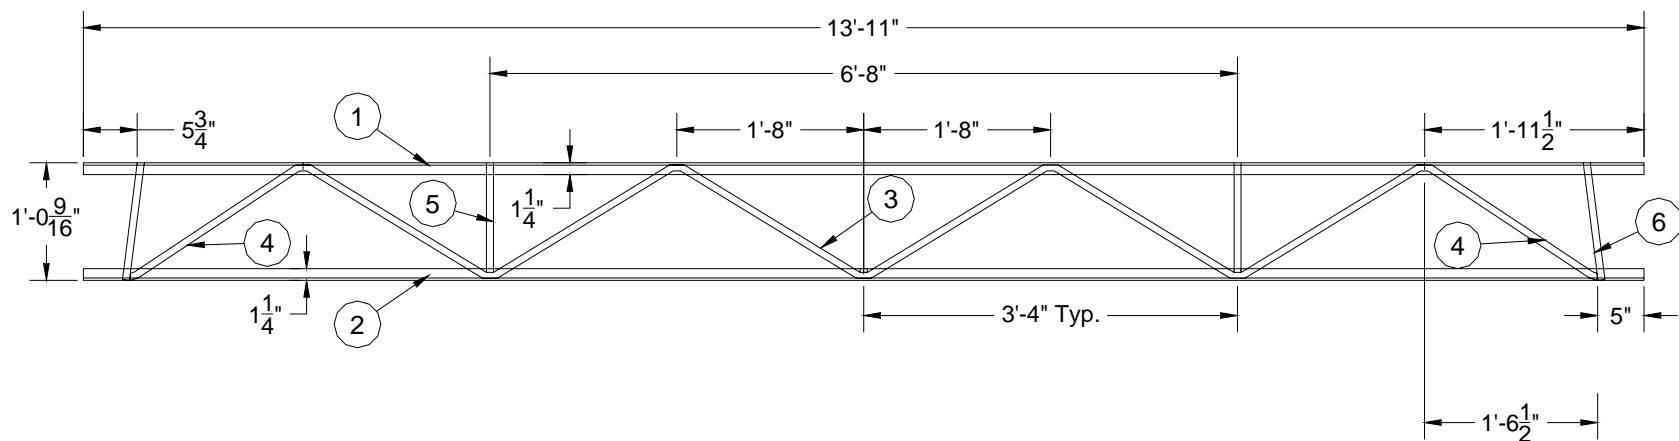
Item	Description	Laclede MK.	Type of Steel	Size	Length
1	Top Chord	6	A572	1-1/2 x 1-1/4 x 0.230 in.	13 ft. - 11 in.
2	Bottom Chord	7	A572	1-1/2 x 1-1/4 x 0.230 in.	13 ft. - 11 in.
3	Main Web	3	A572	0.75 in. Diam. Rod	As Required
4	Web Chord	4	A572	0.75 in. Diam. Rod	As Required
5	Vertical Strut	12	A572	0.75 in. Diam. Rod	As Required
6	Inclined End Strut	2	A572	0.75 in. Diam. Rod	As Required

Figure 4–6. Bridging truss for Assemblies Nos. 3 and 4.

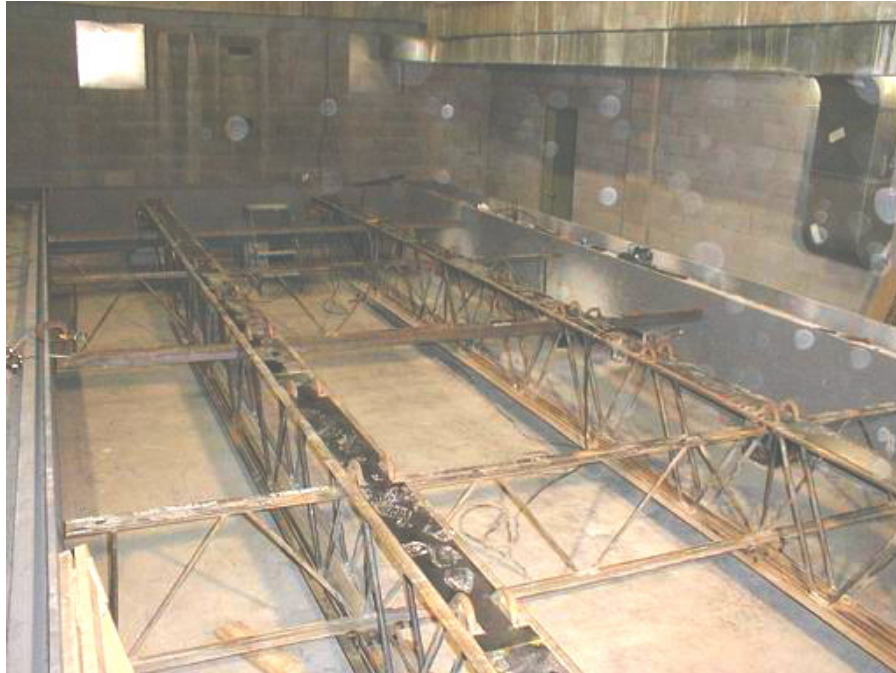
The ends of the main trusses in Test Assembly No. 1 were supported by L6×4×1 structural angles 12 in. long welded to the test frame. The bearing length for each main truss was 3 $\frac{1}{2}$ in. The ends of the main trusses were welded with a $\frac{1}{2}$ in. fillet along the entire bearing length on each side of the trusses (see Fig. 4–8). Steel plates were placed between the ends of the main trusses and the test frame, filling the gap and thus preventing thermal expansion.

Figure 4–7. Structural steel frame of Assembly No. 1.

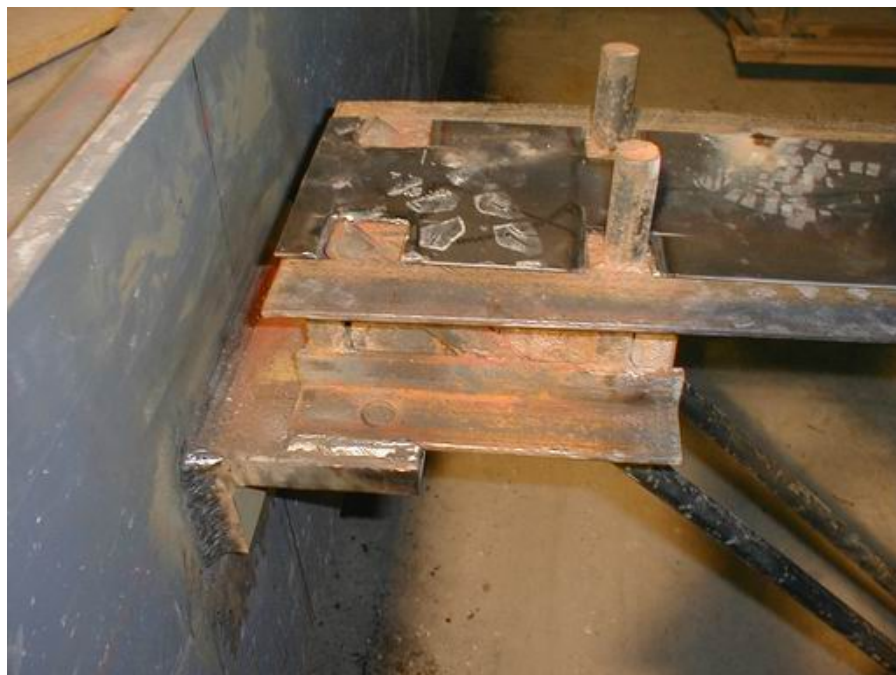
Figure 4–8. Restrained end condition of Assembly No. 1 prior to shimming.

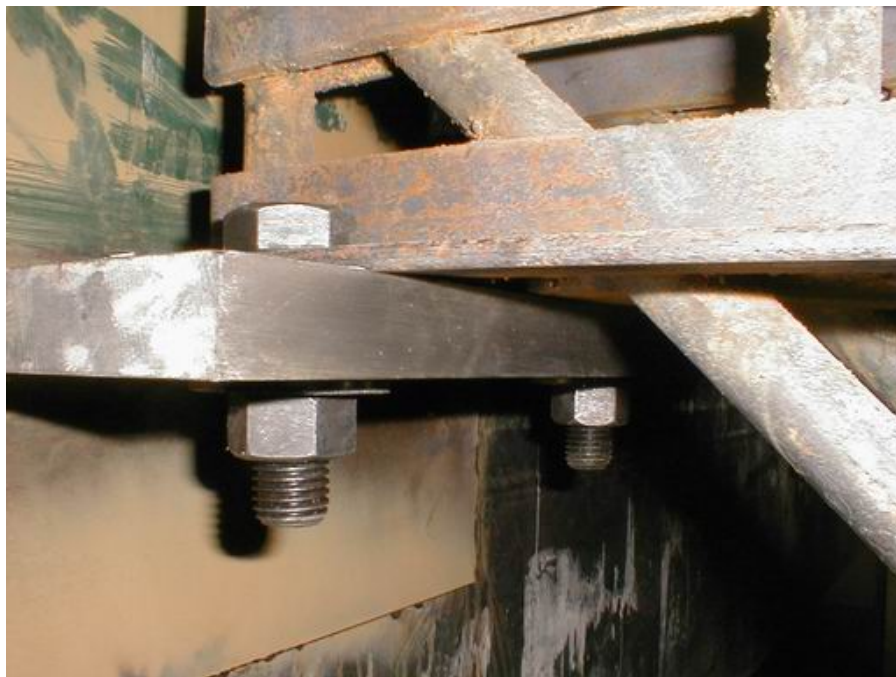
The ends of the main trusses in Test Assembly No. 2 were supported on L 7×4×1 structural angles 14 in. long welded to the test frame. Slotted holes 2-7/8 in. long were provided in the steel angles and the centerline of each slot was located 3 in. from the edge of the angle. The edge distance of the slotted holes was 1¼ in. The bolt holes in the truss bearing angles were $\frac{15}{16}$ in. diameter. The main trusses were bolted to the support angles using two $\frac{7}{8}$ in. diameter by 2½ in. long ASTM A325 bolts with ASTM F436 washers and ASTM A563 nuts as seen in Fig. 4–9. The nuts were hand tightened to provide connection stability without hindering thermal expansion. Also, the trusses and supports were designed so that the bolts were installed close to the inside edge of the slot thus allowing the maximum unrestrained outward movement as the test specimens heated and expanded. The slots extending beyond the edge of the truss support angles are just visible in Fig. 4–13.

Figure 4–9. Unrestrained end condition of Assembly No. 2.

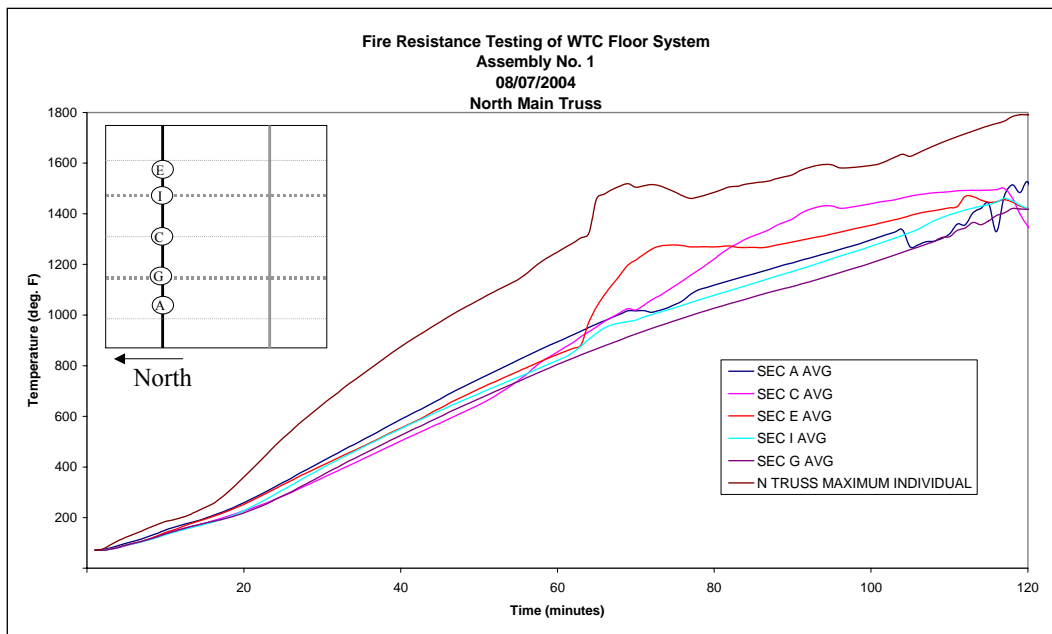
Figure 5–1. Assembly No. 1 – average and maximum individual temperatures on north main truss.

All data shown in the following figures (Figures 5–1 through 5–12) is unedited for the entire duration of the test. However, not all data shown is reliable due to the limitations of the instrumentation, i.e. thermocouples, radiometers and calorimeters. Data may become unreliable past the rating period when structural events occur that can dislodge the instrumentation. Also, protective insulation of the thermocouple wire may burn away and the individual wires can make contact with themselves and/or other neighboring wires rendering the data unreliable. Appendix G gives a listing of the times that various instrumentation failed to give reliable data, as determined by ULI.

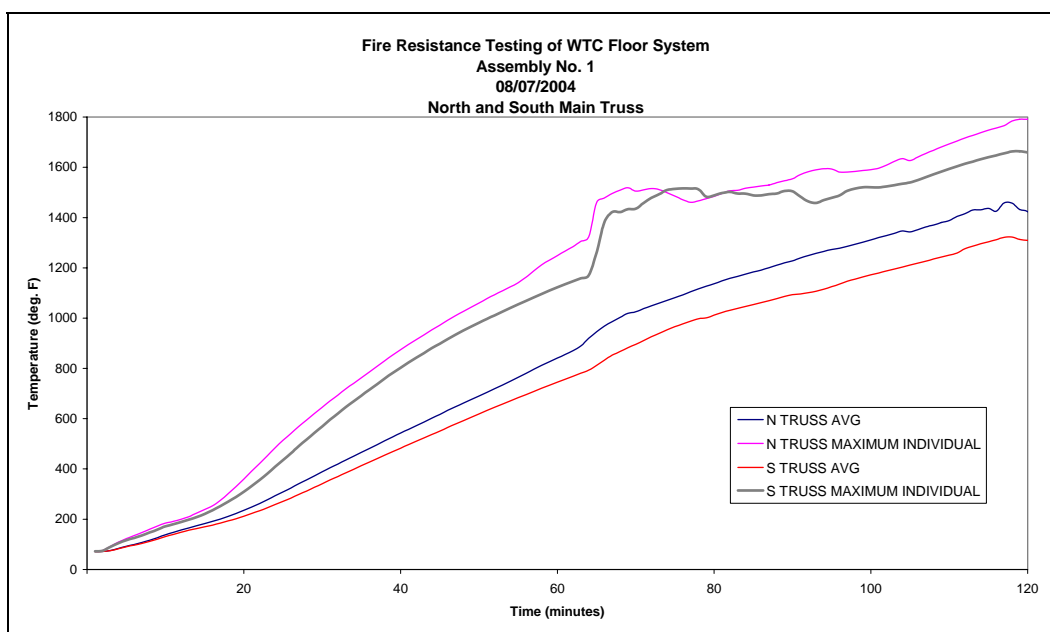
Figure 5–3. Assembly No. 1 – overall average and maximum individual temperatures on north and south main trusses.

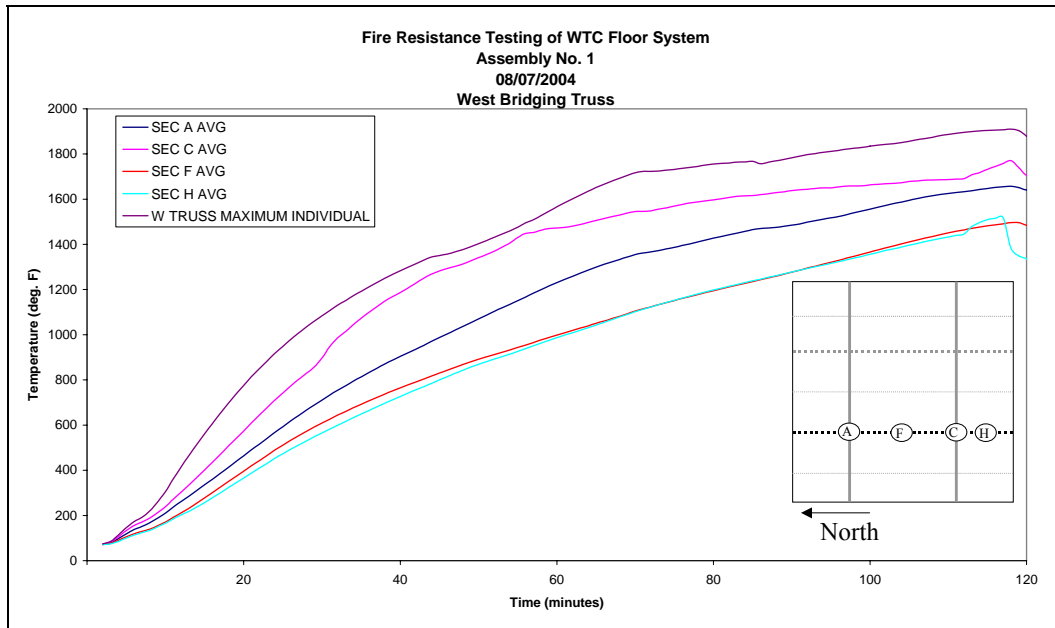
Figure 5–4. Assembly No. 1 – average and maximum individual temperatures on west bridging truss.

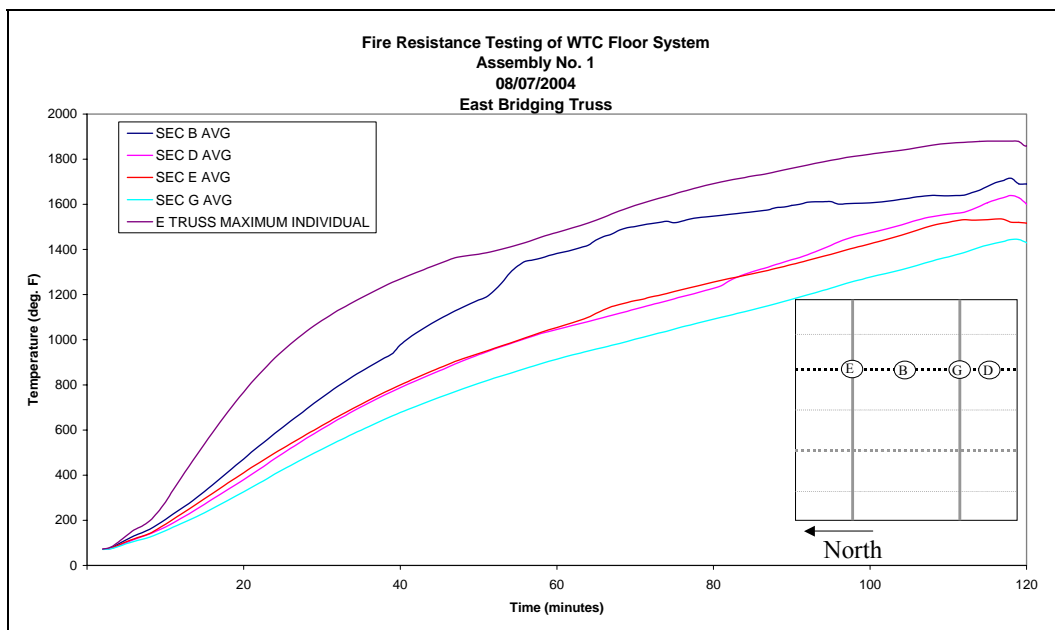
Figure 5–5. Assembly No. 1 – average and maximum individual temperatures on east bridging truss.

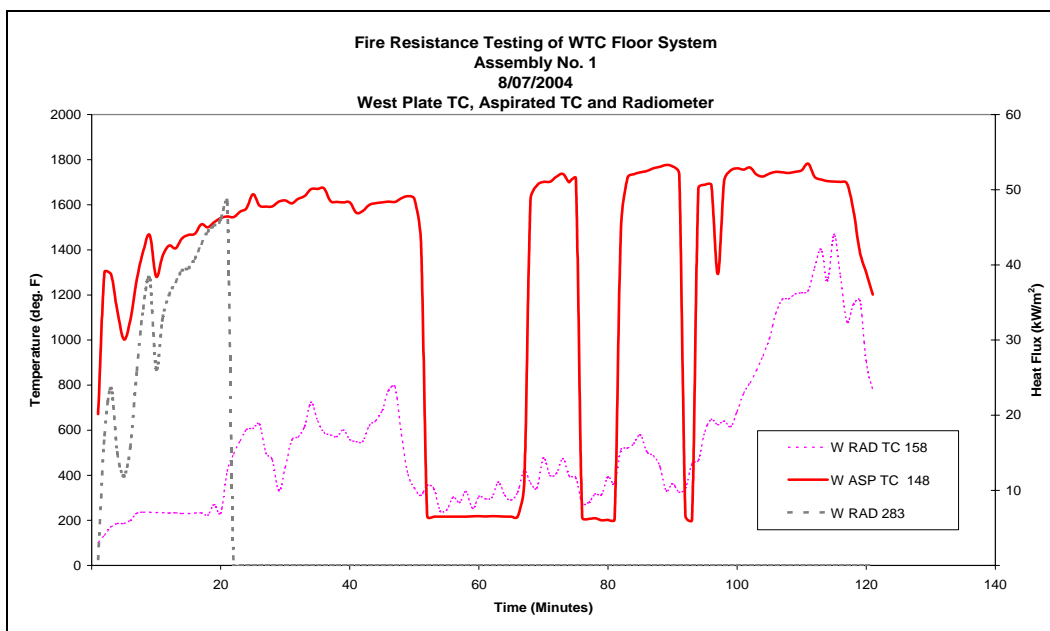
Figure 5–11. Assembly No. 1 – additional instrumentation through west opening.

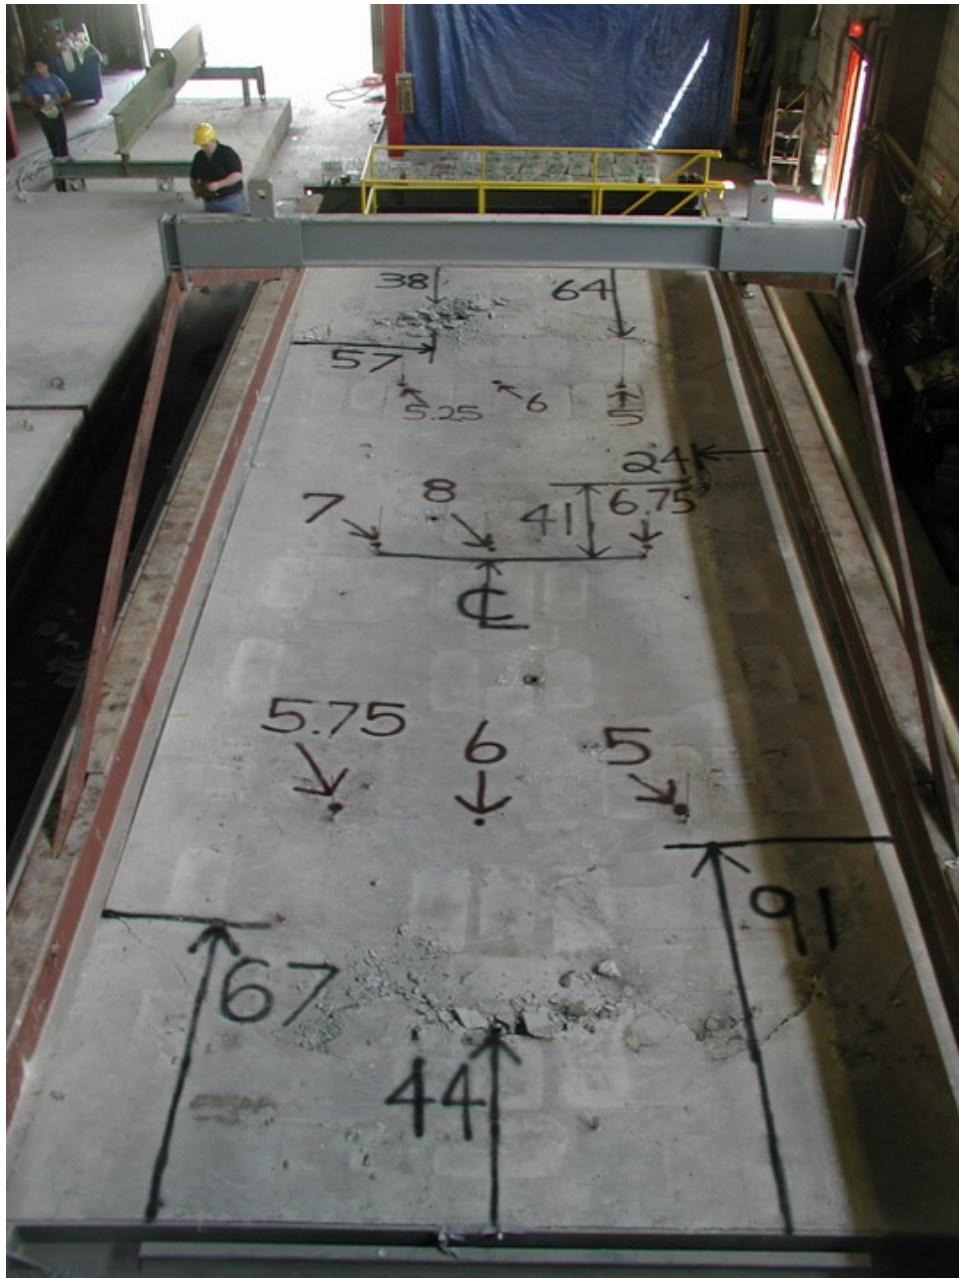
Figure 5-13 shows the unexposed surface of the assembly after all loading equipment was removed (view looking east). Numbers shown at the centerline and quarter points are vertical deflections after cooling. All other numbers are reference dimension as measured from the edge of the slab. Figures 5-14 through 5-19 are additional views of the top of the specimen showing the cracked and spalled concrete and of the underside showing bulging of the metal deck and deformations of the steel trusses after the test specimen had cooled and had been removed from the furnace. To confirm the spalling of the bottom side of the concrete slab and to quantify the depth of spalling, sections of the slab were cut using a diamond concrete wet saw (see Fig. 5-20). The depth of the delamination spalling varied but was on the order of 2 in. to 3 in. as seen in Fig. 5-21.

Figure 5–13. Unexposed surface of Assembly No. 1 after loading equipment was removed.

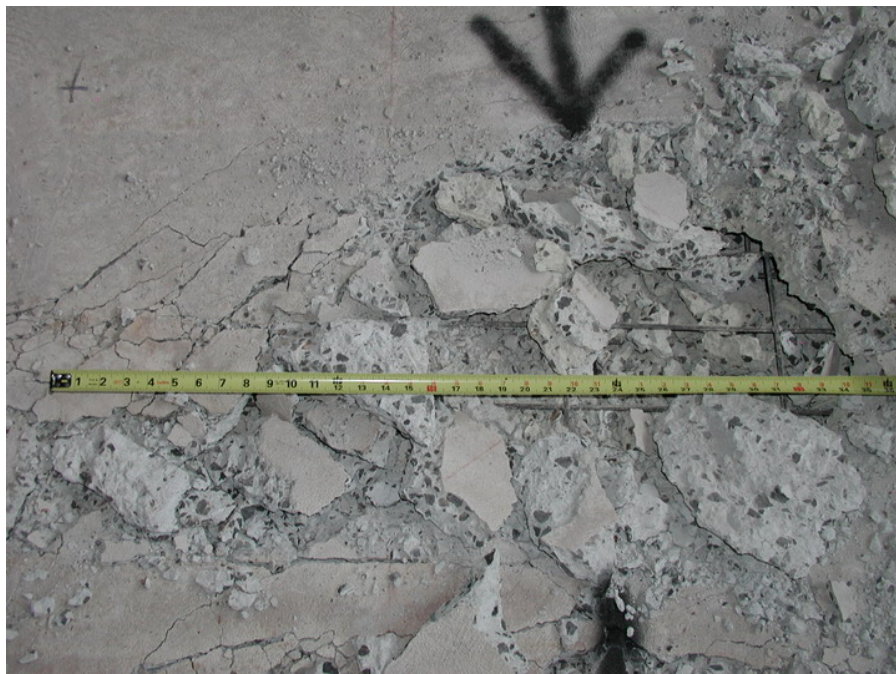
Figure 5–16. Close-up of spalling concrete at east end of Assembly No. 1.

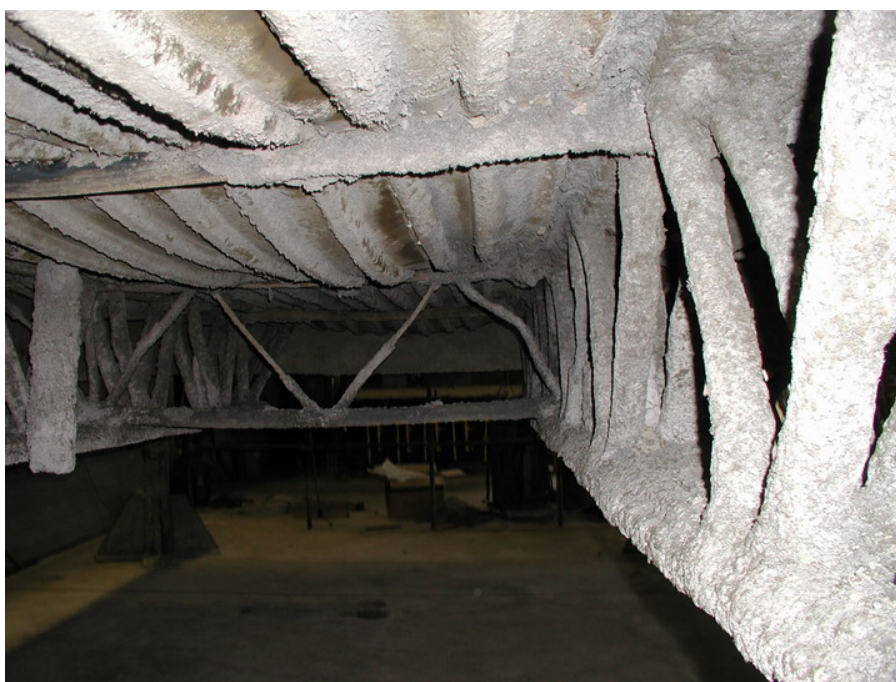
Figure 5–17. View looking east of the exposed side of Assembly No. 1—south main truss seen at right side.

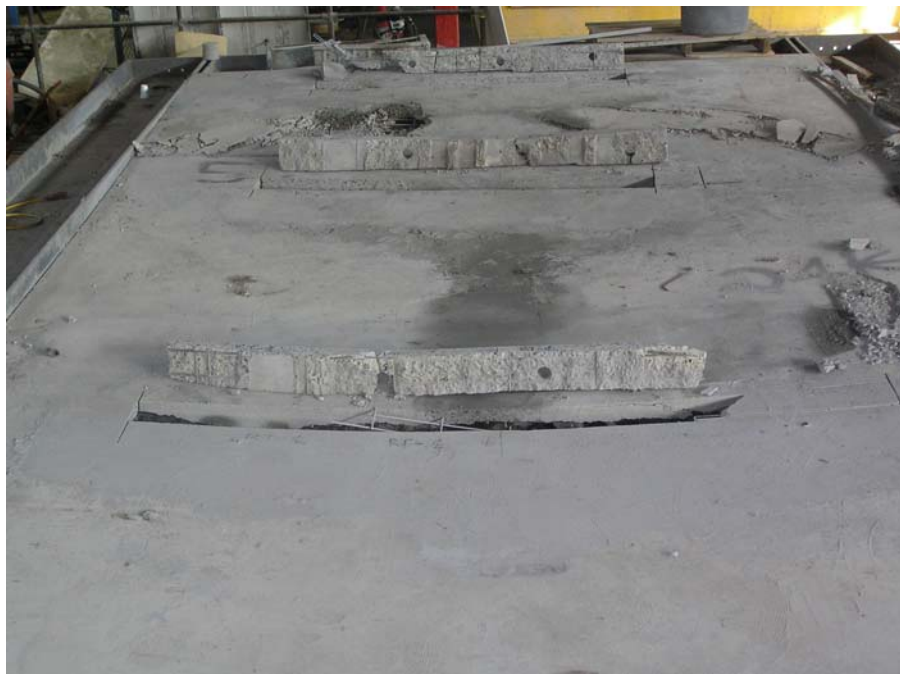
Figure 5–20. Sections cut through concrete slab to confirm delamination spalling.

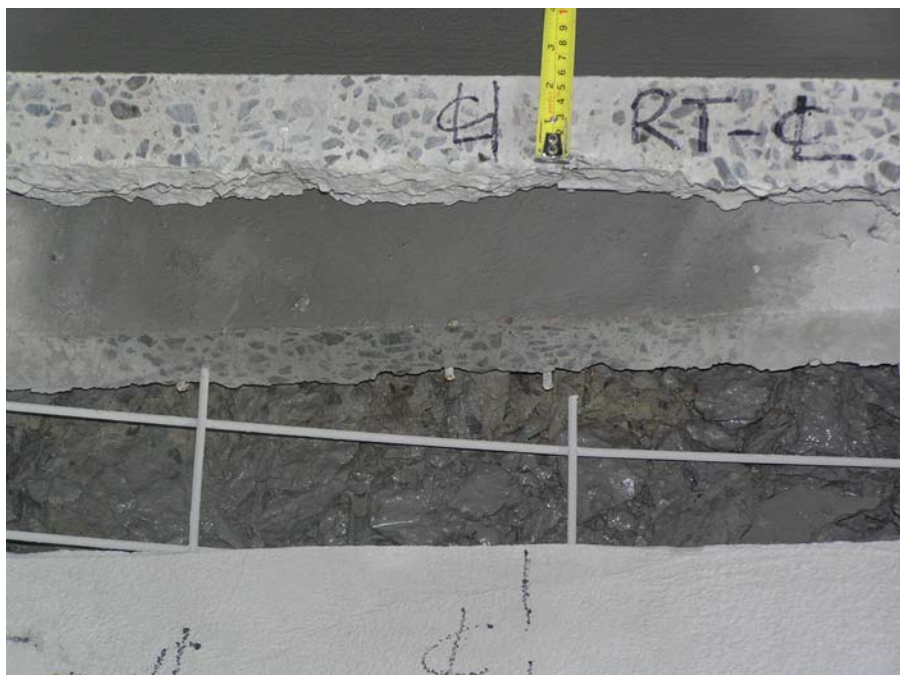
Figure 5–21. Measurement of depth of delamination spalling.

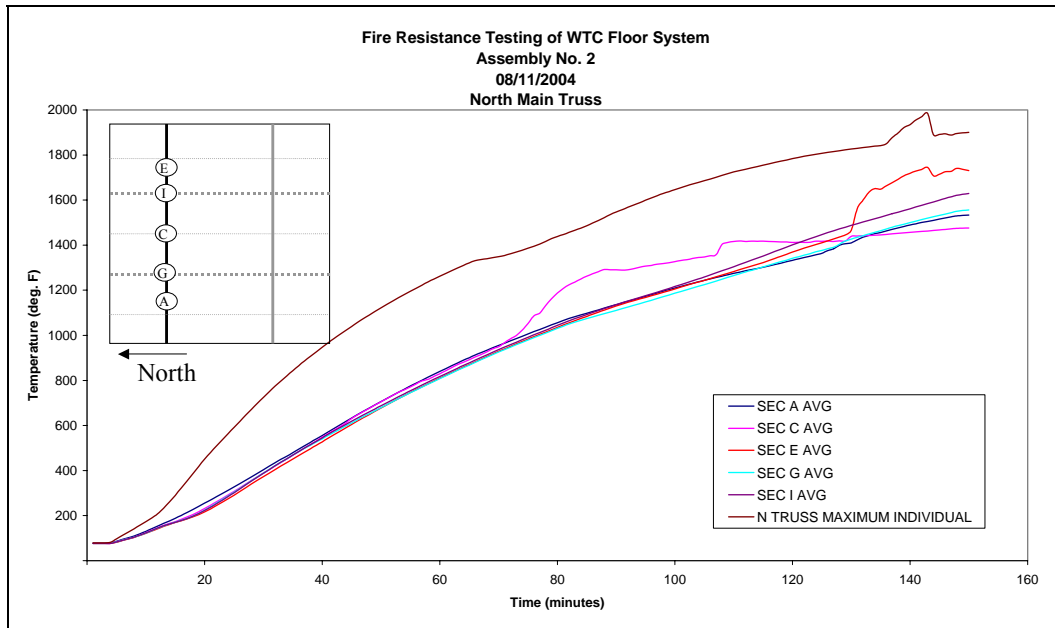
Figure 5–22. Assembly No. 2 – average and maximum individual temperatures on north main truss.

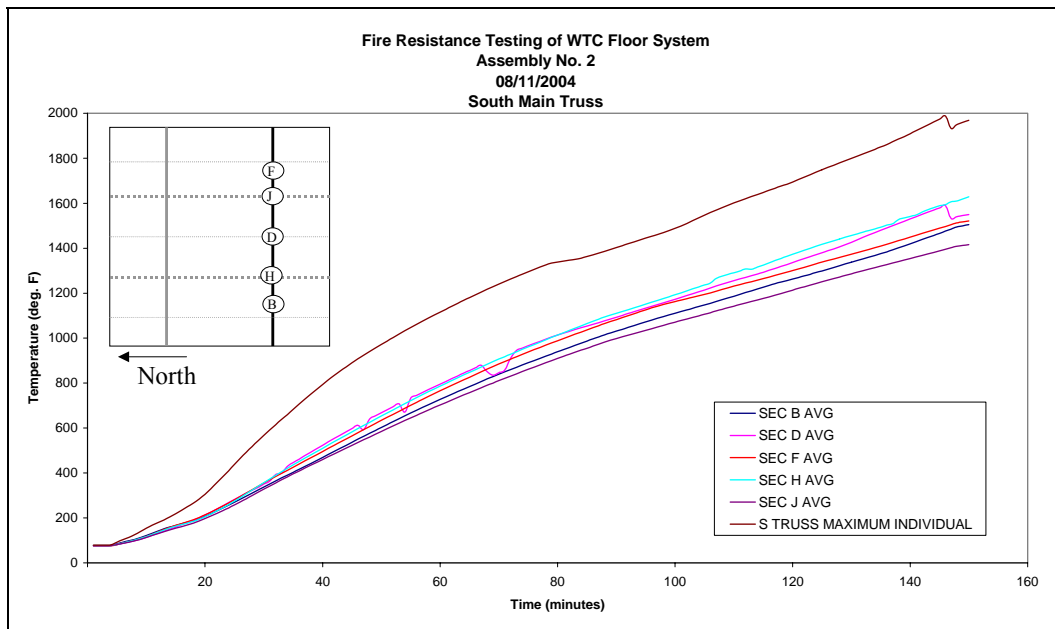
Figure 5–23. Assembly No. 2 – average and maximum individual temperatures on south main truss.

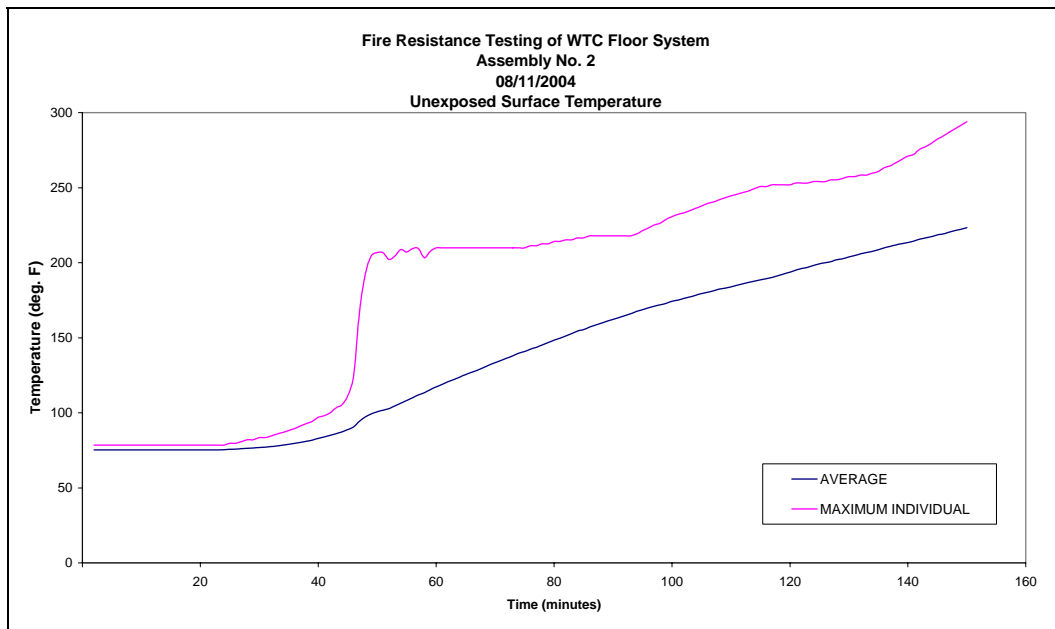
Figure 5–27. Assembly No. 2 – average and maximum individual temperatures on unexposed surface.

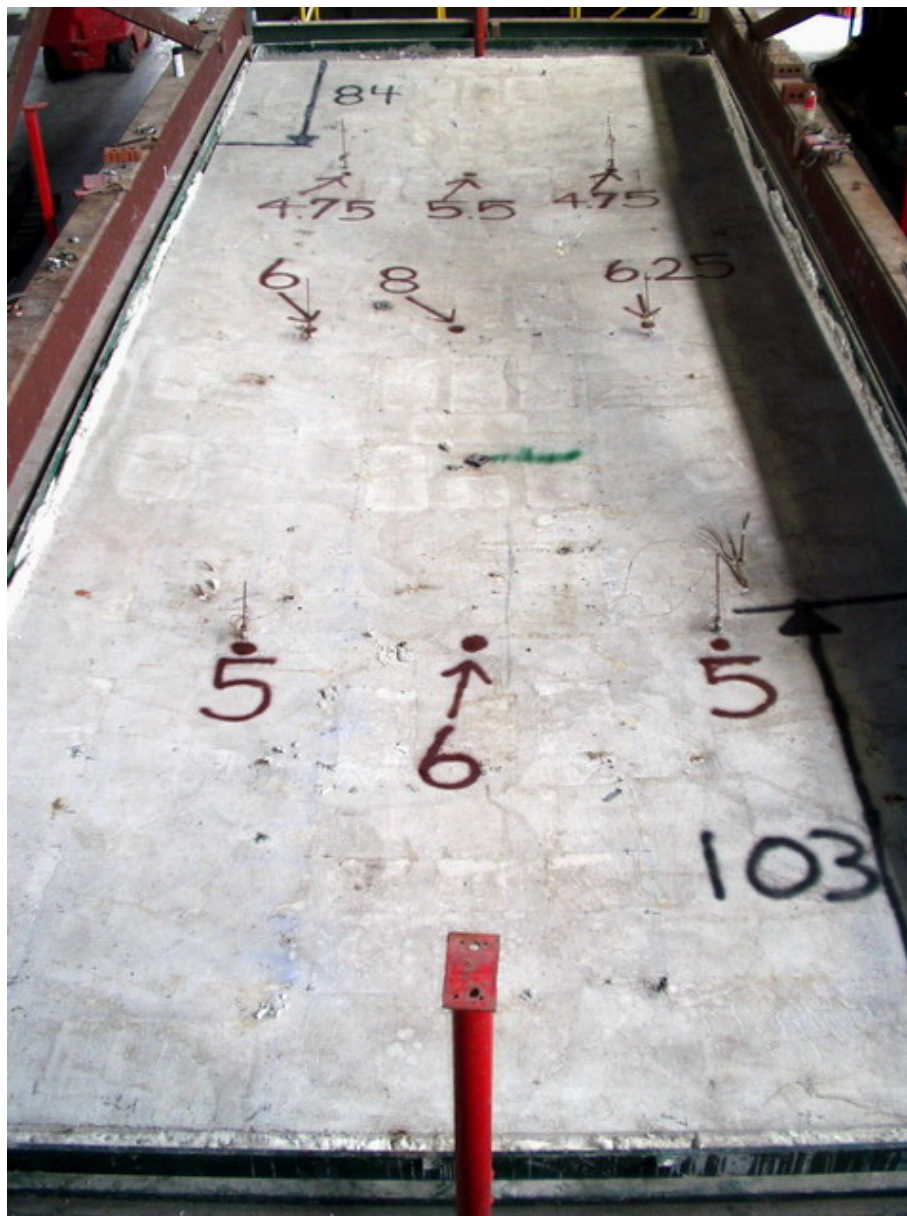
Figure 5–34 shows the unexposed side of the floor assembly after all loading equipment was removed (view looking east). Numbers shown at the centerline and quarter points are vertical deflections after cooling. All other numbers are reference dimension as measured from the edge of the slab. Figures 5–35 through 5–37 are views of the underside of the test specimen showing bulging of the metal deck and deformations of the steel trusses after the test specimen had cooled and had been removed from the furnace.

Figure 5–34. Unexposed surface of Assembly No. 2 after loading equipment was removed.

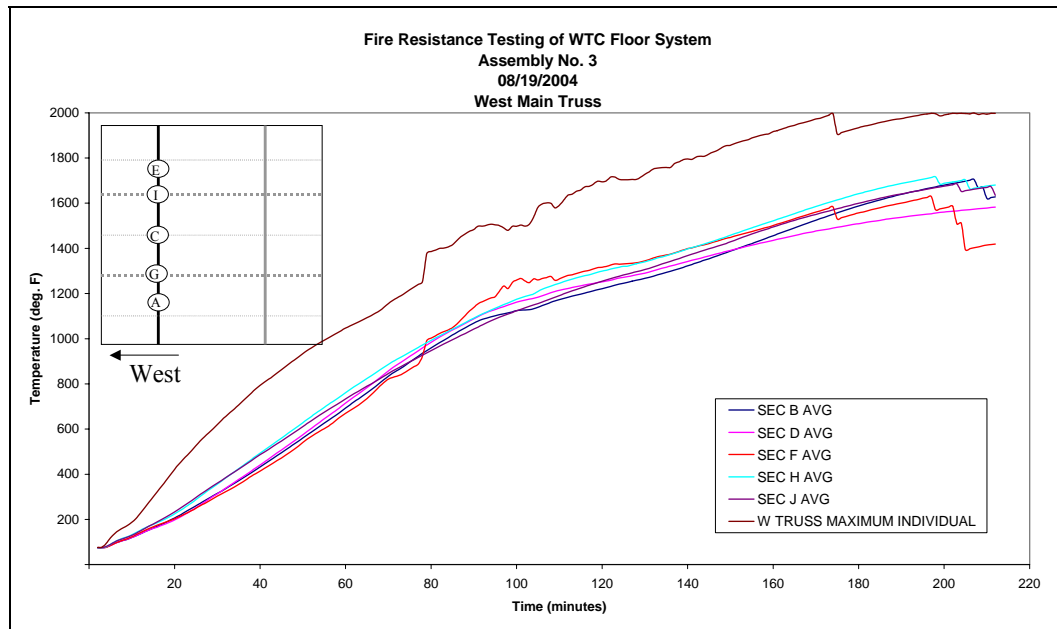
Figure 5–38. Assembly No. 3 – average and maximum individual temperatures on west main truss.

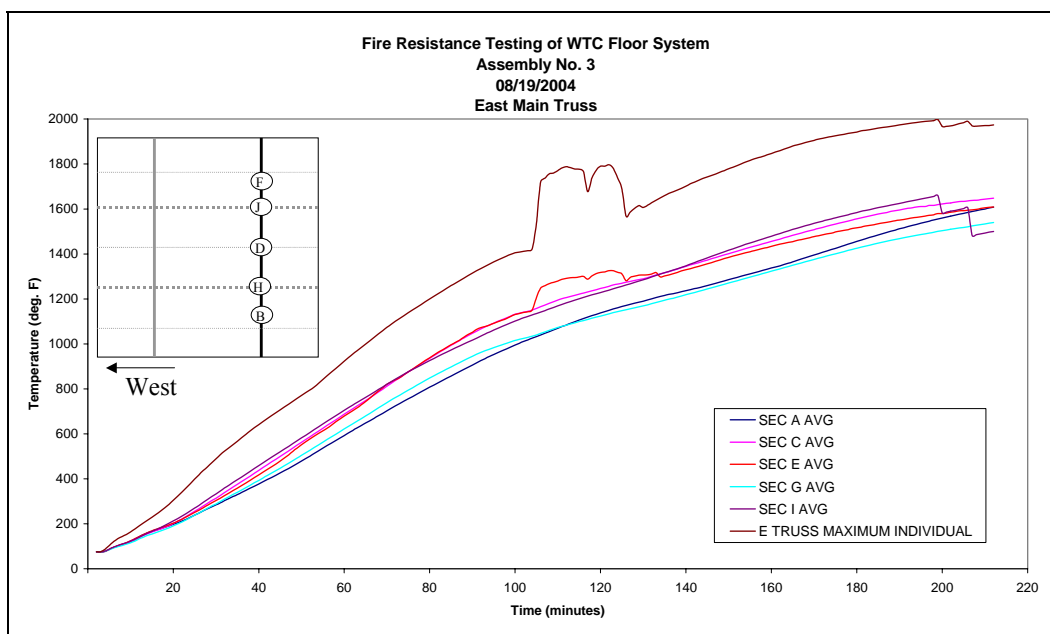
Figure 5–39. Assembly No. 3 – average and maximum individual temperatures on east main truss.
