NIST NCSTAR 1-6B (Draft)

**Federal Building and Fire Safety Investigation of the
World Trade Center Disaster**

Fire Resistance Tests of Floor Truss Systems (Draft)

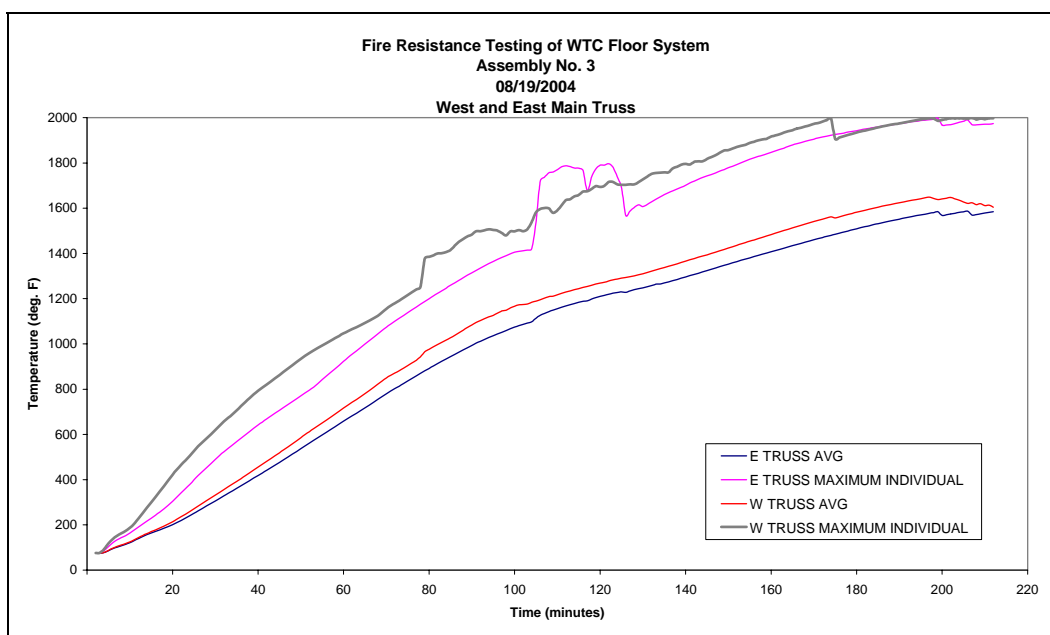
Figure 5–40. Assembly No. 3 – overall average and maximum individual temperatures on west and east main trusses.

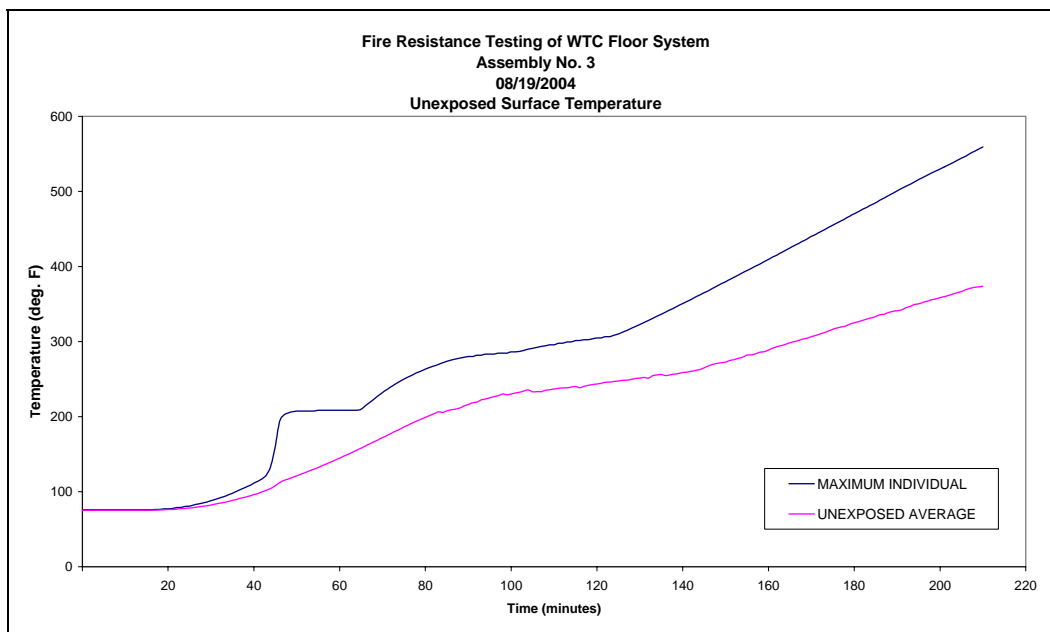
Figure 5-43. Assembly No. 3 – average and maximum individual temperatures on unexposed surface.

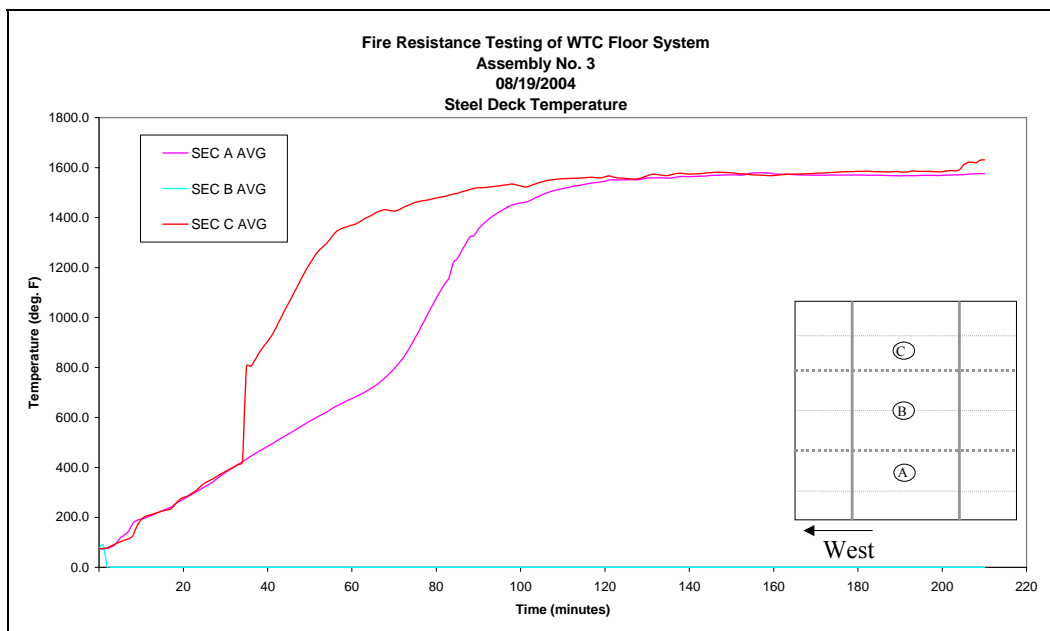
Figure 5-44. Assembly No. 3 – average temperatures on steel deck.

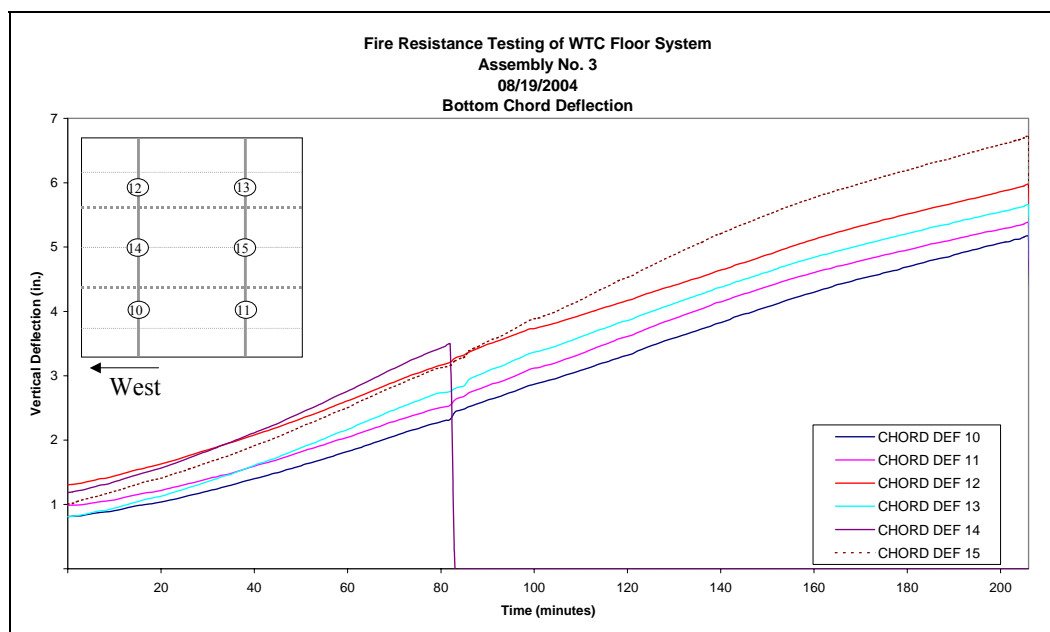
Figure 5–45. Assembly No. 3 – bottom chord deflection measurements.

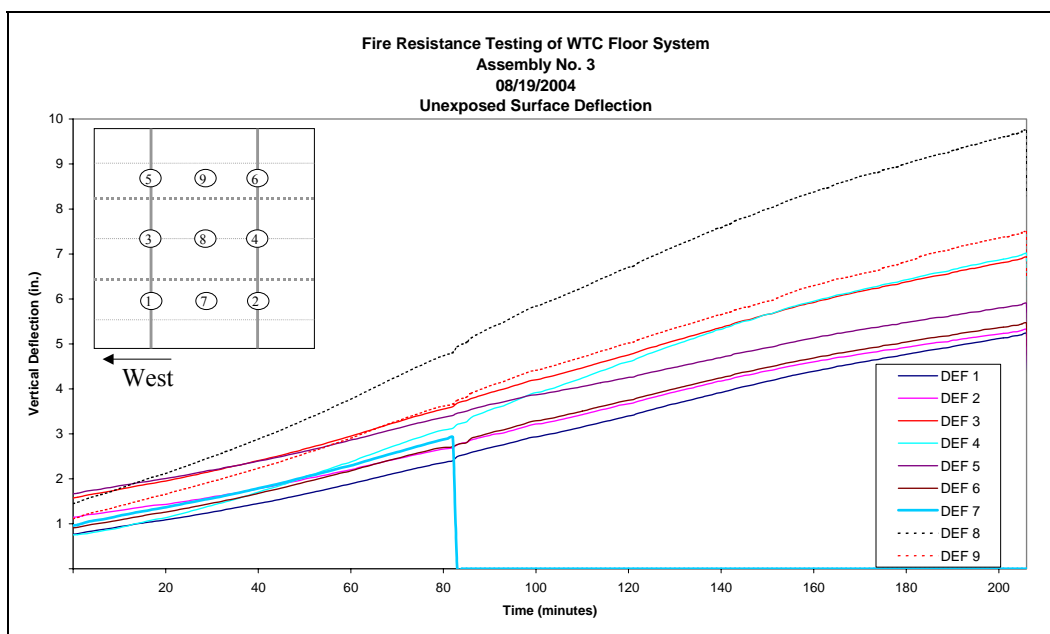
Figure 5–47. Assembly No. 3 – unexposed surface deflection measurements.

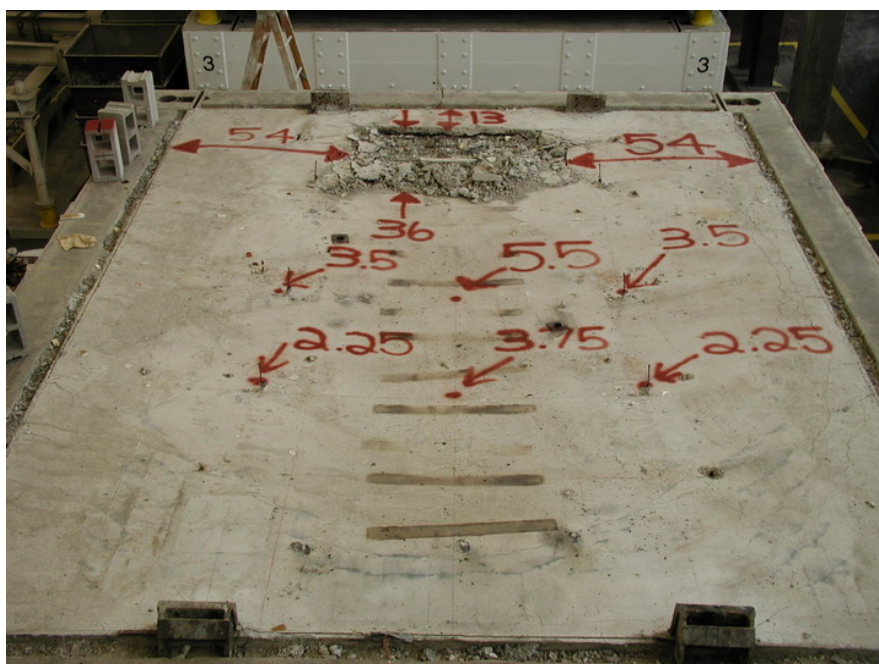
Figure 5-50 shows the unexposed side of the floor assembly No. 3 after all loading equipment had been removed (view looking north). Numbers shown at the centerline and quarter points are vertical deflections after cooling. All other numbers are reference dimension as measured from the edge of the slab. Figures 5-51 through 5-53 are additional views of the post-test condition of the test specimen.

Figure 5-50. Unexposed surface of Assembly No. 3 after loading equipment was removed.

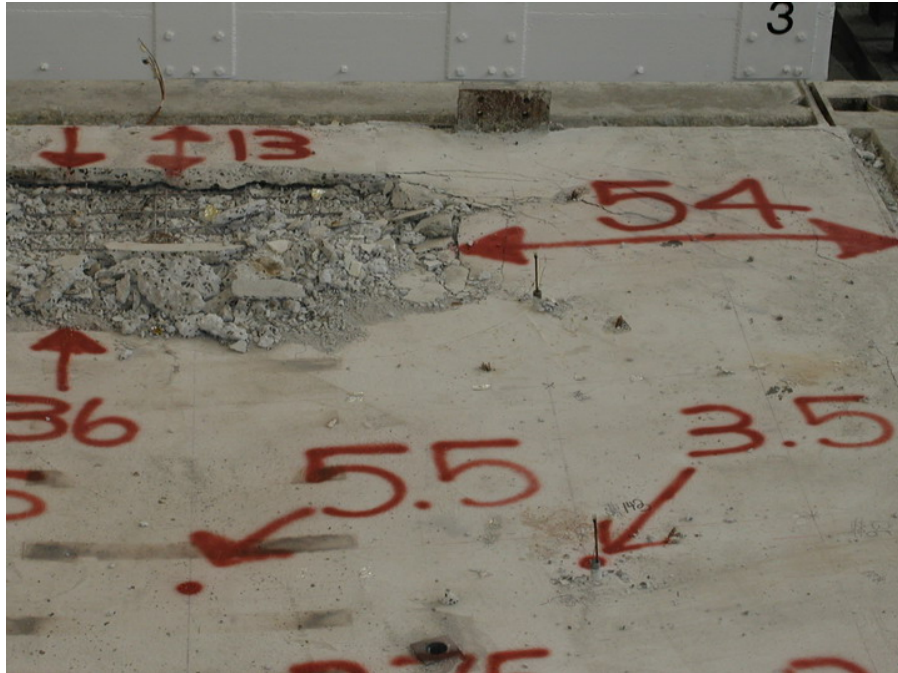
Figure 5-51. Detail of spalling concrete at north end of Assembly No. 3.

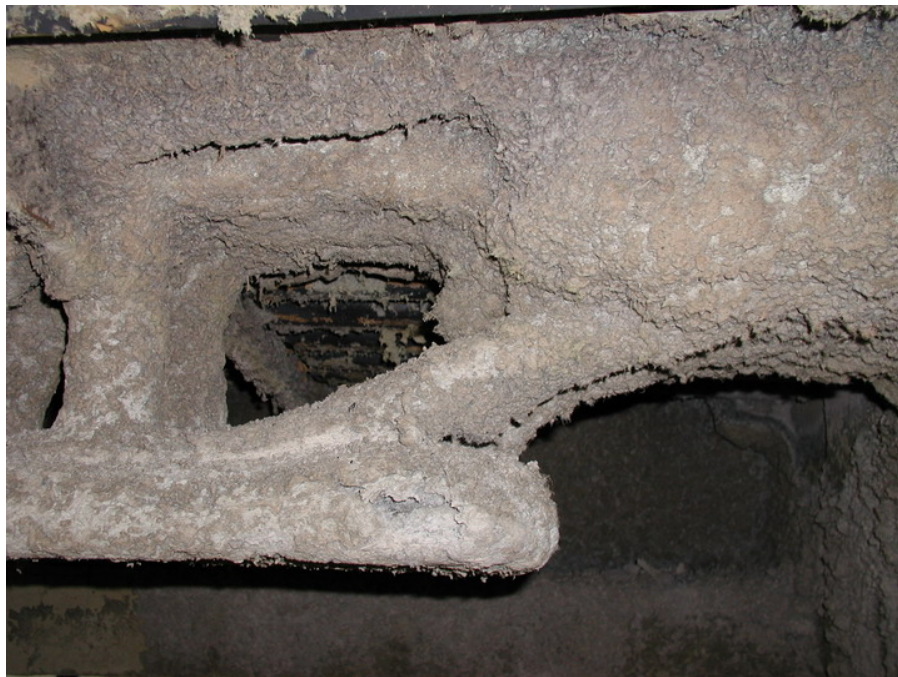
Figure 5-52. View of column-end diagonal strut of west main truss on Assembly No. 3.

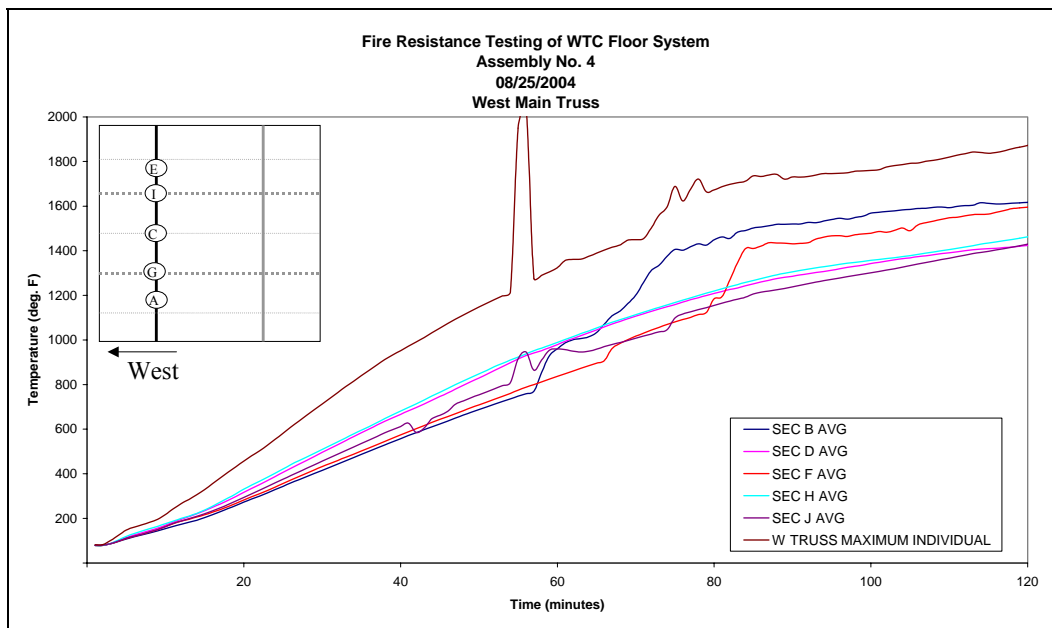
Figure 5–54. Assembly No. 4 – average and maximum individual temperatures on west main truss.

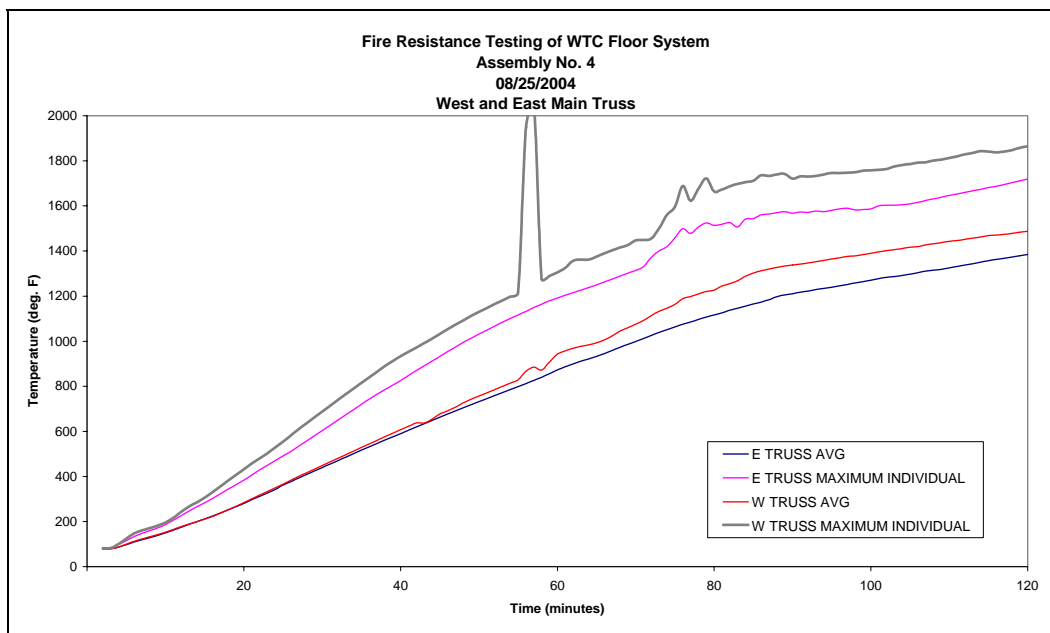
Figure 5–56. Assembly No. 4 – overall average and maximum individual temperatures on west and east main trusses.

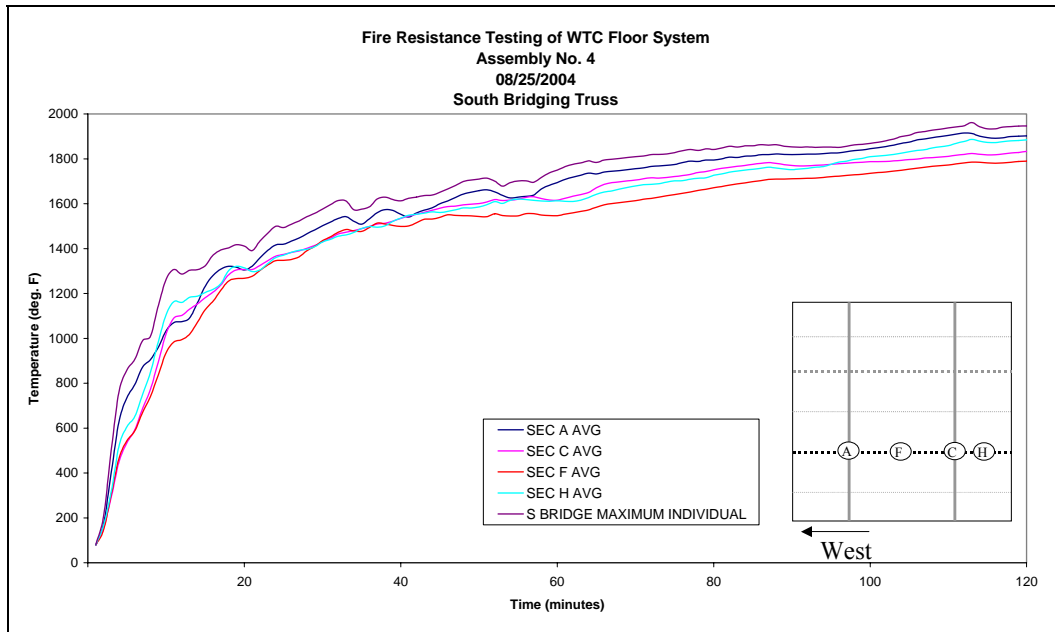
Figure 5–57. Assembly No. 4 – average and maximum individual temperatures on south bridging truss.

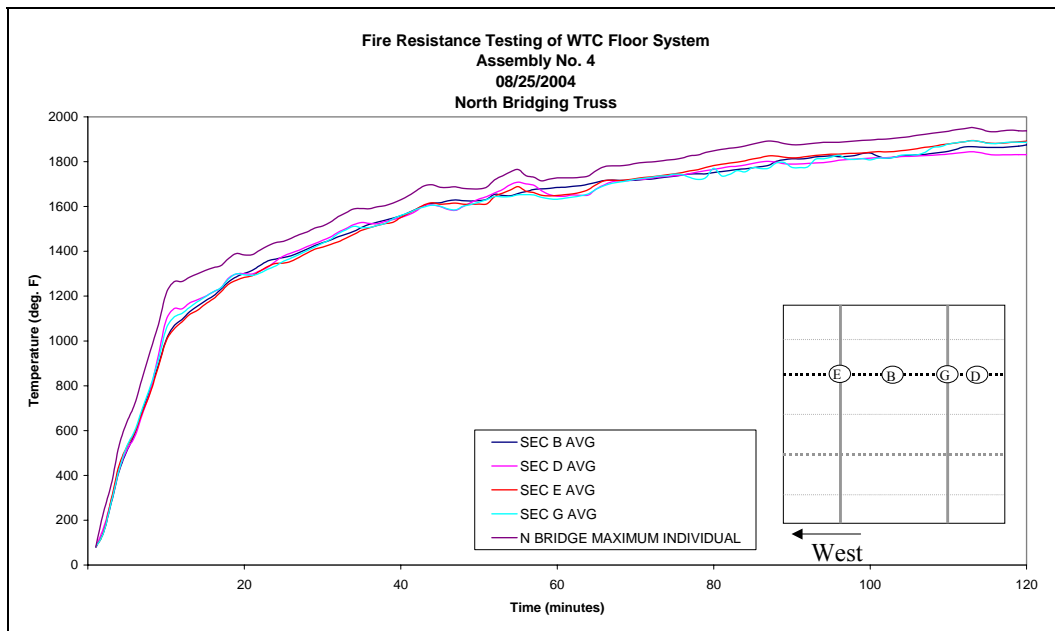
Figure 5–58. Assembly No. 4 – average and maximum individual temperatures on north bridging truss.

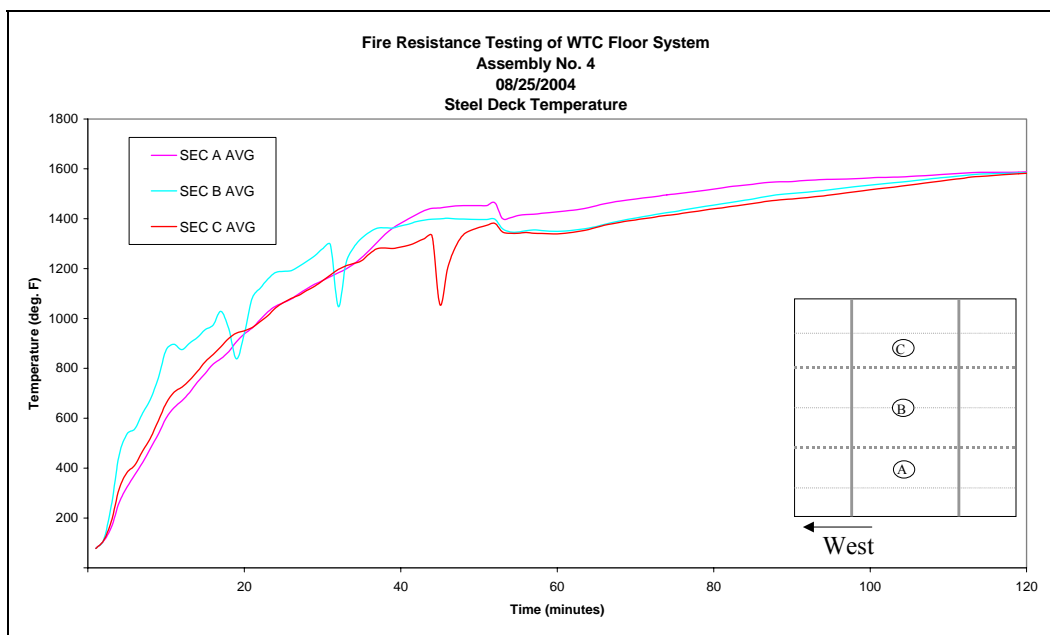
Figure 5–60. Assembly No. 4 – average temperatures on steel deck.

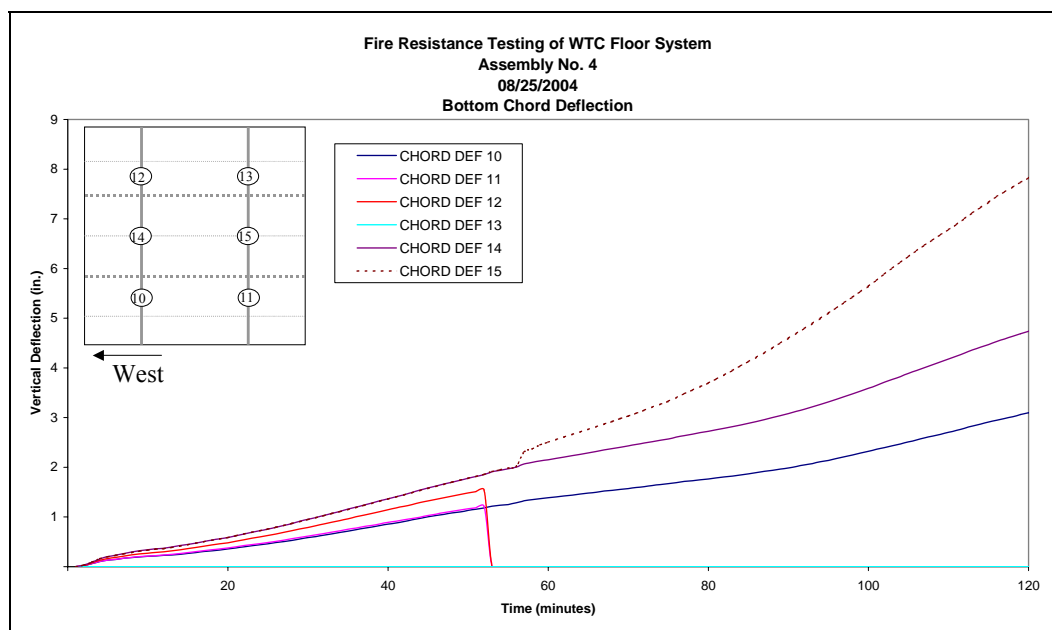
Figure 5–61. Assembly No. 4 – bottom chord deflection measurements.

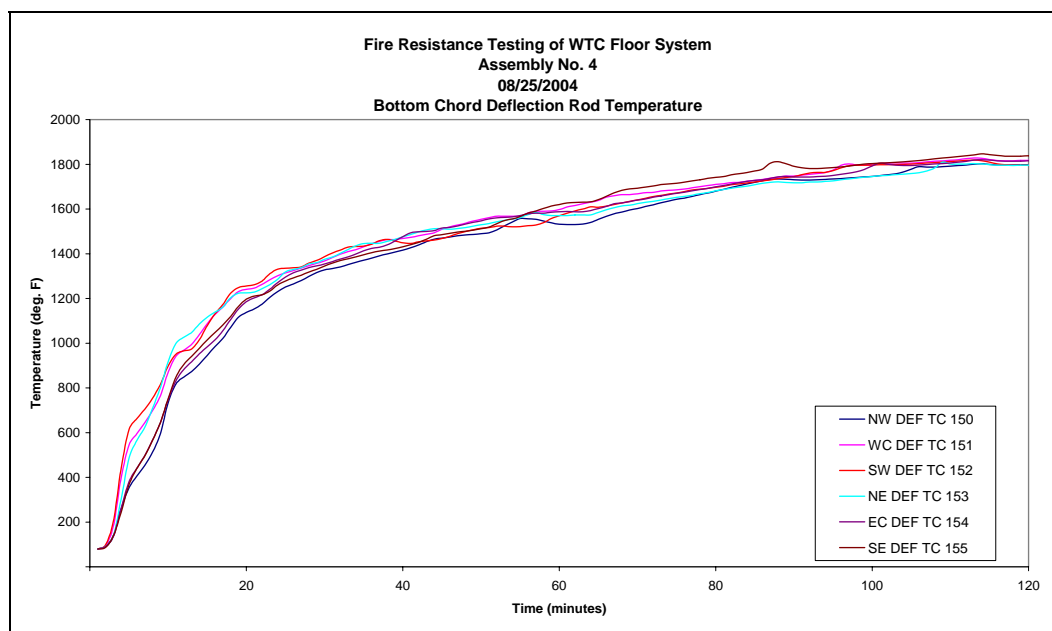
Figure 5–62. Assembly No. 4 – temperatures of bottom chord deflection rods.

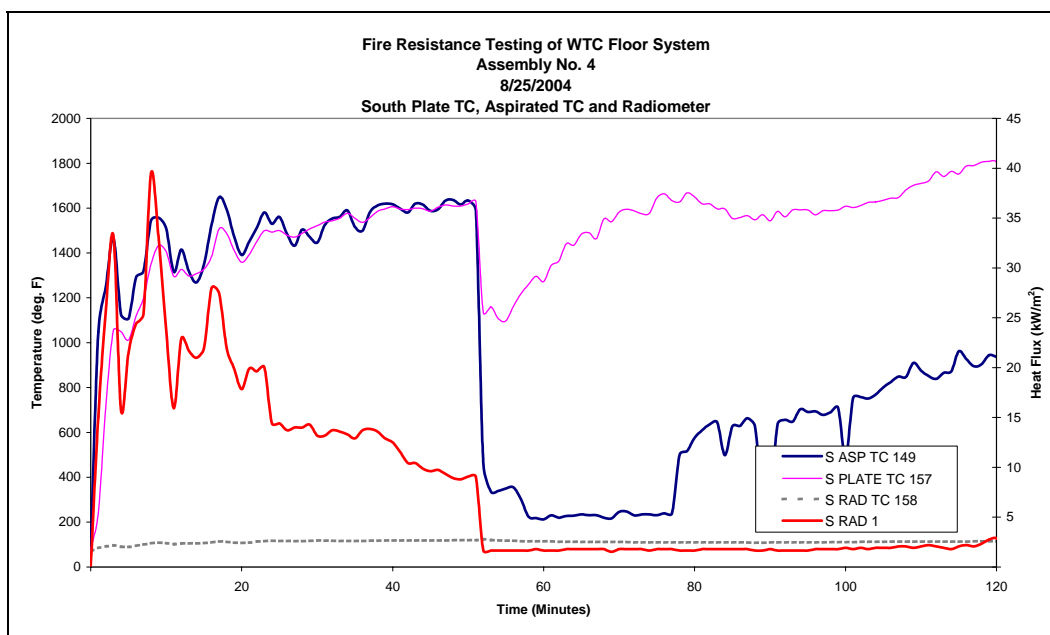
Figure 5–64. Assembly No. 4 – additional instrumentation through south opening.

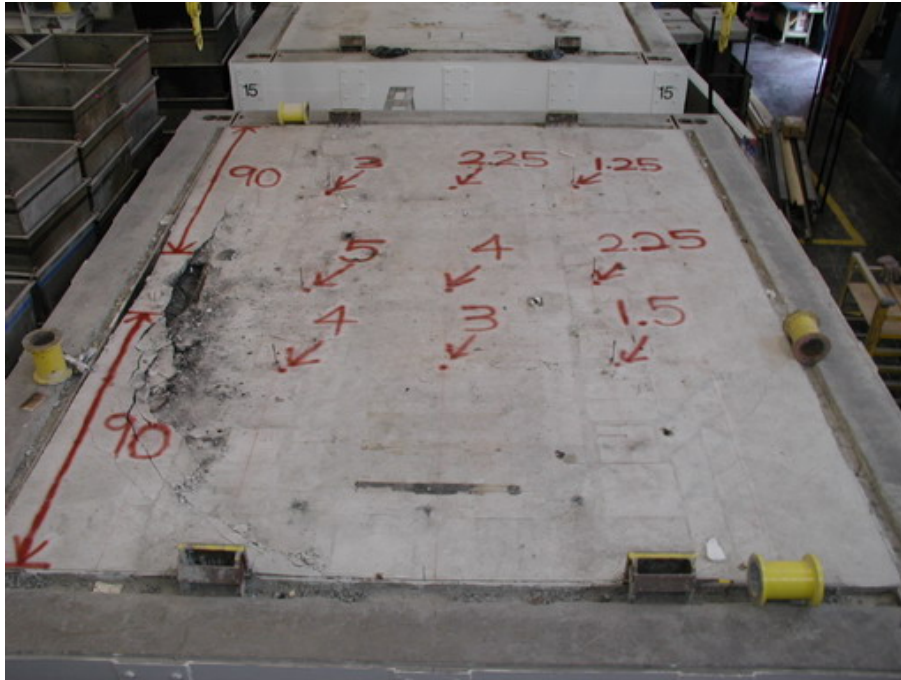
Figure 5–66 shows the unexposed side of the assembly after all loading equipment was removed (view looking north). Numbers shown at the centerline and quarter points are vertical deflections after cooling. All other numbers are reference dimension as measured from the edge of the slab. Figures 5–67 through 5–70 are additional views of the post-test condition of the test specimen.

Figure 5-66. Unexposed surface of Assembly No. 4 after loading equipment was removed.

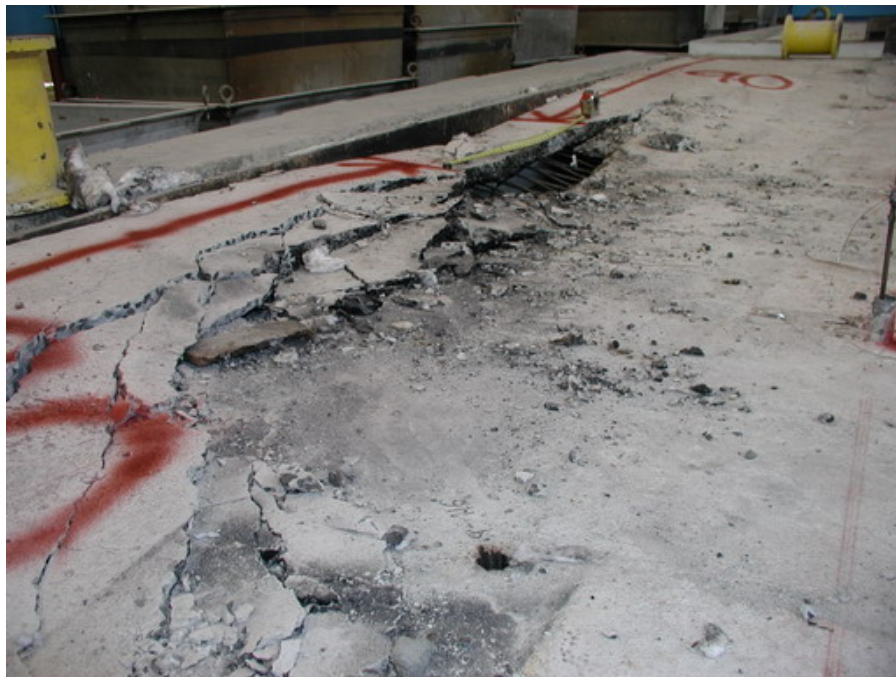
Figure 5-67. Unexposed surface of Assembly No. 4, view of concrete spalling on west side of assembly.

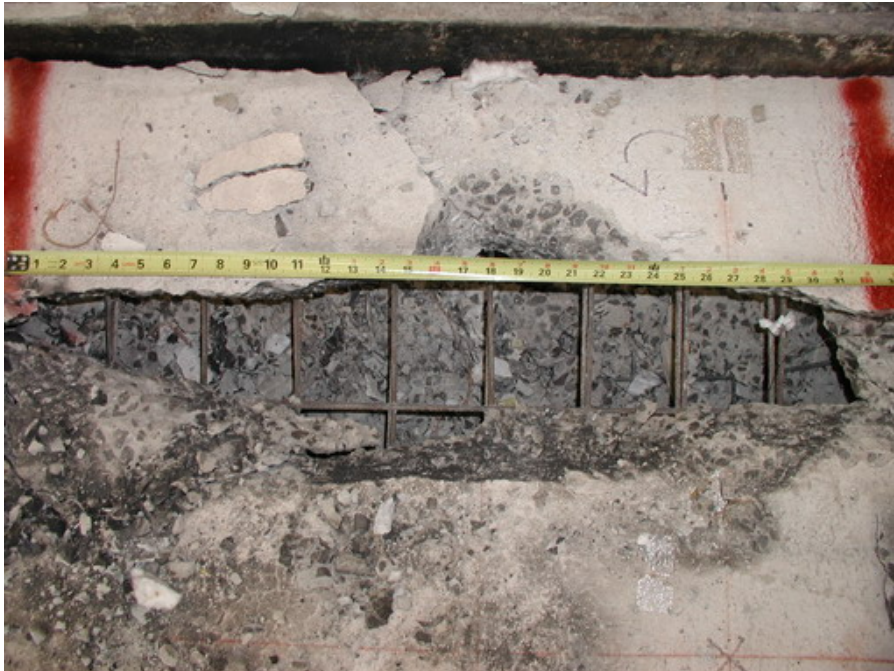
Figure 5–68. Unexposed surface of Assembly No. 4, close-up of concrete spalling on west side of assembly.

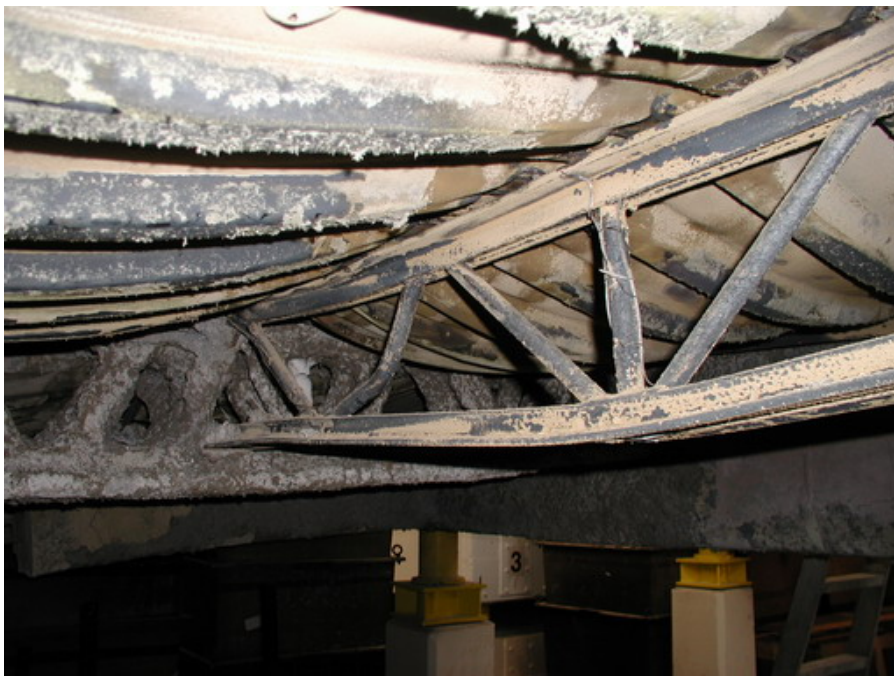
Figure 5–69. Intersection of north bridging and west main truss on Assembly 4.

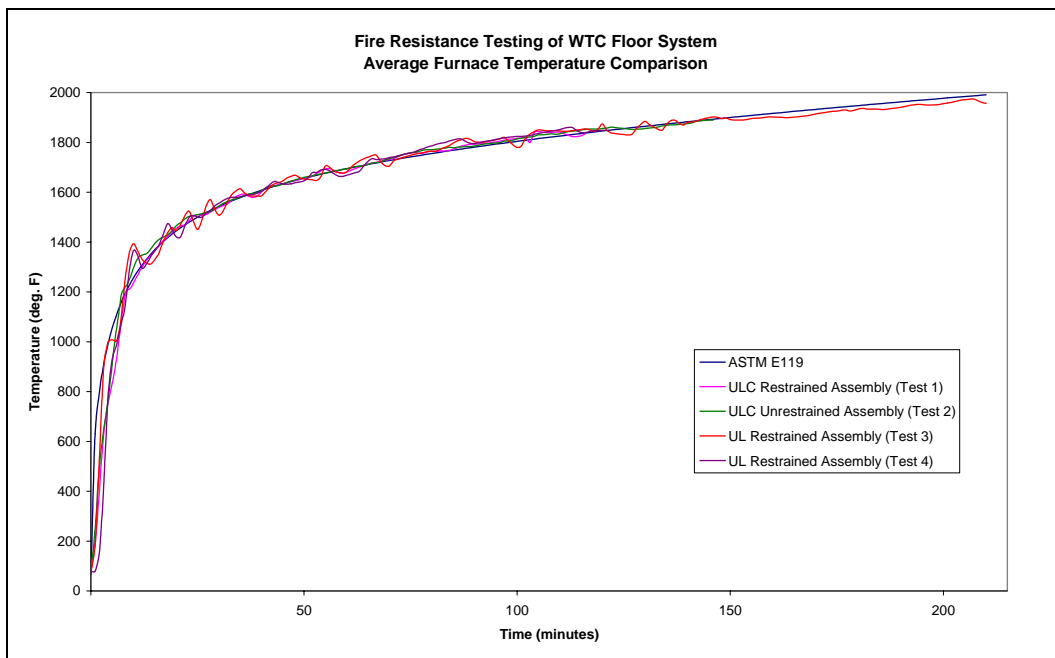
The average furnace temperatures during all four tests and the target time-temperature relationship prescribed by ASTM E 119 are shown in Fig. 6–1. It is seen that the average furnace temperatures were very similar and indeed met the requirements of ASTM E 119.

Figure 6–1. Comparison of average furnace temperatures.

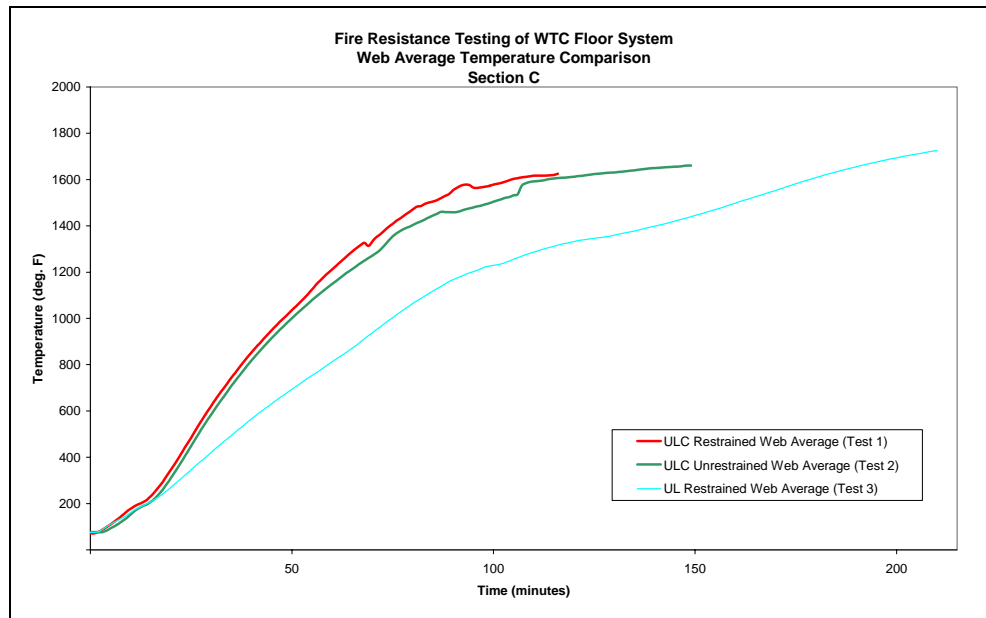
Figure 6–5 presents a comparison of temperatures of the truss web diagonals for the three tests in which the thickness of the fireproofing was $\frac{3}{4}$ in. The web temperatures for the two full-scale tests (35 ft span assemblies) were greater than those for the reduced-scale test (17 ft span assembly) after about 15 min. The reason for this difference is not clear but is possibly due to the relationship between the fireproofing thickness and scale of the steel trusses. Comparison of Figs. 5–35 and 5–50 illustrates the difference in the buildup of fireproofing at the intersections of the webs and chord members between the full- and reduced-scale test specimens, which may affect the rate of heating of the truss web diagonals. These results illustrate that thermal scaling is an issue that needs to be addressed.

Figure 6–5. Average temperature of web diagonals for Test Nos. 1, 2 and 3 (3/4 in. thick fireproofing).

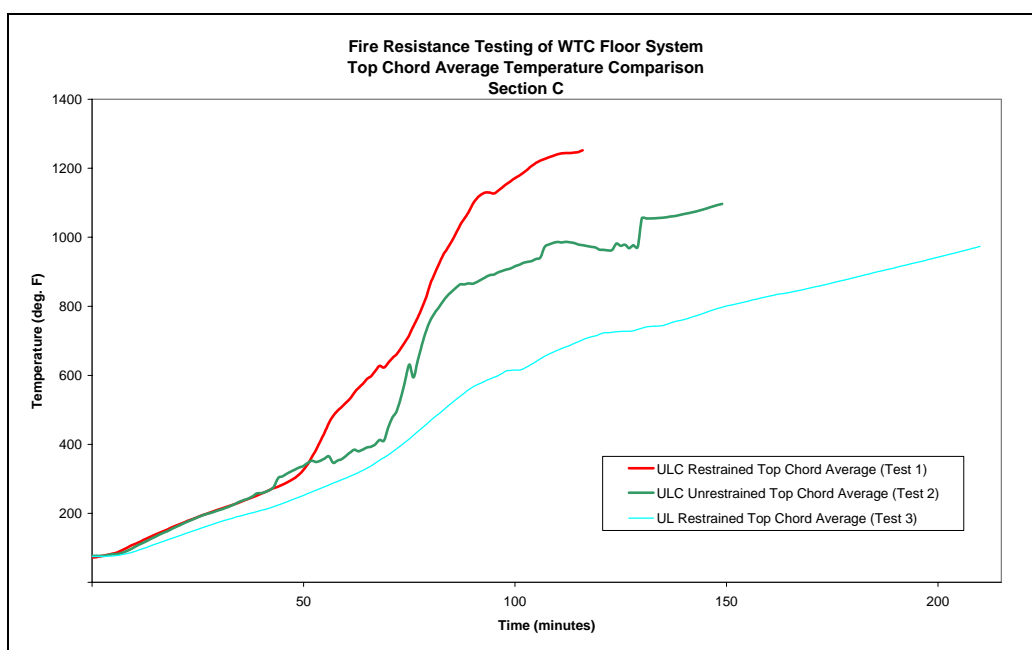
The average temperature of the top chord is plotted in Figure 6–6 for the three test assemblies with $\frac{3}{4}$ in. of fireproofing. The average top chord temperature for the two full-scale tests (35 ft span test assemblies) was greater than the average temperature recorded for the reduced-scale test (17 ft span assembly) after about 50 min. Because of the comparatively abrupt changes in average temperature beginning around 50 min, the difference may be explained by sudden changes such as the onset of spalling of concrete and attendant loss of fire protection. However, since the steel temperatures in the reduced-scale test generally tend to be lower than in the full-scale test, this trend may be explained by a scale-related factor such as the difference in the buildup of fireproofing affecting the rate of heating of the steel as noted above. Further, it is possible that the overspray on the metal deck was greater for test Specimen No. 3 than for the other two tests since the lower chord is closer to the metal deck. This, too, would be a geometrical scaling effect.

Figure 6–6. Average temperature of the top chord for Test Nos. 1, 2 and 3 (3/4 in. thick fireproofing).

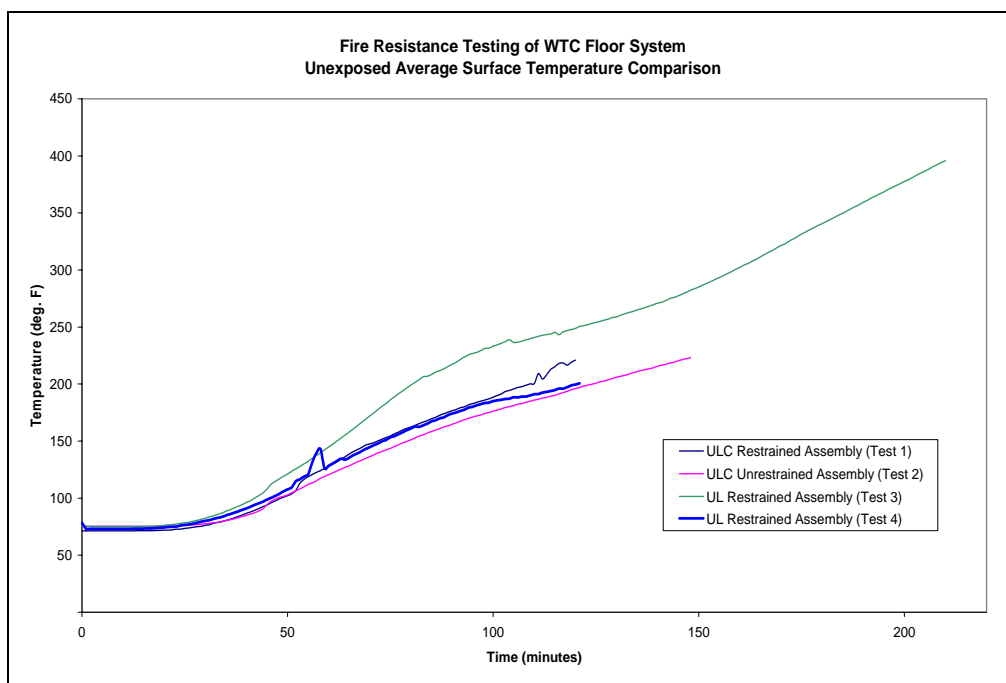
The temperature of the unexposed surface of the floor assemblies is plotted in Fig 6–8. It is observed that the unexposed surface temperatures of all four test assemblies were similar prior to the onset of significant concrete spalling at around 50 min. In Test 4, the surface-mounted TC on the west edge near the center of the span was affected by the explosive failure of the slab and recorded hot gas temperatures.

Figure 6–8. Average temperature of the unexposed surface for all four tests.

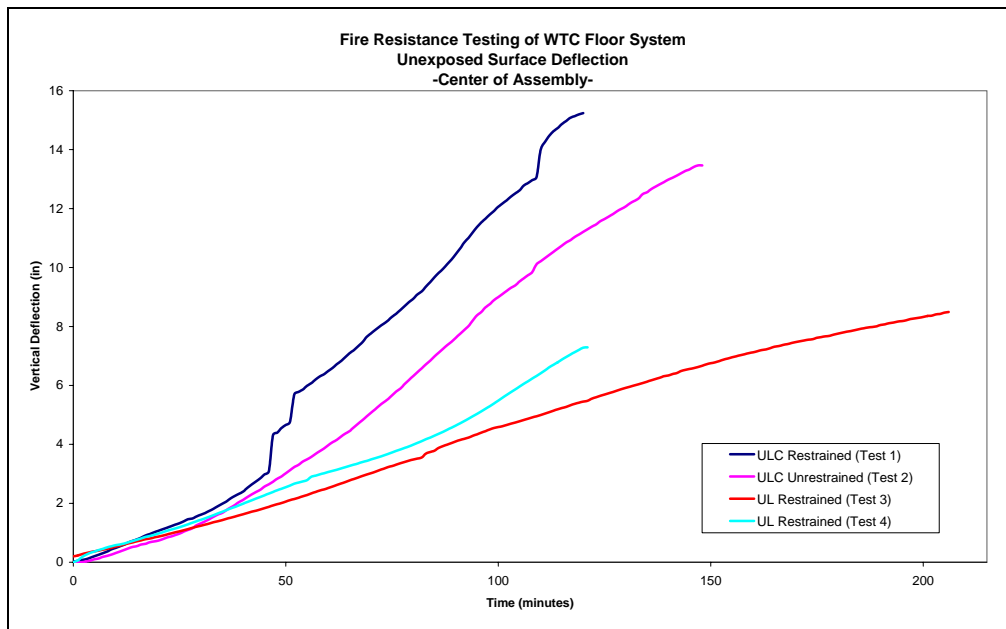
The following plots show the vertical deflection measured at the center of each assembly. Figure 6–9 shows the deflection while Fig. 6–10 shows a plot of the deflection normalized by the span. It is seen that test Assembly No. 1 experienced a significant increase in vertical deflection at 49 min. which corresponds directly to a loud report and visible deflection noted in the test observations. Figure 5–13 shows the damage to the top side of the concrete slab that occurred with the sudden increases in deflection. The normalized curves show good agreement throughout the duration of the tests.

Figure 6–9. Deflection measured at the center of each assembly.

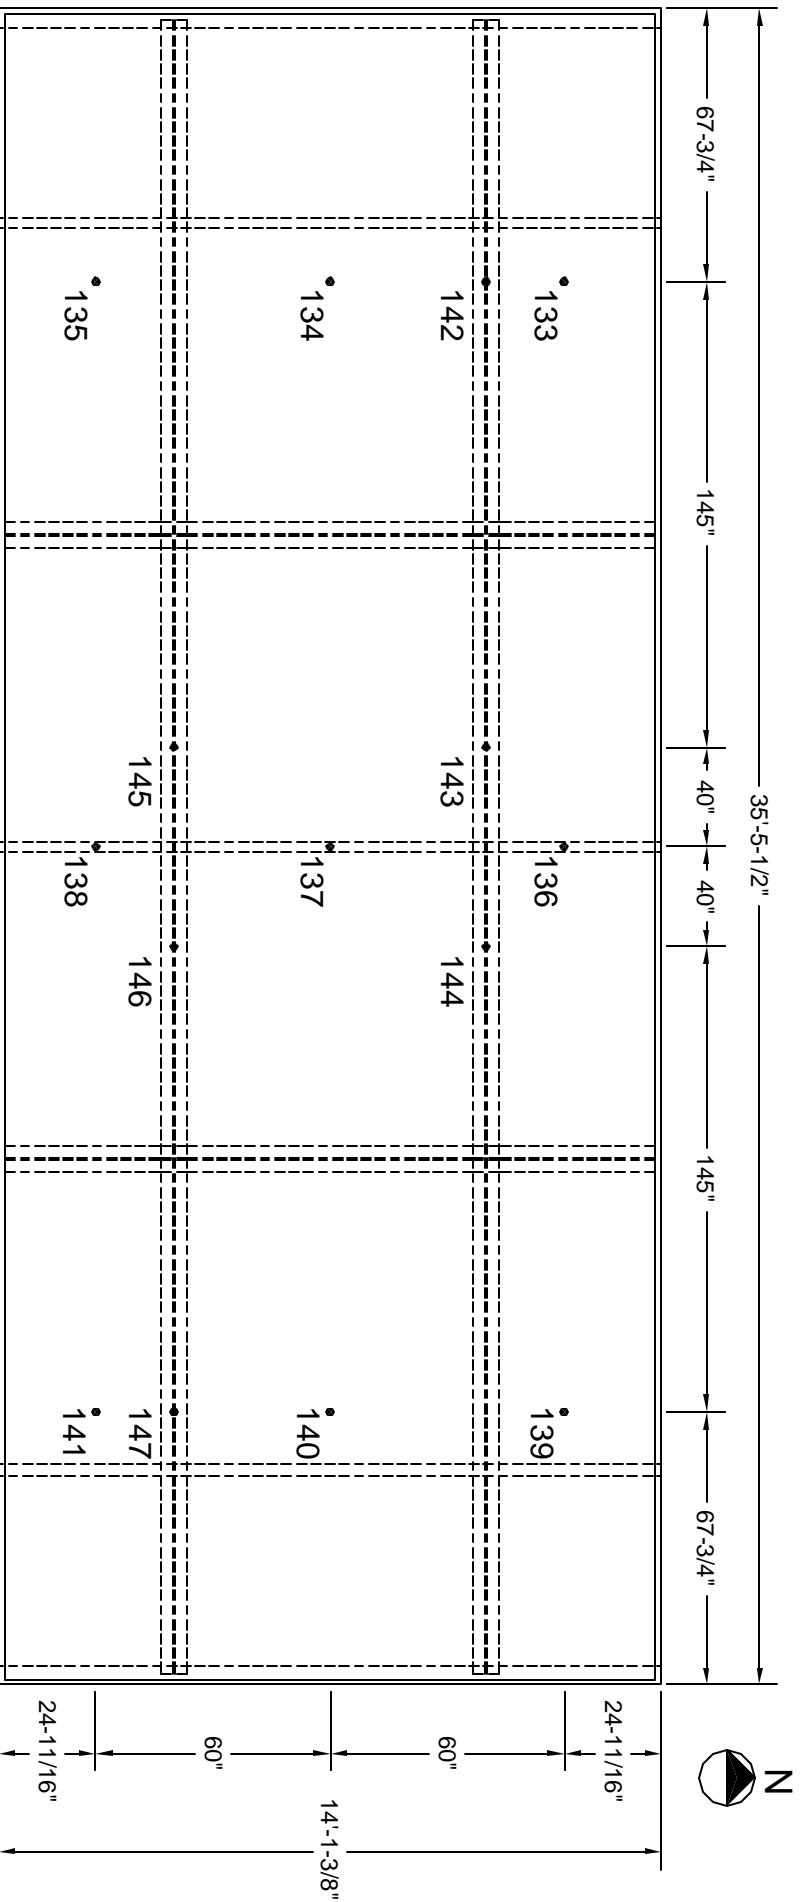
Unexposed Surface Thermocouple Locations

Note: Dimensions for locations may vary slightly depending on deck valley and crest occurrence, and main truss knuckle location in actual construction
