**RECONNAISSANCE REPORT ON DAMAGE TO
ENGINEERED STRUCTURES DURING
THE MAY 1999 OKLAHOMA CITY TORNADO**

Michael A. Riley

Building and Fire Research Laboratory
Gaithersburg, MD 20899-8611

August 2002

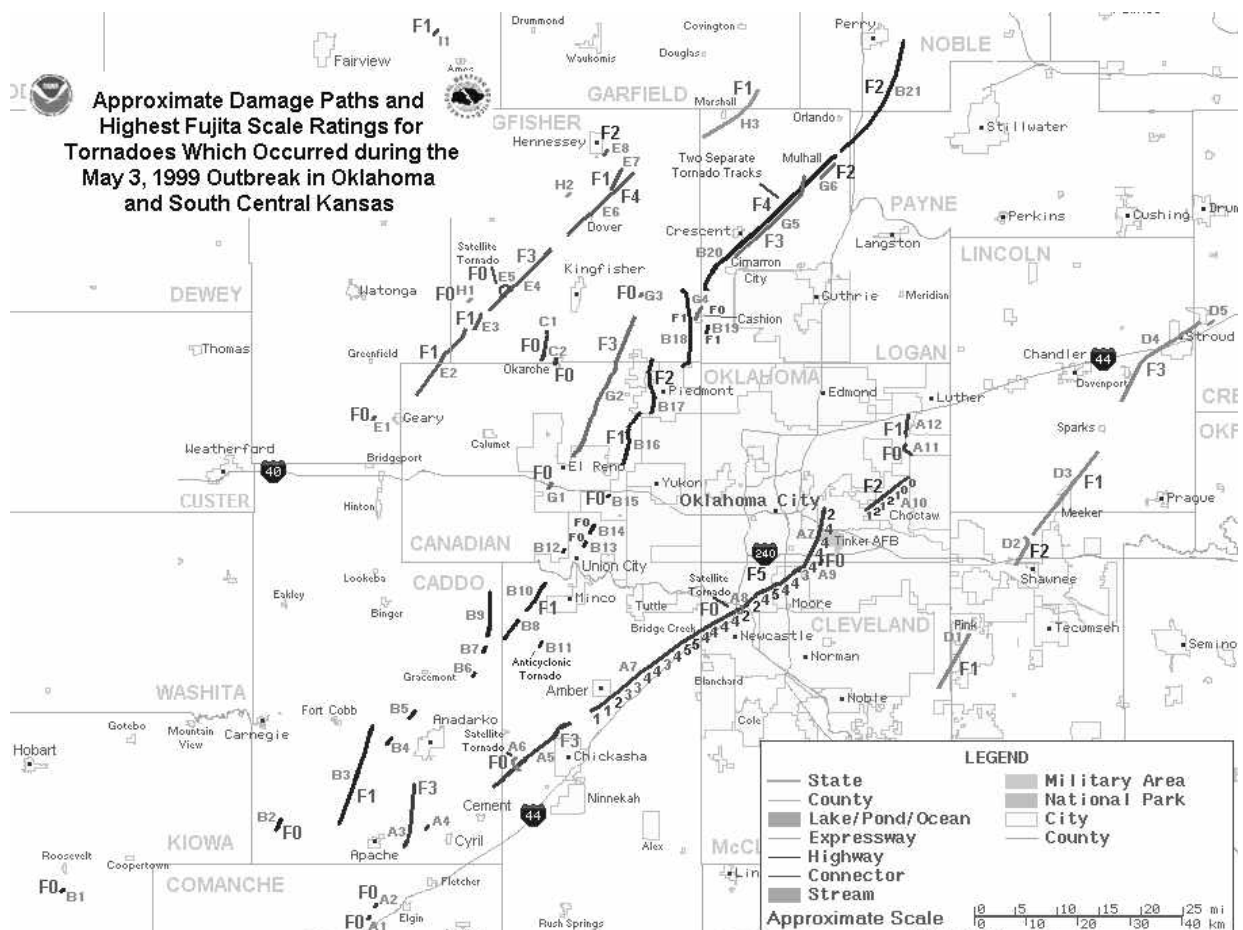
Figure 1-1. Map of Tornado Damage Paths and F-scale Ratings in the Vicinity of Oklahoma City, 01 July, 1999 Revision. (Courtesy of the NWS).

Weather Service identified the threat of tornadoes in the storm developing over the Midwestern US at 1:00 AM on 3 May 1999. The center issued the first tornado watch for the storm at 4:30 PM, and the first, weak tornado (A1 in Figure 1-1) was reported at 4:51 PM. During a ten-hour period that afternoon and evening, the National Weather Service Forecast Office in Norman, Oklahoma issued 116 warnings for tornadoes and severe thunderstorms.

Figure 1-1 shows a map of the tornado damage paths in central Oklahoma. The largest of these tornadoes (A7 in Figure 1-1), which passed through Oklahoma City, was rated as an F5 by the NWS. The other tornadoes were rated from F0 to F4. Table 1-1 lists the storm supercells identified by NWS, the number of distinct tornadoes that could be identified for each, the highest F-scale rating for tornadoes generated by that supercell, and the number of fatalities.

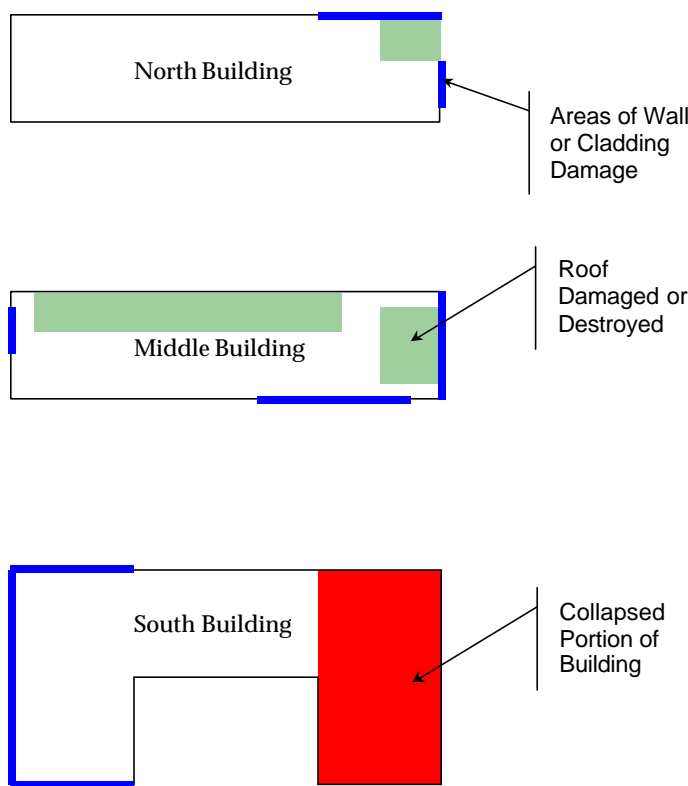
Figure 4-1: Simplified Plan View of Tinker Industrial Park

plan view of the industrial park site is shown in Figure 4-1.

The tornado passed just south of the industrial park, causing the most severe damage to the south building, while the north building was the least damaged.

The south building was the newest of the three buildings. The main section had been completed less than one month before the tornado, and the foundation for an enlarged central section was under construction. The C-shaped portion, shown in Figure 4-1, was completed and the central and eastern portions were occupied. The structure and exterior of the western portion were complete, but the interior was still being finished.
