NBS BUILDING SCIENCE SERIES 165

**Engineering Aspects
of the September 19, 1985
Mexico Earthquake**

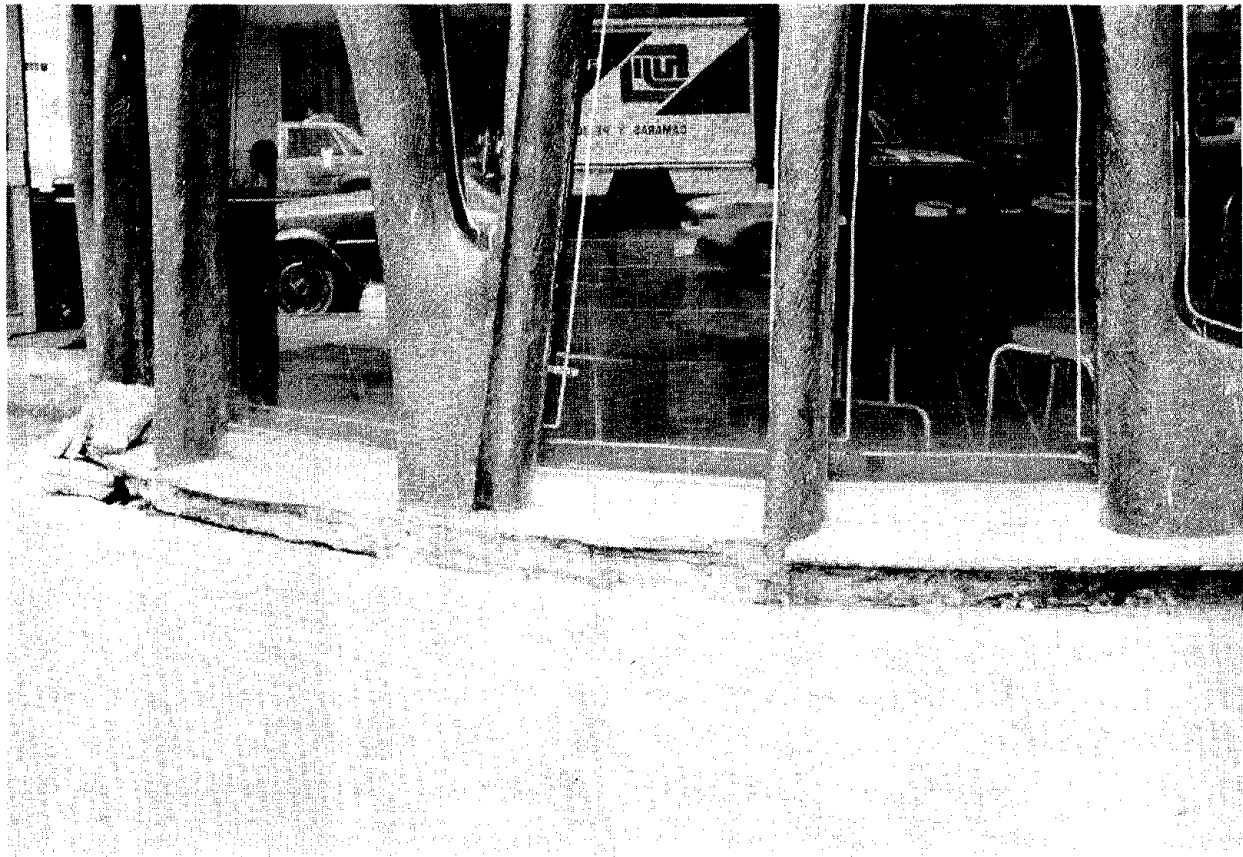
Figure 4.4. Differential displacement between sidewalk and building at the west corner of Versailles and Reforma.

Thus, it is reasoned that the phenomena observed in figures 4.1 through 4.4 are the result of a relaxation in the negative friction forces acting on the piles. This relaxation is the result of loss of shear strength. The loss of shear strength occurred because the clays are sensitive (refer to figure 3.9) and was caused by shear deformations associated with the relative motion between the piles and the surrounding soil. From available data [8] it is estimated that between 85 and 88 percent of the shear strength can be lost. This loss of shear strength does not necessarily lead to an overall foundation failure (it did not cause such a failure in the buildings shown in figures 20 to 23), particularly, since it also results in the relaxation of negative friction forces which the pile had to resist, but it is an important limit state, which should be considered in the design of earthquake-resistant structures founded on sensitive clays.

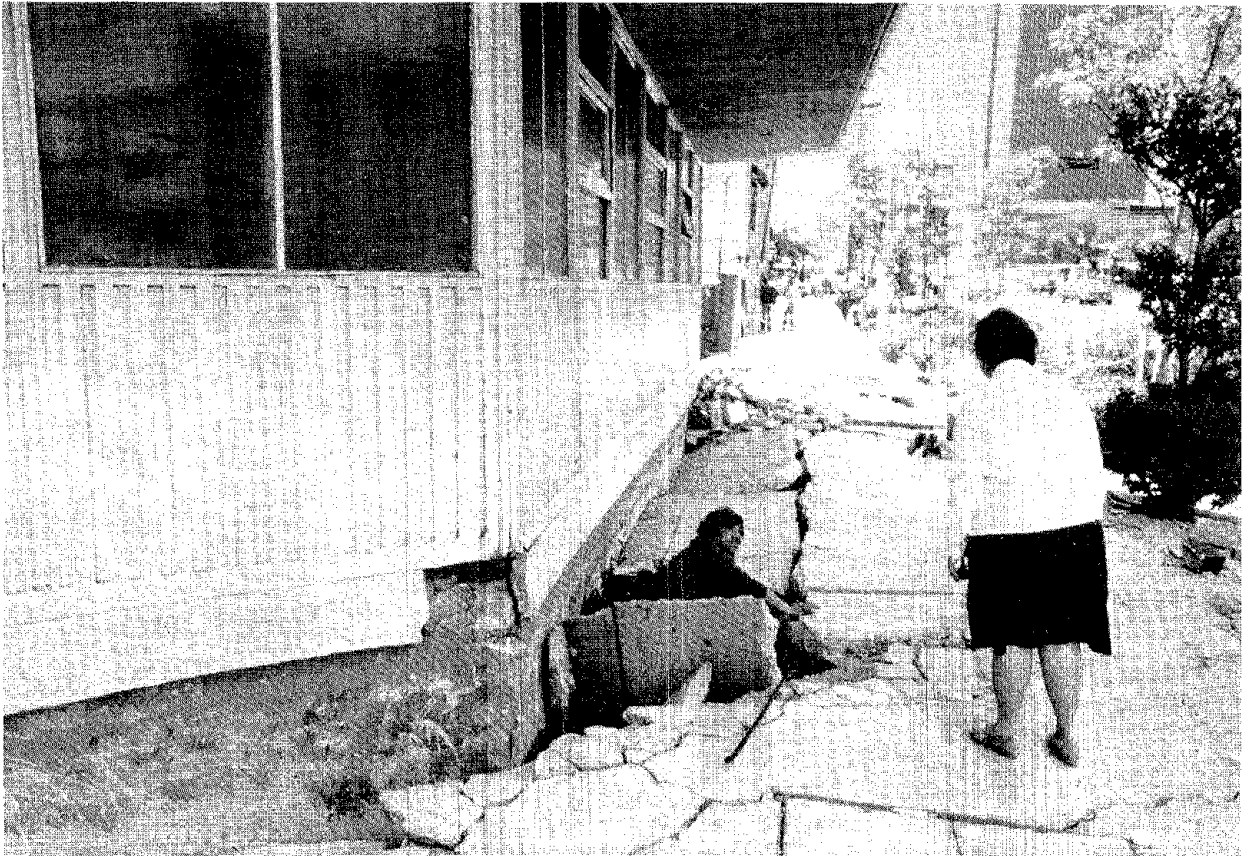
Figure 4.5 shows a tilted ten-story building in the southwest corner of the intersection of Lazaro Cardenas and Fernando. Relative displacements between the building and the sidewalk to the north are shown in figure 4.6, and figure 4.7 shows damage caused to adjacent two-story buildings by the tilting structure. This building is in the vicinity of the severely damaged Communications Center (SCT) where several buildings collapsed. Figure 4.8 shows another tilted building in the same general area in the northwest corner of the intersection of Xola and University. This ten-story building also suffered severe structural and cladding damage. Figure 4.9 shows two- and three-story buildings a short distance to the south on University and opposite the severely damaged Communications Center which apparently did not suffer damage. Likewise, many two-story residential buildings on University to the north of Xola, where two multi-story reinforced concrete buildings (one of them post-tensioned) collapsed, also appeared undamaged.

Figure 4.6. Relative displacement between sidewalk and tilted building at Lazaro Cardenas and Fernando.

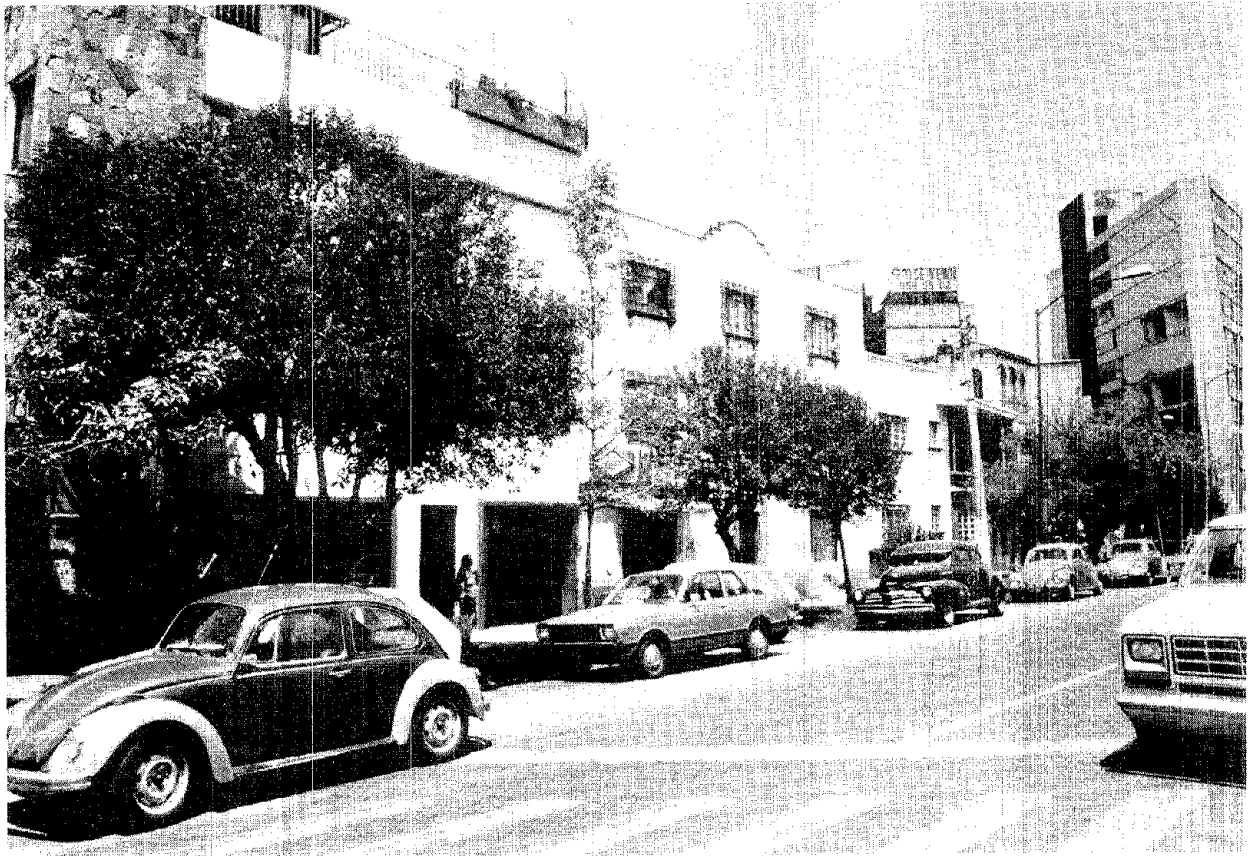
Figure 4.9. Undamaged two and three story buildings on University Boulevard opposite the severely damaged Communications Center.

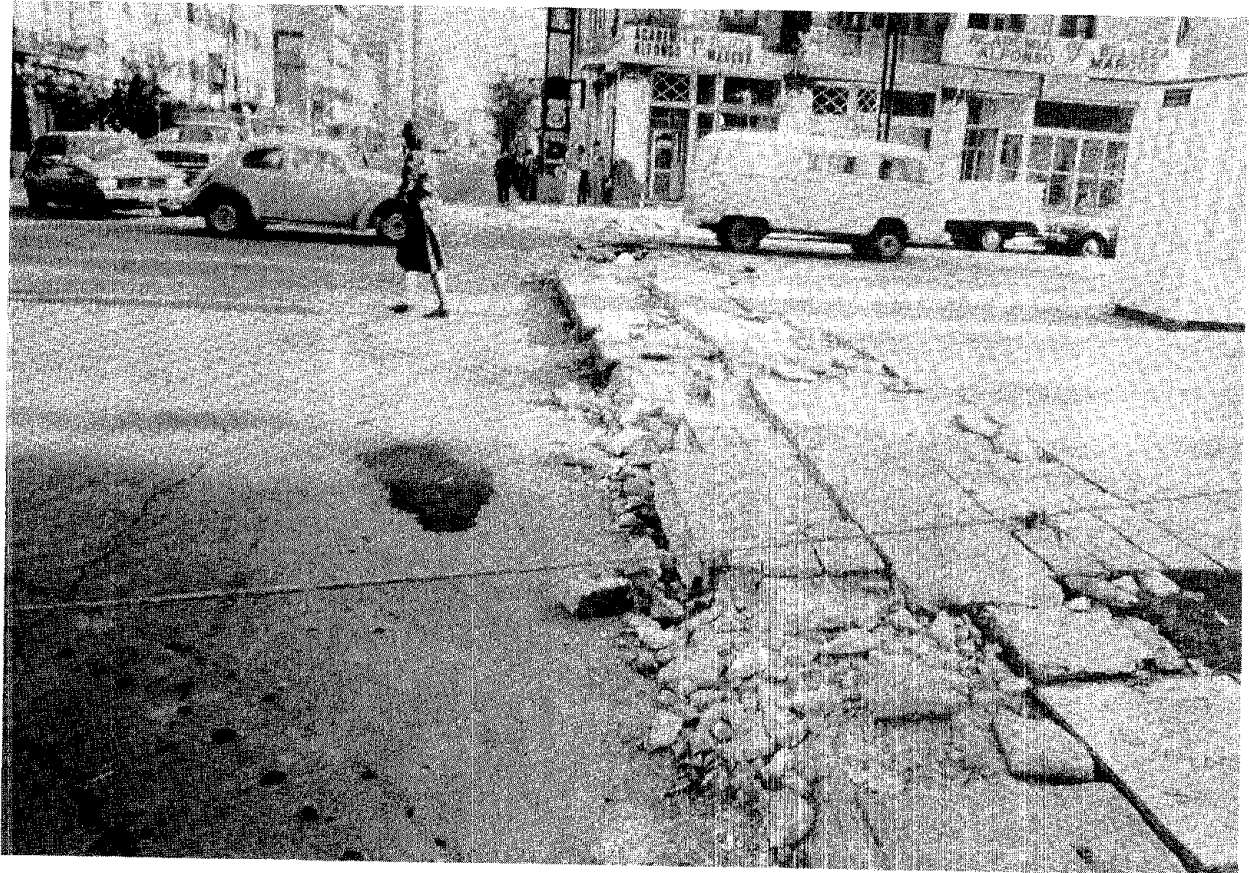
Figure 4.16. Soil disturbance over utility line at the intersection of Monterrey and Obregon.

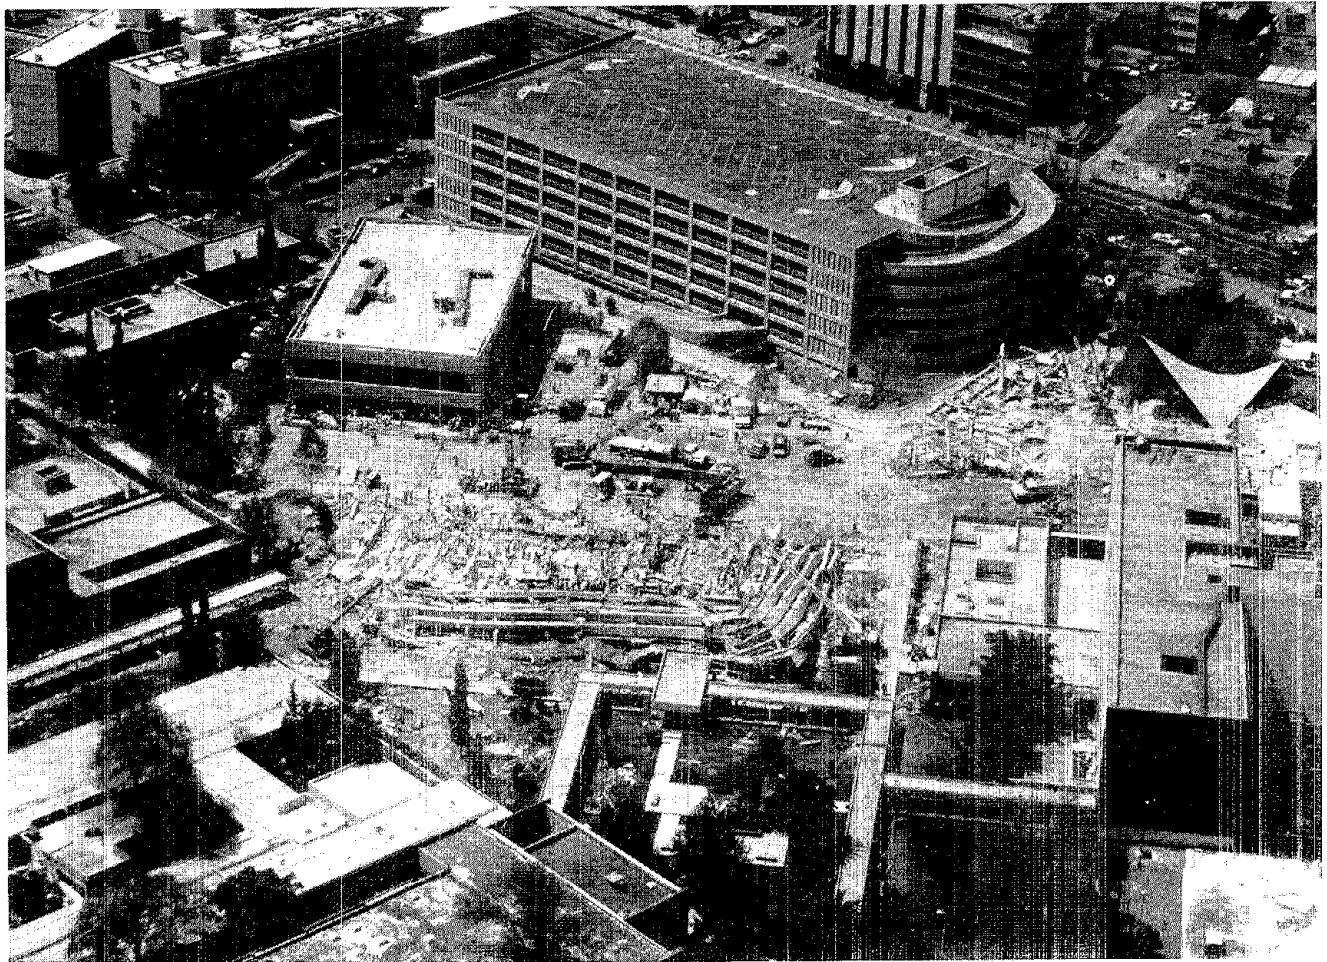
Major buildings at three of the City's largest hospital complexes collapsed, thus impairing use of these critical facilities. All were reinforced concrete frames and typified a common failure mode for this type of construction. Some 1200 people were buried as six buildings collapsed at the Centro Medico and Mexico General Hospital, one of the largest medical facilities in Latin America. Figure 5.4 shows an aerial view of this complex looking towards the southwest and the street intersection of Cuatemoc and Coahuila boulevards. The central (easternmost) structure collapsed towards the east exhibiting a pancaking type collapse similar to those normally associated with flat plate construction. However, the failure mechanism is quite different in this case. Examination of debris from this structure (figure 5.5) showed negligible damage in the beams and girders. The edge spandrel beams were, in contrast to the above discussed weak-beam/strong-column philosophy, quite stiff in comparison to the columns. Consequently, failure was likely initiated by the formation of plastic hinges at the column ends, both above and below the floor level joints with the girders.

Figure 5.4. Aerial view of Mexico General Hospital.

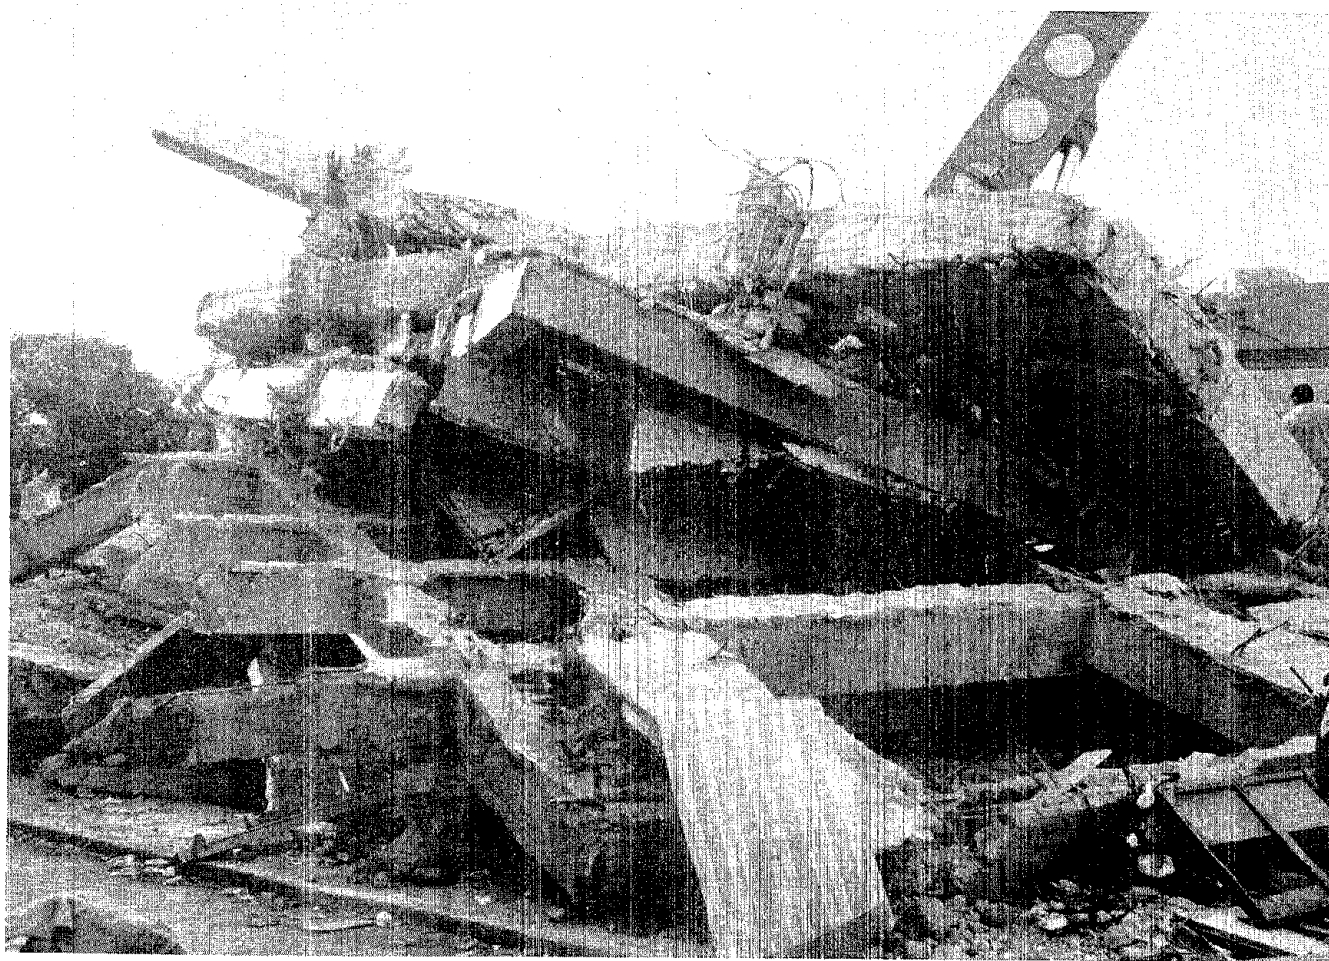
Figure 5.5. Debris from the collapsed Mexico General Hospital.

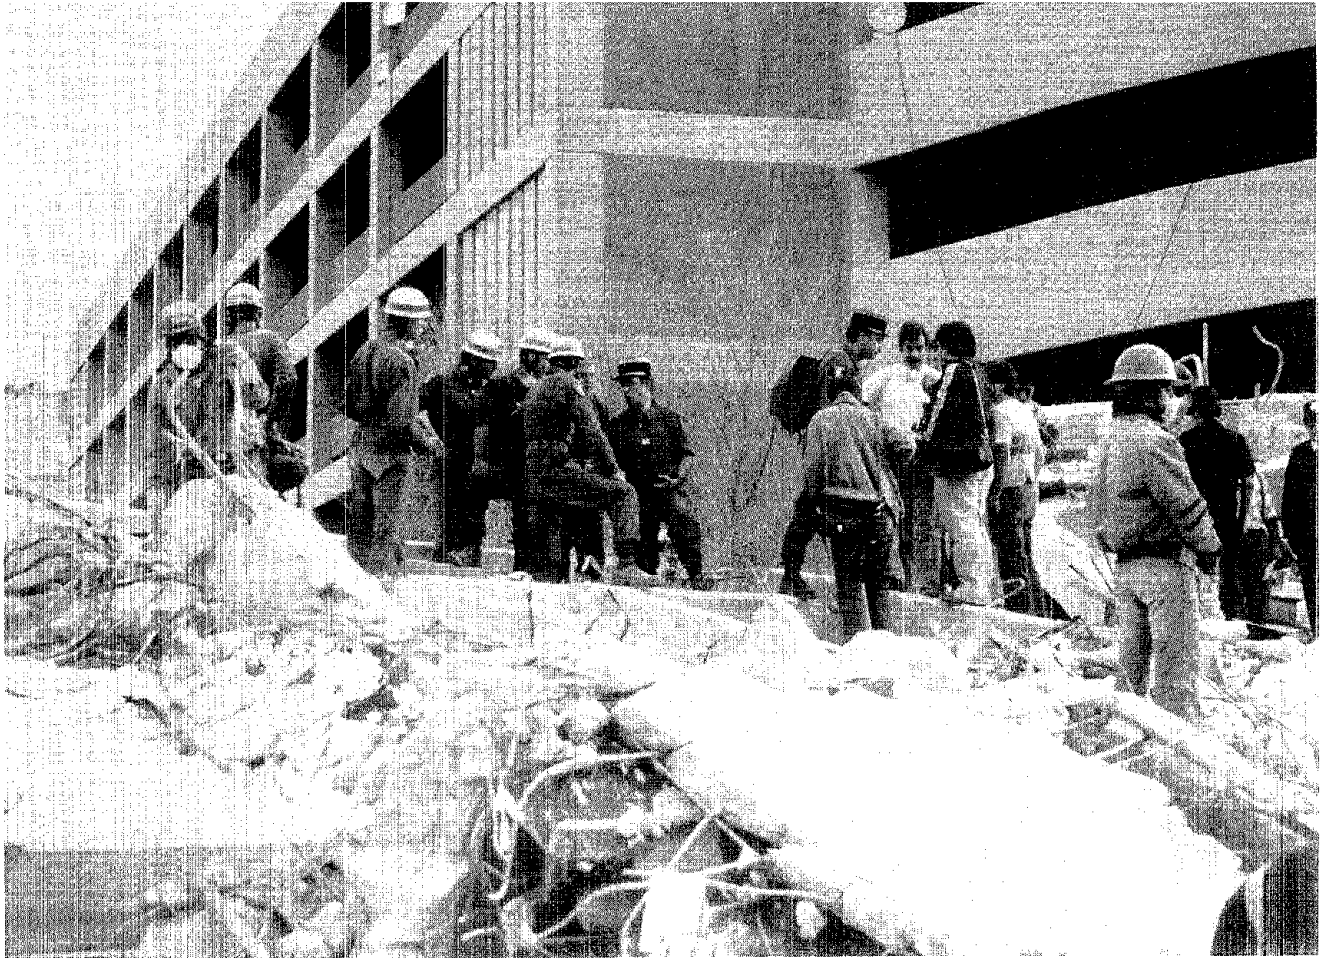
Figure 5.7. Reinforced concrete shearwalls in the corners of the parking garage of the Mexico General Hospital. The group standing in the foreground was part of the dog-rescue team from France. These teams successfully tracked down several survivors trapped in rubble of the buildings that collapsed.

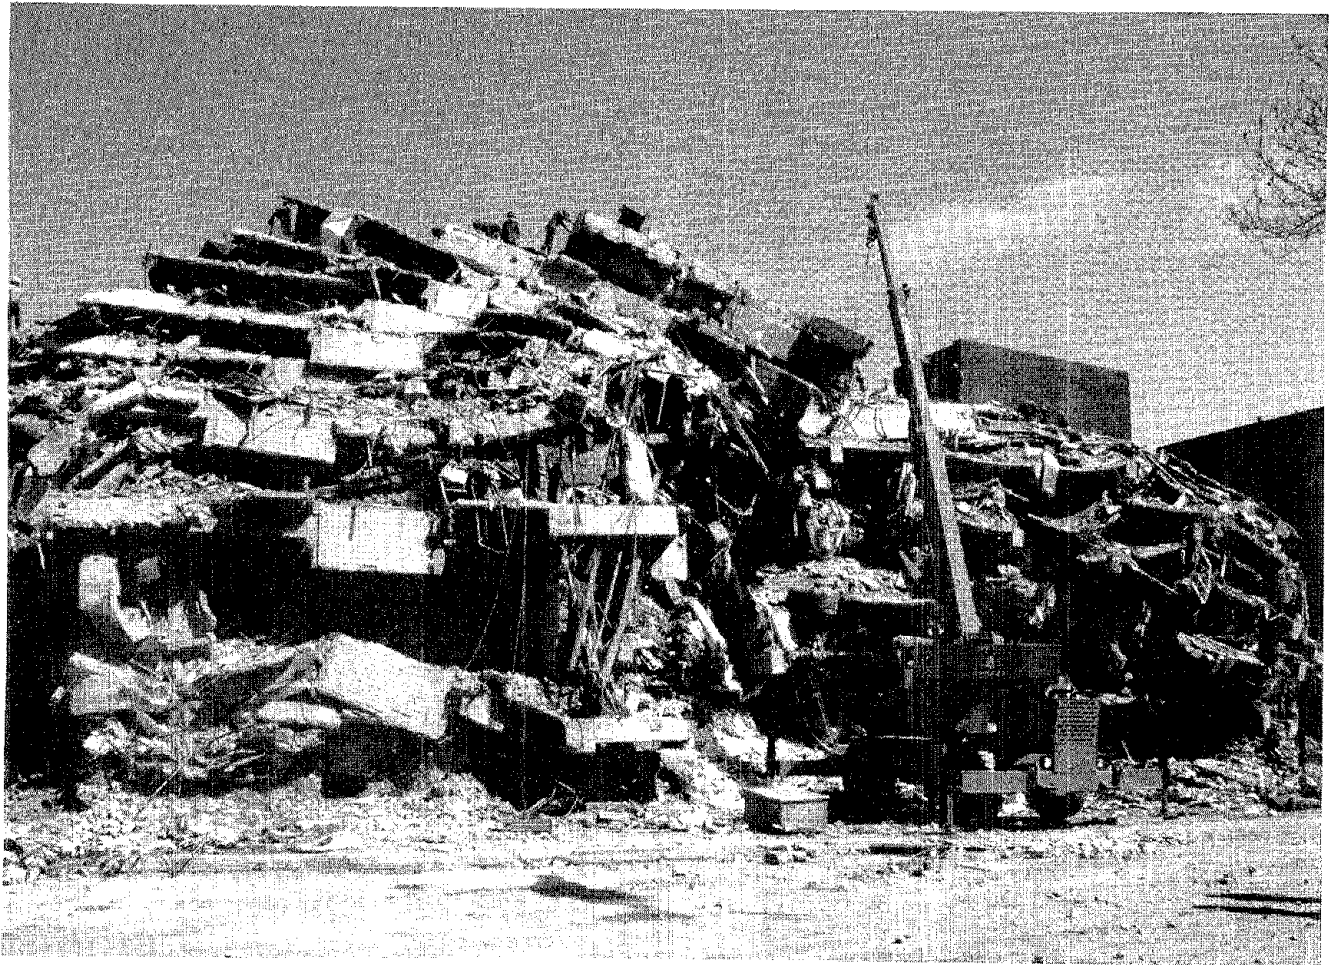
Yet in another hospital building, the Maternity wing of the Juarez Hospital, eight blocks south of the Presidential Palace, 400 medical personnel and patients, notably infants, were trapped. This nine story reinforced concrete frame structure collapsed towards the east also (figures 5.9 and 5.10) exhibiting localized failures at the beam to column joints of each floor. A close-up of various joint details (figure 5.11), indicates that the columns were generally well-proportioned to resist gravity loads. However, figure 5.11 and 5.13 clearly shows minimal to nonexistent confinement through the joints. Furthermore, many joints had longitudinal bar splices at these same critical moment locations. These factors probably contributed to joint failures after a relatively small number of cyclic load reversals.

Figure 5.10. View of collapsed maternity wing of the Juarez Hospital looking east.

continued to retrieve survivors as late as ten days after the earthquake by tunneling through the debris between the floor slabs (see figure 5.10).

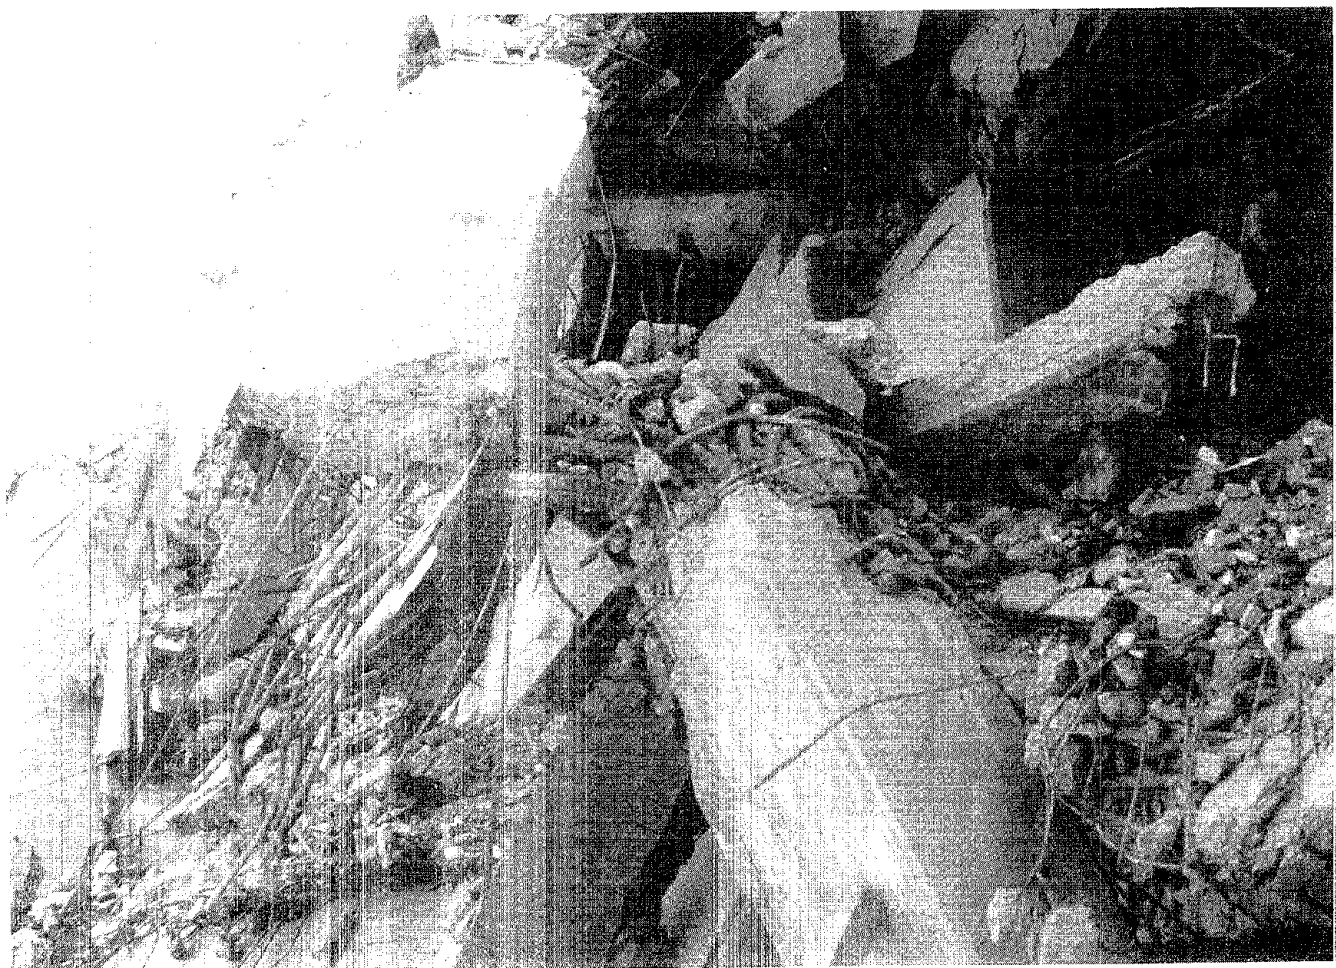
The lack of such confinement, and the presence of splices in such critically underconfined joints -- which could lead to a loss of vertical load bearing continuity as soon as the bond strength is lost following core breakup -- directly contributed to the failure of the Juarez Hospital. This particular structure received considerable media attention as rescue personnel

Figure 5.11. Close up joint details of collapsed Juarez Hospital indicating lack of sufficient confining reinforcement in the vicinity of the joint.

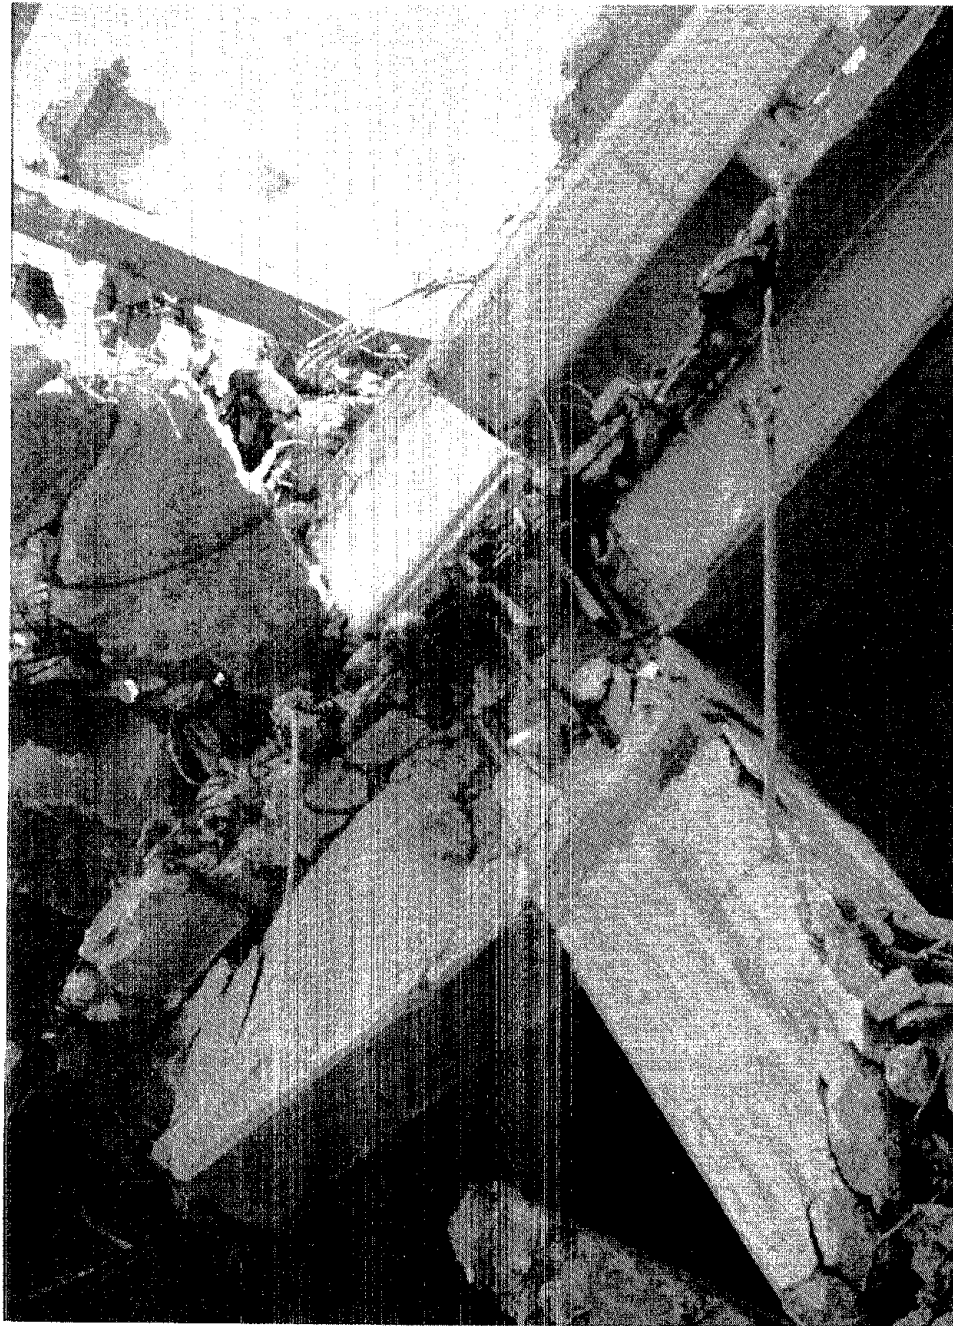
Figure 5.12. Joint details of collapsed Juarez Hospital indicating adverse effect of a splice.

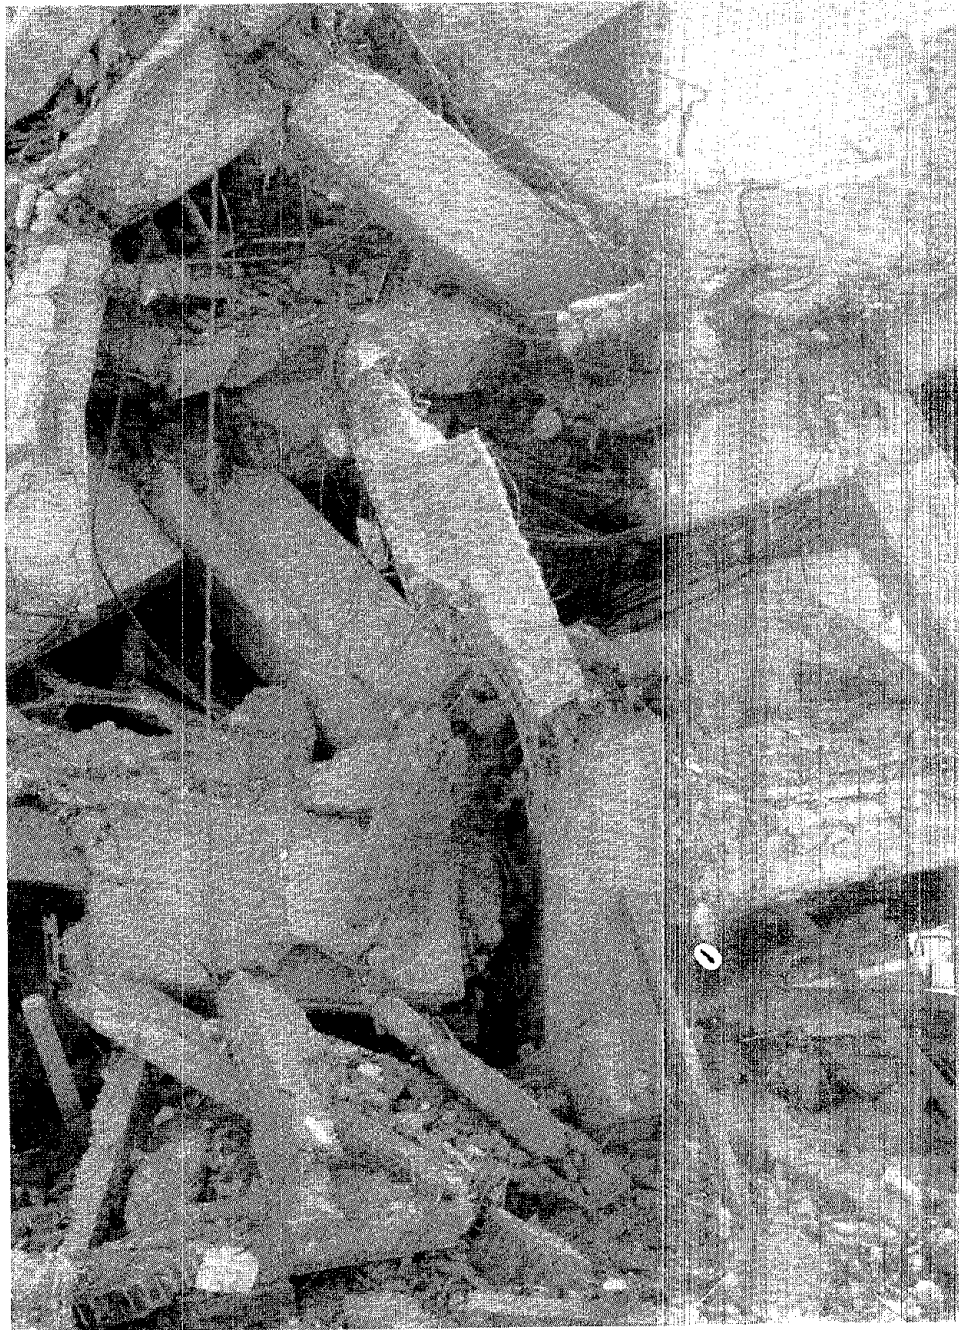
Figure 5.13. View looking south at Juarez Hospital showing how column hinging permitted rotation of successive floors toward the east.

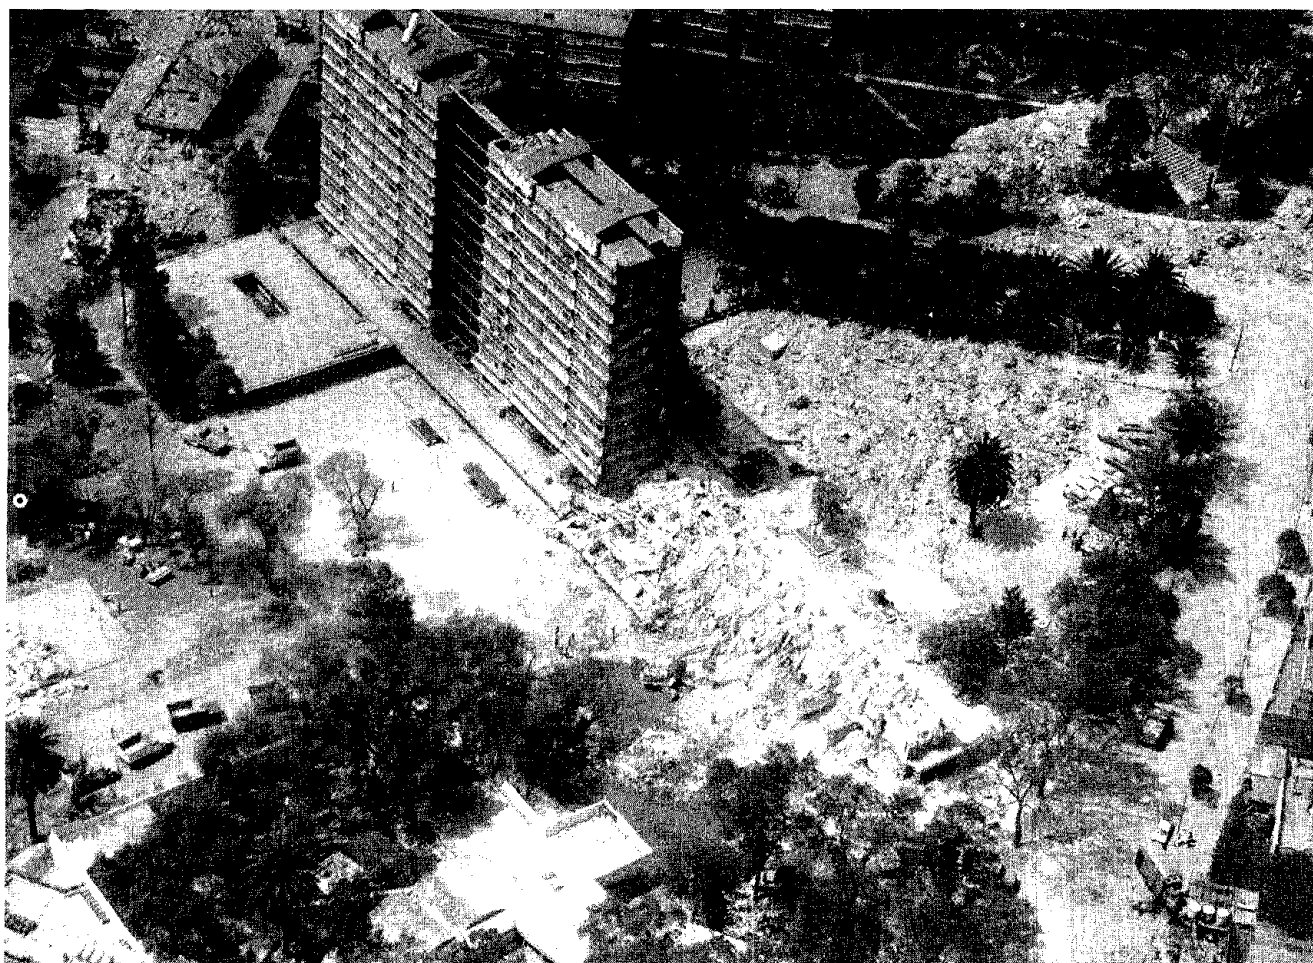
Figure 5.15. The southern two B towers of the Juarez Apartment complex which remained standing.

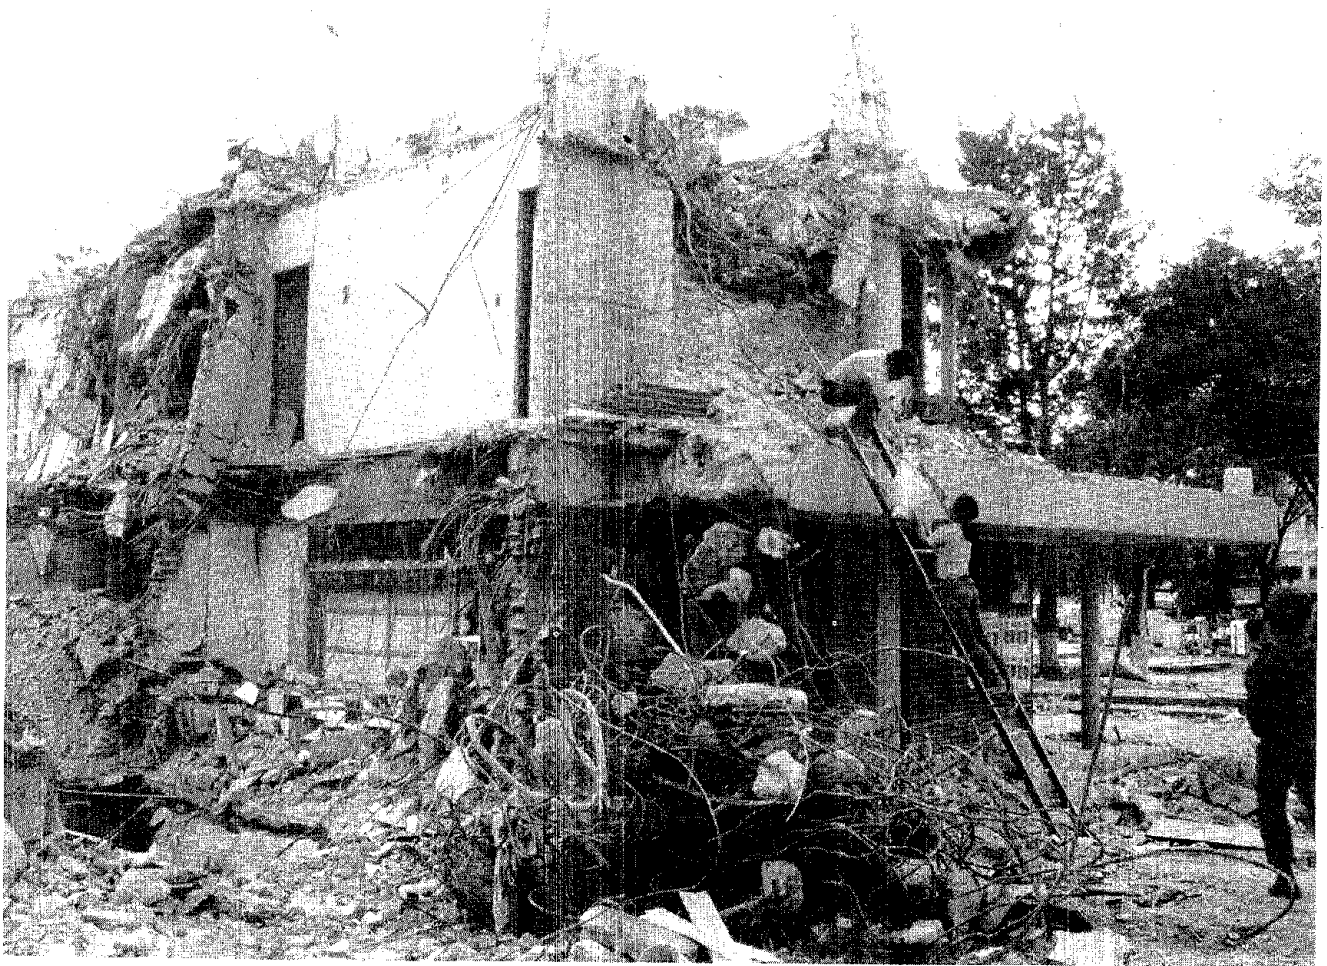
dynamited approximately three weeks following the quake. Figure 5.16 shows a close-up of the first two stories of this structure following removal of debris. It can be seen that the column width was increased in the east-west direction in an effort to stiffen the resistance of the structure in the narrow direction. Nonetheless, based on the debris pattern following the collapse, it appeared that failure of this building was initiated by hinging of the columns in the east-west direction. It is likely that the presence of the thin connecting walkway (see aerial photo, figure 5.15) with the neighboring two towers to the south permitted sufficient independence for each tower to oscillate individually in the east-west direction. This explains why the northern tower was able to collapse without affecting the two southern towers.

Figure 5.16. First two stories of Juarez apartment structure.

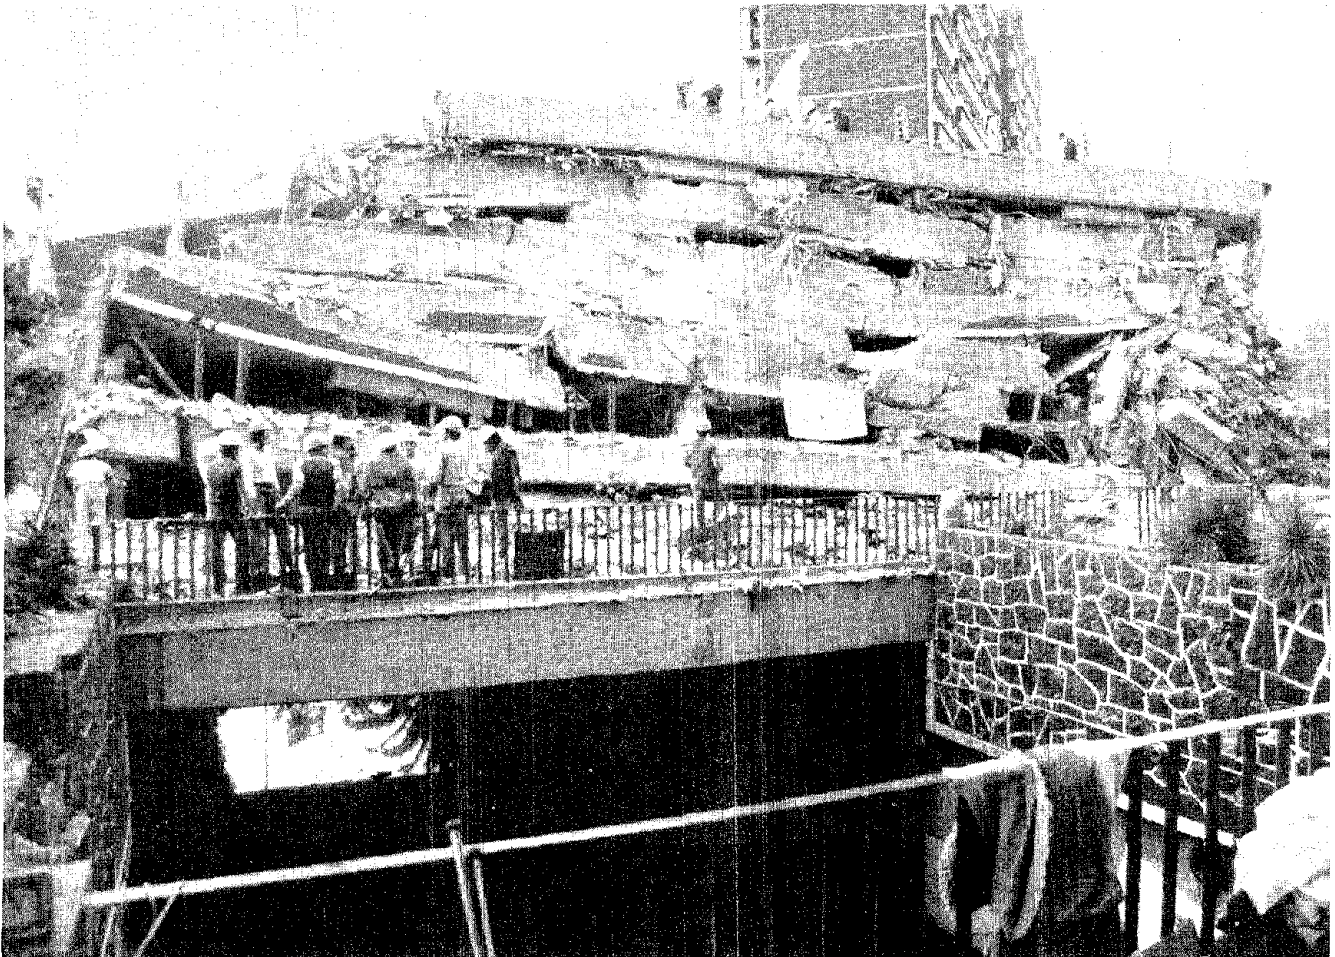
Figure 5.18. Pancake type collapse of eight story apartment.

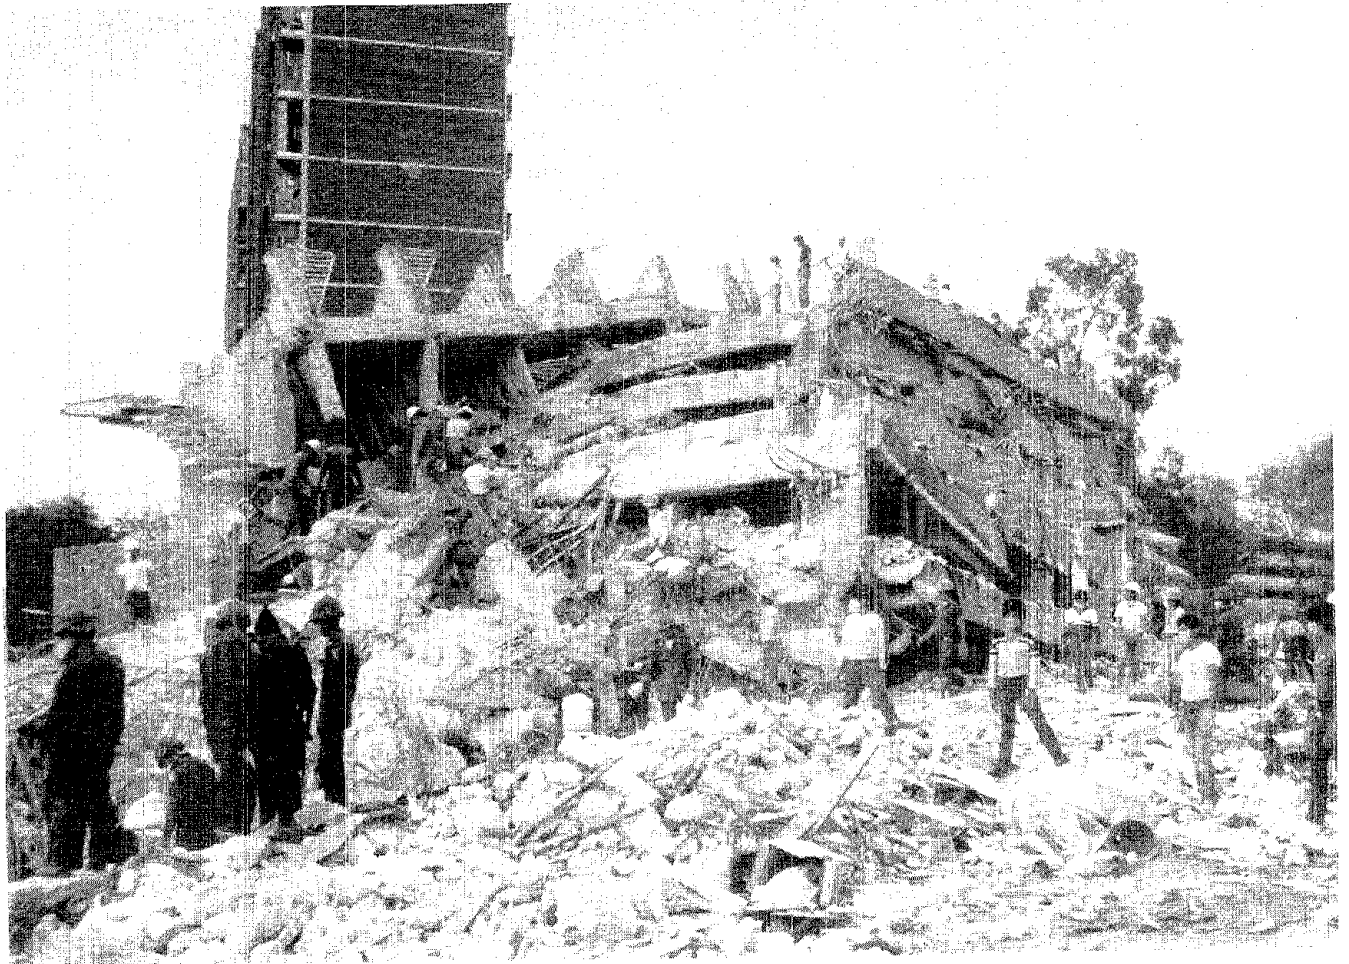
Figure 5.19. View of collapsed apartment looking northeast.

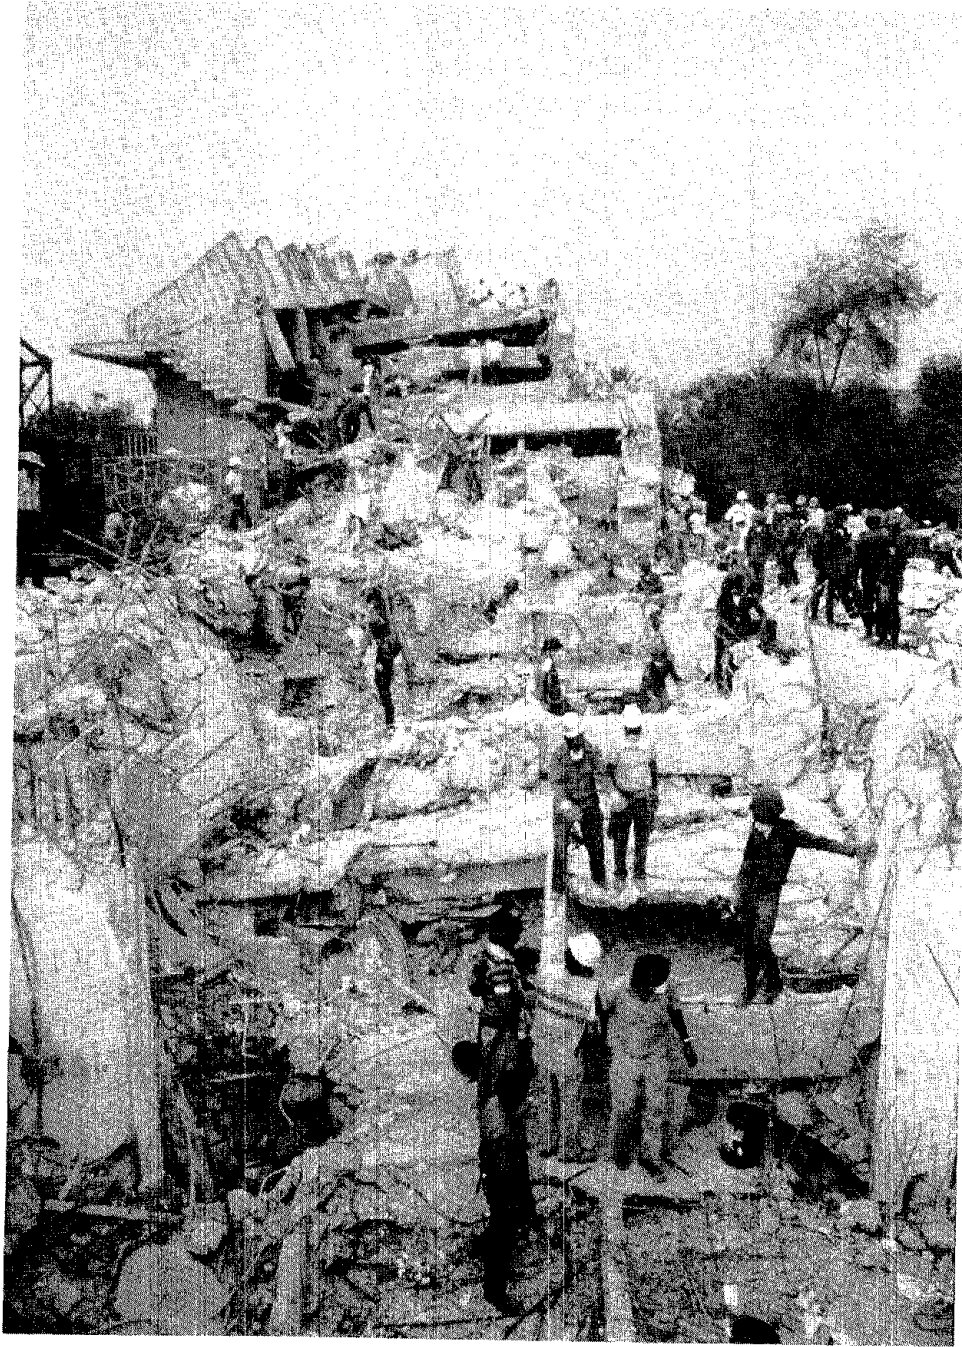
Figure 5.20. View of collapsed apartment structure looking east.

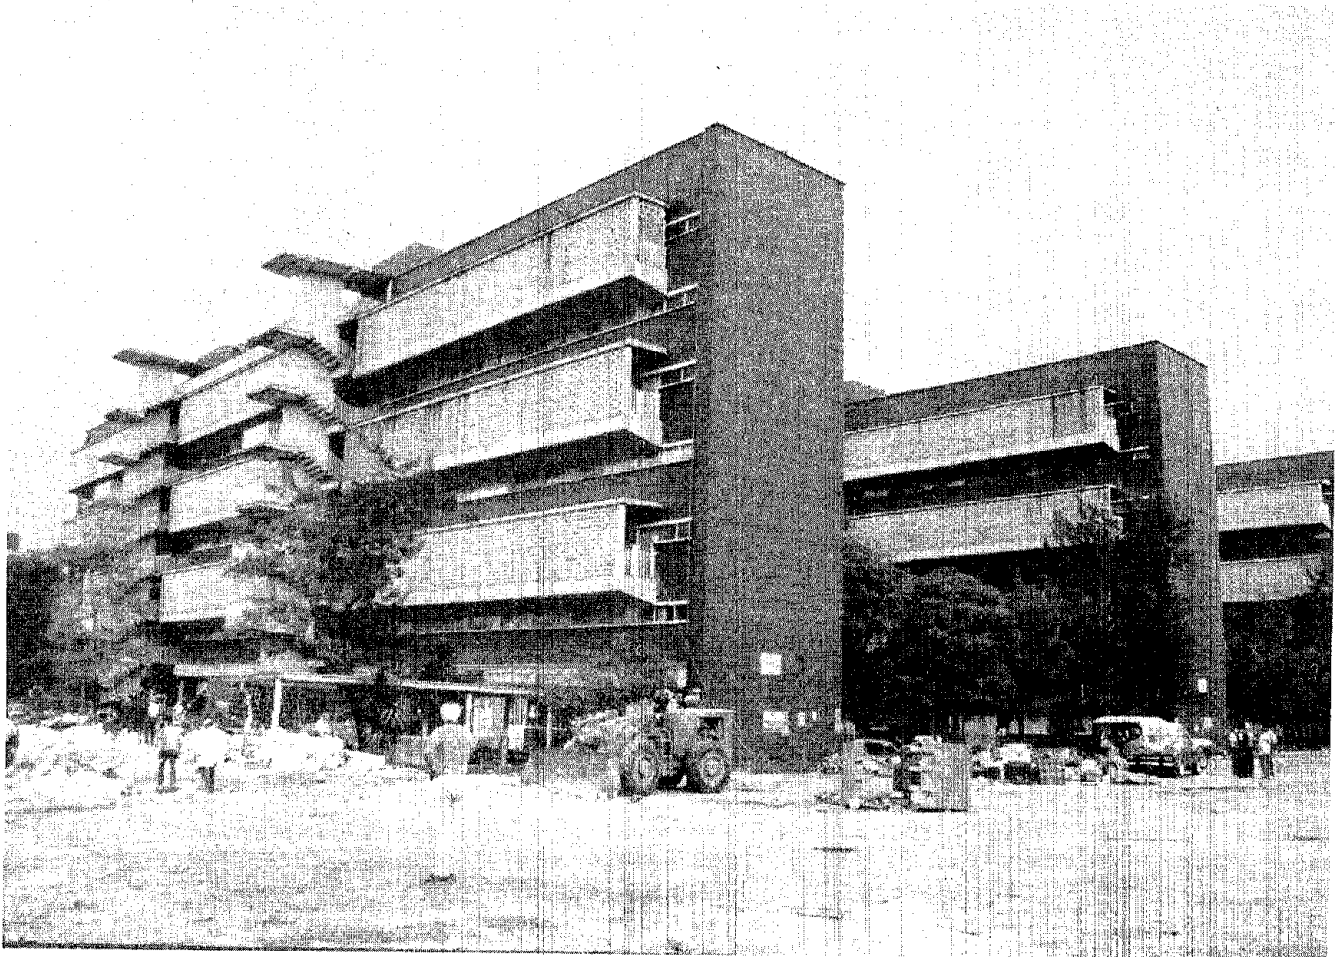
It is of particular interest to know why this particular building collapsed, while its three sister structures (figure 5.21) immediately to the south, did not. Part of the reason may be local variations in the soil consolidation, or perhaps differential-settlement induced stresses, as mentioned in Section 5.2.

Figure 5.21. Undamaged apartment building near identical structure which collapsed.
