NBS BUILDING SCIENCE SERIES 165

**Engineering Aspects
of the September 19, 1985
Mexico Earthquake**

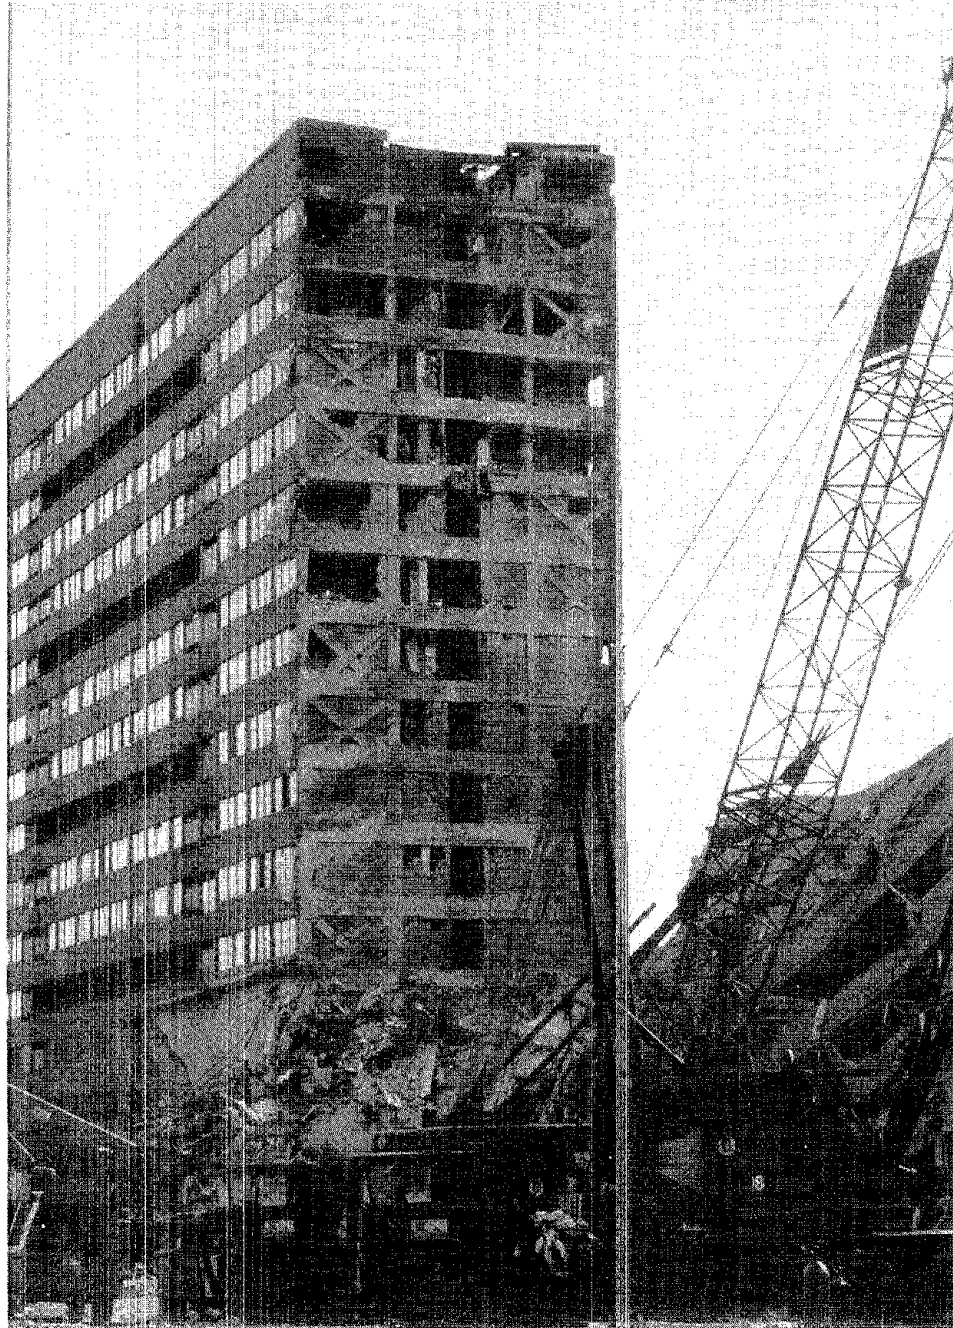
Although the floor levels behaved as flat slabs, they were in fact a special variety of waffle slab. This can be verified by inspection of figure 5.30 which shows the presence of porous blocks used to form the slab, revealed after the ceiling plaster spalled off during the final impact. Figure 5.31 shows the presence of regularly spaced reinforced concrete x-bracing as well as masonry infill walls which would have served to resist lateral forces during the earthquake. Figure 5.32, in fact, shows four structures identical to the Nuevo Leon building in the same vicinity which performed better during the quake.

Figure 5.31. Concrete X-braces in remaining tower of Nuevo Leon Apartment Complex.

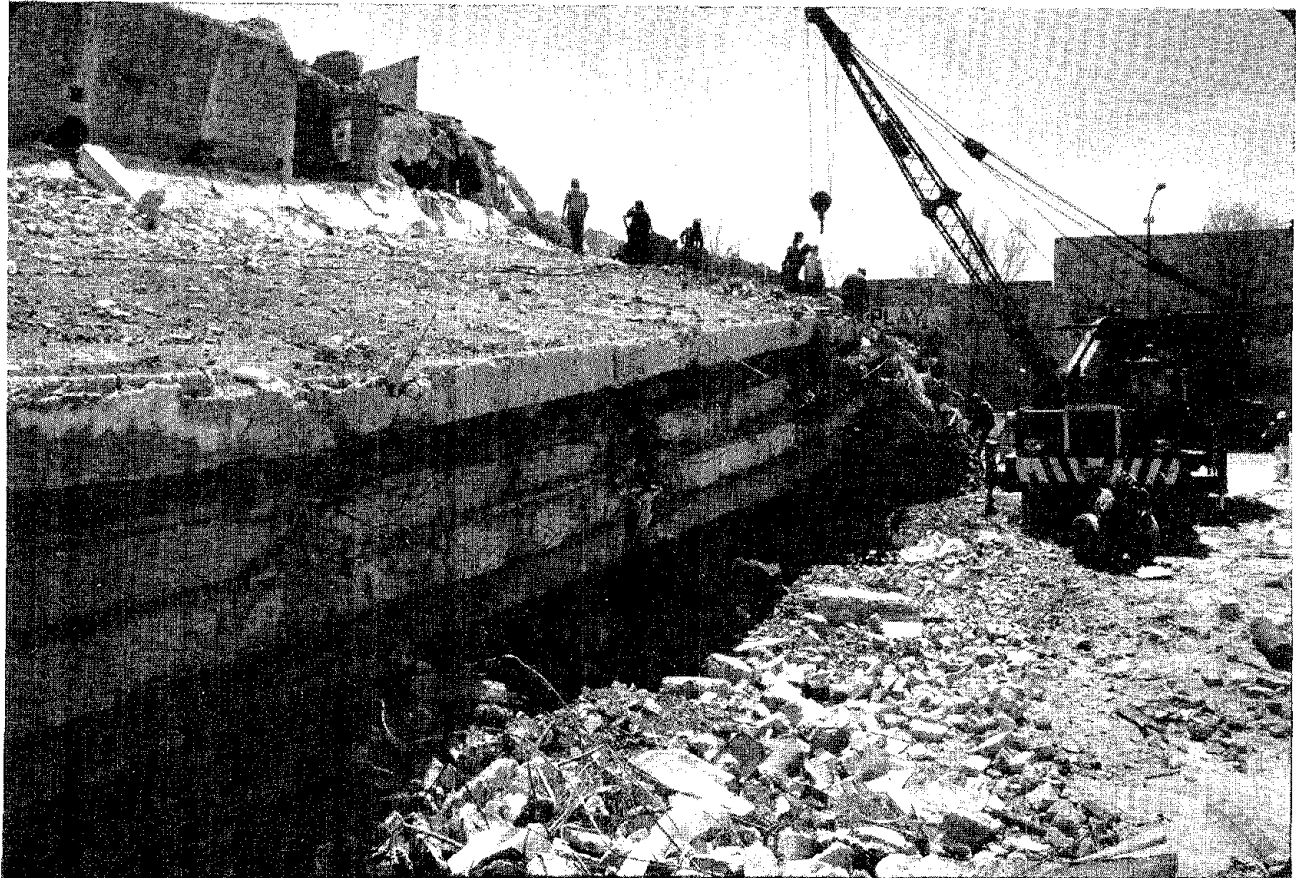
Figure 5.35. Collapsed office building near the corner of Neva and Barragan Streets.

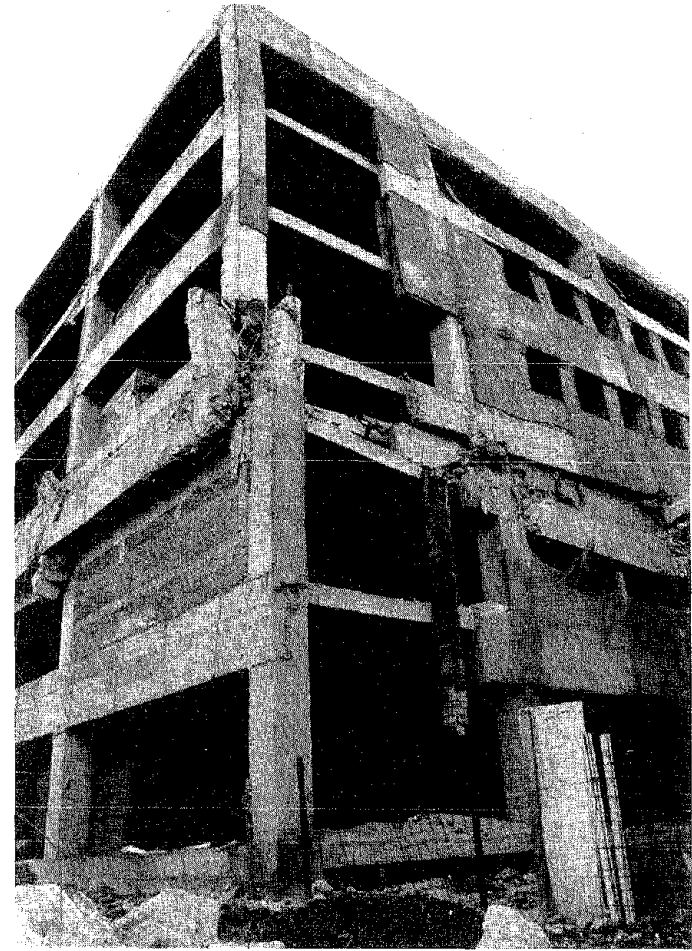
substantial amount of energy prior to buckling outward. On the other hand, the Banco Vencen building near the corner of Ave. Trujano and Hidalgo (figure 5.38 b) was under construction and masonry walls were in the process of being added to some of the upper floors, but were not complete enough to prevent column shear failures from occurring along the entire eastern side of the frame at the third story. Those portions of the building where the infill walls had been completed remained standing. A typical example of a failure of a waffle-slab structure with flexible columns was the 10-story apartment building at the corner of Ave. Dinamarca and Chapultepec shown in figures 5.39 a and b.

(b) Collapsed waffle slab building which was under construction.

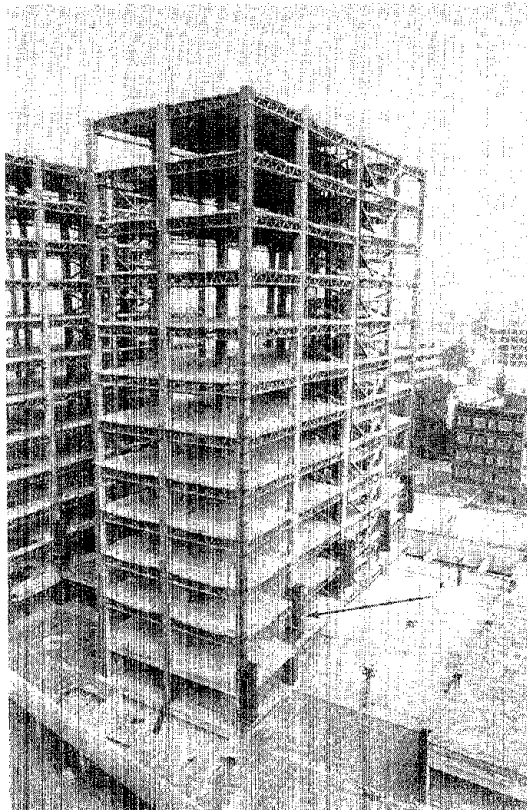
(b) Central 23-story tower (reduced to 14 stories) at Pino Suarez.
Note "C" clamps at bottom right.

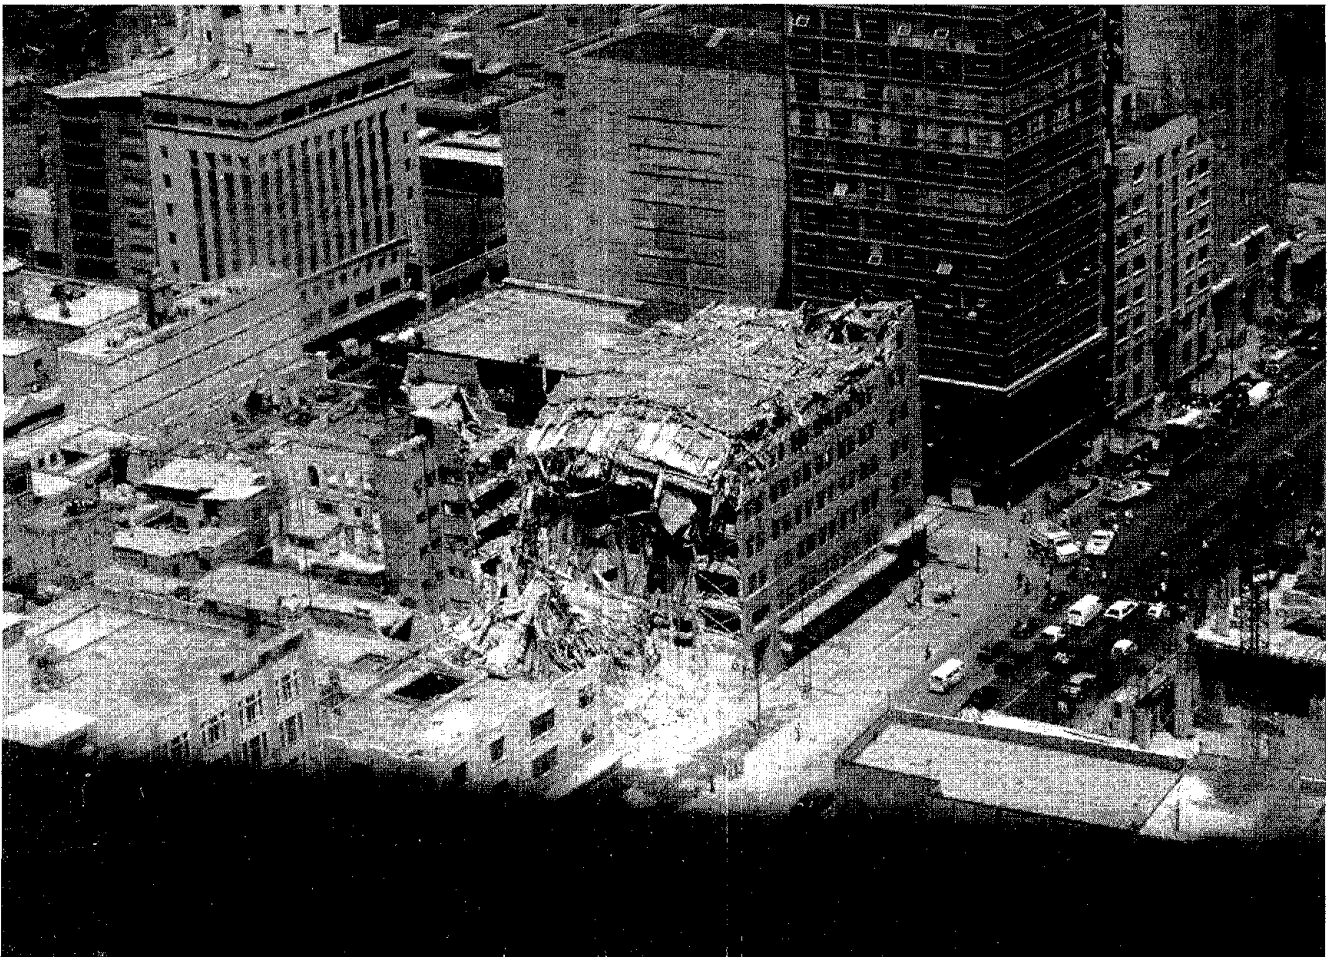
Figure 5.54. Aerial view of the Atlas Building, a typical steel frame structure constructed during the 1940's.

Other steel frame structures performed quite differently from the Pino Suarez Buildings, depending on their location, elevation, and proximity to adjacent buildings. One such example is the Atlas Building (figure 5.54), a 14-story concrete-encased steel frame structure constructed during the 1940's and located just south of Alameda Park on Avenida Lazaro Cardenas. During the 1957 quake this building suffered significant damage to moment-resisting knee braces (steel angles) and was later retrofitted with the diagonal cross bracing visible in figure 5.54.

During the 1985 earthquake the upper seven stories of the building collapsed. The front of the adjacent seven story structure was also destroyed by falling debris from the Atlas building. In the case of the Atlas Building, field evidence indicated that pounding was the principal cause of collapse of the upper floors.

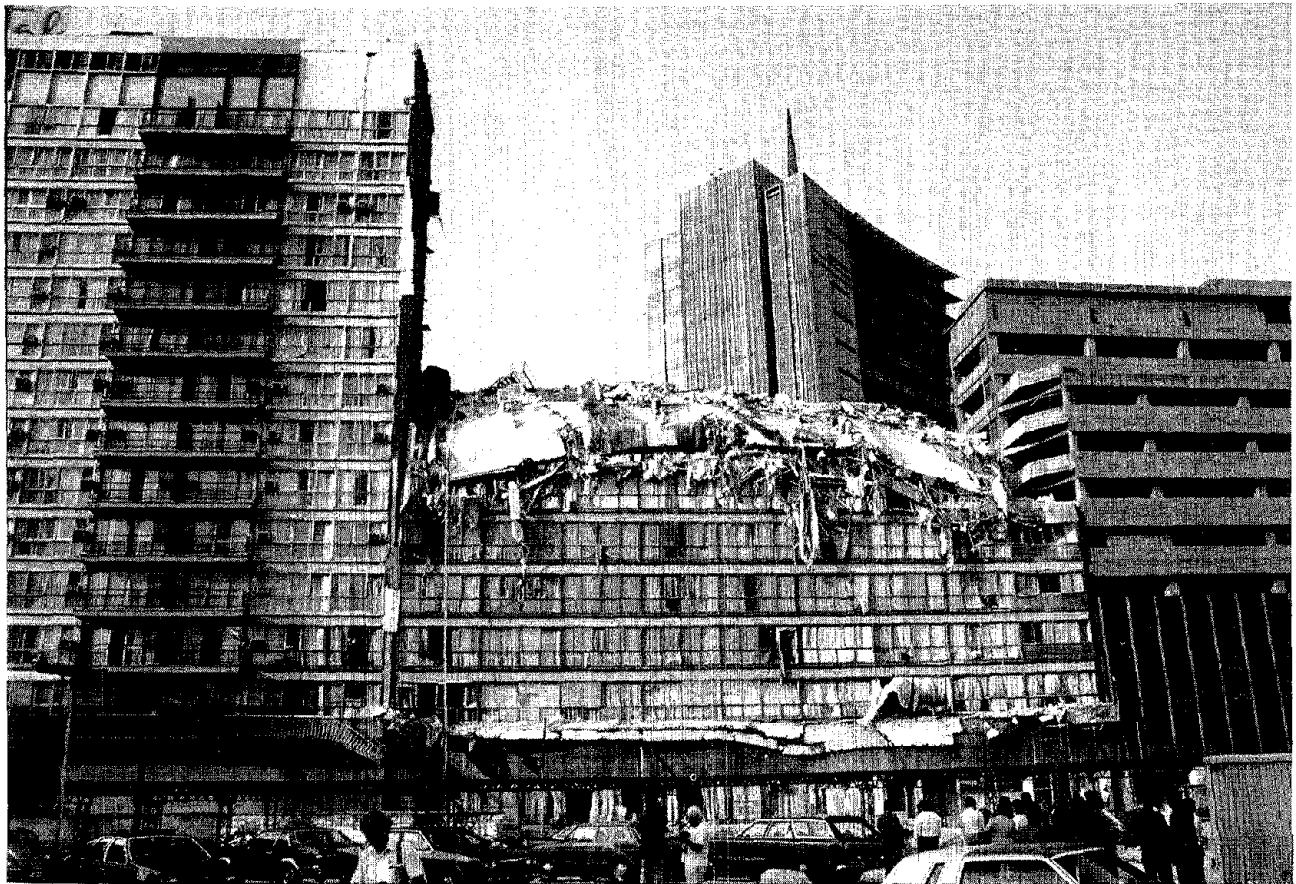
One variant on the pounding problem occurred where expansion joints existed within a structure and where it was possible for the separated substructures to vibrate independently, but where an insufficient "seismic gap" was provided to prevent pounding. An example of this type of failure was the Hotel Continental on Avenida Reforma. The building was V-shaped in plan, largely because of its street corner location, with two independent wings forming the "V" (see figure 5.60). The wing sections, each as tall as the main structure, apparently vibrated out of phase with the stiffer primary building and eventually suffered column failures due to pounding. This, in turn, led to the collapse shown in figure 5.61. Adequate separation between the wings of the building may have prevented such a failure.

Figure 5.61. View looking north of collapsed southern wing of the Continental Hotel on Paseo de la Reforma. The entire complex was subsequently dynamited.

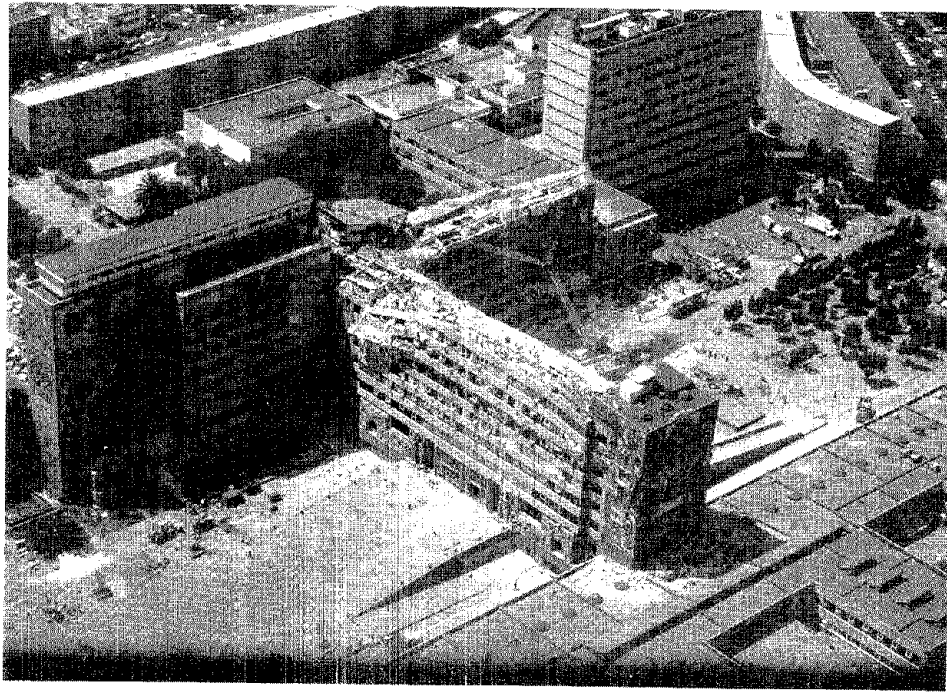
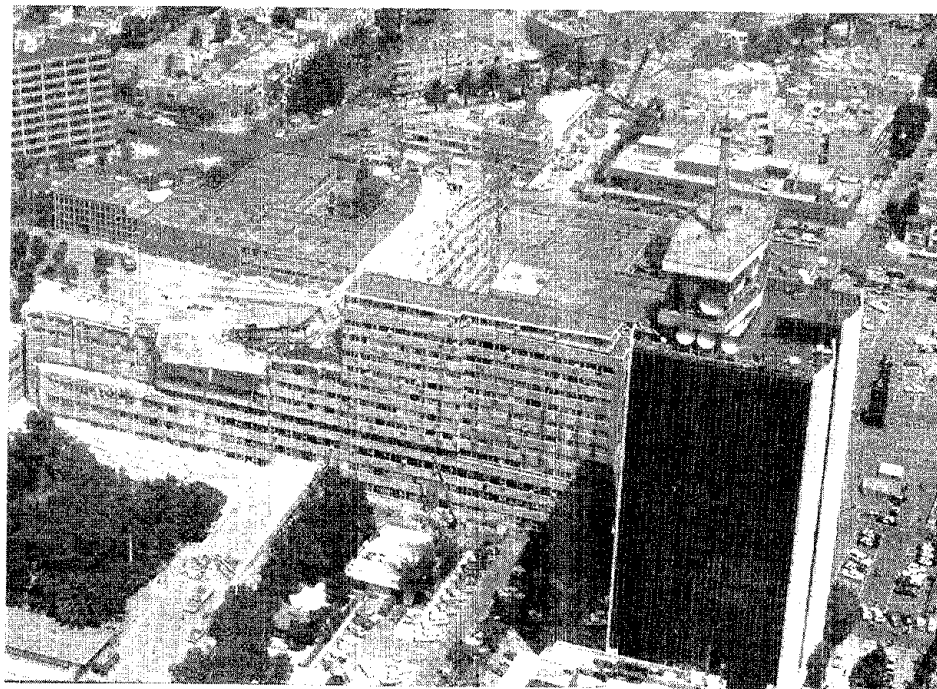
Figure 5.62. Aerial view of SCT Communications Complex.

An example in which building configuration appeared to have led to torsional response during the Mexico Earthquake is illustrated by the 12-story SCT (Secretaria de Comunicaciones y Telegrafos) complex (figure 5.62) on Ave. Lazaro Cardenas, approximately two kilometers south of the central historic portion of the city. The earthquake precipitated a progressive collapse which started near the top of the building at the inside northwest (re-entrant) corner as shown in figure 5.63. The collapse was probably triggered by failure of one of the upper columns (which are often of smaller cross-section and lighter-weight concrete in Mexico City) and then propagated by means of corner column failures along the north face of the west wing and the west face of the north wing of the T as can be seen in figure 5.64. The resulting progressive slab collapse was arrested at the 8th floor, where the 7th floor columns were sufficient to resist the impact load from the collapsing upper stories.

Because of the unusual geometry of the building (essentially a T-shape) and because of the asymmetrical failure mode, a preliminary effort was made to understand the dynamic performance of the structure shortly after the NBS/USGS team returned to the United States in October 1985. A modal analysis was conducted on a simplified version of the building (as shown in the computer-generated image in figure 5.65), under the assumption that the complex could be modeled as a continuous T-shaped structure. This analysis indicated that the fundamental mode of vibration for the SCT building was torsional. From this it was concluded

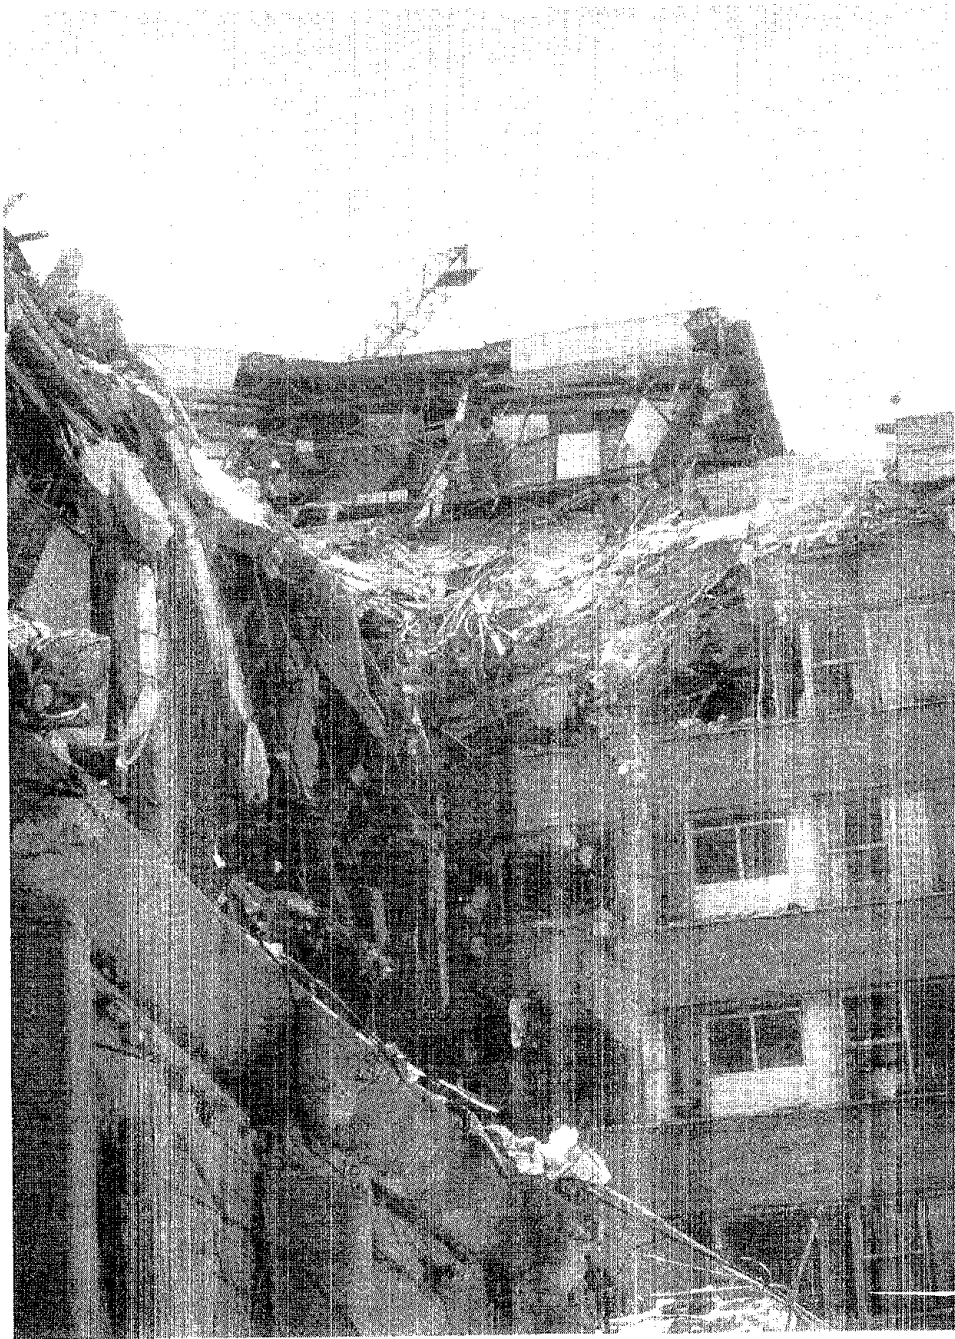
Figure 5.63. Northwest re-entrant corner of SCT Communications Building showing likely initiation point of collapse.

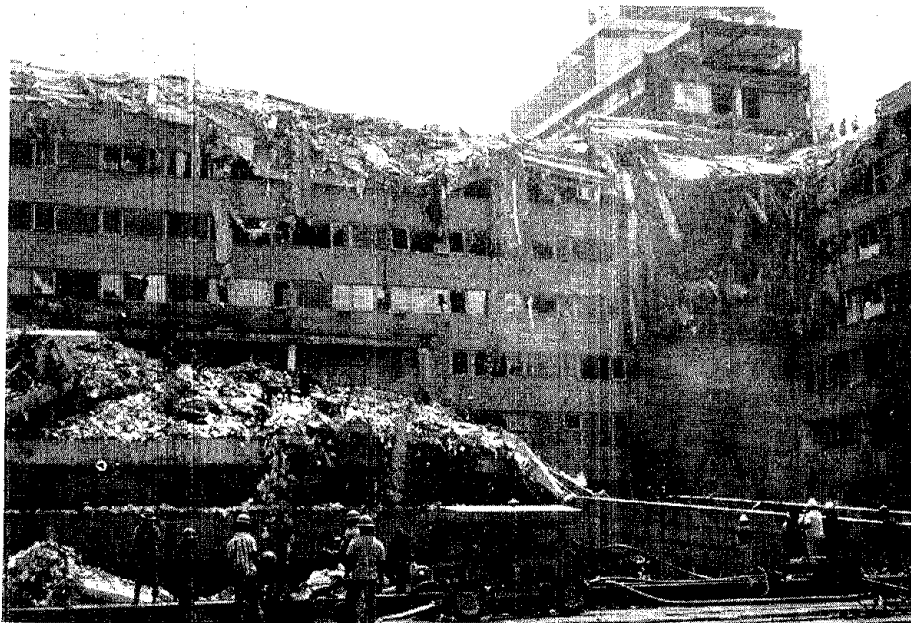
(a) East side of SCT Building.

(b) West side of SCT Building.

Figure 5.64. SCT Communications Building showing extent of progressive collapse.

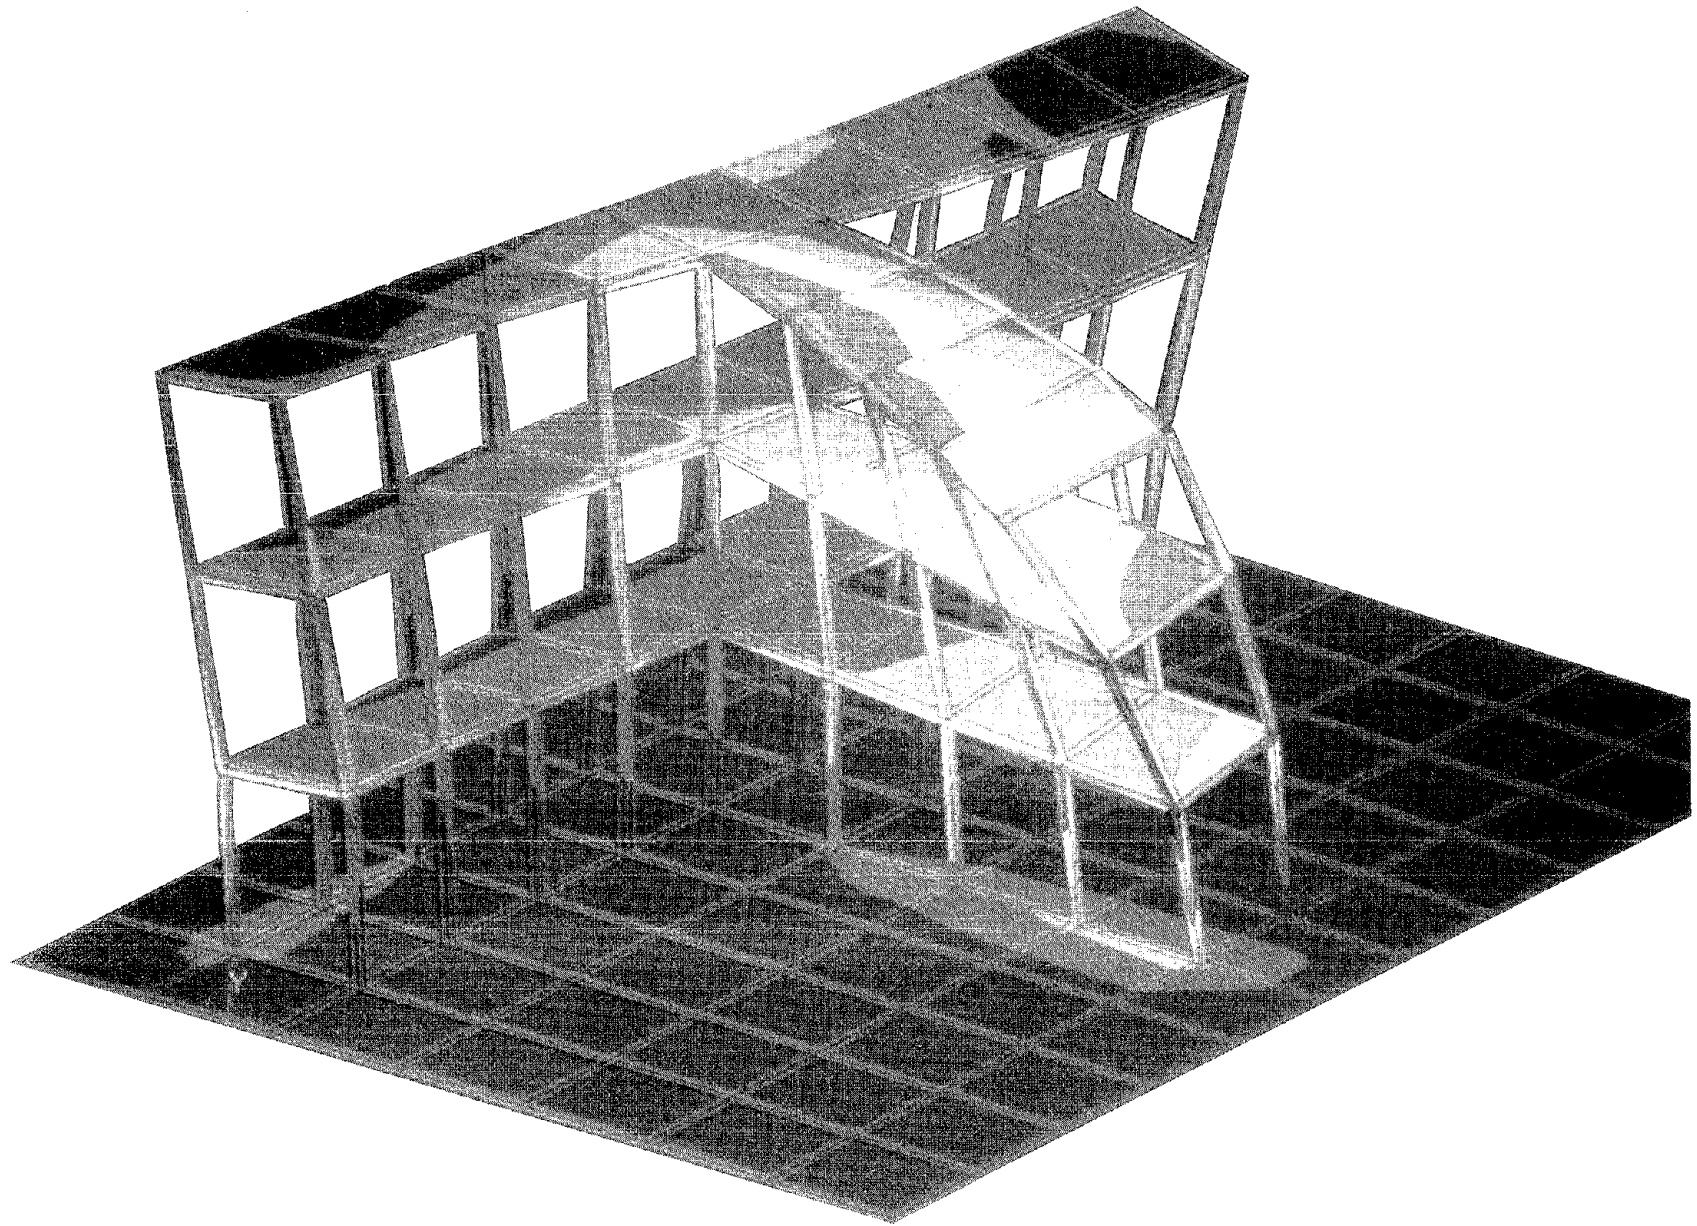
Figure 5.65. Computer generated image of primary (torsional) response mode of a simplified model of the SCT Building.

that large shearing forces would have been generated at the re-entrant corners leading to the initiation of the collapse.

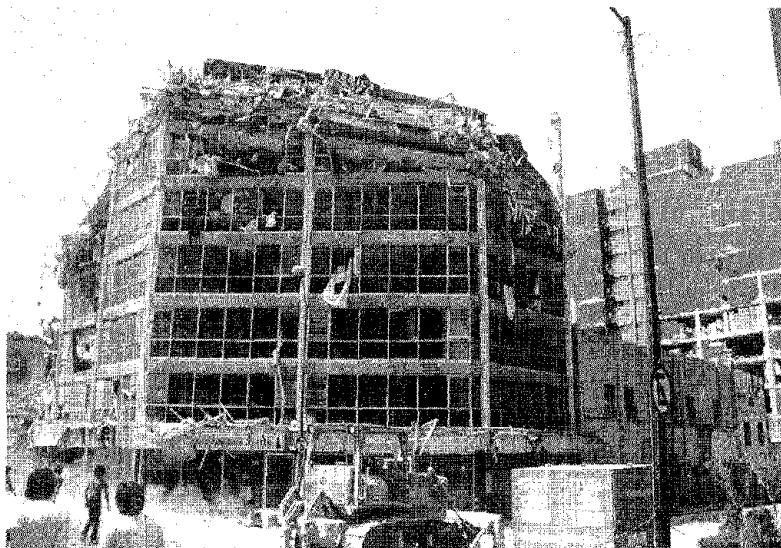
(a) Upper story failure in office building on Ave. Lazaro Cardenas.

(b) Upper story failure in clothing store.

Figure 5.67. Typical upper story failures in building where pounding did not occur.

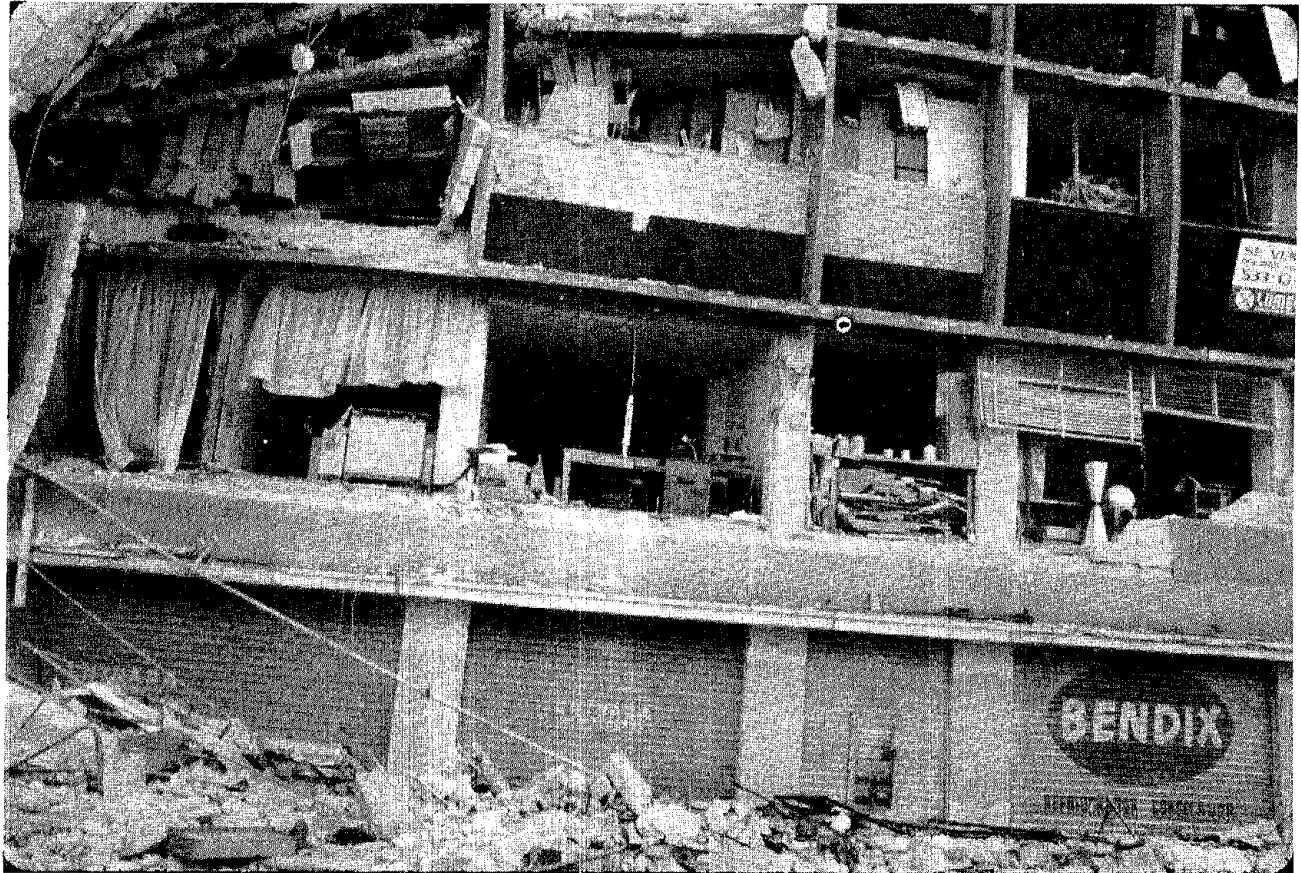
Figure 5.69. Commercial building showing large changes in column stiffness in upper stories.

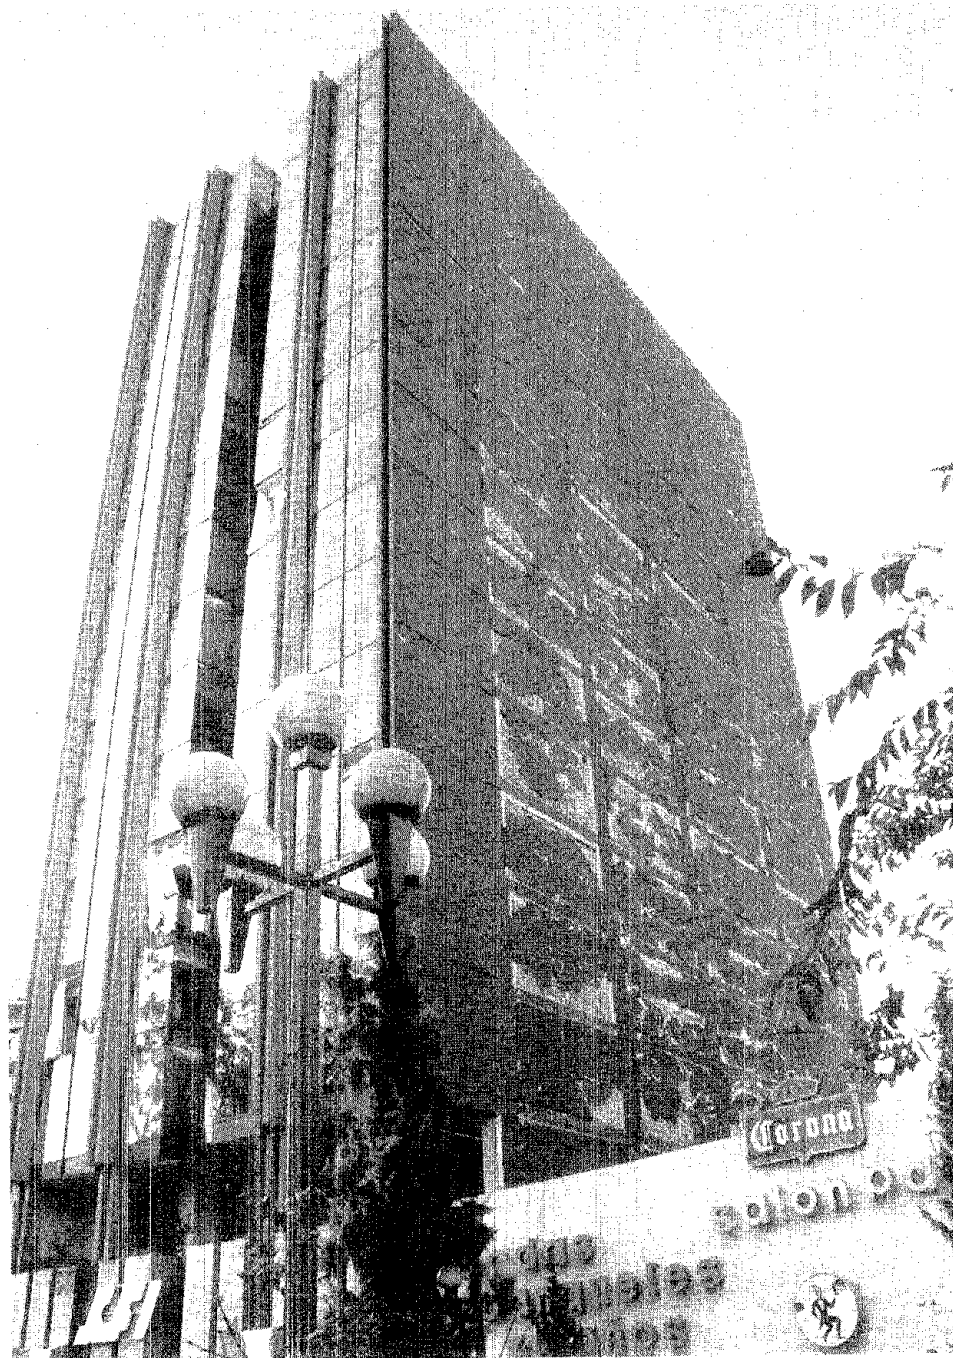
Figure 5.71. Typical high-rise reinforced concrete building with masonry infill walls.
