NIST Special Publication 778

*Performance of Structures During the
Loma Prieta Earthquake of October 17, 1989*

H. S. Lew, Editor

January 1990

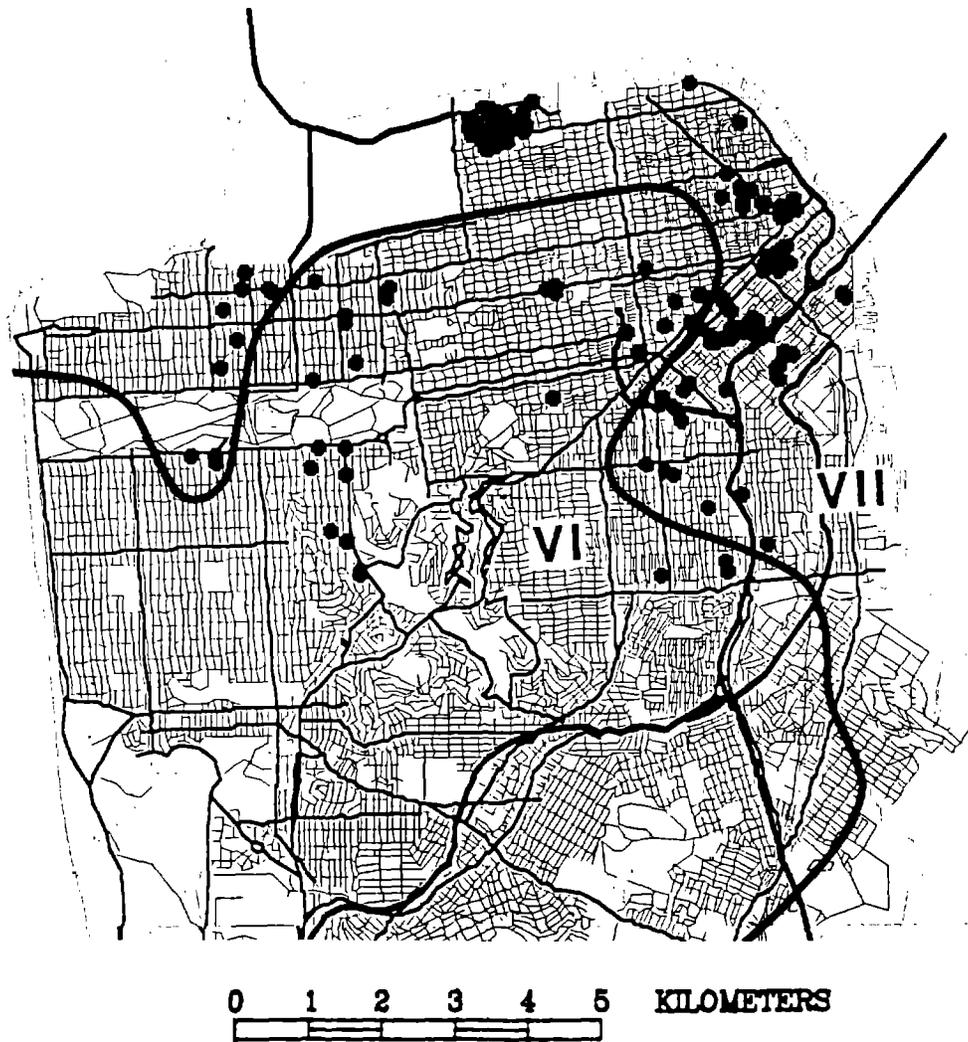
As an example of the wealth of data available, figure 2.4.2 shows some of the safety inspection results available for San Francisco (Lew, 1989). These represent 378 inspected buildings using post-earthquake safety evaluation procedures developed by the Applied Technology Council (ATC, 1989). These are only

Figure 2.4.2 Damage inspections for San Francisco. The figure shows 378 inspections judged as "red" using the ATC postearthquake safety evaluation procedures (ATC, 1989a,1989b). Damage judged sufficiently for a "Red" designation may be caused by either ground shaking, ground failure, or be in a dangerous area. The preliminary intensity contour based on ground shaking effects from figure 2.4.1 is shown for comparison.

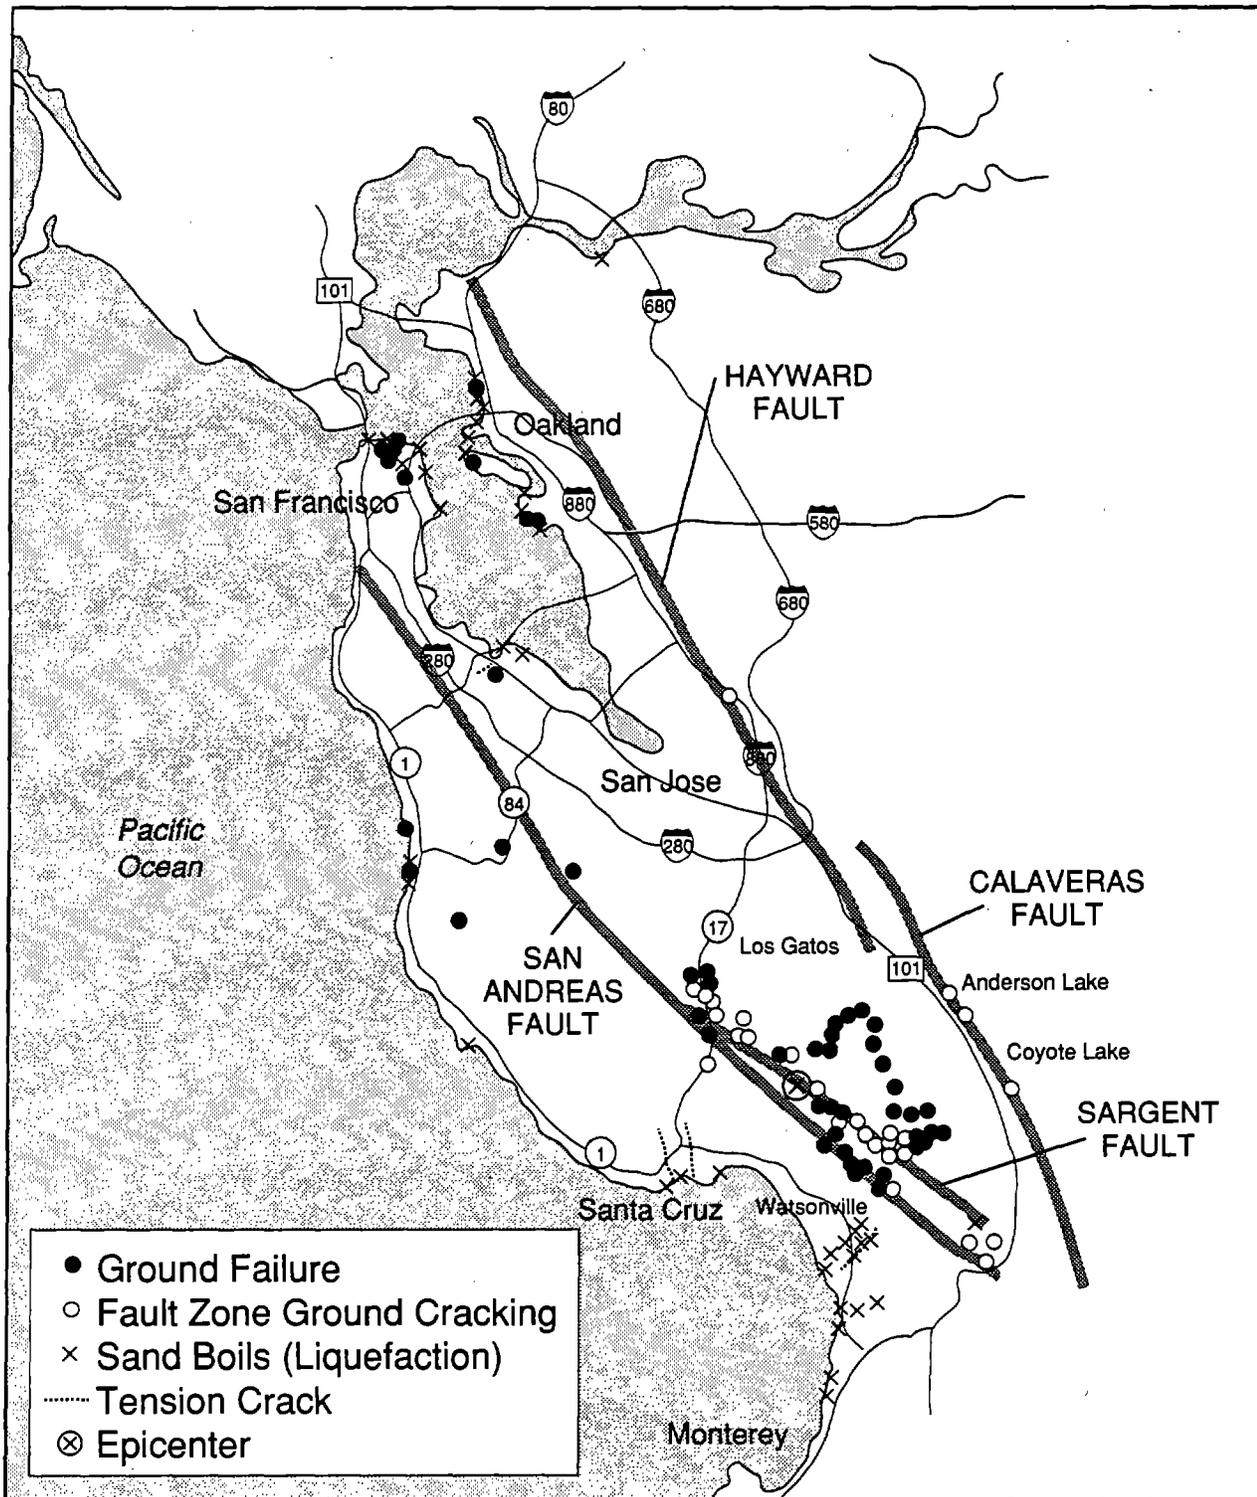
Figure 3.2.1 shows the approximate locations of observed ground failures. Four failure categories are identified: (1) fault zone ground cracking; (2) ground failures; (3) liquefaction; and (4) tension cracks. The observations compiled in the map were recorded by the U.S. Geological Survey in Menlo Park, CA, (prior to October 23, 1989), the University of California at Berkeley (Abolhassan et al., 1989), the U.S. Army Corps of Engineers, and the ICSSC team.

documented by the U.S. Corps of Engineers, and the ICSSC team. The failure categories identified in figure 3.2.1 are not mutually exclusive. For instance tension cracks in embankments may be attributable to a stability failure, in which case they would fall under "ground failures," or to liquefaction.

Figure 3.2.1 Ground failures caused by the Loma Prieta earthquake.

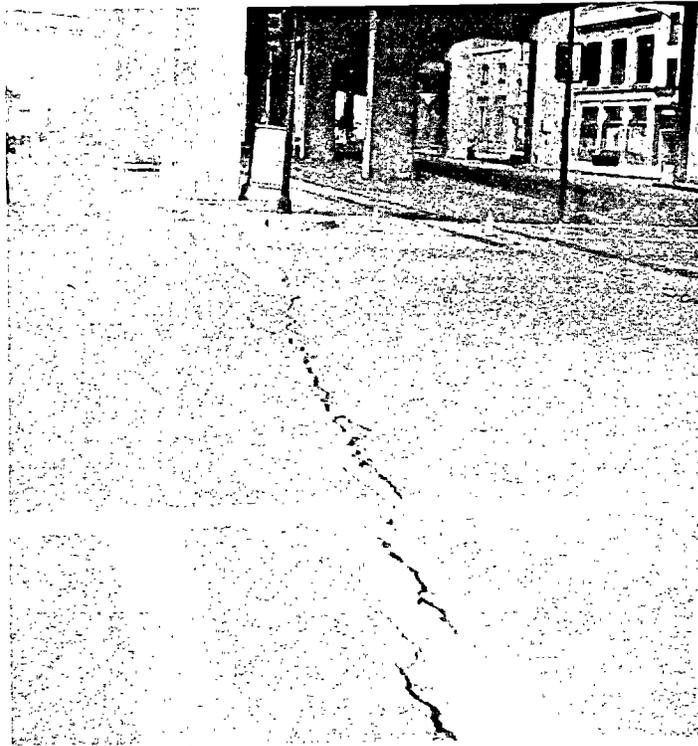
Figure 3.3.5 Tension crack at Mission Street and Embarcadero Freeway.

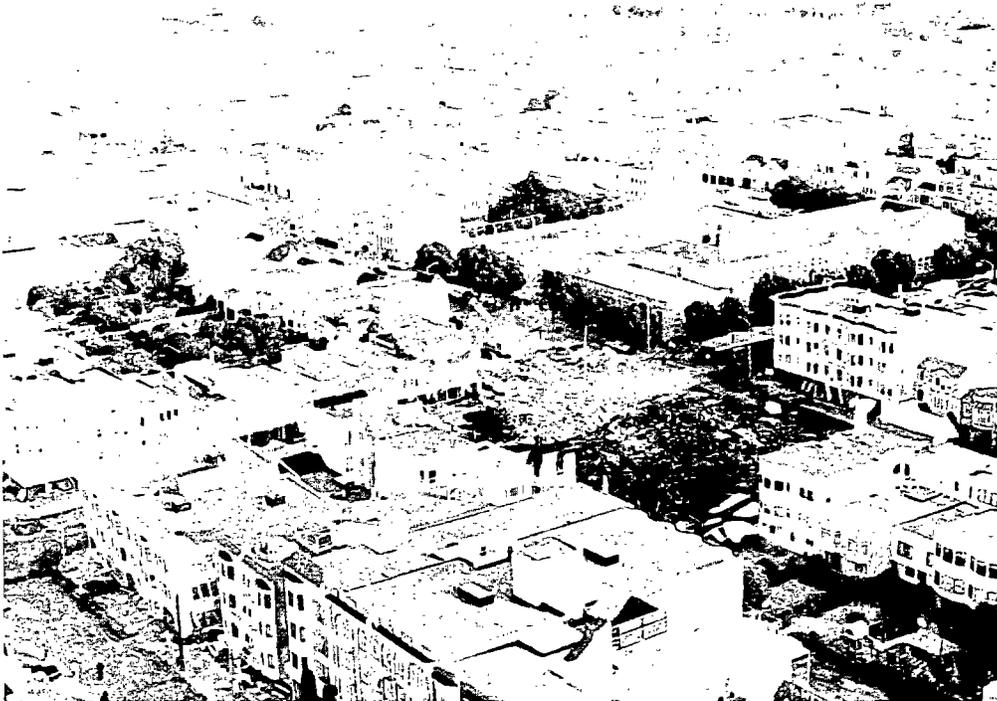
Figure 4.2.5 Aerial view (#3) of portion of the Marina District which suffered extensive damage; dark zone is location of the fire.

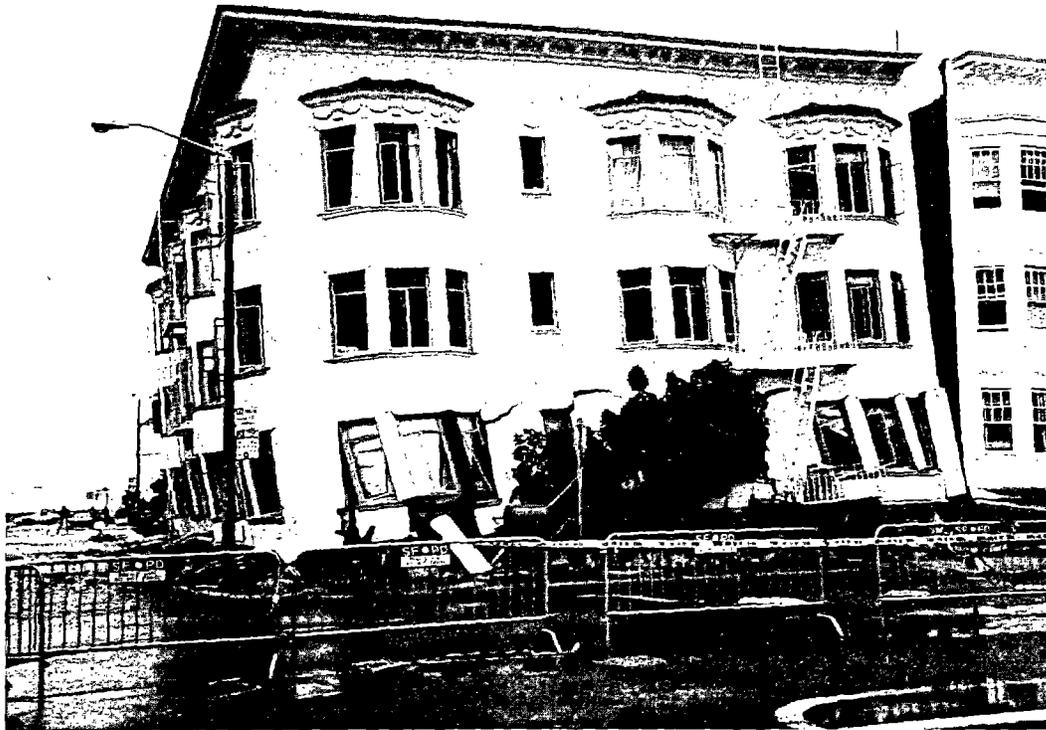
Figure 4.2.7 Two four-story buildings which suffered total collapse of their first stories (location #14).

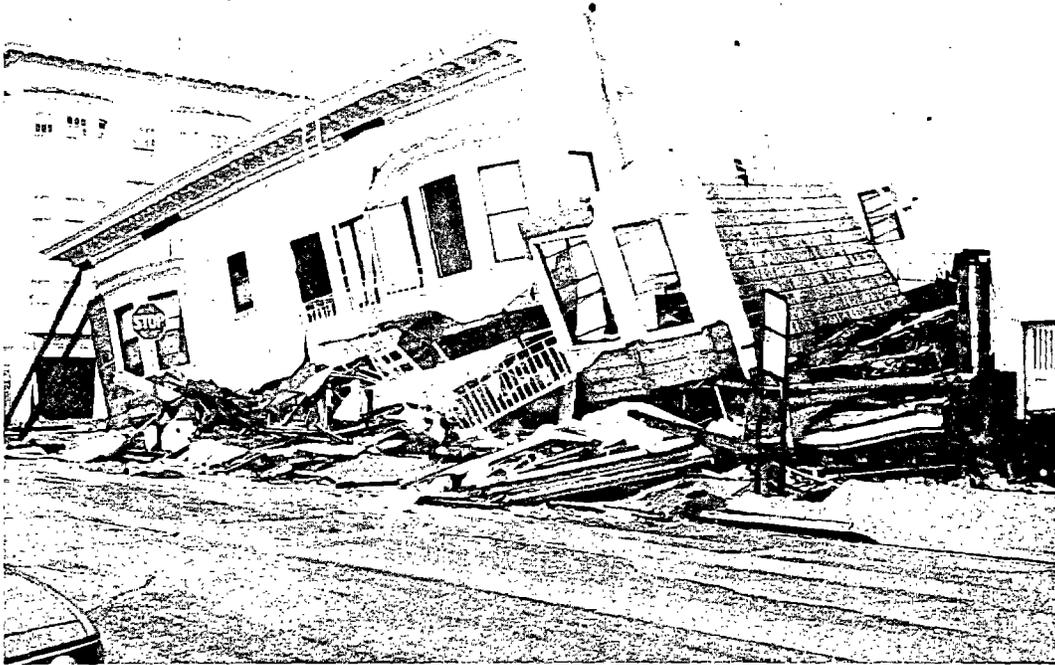
Figure 4.2.8 Four-story building which suffered total collapse of its lower stories (location #3).

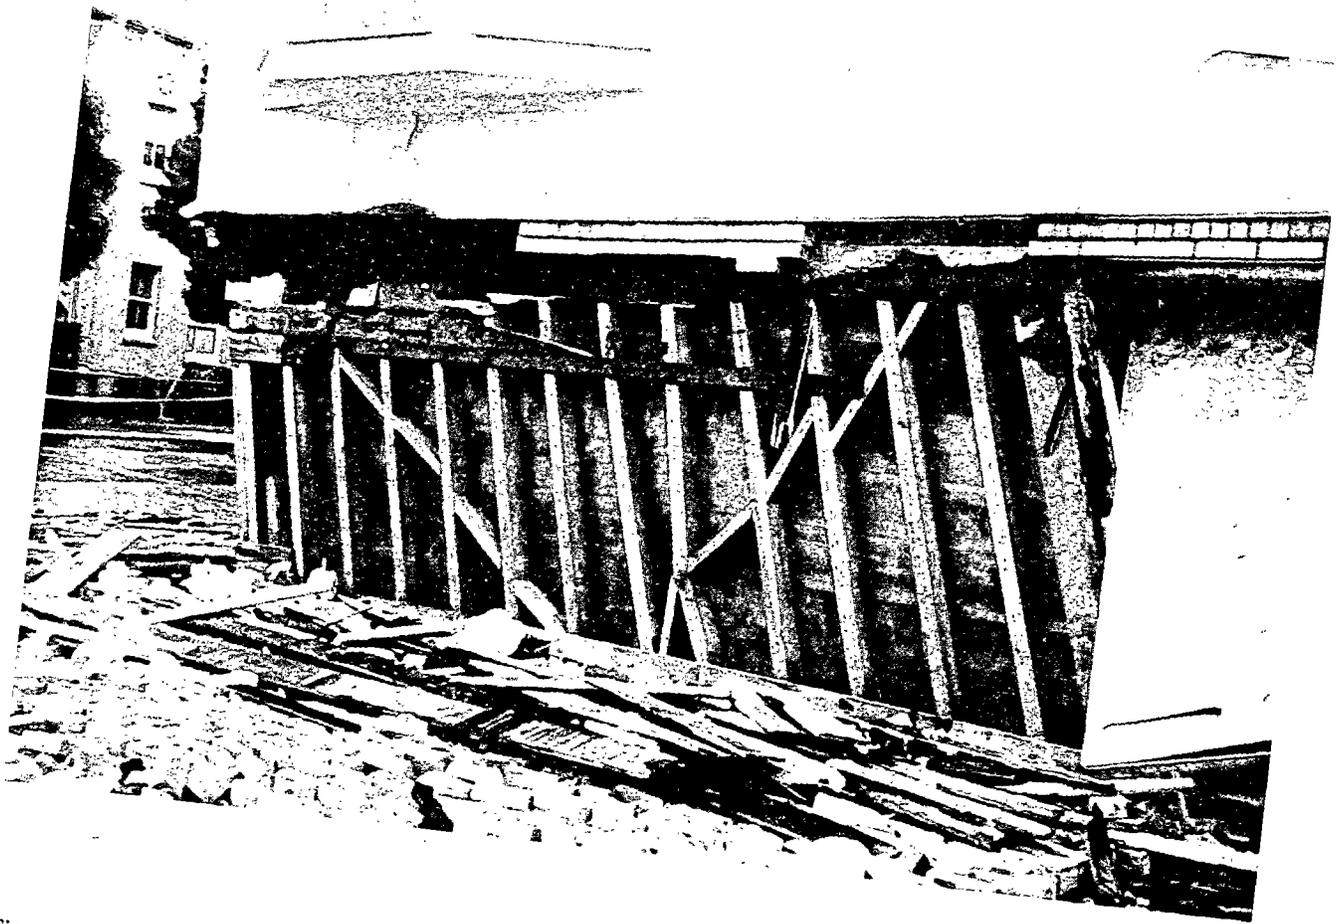
Figure 4.2.16 Detail of ineffective framing system in corner of building at the intersection of Beach and Divisadero Streets (location #5).

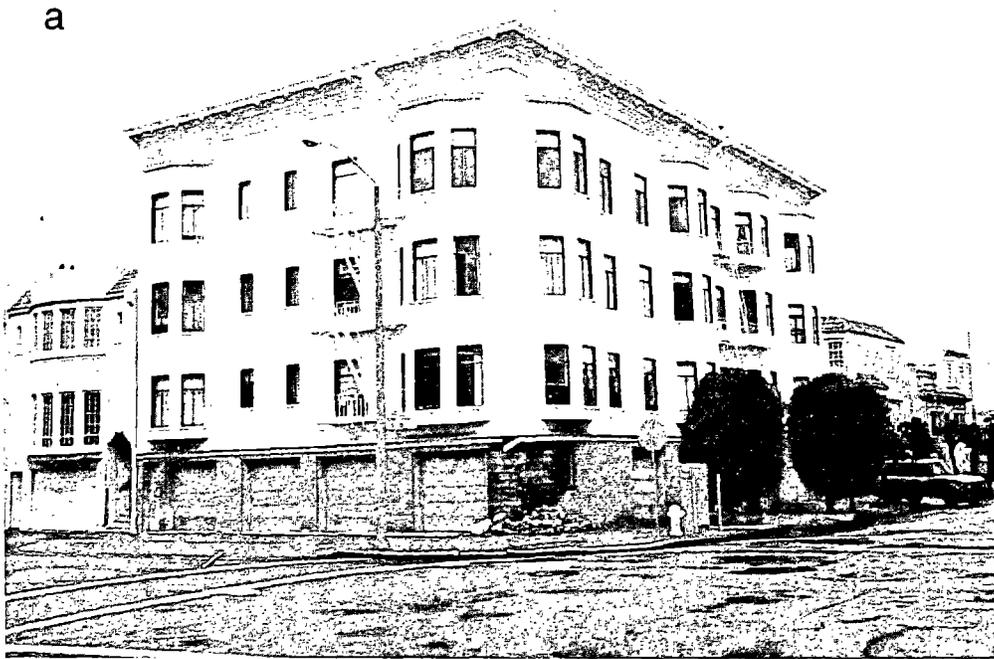
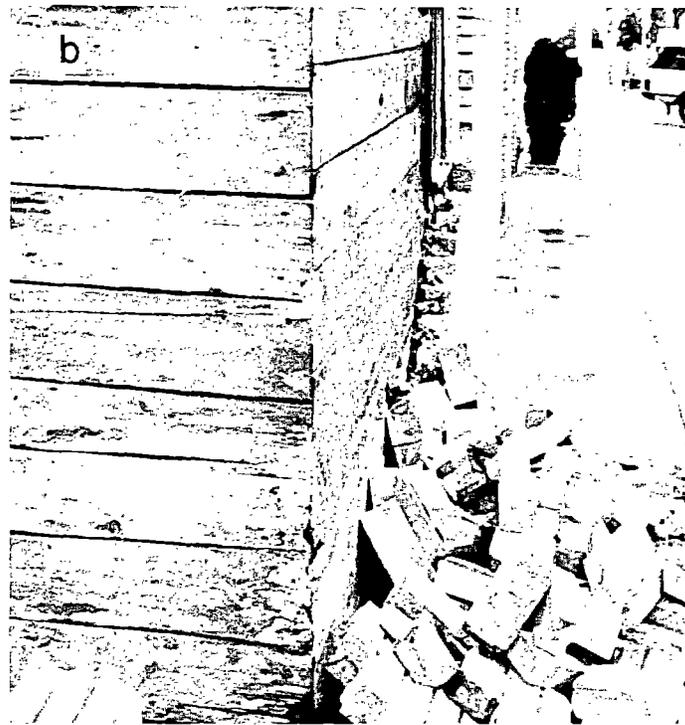
Figure 4.2.19 (a) Example of building with failure of brick masonry facade (location #12) and (b) close-up view of corner showing damaged wood and lack of anchorage to the masonry.

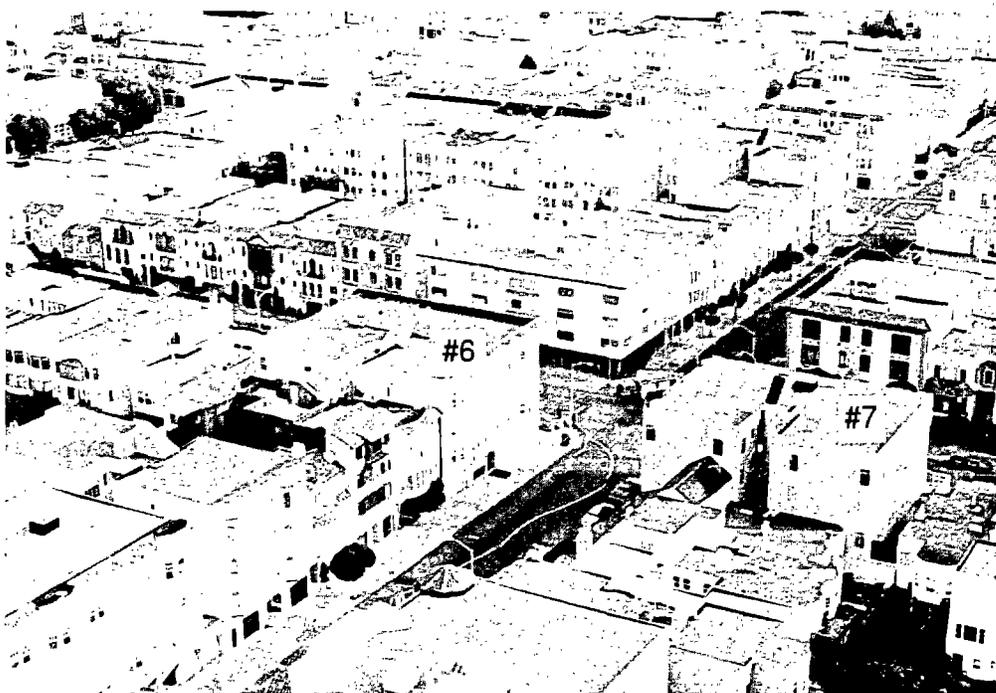
Figure 4.2.21 Aerial view (#4) of the buildings shown in figures 4.2.12 and 4.2.20.

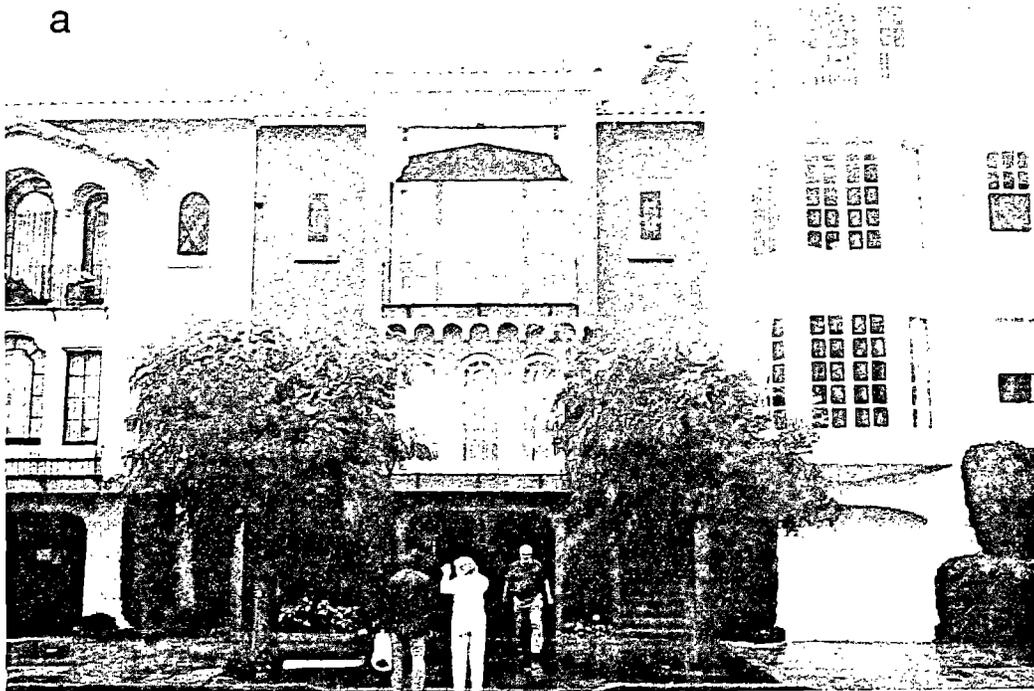
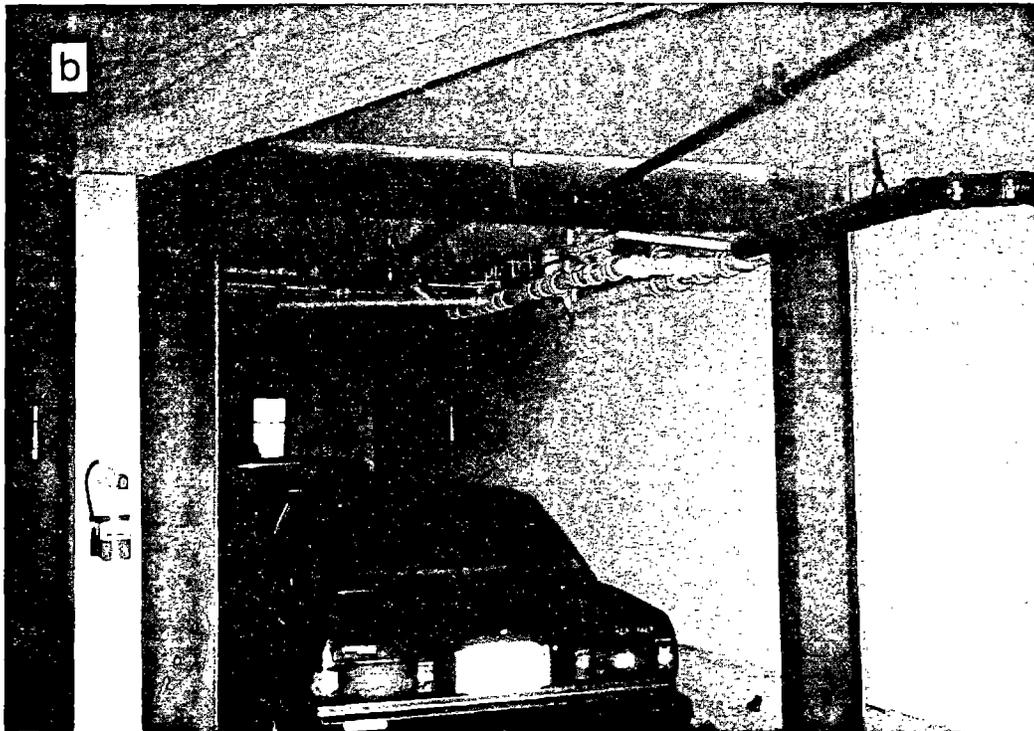
Figure 4.2.22 (a) An undamaged, three-story building (location #8) and (b) view of the moment-resting frame used for retrofitting.

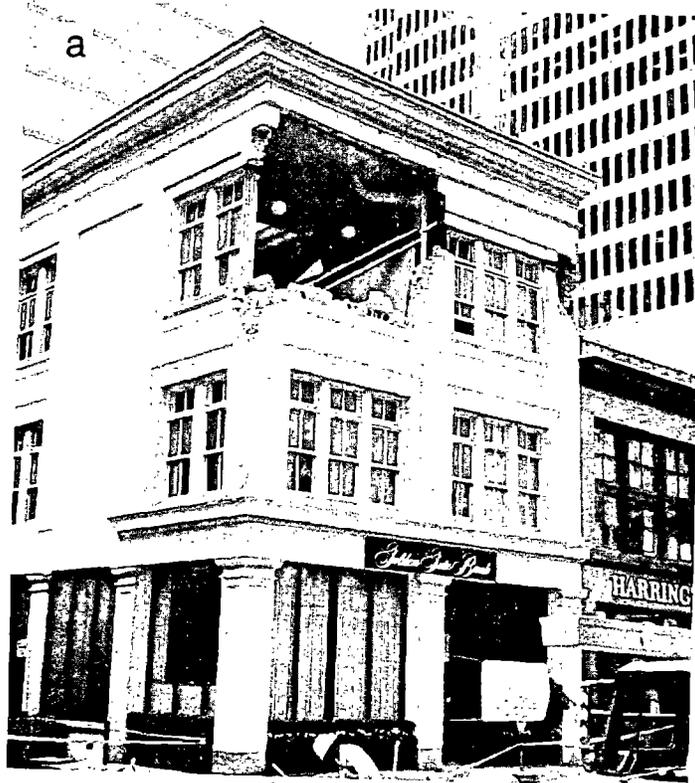
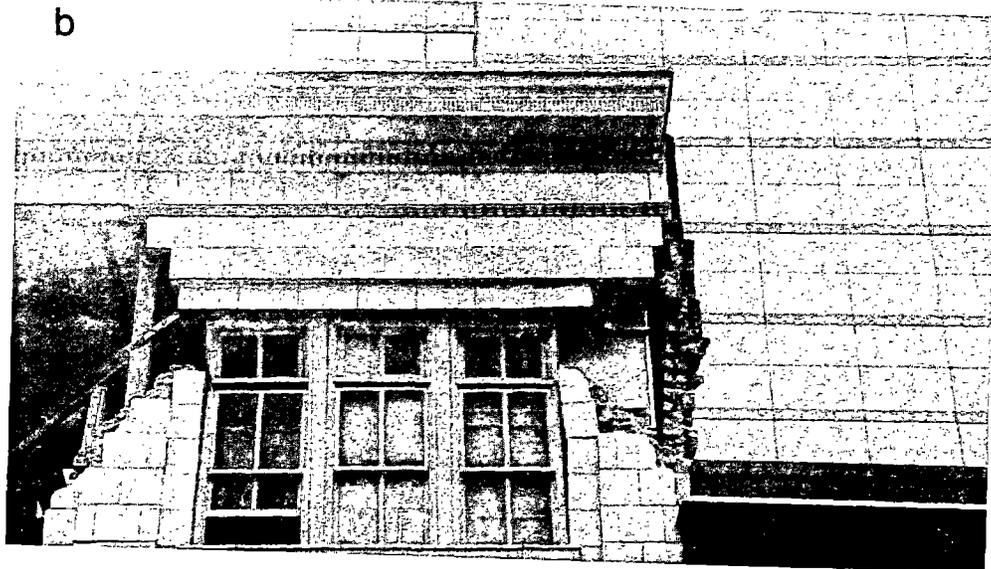
Figure 4.2.28 (a) Damage to the southeastern corner of the Golden State Bank Building; (b) Close-up view of the northeastern corner; damage was likely caused by pounding against the adjacent building.

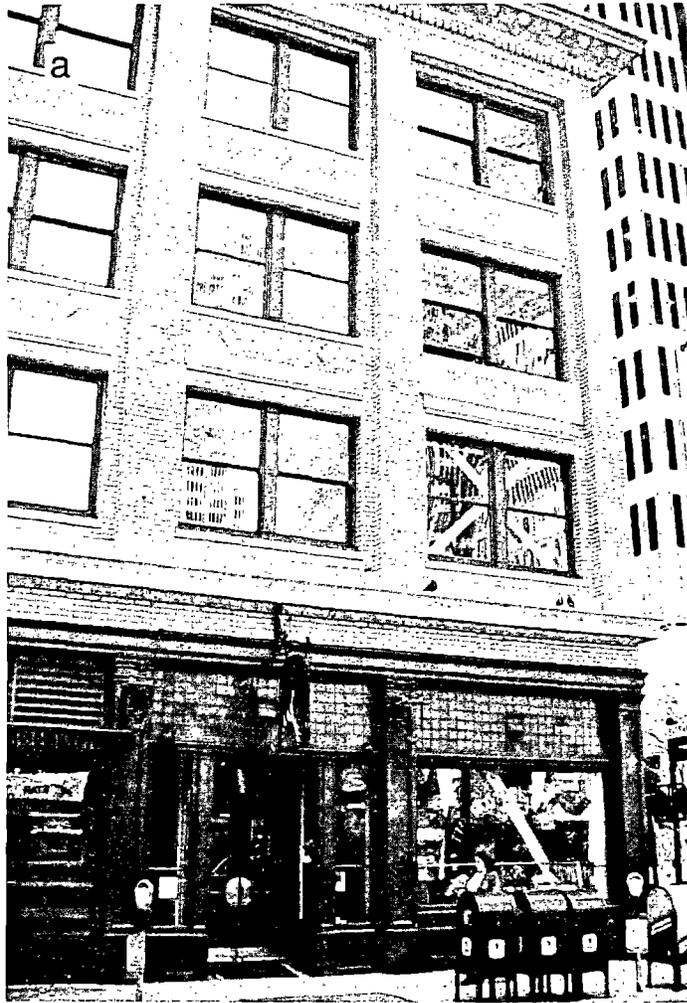
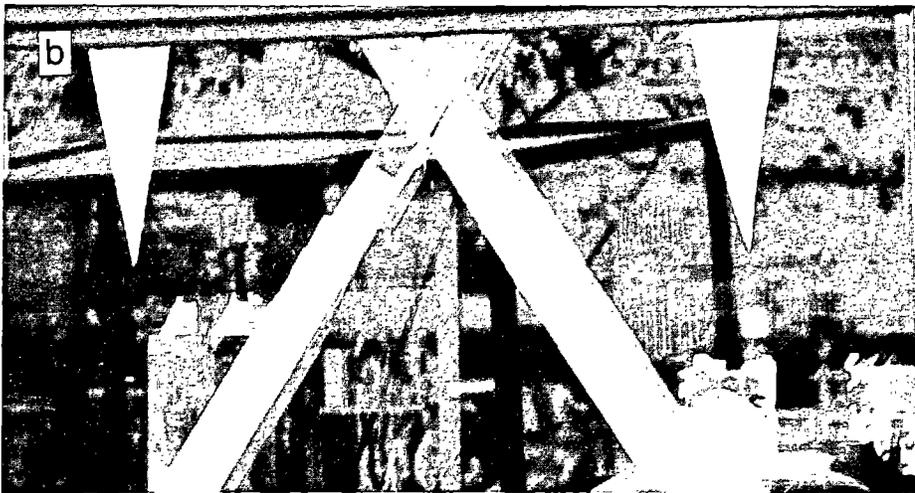
Figure 4.2.29 (a) The historic DeBernardi warehouse building showing the bracing added during seismic retrofitting; (b) close-up view of the bracing showing damage caused by earthquake.

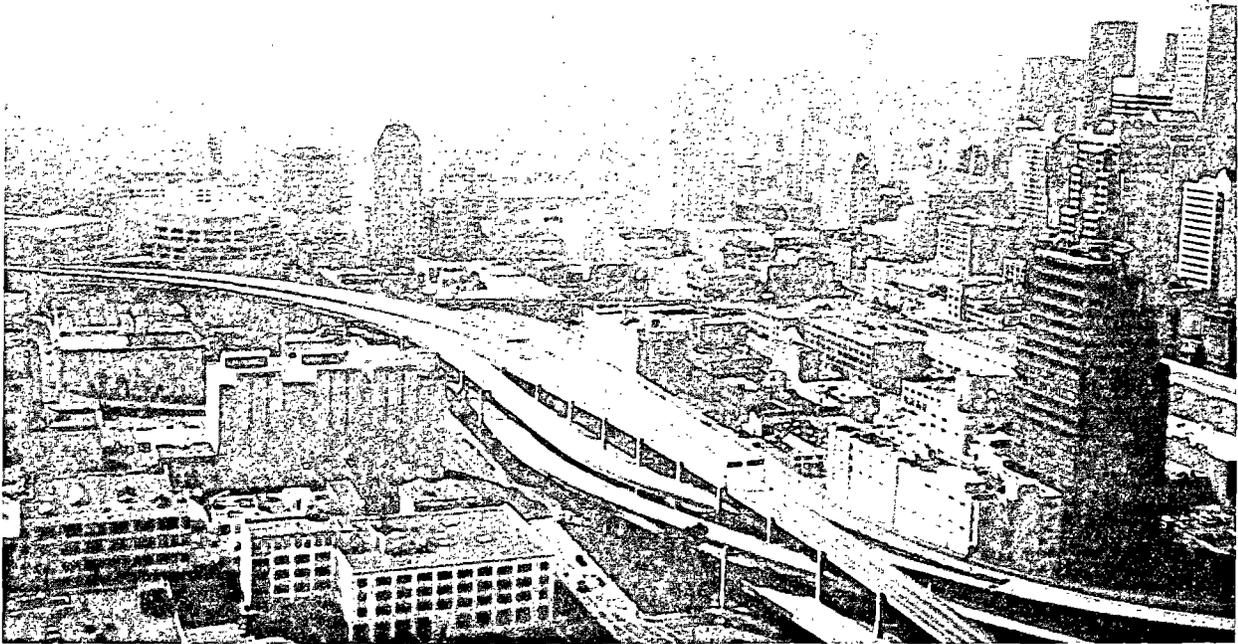
Figure 4.2.31 Aerial view of the south of Market District, looking toward the southwest.

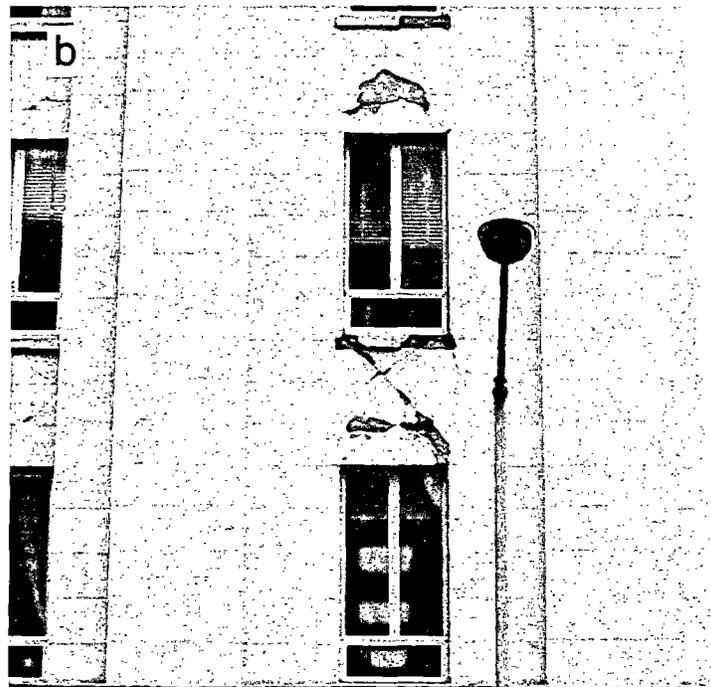
Figure 4.2.33 (a) Reinforced concrete, flat-slab building which sustained severe damage to the exterior walls (location #6); (b) close-up view of damage to spandrels.

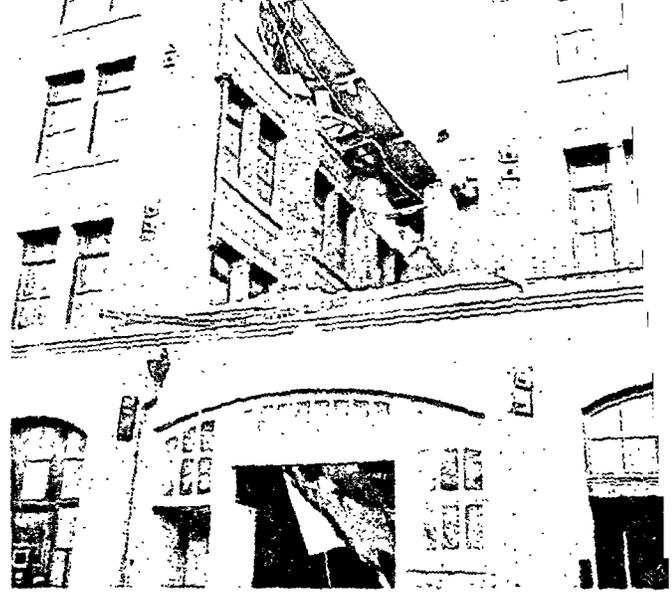
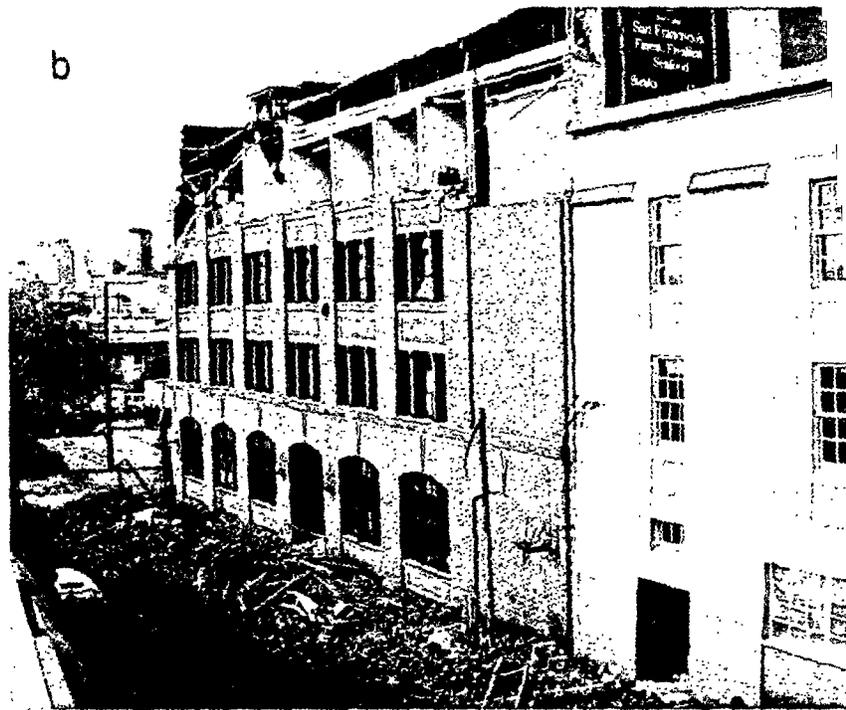
Figure 4.2.34 (a) Damage to upper story of unreinforced masonry building on Blux
(b) damage to the southwestern wall which resulted in the death of

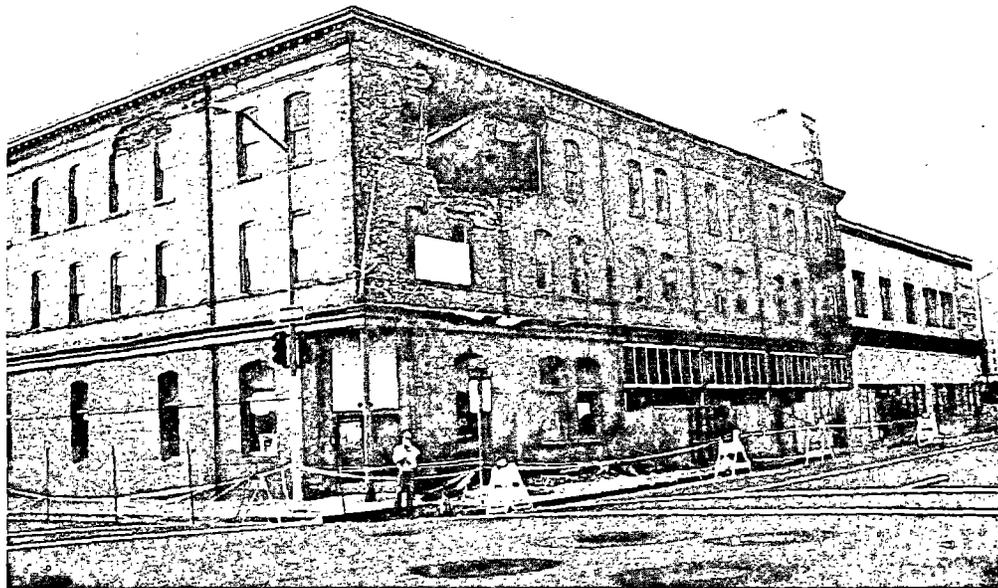
Figure 4.3.4 shows the three-story Clay Building (location #2) which had a serious failure of its unreinforced masonry walls. On the corner opposite to the Clay Building there was a two-story URM

Figure 4.3.4 Damage to the Clay Building, an unreinforced masonry structure (location #2).

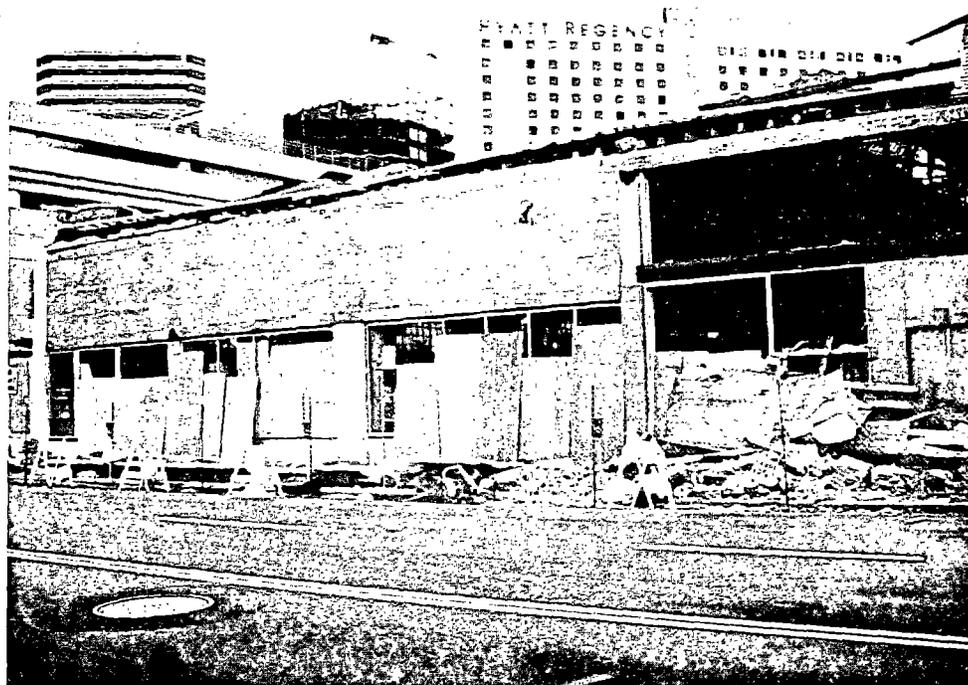
building (location #3) which was apparently built as a produce market in 1917. As is shown in figure 4.3.5, there was failure of the parapet as well as a portion of the infilled wall. The building occupied the entire block, and the eastern portion, which was being renovated, did not appear to have been damaged. Another example of a URM-building failure (location #5) is shown in figure 4.3.6. The collapse of the outer wall crushed three vehicles parked in the adjacent lot. The high-rise steel frame structure, seen in the background of figure 4.3.6, being constructed at 12th Street and Broadway, suffered damage at the top. It was reported⁶ that some steel members and the construction elevator fell to the ground. Fortunately there were only some minor injuries from what could have been a serious accident.

Figure 4.3.5 Extensive damage occurred to a two-story unreinforced masonry building built in 1917 (location #3).

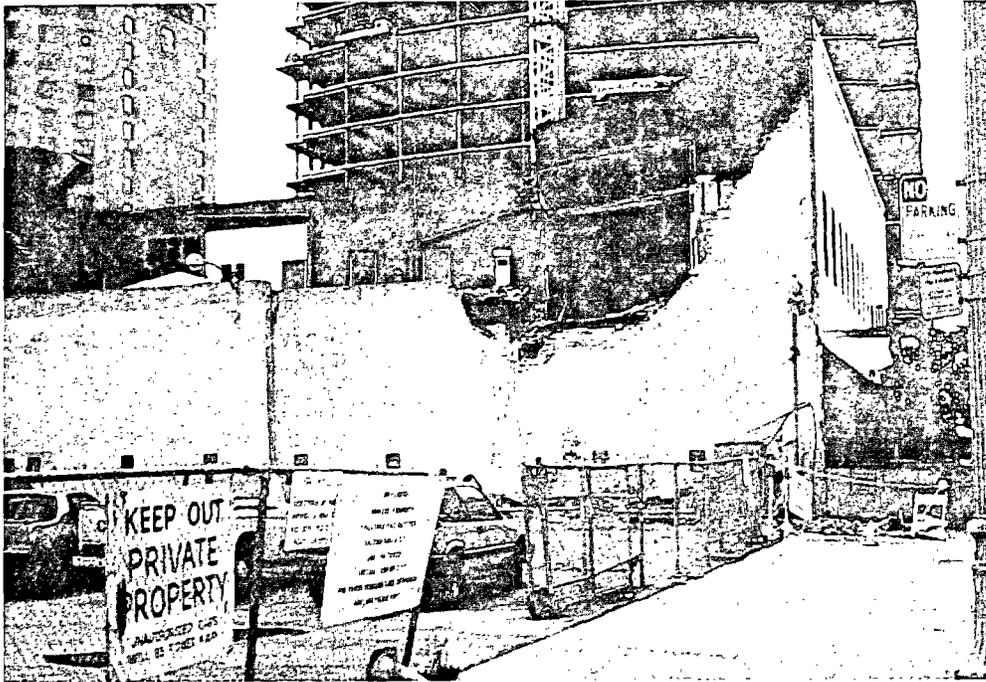
Figure 4.3.6 Collapse of unreinforced masonry wall crushed vehicles in adjacent parking lot (location #5). In background is a steel-framed building under construction which sustained damage.

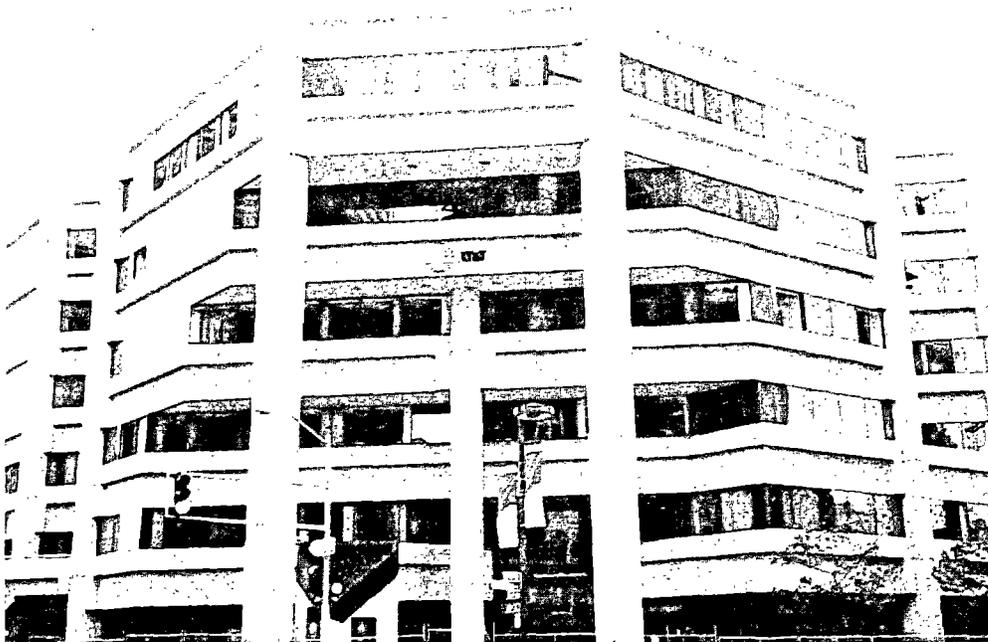
Damage also occurred to some modern buildings. Figure 4.3.7 shows the Trans Pacific Centre at 11th Street and Broadway (location #4). The building had to be evacuated not because of structural damage, but because of ruptured sprinkler lines, broken windows, and fallen ceiling tiles. The 16-story telecommunications building at 20th and Franklin Streets (location #7) suffered damage. The structural system consists of a steel frame with reinforced concrete shear walls. As is shown in figure 4.3.8, extensive damage occurred to the shear walls as well as other concrete structural members.

Figure 4.3.7 Trans Pacific Centre Building which suffered extensive damage due to ruptured water pipes, broken windows, and fallen ceiling tile (location #4).

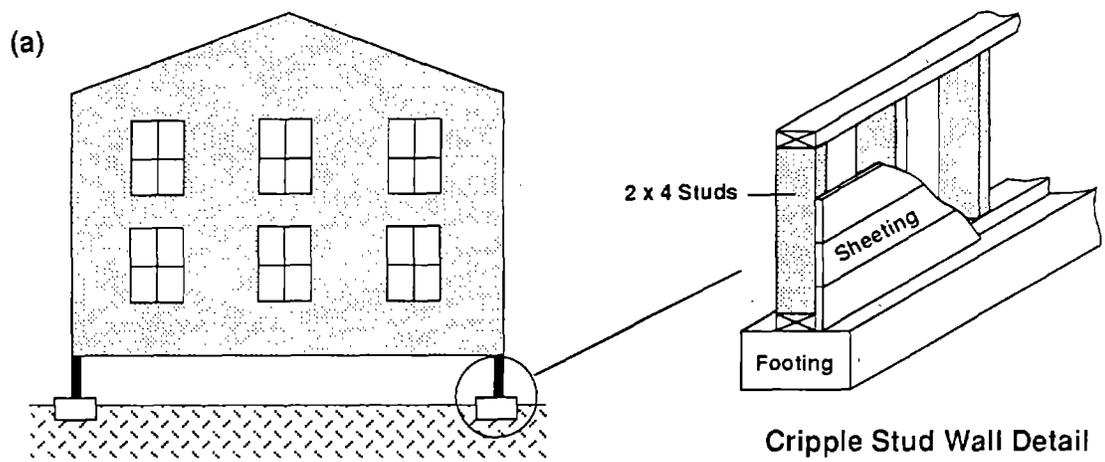
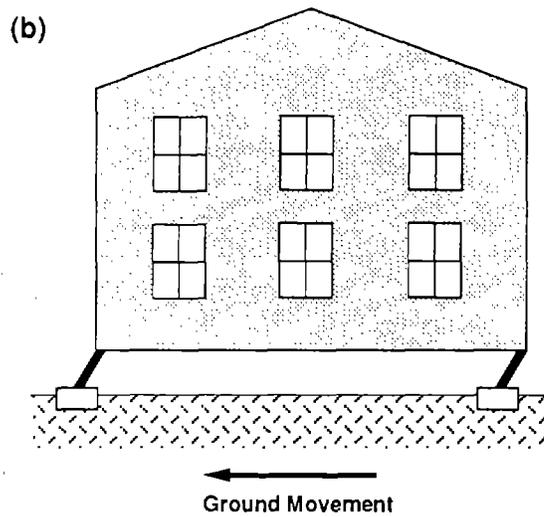
In Los Gatos, about 400 out of 11,000 houses were damaged. Figures 4.4.2 (a) and (b) show examples of damage to wood-framed houses which shifted off of their foundations. The shifting was usually as a result of the failure of the supporting perimeter walls. Figure 4.4.3 illustrates how a house, such as those which failed, is supported. The concrete footings support a short perimeter wall, known as a "cripple stud wall," which supports the frame of the house. The cripple stud walls are typically built using 2-by-4 studs and wooden boards as sheathing. When the ground moved during the earthquake, the cripple stud walls were unable to resist the induced horizontal forces. This caused the walls to sway until they could no longer support the weight of the house. The house crashed to the ground and secondary damage resulted from the impact. The same type of damage was also observed to houses in Watsonville.

Figure 4.4.3 Schematic of failure caused by inadequately braced cripple stud walls: (a) construction of cripple stud wall and (b) failure mechanism.

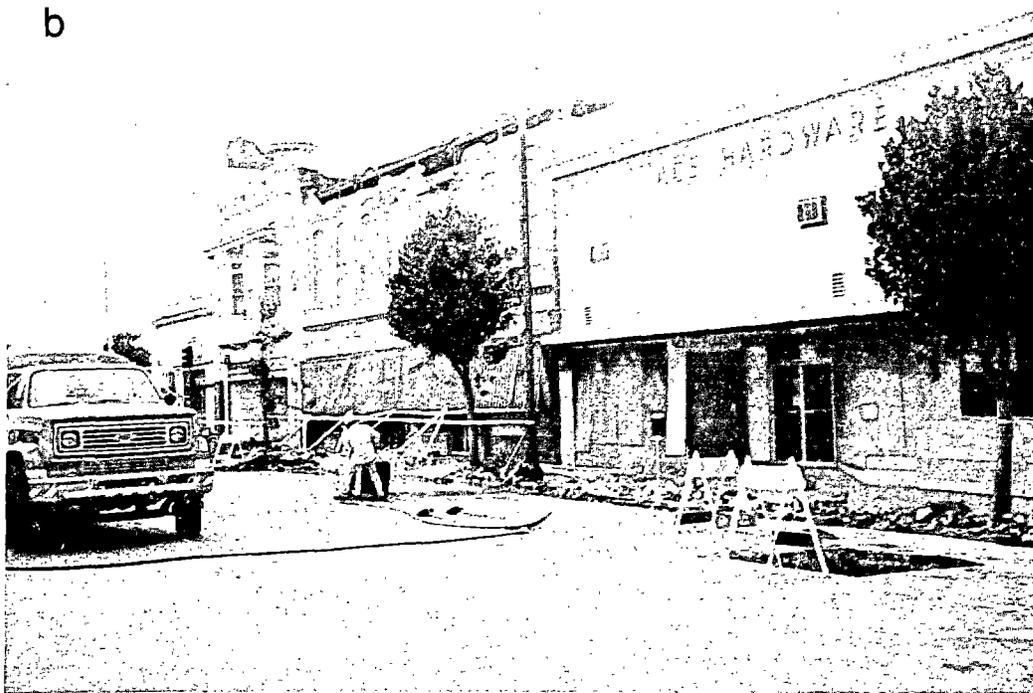
The communities in the epicentral area have a concentration of old URM buildings in their central commercial districts. Extensive damage occurred in these areas. There were numerous parapet failures, which in many cases caused extensive damage to adjoining buildings. In addition, many buildings suffered extreme damage due to inadequate lateral resistance as illustrated by the building in figure 4.4.4 (a). With many openings in the first story, masonry-clad, wood-framed structures, such as this, swayed excessively causing inadequately anchored brick veneers to fall. Along Main Street in Watsonville, many of the storefront windows were destroyed as shown in figure 4.4.4(b). The large openings in the first story of most buildings lead to low lateral strength and the excessive deformations during the shaking lead to glass failures.

Figure 4.4.4 (a) Failure of wood-framed building with masonry walls and multiple opening in first story (Los Gatos); (b) typical damage to parapets and storefront windows (Watsonville).

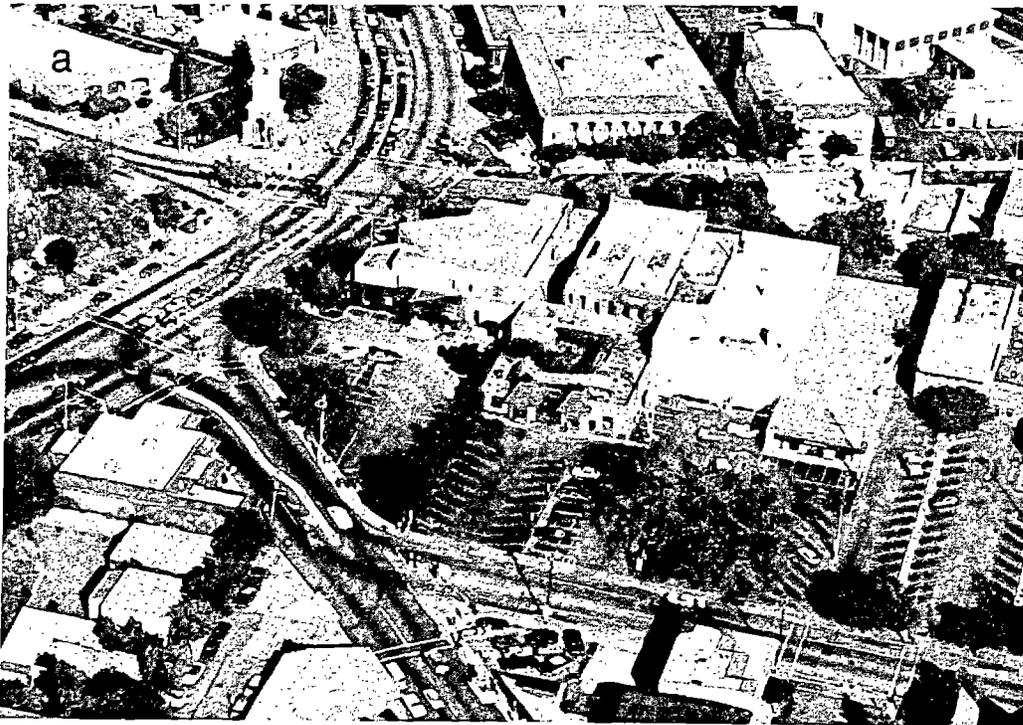
At the center of figure 4.4.8(a) there is a two-story masonry structure at the corner of Pacific Avenue and Water Street (location #1). Figure 4.4.9 shows the appearance of the structure at street level. It was designed about 15 years ago according to the 1973 Uniform Building Code, and it survived without any sign of structural damage. Adjacent to this modern building is an older unreinforced masonry building, which is seen on the left side of figure 4.4.9. Although the facade shows a small amount of damage, the roof of the building collapsed and killed two persons.

Figure 4.4.8 Aerial views of the Pacific Garden Mall: (a) northern portion.
