NIST Special Publication 778

*Performance of Structures During the
Loma Prieta Earthquake of October 17, 1989*

H. S. Lew, Editor

January 1990

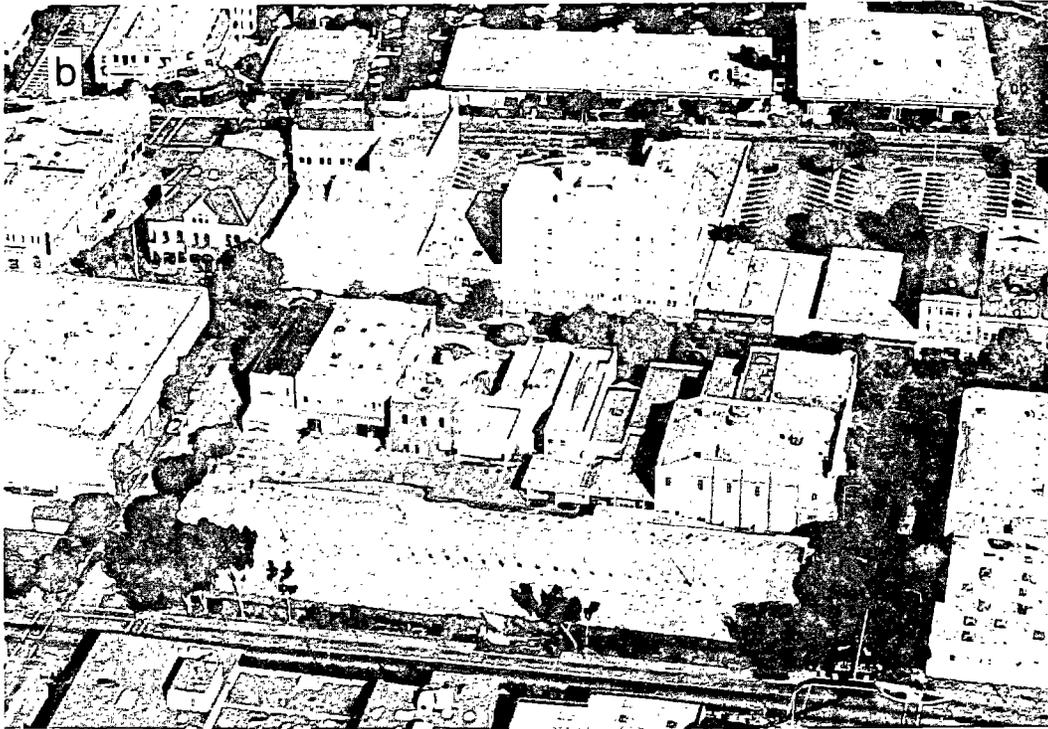
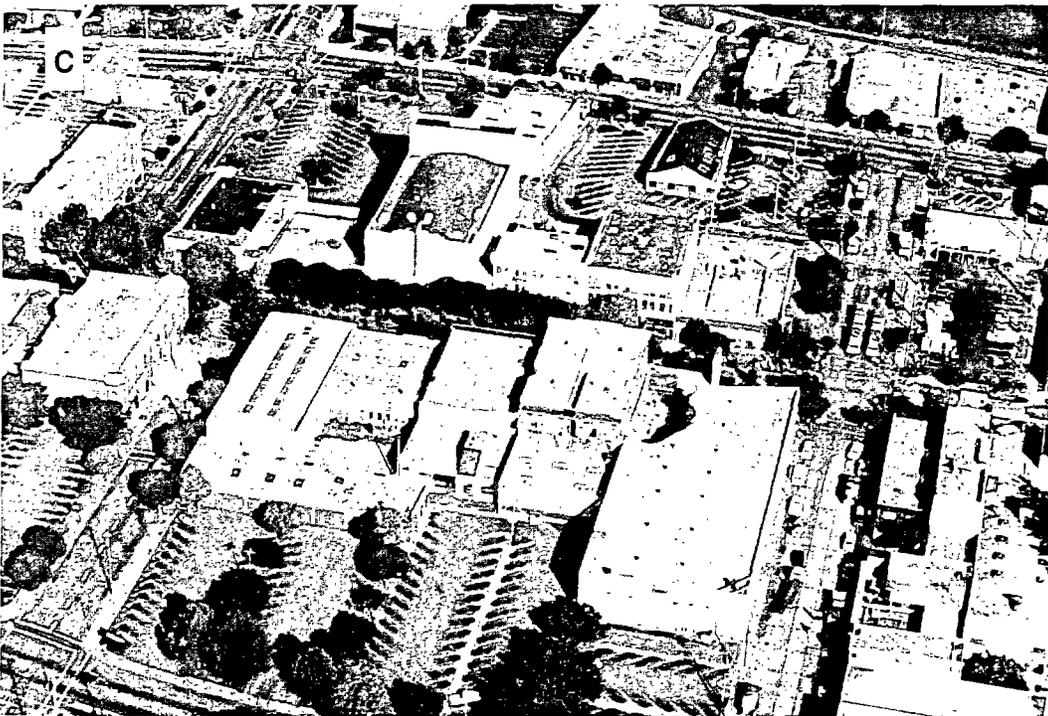
Another roof collapse in the mall caused the death of one person. This failure occurred to the department store on the corner of Pacific Avenue and Cathcart Street, and can be seen in figure 4.4.8(c). The roof failure was caused by the collapse of the top story masonry wall of the adjacent building. This type of damage was observed at several other stores within the mall.

A seven-story building is seen near the center of figure 4.4.8(b) (location #3). This reinforced concrete building, which was reported to have built in the 1920's, was severely damaged. The street level view in

Figure 4.4.8 (Cont'd) Aerial views of the Pacific Garden Mall: (b) central portion, and (c) southern portion.

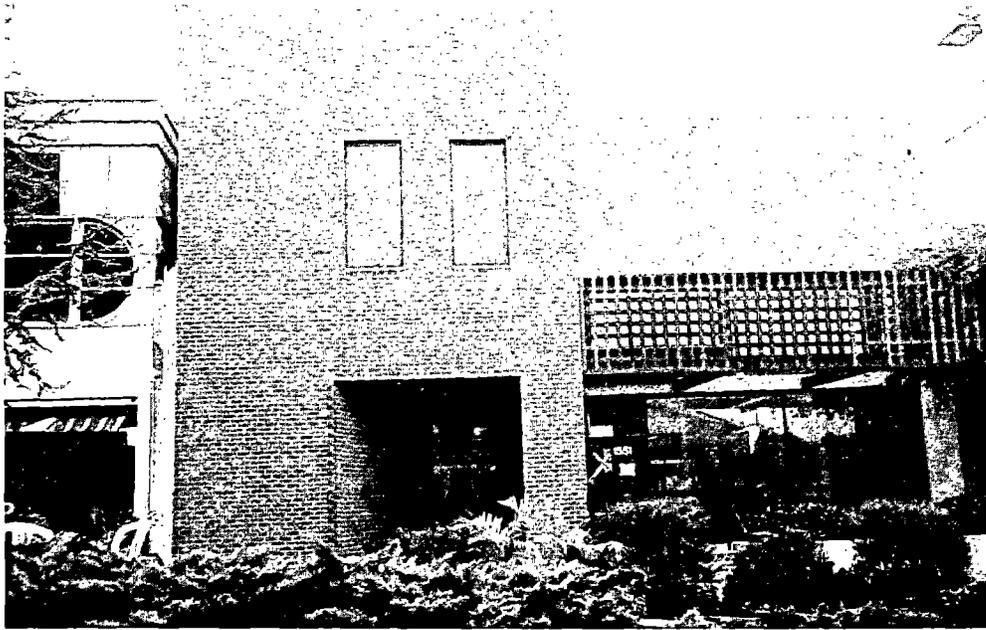
At the center of figure 4.4.8(a) there is a two-story masonry structure at the corner of Pacific Avenue and Water Street (location #1). Figure 4.4.9 shows the appearance of the structure at street level. It was designed about 15 years ago according to the 1973 Uniform Building Code, and it survived without any sign of structural damage. Adjacent to this modern building is an older unreinforced masonry building, which is seen on the left side of figure 4.4.9. Although the facade shows a small amount of damage, the roof of the building collapsed and killed two persons.

Figure 4.4.9 Modern reinforced masonry structure which was undamaged; building on the left suffered roof failure causing two deaths (location #1).

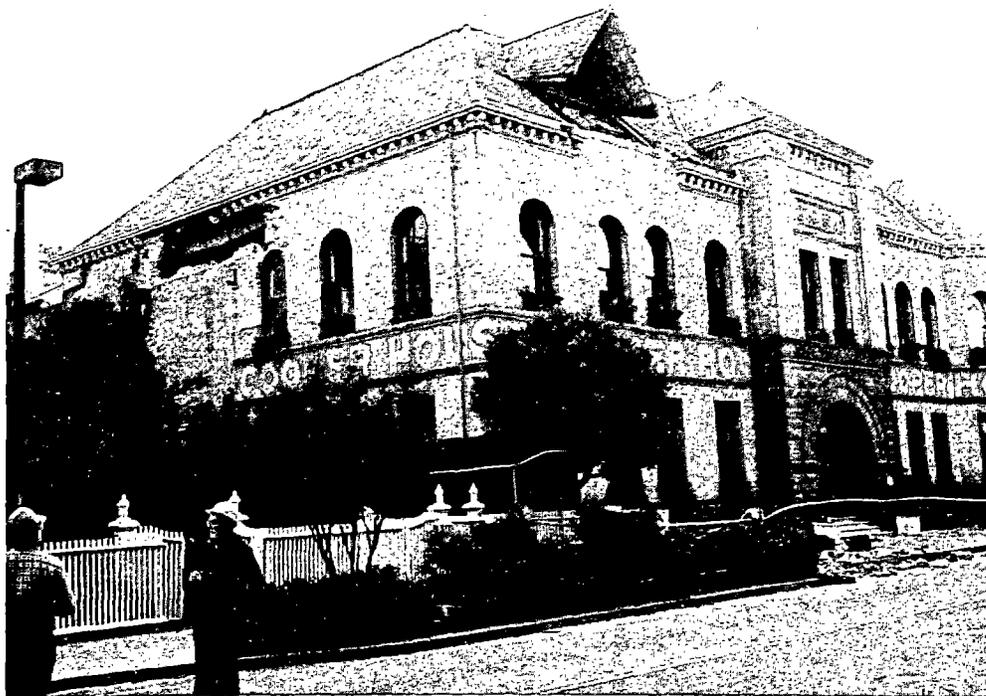
One of the historic structures severely damaged is the Cooper House located on the corner of Pacific Avenue and Cooper Streets (location #2). The unreinforced masonry building was built in the 1880's as the county courthouse. The building was reported to have survived the 1906 San Francisco earthquake⁷, but it was extensively damaged during the Loma Prieta earthquake. As shown in figure 4.4.10, portions of exterior walls collapsed and there were extensive diagonal cracks throughout the exterior walls. The damage was so severe that the building subsequently was demolished.

Figure 4.4.10 Historic Cooper House in Santa Cruz was severely damaged and had to be demolished (location #2).

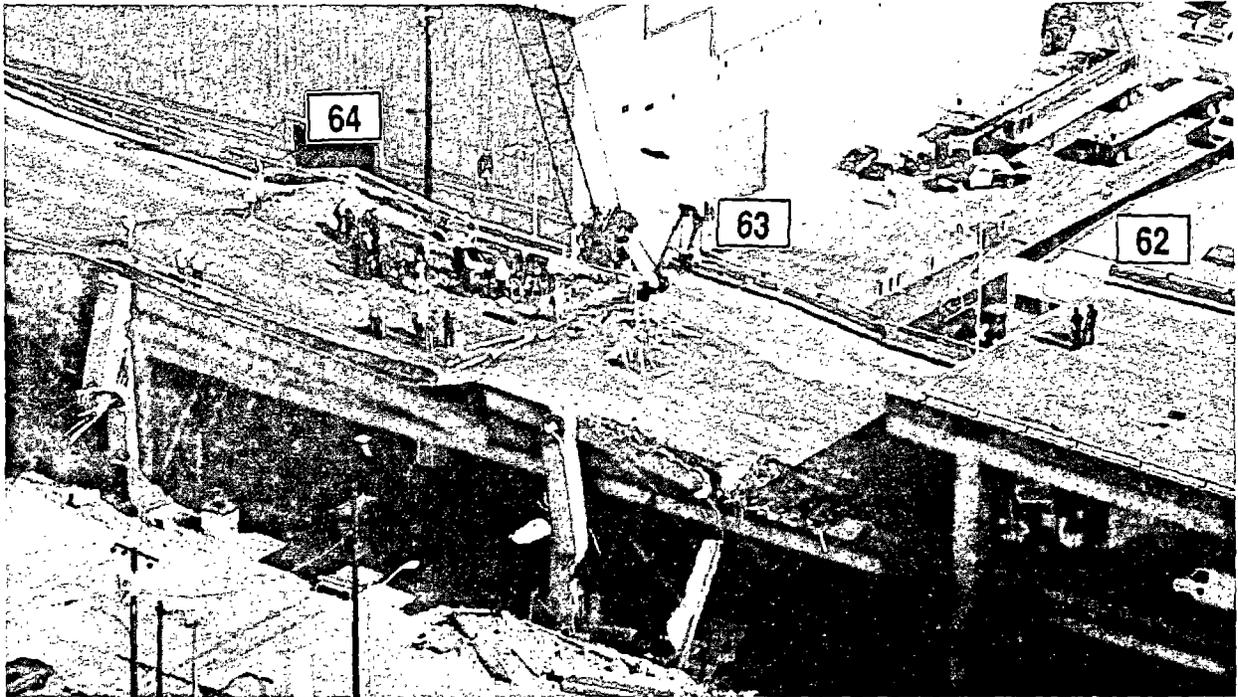
Figure 5.6.22 Aerial photo looking east to the southern limit of the collapsed portion of Cypress Structure between Bents 62-64.

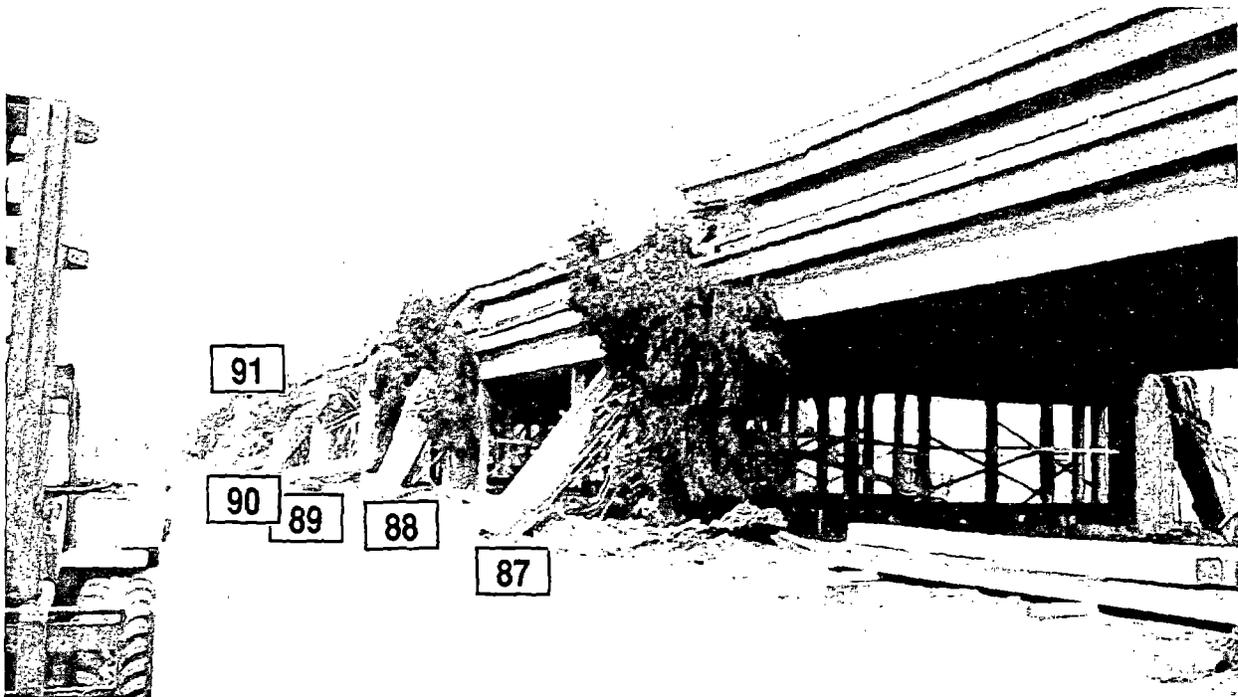
Figure 5.6.23 shows a ground-level view looking northward from Bent 86 on the west side of the expressway. All of the bents visible in this photo were Type 1 which invariably exhibited a symmetrical failure with both upper columns shearing free at their base and being splayed outward as the upper deck fell. The timber posts visible beneath the lower deck were installed by Caltrans under each bent to insure that there was no subsequent settling of the structure during rescue operations. Further evidence that the upper deck fell nearly squarely on the lower deck with no significant sidesway is shown in figure 5.6.24 which is looking northward from atop Bent 80.

Figure 5.6.23 View of the west side of Cypress Structure looking north between Bents 86-92. These were all Type 1 bents which demonstrate the uniformity of the collapse mechanism.

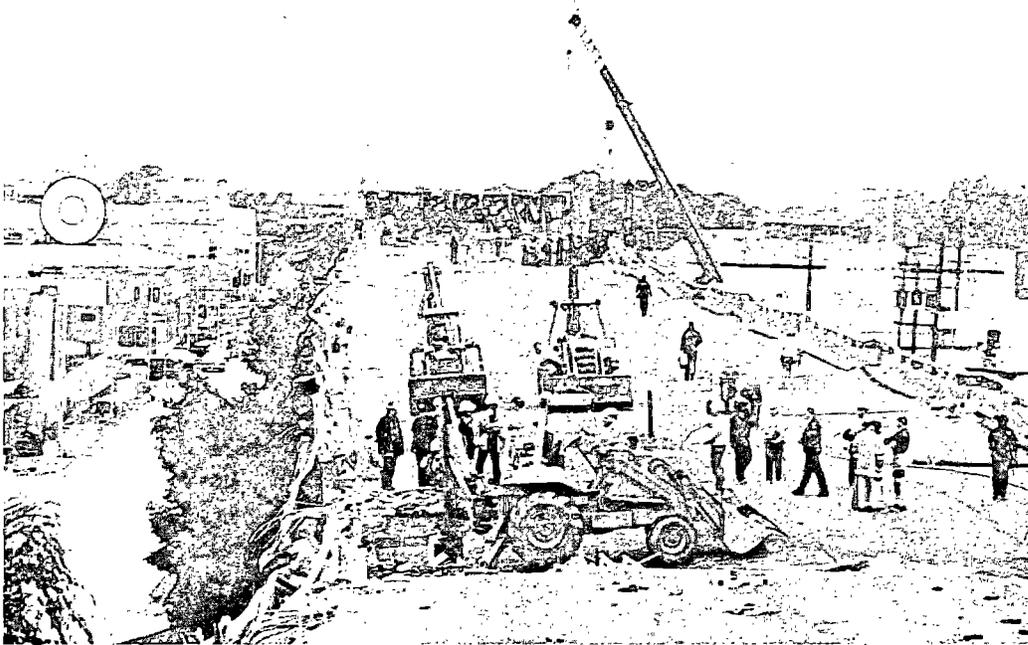
Figure 5.6.24 View of the upper deck of Cypress Structure looking north of Bent 80. This photo illustrates the negligible lateral displacement of the upper deck relative to the lower deck during the collapse.

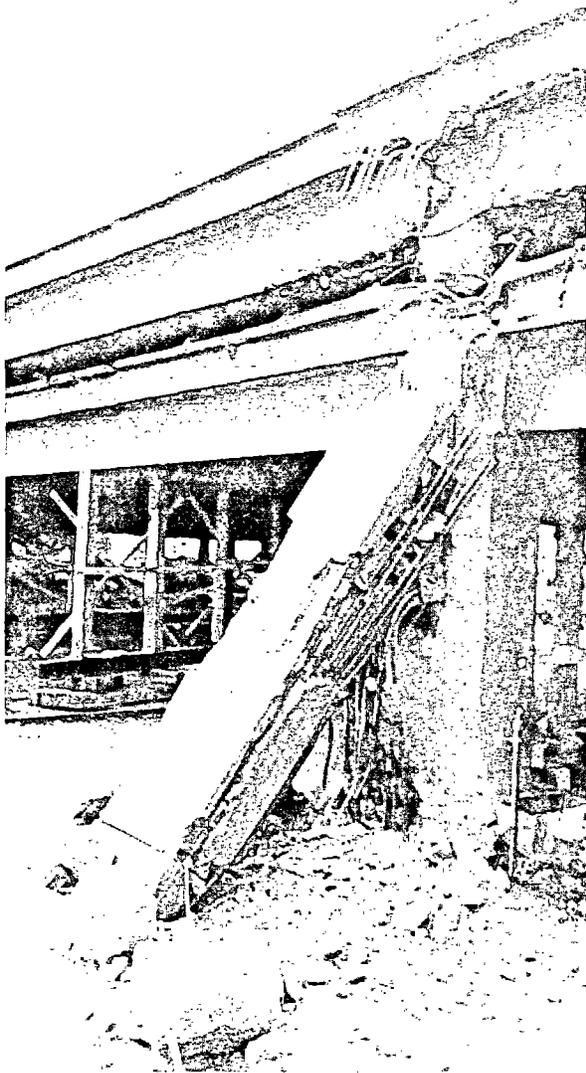
Figure 5.6.26

Failure of the west side of Bent 85. In this particular case a portion of the sheared support pedestal is still attached to the base of the upper column. The top of the column failed explosively and separated from the upper frame girder.

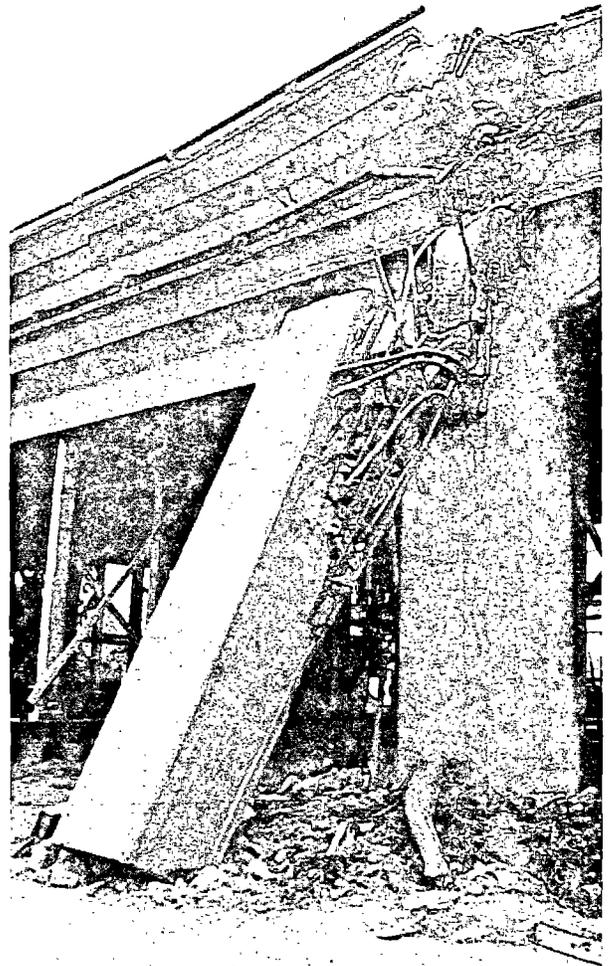
Figure 5.6.27

Failure of the west side of Bent 90. In this case the supporting pedestal for the upper columns was completely disintegrated; only the interior face of axial reinforcement that was present in the pedestal remains imbedded in the lower column. It can be seen that the failure plane followed the face of the curved negative moment steel from the lower frame girder.

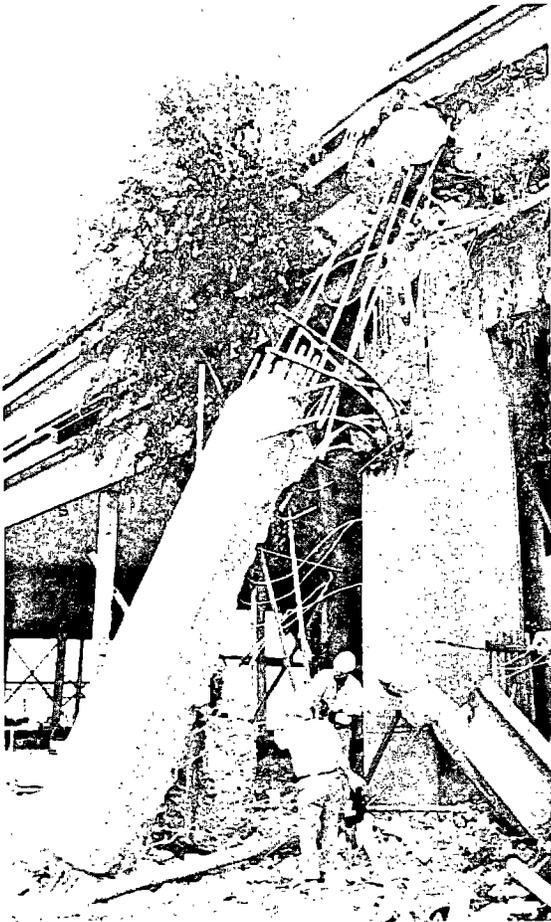
Figure 5.6.28 shows a final variation of a Type 1 bent failure. This particular column, at Bent 94, carried a pipe through its center which drained the upper deck. Given a lack of significant confining reinforcement (note the thin #4 ties which appear as wires compared with the massive #18 axial reinforcement), the presence of this pipe likely served to create the fracture path which split the column.

Failure of the west side of Bent 94. The presence of a central pipe, used to drain the upper deck, permitted a fracture plane to develop through the center of the column. The eastern half of the column disintegrated under compressive load while the western half spalled off.

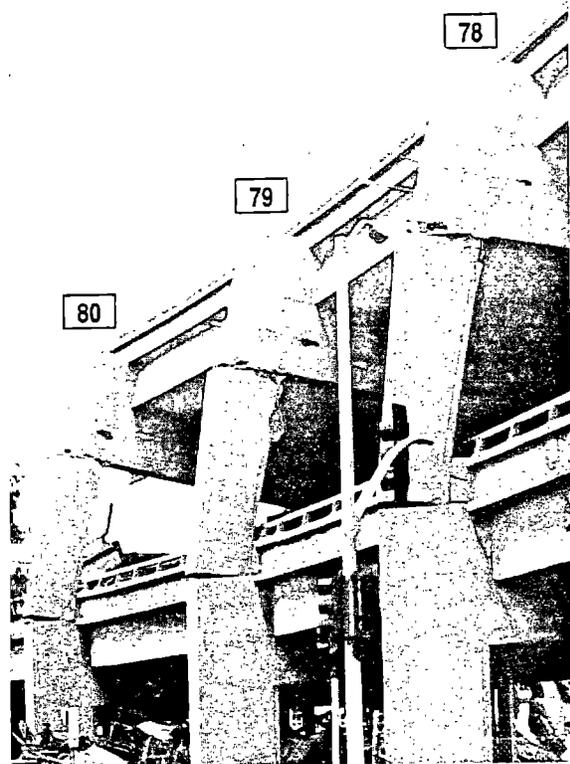
Figure 5.6.29 shows a closeup of a Type 2 bent failure in which the eastern half of a series of three-hinged prestressed bents collapsed, due to shearing failure at the base of the east column, leading to a rigid body rotation of the upper deck about the western, two-hinged columns. As can be seen, the western column shear keys did perform as hinges even under rotations sufficient to cause compressive spalling on the interior face of the columns (fig. 5.6.30). Most of the upper bent girders fractured due to impact-induced bending stresses. This in turn yielded, and subsequently fractured most of the post-tensioning bars which, because they were unbonded, were partially expelled from the girder due to rebound from the release of stored elastic energy, as shown in figure 5.6.31. It is of some significance that Bent 78, the innermost frame in figure 5.6.32, was skewed at an angle of 16 degrees. This difference, although subtle, may be part of the explanation for why this particular section did not fail completely. This performance is to be directly contrasted with Bent 72 (see figs. 5.6.33 and 5.6.34) in which the western two-hinged columns were ejected from the structure. Of particular note in figure 5.6.33 are the bent #10 bars projecting both from the top of the lower bent column as well as the bottom face of the upper bent girder. These represented the only continuous reinforcement through the upper and lower shear keys. Figure 5.6.35 leaves no doubt that lateral confining steel was insufficient to prevent localized fracture of the concrete and the subsequent pullout of these dowels. A closeup of the top of the Bent 71 upper two-hinge column in figure 5.6.35 shows a detail of the still intact shear key, 4-#10 dowel bars, and, in this particular instance, a central drainage pipe. In this case the dowel bars remained intact within the column and pulled out, instead, from the upper girder joint.

A view looking north at the west side of Bents 78-80. These were all Type 2 bents which included prestressing of the upper girders. This particular mode of failure, in which only the east columns of the upper frames failed, is noted as a Type A Failure in subsequent discussions. Type A Failures occurred in Bents 74 through 80 (see figs. 5.6.18 and 5.6.19).

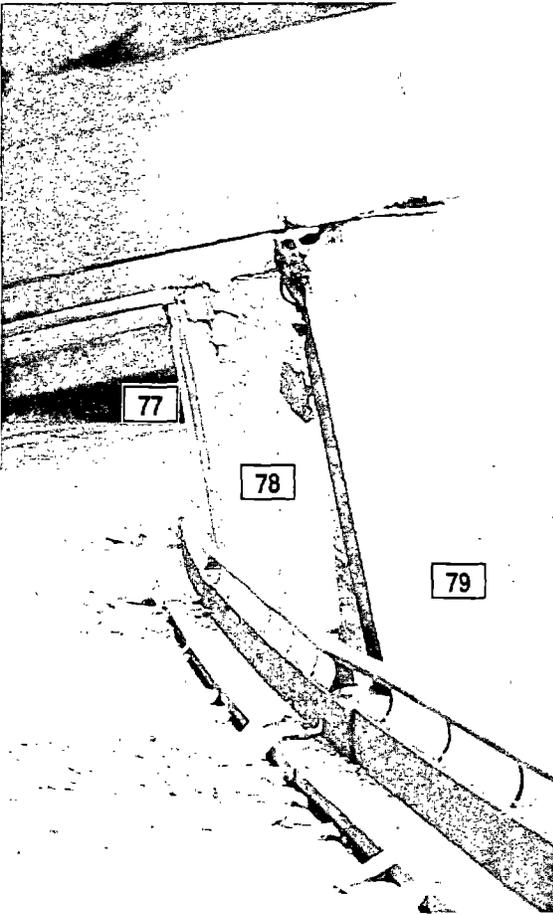
Figure 5.6.30

A close-up view looking south from Bent 80 at the west side of the upper portion of Cypress Structure. Note compression spalling along the interior face of the tops of the columns.

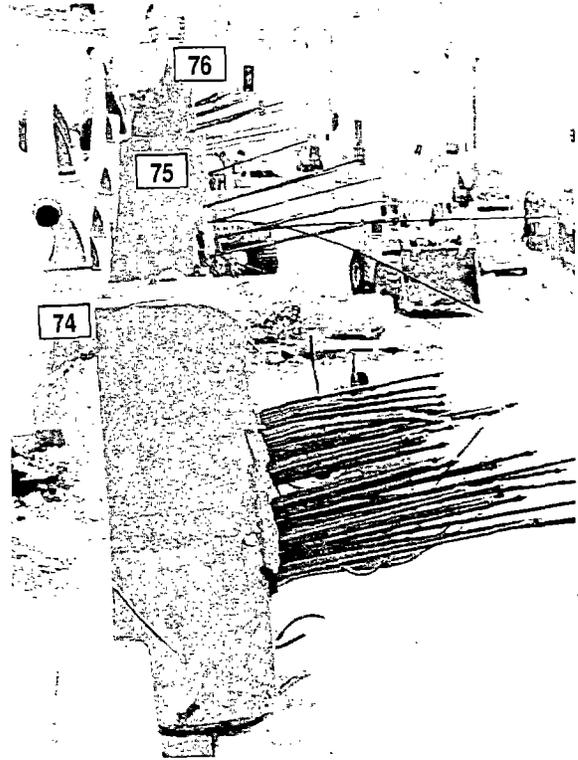
Figure 5.6.31

Due to excessive flexural displacements in the upper frame girder, most of the post-tensioning tendons yielded and then fractured. The tendons were unbonded, to permit extension of the top girder at a later date as part of a planned access ramp. The stored elastic energy drove the tendons from their ducts, as shown here at Bents 74, 75, and 76 on the east side of Cypress Structure.

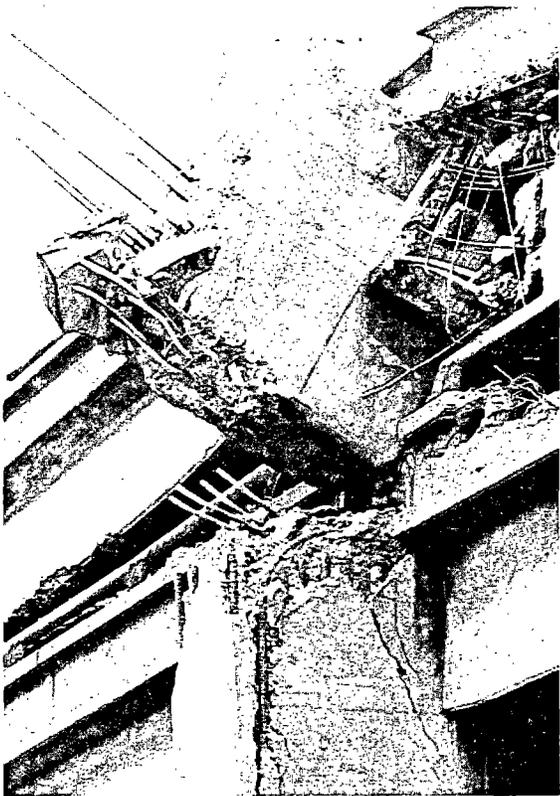
Figure 5.6.33

A close-up of the west side of Bent 72 shows the second, or Type B, variation of failure observed for Type 2 bents. In this case the entire double-hinged upper frame column segment has been ejected from the structure. The 4-#10 bars which passed through the upper and lower shear keys may be seen projecting from the base of the upper girder and the top of the lower column.

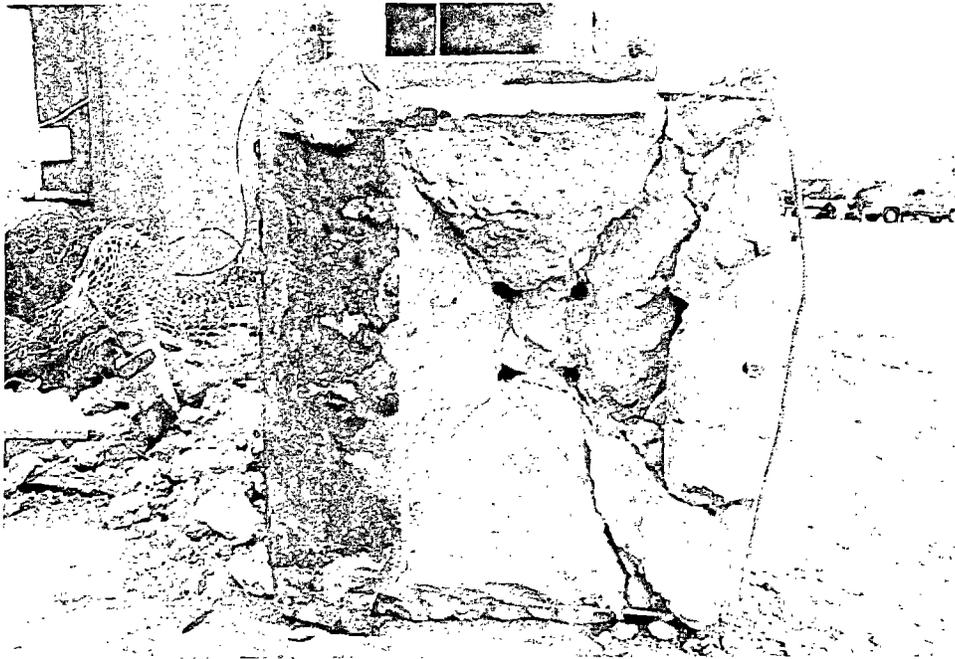
Figure 5.6.34 Detail of the base of the two-hinged column that was ejected from the west side of Bent 72. The 4-#10 dowel bars which passed through the center of the shear key have been pulled free.

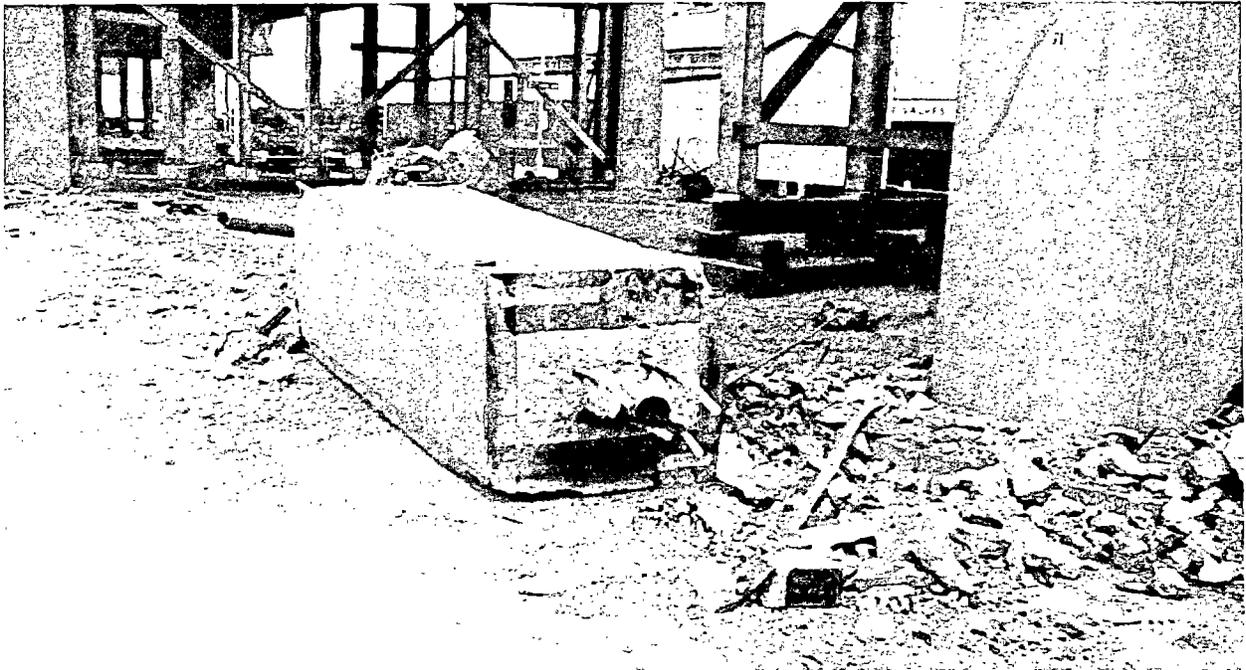
Figure 5.6.35 Detail of the bottom of the two-hinged column that was ejected from the west side of Bent 71 showing central pipe used to drain the upper road deck and the 4-#10 dowel bars used to transfer shear across the hinge.

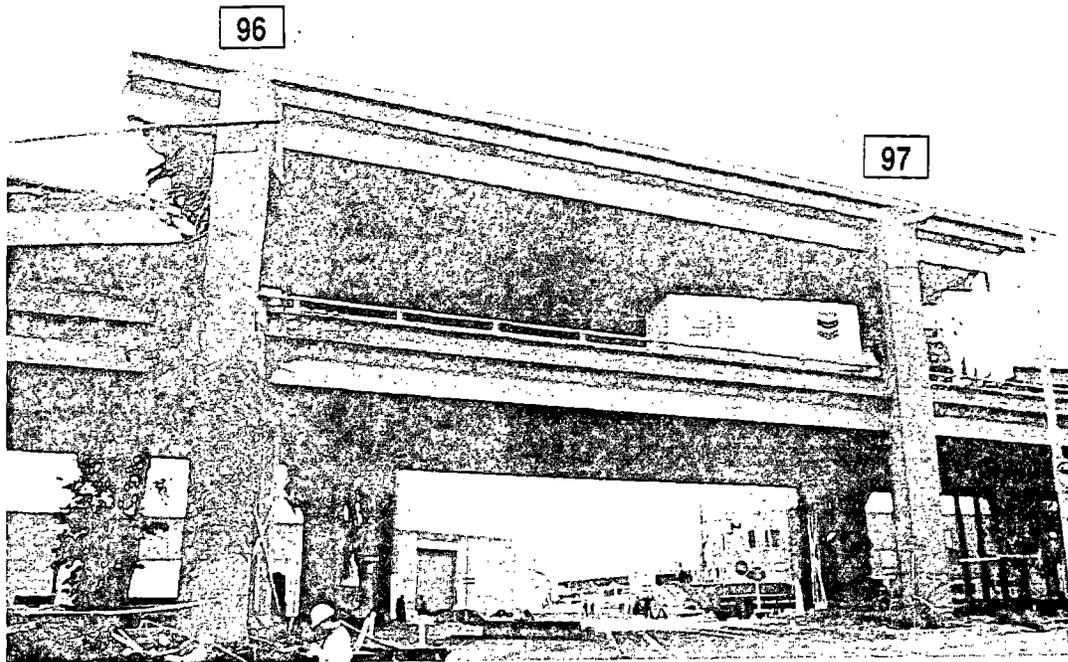
Figures 5.6.36 and 5.6.37 show details of the span between Bents 96 and 97, the only one to remain completely intact between Bents 62 and 113. There are several obvious differences which could account for this. The Type 4 bent, which includes Bents 95-98, contains an additional central column in the lower bent which would serve to limit lateral sway at the first deck level. More importantly, the reinforcing steel at the base of the upper bent columns is continuous with the lower columns, eliminating the pedestal/hinge detail that appears to have contributed to widespread failure in Type 1 bents. Figure 5.6.37 indicates that, despite severe flexurally induced cracking at the lower column/girder joint, the upper and lower

Figure 5.6.36 View looking west towards Bents 96 and 97 which supported the only segment of the upper deck to remain standing between Bents 62 and 113.

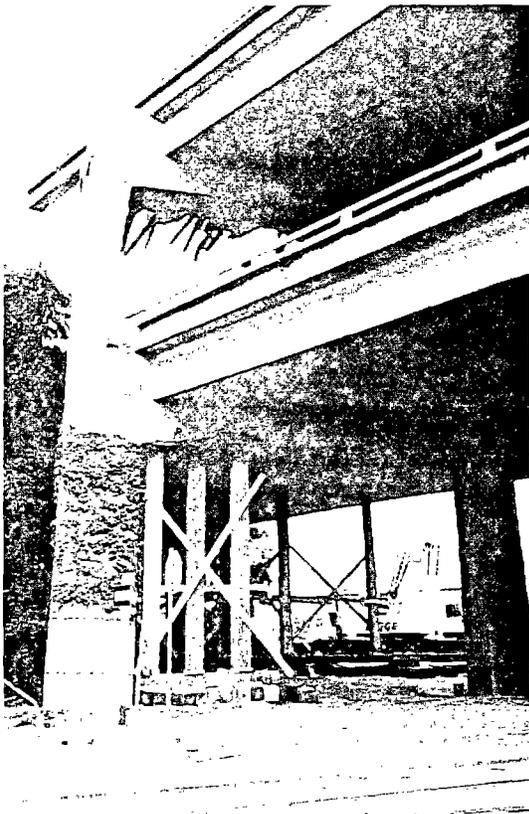
Figure 5.6.37

It is interesting to note that the calculated column shear resistance reported by Priestley et al. (Priestley, 1989) for Type 4 bents (see fig. 5.6.5), when modified to account for the measured compressive strength of the concrete, comes to 398 kips (1770 kN). Accounting for portal frame reaction shear at the column bases for the upper bent, the lateral base acceleration required to achieve failure is 0.38g, i.e., greater than the expected acceleration from the response spectra reported by CDMG (CDMG, 1989b). These frames, as can be seen in figure 5.6.37, suffered significant damage, but remained standing.

Detail of the west side of Bent 97 showing extensive shear cracking at the interior beam/column joint for the lower frame and compression spalling at the upper beam/column joint. Axial reinforcement for the upper frame columns was continuous with the lower frame columns on both east and west sides. This, and the larger cross section, helps to explain why these Type 4 bents did not collapse.

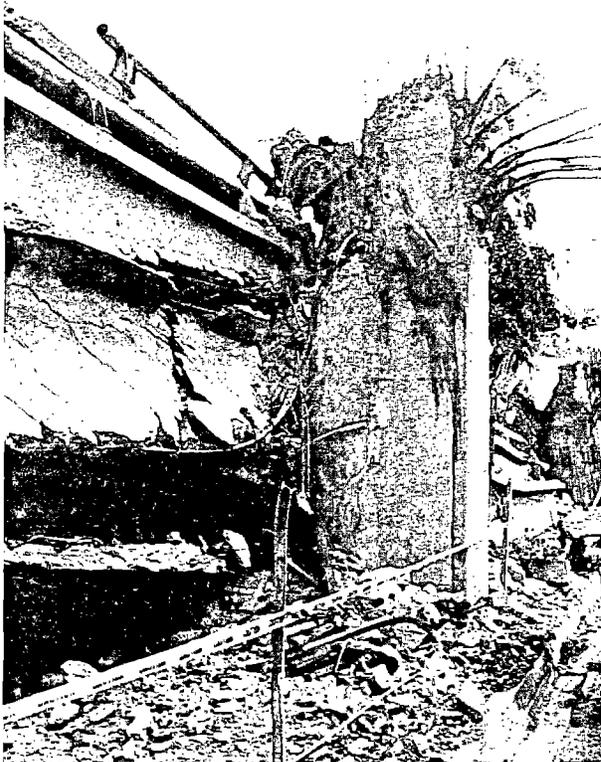
Figure 5.6.39

Close-up of the west side of Bent 105 looking south, illustrating complete shear failure of the lower bent beam/column connection.

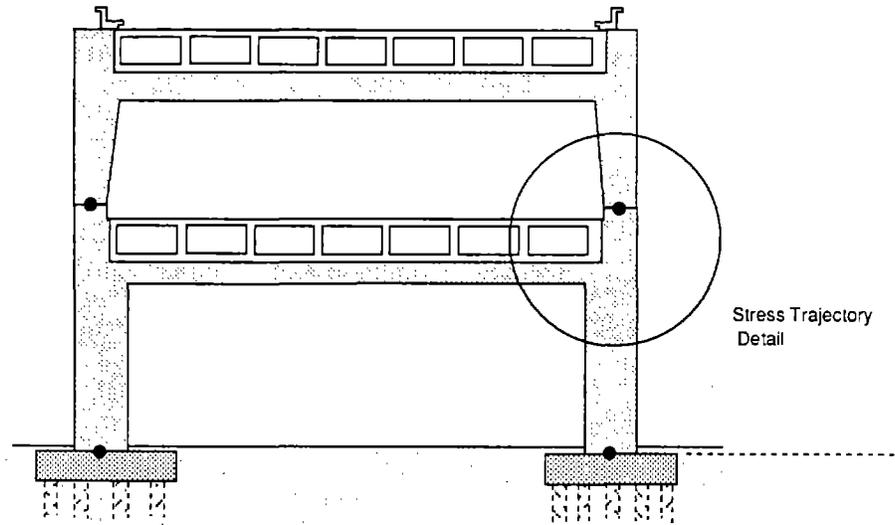
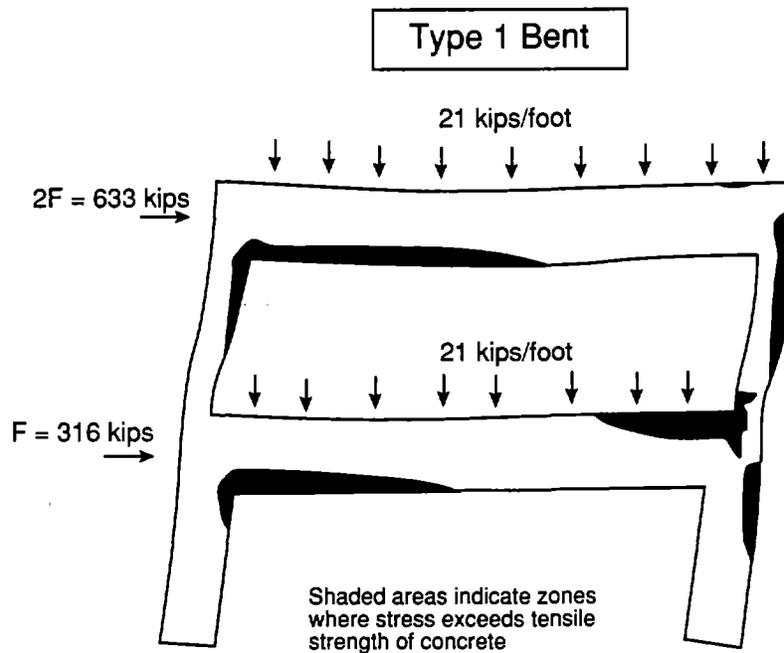
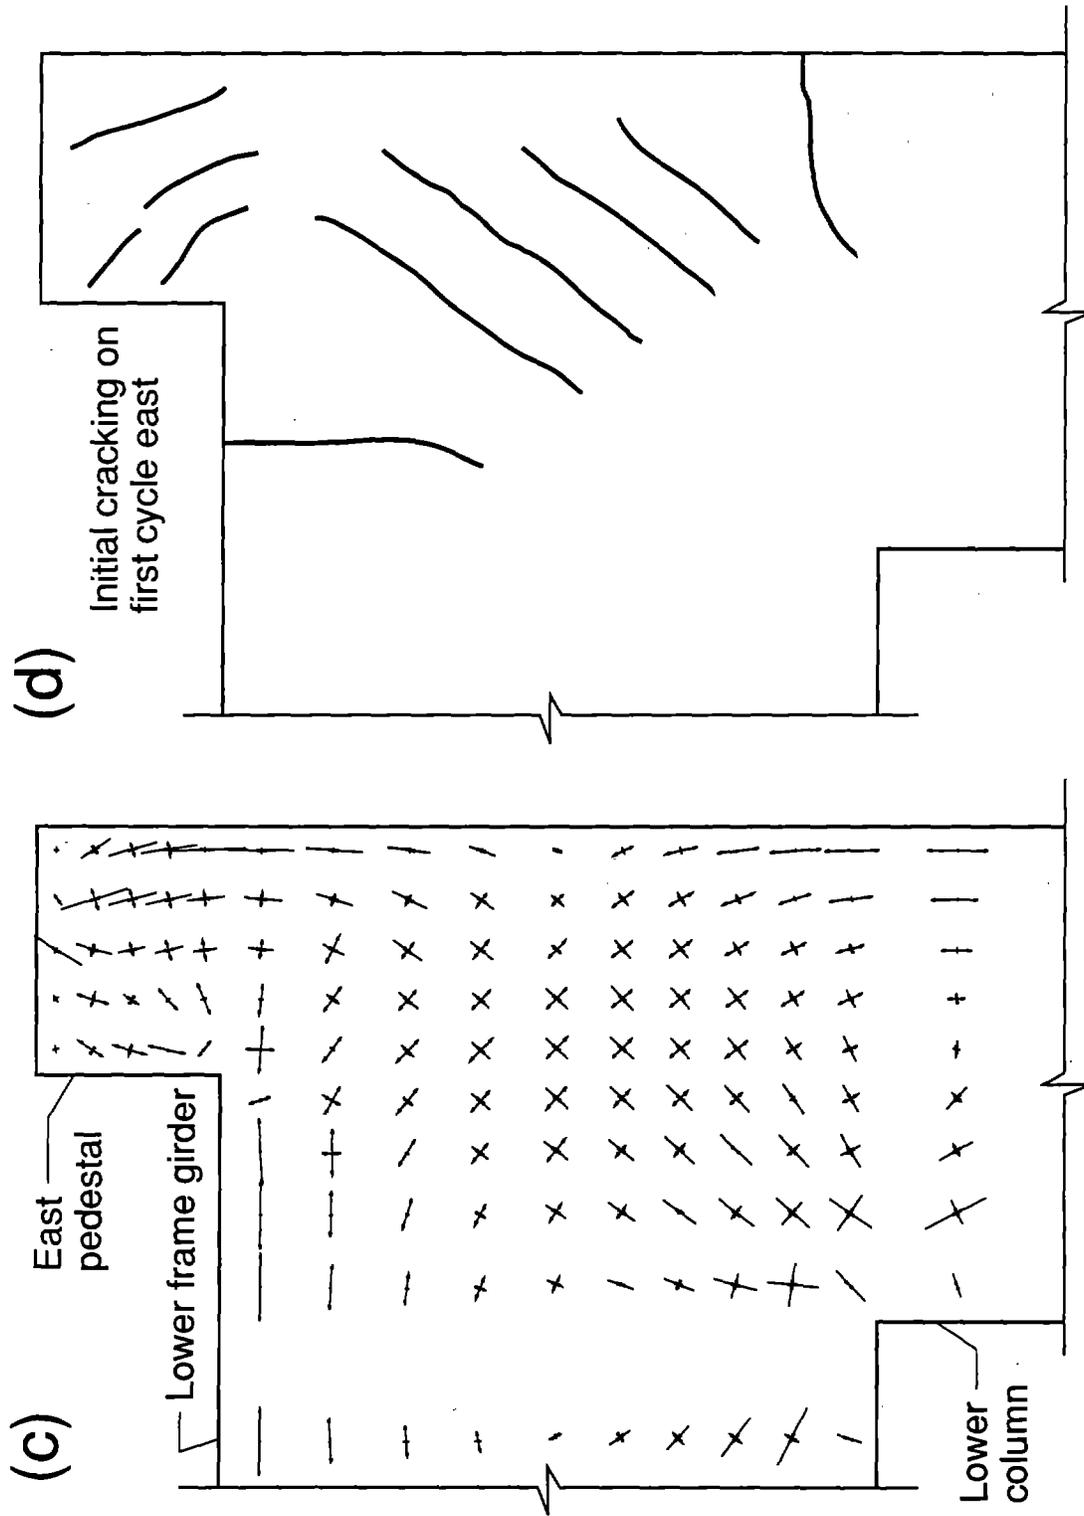
Figure 5.6.44(b) Displaced shape of Type 1 bent under applied loads showing zones of principal tensile stress sufficient to induce cracking.

Figure 5.6.44 (c) Principal stress tensors for pedestal region in Type 1 bent. Scale 0.25 inch = 650 psi (6.3 mm = 4.5 MPa).
 (d) Predicted cracking during first half-cycle of lateral load.

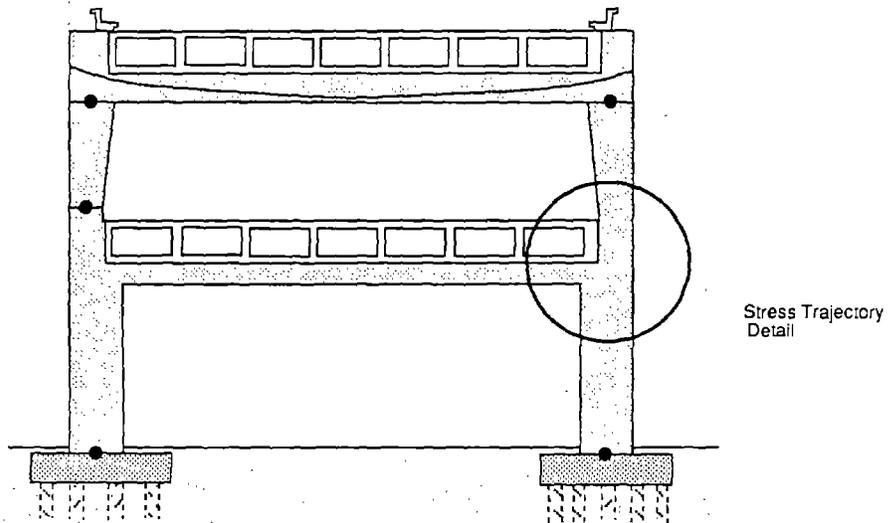
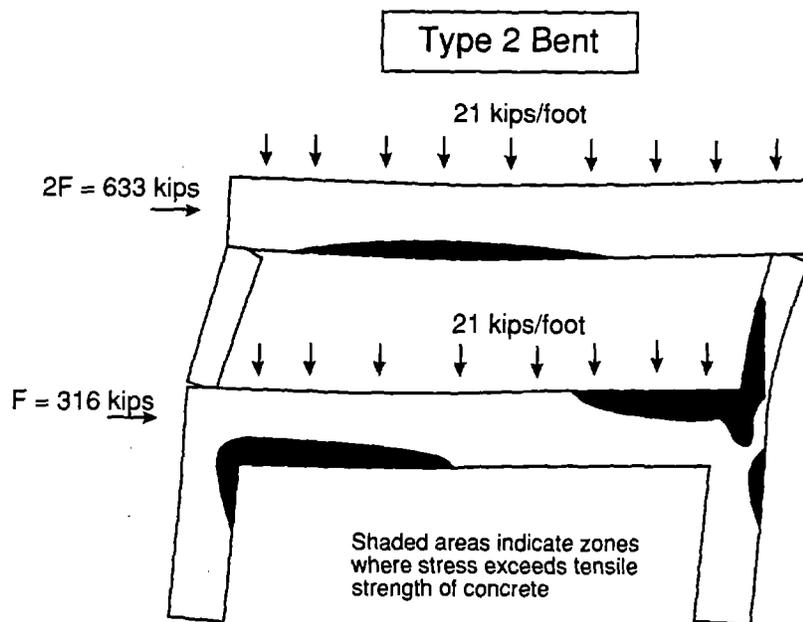
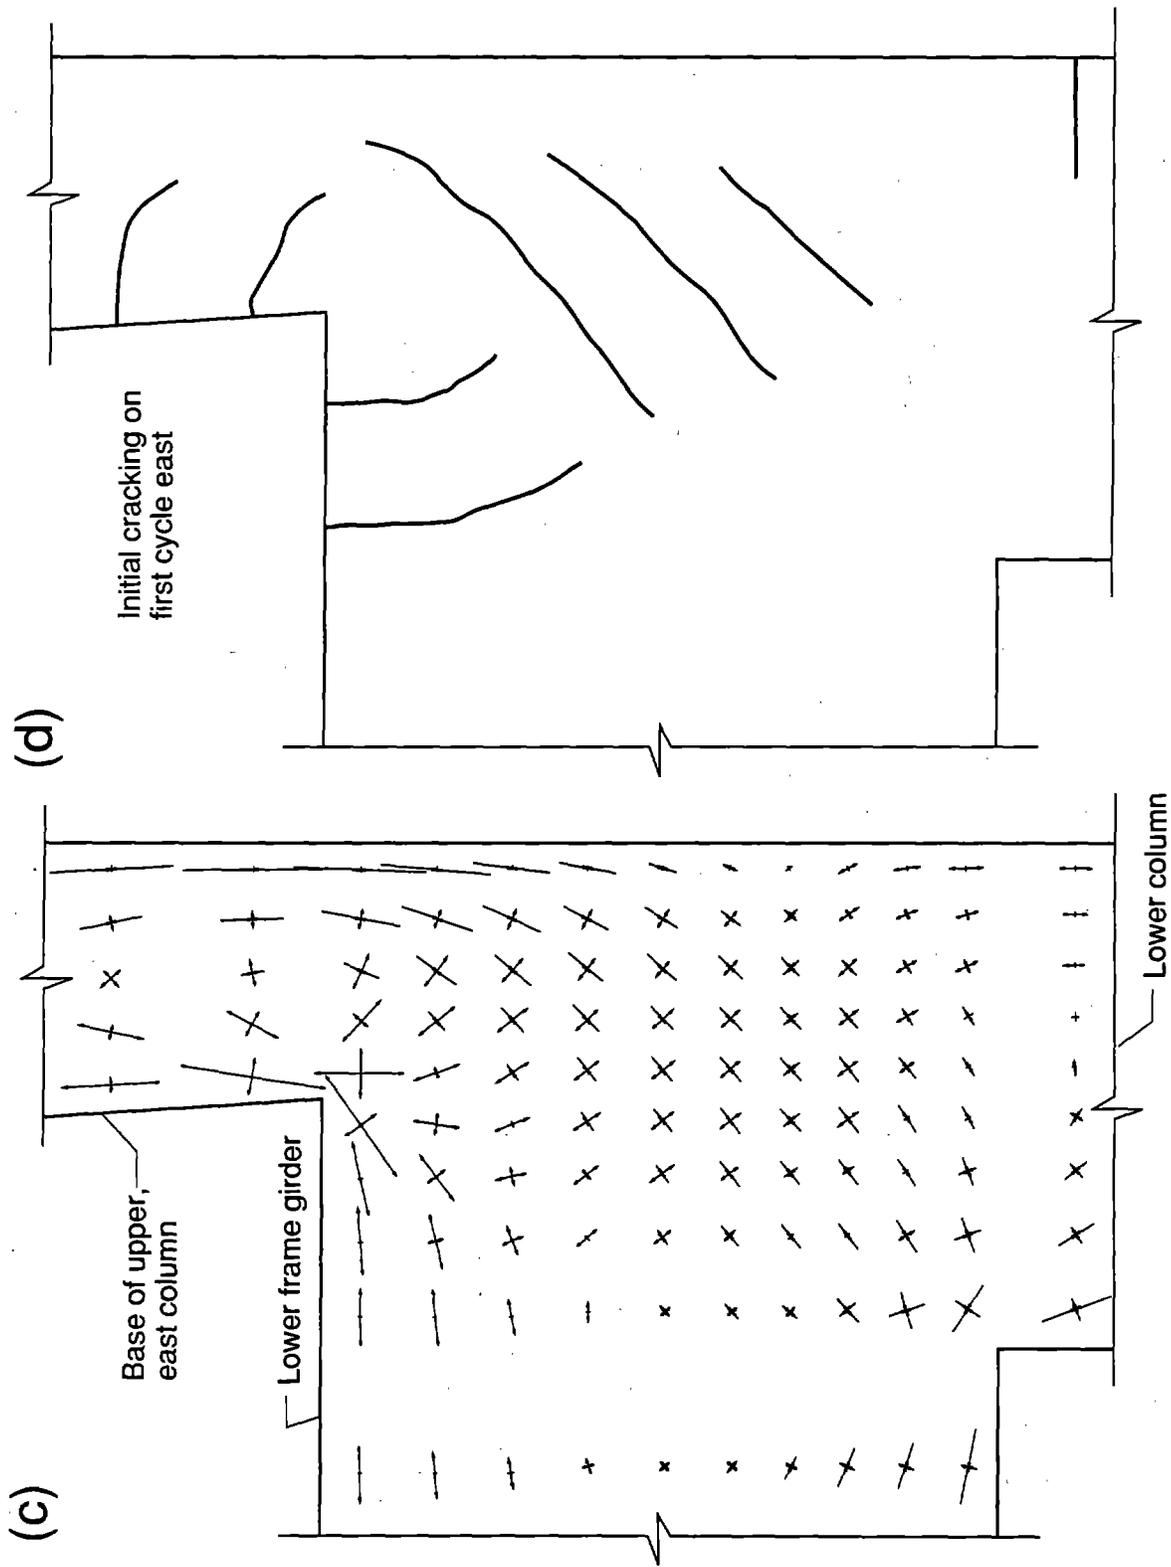
Figure 5.645(b) Displaced shape of Type 2 bent under applied loads showing zones of principal tensile stress sufficient to induce cracking.

Figure 5.6.45 (c) Principal stress tensors for pedestal region in Type 2 bent. Scale 0.25 inch = 650 psi (6.3 mm = 4.5 MPa).
 (d) Predicted cracking during first half-cycle of lateral load.

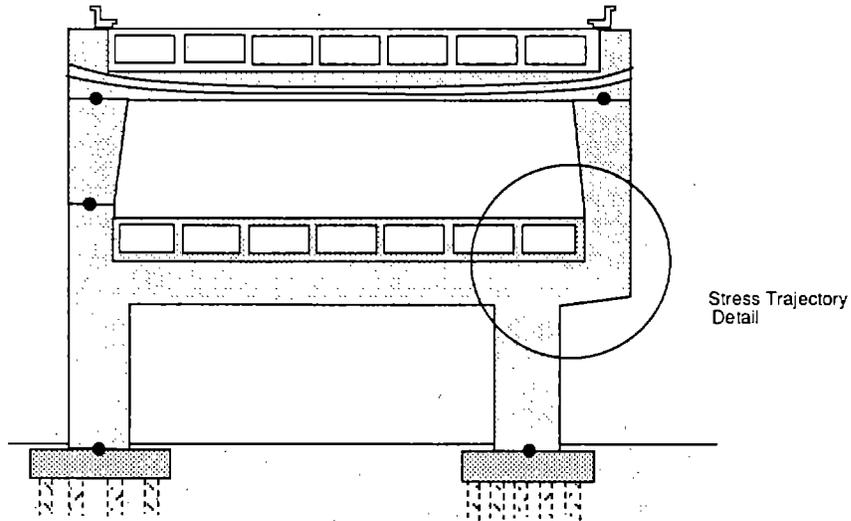
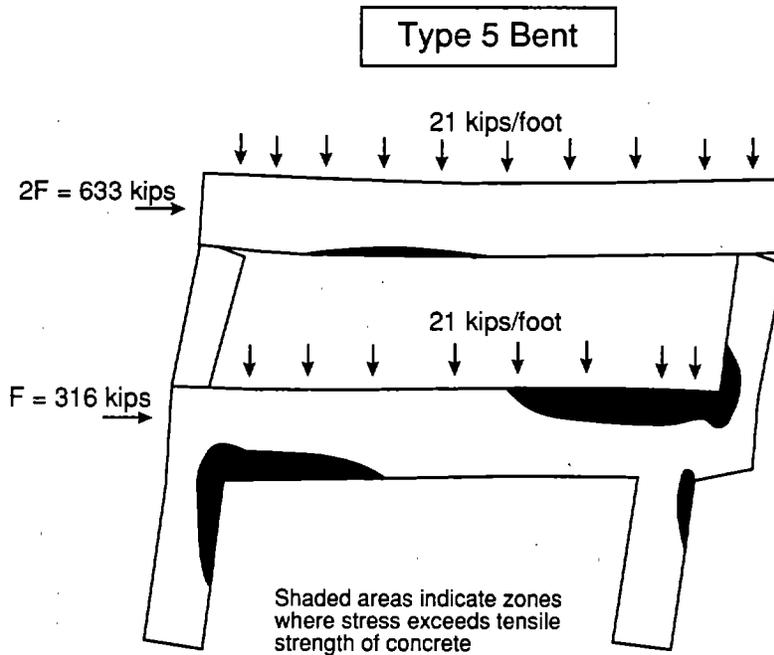
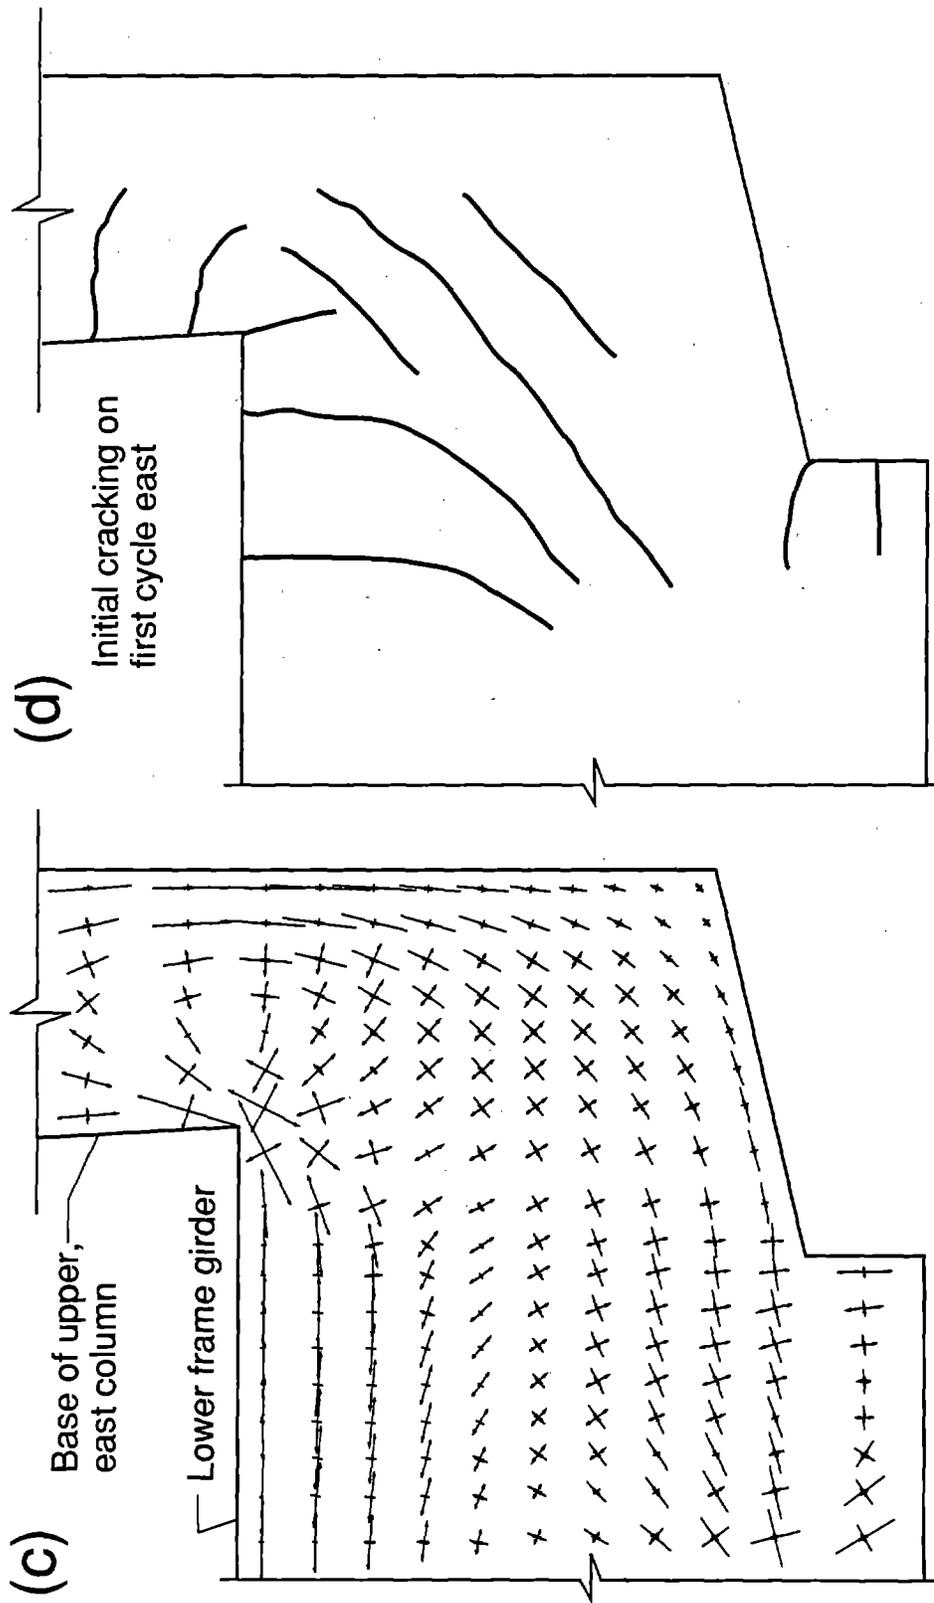
Figure 5.6.46(b) Displaced shape of Type 5 bent under applied loads showing zones of principal tensile stress sufficient to induce cracking.

Figure 5.6.46 (c) Principal stress tensors for pedestal region in Type 5 bent. Scale 0.25 inch = 650 psi (6.3 mm = 4.5 MPa).
(d) Predicted cracking during first half-cycle of lateral load.
