NIST Special Publication 778

*Performance of Structures During the
Loma Prieta Earthquake of October 17, 1989*

H. S. Lew, Editor

January 1990

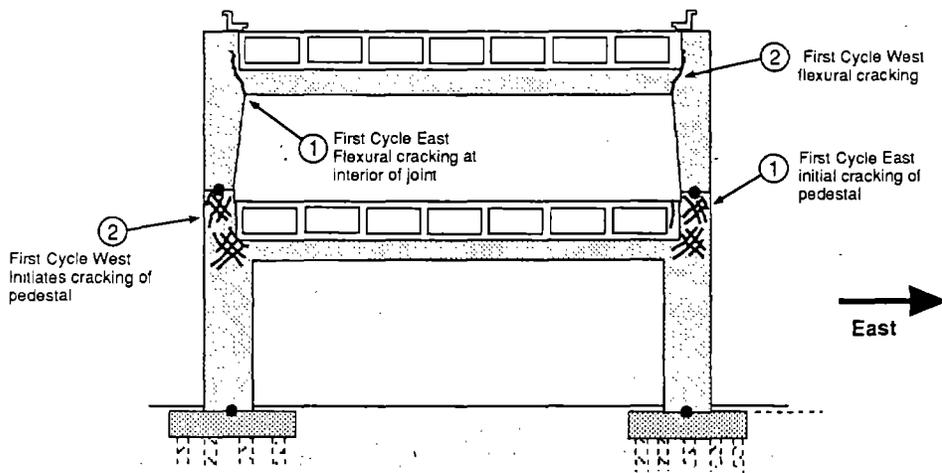
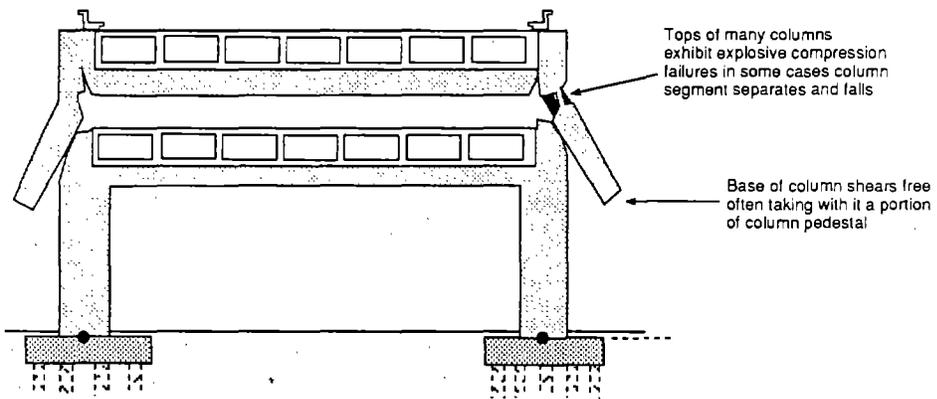
Figure 5.6.47 Top: Anticipated crack initiation sequence for Type 1 bents under lateral loading. Bottom: Observed failure mode for Type 1 bents at Cypress Structure.

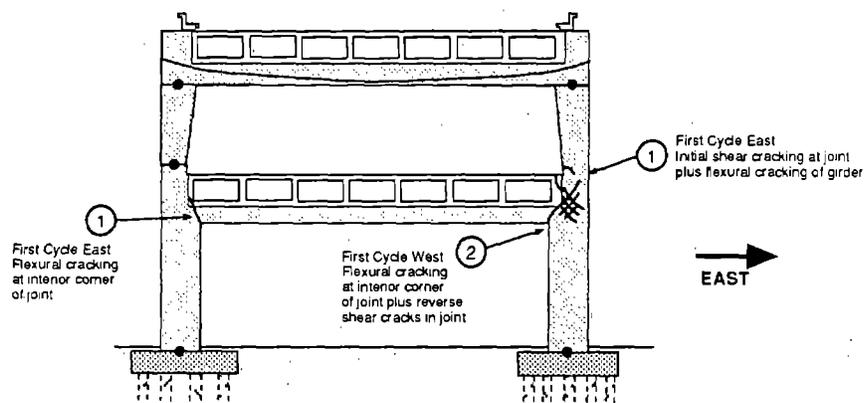
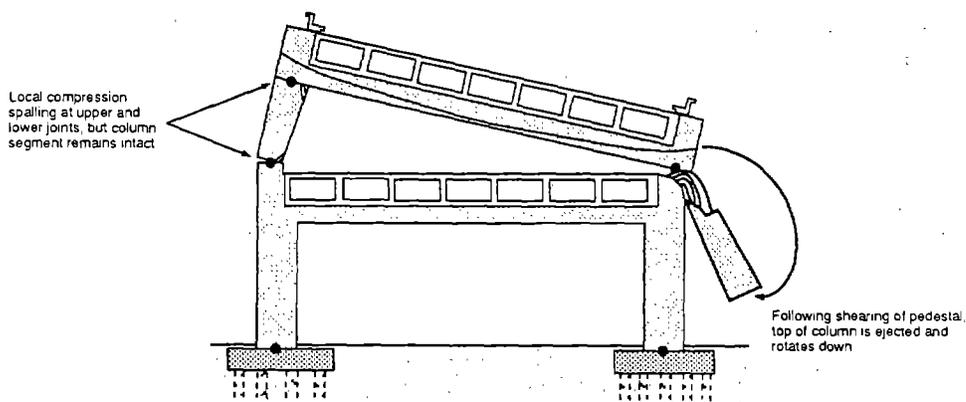
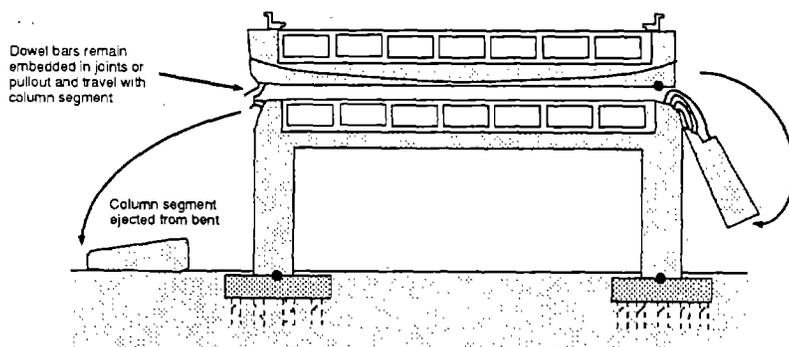
A close-up of the west side of Bent 72 shows the second, or Type B, variation of failure observed for Type 2 bents. In this case the entire double-hinged upper frame column segment has been ejected from the structure. The 4-#10 bars which passed through the upper and lower shear keys may be seen projecting from the base of the upper girder and the top of the lower column.

Figure 5.6.48 Top: Anticipated crack initiation sequence for Type 2 bents under lateral loading. Middle: Observed failure mode "A" for Type 2 bents at Cypress Structure. Bottom: Observed failure mode "B" for Type 2 bents at Cypress Structure.

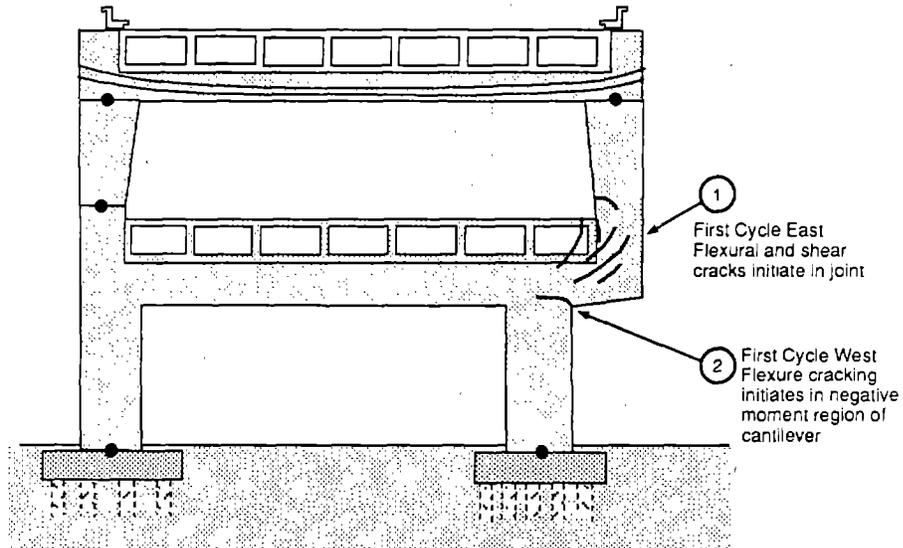
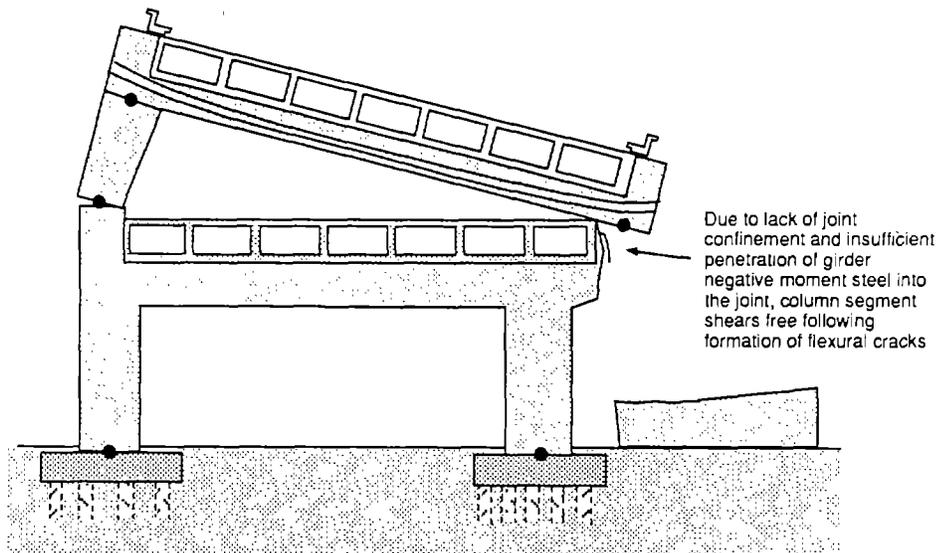
Figure 5.6.49 Top: Anticipated crack initiation sequence for Type 5 bents under lateral loading. Bottom: Observed failure mode for Type 5 bents at Cypress Structure.

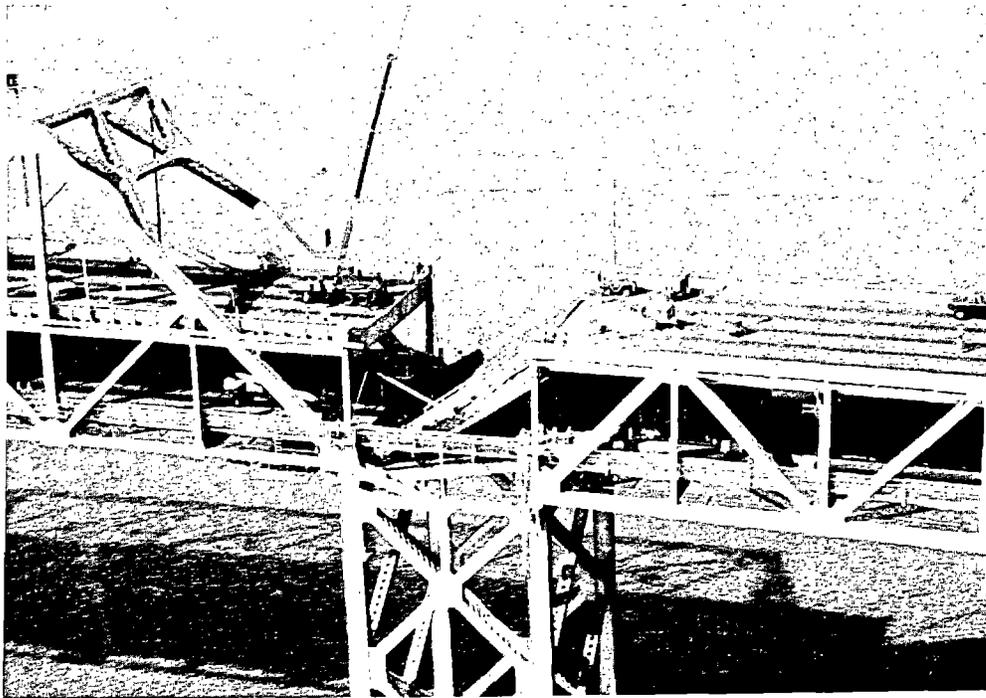
There was no apparent damage as a result of the earthquake to the west bay suspension bridges. First reports of the earthquake via the media, however, showed the dramatic collapse of the 50 foot (15 m) link spans at pier E-9 (see fig. 5.6.4), approximately halfway between Yerba Buena Island and the Oakland landing. Inspection revealed that both the upper and lower decks had simultaneously been pulled off their bearing seats as the truss east of pier E-9 moved, by Caltrans measurements, as much as 10 inches (250 mm) east during the first excursion of motion before returning 5 inches (130 mm) to the west, leaving a residual 5 inch (130 mm) eastward displacement. The western girder seats for the upper and lower bridge decks (see fig. 5.6.6) were simply supported configurations in which the bottom flange of the deck girders sat on a riveted angle bracket while two vertical angle brackets constrained movement of the girder web. The bearing seat was only 6 inches (150 mm) wide, so that when truss E9-E10 moved eastward both top and bottom decks slipped off their respective angle brackets and pivoted downward, landing as shown in figures 5.6.4 and 5.6.5. This mechanism is evident when viewing figures 5.6.7 and 5.6.8 which show closeup photos of the western bearing seats for the lower deck girders and the eastern hinge seat for the upper deck girders, respectively. There is practically no damage visible in figure 5.6.7 to the bearing seats, indicating that the girder flanges had cleared the edge quickly and fell away without any further impacting before the lower deck girders landed on a transformer station mounted on the utility deck on the north side of the bridge. The eastern deck girder supports for the link spans, which were in contrast bolted to the girder, were severely distorted (fig. 5.6.8) and in some cases torn loose. It has been suggested that were it not for the presence of the transformer station both spans would likely have torn

free from the girder restraining bolts and fallen into pier E-9, causing far greater damage⁶. During the fall the upper deck cut through several power and communication lines and additionally severed a water main on the south side, but otherwise the damage was confined to the decks themselves.

Figure 5.7.4 Aerial photo looking north at Pier E-9 on October 19, 1989 showing the collapsed upper and lower 50 foot deck spans.

and that there was some elastic rebound from pier E-10⁷. Within 4 weeks of the quake, Caltrans had replaced the deck girders for the pier E-9 link spans, placed precast concrete panels between them, cast the composite deck, and reopened the bridge for traffic. The 40 1 inch (25 mm) bolts connecting the E-9/E-10 truss shoes to the eastern column tops of pier E-9 were replaced with high strength bolts. Whether this is to the advantage of the bridge during future earthquakes is subject to review. Opinions have been expressed by some⁸ that the shearing of these bolts served as a fuse, isolating pier E-9 from otherwise large lateral loads which could have led to disastrous column buckling.

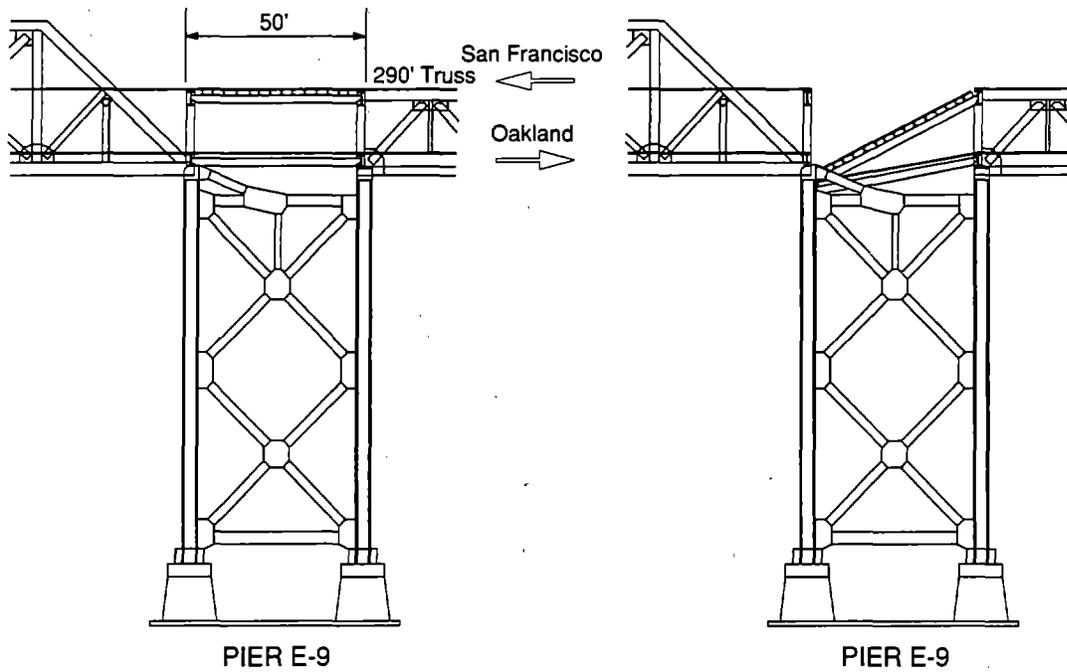
Figure 5.7.5 Schematic detail of Pier E-9 looking north. Evidence indicates that the 290 foot truss segment on the east side of the pier moved eastward, simultaneously unseating both Upper and lower deck segments.

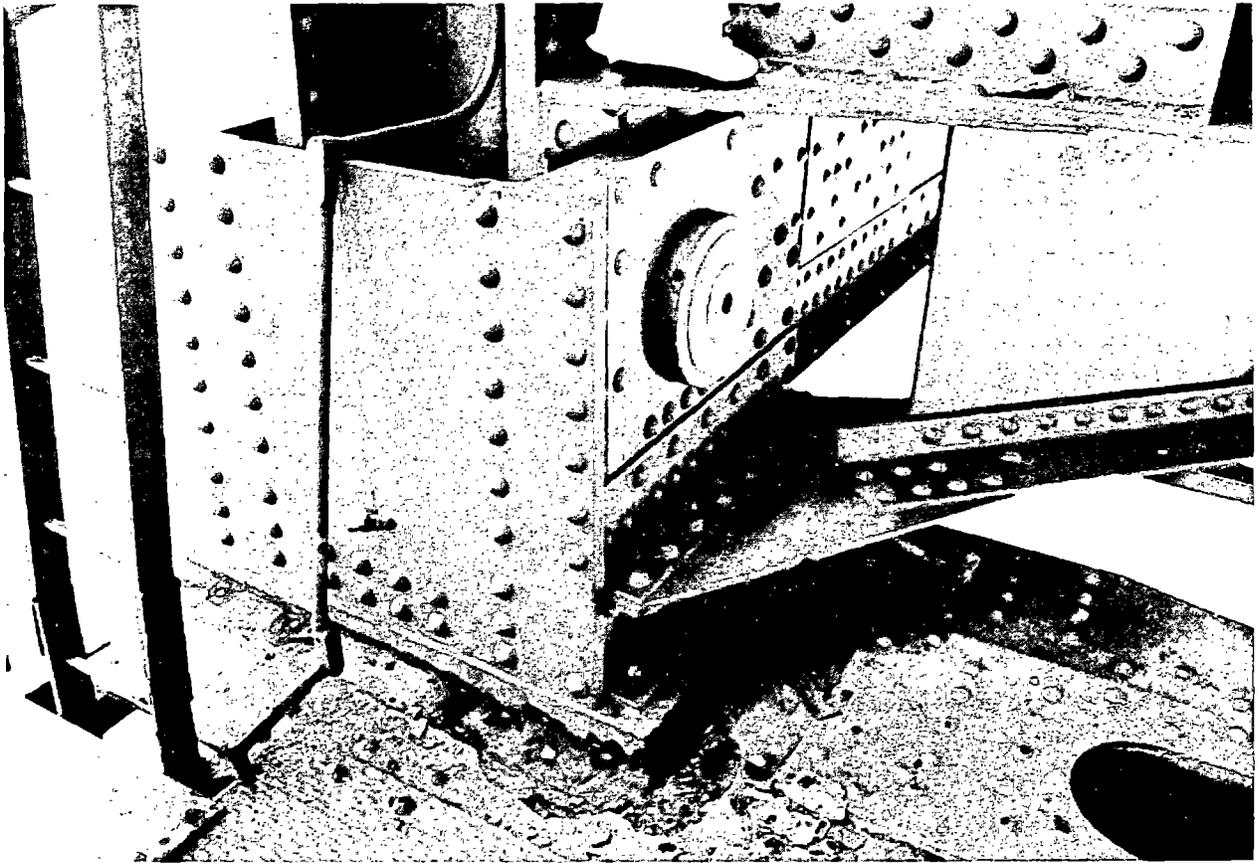
Figure 5.7.9 Close-up of the northeast shoe for the 290 foot truss between Pier E-9 and E-10. During the earthquake this truss moved eastward as much as 10 inches before returning to leave a 5.5-inch residual displacement to the east and 5/8-inch to the north.

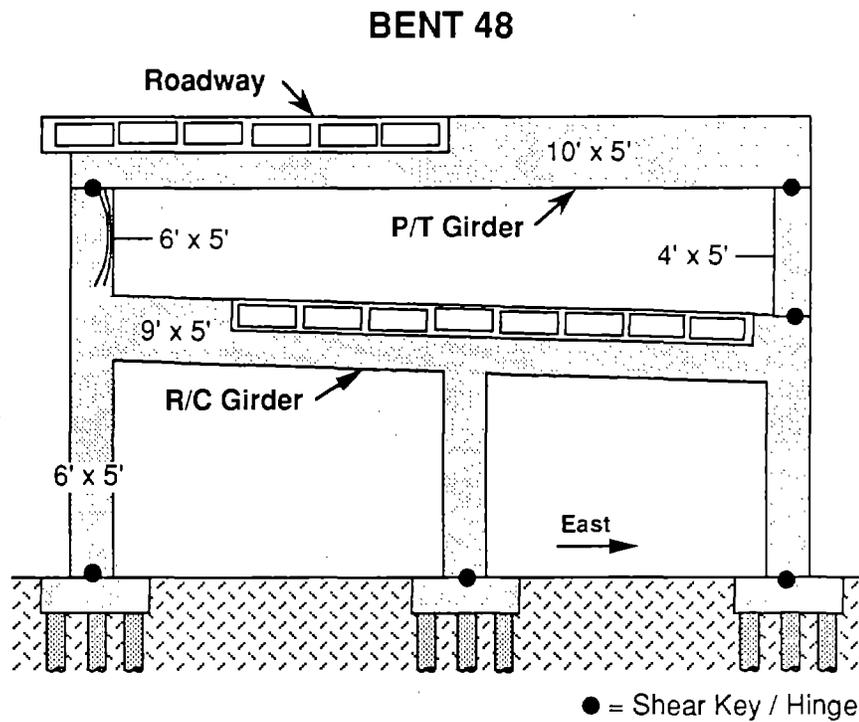
Figure 5.9.3 is a schematic elevation view (looking north) of Bent 48. The top girder is post-tensioned and supports at the columns are designed as pinned connections, with details similar to those used on I-880. The column reinforcement includes #18 longitudinal bars and #4 ties at 12 in. (0.30 m) spacing. The damage occurred at the top of the west-side column. Figure 5.9.4 shows the nature of the damage, which appears to be a combination of diagonal tension failure and splitting parallel to the longitudinal column steel. Note that the girder is permanently displaced toward the east.

Figure 5.9.3 Schematic elevation view of Bent 48 of I-280 (looking north).

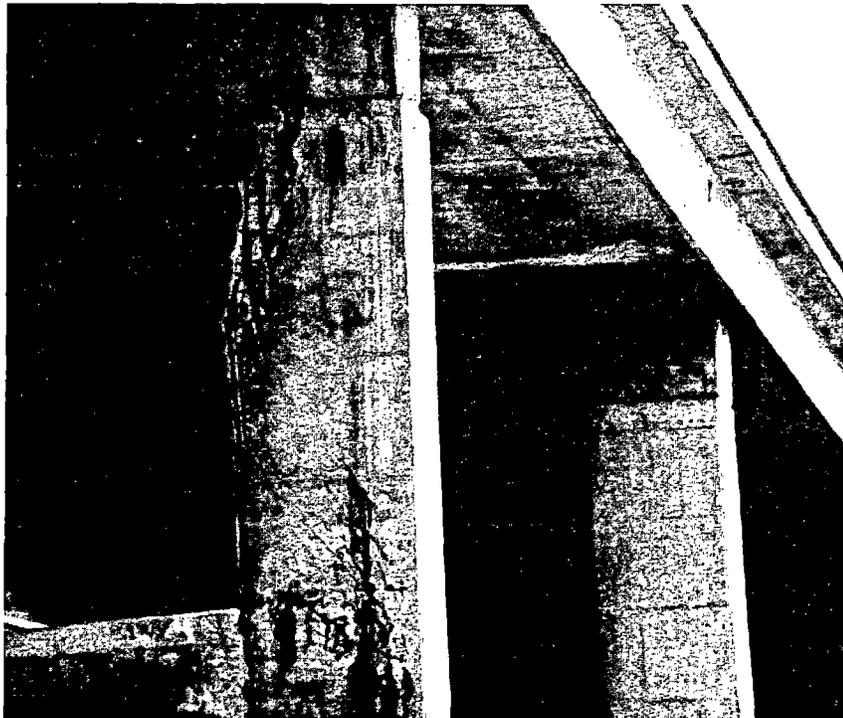
Figure 5.9.4 Damage to west-side column of Bent 48 (looking toward south).

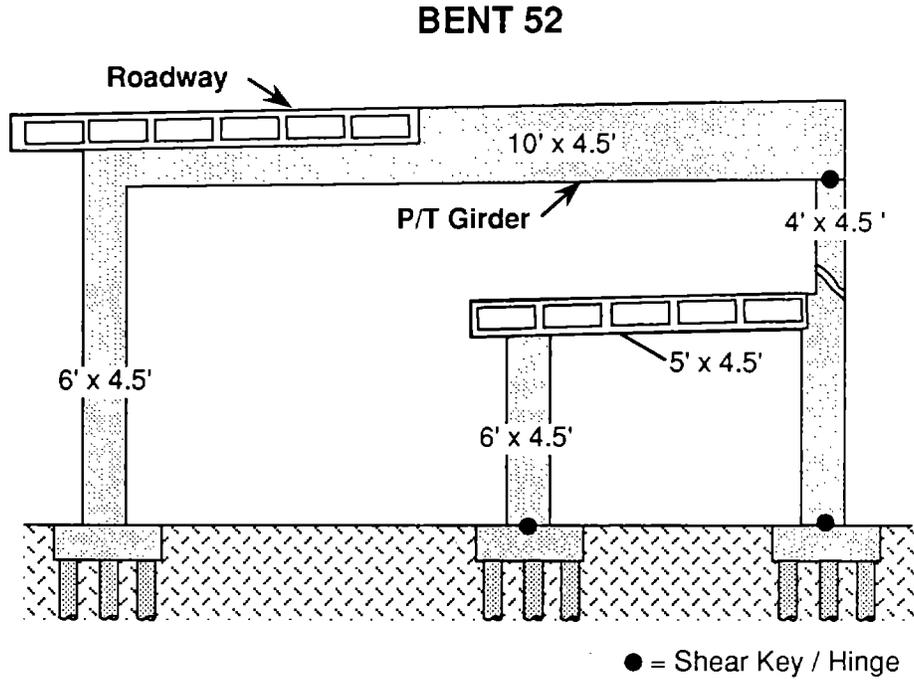
Figure 5.9.5 is a schematic elevation view of Bent 52. The configuration of Bent 51 is similar. The upper, post-tensioned girder is monolithic with the column on the west side and is supported as a pinned connection on the east side. Figure 5.9.6 is view (looking south) as seen from the lower northbound lanes; the upper girder of Bent 52 is in clear view. Damage occurred to the east-side columns of Bents 51 and 52 at approximately the elevation of the roadway. Figure 5.9.7 shows the damage in Bent 52 as it appeared on the northern column face. The damage in Bent 51 was similar as can be seen in figure 5.9.8, which shows that southern column face. Figure 5.9.9 is a close-up view of the damage zone in Bent 51. It is seen that the concrete is extensively fractured and the #4 ties lost their effectiveness because of the inadequate anchorage provided by the 90-degree hooks. The corner #18 bar also appears to have buckled.

Figure 5.9.5 Schematic elevation view of Bent 52 of I-280 (looking north).

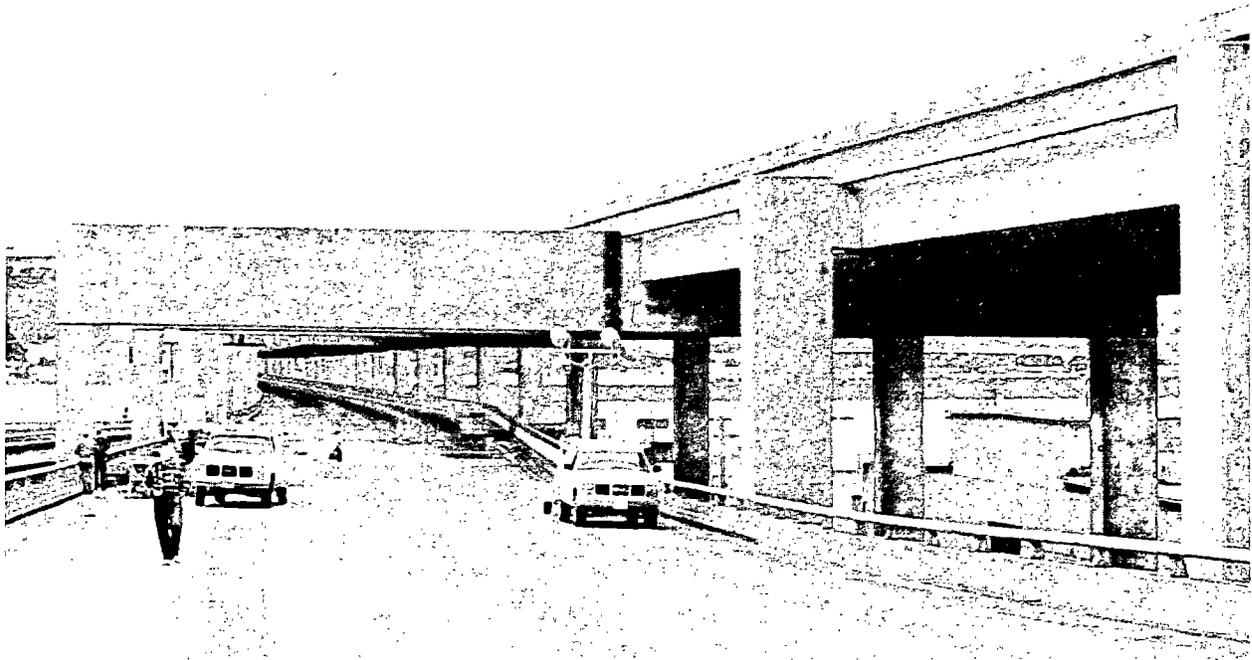
Figure 5.9.6 View looking south on I-280 showing the upper girder of Bent 52.

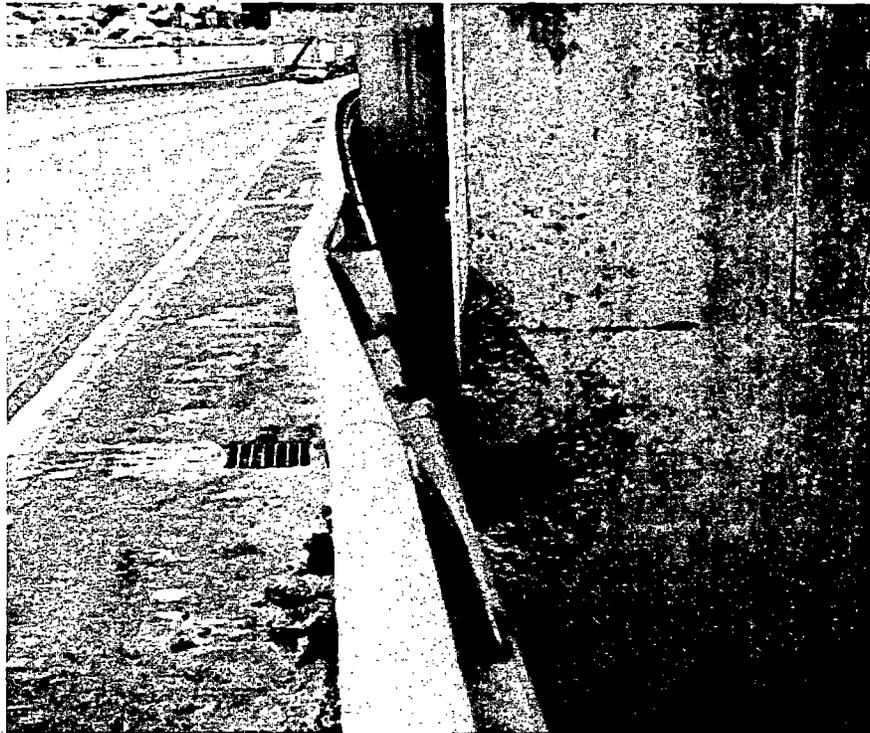
Figure 5.9.10 Pounding damage at I-280 south of Army Street.

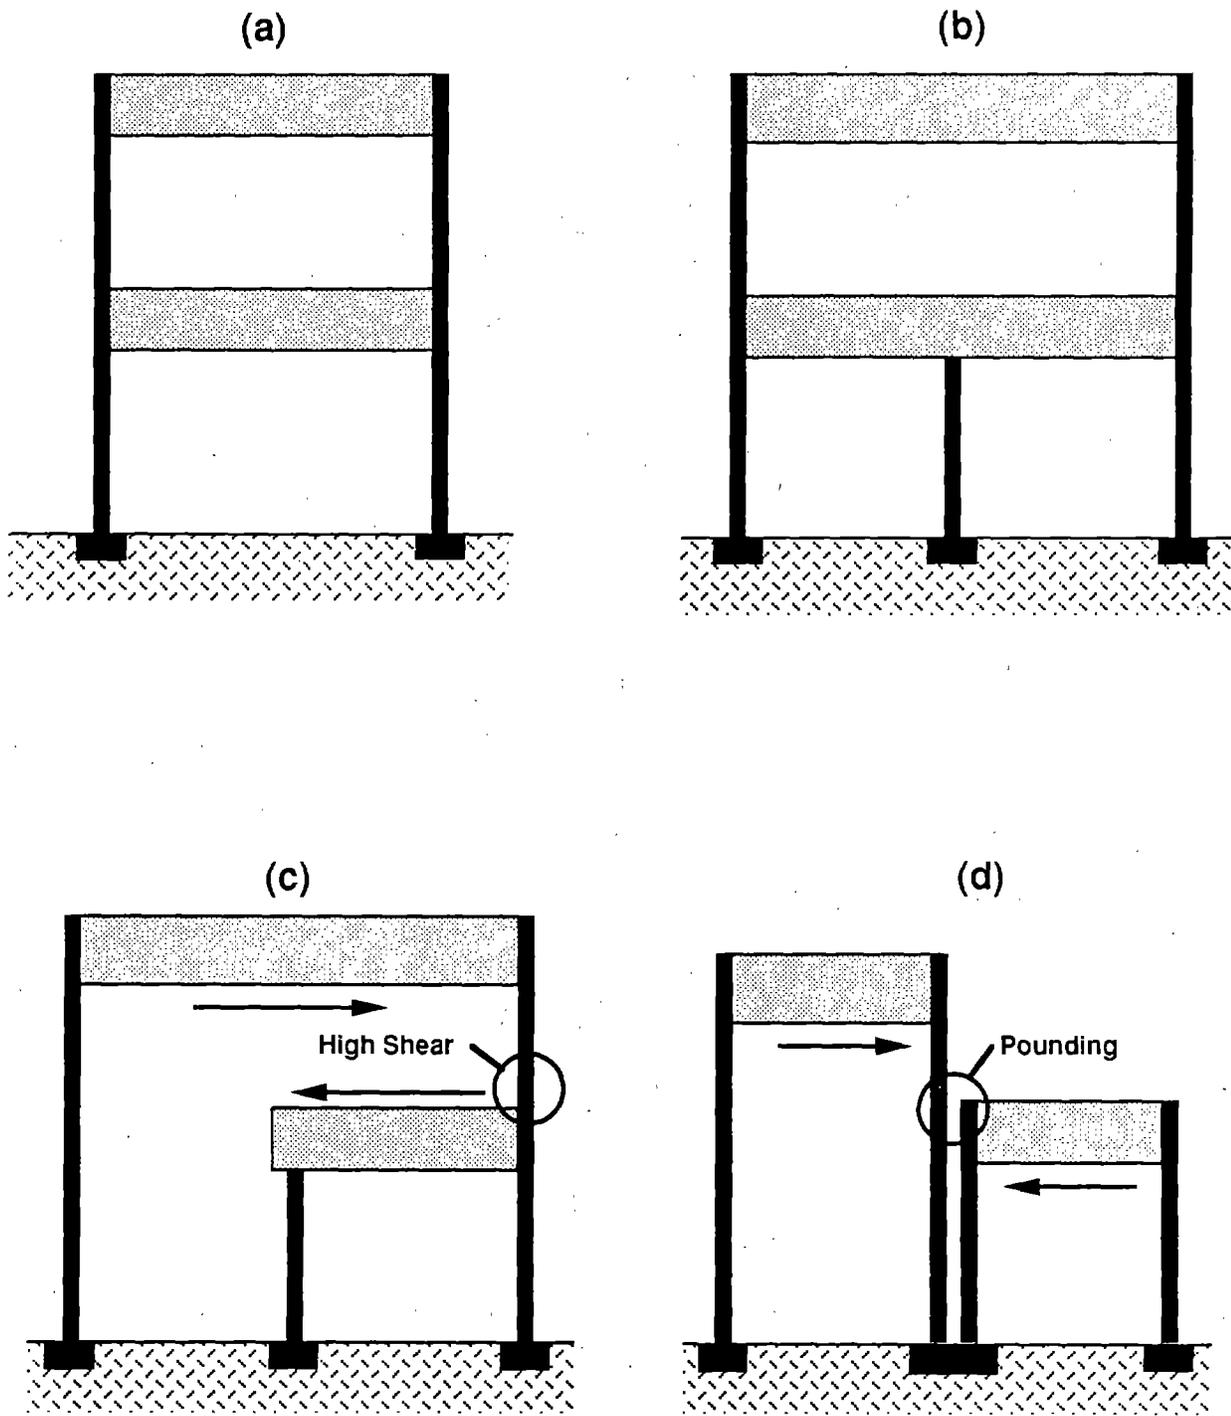
Figure 5.9.11 Schematic illustration of the various structural configurations as I-280 undergoes transition from a two-level to a single-level elevated highway.

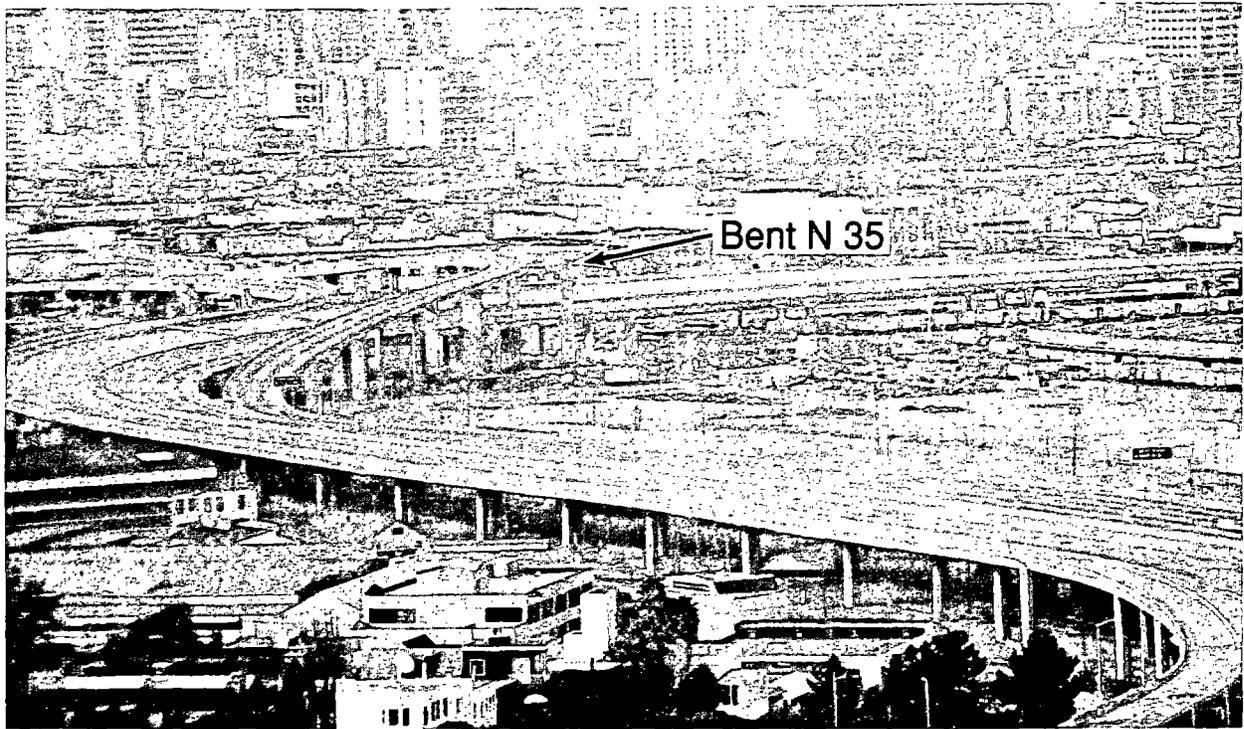
Figure 5.9.12 Aerial view of the Sixth St. exit of I-280.

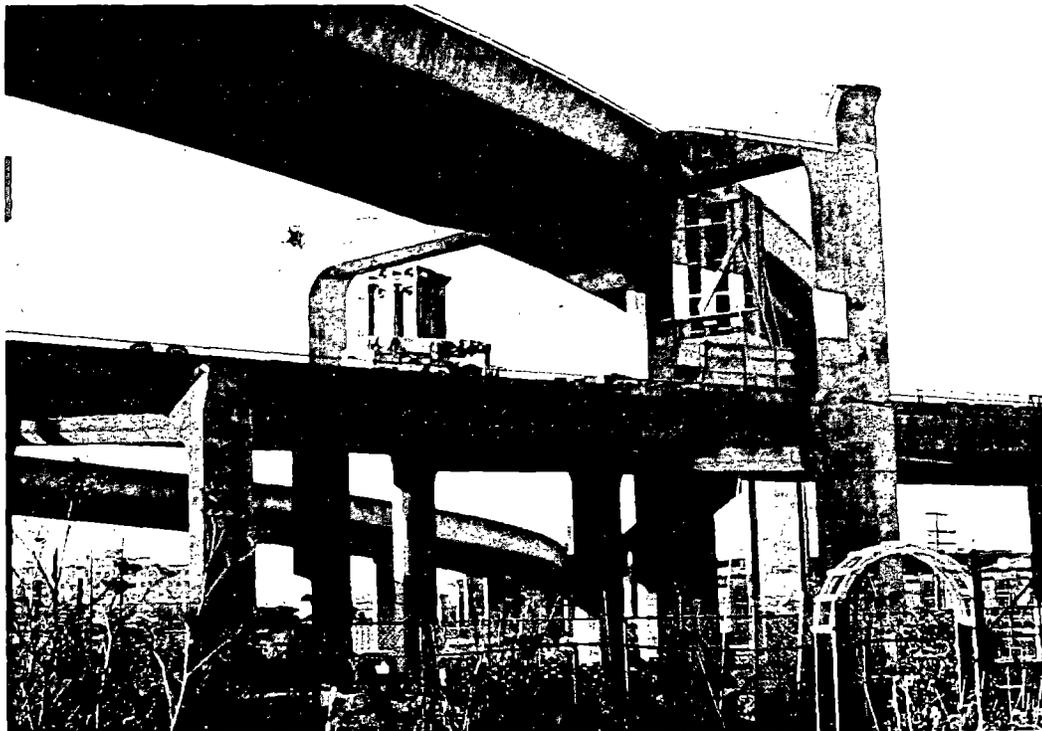
Figure 5.9.13 The Sixth St. exit ramp where it passes over the northbound lanes of I-280. (View is toward west; cribbing was added to provide temporary support.)

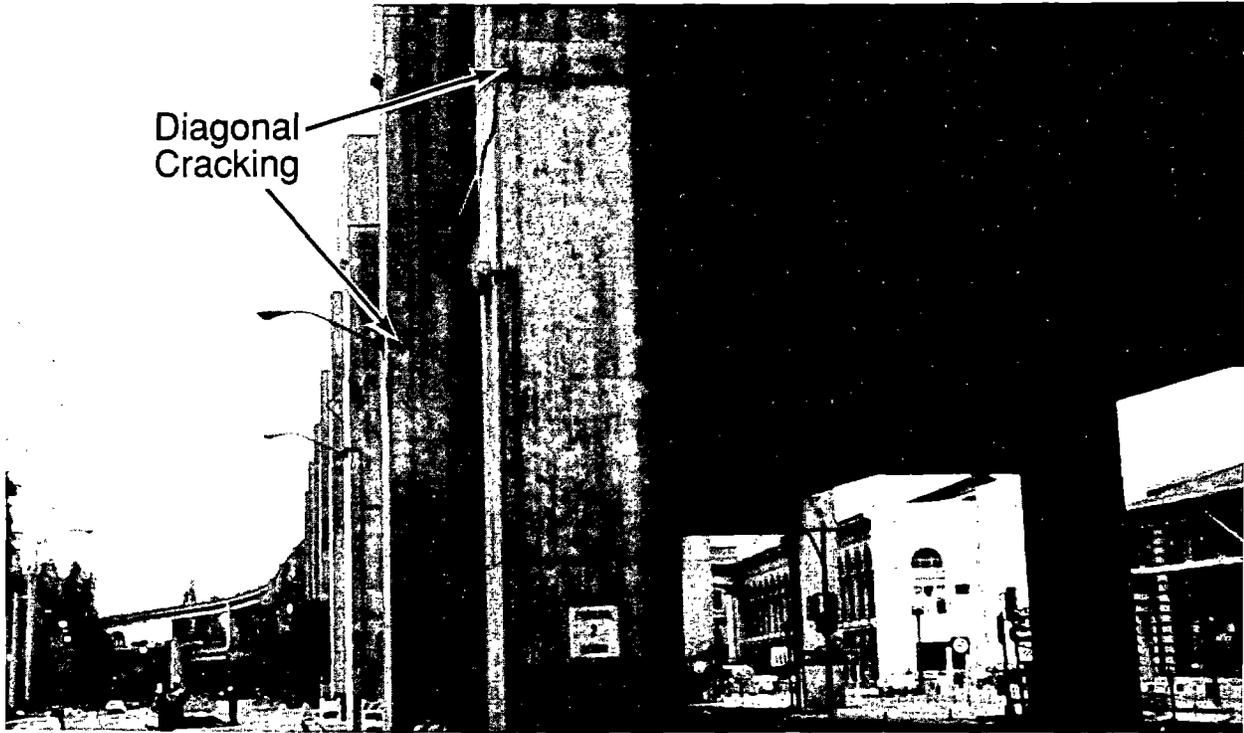
Figure 5.10.2 is a ground-level view looking north along the west side of the freeway; Bent 76 is in the foreground. The vertical metal covers which can be seen at the top girder-column joints protect restraining tendons which were added during the earthquake upgrading in 1972. Figure 5.10.3 is a ground-level view from the east side looking north; Bent 78 is in the foreground. Mission Street is located between Bents 78 and 79 (numbers increase toward the north). The observed damage occurred at the lower girder-column joints in bents located north and south of Mission Street.

Figure 5.10.2 West side of Embarcadero Freeway south of Mission St., Bent 76 is in foreground.

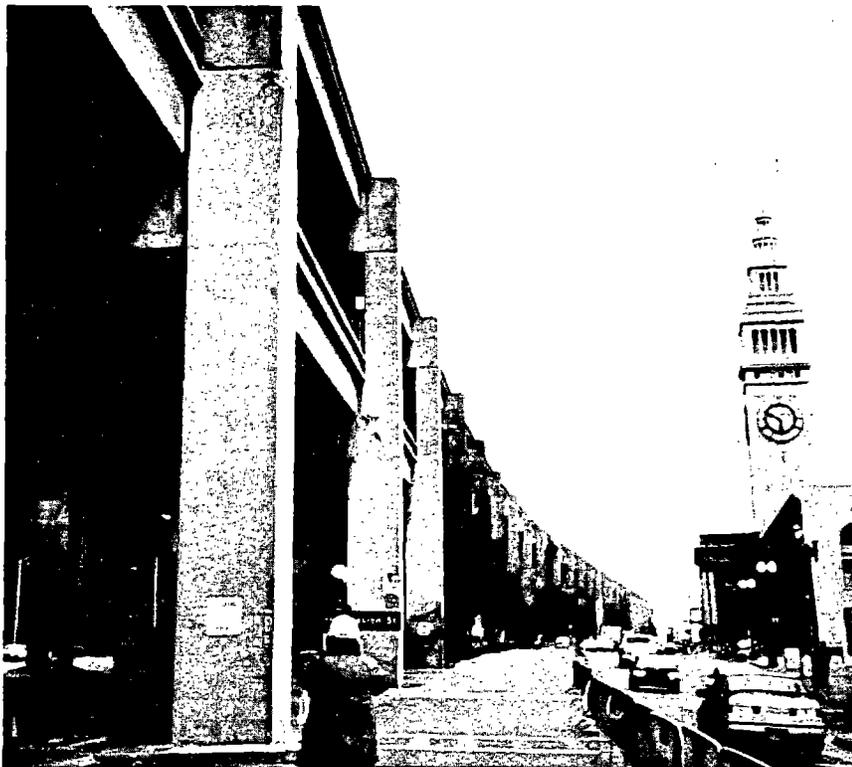
Figure 5.10.3 East side of Embarcadero Freeway at Mission St., Bent 78 is in foreground.

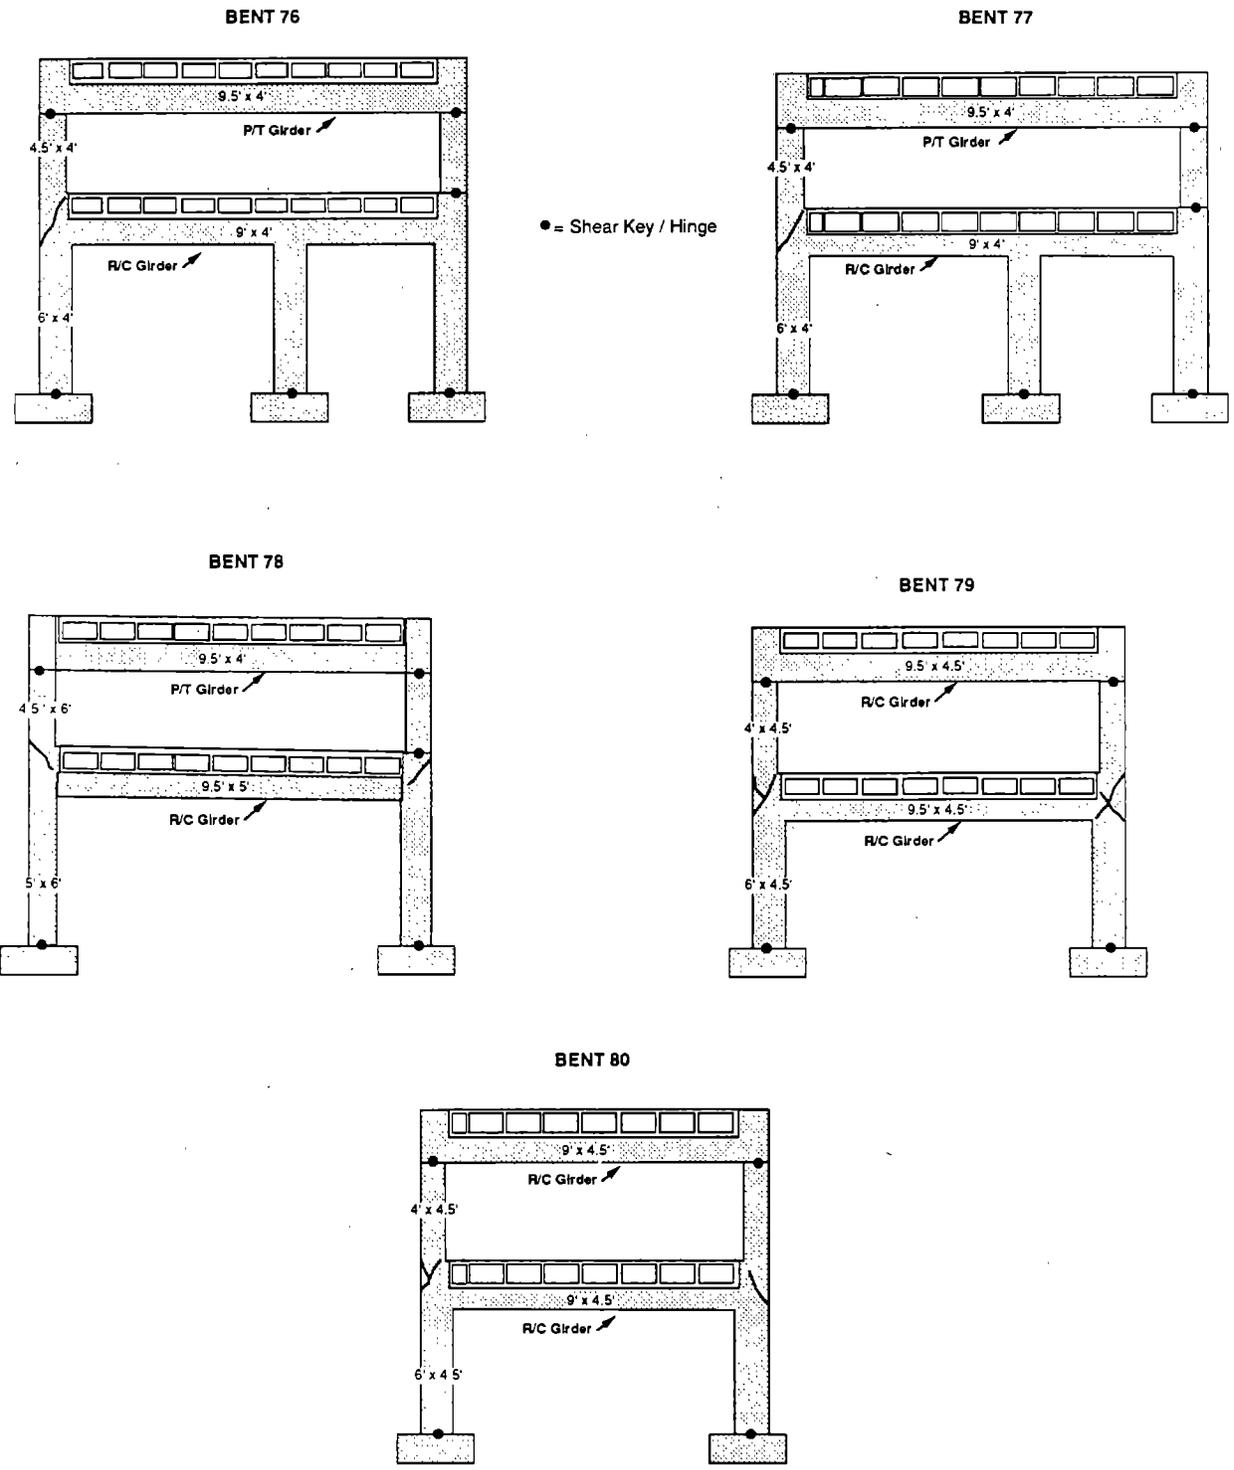
Figure 5.10.4 shows the configurations of the bents to the north and south of Mission Street. As can be seen at the bottom of the aerial photograph in figure 5.10.1, the Embarcadero Freeway undergoes a transition in width south of Mission Street, and this is the reason for the different bent configurations. For the wide portion of the freeway, the upper girder is post-tensioned and supported on pinned joints. A detail similar to that used in the design of I-880 was used for the pinned joints. Likewise, for bents with post-tensioned girders, column segments were pinned at both ends on one of side of the bent. The predominant damage was in the form diagonal cracking within the lower girder-column joint, as indicated by the heavy lines in figure 5.10.4. This indicates that the weakness of the Embarcadero Freeway is similar to that of the collapsed portion of I-880. In no cases were the cracks as severe as those observed in the columns of I-280.

Figure 5.10.4 Schematic of bent configurations and damage at lower girder-column joints.

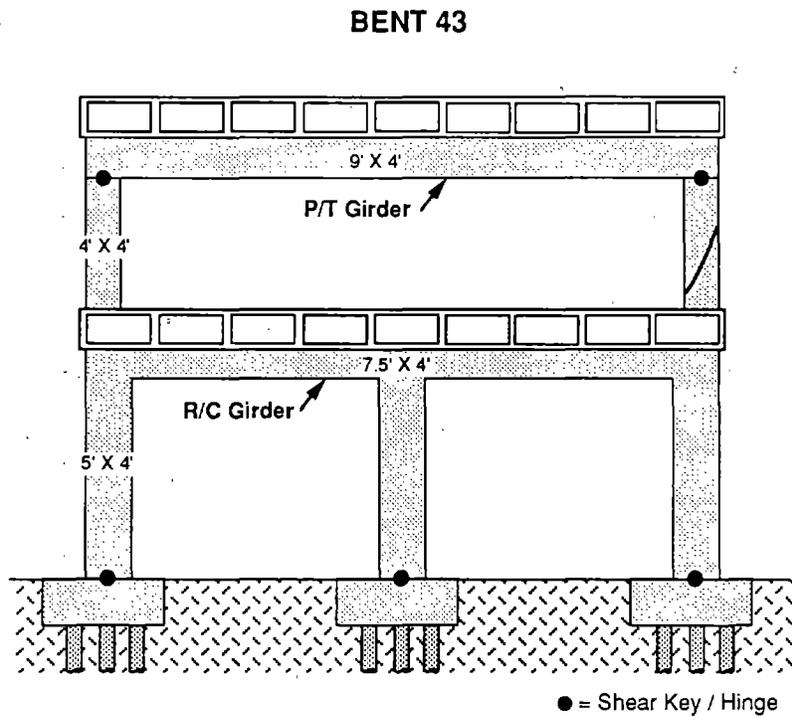
The damaged portion of U.S. 101 is similar in design to the other damaged highway structures that have been discussed. The minimal transverse column reinforcement provided little shear strength for the columns. Further analysis is needed to explain why failure was concentrated within the columns rather than the girder-column joint, as was observed in other damaged elevated highways of similar design.

Figure 5.11.2 Schematic of Bent 43, which had the more severe damage.
