NBSIR 82-2593

Investigation of Construction Failure of the Riley Road Interchange Ramp, East Chicago, Indiana

October 1982

**INVESTIGATION OF CONSTRUCTION
FAILURE OF THE RILEY ROAD
INTERCHANGE RAMP, EAST CHICAGO,
INDIANA**

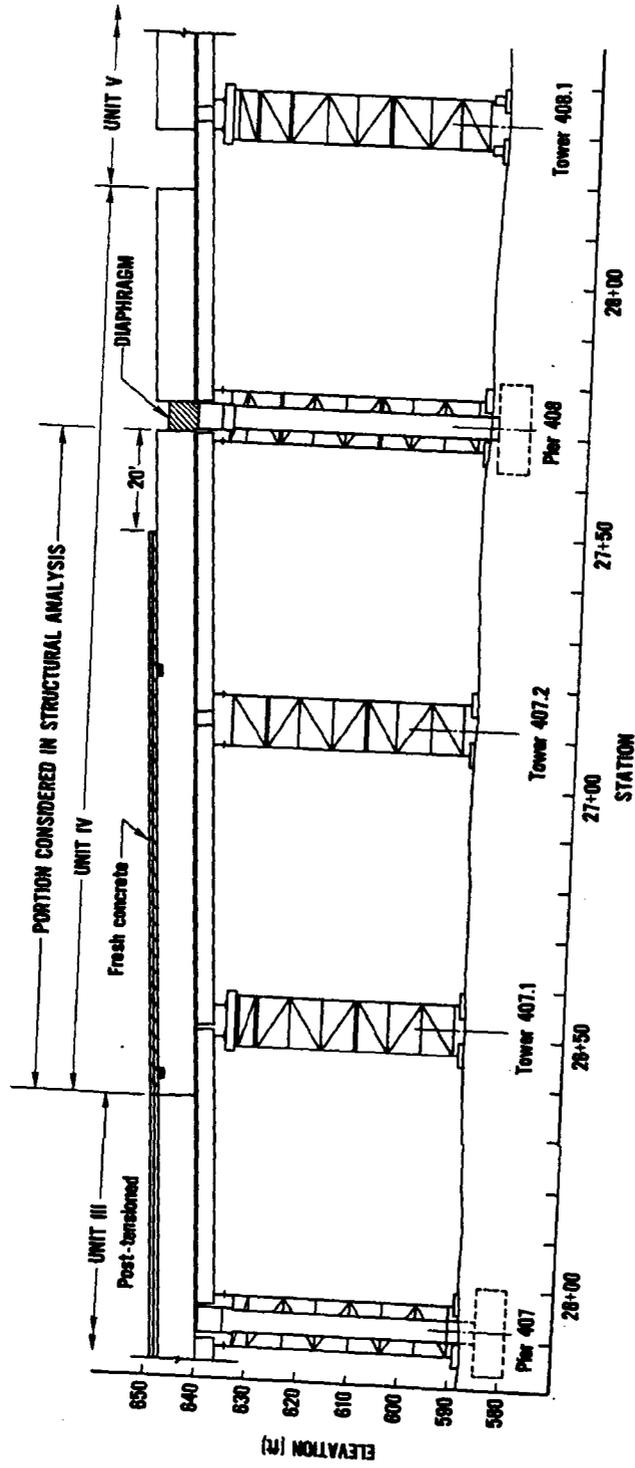
Figure 2.13 State of construction at the time of the collapse

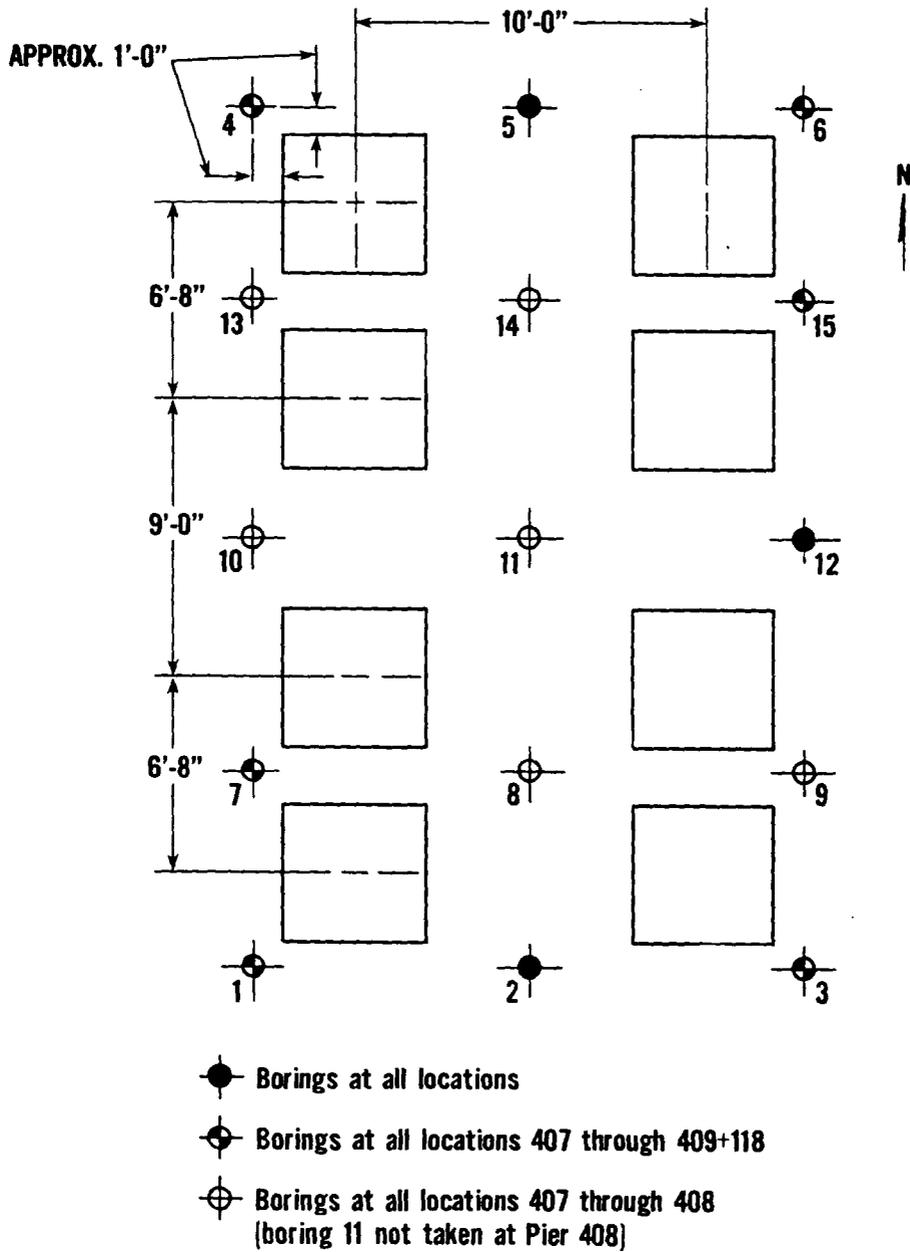
Soil test borings were made along Ramp C after some of the collapse debris had been removed, and the IOSHA provided NBS with the boring data. Soil borings were taken at each tower location from 403.2 to 409.2 as indicated in figure 3.2. In most instances, the soil test borings were 15 ft (4.6 m) deep and samples were taken at 2 ft (0.6 m) intervals using a 2-in (51-mm) outside diameter split spoon sampler. Blow counts from the Standard Penetration Test (ASTM D 1586-67 (1974)) were obtained. Other holes were bored to a depth of 25 ft (7.6 m) or 35 ft (10.7 m) with the samples taken in the same manner. The samples were placed in sealed jars and stored at the project site.

Figure 3.2 Position of soil borings at each tower location

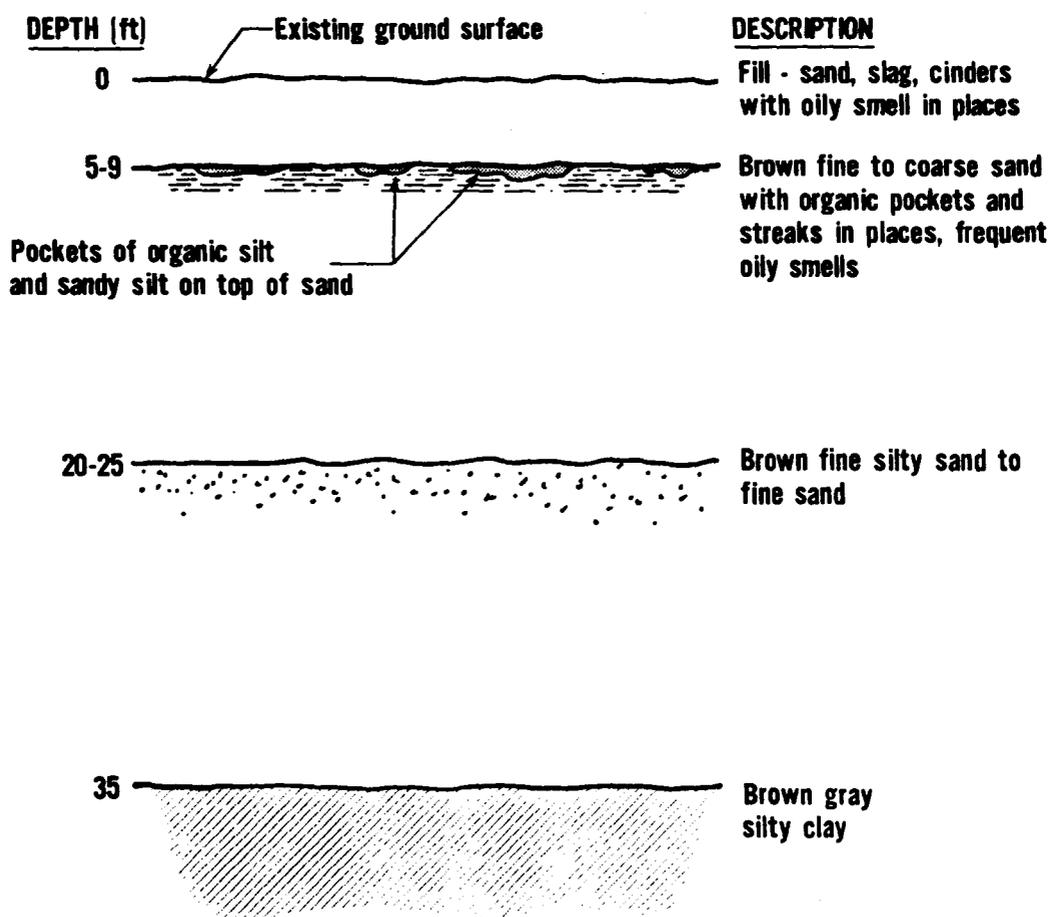
Figure 3.3 depicts the general subsoil condition derived from the sample examinations. It indicates that the ground is covered by a layer of fill 5 to 9 ft (1.5 to 2.7 m) in thickness. The fill is composed of dark brown and gray cinders and slag, sometimes mixed coarse sand and having an oily smell in places. Blow counts from the fill were scattered, and in some places refusal was marked on the field log indicating that difficulties were encountered during sampling. In some other holes, the blow counts were low (<10) indicating that the fill was loosely placed. Below the fill and to a depth of 20 to 25 ft (6.1 to 7.6 m) there is a layer of medium dense to dense brown fine to coarse sand. Pockets of saturated and highly compressible black organic silt and sandy silt, or dark brown sand with streaks of black organic material, were found just below the fill. The organic pockets were estimated to be 1 to 2 ft (0.3 to 0.6 m) in thickness and frequently had an oily smell. Below the sand layer, there is a layer of medium dense to dense brown fine silty sand to fine sand of 10 to 15-ft (3 to 4.6-m) thickness underlain by a stiff brown-gray silty clay to the depth explored.

Figure 3.3 Typical soil profile between tower locations 407.1 and 408 (except adjacent to pier 408)

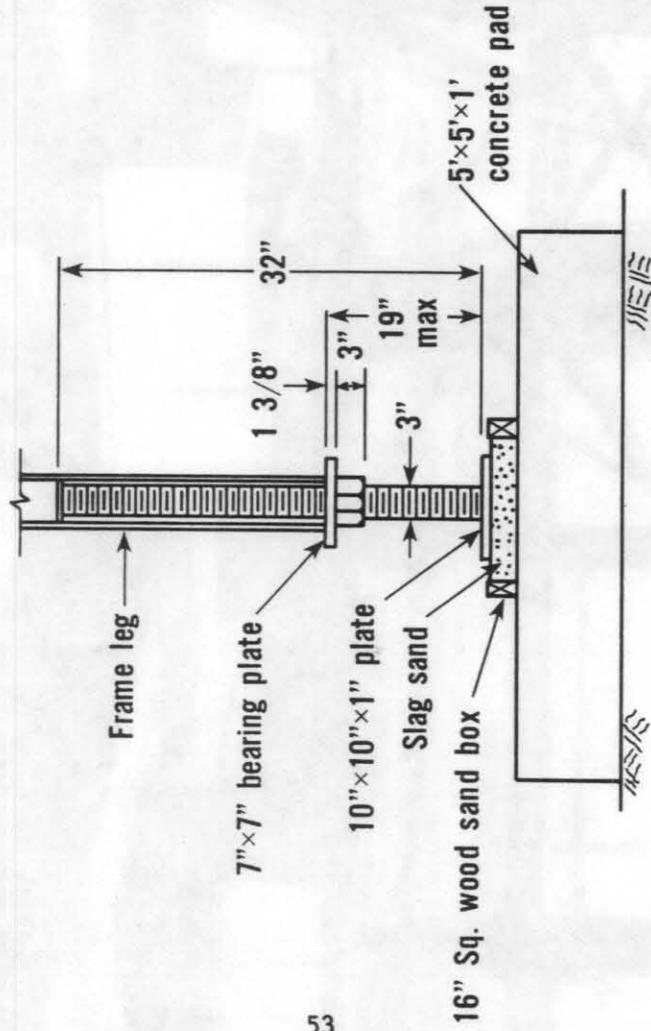
Figure 3.4 Typical support system for shoring tower leg

The lower screw jacks of the shoring towers did not bear directly on the concrete pads (see figure 3.4). According to the structural drawings, the jacks were to rest on circular, metal, sand boxes made of 16-in (41-mm) diameter pipe welded to a 1/4-in (6-mm) steel plate. Field inspections revealed that from tower locations 403.2 to 408.1 (N), the specified sand boxes were not used. Instead, the contractor substituted wood boxes made from ordinary 2 x 4 lumber and an aluminum sheet-metal base. Figure 3.4(b) shows a wood sand box from location 406-H. At some tower locations wood cribbing of nominal 12 x 12-in (305 x 305-mm) cross section was used beneath the boxes. The cribbing was needed to achieve the correct elevation at the top of the shoring towers.

As will be discussed in section 3.3, problems arose with the wood sand boxes and as a result metal banding, as seen in figure 3.4(b), was added as a remedial measure. Banding was reportedly used to prevent the boxes from lifting off the cribbing and to prevent the boxes from spreading laterally during loading. In cases where the sand boxes rested directly on the concrete pads, the hold down was achieved by wedging two pieces of lumber between the bearing plate and two other pieces of lumber laid across the top of the box. In the region between piers 407 and 408, it was determined that cribbing was used only at tower 407.1(S), and at the other locations the sand boxes rested directly on the concrete pads. Figure 3.5 is a view of location 407.1 as it appeared about one month before the accident. The photo was taken by an official of the Federal Highway Administration during an inspection of the construction in mid-March, 1982.

b) Example of wood sand box

a) Lower screw jack dimensions

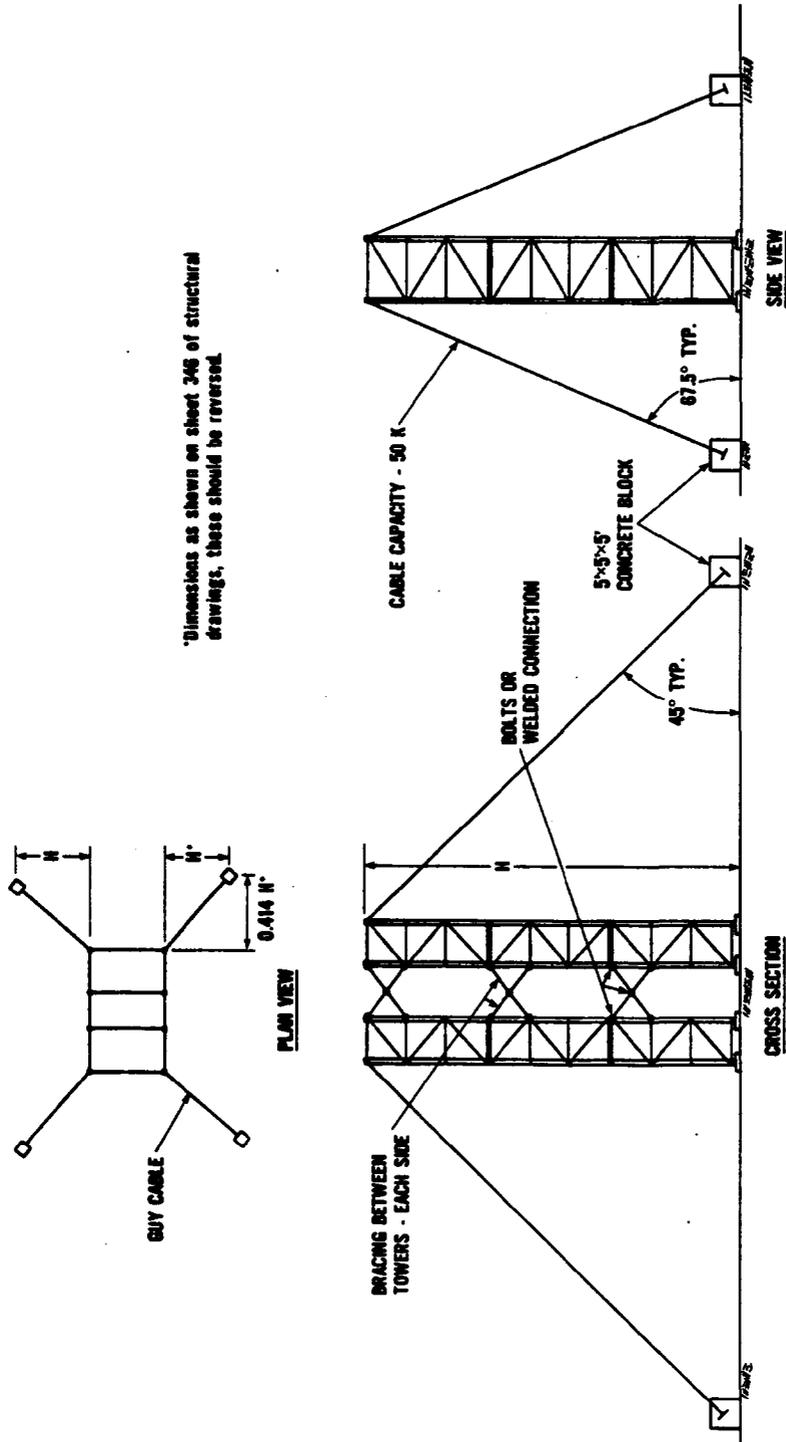
*Dimensions as shown on sheet 346 of structural drawings, these should be reversed.

Figure 3.12a External guying system for shoring towers specified originally in the structural drawings

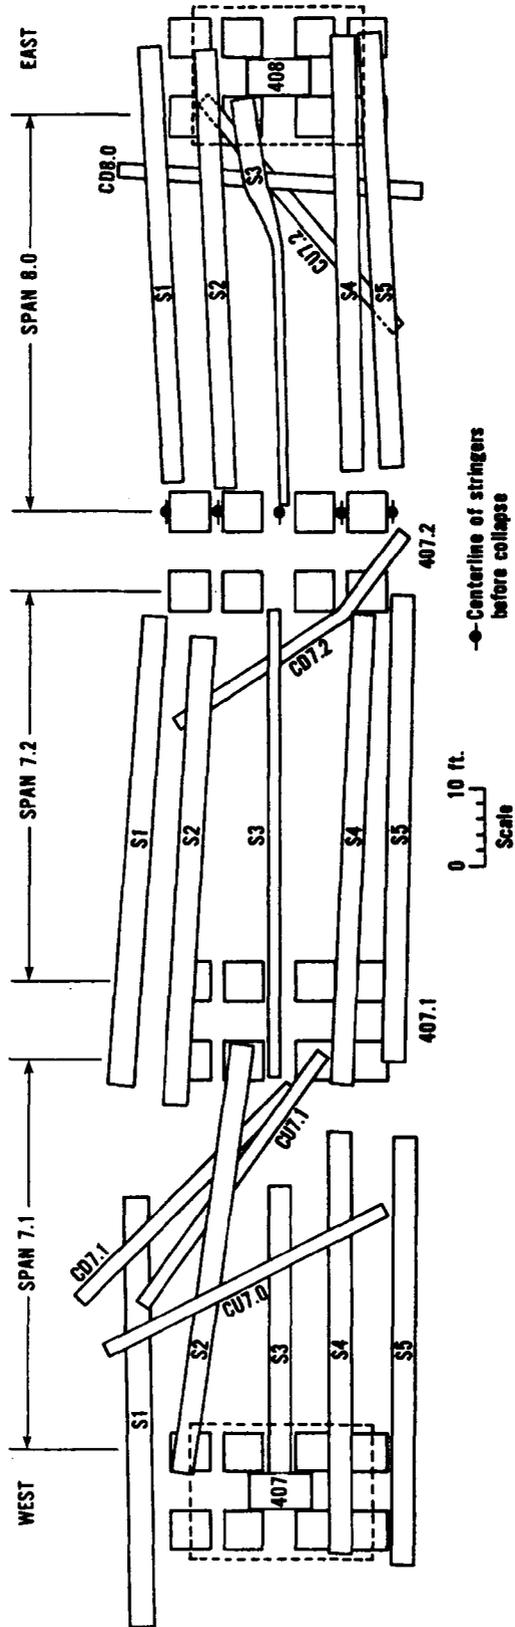
Figure 3.17 Location of crossbeams and stringers after the collapse

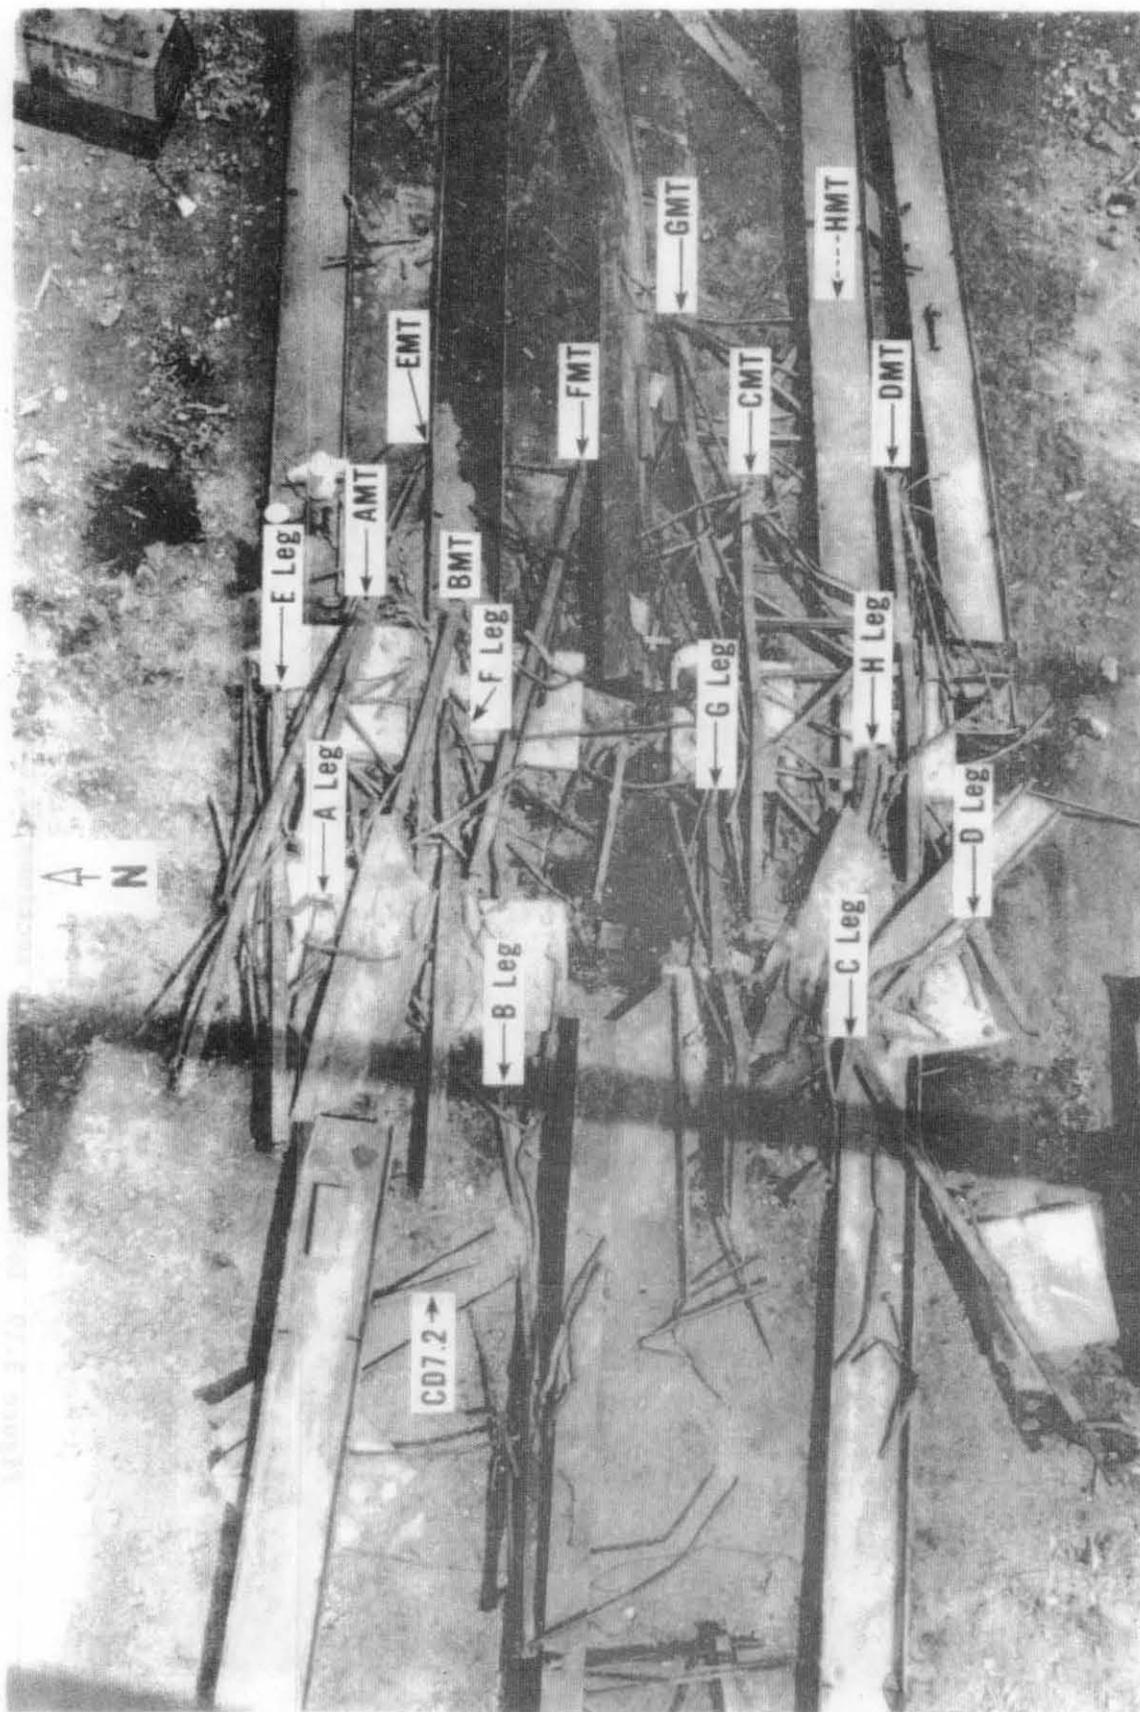
Figure 3.18 Location of various parts of the shoring towers at 407.2

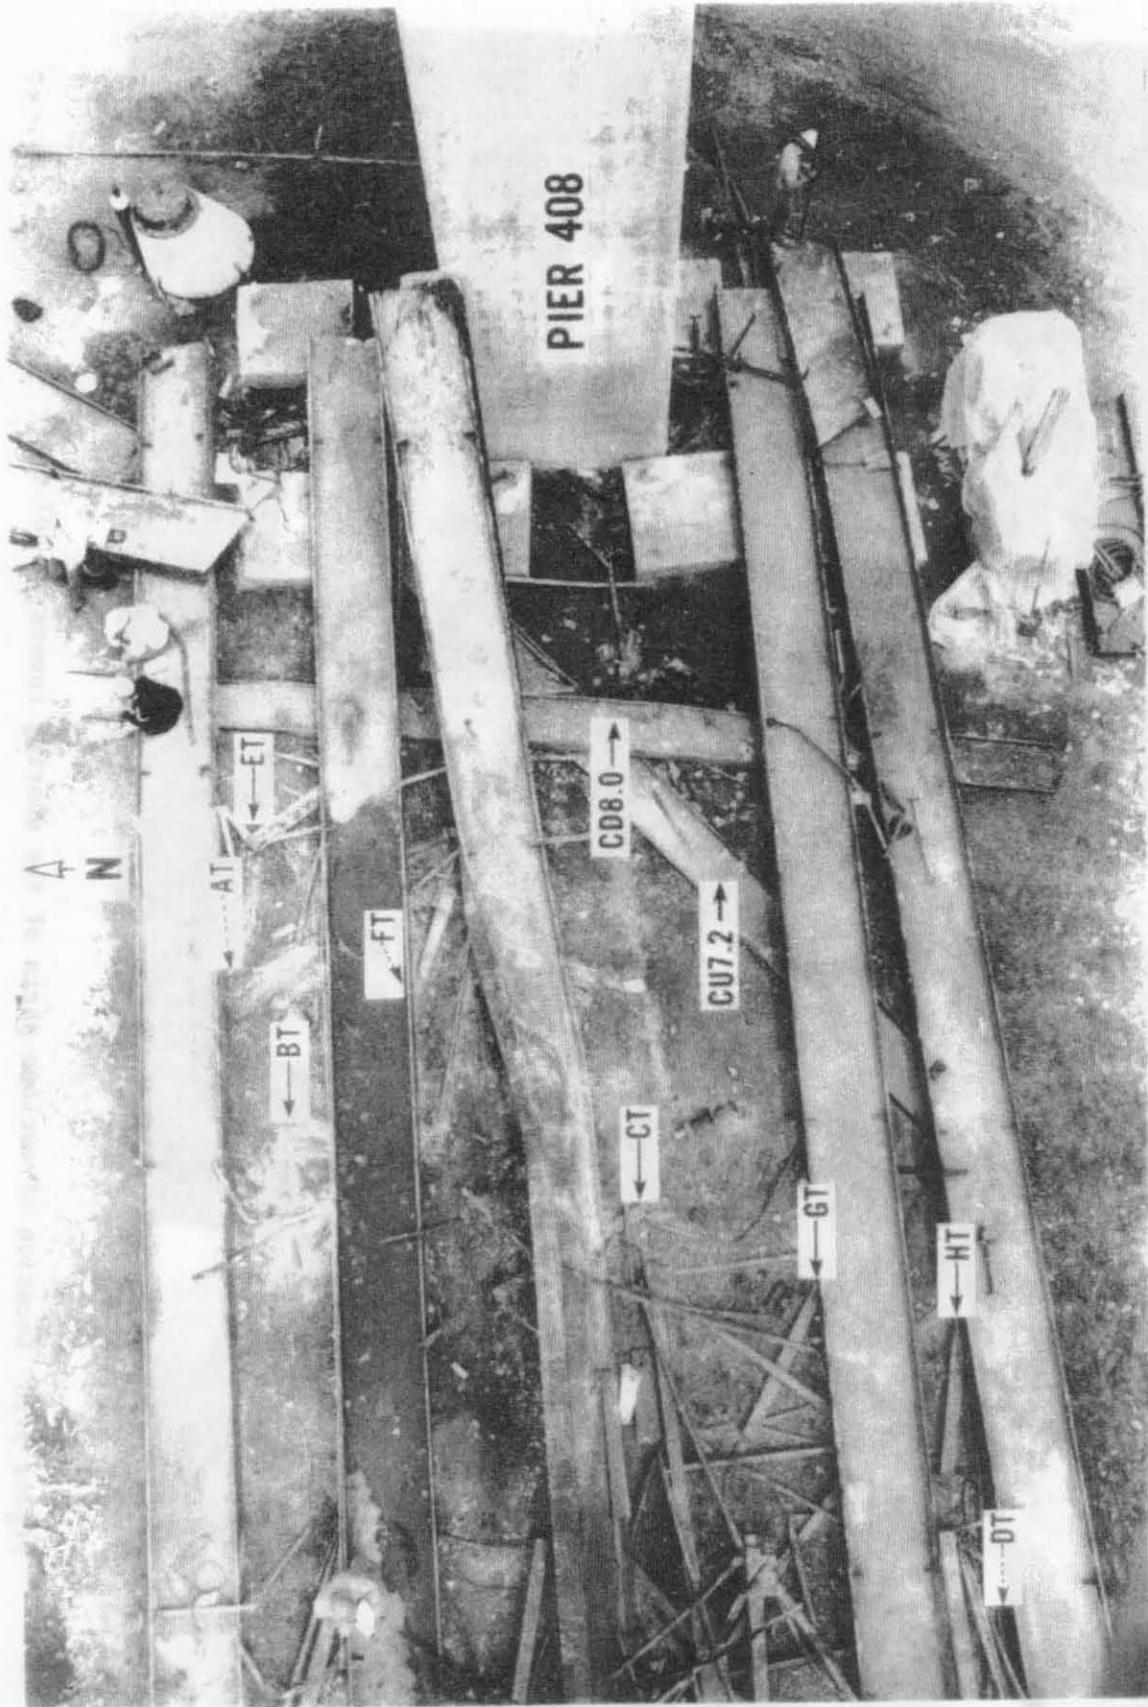
Figure 3.19 Location of the top sections of the shoring towers at 407.2

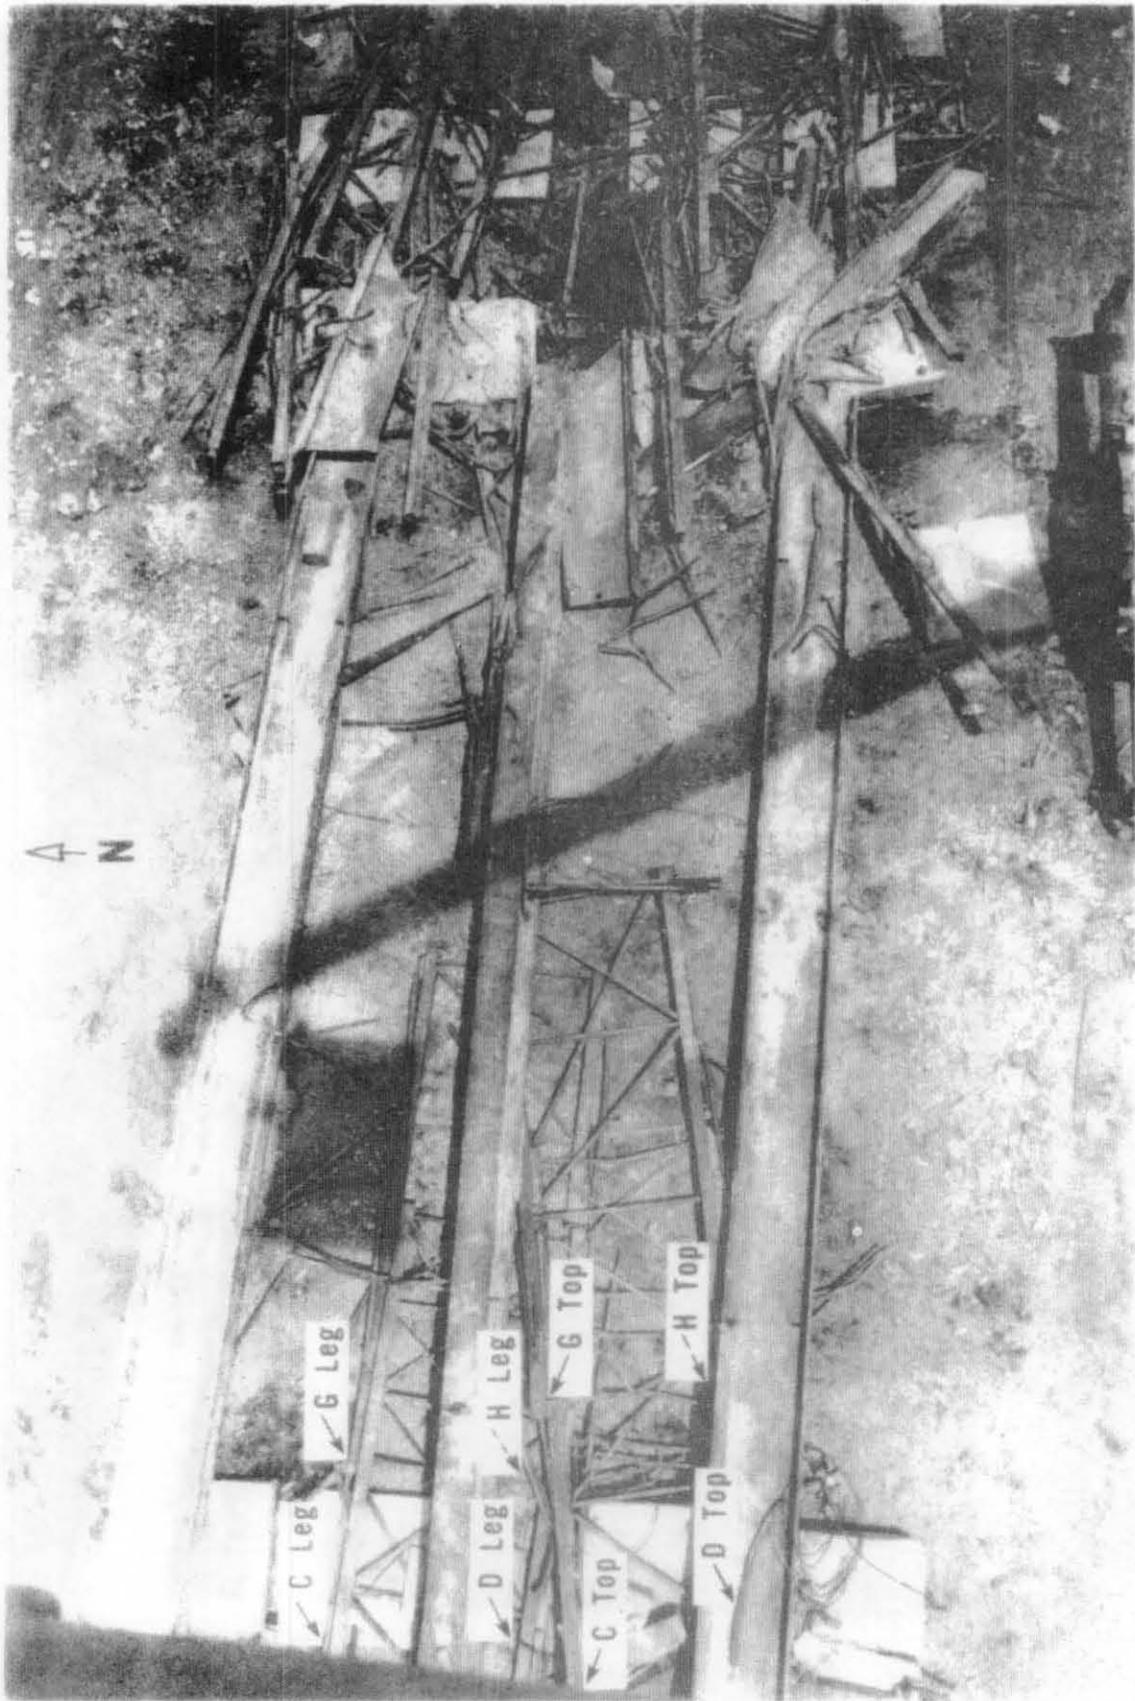
Figure 3.20 Location of parts of the south tower at 407.1

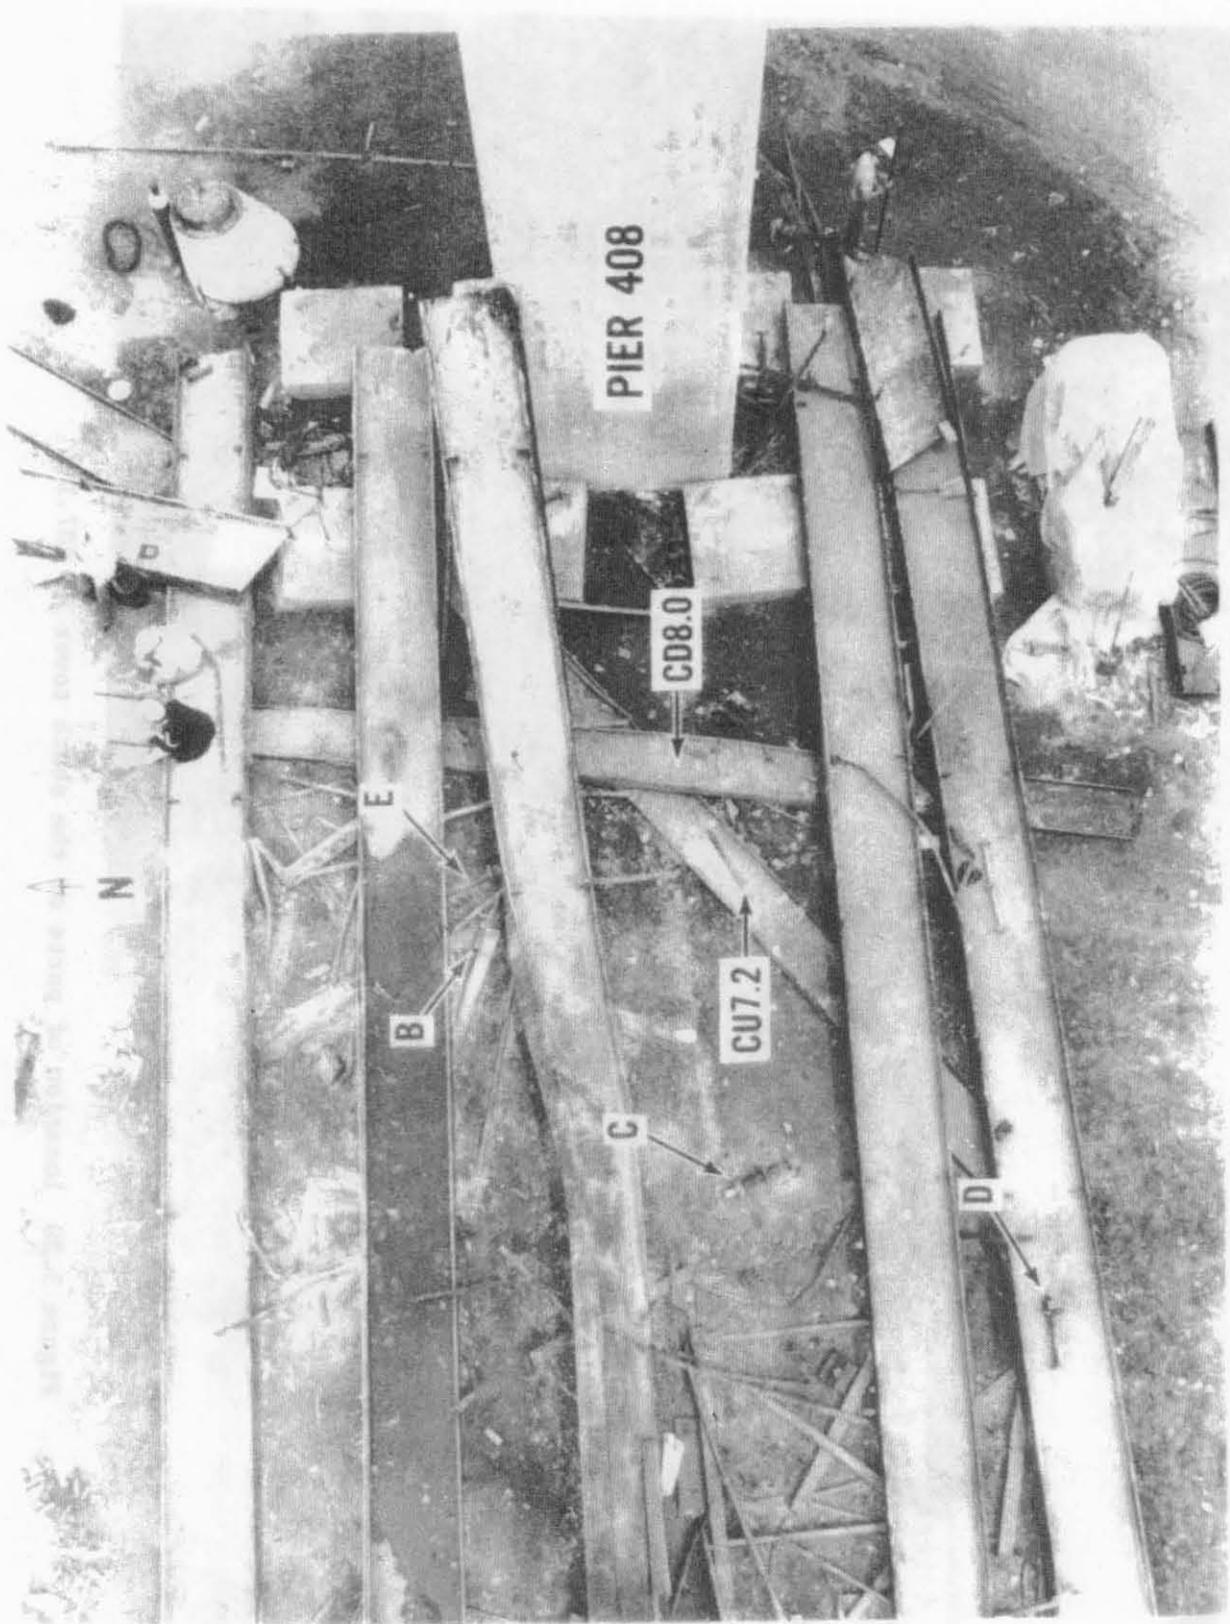
Figure 3.21 shows the positions of the four top screw jacks found in the debris, and the letters indicate to which tower leg each one belonged.

Figure 3.21 Location of top screw jacks and their probable positions in the towers at 407.2

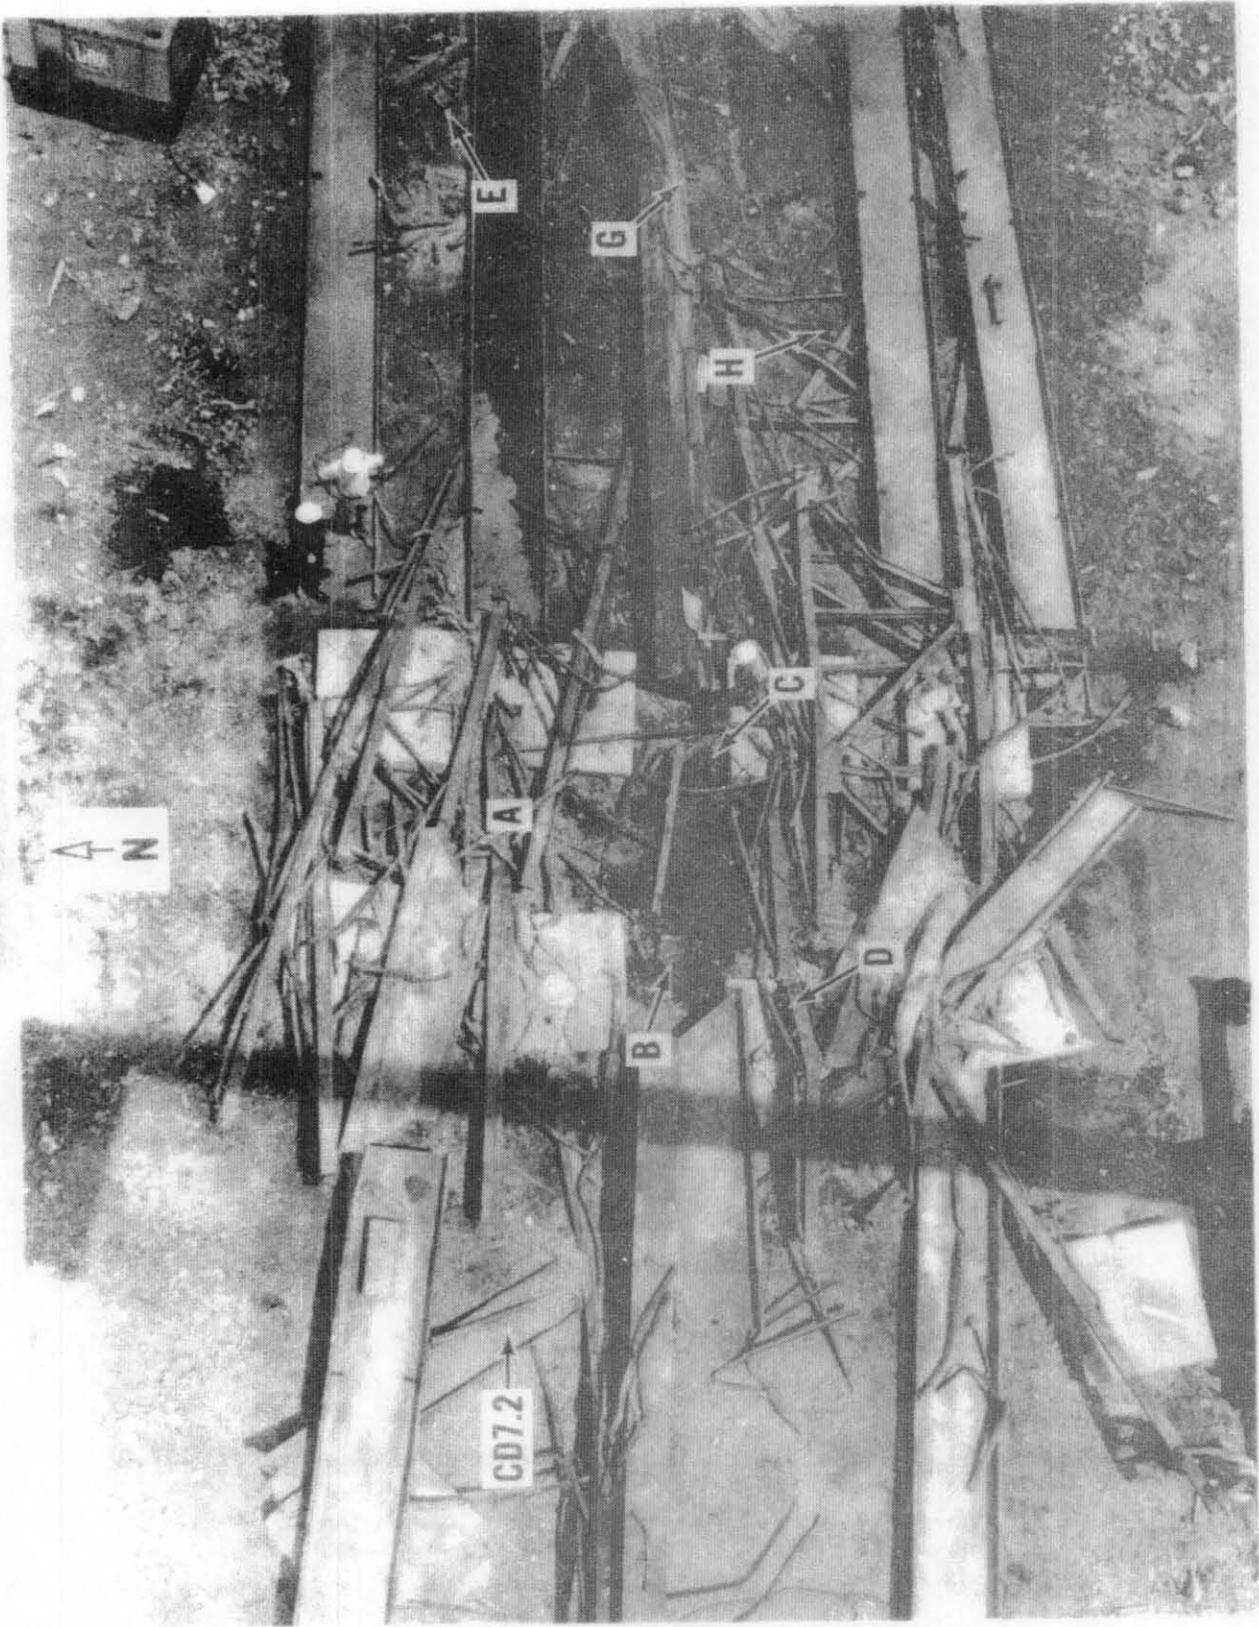
Figure 3.22 Location of tops of U-heads belonging to towers at 407.2

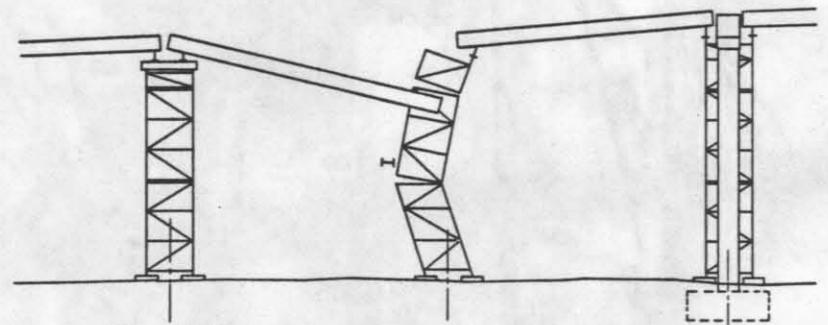
Figure 3.23 Possible collapse sequence of falsework at 407.2

c. Top portion of north tower begins to separate .

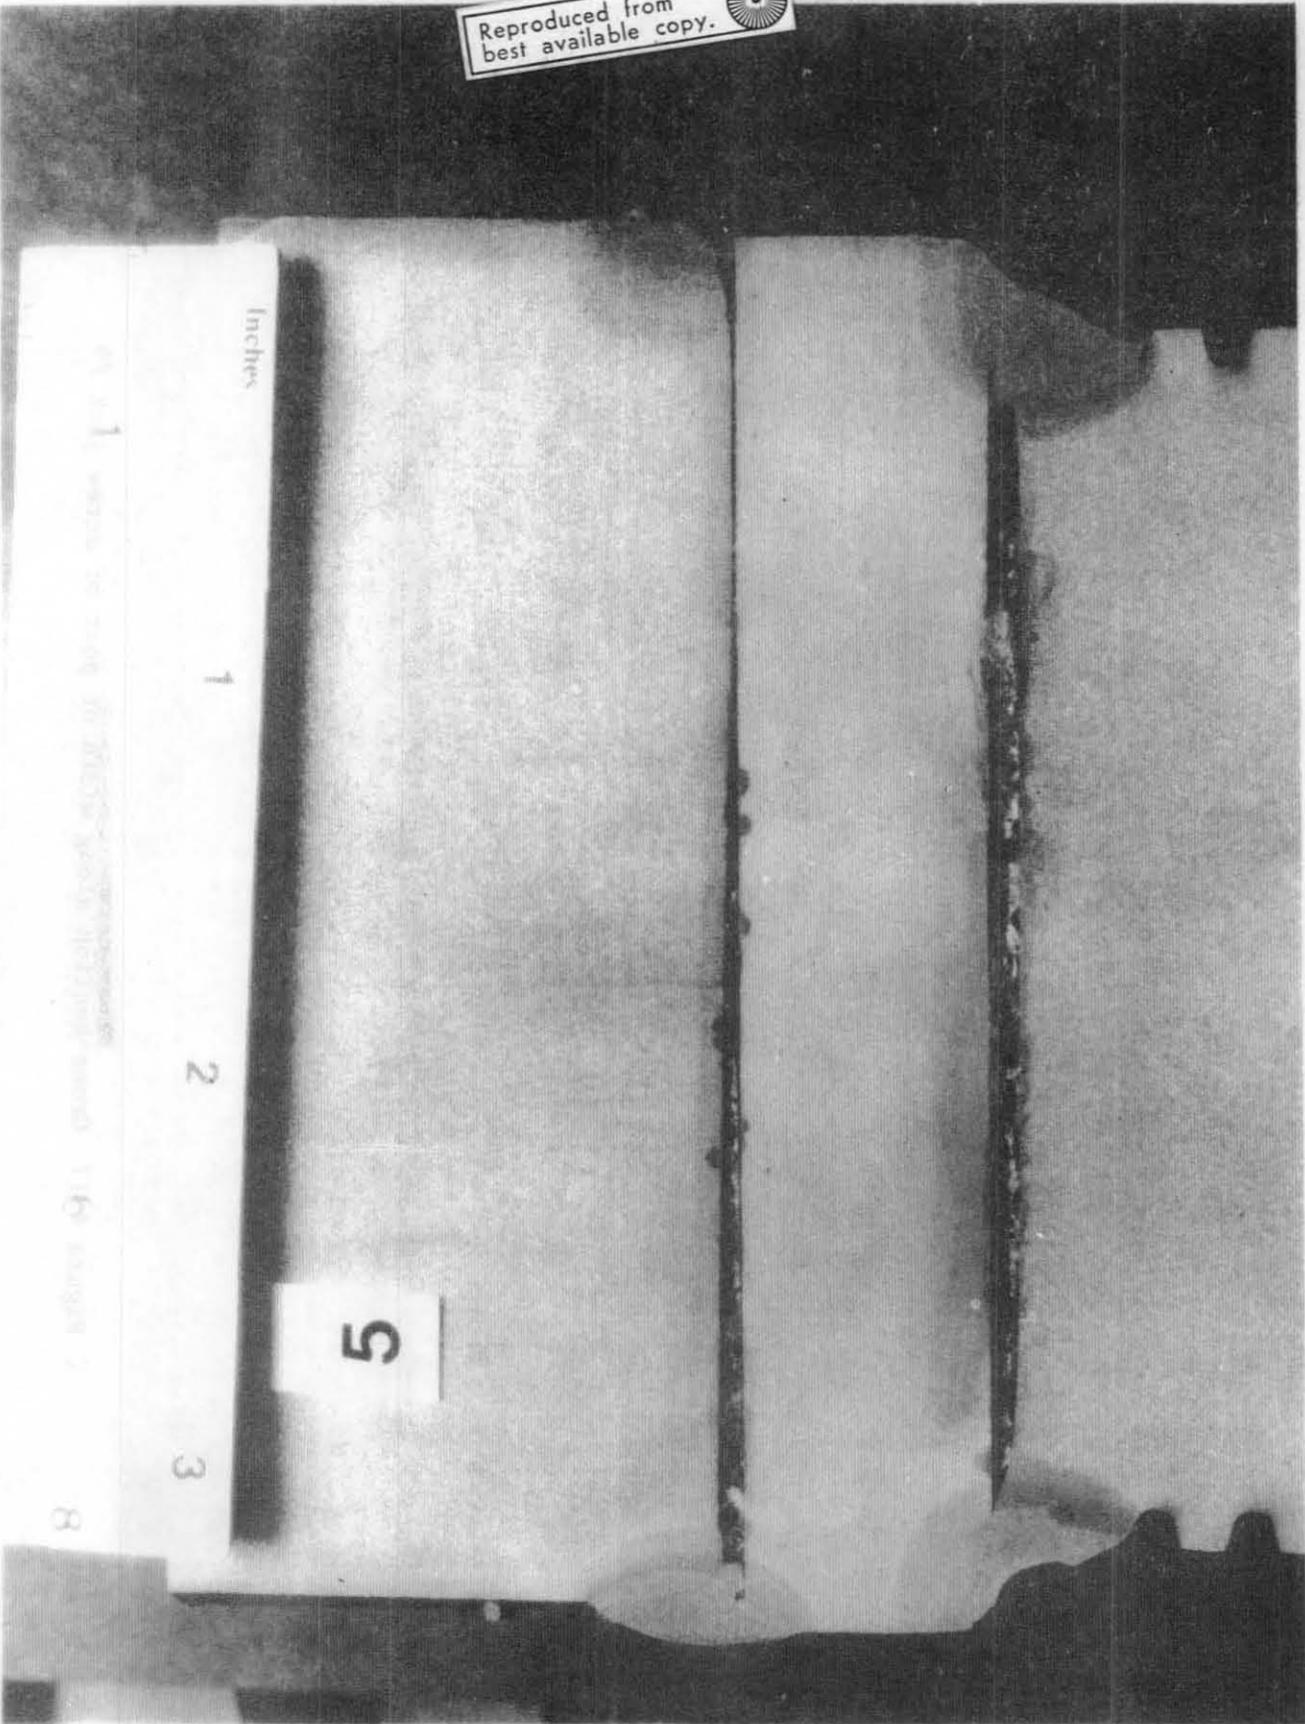
Figure 4.15 Cross-section along diagonal of post of screw Jack #3

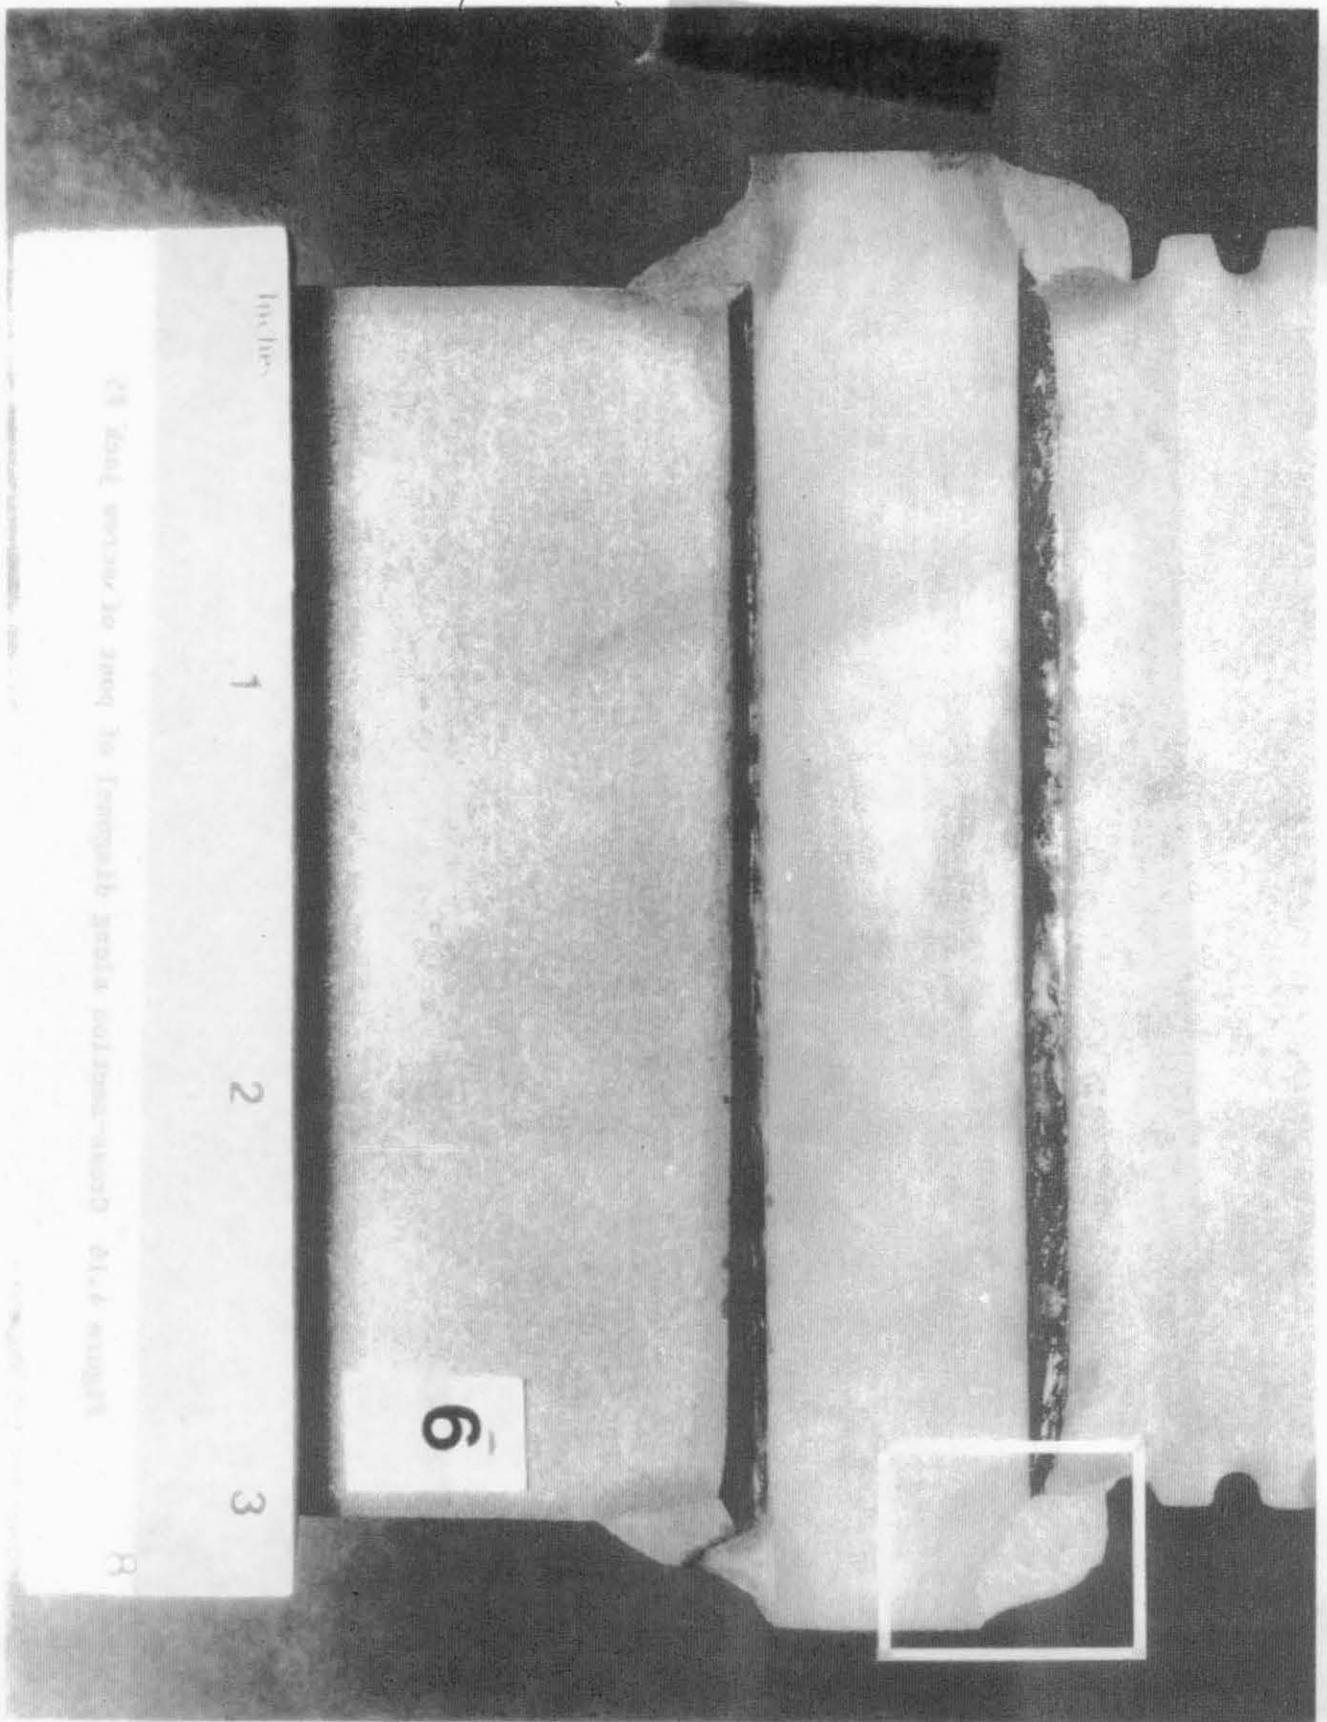
Figure 4.16 Cross-section along diagonal of post of screw jack #5
