NBSIR 82-2593

Investigation of Construction Failure of the Riley Road Interchange Ramp, East Chicago, Indiana

October 1982

**INVESTIGATION OF CONSTRUCTION
FAILURE OF THE RILEY ROAD
INTERCHANGE RAMP, EAST CHICAGO,
INDIANA**

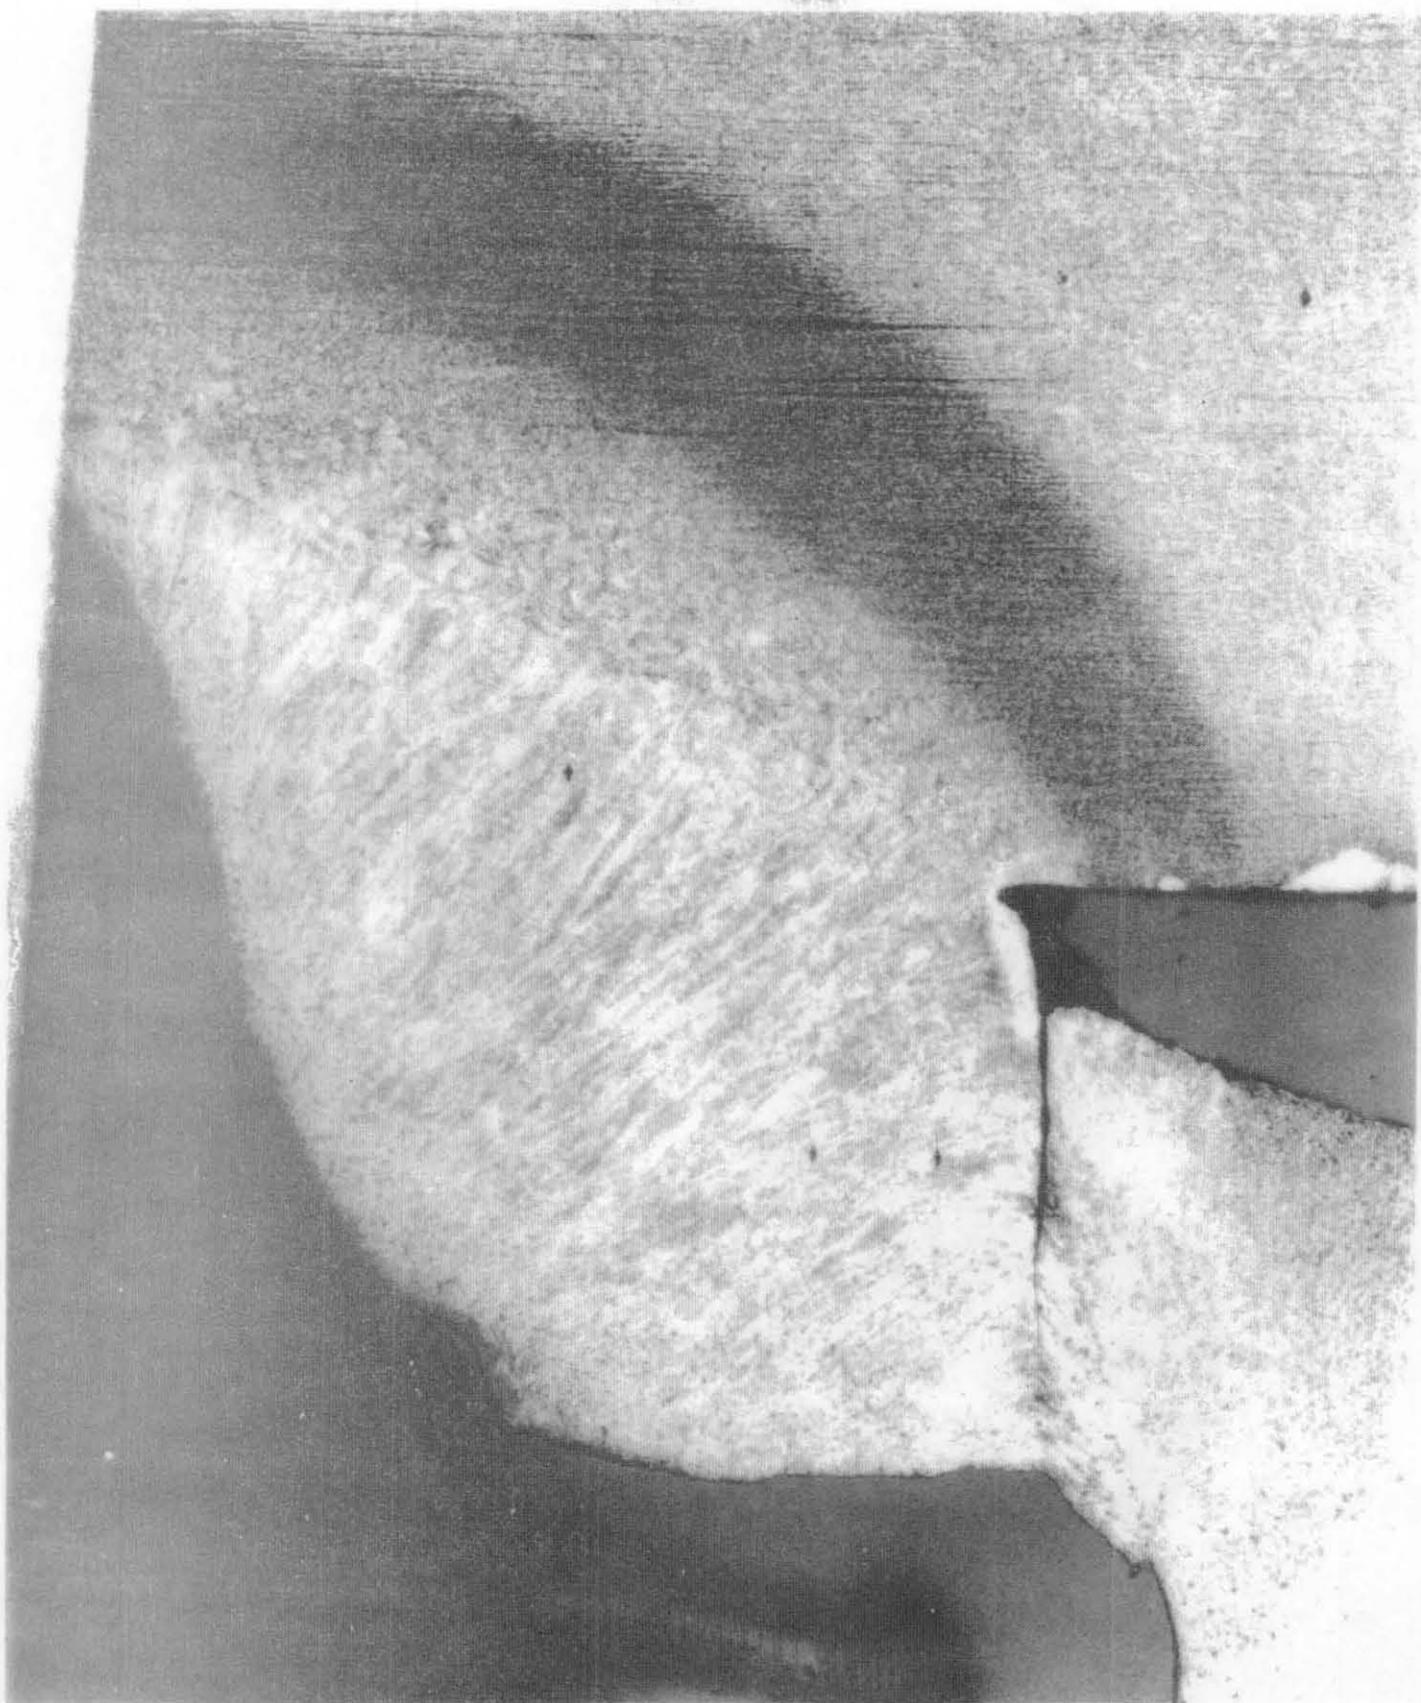
Figure 4.17 Cross-section along width of post of screw jack #9

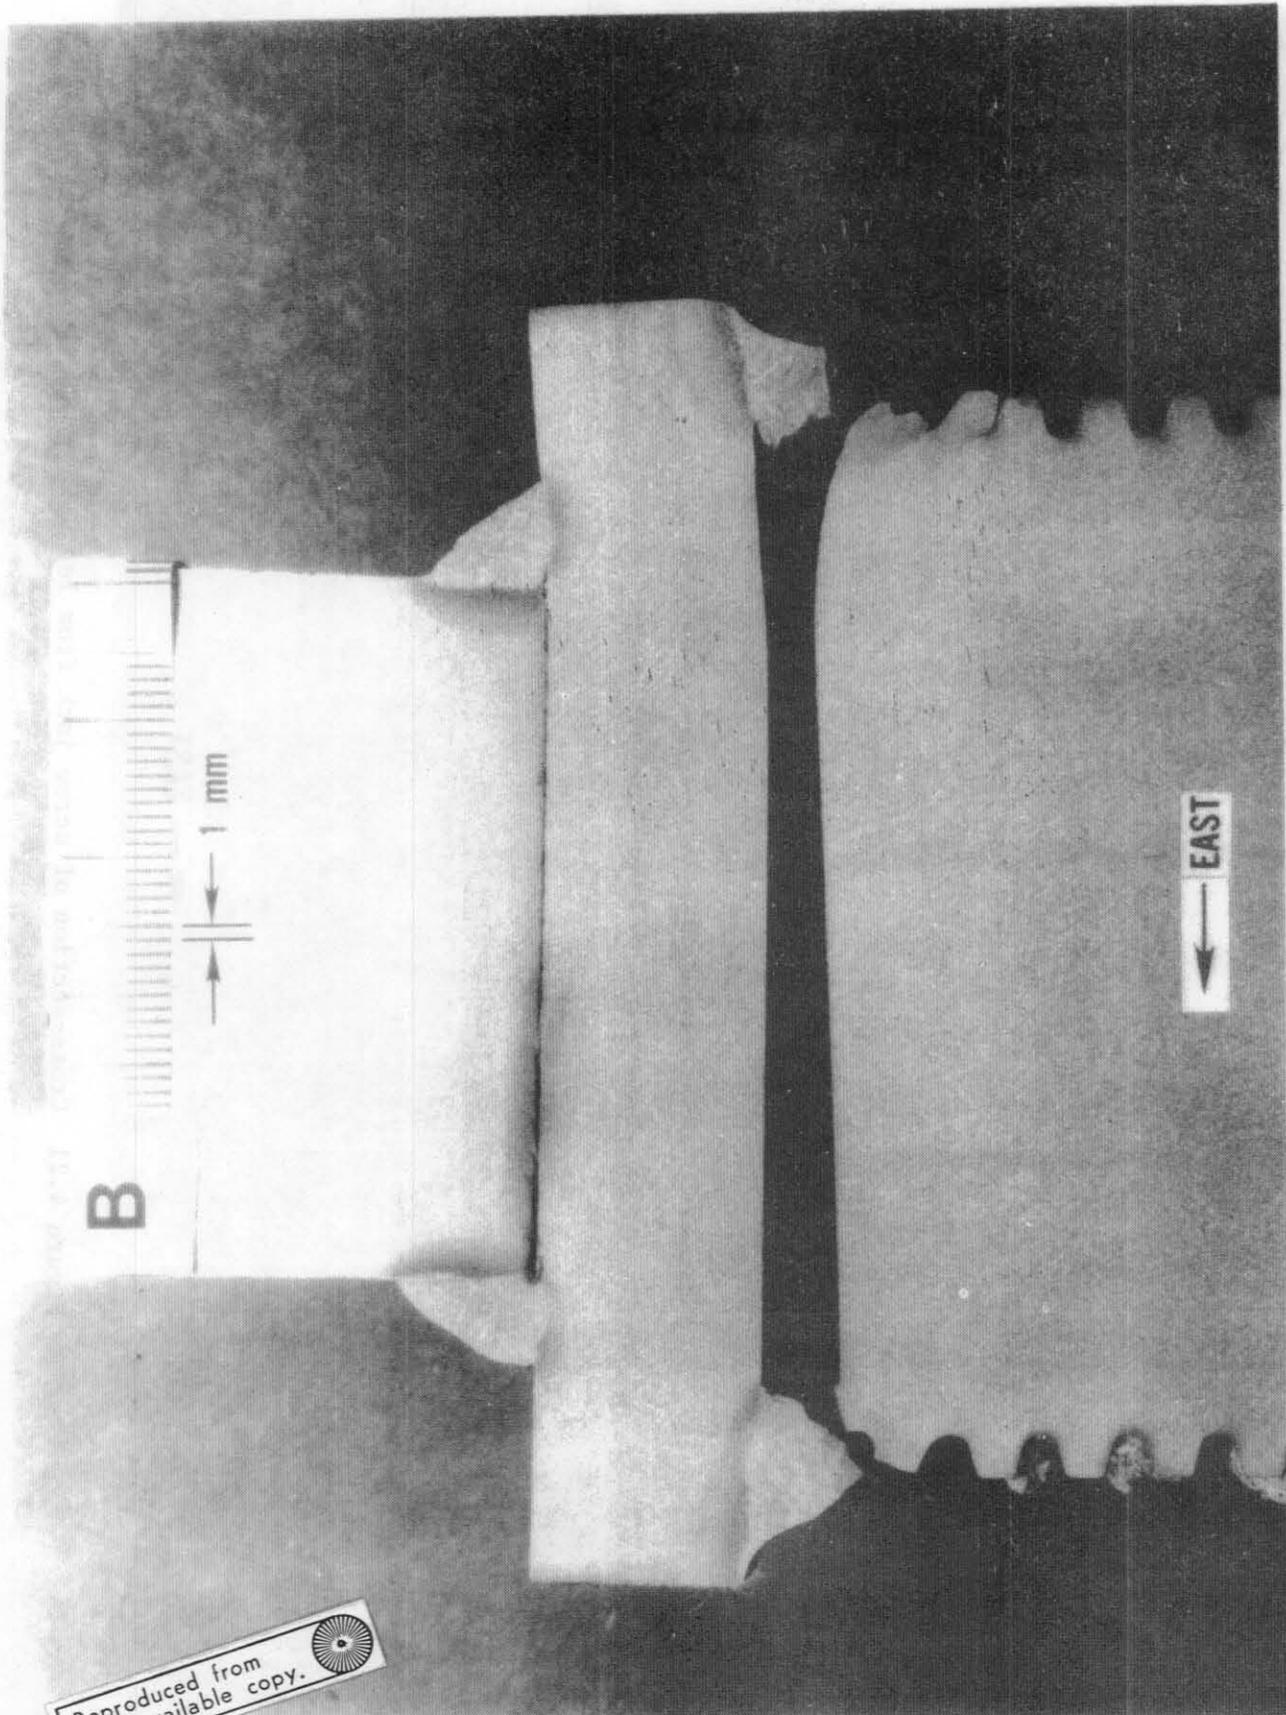
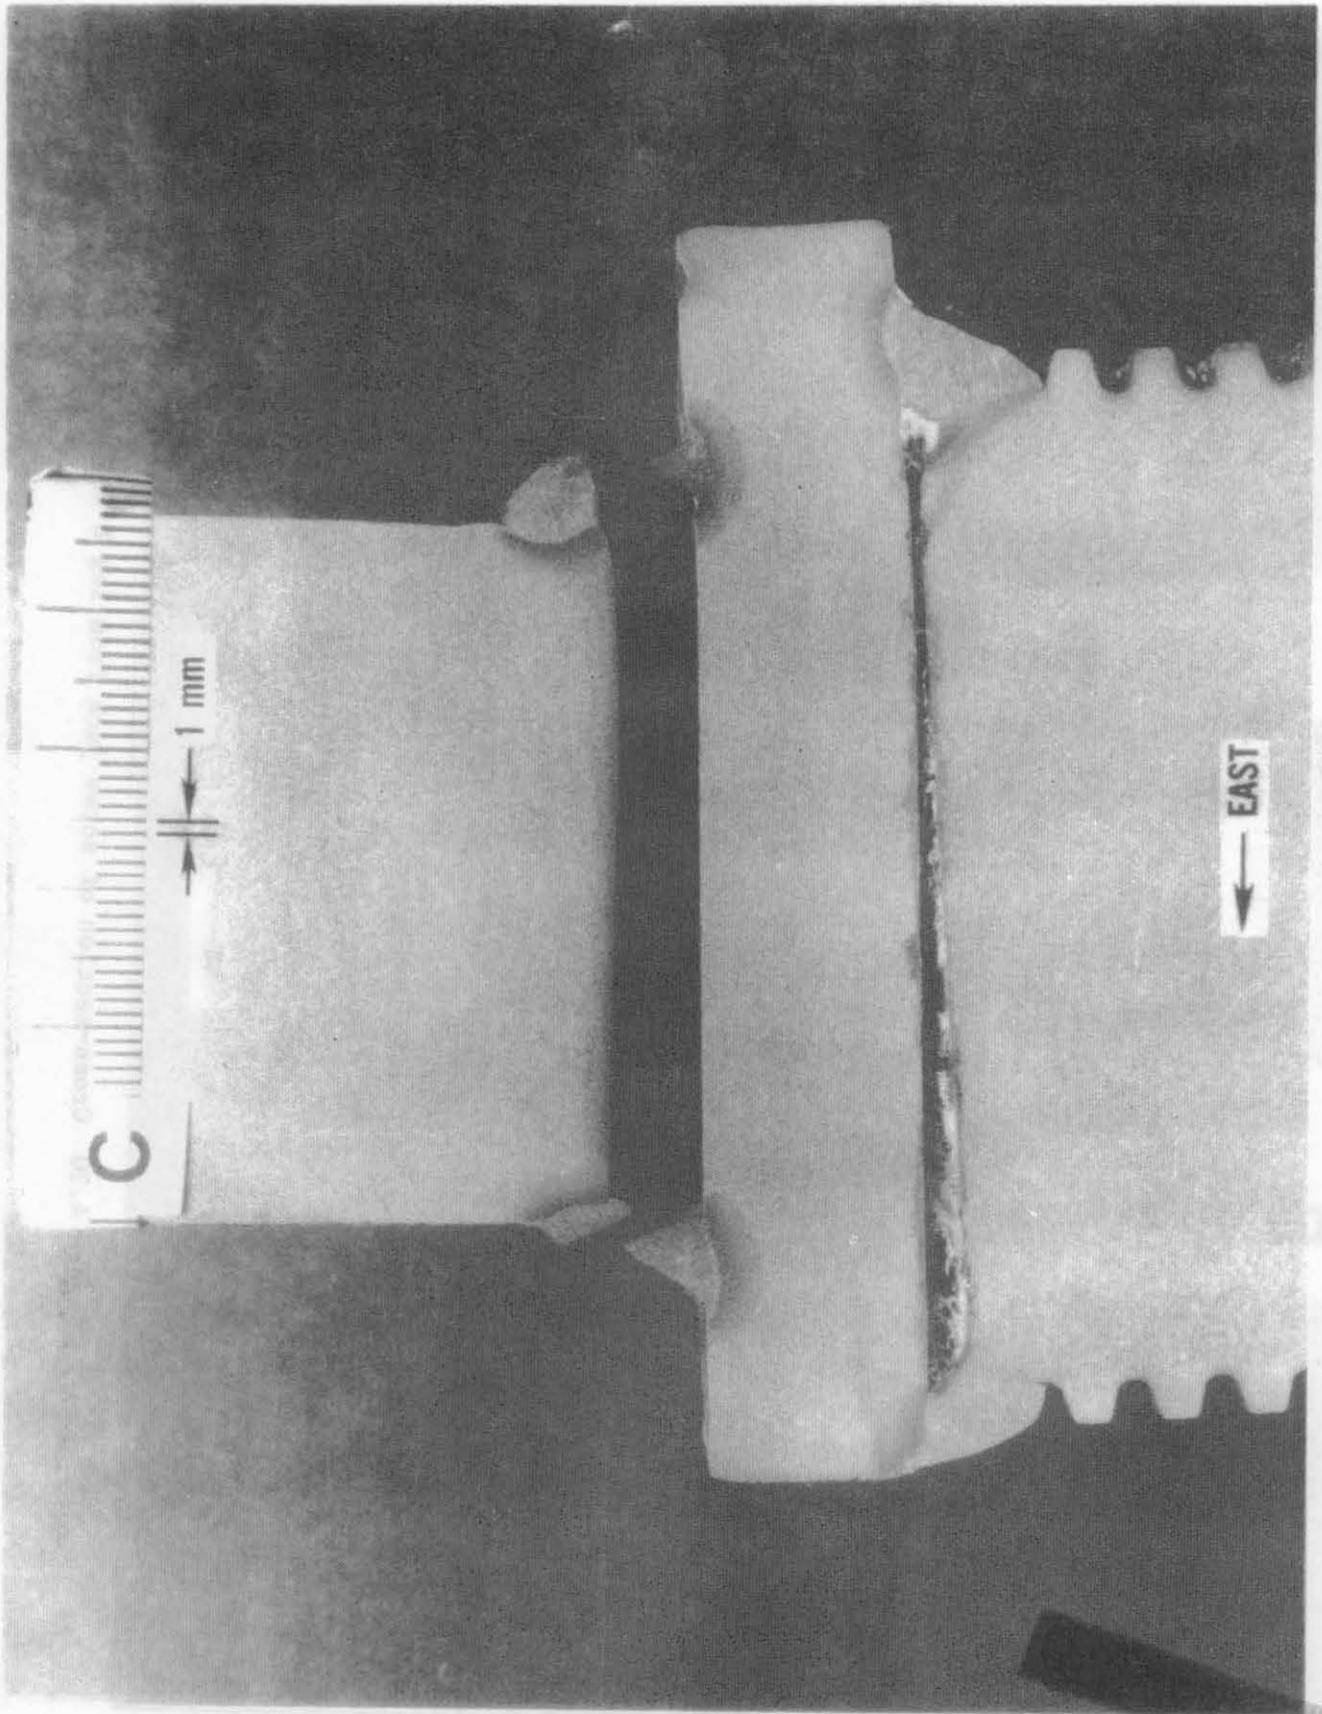
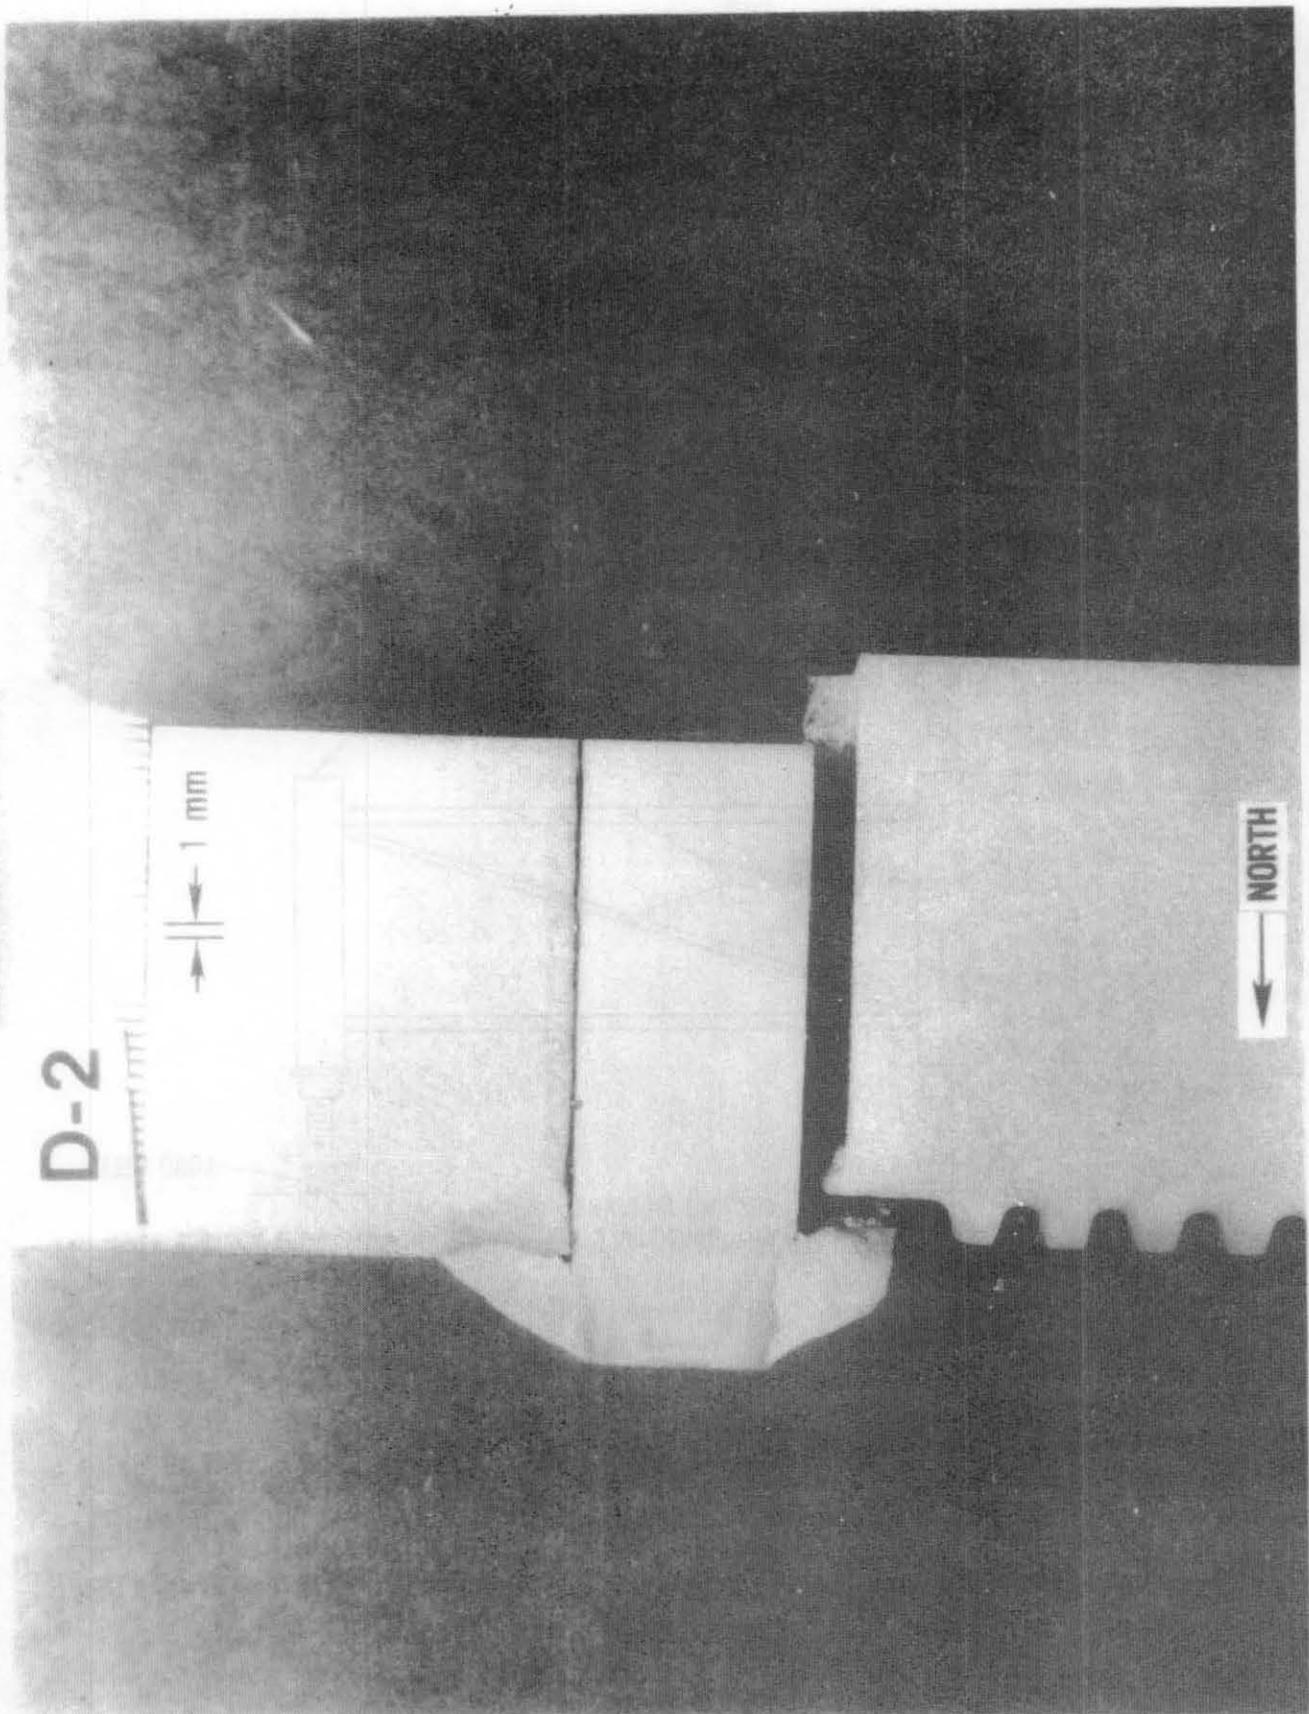
Figure 4.20 Cross-section of screw jack from leg B in tower 407.2(N)

As has been described in section 4.3, the quality of the welds used to fabricate the U-heads at 407.2 was poor and some of them would not have met the minimum weld size requirement in the AWS specification. Therefore, it is possible that the U-heads could have failed if the applied loads produced tensile stresses on the screw jack. A finite element analysis of the crossbeam was performed in which the translations of the tops of the towers at 407.2 were introduced as relative displacements between the top and bottom flanges. The results showed that bending moments would have developed at the U-heads which produce tensile stresses on the east side of the screw jacks. Appendix C describes the finite element model used for this analysis and presents the resulting deflected shapes of the crossbeam. Figure 4.21 clearly shows that the weld on the east side of the rectangular block fractured. Figures 4.20 and 4.21 reveal compressive yielding on the west side of screw jacks B and C, which indicates the direction of failure of the top of the U-heads. This mode of failure is consistent with the analytical prediction. Figure 6.8 is presented as further evidence to confirm this behavior. The photograph shows the U-head at leg D of the south tower at pier 406. It is evident that the top of the U-head is bent toward the west. Failure probably did not occur in this case because the weld quality was sufficient to resist the tensile stresses.

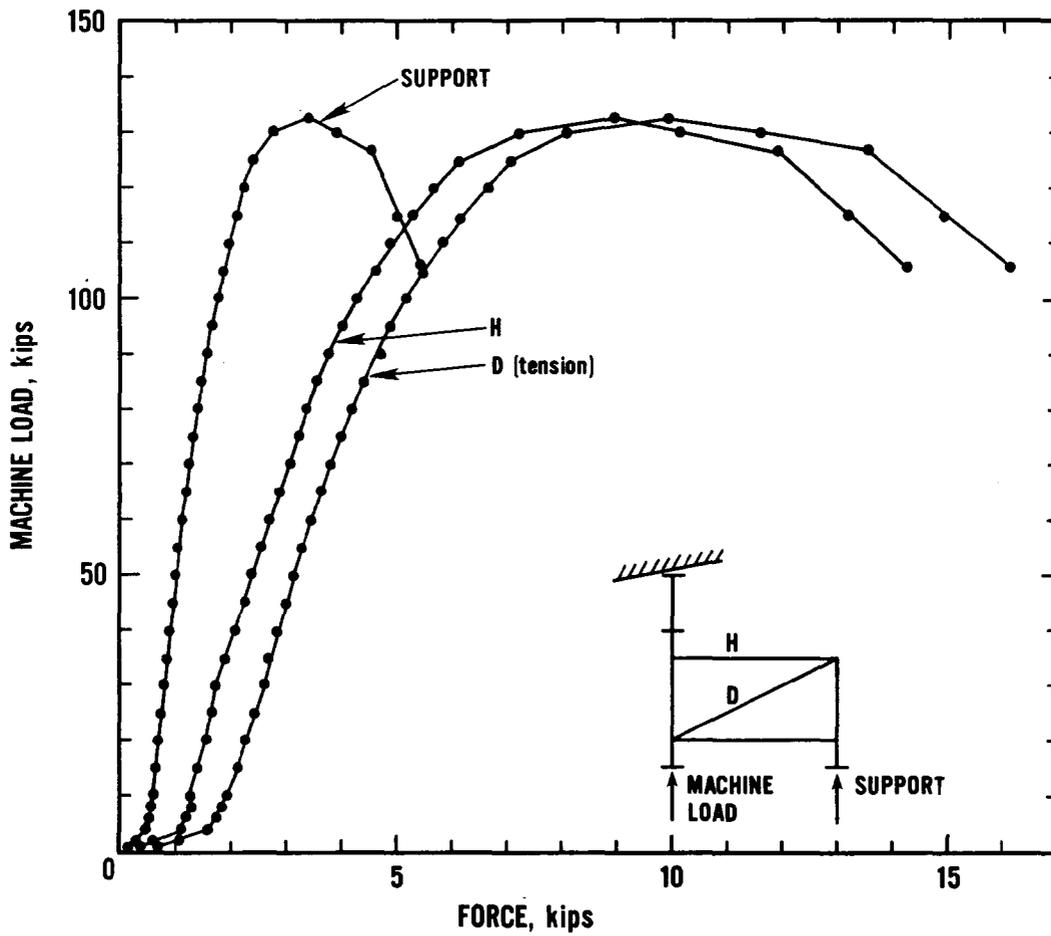
Figure 4.28 Variation of brace forces and support reaction as a function of vertical load (test #2)

Because of the lack of wedges between the longitudinal stringers and the supporting crossbeams, it has been determined from tests (see chapter 4) that horizontal forces are introduced into the upper screw jacks at the bottom of the crossbeams. As illustrated in figure 4.28, the magnitude of this horizontal force increases fairly linearly with increasing axial load until the onset of yielding in the web of the crossbeam. For a vertical load of 100 kips the horizontal force component was equal to at 2.4 kips (10.7 kN). This force, due to the geometry of the contact surface as evidenced in the deflected shapes of the tests (figure 4.29), would be directed parallel to the longitudinal axis of the bridge in an easterly direction (for unit IV). To account for this additional force in the analytical study, a mechanistic model as shown in figure 5.10 was employed. This transforms the vertical stringer reaction into an equivalent vertical load at the screw jack top, plus a horizontal component derived from a linear approximation of the experimentally measured loads. In falsework assembly test #2 the horizontal force was measured indirectly by the various strain gage and load cell elements which monitored forces in the horizontal and diagonal braces. The horizontal force at the screw jack was back

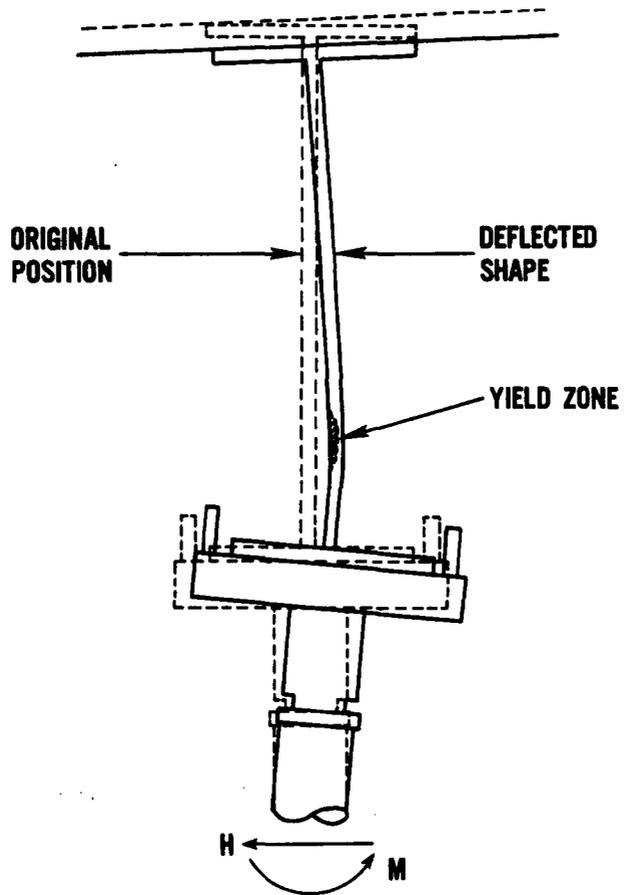
Figure 4.29 Schematic of deflected shape of crossbeam and top of U-head when wedges are not used between stringer and crossbeam

3.57 percent slope. A similar deformed shape of the web was also observed in the NBS laboratory tests (see figure 4.29). As the top of the tower moved toward the east, the bottom flanges of the crossbeams followed it; and the deformed shapes of the crossbeams would have progressively changed as shown by positions 2, 3, and 4. As illustrated in the figure, while the bottom flange translates, it also rotates and the curvature of the web changes. As a result, the direction of the bending moment on the U-heads also would have changed. The NBS falsework assembly tests did not show this change in curvature of the crossbeam web because the test setup was intended to investigate only the effects on the U-heads when wedges were not used between the stringer and crossbeam. While the bottom of the crossbeam translated in the tests, the rigidity of the test configuration did not allow the web of the crossbeam to change its curvature during the translation.

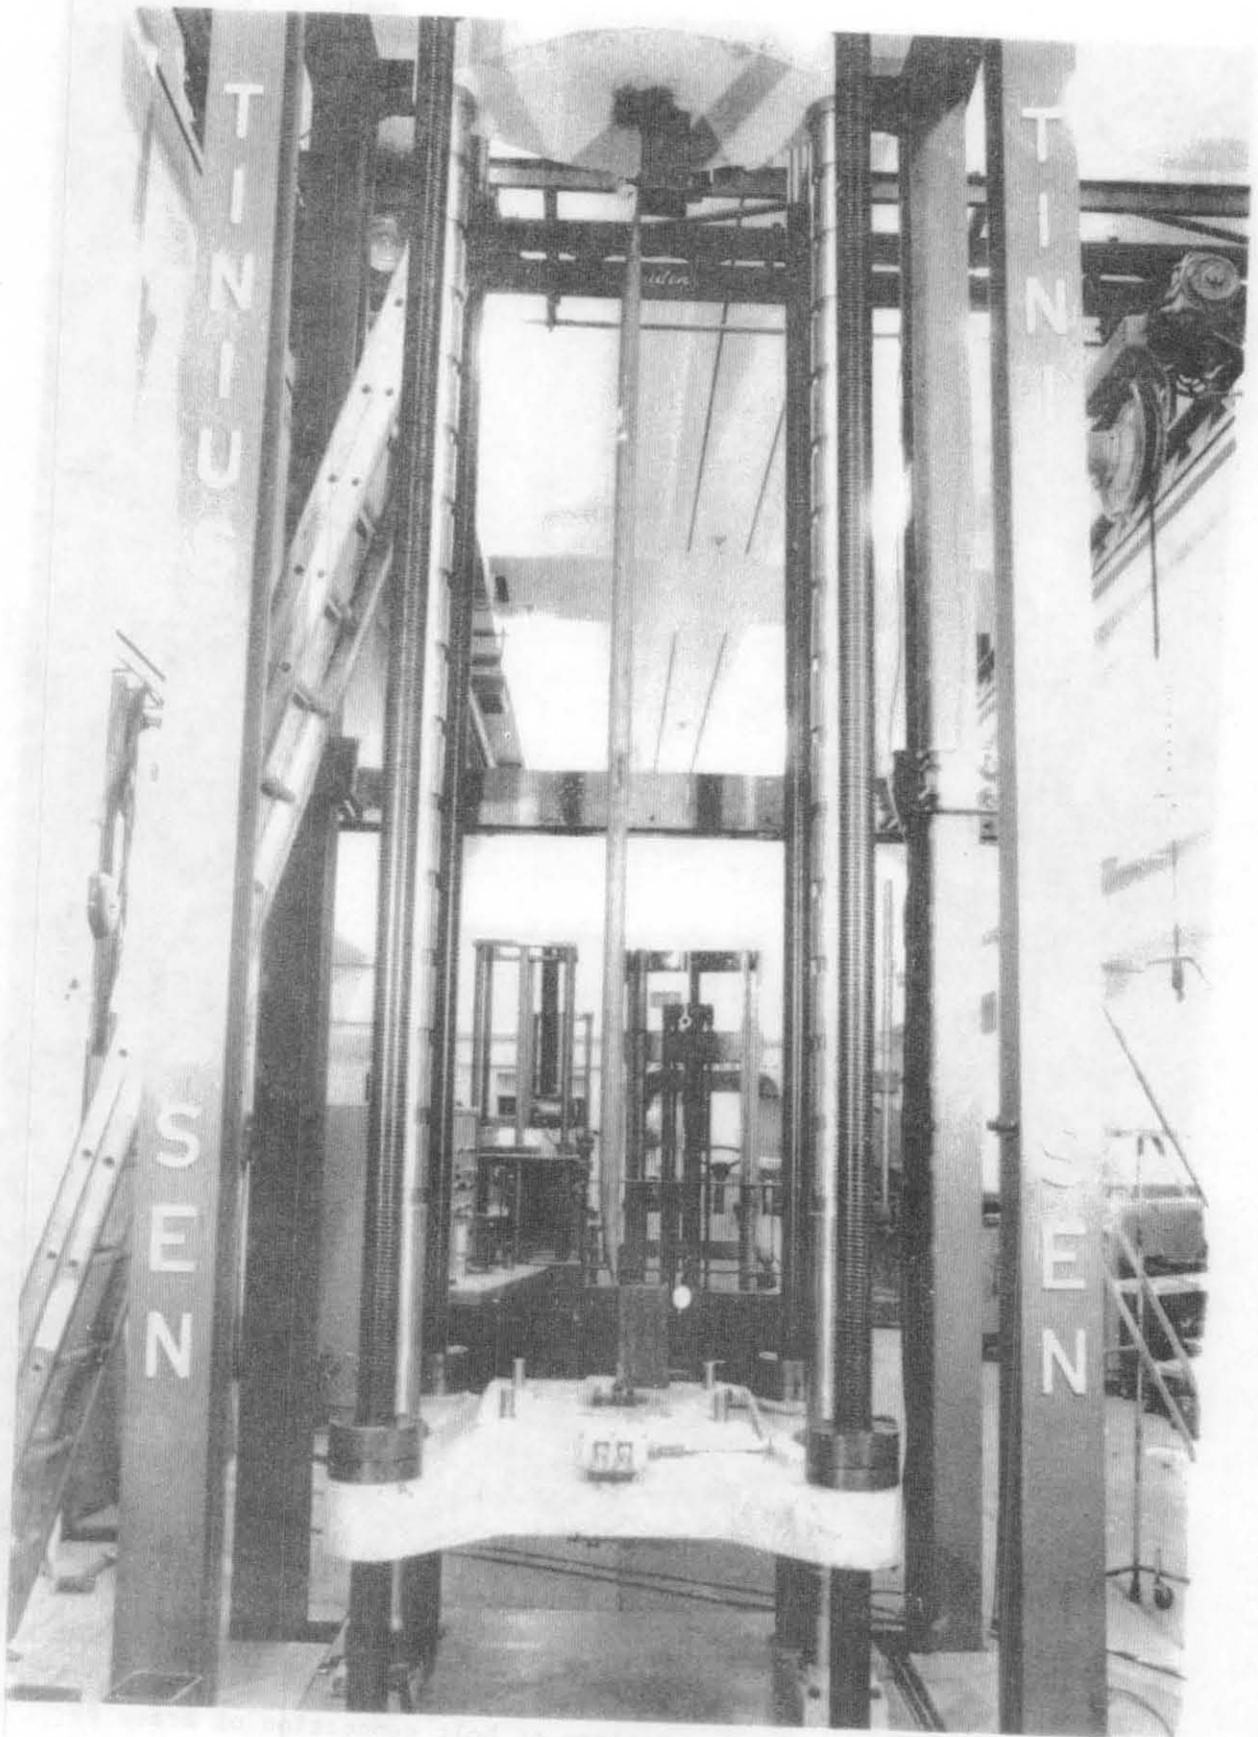
Figure 4.34 Arrangement for tension tests of diagonal braces

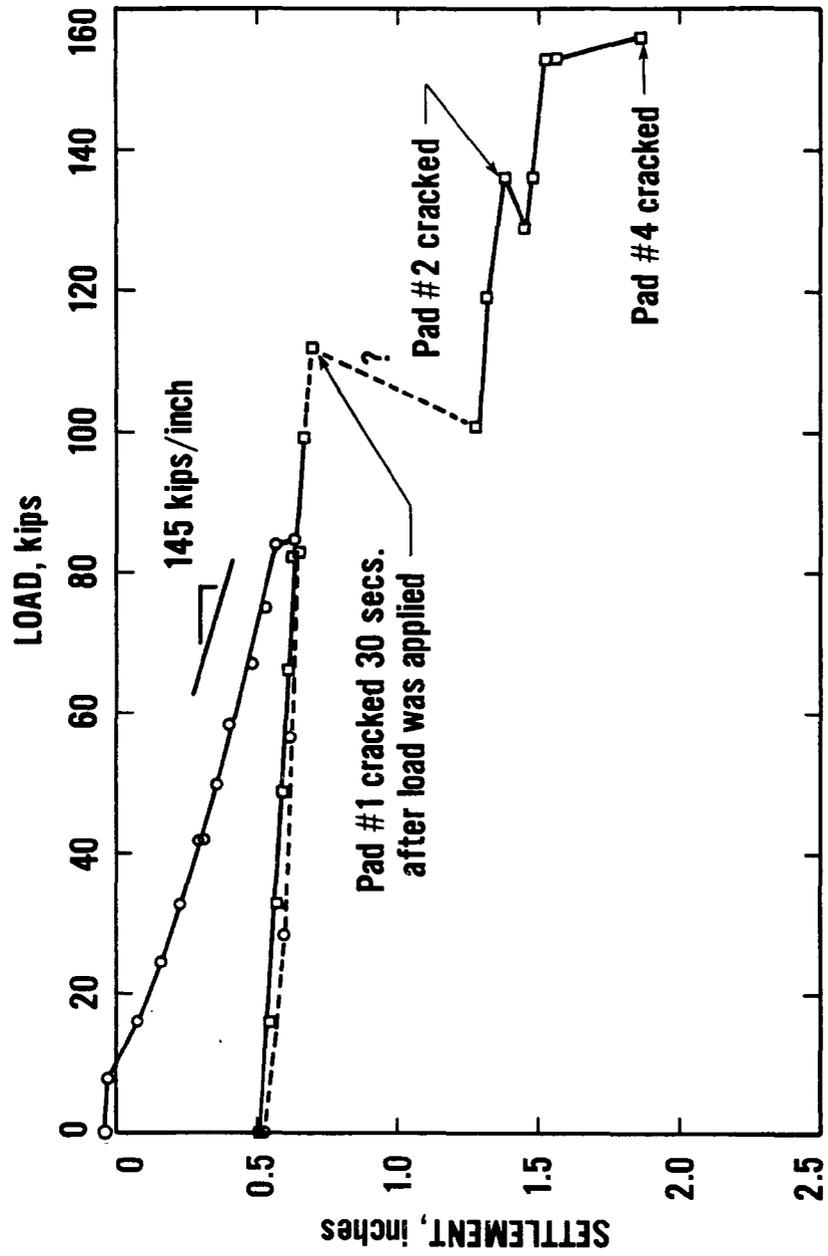
Load-displacement curves for the first pad to crack during each test are given in figures 4.43 through 4.45, for Tests 1, 2, and 3, respectively. The data presented in these figures were the readings recorded at dial #9, which measured the total settlement of the subsoil and the compacted slag in the sand box. Similar plots of the dial #9 readings for other pads are included in Appendix A. The circles are the data for load cycle 1 and the squares are for load cycle 2.

Common features which can be observed from Tests 1 and 2 are summarized as follows: for practical purposes the loading portion of load cycle 1 can be approximated as a straight line in the load range from 30 to 85 kips (134 to 378 kN). The loading curves of cycle 1 from Test 1, conducted in the area which had been precompacted during construction, indicated about 30 percent greater stiffness than from Test 2 which was conducted in an area of less previous compaction. Another common observation is that the pads could take additional load even after they had cracked. This, however, was not the case for pad 2 of Test 3, whose load-displacement curve is given in figure 4.45. In this case, and also for the other pads in Test 3, the pad could not support additional load once it had cracked. This is attributed to bearing failure of the shallow boiler slag layer underneath the pad. The boiler-slag would simply be pushed away by the cracked pad when the load was being re-applied and the pad continued to sink into the boiler slag. The loading portion of load cycle 1 for pad 2 of Test 3 also indicated an approximately linear relationship between the load and displacement; however the foundation was more compressible than observed in Test 2.

Figure 4.43 Load-displacement curves of screw jack base for pad 1 of Test 1

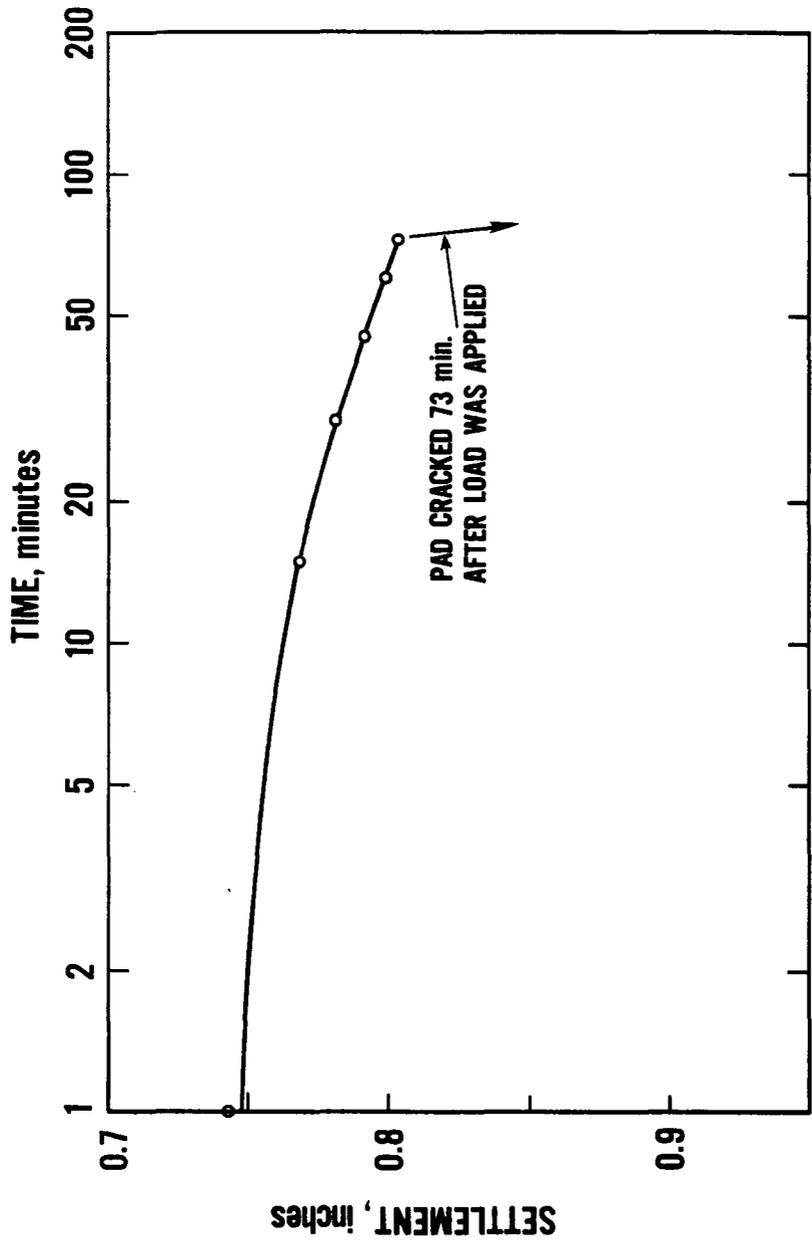
Table 4.4 also gives the duration of the constant load period when the pad cracked. Most pads cracked less than 10 minutes into the holding period. Three of the pads had a sudden failure as the load was being increased, and one pad (pad 1 of Test 2) cracked after the load had been maintained for more than one hour. Two factors are offered in an attempt to explain this delayed failure. Figure 4.46 shows the time-settlement curve obtained from pad 1 in Load

Figure 4.46 Time-settlement curve of screw jack base for pad 1 of Test 2

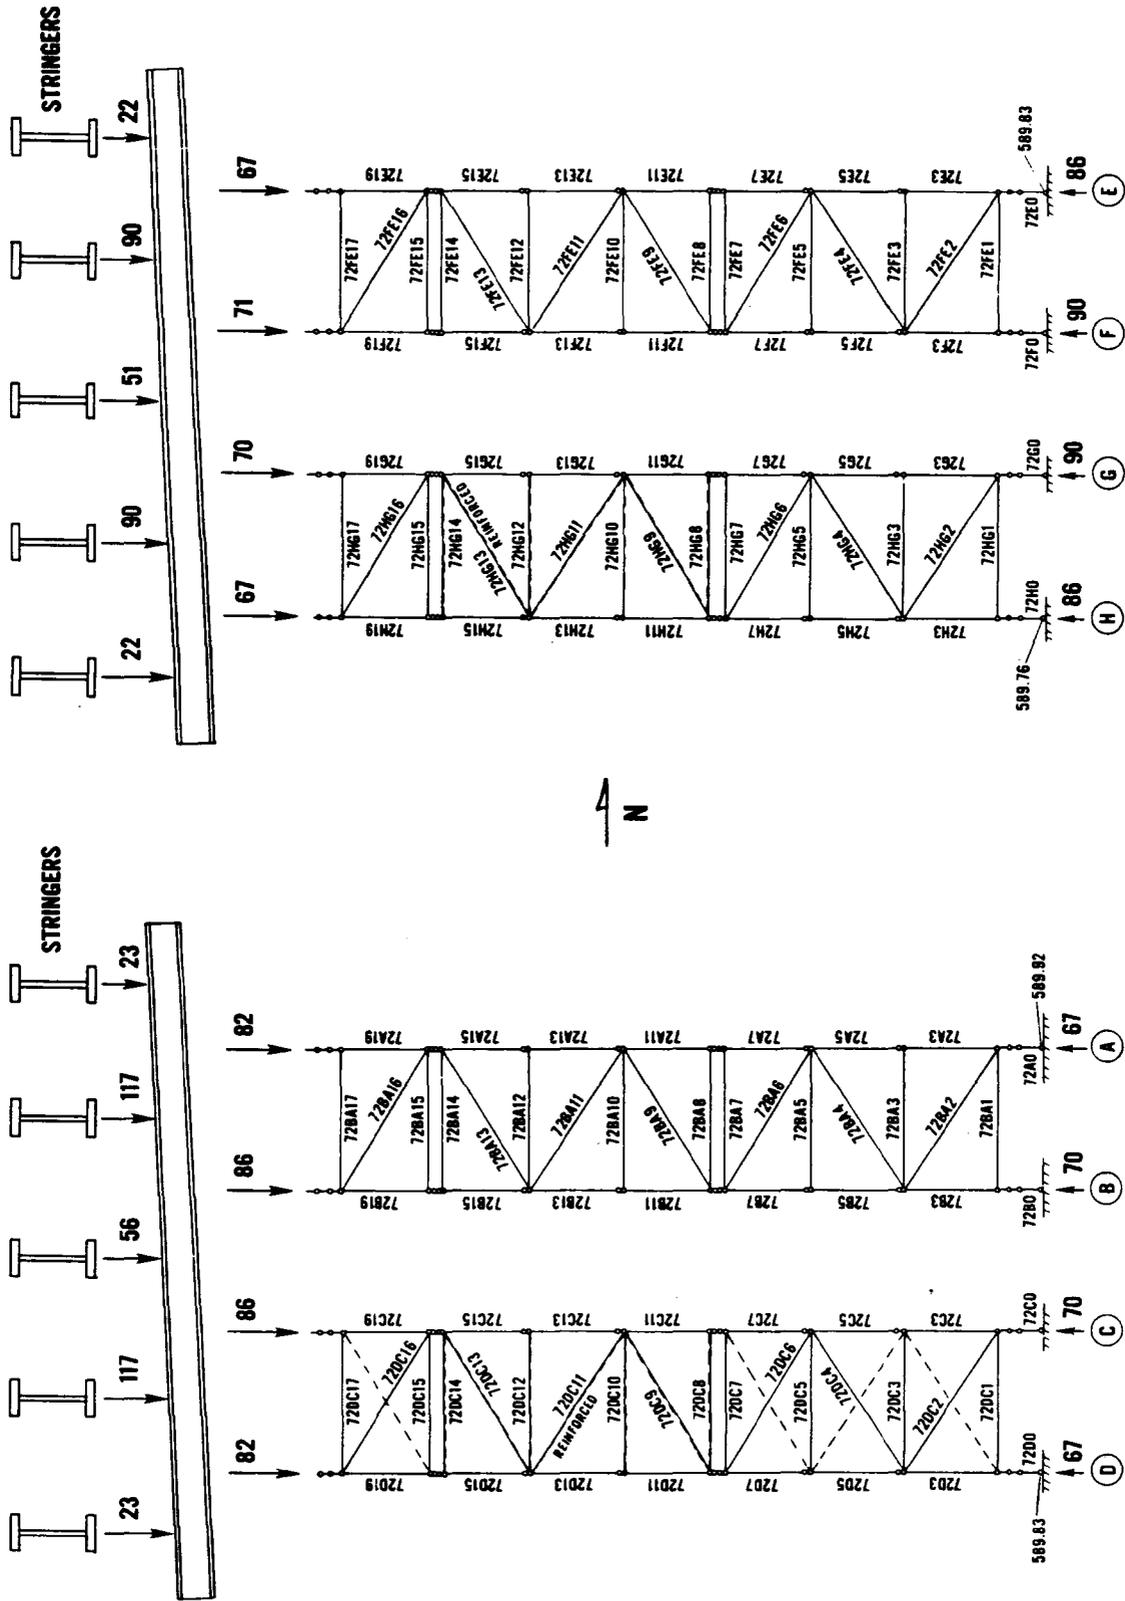
Figure 5.11 Stringers, crossbeam, and support reactions for towers at 407.2, for Case I plus Case II loadings (kips)

W36 x 194 section and 117 kips (521 kN) for the W36 x 260 section (see fig. 5.11). These two different reactions result from the continuity of the concrete box girder over the two supports provided by the shoring towers. When these moment and reaction values due to construction loads are compared with the AISC allowable values of the two stringer cross sections, it is found that the allowable strength values exceed the maximum applied moment and reactions by large margins. The shear capacities of the webs were also computed and they were found to be far in excess of the shear resulting from the applied loads.

Using a nominal yield strength of 36 ksi (350 MPa), the AISC allowable shear capacity of a W24 x 68 section is 135 kips (600 kN). This value is substantially greater than maximum shear of 59 kips (260 kN) occurring between stringer S2 of span 8.0 and the U-head reaction at leg A as shown in figure 5.11.

In accordance with the AISC Specification, the maximum concentrated load that a W24 x 68 section can support without crippling of the web due to a localized force is 276 kips (1230 kN). This capacity is about 2.34 times the maximum stringer reaction of 117 kips (521 kN) (see figure 5.11).

The maximum loads in the falsework assembly tests are greater than the maximum computed load of 86 kips (383 kN) on the U-heads at legs B and C (see figure 5.11). The failure of the falsework assembly was governed by the strength of the crossbeam rather than by the strength of the U-head. This observation suggests that U-heads would not have failed under the applied loads. Thus, it is unlikely that a U-head failure initiated the collapse of unit IV.

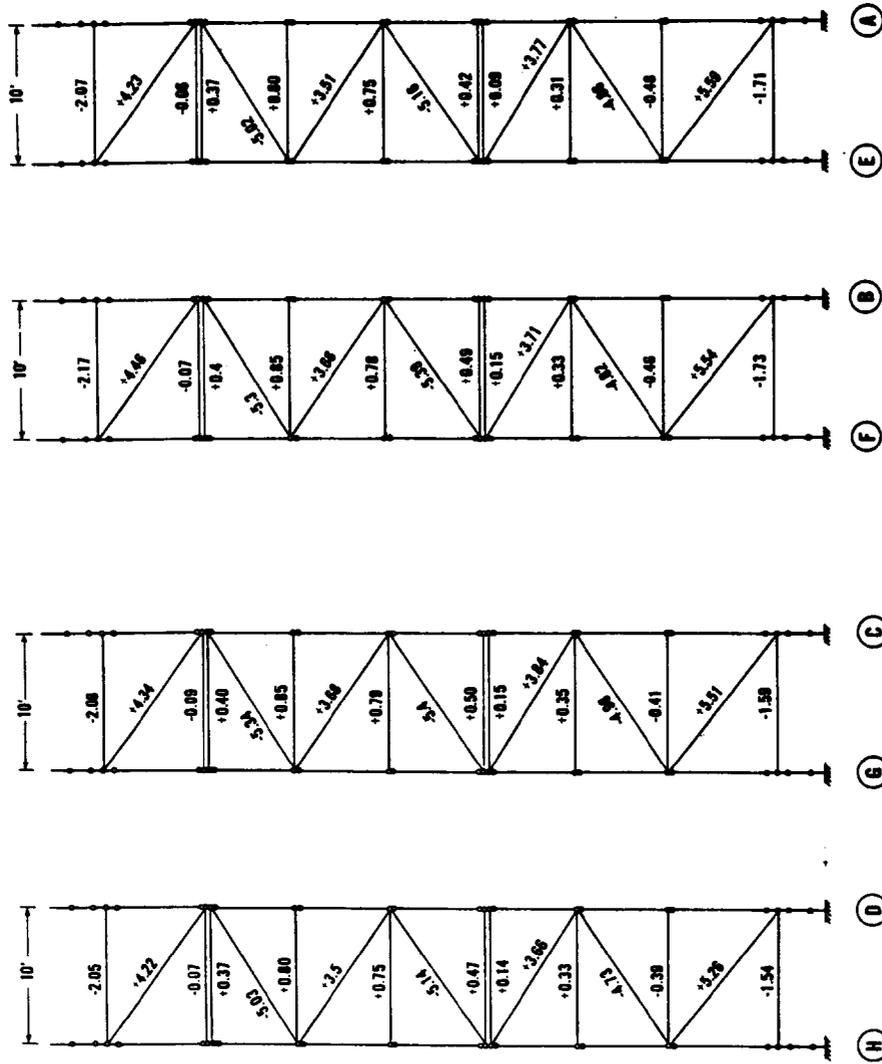
Figure 5.12 Truss brace forces for towers at 407.2 for Case I plus Case II loadings (kips)

When the magnitudes of the computed forces in the bracing members are compared with the average strengths, both in tension and compression, it is found that the forces are less than these strengths (see fig. 5.12). However, the computed compressive forces in some of the diagonal members in trusses BF and CG at 407.2 were either equal to or slightly greater than the lowest compressive test value of 5.3 kips (23.6 kN). It should be noted that this low value was attributed to corrosion in a confined area of the tube rather than to an overall small cross-sectional area. In order to examine the consequences of a possible failure of these highly loaded diagonal members, an analysis was made for the Case II loading with these members removed. The results showed that force redistribution took place and the overall stability of the tower was not affected by the removal of the diagonals. Since in the real structure members would not immediately lose their load carrying capacity upon reaching their buckling loads, the analysis with the diagonal members removed represents a severe condition. Thus, it is unlikely that bracing members failed in tension, and it is unlikely that any diagonal members which might have buckled would have triggered the collapse of the falsework at 407.2.

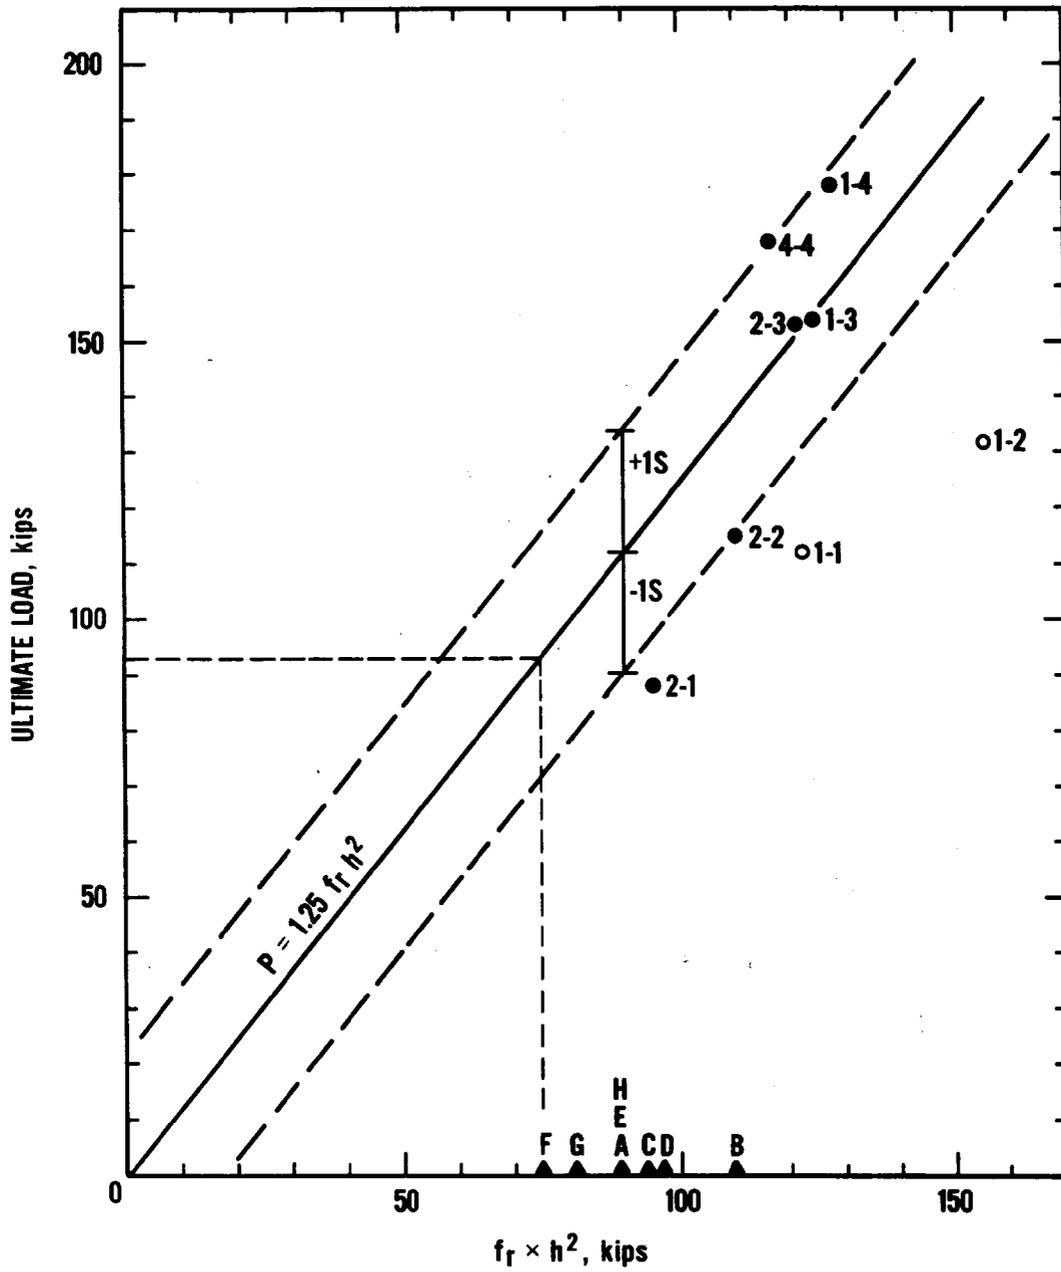
where f_r is the modulus of rupture of the concrete and h is the thickness of the pad. Figure 6.1 shows the results of the full-scale load tests. The ordinate is the observed cracking load of the pad (table 4.4) and the abscissa is $f_r \cdot h^2$. The modulus of rupture was estimated from the average compressive strength, f_c , of the cores taken from the tested pads (table 4.5) using the accepted expression $f_r = 7.5 \sqrt{f_c}$ [6.6]. The pad thickness, h , is based on the average length of the untrimmed cores. Also shown, figure 6.1 is the line representing eq. (6.1), which coincides with the regression line fitted through the origin, excluding the data points 1-2 and 1-1. It is seen the theoretical expression (eq. 6.1) represents the experimental values reasonably well, the residual standard deviation of the line is 22 kips (98 kN). The concrete pads used for the full-scale load tests were previously used to support shoring towers in other portions of the ramp and some were impacted by falling debris during the collapse. Thus, some of the pads could have suffered internal damage which was not discernible. It is believed that the lower than expected strength of pads 1-1 and 1-2 can be attributed to previous damage of the pads.

The values of $f_r \cdot h^2$ for pads A through H of the towers at 407.2 are plotted on the abscissa of figure 6.1. These values are computed based on the average strengths and untrimmed lengths of the cores reported in table 4.6. Although the actual strength of the individual pads could deviate from the straight line $P = 1.25 f_r h^2$, this line is an available means to estimate the expected pad cracking strength. For example, the expected strength for pad F is 94 kips (418 kN) and for pad E it is 109 kips (485 kN). From this figure and the tower leg reactions shown in figure 5.11, it can be concluded that any of pads E, F, G, and H could have been a candidate for cracking when the possible scatter of

actual strength values about the prediction line is taken into consideration. The structural analysis showed that pads F and G at 407.2 were the most heavily loaded pads, each carrying 90 kips (400 kN). As indicated above, the expected capacity of pad F is 94 kips (418 kN), and figure 6.1 indicates that the expected capacity of pad G is about 100 kips (445 kN). Thus, it is reasonable to conclude that one of the pads E through H cracked, with pad F having the highest likelihood of being the first to crack.

Figure 6.1 Cracking loads of concrete pads in field tests vs. ($f_r \times h^2$)
