NBSIR 82-2593

Investigation of Construction Failure of the Riley Road Interchange Ramp, East Chicago, Indiana

October 1982

**INVESTIGATION OF CONSTRUCTION
FAILURE OF THE RILEY ROAD
INTERCHANGE RAMP, EAST CHICAGO,
INDIANA**

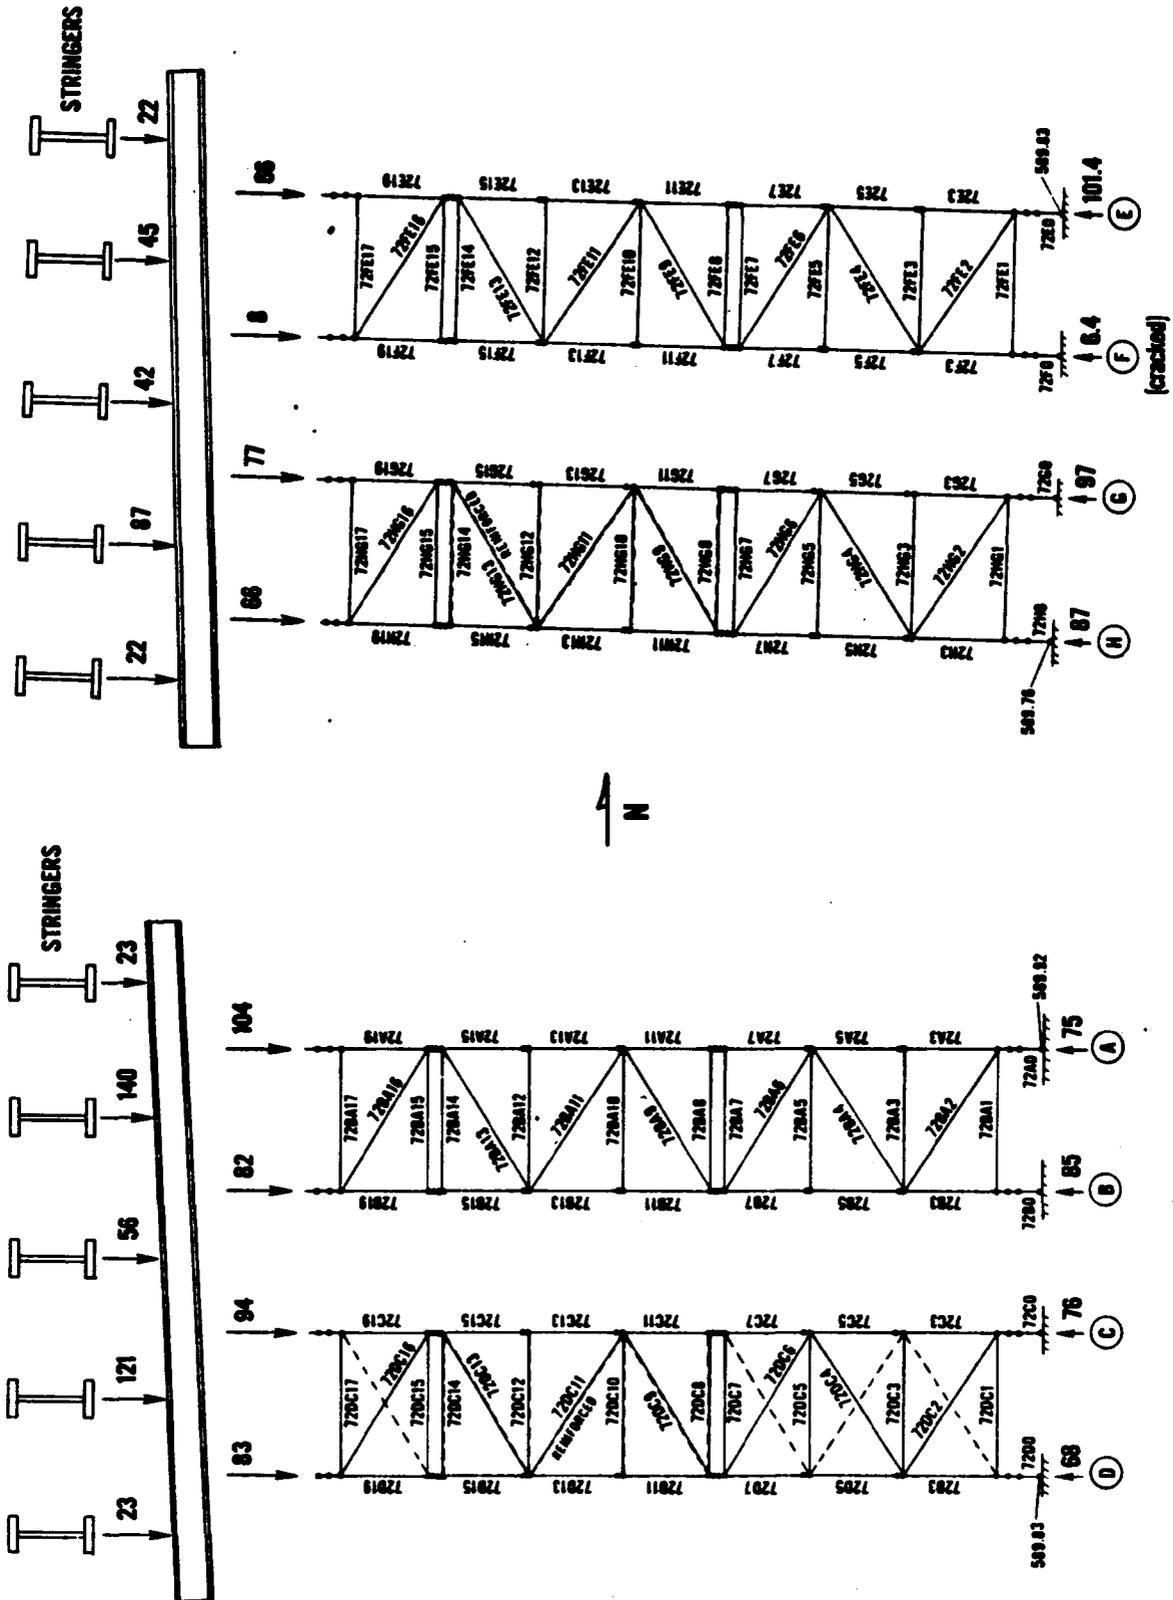
Figure 6.2 Stringer, crossbeam, and support reactions for towers at 407.2 with support settlement of 0.4 in at pad F

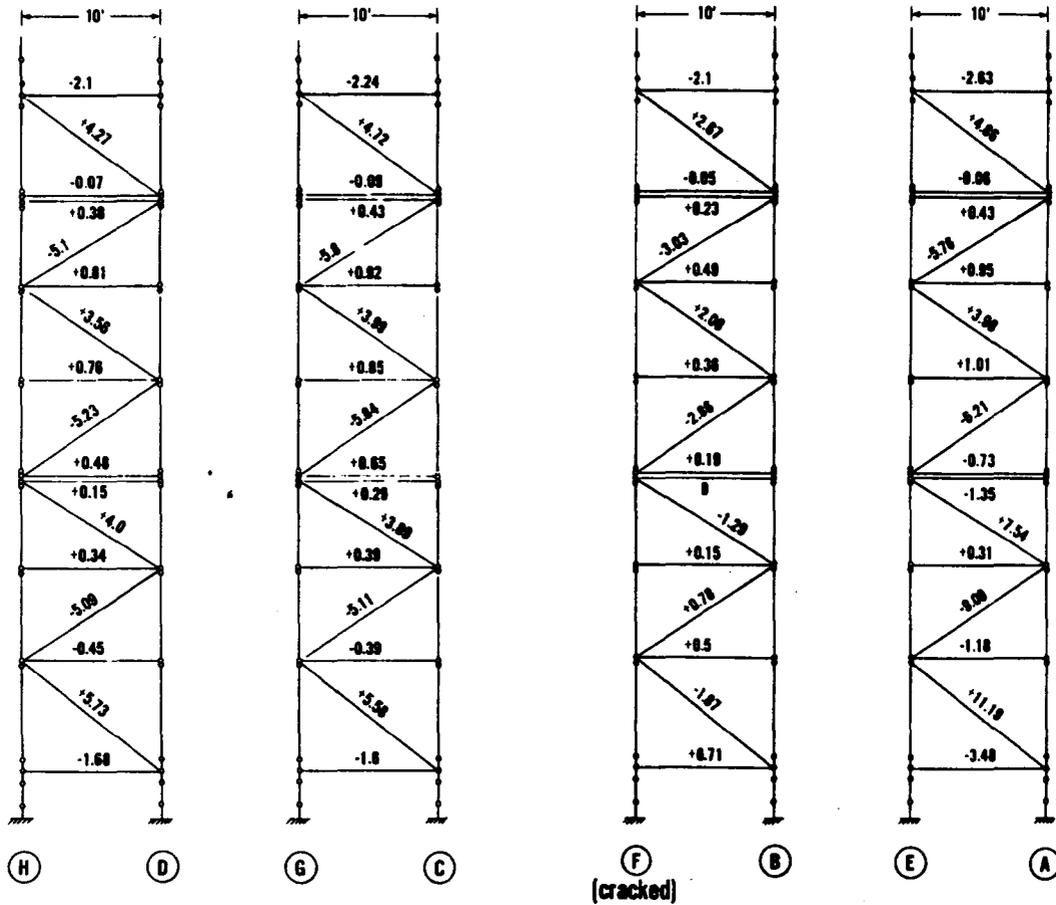
Figure 6.3 Truss brace forces for towers at 407.2 with support settlement of 0.4 in at pad F

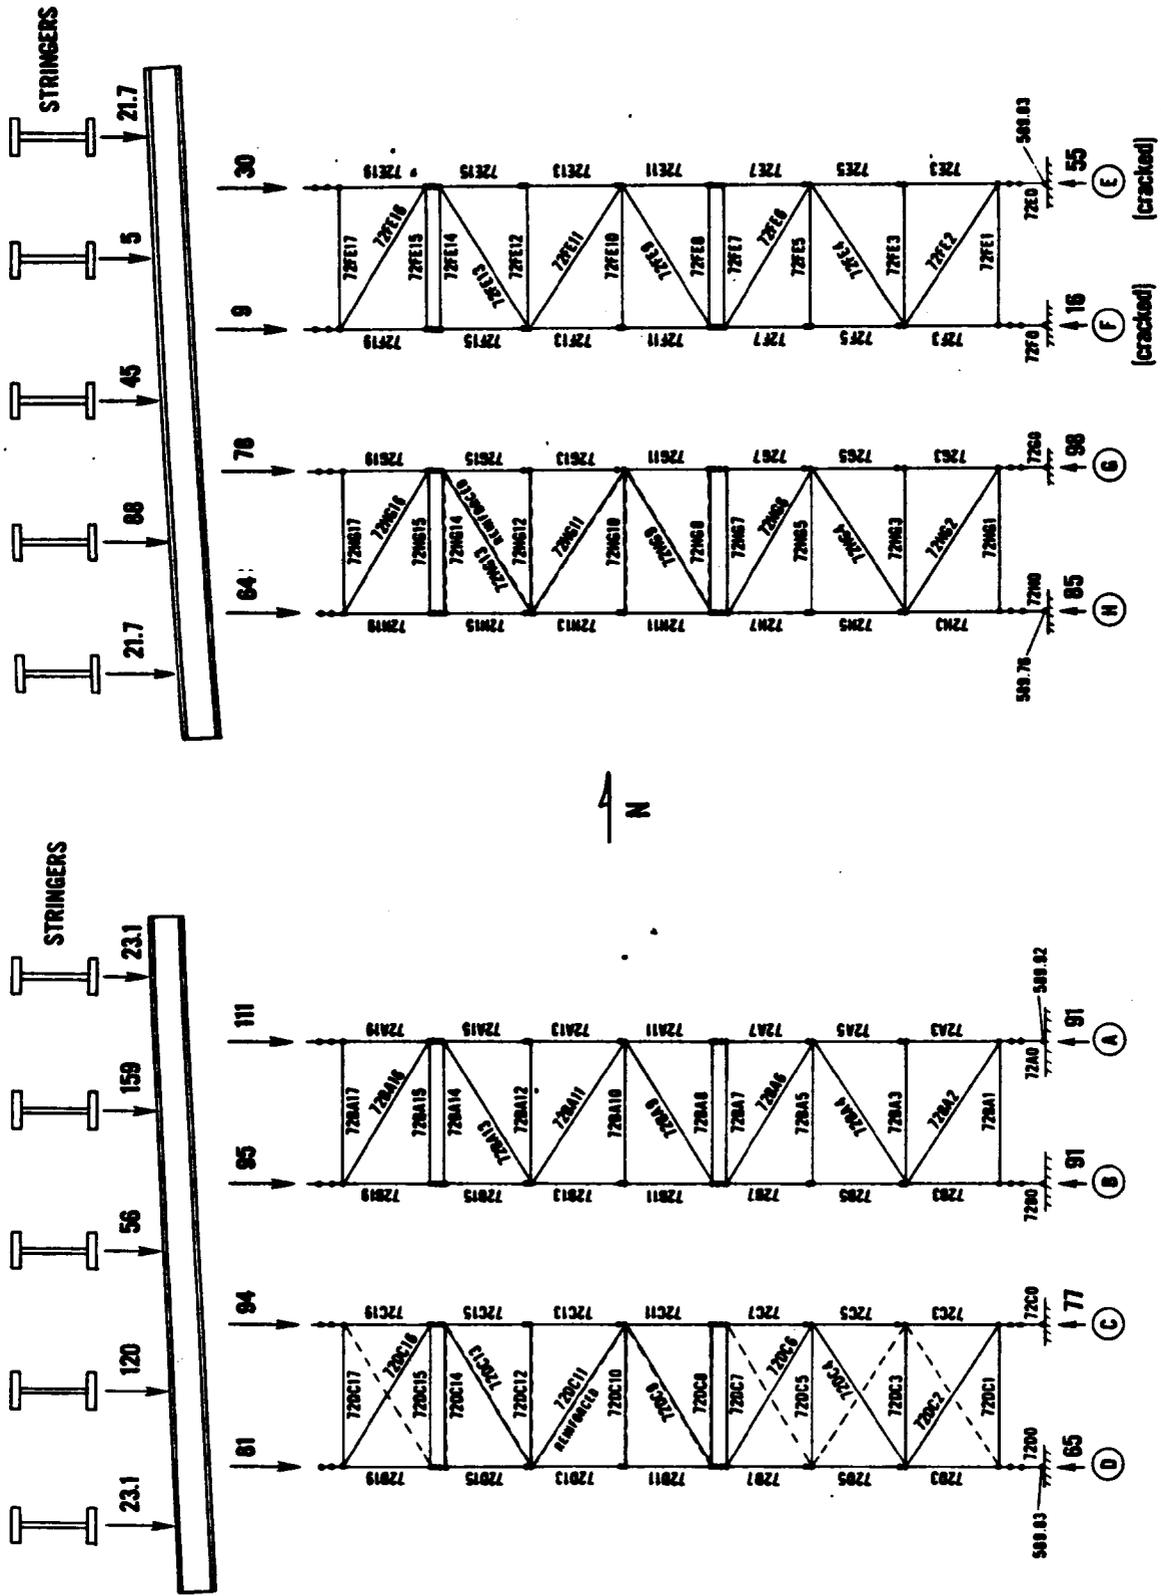
Figure 6.4 Stringer, crossbeam, and support reactions for towers at 407.2 with support settlement of 0.4 in at pads E and F and buckled diagonal 72EA4

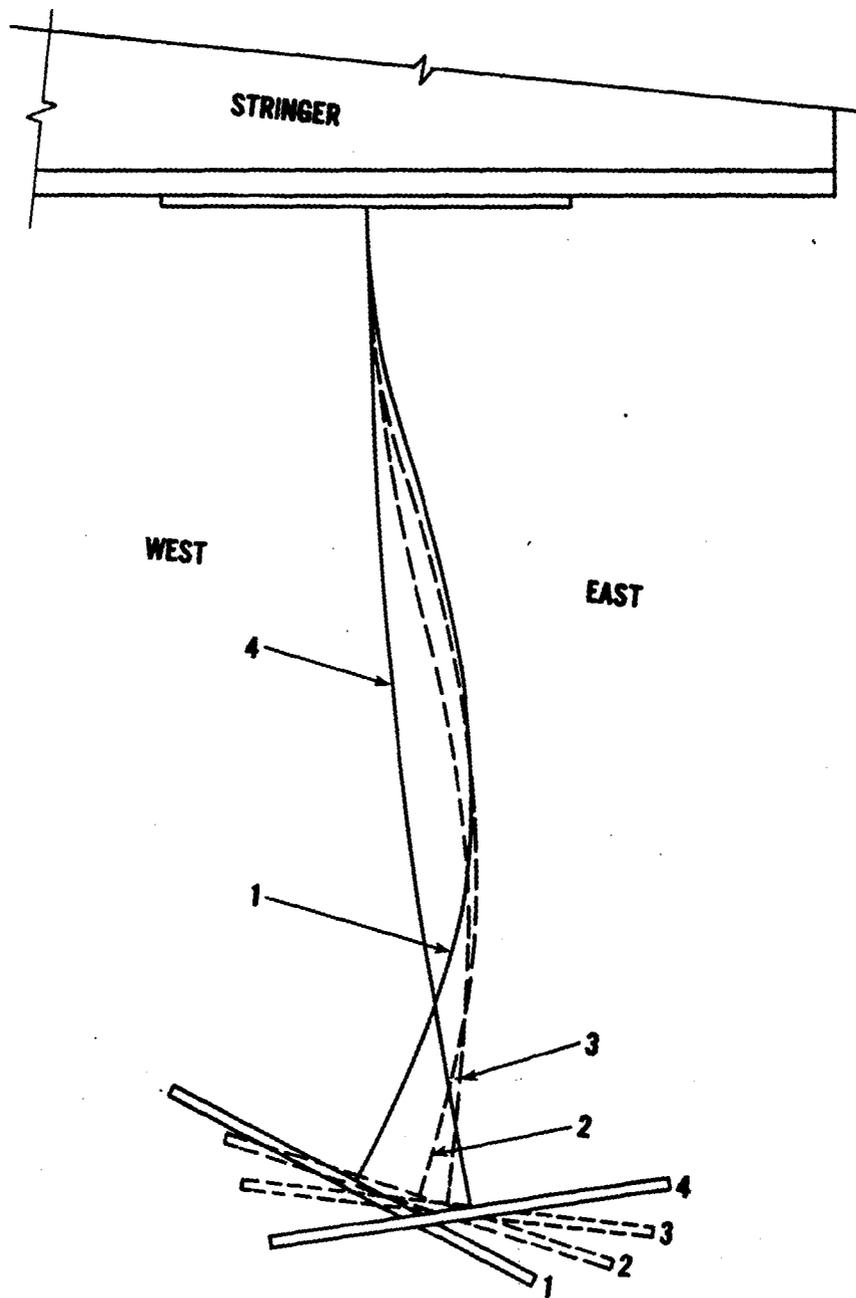
Figure 6.7 Schematic representation of the change in the deformed shape of the crossbeam web as the bottom flange translates eastward

A second analysis was performed in which the U-heads were assumed to provide no rotational restraint to the lower flange of the crossbeam. All other boundary conditions and applied loads were the same as in the first analysis. The resulting deflected shape is shown in figure C.3. This change in curvature of the crossbeam web agrees with the changes described in figure 6.7.

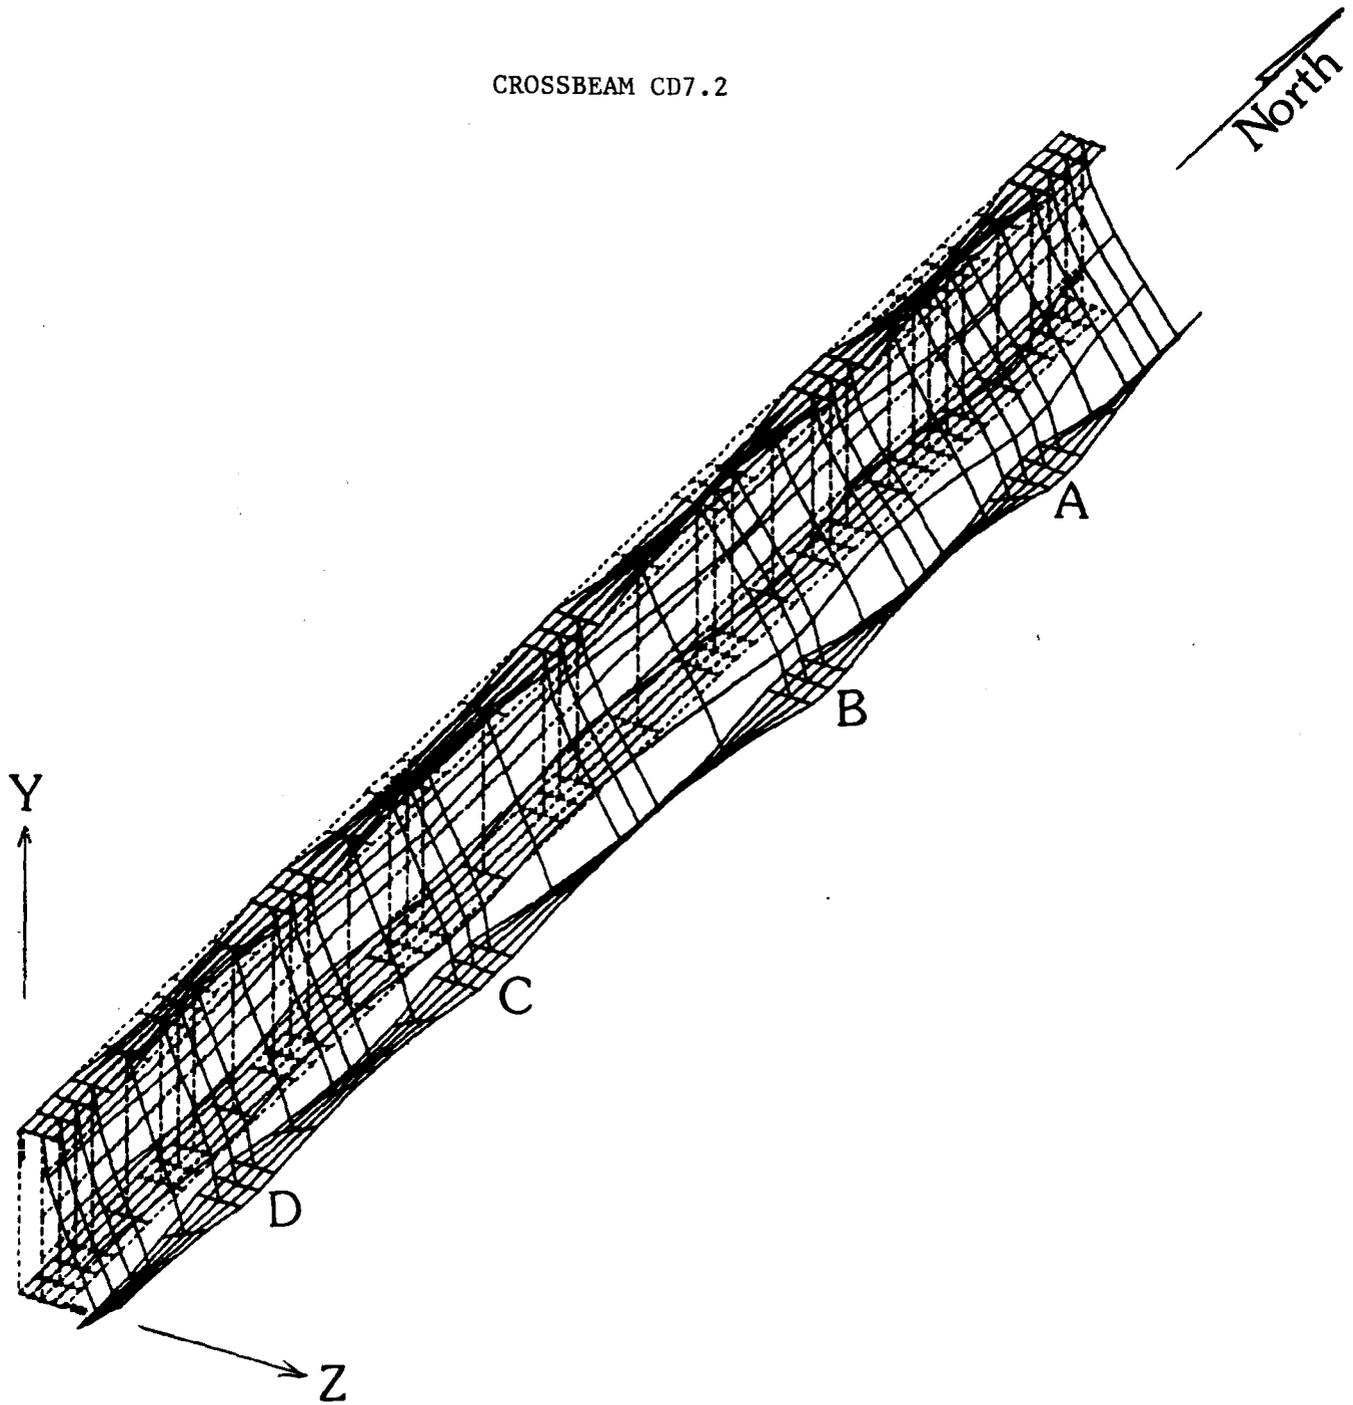
1. The stringer reaction points were assumed to act as fixed supports.
2. The vertical reactions from the U-heads were applied as a distributed load to the web of the crossbeam across the contact width of the U-head top plate.
3. The calculated longitudinal deformations of the crossbeam along the axis of the ramp (figure 6.6) were applied as lateral displacements of the lower flange of the crossbeam at the supporting U-heads.
4. For the initial analysis the top plates of the U-heads were assumed to provide restraint against rotation of the lower flange at the support points.

Figure C.2 Deflected shape of crossbeam for analysis #1. U-head supports are assumed to provide rotational resistance to bottom flange of crossbeam. Dotted lines indicate original position of undeformed beam.

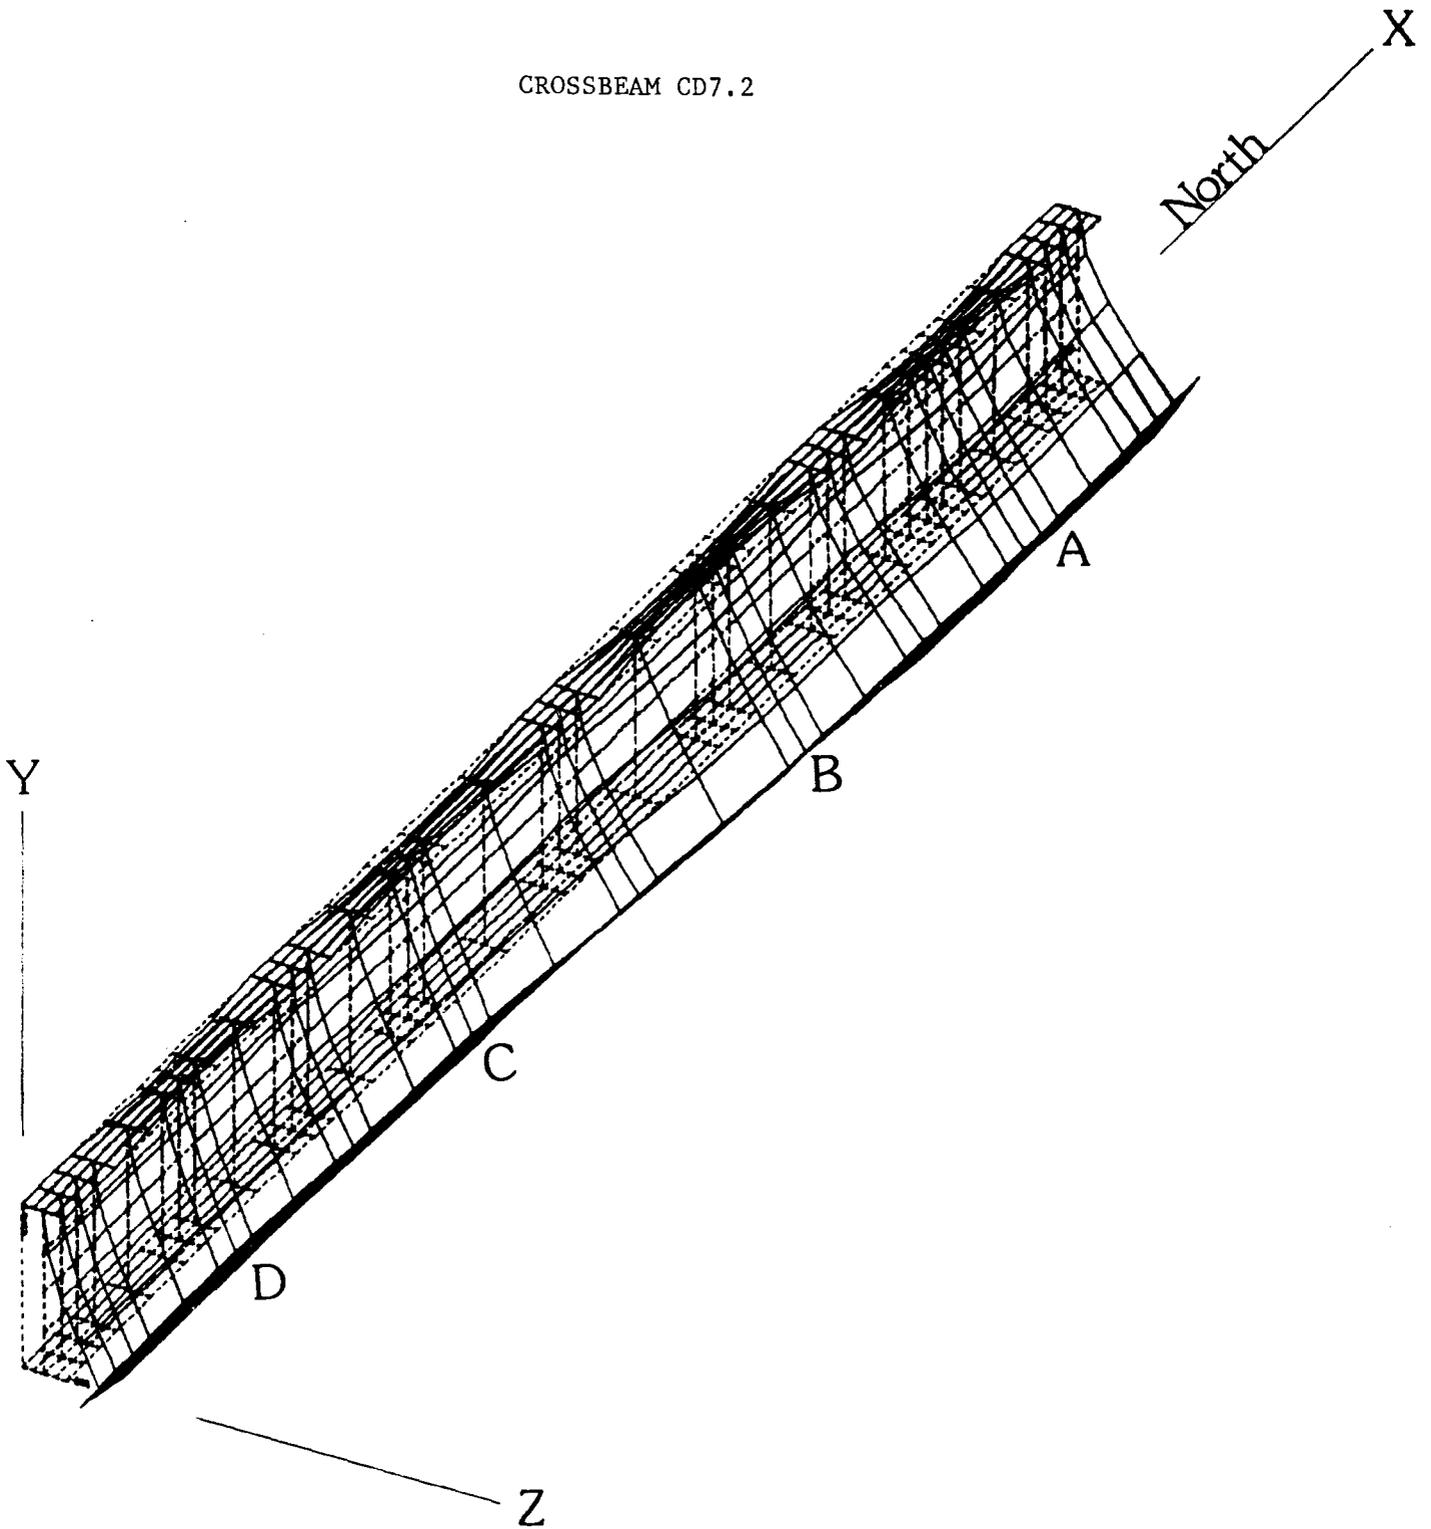
CROSSBEAM CD7.2

Figure C.3 Deflected shape of crossbeam for analysis #2. U-head supports are assumed to provide no rotational resistance to bottom flange of crossbeam. Dotted lines indicate original position of undeformed beam.
