Investigation of the Skyline Plaza Collapse in Fairfax County, Virginia

Edgar V. Leyendecker and S. George Fattal

Center for Building Technology
Institute for Applied Technology
National Bureau of Standards
Washington, D.C. 20234

National Bureau of Standards Building Science Series 94

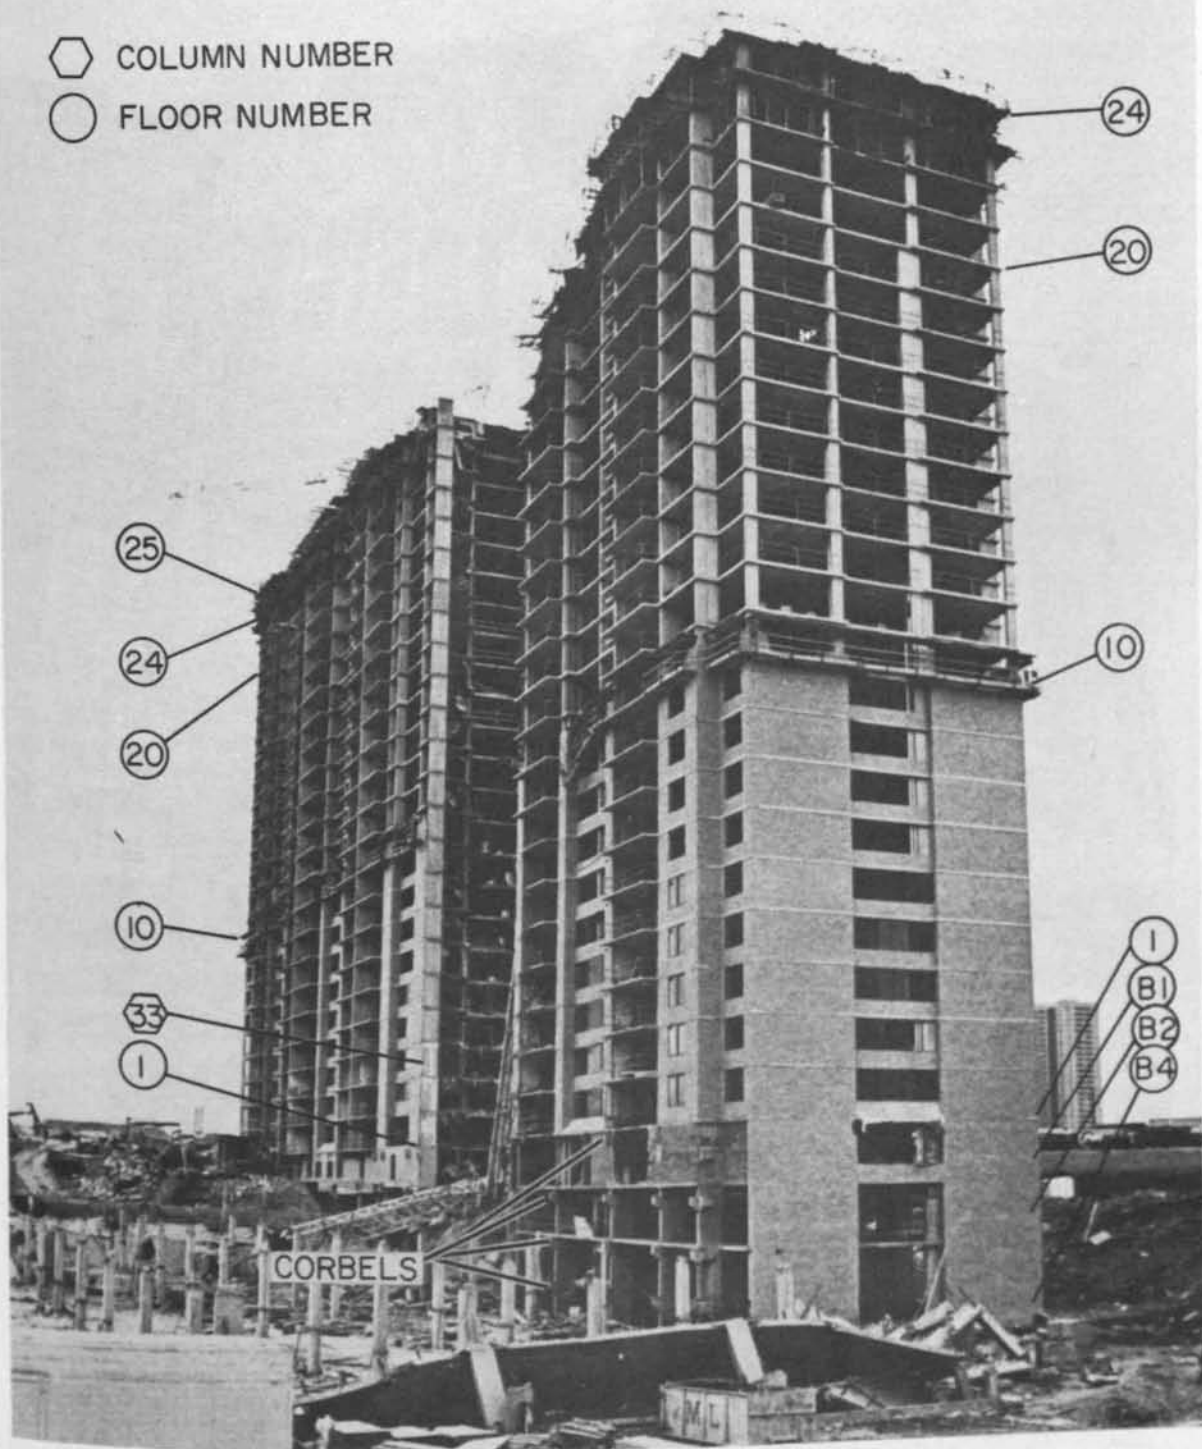
Figure 2.4 General appearance of building A-4 as viewed from the southeast.

The general appearance of the building A-4 as viewed from the southeast after the collapse is shown in figure 2.4. A number of the floors and one of the columns is identified for later reference. Note the absence of a floor slab at level B-3 (in accordance with the plans). Note also the column corbels at floor levels B-3, B-2, B-1, and 1. These corbels supported one edge of the parking garage slabs. Level B-4 of the garage was on grade.

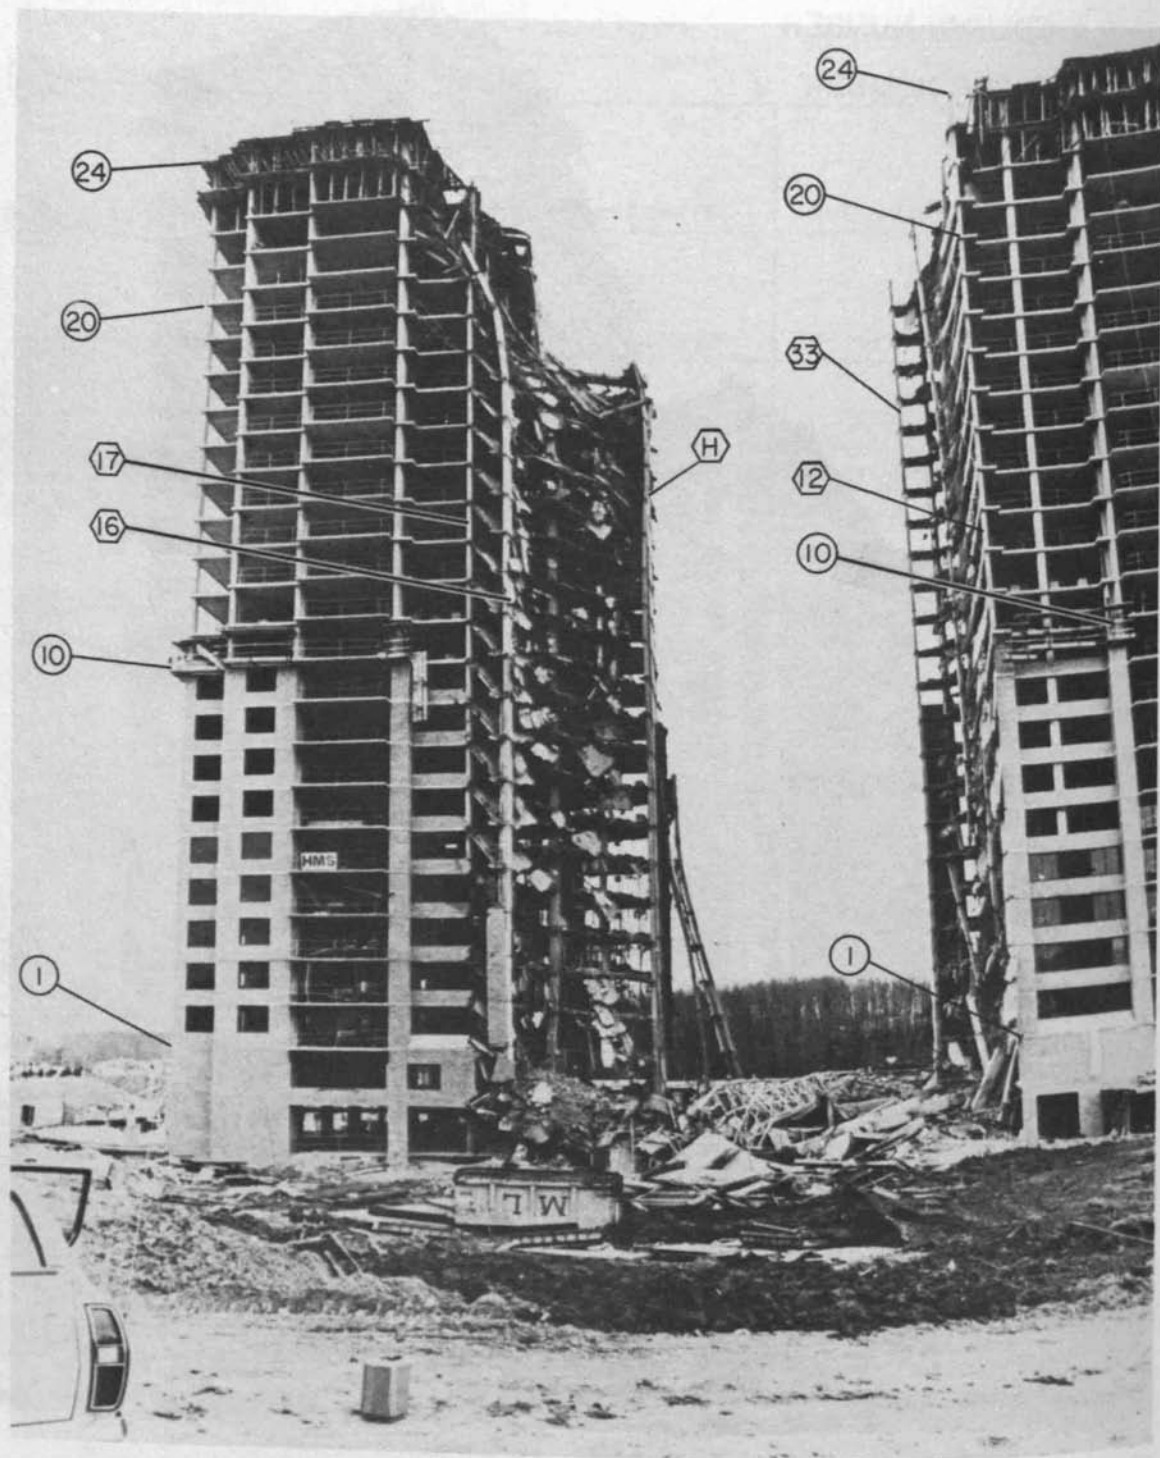
Figure 2.5 General view of the north face of building A-4.

A partial view of the north face of building A-4 is shown in figure 2.5. A number of columns and floors are identified. The collapse extended between shear wall H and column 33 on the south face, a distance of about 65 ft (refer to figure 2.1). On the north face the collapse extended between columns 12 and 17, a distance of about 104 ft. Note that for most floors the slab between columns 16 and 17 did not sever from the main building but is sagging for a one-story height. Below the 20th floor, the horizontal extent of the collapse is as discussed above. Above the 20th floor, the failure zone extended slightly to the west and a greater amount to the east.

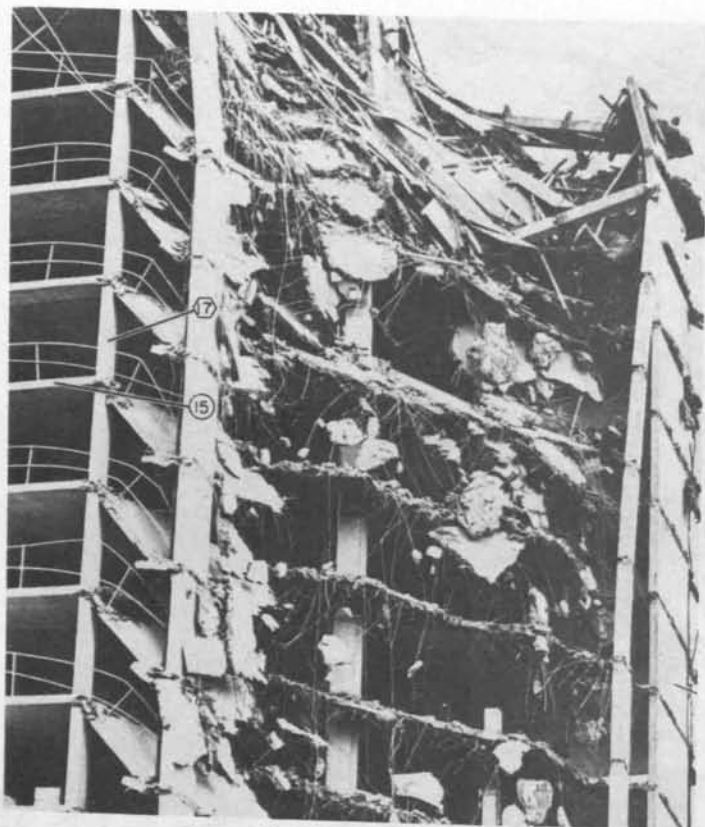
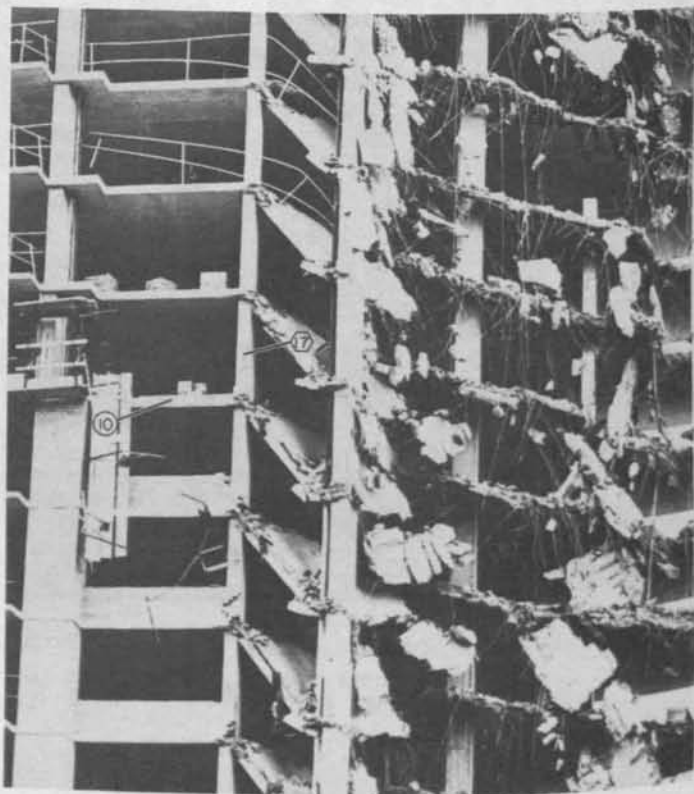
Figures 2.6 through 2.8 are closeup views of the east end of the failure zone. These figures require little comment at this time; however, it should be noted that the formwork is clearly visible in figure 2.6.

Figure 2.7
 Closeup view near the
 top of the east end of
 the failure zone,
 looking south.

Figure 2.8
 Closeup view near the
 midheight of the east
 end of the failure
 zone, looking south.

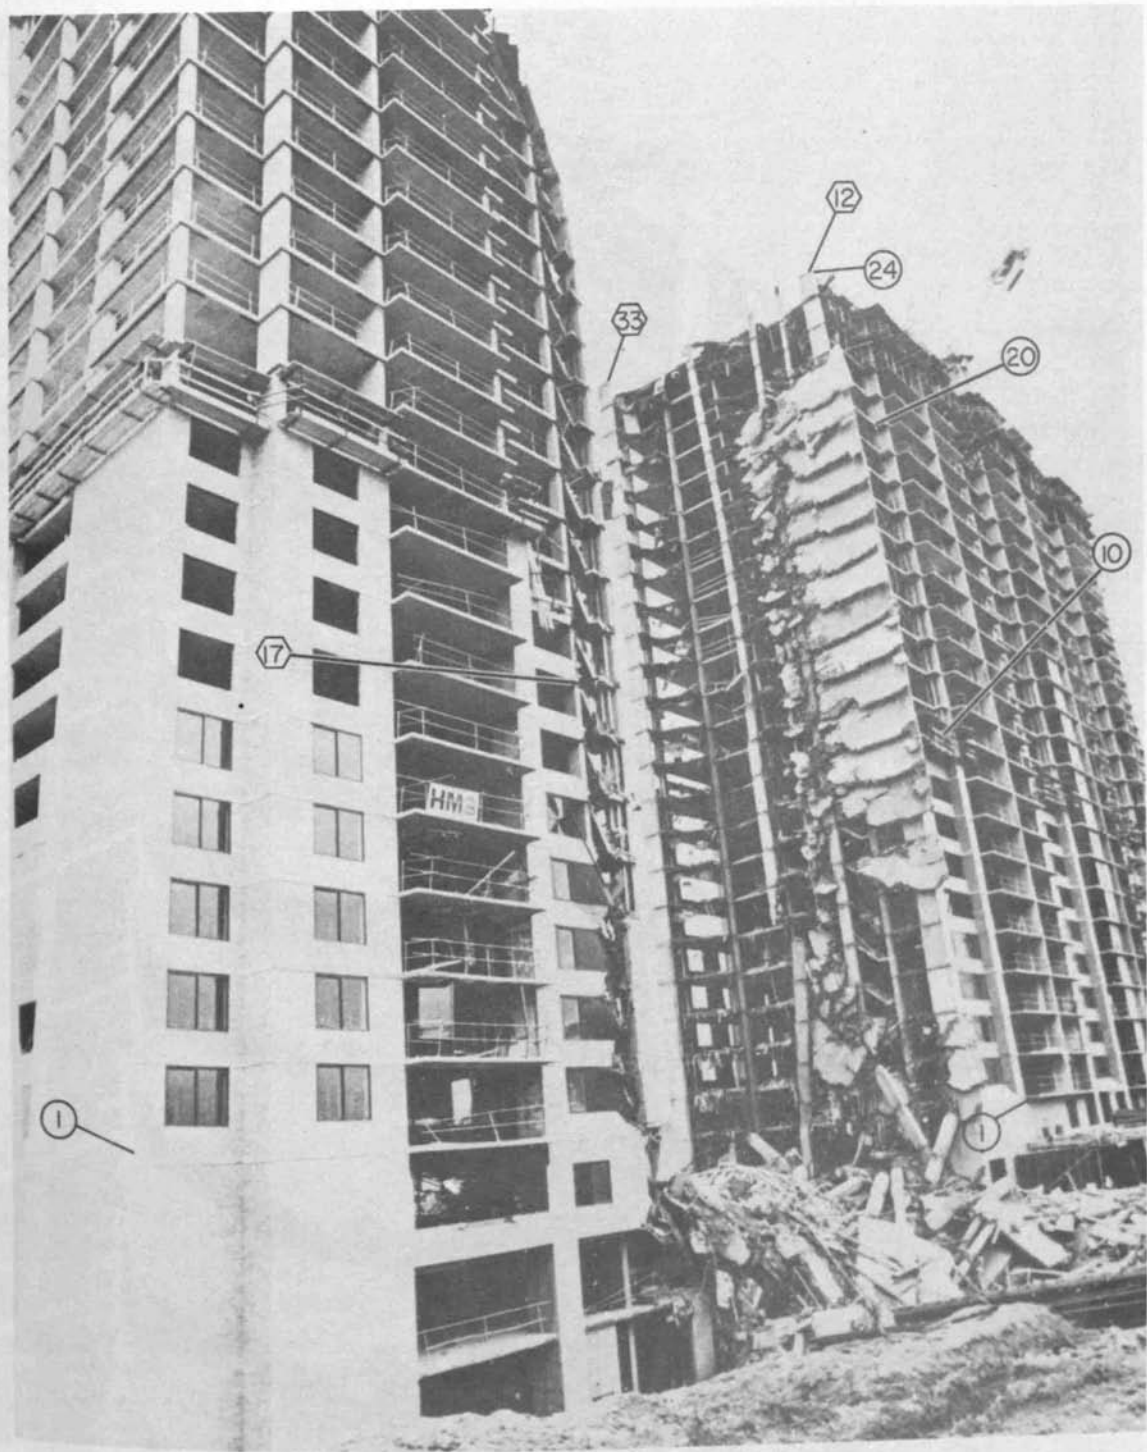
Figure 2.9 General view of building A-4 as seen looking southwest.

A general view of the west end of the failure zone is shown in figure 2.9 along with closeup views in figures 2.10 through 2.12. These figures also require little comment at this time; however, it should be noted that the formwork is clearly visible in figure 2.10.

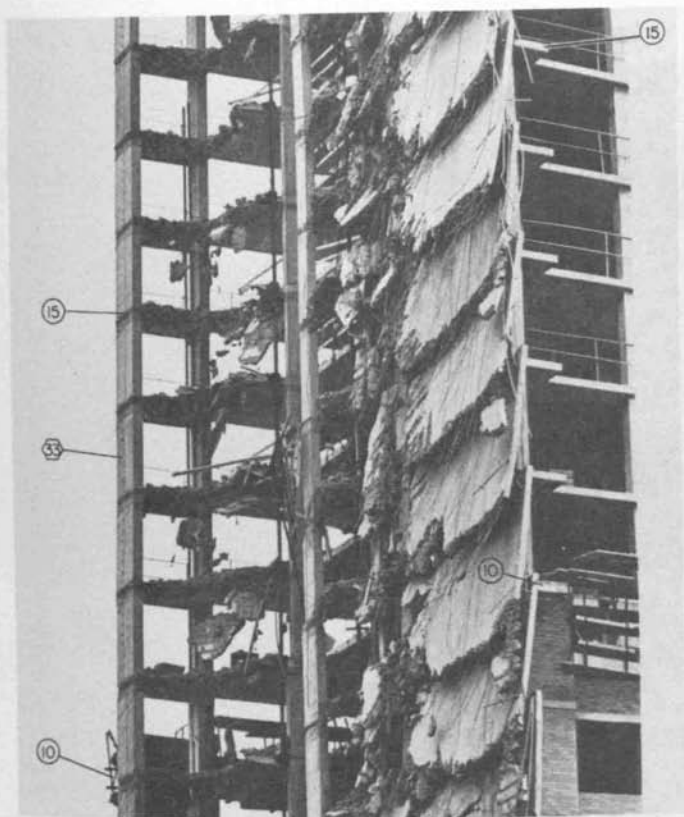
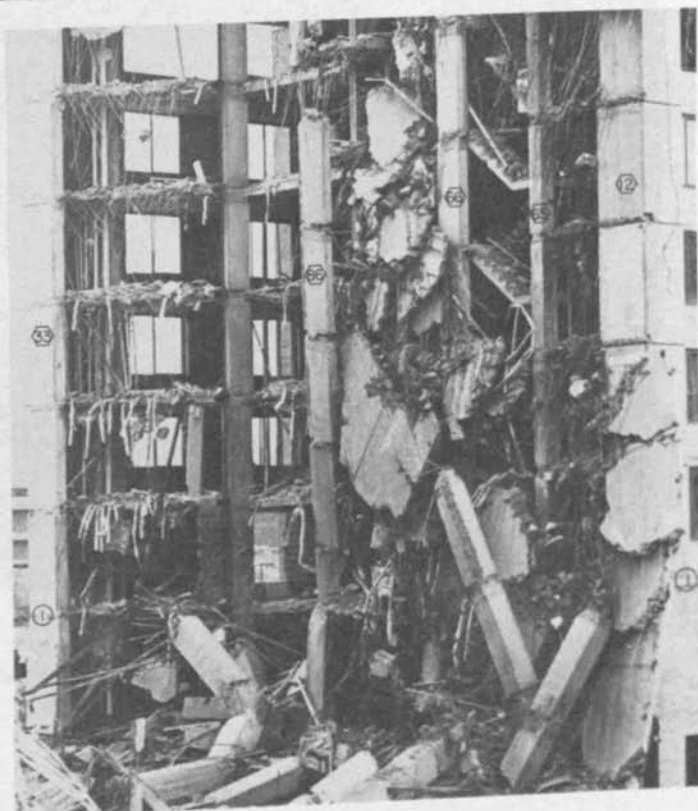
Figure 2.11
Closeup view near the
midheight of the west
end of the failure
zone, looking south-
west.

Figure 2.12
Closeup view at the
bottom of the west end
of the failure zone,
looking southwest.

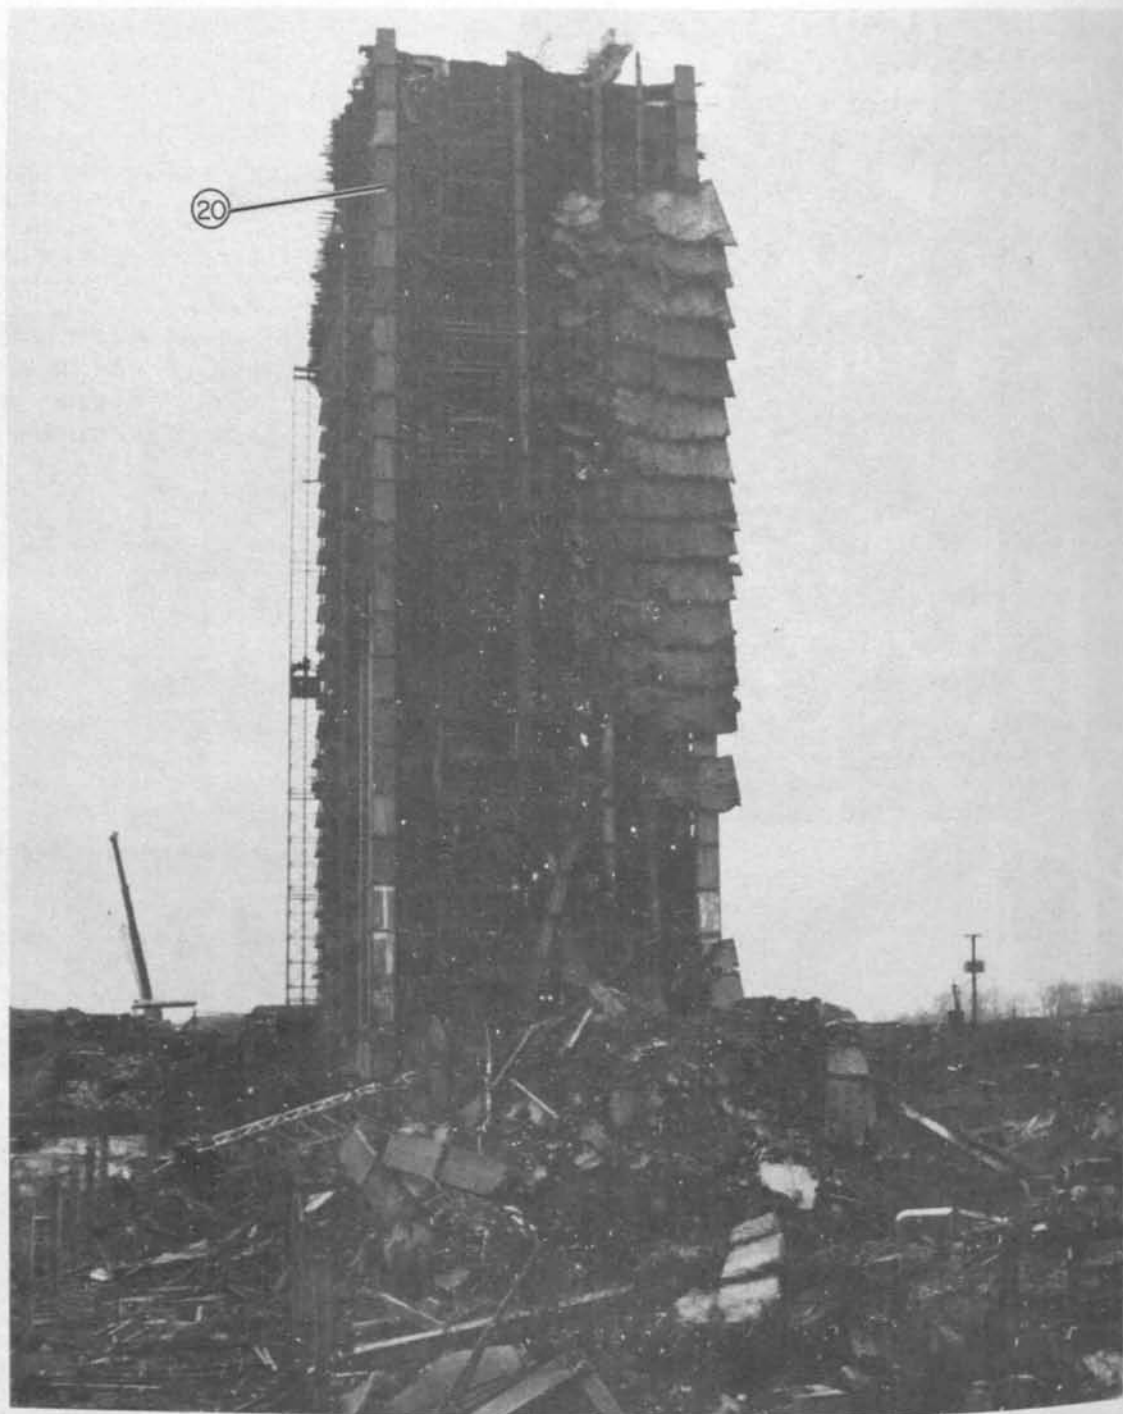
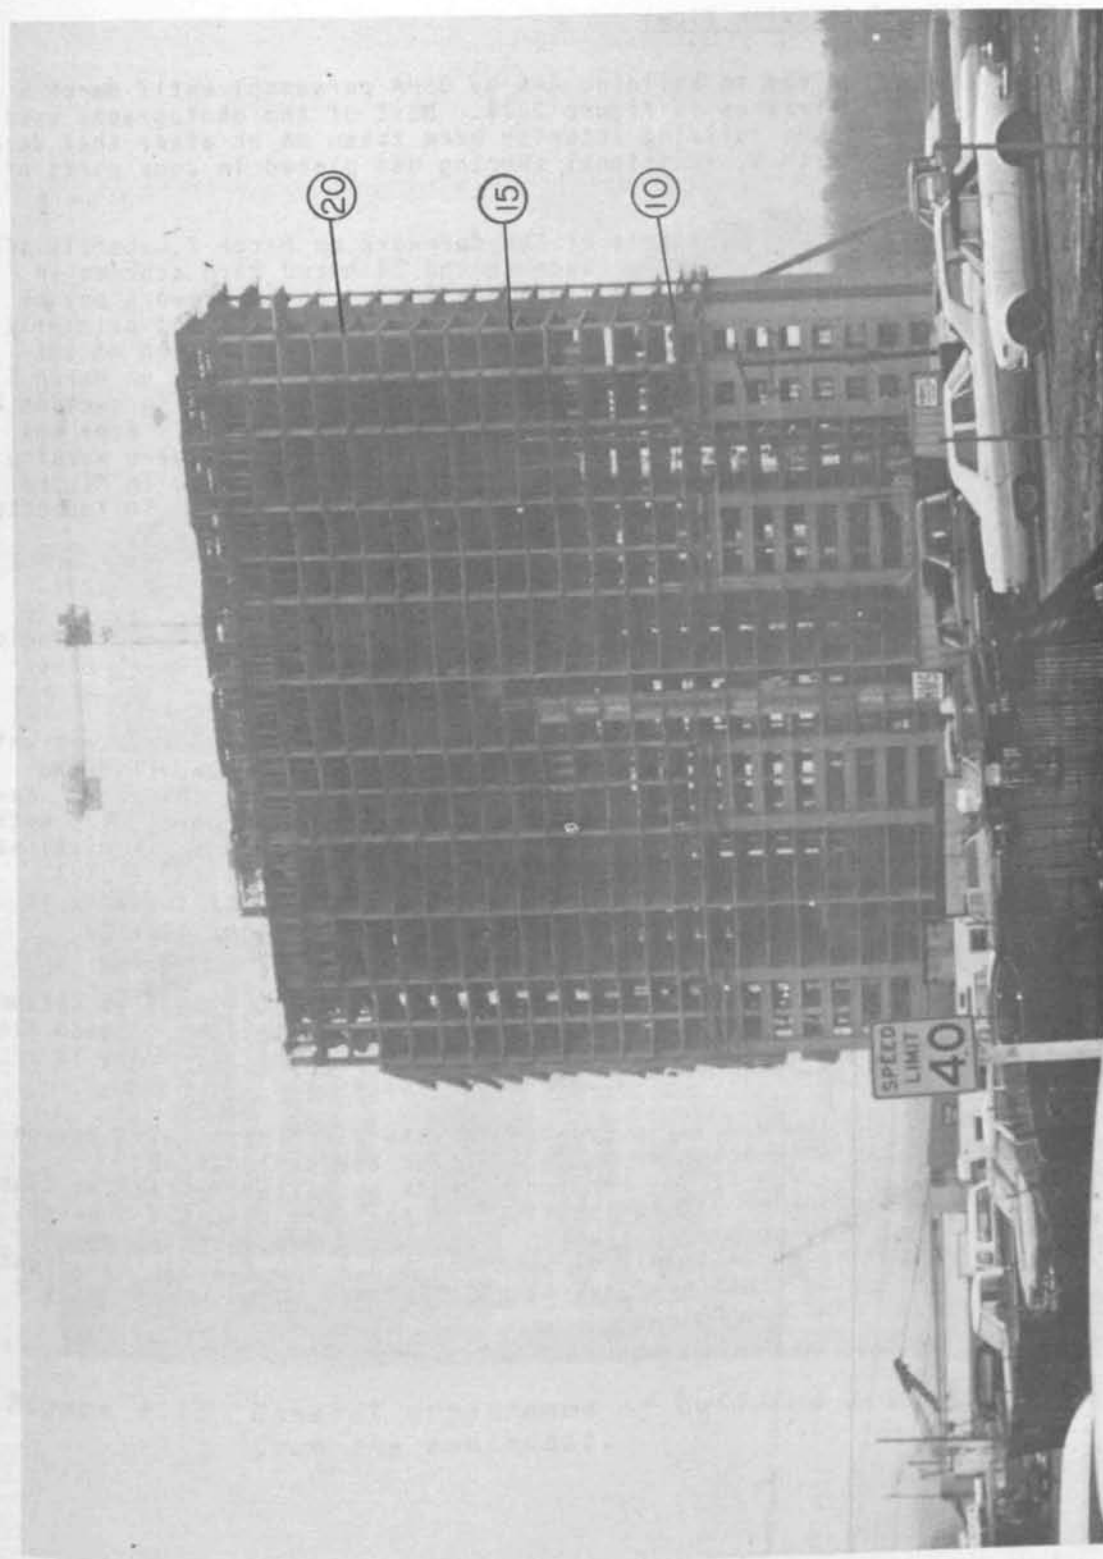
On the night of March 4 the remaining portion of the building to the east of the failure zone was completely demolished, with the result shown in figures 2.13 and 2.14.

Figure 2.13 Appearance of A-4 after the removal of the east end of the building, viewed from the east.

Figure 2.14 North face of building A-4 after partial demolition.

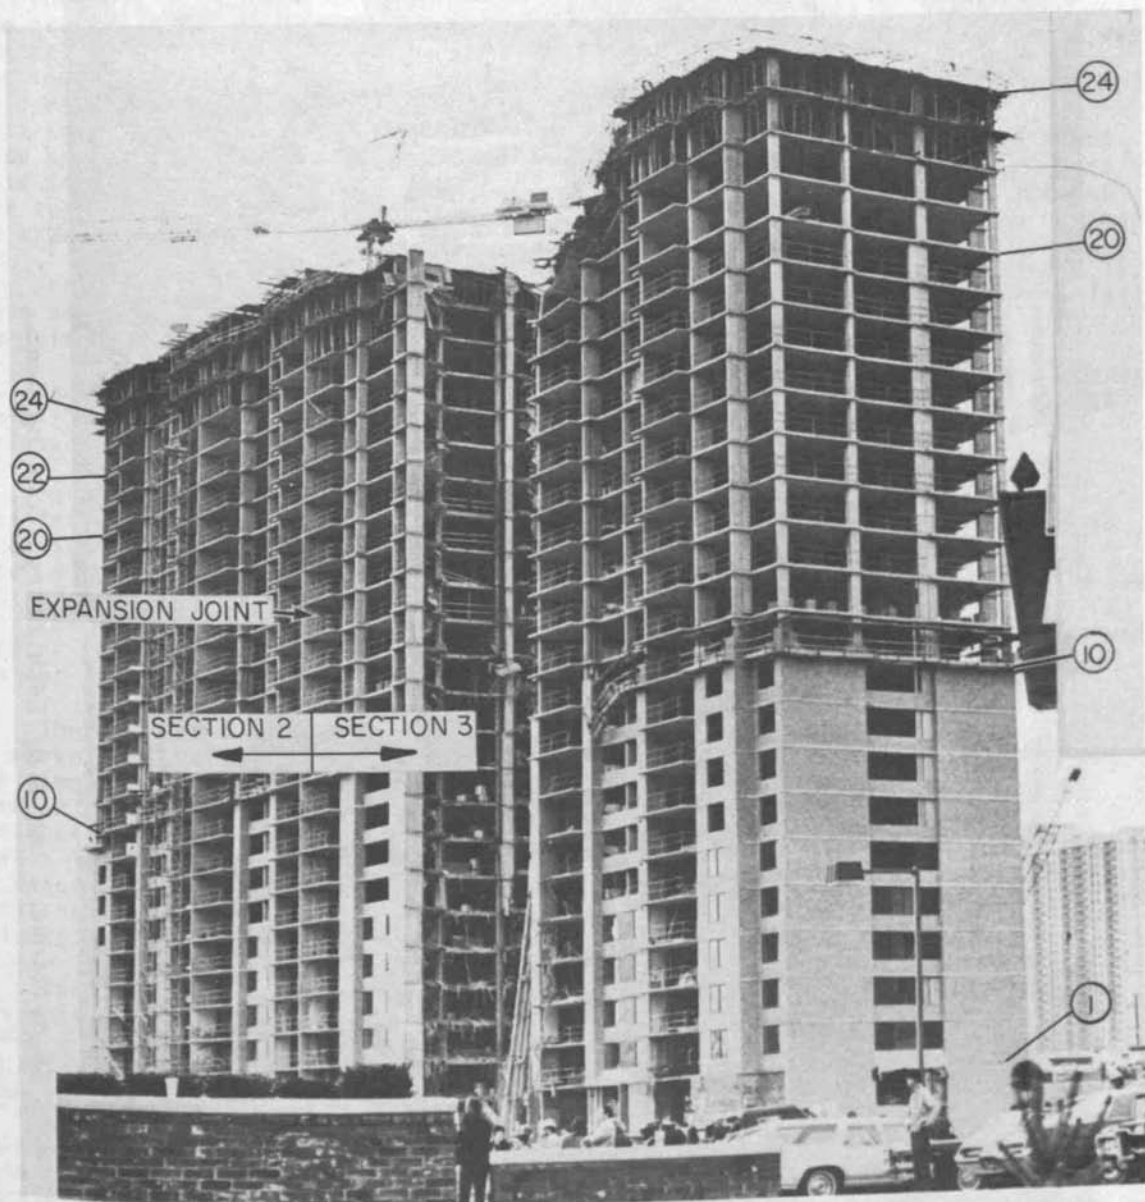
Figure 2.15 General appearance of building A-4 as viewed from the southeast.

Figure 2.15 shows the locations of the formwork on March 2, shortly after the collapse. Full formwork was in place on the 24th and 23rd stories in sections 1 and 2 (refer to figure 2.1 for location). Some formwork may be seen on the 22nd story in sections 2 and 3. In section 2 this is primarily the area around the material elevator shown toward the western end of the south elevation in figure 2.15. Investigation by OSHA personnel on March 5 indicates that the only formwork not stripped on the 22nd story in section 2 was around that elevator. Employee statements indicate that this area was not stripped in order to prevent lumber from falling on bricklayers working below. Formwork may also be seen in section 3 of the 22nd story in figure 2.15. However, closer examination of the 22nd story in figure 2.10 indicates that formwork was stripped in the center portion of the 22nd story.

Full formwork was also in place under section 4 on the 22nd and 23rd stories. No reshoring can be seen under section 4 below the 22nd floor in figure 2.15 or in figures 2.4, 2.5, and 2.6. Some employee statements indicate, however, that reshoring was present below pour 4 on the 21st story. Other statements contradict this.

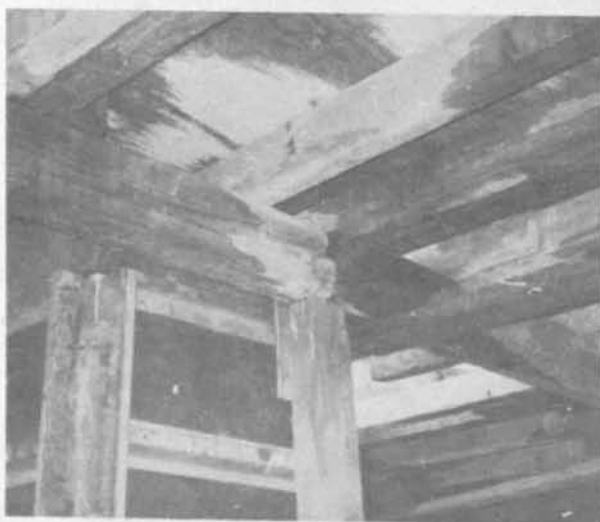
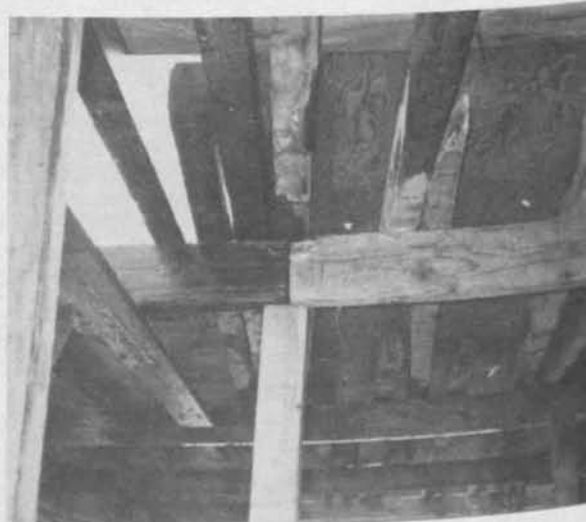
Figure 2.18 Selected details of 24th story forms.

During the NBS site inspection, a considerable portion of the lumber used for the remaining forms in the 24th story was found to be in poor condition or out of plumb. For instance, the top photograph in figure 2.18 shows a stringer with a battered end directly over the shore. The second photograph illustrates a shore which is out of plumb and has a vertical crack near the top. OSHA regulations (ANSI-A10.9, sections 8.1.24 and 8.1.25) [2] require correction of both of these conditions prior to placing concrete (which was not yet placed on these forms).

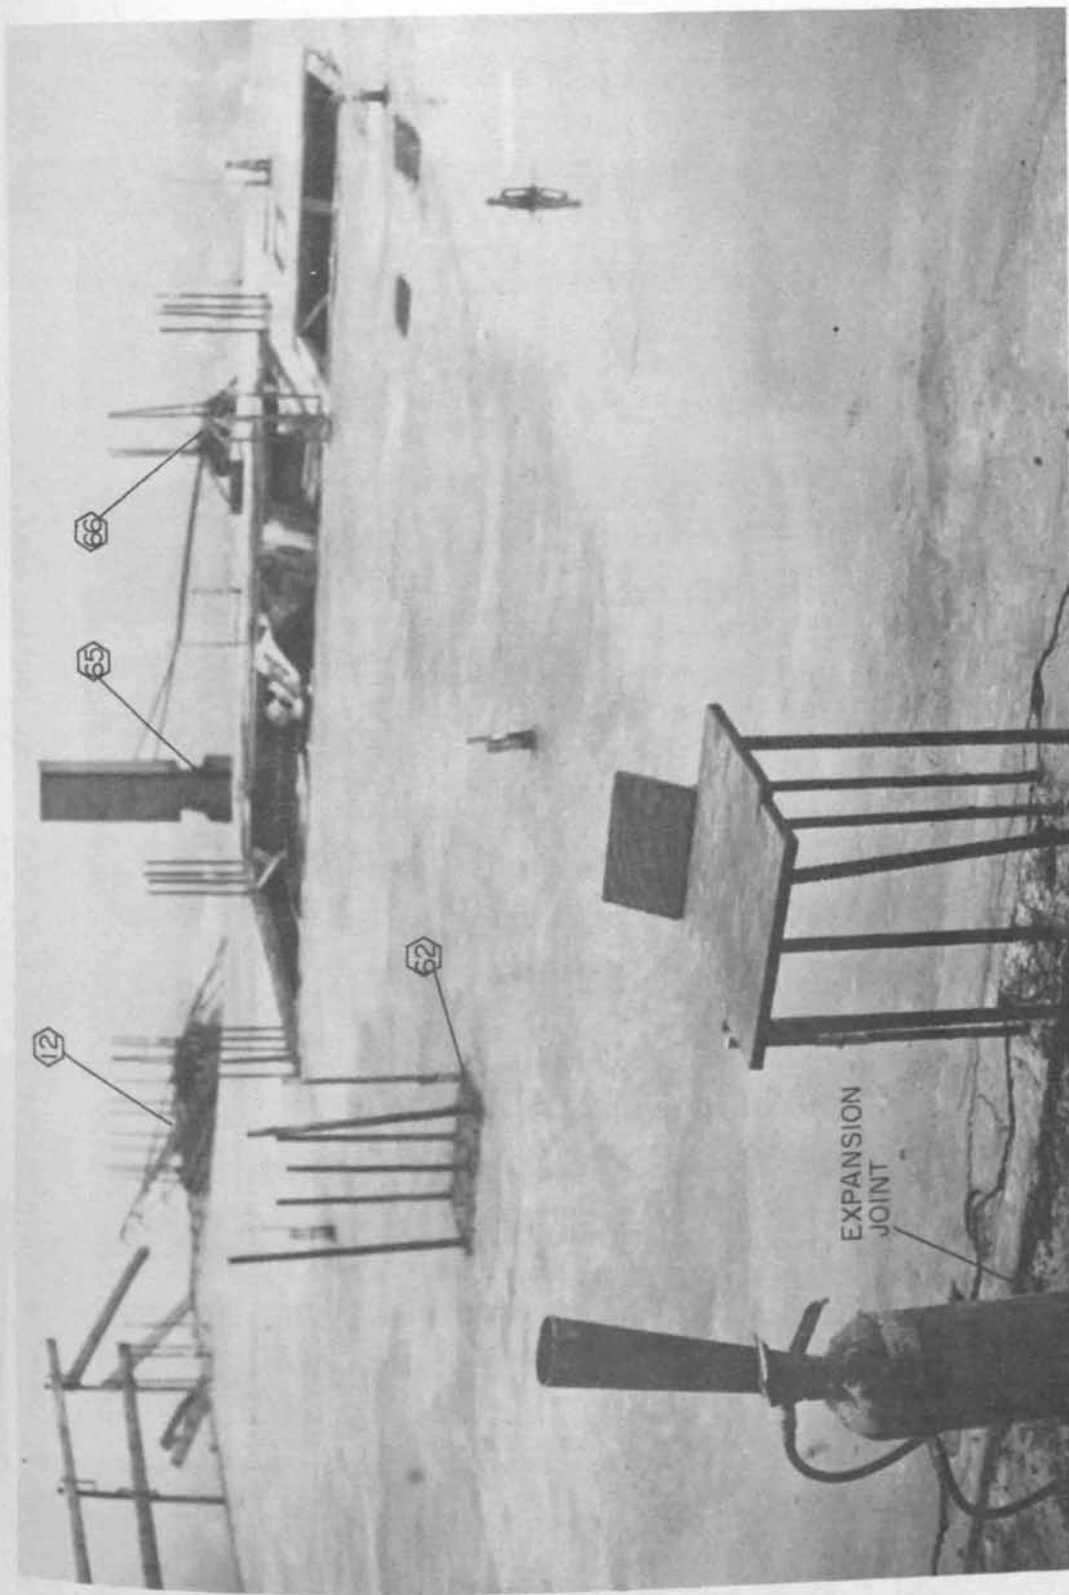
Figure 2.19 Twenty-fourth floor slab in section 3, looking east.

The portion of section 3 of the 24th story slab which remained standing is shown in figure 2.19. This portion of the slab was several hours old at the time of the collapse. Apparently, the only activity on the slab at the time of collapse was work being done by concrete finishers. One concrete finisher working near the stair well (around columns 65 and 66) indicated that a large deflection was seen in the middle of section 3. The statements of numerous employees agree on this point. No statements provided an exact location of the sag. However, the middle of section 3 is about midway between columns 67 and 85 (refer to figure 2.1 for location).

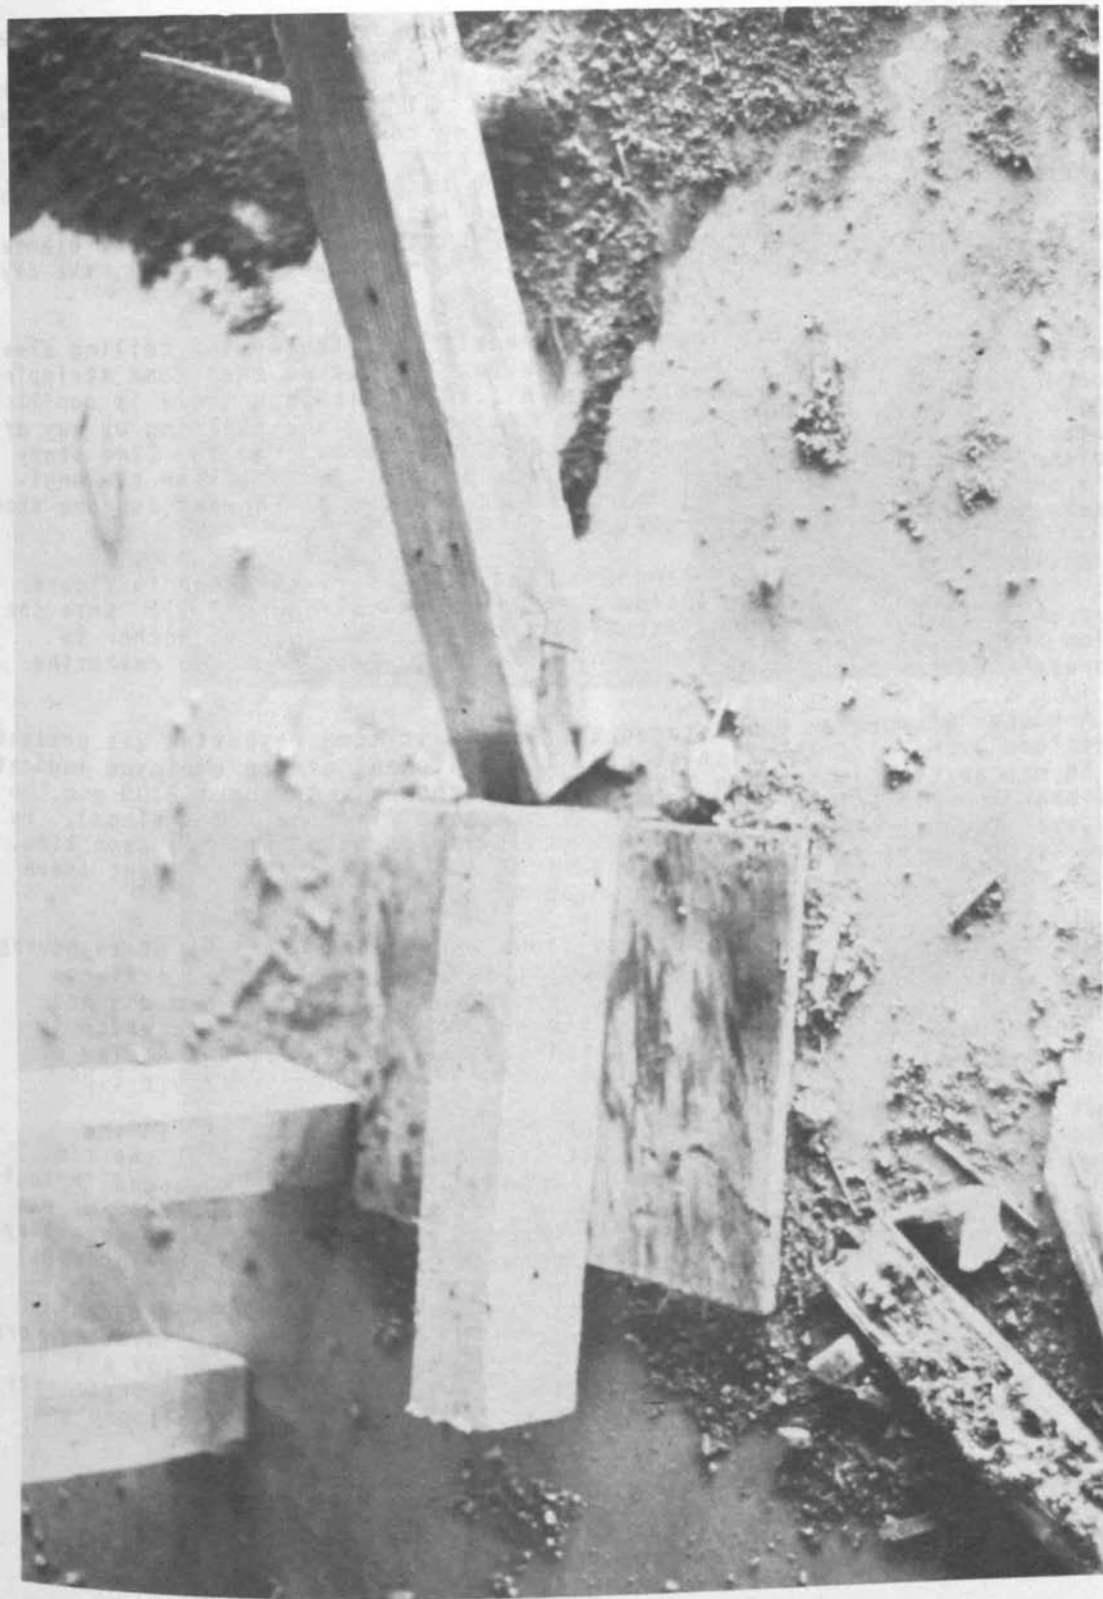
Figure 2.21 Detail at base of lateral bracing, 23rd floor.

The formwork on the 23rd story is shown in figure 2.20. These forms supported the 24th floor which had been cast on February 28 (section 1) and March 1 (section 2). Note the number of shores out of plumb and the location of lateral bracing. The method of attaching the brace to the stringer may be seen in figure 2.20. The method of attaching the brace to the floor is shown in figure 2.21. A portion of a nominal 3 x 4 was nailed to a piece of plywood which was in turn nailed to the floor. A plywood plate was occasionally used to nail the brace to the nominal 3 x 4. Note the absence of such a plate in figure 2.21. Occasionally, the brace was installed with the plate, in other instances, there was no positive attachment of the brace to the floor. In one case, the plywood stop was not nailed to the floor, providing no lateral resistance.

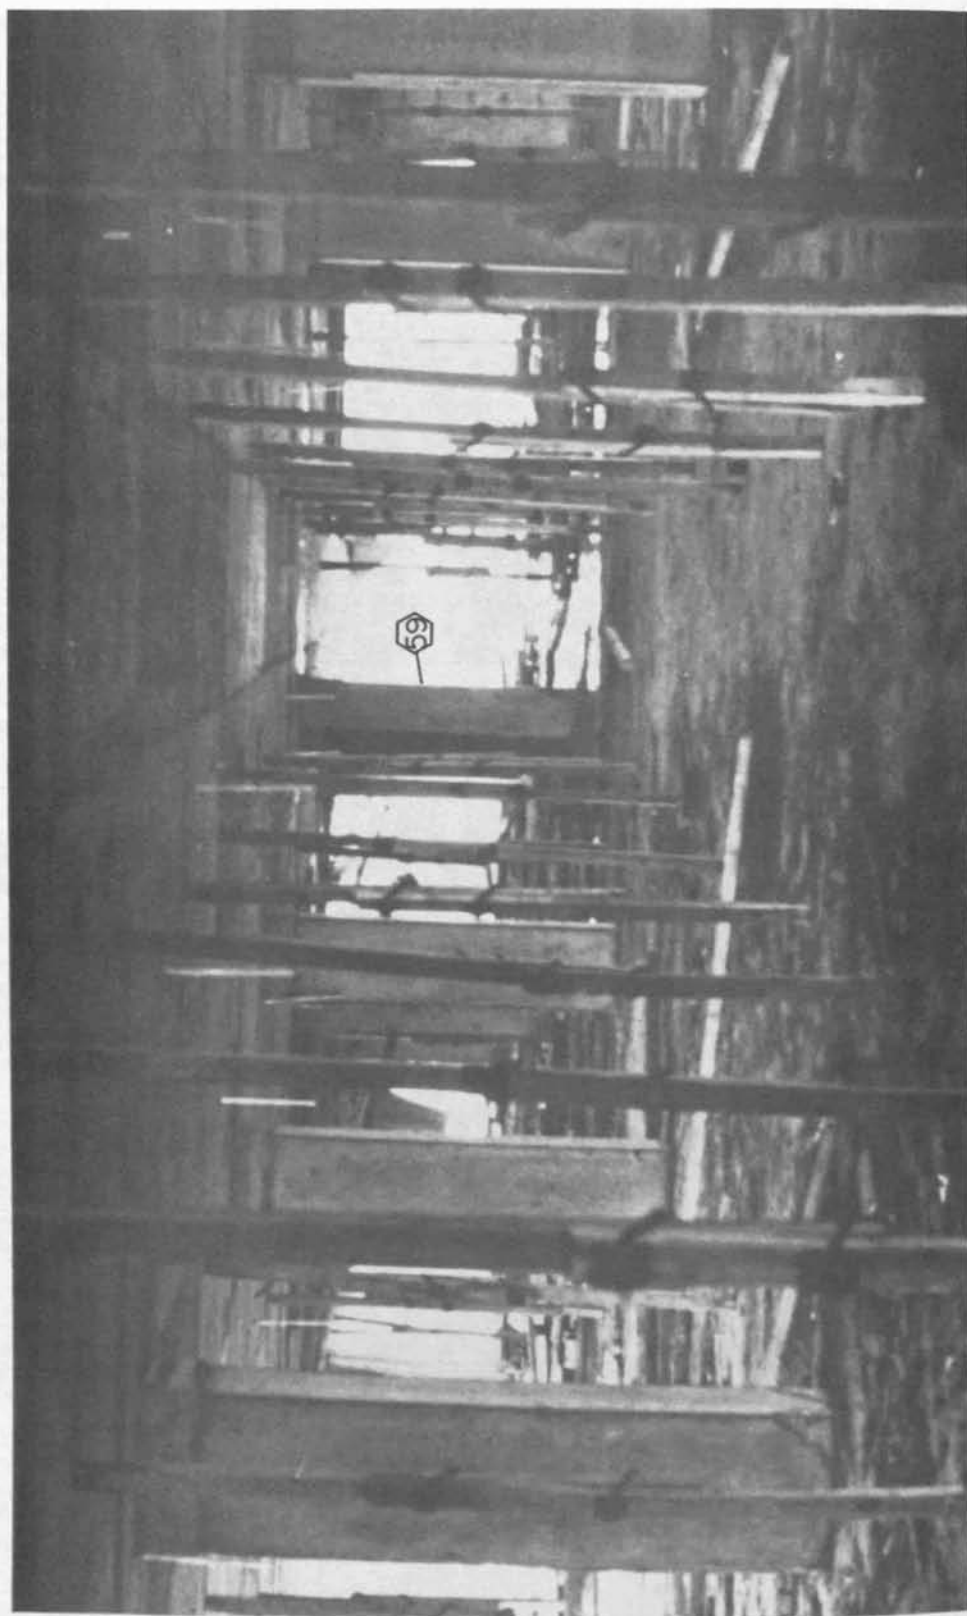
Figure 2.23 Reshoring in section 2 of 22nd story, looking east.

Reshoring in section 2 of the 22nd story as of March 6 is shown in figure 2.23. OSHA investigators have indicated that the reshoring on March 5 was not as extensive as shown in figure 2.23. Apparently on March 5 the reshores were principally in place on the balconies, as they were on March 3, the day of the collapse.

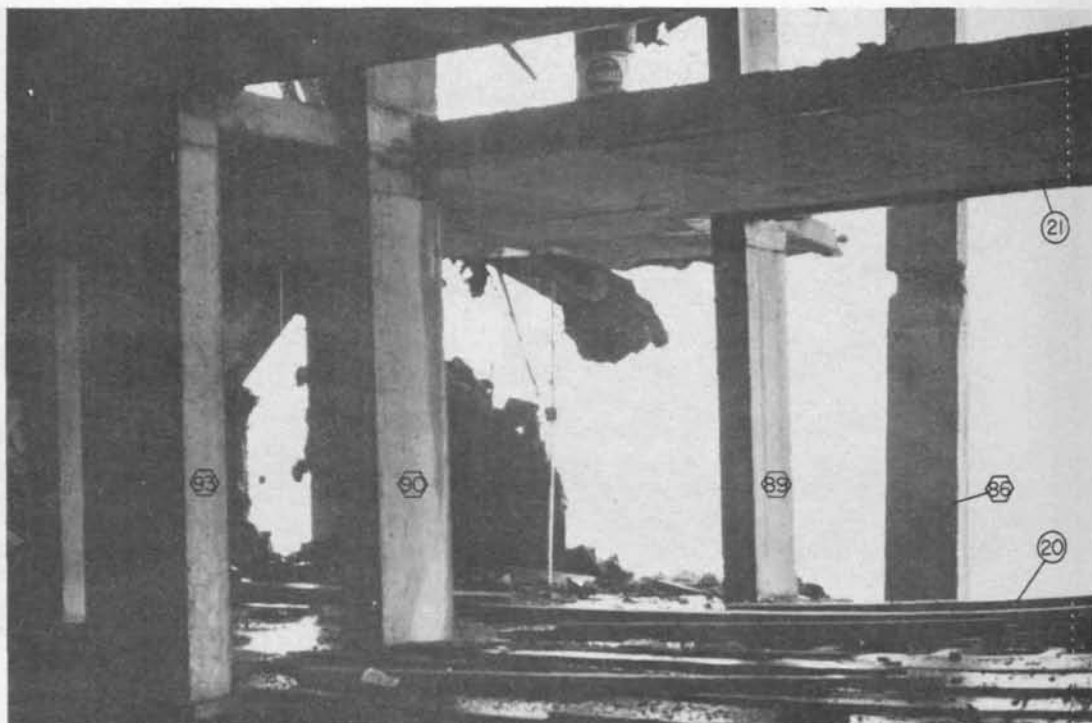
Figure 2.26 Section 3 of 20th story, looking east.

As shown in figure 2.25, the 20th floor was completely bare of reshoring. This was reportedly the case for sections 1 through 4. Note the presence of shear walls A and B. These walls were not present (the design did not require them) above the 20th story. Note also the erection crane which is barely visible to the left of the designation for shear wall A. A view of the failure section at the end of the 20th floor is shown in figure 2.26.

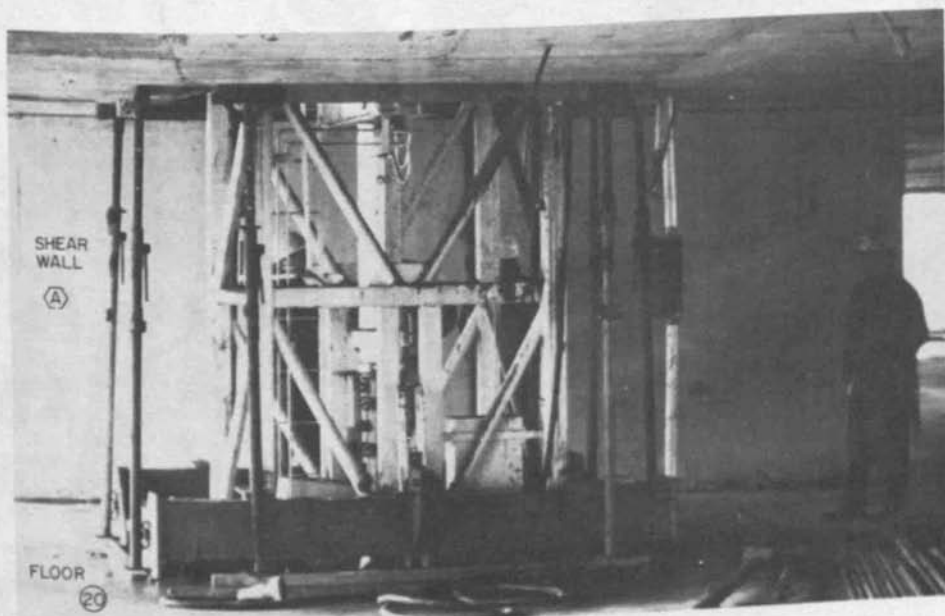
Figure 2.33 Climbing frame for crane no. 1.

Crane no. 1 was supported by the climbing frame, the lower support, on the 20th floor as shown in figure 2.33. The upper support was provided on the 22nd floor as shown in figure 2.34. This total distance is 18 ft, slightly less than the manufacturer's specified 18 ft 4 in. A typical corner clamp detail on the 22nd floor is shown in figure 2.35. Note the cracked slab where the clamp is attached.

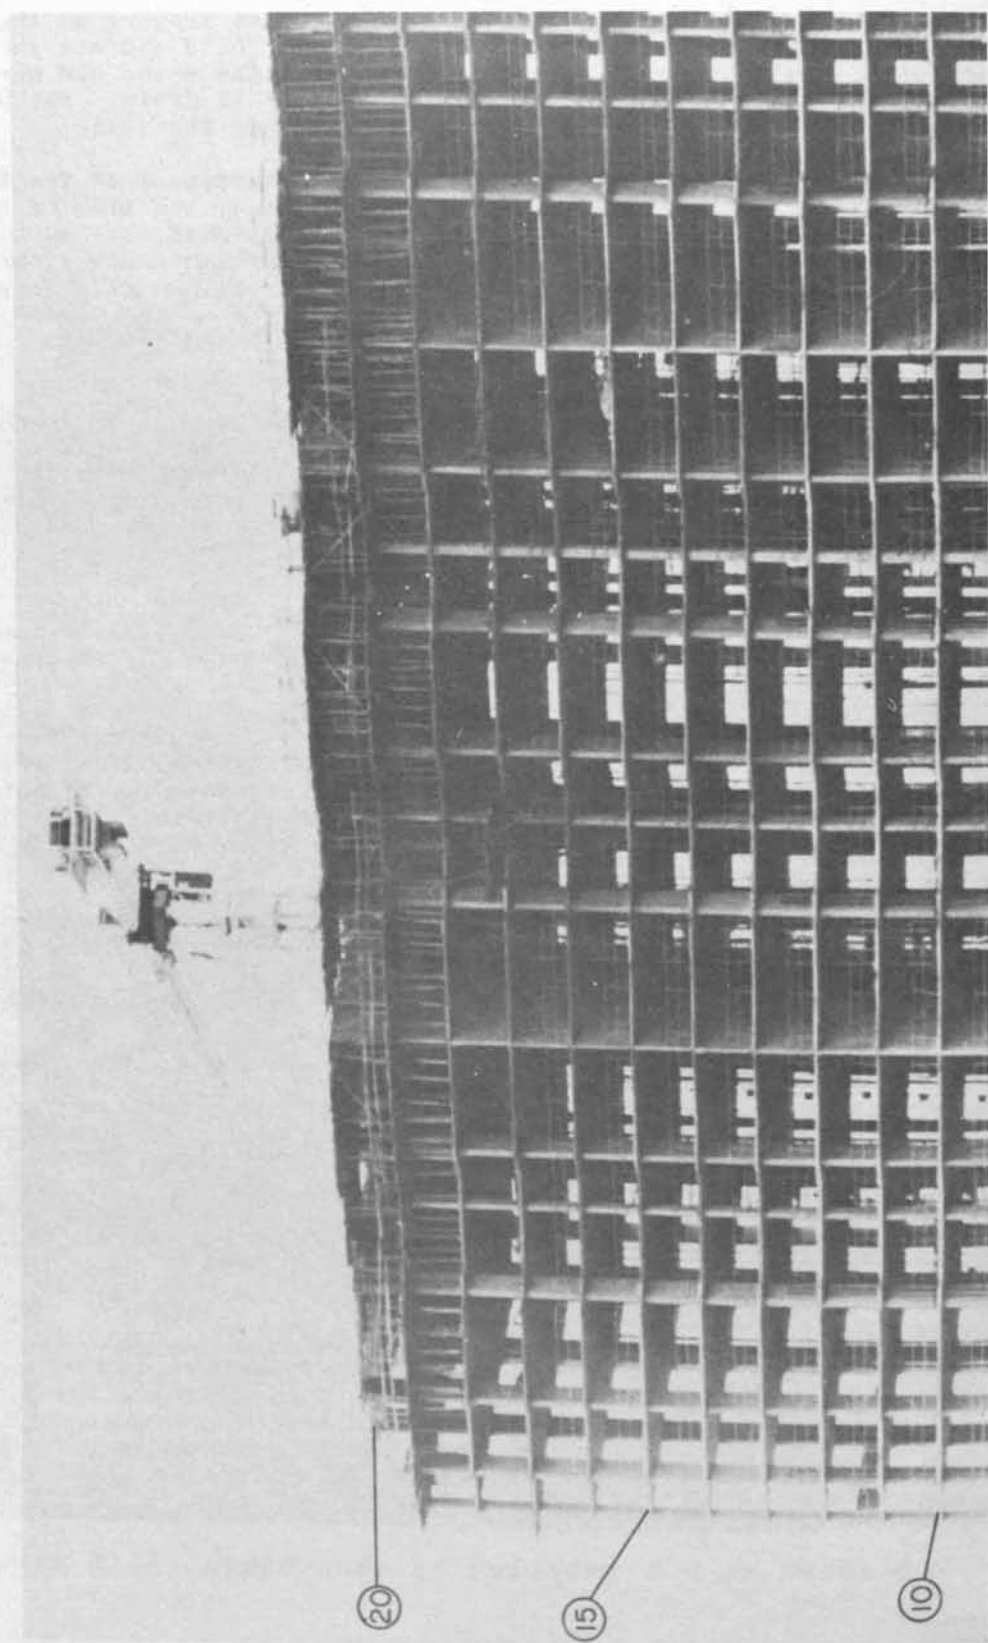
Figure 2.38 Closeup view of figure 2.36 showing crane no. 2 base support.

Examination of figure 2.38 establishes the lower crane support on the 10th floor and establishes that the crane, as installed, could operate through a ten-story height of building. It should be noted that the crane had marginal clearance to cast the 20th floor although it appears that it could. The photos were not clear enough to determine shoring conditions under the crane.
