Investigation of the Skyline Plaza Collapse in Fairfax County, Virginia

Edgar V. Leyendecker and S. George Fattal

Center for Building Technology
Institute for Applied Technology
National Bureau of Standards
Washington, D.C. 20234

National Bureau of Standards Building Science Series 94

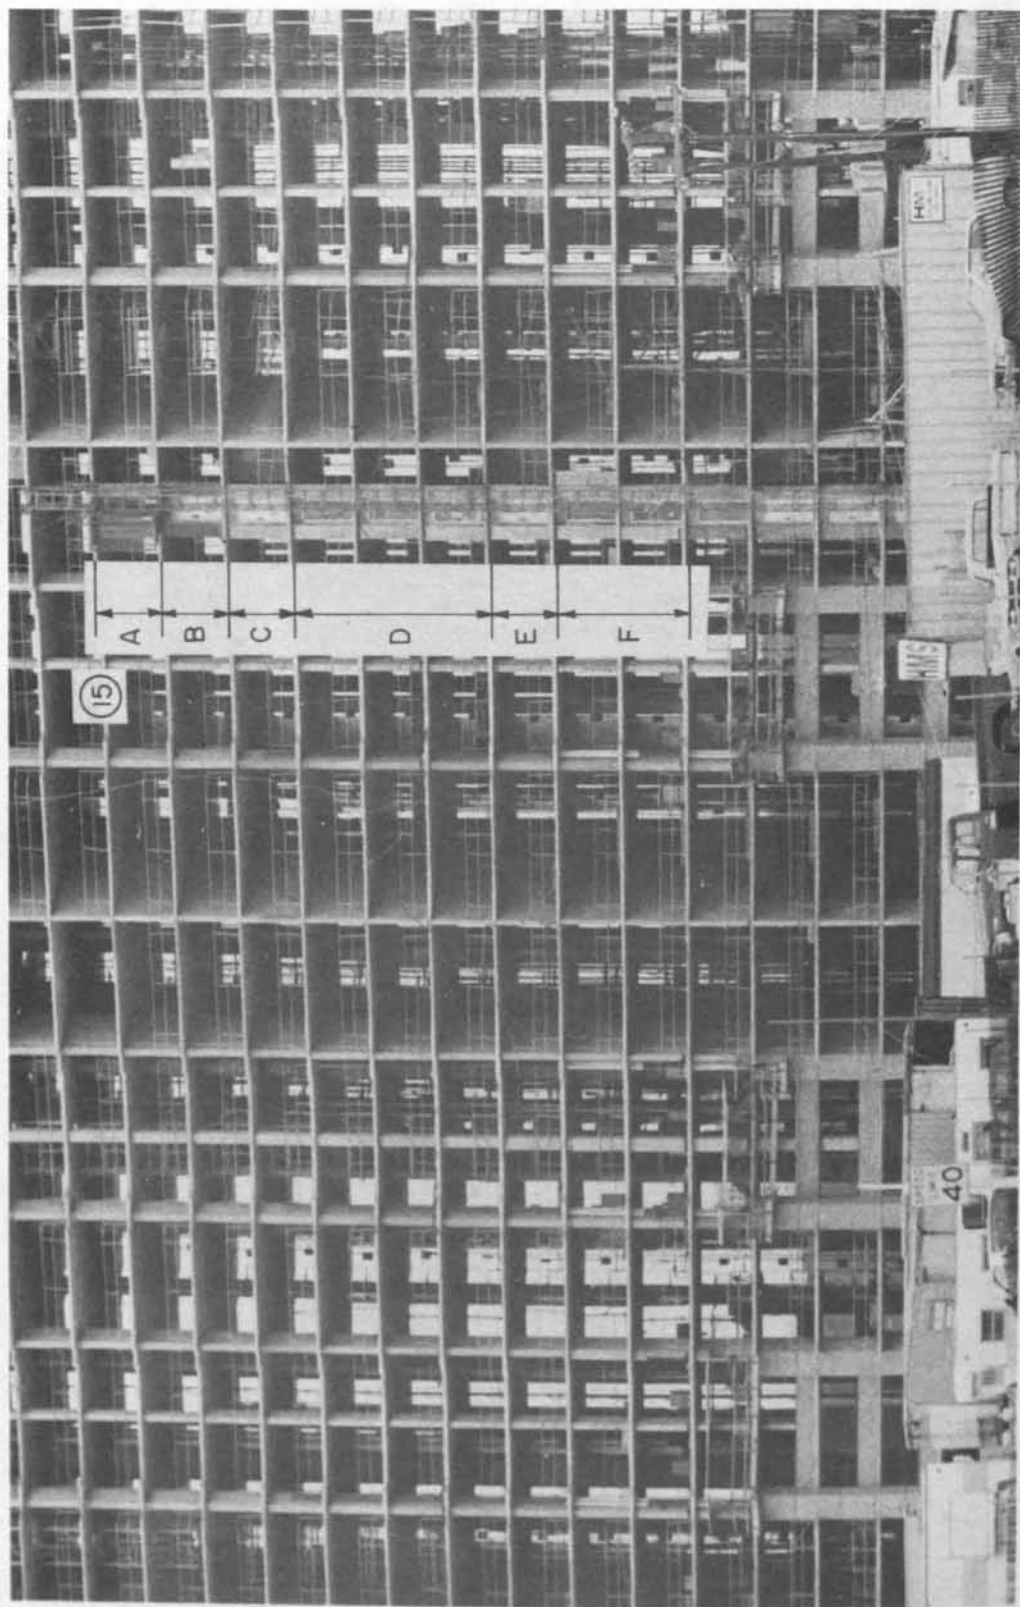
Figure 2.40 Closeup of elevator on north face.

Examination of figures 2.40 and 2.42 indicates that either the crane shoring or the formwork for the concrete closure slab of the crane opening was in place in the third through thirteenth stories on the day of the photograph. Conditions below the third story are not visible in the photograph.

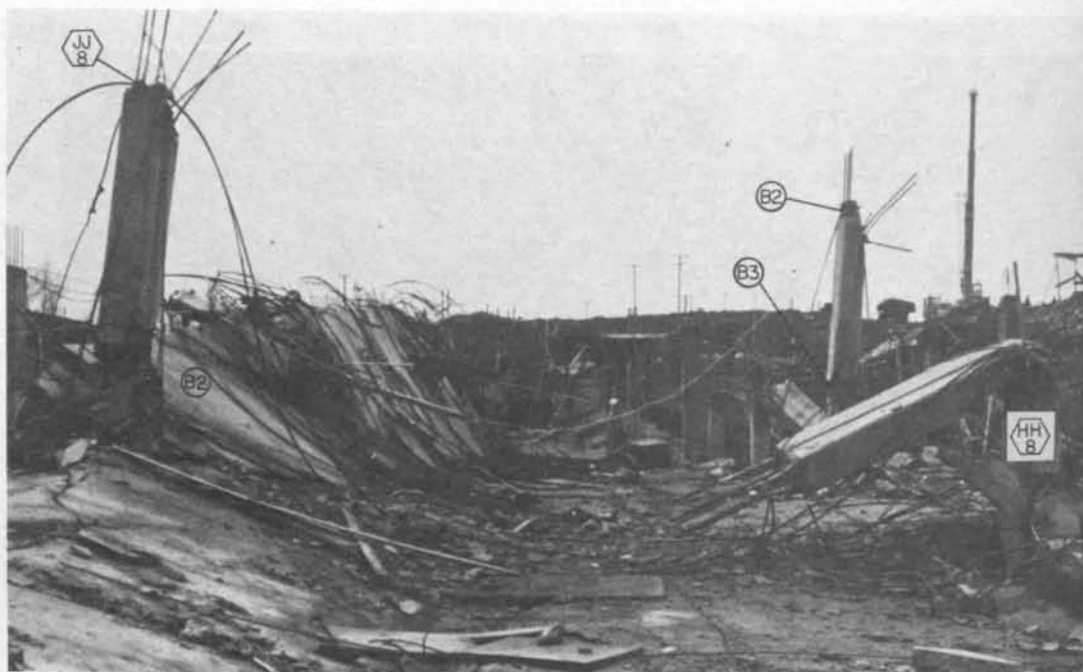
Figure 2.45 View looking west of slab B-2 between column lines HH and JJ.

Figure 2.46 Edge of slab B-2 at columns JJ-5 and JJ-6.

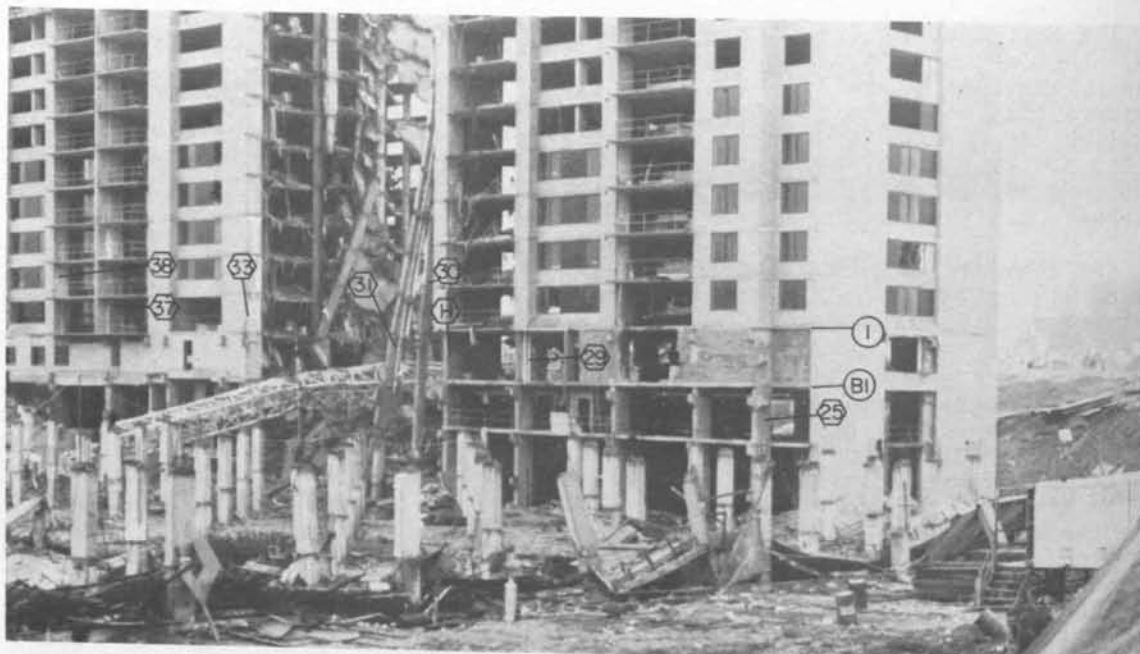
Figure 2.49 View of garage area looking northwest showing crane no. 2 and column corbels on building A-4.

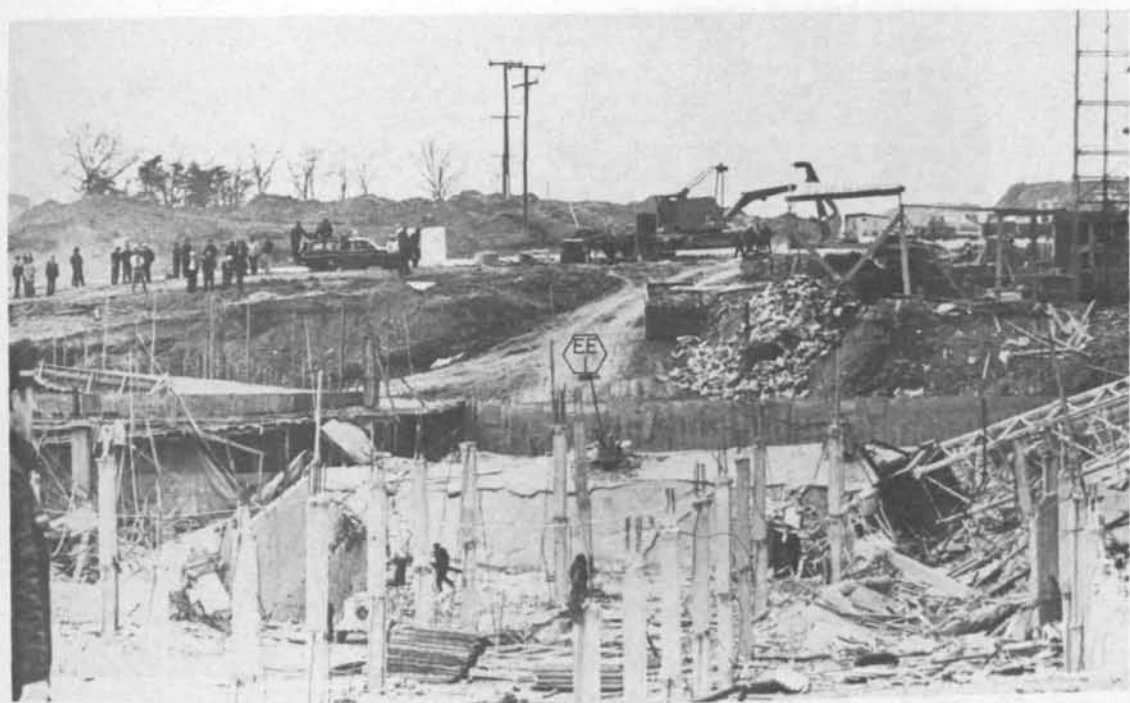
Figure 2.51 View looking west of area between the ramp and building A-4.

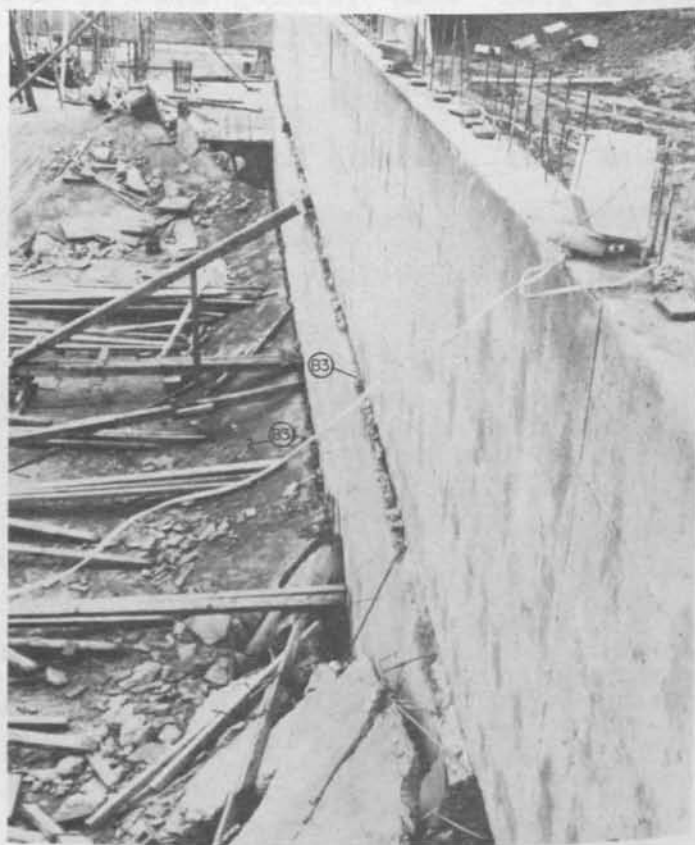
Figure 2.54 Slab support on western wall of parking garage.

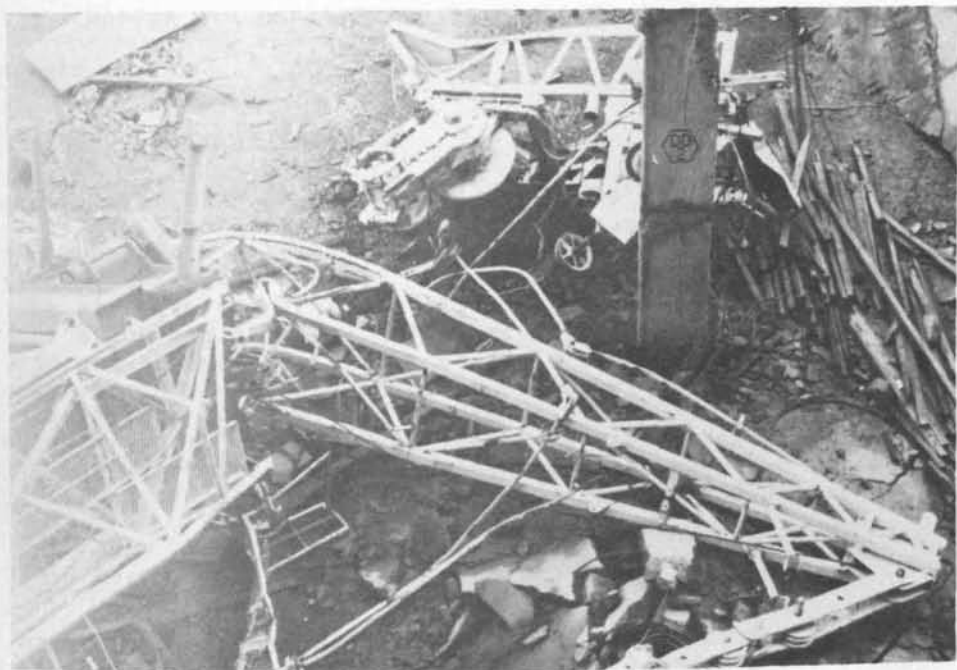
Figure 2.55 Position of fallen crane near column DD-2 looking south.

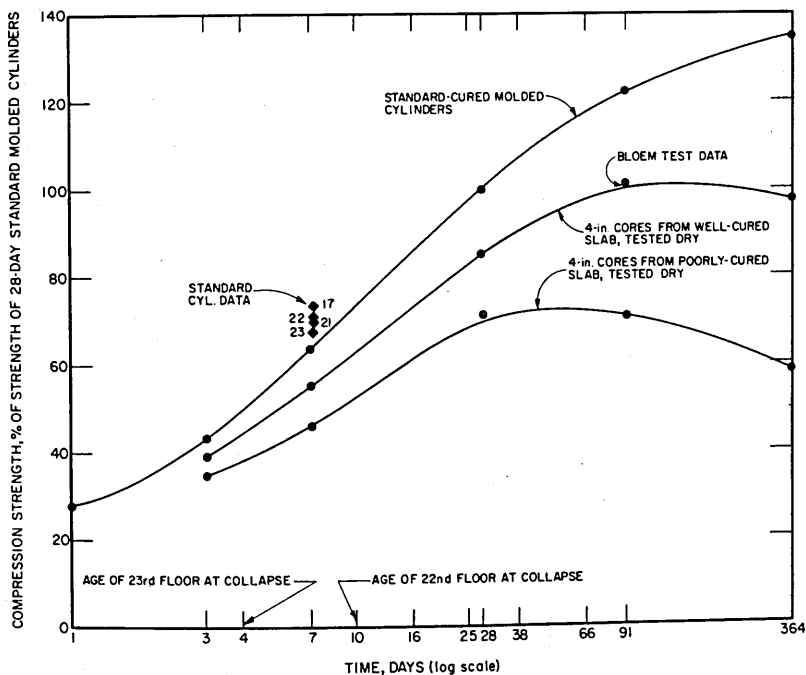
Figure 3.3 Strength measures for concrete cores and cylinders.

Estimates were obtained for a range of standard 6-in diameter cylinders by converting from the age at time of test to 28-day 6-in cylinder strength using the curves of figure 3.3. The calculations rounded to the nearest 5 psi follow:

The cores are used as a measure of in-situ strength. The Klieger data require the use of 28-day strengths. The core strengths for the 22nd and 23rd floors are converted to 28-day strengths by using figure 3.3. The basic core data are multiplied by the ratio of the 28-day fraction to the fraction at the date tested. These calculations rounded to the nearest 10 psi follow:

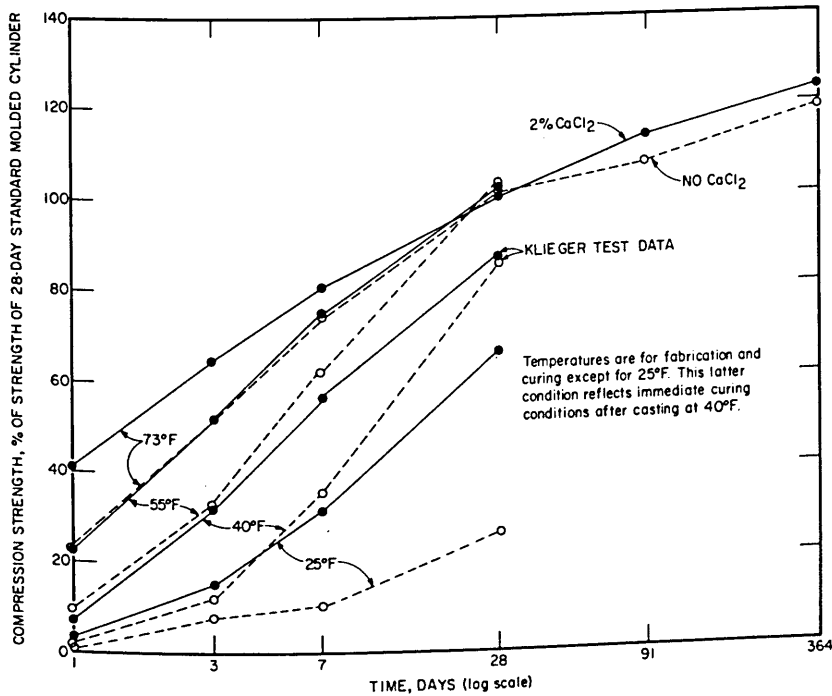
Figure 3.4 Development of concrete strength under various curing temperatures.

A set of curves have been drawn in figure 3.4 from data obtained by Klieger [14]. These curves, although obtained from normal weight aggregate concrete, indicate the effect of curing temperatures and 2 percent calcium chloride on concrete compressive strength development. The 73°F curing curve without calcium chloride represents strength gain under standard conditions. Note the accelerating effect on strength development of 2 percent calcium chloride. For example, a concrete cured at 55°F with 2 percent calcium chloride is equivalent in strength (during the first 28 days) to the same concrete cured at 73°F. Although not used in all floors, 2 percent calcium chloride was used for the 17th and 21st through 24th floor slabs.

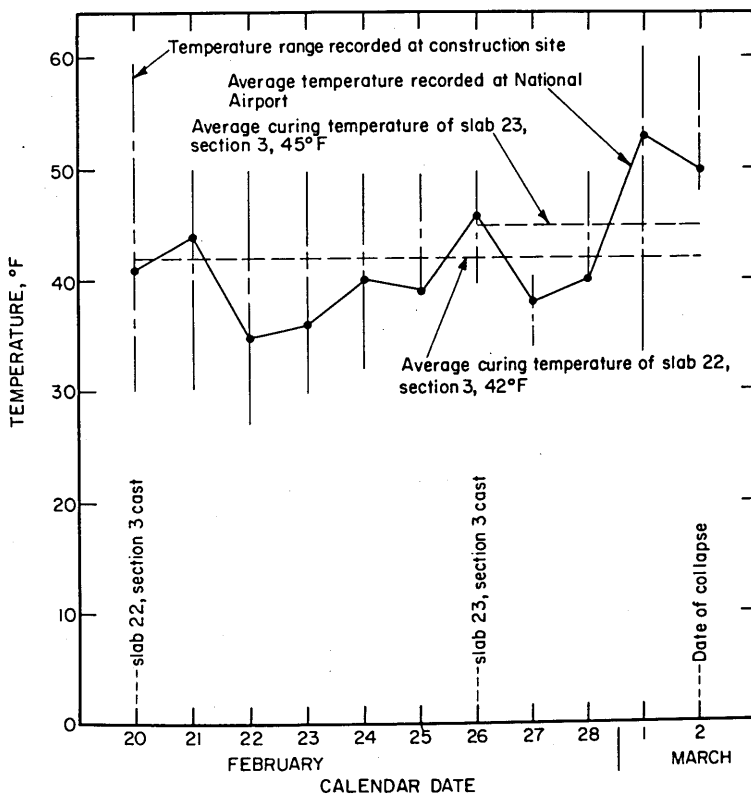
Figure 3.5 Temperature history for section 3 on 22nd and 23rd floor slabs.

In order to convert these strengths into estimates at the time of collapse the curing temperature should be considered. The average temperature history has been shown in figure 3.5 (enlarged from figure 2.3). The average air temperature was 42°F for the 22nd floor and 45° for the 23rd floor (temperatures as recorded at National Airport). Estimates of strength using the Klieger data for 2 percent calcium chloride in figure 3.4 (and interpolating between temperature curves) yields the following results rounded to the nearest 10 psi:

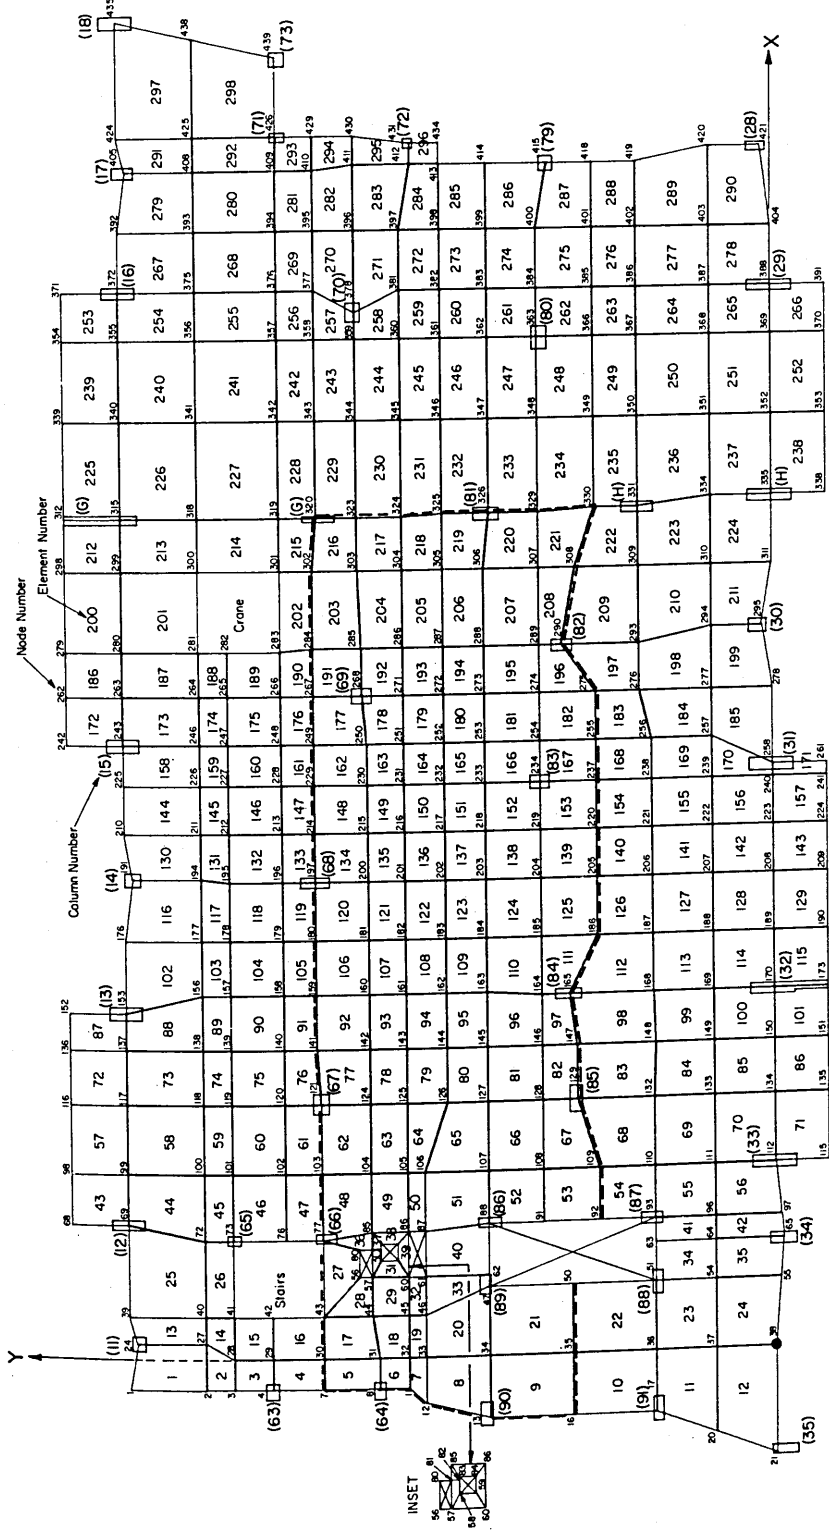
Figure 4.2 Finite element grid for slab analysis.

Three finite element analyses were made for the slab assembly in the region of collapse. The approximate area of collapse is shown in figure 4.1. All three analyses were based on the grid model shown in figure 4.2.

The accuracy of a finite element analysis is generally improved as the number of elements is increased and as the elements become more square. In constructing the grid, a finer mesh was used in the region west of the crane tower opening, where failure was assumed to have been initiated. The boundaries of the rectangular grid are approximately defined by the column line 18-73-72-79-28 on the east and column line 11-63-64-90-91-35 on the west. This area encompasses the failure region and extends about one column line beyond its boundaries on each side.

The grid layout in figure 4.2 is different from the slab in the contract drawings in certain aspects. The balcony slabs were assumed extending to the centerlines of the end columns. Likewise the boundary of the slab at north and south fascias between balconies was assumed extending to the centerlines of the flanking columns, eliminating, in effect, the stepped portion of the slab between a balcony and an adjacent fascia. Wherever possible, rectangular or square plate elements were used to construct the grid. In order to make column centroids coincident with nodal points of the grid a few trapezoidal plate elements were also introduced. By using a finer mesh one could develop a model which would more precisely represent the actual assembly. However, such a refinement is not justified because it would not significantly affect the results [7A].

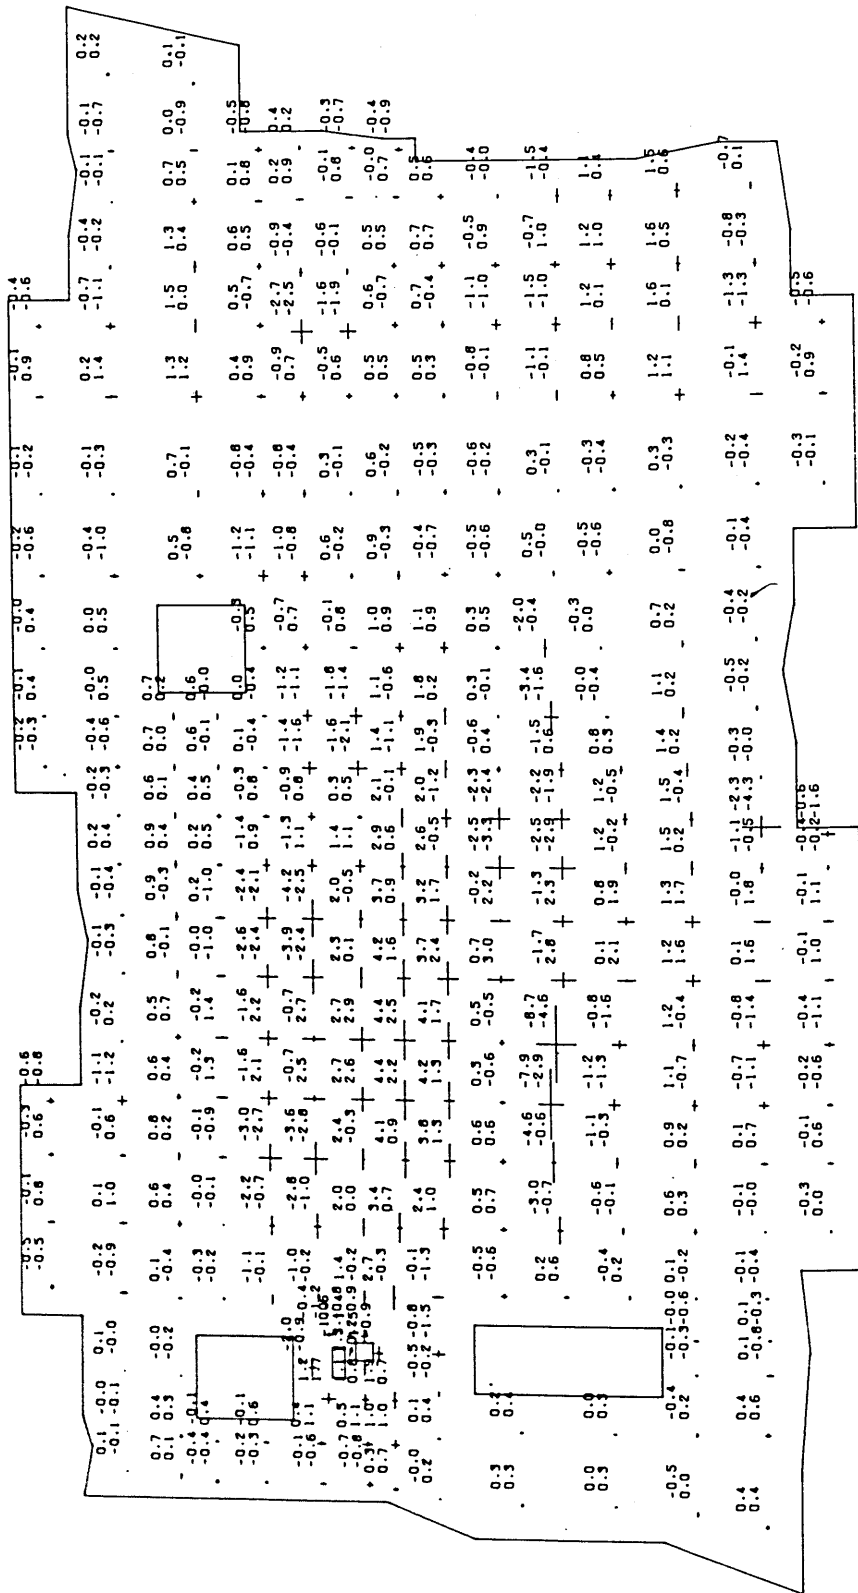
Figure 4.5 Internal moments in slab-case 3.

Case 3: Some of the employee statements indicated that removal of shoring under the 23rd-floor slab in the central corridor area of the building was in progress on the day of the collapse (see section 2.2.2). A loading simulating the condition of partial removal of shoring was used. This Case is similar to Case 1 except the loads on the 23rd floor slab were reduced outside the region bounded by grid lines 7-320, 320-330, 330-16, and 16-7 as indicated in figure 4.2. To obtain these reduced loads, the loads from case 1 were multiplied by a factor which was based on the assumption that 22nd and 23rd floor slabs shared the loads on the 23rd floor in proportion to their respective elastic moduli. The modulus of elasticity of the 23rd floor slab was the same as was used in Case 1. The modulus of elasticity of the 22nd floor slab was calculated on the same basis as described in Case 1 using the average estimated concrete strength at the time of collapse of 1340 psi for the 22nd floor slab (see section 3.1.4).

Figures 4.3 through 4.5 show the analytical results for cases 1 through 3. Moments M_x (rotation about x-axis) and M_y (rotation about y-axis) are designated by horizontal and vertical lines, respectively. They are shown plotted in pairs (and approximately to scale) at the centroids of slab elements. The numerical entries are moment magnitudes at the centroids and are expressed in units of foot-kips per linear foot of slab. Moments producing compression in the top of the slab are positive.

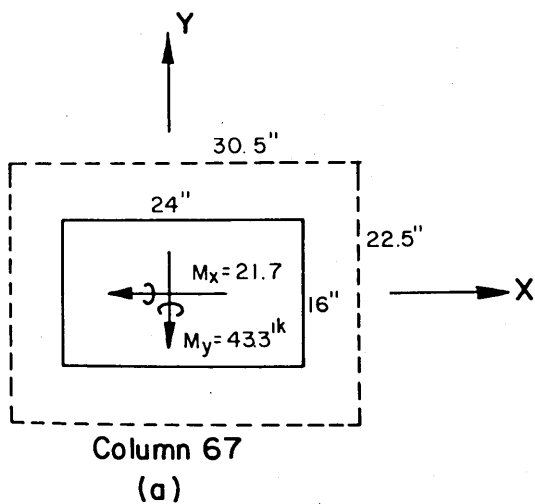
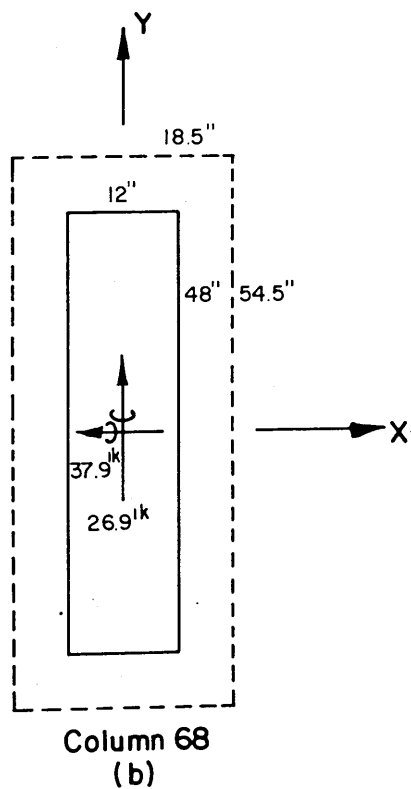
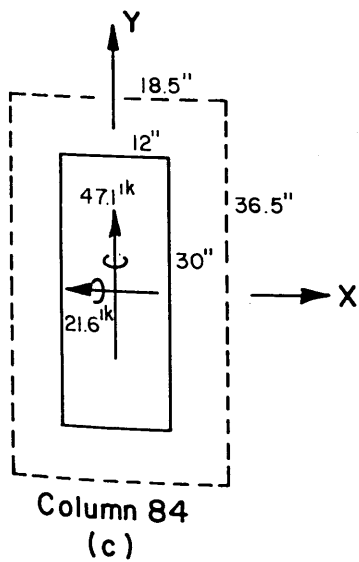
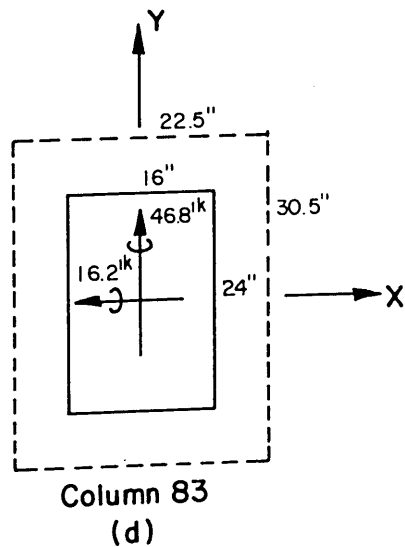
Figure 4.12 Critical section for shear in the slab around columns 67, 68, 83, 84.

From the analytical results, axial loads and moments transmitted to column elements from the floor system were assessed in relation to peripheral column dimensions in order to establish which of the columns would be expected to create a severe shear condition in the slab. Figure 4.12 shows the four most critical regions identified at columns 67, 68, 83 and 84.

Figure 4.13 tabulates the results of the analysis of shear stresses in the 23rd-story floor slab for cases 1 through 3, based on the critical sections shown in figure 4.12. Maximum shear stresses calculated in accordance with eq. (4.1) are given in column 3. Column 4 gives the required compressive strength to resist this shear as determined from equation (4.3) and column 5 gives the probable range of in-situ concrete strength at the time of collapse.
