NBS SPECIAL PUBLICATION **592**

An Investigation of the Miyagi-ken-oki, Japan, Earthquake of June 12, 1978

This document is the result of the investigation by the U.S. team on the earthquake. It describes geologic features of the earthquake-stricken area, and damage to human-made structures. It is hoped the information presented in this document will add to the knowledge of seismology and earthquake engineering.

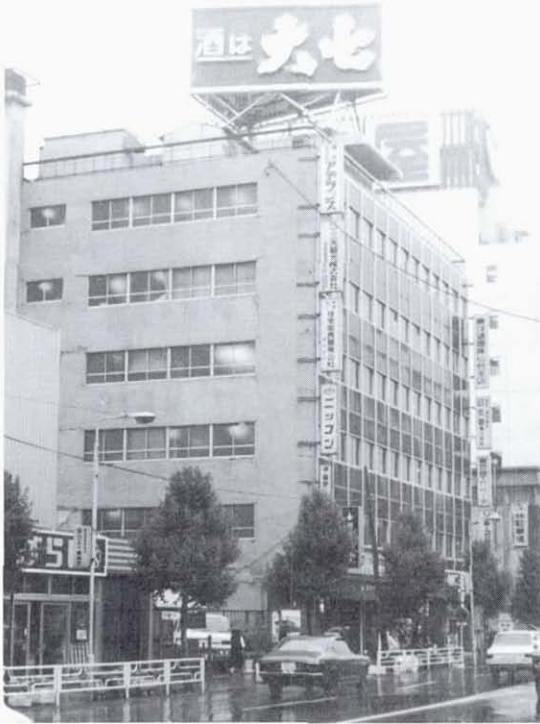
Figure 5.4 Minami Machidori Building, Sendai. The cracking to the brick veneer is typical for many similar buildings in the city.

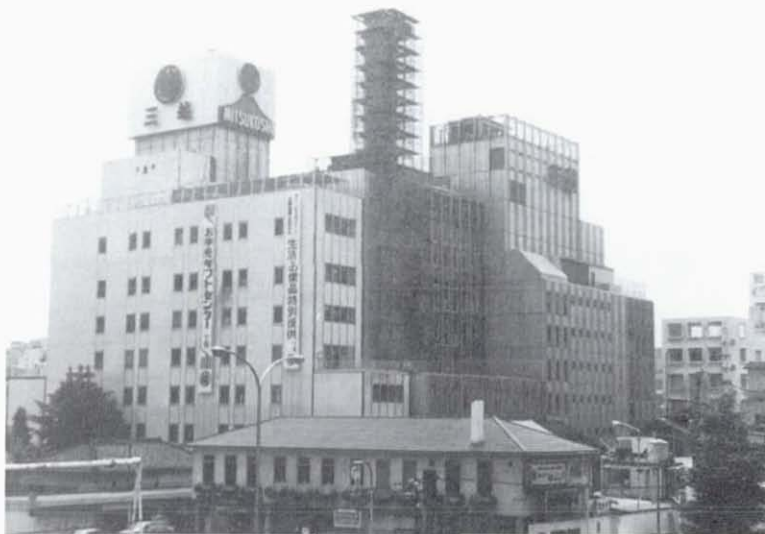
Figure 5.8 Chimney damage to the Mitsukoshi Department store. Numerous such chimneys suffered such damage.

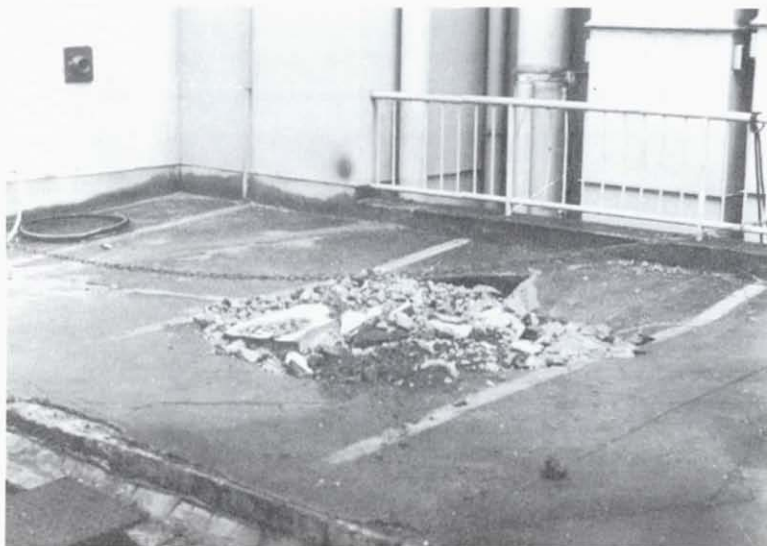
Figure 5.10 Impact area of chimney failure (see Figure 5.9)

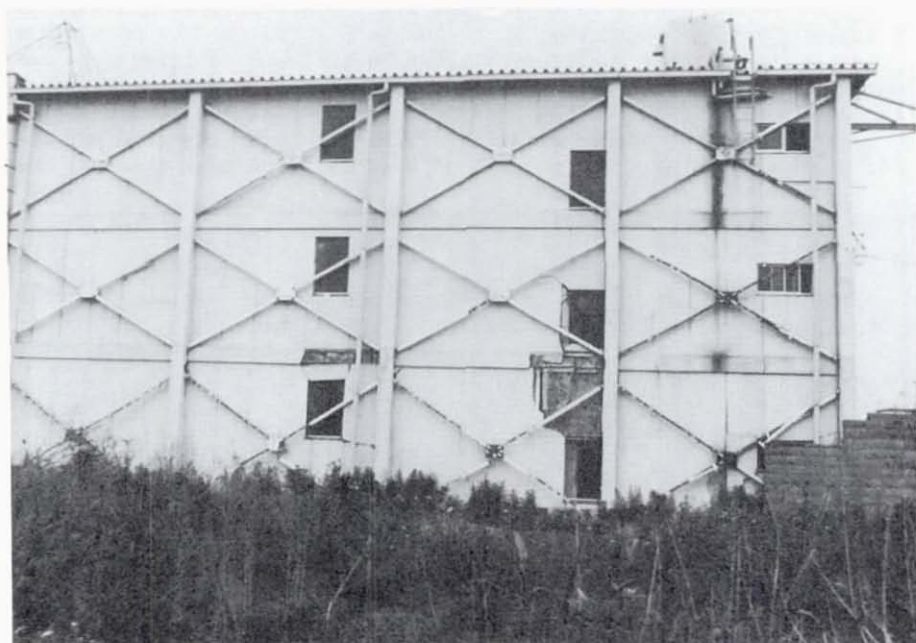
Earthquake resistance in steel buildings is provided either through the use of moment-resisting frames or through diagonal bracing. When braces are used as earthquake resisting elements, it is normal practice to design them so as to carry all of the horizontal force. An example of such a structure is a steel framed furniture warehouse on the outskirts of Sendai shown in Figure 5.11. There were many examples where the bracing members buckled under stress reversal or the connections failed. A number of the transverse diagonal braces used in this warehouse sheared at their bolted cross connections (Figure 5.12).

Figure 5.11 A damaged steel-framed furniture warehouse on the outskirts of Sendai.

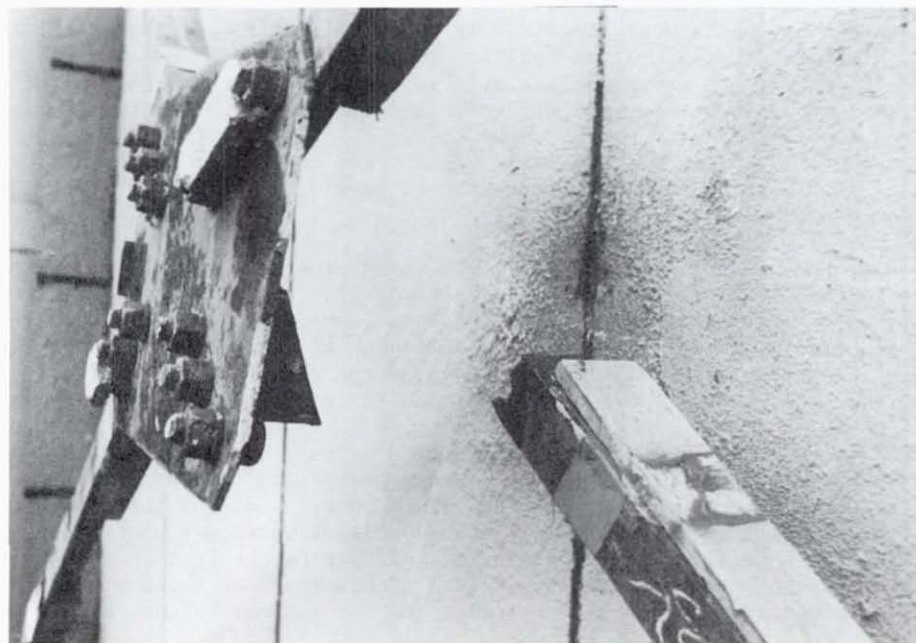
Figure 5.12 Detail of failure in transverse diagonal braces.

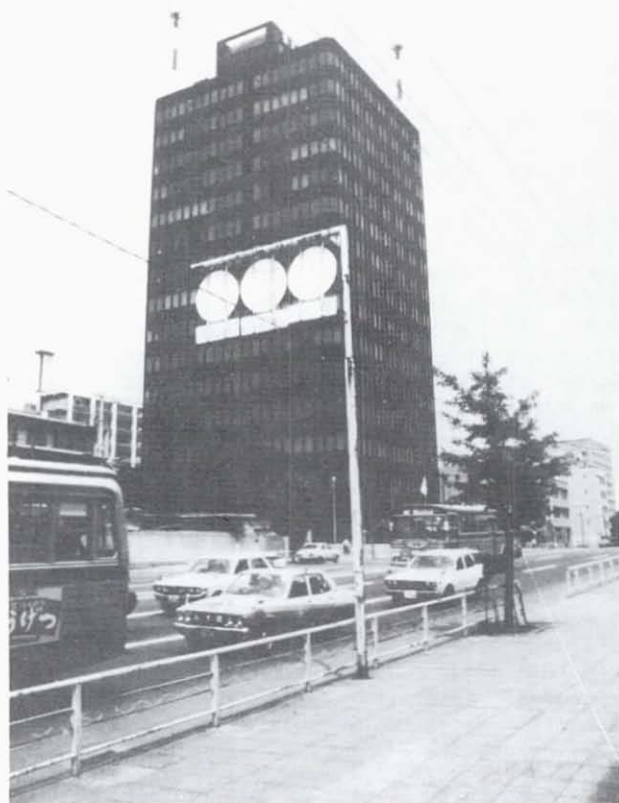
Many modern high-rise buildings in Sendai have steel frames, and these generally performed very well during the earthquake. One example is the Sendai Second Government Building in the downtown area (No. 2 in Figure 5.3), a 17-story structure built in 1973 (Figures 5.13 and 5.14.) The building is situated on a raft foundation, where the underlying soil conditions are good. The frame was designed by dynamic analysis for a maximum base acceleration of 0.2 g. The building is instrumented with strong motion accelerometers at the 15th floor and second basement levels, and a downhole at 40 m below grade. The building suffered virtually no damage, although there was some minor diagonal cracking in the concrete stairwells leading to the basement.

Figure 5.13 Sendai Second Government Building. This modern steel frame structure suffered no damage.

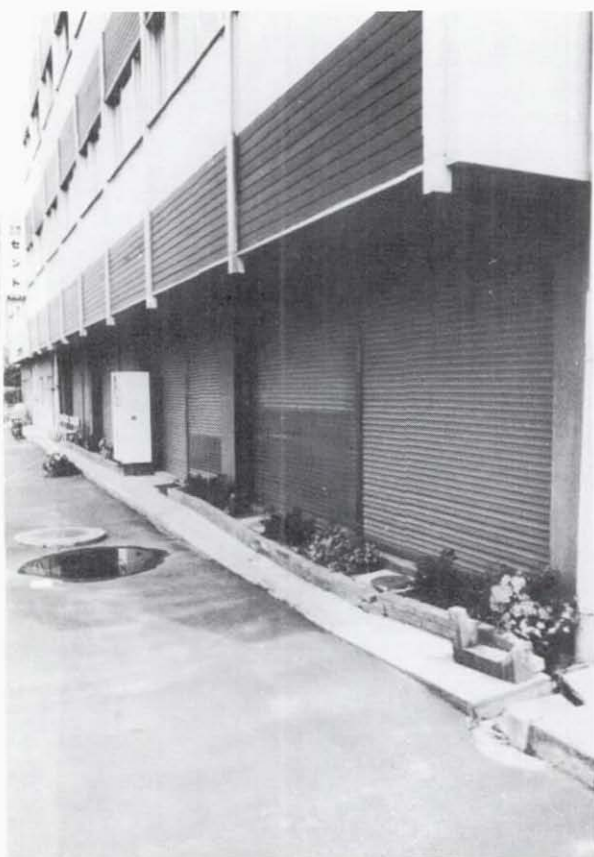
There was extensive evidence of ground settlement in the Oroshicho area, including settlement of asphaltic concrete sidewalks and slumping around building foundation walls, as in Figures 5.20, and 5.21.

Figure 5.20 Oroshicho area, Sendai.  
Ground settlement.

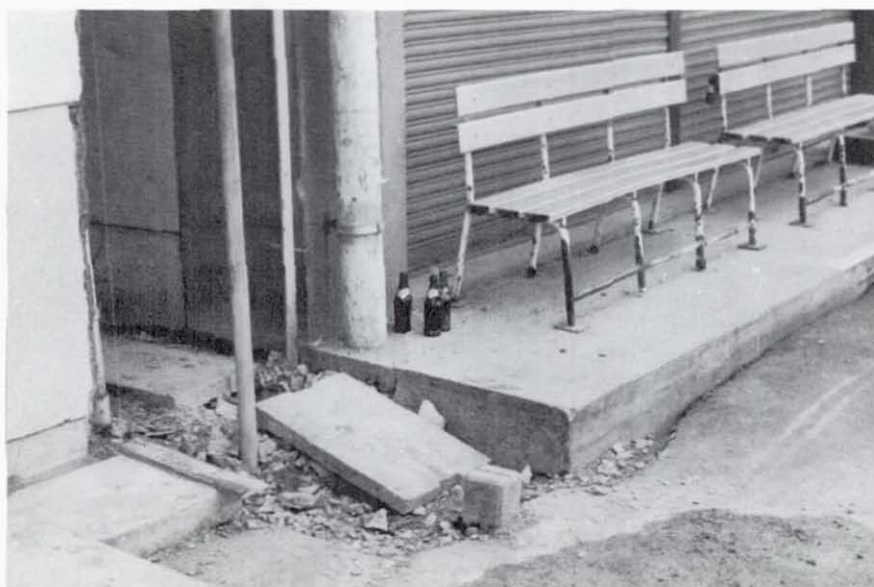
Maruyoshi Building (No. 6, Figure 5.3). This was a three-story reinforced concrete frame building, one span by three, with the long axis of the building running in the E-W direction. There was a 2 m overhang on the north side of the structure (Figure 5.22). The wall shown at the west end was continuous from the second-story on up. The building had a flexible first-story. The building suffered extensive damage to the first-story (Figure 5.23) and, as shown in Figure 5.24 was tilting toward the north. The first story columns on the south side of the building failed in shear due to the strong N-S motion. A detail of the beam-column joint where the second-story floor beam frames into the first-story column is shown in Figure 5.25. Column ties appeared to be spaced at about 300 mm. The shear wall on the west end of the structure appeared to be undamaged. Unfortunately, this caused the structure to behave as an inverted pendulum and caused the first-story columns to accept even more shear. Note the use of the undeformed bars in the beam-column joint (Figure 5.25).

Figure 5.22 Plan view of Maruyoshi Building, Oroshicho area. Note overhang to the north.

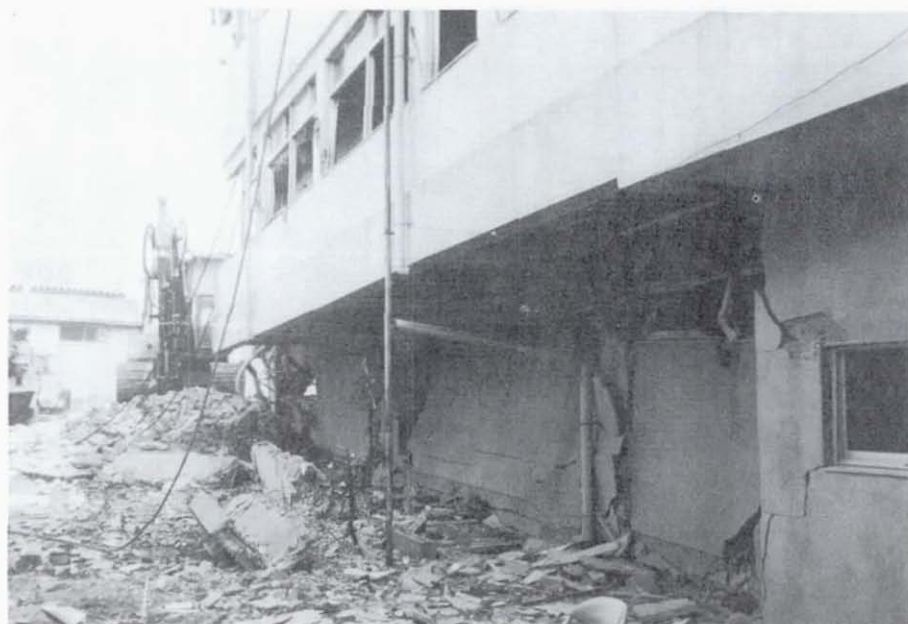
Figure 5.24 Maruyoshi Building, view from the east. Failure of first story columns occurred in shear.

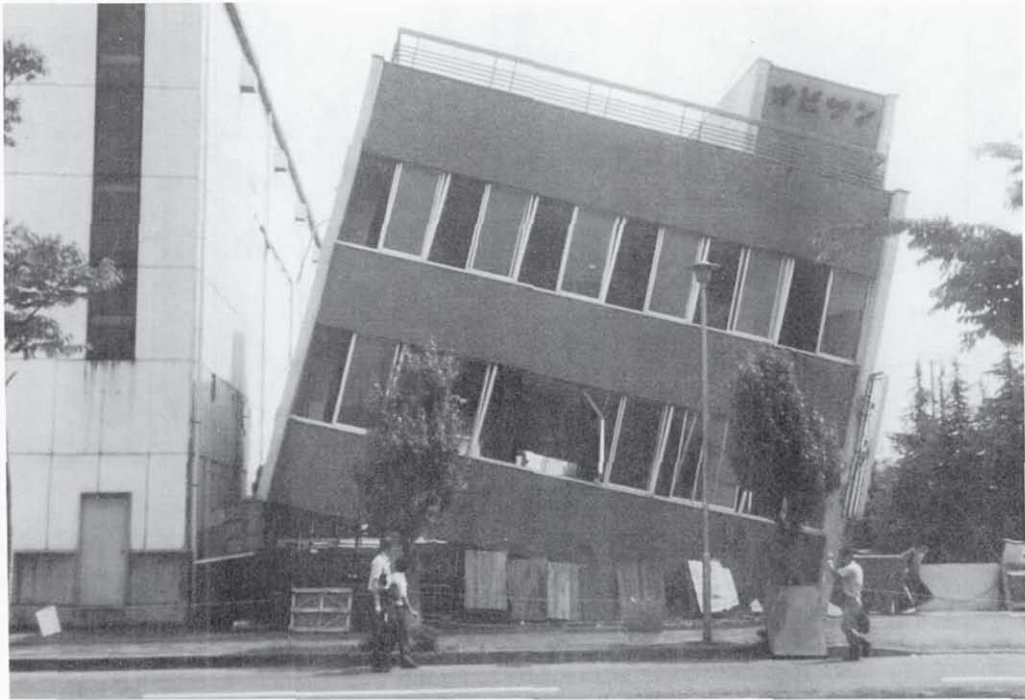
Figure 5.27 Obisan Building, viewed from the North. This three story reinforced concrete frame building had a heavy eccentric stairwell cantilevered over the column line at the right end of the building.

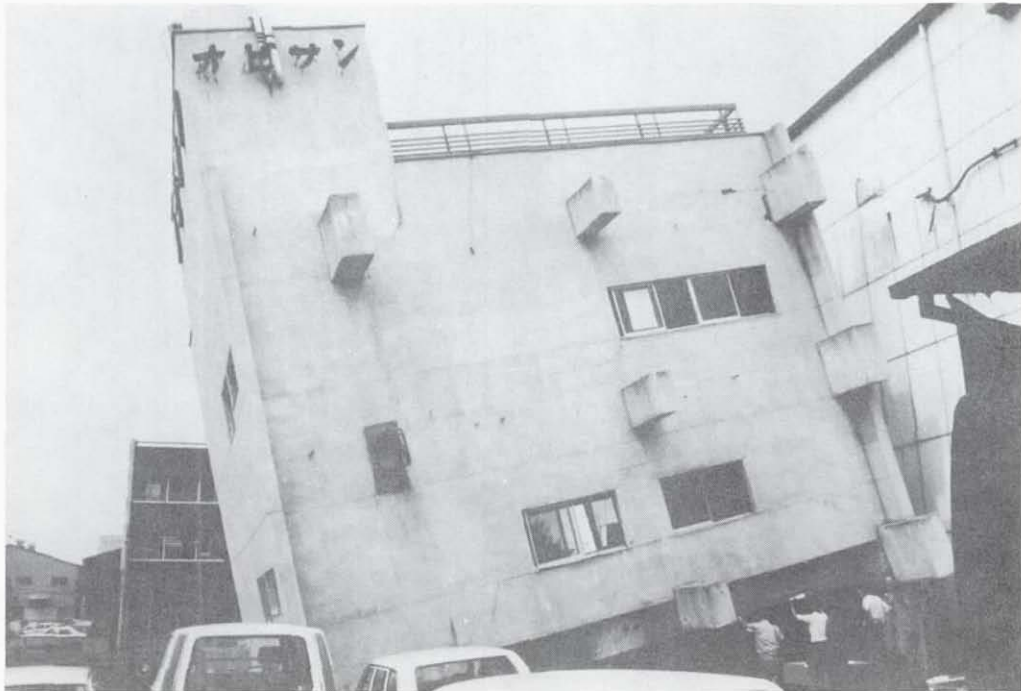
Figure 5.28 Obisan Building, viewed from the south. The upper stories rotated as a rigid body when the first floor column support was lost.

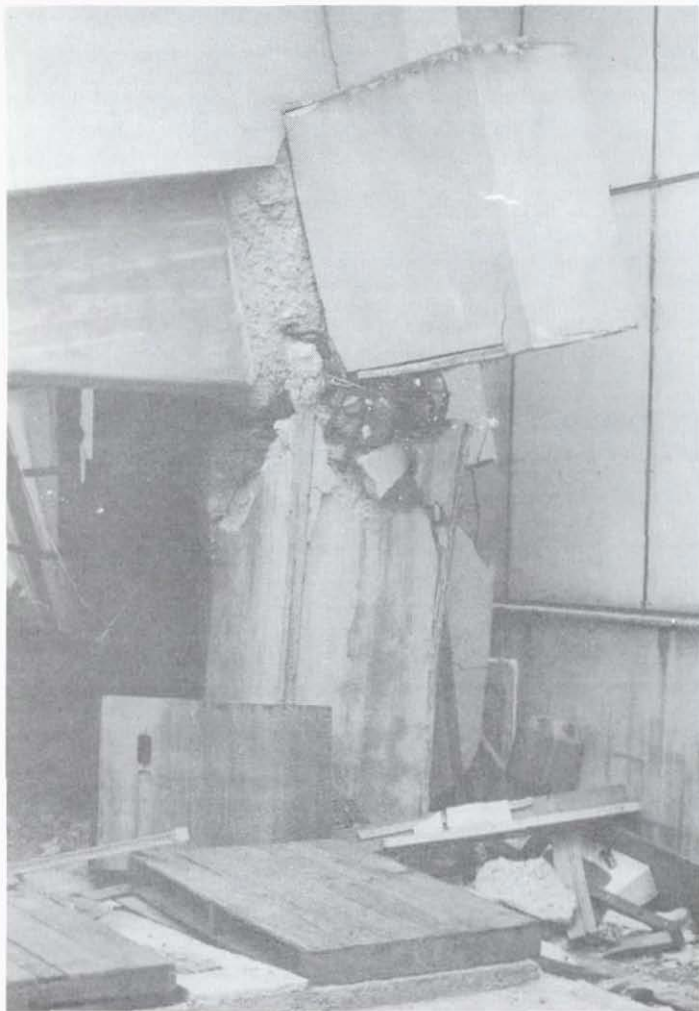
Figure 5.29 Obisan Building, detail of southeast column.

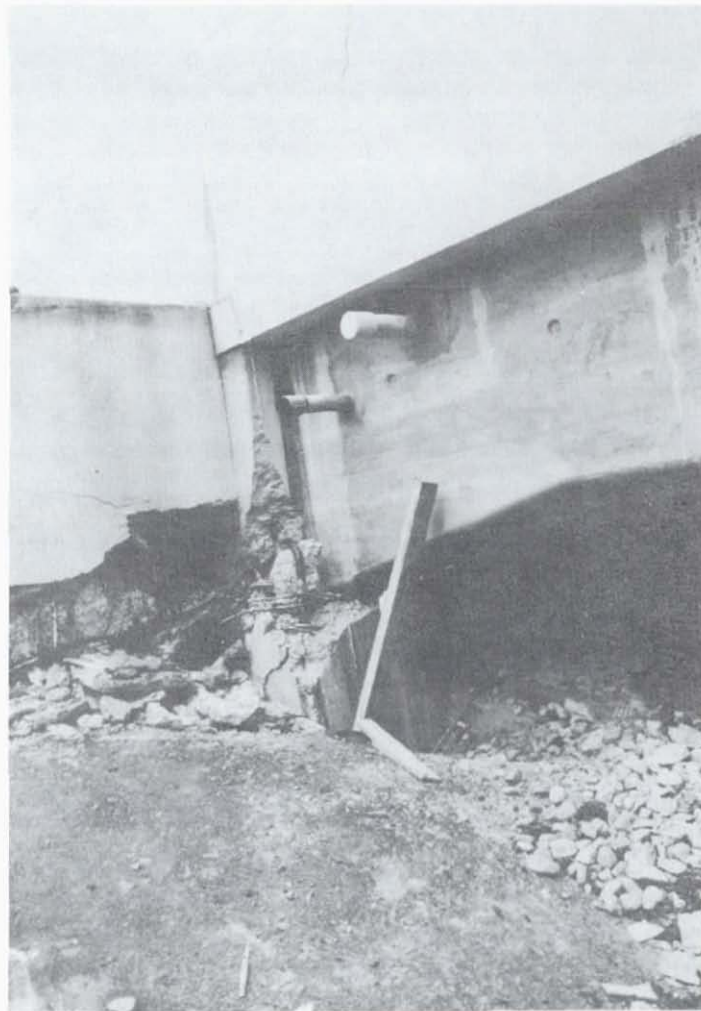
Figure 5.30 Obisan Building, detail of southwest column adjacent to overhang.

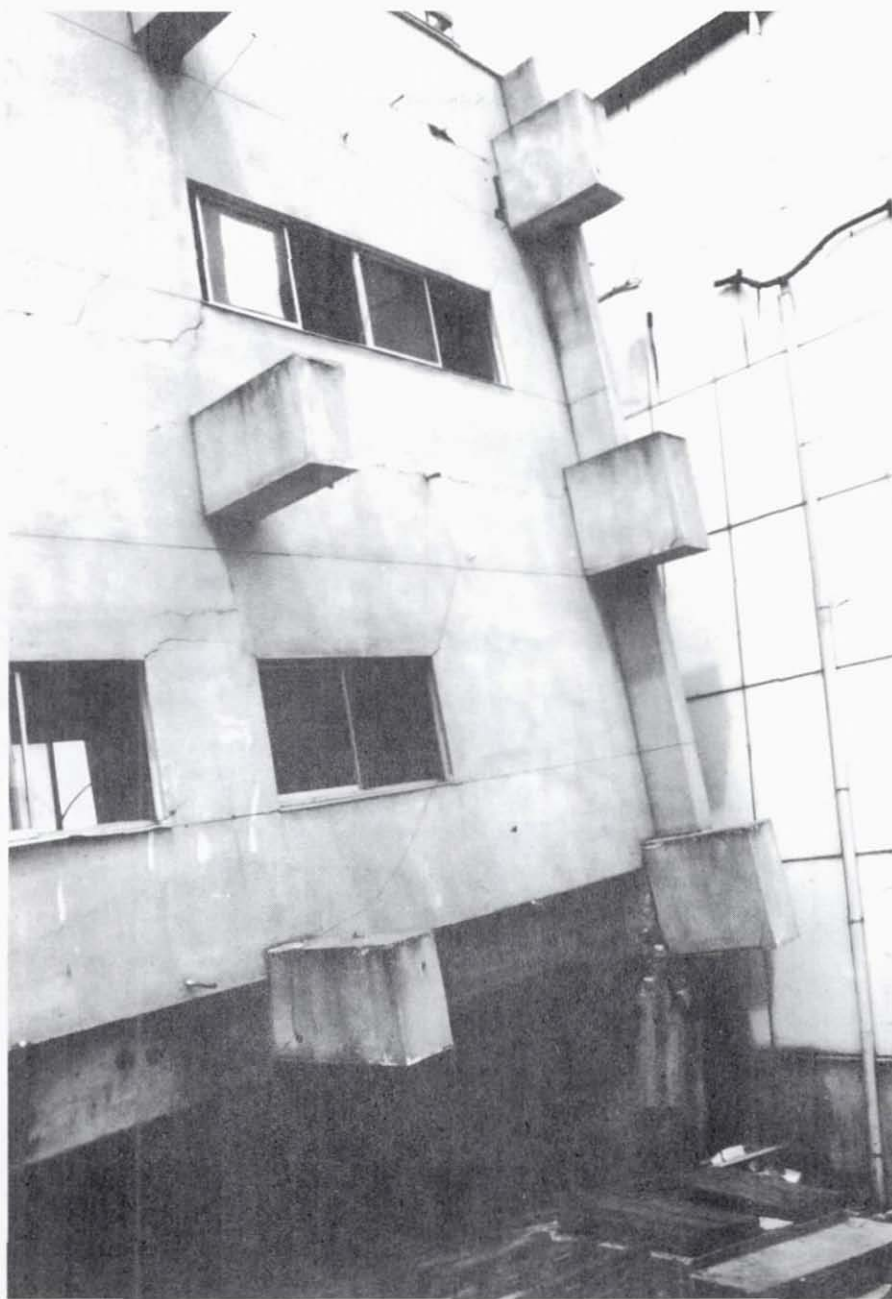
Figure 5.31 Obisan Building, south face. Walls above first story remained essentially intact.

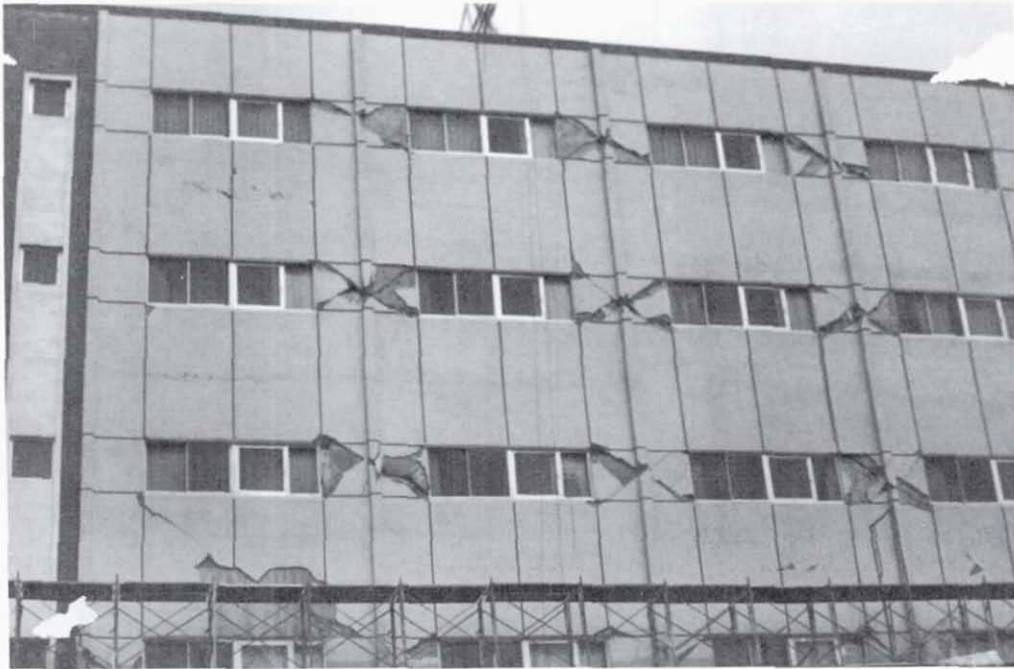
extensive diagonal cracking in the panels between window openings on both east (Figure 5.34) and west faces (Figure 5.35); this damage is especially severe on the west face, as shown in the detail in Figure 5.36. The decorative ceramic brick facing on the north side of the building did not appear to be damaged.

Figure 5.36 Maruhon Building, west face. Detail of the damage to panels between windows.

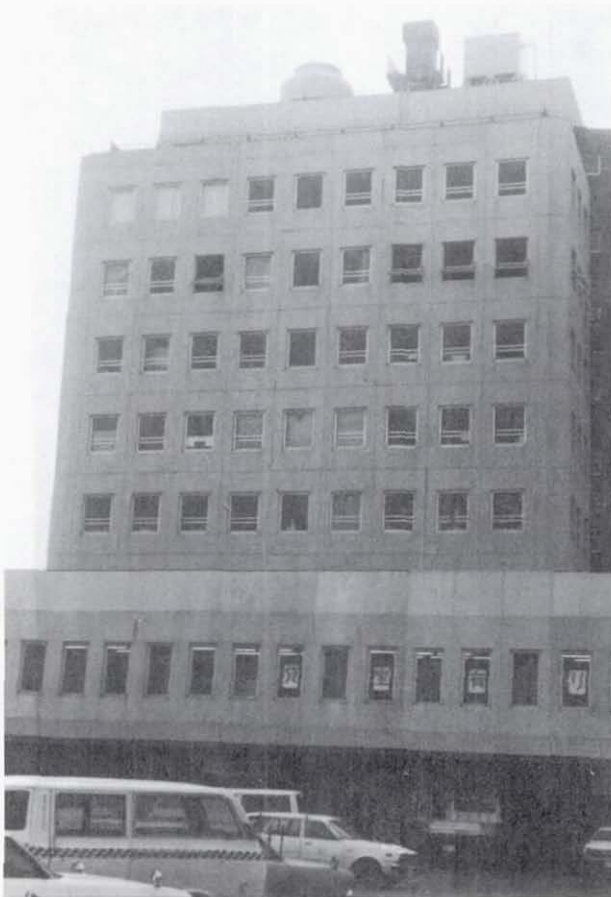
Despite the level of damage in the Oroshicho area, many buildings performed quite well. As an example, Figure 5.37 illustrates a 9-story building which was only slightly damaged. No details about its construction are known.

Figure 5.37 A slightly damaged 9 story building in the Oroshicho area of Sendai.

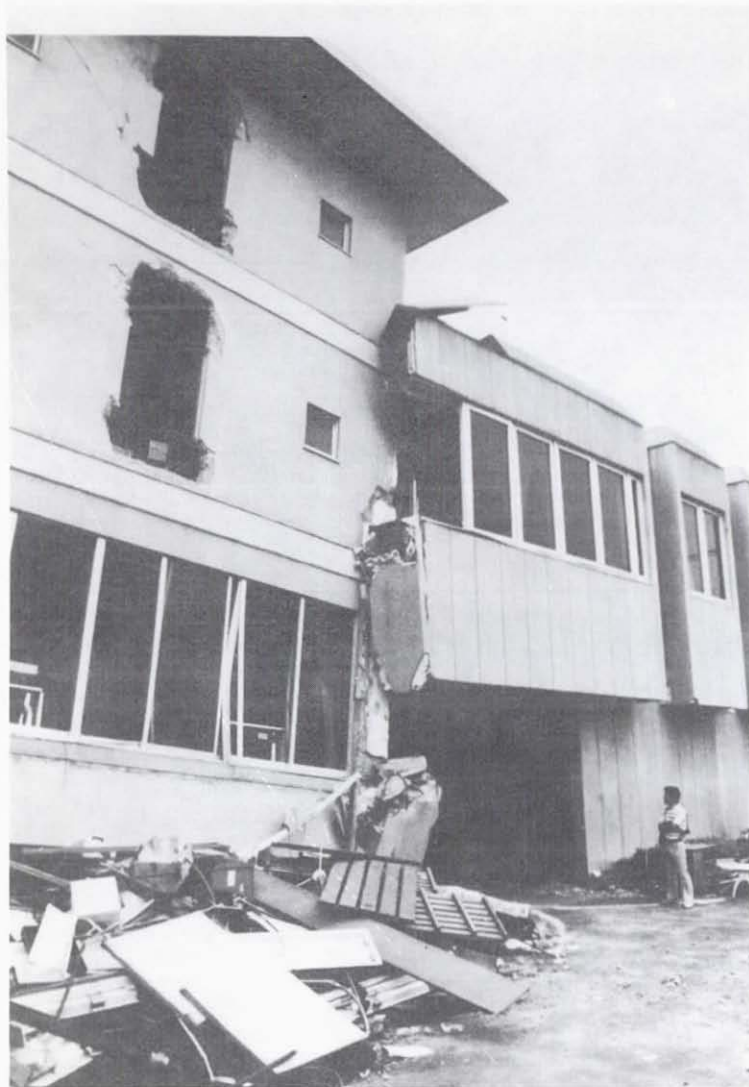
Figure 5.40 Yazaki Industries, showing area of impact between steel and reinforced concrete frames.

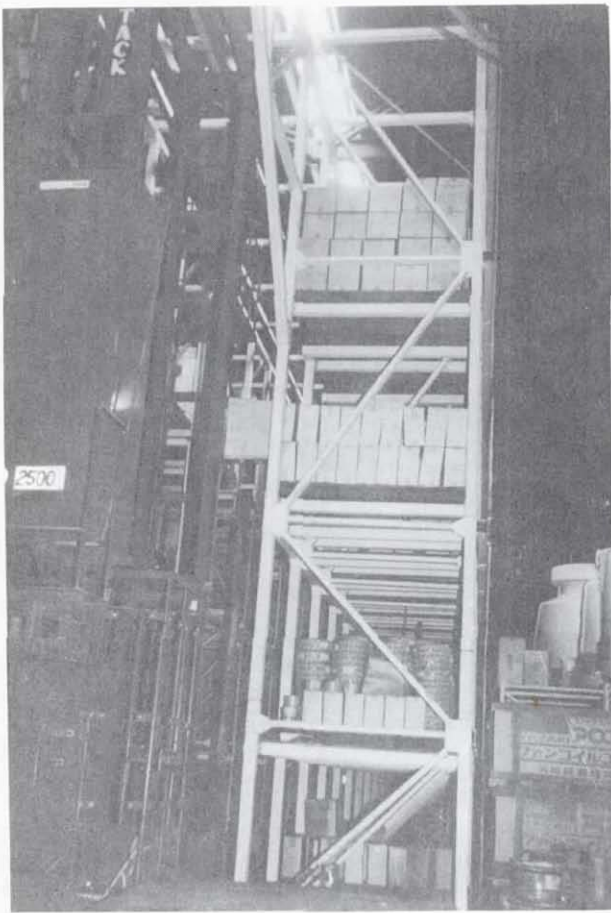
The steel frame warehouse behind the collapsed building (Figure 5.38) did not appear to be damaged. The warehouse contained numerous heavy tubular steel frame storage racks with diagonal braces, as shown in Figure 5.44. The storage racks stand approximately 7 m in height and are anchored to the concrete floor by being bolted or welded to steel plates in the floor. Although none of the racks had collapsed, the bottom diagonal braces appeared to have buckled on several racks, as shown in Figure 5.45.

Figure 5.44 Yazaki Industries warehouse building. A number of multi-level tubular steel storage racks had damaged transverse braces at ground level.

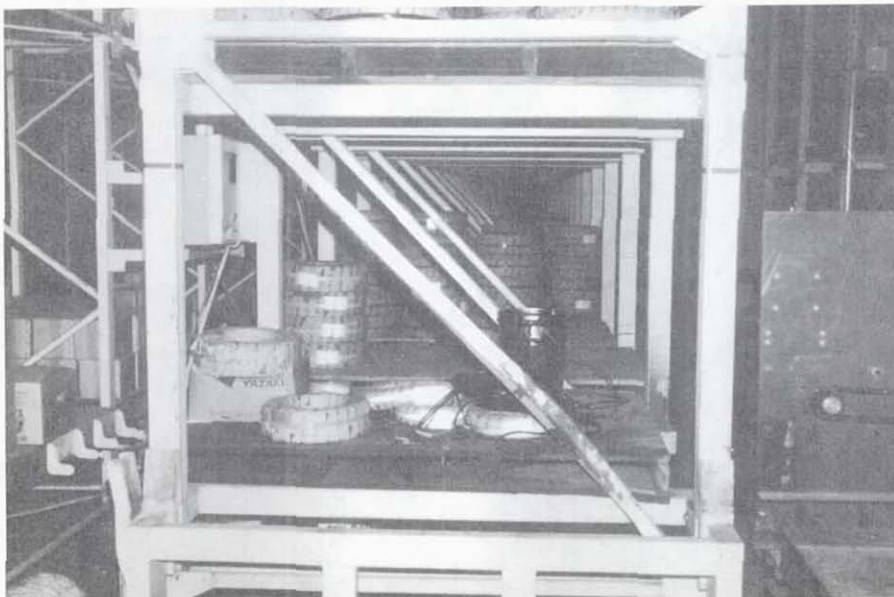
Figure 5.45 Yazaki Industries warehouse. Detail of diagonal brace at bottom of storage rack.

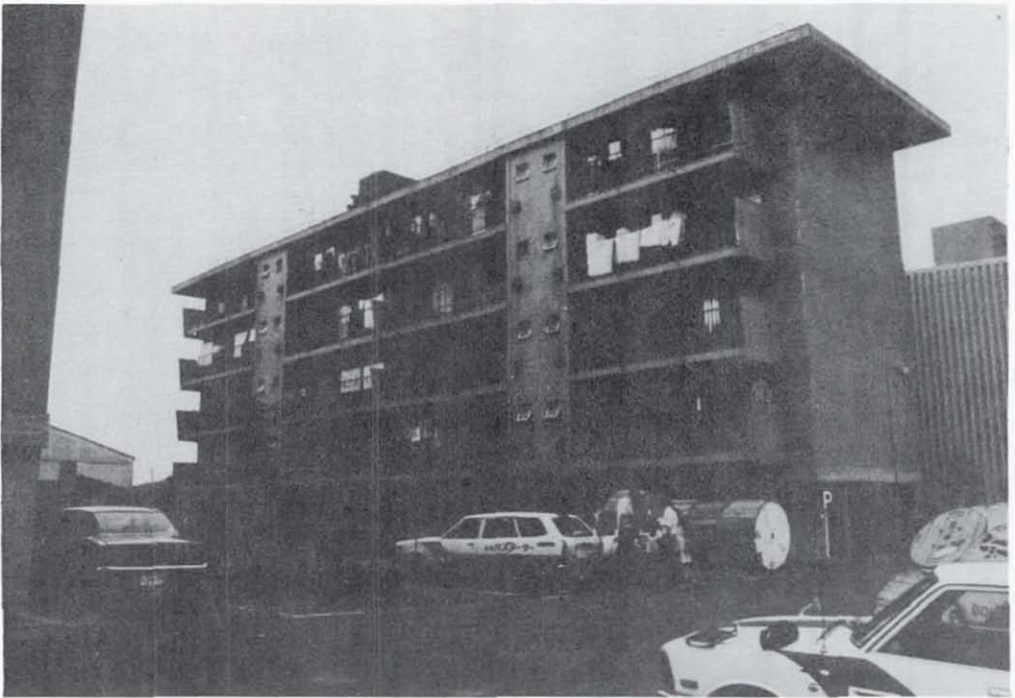
On an adjacent site to the south of the warehouse, there are two five-story reinforced concrete frame apartment buildings with shear walls oriented in the N-S direction. There was no apparent damage to either of these buildings, one of which is shown in Figure 5.46.

Figure 5.46 Apartment building adjacent to Yazaki Industries warehouse building to the south. The building was undamaged.

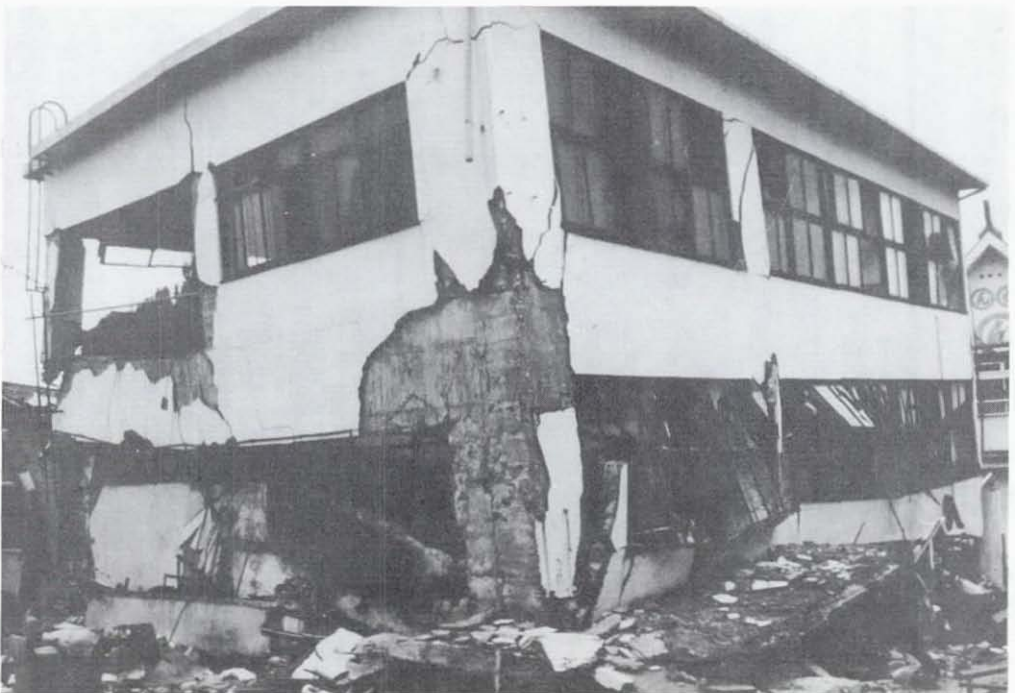
Paloma Building (No. 12, Figure 5.3). This reinforced concrete frame structure faced north and was located on Japan National Highway 45. It was a three-story rectangular building, two spans by three, with a shear wall on the west end of the building. The first floor was used for display, and had a large open area on the north and east side of the first floor. The main axis of the building ran in the E-W direction. Figures 5.4 and 5.48 show the Paloma Building viewed from the east following the earthquake. Failure occurred in the columns at this end of the building, causing the building to tilt toward the east. However, the shear wall at the west end of the building was also badly damaged (Figures 5.49 and 5.50). It is likely that the eccentricity caused by the presence of the shear wall on only one end of the building caused a torsional mode of failure for the structure.

Figure 5.47 Paloma Building - Viewed from the east. Collapse occurred at the east end of the building.

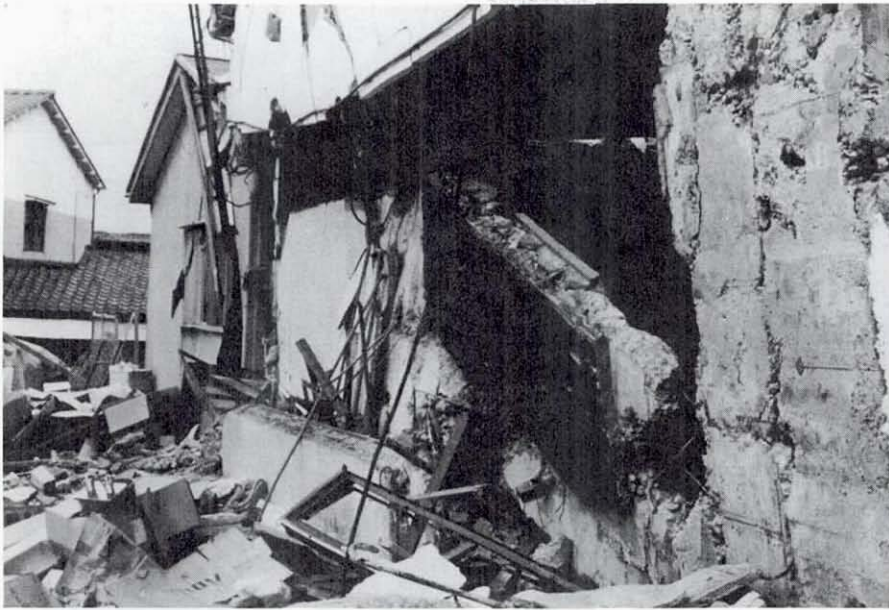
Figure 5.48 Paloma Building. - Detail of first story, east end, showing inferior quality concrete.

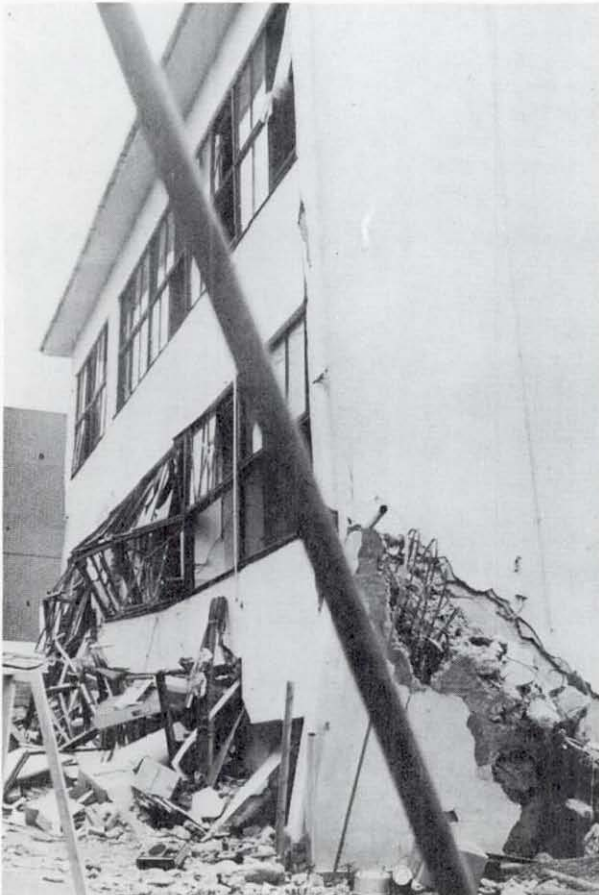
Figure 5.49 Paloma Building, west face.

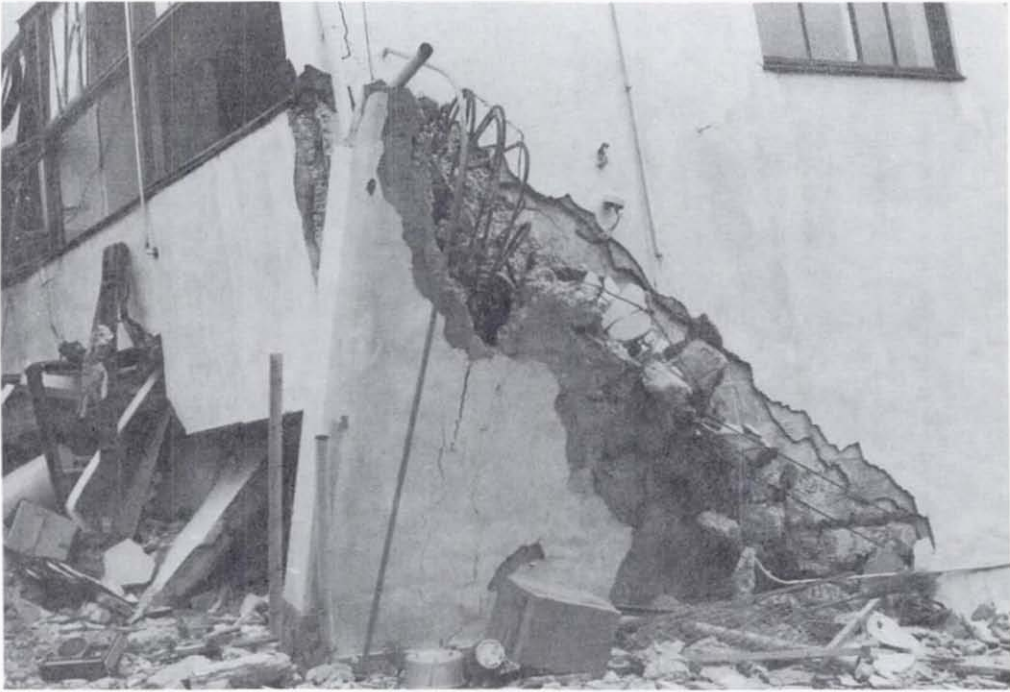
Figure 5.50 Paloma Building, detail of shear wall on west end of building.

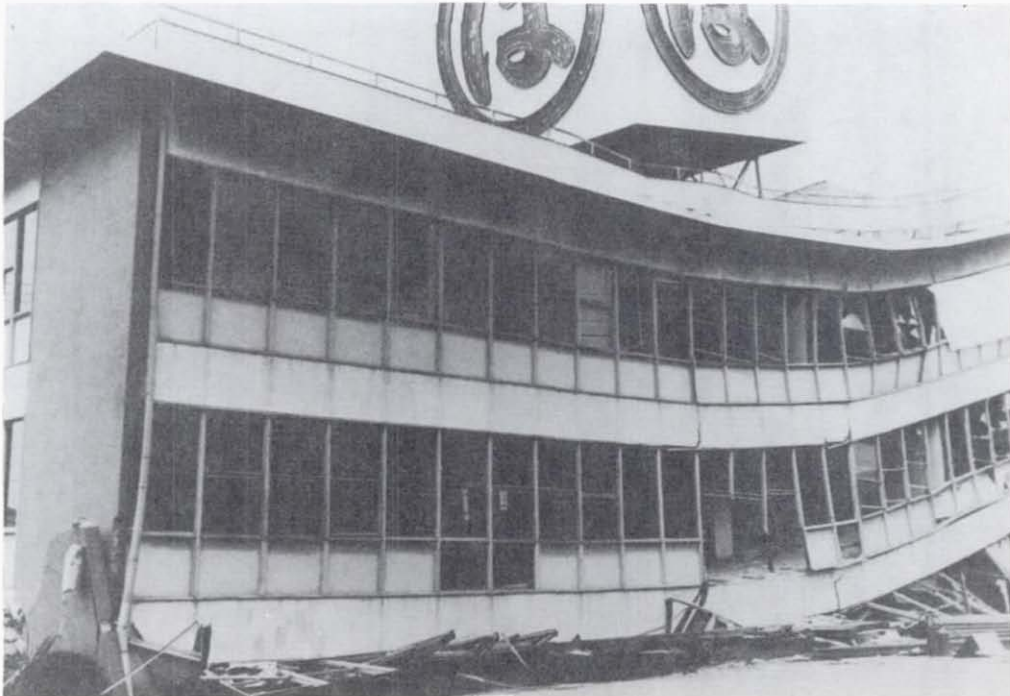
Taiyo Fisheries Plant (No. 11, Figure 5.3). This was a three-story building with a reinforced concrete frame, one span by five, the main axis of which was in the N-S direction. There were shear walls on the north and south ends of the structure. As shown in Figures 5.51 and 5.52, the first-story columns in the middle of the building failed, causing the central portion of the building to collapse but leaving the ends standing. The shear walls at the north end of the structure (running in the E-W direction) were badly cracked. At the time the site was visited, the building was being demolished.

Figure 5.51 Taiyo Fisheries Plant, viewed from the west. The first story columns in the center portion of the building failed, leaving the ends of the building standing. (Japan National Land Agency photograph)

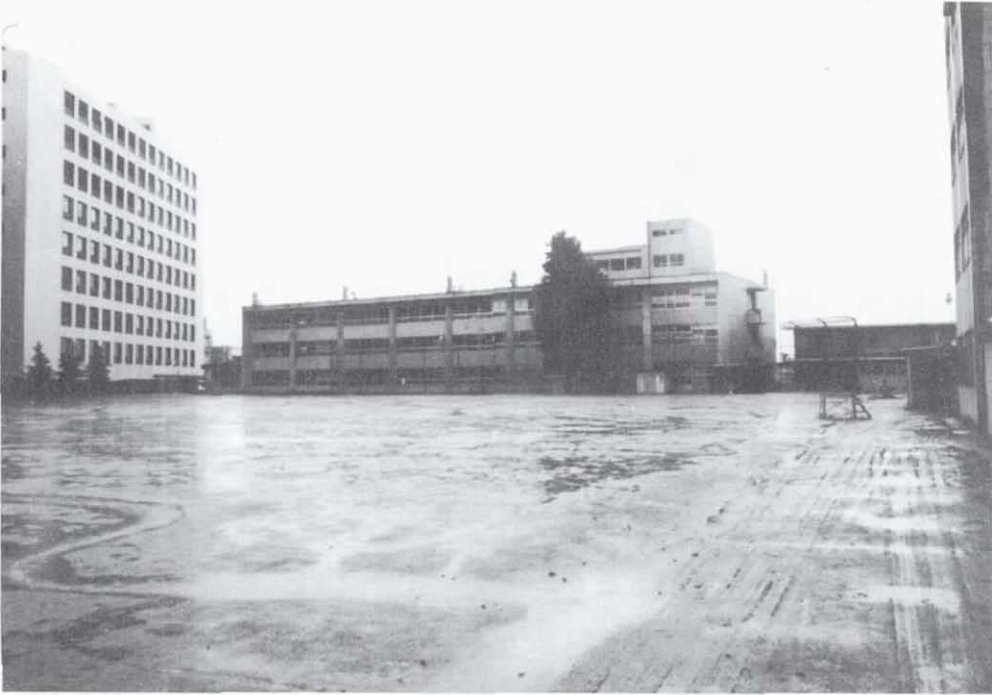
The west face elevation and the school yard are shown in Figures 5.53 and 5.54. The exterior first-story columns were all severely damaged, the shear cracks occurring just above the infill panels, (Figures 5.55 and 5.56). In many cases the width of the cracks was over 20 mm. The upper story columns showed less shear cracking. The interior columns did not appear to be damaged. They lacked the stiffening provided by the infill panels. A corridor ran along the length of the building in the middle, and the shear walls were not continuous across the width of the building. Undeformed reinforcing bars were used in the columns. The ties in the exterior columns were spaced at roughly one-half the maximum dimension of the column.

Much of the damage at Tonan High School may be attributed to the unfavorable orientation of the shear walls with respect to the direction of strongest shaking (N-S). A building adjacent to the school but oriented perpendicular to it, which was constructed about the same time and in which the shear walls run in the N-S direction, was undamaged, aside from a few broken windows.

Figure 5.53 Tonan High School, west face. A small bluff on the opposite side of the building may have amplified ground motion. The adjacent structures were undamaged.

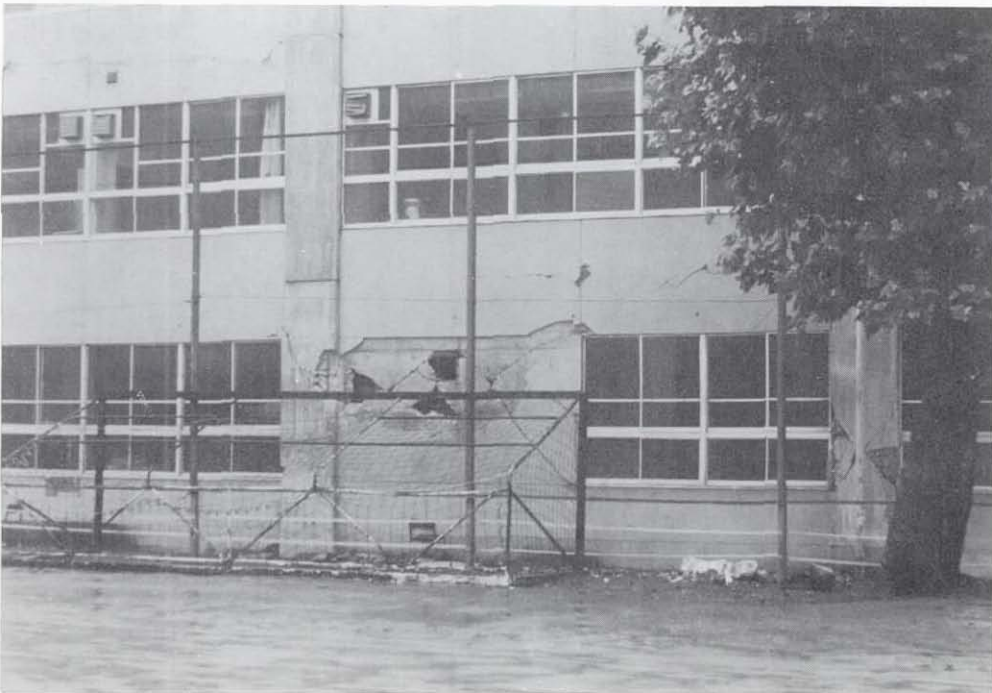
Figure 5.54 Tonan High School - Detail of damage to west face.

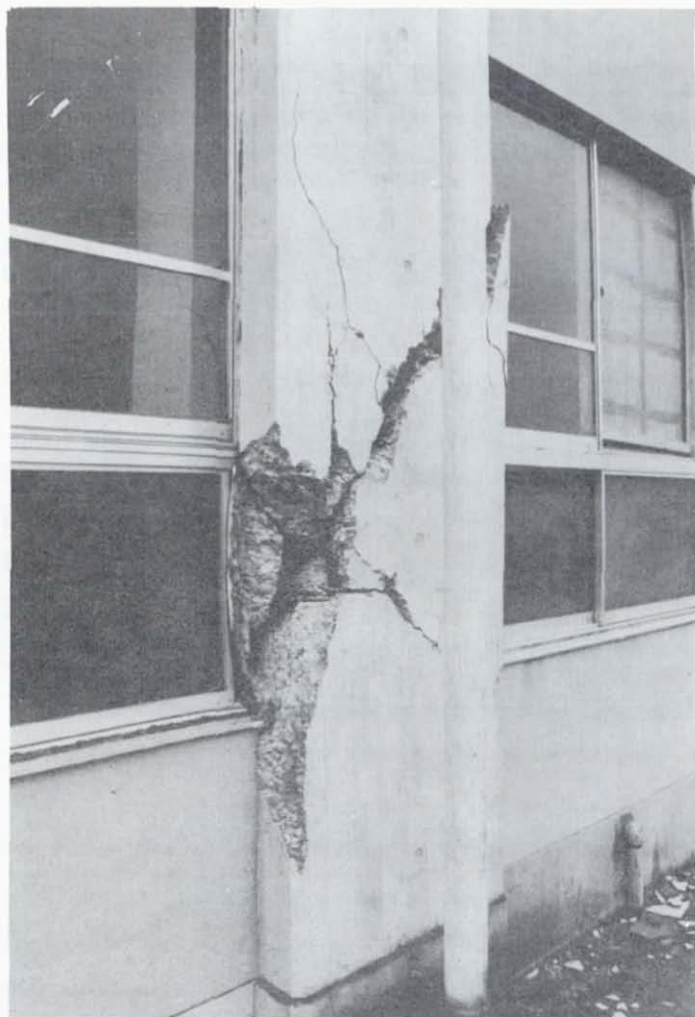
Figure 5.55 Tonan High School. Detail of shear cracking in exterior column above partial infill panels on east face

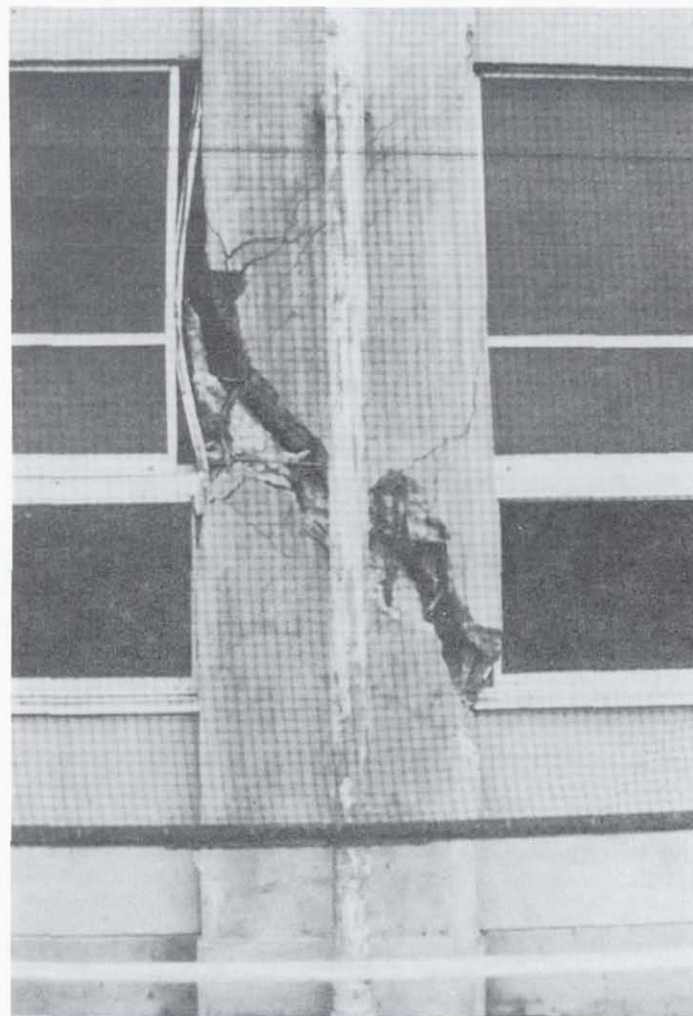
Figure 5.56 Tonan High School. Detail of column damage, exposing reinforcement.

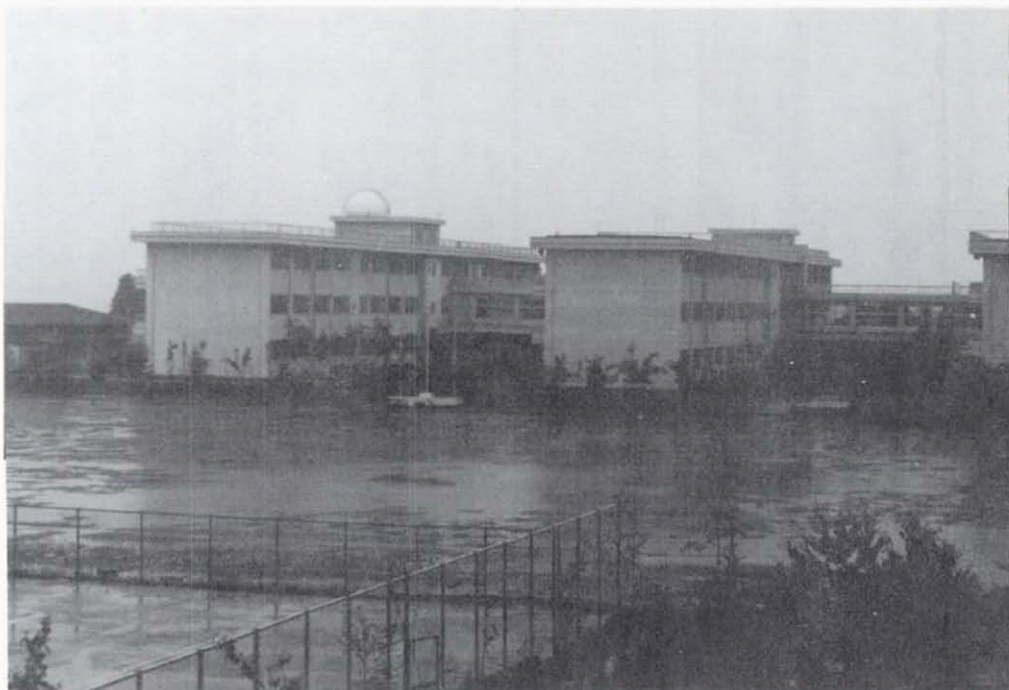
Figure 5.58 shows the east elevation of the three classroom buildings, and Figure 5.59 shows the front entrance on the north side of building 1. The badly cracked panel above the entrance is not connected to the ground floor. The interior corridor walls in the building had extensive diagonal cracks, as shown in Figure 5.60. Figure 5.61 shows the northeast corner of building 2 along the foundation. The diagonal crack at the corner of the exterior wall indicates that either uplifting or settlement of the foundation took place. Figures 5.62 and 5.63 show typical damage on the north and south sides of one of the classroom buildings. Damage was relatively greater on the north side of the building where the columns were stiffened by the infill panels. Although there were numerous diagonal cracks emanating from window openings on the north side, the main columns did not appear to be badly cracked.

Figure 5.58 Izumi High School. Three adjacent reinforced concrete frame buildings with shearwalls suffered minor damage.

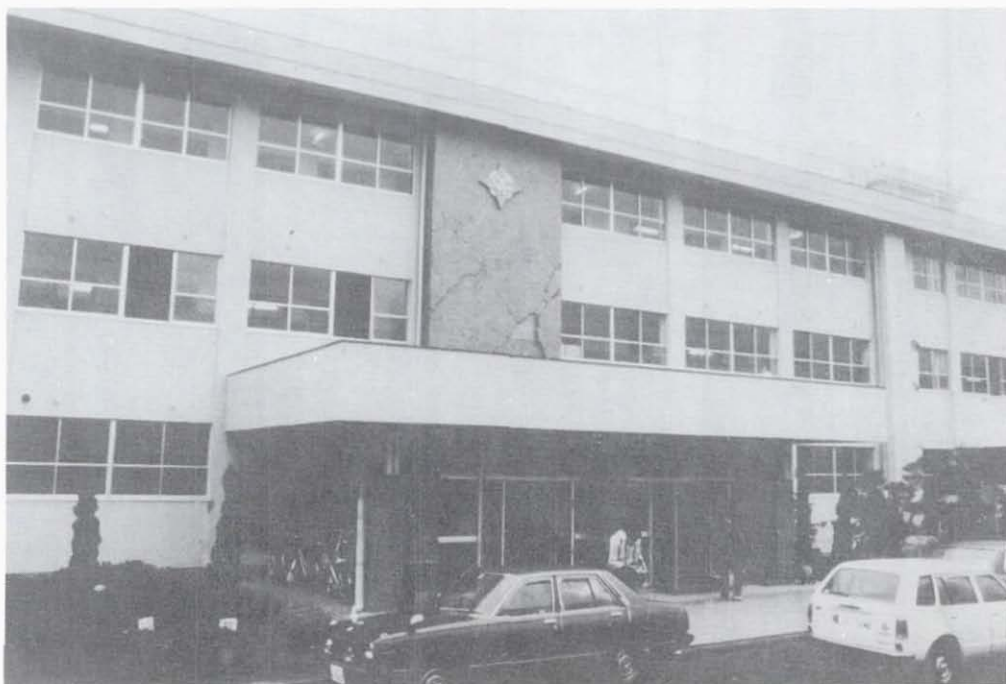
Figure 5.59 Izumi High School. Detail of panel over north entrance to building 1.
