NBS SPECIAL PUBLICATION **592**

An Investigation of the Miyagi-ken-oki, Japan, Earthquake of June 12, 1978

This document is the result of the investigation by the U.S. team on the earthquake. It describes geologic features of the earthquake-stricken area, and damage to human-made structures. It is hoped the information presented in this document will add to the knowledge of seismology and earthquake engineering.

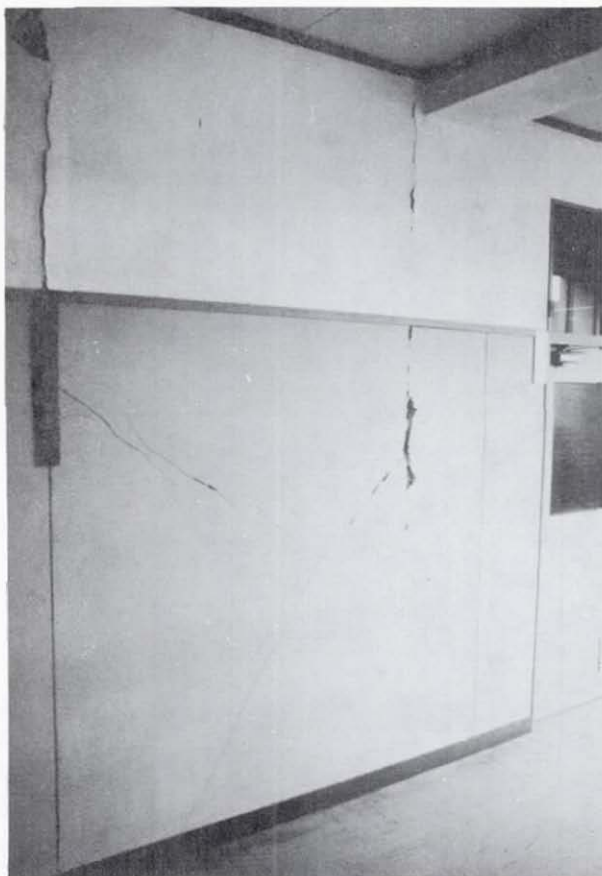
Figure 5.58 shows the east elevation of the three classroom buildings, and Figure 5.59 shows the front entrance on the north side of building 1. The badly cracked panel above the entrance is not connected to the ground floor. The interior corridor walls in the building had extensive diagonal cracks, as shown in Figure 5.60. Figure 5.61 shows the northeast corner of building 2 along the foundation. The diagonal crack at the corner of the exterior wall indicates that either uplifting or settlement of the foundation took place. Figures 5.62 and 5.63 show typical damage on the north and south sides of one of the classroom buildings. Damage was relatively greater on the north side of the building where the columns were stiffened by the infill panels. Although there were numerous diagonal cracks emanating from window openings on the north side, the main columns did not appear to be badly cracked.

Figure 5.60 Izumi High School. An interior corridor wall in classroom building 1 aligned in the longitudinal direction of the building.

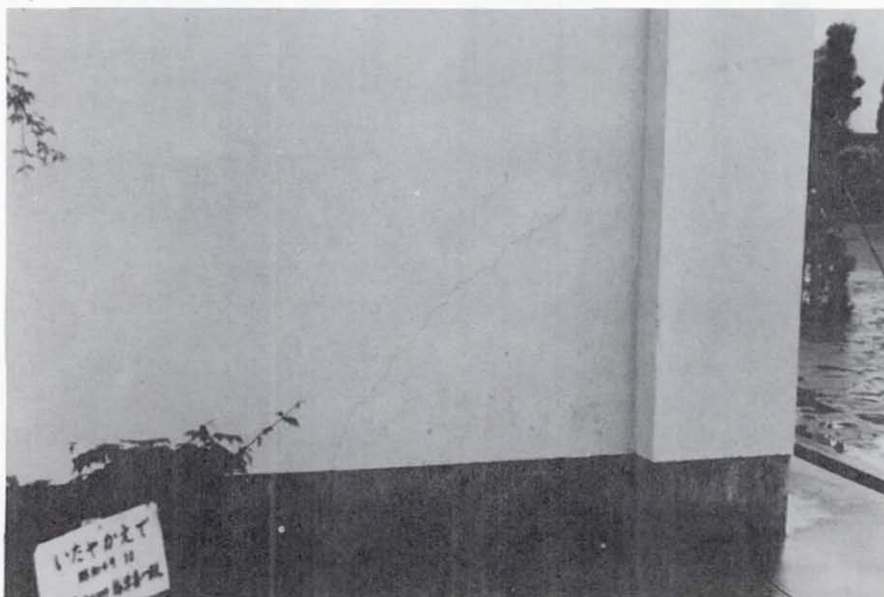
Figure 6.61 Izumi High School. The diagonal crack in the exterior wall shows that foundation settlement or uplift took place at the corner.

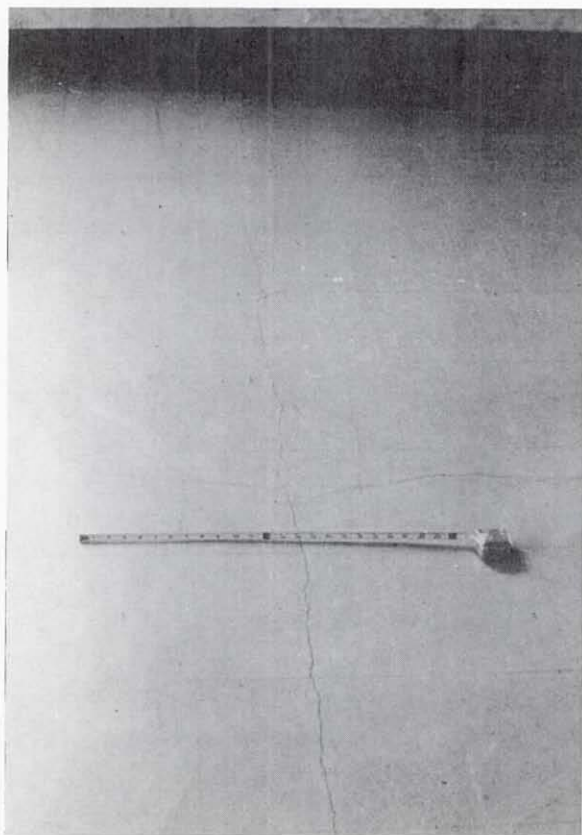
Figure 5.66 Tohoku Institute of Technology. Typical cracking of floor diaphragms at the sixth floor level, building 5.

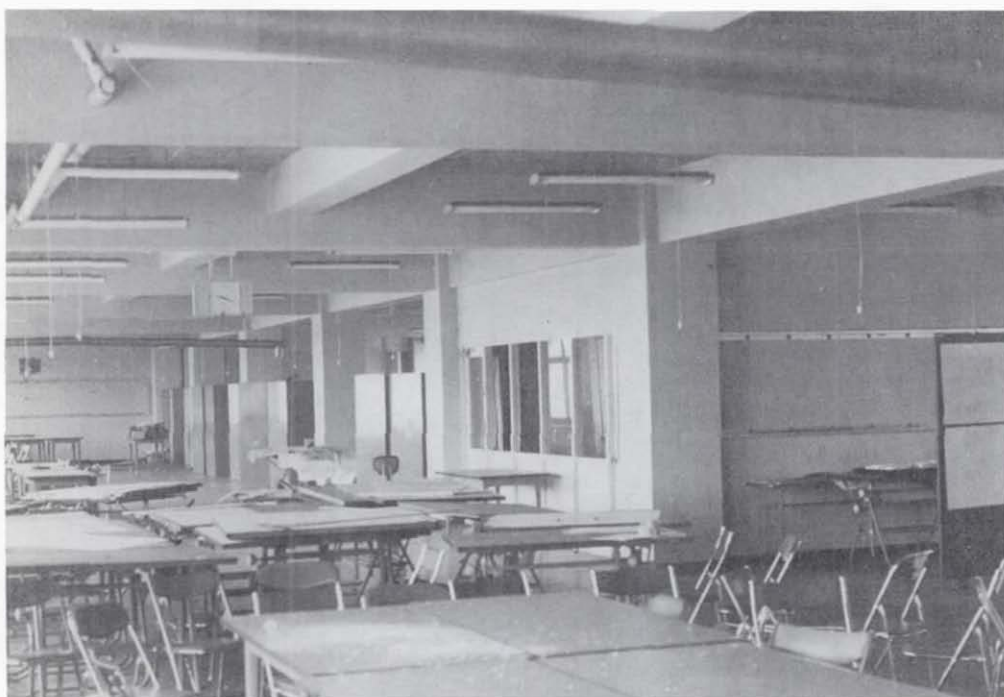
Figure 5.69 Tohoku Institute of Technology, Building 5. Seventh story interior, looking towards the lightly damaged southern exterior frame.

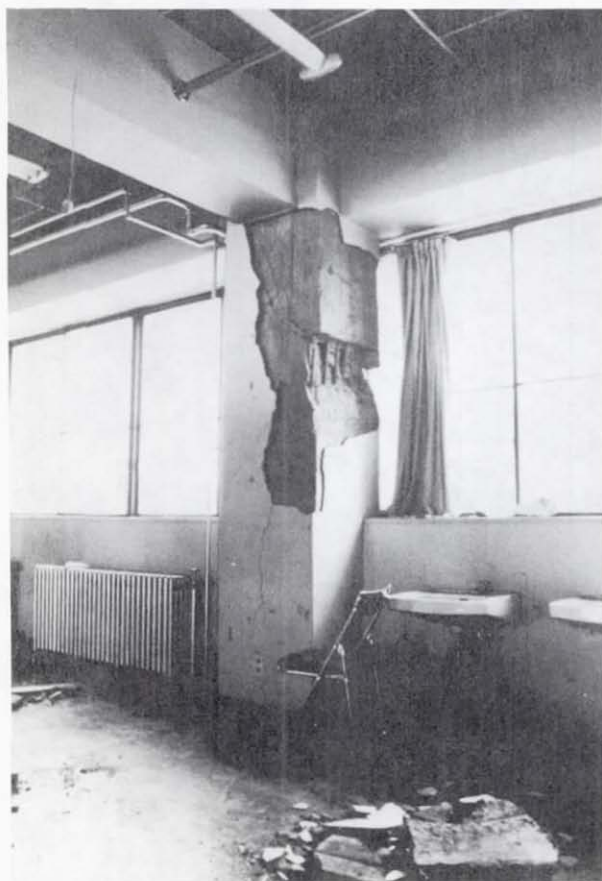
The columns on the northeast side of building 5 were seriously damaged. Figure 5.67 and 5.68 show typical damage to exterior columns on the upper stories (stories 6 - 8). The infill panels stiffened the exterior columns on the northeast side of building 5. In contrast, the exterior columns on the southwest side and the interior columns had no such stiffening, were relatively flexible (Figure 5.69) and suffered no apparent damage. The lower story columns on the northeast side showed significant shear cracking and spalling, as illustrated in figure 5.70 for one exterior column on story four. Crack widths exceeded 10 mm in several instances. Visible column ties were spaced 250 mm apart and were wrapped around the corner longitudinal bars without hooks. Interior transverse shear walls also showed diagonal cracks. In at least one case where the transverse wall was connected to a column, the diagonal crack in the wall continued on into the column. The transverse walls were connected to the columns on the north side with the tie beams. Figure 5.71 shows one of these tie beams following the earthquake.

Figure 5.70 Tohoku Institute of Technology, Building 5. Damage to column on north side of third story. The tie spacing is 25 cm.

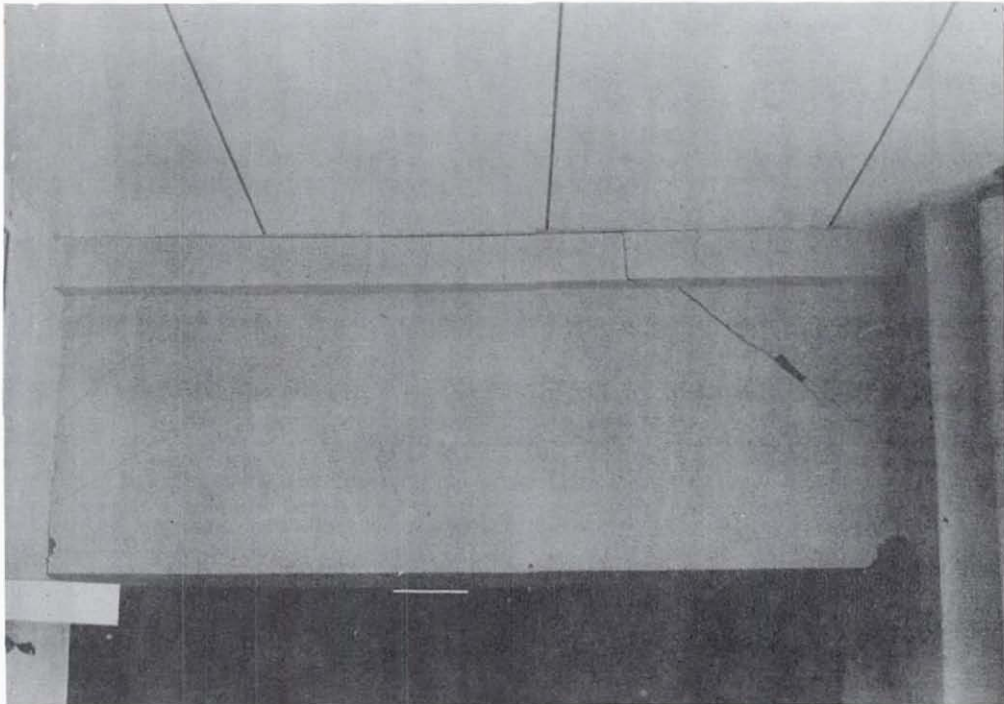
Figure 5.71 Tohoku Institute of Technology, Building 5. The tie beam over a sixth floor corridor connecting two shear walls shows diagonal cracks at both ends.

It was reported that building 3 will be demolished and building 5 will be repaired. Estimates of the costs of repair for these structures were unavailable.

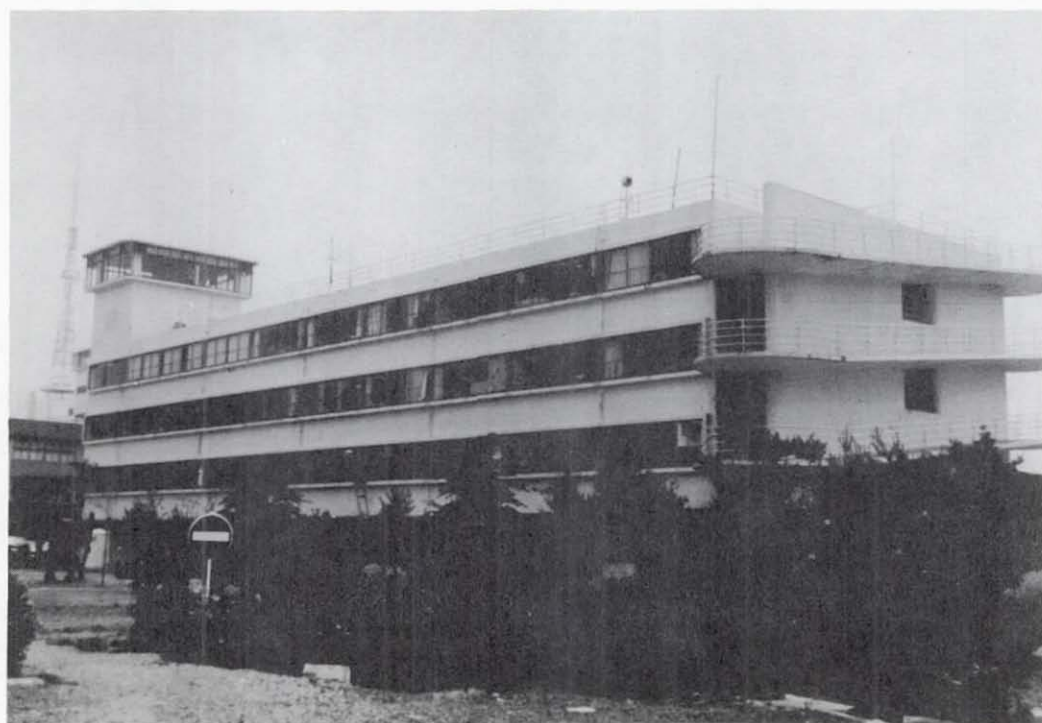
The northeast facade of building 3 is shown in Figure 5.74. This is a four-story reinforced concrete frame building, ten spans by two. While the relatively flexible interior columns were undamaged, all of the exterior columns on the first-story cracked in shear just above the infill panels, as shown in Figure 5.75. Figure 5.76 illustrates this more clearly at one of the first-story columns on the northeast side of building 3. As can be seen, the reinforcement is undeformed. We were informed that core samples taken out of the spandrels showed no apparent damage to the concrete.

Figure 5.74 Tohoku Institute of Technology, Building 3. General view of the north elevation.

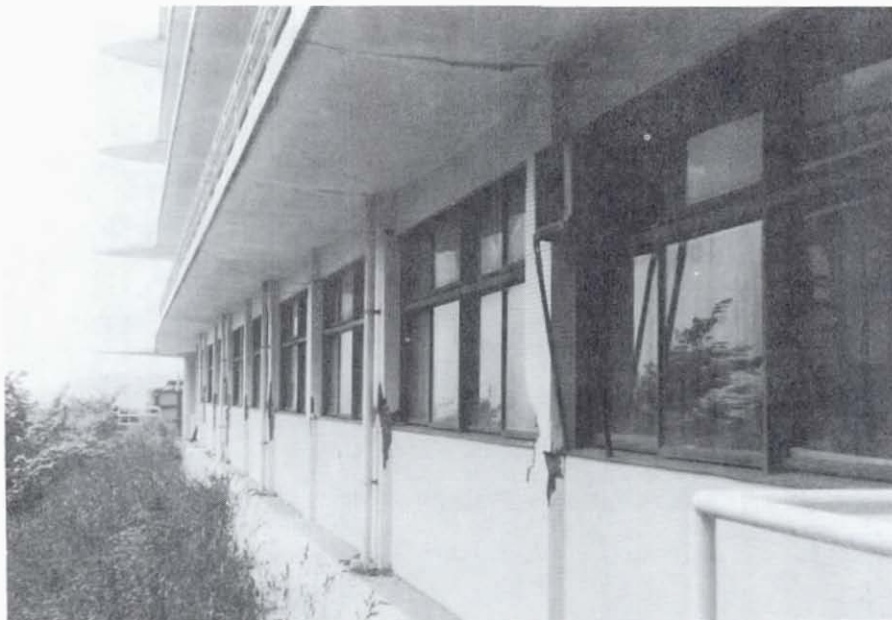
Figure 5.75 Tohoku Institute of Technology, Building 3. Damage to the ground floor columns on the south side of the building. Similar damage is present on the opposite side of the building.

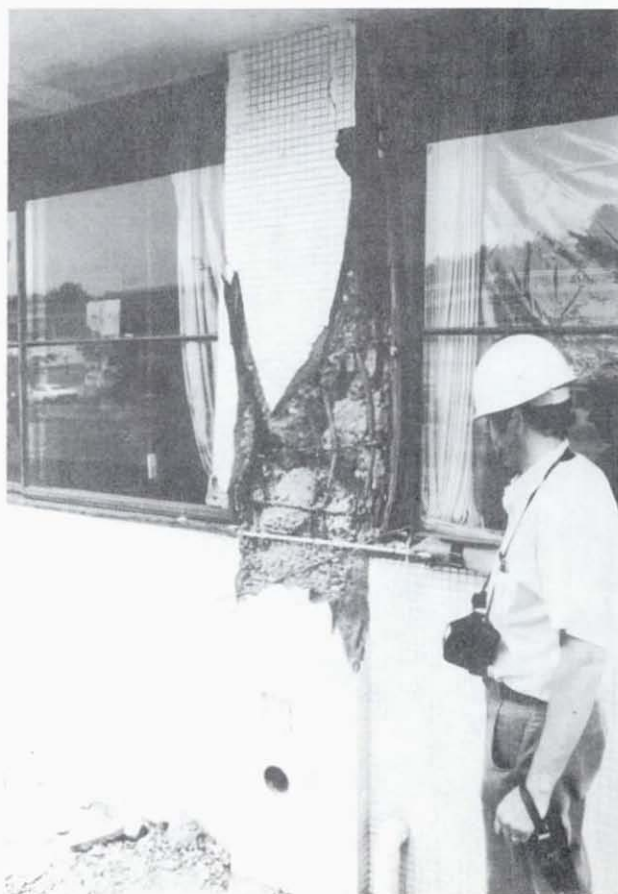
Figure 5.76 Tohoku Institute of Technology, Building 3. Typical damage to ground story exterior column on north side of building.

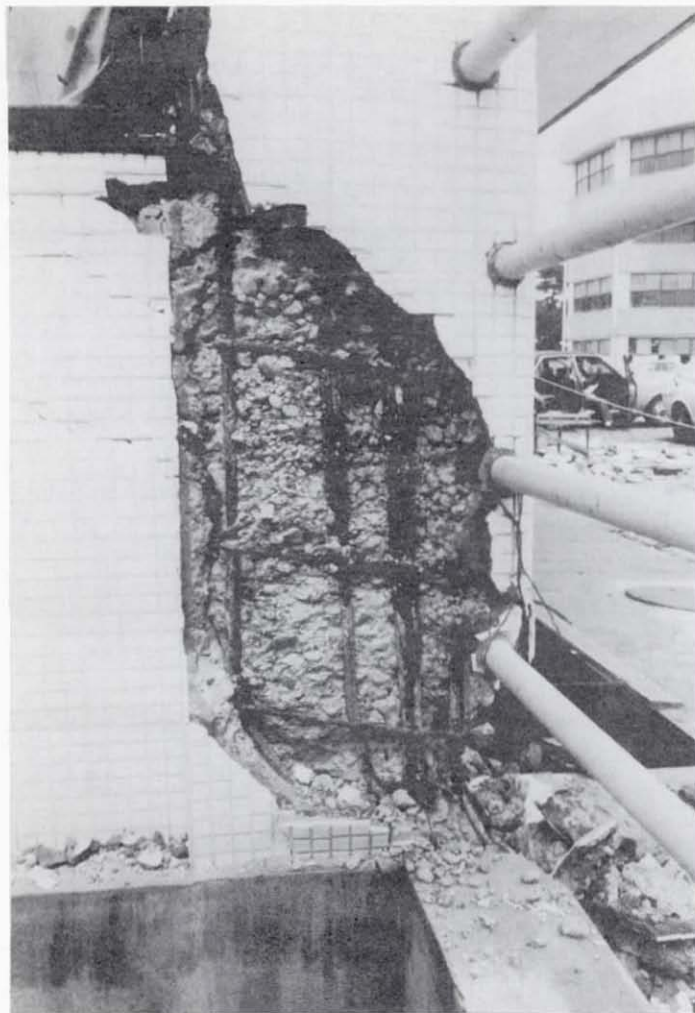
Around the entrance on the east side of building 3 and the southeast corner of its first-story, large areas of the tile facing and concrete underneath had spalled off, exposing the reinforcement (Figure 5.77). At this location, the vertical reinforcing bars were bent manually during construction in order to force them to conform to the building working drawings. The reinforcement appeared to have less than 10 mm concrete cover. The interior walls of building 3 showed extensive diagonal cracking (Figure 5.78). However the interior columns were apparently not damaged.

Figure 5.77 Tohoku Institute of Technology, Building 3. Detail of one of the damaged columns of the exterior frame on the south side of the building showing reinforcing details.

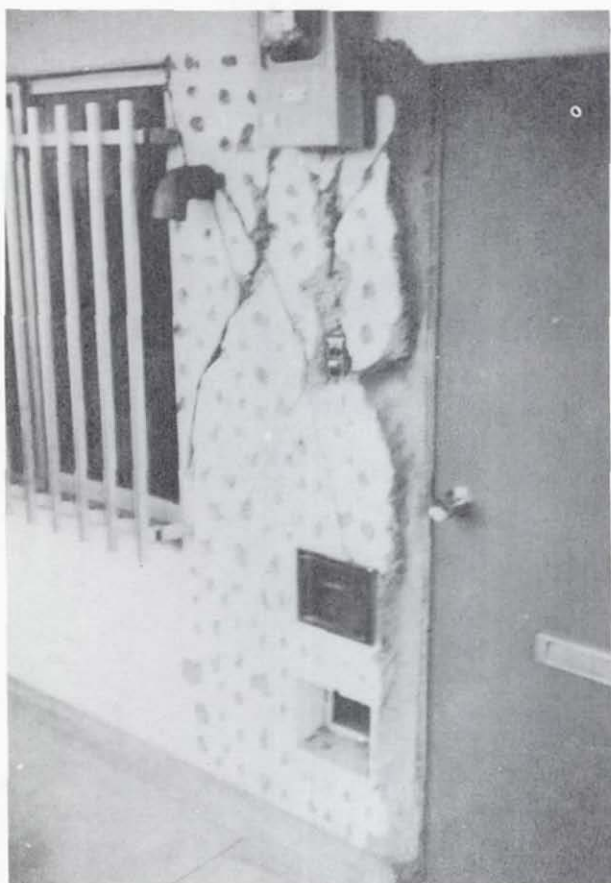
Figure 5.82 Sunny Heights Apartment Building. Detail of cracking of panels adjacent to doorways. Such cracking was typical at all levels on the east facade of the structure.

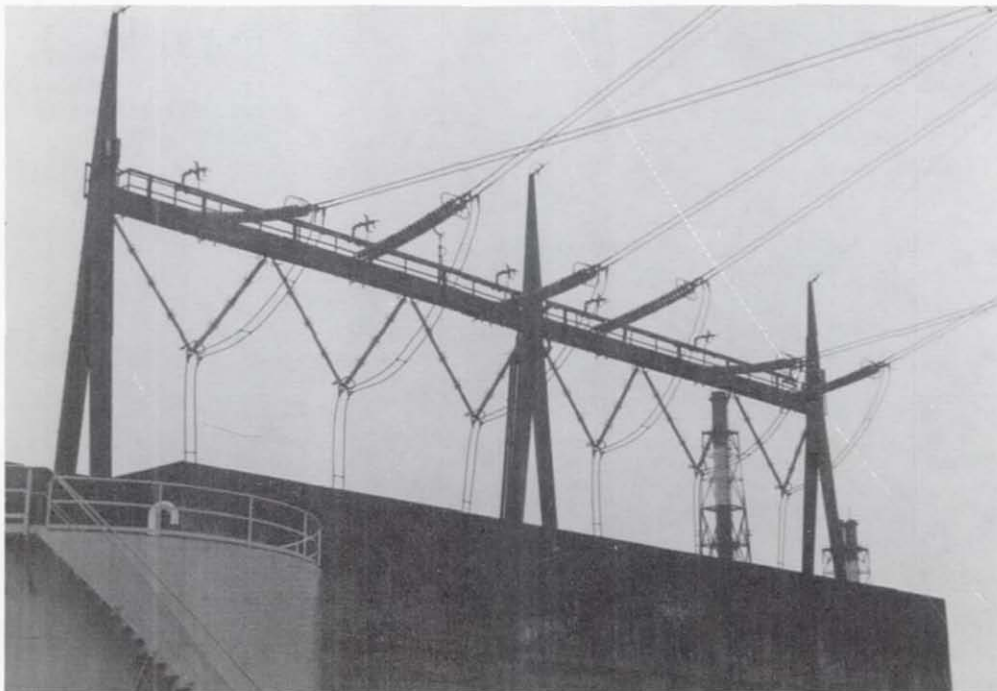
Figure 6.10 Fukushima Nuclear Power Plant. Broken ceramic insulators were the only damage reported for the site. The damaged insulators had been replaced, as illustrated above, within hours after the earthquake and before the reconnaissance visit.

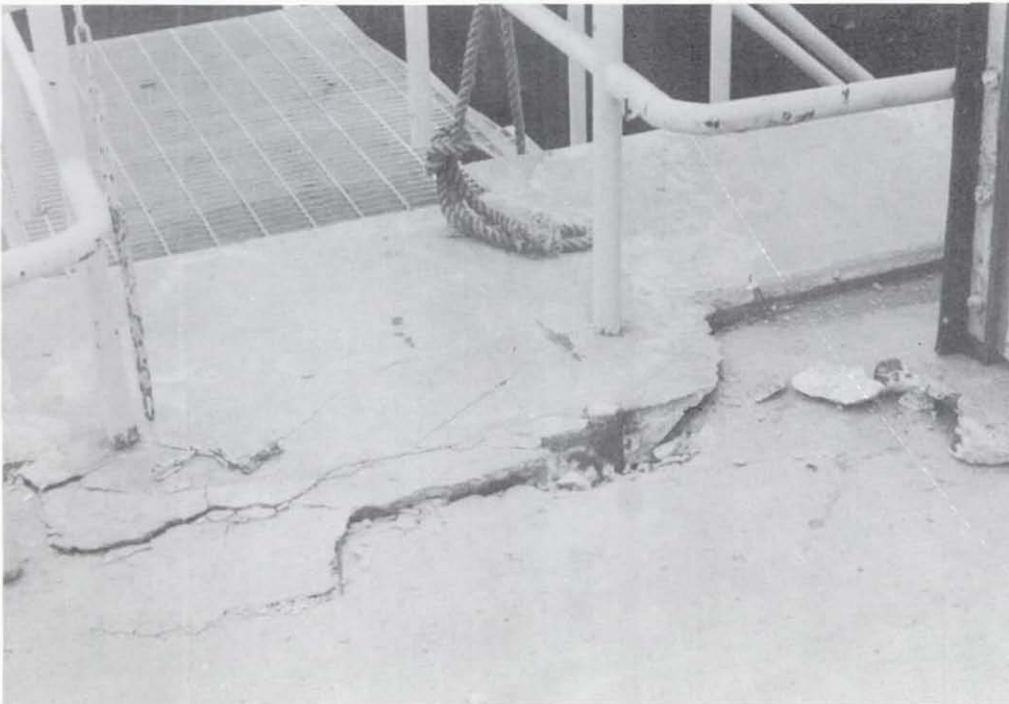
Minor settlement occurred throughout the site. Much of this settlement occurred in the vicinity of buried piping (Figure 6.14). About 1 cm of settlement occurred at the intake structure and the paving around the structures was cracked; however the structure was operational and did not seem to require repairs (Figure 6.15).

Figure 6.15 New Sendai Power Plant, Tohoku Electric Power Company: damage around the water intake structure from minor settlement. Other examples of minor settlement were observed throughout the site.

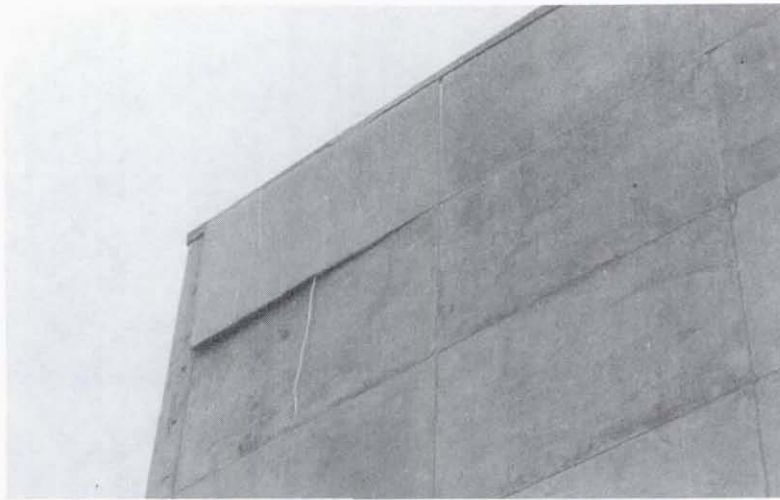
Building damage was limited to some of the interior walls of the administration building and to the facing precast panels of the turbine buildings (Figure 6.16). Some of these panels were loosened; presumably the attachments to the steel framing were damaged.

Figure 6.16 New Sendai Power Plant, Tohoku Electric Power Company: a loosened exterior facing panel in the turbine building. This was the only obvious damage to the exterior of the structure. The shear walls of the adjacent administration building showed extensive cracking.

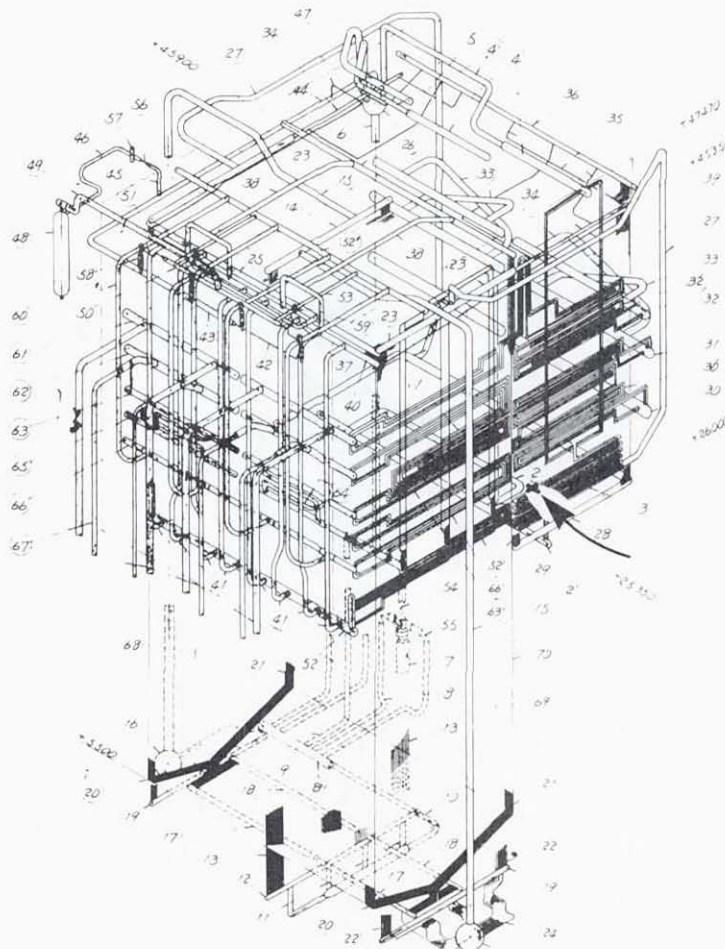
Both Unit 1 and Unit 2 suffered damage to tubing inside the boilers (Figure 6.17). A small furnace platen cooler tube inside the slag screen was sheared in the Unit 1 boiler (Figure 6.18). A similar failure occurred in the boiler of Unit 2 to one of the reheater spacer tubes. The suspended boilers and their structural supports also pounded against one another and also sustained some damage (Figure 6.19).

Figure 6.17 New Sendai Power Plant, Tohoku Electric Power Company. The arrow points to the location of the damaged horizontal spacer tubes in the 600-MW boiler of Unit No. 2. (See Figure 6.18).

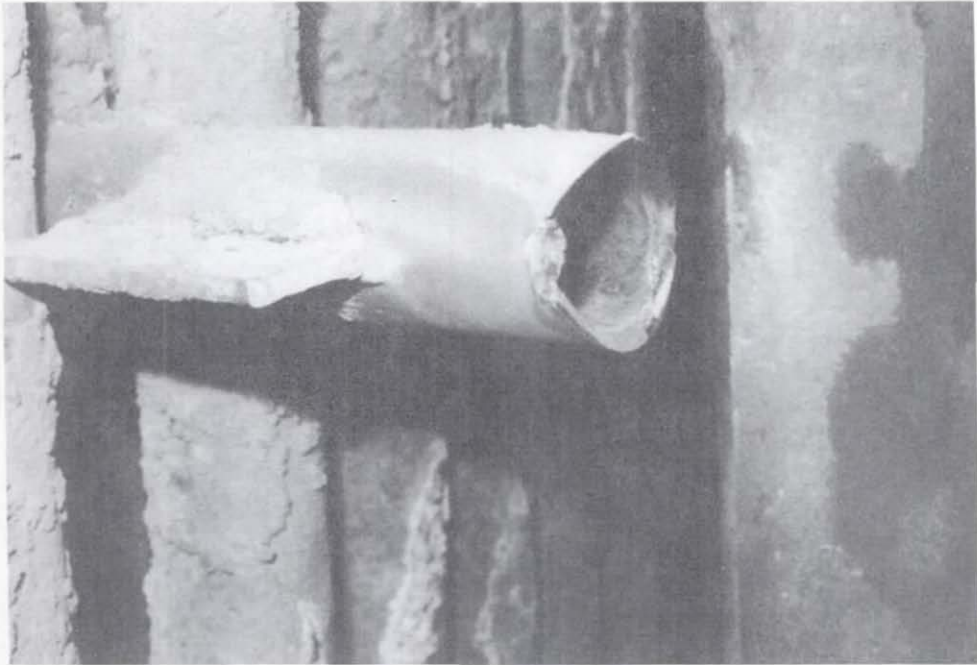
Figure 6.18 New Sendai Power Plant, Tohoku Electric Power Company: damage to the two boilers consisted of shearing of spacer tubes for the furnace platen cooler tubes inside the boiler. (Tohoku Electric Power Company photograph)

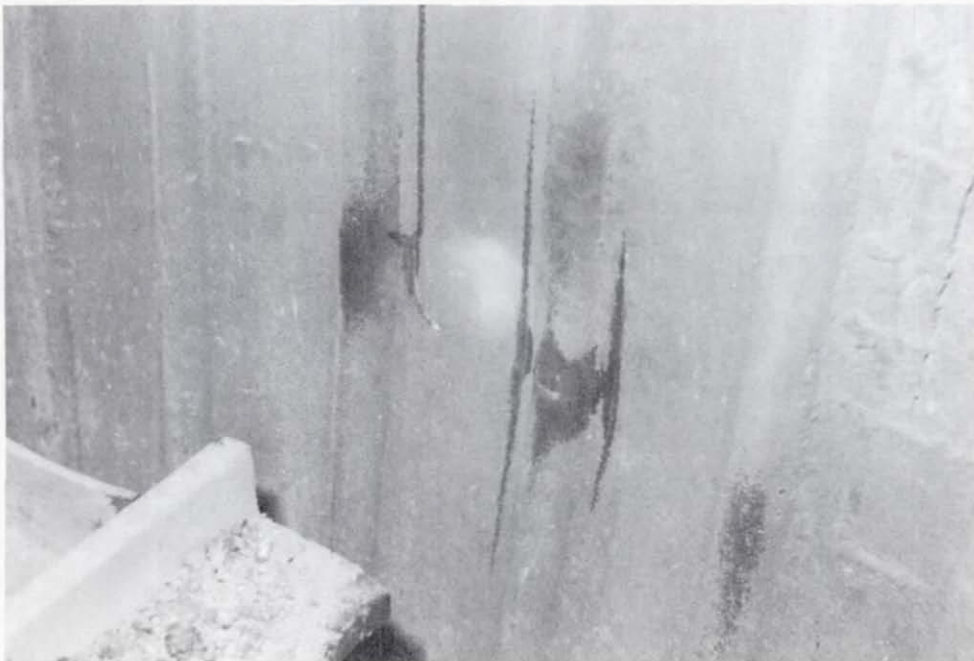
Figure 6.19 New Sendai Power Plant, Tohoku Electric Power Company: a view of the exterior of the boiler walls showing evidence that the suspended boiler had pounded against the surrounding support structure. (Tohoku Electric Power Company photograph)

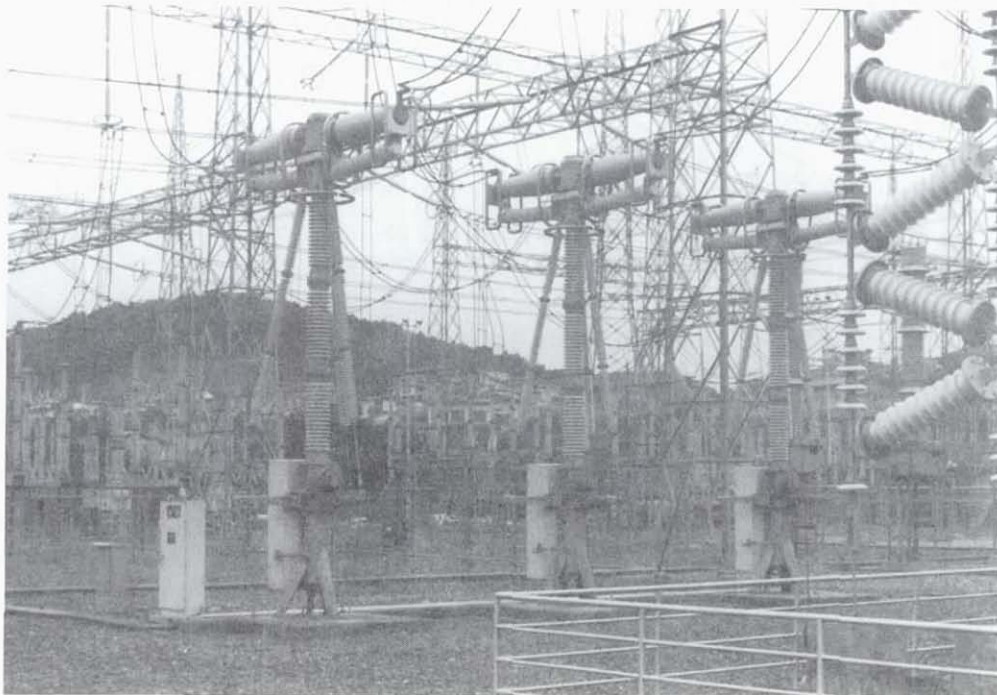
Figure 6.23 Sendai Substation, Izumi: typical damage to 3-phase T-shaped circuit breakers (as shown in previous figure). Note the complete failure of one and the damage to the three guides of the second circuit breaker. All steel supports appear to be undamaged. The photograph was taken immediately after the earthquake before repairs were initiated. (Tohoku Electric Power Co. photograph)

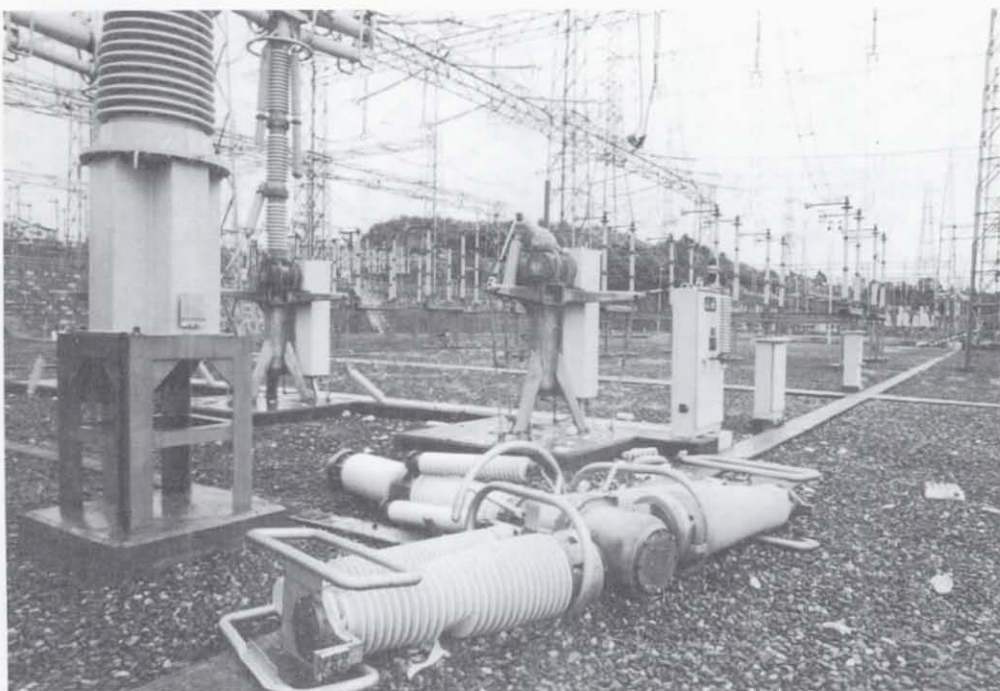
Figure 6.24 Sendai Substation, Izumi: another three failed 3-phase, T-shaped circuit breakers. Note the failed main stems, the loose guide wires and the undamaged steel supports which are attached to their foundations. (Tohoku Electric Power Co. photograph)

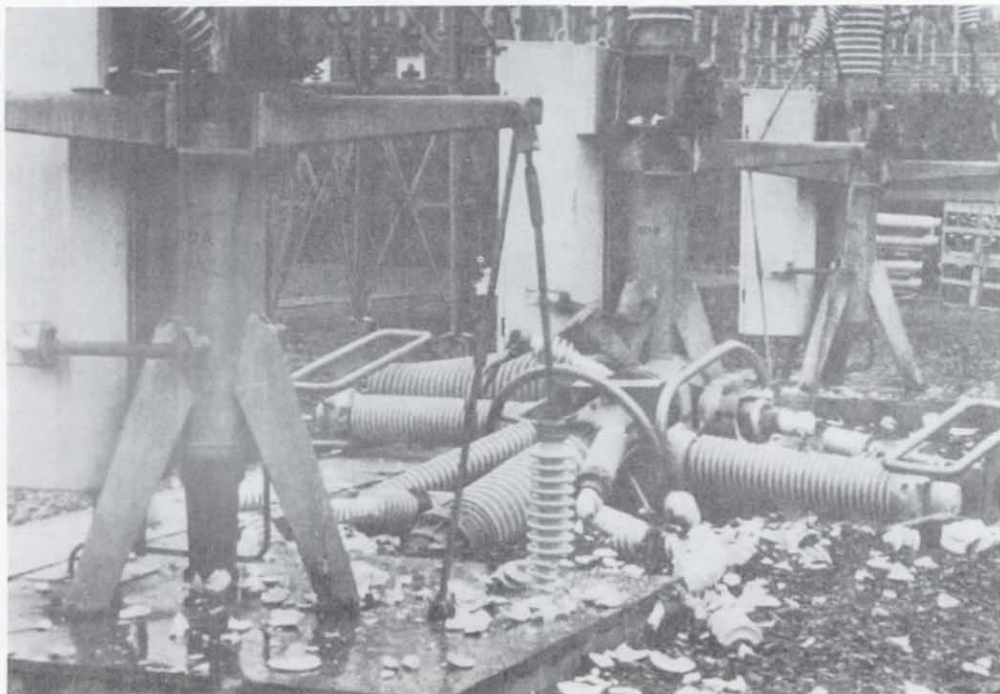
Figure 6.25 Sendai Substation, Izumi: damage to a circuit breaker (right), and two lightning arresters (center). The bushings of the transformer in the background appear to be undamaged; however, the lightning arrester is leaning. (Tohoku Electric Power Co. photograph)

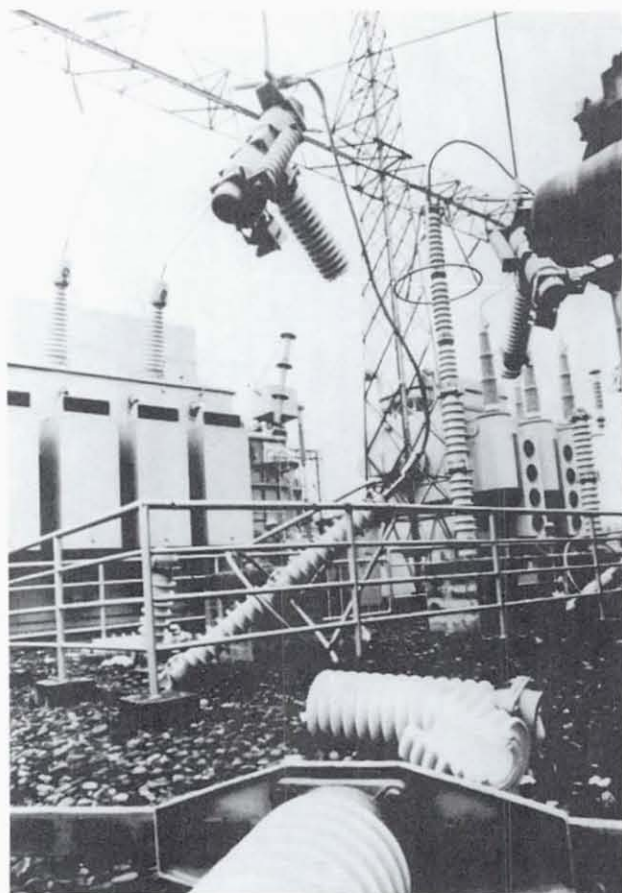
Figure 6.26 Sendai Substation, Izumi: Severe damage to circuit breakers (center of photograph - note the failed columns of live tank design, probably with gas reservoirs), current transformers (with the tapered bushings - some of the stems are also damaged), and reactors (to the left) with presumably broken connections. (Tohoku Electric Power Co. photograph)

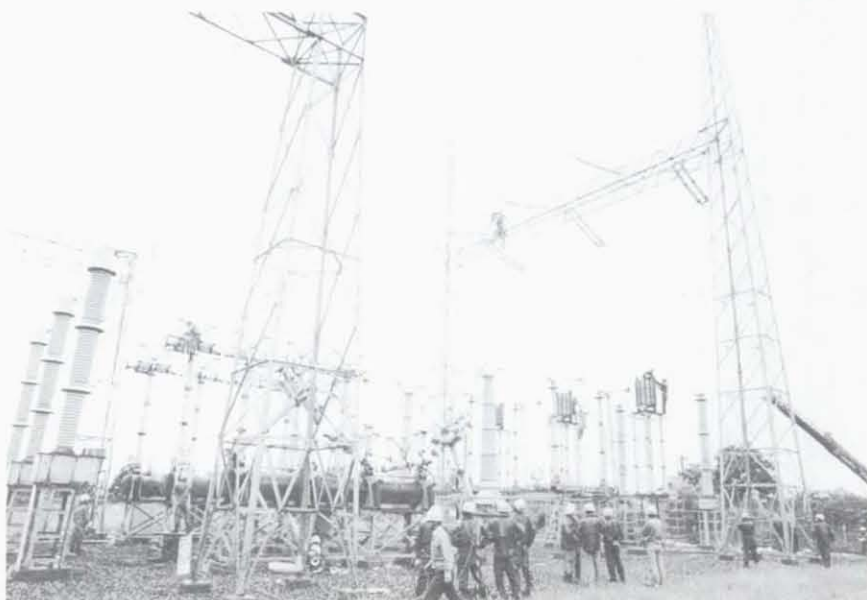
Figure 6.27 Sendai Substation, Izumi. Severe damage to several circuit breakers of live tank design. Note the lack of damage to the structural steel supports and the steel components of the equipment. (Tohoku Electric Power Co. photograph)

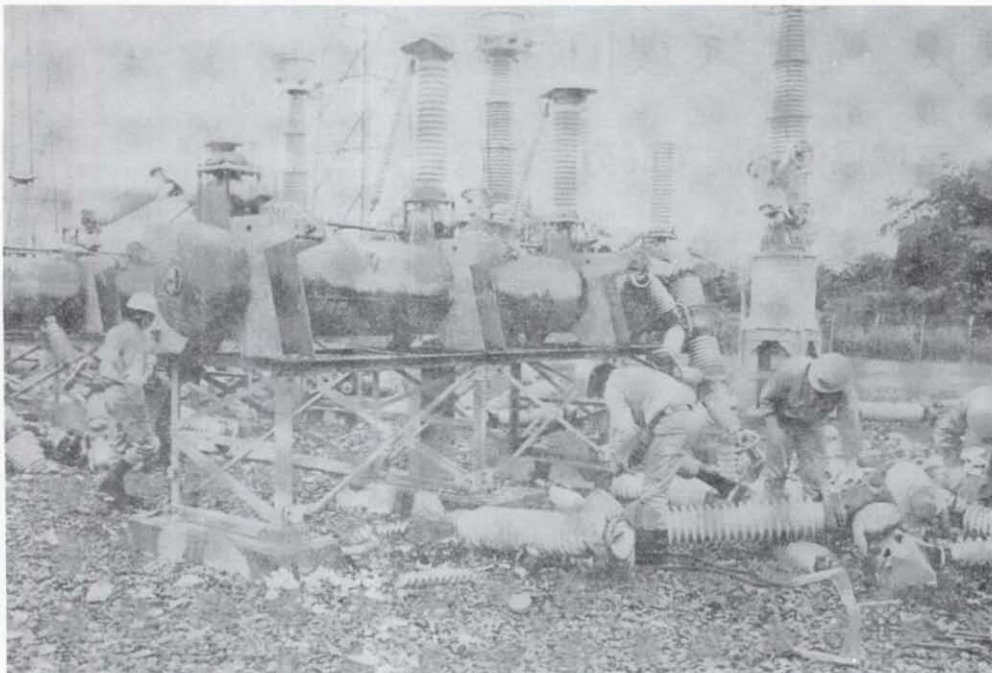
Figure 6.28 Sendai Substation, Izumi; one of several piles of broken equipment, including several line traps or reactors in the back (note the damaged base of the left stem) and the horizontal tanks of several circuit breakers of the live tank type (in the foreground are the failed columns of the circuit breakers and of other equipment).

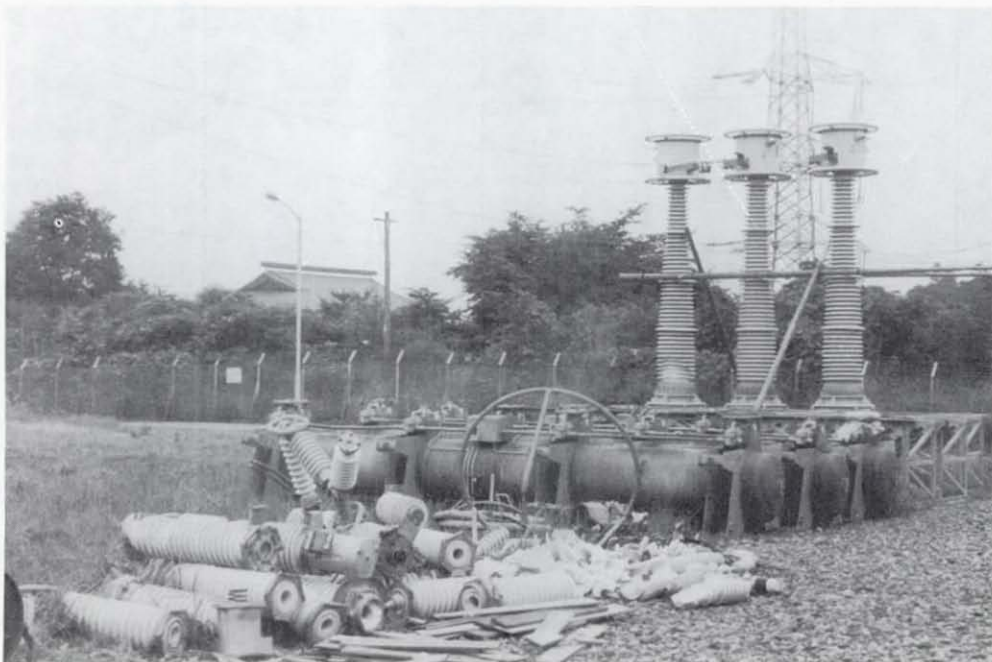
Figure 6.29 Sendai Substation, Izumi; a repaired but still disconnected transformer. All of the transformers at the substation lost some bushings or lightening arrestors. Some damaged parts were being replaced at the time of the investigation.

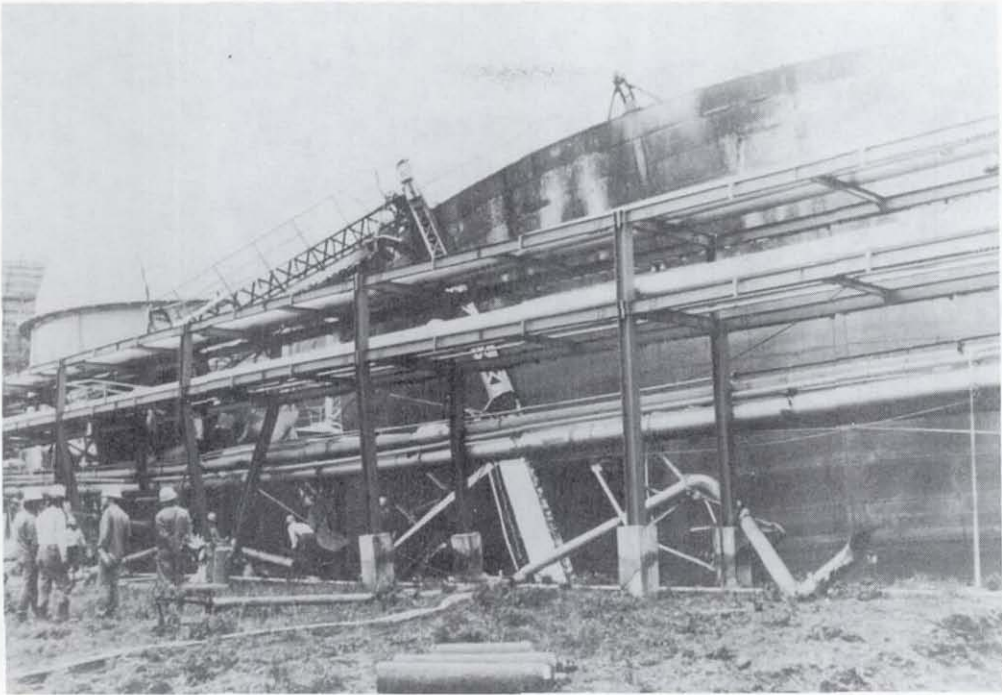
The collapsed holder caught on fire shortly after failure, and all of the stored gas was consumed. The fire burned out, or was extinguished, about 25 minutes later, and did not spread to the nearby high pressure propane tanks. The most serious damage to the gas facility was caused by the collapsing holder. It struck the nearby pipeway for many of the tanks at the plant, causing much damage to the piping systems and other associated equipment. Figure 6.31 shows the collapsed holder and the damaged pipeway just after the earthquake. At the time of the investigation a new pipeway had been erected on the concrete pedestals of the old pipeway, and repairs of the pipelines were proceeding, Figure 6.32. These pipes service the remaining undamaged gas tanks.

Figure 6.31 Haranomachi Plant, Sendai Gas Bureau; collapsed gas holder and the damaged adjacent pipeway structure just after the earthquake, (Sendai Gas Bureau Photograph)

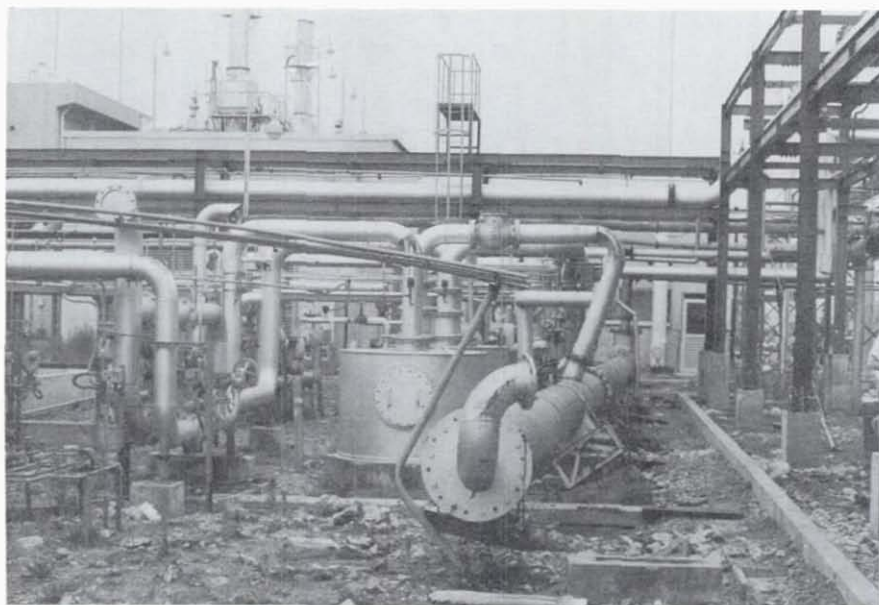
Figure 6.33 Haranomachi Plant, Sendai City Gas Bureau: damage to piping and other equipment and supports caused by impact from the collapsed gas holder and the adjacent pipeway. The newly erected pipeway is to the right.

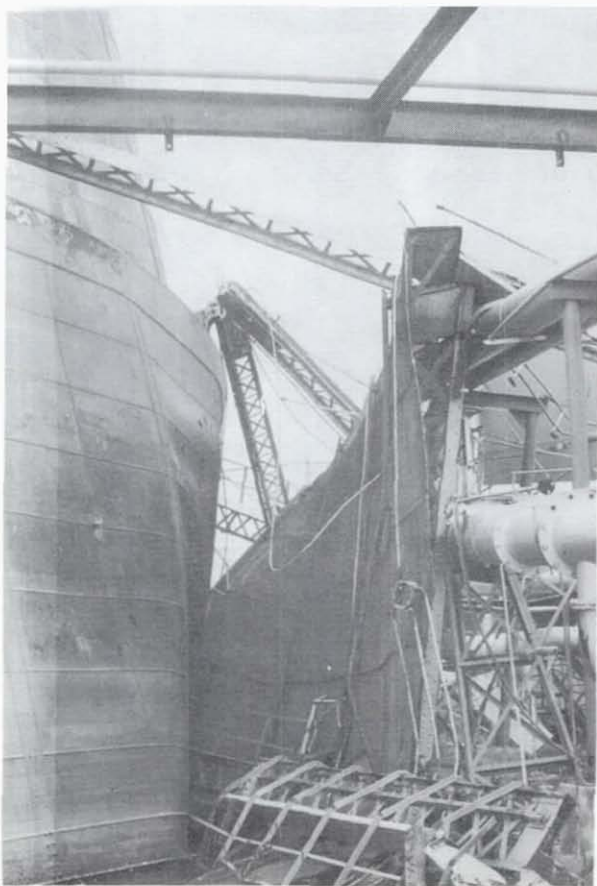
Figure 6.34 Haranomachi Plant, Sendai City Gas Bureau: damage to the telescoping gas holder and to some of the nearby pipeways and equipment. The trusses are portions of the original support structure that had surrounded the tank.

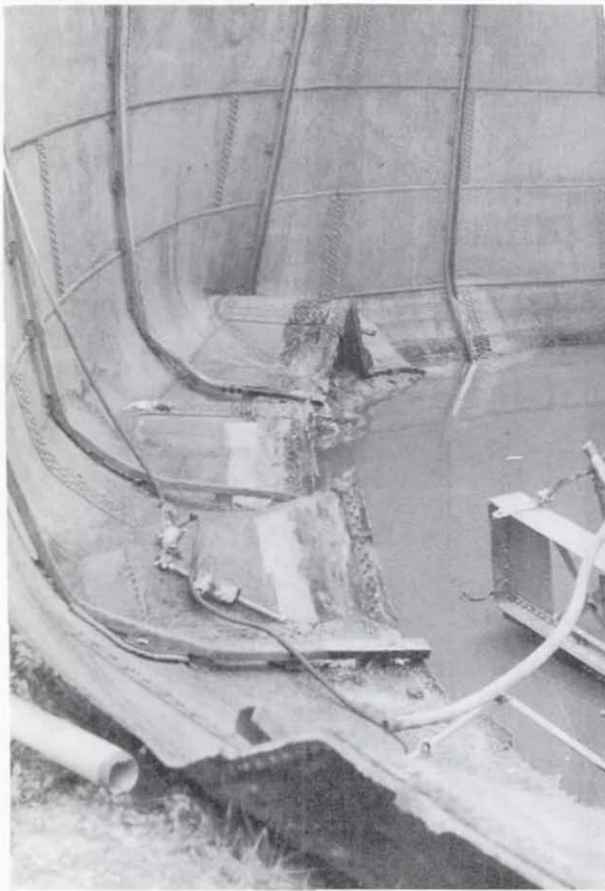
Figure 6.35 Haranomachi Plant, Sendai City Gas Bureau: buckling damage to the lower portion of one segment of the gas holder.

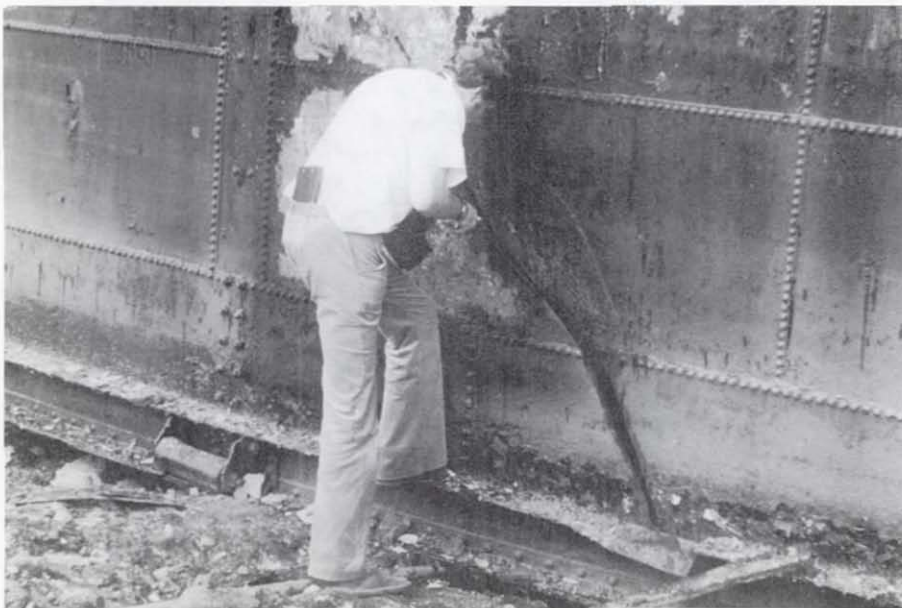
Figure 6.36 Haranomachi Plant, Sendai City Gas Bureau: a fracture of the 3/8-in. plate wall of the collapsed gas holder. The length of the fracture is approximately 1.5 m (5 ft).

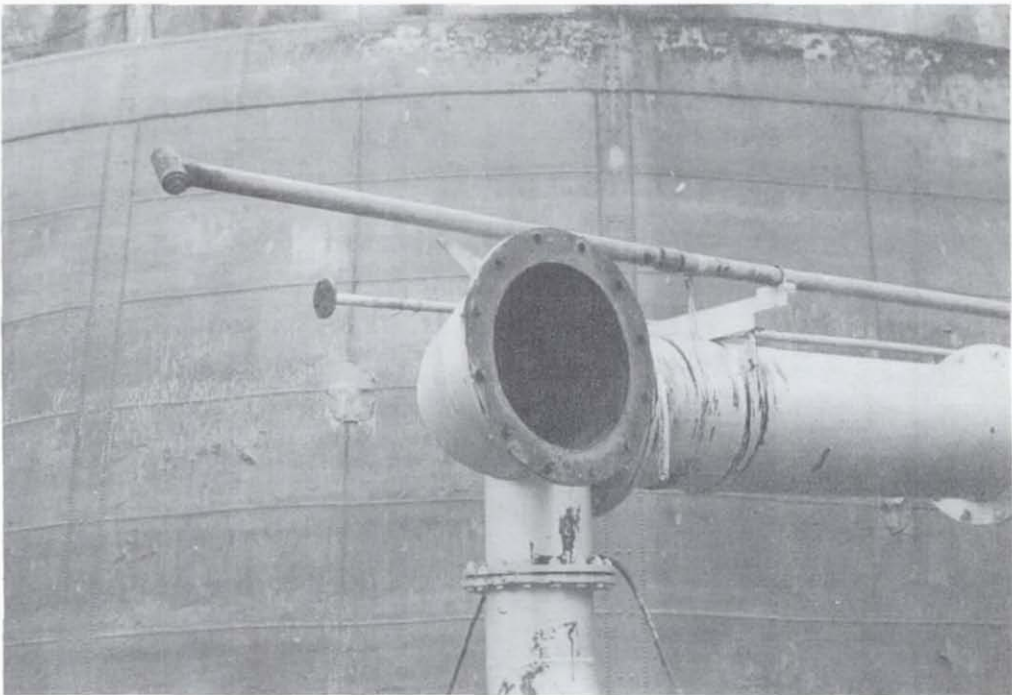
Figure 6.37 Haranomachi Plant, Sendai City Gas Bureau: sheared pipe flange connections in the pipeway structure in the vicinity of the collapsed gas holder.

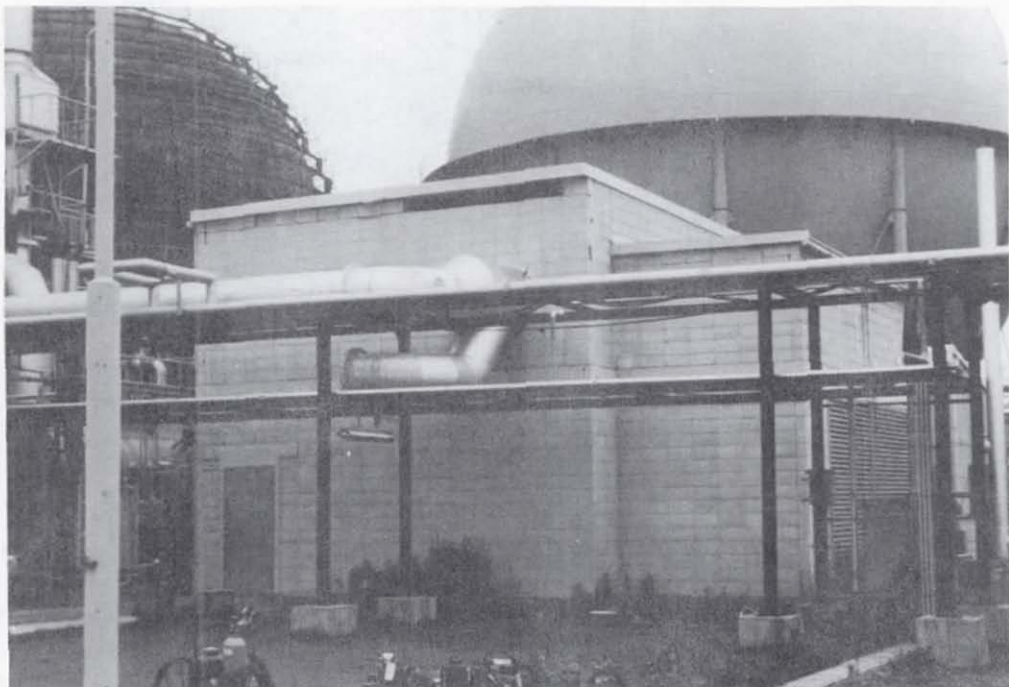
There was evidence of damage throughout the facility (Figures 6.33 through 6.38); however, none of the other tanks at the facility are believed to have suffered major damage. Some damage was due to pounding between buildings and pipes that penetrated the building walls (Figure 6.39). Unanchored pipe supports often moved on their pedestals, and reinforced concrete block structures suffered damage to their structural elements.

Figure 6.39 Haranomachi Plant, Sendai City Gas Bureau: a damaged reinforced concrete block structure. Some of the damage was due to pounding between the large diameter pipe and the structure at the pipe penetration.
