NBS SPECIAL PUBLICATION **592**

An Investigation of the Miyagi-ken-oki, Japan, Earthquake of June 12, 1978

This document is the result of the investigation by the U.S. team on the earthquake. It describes geologic features of the earthquake-stricken area, and damage to human-made structures. It is hoped the information presented in this document will add to the knowledge of seismology and earthquake engineering.

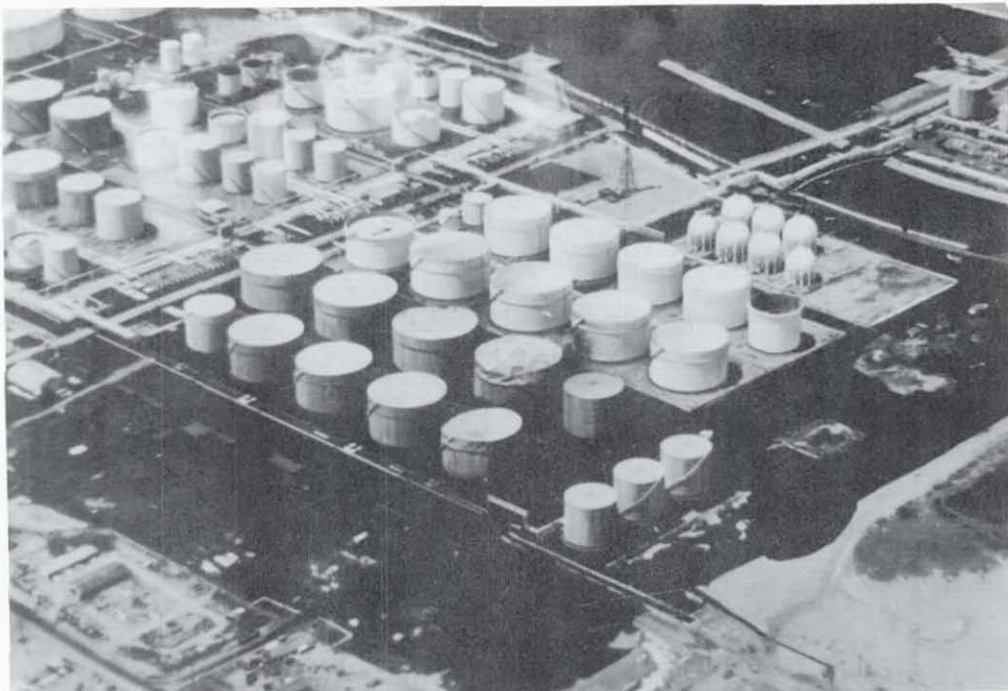
Figure 6.41 Sendai Refinery, Tohoku Oil Company, Ltd.: an overall view of the refinery's tank farm. The spilled oil appears as the dark area of the photograph. (Tohoku Oil Company photograph)

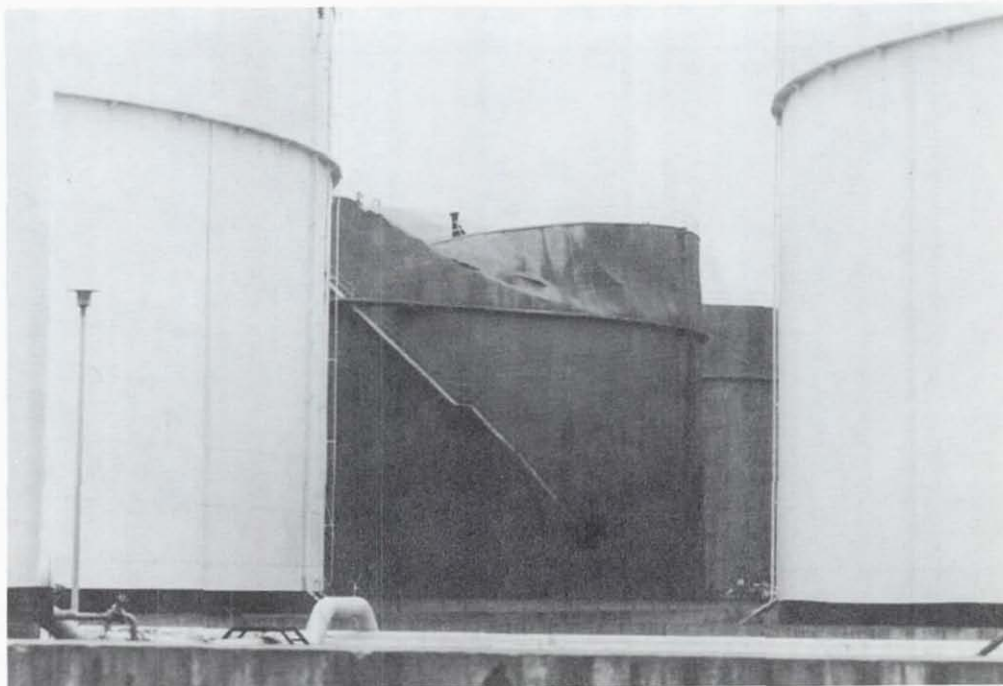
Figure 6.42 Sendai Refinery, Tohoku Oil Company, Ltd.: one of the three failed storage tanks. The damage illustrated is due to suction caused by rapid evacuation of the oil through the ruptured connection of the base and wall of the tank. The several tanks, of similar size, in the foreground are thought to be undamaged.

At the time of the investigation a thick film of oil still covered much of the refinery grounds. Thus, the fire hazard was great, and the investigating team was unable to observe the details of the damage to the tanks. It is believed that the tanks shown in Figures 6.42 through 6.44 failed at their bases. The oil drained rapidly, causing a vacuum inside, which imploded the tanks. Three other tanks suffered damage and will need repair.

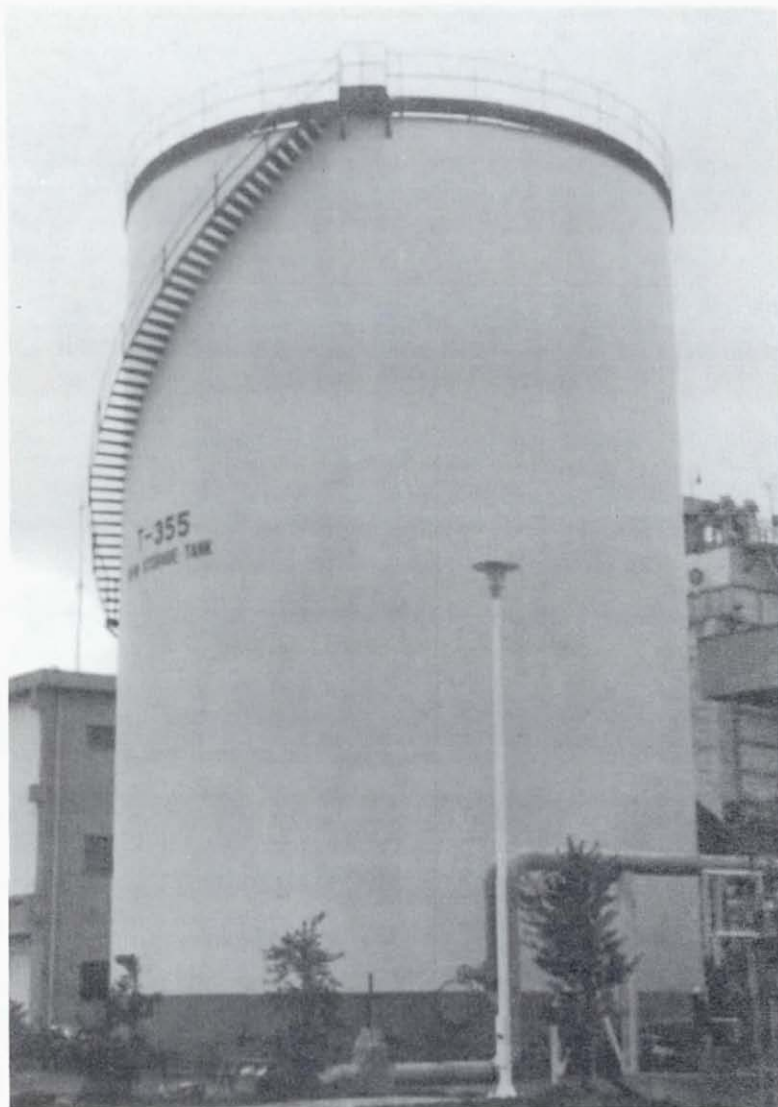
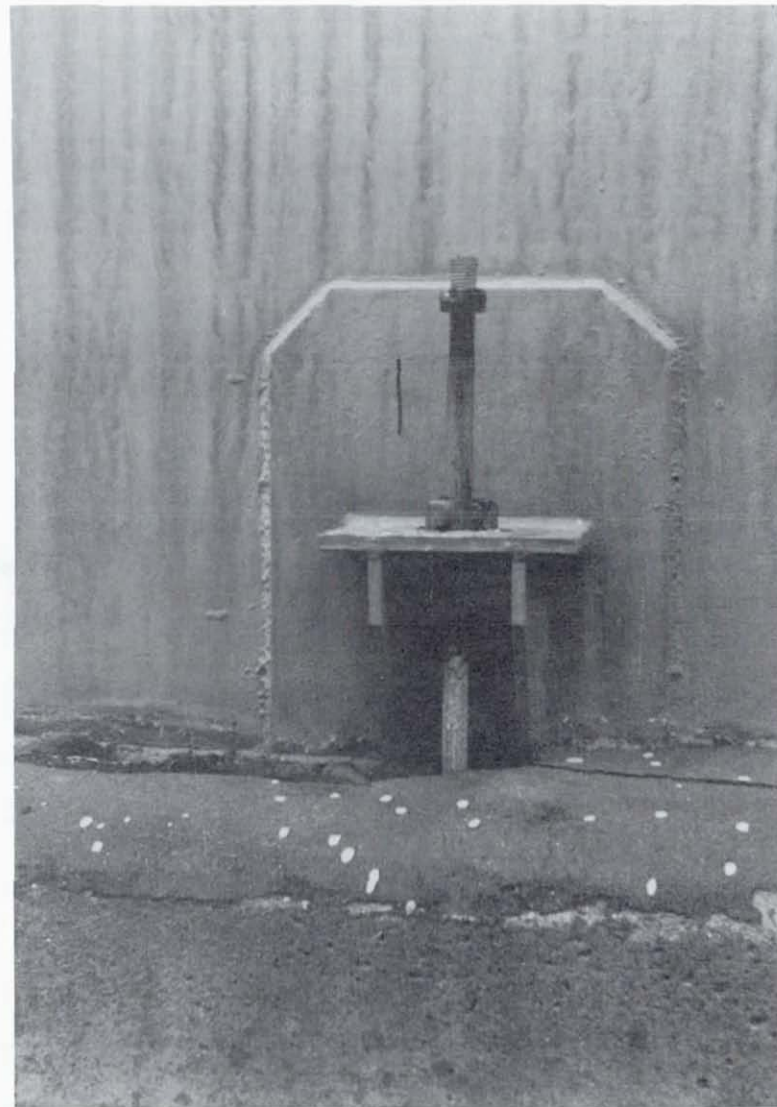
Figure 6.45 Sendai Refinery, Tohoku Oil Company, Ltd. A large water storage tank (left) near the main refinery complex appeared to have experienced significant rocking. Detail (right) of one of the pulled-out, or stretched, anchor bolts of the water storage tanks shown at left.

Another large water storage tank experienced interesting damage (Figure 6.45). The welded steel plate tank was anchored with bolts, spaced at approximately 6 ft (2 m), and embedded in a continuous concrete pad. The bolts around the entire circumference were stretched, or more likely, pulled out from their embedment from 1 to 6 in (2.5 to 15 cm). However, there was no apparent buckling or other damage to the steel base of the tank.

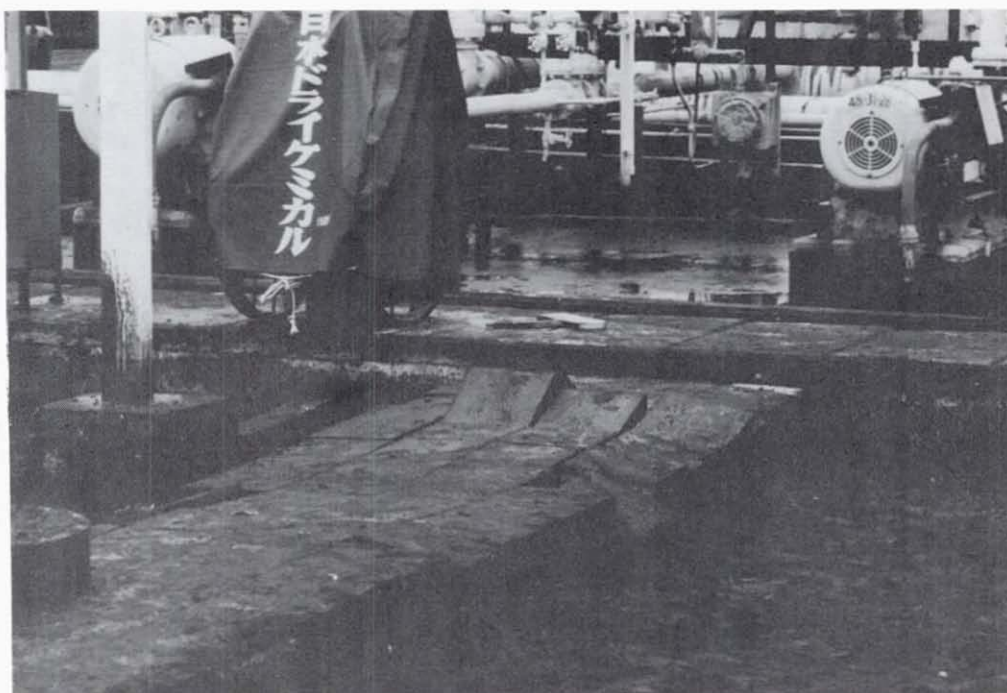
Figure 6.48 Sendai Refinery, Tohoku Oil Company, Ltd.: ground settlement at the refinery.

Figure 6.47 shows a partial view of the refinery, including several towers, heaters, boilers and a heavily braced steel stack. These structures are reportedly undamaged. The team was able to view some of the lower structures; no structural damage was observed. At the time of the reconnaissance, most of the equipment within the refinery complex had not yet been checked for operability. There was concern that some of the control equipment, and other minor operating equipment might have been damaged. Local settlements may have damaged some equipment, as illustrated in Figure 6.48. The pipeway support structures that were examined showed no significant damage.

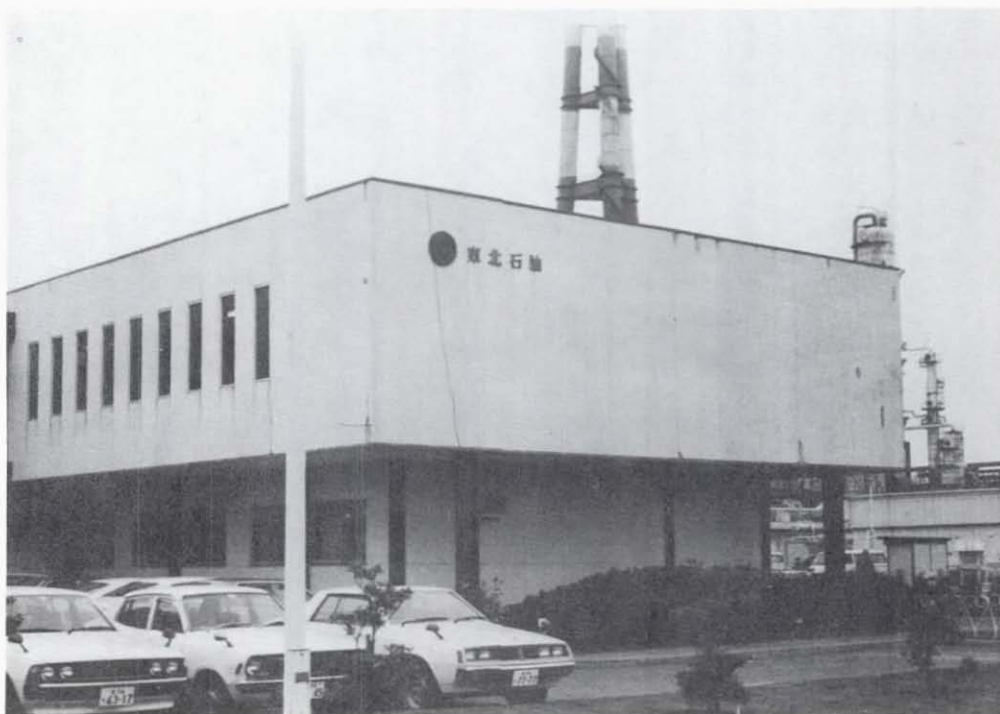
Figure 6.49 Sendai Refinery, Tohoku Oil Company, Ltd.: A wing of the damaged steel-framed administration building. Damage was obvious only to the architectural finishes.

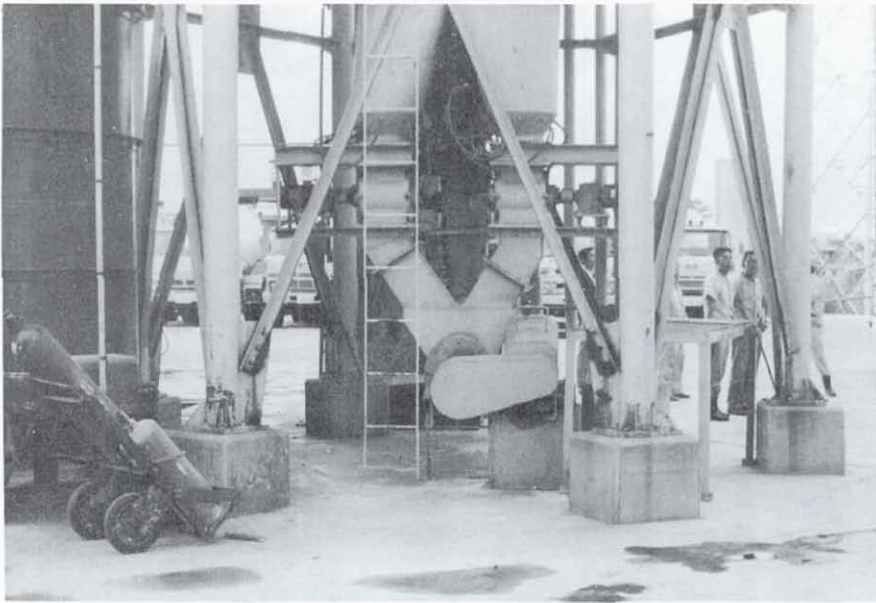
Figure 6.50 Concrete Batch Plant, Sendai: view of the repaired supporting substructure of a cement bin and related equipment. The sheared bolts at the brace connections have been removed and the braces have been welded to the gusset plates. Some of the buckled braces have been replaced entirely.

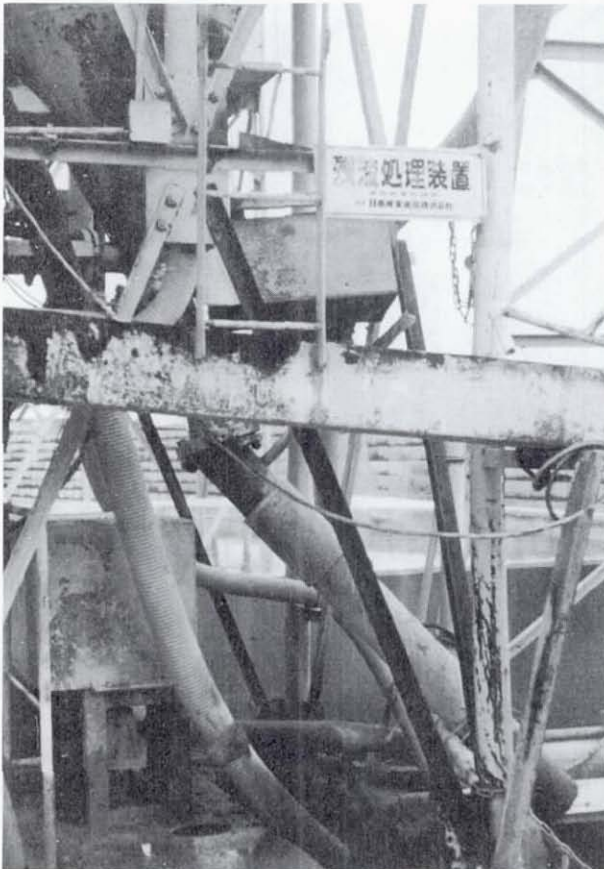
Figure 6.51 Concrete Batch Plant, Sendai: a detail of a replaced, and presumably buckled, diagonal brace. A number of similar repairs were carried out within two days after the earthquake.

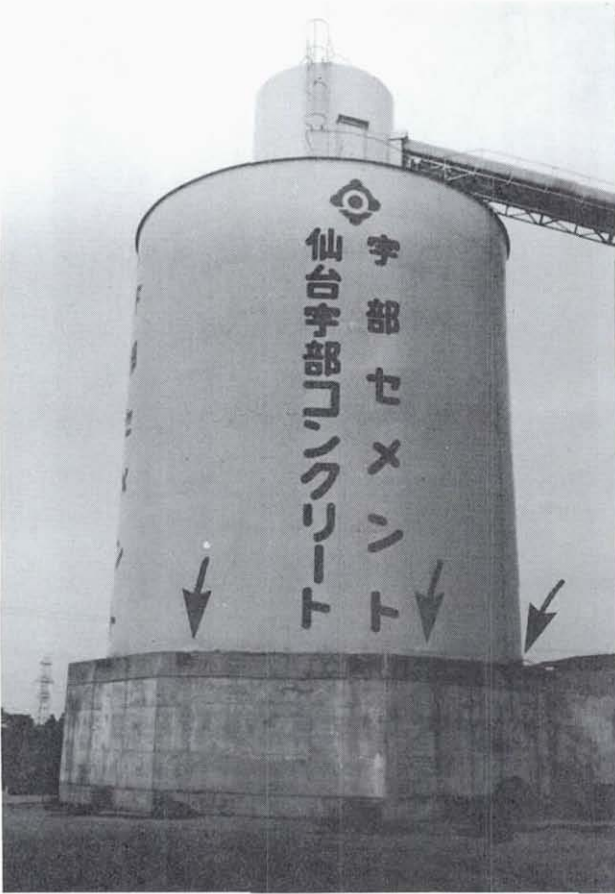
A large welded steel plate storage tank, containing sand and gravel, and reportedly full during the earthquake, which was supported on a massive concrete pedestal, suffered buckling along several locations at the base of the steel plate (Figures 6.52 and 6.53). It seems apparent that the buckling was caused by overturning forces, rather than by sloshing of the contents. The tank and its superstructure and support structure did not experience any other damage.

Figure 6.52 Concrete Batch Plant, Sendai:  
a large gravel-and-sand-  
storage tank experienced  
buckling of the welded steel  
plate at its base.

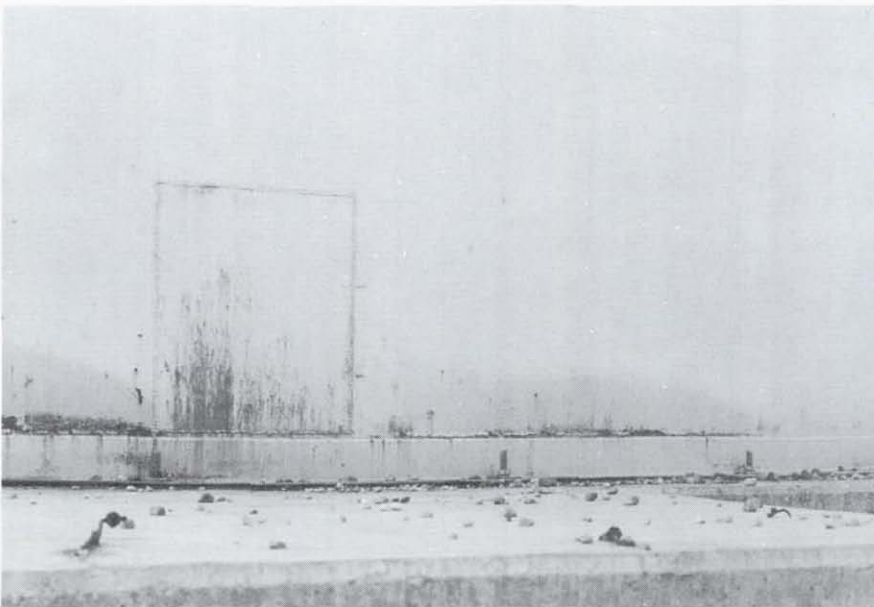
Figure 6.53 Concrete Batch Plant, Sendai: a detailed view of the  
damaged base of the sand and gravel storage tank.  
Note the closely spaced anchor bolts. Similar damage  
occurred at several locations along the circumference.

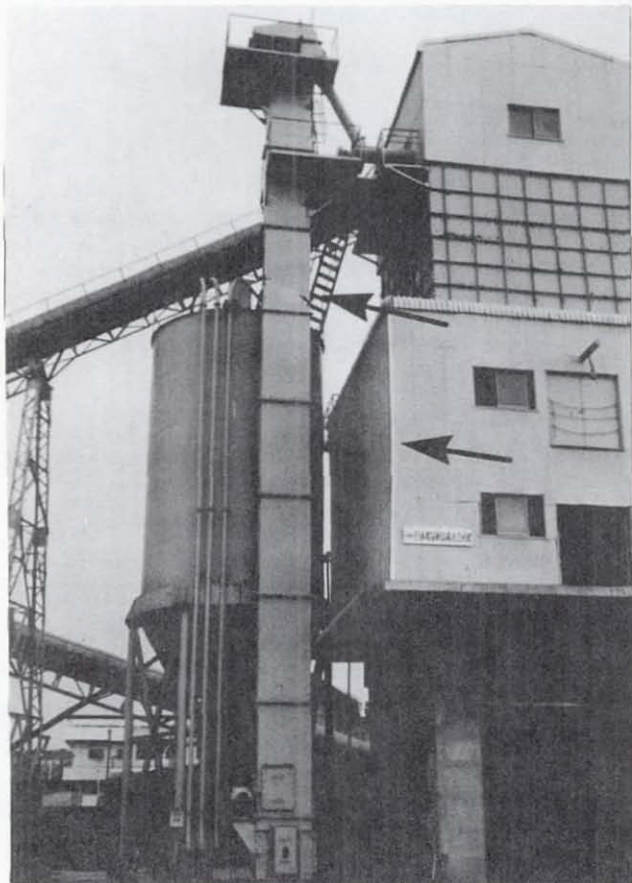
One of the light steel-framed structures at the plant was damaged, as shown in Figure 6.54, apparently because of inadequate lateral bracing. The differential displacement caused by the failure of the structure was responsible for damage to a connecting vertical steel stack and associated piping. The stiffer first floor reinforced concrete structure was undamaged. A similar structure, Figure 6.55, located in the immediate vicinity of the plant and properly braced with light steel cable or rod braces, did not suffer damage. The latter type of construction is quite common in Sendai, and generally appeared to experience no significant damage.

Figure 6.54 Concrete Batch Plant, Sendai: displacement due to damage to the light, unbraced steel superstructure damaged the vertical stack and the conveyor belt structure.

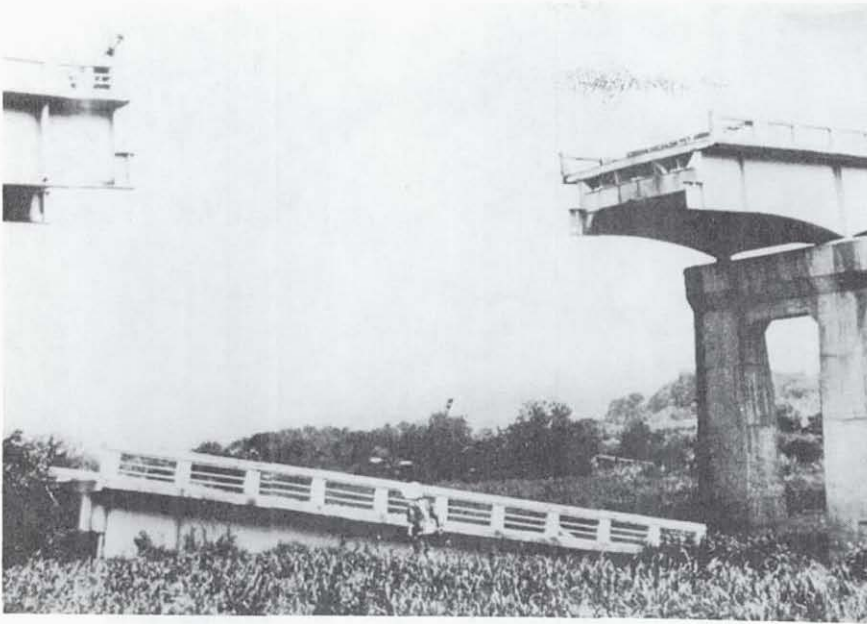
Figure 7.3 Kin-noh Bridge. View of the collapsed suspended plate girder span. Similar damage occurred to bridges in the 1971 San Fernando and 1976 Guatemala earthquakes because of lack of superstructure restraint and small bearing seats. Suspended spans are no longer used in seismically active areas. (Courtesy J.M.O.C.)

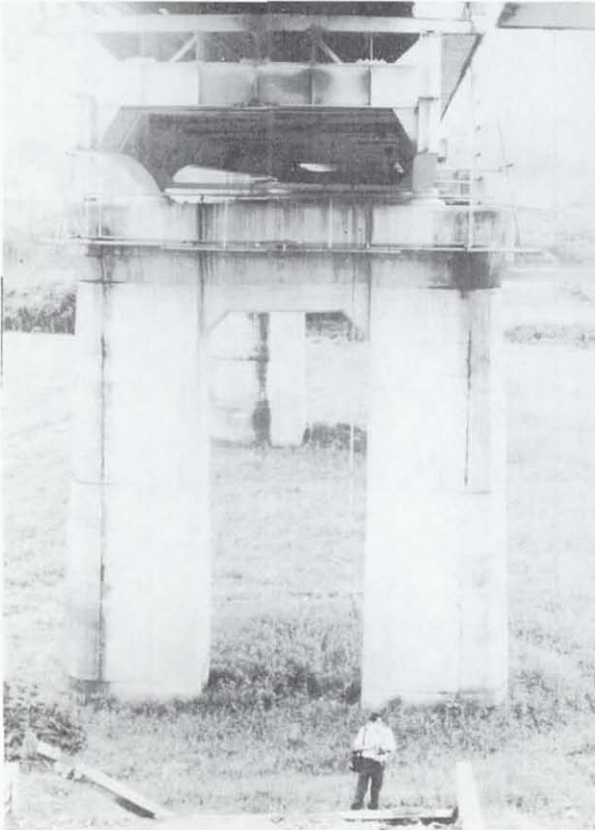
Figure 7.4 Kin-noh Bridge. The only visible pier damage occurred at Pier 8, which is adjacent to the collapsed suspended span. Shear cracking extended 125 cm through the 152 cm deep pier, approximately one-fourth the way up the column from grade.

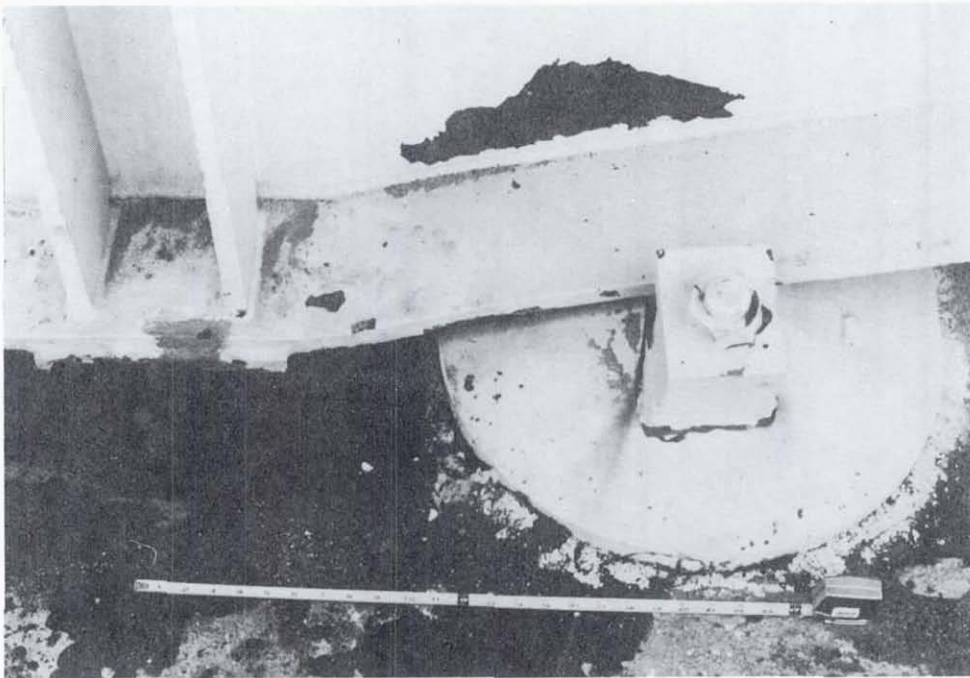
Figure 7.5 Kin-noh Bridge. The girders at Pier 8 displaced longitudinally toward the abutment 55 cm allowing the unrestrained suspended span to drop off the 45 cm hinge seat. The movable girder bearing plate came to rest at the edge of the pier cap. The fixed bearing on Pier 7, the opposite side of the suspended span, displaced longitudinally 0.5 cm.

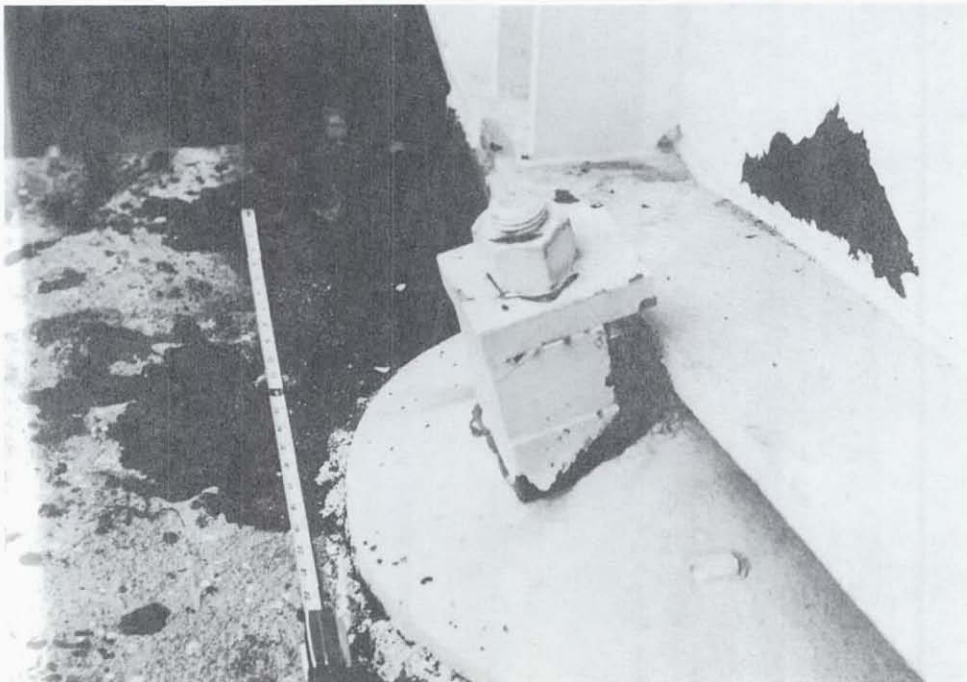
Figure 7.6 Kin-noh Bridge. Evidence of minor transverse displacement of the main girder with broken keeper. This reportedly occurred at the time of the February 20 earthquake.

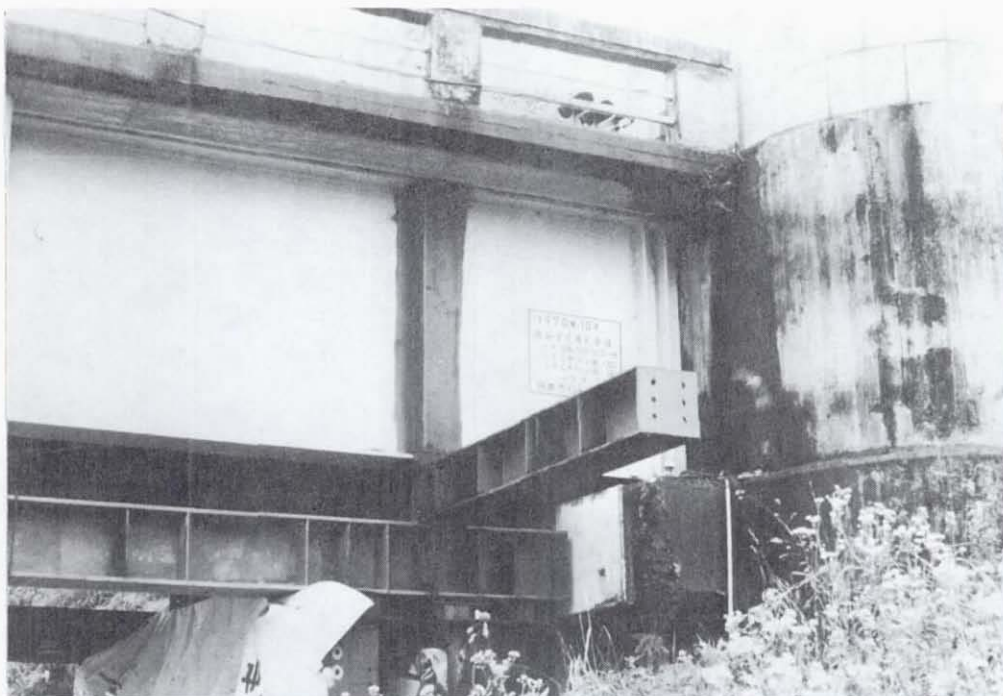
Figure 7.7 Kin-noh Bridge. Damaged abutment from the February 20, 1978, 6.7 magnitude earthquake. New web stiffener at point of temporary shoring.

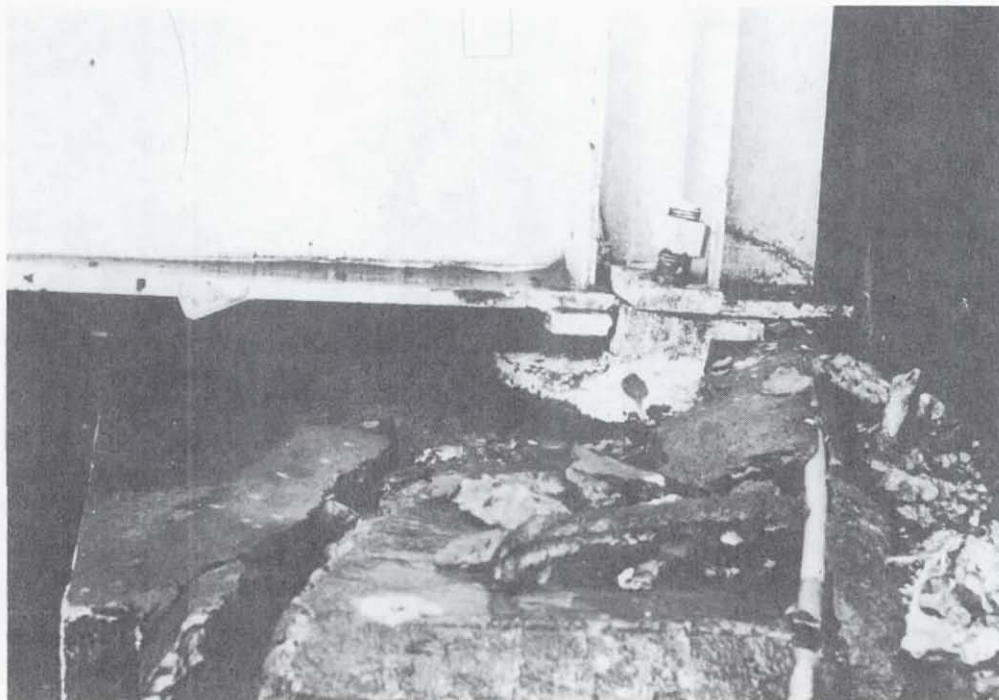
Figure 7.8 Kin-noh Bridge. Detail of bearing damage and abutment ledge failure, from February earthquake. Note extension of anchor bolt caused by 20 cm displacement of span towards abutment.

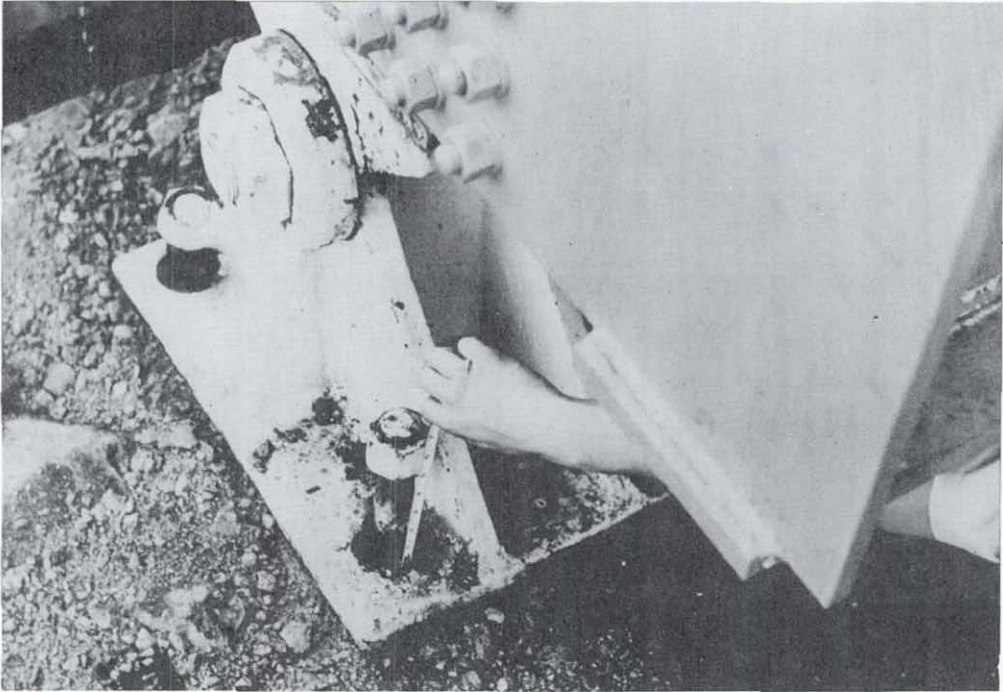
Figure 7.9 Kin-noh Bridge. Extension of anchor bolts at Pier 6. The foreground shows a portion of repaired lower chord truss member.

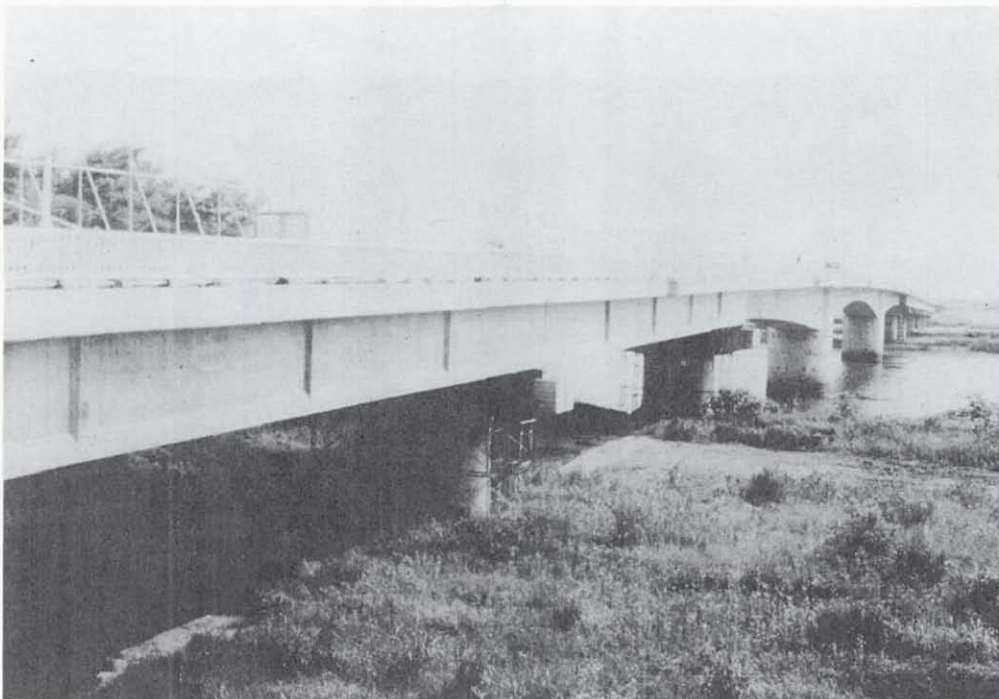
Figure 7.11 General view of the Yuriage Bridge showing the first two columns which were heavily damaged.

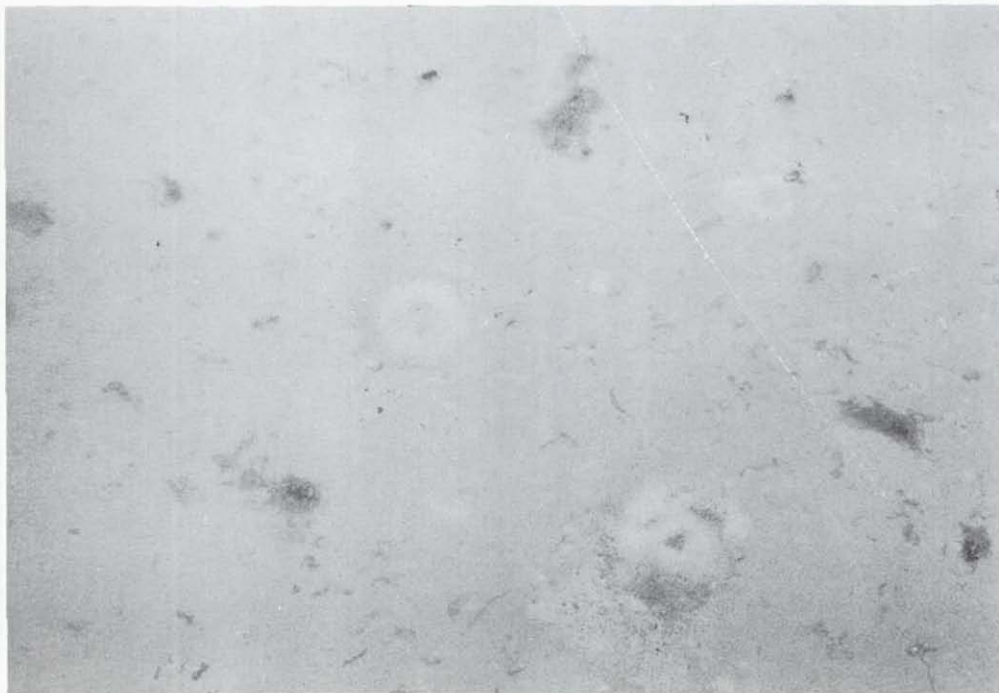
Figure 7.12 Yuriage Bridge. Liquefaction in the flood plan below the bridge.

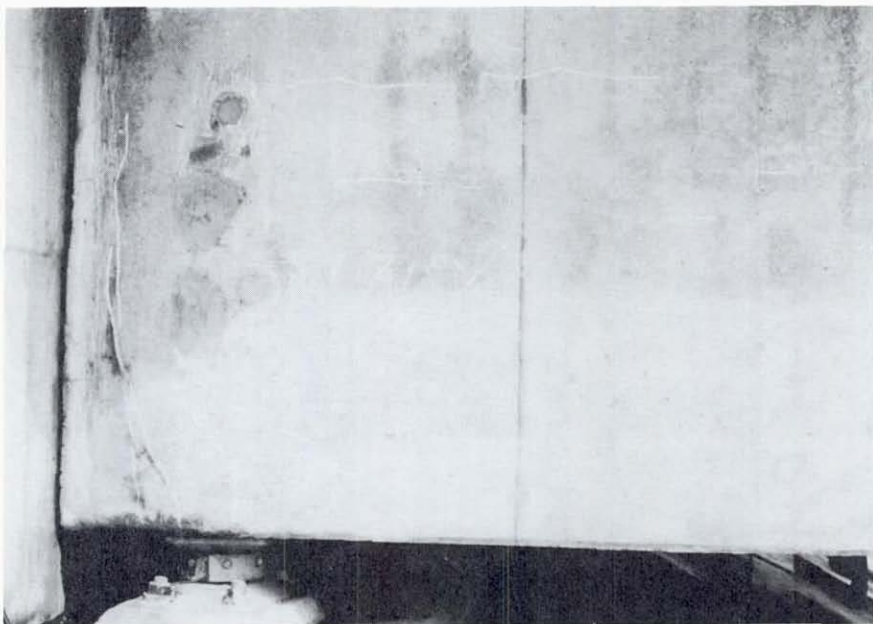
Figure 7.13 Yuriage Bridge. Evidence of light girder impacting with the abutment and pronounced shear cracking of exterior girder at the bearing.

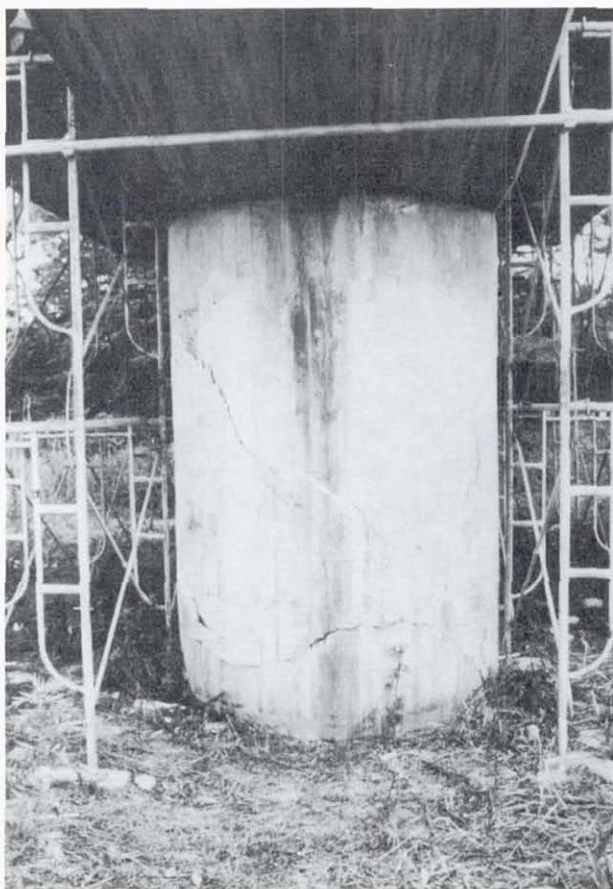
Figure 7.14 Yuriage Bridge. Pier 1, founded on a caisson 19 m deep and 2 m by 4 m in plan, suffered heavy shear cracking. The pier cap was reported to have settled uniformly 5 cm.

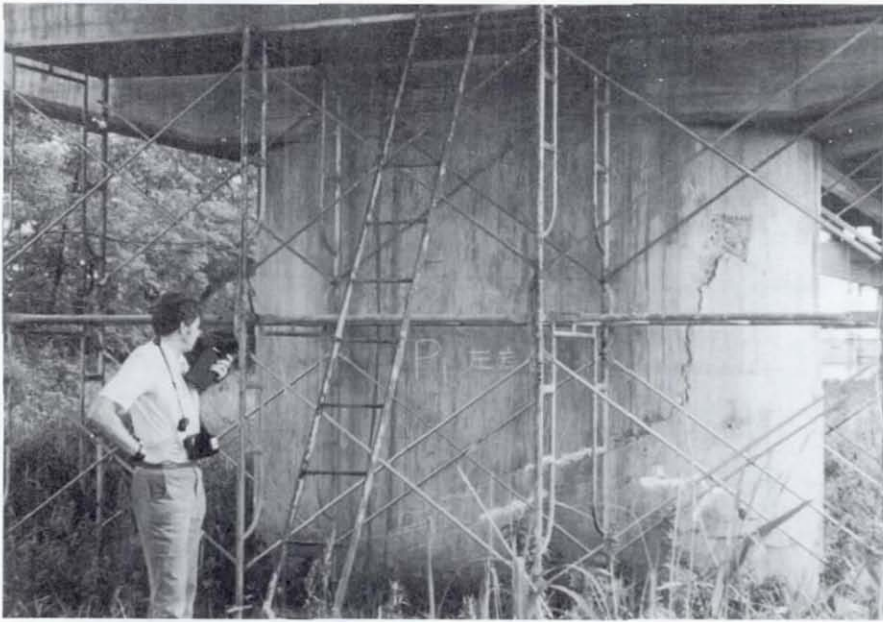
Figure 7.15 Yuriage Bridge. The face of Pier 1 showing severe distress. The plaster of paris patchwork is used to determine if additional pier cracking has occurred.

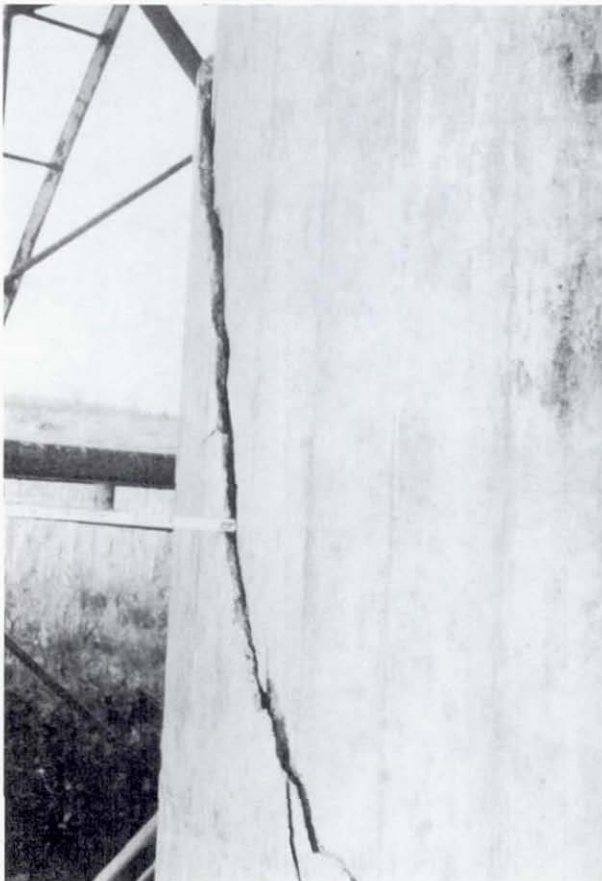
Figure 7.16 Yuriage Bridge. Detail showing 1 cm offset of cracking, indicating torsion in pier.

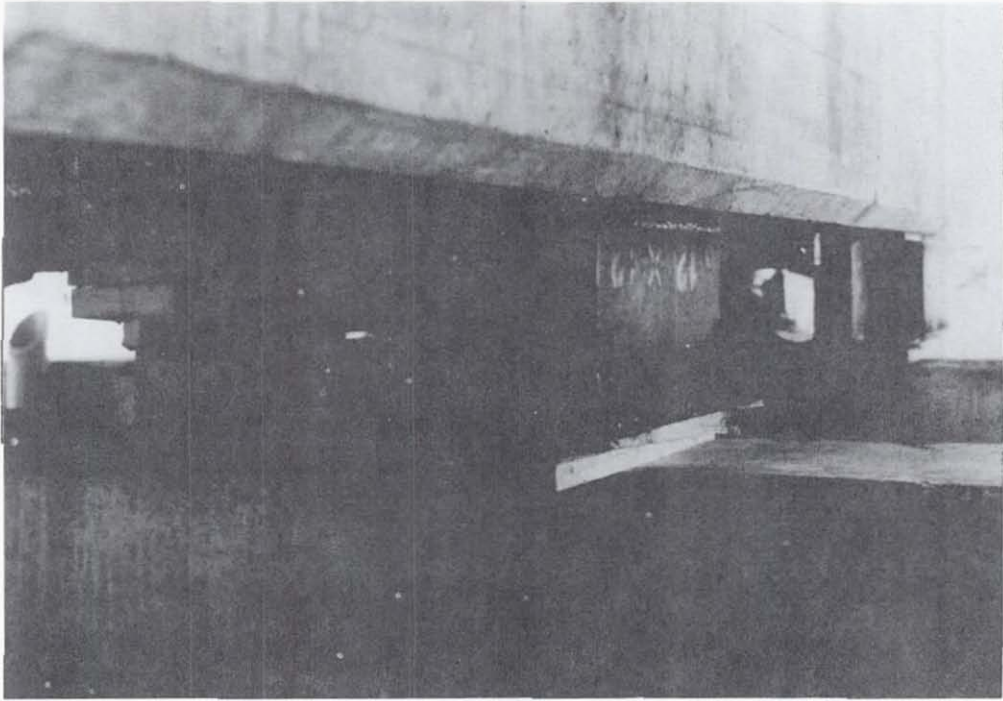
Figure 7.17 Yuriage Bridge. Temporary girder supports at Pier 1. Bearings showed evidence of girder displacement - broken keeper and containment plates.

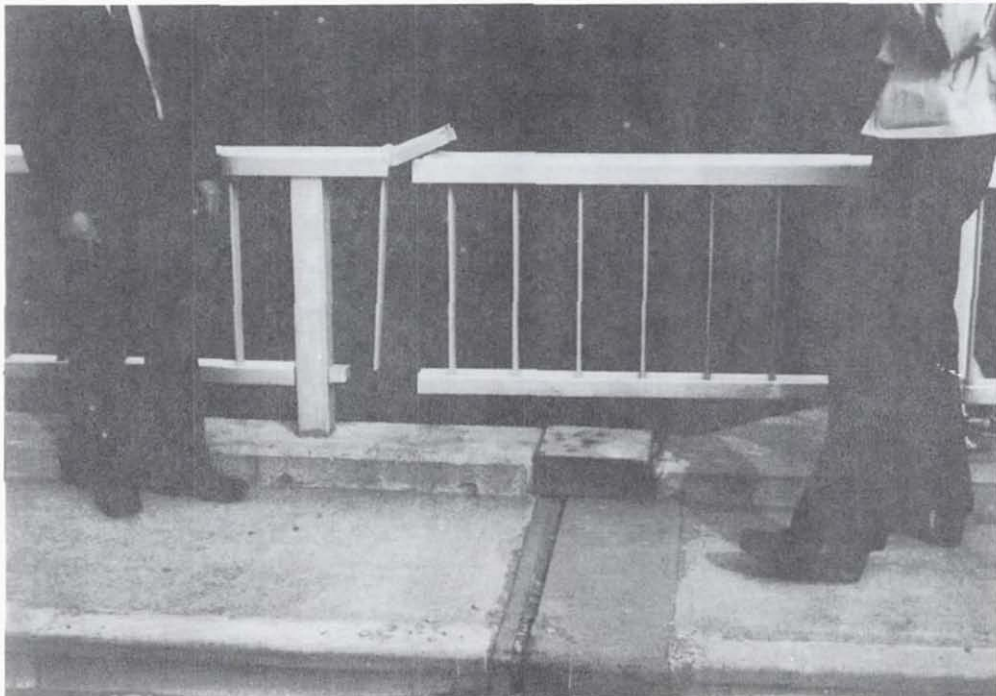
Figure 7.18 Yuriage Bridge. Evidence of 8 cm of longitudinal movement as shown at the handrail expansion joint, Pier 2. However, there was no evidence of damage to the girders or the second pier.

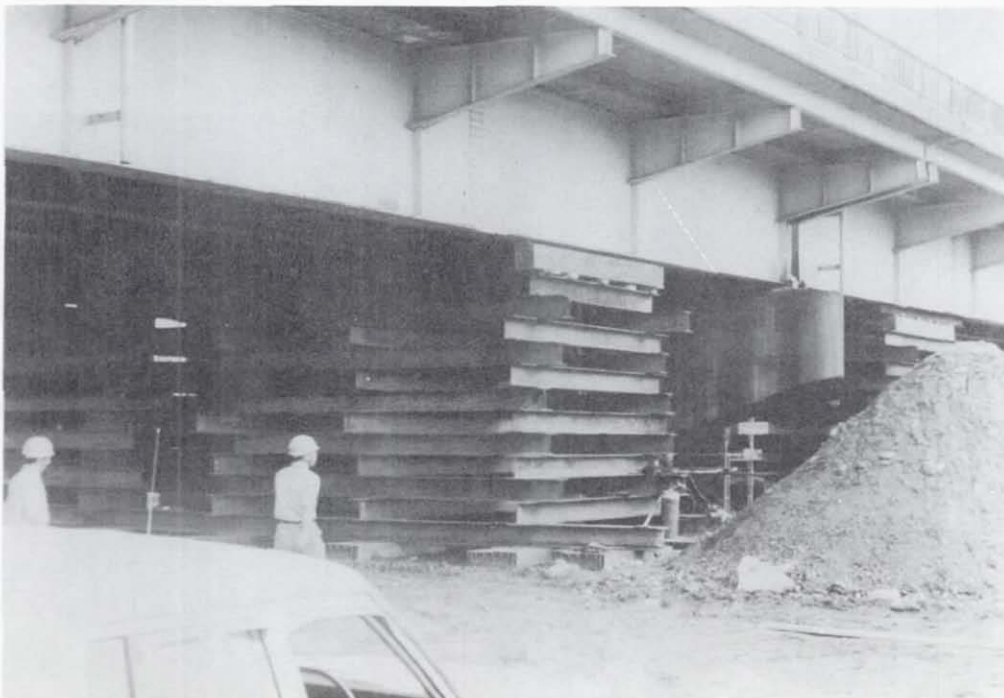
Figure 7.20 Sendai Ohashi Bridge. Temporary cribbing used to support the steel plate girders.

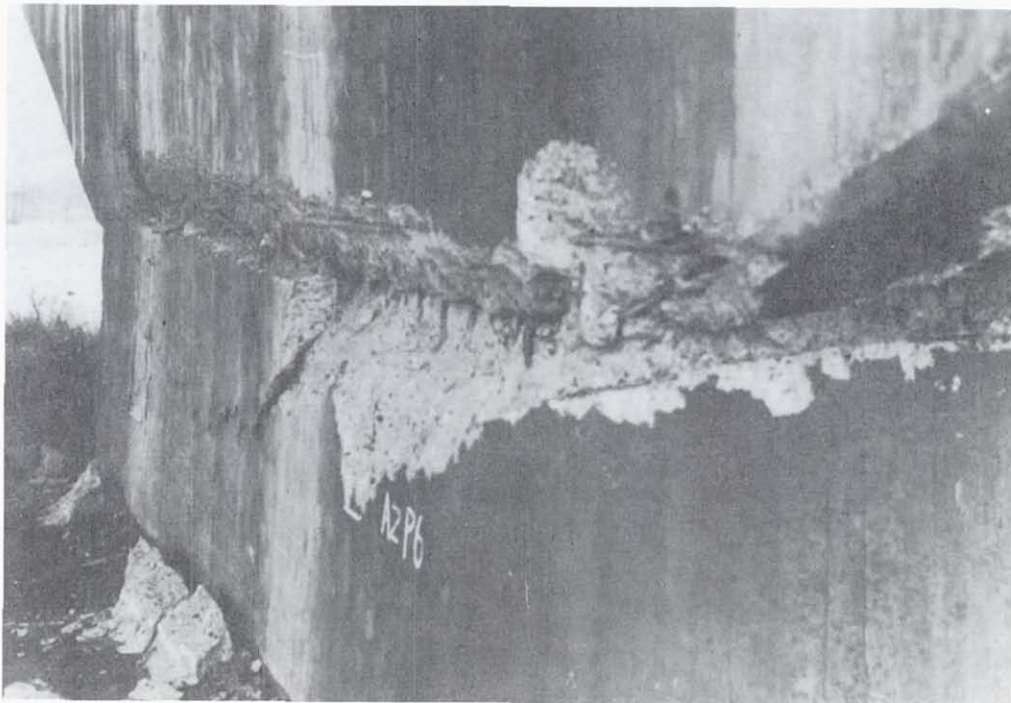
Figure 7.22 Sendai Ohashi Bridge. Typical pier damage at the construction joint between pier and cap. The vertical rebar are buckled across the joint. Significant concrete spalling is evident. Horizontal cracking around the pier was discovered upon excavation of soil around the piers. (Courtesy J.M.O.C.)

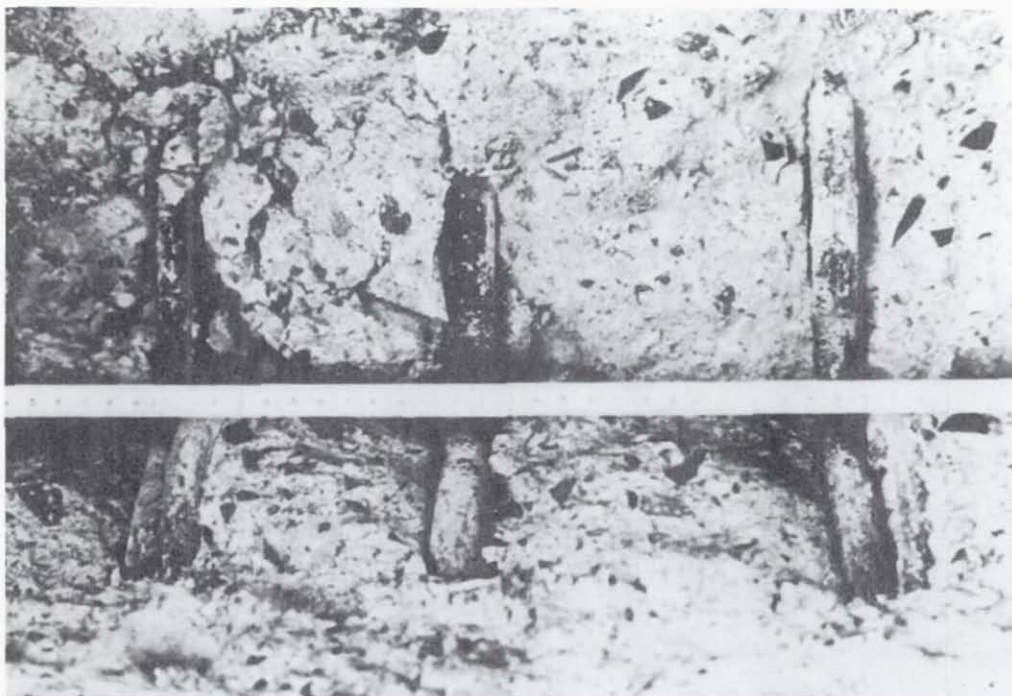
Figure 7.23 Sendai Ohashi Bridge. Detail showing buckled vertical rebar at the construction joint. Strong motion records in Sendai indicated approximately 100 gal. vertical accelerations. (Courtesy J.M.O.C.)

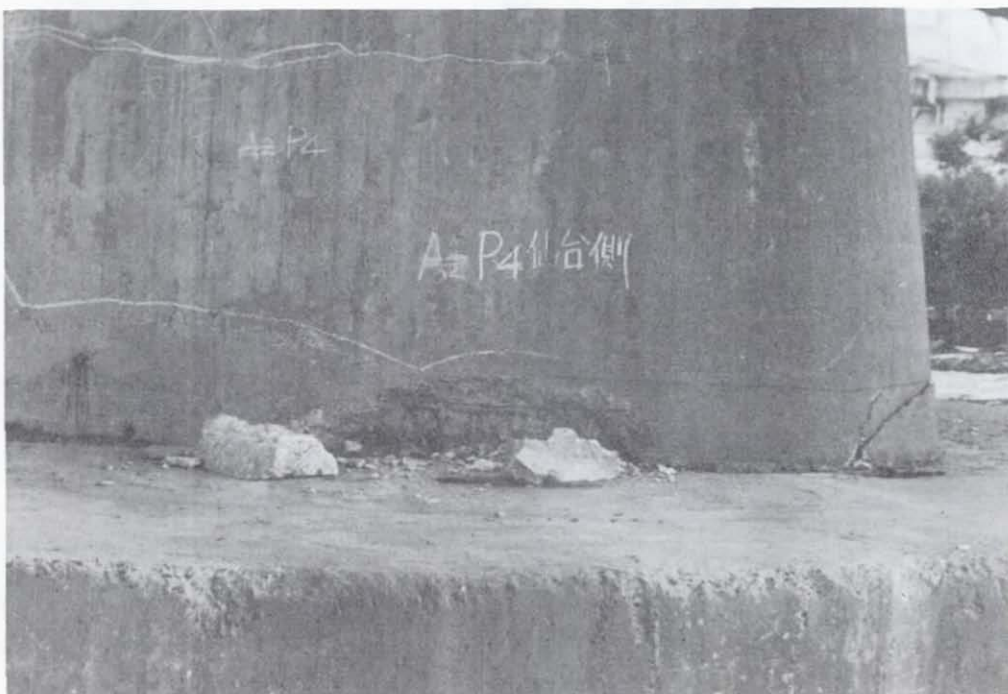
Figure 7.24 Sendai Ohashi Bridge. Typical damage to the base of a pier before repair.

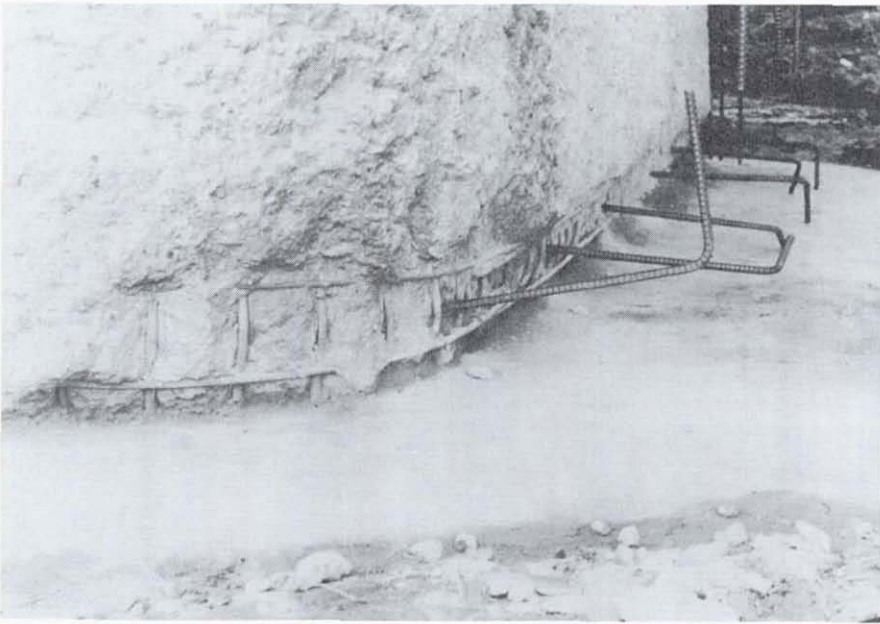
Figure 7.25 Sendai Ohashi Bridge. Typical damage being repaired at the base of the pier. Note the outward buckling of the underformed vertical rebar. The concrete cover had been roughened, the footing strengthened, and additional rebar placed to strengthen the pier.
