NBS SPECIAL PUBLICATION **592**

An Investigation of the Miyagi-ken-oki, Japan, Earthquake of June 12, 1978

This document is the result of the investigation by the U.S. team on the earthquake. It describes geologic features of the earthquake-stricken area, and damage to human-made structures. It is hoped the information presented in this document will add to the knowledge of seismology and earthquake engineering.

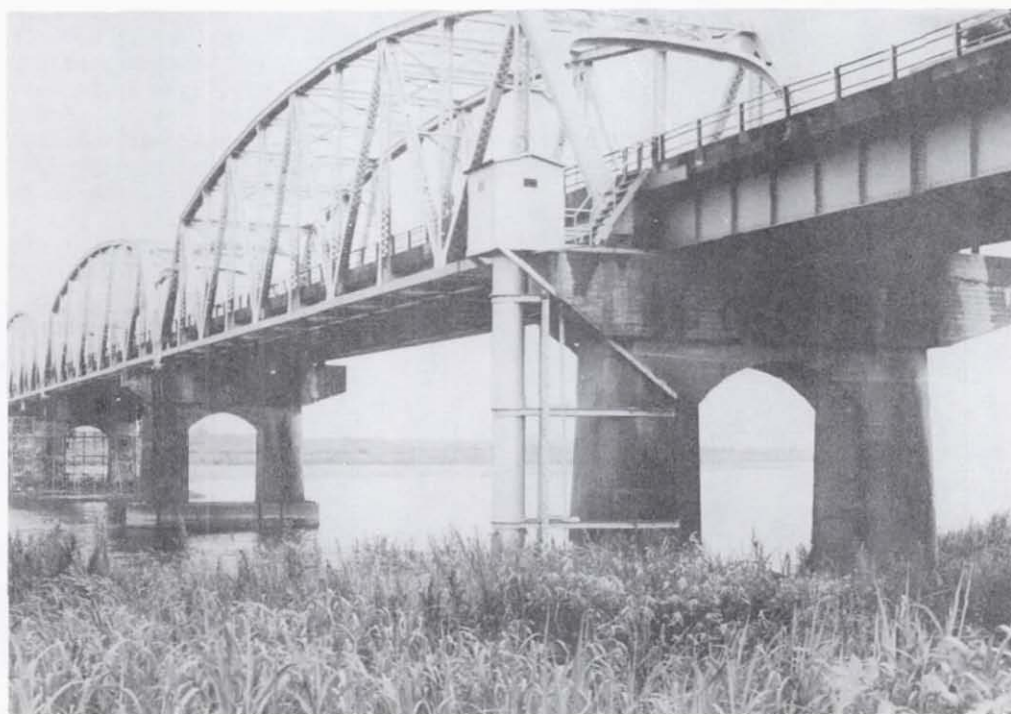
Figure 7.28 General view of the Abukuma Bridge. Note the trace of pier cracking on the pier in the foreground and scaffolding at and surface preparation of the pier in the background.

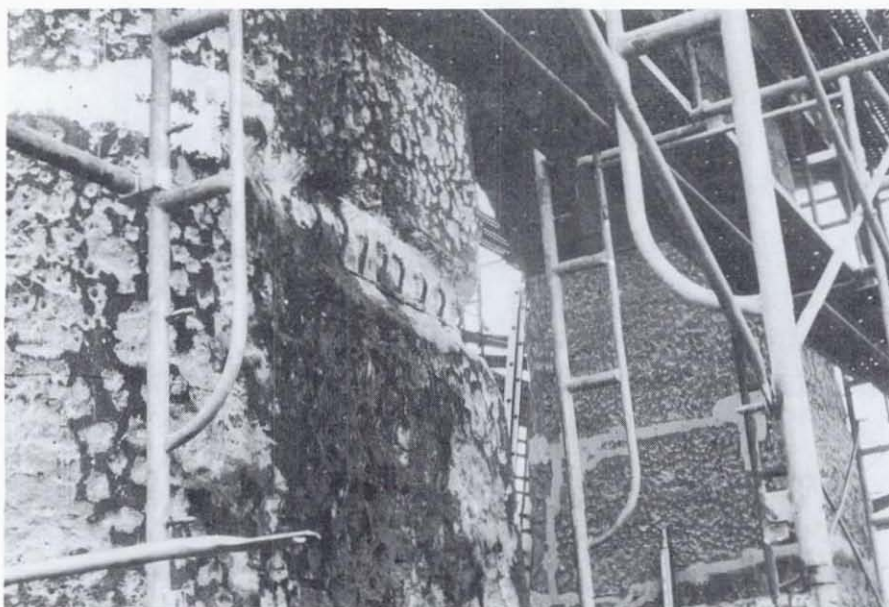
Figure 7.29 Abukuma Bridge. Outward buckling of vertical rebar at one of the damaged piers.

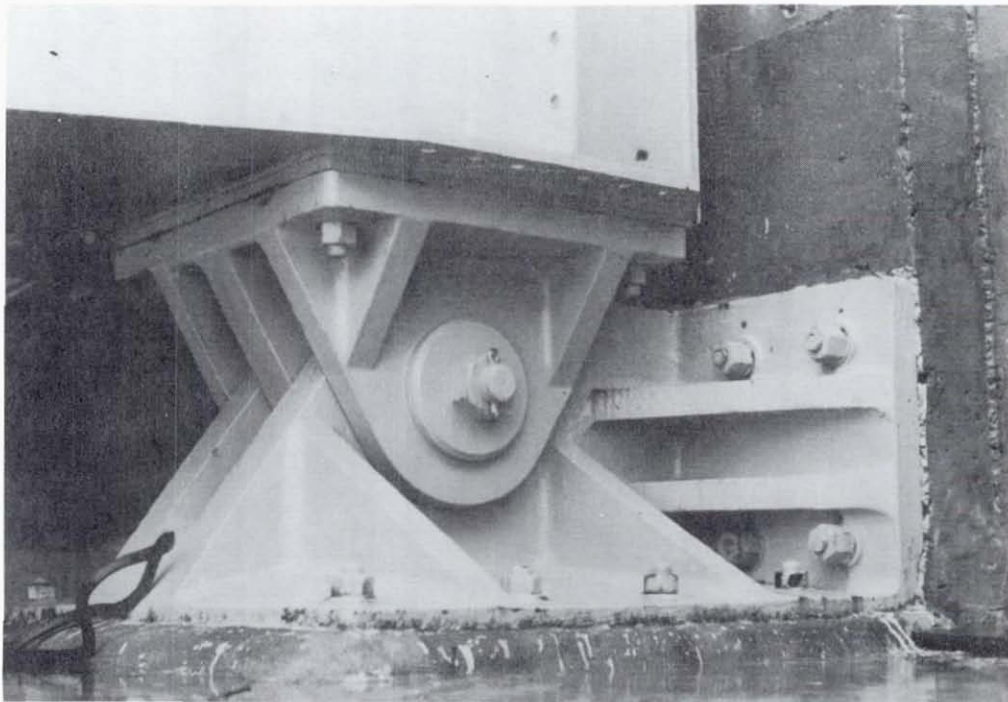
Figure 7.35 Kitakami Ohashi Bridge. Detail of a seismic bearing device at the abutment.

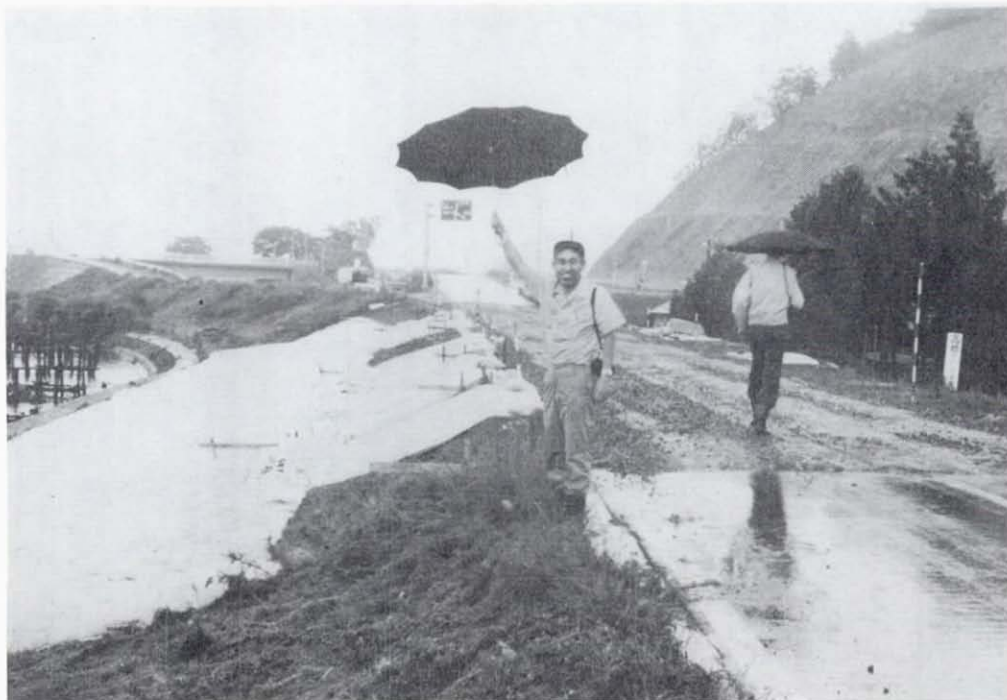
Figure 7.36 Road damage and temporary stabilization of the Kitakami Dike near the bridge site.

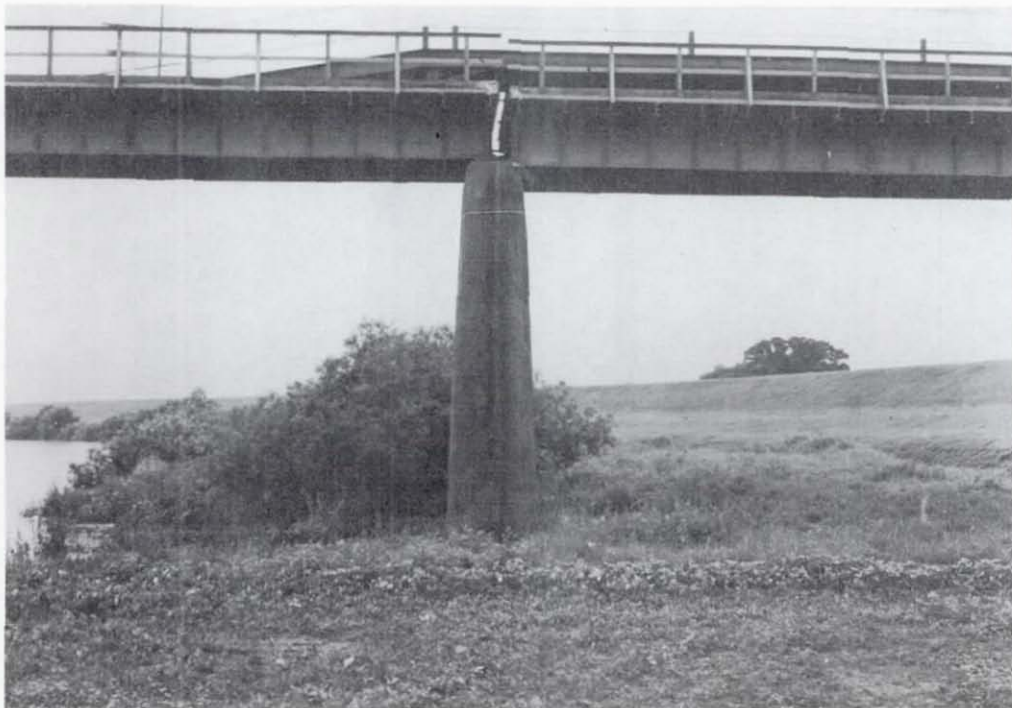
Figure 7.38 Longitudinal displacement of superstructure. Note the temporary structure which spans the dislodged main span.

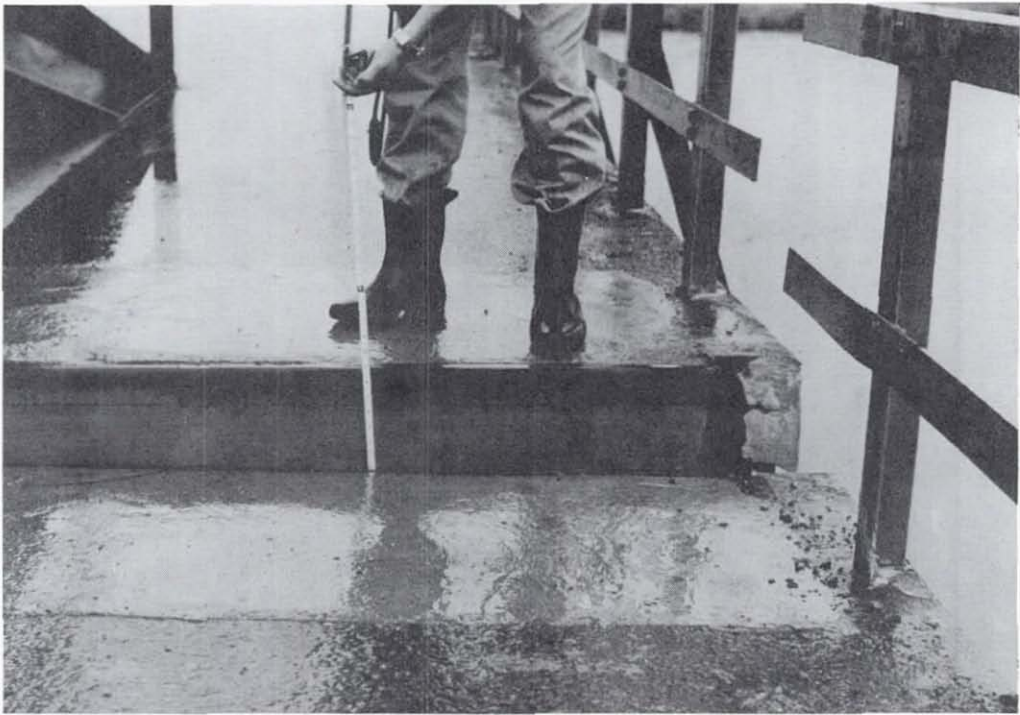
Figure 7.39 Vertical displacement of dislodged span.

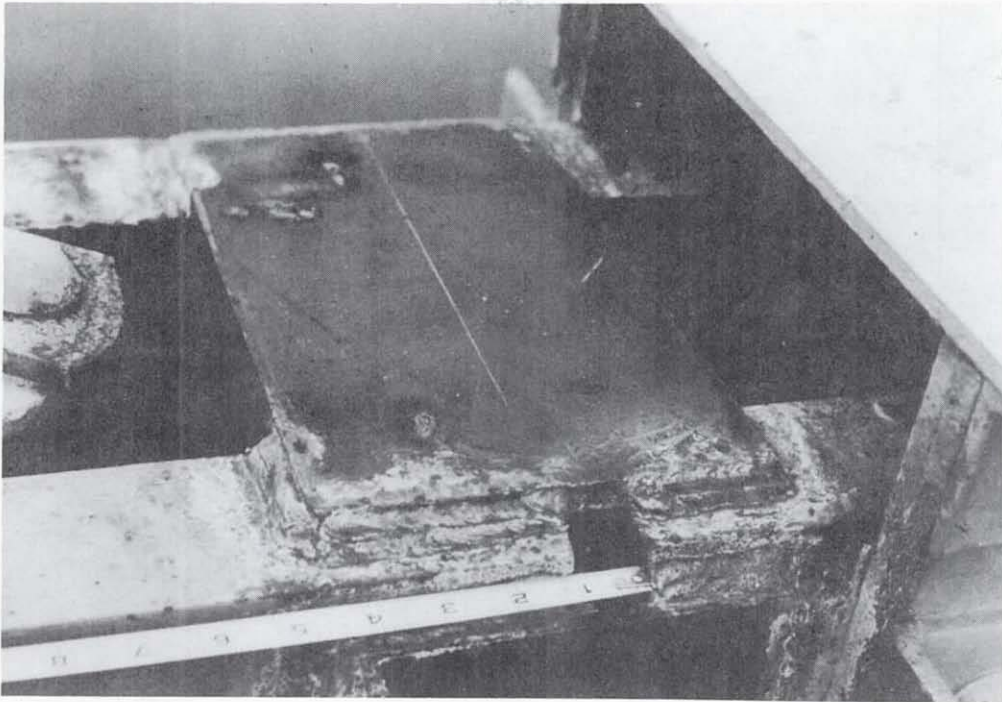
Figure 7.41 Maiya Ohashi Bridge. Steel plates welded to the top chord channel members. Note the clean fracture at a line passing through the centerline of the rivet holes of the lattice bracing and the permanent 2.5 cm separation.

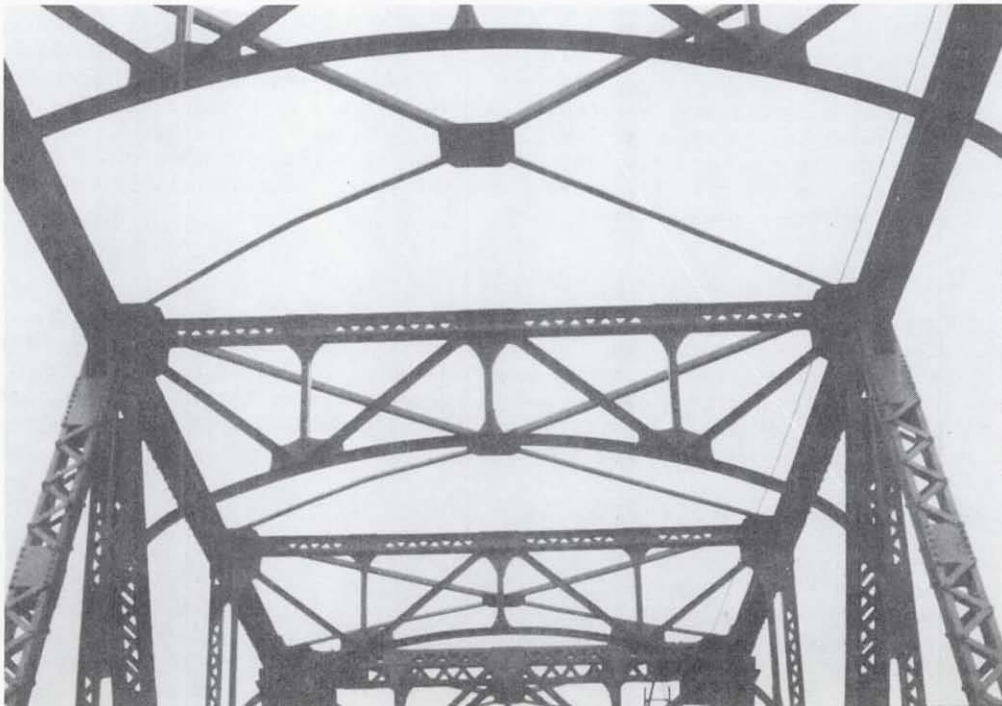
Figure 7.42 Maiya Ohashi Bridge. Buckled lateral bracing of the overhead truss.

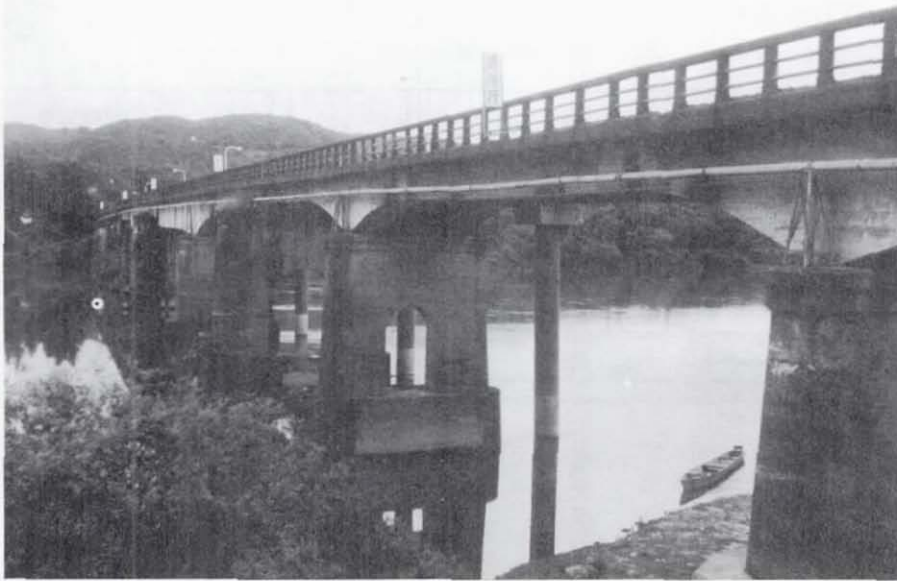
The Toyoma Bridge is a 13-span concrete T-beam bridge constructed in 1945, (Figure 7.43). Prior to the earthquake, the bridge, located about 60 km northeast of Sendai, was restricted to automobile traffic because of damage suffered during the February 20, 1978, earthquake. The bridge was closed following the June earthquake. Flexural induced cracking of the girders occurred at the center of the spans and at the haunched ends over the piers. Shear cracking was also noted at the corners of the concrete hinge seats of several suspended spans. The ground motion, between 0.1 and 0.2g, was sufficient enough to induce pavement cracking of the roadway.

Figure 7.43 General view of the Toyoma Bridge which was closed to traffic. The columns in the background support an independent steel box girder pedestrian structure which was undamaged.

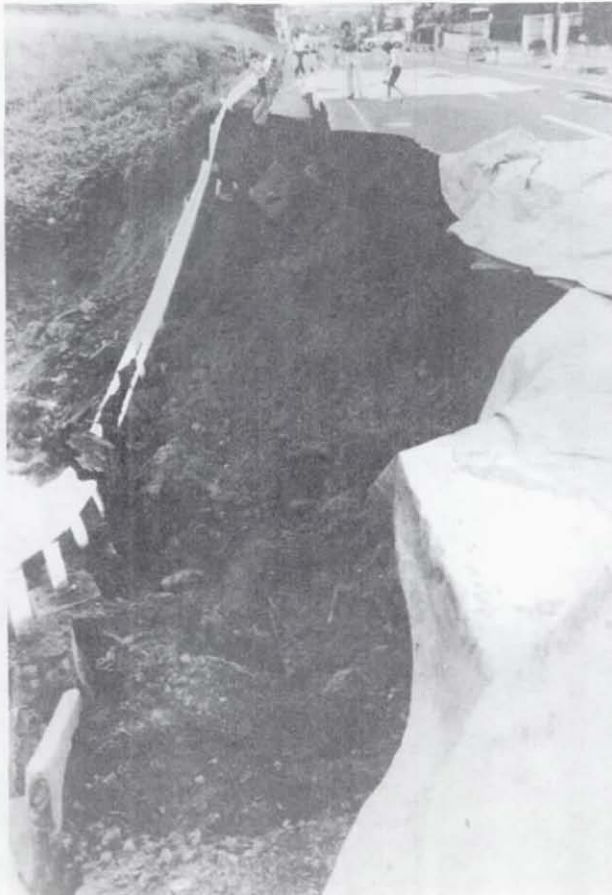
Widespread highway damage (e.g., Figure 7.44) occurred in the region north and east of Sendai. Typical damage included settlement of bridge approaches, cracking of pavements, failure of roadway embankments, and blockage of roads from rockslides. This type of damage has been documented in reports on previous large earthquakes in Alaska, Japan, California, and Guatemala and is virtually impossible to design against.

Figure 7.44 Typical Road Fill Failure.

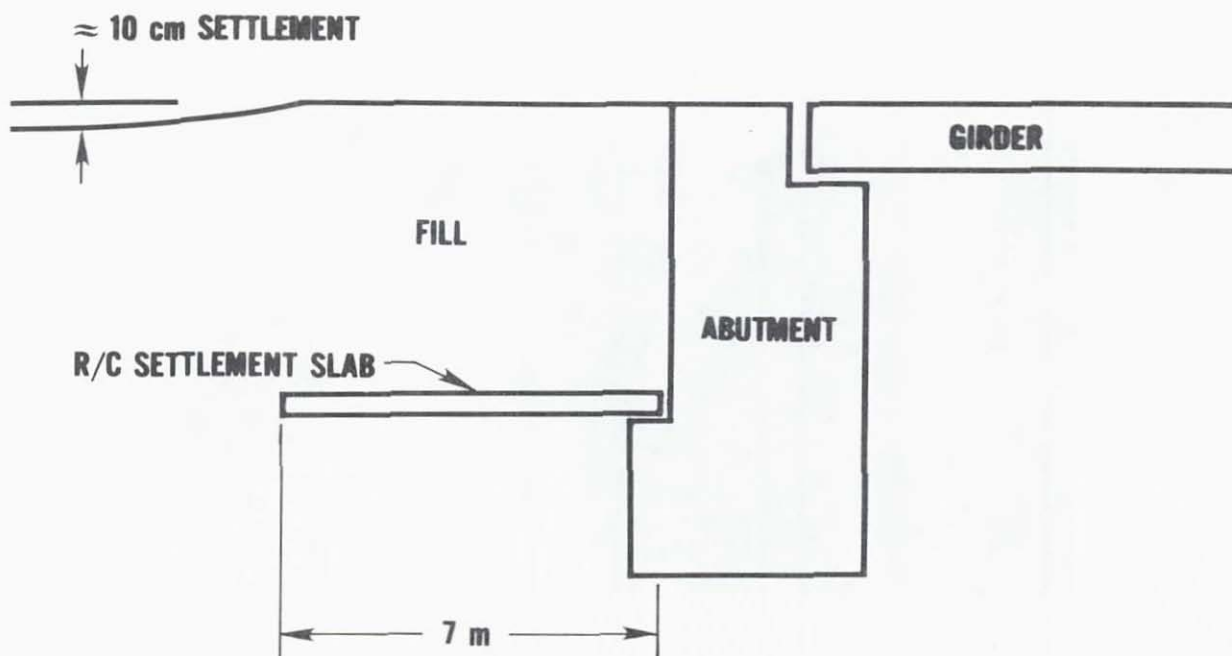
Reinforced concrete approach settlement slabs were used at many of the bridge abutments. Use of the slabs forced settlement to occur at the end of the slab instead of at the abutment, as illustrated in Figure 7.45.

Figure 7.45 Detail of Reinforced Concrete Approach Settlement Slabs.

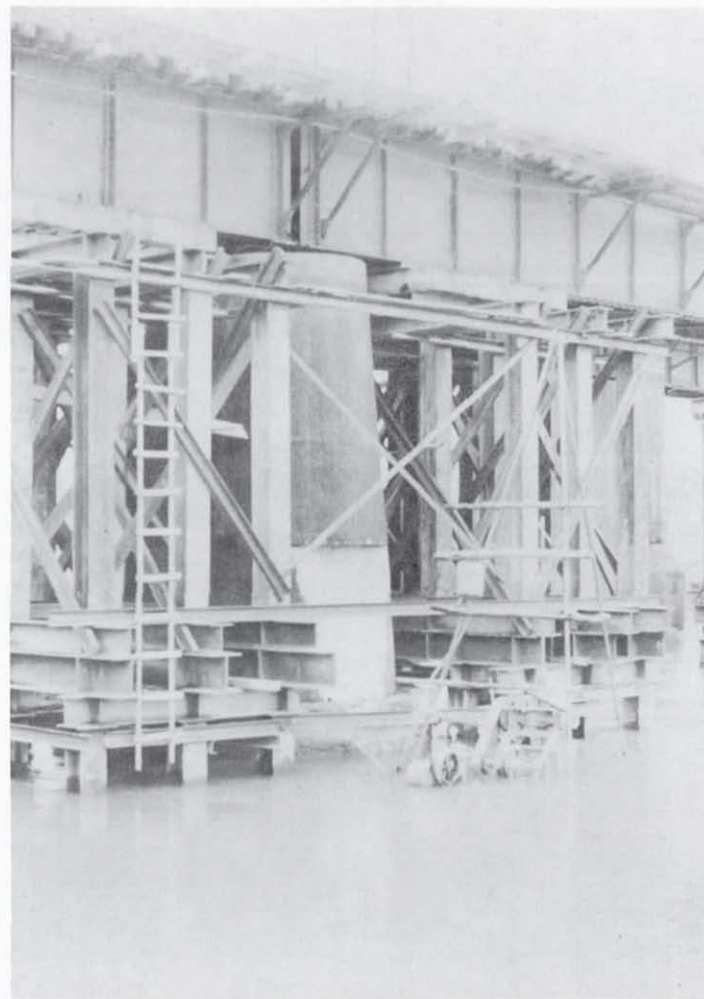
The Eai River Bridge (Figure 7.48), owned by the Japanese National Railways (JNR), is a dual eight-span steel plate girder structure 160 m in length, which is located 40 km northeast of Sendai. The superstructure is supported by massive unreinforced concrete gravity piers on caisson foundations. Ground acceleration in the area was estimated by the Ministry of Construction to be 200-250 gal. Two piers were severely damaged when large wedged shaped sections of concrete dropped out below a construction joint.

Figure 7.48 Eai River Bridge. Damaged pier of Eai River Rail Bridge. Temporary pier supports were constructed following the earthquake. Full train service was established approximately 10 days after the earthquake.

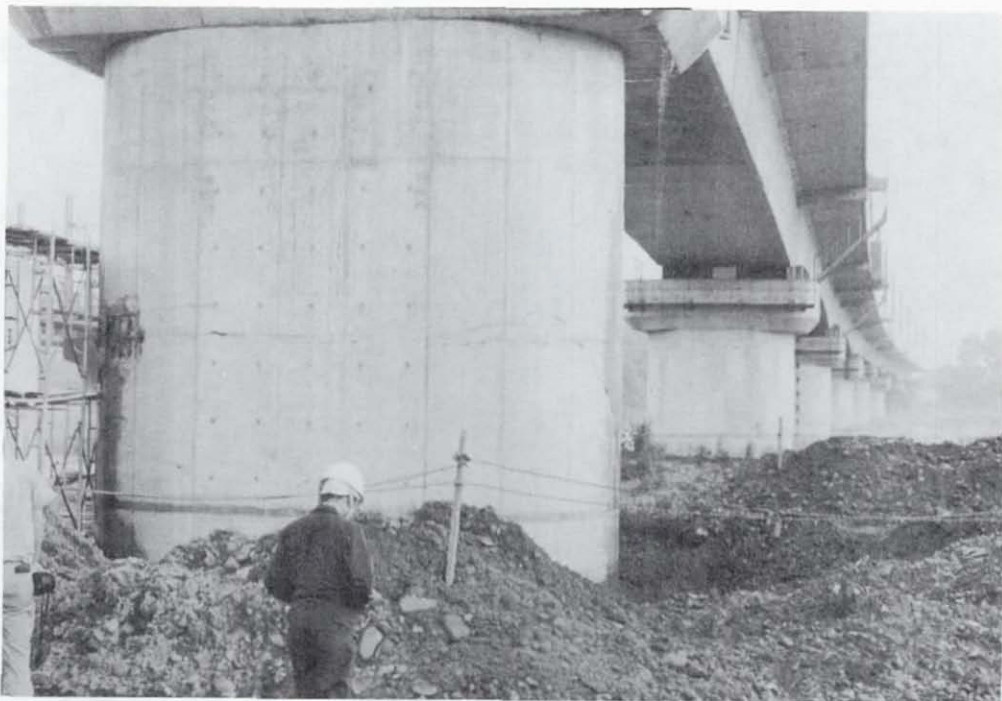
Figure 7.49 The Natori River Bridge is a three-span continuous single cell reinforced cast-in-place concrete box girder structure on 3 m x 6 m piers approximately 8 meters above grade. Typical damage included cracking in the central part of the pier where the gross cross-sectional area of vertical steel was reduced.

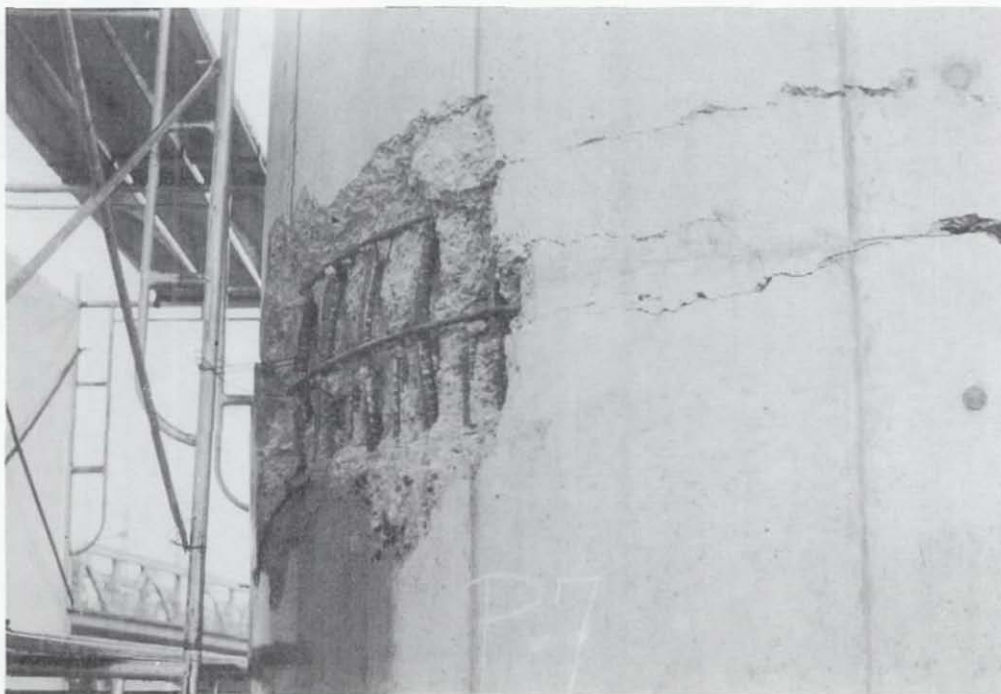
Figure 7.50 Natori River Bridge. Detail of spalled concrete at the Natori River Bridge site showing the buckled vertical rebar.

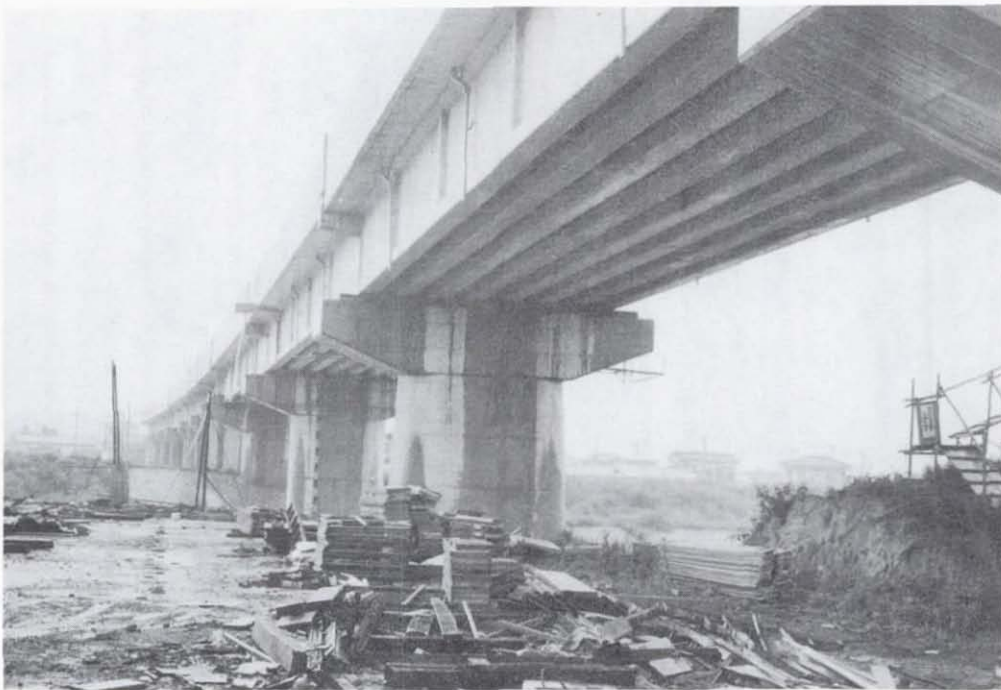
Figure 7.51 Typical structures which experienced pier cracking near the Rifu Construction Office of the Sendai Shinkansen Construction Bureau, JNR.

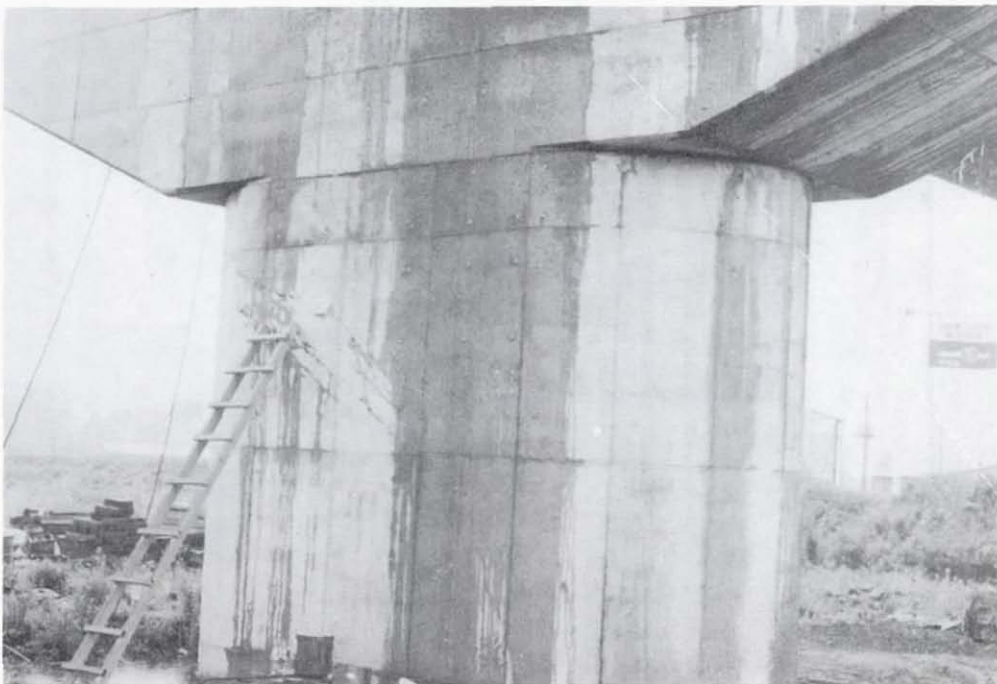
Figure 7.52 Shear cracking in the relatively lightly reinforced upper portion of the pier.

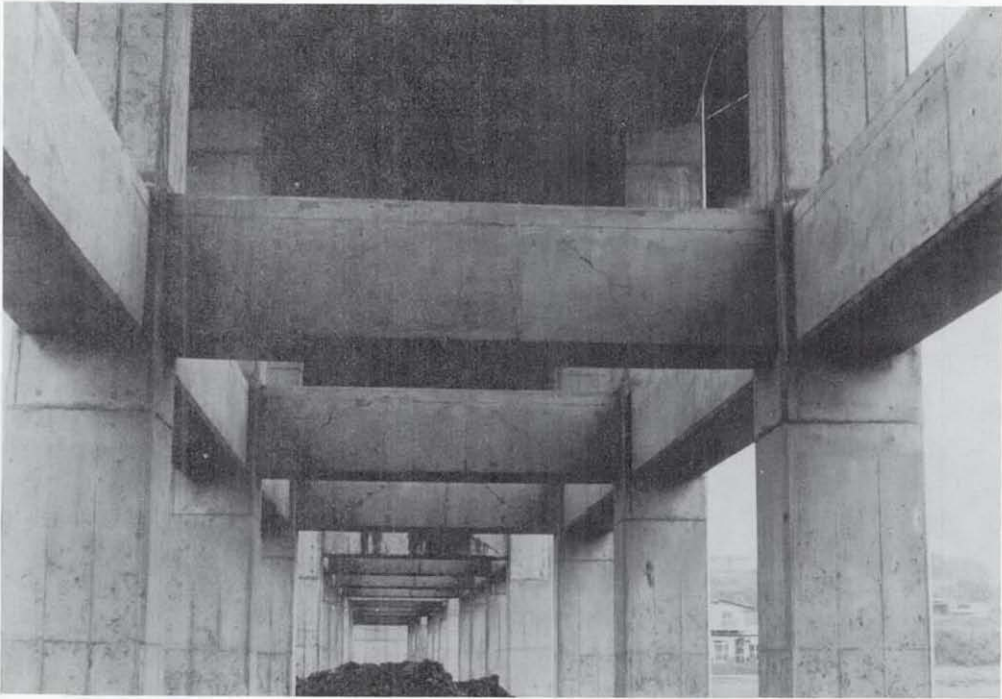
Figure 7.53 Tensile cracking of space frame tie beams near the Rifu Construction Office.

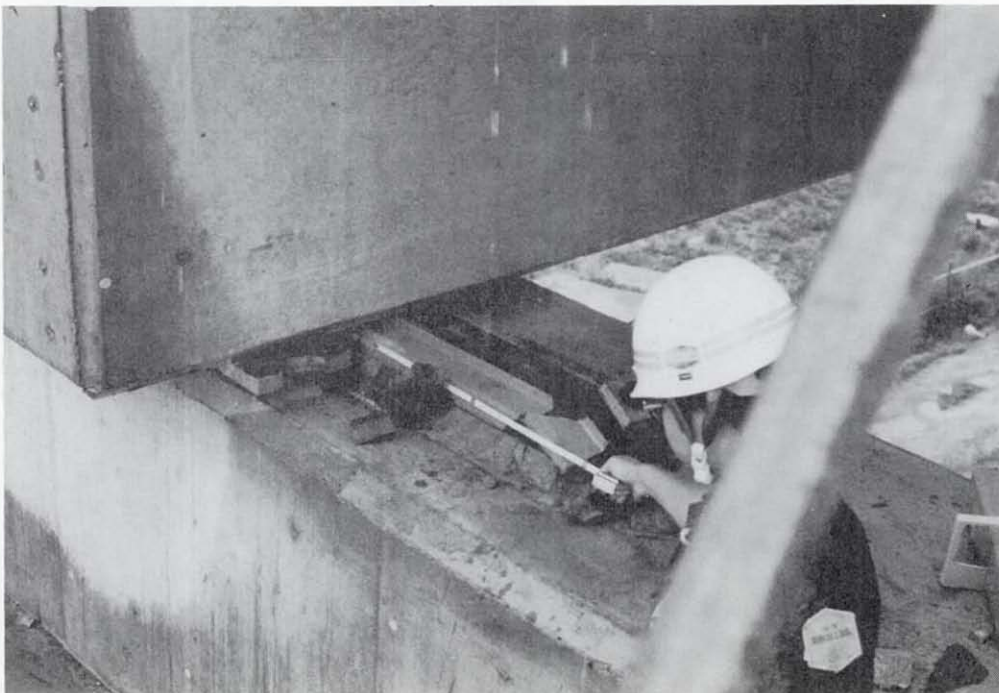
Figure 7.54 Failure of a bearing plate supporting a single cell box girder near the Higashi Sendai Construction Office. Girder displaced laterally 50 cm.

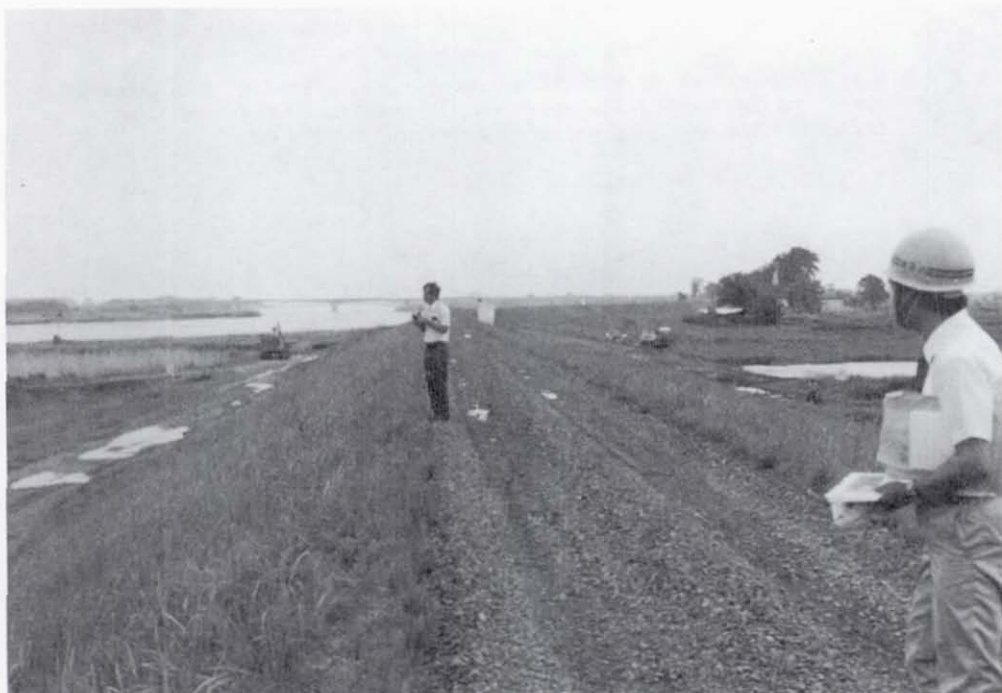
At Site 1, liquefaction caused slumping, lateral spreading, and settlement of up to 1.5 m along a 160-m-long section of the dike (Figures 8.2, 8.3, and 8.4). Longitudinal cracks several tens of meters long opened in the dike crest. Between the dike and the river, fissures striking obliquely to the dike formed, and sand was ejected from them (Figure 8.5). Other fissures trending parallel to the dike and the river formed near the river bank, more than 100 m from the base of the dike. The occurrence of fissures and sand boils in ground away from the dike indicates that liquefaction took place primarily in material beneath the dike and not in the dike material itself.

Figure 8.2 Site 1, Natori River, view downstream (southeast) along repaired portion of dike. Dike is made of compacted sand. It rises 2 m above the high water level of the river and has side slopes of 2H:1V. Natori River in center-left background.

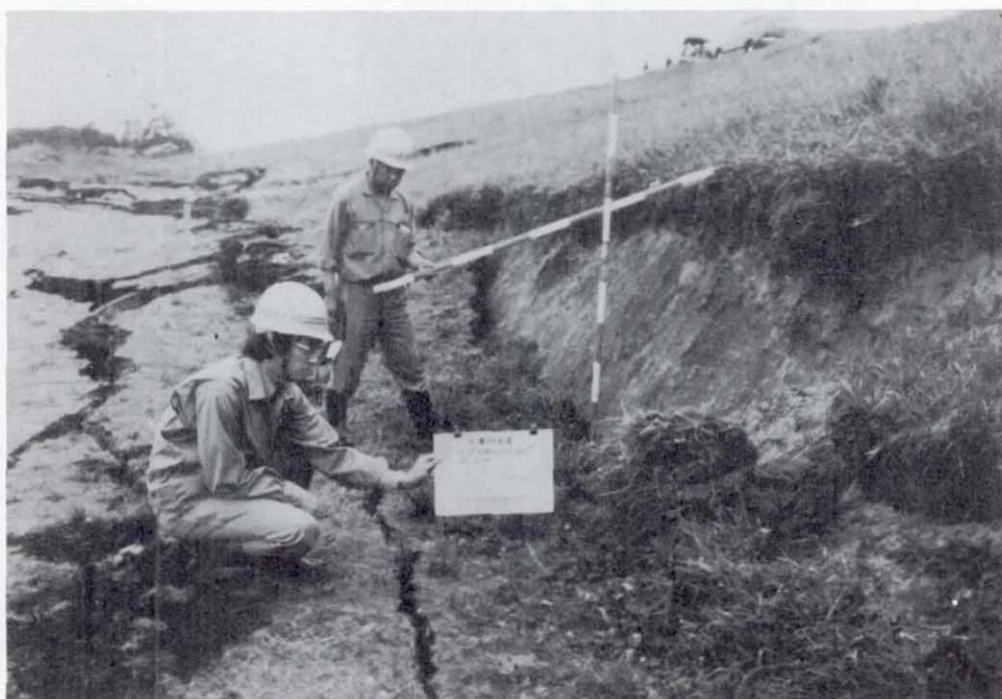
Figure 8.3 Site 1, Natori River. Slumping of dike on flank away from river. View north. (Photo courtesy Tohoku Regional Construction Bureau)

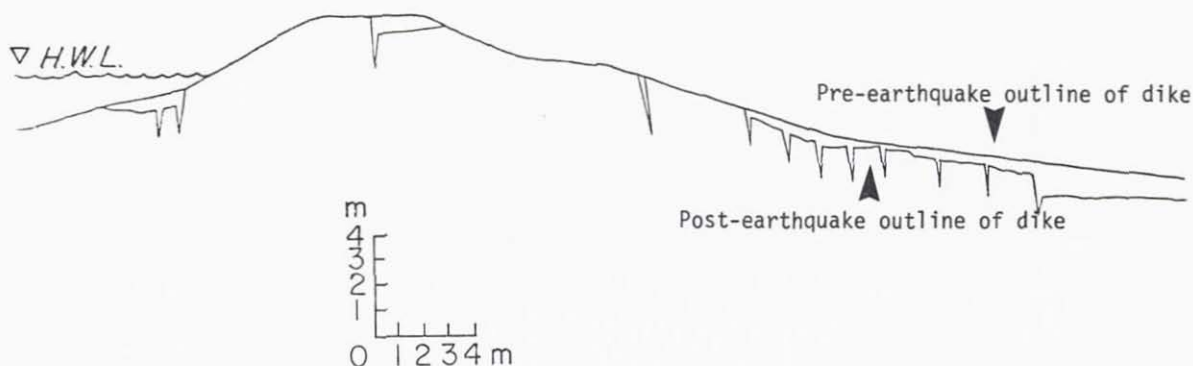
Figure 8.4 Site 1, Natori River--cracking, settlement, slumping, and lateral spreading induced by liquefaction. (From Tohoku Regional Construction Bureau, MOC, unpublished data)

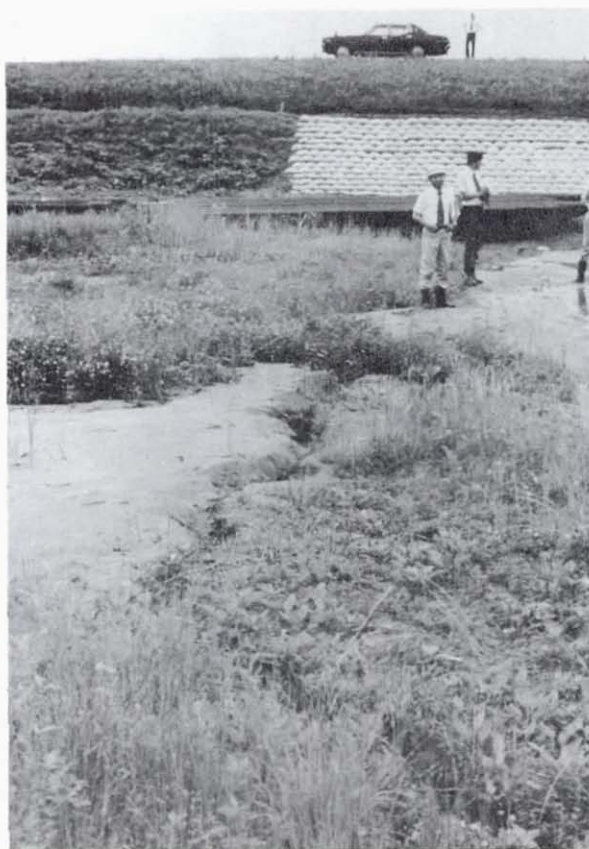
Figure 8.5 Site 1, Natori River. Liquefaction-induced cracks and sand boils in ground between river and dike indicate that liquefaction took place in materials beneath the dike. Sand in center-ground to left of crack is from sand boil. Sand bags on dike were placed after the earthquake as a repair measure. View is south.

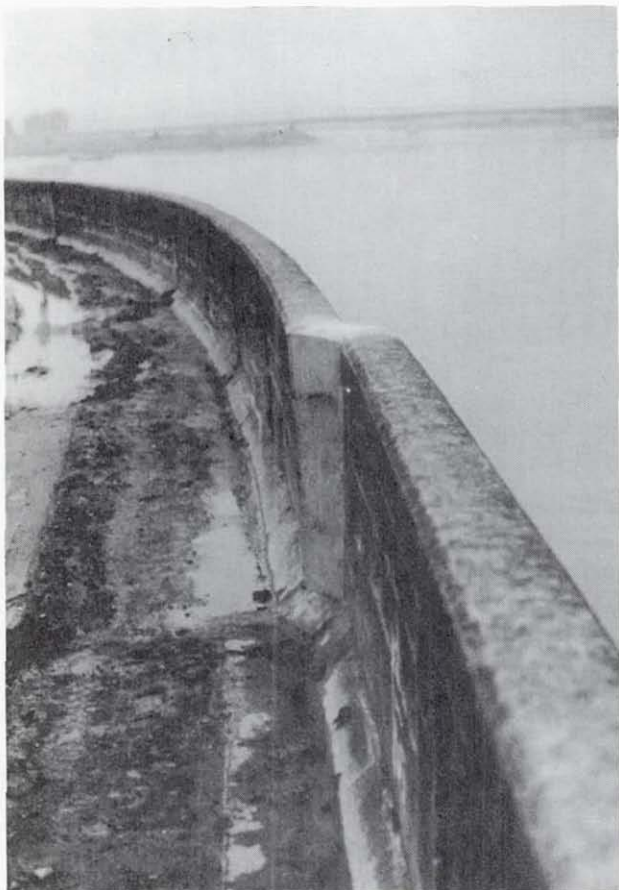
Figure 8.6 Site 2, Natori River. View is west along repaired portion of dike. Note patch across offset in retaining wall offset caused by lateral spreading during earthquake. Retaining wall rises approximately 1 m above roadway.

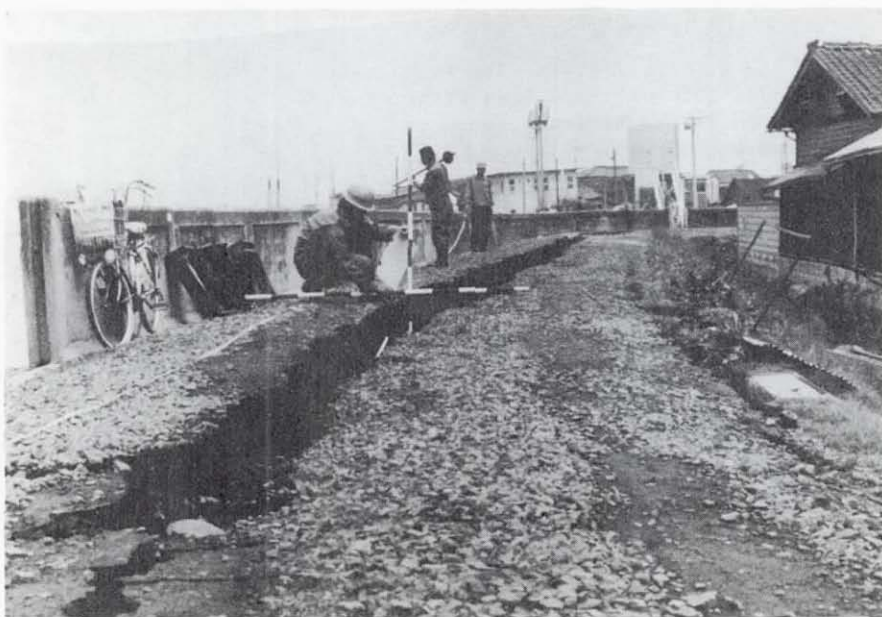
Figure 8.7 Site 2, Natori River. Settlement, lateral spreading, and longitudinal cracking of dike. View is east.  
(Photo courtesy Tohoku Regional Construction Bureau)

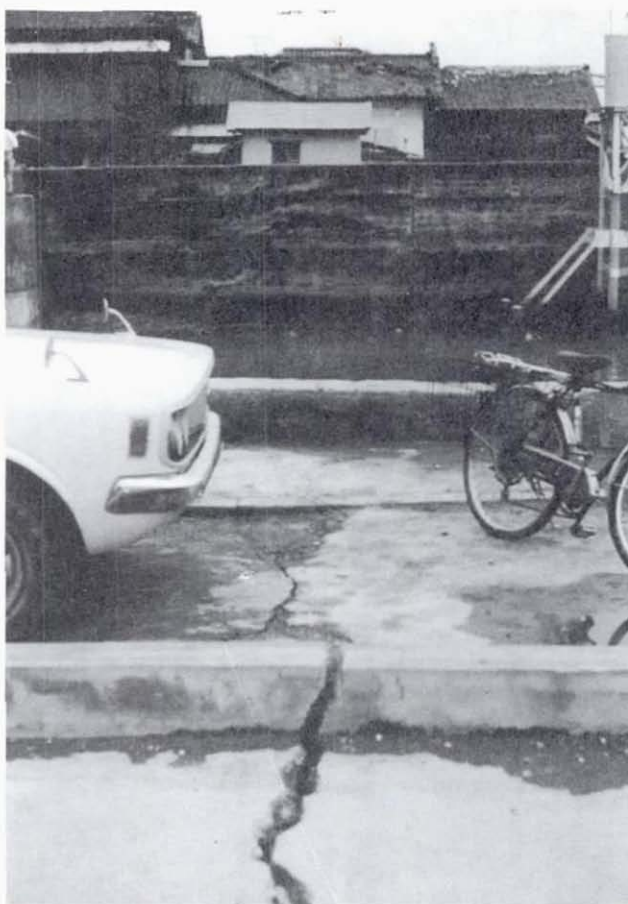
Figure 8.8 Site 2, Natori River. View is west across tributary of Natori River. Dike section shown in Figs. 8.6 and 8.7 is to right of houses in background of this figure. Note crack in concrete pavement in foreground is aligned with crack in retaining wall in background.

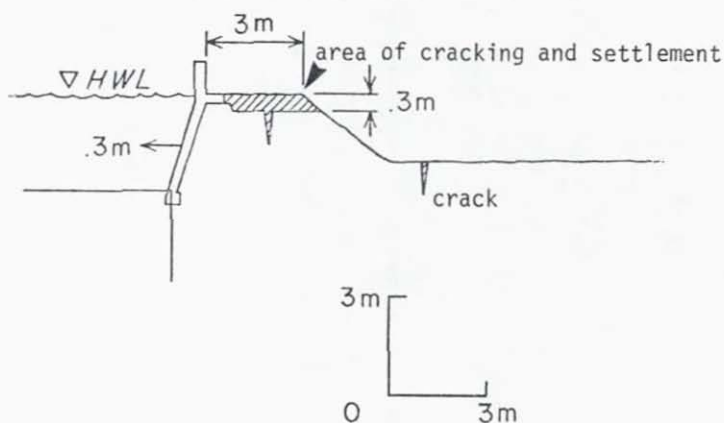
Figure 8.9 Site 2, Natori River--Retaining wall moved laterally and dike crest settled (From Tohoku Regional Construction Bureau, MOC, unpublished data)

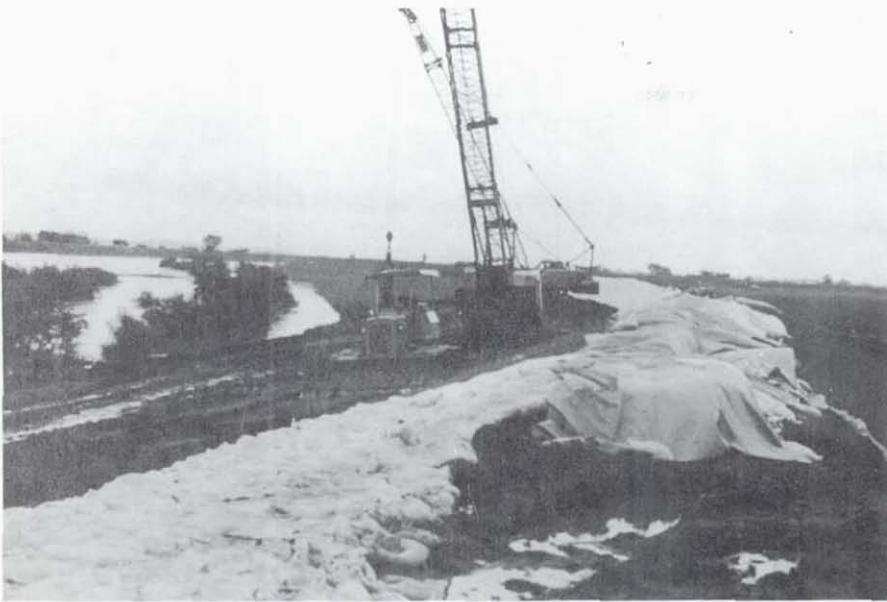
Figure 8.10 Site 3, Yoshida River. View east (downstream) along section of dike where repairs are underway. Dike crest settled as much as 1 m over a length of 5 km. Sand bags have been placed as part of repair process.

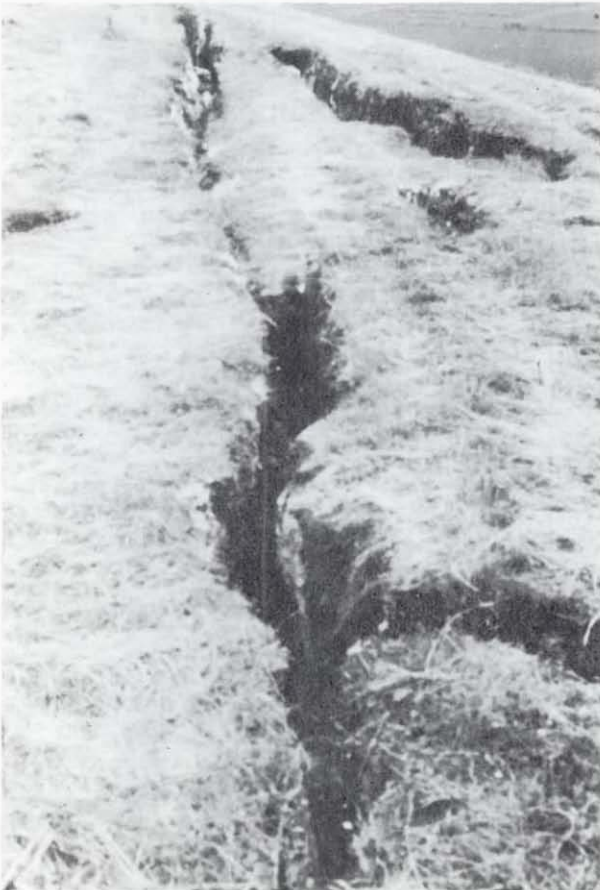
Figure 8.11 Site 3, Yoshida River. Cracks in dike caused by slumping and lateral spreading. Cracks are 10-30 cm wide. View is west. (Photo courtesy K. Kawashima, PWRI)

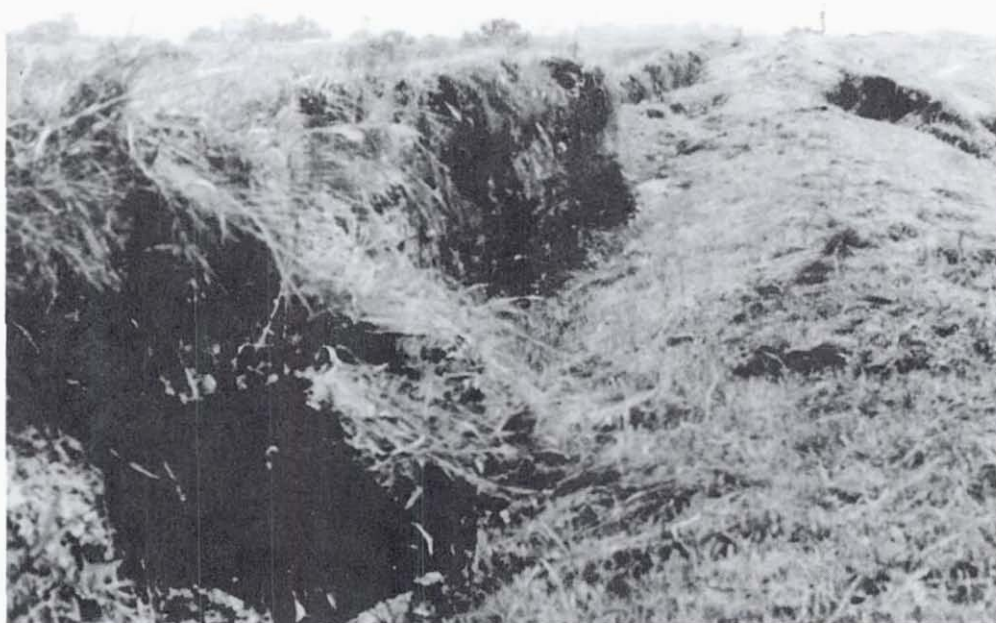
Figure 8.12 Site 3, Yoshida River. Scarps in dike caused by slumping. Note man in background for scale. (Photo courtesy K. Kawashima, PWRI)

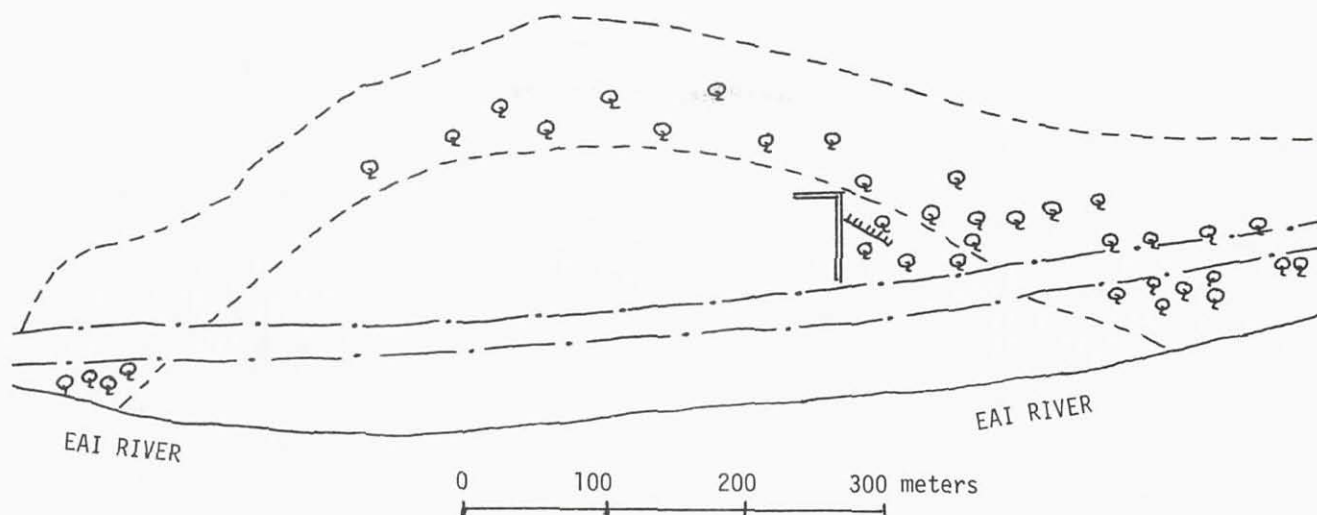
Sand boils were common in an old river channel at Site 4, on the right bank of the Eai River (Figure 8.14). A concrete block fence near this channel was cracked by lateral spreading toward the old channel bank (Figure 8.15). Damage to the dike on this side of the river was minor. Across the river from Site 4, cracks up to 80 cm deep and 10 cm wide occurred in the dike. On both sides of the river, the foundation material contains much soft clay. Some layers of silt and sand may also be present. It was reported that the dikes were built relatively slowly, and significant settlement took place during construction (K. Kawashima, PWRI, oral communication).

Figure 8.14 Site 4, Eai River--Most sand boils occurred in old river channel. Minor cracking of dike apparently occurred where dike crosses old channel, but cracks were repaired prior to visit. (After Tohoku Regional Construction Bureau, MOC, unpublished data)

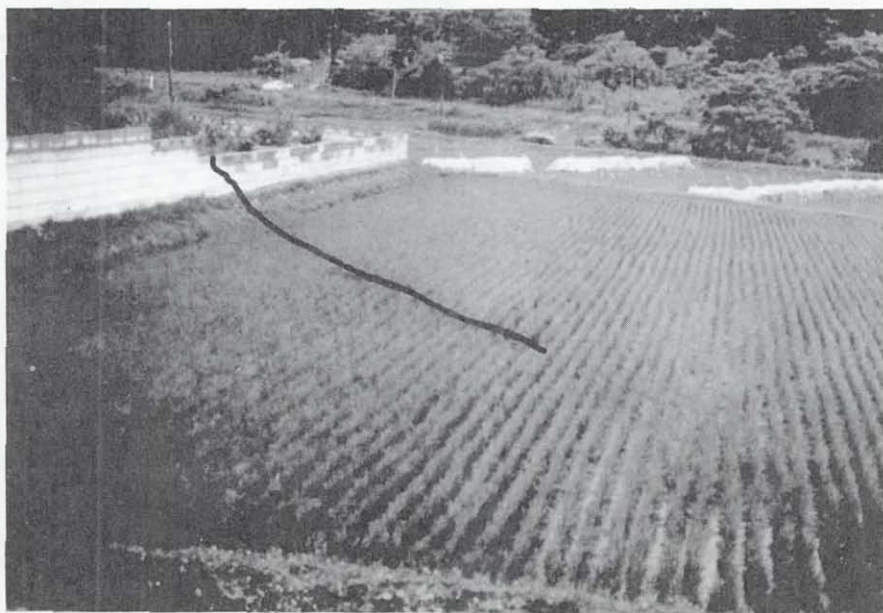
Figure 8.15 Site 4, Eai River - View southwest from crest of dike. Crack (indicated by heavy line) in fence and rice field caused by lateral spreading toward bank of old channel in background.

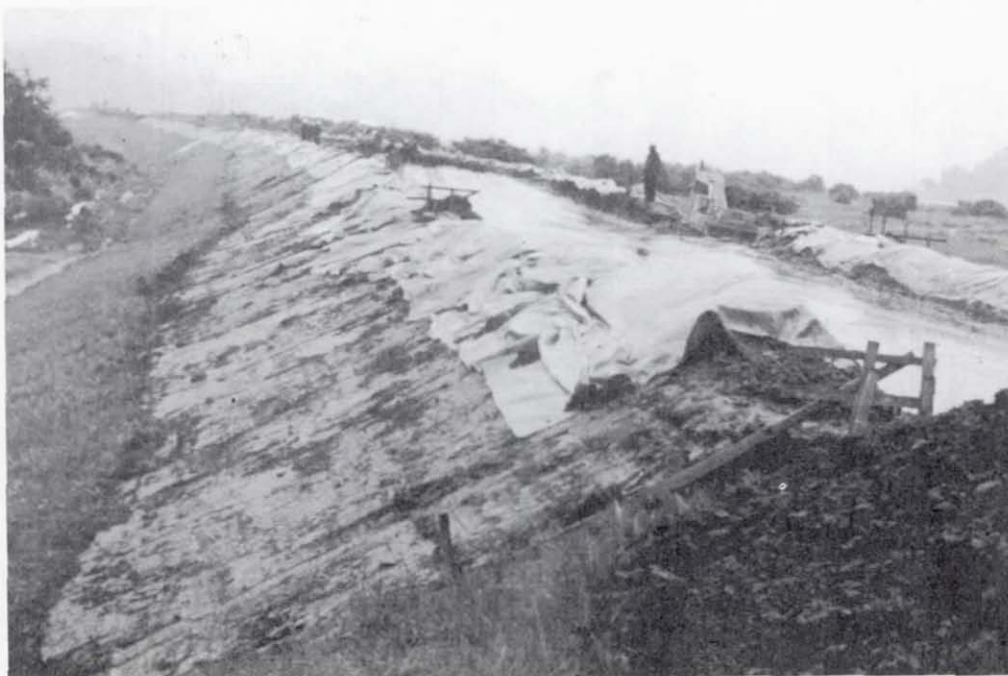
Figure 8.17 Site 6, New Kitakami River. View east along crest of dike and highway that are being repaired. Uneven nature of highway surface is due to liquefaction-induced differential settlement. Settlements of up to 1.5 m occurred along a distance of 4 km.
