NBS SPECIAL PUBLICATION **592**

An Investigation of the Miyagi-ken-oki, Japan, Earthquake of June 12, 1978

This document is the result of the investigation by the U.S. team on the earthquake. It describes geologic features of the earthquake-stricken area, and damage to human-made structures. It is hoped the information presented in this document will add to the knowledge of seismology and earthquake engineering.

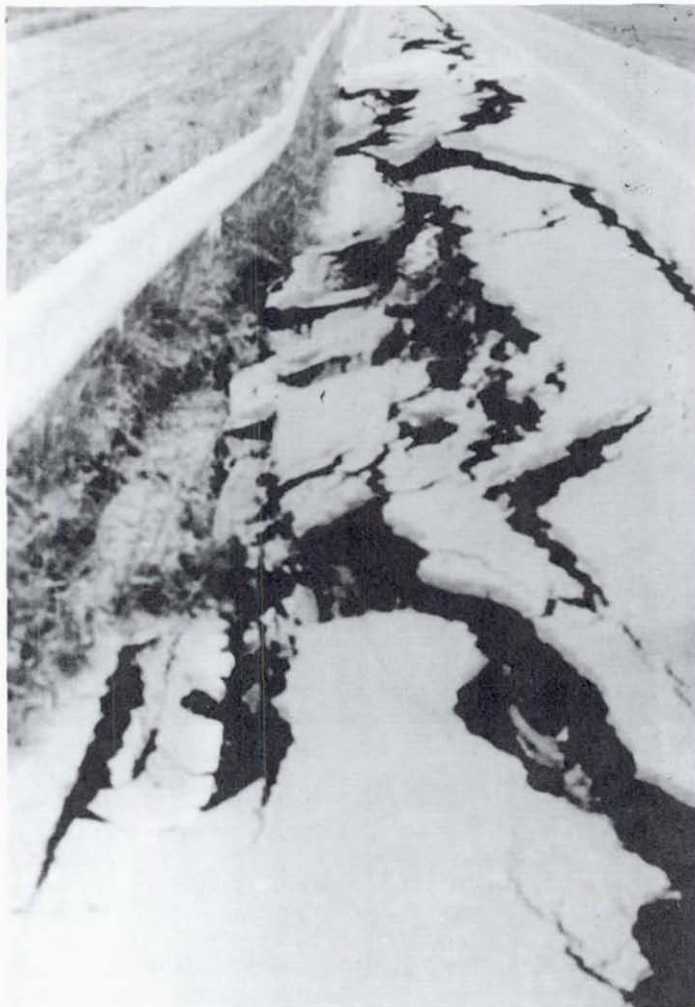
Figure 8.18 Site 6, New Kitakami River. Cracking of dike crest and roadway due to liquefaction-induced slumping. (Photo courtesy K. Kawashima, PWRI)

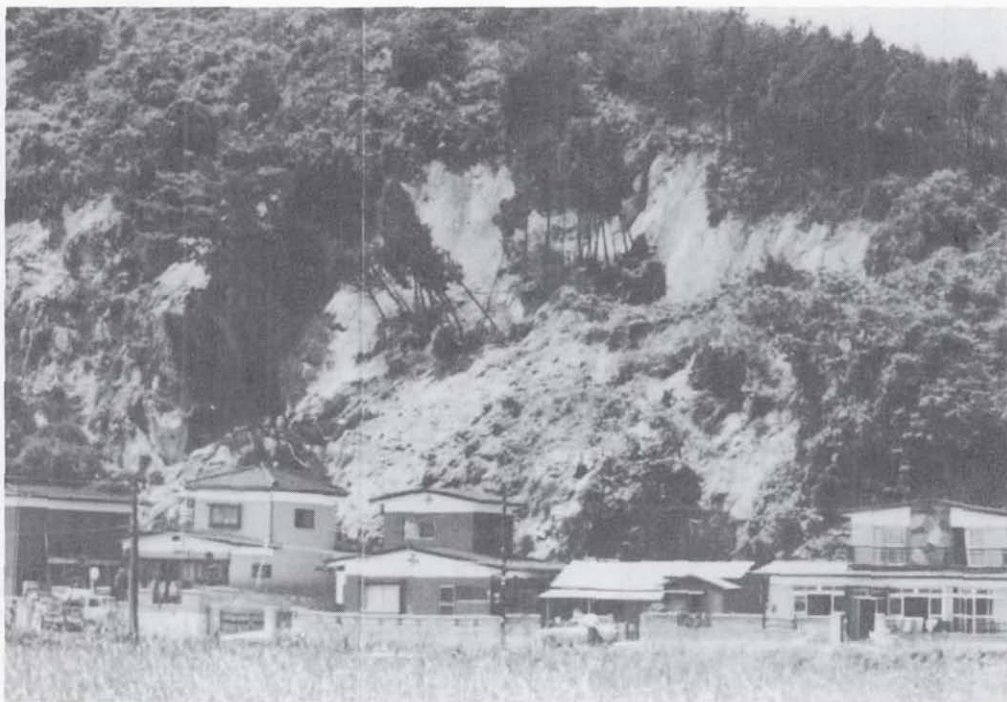
Two of the largest rock falls from the earthquake occurred near Takayamashita in Matsushima town west of the Takagi River on steep (greater than 45°) natural slopes. The larger of these rock falls (Figure 9.2) occurred in a deeply weather and closely jointed Miocene tuff breccia (Geologic Map of Miyagi Prefecture) exposed in a 45-m scarp. The slope affected is approximately 110 m wide, and the volume of debris is about 6,000 m³. The rock fall damaged four houses built next to the slope. A close view of some of the damage to the house second from the left in Figure 9.2 is shown in Figure 9.3.

Figure 9.2 Rock fall on steep slopes of Miocene pumiceous tuff breccia near Takayamasuita. This rock fall damaged four houses close to the base of the slope. (Photograph courtesy of Y. Tsuruya, Slope Protection Division, Ministry of Construction).

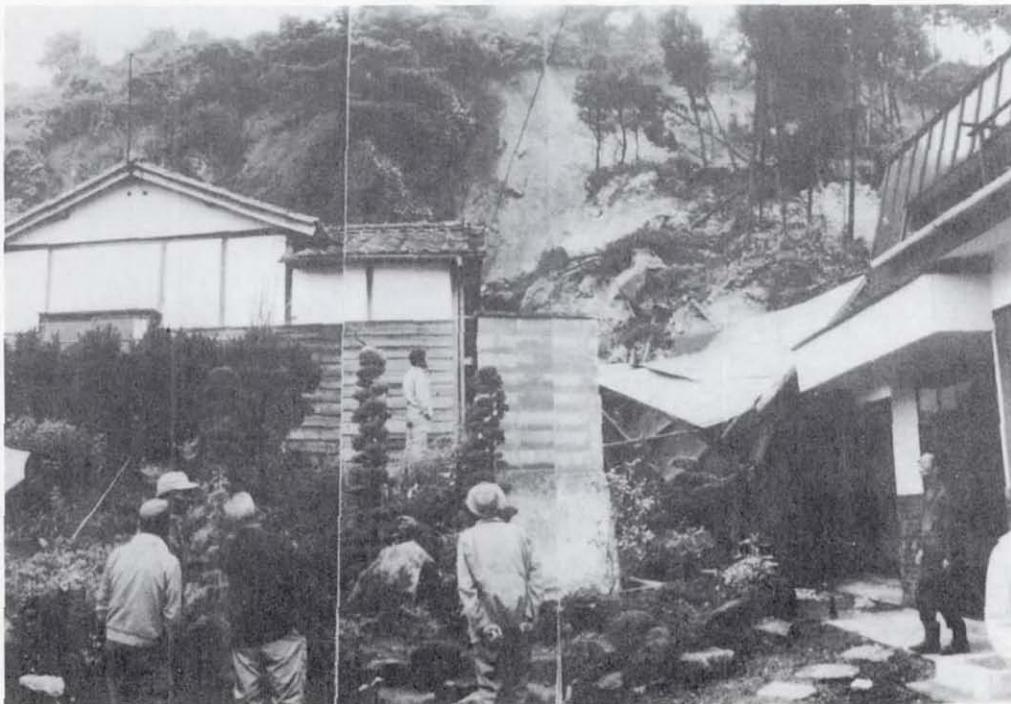
Figure 9.3 Closeup of rock fall damage to houses shown in left portion of figure 9.2. (Photograph courtesy of Y. Tsuruya)

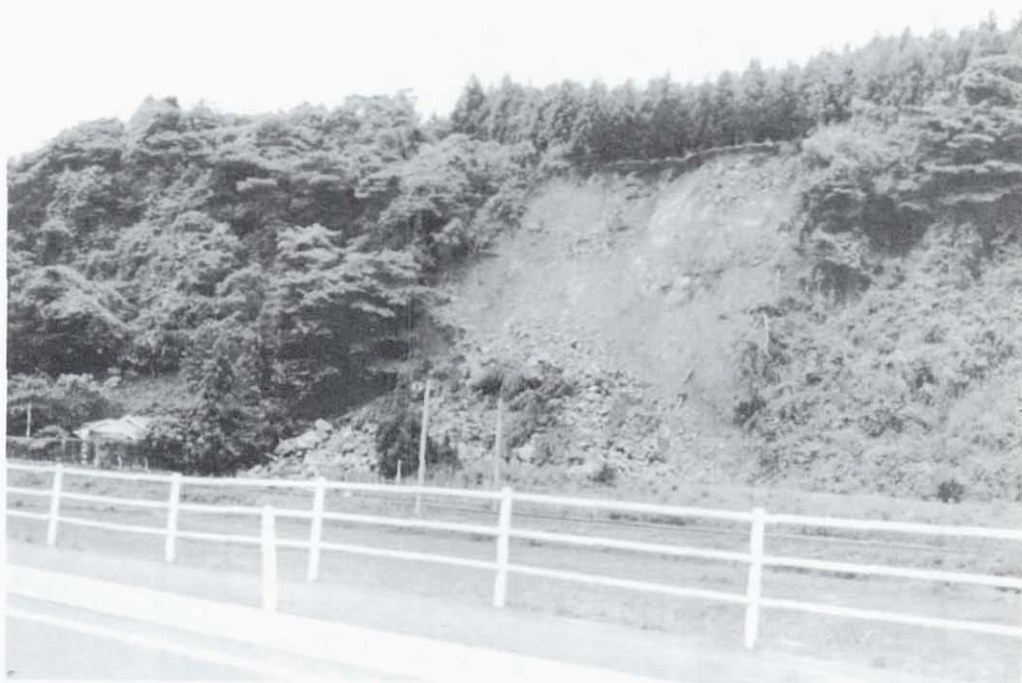
Figure 9.4 Rock fall on steep slopes in volcaniclastic sediments.

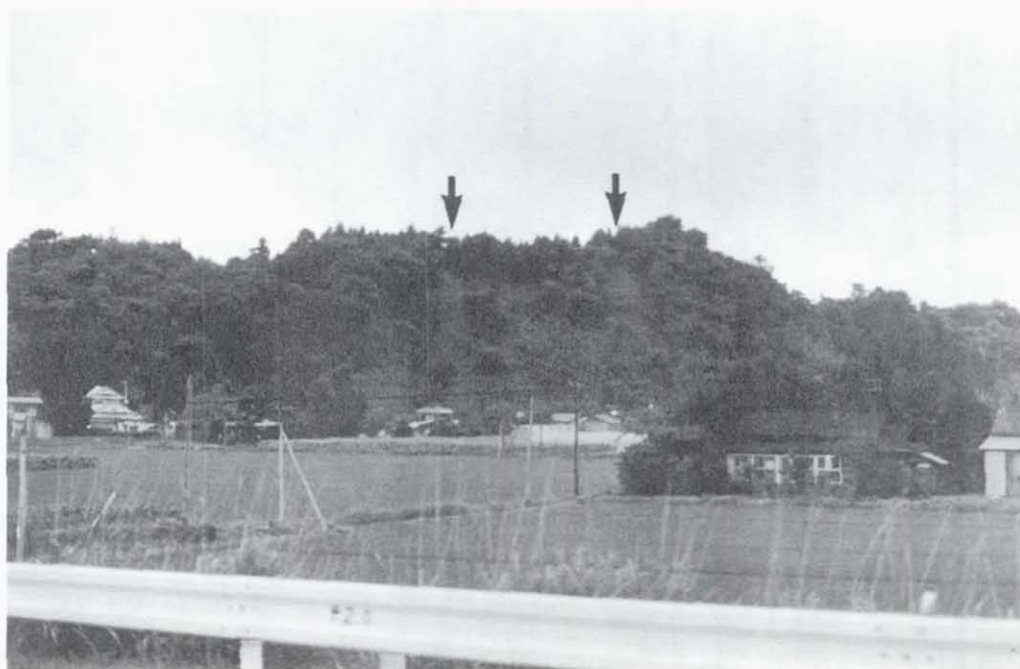
Figure 9.5 Rock falls (arrows) in steep bluffs bordering flood plain near mouth of Naruse River.

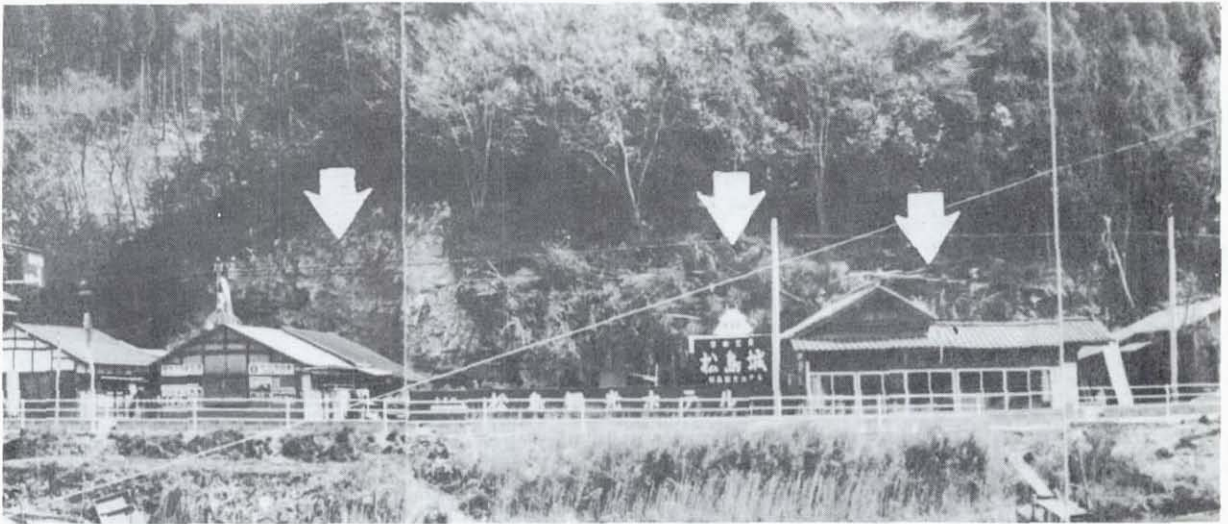
Near Atago in Matsushima, approximately 1.0 km east of the Site No. 1, rock falls from tuff, similar to the tuff forming the larger rock fall at Site No. 1, damaged outbuildings near three houses. About 500 m³ of debris was shaken from cut slopes 15 m in high beneath which houses and storage buildings were closely juxtaposed (Figure 9.6). Most of the damage was not to the houses proper but to attached storage sheds and outbuildings as shown in Figure 9.7.

Figure 9.6 Panoramic view of houses damaged by rock fall from adjacent cut slope in tuff*. Rightmost arrow points to area shown in figure 9.7. (Photograph courtesy of Y. Tsuruya).

* Arrows point to failure scarps.

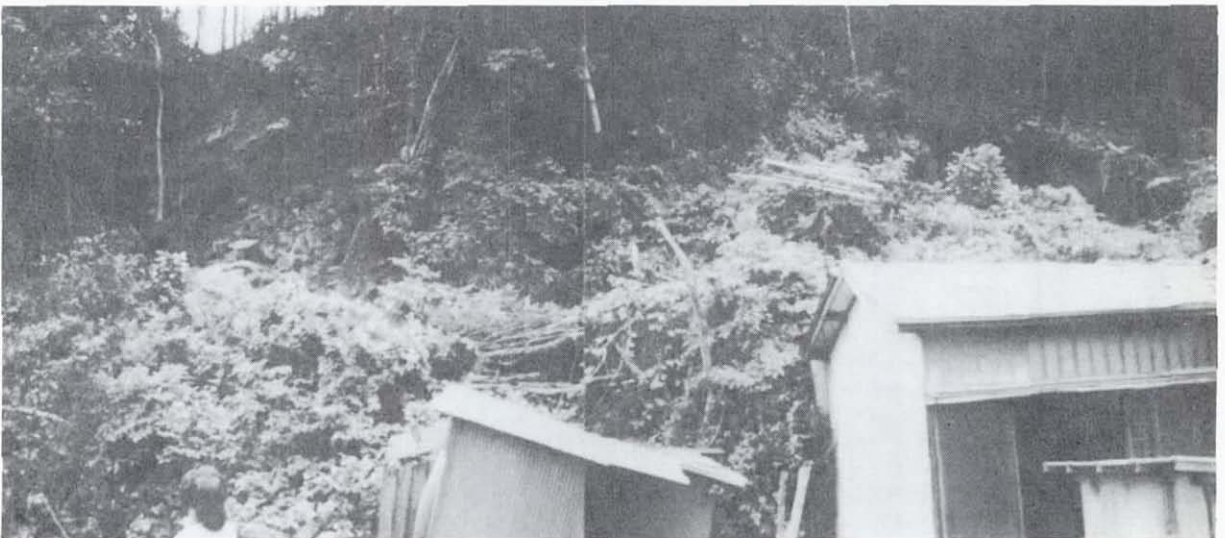
Figure 9.7 Closeup of rock fall and damage to buildings shown in right-hand portion of figure 9.6. (Photograph courtesy of Y. Tsuruya)

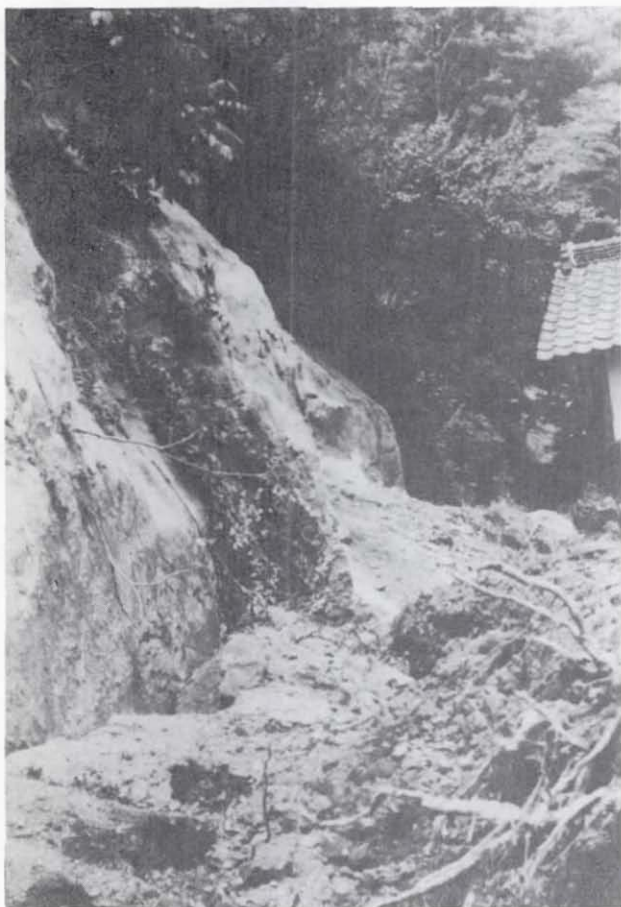
Approximately 3 km east of Atago in Mototetaru, Matsushima, small rock falls occurred in tuff-breccia deposits, damaging several storage buildings adjacent to houses. Failures occurred along a section of cut slope about 100 m in long and produced about 200 m³ of debris. The slope is 10-13 m high and is inclined at about 60°. One rock fall and a scarp exposing tuff breccia is shown in Figure 9.8.

Figure 9.8 Rock fall from steep slope in pumiceous tuff breccia near Mototataru. Failure was about 200 m³ in volume. (Photograph courtesy of Y. Tsuruya)

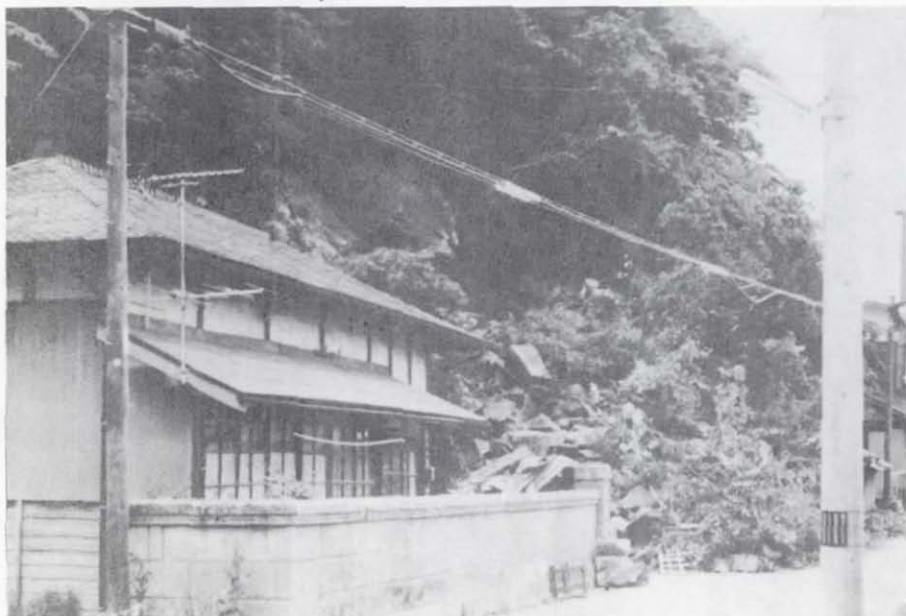
At Kakinoura in Matsushima, about 100 m³ of blocky debris was produced by a seismic-induced rock fall in tuff that damaged a concrete wall adjacent to a house. This rock fall occurred on the nose of a narrow ridge of about 35 m local relief. The slope failed along pre-existing fractures or joints and produced blocks of debris as long as 1.0 m. The size of the blocks reflects the fracture spacing of the rock. The rock fall and the house adjacent to the damaged concrete wall are shown in Figure 9.9. Two other small rock falls nearby did minor damage to walls of three other houses.

Figure 9.9 Rock fall in Miocene tuff causing damage to concrete wall adjacent to house. (Photograph courtesy of Y. Tsuruya)

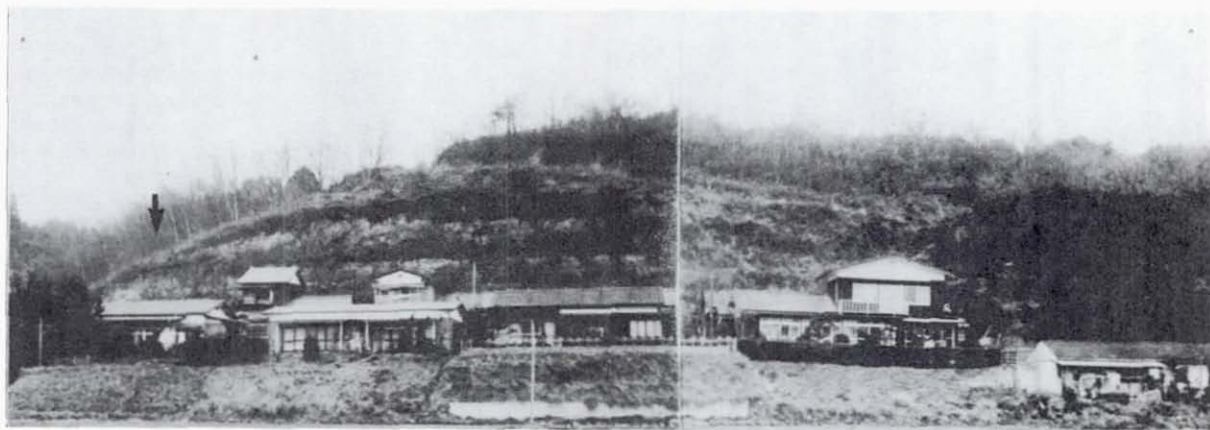
At Kitashionai, Murata, 25 km southwest of Sendai, another steep slope in tuff failed, generating a small rock fall damaging one house. Figure 9.10 shows several houses near the nearly vertical cut slope about 15 m high. One of these houses suffered damage to a retaining fence and part of the roof. A closeup of the rock fall and roof damage is shown in Figure 9.11.

Figure 9.10 Panorama of cut slope near Kitashiona in Miocene tuff which produced rock falls during earthquake damaging nearby houses. Arrow points to damaged house shown in closer view in figure 9.11. (Photograph courtesy of Y. Tsuruya)

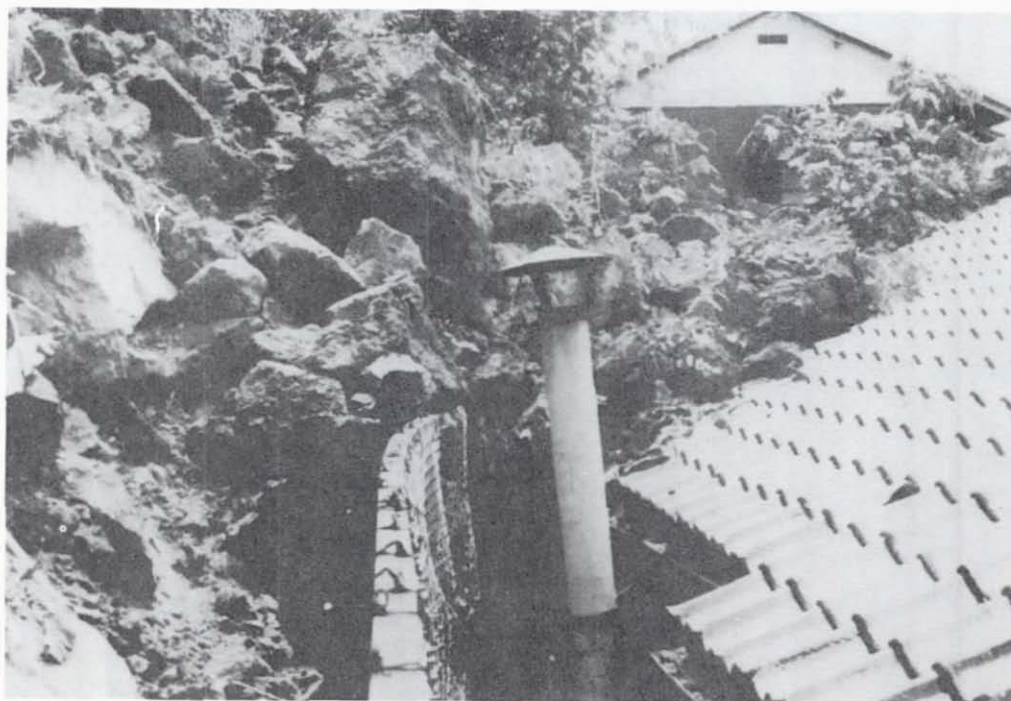
Figure 9.11 Rock fall damage to retaining wall and roof of house in left-hand portion (arrow) of figure 9.10. (Photograph courtesy of Y. Tsuruya)

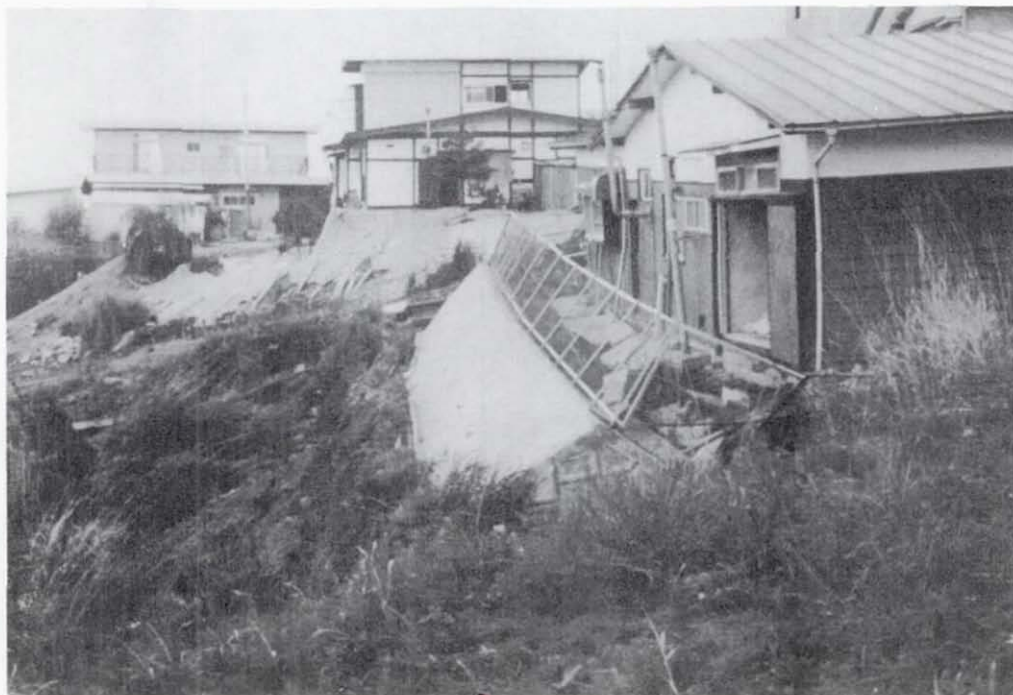
Many slope failures in artificial fill took place within the city limits of Sendai. These failures were mainly slumps. In the neighborhood of Midorigaoka, a large rotational slump occurred in a fill slope of about 15°, composed of gravelly clay. From the headwall scarp to toe, the slump extends approximately 70 m horizontally and 20 m vertically (Y. Matsuzaki, 1978, unpublished data); it is approximately 30 m wide and about 14 m in maximum thickness, thus the approximate volume is 30,000 m³. Most of the slump was above and to the right of one of the 1400 concrete slope-protection dams (sabo works) in Sendai (Figure 9.17). The slump-mass had been covered with nylon tarps before the photograph was taken to prevent infiltration of rainfall.

Figure 9.17 Rotational slump in artificial fill in Sendai (area covered by tarps) which destroyed one house and is threatening others. To left of slump is concrete slope protection dam (sabo works).
