NIST NCSTAR 1-1C (Draft)

**Federal Building and Fire Safety Investigation of the
World Trade Center Disaster**

Maintenance and Modifications to Structural Systems (Draft)

September 2005

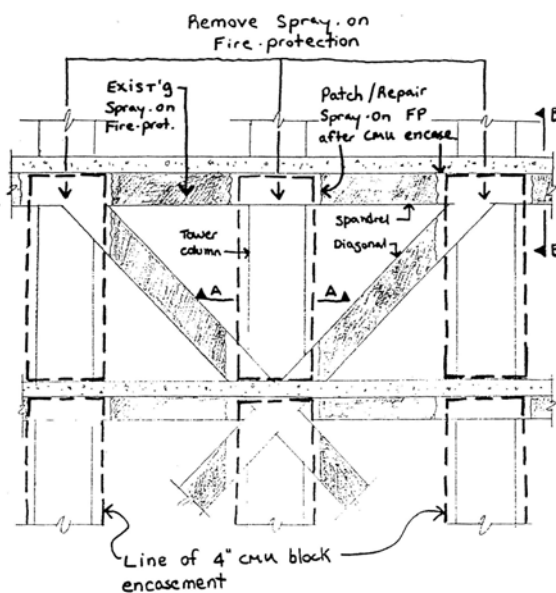
Section @ Tower - CMU BLOCK ENCASEMENT
Subgrade

REV.	LERA	LESLIE E. ROBERTSON ASSOCIATES CONSULTING STRUCTURAL ENGINEERS	P1003118	DRAWING NO.
	WTC - Explosion		DRAFT H.G.	FS-433.1
	Tower Columns		DESIGN	
	CMU BLOCK ENCASEMENT		CHECK	24 Jan. 94

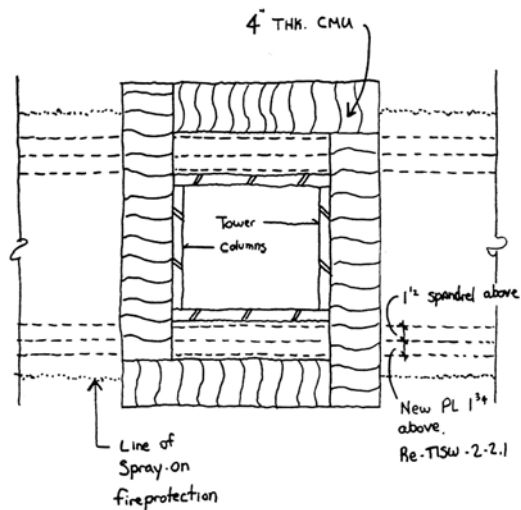
A2 Plan for Tower Column Encasement for Columns 321 324 327
TOWER 1 - Subgrade

REV.	LERA	LESLIE E. ROBERTSON ASSOCIATES CONSULTING STRUCTURAL ENGINEERS	P1003118	DRAWING NO.
	WTC - Explosion		DRAFT H.G.	FS-433.3
	Tower Columns		DESIGN	
	CMU BLOCK ENCASEMENT		CHECK	24 Jan. 94
