Appendix A

EXAMPLES OF PERIMETER PANEL FLOOR TRUSS CONNECTORS

The floor trusses were attached to the perimeter panels at the interior intersection of the columns and spandrels by different types of connectors. The following appendix displays photographic examples, taken by National Institute of Standards and Technology (NIST), of these types of connectors as observed on the recovered panels.

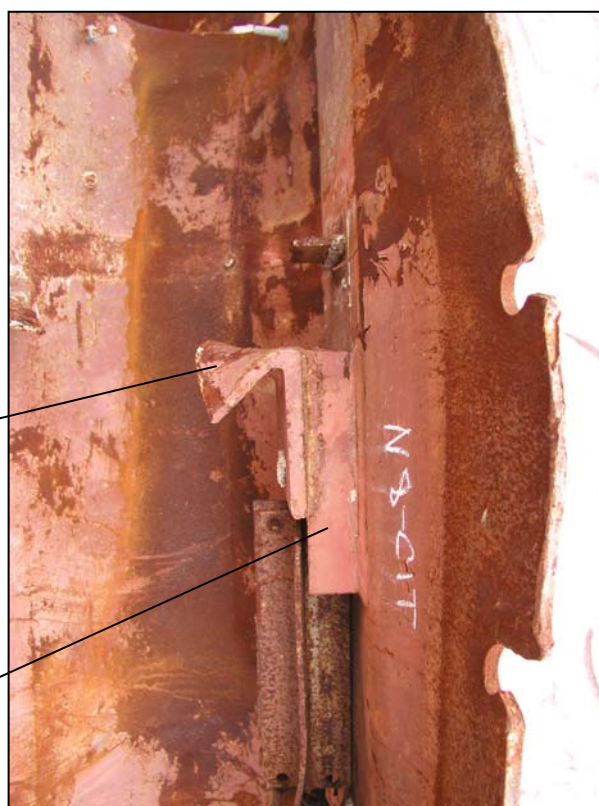
Figure A1b: Type A floor truss connector

Seat

Standoff plates used to attach seat to column interior

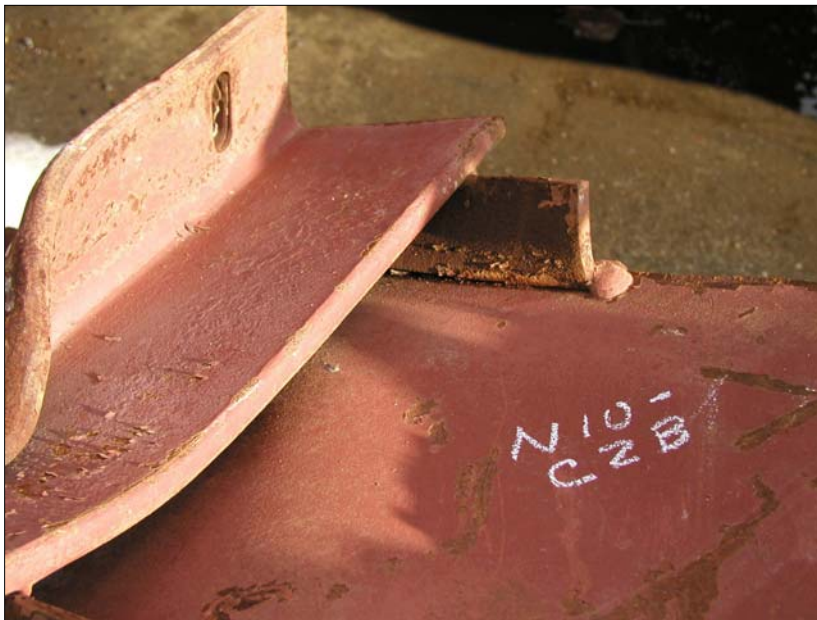
**Connection N10-C2B**

Standoff plate welded on only one side

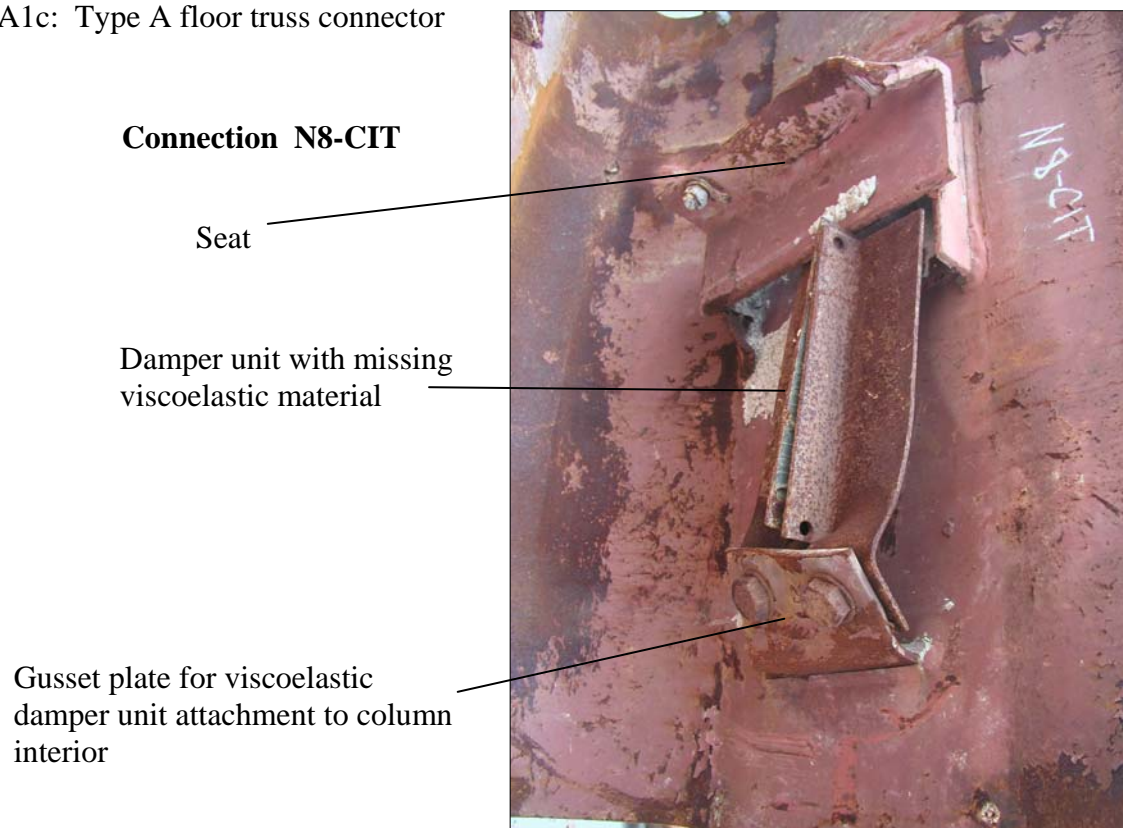
**Connection N8-CIT**

Seat

Damper unit with missing viscoelastic material

Gusset plate for viscoelastic damper unit attachment to column interior

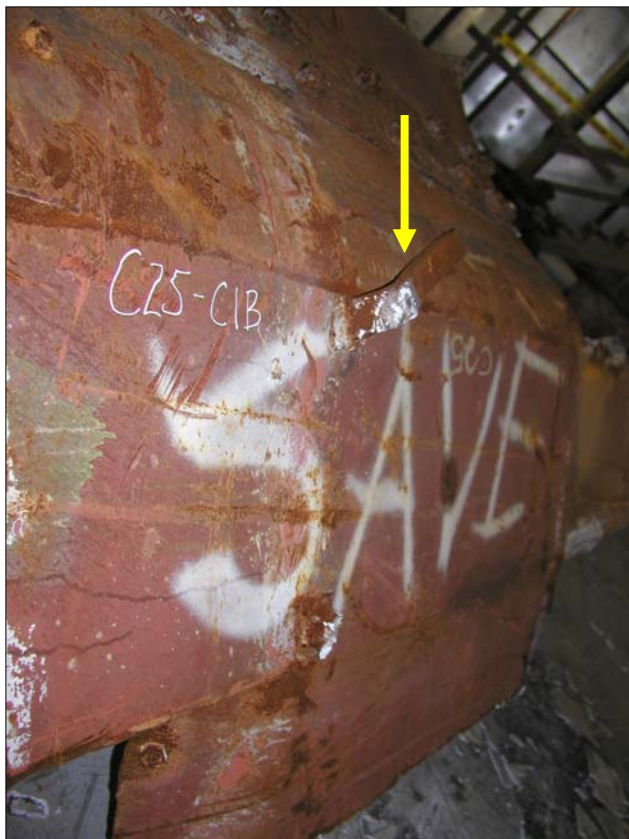
**Connection C25-C1B**

Portion of diagonal bracing straps remain attached to spandrel; welded directly to the spandrel.

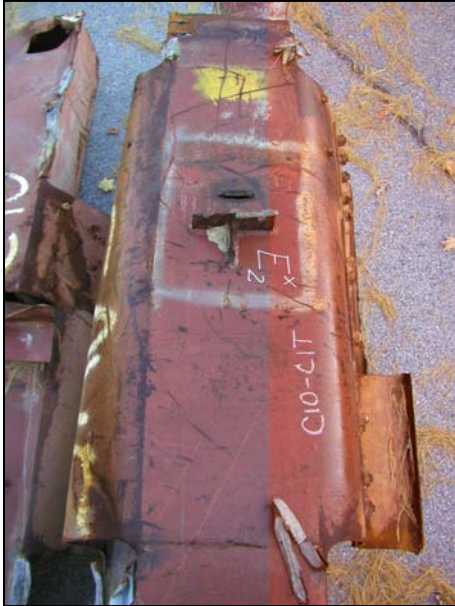
**C10-C1T (WTC 1, Col.452, Fl 88)**

Type B

Gusset plate ripped completely out of spandrel;
 Small seat intact, bent downwards, 1 bolt hole
 intact, other ripped out;
 No evidence of gusset plate for damper unit.

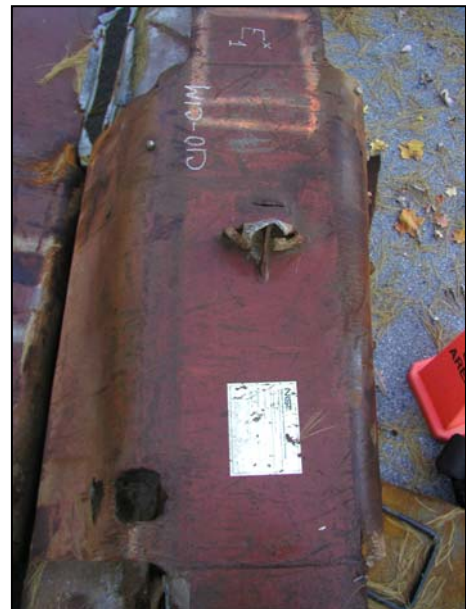
**C10-C1M (WTC 1, Col.452, Fl 87)**

Type B

Gusset plate ripped completely out of spandrel;
 Small seat intact, corners bent downwards, 1 bolt
 hole intact other ripped out;
 No evidence of gusset plate for damper unit.

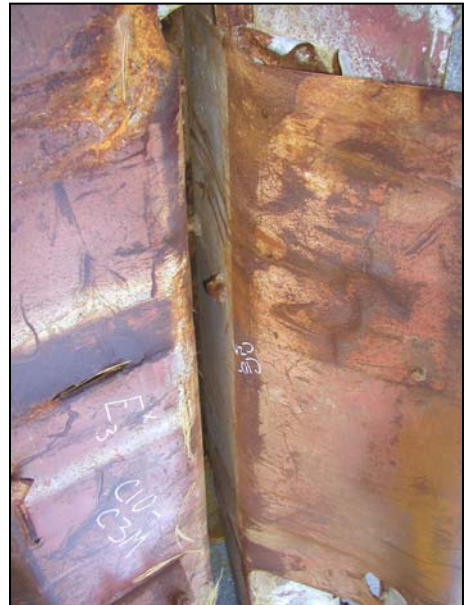
**C10-C2M (WTC 1, Col.451, Fl 87)**

Type D

2 1-inch portions of diagonal bracing straps remain.

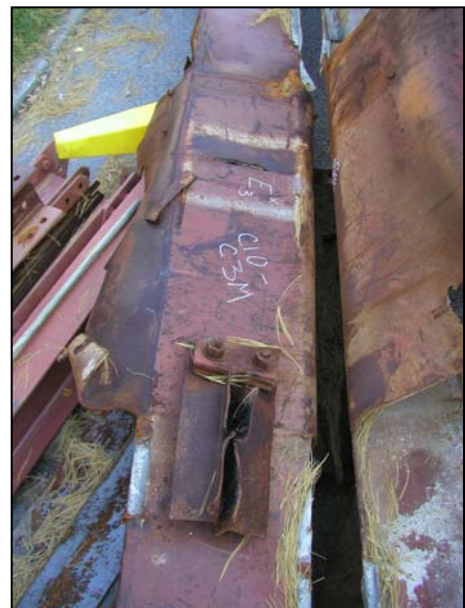
**C10-C3M (WTC 1, Col.450, Fl 87)**

Type A

Gusset plate ripped completely out of spandrel; Only 1 standoff plate remains, rest ripped off at welds; Gusset plate with damper unit intact, bent downwards.

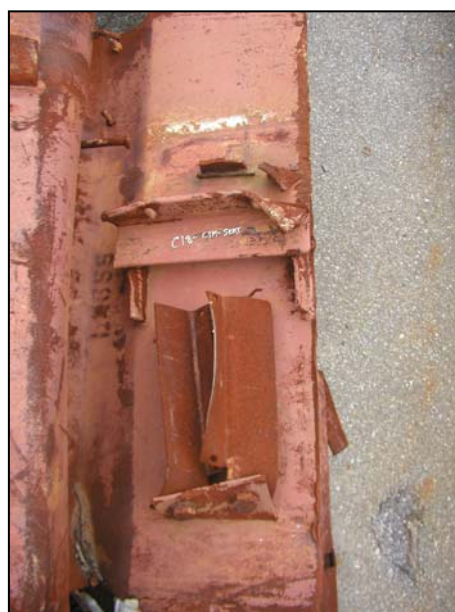
C18-C1M (WTC 2, Col.231, Fl 95)

Seat intact, both bolt holes intact, slight damage to one corner, bent downwards;

Gusset plate with damper unit intact, bent upwards.

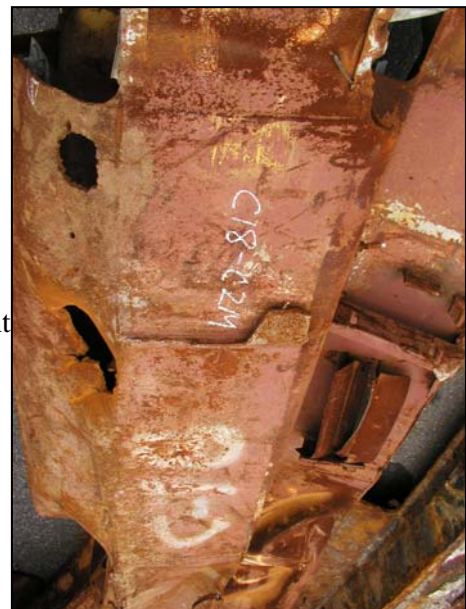
C18-C2M (WTC 2, Col.230, Fl 95)

Very small portion of large gusset plate remains, bent upwards.

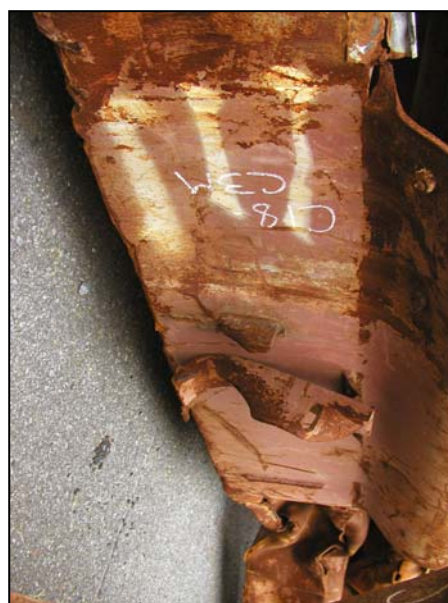
C18-C3M (WTC 2, Col.229, Fl 95)

Gusset plate intact, bent downwards;
Seat intact, bent down and in towards column, 1
bolt hole intact, other ripped out;
Gusset plate for damper unit ripped off at weld.

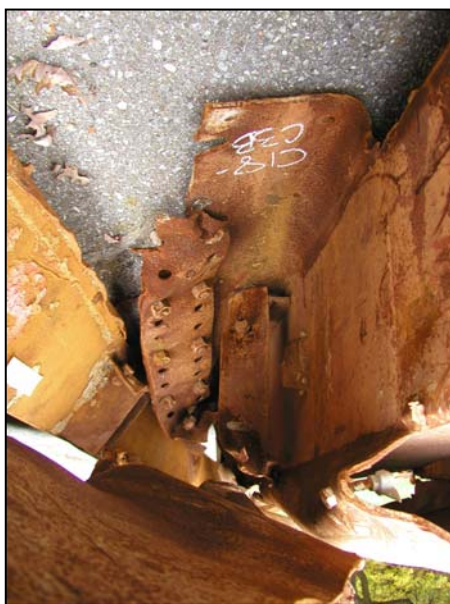
C18-C3B (WTC 2, Col.229, Fl 94)

Gusset plate intact;
Seat intact, both bolt holes intact with 1 bolt and nut,
some damage to corners;
Gusset plate with damper unit intact, bent downwards.

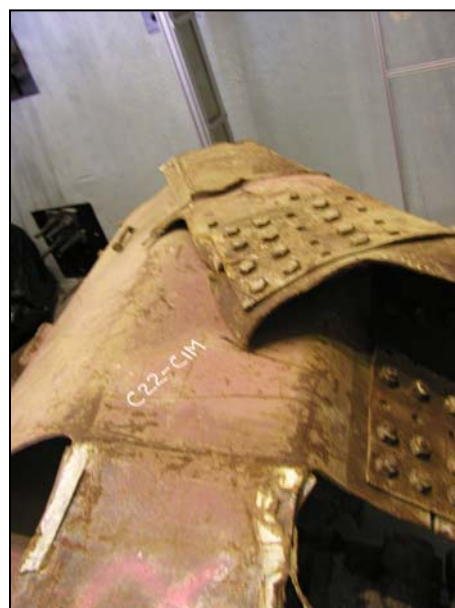
C22-C1M (WTC 1, Col.158, Fl 95)
Type C
Seat Detail: 5210

Large gusset plate ripped off at weld.

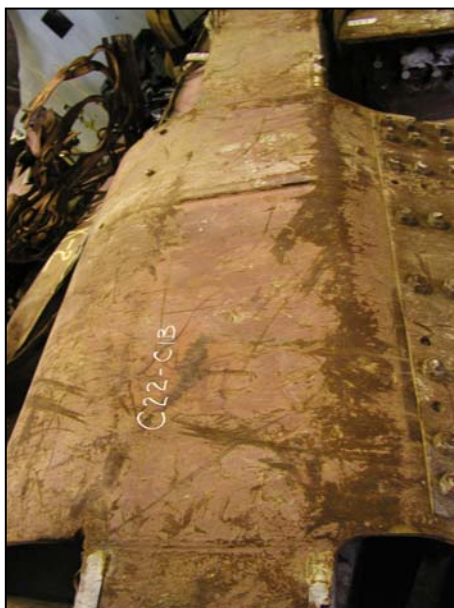
C22-C1B (WTC 1, Col.158, Fl 94)
Type C
Seat Detail: 5210

Large gusset plate ripped off at weld.

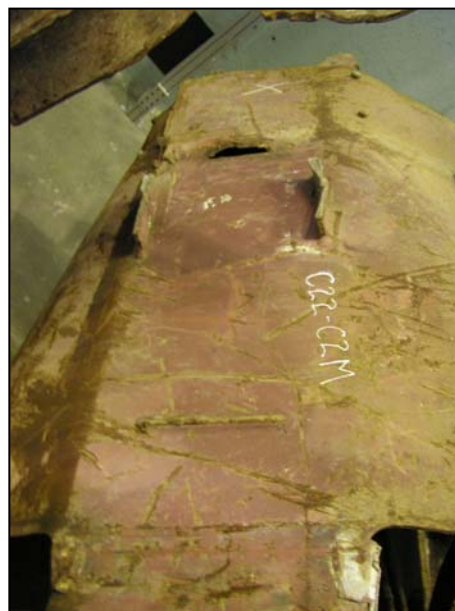
C22-C2M (WTC 1, Col.157, Fl 95)

Gusset plate ripped completely out of spandrel;
Only standoff plates remain, seat ripped off at welds;
Gusset for damper unit ripped off at weld.

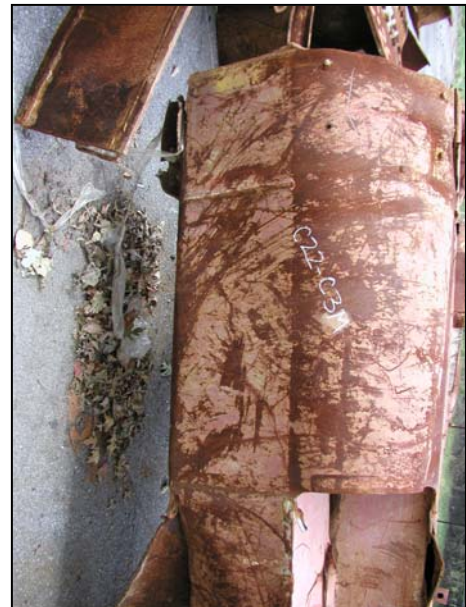
C22-C3M (WTC 1, Col.156, Fl 95)
Type C
Seat Detail: 5110

Large gusset plate ripped off at weld.

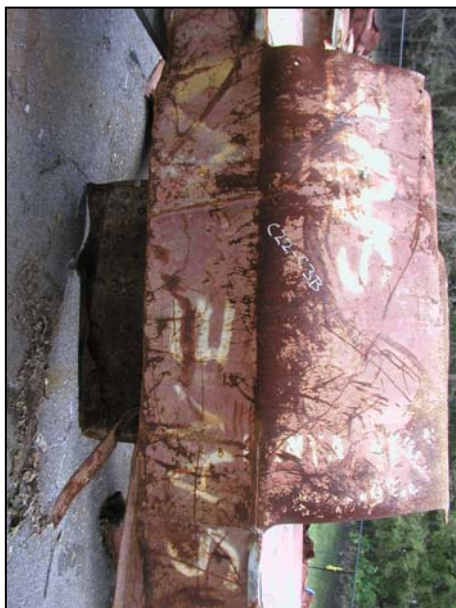
C22-C3B (WTC 1, Col.156, Fl 94)
Type C
Seat Detail: 5110

Large gusset plate ripped off at weld.

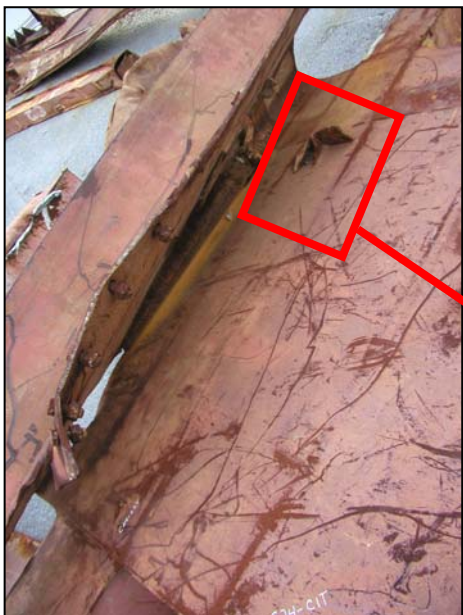
**Mechanical floor panel****C24-C2T (WTC 2, Col.203, Fl 77)**

Gusset plate with vertical support, torn and bent down wards.

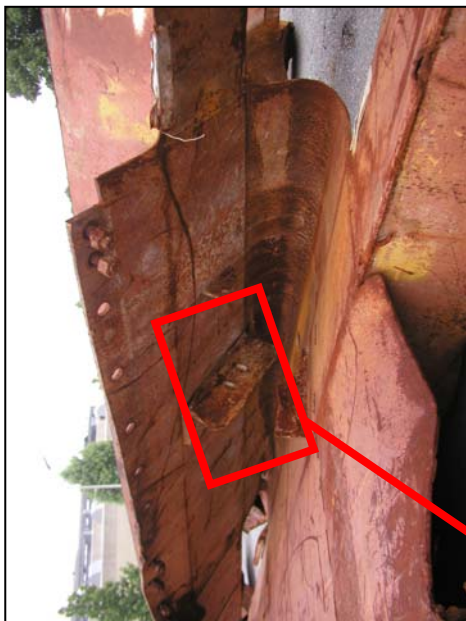
**Mechanical floor panel****C24-C3T (WTC 2, Col.202, Fl 77)**

Gusset plate intact;
Seat intact, 1 side bent down, both bolt holes intact;
Gusset plate for dampers ripped off at welds.

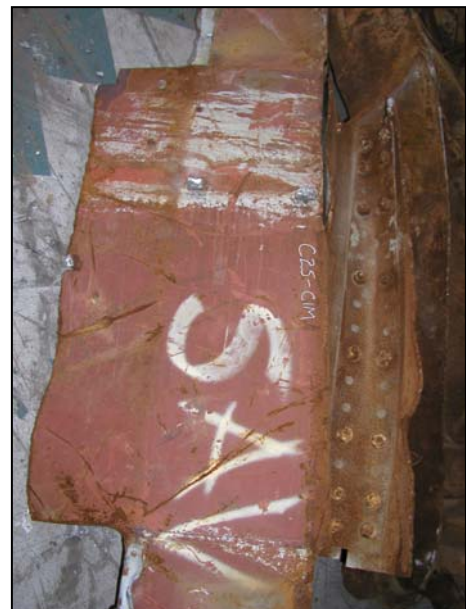
C25-C1M (WTC 1, Col.207, Fl 91)

1-in portion of diagonal bracing strap remains, other is ripped off at weld.

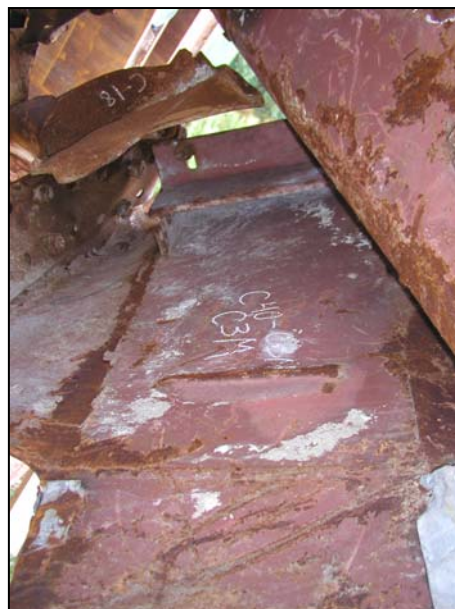
C40-C3M (WTC 1, Col.135, FI 100)

Gusset for damper unit ripped off at weld.

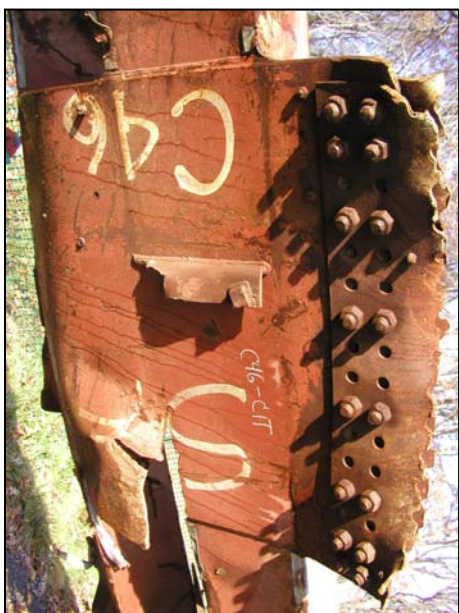
**C46-C1T (WTC 2, Col.158, Fl 71)**

Gusset plate remains, bent downward.

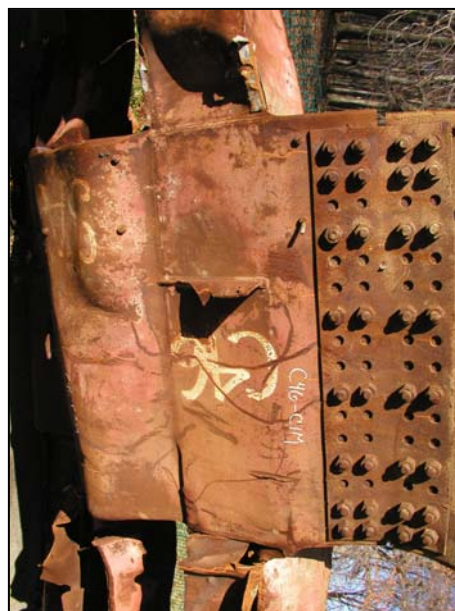
**C46-C1M (WTC 2, Col.158, Fl 70)**

Portion of gusset plate remains, bent downward.

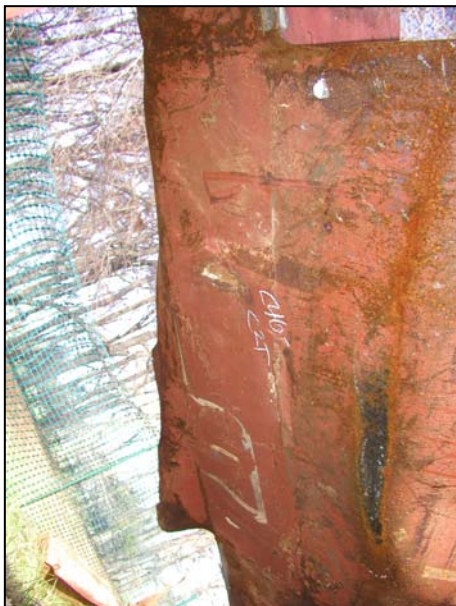
**C46-C2T (WTC 2, Col.157, Fl 71)**

Gusset plate intact;
 Only portions of standoff plates remain;
 Gusset plate for damper unit ripped off at weld.

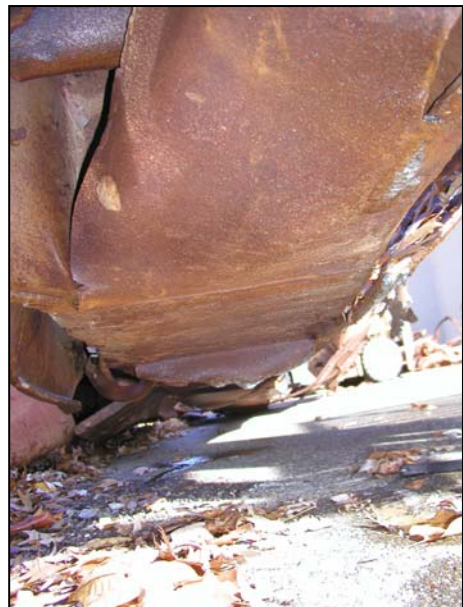
C46-C3M (WTC 2, Col.156, Fl 70)

Large gusset plate intact, bent downwards, 2 long diagonal bracing straps remain as well.

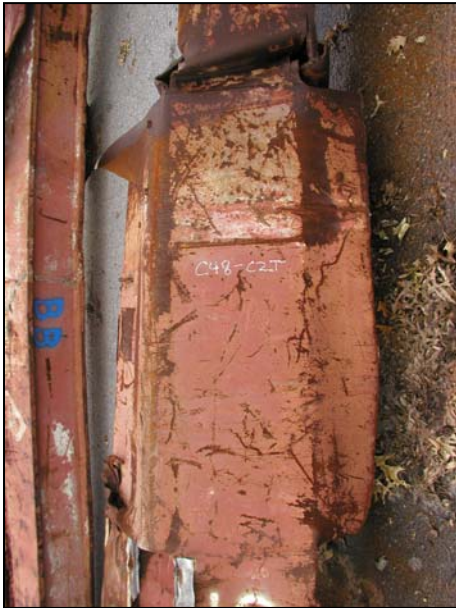
**C48-C2T (WTC 2, Col.442, Fl 94)**

Large gusset plate ripped off at weld.

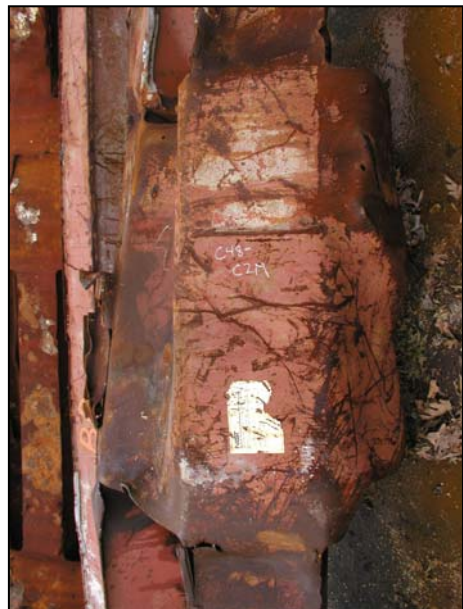
**C48-C2M (WTC 2, Col.442, Fl 93)**

Large gusset plate ripped off at weld.

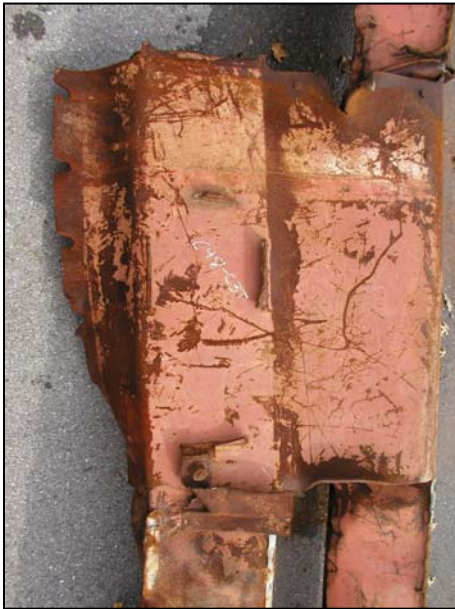
**C48-C3T (WTC 2, Col.441, Fl 94)**

Gusset plate intact;
 1 standoff plate remains, rest ripped off at welds;
 Portion of gusset plate with damper unit intact, bent downwards.

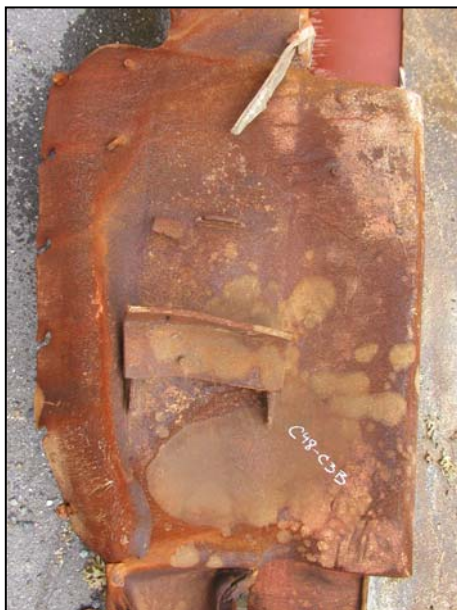
**C48-C3B (WTC 2, Col.441, Fl 92)**

Gusset plate intact;
 Seat intact, bent in towards column, both bolt holes
 intact;
 No evidence of gusset plate for damper unit.

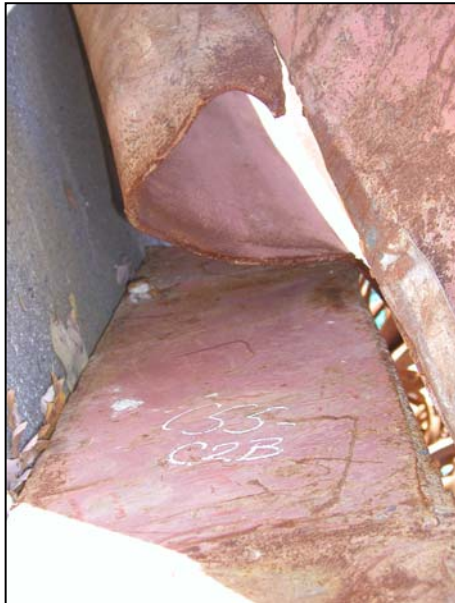
C55-C2B (WTC 1, Col.209, Fl 95)

One diagonal bracing strap ripped off at weld, other
Has about 1 in left.

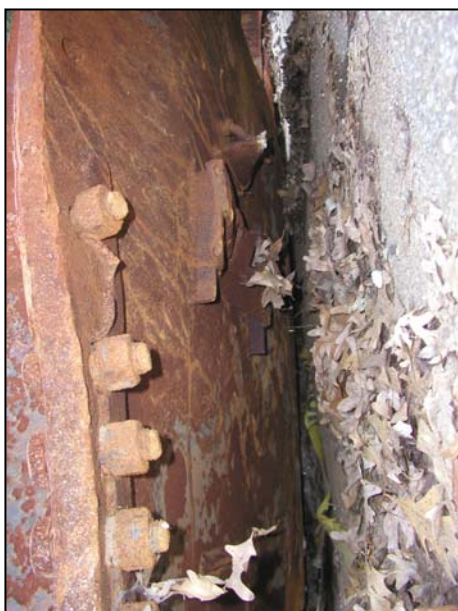
**C89-C3T (WTC 2, Col.214, Fl 15)**

Gusset plate intact with shear bolt, bent up;
 Seat intact, bent down, 1 bolt hole intact, other
 ripped through;
 Gusset plate for damper unit ripped off at weld.

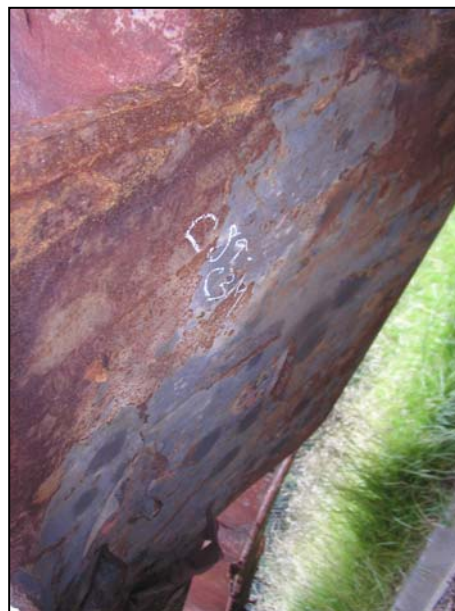
**C89-C3M (WTC 2, Col.214, Fl 14)**

Gusset plate ripped off at weld;
 Standoff plates ripped off at welds;
 Portion of gusset plate for damper unit remains,
 damper units gone.

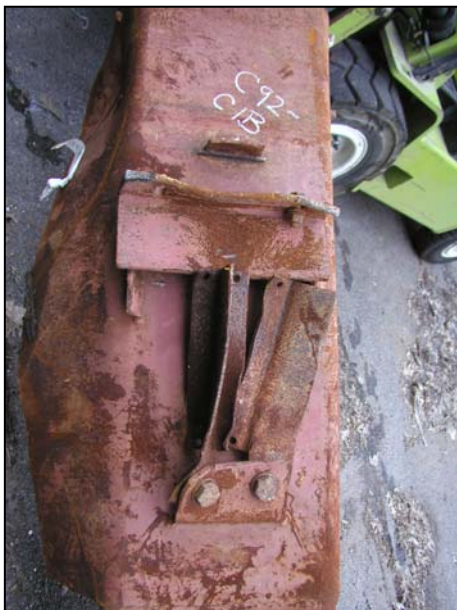
C92-C1B (WTC 2, Col.131, Fl 94)

Gusset plate with damper unit intact, bent up.

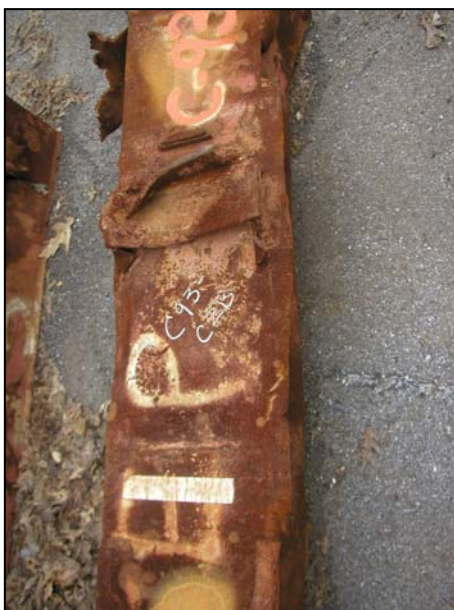
C93-C2B (WTC 1, Col.339, Fl 98)

Gusset plate ripped off at weld;
Seat intact, pushed in and bent down, both bolt holes
ripped through;
Gusset plate for damper unit ripped off at weld.

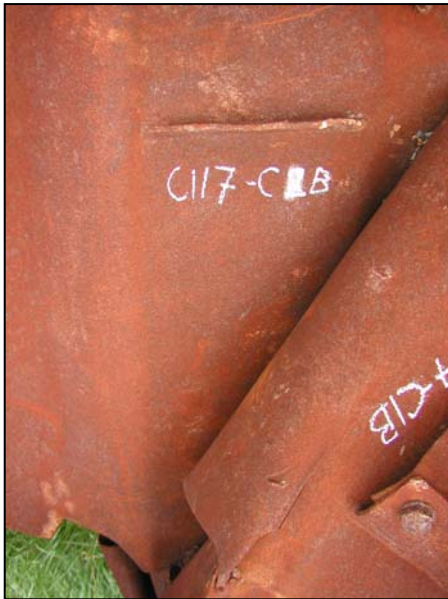
C117-C2B (Col.unknown, Fl 102)
Type C
Seat Detail:

Portion of gusset plate remains.

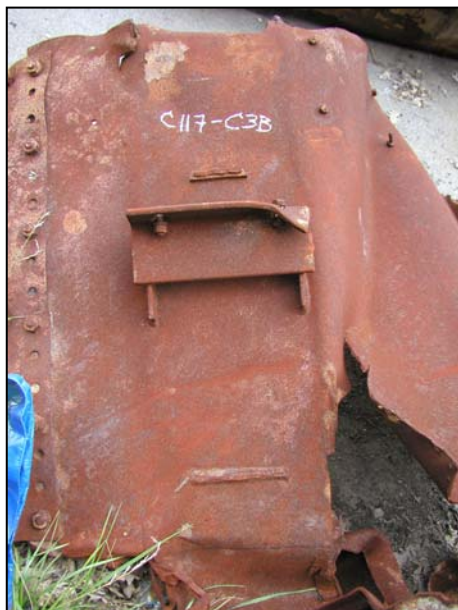
C117-C3B (Col.unknown, Fl 102)

Gusset plate ripped off at weld;
Seat intact, half bent down, both bolt holes intact with bolts;
Gusset plate for damper unit ripped off at weld.

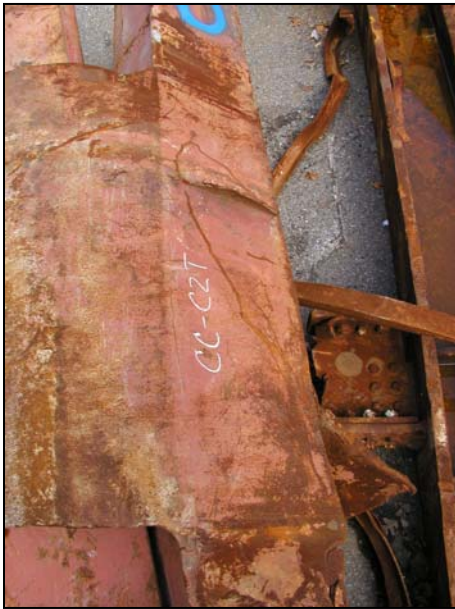
**CC-C2T (WTC 1, Col.124, Fl 73)**

Portion of large gusset plate remains.

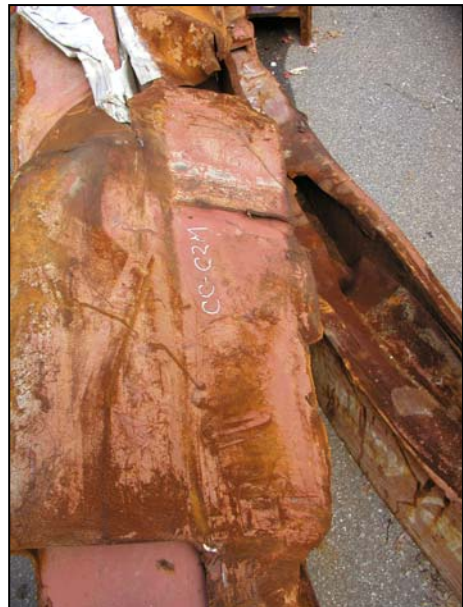
**CC-C2M (WTC 1, Col.124, Fl 72)**

Large gusset plate ripped off at weld.

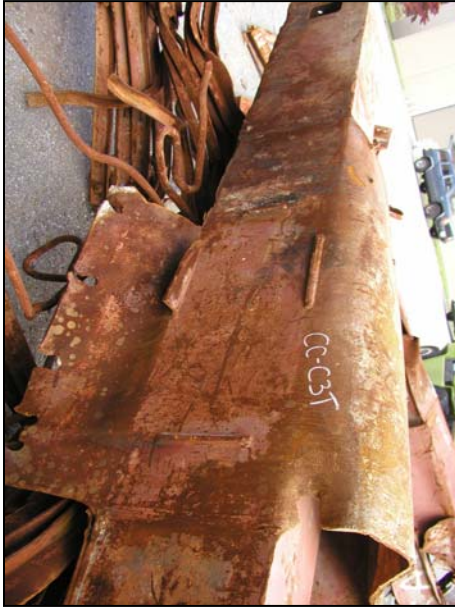
**CC-C3T (WTC 1, Col.123, Fl 73)**

Gusset plate ripped off at weld;
 Only 1 standoff plate remains, rest ripped off at welds;
 Gusset plate for damper unit ripped off at weld.

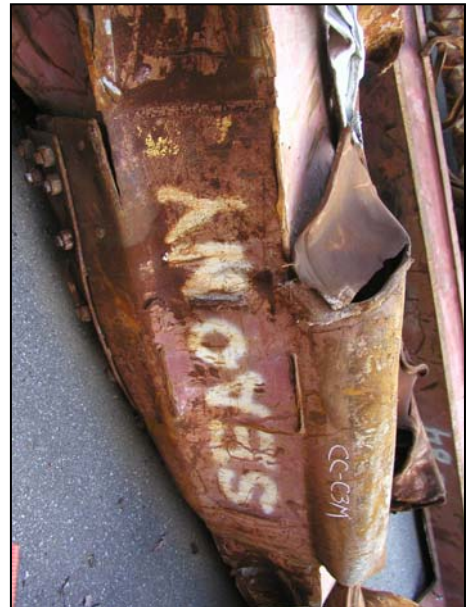
**CC-C3M (WTC 1, Col.123, Fl 72)**

Gusset plate ripped off at weld;
 Standoff plates ripped off at welds;
 Gusset plate for damper unit ripped off at weld.

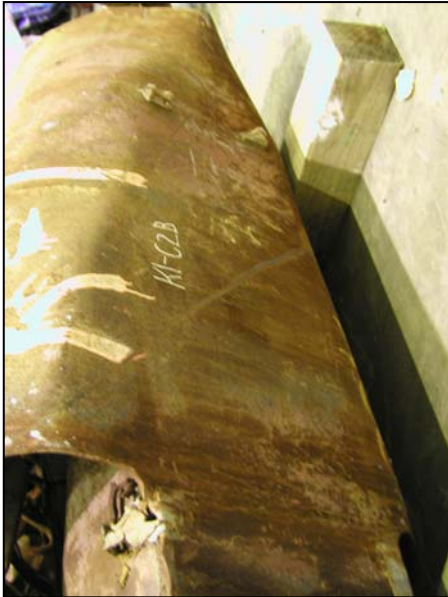
K1-C2B (WTC 1, Col.209, Fl 98)
Type D
Seat Detail: 5210

Both diagonal bracing straps ripped off at weld.

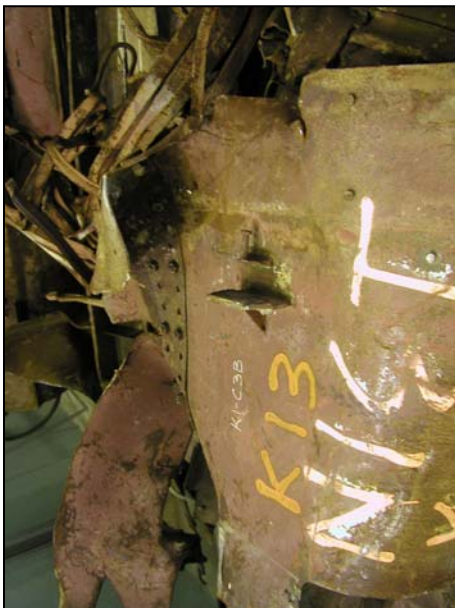
K1-C3B (WTC 1, Col.208, F1 98)

Gusset plate remains with shear bolt;
Small seat intact, 1 bolt hole intact, other is
covered by a welded plate;
No evidence of gusset plate for damper unit.

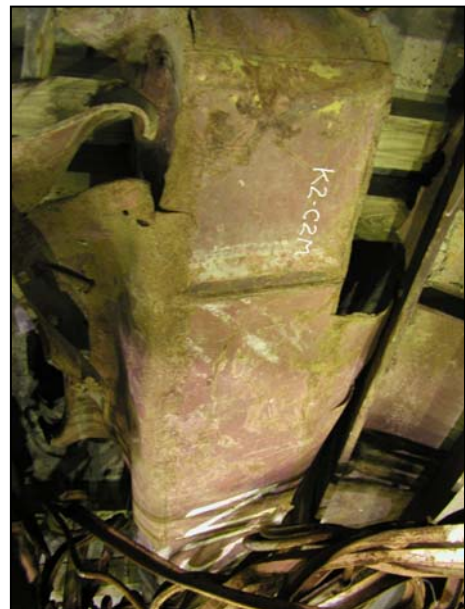
K2-C2M (WTC 1, Col.236, Fl 94)

Gusset plate ripped off at weld.

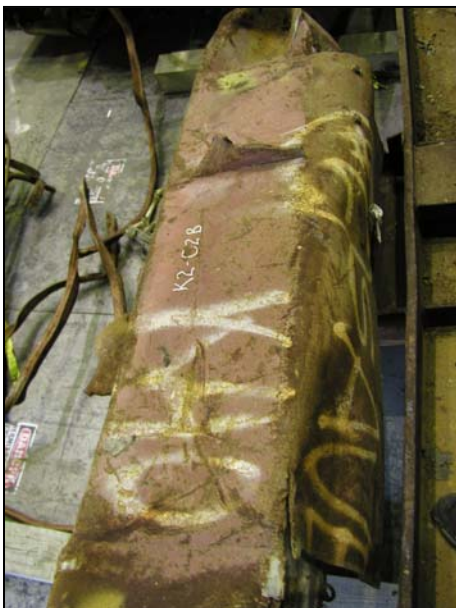
K2-C2B (WTC 1, Col.236, Fl 93)

Portion of gusset plate remains.

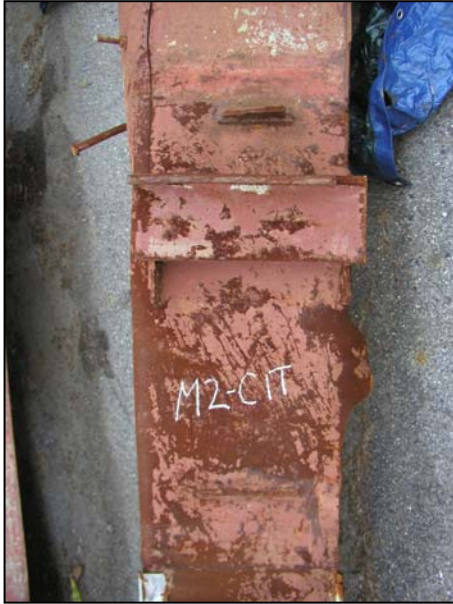
**M2-C1T (WTC 1, Col.131, Fl 99)**

Gusset plate remains;
 Seat intact, 1 bolt hole remains intact, other ripped out;
 Gusset plate for damper unit ripped off at weld.

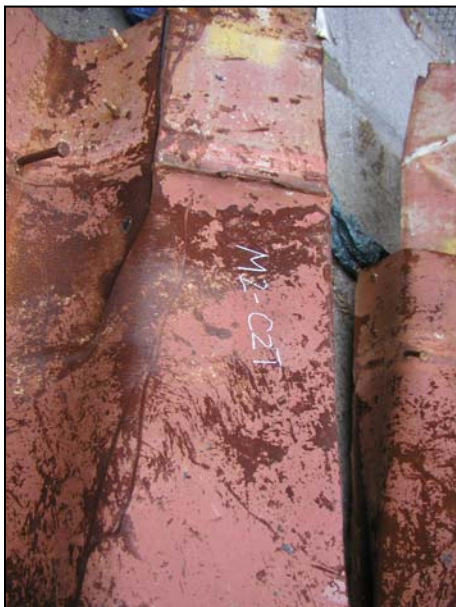
**M2-C2T (WTC 1, Col.130, Fl 99)**

Gusset plate ripped off at weld.

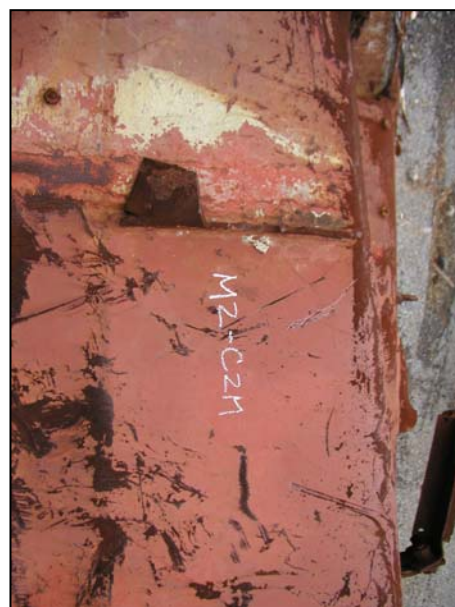
**M2-C2M (WTC 1, Col.130, Fl 98)**

Portion of gusset plate remains, bent up.

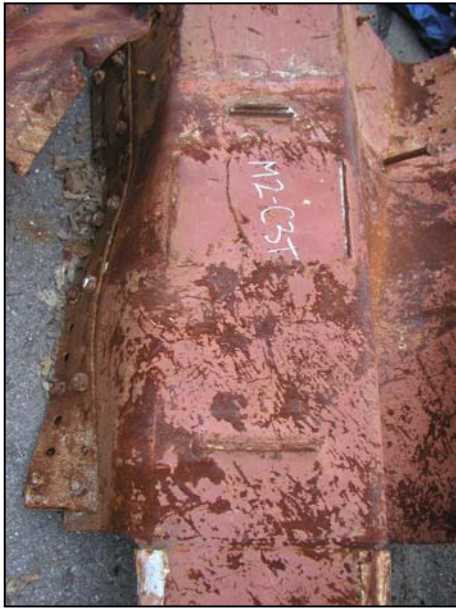
**M2-C3T (WTC 1, Col.129, Fl 99)**

Gusset plate ripped off at weld;
 Standoff plates ripped off at welds;
 Gusset plate for damper unit ripped off at weld.

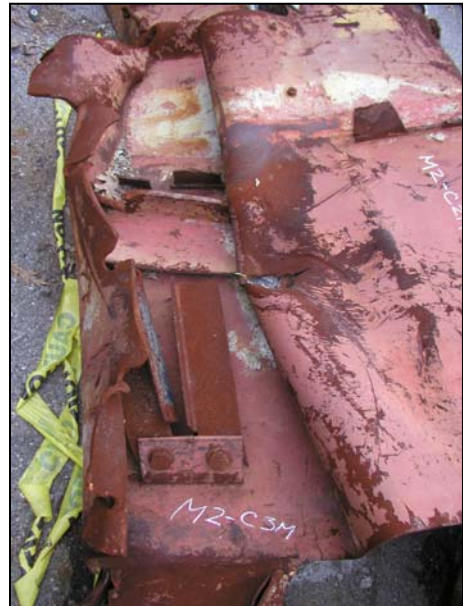
**M2-C3M (WTC 1, Col.129, Fl 98)**

Gusset plate remains;
 Seat intact, bent down, 1 bolt hole remains intact
 with bolt, other ripped out;
 Gusset plate with damper unit intact, bent up.

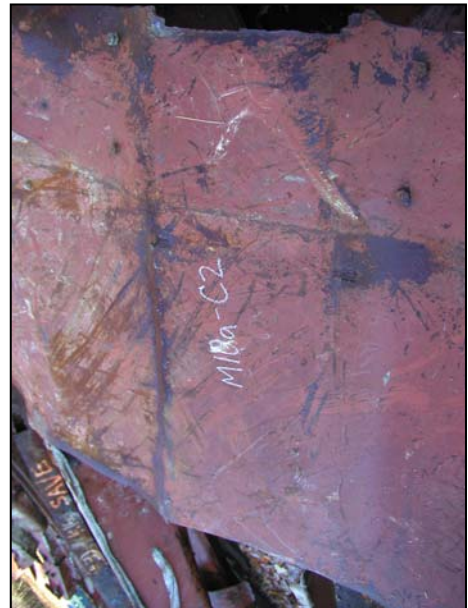
M10a-C2M (WTC 2, Col.209, Fl 84)

Both diagonal bracing straps ripped off at weld.

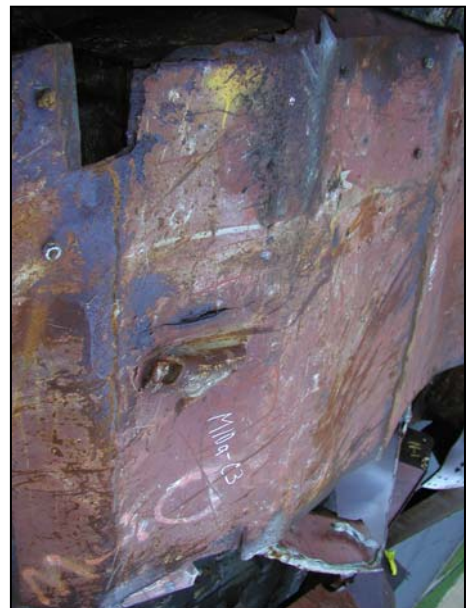
M10a-C3M (WTC 2, Col.208, Fl 84)
Type B
Seat Detail: 5010

Gusset plate ripped completely out of spandrel;
Small seat remains, highly deformed, bent
downwards, 1 bolt hole intact;
No evidence of gusset plate for damper unit.

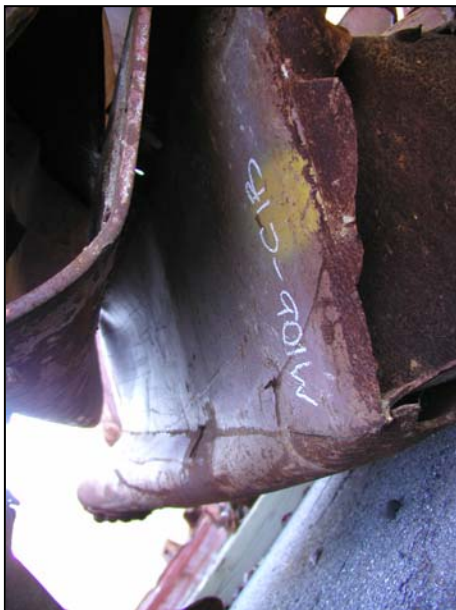
M10b-C1B (WTC 2, Col.207, Fl 84)
Type D
Seat Detail: 5110

Both diagonal bracing straps ripped off at weld.

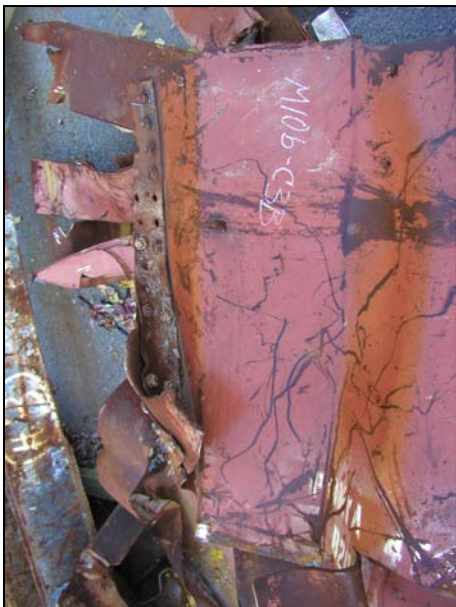
M10b-C3B (WTC 2, Col.205, Fl 84)
Type D
Seat Detail: 5110

1-in portion of diagonal bracing strap remaining,
other ripped completely out of spandrel.

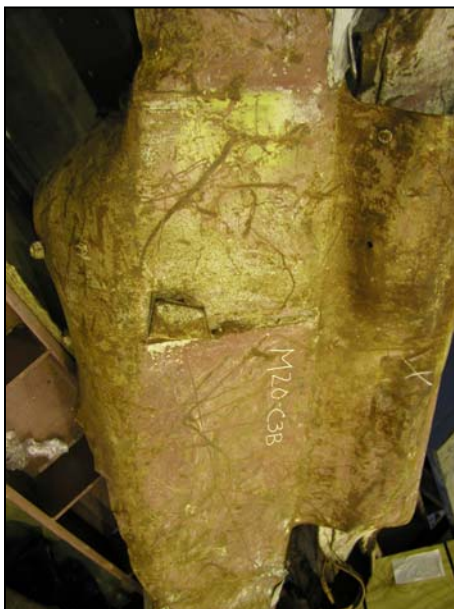
M20-C3B (WTC 1, Col.120, Fl 100)
Type C
Seat Detail: 5210

Portion of gusset plate remains, bent upward, rest
ripped off at weld.

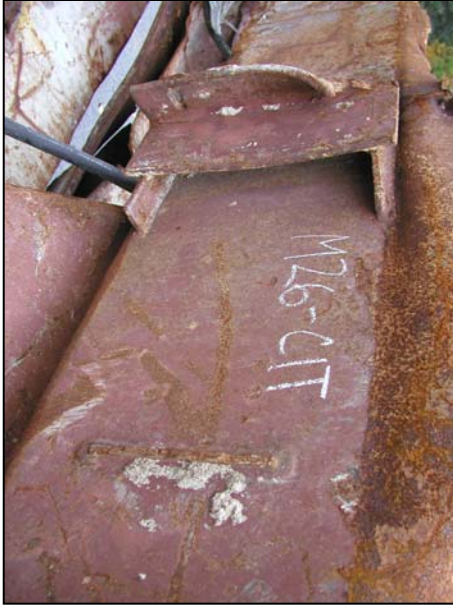
**M26-C1T (WTC 1, Col.131, Fl 93)**

Gusset plate ripped off at weld;
 Seat intact, bent downwards, 1 bolt hole remains
 intact, other ripped out;
 Gusset for damper unit ripped off at weld

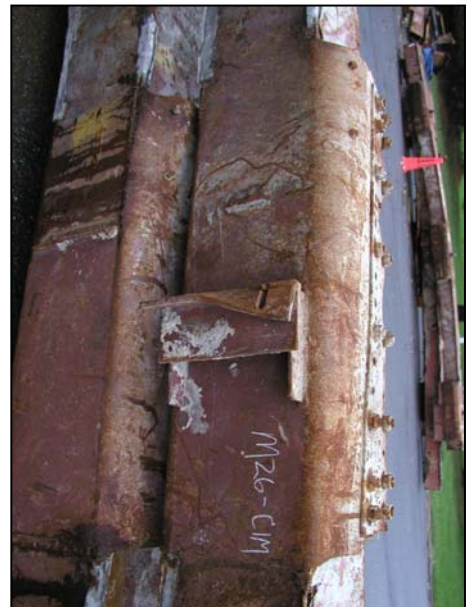
**M26-C1M (WTC 1, Col.131, Fl 92)**

Gusset plate ripped off at weld;
 Seat intact, bent downwards, 1 bolt hole remains
 intact, other ripped out;
 No evidence of gusset for damper unit.

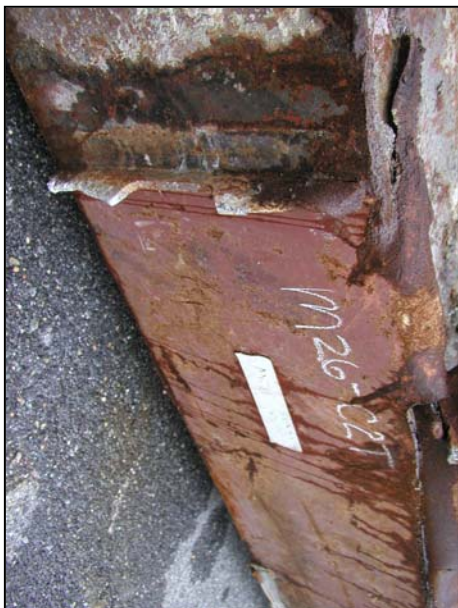
**M26-C2T (WTC 1, Col.130, FI 93)**

Gusset plate ripped at weld.

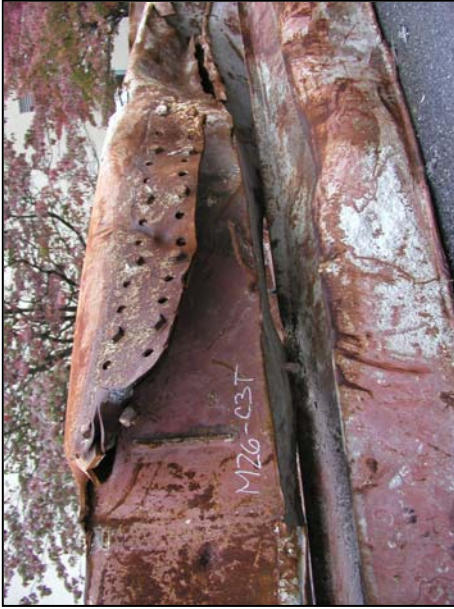
**M26-C3T (WTC 1, Col.129, Fl 93)**

Gusset plate remains;
 Only 1 standoff plate remains, seat and other
 standoff plate ripped off at welds;
 No evidence of gusset plate for damper unit.

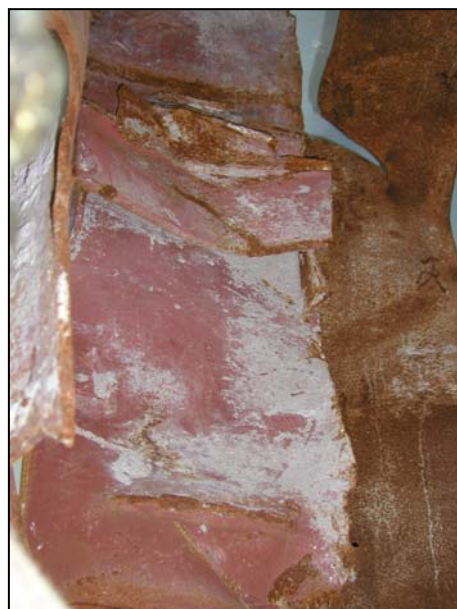
M27-C1M (WTC 1, Col.131, Fl 95)

Small portion of gusset plate remains;
Seat intact but deformed, bent in towards column,
both bolt holes ripped out;
Gusset for damper unit ripped off at welds.

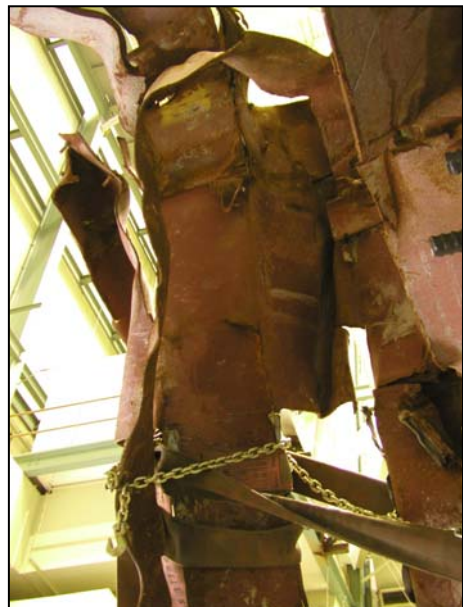
M27-C2M (WTC 1, Col.130, Fl 95)

Gusset plate remains, half bent upwards and half downwards, diagonal bracing strap attached.

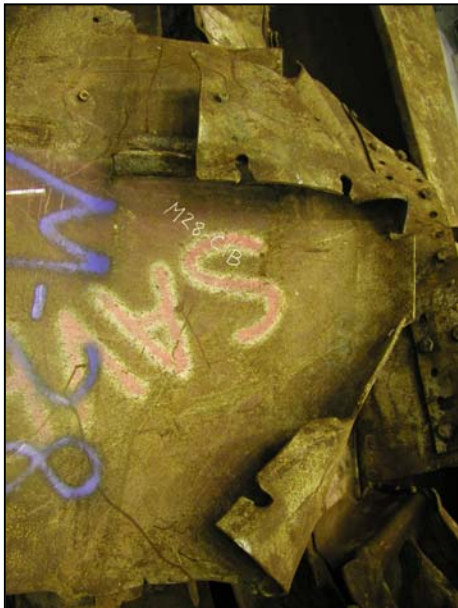
c)

M28-C1B (WTC 2, Col.346, Fl 99)

Type C
Seat Detail: 5110

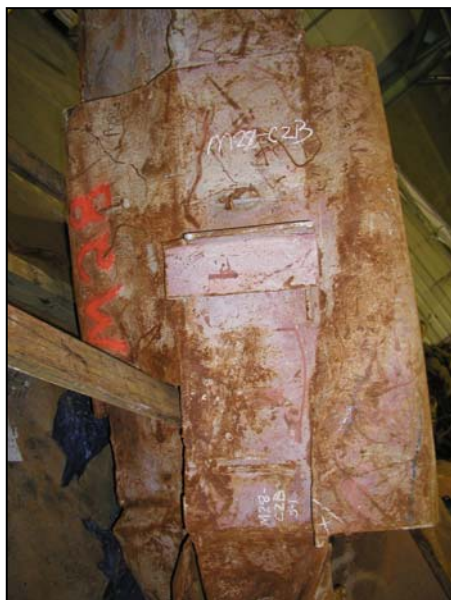
f)

M28-C2B (WTC 2, Col.345, Fl 99)

Type A

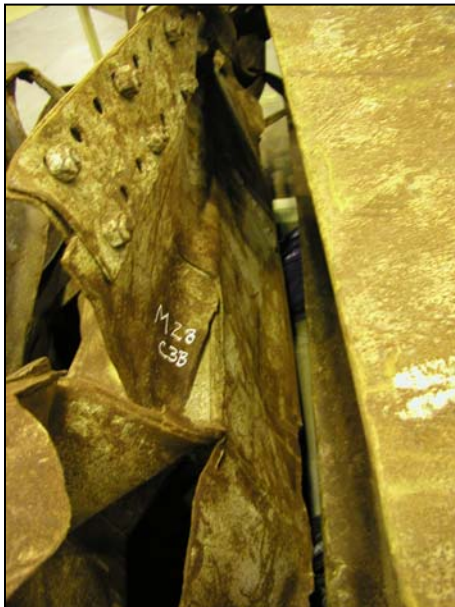
i)

M28-C3B (WTC 2, Col.344, Fl 99)
Type C
Seat Detail: 5110

Gusset plate ripped off at weld.

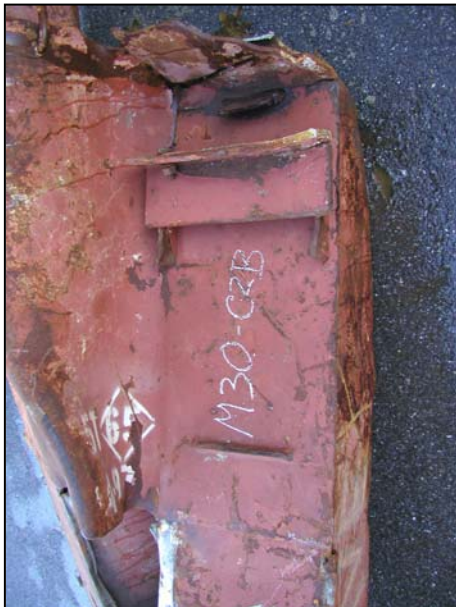
f)

M30-C2B (WTC 1, Col.133, Fl 95)

Type A
Seat Detail: 1411

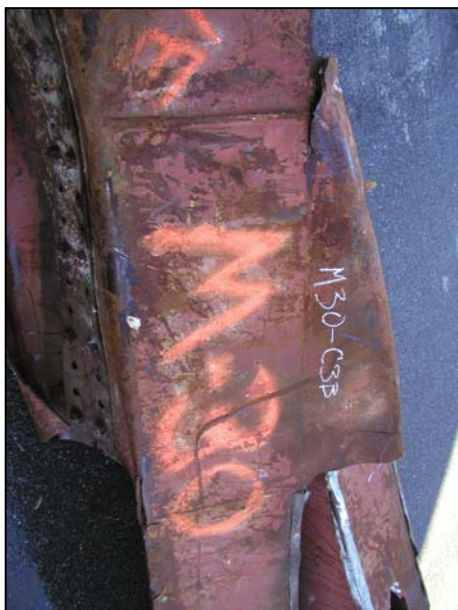
i)

M30-C3B (WTC 1, Col.132, Fl 95)
Type C
Seat Detail: 5210

Gusset plate ripped off at weld.

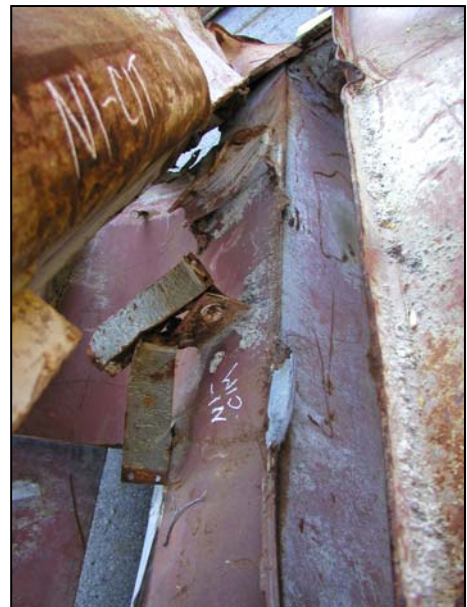
b)

**N1-C1M (WTC 1, Col.219, Fl 84)**

Type A

Gusset plate remains;
Seat intact, bent downwards, both bolt holes intact;
Gusset plate with damper unit intact, bent downwards.

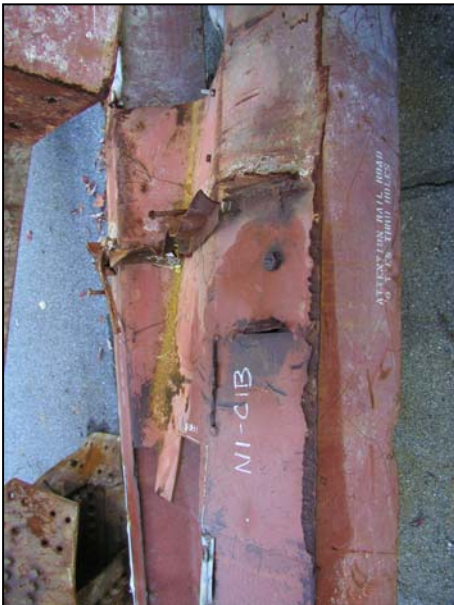
c)

**N1-C1B (WTC 1, Col.219, Fl 83)**

Type A

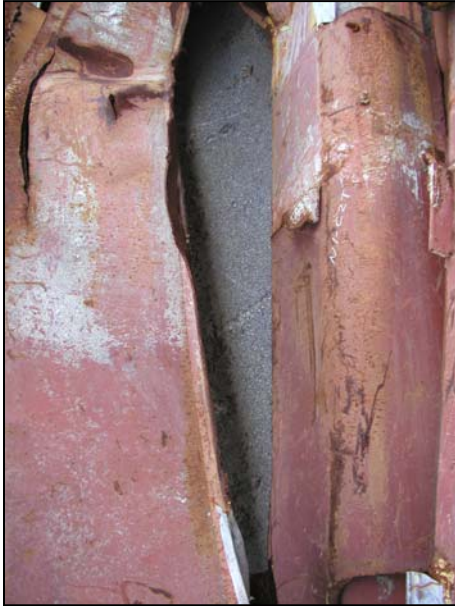
d)

**N1-C2T (WTC 1, Col.218, Fl 85)**

Type C

Portion of gusset plate remains, bent downwards.

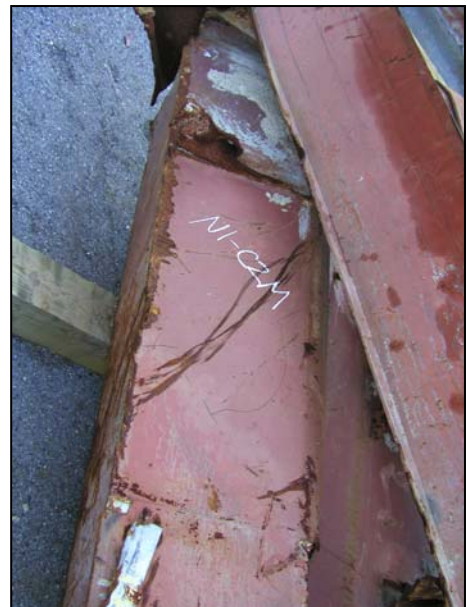
e)

**N1-C2M (WTC 1, Col.218, Fl 84)**

Type C

Gusset plate remains, but half ripped away from spandrel at weld.
