Appendix A

EXAMPLES OF PERIMETER PANEL FLOOR TRUSS CONNECTORS

The floor trusses were attached to the perimeter panels at the interior intersection of the columns and spandrels by different types of connectors. The following appendix displays photographic examples, taken by National Institute of Standards and Technology (NIST), of these types of connectors as observed on the recovered panels.

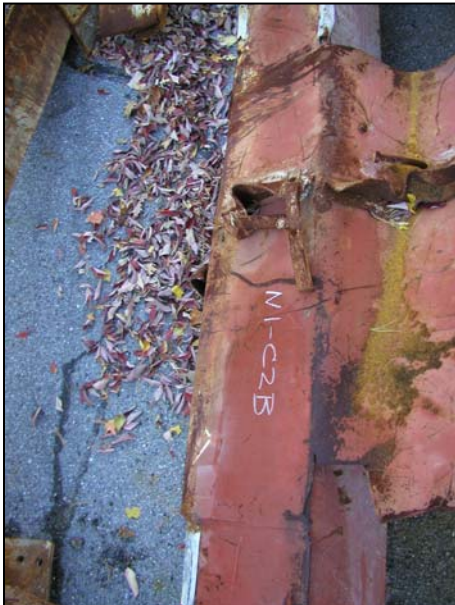
f)

**N1-C2B (WTC 1, Col.218, Fl 83)**

Type C

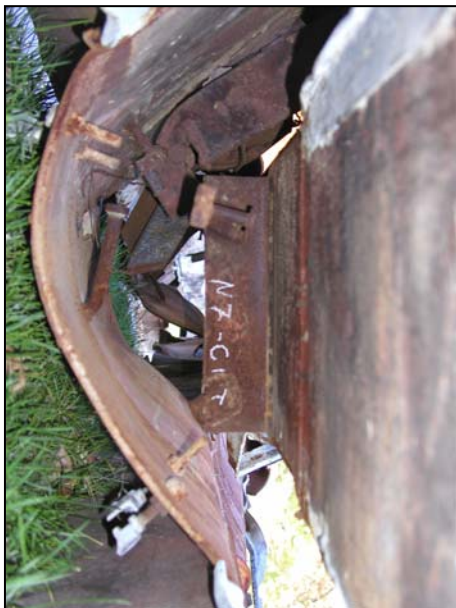
a)

**N7-C1T (WTC 1, Col.128, Fl 100)**

Type C

Portion of gusset plate remains, bent downward.

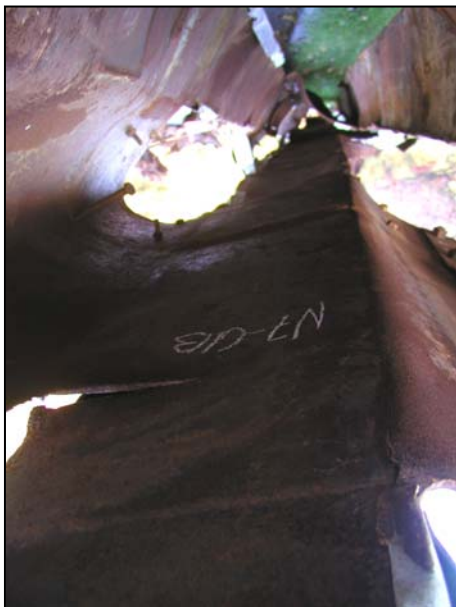
c)

**N7-C1B (WTC 1, Col.128, Fl 98)**

Type C

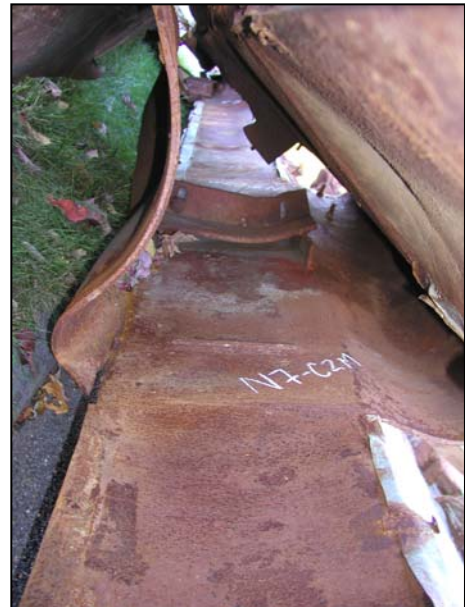
e)

**N7-C2M (WTC 1, Col.127, Fl 99)**

Type A

Gusset plate ripped off at weld;
 Seat intact, bent in towards column, both bolt holes intact, 1 with bolt and nut;
 Gusset plate for damper unit ripped off at weld.

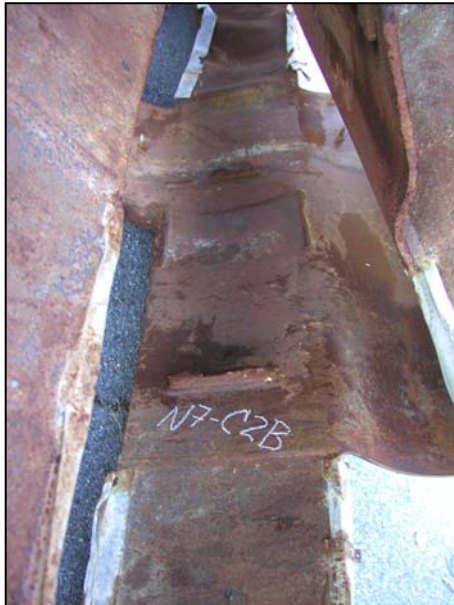
f)

**N7-C2B (WTC 1, Col.127, Fl 98)**

Type A

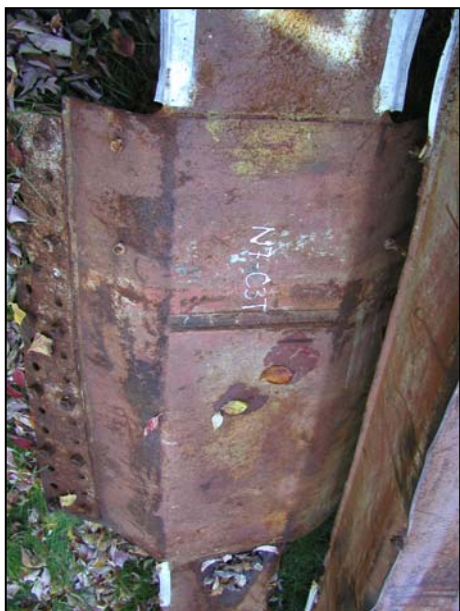
g)

**N7-C3T (WTC 1, Col.126, Fl 100)**

Type C

Gusset plate ripped off at welds.

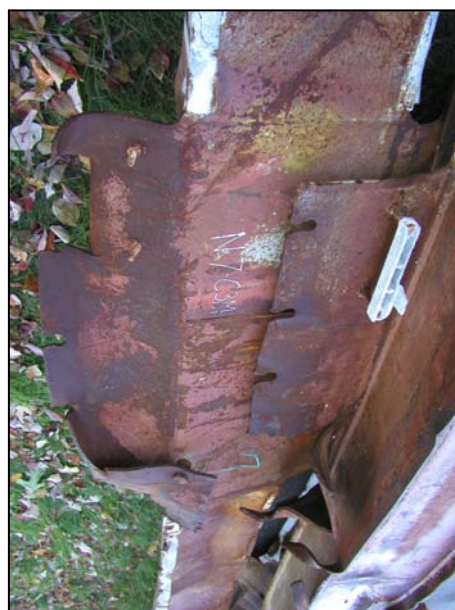
h)

**N7-C3M (WTC 1, Col.126, Fl 99)**

Type C

Gusset plate ripped off at welds.

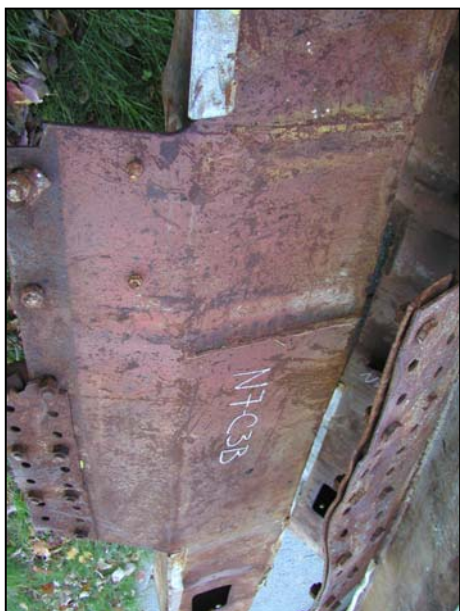
i)

**N7-C3B (WTC 1, Col.126, Fl 98)**

Type C

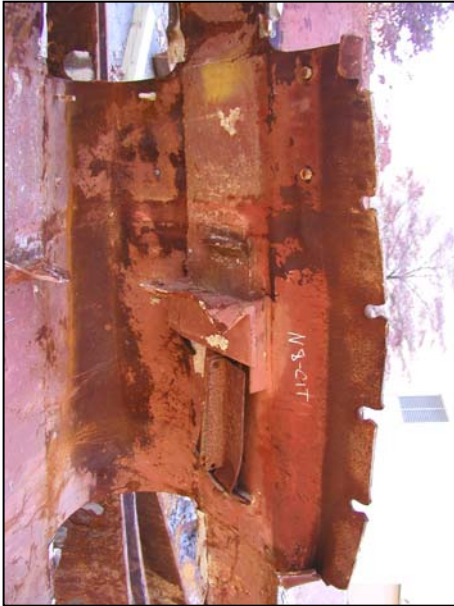
a)

**N8-C1T (WTC 1, Col.143, Fl 100)**

Type A

Gusset plate intact;
 Seat intact, partially bent downwards, both bolt
 holes intact, 1 with bolt and nut;
 Gusset with damper unit intact, bent upwards.

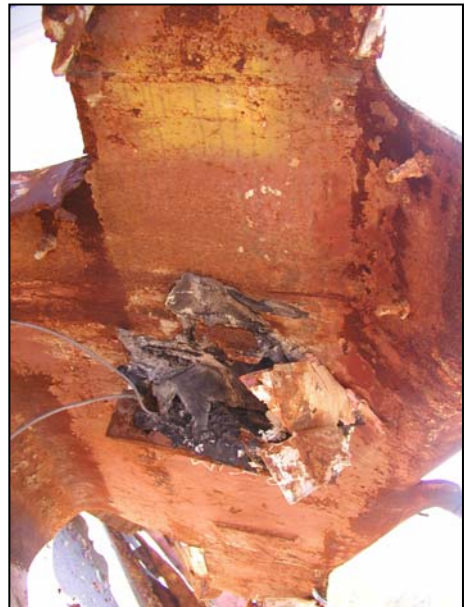
b)

**N8-C1M (WTC 1, Col.143, Fl 99)**

Type A

Gusset plate intact;
 Seat intact, partially bent downwards, both bolt
 holes intact with bolts and nuts;
 Gusset for damper unit ripped off at weld.

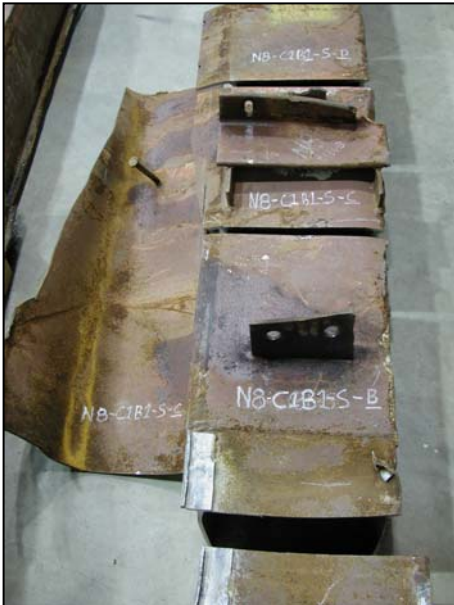
c)

**N8-C1B (WTC 1, Col.143, Fl 98)**

Type A

Portion of gusset plate remains;
 Seat intact, partially bent downwards, one bolt hole
 intact, other ripped out;
 Gusset plate for damper unit intact, bolt holes intact,
 damper unit missing

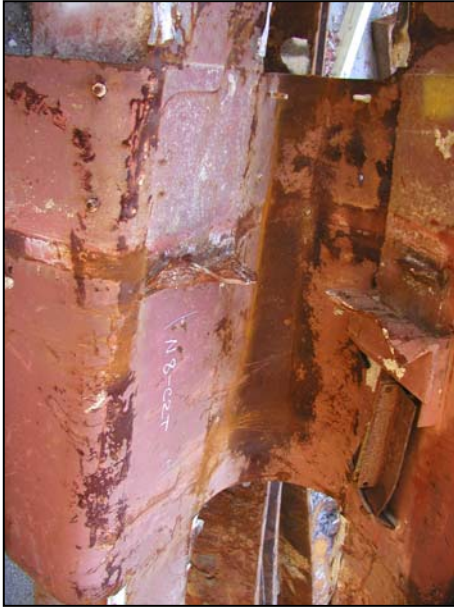
d)

**N8-C2T (WTC 1, Col.142, Fl 100)**

Type C

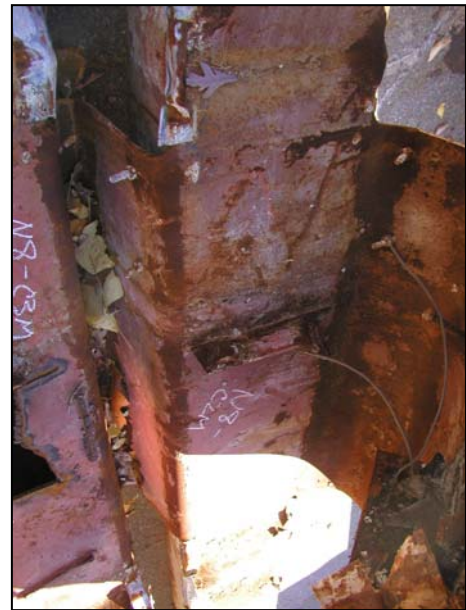
e)

Gusset plate intact with portion of diagonal bracing strap attached, bent downwards.

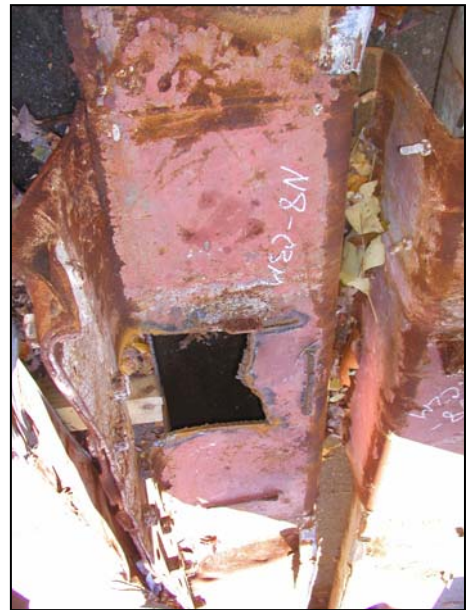
**N8-C3M (WTC 1, Col.141, Fl 99)**

Portion of gusset plate intact;
 Seat intact, both bolt holes intact with bolts and nuts;
 Gusset plate for damper unit ripped off at weld.

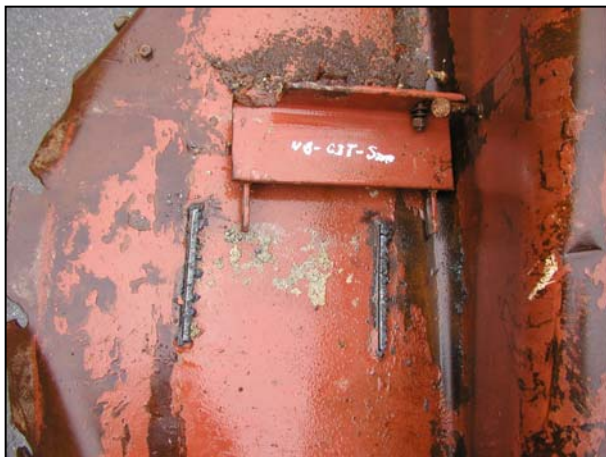
**N8-C3T (WTC 1, Col.141, Fl 100)**

Cut for Boulder on 10/02

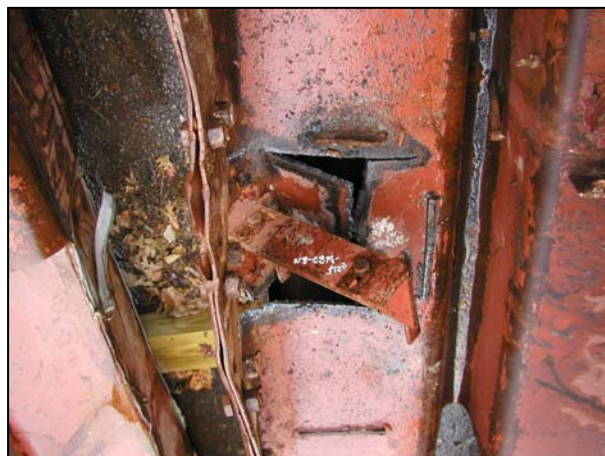
**N8-C3M (WTC 1, Col.141, Fl 99)**

Cut for Boulder on 10/02

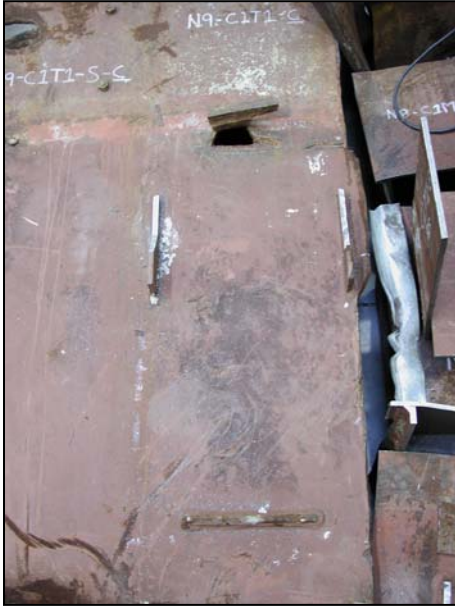
**N9-C1T (WTC 1, Col.155, Fl 104)**

Gusset plate ripped completely out of spandrel;
Only part of 1 standoff plate remains, rest ripped off at welds;

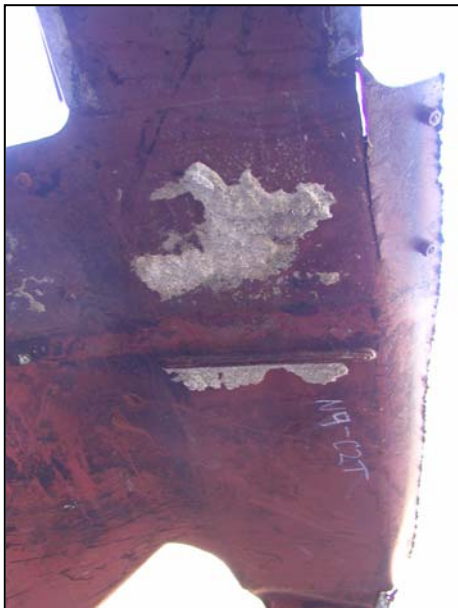
**N9-C2T (WTC 1, Col.154, Fl 104)**

Gusset plate ripped off at weld.

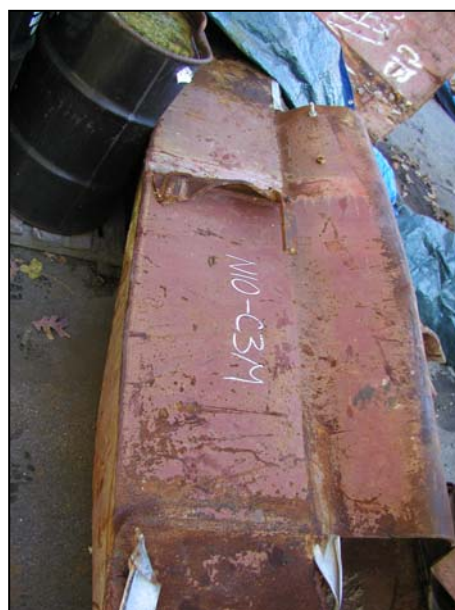
N10-C3M (WTC 1, Col.114, Fl 91)

Gusset plate remains, bent downwards, with portion of diagonal bracing strap still attached.

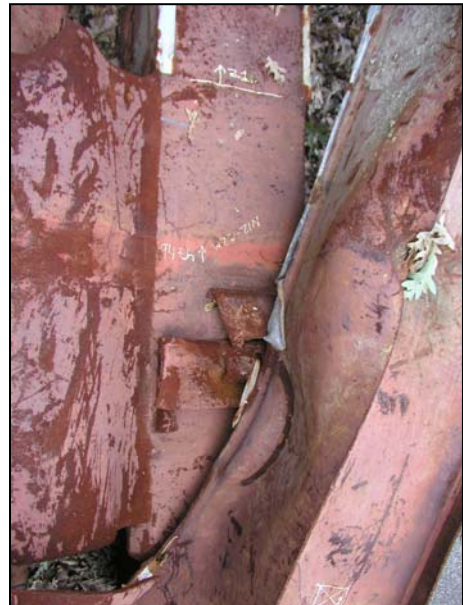
**N12-C2M (WTC 1, Col.206, Fl 94)**

Gusset plate intact, bent downwards;
 Seat intact, bent downwards and in towards
 column, one bolt hole intact, other ripped out;
 Gusset plate for damper unit ripped off at weld.

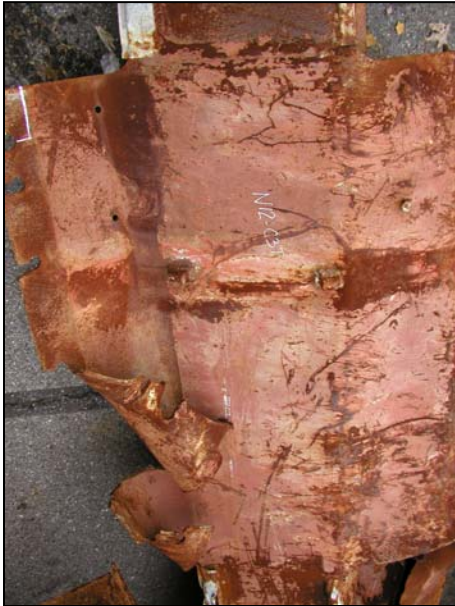
**N12-C3T (WTC 1, Col.205, Fl 95)**

2 1-in portions of diagonal bracing straps remaining

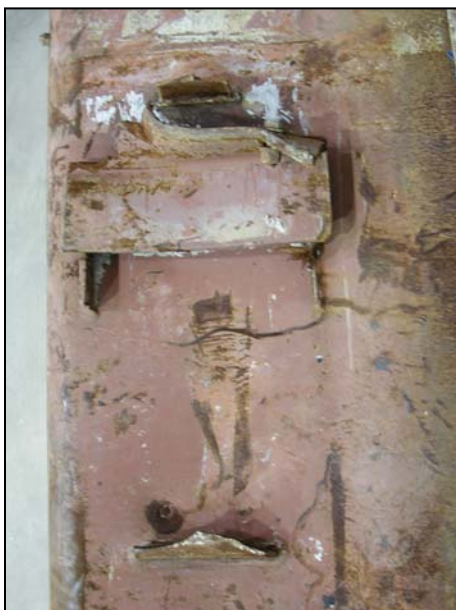
N13-C1B (WTC 1, Col.131, Fl 100)
Type A
Seat Detail: 1411

Gusset plate remains;
Seat intact, bent upwards, 1 bolt hole ripped but still
has bolt and nut, other completely ripped out;
Portion of gusset plate remains, bent upwards.

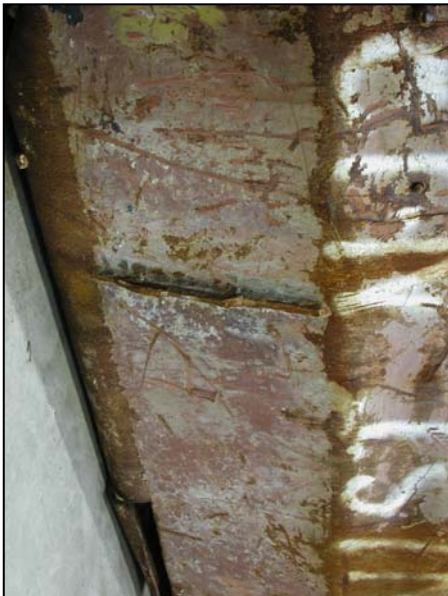
N13-C2B (WTC 1, Col.130, Fl 100)
Type C
Seat Detail: 5210

Gusset plate ripped off at weld.

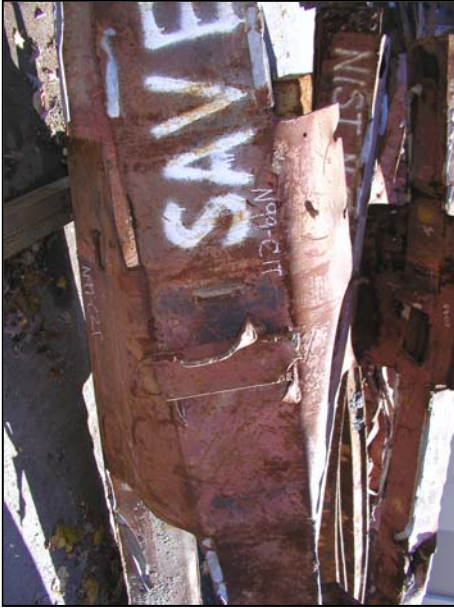
**N99-C1T (WTC 1, Col.149, Fl 102)**

Gusset plate intact;
 Seat intact, bent upwards, both bolt holes ripped out;
 Gusset for damper unit ripped off at weld.

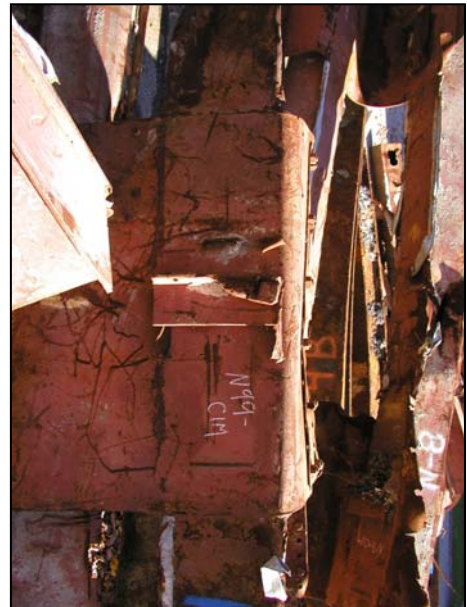
**N99-C1M (WTC 1, Col.149, Fl 101)**

Gusset plate ripped off at weld;
 Seat intact, partially bent downwards, 1 bolt hole intact, other ripped through but bolt remains;
 Gusset for damper unit ripped off at weld.

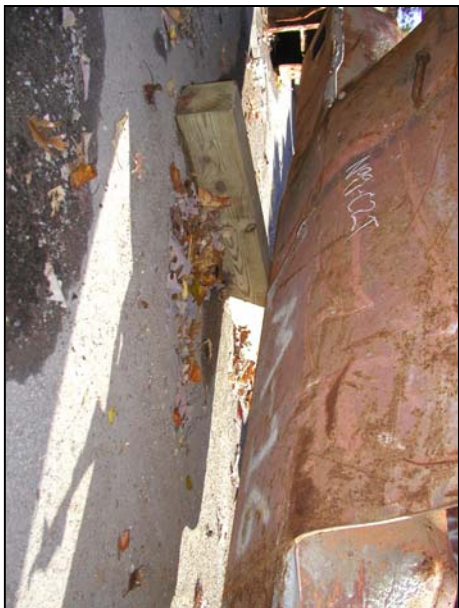
**N99-C2T (WTC 1, Col.148, Fl 102)**

Gusset plate ripped off at weld.

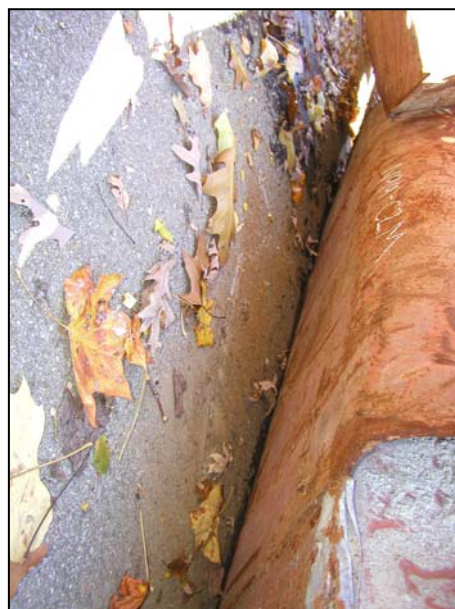
**N99-C2M (WTC 1, Col.148, Fl 101)**

Gusset plate ripped off at weld.

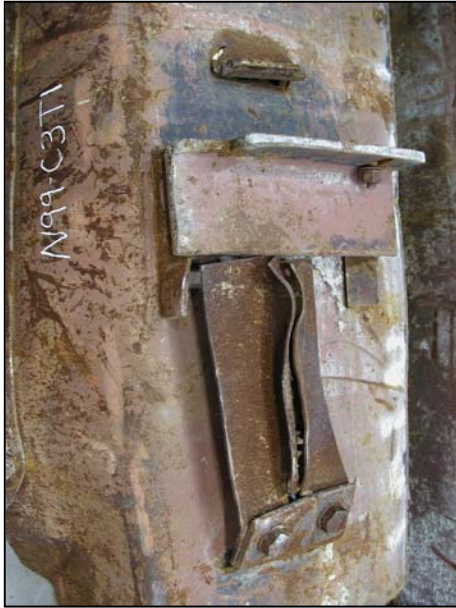
**N99-C3T (WTC 1, Col.147, Fl 102)**

Gusset plate intact;
 Seat intact, 1 bolt hole intact with bolt and nut, other ripped out;
 Gusset for damper unit ripped off at weld.

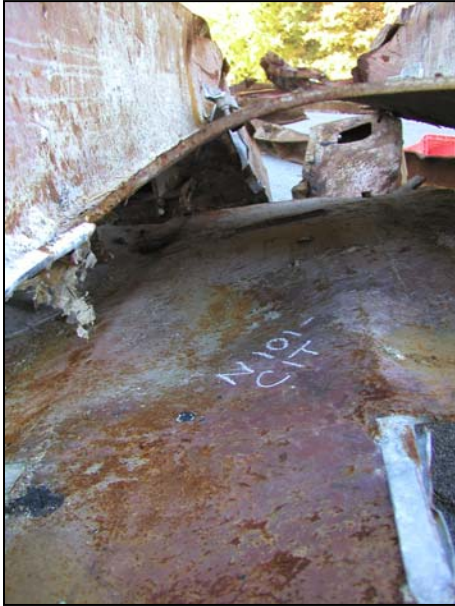
**N101-C1T (WTC 1, Col.134, Fl 103)**

Gusset plate ripped off at weld.

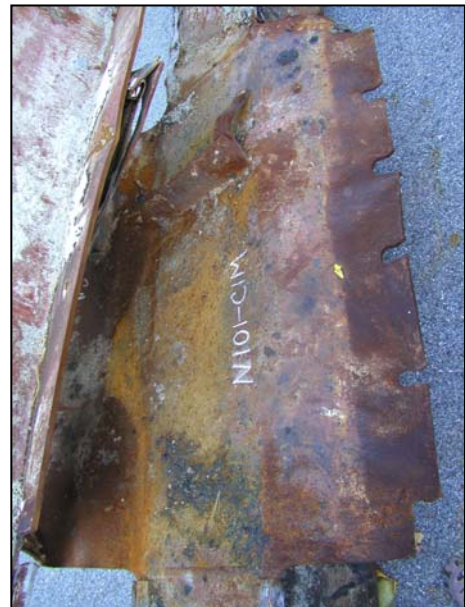
**N101-C1M (WTC 1, Col.134, Fl 102)**

Gusset plate intact with diagonal bracing strap attached, bent upwards.

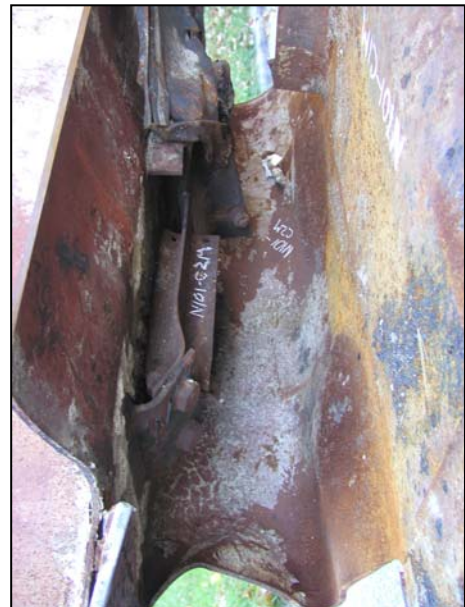
**N101-C2M (WTC 1, Col.133, Fl 102)**

Gusset plate intact, bent upwards;
 Seat intact, both bolt holes intact with bolts and nuts;
 Gusset with damper unit intact, bent upwards.

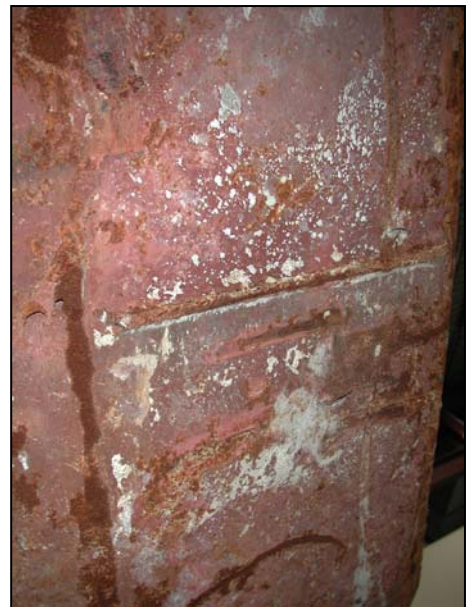
**N101-C3M (WTC 1, Col.132, Fl 102)**

Gusset plate ripped out at weld.

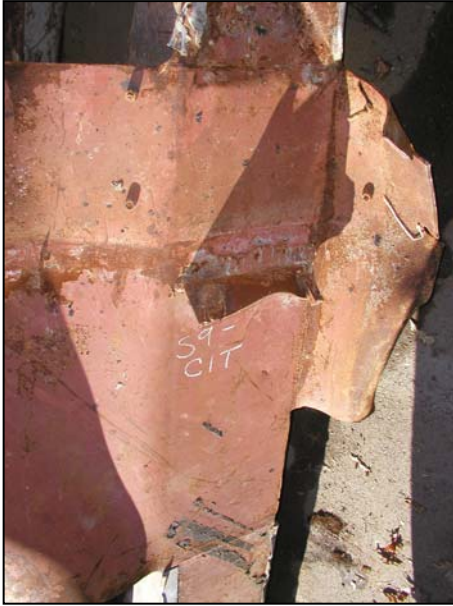
**S9-C1T (WTC 1, Col.134, Fl 100)**

Gusset plate intact, bent downwards, with diagonal bracing strap attached.

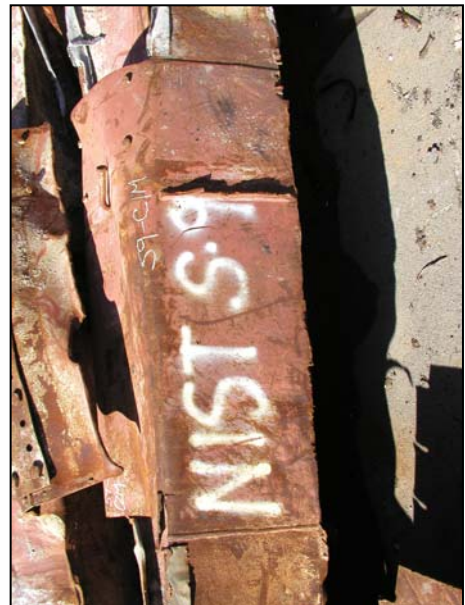
**S9-C1M (WTC 1, Col.134, Fl 99)**

Gusset plate ripped off at weld.

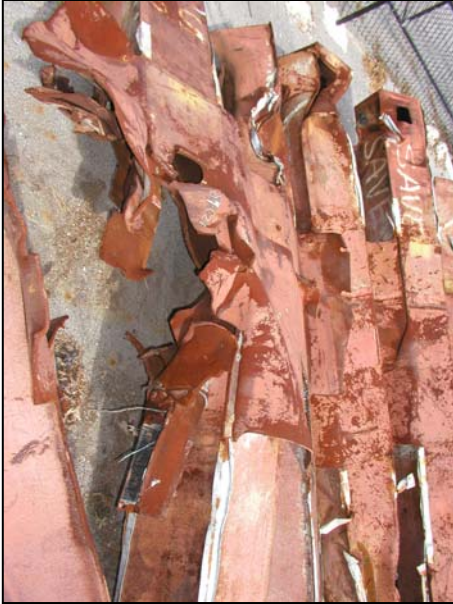
**S9-C2T (WTC 1, Col.133, Fl 100)**

Gusset plate intact;
Seat intact, bent in towards column, 1 bolt hole intact
with bolt and nut;
Gusset plate for damper unit ripped off at weld.

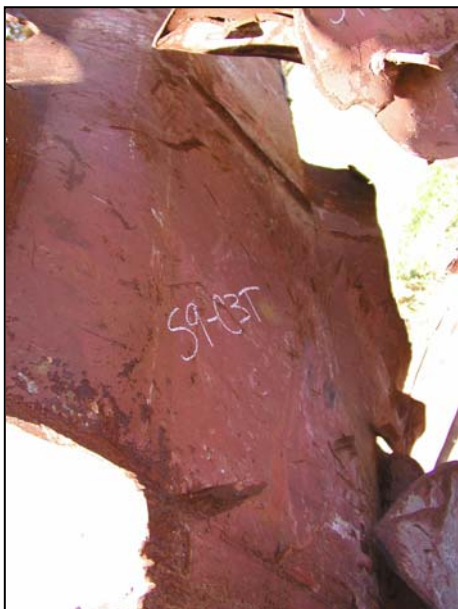
**S9-C3T (WTC 1, Col.132, Fl 100)**

Gusset plate ripped out at weld.

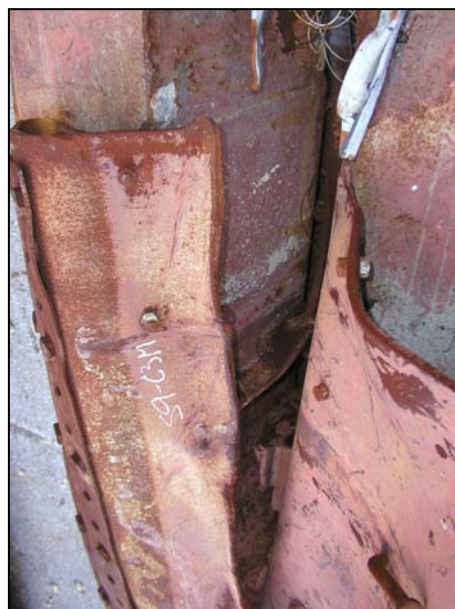
**S9-C3M (WTC 1, Col.132, Fl 99)**

Gusset plate intact with portion of diagonal bracing strap attached.

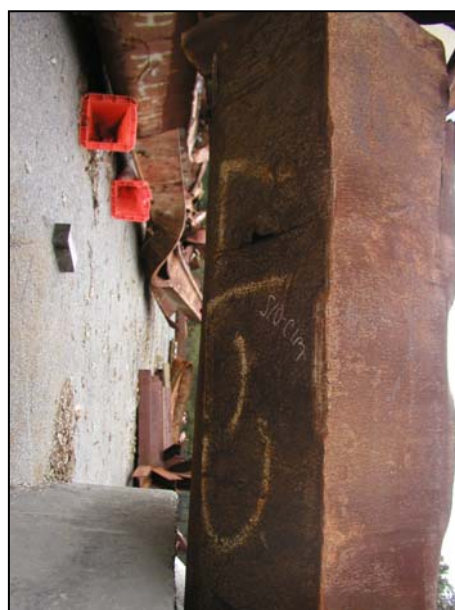
S10-C1M (WTC 1, Col.225, Fl 94)

Gusset plate ripped out of spandrel;
Shear plates ripped off at welds;
Gusset plate for damper unit ripped off at weld.

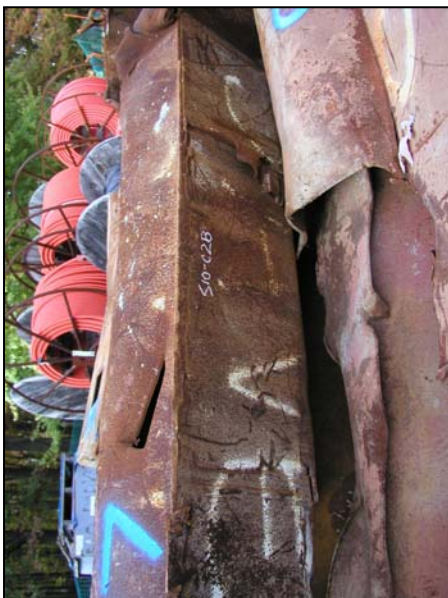
S10-C2B (WTC 1, Col.224, Fl 93)
Type C
Seat Detail: 5110

Portion of large gusset plate remains, bent downwards.

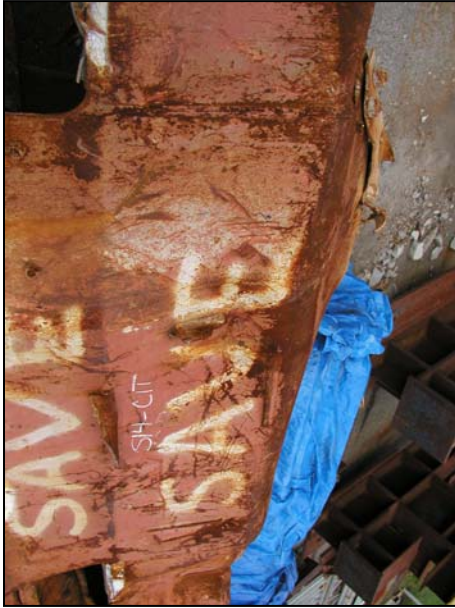
**S14-C1T (WTC 2, Col.219, Fl 94)**

Gusset plate ripped completely out of spandrel;
Seat intact but badly deformed, half bent upwards and half bent downwards, both bolt holes ripped through though bolts and nuts remain;
Gusset plate with damper unit intact, bent upwards.

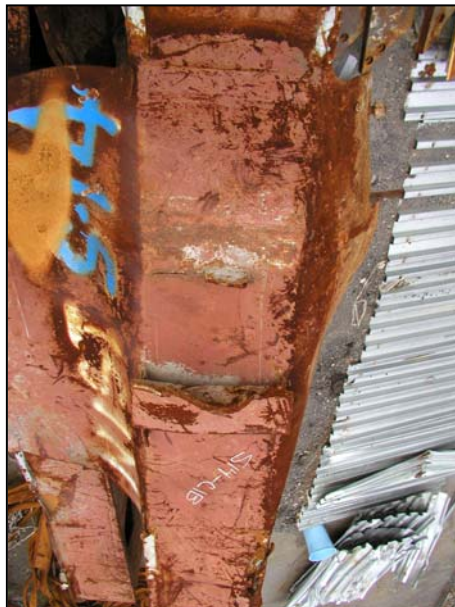
**S14-C1B (WTC 2, Col.219, Fl 92)**

Type A

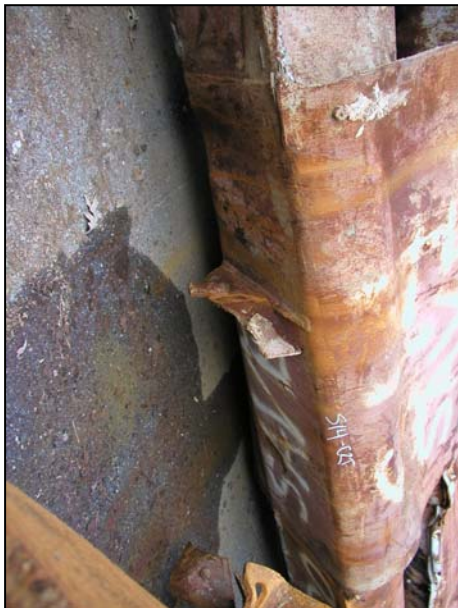
**S14-C2T (WTC 2, Col.218, Fl 94)**

Type C

Large gusset plate ripped off at weld.

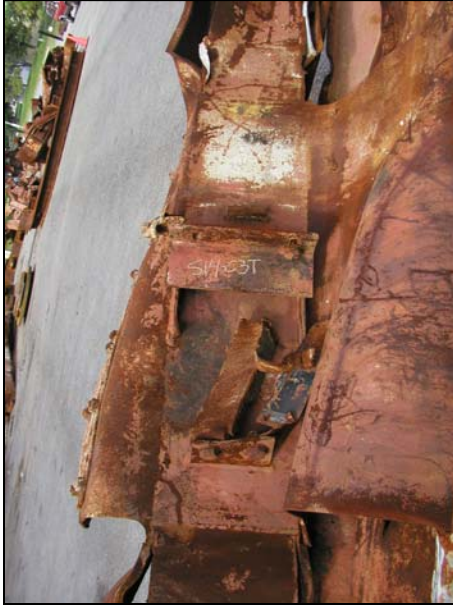
**S14-C3T (WTC 2, Col.217, Fl 94)**

Gusset plate intact;
 Seat intact, both bolt holes intact, only one has bolt and nut;
 Gusset plate with damper unit intact, bent upwards.

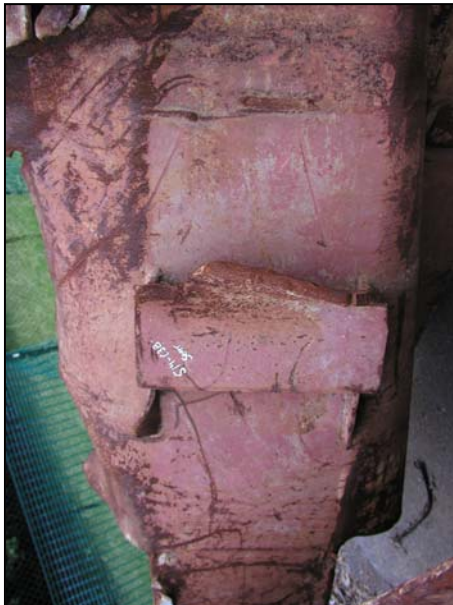
**S14-C3B (WTC 2, Col.217, Fl 92)**

Type A

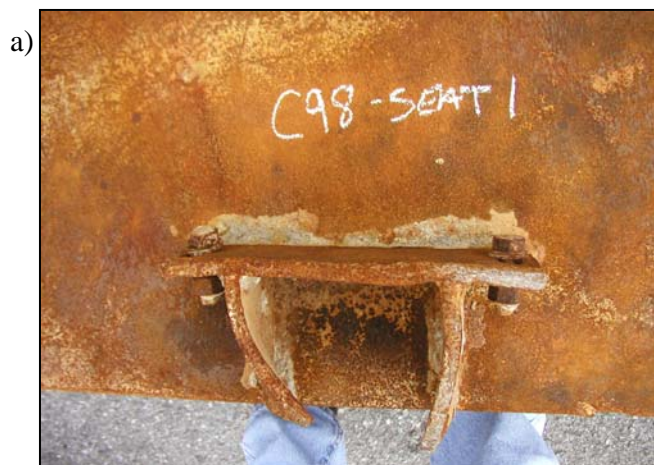
Seat 1: Both holes intact, both have bolts remaining, seat was bent

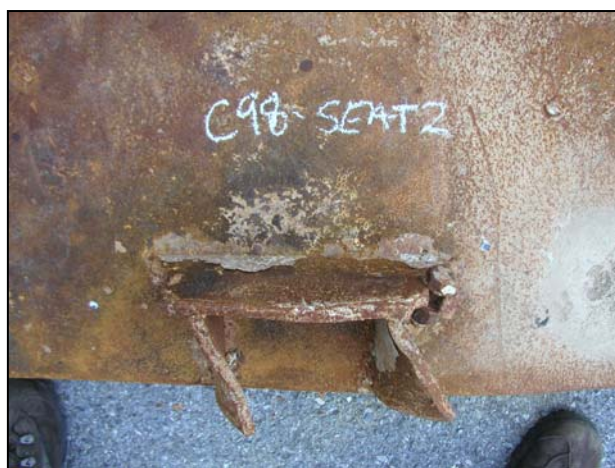
Figure C-5. Sample C-98, channel with two seats.

Seat 2: Both holes ripped through, one has bolt remaining, seat was bent

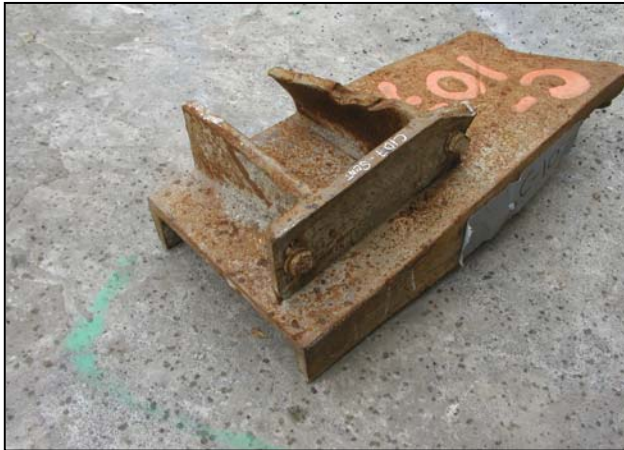
Figure C-7. Sample C-107, channel with one seat.

One seat with both holes intact, both holes have bolts remaining

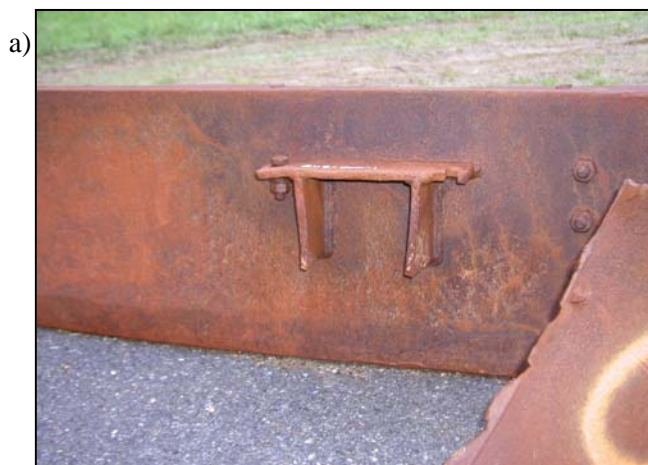
Seat 1: One hole intact with bolt, other ripped out

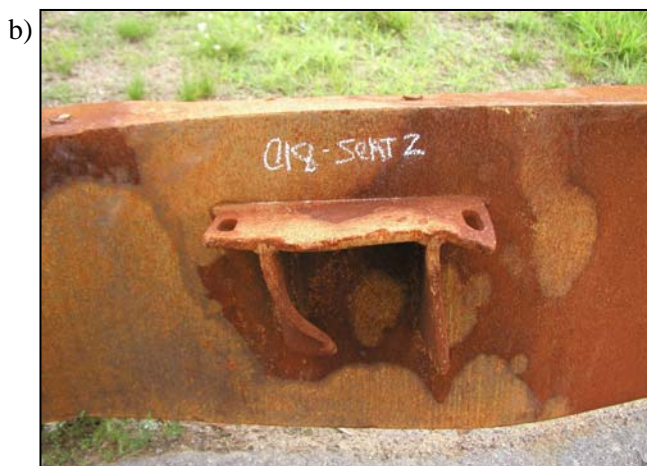
Seat 2: Both holes intact, seat was slightly bent

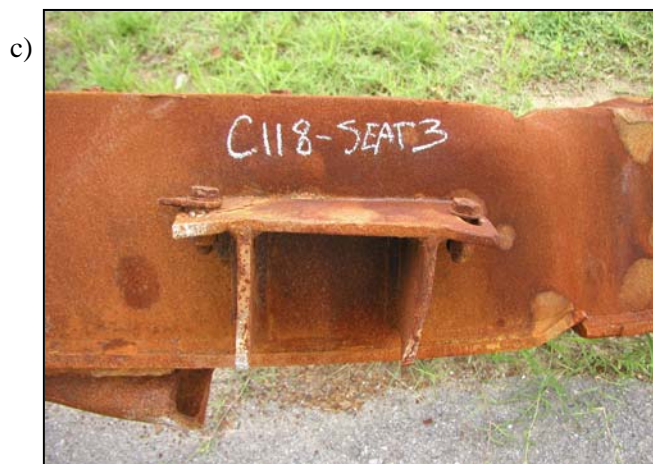
Figure C-8. Sample C-118, channel with three seats.

Seat 3: Both holes intact with bolts remaining

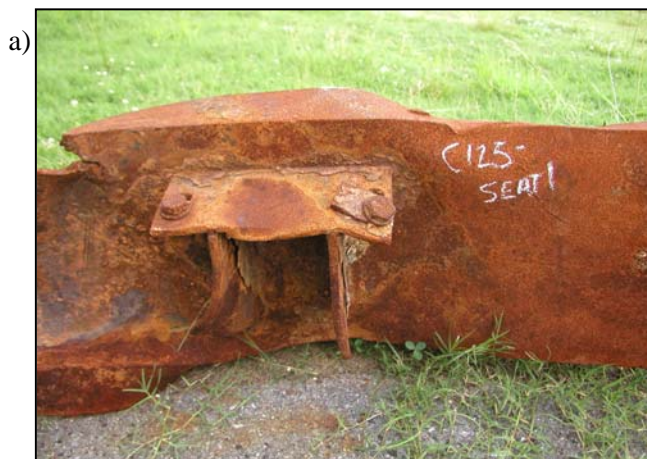
Seat 1: Both holes intact with bolts remaining, one has piece of angle attached, seat was bent

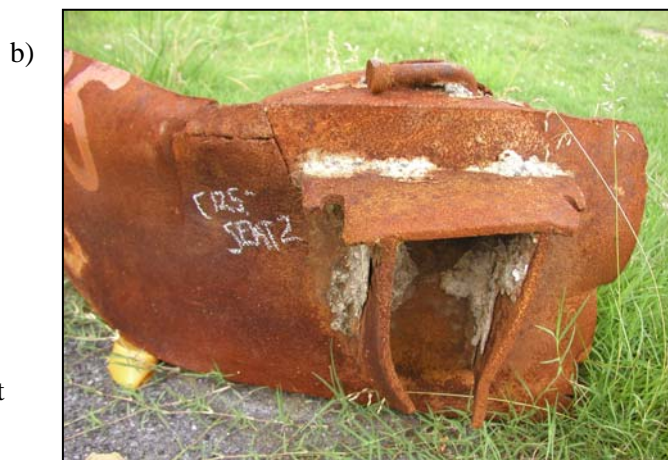
Figure C-9. Sample C-125, channel with two seats.

Seat 2: Both holes ripped out, seat was bent

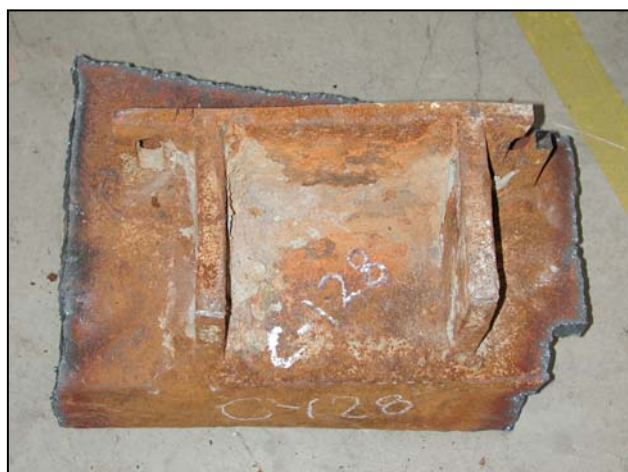
Figure C-10. Sample C-128, channel with one seat.

One seat with one hole intact with bolt, other is ripped out

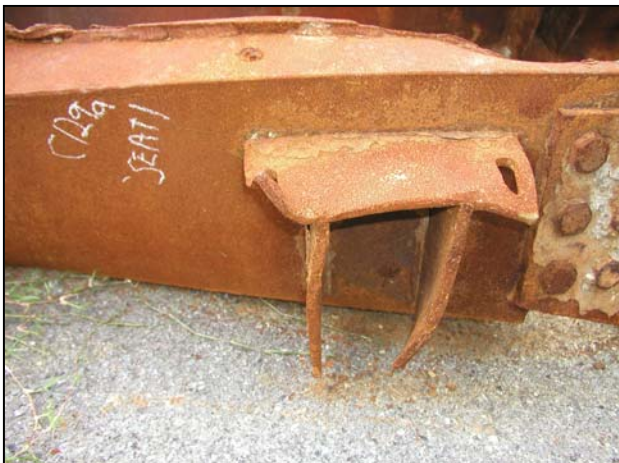
Seat 1a: One hole intact, other ripped out, seat was bent

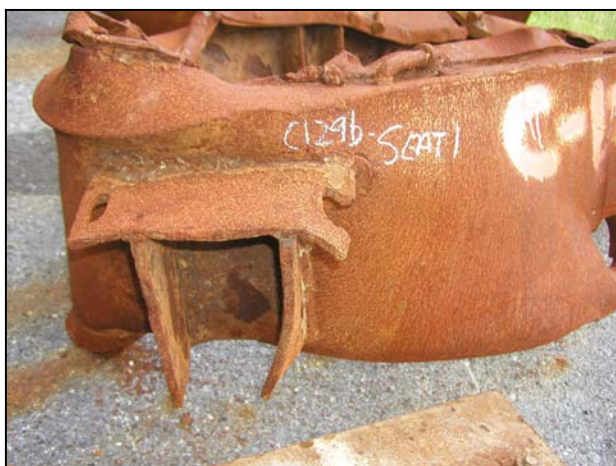
Seat 1b: One hole intact with bolt, other is ripped out, seat was bent

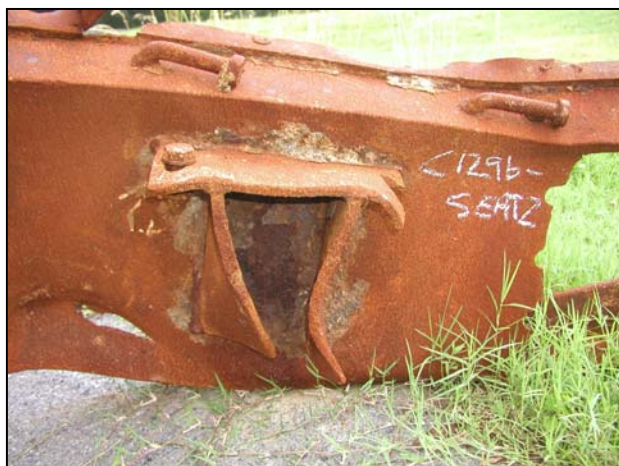
Figure C-11. Sample C-129, two connected channels with three seats.

Seat 2b: Both holes intact, seat was bent

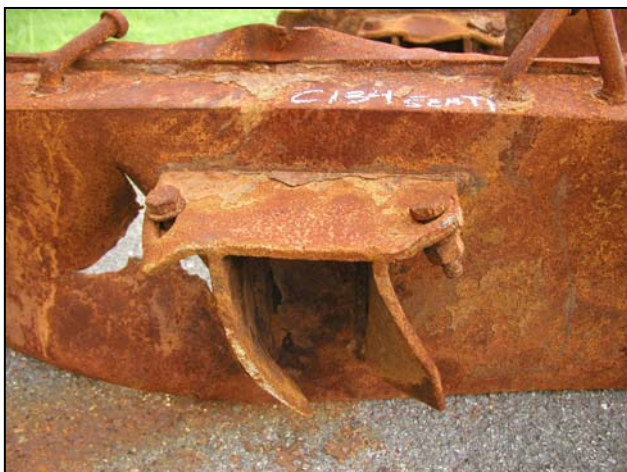
Figure C-12. Sample C-134, channel with one seat.

One seat with both holes intact, both holes have bolts remaining, seat was bent

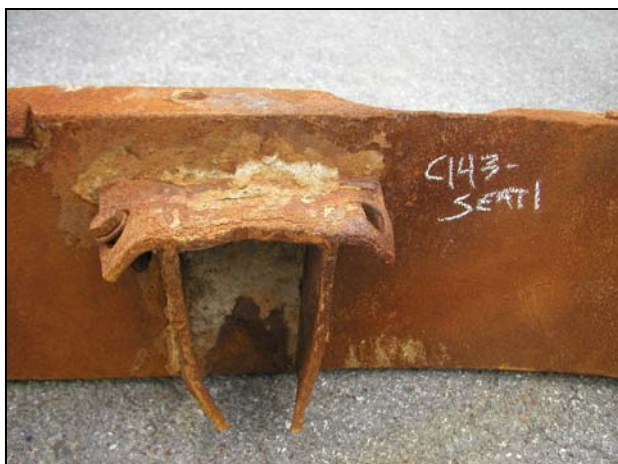
Seat 1: Both holes intact, one has bolt remaining, seat was bent

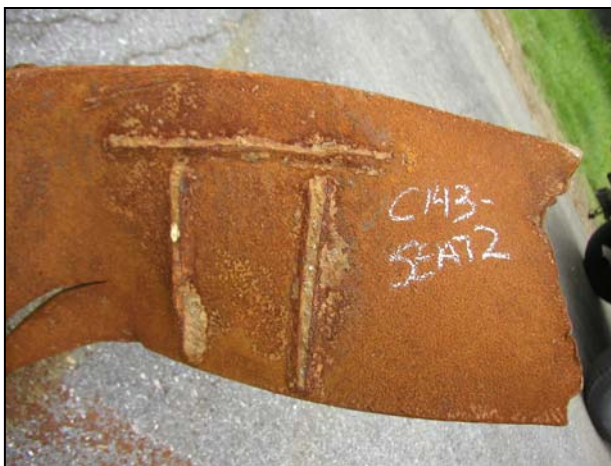
Figure C-15. Sample C-143, channel with two seats.

Seat 2: Ripped off at the weld

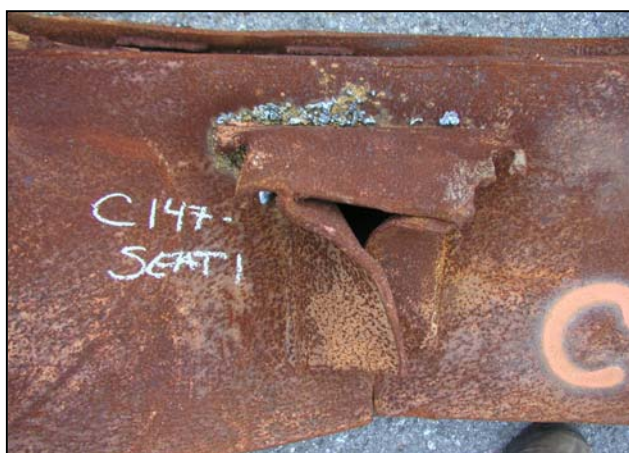
Figure C-18. Sample C-147, channel with one seat.

One seat with both holes ripped out,
seat was bent

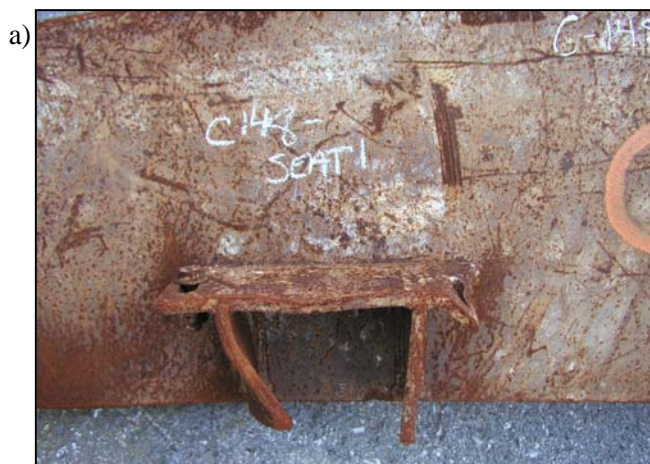
Seat 1: Both holes intact, one has
bolt

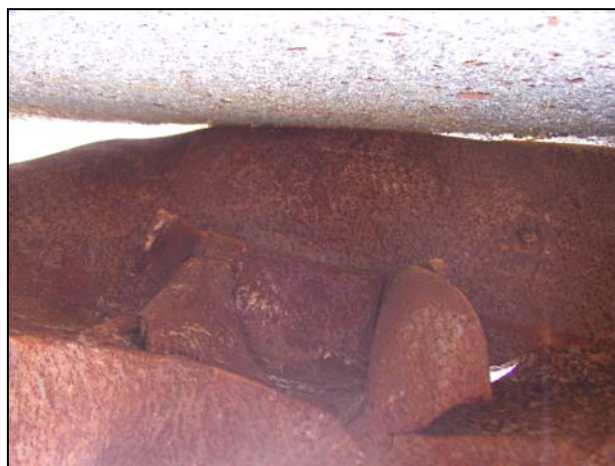
Figure C-19. Sample C-148, channel with two seats.

Seat 2: Both holes ripped out,
seat crushed

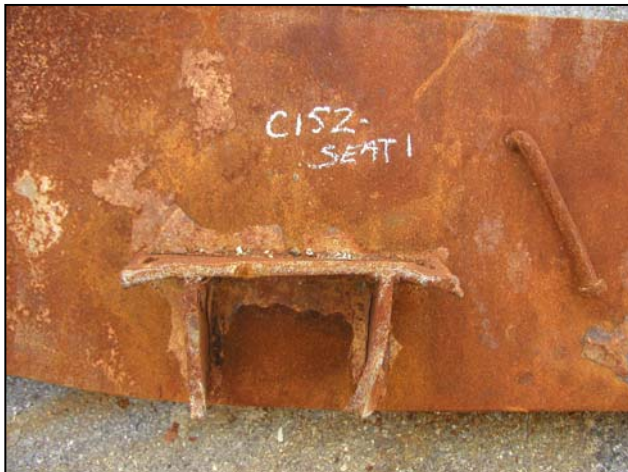
Figure C-20. Sample C-152, channel with one seat.

One seat with both holes intact

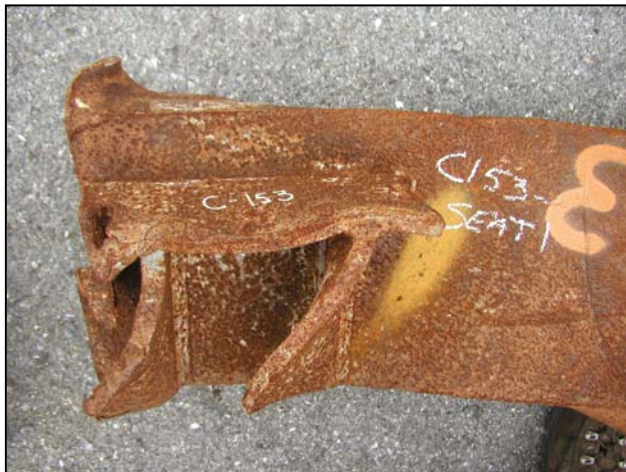
Figure C-21. Sample C-153, channel with one seat.

One seat with both holes
ripped out, seat was bent

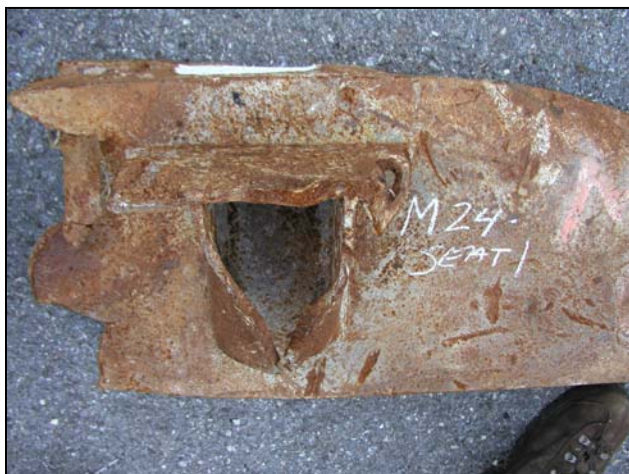
Figure C-22. Sample M-24, channel with one seat.

One seat with both holes intact,
seat was bent

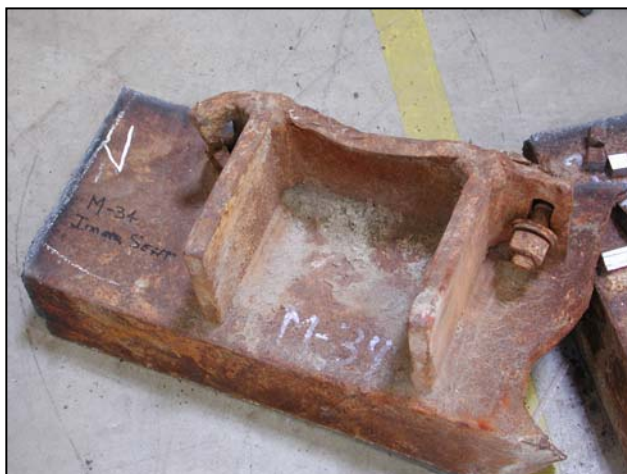
Figure C-23. Sample M-34, channel with one seat.

One seat with one hole intact with
bolt remaining, other was ripped out

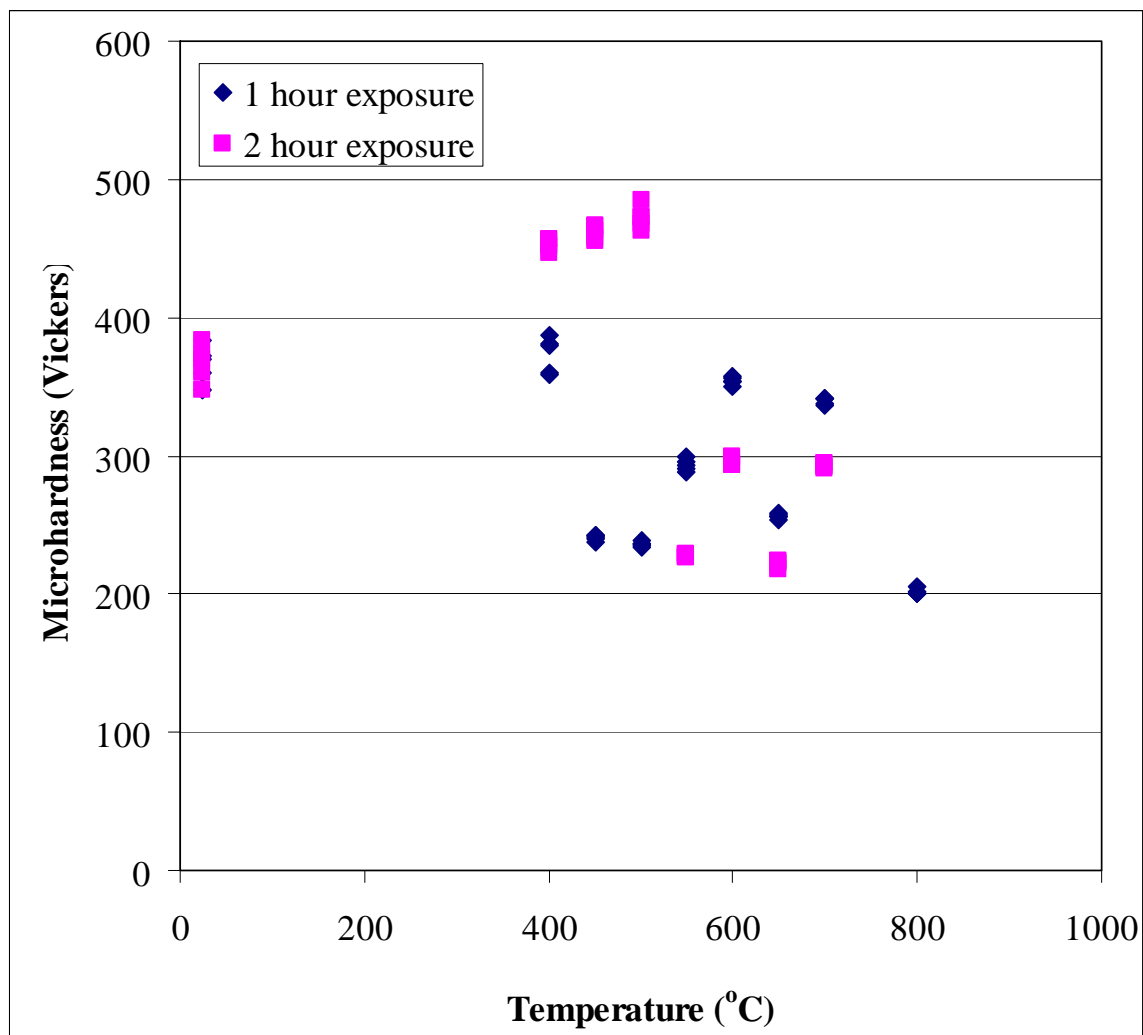
The washers used on the vertical and spandrel bolted connections of the panels of the exterior wall were punched from high strength steel sheet and were subjected to a post-manufacturing anneal to decrease the possibility of warping or cracking. These washers have a high hardness which relies on metastable microstructures and residual stresses that may change with high temperature exposure. The hardness of the washers of the vertical and spandrel panel connections was examined to see if they could give an indication of the maximum temperature of exposure for a given associated component.

Figure D-5. Plot of Vickers microhardness versus exposure temperature for washers recovered from WTC structural steel.
