Appendix A

EXAMPLES OF PERIMETER PANEL FLOOR TRUSS CONNECTORS

The floor trusses were attached to the perimeter panels at the interior intersection of the columns and spandrels by different types of connectors. The following appendix displays photographic examples, taken by National Institute of Standards and Technology (NIST), of these types of connectors as observed on the recovered panels.

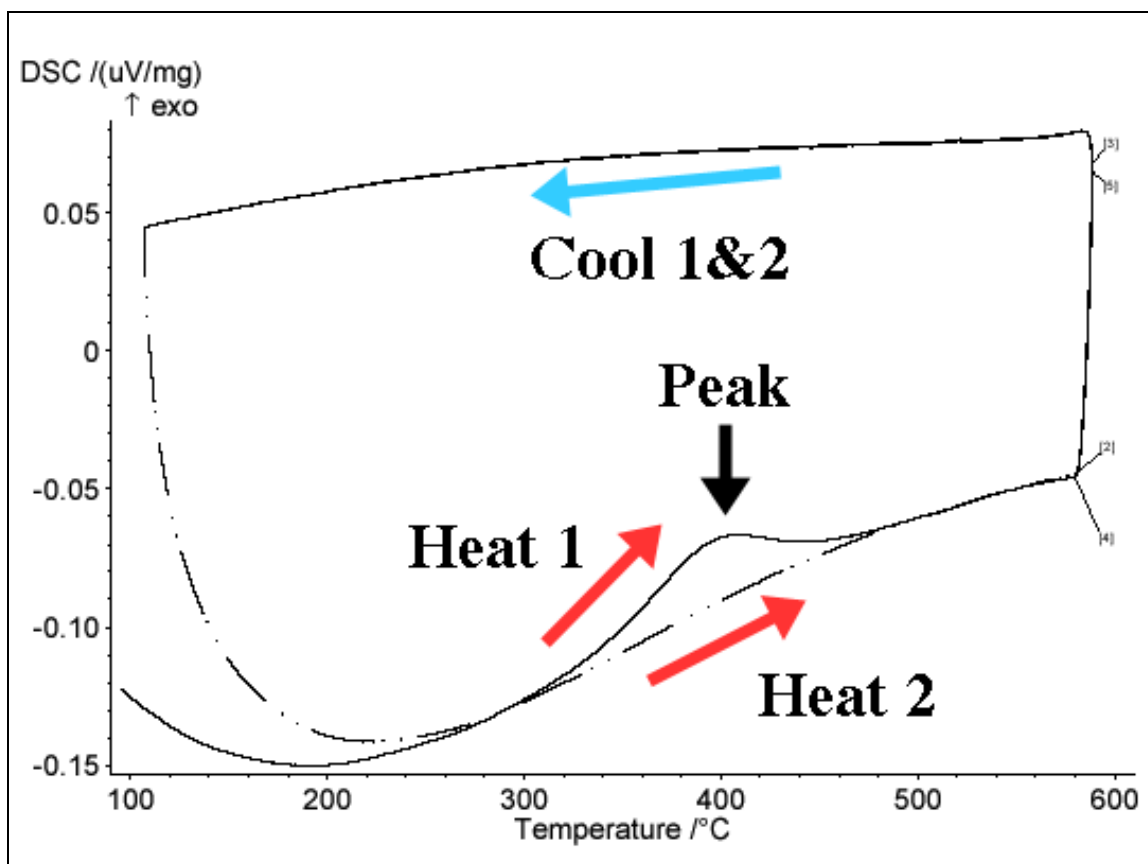
Samples of weld and base metal were cut from pieces retrieved from the WTC. These were subjected to DTA scans over a temperature range of 0 °C to 800 °C. DTA tests were performed on samples from three locations: weld metal, inner web, and flange plate from a sample with $F_y = 100$ ksi (panel C-10). The initial microstructure of the inner web and flange plate was quenched and tempered. Cylinders, 3 mm diameter and 1 cm long, were cut by Electrical Discharge Machining (EDM). The cylinder from the weld metal was cut with its axis parallel to and centered in the weld zone. Other samples were cut from several locations from the flange and inner web away far from the weld zone. DTA scans were performed in gettered Ar on ~100 mg slices from the EDM cylinders.

Figure D-6. DTA scans of weld metal taken from panel C-10 (A451: 85-88). First scan shows exothermic peak from non-equilibrium structure. Peak is missing in subsequent scan.

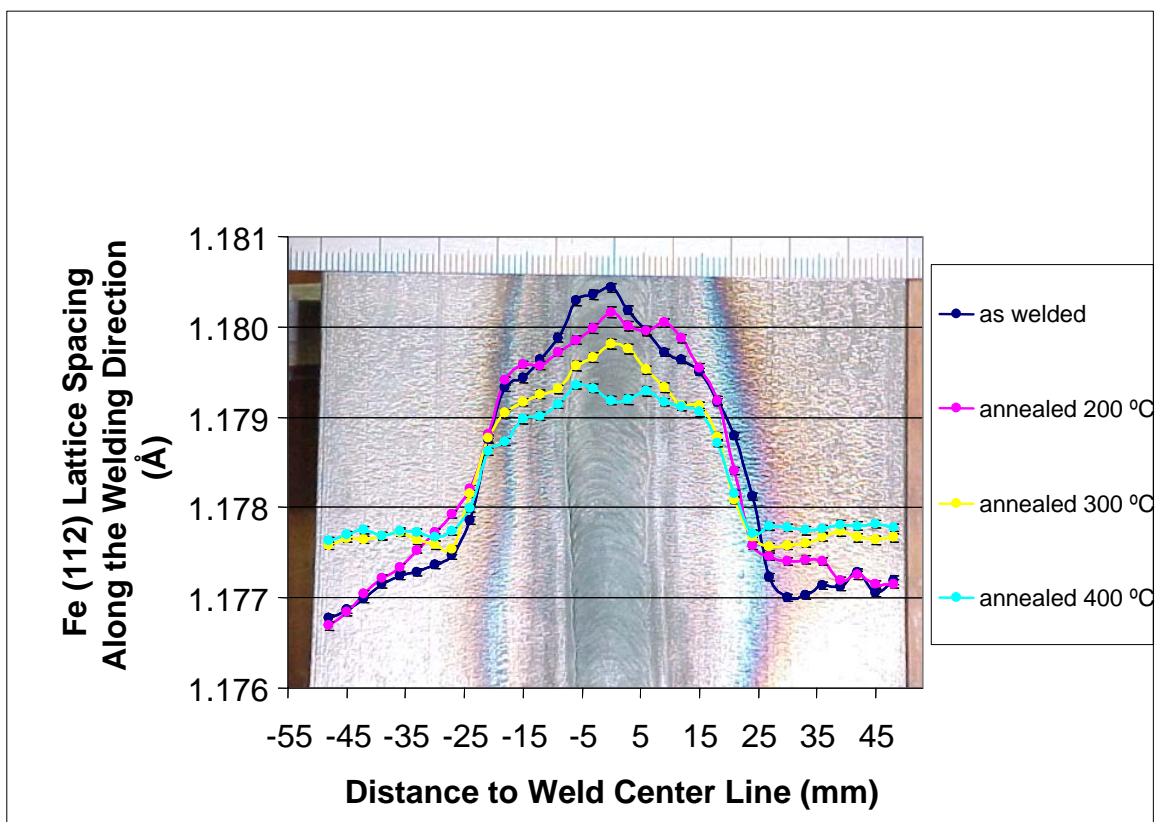
In addition to metastable microstructural phases, residual stresses develop during weld cooling. These form when the yield stress of the cooling metal increases sufficiently to resist deformation against the thermal expansion (contraction) stresses within the weld metal. If the weld metal cools fast enough, the stresses trapped within the structure are large. Annealing at a given temperature will allow the stresses to relax by lowering the flow stress of the metal and allowing plastic flow to occur. Measurement of the residual stresses in welds was surveyed as a possible indicator of the temperature that might have been reached in a fire.

Figure D-7. Residual stress profiles measured in prototype welds on non-WTC steel using neutron diffraction.

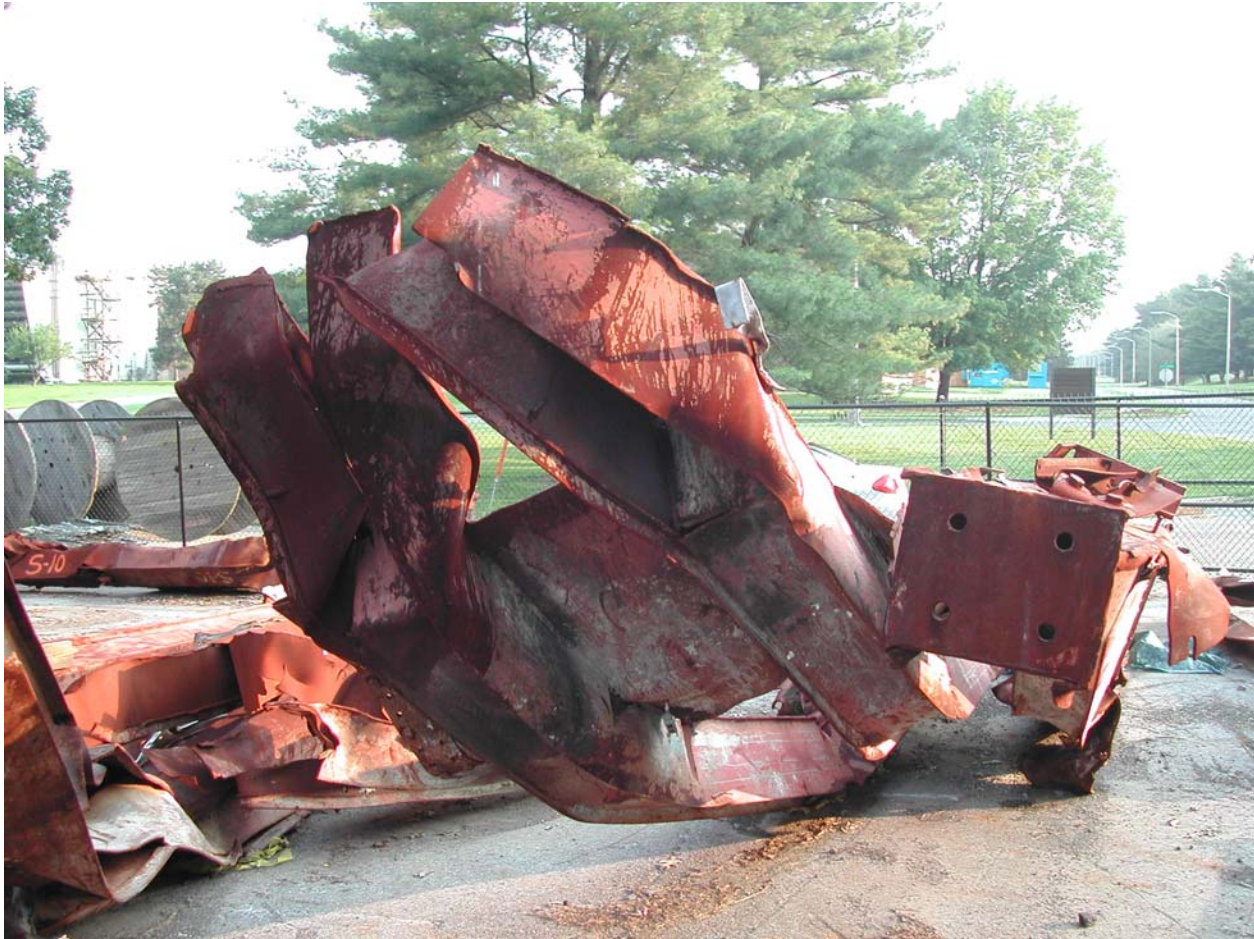
Figure 12. The extreme ends of the column elements in Piece M-2

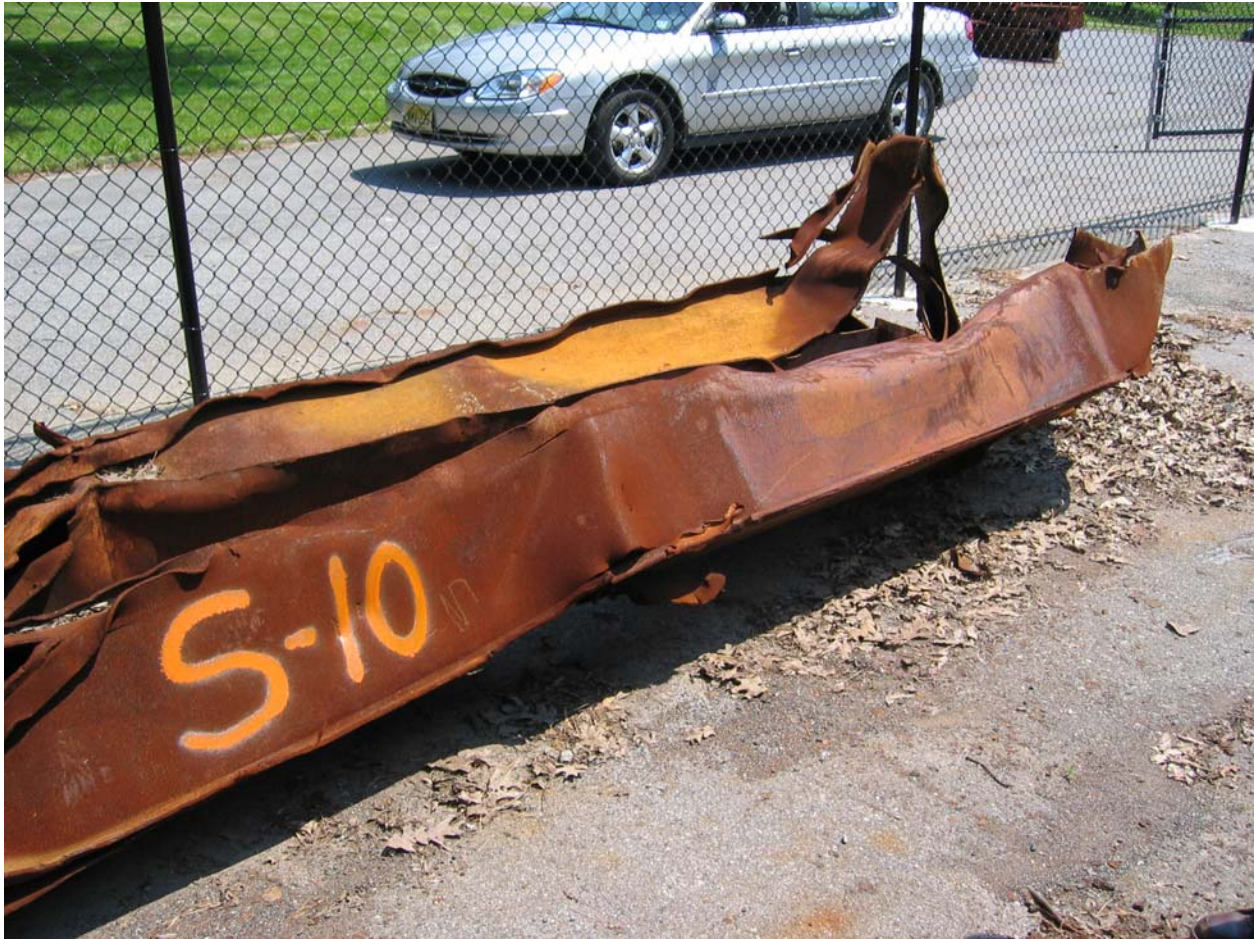
These judgments were based on visual observation of particular patterns of the presence or the absence of the visual effects of fire. The visual effects included: the presence and loss of primer paint; surface discoloration and intensity of rusting at the exposed steel; and localized distortion interpreted as possible local buckling caused by heat-related expansive strains. The last phenomenon is analogous to local buckling of exposed flanges of wide flange steel beams in structural steel floor framing beams exposed to fires. The primary pattern identified and relied upon was the presence of typically more than one visual indicator of possible fire effects on various surfaces of the individual column elements only at window openings, accompanied by the absence of these possible fire effects on the spandrel areas of the column panel. Figure 15 shows such a pattern on Piece S-10, where, from lower left to upper right in the figure, the first rusted area corresponds to possible fire effects at the 93rd floor window opening; the area of intact primer paint corresponds to the spandrel panel at the 94th floor; and the rusted remnant at the end of column corresponds to the bottom of the window opening at the 94th floor. Figure 16 shows a similar pattern on Piece M-4, where the inside faces of the column elements at the window opening exhibit possible effects of fire, while inside faces of the spandrel elements, and also the side faces of the column elements, do not exhibit these possible effects of fire. On some pieces, the observable pattern is much more subtle. Figure 17 shows the lower end of Piece K-2, where the possible fire effects are observed on the inside column face, concentrated at the head of window opening at the 92nd floor. On Piece K-2, it may be possible that the presence of the ceiling protected the spandrel area from exposure to fire.

Figure 15. Pattern of possible fire effects (absence of paint at left; presence of paint at right) observable on the side face of Column 224 of Piece S-10

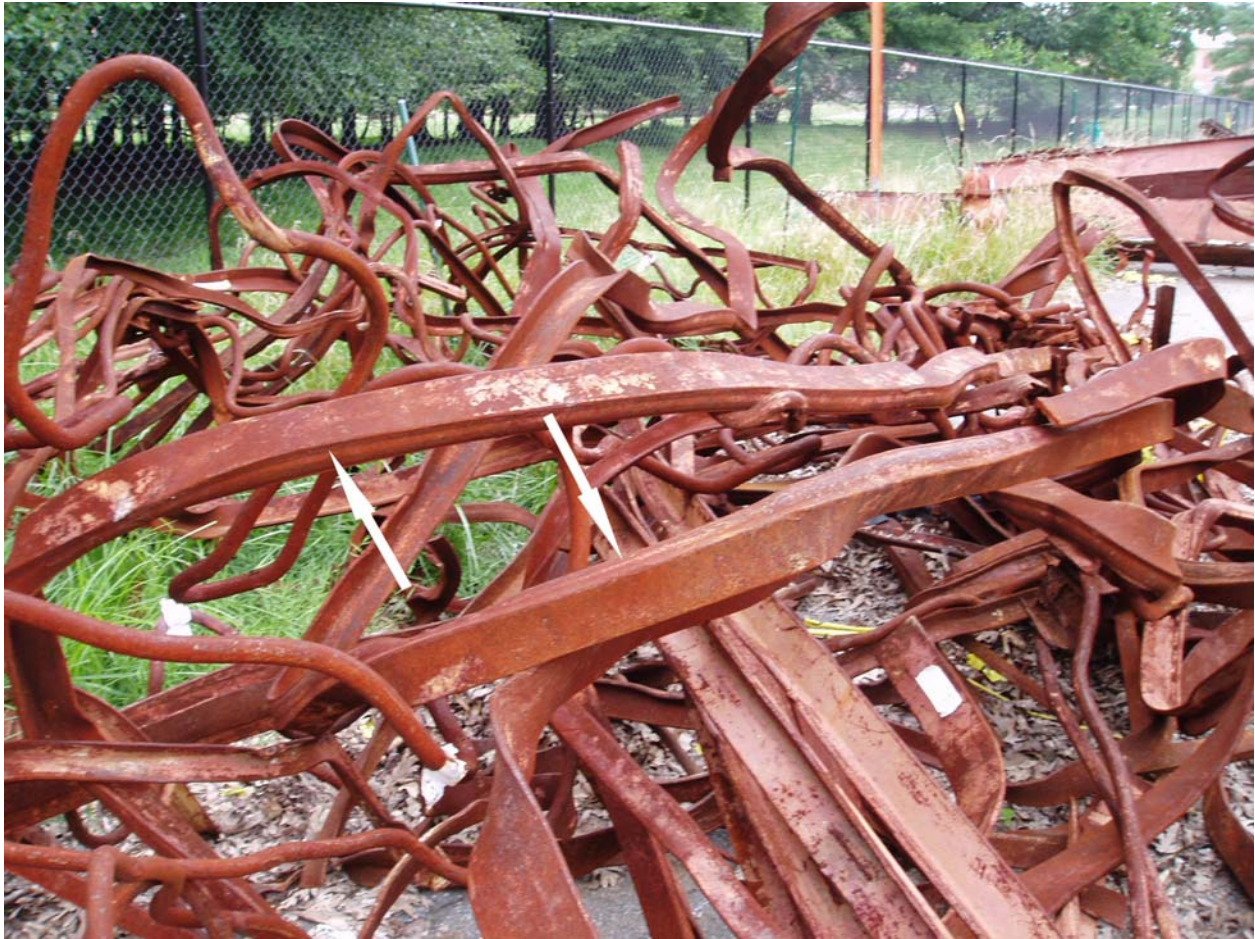
The rolled-steel angle shapes used in making the chords of the floor trusses exhibited a shallow, round rib running longitudinally on the vertical leg of the angle. This rib is visible on truss chords seen in Figure 19. This rib is a proprietary feature of floor trusses manufactured by Laclede Steel. The web-to-chord welds on the recovered truss remnants were observed to have been made by the electric resistance weld process, also typical of Laclede Steel trusses.

Figure 19. Close view of some recovered floor truss material. Arrows point to truss chords that exhibit longitudinal rib typical of floor trusses manufactured by Laclede Steel

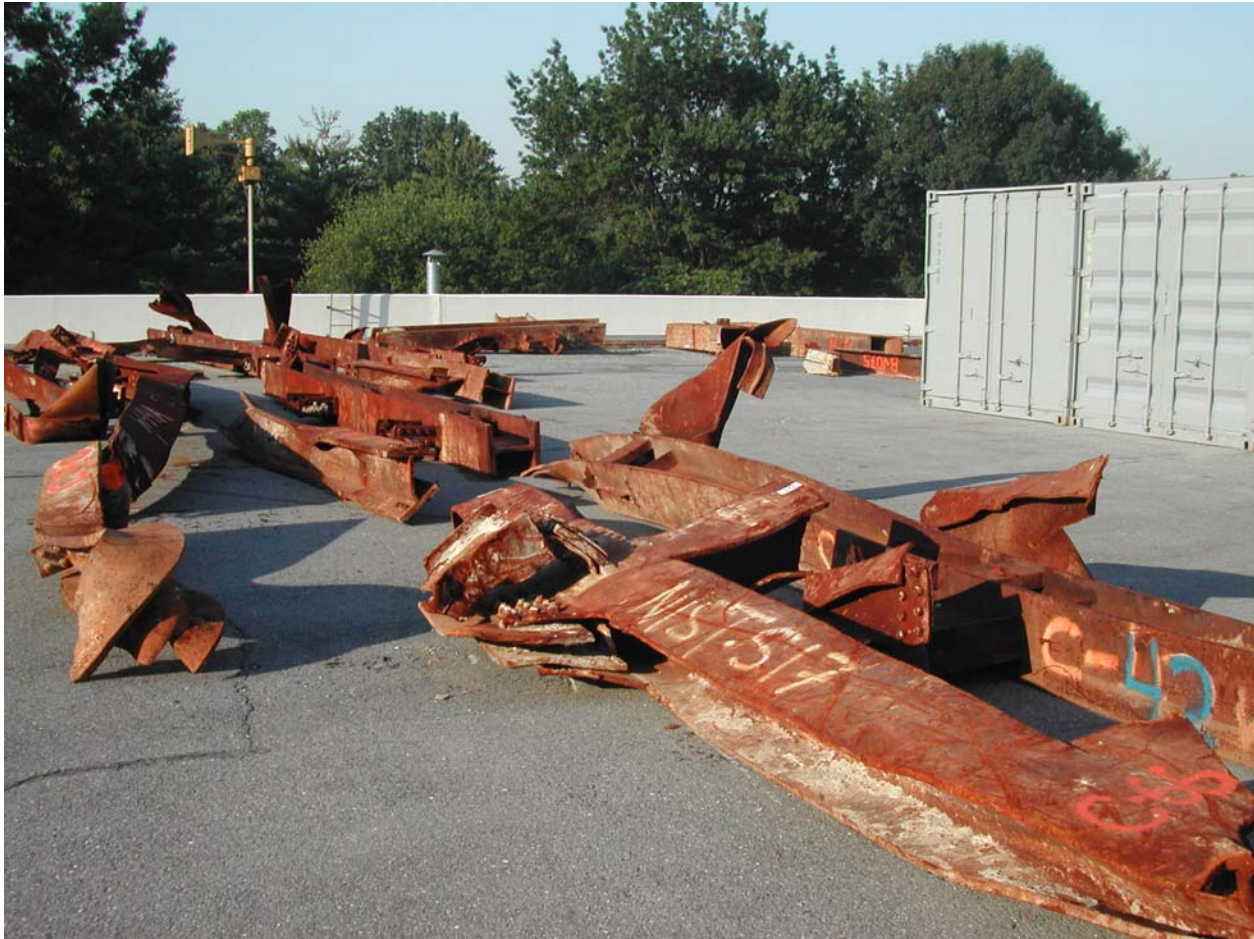
WJE surveyed six pieces believed to have been recovered from structures other than WTC 1 and WTC 2, Figure 20. The pieces surveyed by WJE were prefabricated column-and-beam assemblages, typically comprised of heavy rolled wide-flange columns with pairs of rolled wide-flange beam stubs framing into the strong-axis plane of bending of the column. Typically, two floor levels of floor beam stubs were observed on each piece. In some instances, the pieces had remnants of connections for diagonal elements that also framed into the column tree. Detailed observations and photographs of pieces recovered from structures other than WTC 1 and WTC 2 can be found in Attachment C.

Figure 20. General view of several pieces believed to have been recovered from structures other than WTC 1 and WTC 2

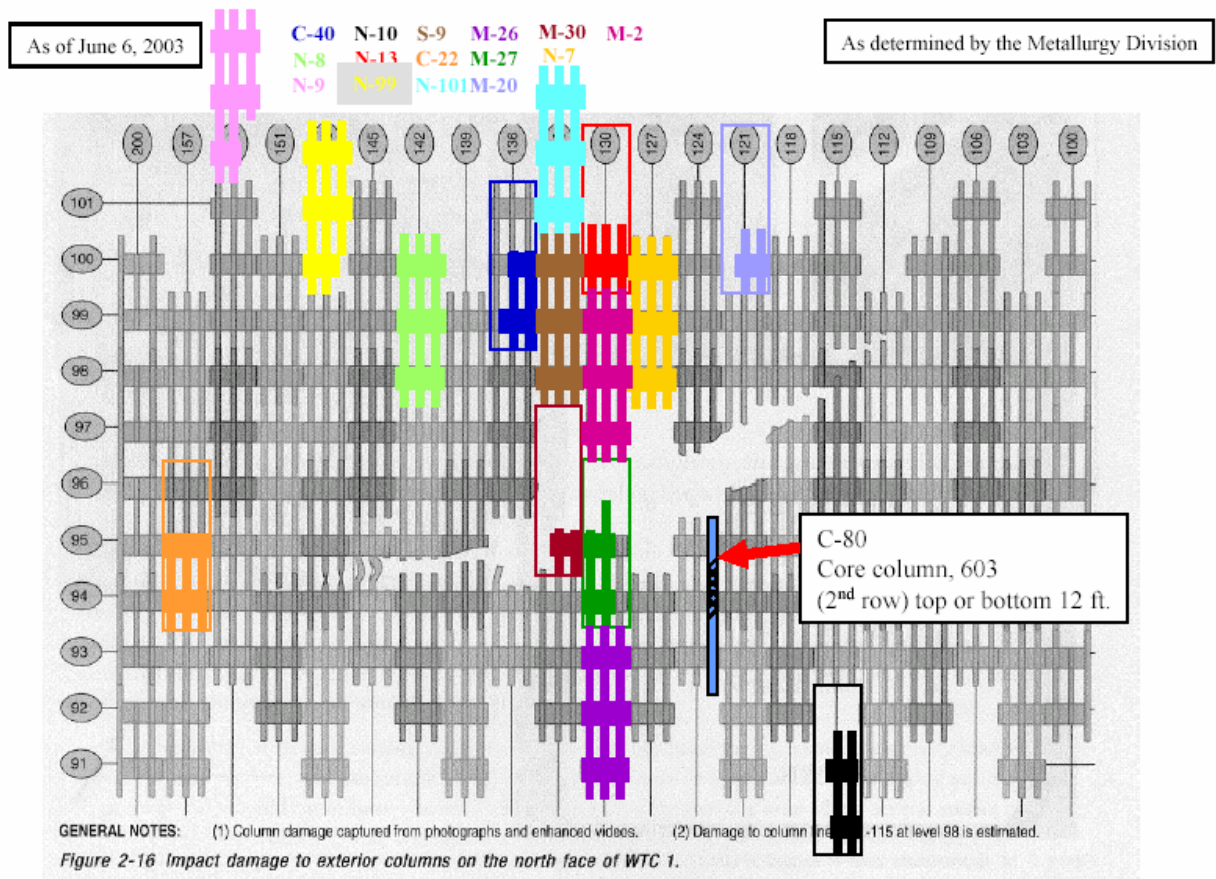
As described previously in Section 3.2, three significant pieces from WTC 1 that were directly impacted by the aircraft were examined: M-2, M-27 and M-30. In the as-built structure, Piece M-27 was located immediately below and connected to Piece M-2, and also immediately adjacent to and connected to Piece M-30. The as-built relationship between these pieces is shown in Figure 21.

Figure 21. Original locations within WTC 1 of Pieces M-2, M-27 and M-30.

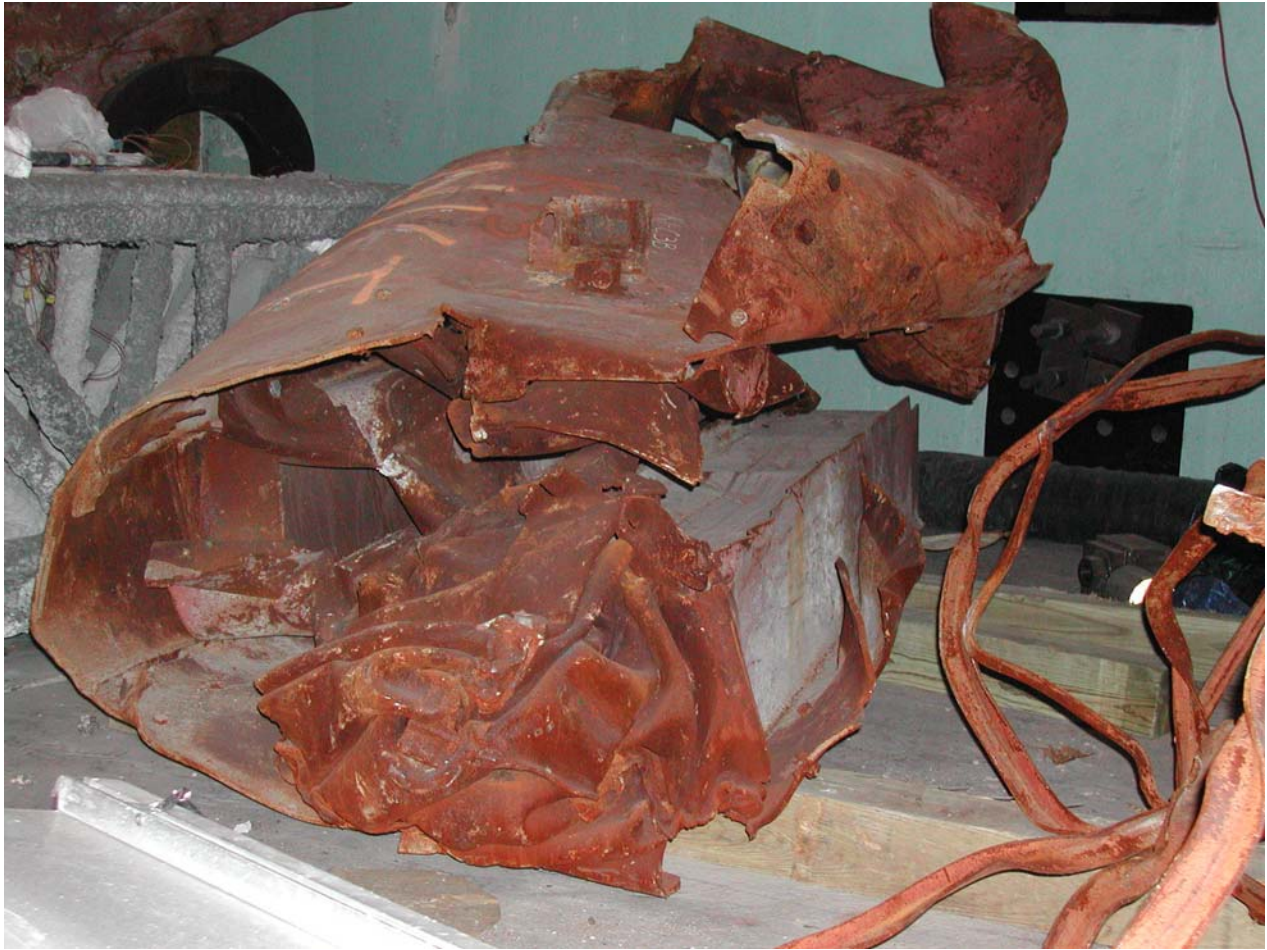
Of note is Piece K-1, shown in Figure 22 and further described in Attachment A. The piece is unique among the recovered steel in that the upper part of one column has probably collapsed in compression in an accordion-like manner. No other similarly-collapsed piece is found among the recovered steel at NIST that was surveyed. The accordion-like collapsed part of this column remains in general concentric axial alignment with the lower portion of the same column, which is relatively undistorted even after salvage and recovery operations. It cannot be readily distinguished whether this failure took place at a high or low rate of loading; whether elevated temperatures contributed to the observed condition; whether or not this failure occurred at about the time of collapse initiation; or if the observed condition is a result of impact as the piece fell to the ground.

Figure 22. Piece K-1, which has collapsed in compression

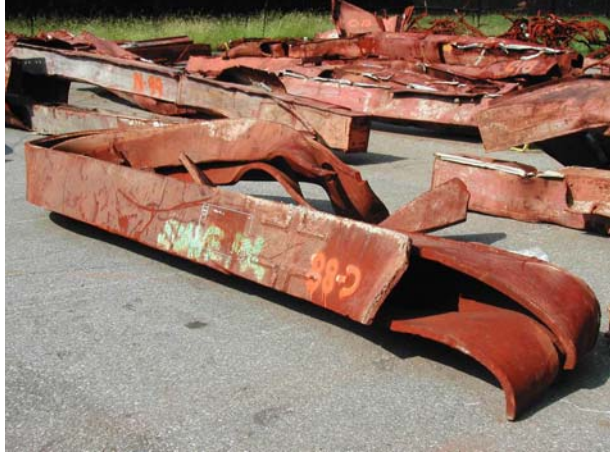
<p>Figure F-A-1a: General view of C-88. The bottom of the column is at lower right in this view. Column splice can be observed between paint marks "SAVE" and "C-88". The side of the column with paint marks faced into a vertical shaft.</p>		<p>Box-shaped core column (Figure A-1). Includes column splice located at floor 80; that portion above the splice is identified as Piece C88a, and that portion below the splice is Piece C88b. (Piece C88c is a large plate fragment cut from the upper end of C88a.) Piece C88b was at a floor level directly impacted by the aircraft.</p> <p>By locating remaining fragments of connections, it was possible to determine the orientation of the piece within the structure. Floor plans showed that one face of the box column faced into an open vertical shaft.</p> <p>At the lower end of the column (Piece C88b), three of the four flange plates exhibit a J-shaped deformed shape (Figures A-1 and A-2). The direction of bend of the hook of the J not consistent with aircraft impact. It is likely, therefore, that the final distorted shapes of these three flanges of the box column were a result of the collapse event. The ends of these three flange plates have been flame cut.</p> <p>The surface condition of these same three flanges at the immediate vicinity of the distortion is rusty (Figures A-1 and A-2), suggesting that the flanges were possibly exposed to fire. The sharpness of the bends in the distorted area, along with the lack of cracking of the steel at the sharp bends, suggests that the steel was at an elevated temperature at the time that the distortion occurred. It is possible that the fire that may have affected these pieces was the fire immediately following the aircraft impact.</p>

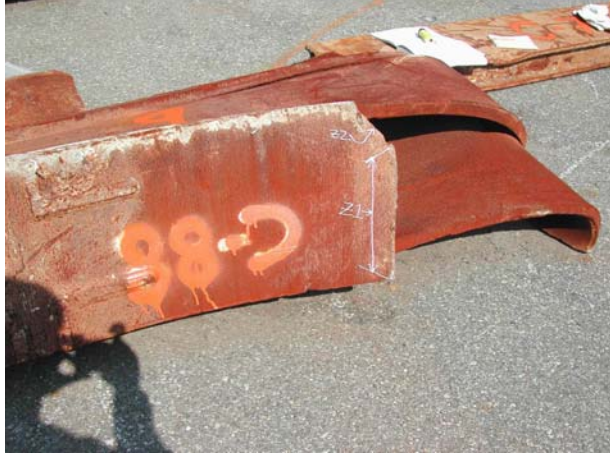
<p>Figure F-A-1b: General view of identified areas Z1 and Z2.</p>		<p>The fourth flange was severed at a different vertical location and in a different fashion than the other three flanges (Figure A-2). This is the flange that faced into the open vertical shaft. The distorted shape for this flange is consistent with the direction of aircraft travel at the time of impact. This distortion could also have been caused by the collapse of the tower.</p>

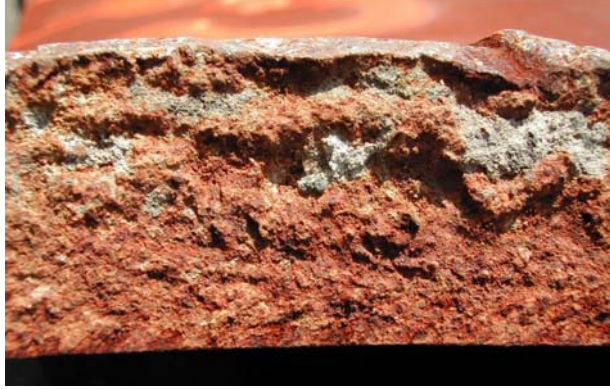
<p>Figure F-A-1c: Close view of fracture surface at area Z1. (The upper horizontal edge of the fracture surface has been damaged due to shipping and handling of the piece.)</p>		<p>The fracture surface at the severed end was visually examined close-up. Two areas of interest along the severed end were identified as Z1 and Z2. Area Z1 is a fracture of the steel that appears to have occurred in a non-ductile manner because there is no visible constriction ("neck-down") of the flange plate thickness in the immediate vicinity of the fracture. It is probable that this is a non-ductile fracture that occurred at a high rate of strain as a result of the tower collapse or aircraft impact. Representative fracture surface of Z1 is shown in Figure A-3.</p> <p>Identified area Z2 visually appears to be a flame cut edge. The flame cutting probably occurred sometime during the salvage, shipping and handing of the piece following collapse.</p>

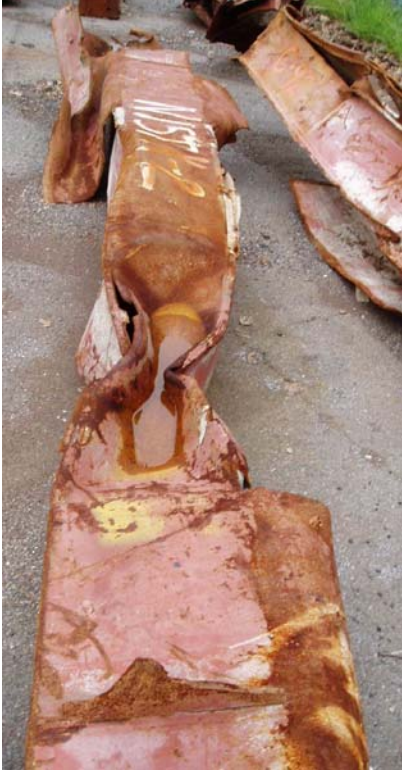
<p>Figure F-A-3b: Closer view of column at 93rd floor window. Spandrel at 93rd floor is at bottom of photo.</p>

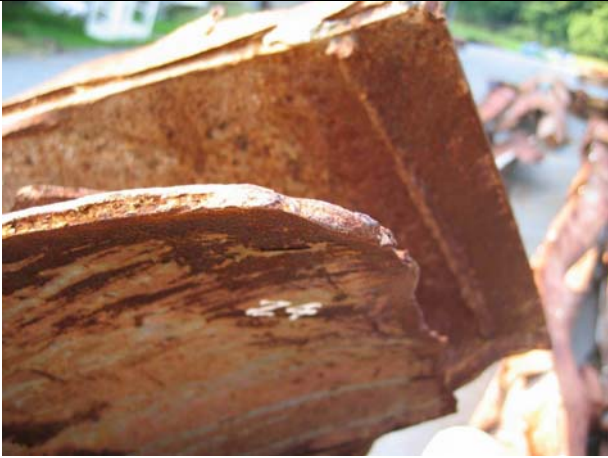
<p>Figure F-A-4d: Zone Z4.</p>		<p>Z4: Outside web plate of Column 2 (Figure A-12) is visibly constricted ("necked down") at vicinity of probable weld to column base plate. Probable cause is high rate of tensile loading due to aircraft impact. Similar effect was noticed on outside web plate of Column 1.</p> <p>Z5, Z6: Fracture (Figure A-13) of flange plates at weld to column base plate at Column 2 exhibit a possible longitudinal shear failure instead of the tensile failure observed at Z4. Similar observation can be made for Column 1.</p> <p>Z7: Fragments of floor slab concrete (Figure A-14) with fragments of welded wire reinforcement and metal deck have been entrapped by bent-over connection plate element on Column C2. These are probable actual materials from the as-built 97th floor slab.</p>

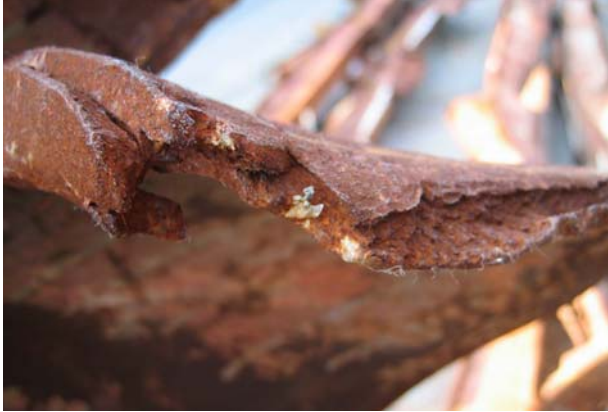
<p>Figure F-A-4e: Representative fracture at Zones Z5 and Z6.</p>

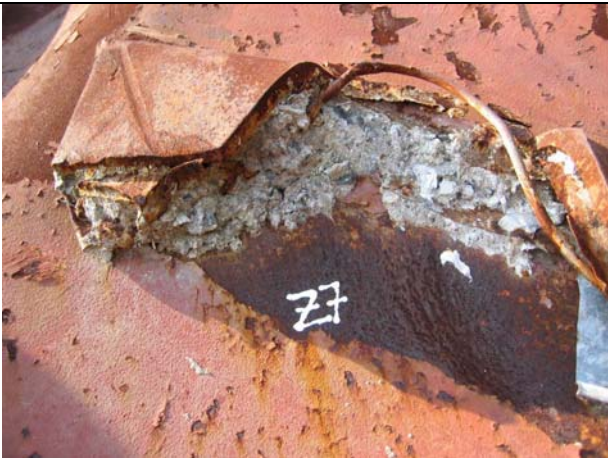
<p>Figure F-A-4f: Entrapped concrete fragments.</p>

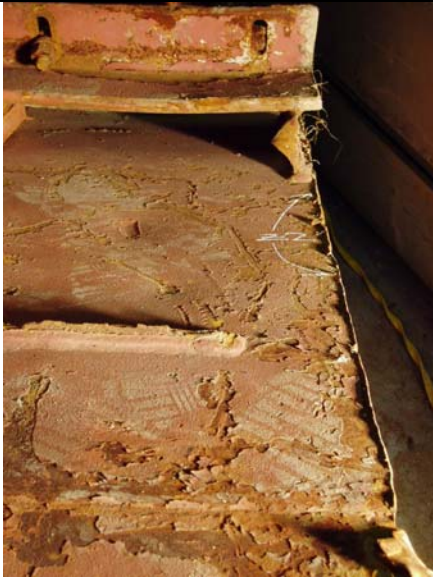
<p>The 95th floor spandrel plate has probably fractured in transverse shear along the right edge of Column 133. (This edge is marked Z2 in Figure A-22.) It is very likely that this fracture was caused by the impact of the aircraft and therefore occurred at a high rate of loading.</p>	
<p>Figure F-A-6d: View of severed 95th floor spandrel plate at edge of Column 133. Column 134 would have been to the right.</p>

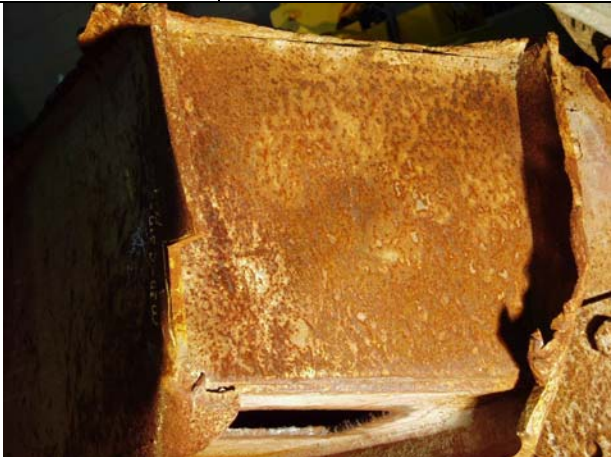
<p>Figure F-A-6f: Close view of severed Column 132, viewed as if looking down from above. Inside face of column is at top of photo.</p>

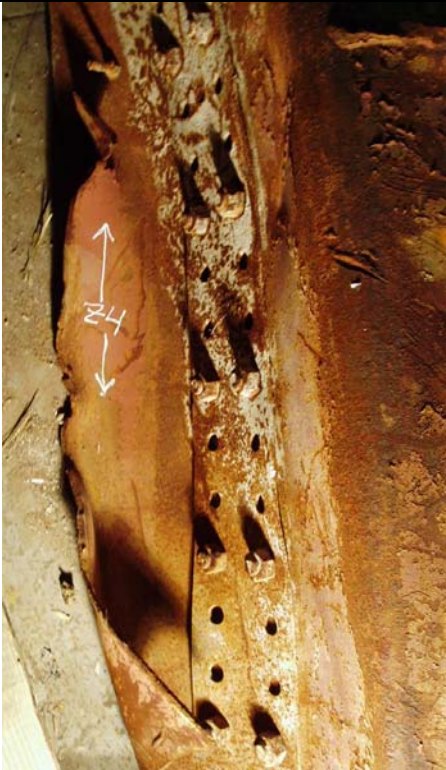
<p>The 95th floor spandrel splice at the left of Column 132 was recovered with this piece. The recovered connection materials include bolts and connection plate. A fragment of the spandrel plate that extended from the splice to Column 131 was also recovered with this piece. The opposite edge of this additional piece, marked Z4 in Figure A-25, has a fracture surface that is inclined at 45 degrees. It is not certain that this fracture was caused by impact of the aircraft, because photographic evidence (FEMA 403, Figure 2-15) suggests that this segment of the 95th floor spandrel, although bent inward, may still be intact. Column 131 and the associated spandrel panel at the 95th floor were recovered as part of Piece M-27. There is a chance that the fracture surface that would mate to the fractured edge marked Z4 may exist on piece M-27.</p>

<p>Figure F-A-6g: View of severed 95th floor spandrel plate to left of Column 132, showing spandrel connection bolts and connection plate. Column 131 would have been at left, and Column 132 is at right</p>

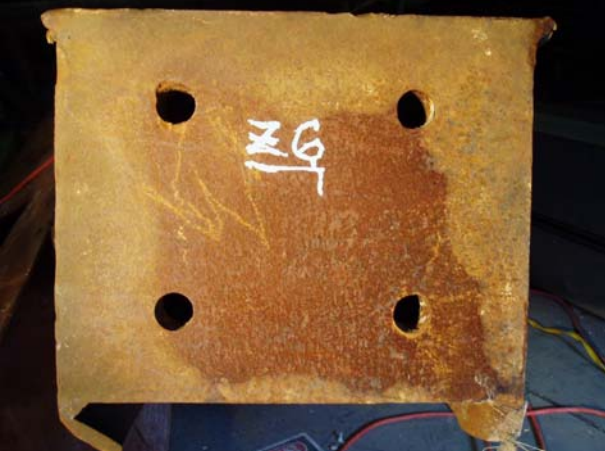
<p>Figure F-A-6j: Base of Column 133. Outside face is down.</p>

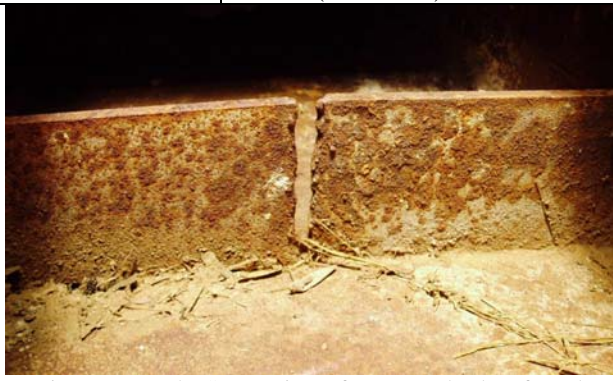
<p>Figure F-A-6k: Separation of rectangular bar found inside access hole at base of Column 132. The inside surface of the outside column face plate is at the bottom of the photo.</p>		<p>A unique separation, Figure A-29, was observed in a small rectangular bar found inside the rectangular access hole at the base of Column 132. The location was marked Z7 on the inside face of the column piece. The rectangular bar is believed to be an aid for fabrication used to support the column outside face plate at the proper position for welding. The bar appears to have ruptured, perhaps in tension, or has been flame cut.. It is not know if this condition is related to the impact of the aircraft into this piece, or is related to original fabrication.</p>

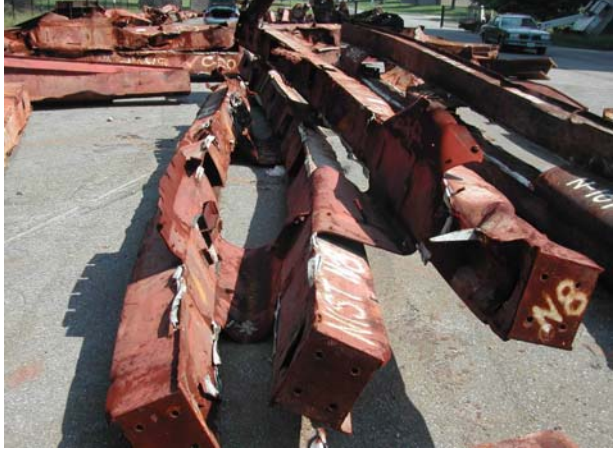
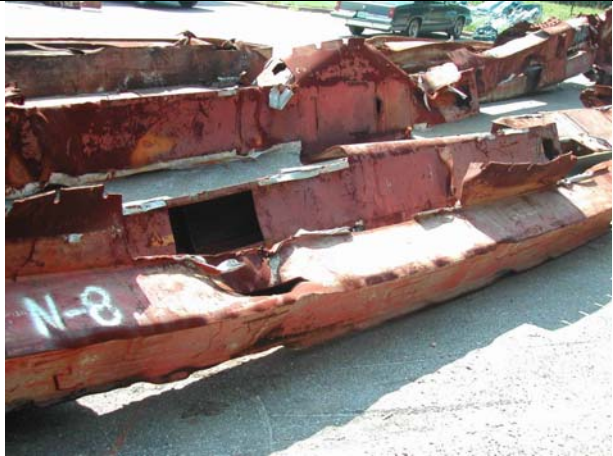
Figure F-A-7a: Piece N-8.

<p>Given location in structure, this exterior column panel was not affected by aircraft impact. Potential effects due to fire following aircraft impact were observed on columns as follows:</p> <p>Window at 97: Little or no fire effect Spandrel at 98: Little or no fire effect Window at 98: Some local buckling and some loss of primer paint indicative of possible fire effect Spandrel 99: Little or no fire effect Window 99: Some possible fire effect Spandrel 100: Little or no fire effect Window 100: Fire effect uncertain</p>

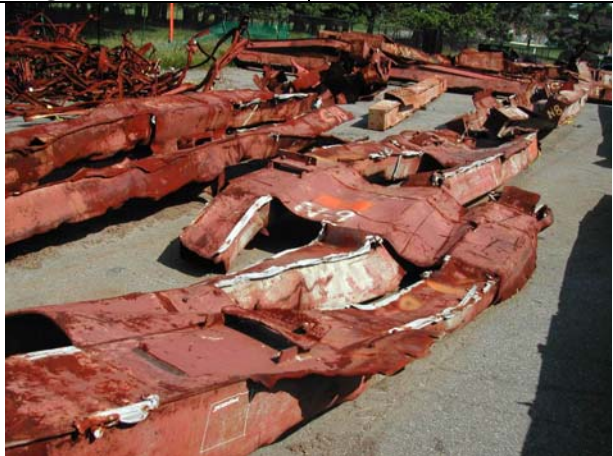
Figure F-A-8: Piece N-9.

<p>Given original location in building, this exterior column piece has not been affected by direct aircraft impact. Fire effect uncertain: some local buckling on inside faces of columns, along with moderate loss of paint, suggest possible fire effect. However, these visual features are not so pronounced so as to strongly indicate that these are effects due to fire.</p>

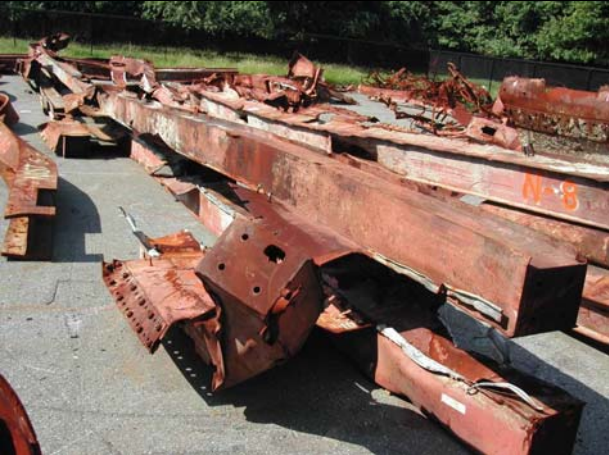
<p>Exterior column panel from face of aircraft impact on WTC 1, but from floor levels that are above the direct impact zone. Consequently, piece is presumably not affected by aircraft impact. Little or no effects of fire were observed on this piece.</p>	
Figure F-A-10: Piece N-101.

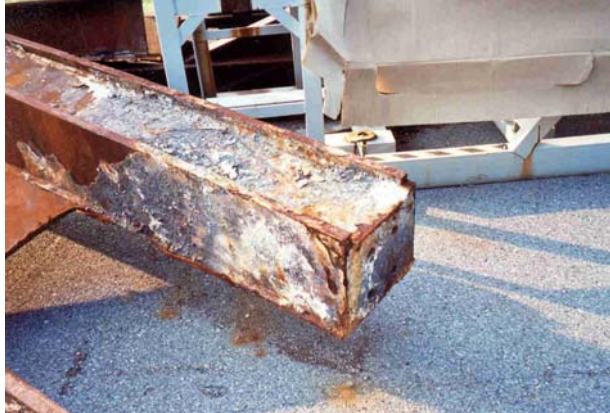
<p>Two exterior box columns from one column panel with fire residue on the end of one column member. Because the residue is on the end plate of one member, it suggests that residue was deposited after the end plate was separated from its matching piece, meaning that residue deposit would have occurred after the collapse.</p>	
<p>Figure F-B-1a: End of one column on Piece AA.</p>

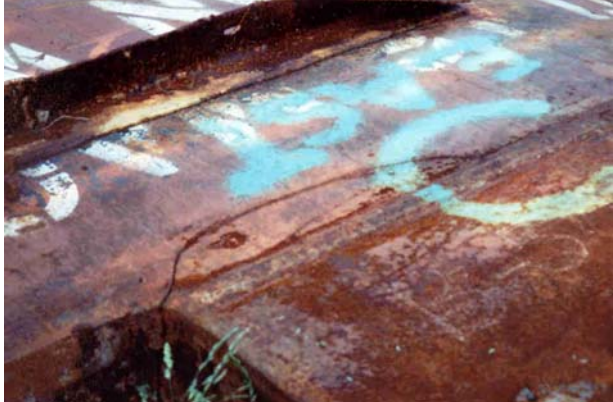
<p>Low level tree haunch with a crack. The nature of the crack suggests that the crack initiated at the weld. Cracks of this nature are known to be a potential problem for welded joints in heavy pieces of fabricated structural steel. The crack probably occurred at the time the piece was fabricated, due to triaxial restraint of weld shrinkage during cooling of the original weld. It is our opinion that the crack was existent at the time of building collapse. The crack may have been extended during erection at the time of original construction.</p> <p>It is very unlikely that the crack was extended or enlarged as a result of aircraft impact or building collapse. It is also very unlikely that the presence of these cracks had any adverse effect on the performance of the building as it may relate to the aircraft impact, fire following aircraft impact, and initiation of progressive collapse. This is because the large compressive forces to gravity loads in the column due would tend to keep these cracks closed, even under loads associated with these extreme events.</p>

Figure F-B-2b: View of crack observed on Piece B5004.

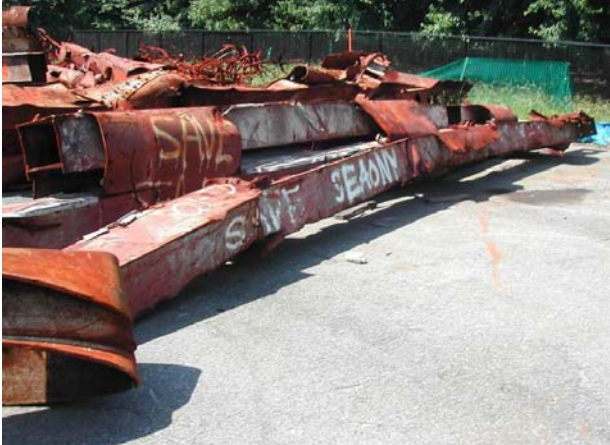
<p>Given the location in the building, this piece was not affected by aircraft impact. Visual indications of fire effect were not readily observed. Observed damage and distortions are probably due to collapse event and subsequent handling.</p>		
<p>Figure F-B-4: Piece C-10.</p>

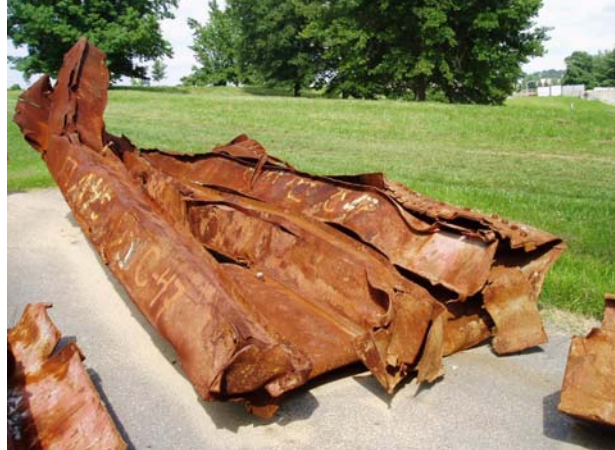
Piece ID Mark:	C-47	By & Date:	CP / 30 July 2003
Bldg: WTC1 or WTC 2	Column: unknown	Floors: unknown

<p>Partially recovered exterior column panel from WTC 1 or WTC 2. General indications of fire effects widely distributed throughout piece. This observation suggests that the observed effects were a result of fire after collapse.</p>	
Figure F-B-6: Piece C-47.

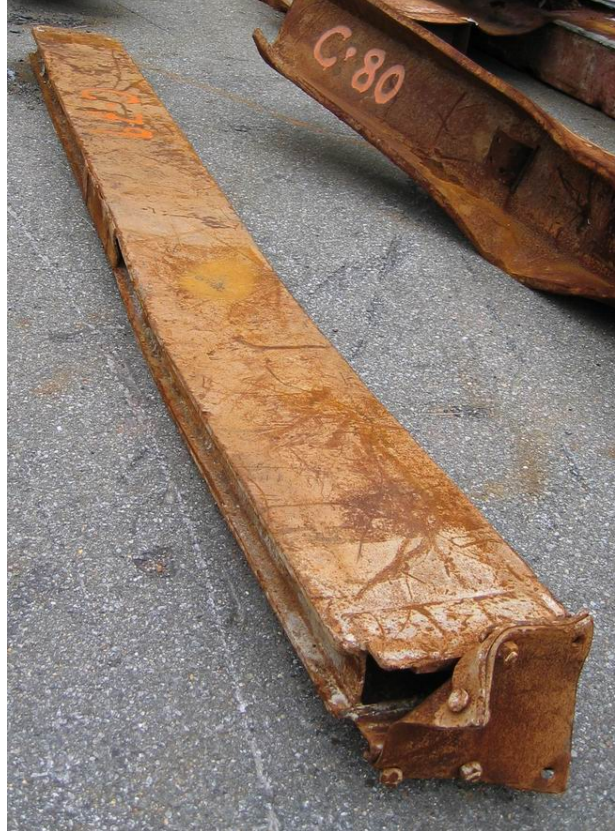
Piece ID Mark:	C-79	By & Date:	JH / CP / 30 July 2003
Bldg: WTC 1 or WTC 2	Column: unknown	Floors: unknown

<p>Rectangular box beam shape. Connections at ends of the element indicate that this is a horizontally-spanning element. Concrete fragments were observed inside of the box beam. This concrete is well-bonded to the beam and conforms to the interior shape of the beam. This suggests that the concrete is probably from original construction.</p>	
Figure F-B-7: Piece C-79.

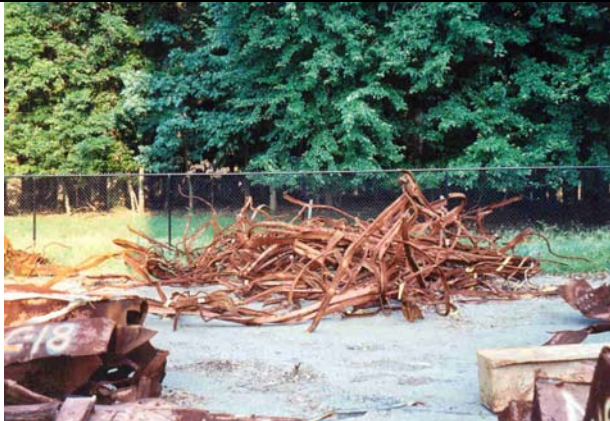
Piece ID Mark: C-53		By & Date: RT / 25 June 2003 CP & JH / 31 July 2003	
Bldg: WTC 1 or WTC 2		Column: not applicable	Floors: unknown

<p>Badly tangled remains of Laclede Steel open web steel trusses. The intermingling of the trusses suggests that this occurred during impact, collapse, salvage operations, hauling, storage, or any combination of these events. It is not possible to sort out what damage occurred when.</p> <p>Figures B-11 through B-18 show some of the connection joints within the truss members themselves. The trusses were fabricated with extensions of diagonal web members at the top chord panel points and at end bearing details that develop composite action with the concrete topping slab. As was typical for trusses and joists manufactured by Laclede Steel, the web elements are electric resistance welded to the top and bottom chord angles. Although the angles and web elements are severely distorted in the immediate vicinity of the panel points, the actual welded connections remain intact.</p> <p>Intact welds could be tested. These tests would provide a lower bound to the joist connection capacity. Small lengths of undistorted remnants of the chord angles and web rounds could be tested to provide the equivalent of mill test data.</p>

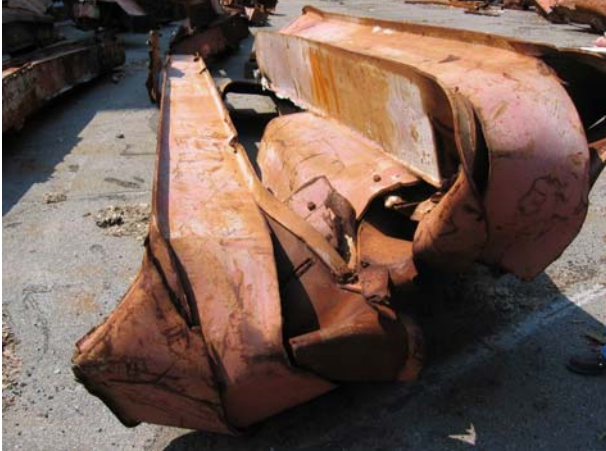
Piece ID Mark:	N-1	By & Date:	CP / 24 June 2003
Bldg: WTC 1	Column: 218	Floors: 82 - 85

<p>This column is from well below the aircraft impact zone. Panel is bent in half at about mid-length. No indication of fire effect. Given location in building, probable cause of observed damage and distortion is the collapse event and subsequent handling.</p>	
Figure F-B-10: View of piece N-1.

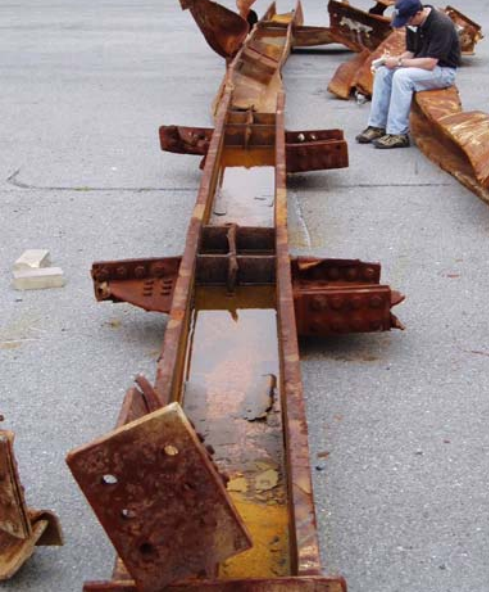
Piece ID Mark:	C-85	By & Date:	CP & JH / 31 July 2003
Bldg: unknown	Column: unknown	Floors: unknown

<p>Figure F-C-5a: Overall view of Piece C-85. (Note: Piece C-66 lies beyond Piece C-85 at top of picture.)</p>		<p>Wide flange shape probably from a structure other than WTC 1 or WTC 2.</p> <p>Remnants of probable diagonal or lateral braces frame into weak axis plane of the column.</p> <p>Remnants of wide-flange beam stubs frame into strong axis side of the column. On one side of the column, the beams appear to have deflected downward and have fractured in net tension through top flange at bolt holes and have torn out through web. Bottom flange connection plate has torn out in tension at weld of connection plate to face of column.</p> <p>The connections on the opposite side of the column require further study. While these beams appear to have fractured in tension, the line of probable fracture passes through the gross section, not the net section through bolt holes in the beam flange. This probable fracture is not consistent with a fracture in direct tension that would be expected to pass through the net tension sectional area.</p> <p>The column base connection plate has fractured in half, probably as the column deflected out-of-plane (weak axis bending plane) during collapse. A fragment of probable floor deck concrete remains in place just above the column base connection plate.</p> <p>Did not visually assess for fire effects.</p>

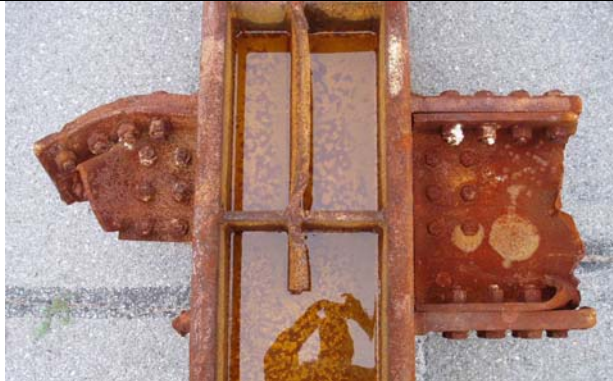
<p>Figure F-C-5b: Piece C-85, connections of beams to column.</p>

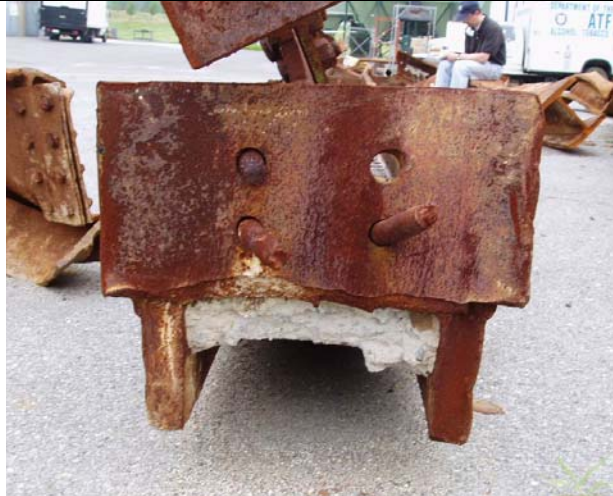
<p>Figure F-C-5c: Piece C-85, column connection plate at base of column</p>

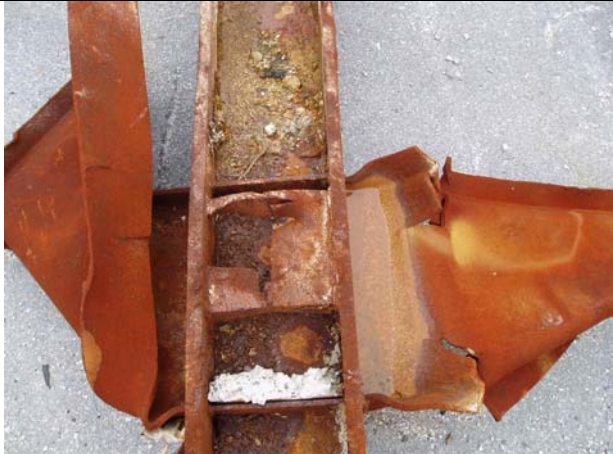
Figure F-C-6a: Piece M-11 overall view.

Piece ID Mark: M-11		By & Date: CP & JH / 31 July 2003	
Bldg: unknown	Column: unknown	Floors: unknown	Fire effects
 		<p>Two-story wide flange column piece. The column piece itself exhibits a very slight twist but is otherwise generally straight.</p> <p>The fractures of the connections at the free ends of the beam stubs suggest that the beam stubs were in axial tension at the time of failure.</p> <p>The outstanding ends of the beam stubs exhibit probable fire effects as evidenced by the severe distortions of the beam stub element.</p>

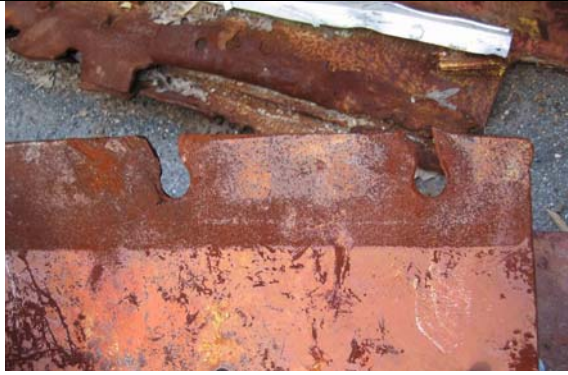
<p>Figure F-D-1a: Spandrel connection failure Type 1</p>	<p><u>Type 1</u> Edge-distance bolt tear-out from spandrel plate</p>
