Appendix A

EXAMPLES OF PERIMETER PANEL FLOOR TRUSS CONNECTORS

The floor trusses were attached to the perimeter panels at the interior intersection of the columns and spandrels by different types of connectors. The following appendix displays photographic examples, taken by National Institute of Standards and Technology (NIST), of these types of connectors as observed on the recovered panels.

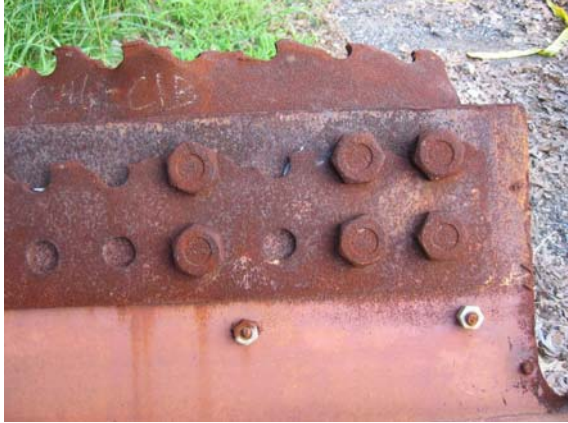
<p>Figure F-D-1b: Spandrel connection failure Type 2</p>	<p><u>Type 2</u> Edge-distance bolt tear-out from connection splice plate</p>

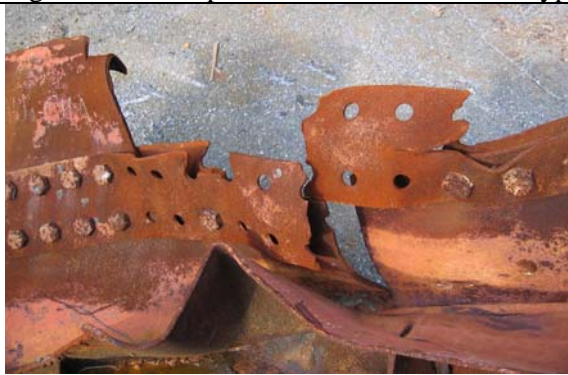
<p>Figure F-D-1c: Spandrel connection failure Type 3</p>	<p><u>Type 3</u> Combination of Type 1 and Type 2: Edge distance bolt tear-outs observed on both spandrel plate and splice plate</p>

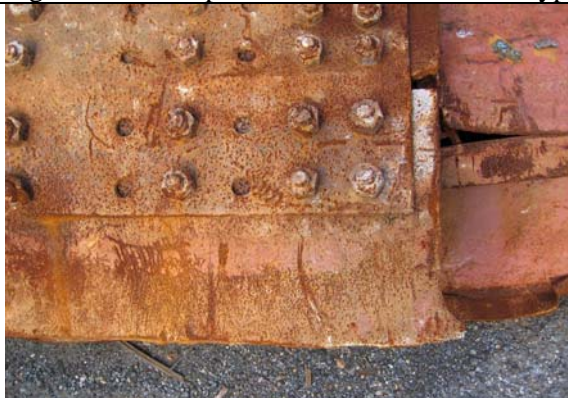
<p>Figure F-D-1d: Spandrel connection failure Type 4</p>	<p><u>Type 4</u> Fracture of spandrel plate away from splice plate connection</p>

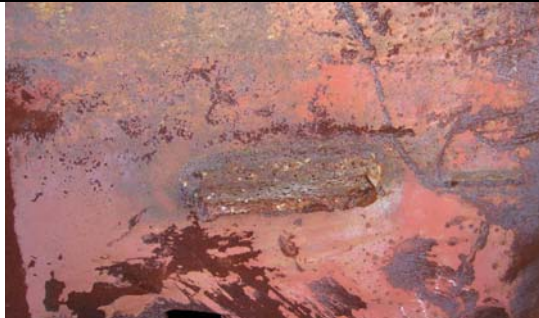
<p>Figure F-D-3a: End gusset failure mode Type 1</p>	<p><u>Type 1</u></p> <p>Fracture of top plate through gross section away from weld to face of column</p>

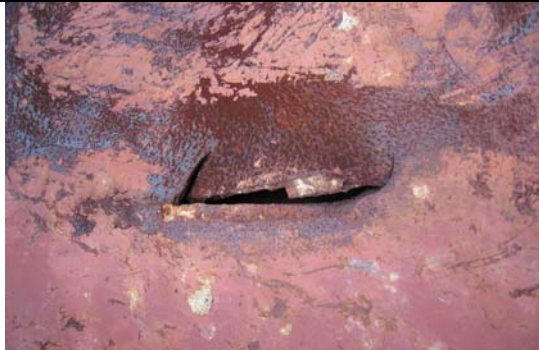
<p>Figure F-D-3b: End gusset failure mode Type 2</p>	<p><u>Type 2</u></p> <p>Tear-out of top plate and weld from the parent material of the column face</p>

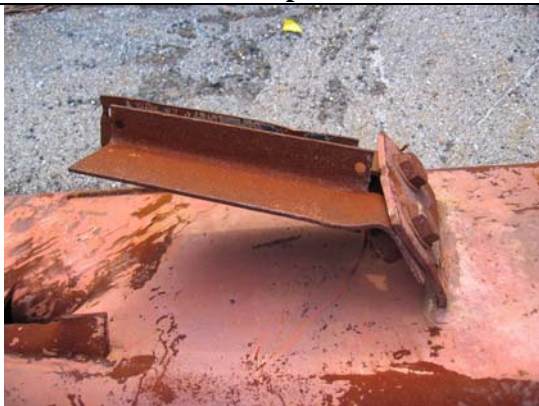
<p>Figure F-D-4a: Damper connection failure Type 1</p>	<p><u>Type 1</u></p> <p>Remnants of the damper and its connection plate remain attached to column</p>

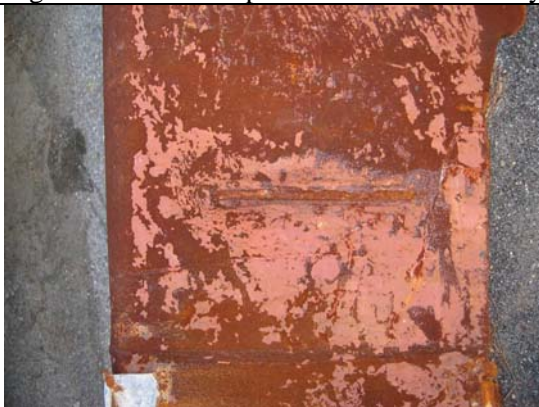
<p>Figure F-D-4b: Damper connection failure Type 2</p>	<p><u>Type 2</u></p> <p>Damper and its connection plate are missing, typically fracturing at weld of connection plate to face of column</p>
