**NIST NCSTAR 1-3 (Draft)**

**Federal Building and Fire Safety Investigation of the  
World Trade Center Disaster**

# **Mechanical and Metallurgical Analysis of Structural Steel (Draft)**

September 2005

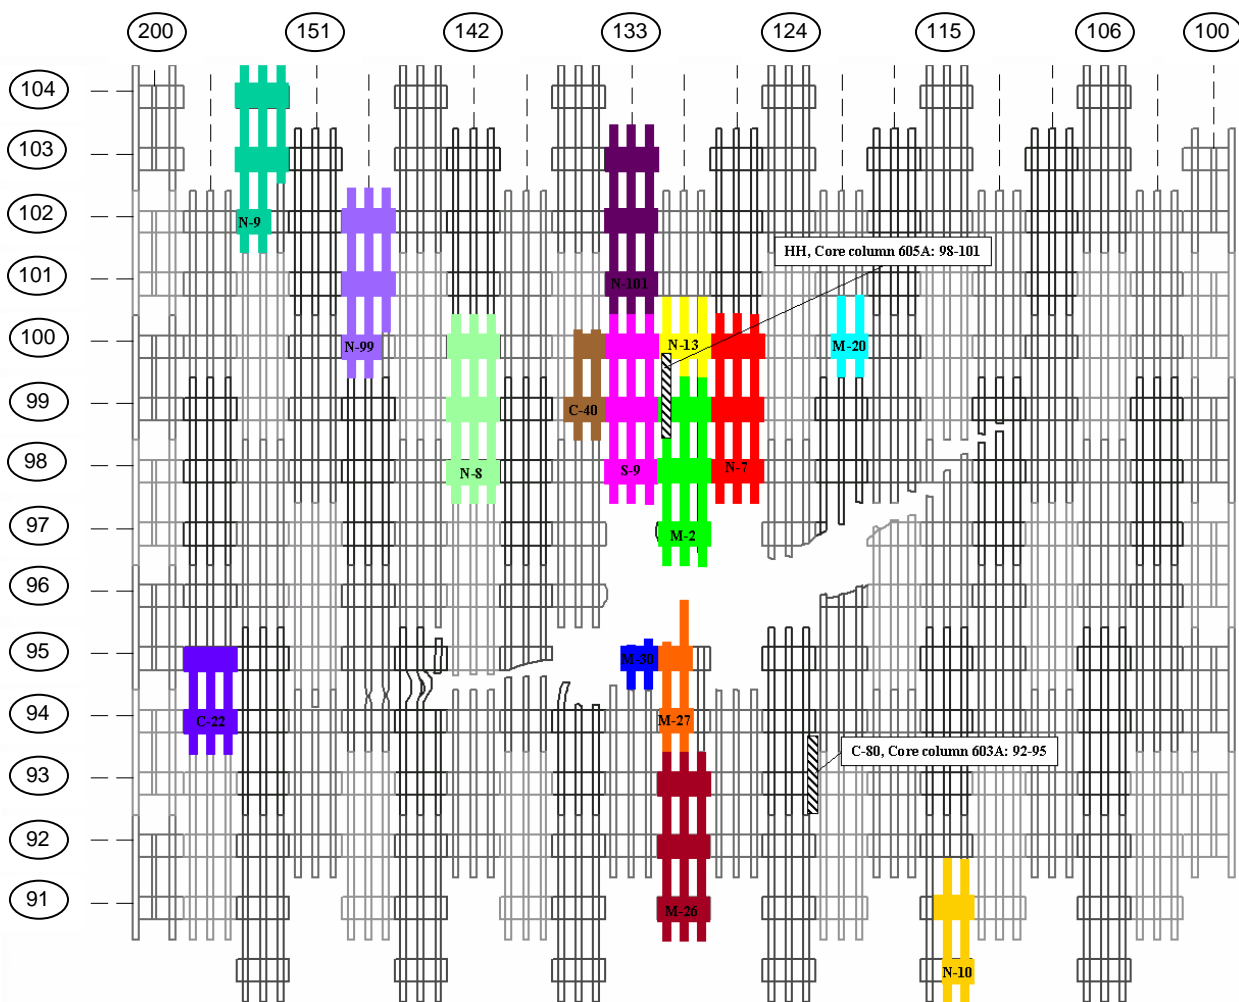
Photographic evidence indicated that damage to WTC 1 due to aircraft impact occurred from the 94th to 99th floors and was bounded by columns 111 through 152. For WTC 2, the impact area was lower, with damage found from the 77th to 85th floors. While the damage appeared to be bounded by column lines 411 and 440, the starboard wing of the aircraft may have struck columns even closer to the southeast corner of the building. This area was persistently obscured by smoke, however, and no clear images were available. From this information, NIST was able to determine which perimeter panels and core columns could be used to comment on damage (physical and fire) and possible failure mechanisms in this area. Fig. 5–5a shows an overlay of the recovered exterior panels in and around the impact zone of WTC 1. Samples C-80 and HH, both core columns, were also identified as residing near the impact zone. The recovered portion of each column is approximately represented in this image. No similar impacted exterior panels were recovered for WTC 2; however, two core columns were recovered, Fig. 5–5b.

**Figure 5–5a. Interpreted column damage, from photographic evidence, to north face of WTC 1, with overlay of recovered steel identified by NIST. Colored regions represent recovered portions. Both core columns (#603 and #605) are in the second row from the north face of WTC 1.**

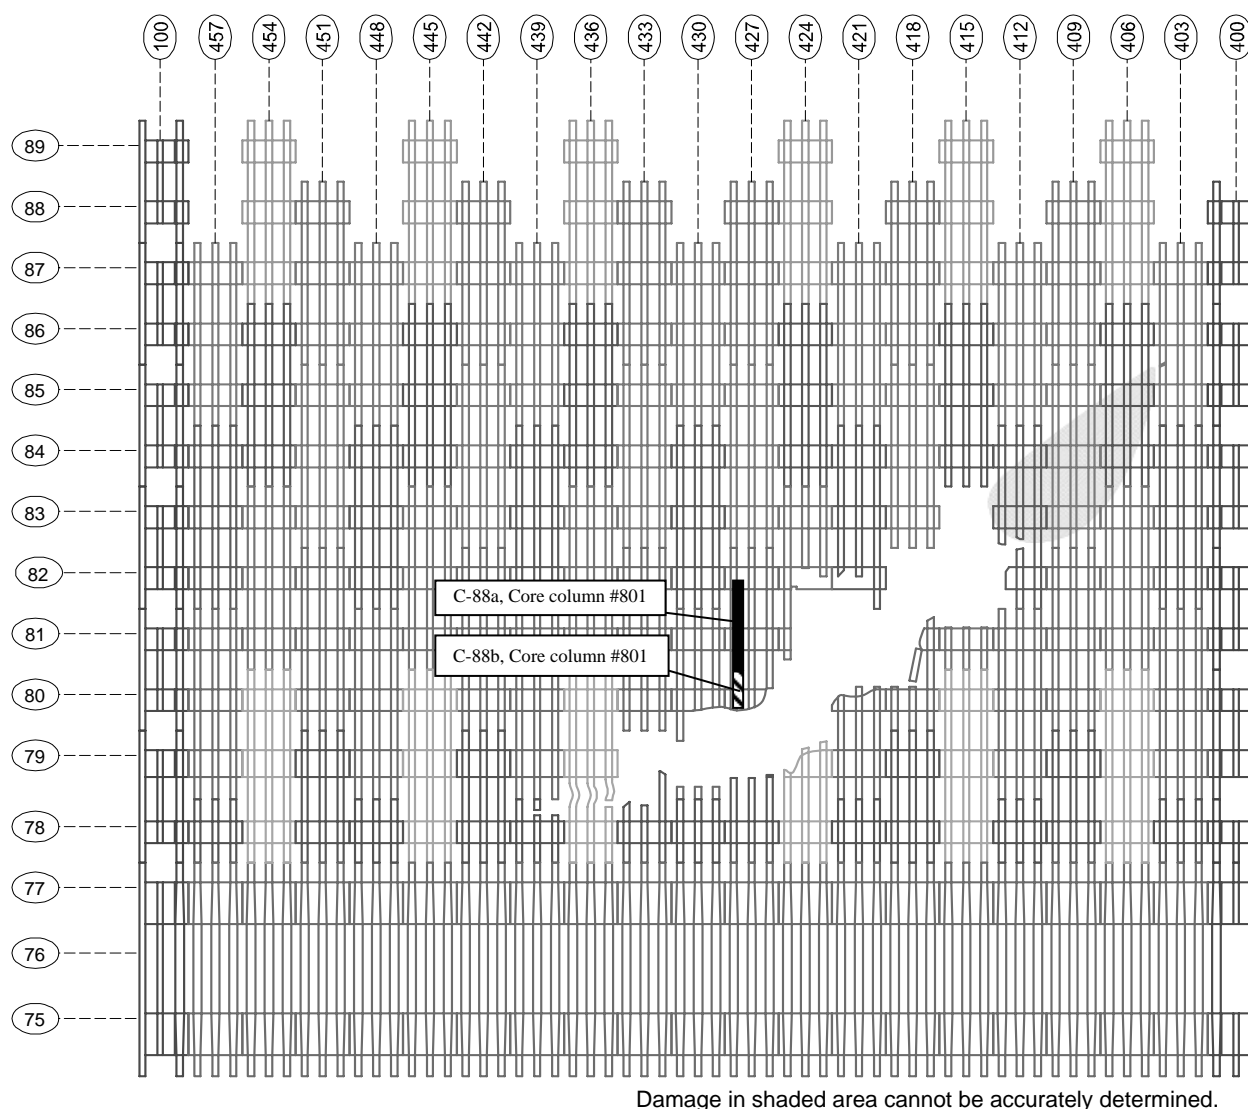
**Figure 5-5b. Interpreted column damage, from photographic evidence, to south face of WTC 2, with overlay of recovered steel identified by NIST. Samples shown represent recovered portions. Core column line 801 is in the row closest to the south face of WTC 2.**

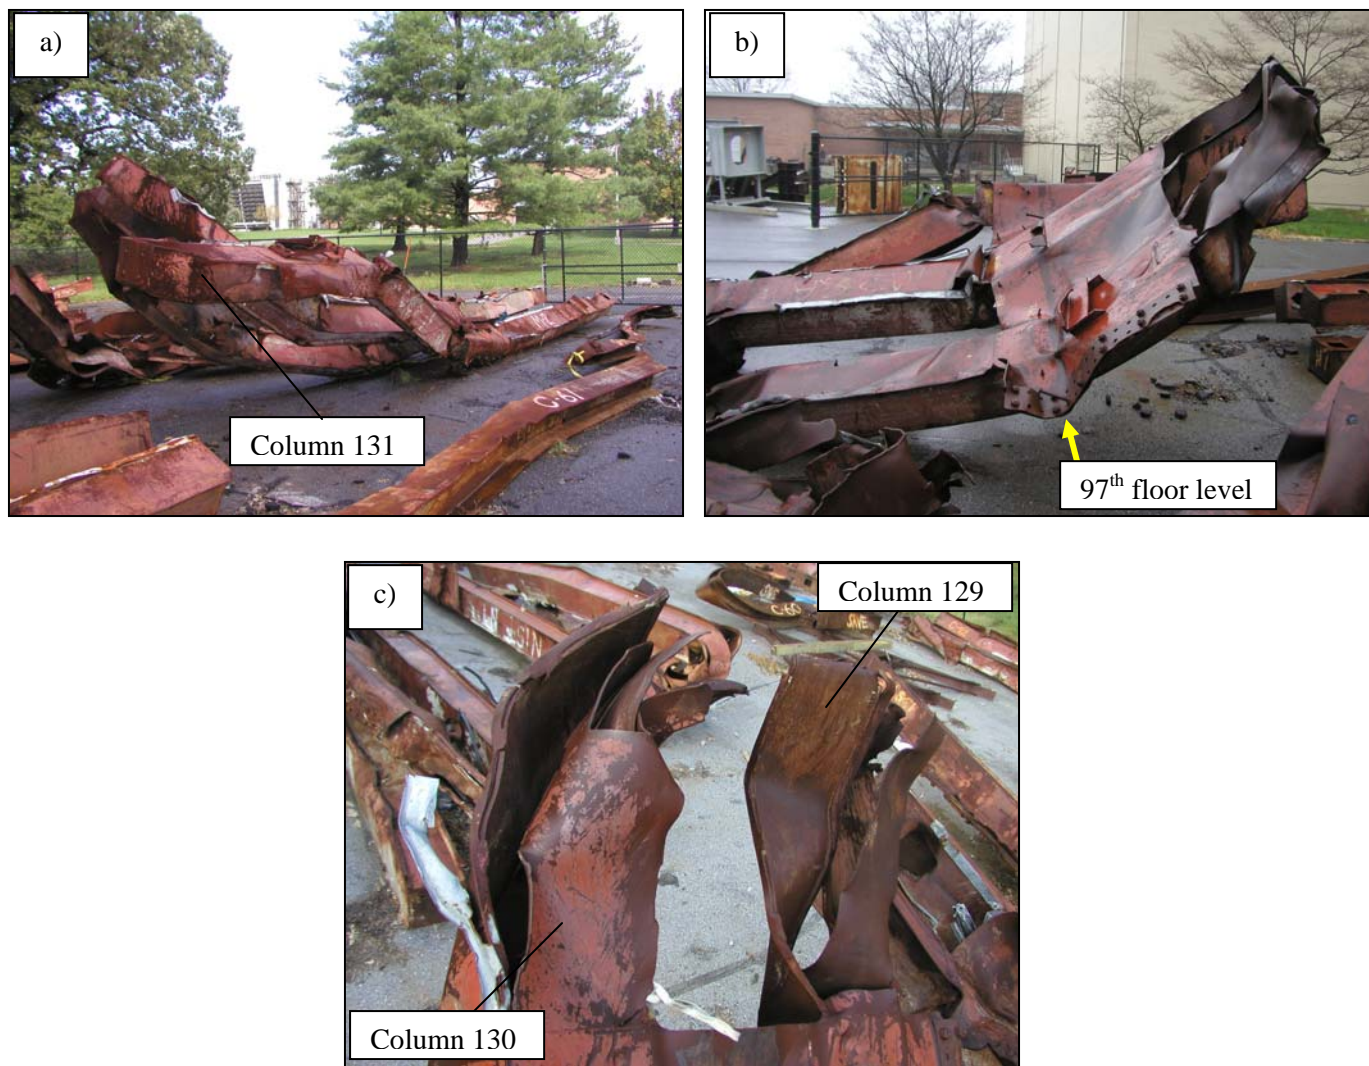
Damage to the lower portion of panel M-2 (WTC 1, column line 130, floors 96 to 99) was clearly associated with impact, which led to the missing endplates for columns 129 and 130. The inner and outer web plates of both columns have thinned in this area due to plastic deformation, Fig. 6-23a. The fracturing of the plates propagated as a 45 degree slant crack, oscillating between positive and negative 45 degrees with respect to the normal of the plate. The necking (thinning) of the outer web plate, plotted in Fig. 6-23b, indicates significant ductility, even at the high-strain rates associated with impact. Large buckles were observed on both flanges for columns 129 and 130 with some splitting occurring in the base material of the flanges (Figs. 6-24a and 6-24b) and spandrels (Fig. 6-24c). However, the welds found near this bending point remained intact (Fig. 6-24d).

**Figure 6–22. a) Overall view of panel M-2 (A130: 94-97). Bottom of panel is on the left-hand side of the picture and the outside of the panel is facing down, b) major bend in panel located at the 97th floor level, and c) splayed bottoms of columns 129 and 130.**

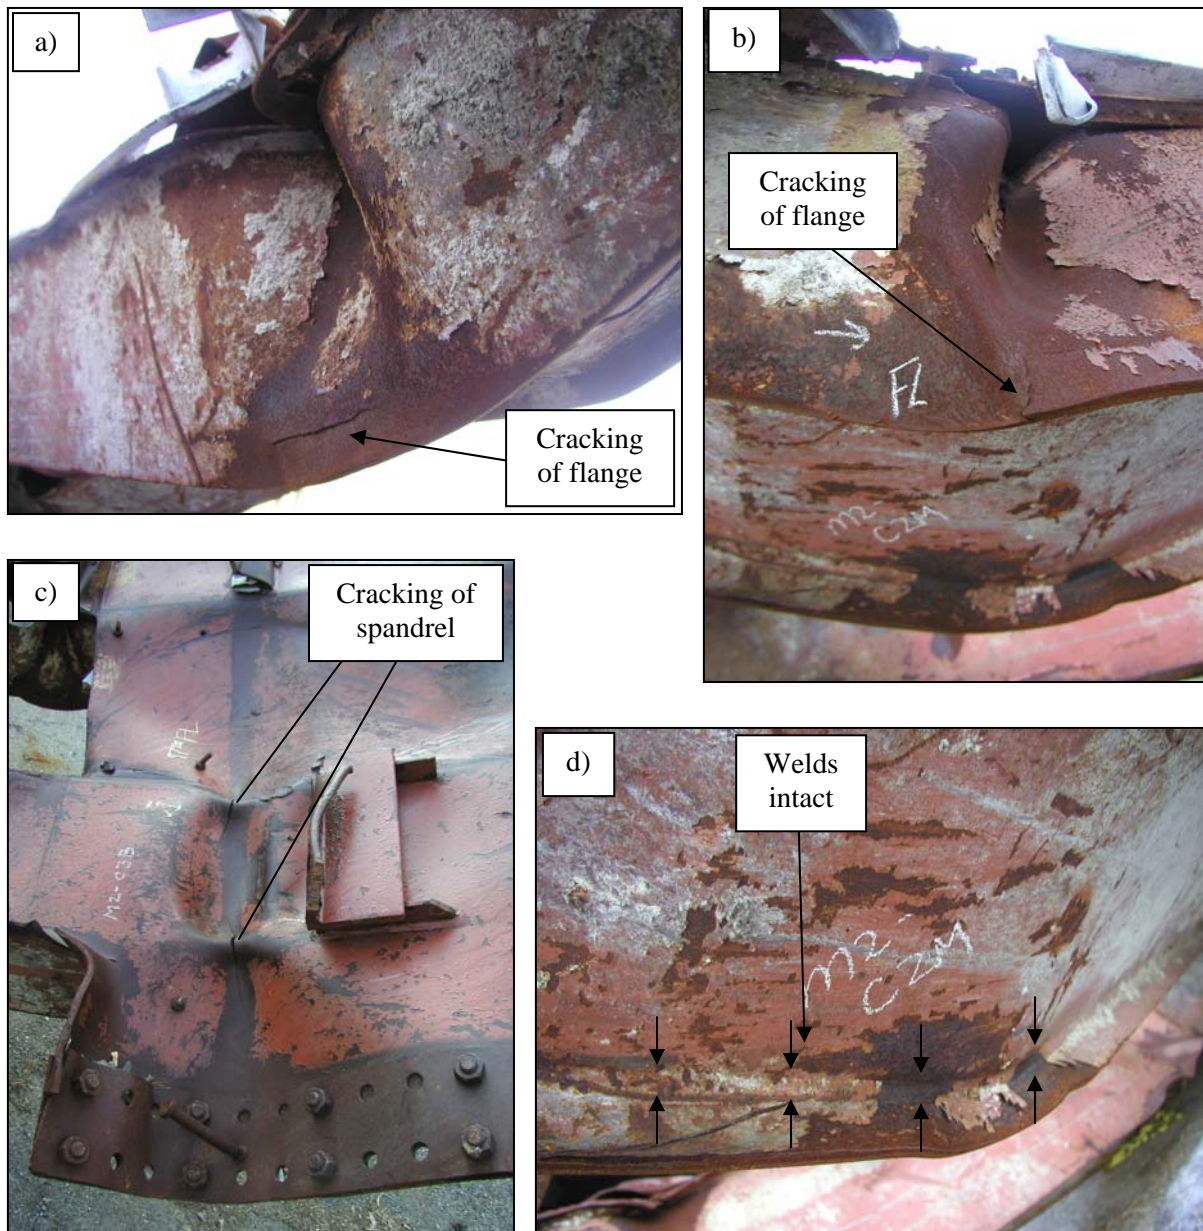
**Figure 6–23. Thinning of outer web from column 130 of panel M-2 (A130: 96-99).**  
**a) Photograph showing thinning, b) graph indicating plate thinning near fracture surface.**

Of particular interest was the fracture behavior of the plates composing the columns that were directly impacted by the airplane. Fractures of the plates in areas away from a welded joint (e.g., fracture occurring perpendicular to the rolling direction of the outer webs of panels M-30 and S-9) exhibited ductile behavior, including necking and thinning away from the fracture, despite the high-strain rates.

Conversely, fractures occurring parallel and directly next to a welded joint exhibit little or no ductile characteristics. Diminished properties of the heat affected zone in the base plate, the geometry of the joint with respect to the direction of impact, stress concentrations due to the geometry, and the orientation of the crack propagation with respect to the rolling direction of the plate are expected to contribute to the lack of ductility.

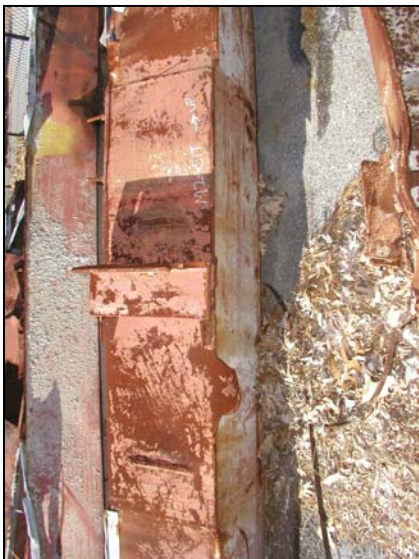
**M2-C1T**

Column 131, 99<sup>th</sup> floor

Failure mode: Type 4a, fracture of spandrel

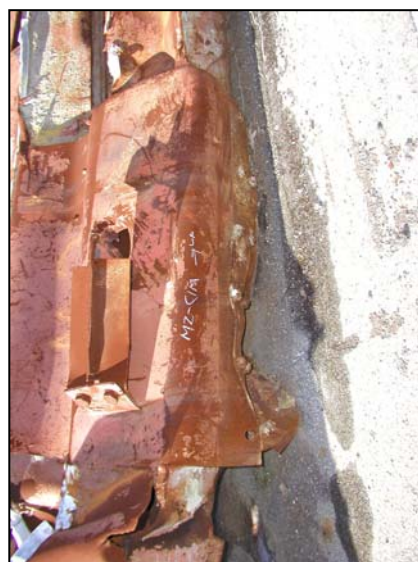
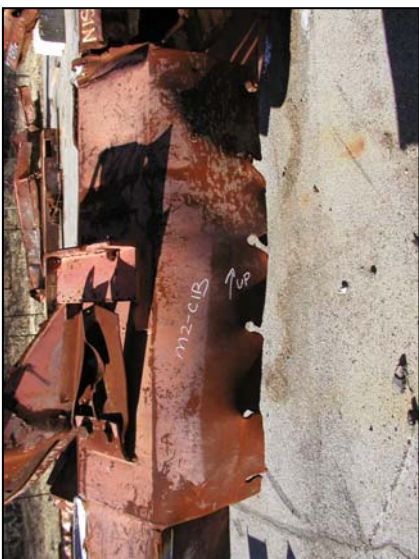
**M2-C1B**

Failure mode: Type 3, mixed mode of fracture and bolt hole tear out, portion of spandrel from S9-C3B still attached

Column 131, 97<sup>th</sup> floor

Failure mode: Type 1a, bolt hole tear out

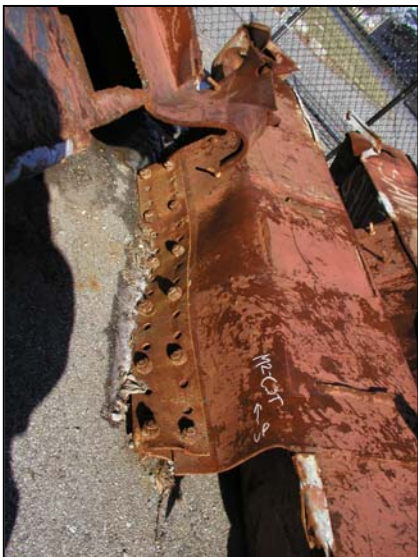
**M2-C3T**

Column 129, 99<sup>th</sup> floor

Failure mode: Type 1b, bolt hole tear out

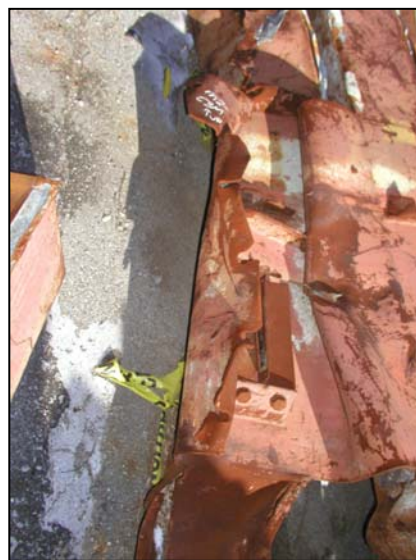
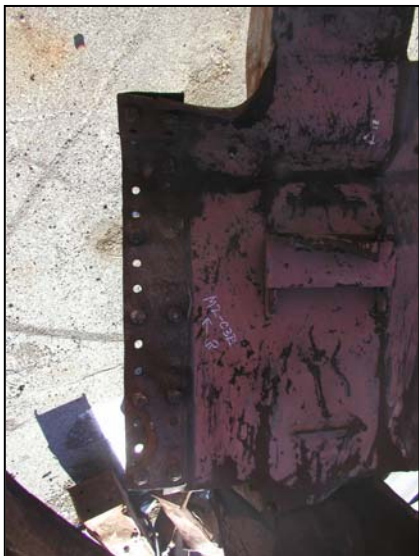
**M2-C3B**

Failure mode: Type 1a, bolt hole tear out

Column 129, 97<sup>th</sup> floor

Failure mode: Type 1b, bolt hole tear out

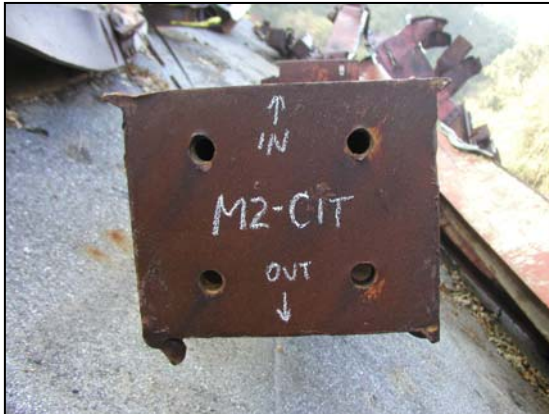
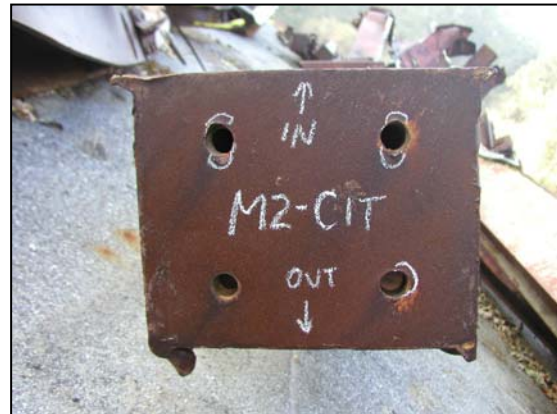
**M2-C1T**  
**WTC1**  
**Col 131**  
**F1 99**

**Figure 6–26. Photographs of recovered end plate connections from sample M-2 (A127: 97-100). Both ends of column 131 had bolt failure that resulted in deformation of the bolt holes in the end plates.**

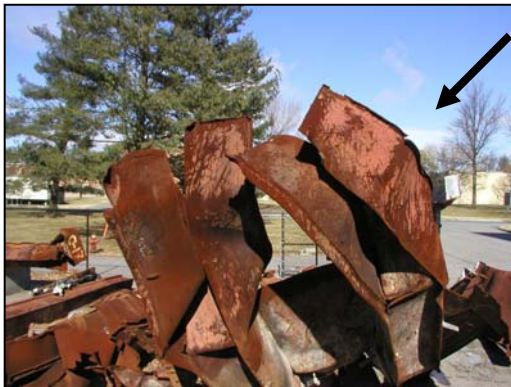
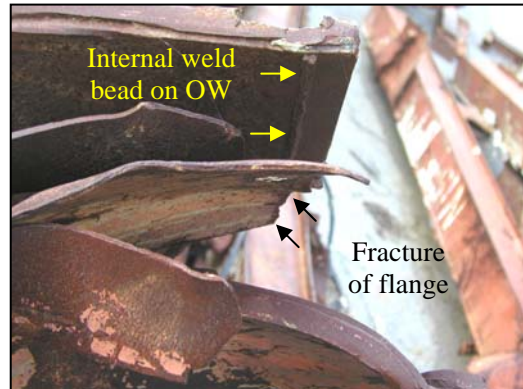
M2-C2B  
WTC1  
Col 130  
F1 96

The state of the recovered bottom portion of columns 129 and 130 was nearly identical to the condition after the impact for panel M-2 (A130: 96-99). Both end plates were ripped completely out of the column, Fig. 6–26. Failure was a mixture of fracture in the base plates (portion of the flange/web still attached to the end plate) and clean separation of the end plate from the flange/web (complete flange/web recovered with internal weld bead visible). Bolt hole deformation for column 131 indicated that the connection was broken by bending inward of the lower column of the connection. Finally, while bolt failure was observed at the 99th floor splice of column 129, it can be noted that some separation existed between the flange plates of the column and the endplate.

**Figure 6–26. Photographs of recovered end plate connections from sample M-2 (A127: 97-100). The upper end plate experienced bolt hole failure. The bottom end plate of column 130 was ripped out upon impact of the airplane. Failure was found to be a mixture of fracture in the base plates (portion of the flange/web still attached to the end plate) and clean separation of the end plate from the flange/web (complete flange/web recovered with internal weld bead visible) (continued).**

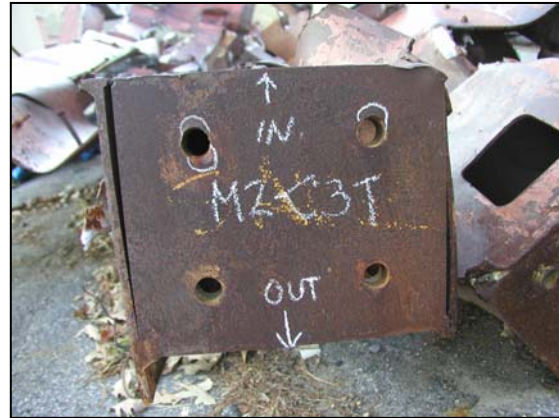
**M2-C3T**

**Figure 6–26. Photographs of recovered end plate connections from sample M-2 (A127: 97-100). The upper end plate experienced bolt hole failure. The bottom end plate of column 129 was also ripped out upon impact of the airplane. Failure was found to be a mixture of fracture in the base plates (portion of the flange/web still attached to the end plate) and clean separation of the end plate from the flange/web (complete flange/web recovered with internal weld bead visible) (continued).**

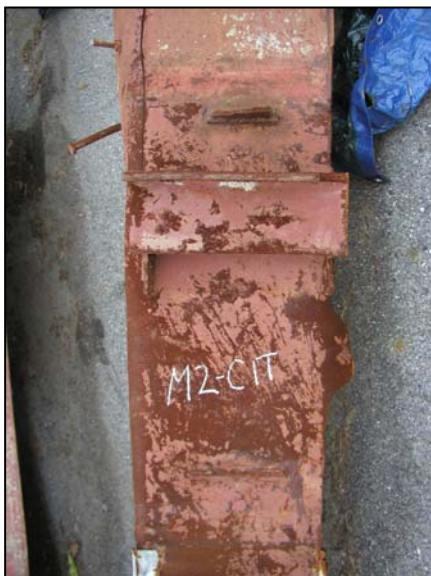
**M2-C1T (Co 131, FI 99)**

Type A

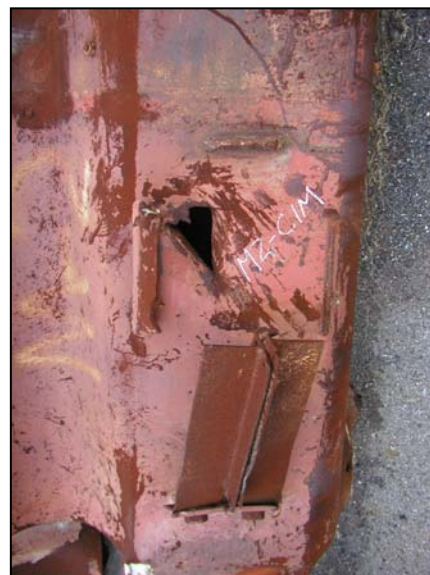
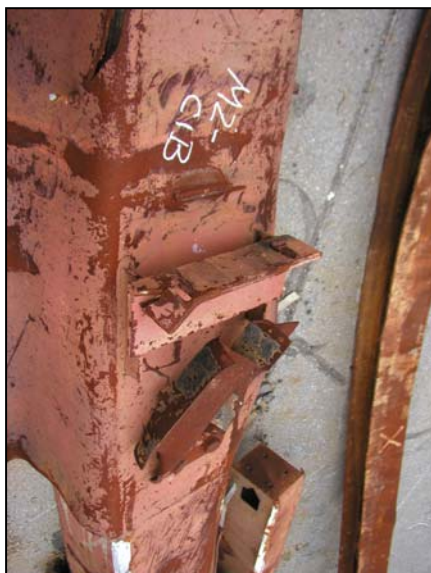
**M2-C1B (Co 131, FI 97)**

1 standoff plate remains, seat and other standoff plate ripped off at welds;

Gusset plate with damper unit intact, bent up.

Type A

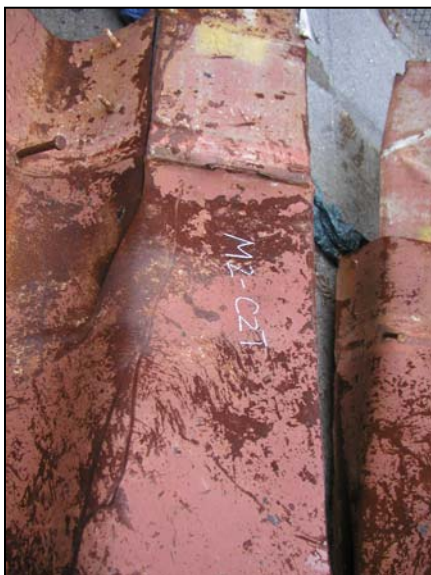
**M2-C2T (Co 130, Fl 99)**

Type C

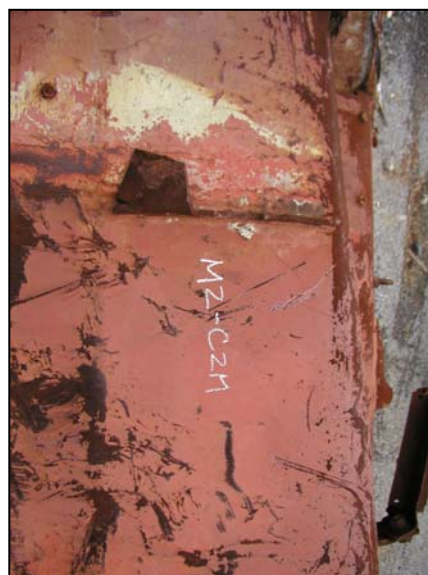
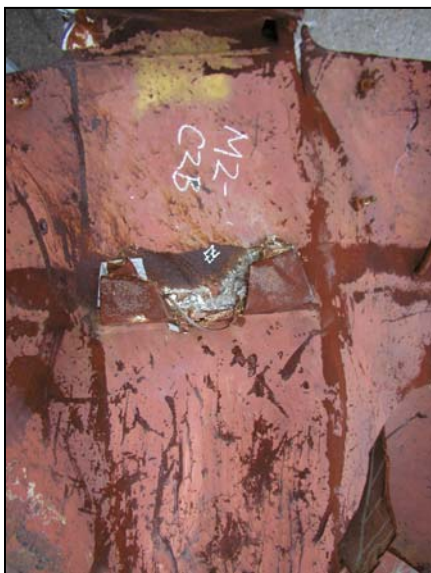
**M2-C2B (Co 130, 97)**

Portion of tab plate remains, bent up.

Type C

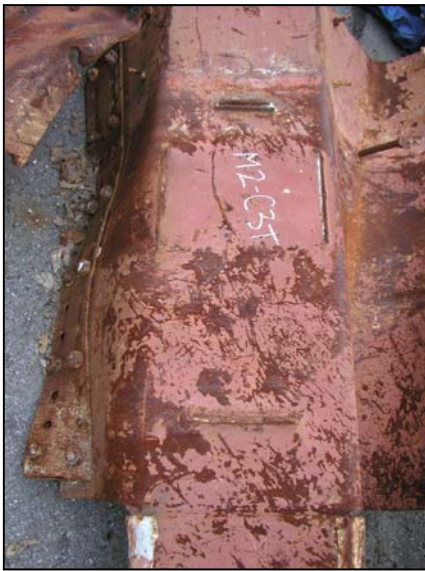
**M2-C3T (Co 129, Fl 99)**

Type A

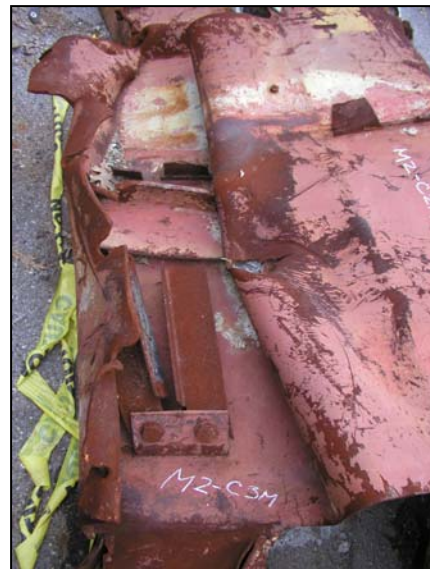
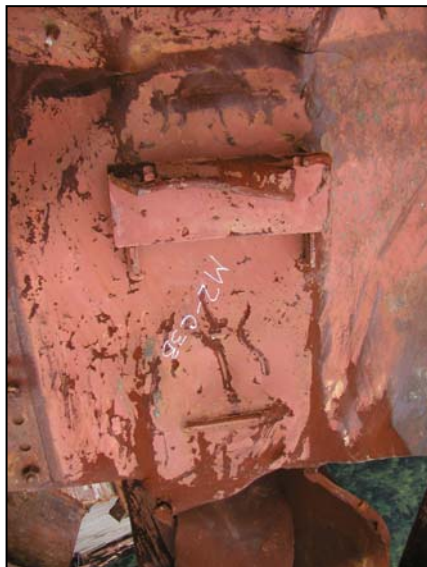
**M2-C3B (Co 129, Fl 97)**

Tab plate remains;

Seat intact, bent down, 1 bolt hole remains intact with bolt, other ripped out;

Type A

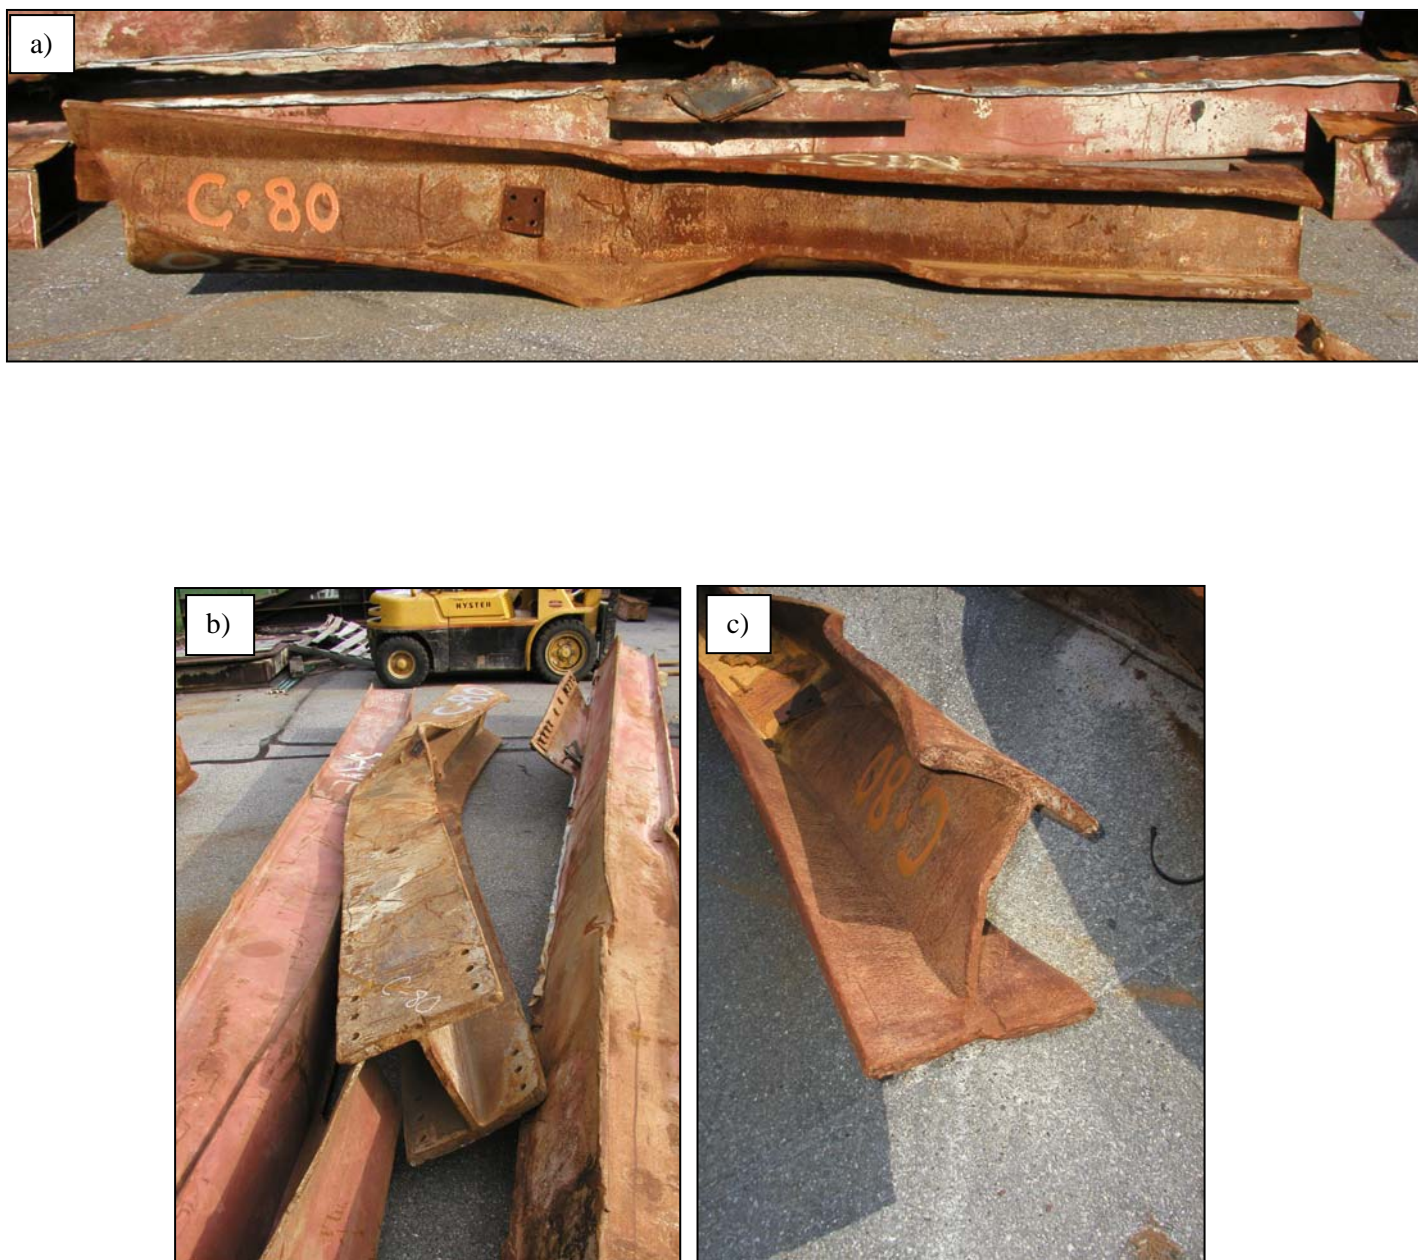
Sample C-80 (Fig. 6–30a), from WTC 1, was a 36 ksi wide-flange located in the middle of the second row of core columns along the north face. Only the lower third of the column was recovered (approximately 13 ft). The location of the column indicated that it did not sustain impact damage. Consistent with the column’s position, modeling results indicated that this column was not in the path of the aircraft debris (NIST NCSTAR 1-2). Different failure modes were observed for each end (Figs. 6–30b and 6–30c). Bolt fracture occurred at the lower portion of the column (92nd floor region), while the upper portion of the wide-flange was torn through its section (near the 93rd floor region). No visible necking (localized reduction in area) was observed in the immediate vicinity of the fracture.

**Figure 6–30. Core column C-80 (603A: 92-95). a) Overall view of recovered column, b) view of connection in the 92nd floor region, failure as a result of bolt fracture, and c) torn end of column near the 94th floor region.**

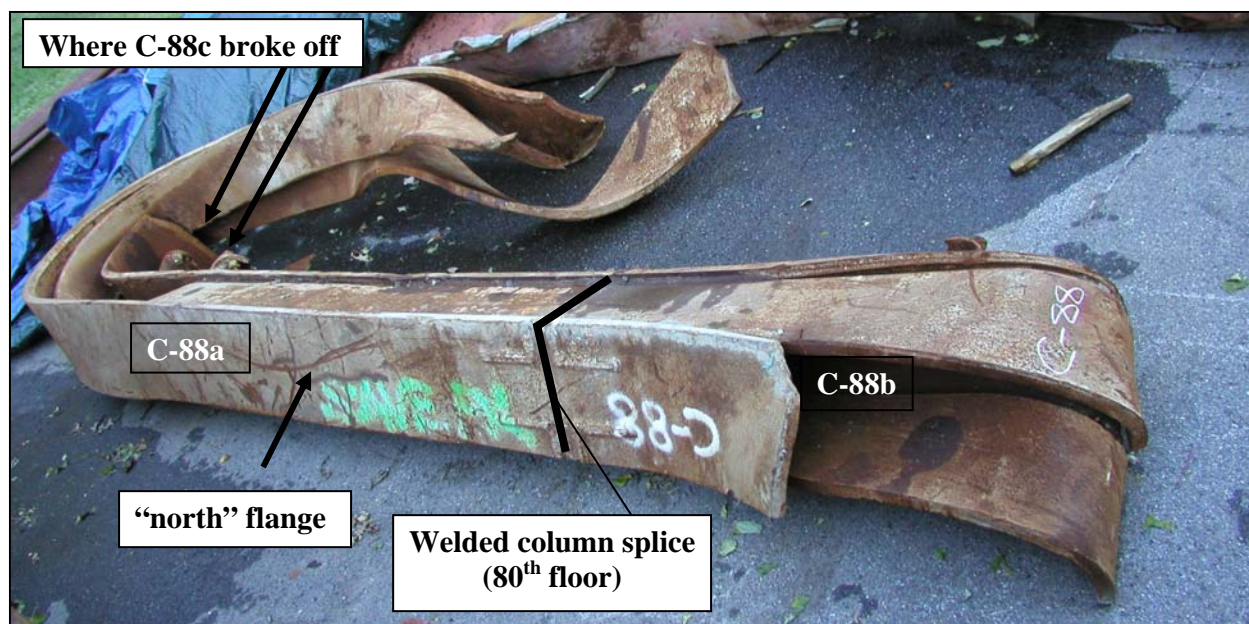
Core columns C-88a and C-88b, from WTC 2, were unique among the recovered core elements in that the columns were still connected at the welded column splice, Fig. 6–31. Both columns were 42 ksi built-up box columns with their shared splice in the 80th floor level. The lower 16 ft of C-88a was recovered (floors 80 through 82), whereas the upper 8 ft of C-88b was still attached (primarily within the 80th floor). The location of the column C-88b suggested that impact damage may have been sustained. Both webs and the “south” flange were severely bent to the east and had flame cut ends, Fig. 6–32. The bends occurred just below the connector for the channel associated with the 80th floor. The “north”

**Figure 6–31. Overall view of recovered core columns C-88a (801B: 80-83) and C-88b (801B: 77-80).**

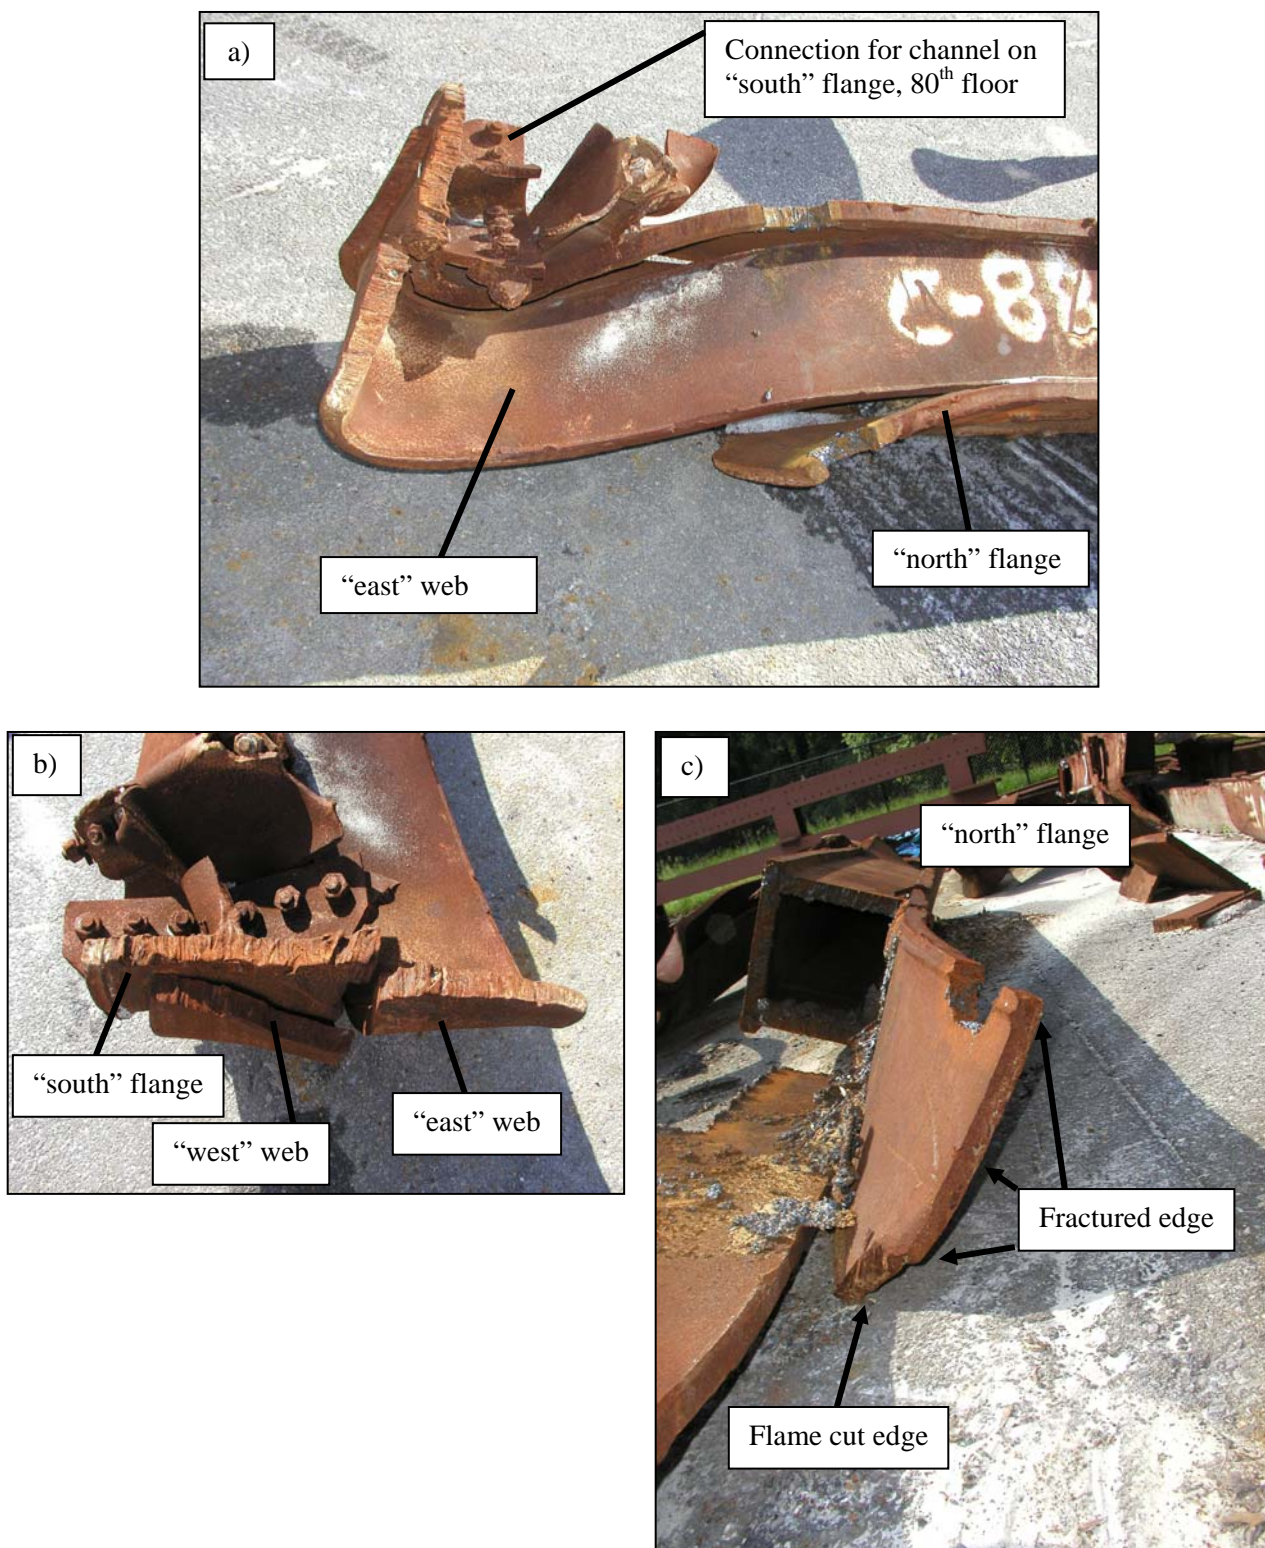
**Figure 6–32. Damage associated with core column C-88b (801B: 77-80). a) Overall view of failed end, b) bottoms of "south" flange and both webs bent towards the east just below the 80th floor level, ends were flame cut, and c) "north" flange bent towards the north, majority of plate was fractured with some flame cutting.**

flange had a less significant bend toward the north, with approximately 80 percent of the failed end of the plate as a fracture. There was no visible necking of the plate in the area of failure, with the remaining portion of the plate having been flame cut during the recovery effort. This flange was fractured roughly 2 ft below the splice in the 80th floor level. The fracture surfaces were too corroded for analysis. It was believed that the damage of the south flange and the two webs occurred during collapse of the building as the direction of bending was not consistent with the travel of the airplane. However, the damage to the north flange may have been a result of impact damage, as the severity and location of the plate failure was different from the other three plates of the column, and the direction of the bend was consistent with the travel of the airplane. The baseline analysis of the damage model indicated that this core column was not damaged as a result of the impact (NIST NCSTAR 1-2). However, another analysis with parameters set to increase the amount of damage indicated that impact damage was sustained. Core column C-88a did not sustain impact damage as (1) the damage (81st floor level) was above the floors of impact in this region (79th floor level), (2) the columns were bent downward indicating overloading of the column from above, and (3) the bending direction of the plates was opposite to the direction of the travel of the plane. This is also consistent with the modeling results (NIST NCSTAR 1-2).

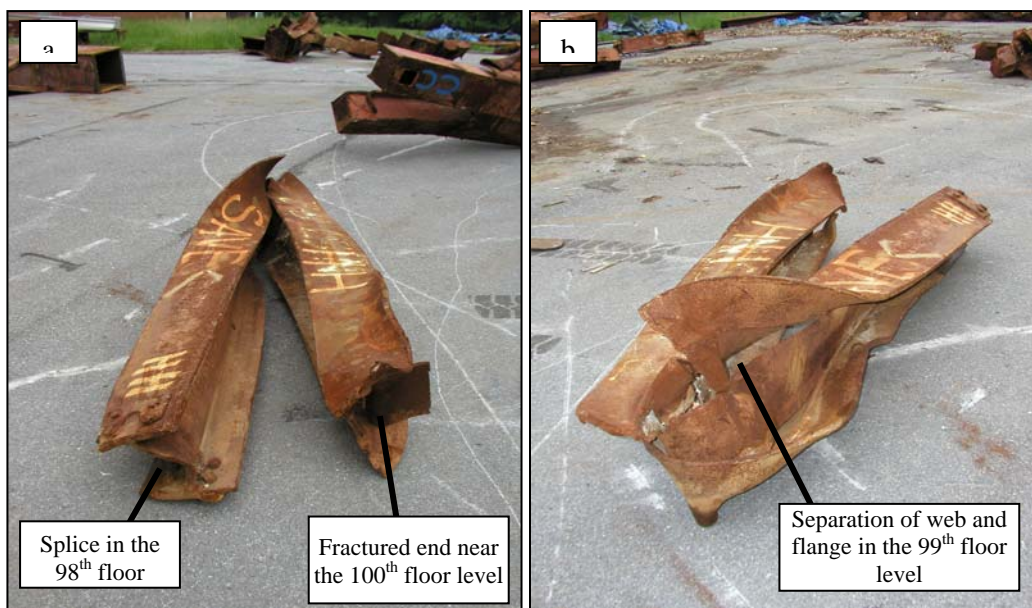
Aside from the three columns discussed above, only one other core column was recovered from within the fire region. Sample HH from WTC 1, Fig. 6–33, was a 42 ksi wide-flange positioned near the middle of the second row of core columns along the north face. The bottom half of the column was recovered (approximately 16 ft). The location of the column was such that damage could not have occurred during the impact. This was corroborated by the modeling results that indicated the core column was not hit during the impact (NIST NCSTAR 1-2). The failure mode of each end was different (Fig. 6–33a). Fracture of the plates used in the bolted connection occurred at the lower portion of the column (98th floor region), while the upper portion was torn through the material (100th floor region). Additionally, the sample was nearly bent in half (99th floor region), with complete fracture of one flange. Figure 6–33b shows that the flanges have become separated from the web in the region of the bend.

**Figure 6–33. Core column HH (605A: 98-101). a) Fracture at both ends and b) separation between flange and web in the 99th floor region.**

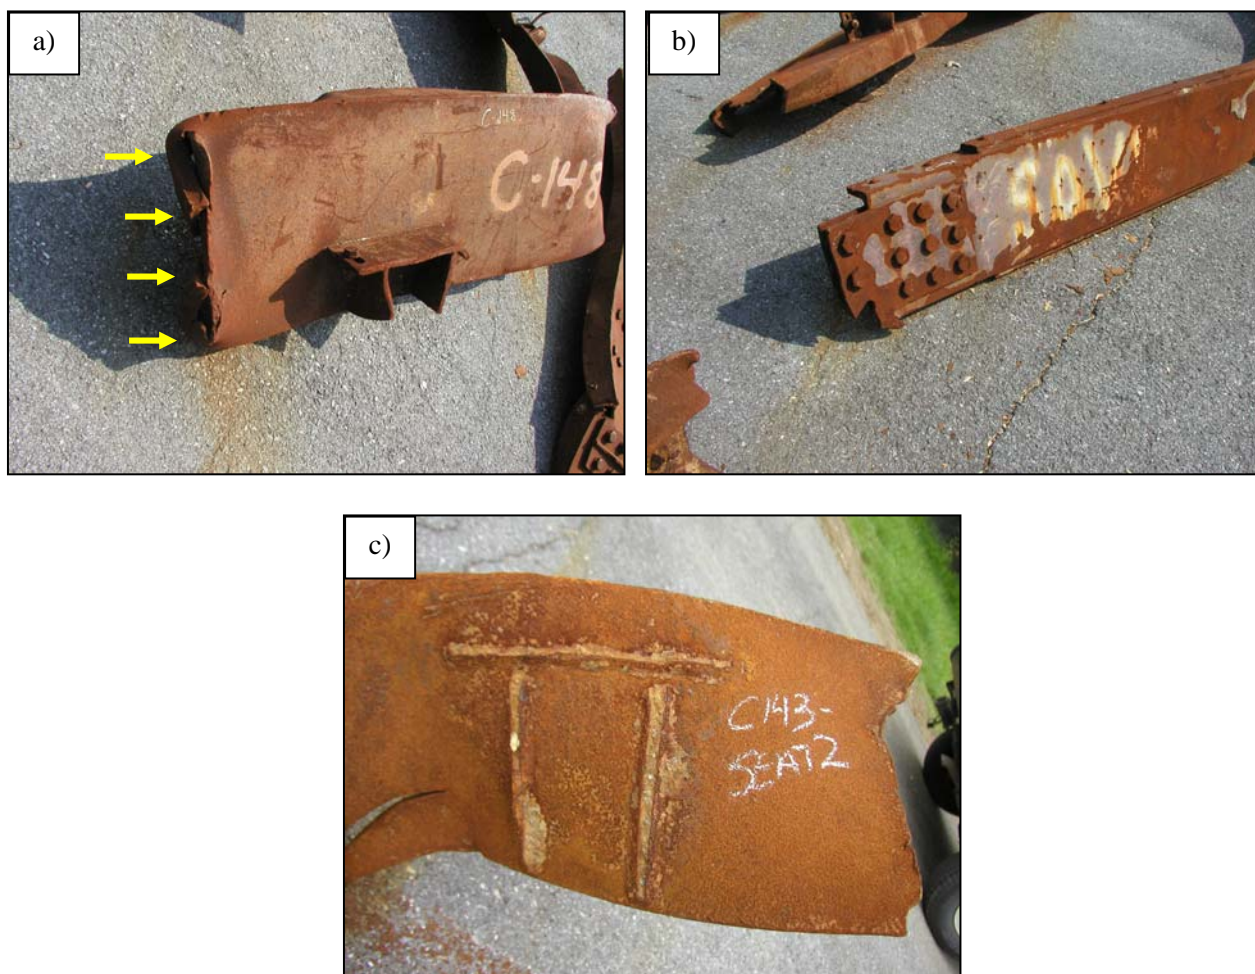
An analysis was conducted to evaluate the failure modes of the recovered channel material and the condition of the core truss seats. Of the 24 channels used to support the floor trusses, half failed at both ends within the channel itself, Fig. 6–34a, while the others failed at one or both of the end connectors, Fig. 6–34b. Twenty-one pieces of channel had seats or remnants of seats attached. Over 90 percent of the seats (31 total) were still intact with the majority of these somewhat deformed. Only two seats had been ripped completely from the channel at the welded joint between the seat and the channel, as shown in Fig. 6–34c. Half of the retained seats were observed to have both bolt holes still intact, while the other half had at least one bolt hole ripped out.

**Figure 6–34. Failure modes of core channels. a) Fracture through channel as indicated by arrows, b) failure associated with end connector, and c) seat ripped off at welded connection to channel.**

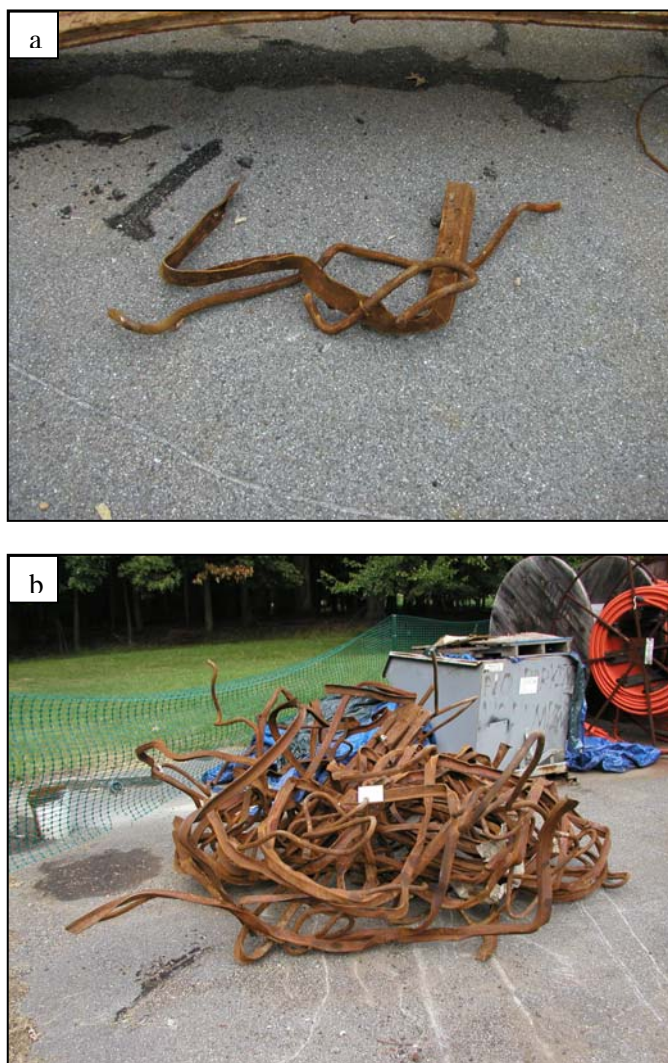
Samples received at NIST were either small sections (less than 3 ft to 4 ft in length) of chord and rod material (Fig. 6–35a) or large, entangled masses in the form seen in Fig. 6–35b. According to Structural Engineers Association of New York (SEAoNY) volunteer members involved in the recovery effort, it was necessary to “ball up” any truss pieces of significant size to facilitate removal from the WTC site and subsequent handling in the recovery yards. This was necessary since the primary and bridging trusses for a given floor were welded together into huge grids. During the collapse, these lightweight floor sections were severely damaged and could not be easily removed. Thus, it is unknown when specific damage features occurred. Further, it is likely that sections of multiple trusses were “balled” together and labeled as a single unit rather than that NIST labeled samples consisting of just one pre-fabricated truss unit.

**Figure 6–35. Examples of recovered floor truss material. a) Small sections of rod and chord (sample C-53) and b) “balled-up” sections of rod and chord (C-137f).**

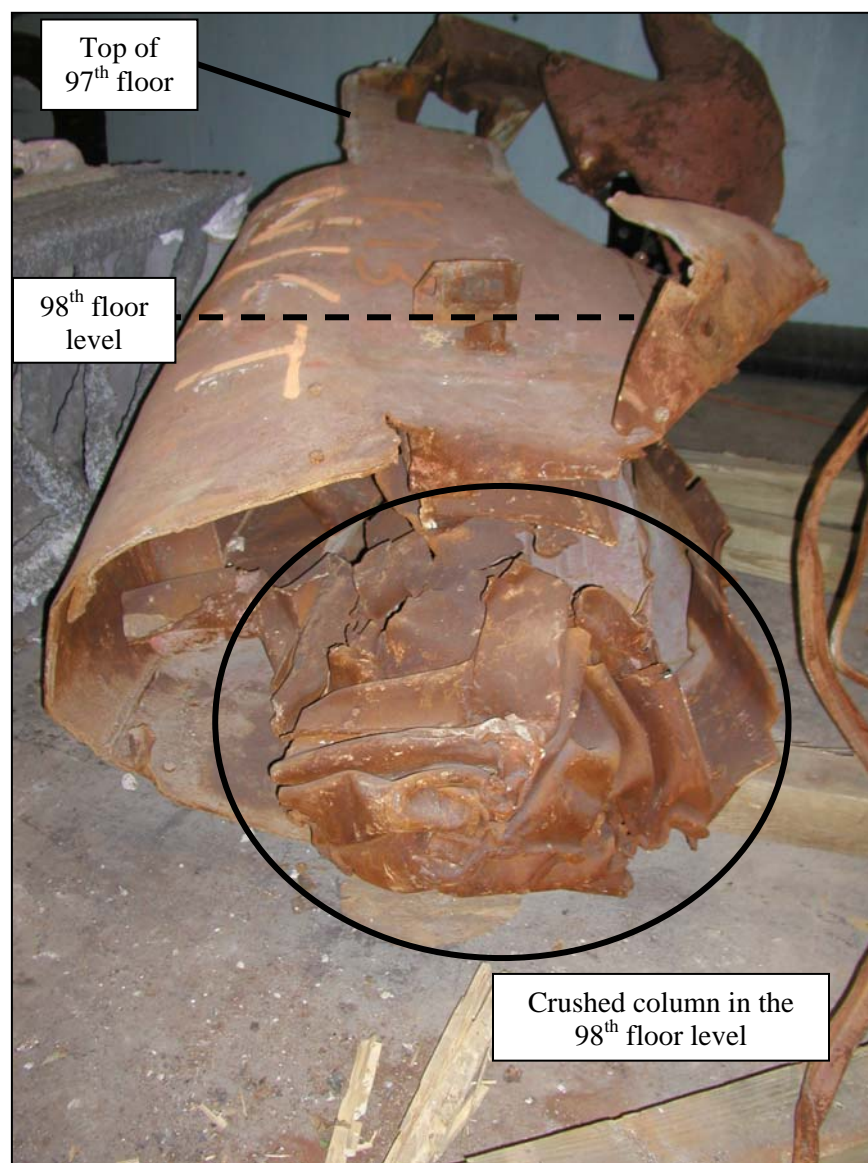
1. Panel K-1, WTC 1, column 210, flange and inner web of 98th floor region. Prior to the collapse of WTC 1, the panel was observed to have experienced varying degrees of fire exposure for a minimum of 31 cumulative minutes in this area. A unique feature of this panel is that the upper portion of the column was crushed while generally maintaining concentric axial alignment with the lower portion of the column, Fig. 6–36. This suggests that deformation occurred at the onset of collapse, while the lower portion of the column was still constrained due to the bolted splice (endplates).

**Figure 6–36. Crushed portion of column 210 in the area of the 98th floor (from sample K-1, A209: 97-100). Paint had mud cracking characteristic in this region.**
